# Embedded optical fibres for monitoring pressurization and impact of filament wound cylinders

## ABSTRACT

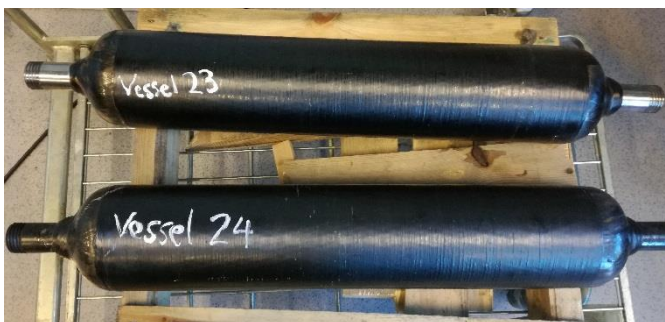
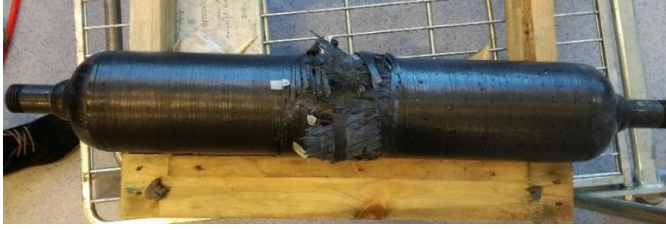
The pressure vessels for this study were made by filament winding around a hybrid mandrel, consisting of steel domes and a cylindrical polyethylene mandrel. The dimensions of the cylinders are as follows: cylindrical section length 600 mm, mandrel diameter of 140 mm and ca. 3 mm thick composite overwrap. Slightly different dome geometries were used throughout the project, which is expected to have no effect for the current study. To ensure pressure tightness, a thin polyurethane liner was injected after the filament winding was finished. Examples of typical pressure vessels before and after burst testing can be seen in Figure 1.

Figure 1: Pressure vessels before and after burst testing.

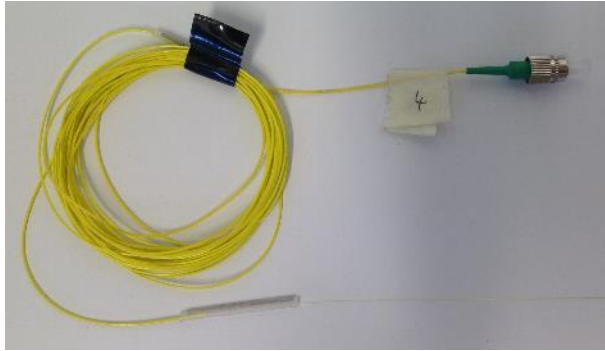
The measuring fibre, denoted as primary coated optical fibre (PCOF), was embedded into the composite layup. The PCOF was spliced to a more robust secondary coated optical fibre (SCOF), which transferred the signal after egressing to the outside of the vessel. SCOF also includes a connector port to the LUNA OBR 4600 apparatus. An overview of the OF sensor and the interrogator is shown in Figure 2. Even though optical fibres were only embedded inside the layup for this study, surface mounted optical fibres can also be used for impact detection and strain monitoring. One concern related to surface mounted OFs is the lack of natural protection from the composite layup.

(a) The sensor: SCOF with a connector and a tag, spliced to PCOF

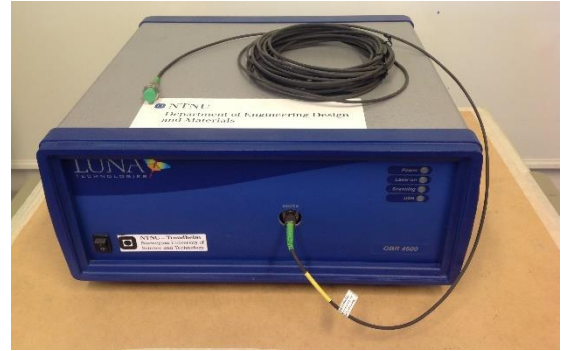
(b) The interrogator apparatus, LUNA OBR 4600

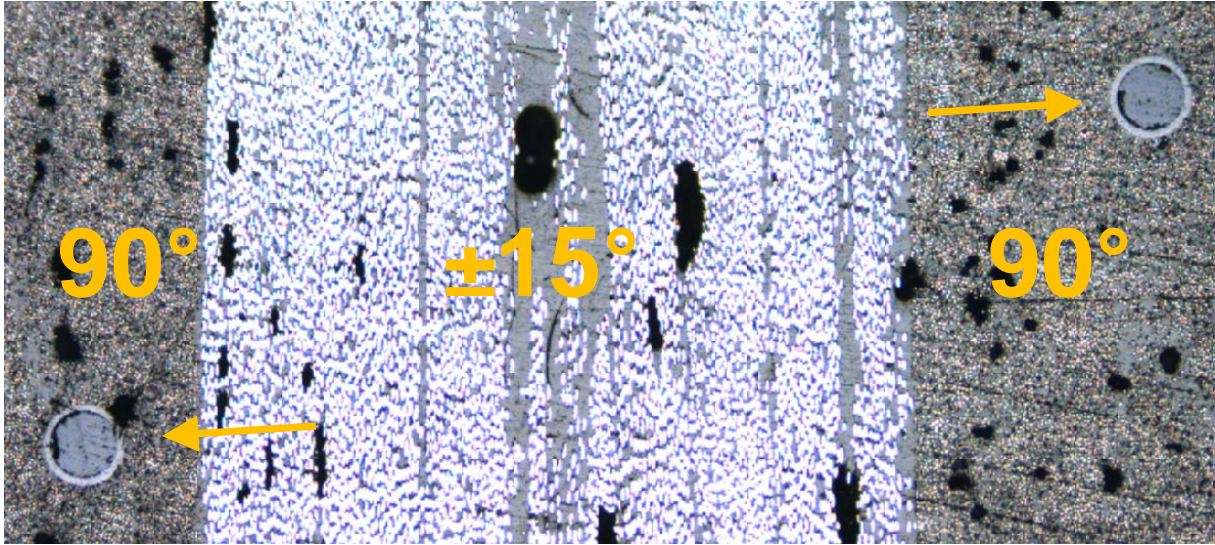
*Figure 3: Optical fibres embedded between the hoop layers of filament wound pressure vessels. Arrows point to the optical fibres at two depths in the composite overwrap.*

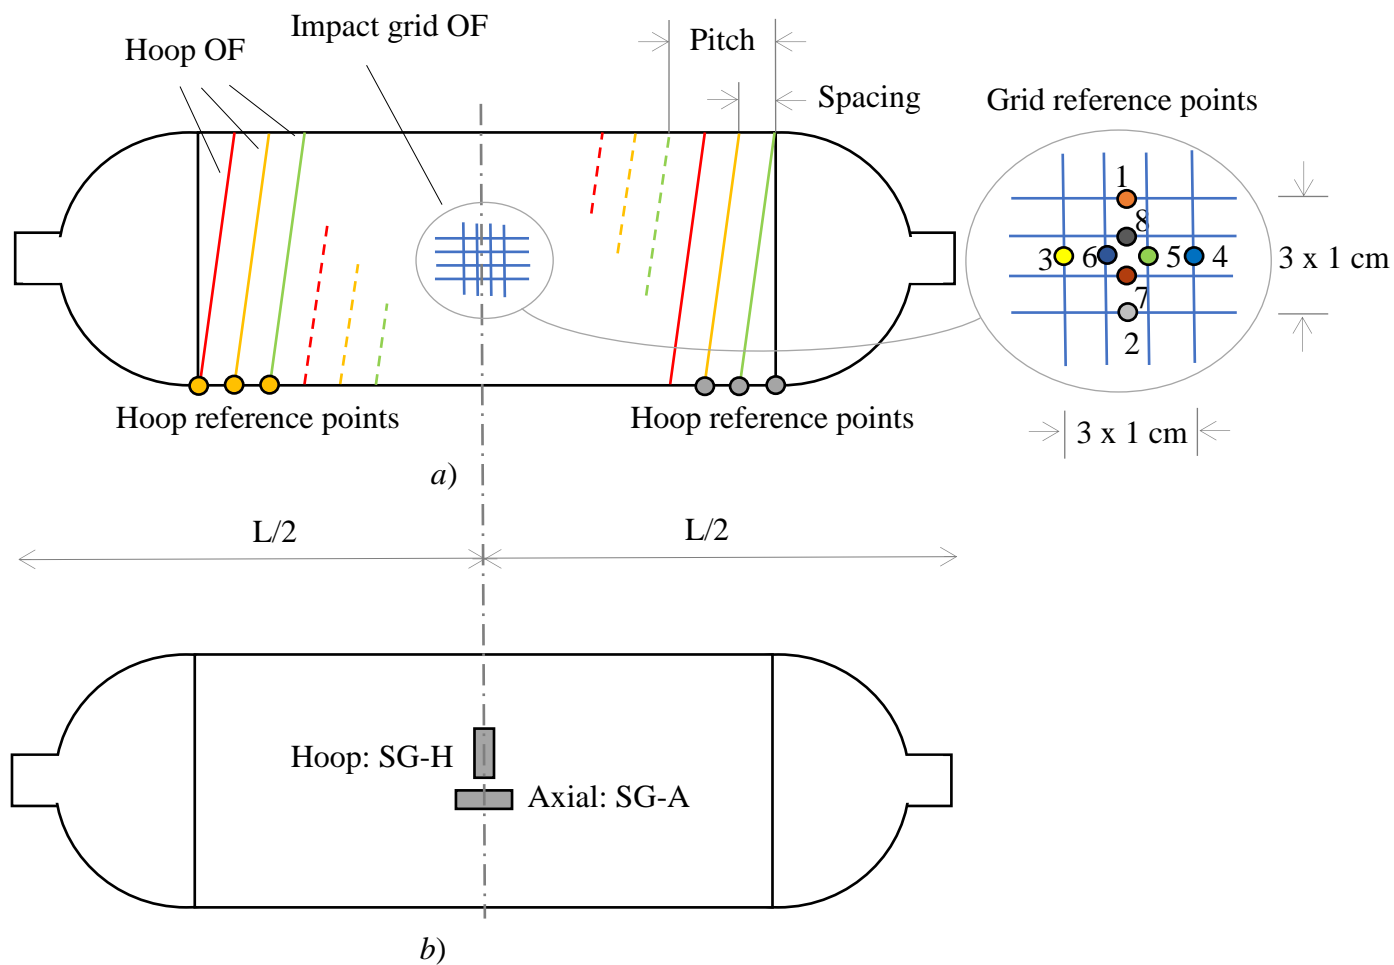
Two different optical fibre configurations were utilized, as shown in Figure 4. The first, an impact grid, consists of one optical fibre forming two sub-grids inside a  $3 \times 3 \text{ cm}^2$  region. The fibre is guided through two concentric squares with  $1 \times 1 \text{ cm}^2$  and  $3 \times 3 \text{ cm}^2$  sizes. The grid positioning with reference locations is shown in Figure 4(a) and snapshots of the actual embedding of grid OFs in Figure 5. The second main fibre configuration is called a hoop placement where the optical fibre is laid down on a spiral pattern, with a pitch of either 20 or 30 mm. The hoop optical fibre configuration is also shown in Figure 4(a) and Figure 5. The number of embedded optical fibres differs between the pressure vessels, as reported in Table 1. For vessels 1 to 3, there was one impact grid and three hoop optical fibres for both intralayers. This configuration is shown in Figure 4(a). The hoop fibres had a pitch of 30 mm and offsets of 10 mm relative to each other, meaning that the fibres cover the entire cylindrical section with a spacing of 10 mm. In vessels 8 to 10 there were no impact grids, only two hoop fibres in both intralayers. The hoop fibres for these vessels had a pitch of 20 mm and an offset of 10 mm to get the same 10 mm spacing as for the first vessels. Using several independent fibres to cover the cylinder surface increases the survival yield for optical fibres, considering production and the impact event. The length of the OFs inside the vessel, from reference to reference, was approximately 9 m for Vessels 1 to 3, and approximately 13.5 m for Vessels 8 to 10.

Figure 4: The pressure vessel instrumentation: a) OF positions and reference point locations b) SG positions

In addition to embedded OFs, surface mounted strain gauges (SGs) were used for monitoring the vessels during pressurization. The SGs by Tokyo Sokki Kenkyujo, types FLA-5-11-1L and FLA-6-11-3L, had 6 mm and 5 mm gauge lengths, respectively. Both axial and hoop SGs were mounted in the centre of the cylinder, as shown in Figure 4(b).

When analysing an impact with the OF grid (see Figure 4), the impact location was positioned to the centre of the grid, made up of two concentric squares. The strain readings from a 60 J impact are shown in Figure 15. Points 1 to 4, the midpoints of the larger square, register much lower absolute strain values than points 5 to 8, the midpoints of the smaller square (see Figure

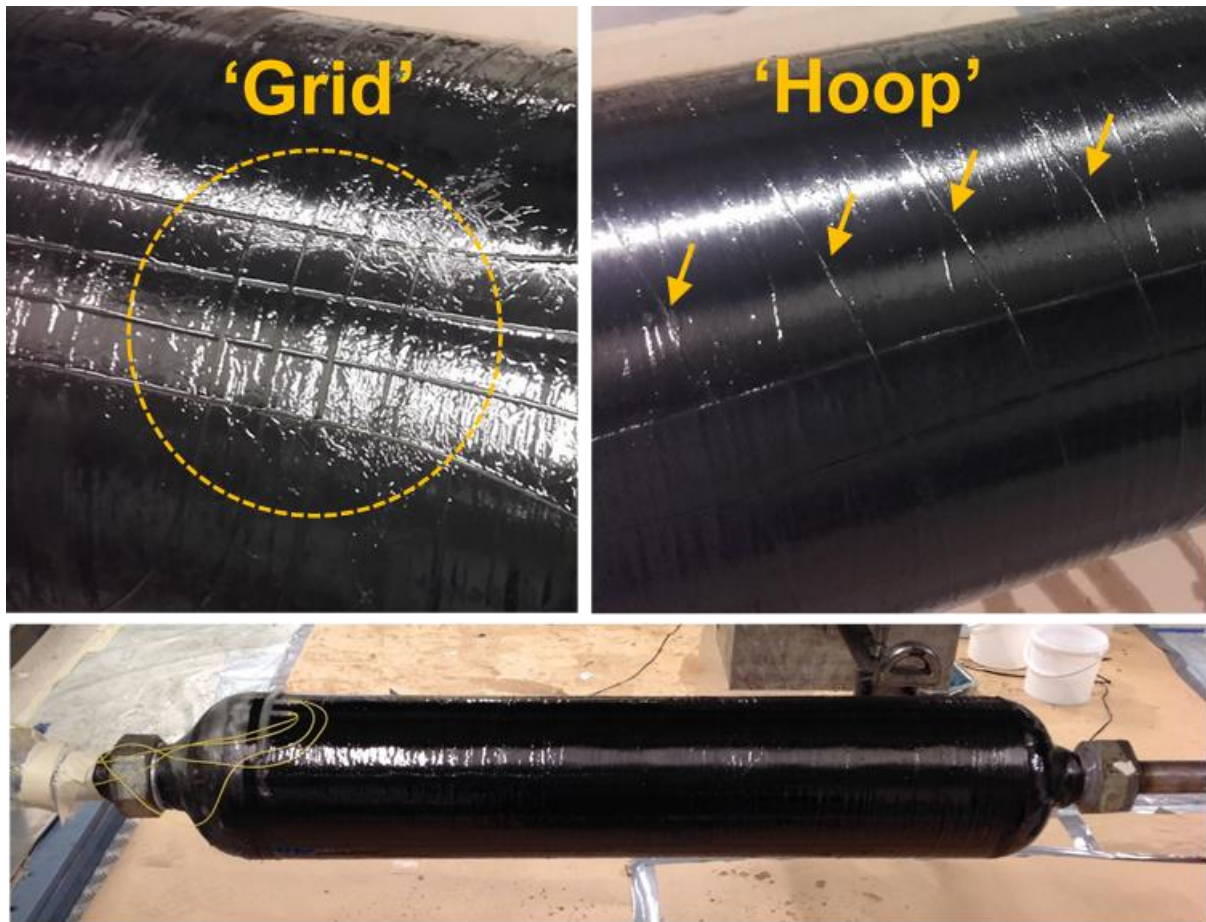
The OBR scans provide longitudinal strain values as a function of position along the optical fibre. In order to map the position of the strain signal to the actual position on the vessel, reference positions were established, as seen in Figure 4(a). This was done by applying a small force directly on an OF after it had been placed on the vessel, and simultaneously running a scan to record the spatial position of the signal. The referencing was carried out in the middle of the filament winding process. Both start and ending points for the optical hoop fibres were recorded. For the impact grids, the reference positions were recorded at the midpoints of both concentric squares. After the fibres were positioned on the vessel, and the reference positions established, the winding was continued. The SCOFs were secured to the vessel after the layup was completed, as seen in Figure 5.

*Figure 5: Placement of embedded OFs during manufacturing and a finished pressure vessel.*

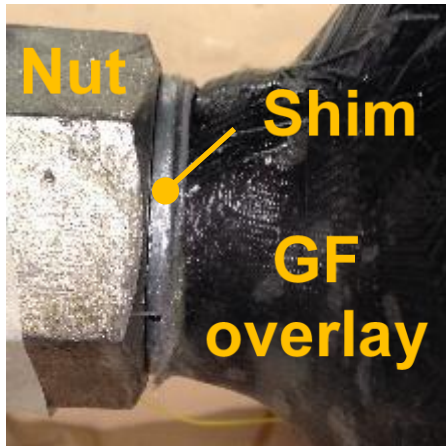
The first batch of pressure vessels had a low OF survival rate (ca. 50 %). Most of the fibres failed at the point where they egressed from the laminate, at the neck of the pressure vessel. The neck was connected to the fixture of the winding machine with a large nut. The fibres egressed from the composite in the neck region and got damaged when the nut was unwound after filament winding. The solution was to put a shim between the nut and the composite, as seen in Figure 6. In addition, when the winding was finished, a thin layer of glass fibre was laid over the dome to protect the entire egress region (Figures 5 and 6). The shim was covered with a thin layer of resin, to prevent it from moving when the nut was removed. By utilizing this technique, the survival rate of the OFs increased from approximately 50 % to almost 100 %.

*Figure 6: Protective shim at the neck*

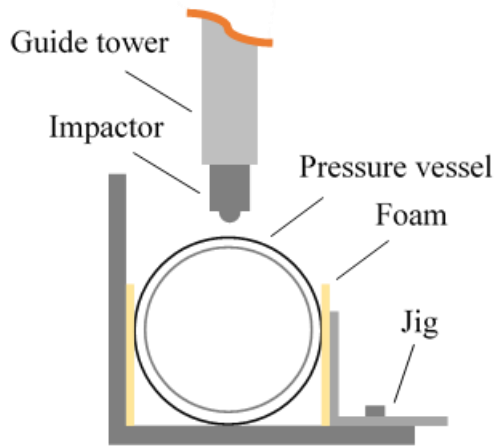
The impact itself and post-impact inspection with optical fibres were performed on non-pressurized vessels. The impacts were carried out using a drop tower assembly. The impact setup, shown in Figure 7, consists of a jig, a guide tower and a steel  $\varnothing = 20$  mm hemispherical impactor. The jig had foam padding on vertically supported sides. The vessel was lightly clamped between two vertical profiles, along the cylindrical length. Impacts were usually performed before the burst tests. Only in the cases when healthy pressure vessels were leaking, the impact testing was performed post-pressurization to gather more data from optical fibre networks. All of the pressure vessels and impacts presented in this study are summarized in Table 1.

Figure 7: The impact setup

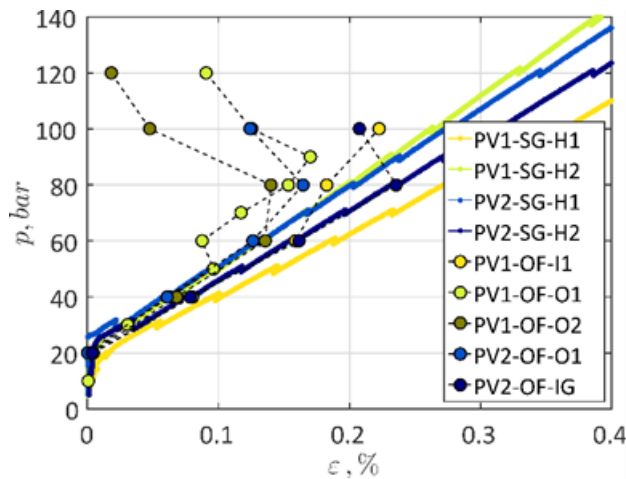
Figure 8: Pressure vs strain in pressure vessels 1 and 2 (Mode 3).

During pressurization up to 50 bar, a good correlation between SGs and OF strains was observed. However, the hoop OFs struggled to give meaningful results when the pressure exceeded 50-60 bar, as seen in Figure 8. The strains in the OF grid agreed with the strain gauges

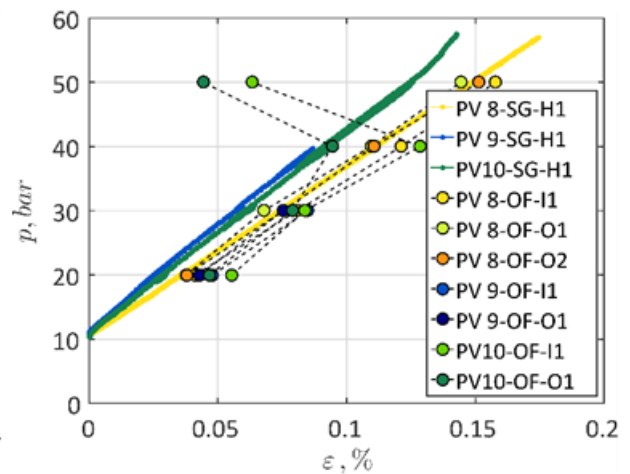
Figure 9: Pressure vs strain in vessels 8, 9, and 10 (Mode 3). Kept separate from 1 and 2 due to vessels failing burst test and reaching low max.

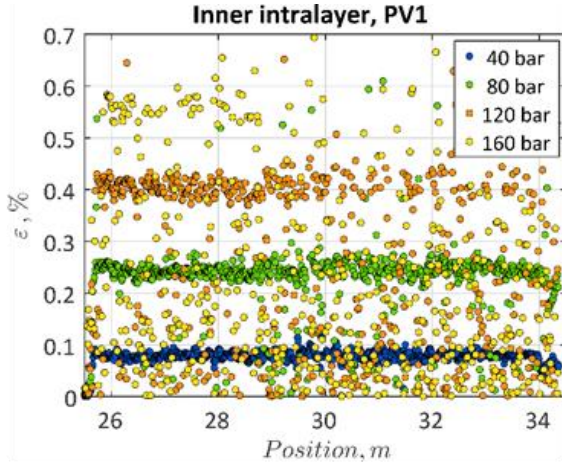
During the validation measurements (OF comparison to other OFs and strain gauges), the noise in the strain readings appeared when the pressure exceeded ca. 50 bar. At this pressure level matrix cracks started to appear, and due to the OFs not being exactly parallel with the carbon fibres, the matrix cracks would occasionally cross the OFs at some locations. These matrix cracks will cause high local strains, which disrupt the signal. The OFs were obviously no longer able to track the increasing strains when the pressure reached 100 bar, as seen in Figures 10 and 11. This manifested as measuring falling average strains, due to outliers, even though in reality the strains were increasing. An increasing number of data points drop out of the average region, which drags down the average strains. Above 100 bar, the strain results mostly displayed noise, rendering the OFs useless for strain analysis. As previously mentioned, the grid fibres were able to give realistic strain readings at slightly higher pressures compared to hoop OFs. Grid fibres travel in the axial direction to the centre of the vessel, and proceed to run through several loops there, meaning that they were likely crossing many more matrix cracks along the way.

Figure 10: Noise problems above 100 bar in Vessel 1 (Mode 3)

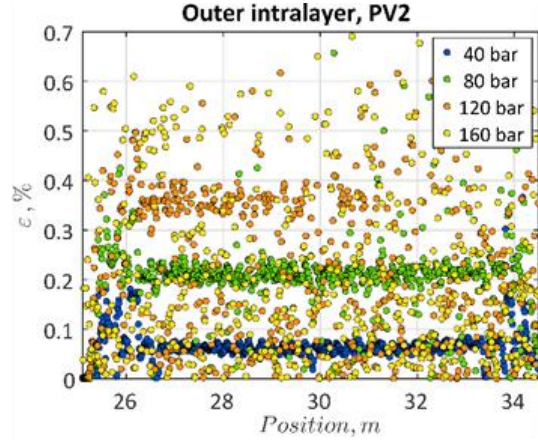
Figure 11: Noise problems above 100 bar in Vessel 2 (Mode 3)

where  $\Delta\varepsilon_{P_0 \rightarrow P_n}(s)$  is the strain increase from a base pressure level  $P_0$  to a given pressure level  $P_n$  in position  $s$  along the optical fibre, and  $\Delta\varepsilon_{P_{i-1} \rightarrow P_i}(s)$  is the change in strain between the intermediate pressure levels at position  $s$ . Successful results of implementing the algorithm can be seen in Figures 12 and 13. Compared to the constant reference, the running reference of Eq. (1) provides realistic strain measurements to very high pressure values, and gives comparable results to the strain gauges. The difference between the two post-processing methods is clear when comparing Figure 8 to Figure 12. With the running reference method the OFs follow the SGs almost all the way to 300 bar, approximately 90% of the burst pressure for Vessel 1 and 2. Vessel 2 was subjected to an impact before pressurization, and the repercussions of this become visible at elevated pressures, which is also seen in Figure 13. At 160 bar the fibre appears to be cut off at the middle of the cylinder, which is where the impactor struck. When comparing Figure 13 to the constant ref. method for the same cylinder in Figure 11, the signal has less noise.

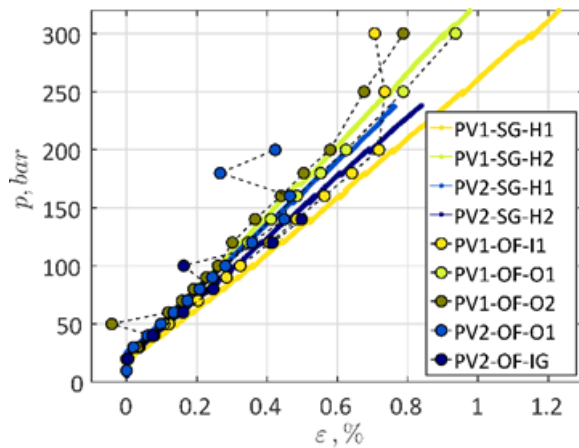
Figure 12: Pressure vs strains in Vessel 1 and 2, running ref. method (Mode 3)

The running reference method clearly improves strain readings at higher pressures, however, there are still signs of noise when measuring strains close to burst pressure levels, or measuring around a damaged area. The presence of noise can in those cases be interpreted as signs of damage, and highlights the presence of matrix cracks or other causes for localized abrupt strains. Noise may also be caused by overly large steps for strain measurements taken at higher pressures (50 bar steps for pressures exceeding 200 bar), which increases the possibility for zero correlation between the calculated and reference states, as discussed earlier.

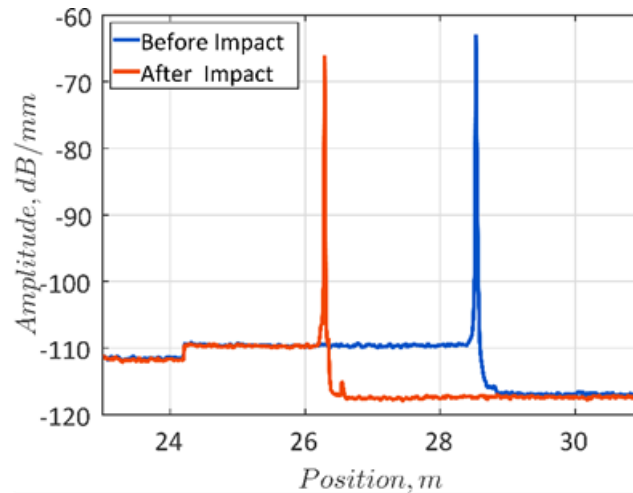
The simplest impact detection method is based on the fibre's ability to transfer a signal. A damage large enough to sever or significantly damage the fibre is an indicator of damage to the vessel. Figure 14 shows how the amplitude peak from the end of the fibre shifts to the location where the fibre is severed by the impact. Similar experiments have been carried out by others before, e.g. Knapp and Robertson [21], however the properties of the OBR enable also to determine the location of the fracture. Both hoop and grid OFs successfully detected impacts in this way. The hoop method does not rely on knowing where the impact will take place, as the whole cylindrical region is covered by a grid of OFs. For the vessel presented in Figure 14 the severed fibre pinpoints the location of impact for a hoop optical fibre. This vessel had already been impacted and severed at a previous occasion, thus only the section of fibre between 24.2 and 28.8 m, was transmitting signal during this final impact. Typically, the optical fibres in the outer layer became severed. Impact energies varied from 20 J to 100 J, and none were able to sever fibres in the inner intralayer. On the other hand, even the lowest energy impacts could sever optical fibres in the outer layer, positioned one hoop layer deep from the surface. This finding supports the idea of embedding the sensor inside the composite, which differs from most other NDE methods[1].

Figure 14: Hoop fibre signal in Vessel 8 before and after the 20 J impact. The OF is inside the vessel between 24.2 m and 28.8 m locations, in the outer intralayer.

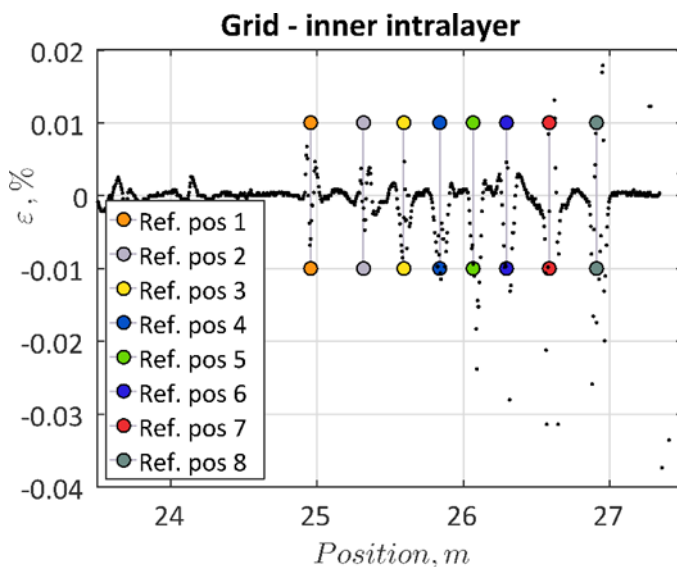
The full potential of the OBR becomes more apparent with the use of strain analysis. The strain sensing is based on comparing pre- and post-impact measurements, or investigating the changes in the strain field during pressurization. For all impact cases Mode 2 parameters were used, to keep the strain sensing resolution as high as possible without excessive noise. From measurements during the production, it was observed that the OFs detect residual strains. An impact energy high enough to cause a sufficient damage of the composite will lead to a release of these residual strains and possible inelastic deformations. This change of strain can be measured when the vessel is not pressurized. When the vessel is pressurized, strain concentrations caused by the impact damage can also be detected.

Figure 15: Strains vs reference markers in the grid, Vessel 1 (Mode 2)

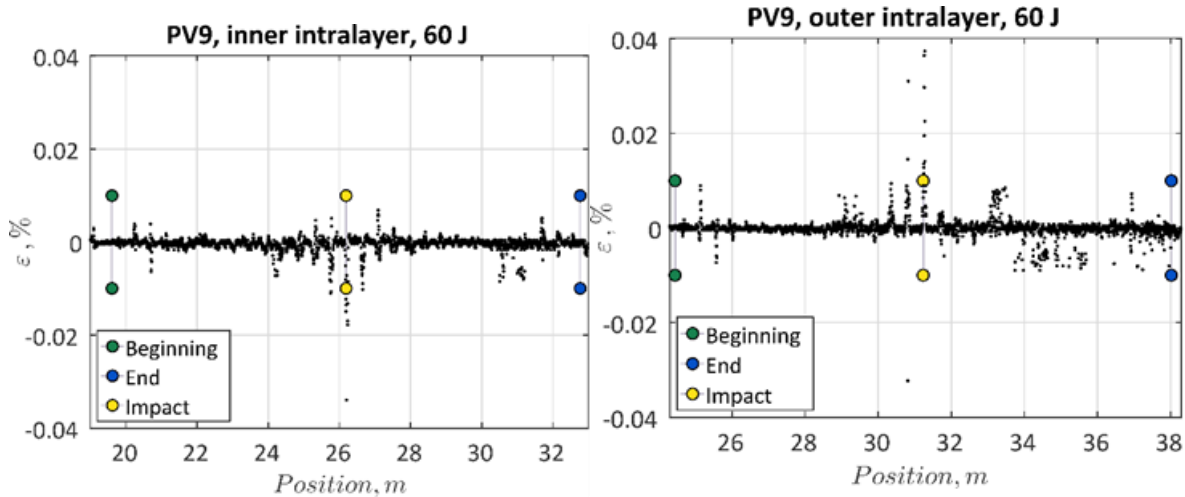
Much information can be obtained by looking just at hoop strains, and a long sequence of hoop fibres is easily installed on the vessel. A comparison of hoop fibre strain measurements can be seen in Figures 16 and 17, which highlights the difference in the residual strains in inner and outer intralayers. The continuous peaks forming around the impact location depend on the value of the residual strain being released, which should be the same if caused by a large or a small impact. However, the higher energy impacts appear to have higher strain peaks around the impact location, as well as more scatter in strain values, which extend higher than the continuous peak. The difference between the two intralayers (Figures 16 and 17), confirms that the location – depth of the OFs – is also relevant for impact detection.

Figure 16: Inner intralayer strains after impact on Vessel 9, with reference markers (Mode 2)

Figure 17: Outer intralayer strains after impact on Vessel 9, with reference markers (Mode 2)

In Figures 16 and 17 the strains are plotted against the position along the OF length. A network of OFs embedded inside the pressure vessel opens new possibilities for creating detailed visualizations of the damage area. Since the geometry of the vessel is known, the position along the fibre can be decomposed, and plotted on a surface, as seen in Figure 19.

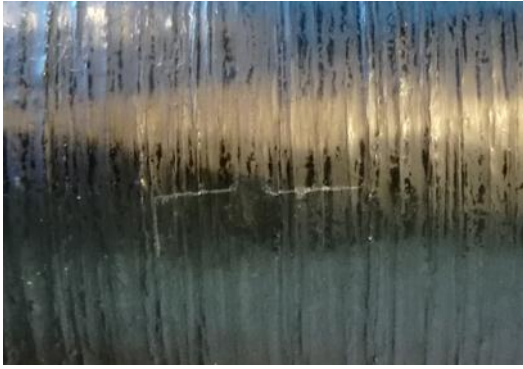
It is obvious that the impact affects a much larger area than what is observed in visual inspection. A typical severe damage on the cylinder surface is shown in Figure 18, consisting of a small imprint from direct impactor contact and fibre fractures in the outermost ply, progressing symmetrically in the axial direction [39]. The visible traces of impacts are very localized, confined to a 30-50 mm region. However, the OFs measure strain peaks from internal delaminations (releasing residual strains), which are visible over almost the entire length of the cylinder.

Figure 18: Severe impact damage on the cylinder surface

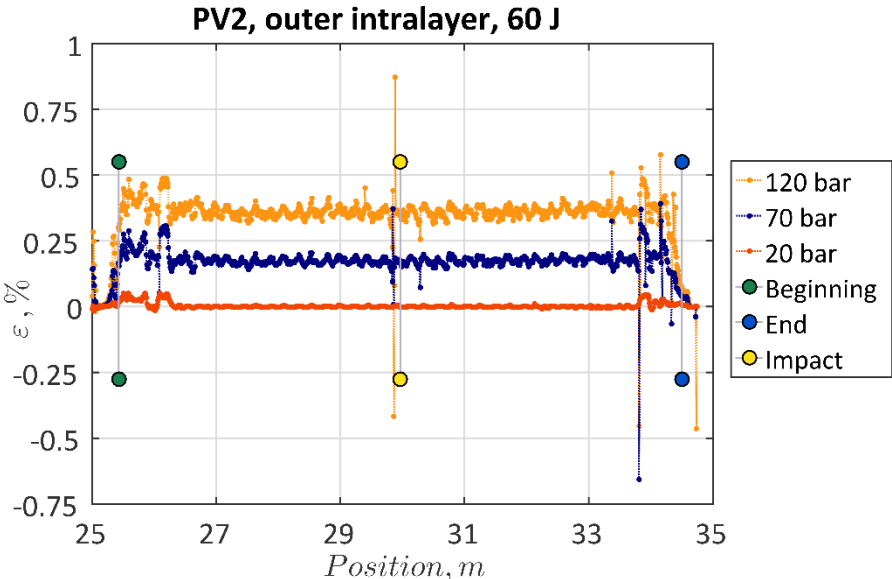
The previous detection cases were based on non-pressurized vessels. During examination of the pressurization data, evidence of damage could also be revealed by looking at the hoop optical fibres under pressurization. In Figure 20, a strain vs position plot of pressure vessel 2 is shown. The data was already presented in Figure 13, but now all measurement points are connected as a line in the plot. Results for three pressure levels are shown; 20 bar, 70 bar and 120 bar. The highlighted impact is based on the true midpoint of the vessel, where the impact was performed. For the low pressure of 20 bar, the strains are roughly constant. They show small periodic peaks over the centre of the vessel; no indication of damage is present. For the higher pressure levels, the strains around the impact region begin to deviate from the strains seen over the rest of the vessel. For the highest pressure the centre peak grows higher, indicating increasing damage. As seen in Figure 13, the fibre was severed at 160 bar.

The periodic peaks in the roughly constant regions of the strain plots, appearing at both sides of the impact, are spaced by ca. 40-50 cm. This equates to one hoop circumference, which in relation to the optical fibre pitch for PV2, translates to a distance of 30 mm on the vessel surface in the axial direction. It is a secondary effect attributed to initial ovality of the vessel, but it is outside the scope of this paper to investigate this effect in detail. The strain fluctuations in the beginning and end regions are a result of the mandrel configuration, where the steel end domes transition abruptly to a less rigid polyethylene mandrel. The strain peaks caused by impact damage can be easily identified, since they are larger than the periodic peaks and grow with increasing pressure.

Figure 20: Strains vs position along the optical fibre for three pressure levels, Vessel 2 (Mode 3).
