## Field and model tests of riprap on steep slopes exposed to overtopping

Priska H. Hiller, Leif Lia & Jochen Aberle

The comparability of large-scale field tests of dumped and placed riprap with a stone diameter of 0.37 m and corresponding model tests in a scale of 1:6.5 was investigated in terms of stability, packing density and visually observed flow pattern. The tested riprap protections were exposed to overtopping on a slope of 1:1.5 (vertical: horizontal). The results for dumped riprap revealed similarity between the field and model tests based on the critical stone-related Froude number as a measure of the stability, packing density, flow pattern and overtopping depth. The field and model tests with placed riprap showed good agreement in regard to flow pattern and overtopping depth. However, the placed riprap in the model tests was denser packed and more stable than in the field indicating laboratory effects. Placed riprap withstood up to 10 times higher unit discharges than dumped riprap, 6–8 m<sup>2</sup>s<sup>-1</sup> in the field tests.

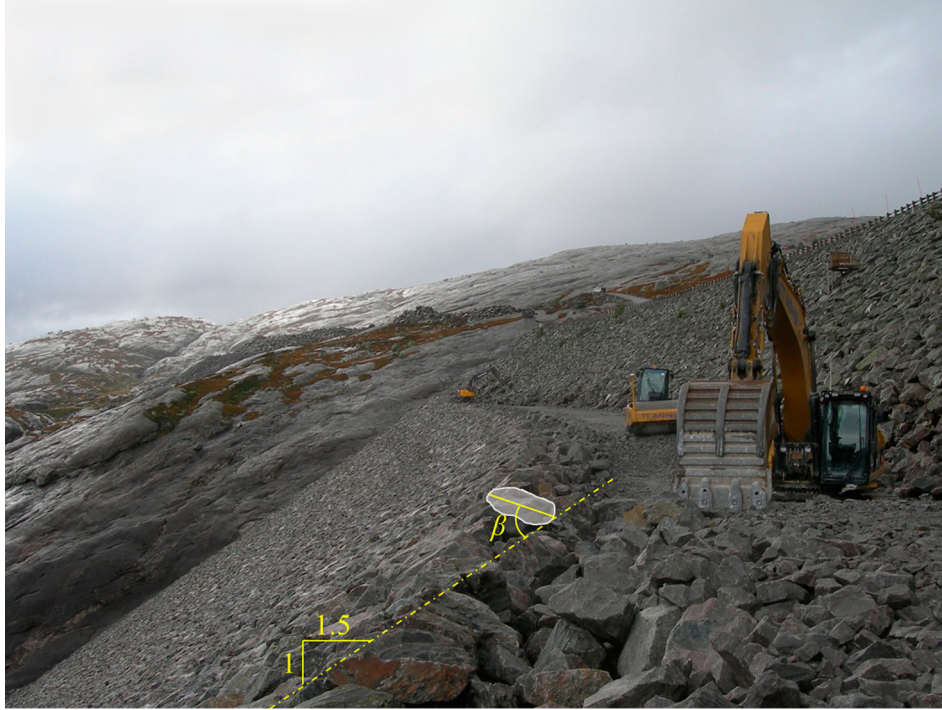
Figure 1. Rehabilitation work on the 129 m high dam Svartevatn in Norway. The riprap stones on the downstream slope are placed one by one in an interlocking pattern with their longest axes inclined towards the dam. The inclination angle  $\beta$  is the angle between the longest axis of a stone and the slope as indicated in the picture. (Photo NTNU).

stability when varying the inclination angle  $\beta$  between the slope and the longest axes of the riprap stones (see Figure 1). They reported the highest stability for  $\beta = 90^\circ$ , i.e. stones placed with their longest axes perpendicular to the slope. However, there was not sufficient information available in their study to determine  $P_c$  for a quantitative comparison with the aforementioned studies.

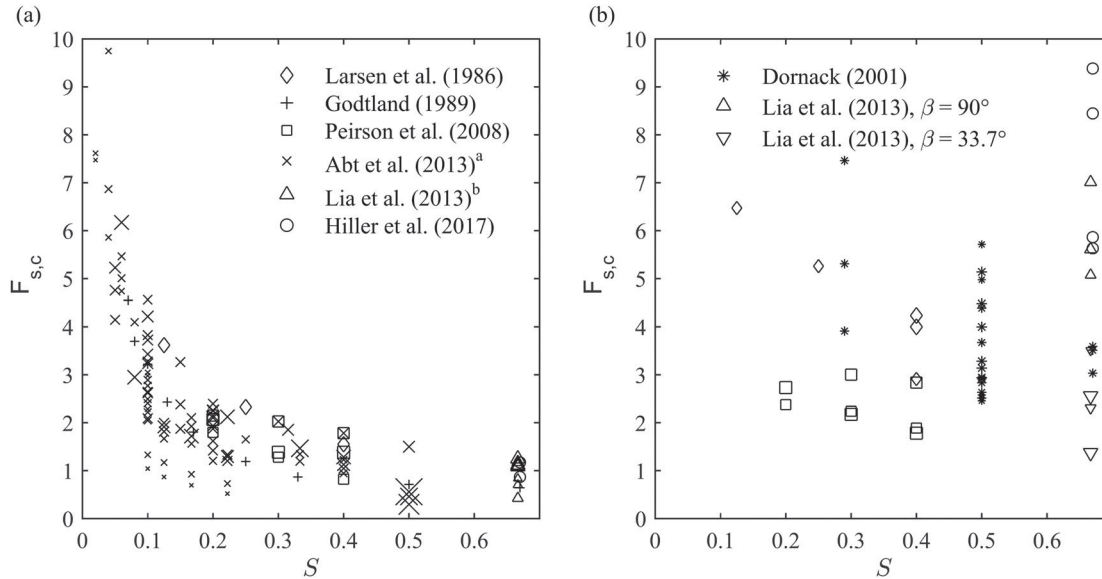
Figure 2. Existing data for the stability of dumped (a) and placed (b) riprap. The marker size is proportional to the used stone size (the marker size in the legend corresponds to  $d = 0.1$  m). The legend for (a) applies also for (b). <sup>a</sup>The data from Abt et al. (2013) include data points of eight different studies. <sup>b</sup>Only data are presented from experiments with a locked dam toe.

The critical stone-related Froude number  $F_{s,c}$  for placed riprap is plotted as a function of slope in Figure 2(b) using data reported by Larsen et al. (1986), Dornack (2001), Peirson et al. (2008), Lia et al. (2013) and Hiller et al. (2017). The direct comparison of Figure 2(a) with Figure 2(b)

reveals that  $F_{s,c}$  scatters more for placed riprap than for dumped and that placed riprap is more stable, especially at steep slopes. Moreover, some studies found that the discharge capacity of the experimental facility was not large enough to induce failure of placed riprap (e.g. Sommer 1997; Lia et al. 2013; Hiller et al. 2017). For these studies,  $F_{s,c}$  corresponded to  $F_{s,c} > 3.3$  (Sommer 1997, with  $0.25 \leq S \leq 0.5$  and  $q_{\max} = 0.5 \text{ m}^2 \text{ s}^{-1}$ ),  $F_{s,c} > 3.1$  (Lia et al. 2013, with  $S = 0.67$  and  $q_{\max} = 0.19 \text{ m}^2 \text{ s}^{-1}$ ) and  $F_{s,c} > 11.5$  (Hiller et al. 2017, with  $S = 0.67$  and  $q_{\max} = 0.49 \text{ m}^2 \text{ s}^{-1}$ ). Few design relationships have been developed specifically for placed riprap, as for example, by Knauss (1979), Sommer (1997) and Dornack (2001). These approaches were evaluated in Hiller et al. (2017) and are not discussed here.

A possible explanation for the variability of  $F_{s,c}$  in Figure 2(b) is the difference in packing factors, which varied from  $P_c = 0.53$  (Hiller et al. 2017) to  $P_c = 0.65$  (Larsen et al. 1986),  $P_c = 0.80$  (Dornack 2001) and  $P_c = 0.94$  (Peirson et al. 2008). The different  $P_c$  values may be related to the shape of the stones used, in addition to the quality of the packing. The ratio between the longest and intermediate axes of the stones used in Hiller et al. (2017) was  $a/b_s = 2.0$ , and the stones were more oblong than in Dornack (2001),  $1.4 < a/b_s < 1.8$ , or Larsen et al. (1986),  $a/d_s = 1.6$  ( $d_s$  was used instead of  $b_s$  due to missing information for  $b$  and  $c$ ). No specific information about the stone shape was found for Peirson et al. (2008). Oblong stones placed with their  $a$ -axis towards the slope can be denser packed than stones having the same volume and a more cubical form, resulting in lower  $P_c$  values (Lindford and Saunders 1967). Moreover, Lia et al. (2013) found that denser arrangement of the riprap stones resulted in higher

The dumped riprap in the field test F15D1 failed during the increase of the discharge from 0.4 to 0.8  $\text{m}^2\text{s}^{-1}$  (i.e.  $0.6 < F_{s,c} < 1.2$ ) and the corresponding model test D02 failed at  $F_{s,c} = 1.2$  ( $q_c = 0.05 \text{ m}^2\text{s}^{-1}$ ). The packing factors in the field and model tests agreed well with  $P_c = 0.84$  and  $P_c = 0.83$ , respectively, and  $F_{s,c}$  was in the same range as the majority of the data points in Figure 2(a).

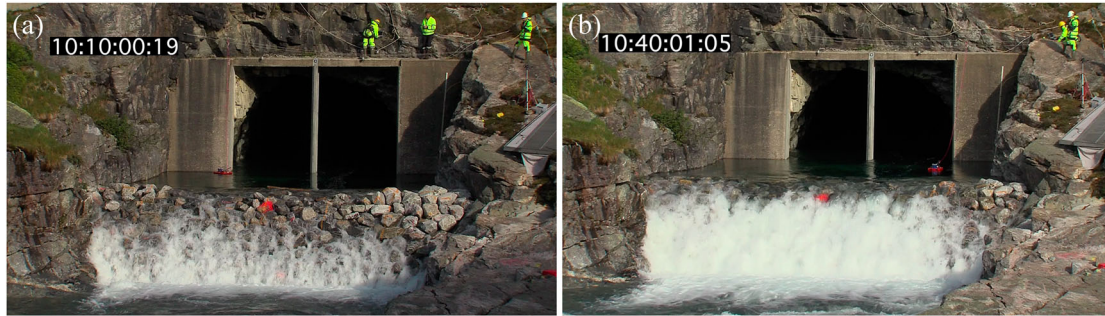
Figure 5. Picture frames of the test F15D1 with dumped riprap: (a) partly overtopped test dam with most of discharge as through flow  $q = 0.2 \text{ m}^2\text{s}^{-1}$  ( $F_s = 0.3$ ); (b) cascading flow at  $q = 0.4 \text{ m}^2\text{s}^{-1}$  ( $F_s = 0.6$ ). (Video: S. R. Skilnand).

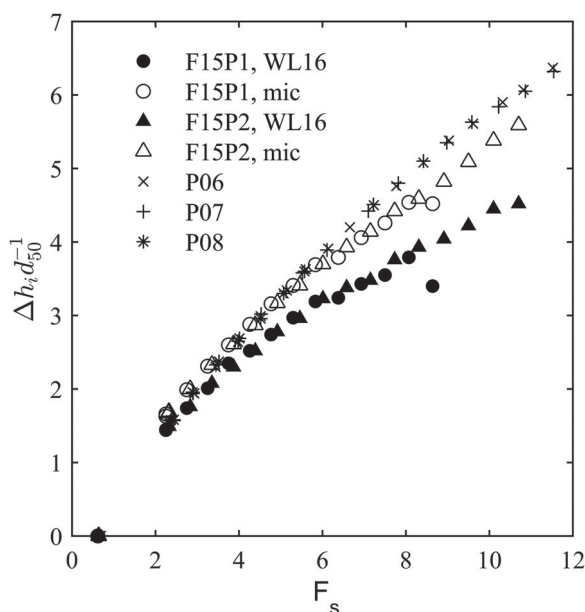
Figure 8. Relative submergence  $\Delta h_i/d_{50}$  as a function of the stone-related Froude number for the field and model tests.
