Hydrogen Embrittlement of 25Cr duplex stainless steel exposed to well fluid with H₂S - effect of cold working and product form

Materials Science and Engineering

Submission date: July 2017

Hydrogen Embrittlement (HE)/Sulfide Stress Cracking
(SSC) of corrosion resistant alloys in H₂S environment -
the effect of product form and cold working

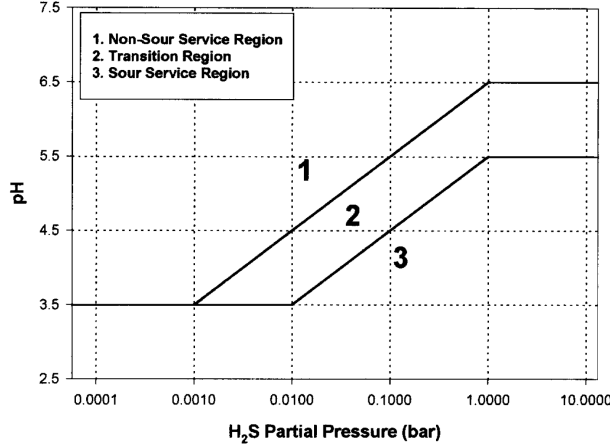
Figure 2.1: Relationship between pH and H₂S-content on sour service of a general MSS or CS.¹⁸

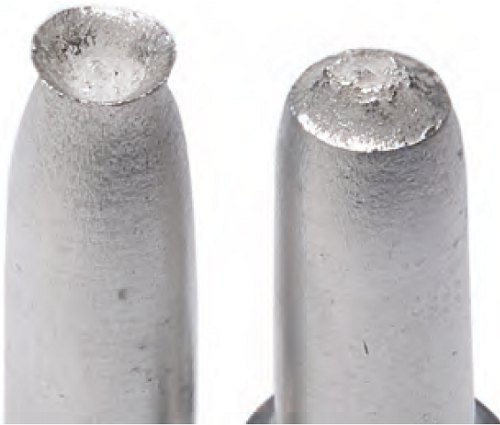
Figure 2.2: Ductile Cup-and-cone fracture of an aluminium specimen.²⁴

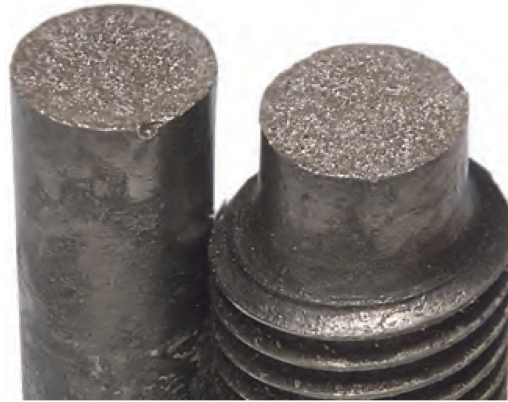
Figure 2.3: Brittle fracture surface of a mild steel.²⁴

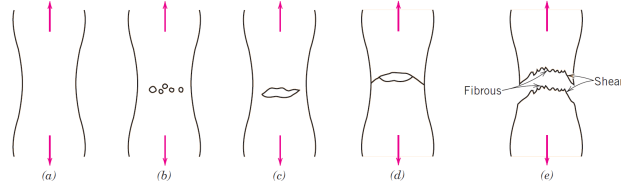
Figure 2.4: Illustration of the different stages in a ductile cup-and-cone fracture.²⁴

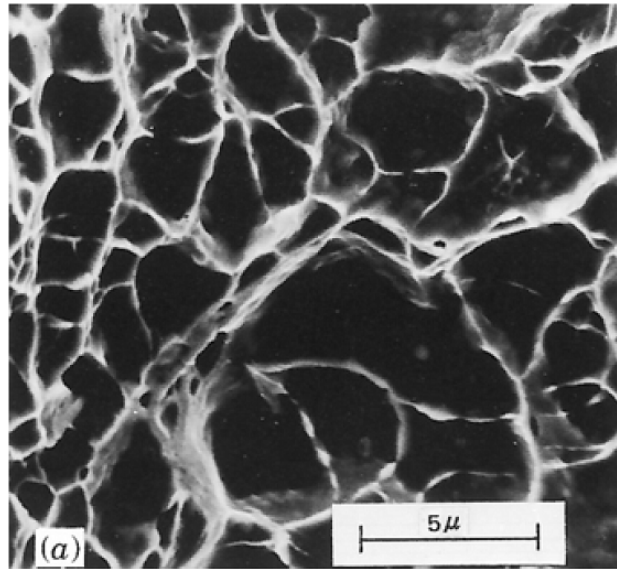
Figure 2.5: SEM photo showing the characteristic spherical dimples of a ductile fracture surface. Magnification 3300X.²⁴

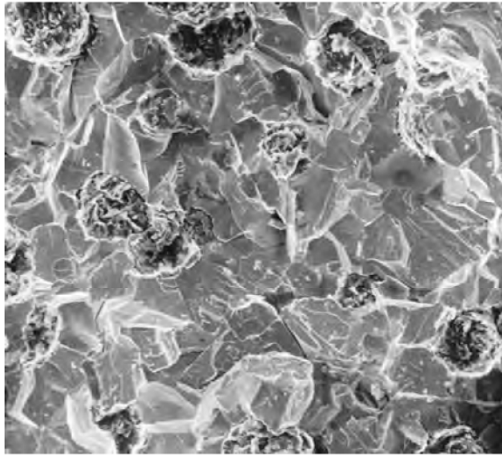
Figure 2.6: SEM of a transgranular brittle fracture. Magnification unknown.²⁴

preferred as it has a much better resolution and depth of field, which are both needed to investigate a surface with larger topographic features. Investigation of a ductile fracture surface in SEM, as shown in figure 2.5, will illustrate the spherical dimples, which is a characteristic of a ductile fracture from a tensile stress load. A transgranular and intergranular fracture are shown in figure 2.6 and figure 2.7, respectively.²⁴

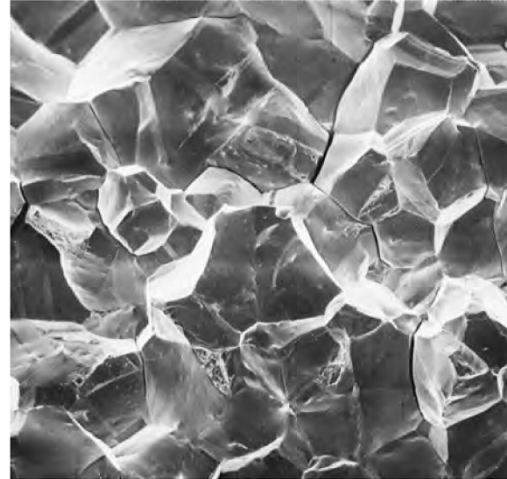
Figure 2.7: SEM of a intergranular fracture surface. Magnification 50X.²⁴

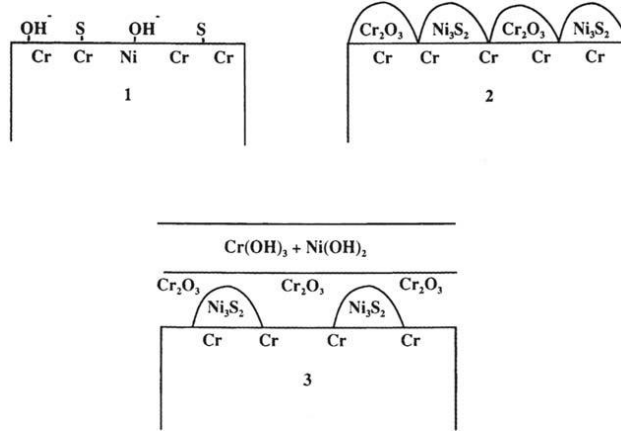
Figure 2.8: Illustration of the "competition" between formation of Cr-oxides and Ni-sulfides on the surface of a Ni-Cr-Fe-alloy.²⁶

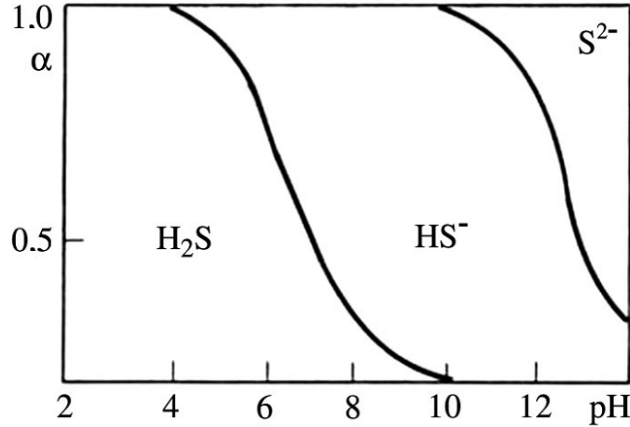
Figure 2.9: Dissociation (α) of H_2S , HS^- and S^{2-} as function of pH.²⁷

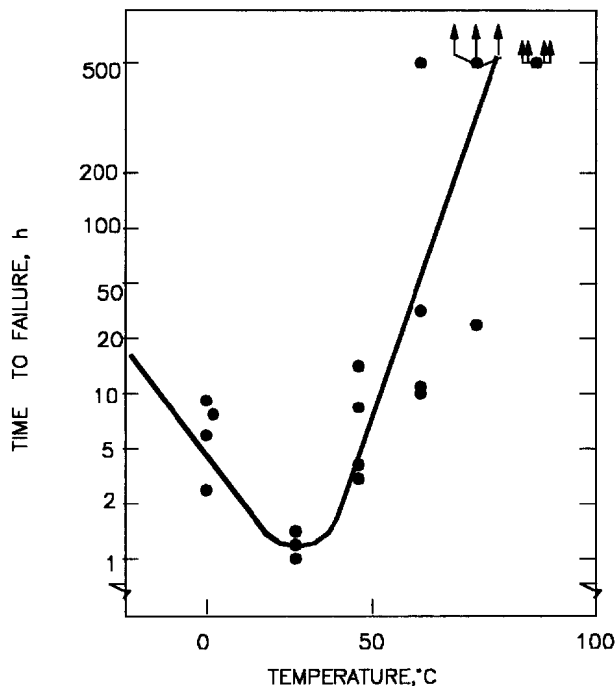
Figure 2.10: Relationship between time to SSC-failure and temperature for a low alloy C-Mn steel.¹⁸

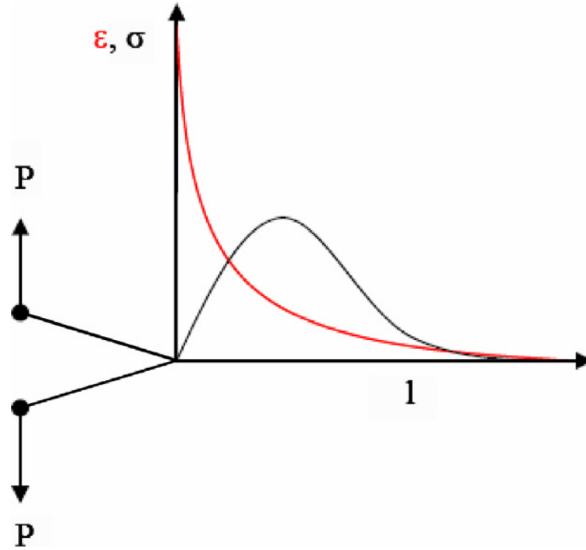
Figure 2.11: Stress and strain fields ahead of a crack.³²

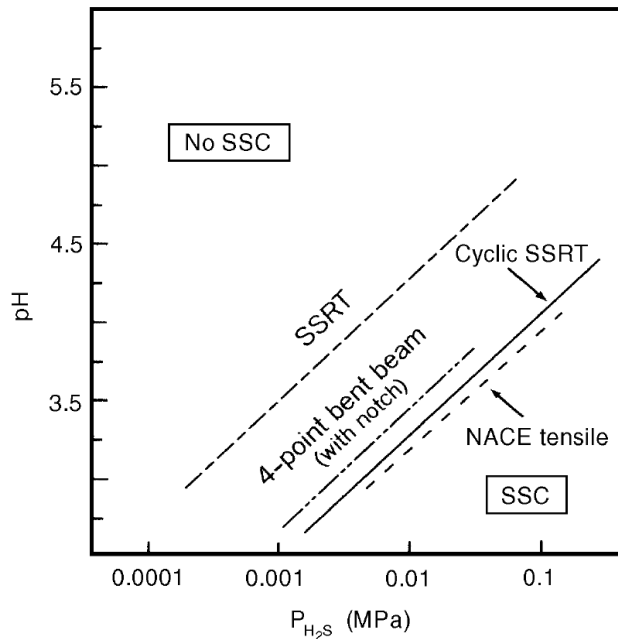
Figure 2.12: Comparison of SSC test results of a M13Cr-95 MSS with different test methods.⁵

The severity of SSRT compared to a static tensile test is well illustrated in figure 2.12, where failure and no-failure of a MSS as a function of pH and partial H₂S pressure is plotted for different test methods. Results from these methods can be good to complement each other, but cannot necessarily be directly compared.⁵

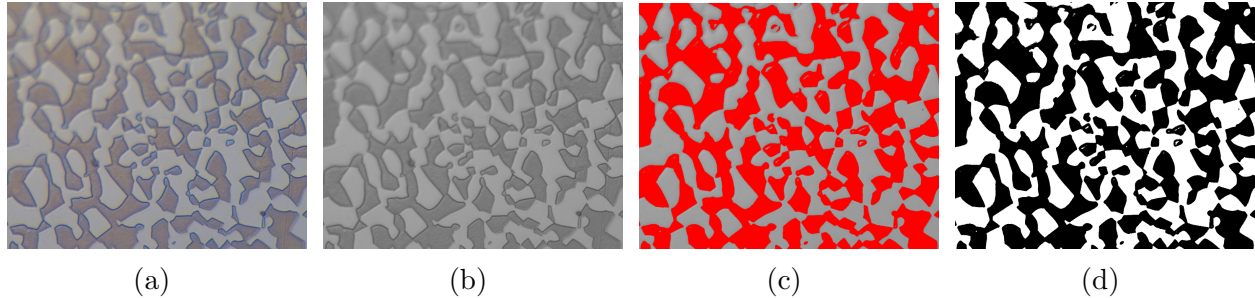
Figure 3.2: The four steps of preparing an image for ferrite counting: crop a clean LOM image (a), convert to 8-bit (b), define ferritic area (c) and convert to black and white for counting of black pixels/ferrite (d).

done by cropping and converting pictures of a clear area with a minimum amount of scratches or contaminations to 8-bit pictures, before being converted to a black/white image. Black (ferrite) and white (austenite) pixels are then counted by the computer. The process is illustrated in figure 3.2.

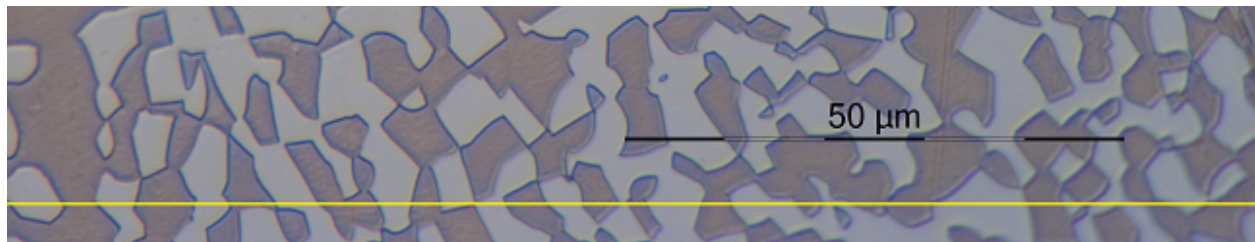
Figure 3.3: Example of setup of yellow line on LOM picture of a Duplex SS to measure and determine the average γ -spacing.

To find the Austenite-spacing (γ -spacing) a yellow line was drawn parallel to the scale bar, as illustrated in figure 3.3. The scale bar was then measured in the software to determine the pixel per μm ratio. The distance in-between all austenite grains along the yellow line was gathered followed by calculation of average distance and standard deviation. For each material and deformation grade this was done twice; once for the transverse cut and once for the longitudinal. Results are shown in table 4.4.

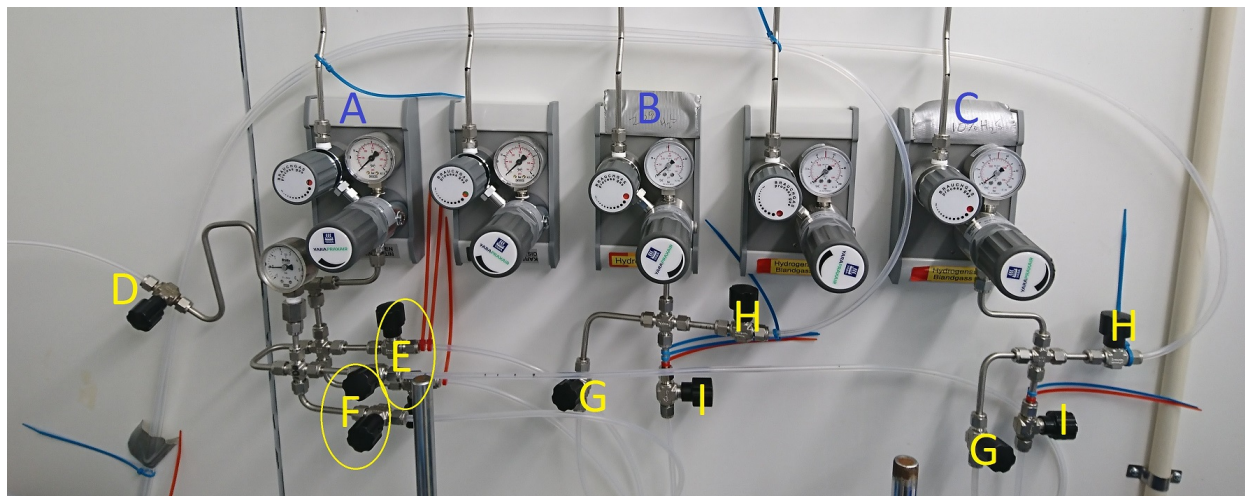
Figure 3.4: Inlet pressure control valves for N_2 and H_2S : N_2 control valves (A), 10/20% H_2S control valves (B/C), N_2 to NACE Solution A container (D), N_2 to Manifold (E), N_2 to flush H_2S systems through valve G (F), inlet valve for flushing H_2S system with N_2 (G), outlet to filter used when flushing (H), H_2S to manifold (I).

Main gas pressure and flow control valves are shown in figure 3.4. Both the N_2 and the H_2S gas is led into a manifold where output gas for each test cell can be controlled, as well as another flow control valve. In addition, the figure shows how extra gas lines are connected to flush the H_2S lines with N_2 . Figure 3.5 shows the manifold with inlets, outlets, gas selection and gas flow valves.

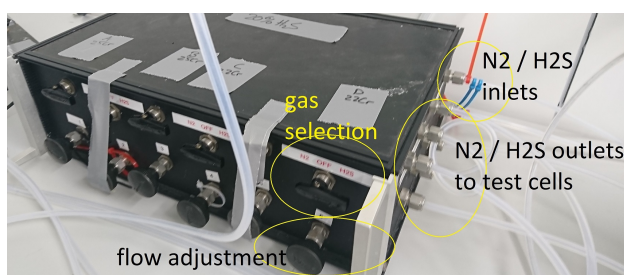
Figure 3.5: Control manifold used to adjust flow and input gas to cells. Yellow circles from upper right to lower left show the input connection points for gas, the output lines to different test cells, gas selection valve (N_2 , closed or H_2S) and flow control valve.

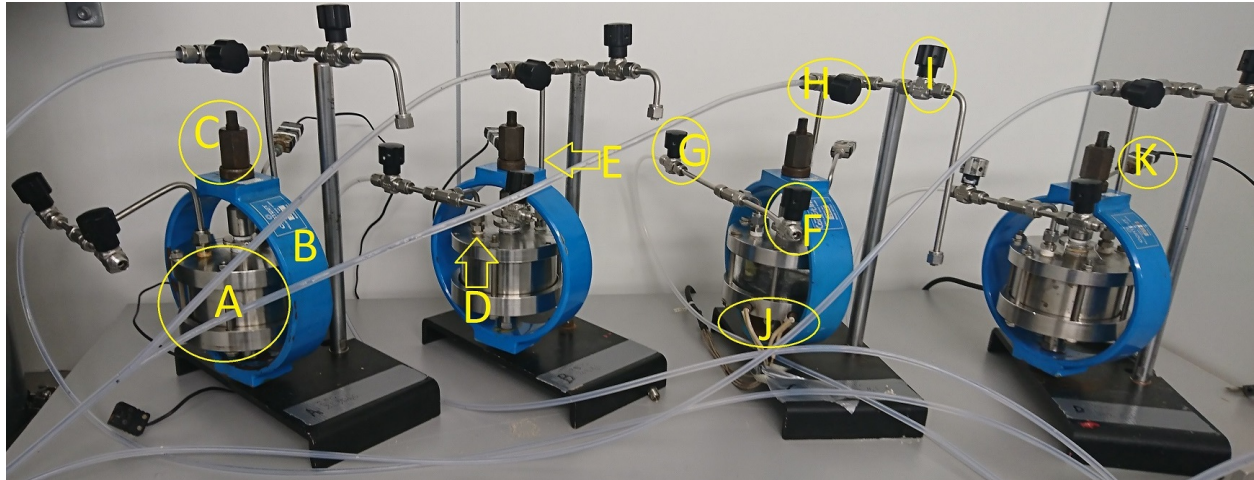
Figure 3.6: Final assembly of test cells in autoclaves: Test cell (A), Autoclave (B), bolt for tensioning of sample (C), gas inlet (D), gas outlet (E), valve for liquid filling from test solution storage container (F), valve for gas from manifold to inlet (G), valve for normal gas outlet to NaOH-bucket (H), "contingency-valve" (I), heating rods (J), thermocouple connection (K).

Figure 3.6 shows the final assembly of the test cells in the autoclaves with valves and heating equipment connected. The test cells are sealed with O-rings around the tensile test rod to avoid leakage, as seen in figure 3.7.

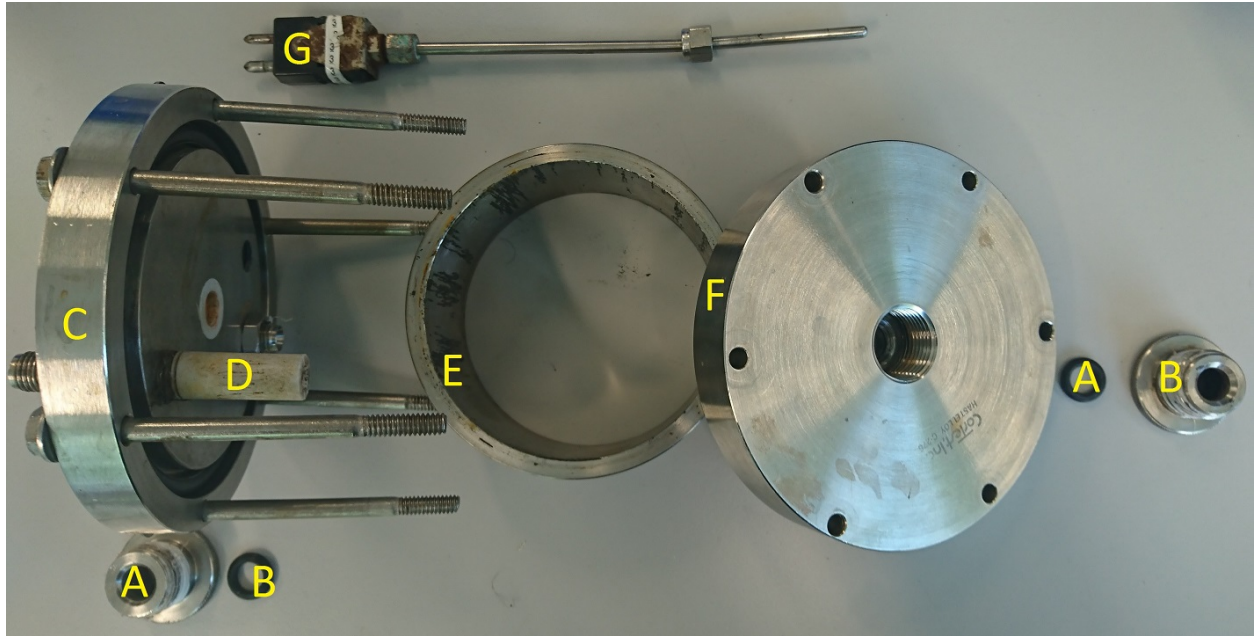
Figure 3.7: Disassembled test cell with showing container lock bolts for tensile test rod (A), O-rings for tensile test rod (B), top lid (C), gas inlet for bubbling in solution (D), container wall (E), bottom lid (F), thermocouple (G).

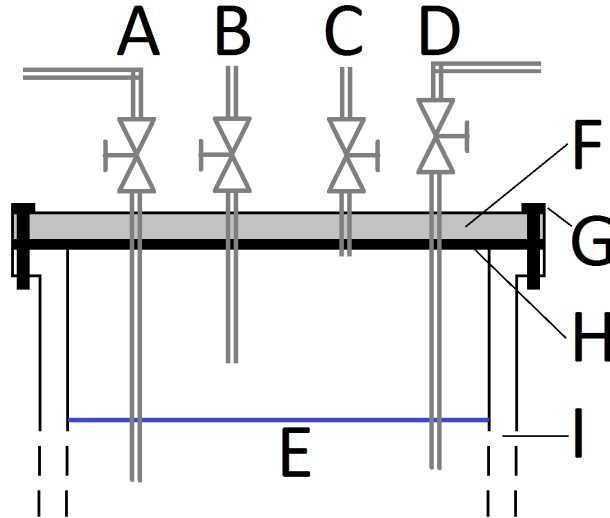
Figure 3.8: Sketch of NACE Solution A container: outlet for NACE Solution A to test container (A), inlet for new NACE Solution A (B), outlet for air during purging (C), inlet for N₂ (D), NACE Solution A (E), Plexiglas Lid (F), bolts (G), O-ring (H) and container (I)

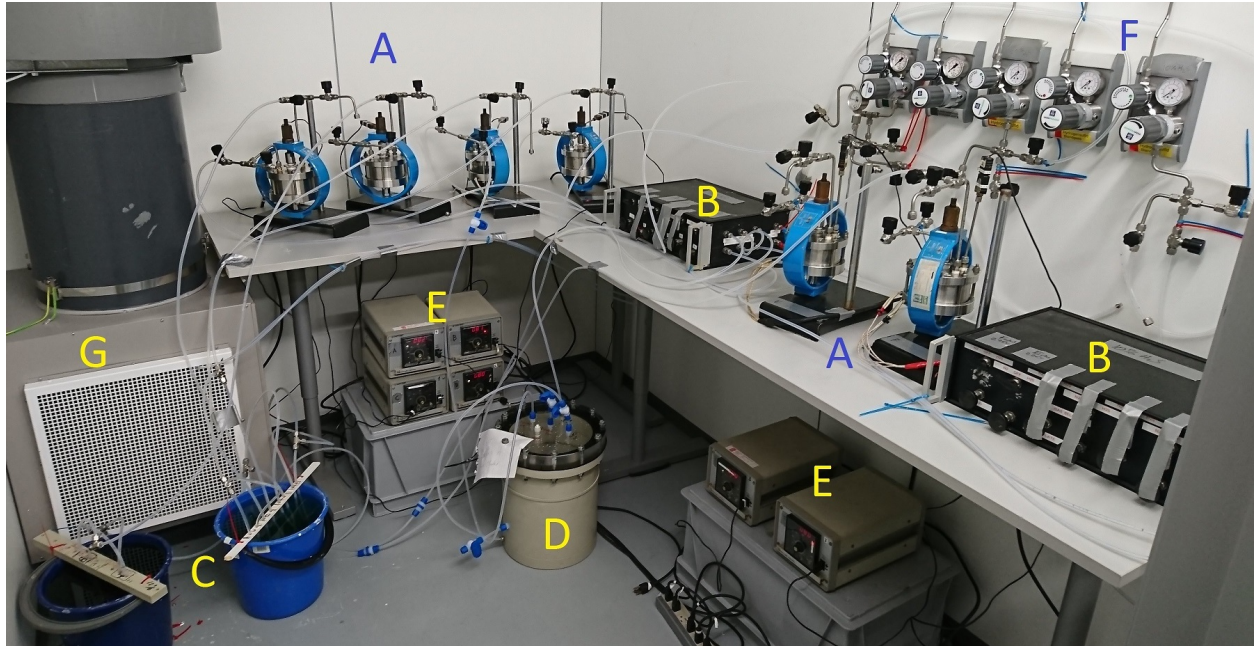
Figure 3.10: Overview of the experiment: Autoclaves with tensile test rods (A), manifold (B), NaOH buckets (C), container for NACE Solution A (D), heating equipment (E), main inlet valves with pressure control valve and gauge (F) and inlet to filter (G).

The final setup is shown in figure 3.10. Details about components and setup procedure are explained in the preceding sections. A simplified sketch of the setup is shown in figure 3.11.

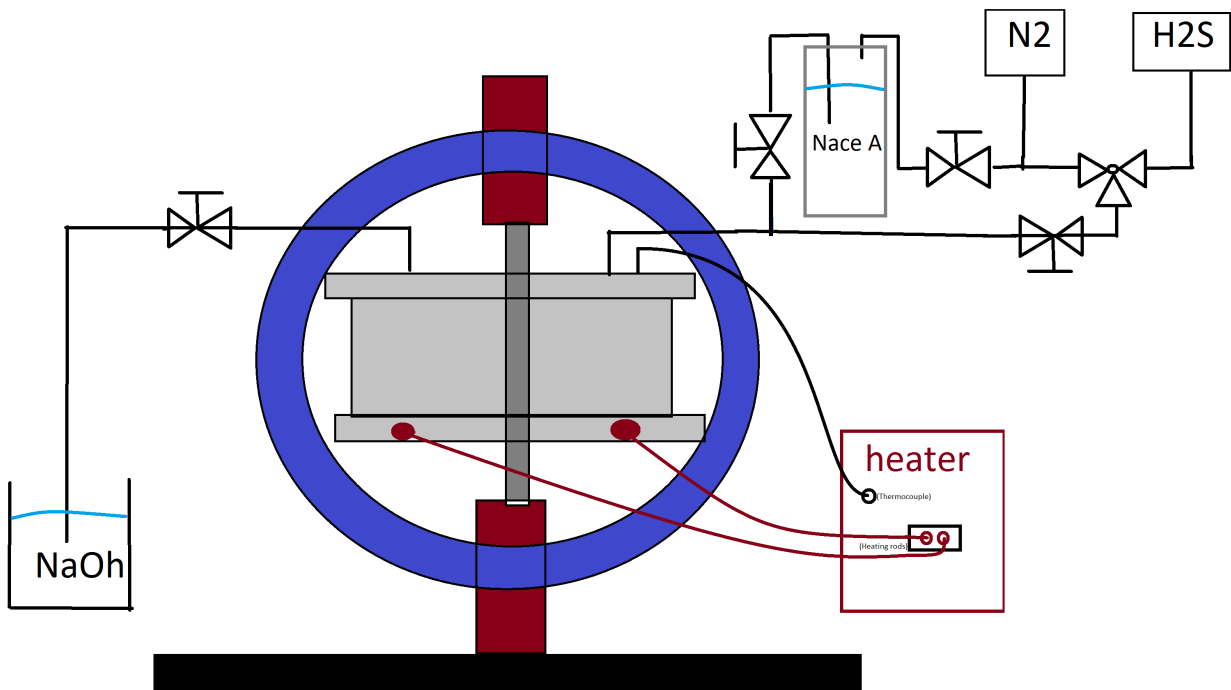
Figure 3.11: Simplified sketch of experiment setup

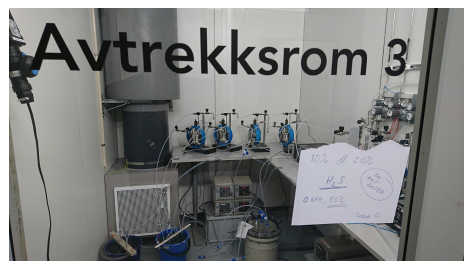
(a) Closed of test room with warning sign.

Figure 3.13: Equipment used as different safety tools

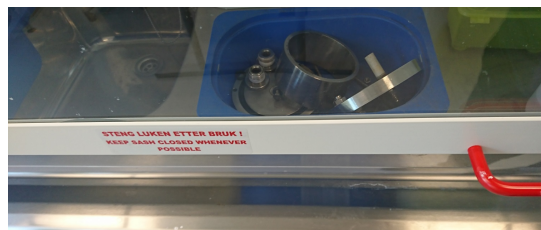
(c) Disassembly of test cell under ventilated fume hood.

As described in the test equipment section, handling of equipment that has had H₂S inside was purged with N₂, and then opened under a ventilated fume hood, as shown in figure 3.13c.

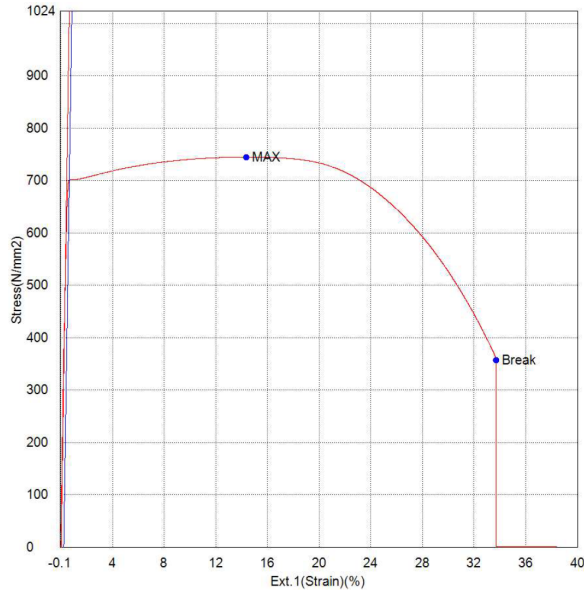
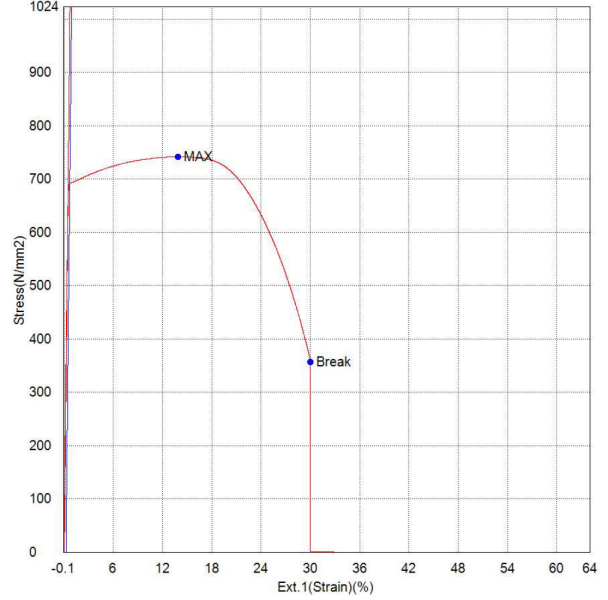
Figure 4.1: Stress-strain diagrams of tensile tests of 22Cr Duplex SS with 4.8% pre-deformation at elevated temperatures.

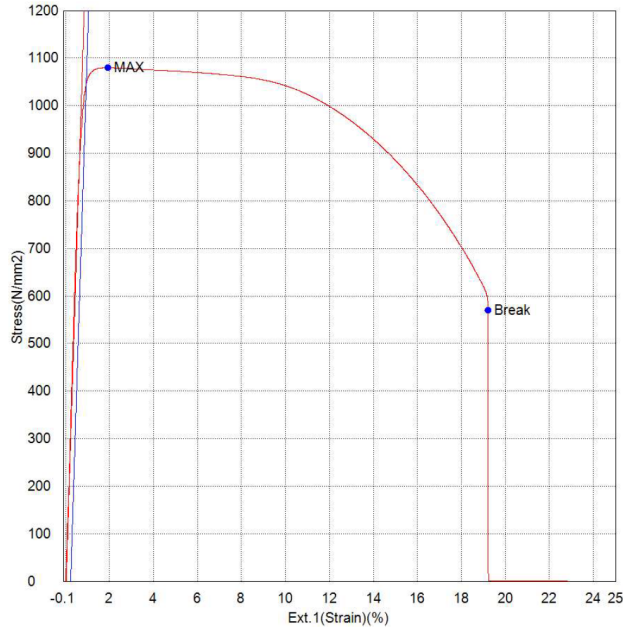
Figure 4.3: Stress-strain diagram of tensile test of ATI-830 at 150°C with 0% pre-deformation.

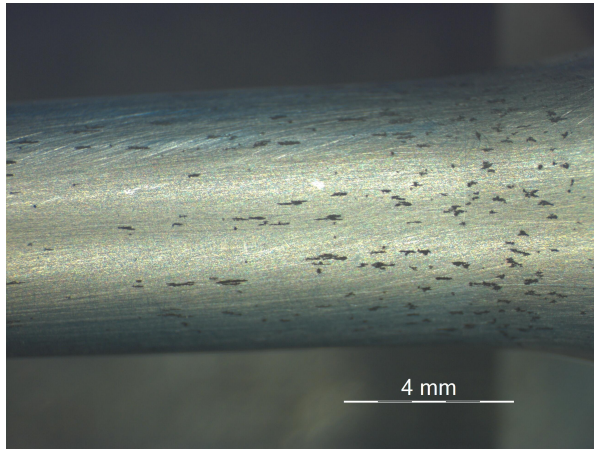
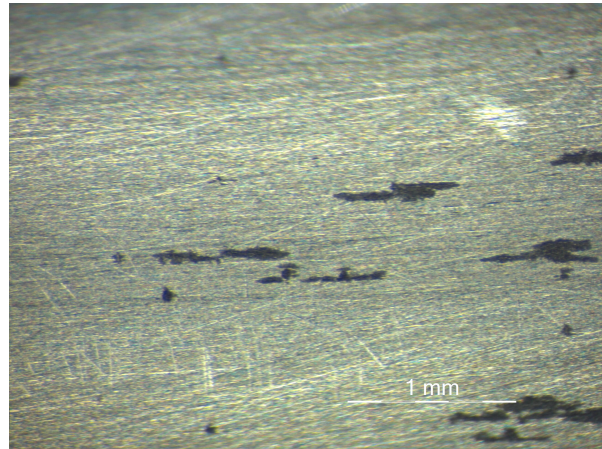
Figure 4.13: Sample A: 22Cr with 4.8% deformation tested in 10%H₂S and 90°C . Samples not cleaned prior to investigation.

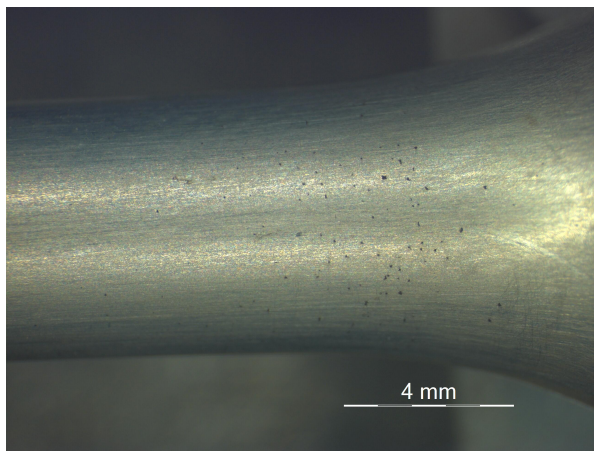
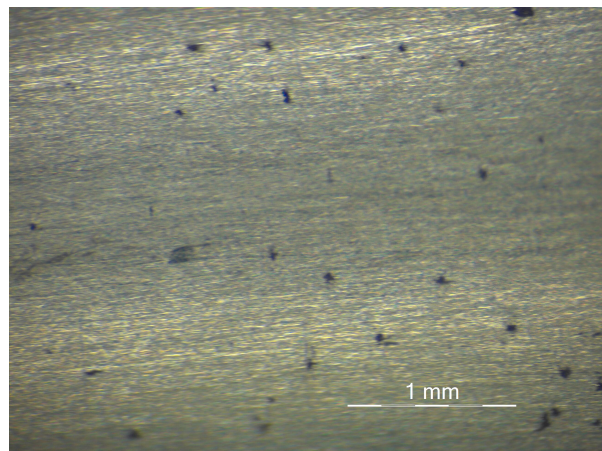
Figure 4.14: Sample B: 22Cr with 4.8% deformation tested in 10%H₂S and 90°C . Samples not cleaned prior to investigation.

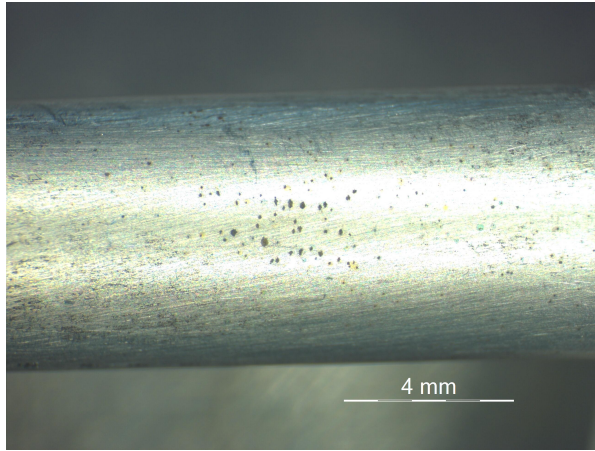
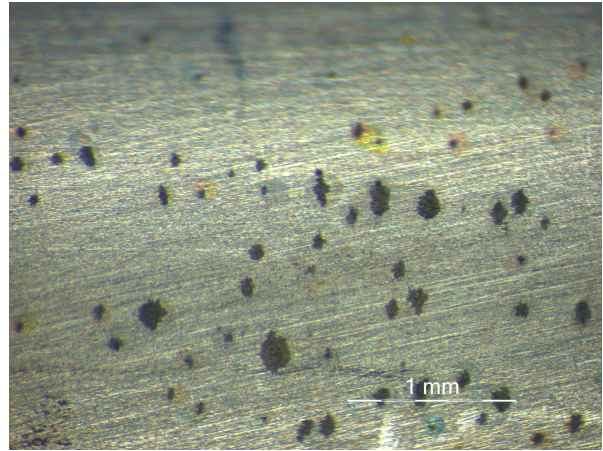
Figure 4.15: Sample E: 22Cr with 4.8% deformation tested in 10%H₂S and 80°C . Samples not cleaned prior to investigation.

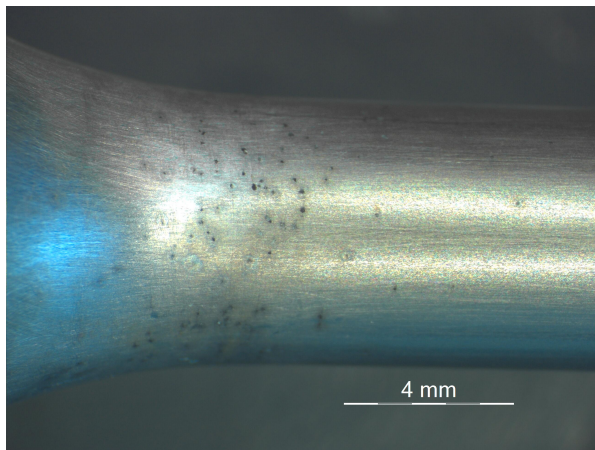
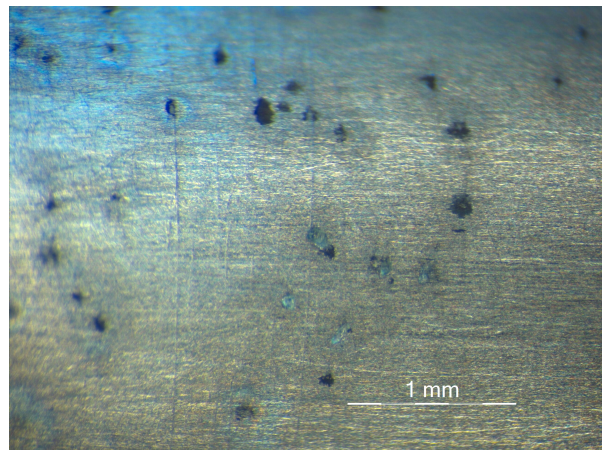
Figure 4.16: Sample F: 22Cr with 4.8% deformation tested in 10%H₂S and 80°C . Samples not cleaned prior to investigation.

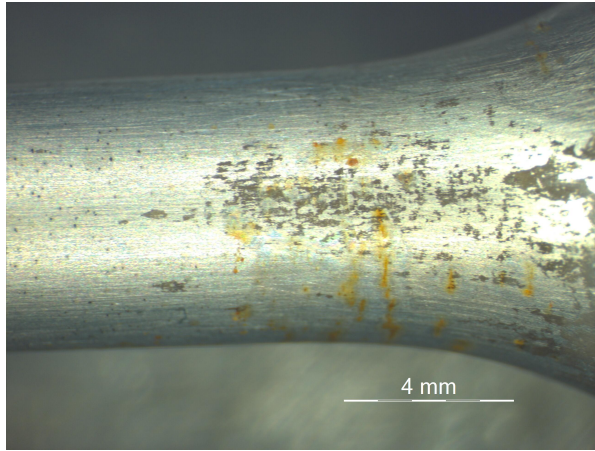
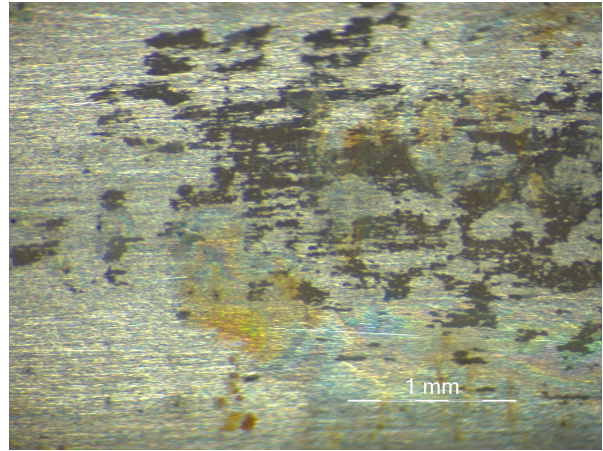
Figure 4.17: Sample H: 22Cr with 4.8% deformation tested in 20%H₂S and 80°C . First of two locations photographed. Samples not cleaned prior to investigation.

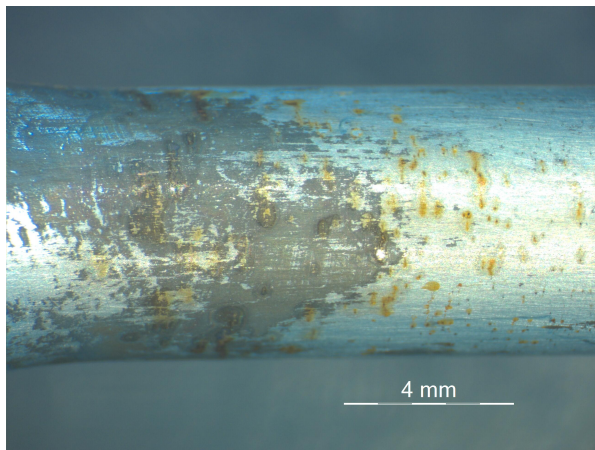
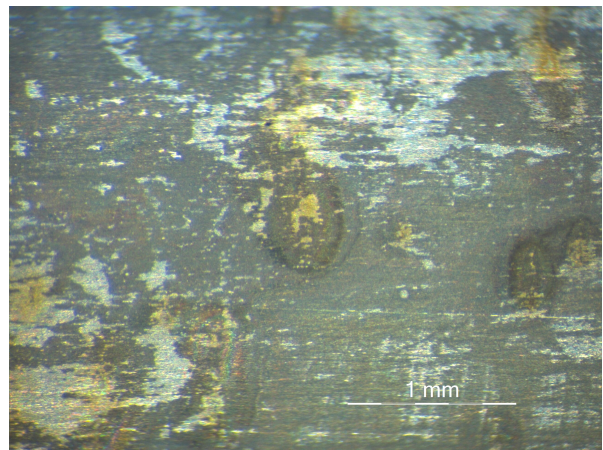
Figure 4.18: Sample H: 22Cr with 4.8% deformation tested in 20%H₂S and 80°C . Second of two locations photographed. Samples not cleaned prior to investigation.

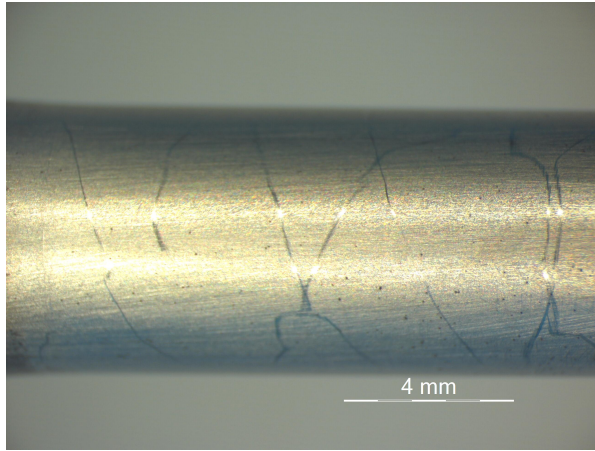
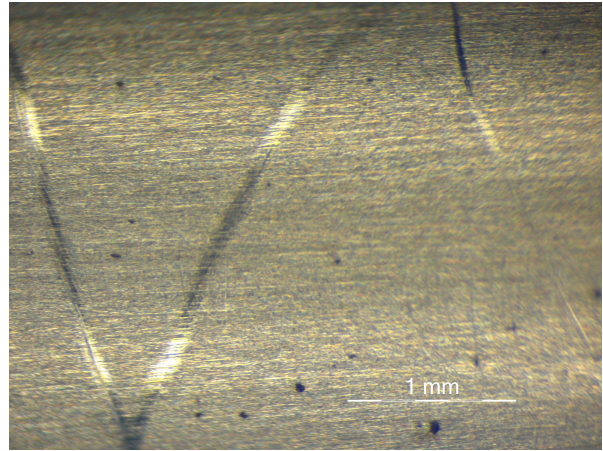
Figure 4.19: Sample K: 22Cr with 4.8% deformation tested in 20%H₂S and 80°C . Samples cleaned with soap and hot water.

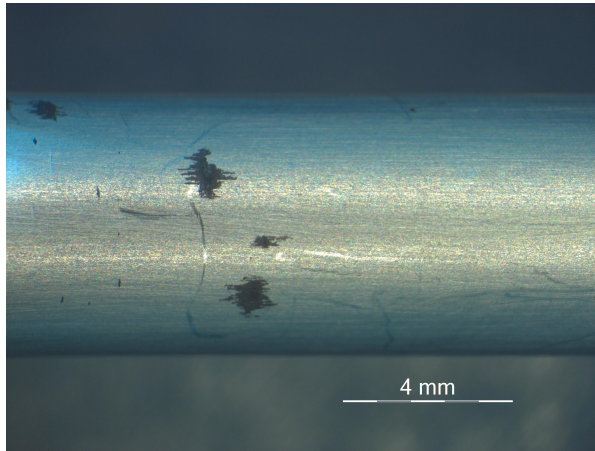
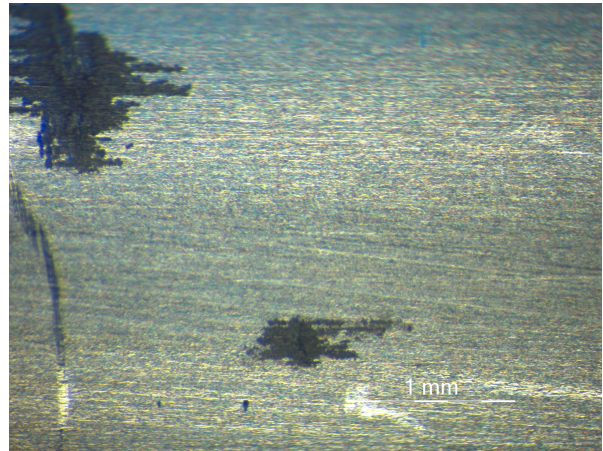
Figure 4.21: Sample C: 25Cr with 4.8% deformation tested in 20%H₂S and 90°C . Samples not cleaned prior to investigation.

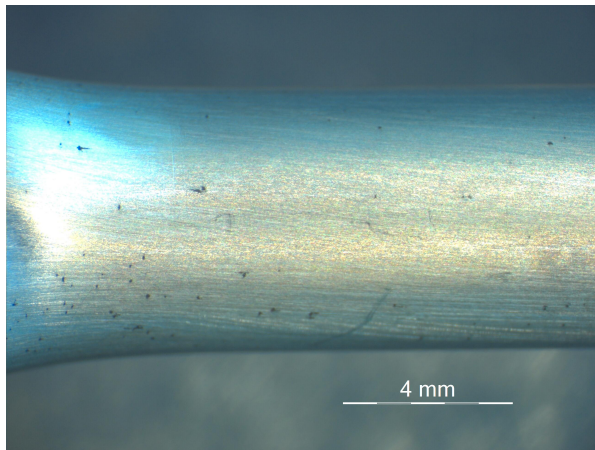
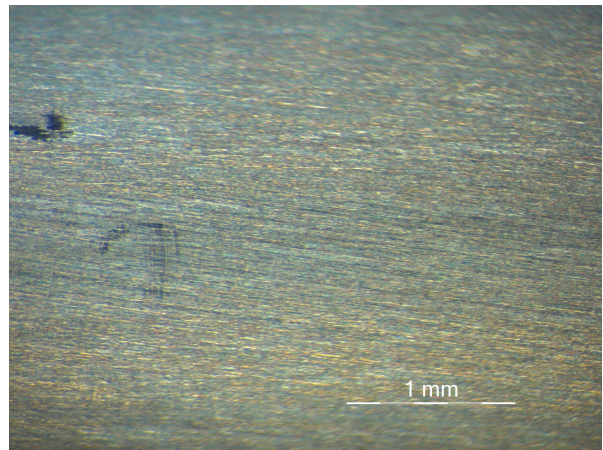
Figure 4.22: Sample D: 25Cr with 4.8% deformation tested in 20%H₂S and 90°C . Samples not cleaned prior to investigation.

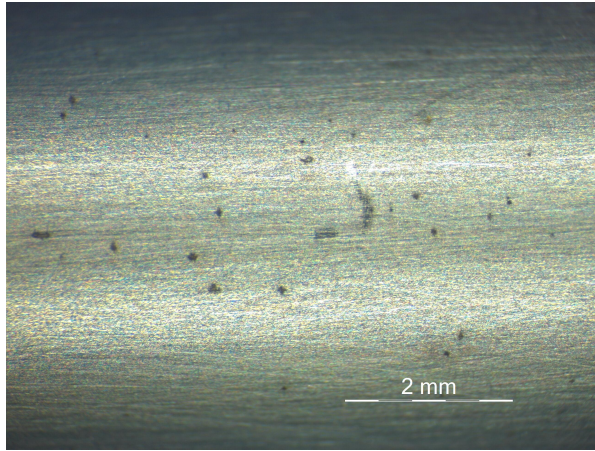
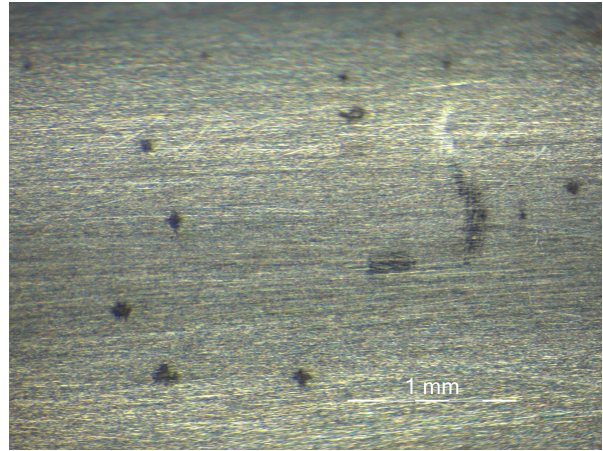
Figure 4.23: Sample I: 25Cr with 4.8% deformation tested in 20%H₂S and 80°C . Samples not cleaned prior to investigation.

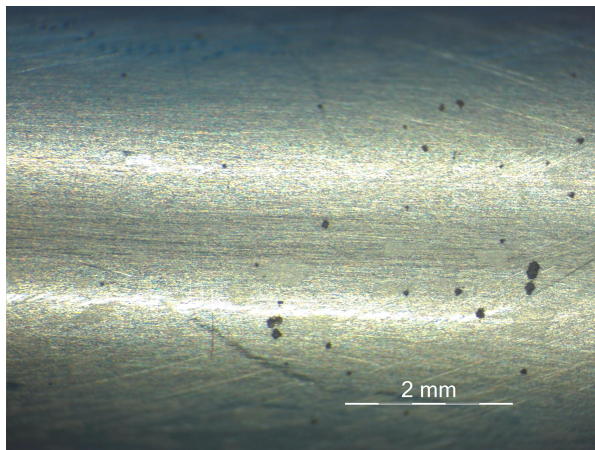
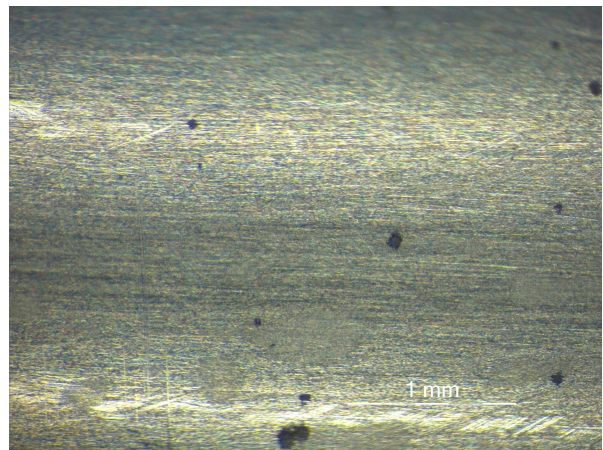
Figure 4.24: Sample J: 25Cr with 4.8% deformation tested in 20%H₂S and 80°C . Samples not cleaned prior to investigation.

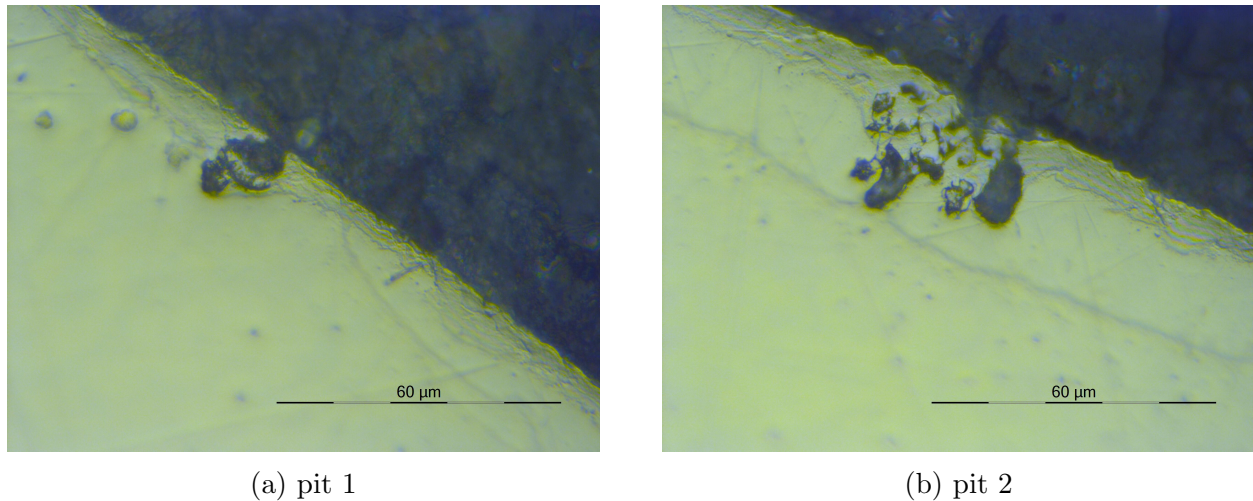
Two typical pits photographed are shown in figure 4.26. The pits have a typical depth of $< 30\mu m$ and showed no signs of microcracking in the bottom of the pits. The same pits can be seen in the overview picture shown in figure 4.27.

Figure 4.26: Two typical pits found on a cross section of sample K at 1000X magnification

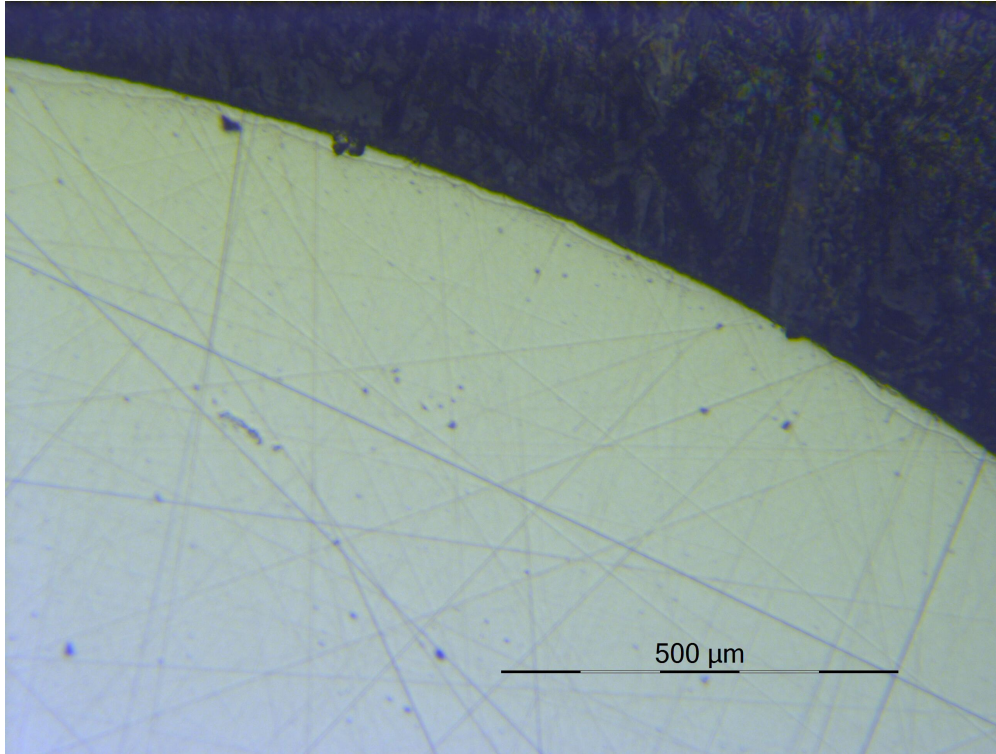
Figure 4.27: An overview of sample K at 100X magnification.

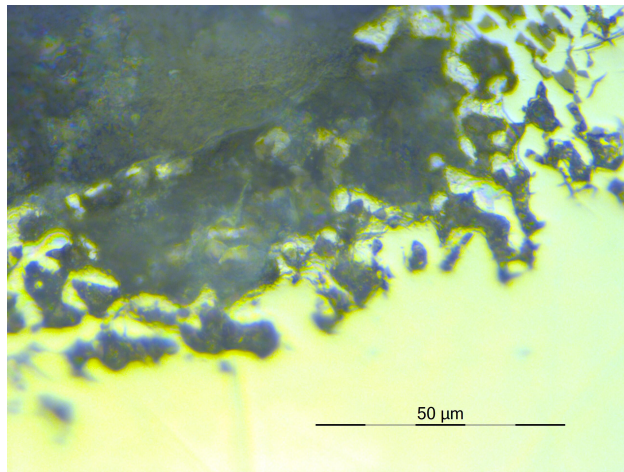
A typical pit photographed is shown in figure 4.28. The pits had a typical depth of $<50\mu m$ and showed no signs of microcracking in the pottom of the pits. The same pit can be seen in the overview picture shown in figure 4.29

Figure 4.28: A typical pit found on a cross section of sample N at 1000X magnification.

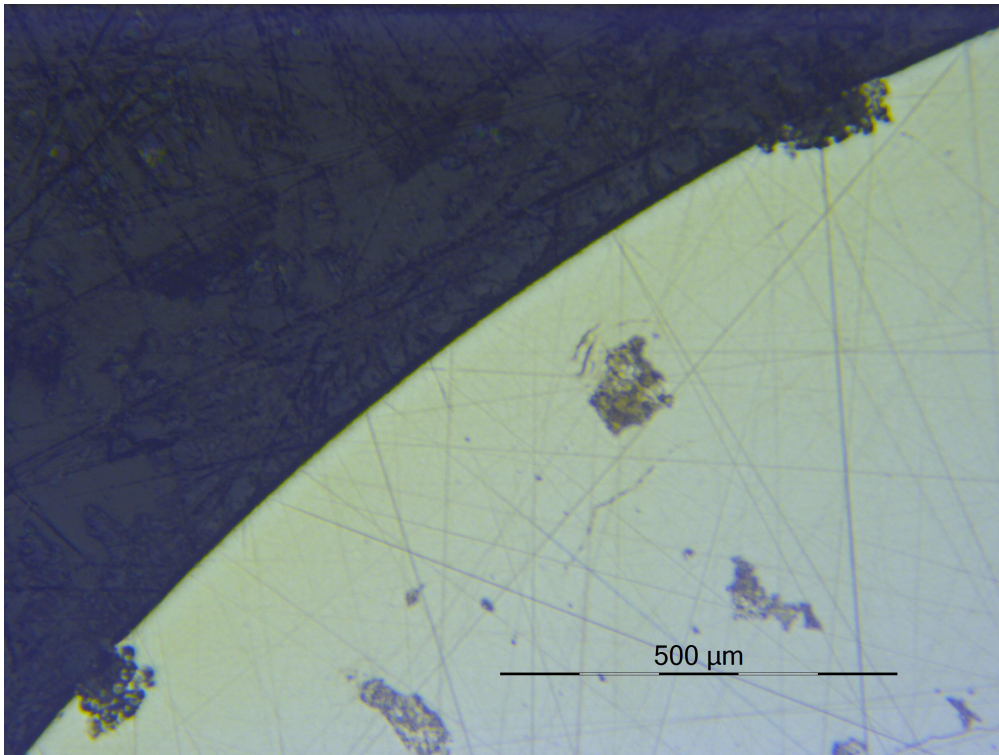
Figure 4.29: An overview of sample N at 100X magnification.
