Rock Breaking Under Rolling TBM Disc Cutters in Hard Rock Conditions

Visualization and documentation of
cracks

Thesis for the degree of Philosophiae Doctor

Trondheim, March 2019

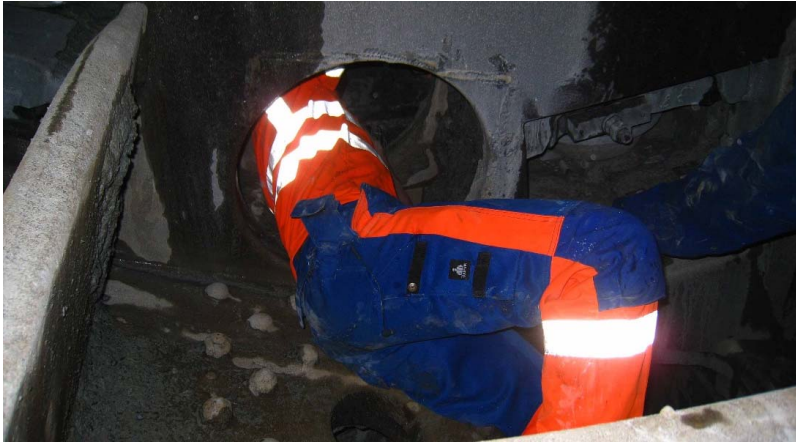
Figure 4.1: Inspection hole at the ARM Project.

is approximately 50 centimeters deep. A picture showing the dimension of the inspection hole is presented in Figure 4.1. Both transportation of equipment and samples, and sampling through the inspection hole is therefore challenging, given the limited degree of freedom inside and through the inspection hole.

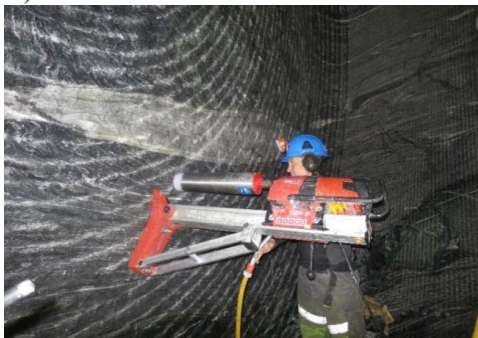
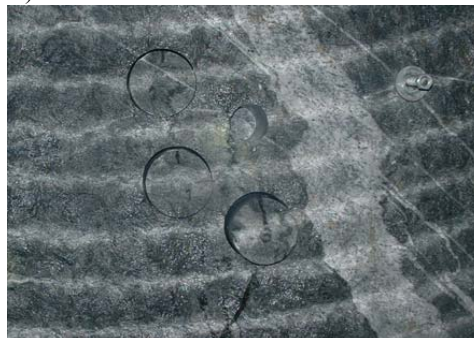
Figure 4.4: A) Core drilling into the face of the Nedre Røssåga headrace tunnel. B) Picture showing a typical sampling pattern.

The TBMs at the AMR Project and the Nedre Røssåga headrace tunnel have different diameters, and different cutter spacing. To get the most comparable samples, it was preferable to get samples with the same relative positioning. The ratio between the distance from the center of the TBM to cutter grooves number 34 – 38 and the radius of the TBM at the AMR Project was calculated by formula [4.1]. The ratio was used to find the corresponding cutter grooves for the TBM at the Nedre Røssåga headrace tunnel. Cutter grooves number 22 – 25 were found to be the corresponding cutter grooves, see Table 4.5. Two pictures from the core drilling at the Nedre Røssåga headrace tunnel can be seen in Figure 4.4.

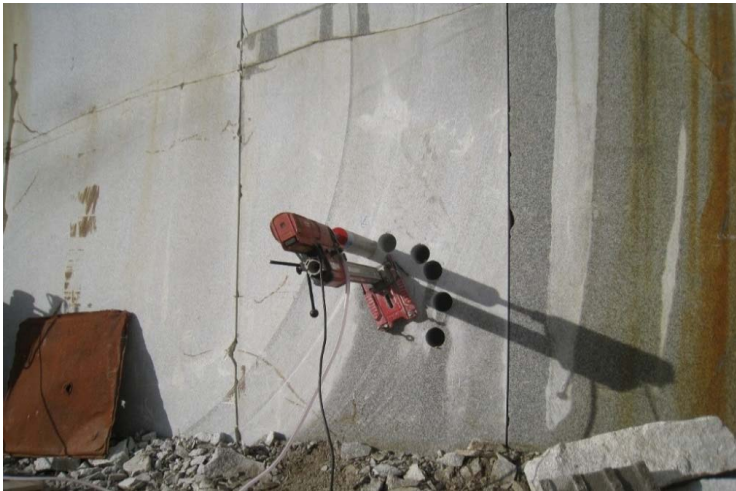
Figure 4.8: Core drilling at a vertical wall at the Trondhjemite quarry.

The sampling took place on a vertical, wire sawed wall with no visible cracks or intrusions interfering the sampling area. Location can be seen in Figure 4.8.

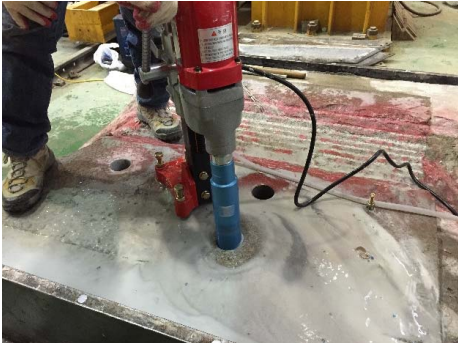
Figure 4.10: Core drilling after testing. Note that the core drilling were performed from the bottom of the specimen (photo: Yongbeom Seo).

Sequential cutting operation means that the lines are cut with a predefined spacing from one side of the specimen towards the other side, until the desired number of lines are cut. With random cutting operation, the desired number of lines are cut in random order, causing the cutter to be relocated sideways in both directions and with irregular intervals until the desired number of lines are cut. The predefined cutter spacing is constant. The two cutting operations are illustrated in Figure 4.9. A rock specimen after testing, prior to core drilling can be seen in Figure 4.10.

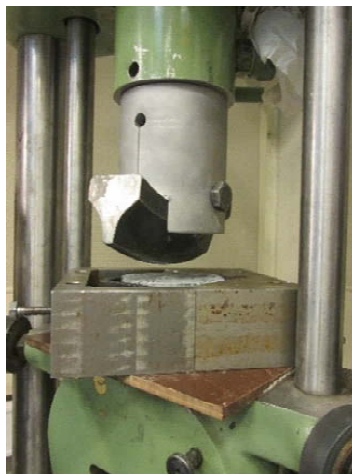
Figure 4.23: Apparatus used to partially clove the core sample.

In order to initiate a crack close to the preferred geometry, the core sample was partly clove with an applied load. A part of a used cutter ring from a TBM was used as an indenter and a point load was applied in the 90-270° direction of the core, see Figure 4.23. By using a low confinement stress and a low loading rate, a semi-planar crack with decreasing width along the core length was initiated. It was of great interest to keep the base of the core intact so that measured values in this section could be compared with the preliminary results. The geometry of this crack can be seen in Figure 4.22B and B.

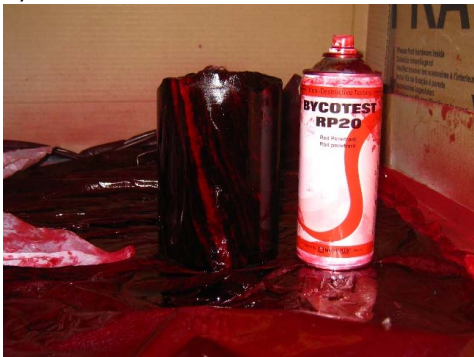
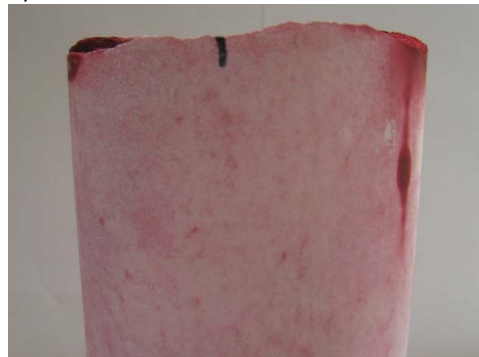
Figure 4.26: A) Application of penetrant. B) Core sample after application of developer, but before the cracks were fully developed.

After drying, the penetrant was applied to the samples by spraying. Suitable penetration time depends on the properties of the penetrant, the temperature of its application, the material of the test substance and the type of discontinuities to be indicated. Penetration time may vary from five to 60 minutes. For the samples used for this Ph.D.-study, the cracks and discontinuities needed a minimum of 15 minutes to absorb the penetrant. The penetration must not, under any circumstances be allowed to dry during penetration time, and the use of a fume cupboard increased the risk of the samples drying out. To keep the samples wet throughout the penetration time, more penetrant was applied every five minute. The samples were also wrapped in a thin plastic foil. A picture from the application of the penetrant can be seen in Figure 4.26a.

Once the samples were dry, a thin layer of BYCOTEST developer was applied. When sprayed on, the developer makes a white film on the sample surface, and after some minutes the cracks visualize as red lines on the white surface. The cracks are only visible as lines a limited time before the area around the cracks is colored red as well. Generally, the visualization of the cracks take between five and 30 minutes. For the samples used for this Ph.D.-study, the visualization took five to seven minutes, depending on the rock type. In general, it is preferable to perform the first visual inspection of the sample immediately after applying the developer or as soon as it has dried, as this facilitates the interpretation of the cracks. In this study, the samples were visually inspected from the developer was applied until the development time was completed. A picture from the application of the developer can be seen in Figure 4.26B.

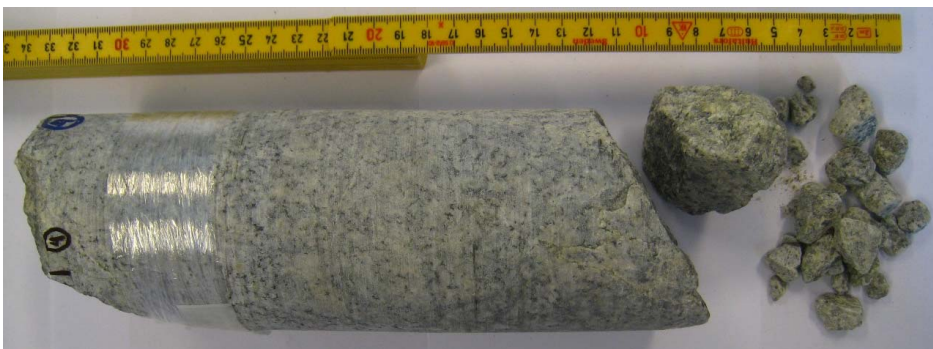
Only one out of six core samples from the AMR Project was a perfect cylinder. The five other core samples were either split into several larger pieces or even consisted of crushed parts with gravel sized pieces at the top of the core. Figure 5.1 shows core sample AMR_11579_1-3_34 where the 3-4 first centimeters from the face consisted of gravely pieces. The plane passing through the core sample on the right side is an open preexisting crack with some filling of feldspar or brittle and porous quarts.

Figure 5.1: Core sample AMR_11579_1-3_34.

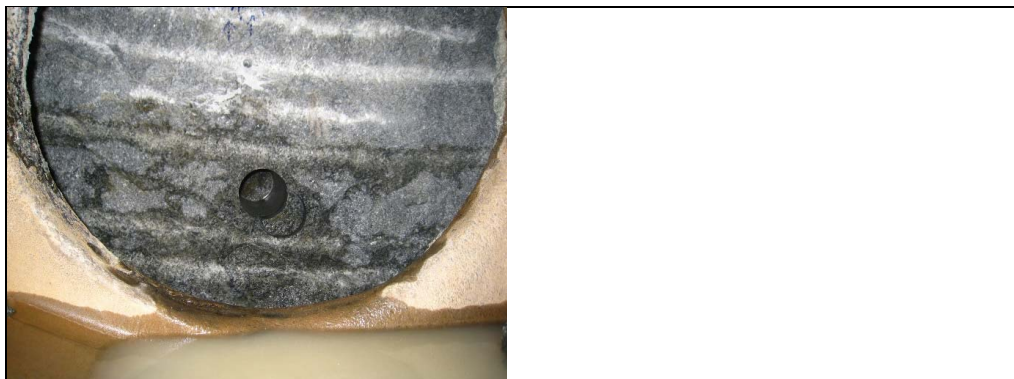
Figure C1.1: Sampling at AMR_11573.

Date:	25.02.2013	Rock type:	Monzo granite
Chainage	11572.9	σ_c :	275-372 MPa
Average RPM:	5.9	SJ:	3.3 – 3.7 (very high)
Average thrust:	16 000 kN	S ₂₀ :	47.5 – 50.9 (medium)
Average tonn/disc:	No data	DRI:	43-45 (medium)
Average pressure:	220 bar		
Penetration:	25 mm/min		
	1.5 m/h		
Average torque:	No available information		
Number of cores:	1

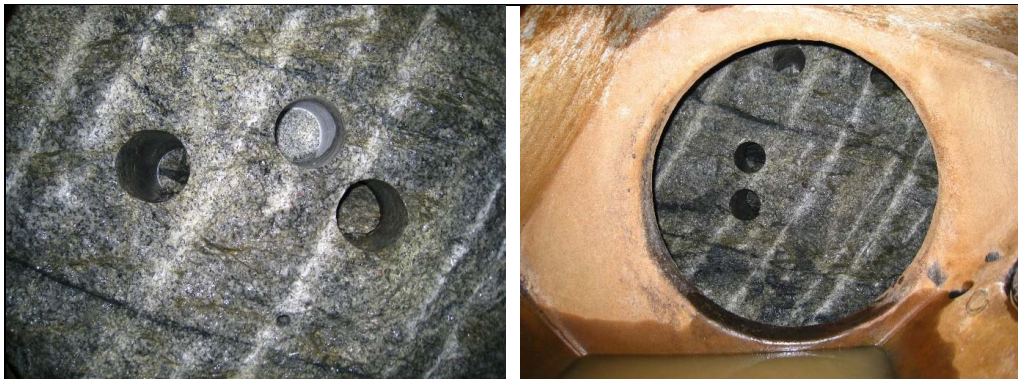
Figure C1.3: Sampling at AMR_11579.

Date:	26.02.2013	Rock type:	Monzo granite
Chainage	11578.8	σ_c :	275-372 MPa
Average RPM:	5.5	SJ:	3.3 – 3.7 (very high)
Average thrust:	16 000 kN	S ₂₀ :	47.5 – 50.9 (medium)
Average tonn/disc:	No data	DRI:	43-45 (medium)
Average pressure:	220 bar		
Penetration:	27 mm/min		
	1.6 m/h		
Average torque:	No available information		
Number of cores:	1

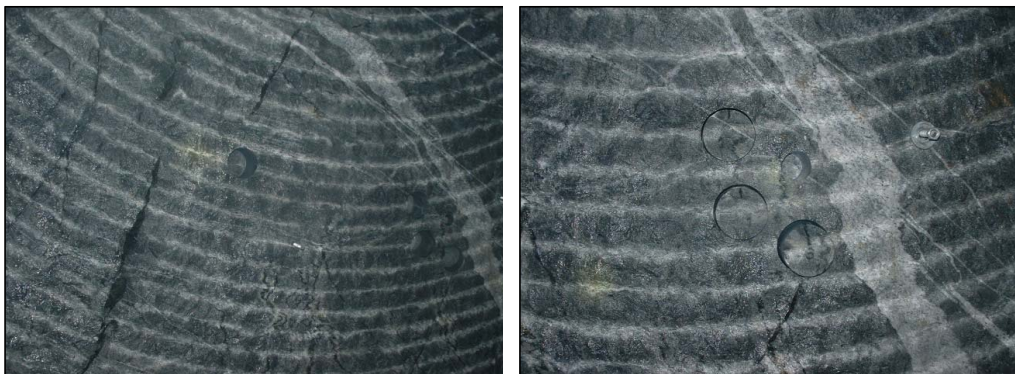
Figure D1.1: Sampling at R_1184.

All cutters where 19" cutters, with a cutter width of 7/8".

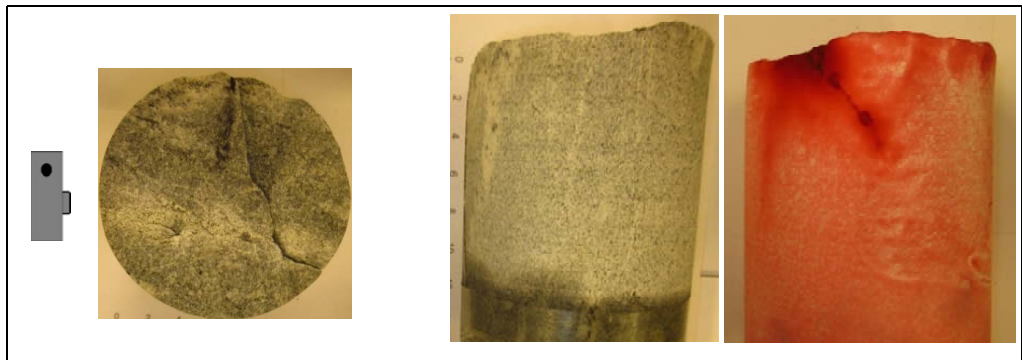
Figure D1.2: Core sample R_1184_1-1_21.

Circumference:	328 mm	Distance from 0-line to lowest point on surface:	19 mm
Number of cracks:	13	Area between 0-line and surface:	22.4 cm ²
Number of cracks with dip < 3°:	2

Additional information:
 The longest crack propagates through the entire core, but was not observed further in the borehole.

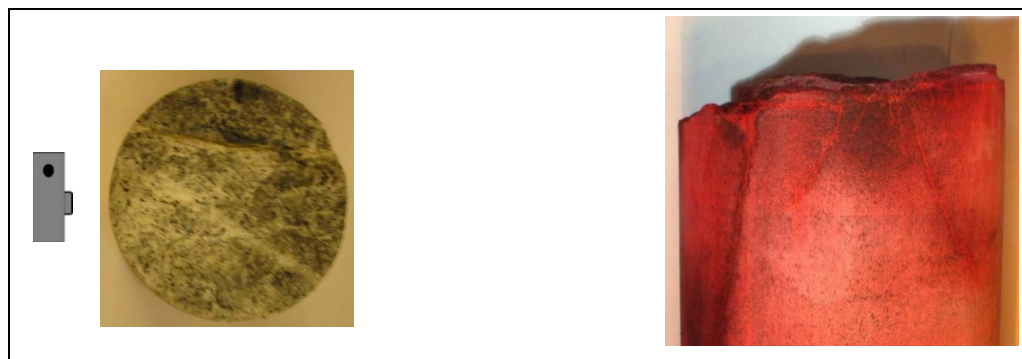
Figure D1.3: Core sample R_1184_1-2_22.

Circumference:	325 mm	Distance from 0-line to lowest point on surface:	16 mm
Number of cracks:	16	Area between 0-line and surface:	19.3 cm ²
Number of cracks with dip < 3°:	3

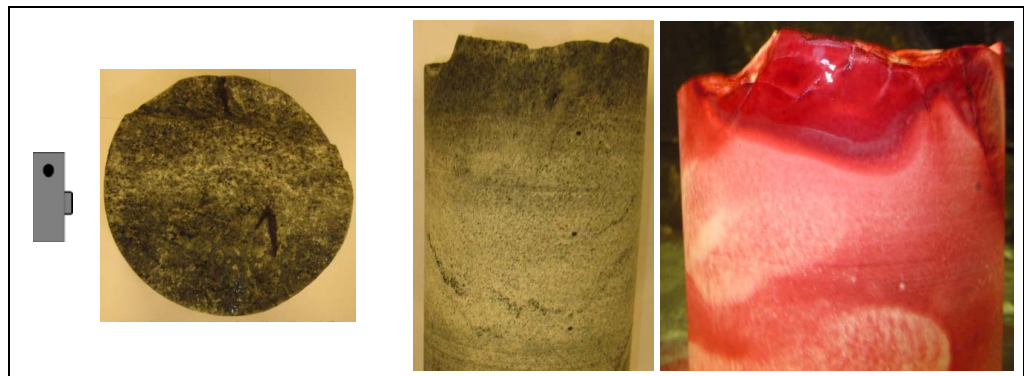
Figure D1.5: Core sample R_1184_1-4_24.

Circumference:	328 mm	Distance from 0-line to lowest point on surface:	18 mm
Number of cracks:	30	Area between 0-line and surface:	27.6 cm ²
Number of cracks with dip < 3°:	6

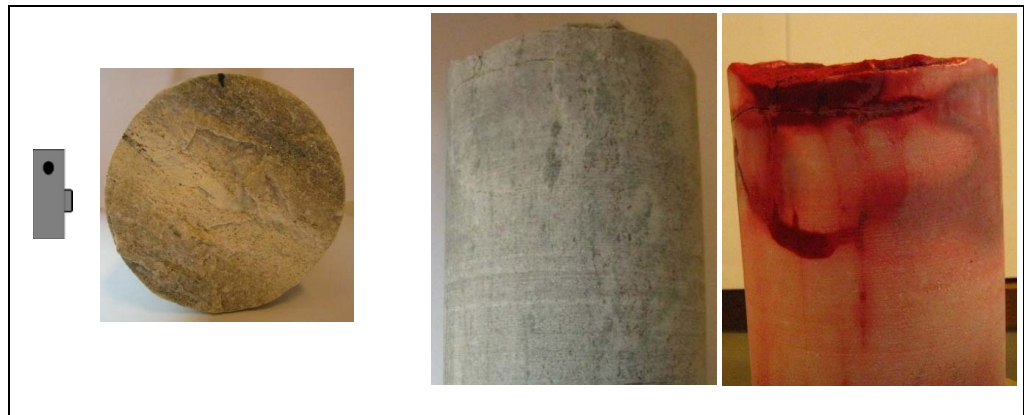
Figure D1.14: Core sample R_3112_3-2_22.

Circumference:	329 mm	Distance from 0-line to lowest point on surface:	11 mm
Number of cracks:	18	Area between 0-line and surface:	17.6 cm ²
Number of cracks with dip < 3°:	0

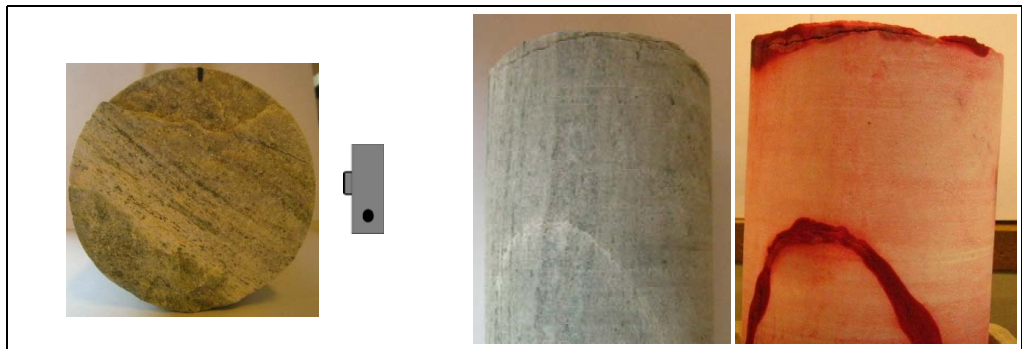
Figure D1.15: Core sample R_3112_3-3_23.

Circumference:	329 mm	Distance from 0-line to lowest point on surface:	11 mm
Number of cracks:	12	Area between 0-line and surface:	15.9 cm ²
Number of cracks with dip < 3°:	2

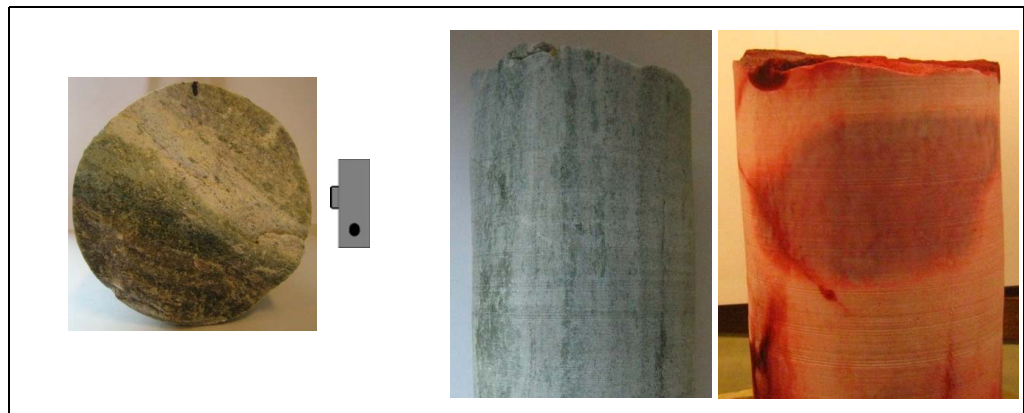
Figure D1.16: Core sample R_3112_3-4_23.

Circumference:	322 mm	Distance from 0-line to lowest point on surface:	11 mm
Number of cracks:	13	Area between 0-line and surface:	15.4 cm ²
Number of cracks with dip < 3°:	2

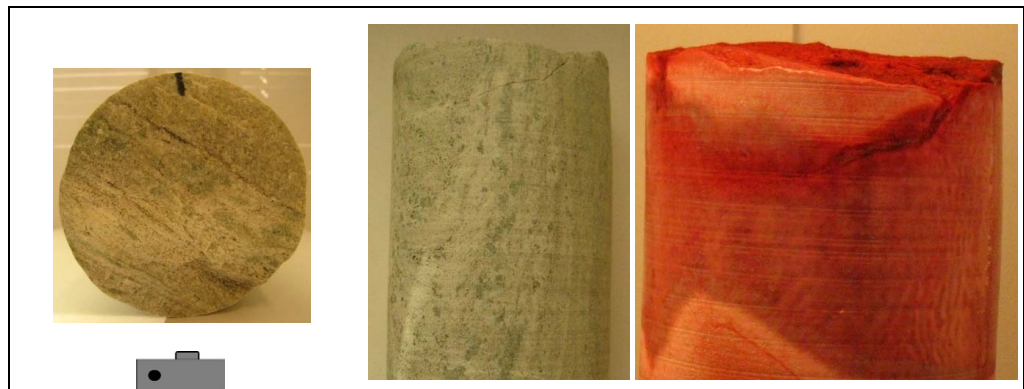
Figure D1.20: Core sample R_3112_4-4_24.

Circumference:	321 mm	Distance from 0-line to lowest point on surface:	15 mm
Number of cracks:	18	Area between 0-line and surface:	16.6 cm ²
Number of cracks with dip < 3°:	4

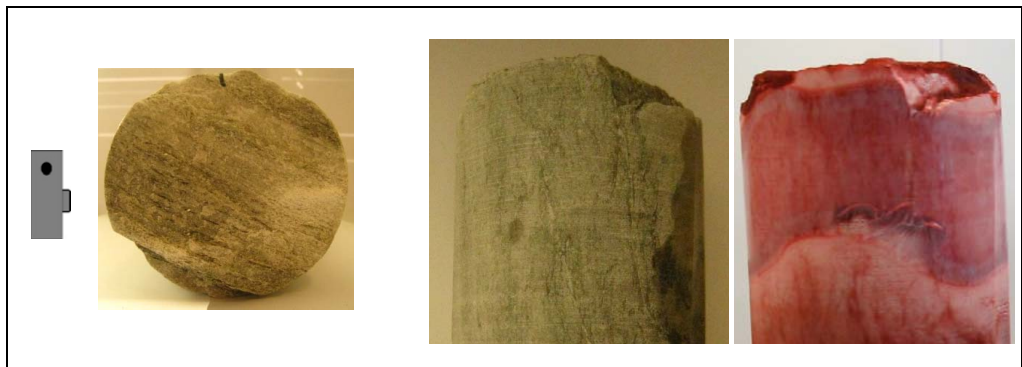
Figure D1.21: Core sample R_3112_5-1_27.

Circumference:	328 mm	Distance from 0-line to lowest point on surface:	21 mm
Number of cracks:	26	Area between 0-line and surface:	31.4 cm ²
Number of cracks with dip < 3°:	3

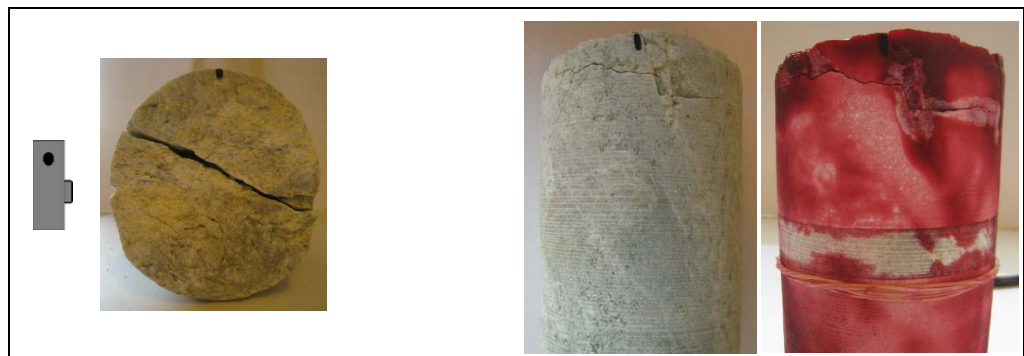
Figure D1.24: Core sample R_3112_6-1_37.

Circumference:	319 mm	Distance from 0-line to lowest point on surface:	30 mm
Number of cracks:	24	Area between 0-line and surface:	45.5 cm ²
Number of cracks with dip < 3°:	5

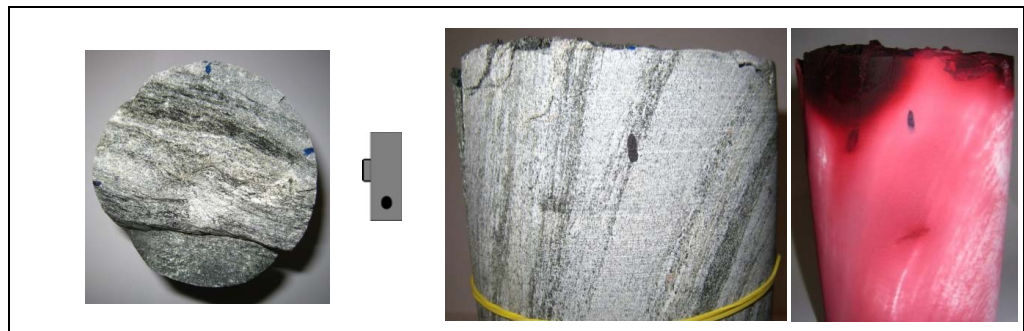
Figure D1.26: Core sample R_5437_1-1_21.

Circumference:	328 mm	Distance from 0-line to lowest point on surface:	23 mm
Number of cracks:	21	Area between 0-line and surface:	36.5 cm ²
Number of cracks with dip < 3°:	2

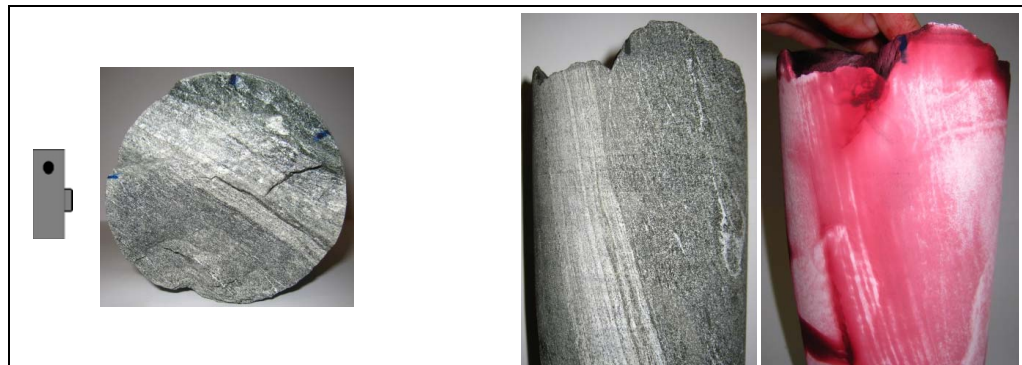
Figure D1.28: Core sample R_5437_1-3_23.

Circumference:	328 mm	Distance from 0-line to lowest point on surface:	24 mm
Number of cracks:	16	Area between 0-line and surface:	37.4 cm ²
Number of cracks with dip < 3°:	1

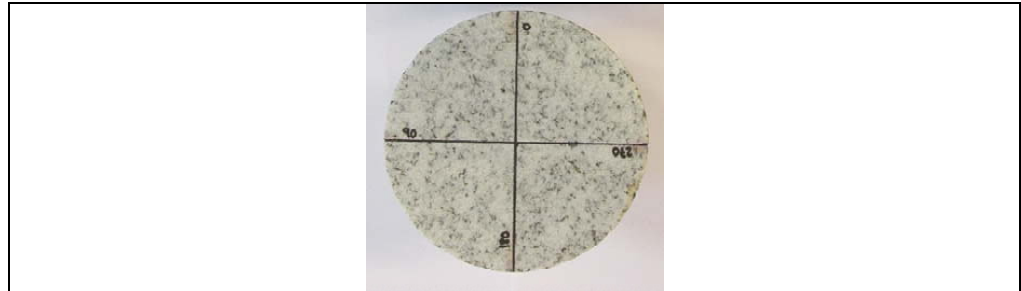
Additional information:
Used for sound velocity measurements before and after initiation of cracks.

Figure F1.18: Core sample S_9-2.

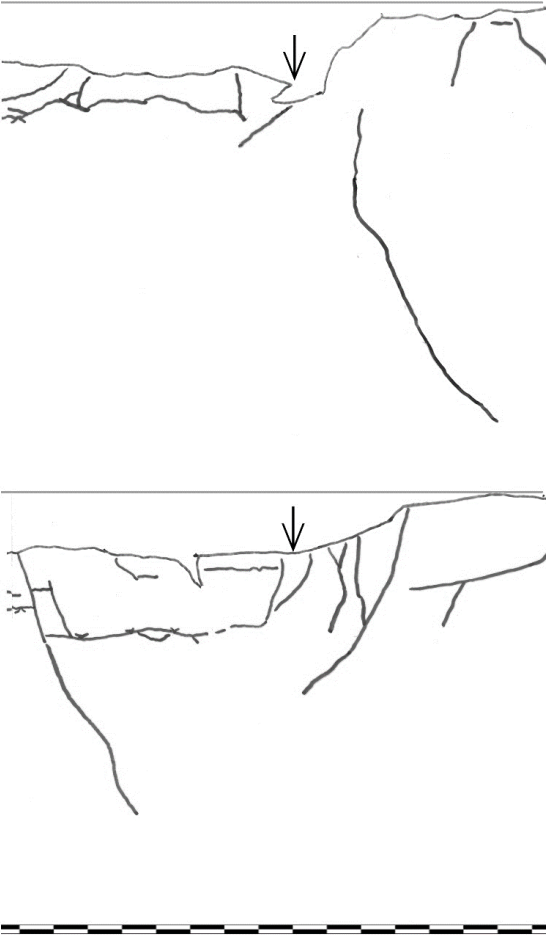
R_3112_6-1_37

Figure I1.22: Surface and crack pattern under the cutter groove in core sample R_3112_6-1_37.

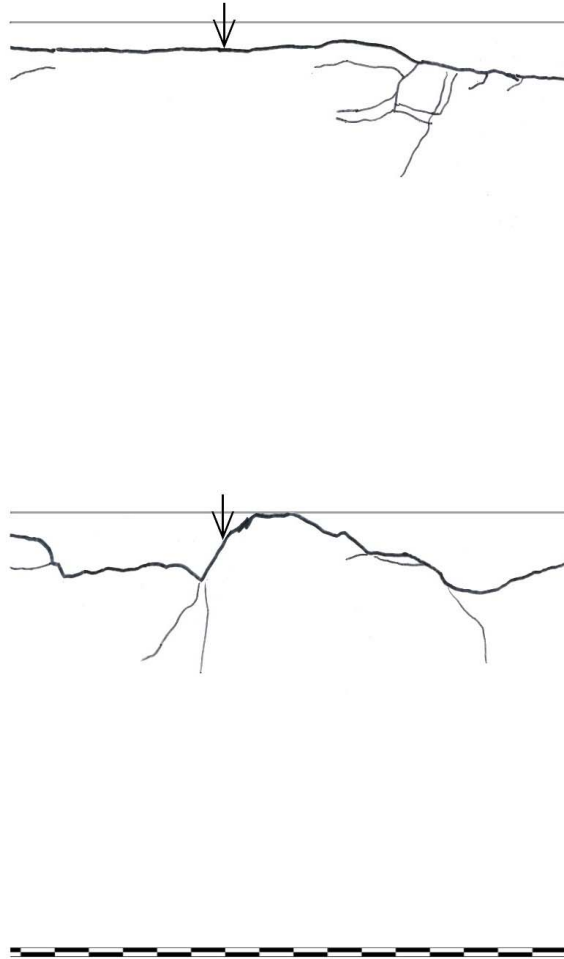
R_5437_1-3_23

Figure I1.25: Surface and crack pattern under the cutter groove in core sample R_5437_1-3_23.

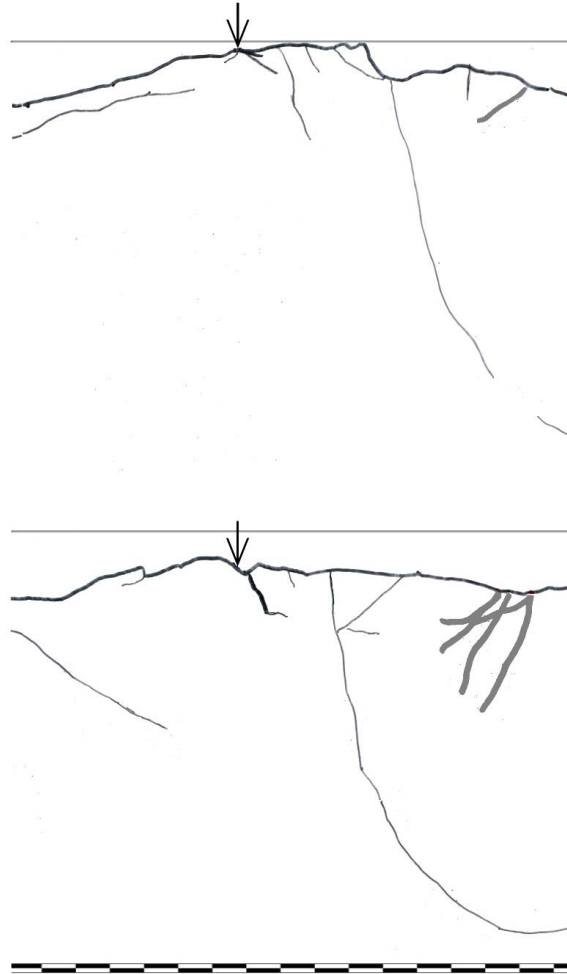
R_5437_2-4_24

Figure I1.30: Surface and crack pattern under the cutter groove in core sample R_5437_2-4_24.

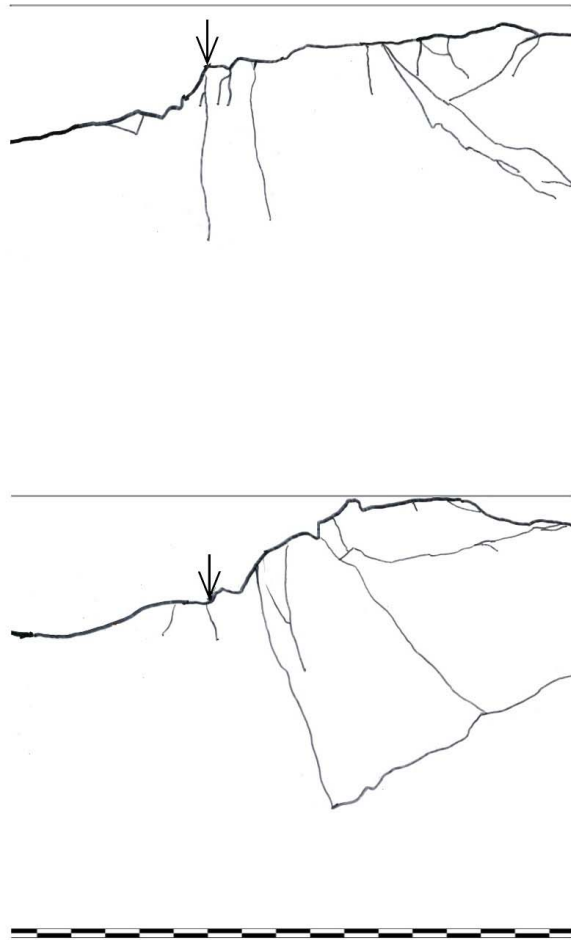
R_5437_3-4_25

Figure I1.34: Surface and crack pattern under the cutter groove in core sample R_5437_3-4_25.

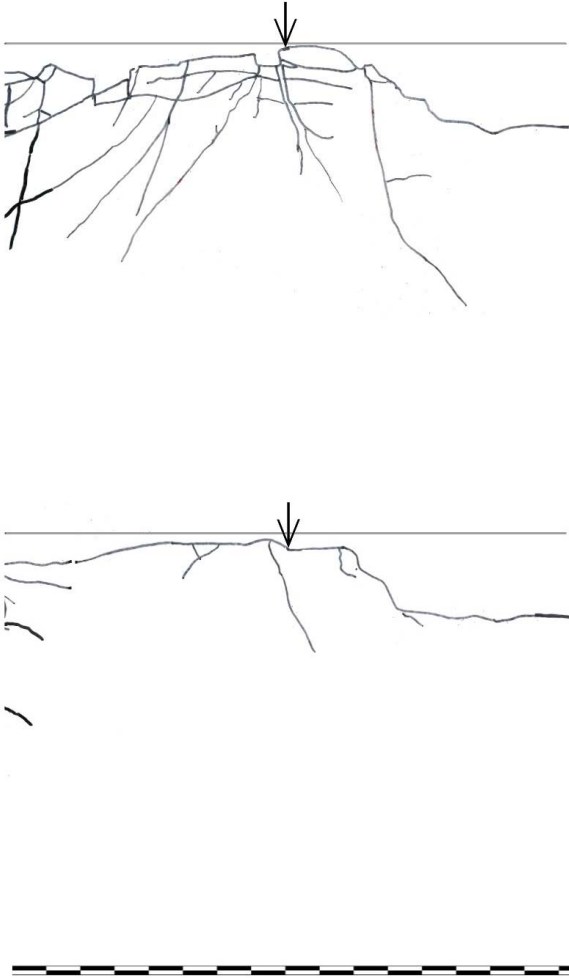
R_5437_4-4_24

Figure I1.38: Surface and crack pattern under the cutter groove in core sample R_5437_4-4_24.

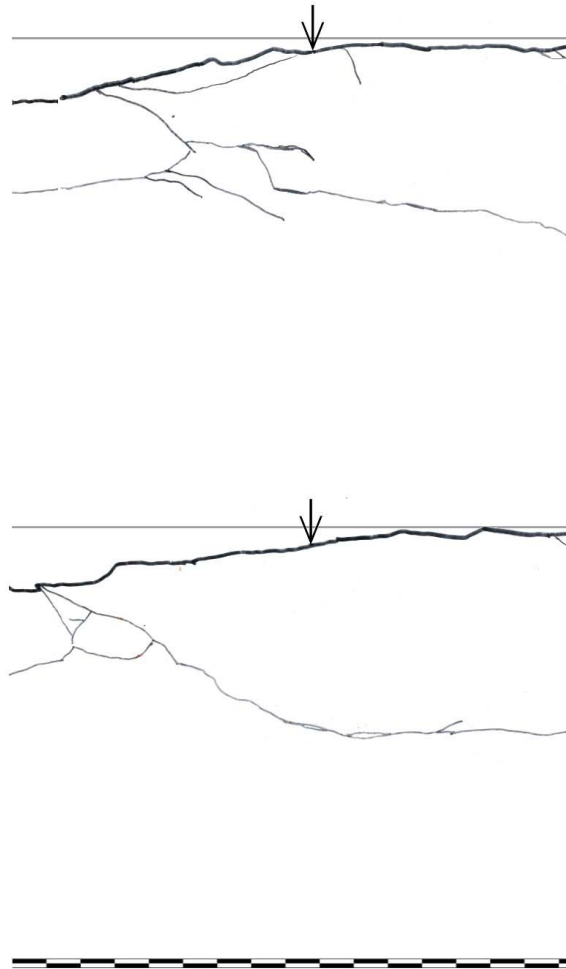
R_5458_1-3_23

Figure I1.41: Surface and crack pattern under the cutter groove in core sample R_5458_1-3_23.

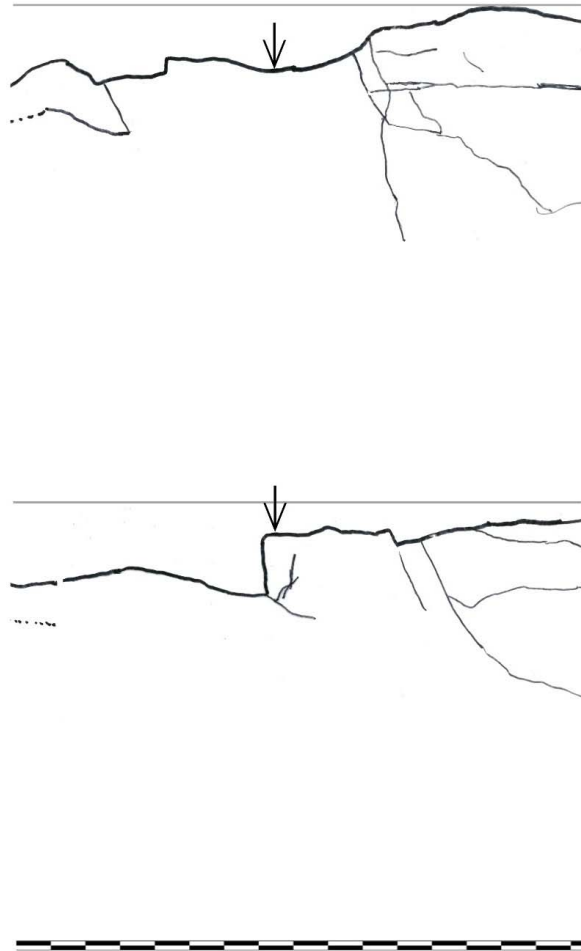
R_5458_4-1_21

Figure I1.51: Surface and crack pattern under the cutter groove in core sample R_5458_4-1_21.
