Critical temperature of welded 25Cr duplex stainless steel in seawater

Master's thesis in Chemical Engineering and Biotechnology

The Norwegian Public Roads Administration (NPRA) is planning to build the world's longest pontoon bridge to cross Bjørnafjorden as a part of the project Coastal Highway Route E39. One of the favored design alternatives involves carbon steel pontoons with a 25Cr super duplex stainless steel (SDSS) section surrounding the pontoon in the splash zone. It is important that the right materials are used in the bridge to fulfill its required lifetime of 100 years. Although SDSS is a strong material with excellent corrosion resistance, its temperature limits in seawater are still a subject of debate. In addition, other design specifications such as welding, coatings and cathodic protection (CP) further challenge the material in this environment.

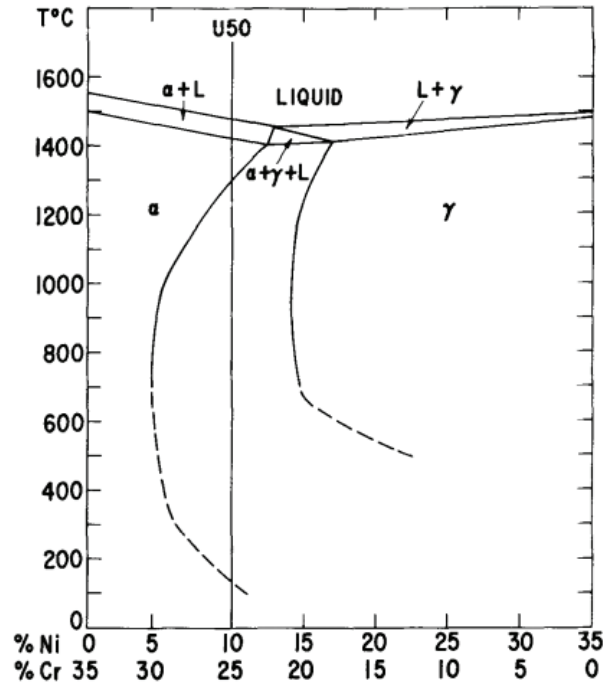
Figure 2.1: Pseudo-binary phase diagram of 65%Fe-Cr-Ni [14].

The duplex microstructure is a result of increasing the Cr content of stainless steels to above 20 wt% and heat treatment in the $\alpha + \gamma$ field. Figure 2.1 shows a phase diagram for a DSS based on a pseudo-binary phase diagram for an alloy with 65 % Fe [13]. This figure illustrates DSSs solidify as 100 % ferrite before reaching the solvus line. Austenite then nucleates and grows, first at the ferrite grain boundaries and later within the ferrite grains along preferred crystallographic directions [9]. As the $\alpha \rightarrow \gamma$ transformation takes place, alloying elements diffuse with γ -stabilizers such as C, N, Ni and Cu, concentrating in the austenite and α -stabilizers such as Cr, Mo and W, concentrating in the ferrite [9].

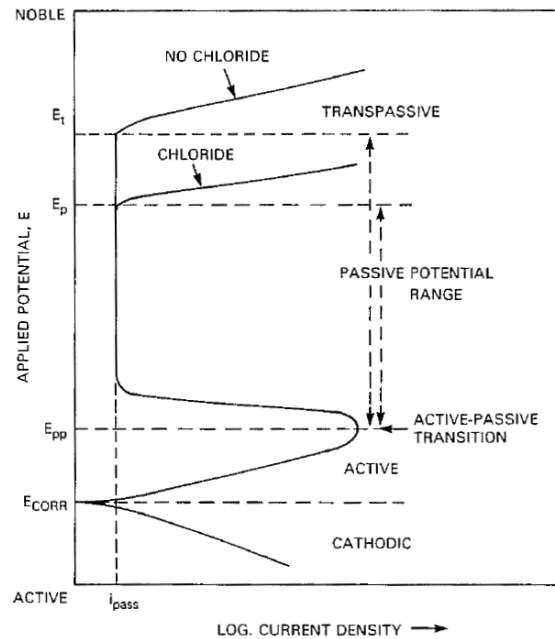
Figure 2.3: Schematic illustration of a polarization curve for a stainless steel showing the potential vs. current behavior during passivity [21].

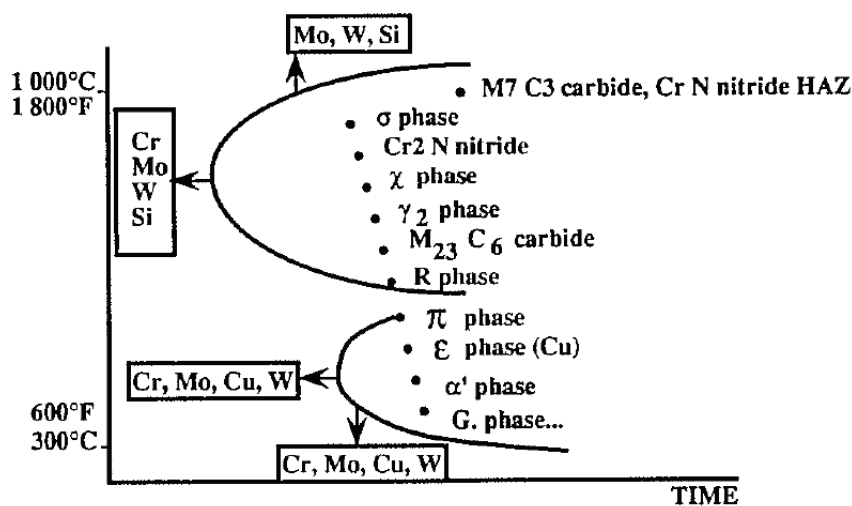
Figure 2.4: TTT diagram illustrating the effect of different alloying elements in the precipitation of various species [27].

Prolonged exposure in the temperature range 300–1000 °C, such as during heat treatment or welding, leads to the undesirable precipitation of intermetallic phases in DSS due to high alloy content and the presence of ferrite [9, 25, 26]. SDSSs are therefore more susceptible to intermetallic phase formation than normal DSSs. Figure 2.4 shows a time temperature transformation (TTT) diagram illustrating the possible precipitations that can take place in SDSS and how different alloying elements affect their occurrence.

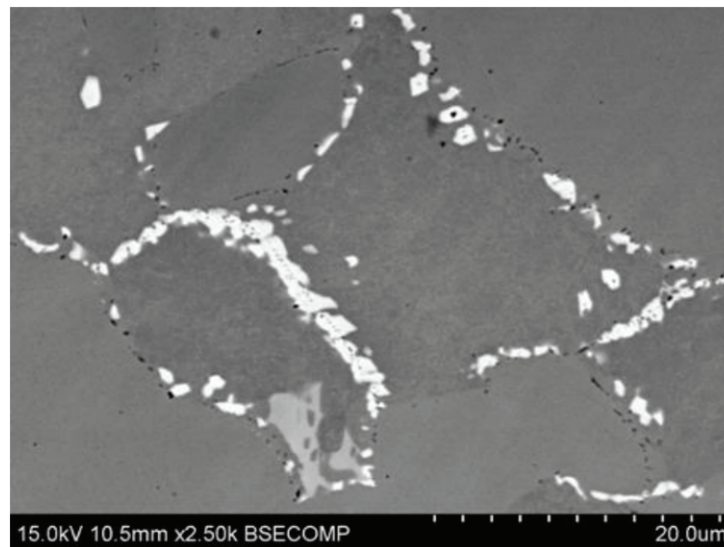
Figure 2.5: σ (light gray particles) and χ (white particles) precipitates in S39274 imaged by SEM/BSE [30].

The χ phase often coexists with the σ phase and, since it also decreases toughness and corrosion resistance, it is difficult to isolate its effects [28]. Figure 2.5 shows the σ and χ precipitates in S39274, a W-containing SDSS [29].

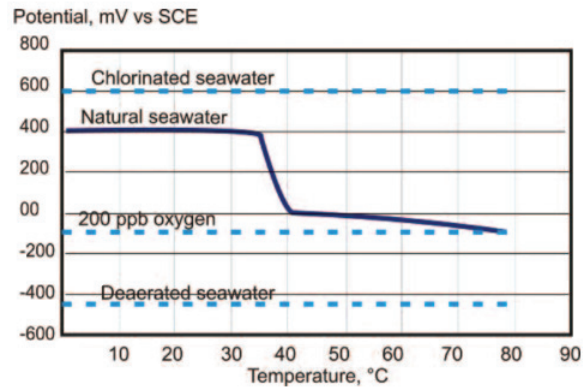
Figure 2.6: Corrosion potentials of Sandvik SAF 2507 in different types of seawater environments [68].

Shifting the corrosion potential of stainless steels to higher values due to ennoblement by biofilms or chlorination makes the material more susceptible to localized corrosion attacks. For SDSS, ennoblement due to biofilm reaches values above +300 mV vs. SCE after a few weeks of exposure [12, 56], whereas in chlorinated seawater these values can reach +600 mV vs. SCE [12, 67]. The corrosion potentials of SAF 2507 (S32750) in different types of seawater environments are shown in Figure 2.6.

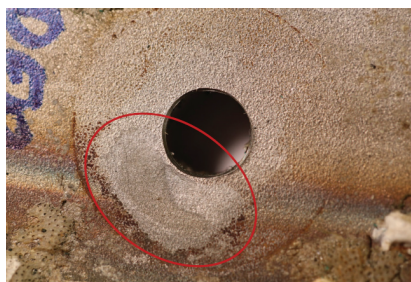
Figure 3.1: Corrosion attack under an artificial crevice former on the HAZ [90].

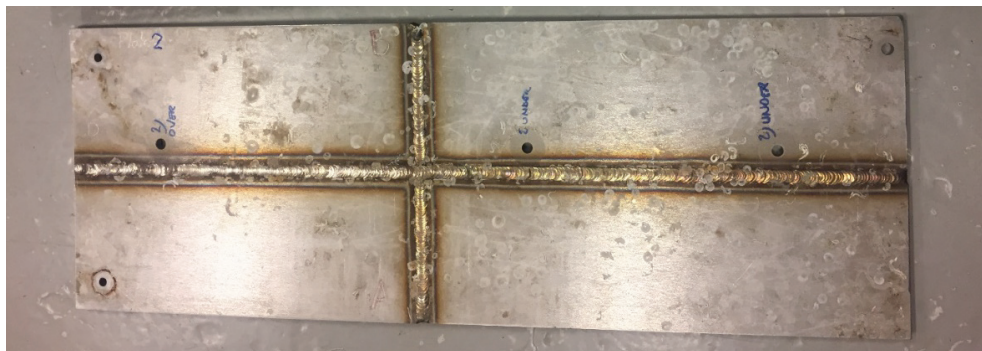
(b) Sample welded under high heat input without pickling.

Figure 3.2: Welded samples of different qualities after exposure [90].

Knudsen from SINTEF Industry [90] carried out a field test from the 21st of June to the 16th of November of 2018 of welded S32750 in natural seawater in Oslofjorden. The summer of 2018 was considered to be warmer than usual, so it was assumed the samples experienced temperatures above 20 °C. The samples were TIG-welded manually using Zeron 100X [91] as filler metal. Artificial crevices were placed on the HAZ of four different welded plates which had four different weld qualities; two welded under normal heat input, of which one was pickled after welding and the other was not, and two welded under high heat input, of which one was pickled after welding and the other was not. None of the welding procedures, however, precipitated σ phase. Crevice corrosion attacks initiated on all not pickled samples while the pickled samples showed no signs of corrosion. It was then concluded that pickling reduces the risk of crevice corrosion initiation significantly in an environment similar to Bjørnafjorden. Figure 3.1 shows a corrosion attack on one of the samples and Figure 3.2 shows two of the weld qualities tested after exposure. The holes in the samples on the HAZ correspond to the spots where the artificial crevices were located, not to be confused with the holes at the corners which were used to secure the samples.

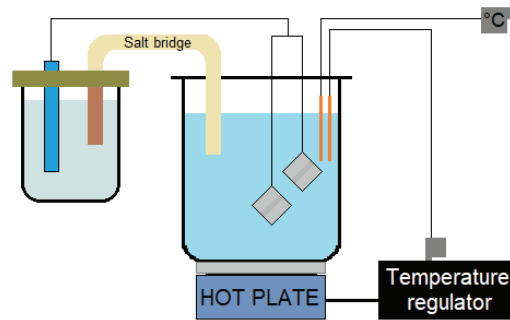
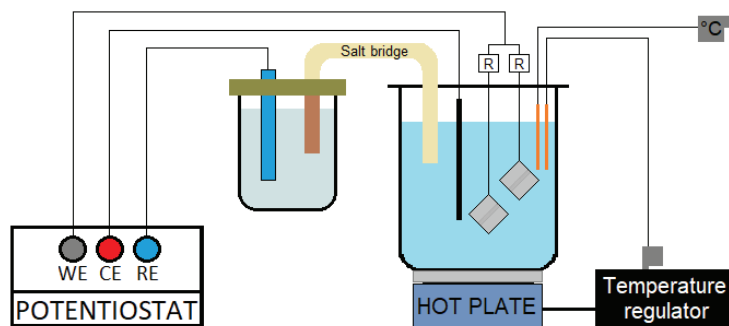
(a) Schematic diagram of the experimental setup for freely-exposed samples.

(b) Schematic diagram of the experimental setup for polarized samples.

Figure 4.3 shows the experimental setup used to determine the critical temperature of polarized and freely-exposed samples. In these figures, WE, CE and RE stand for working electrode, counter electrode and reference electrode respectively, while R symbolizes the resistances the samples were connected to and which are equal to 1Ω .

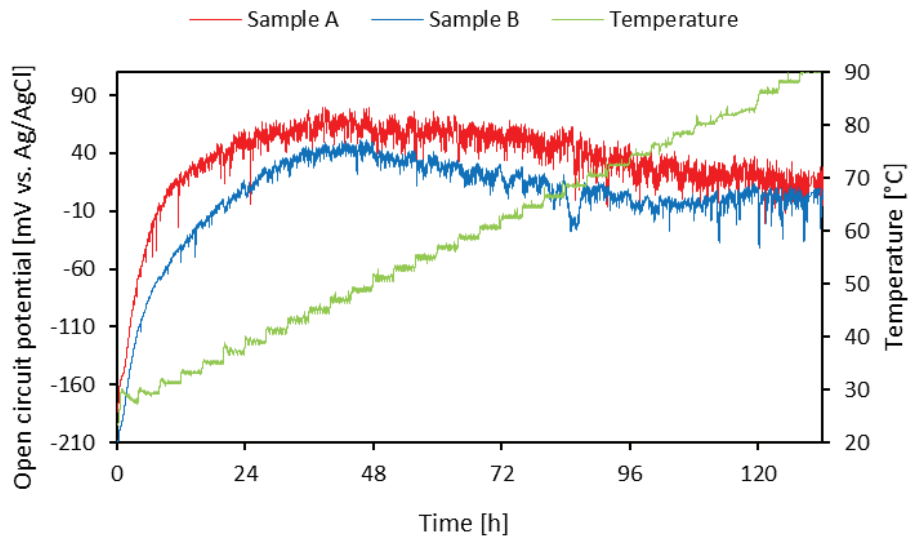
Figure 4.4: Open circuit potential development as a function of time and temperature for the TIG-welded, not pickled, not coated samples exposed at OCP.

The TIG-welded, not pickled, not coated samples exposed at OCP did not initiate corrosion during the test which ran until 90 °C as it can be seen from the lack of a potential drop in Figure 4.4. Additionally, brown rust was not seen on the samples during the test and corrosion attacks were not detected with the microscope.

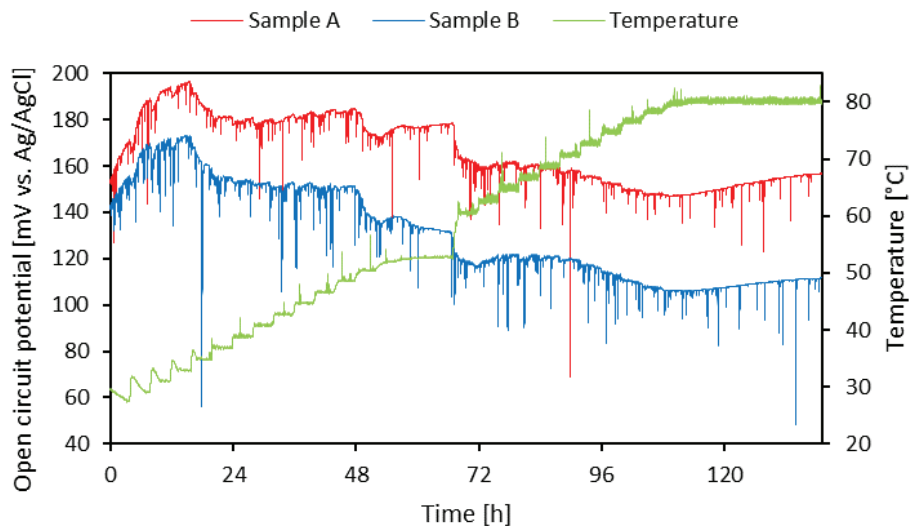
Figure 4.5: Open circuit potential development function of time and temperature for the laser-welded, not pickled, not coated samples exposed at OCP.

Similarly, for the laser-welded not pickled, not coated samples exposed at OCP, no corrosion attack seems to have taken place as it can be seen in Figure 4.5 where the only drops are a product of noise in the data. Also, brown rust was not seen on the samples during the test and corrosion attacks were not detected with the microscope. However, some faults with the temperature regulator made the temperature stay at 80 °C for the remainder of the test instead of increasing all the way to 90 °C. Another similar fault took place after approximately 57 hours which explain the abrupt change in temperature from 52 °C to 60 °C.

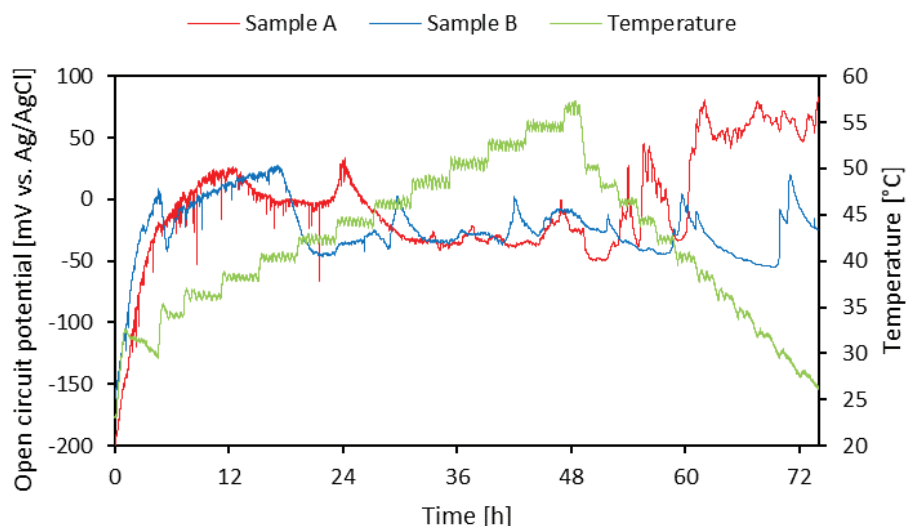
Figure 4.6: Open circuit potential development as a function of time and temperature for the TIG-welded, not pickled, coated samples exposed at OCP.

Figure 4.6 shows the OCP development for the TIG-welded, not pickled, coated samples exposed at OCP. Also, the first temperature decrease is larger than the planned 2 °C due to faults with the temperature regulator. Nevertheless, it is possible to see that the potential of Sample B begins to drop at 40 °C which was confirmed by the presence of orange rust before the temperature was increased to 42 °C. For Sample A, however, the T_{crit} was less evident due to a more gradual decrease in potential. Very small amounts of brown rust were seen as the temperature was 42 °C, therefore, this temperature was later chosen to be T_{crit} for Sample A, even though the OCP had stayed approximately constant since the temperature change to 40 °C. Because the potential drop happened gradually as the samples began to corrode, the temperature regulator was not adjusted to decrease the temperature until the day after, when the presence of brown rust was more visible for Sample A. Moreover, it can also be seen in Figure 4.6 that only Sample A managed to repassivate during the test.

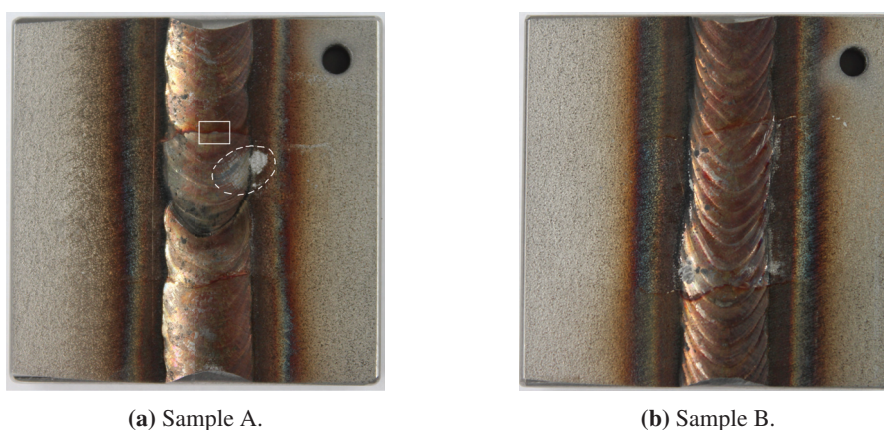
Figure 4.7: Corrosion attacks on the TIG-welded, not pickled, coated samples exposed at OCP.

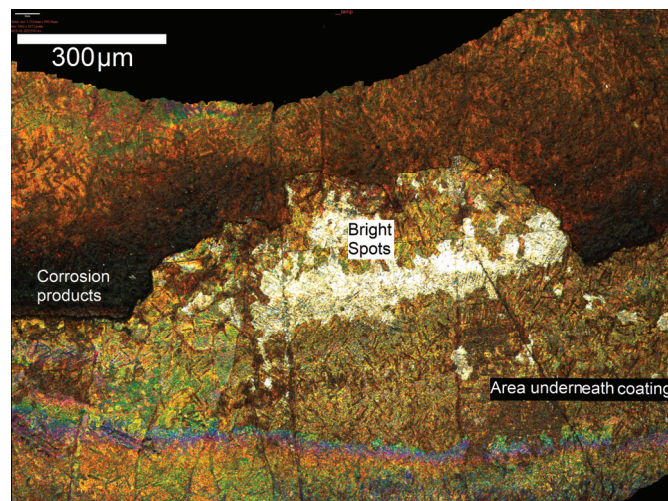
Figure 4.8: Corrosion damage along the coating edge of the TIG-welded, not pickled, coated, Sample A which was exposed at OCP.

shows that this attack, like the other ones on these samples, is shallow.

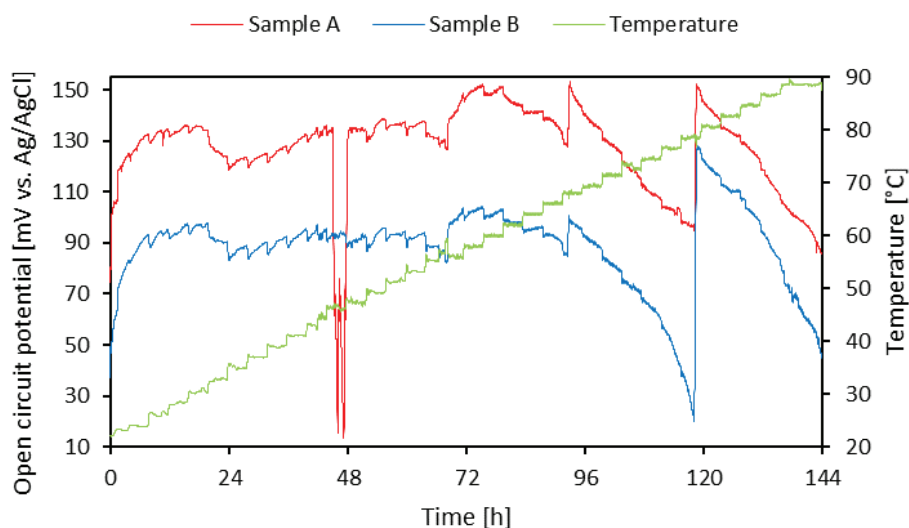
Figure 4.9: Open circuit potential development as a function of time and temperature for the TIG-welded, pickled, coated samples exposed at OCP.

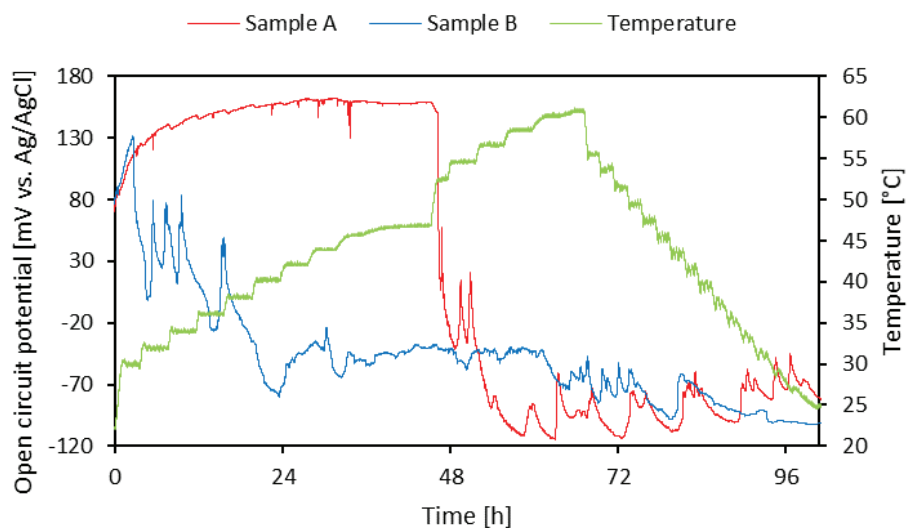
Figure 4.10: Open circuit potential development as a function of time and temperature for the laser-welded, not pickled, coated samples exposed at OCP.

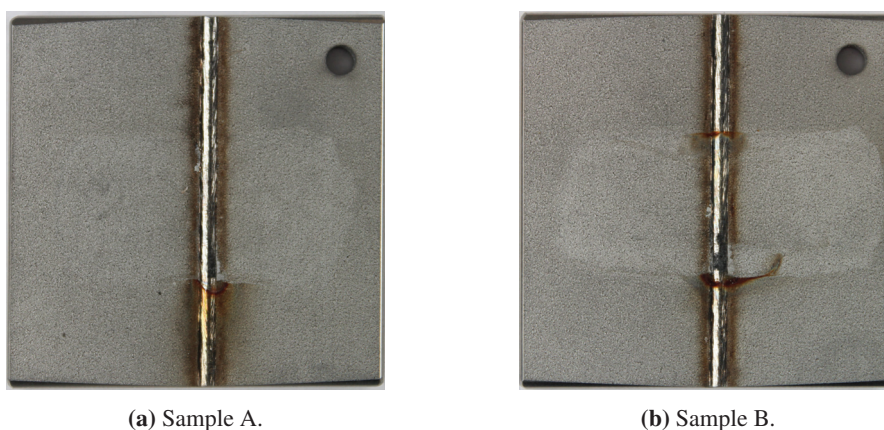
Figure 4.11: Corrosion attacks on the laser-welded, not pickled, coated samples exposed at OCP.

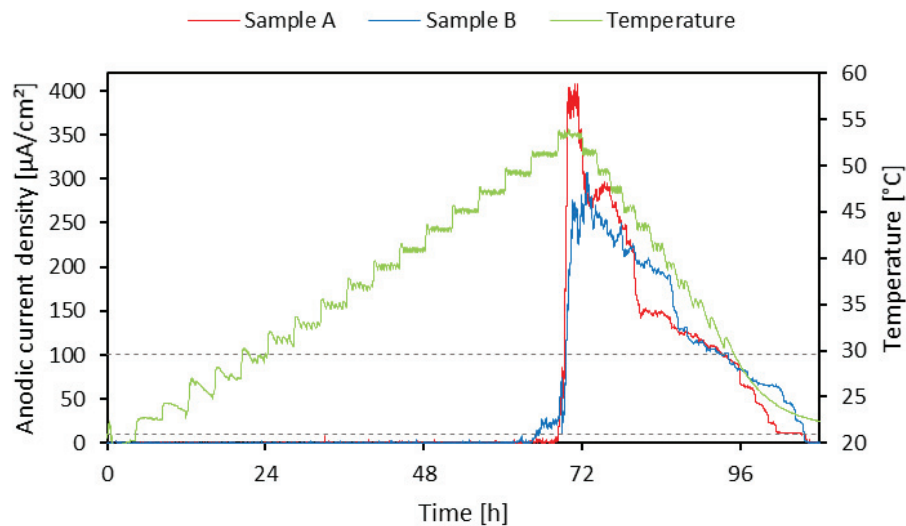
Figure 4.12: Anodic current density as a function of time and temperature for the TIG-welded, not pickled, not coated samples polarized to +400 mV vs. Ag/AgCl.

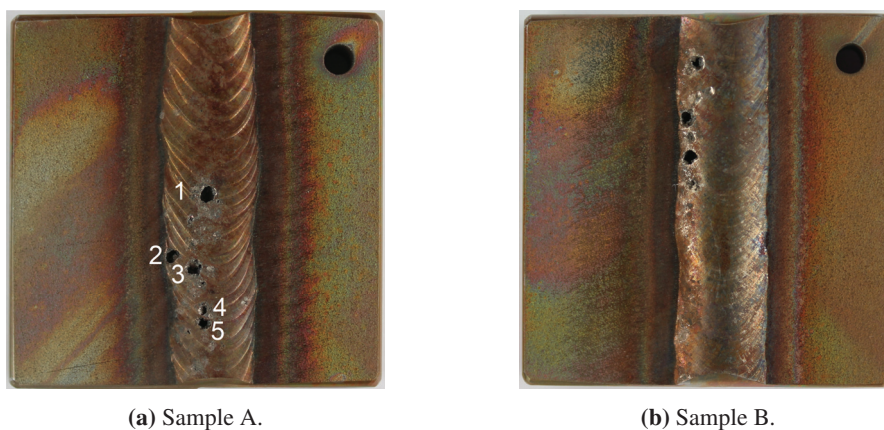
Figure 4.13: Corrosion attacks on the TIG-welded, not pickled, not coated samples polarized to +400 mV vs. Ag/AgCl.

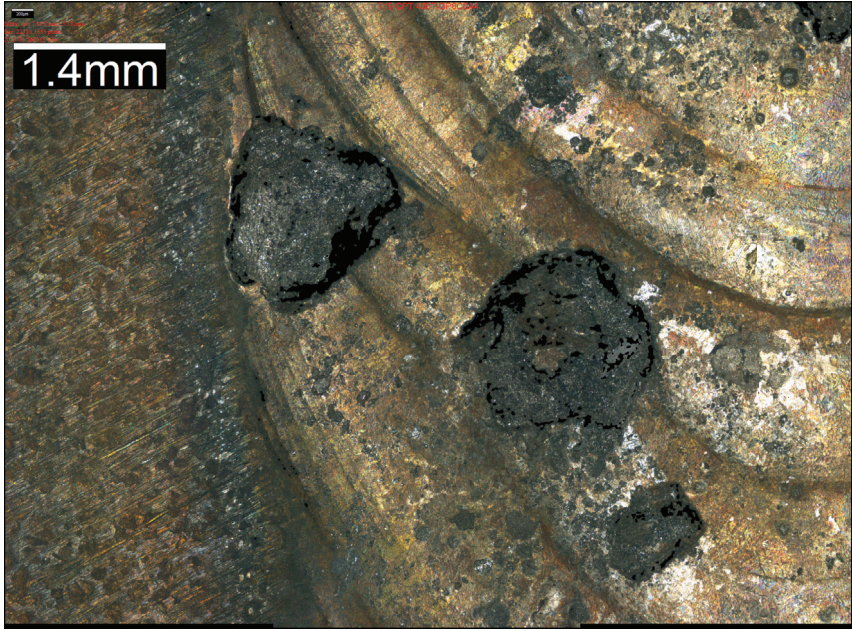
(a) IFM image showing corrosion attack.

Figure 4.15: Corrosion attack in the form of pitting on the TIG-welded, not pickled, not coated Sample A (Pit 2 and 3) which was polarized to +400 mV vs. Ag/AgCl, imaged by IFM.

The largest pits in Sample A were examined further in the IFM. Figure 4.14 shows Pit 1, Figure 4.15 shows Pit 2 and 3, and Figure 4.16 shows Pit 4 and 5. Pit 1 had a depth of 1.34 mm, Pit 2 was 1.18 mm deep, Pit 3 was 1.24 mm deep, Pit 4 was 0.78 mm deep, and Pit 5 was 1.53 mm deep.

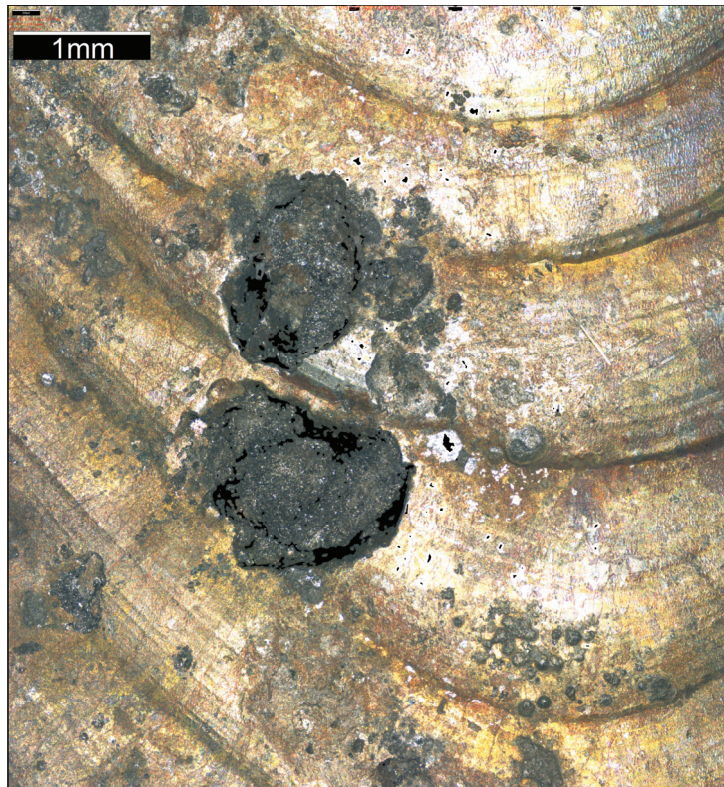
(a) IFM image showing corrosion attack.

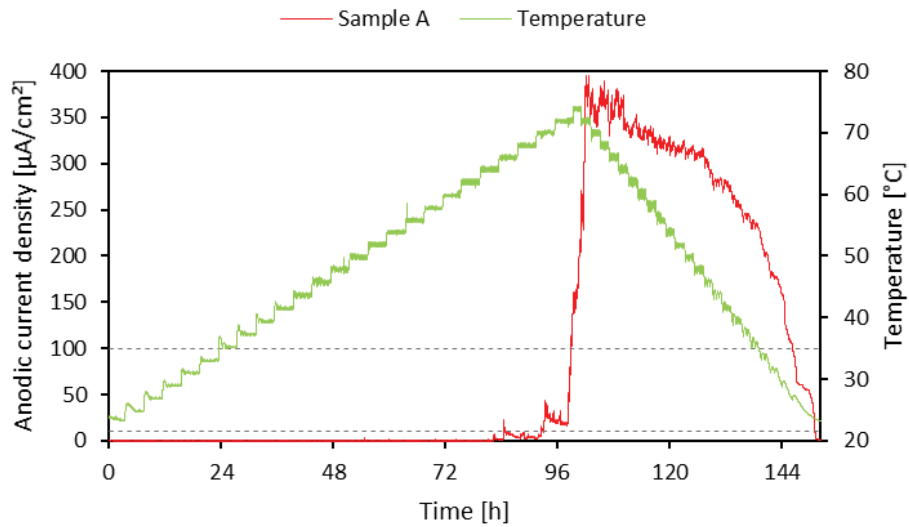
Figure 4.17: Anodic current density as a function of time and temperature for the TIG-welded, pickled, not coated sample polarized to +400 mV vs. Ag/AgCl.

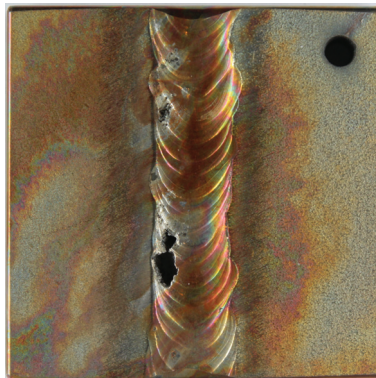
Figure 4.18: Corrosion attacks on the TIG-welded, pickled, not coated sample polarized to +400 mV vs. Ag/AgCl.

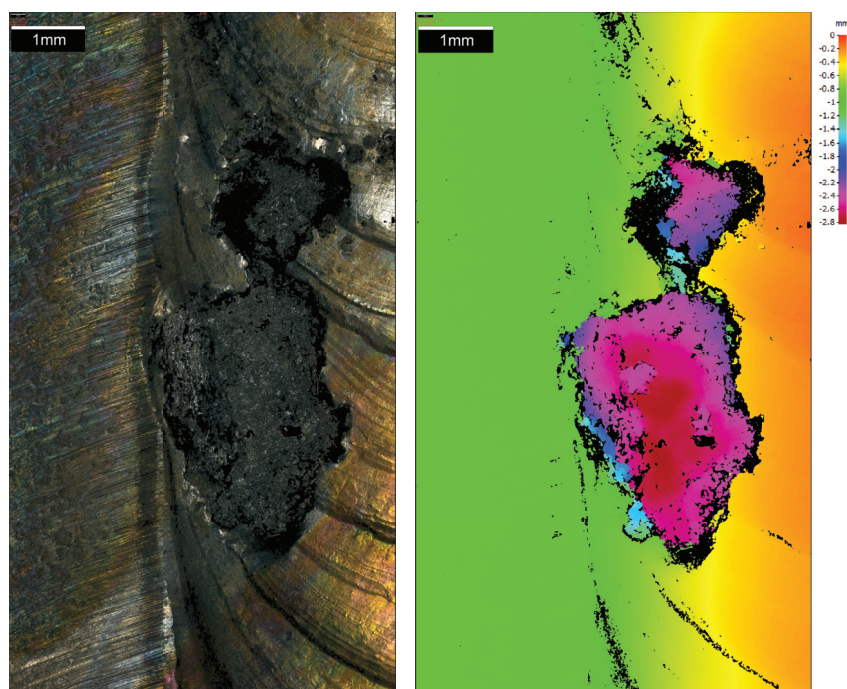
(a) IFM image showing corrosion attack.

The largest pit in the sample was imaged in the IFM as shown in Figure 4.19. The pit reached a depth of 2.12 mm.

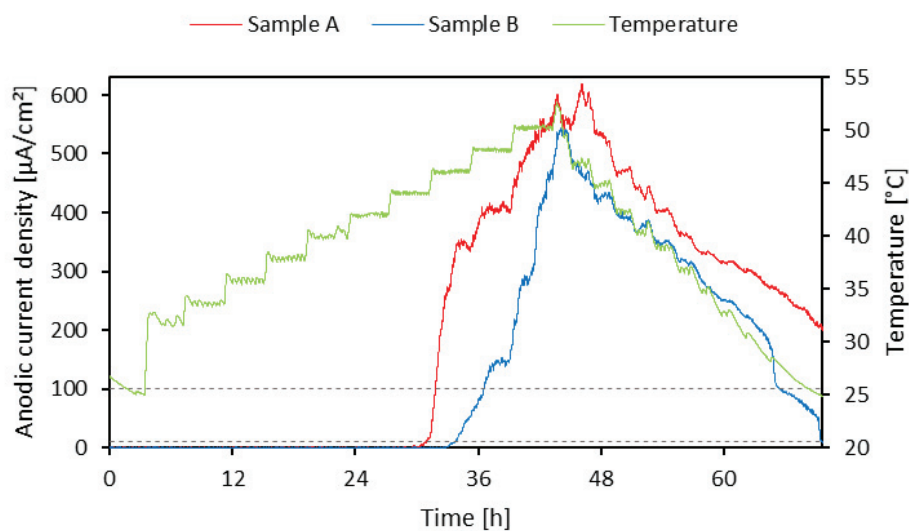
Figure 4.20: Anodic current density as a function of time and temperature for the laser-welded, not pickled, not coated samples polarized to +400 mV vs. Ag/AgCl.

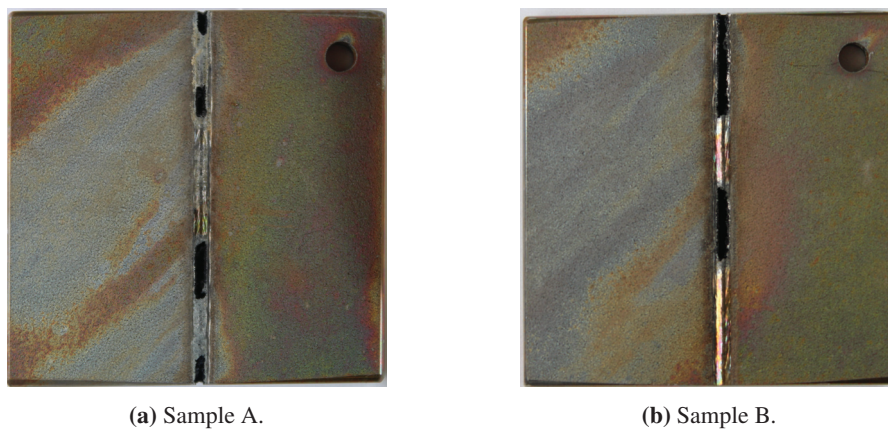
Figure 4.21: Corrosion attacks on the laser-welded, not pickled, not coated samples polarized to +400 mV vs. Ag/AgCl.

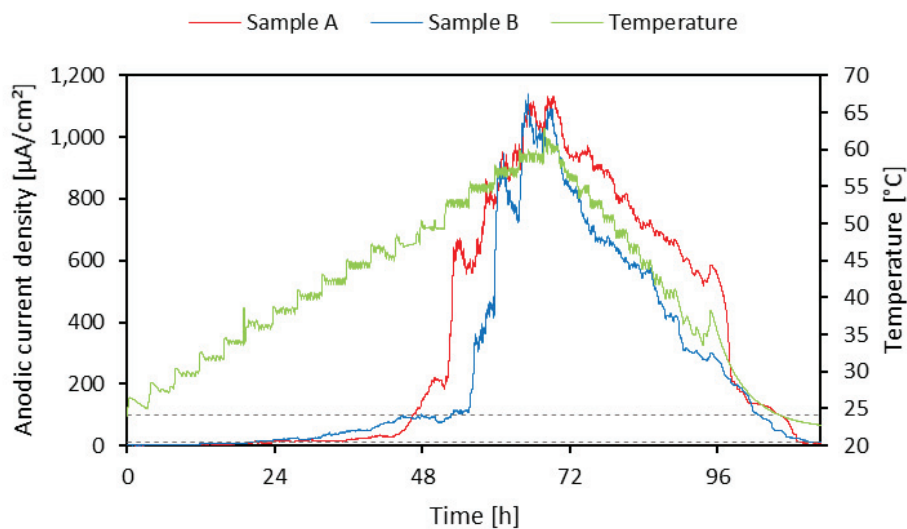
Figure 4.22: Anodic current density as a function of time and temperature for the TIG-welded, not pickled, coated samples polarized to +400 mV vs. Ag/AgCl.

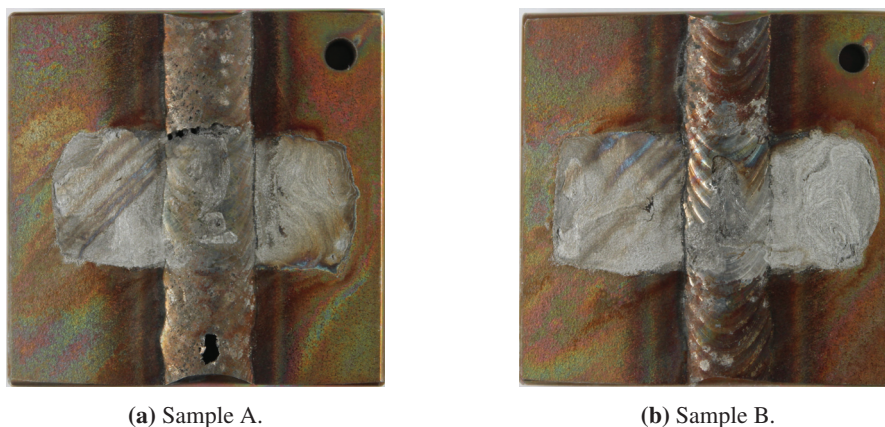
Figure 4.23: Corrosion attacks on the TIG-welded, not pickled, coated samples polarized to +400 mV vs. Ag/AgCl.

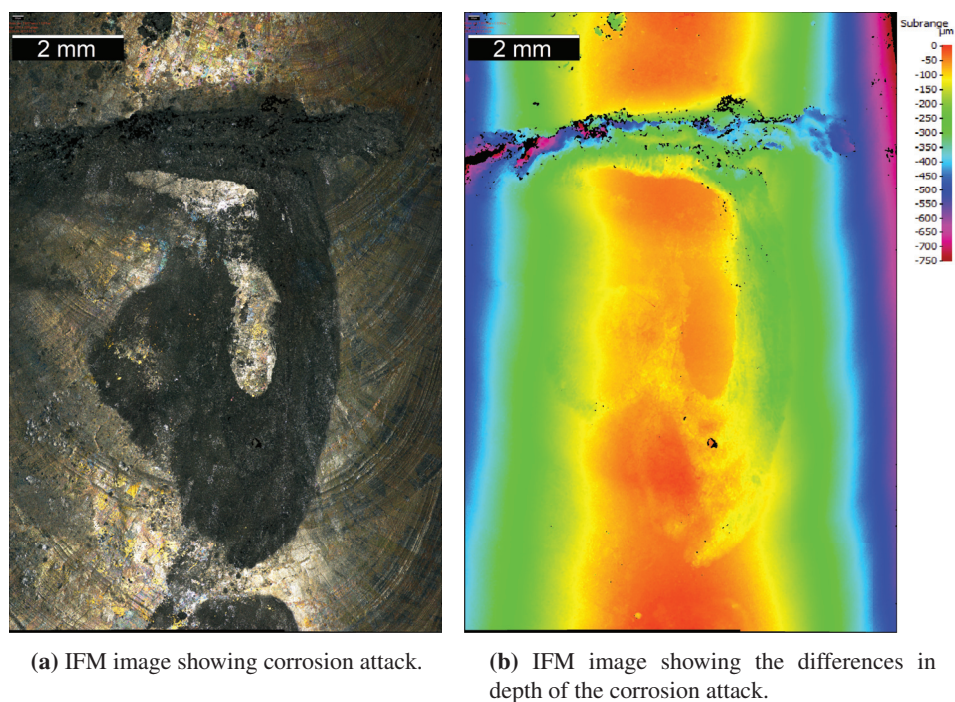
Figure 4.24: Crevice corrosion attack on the TIG-welded, not pickled, coated Sample A which was polarized to +400 mV vs. Ag/AgCl, imaged by IFM.

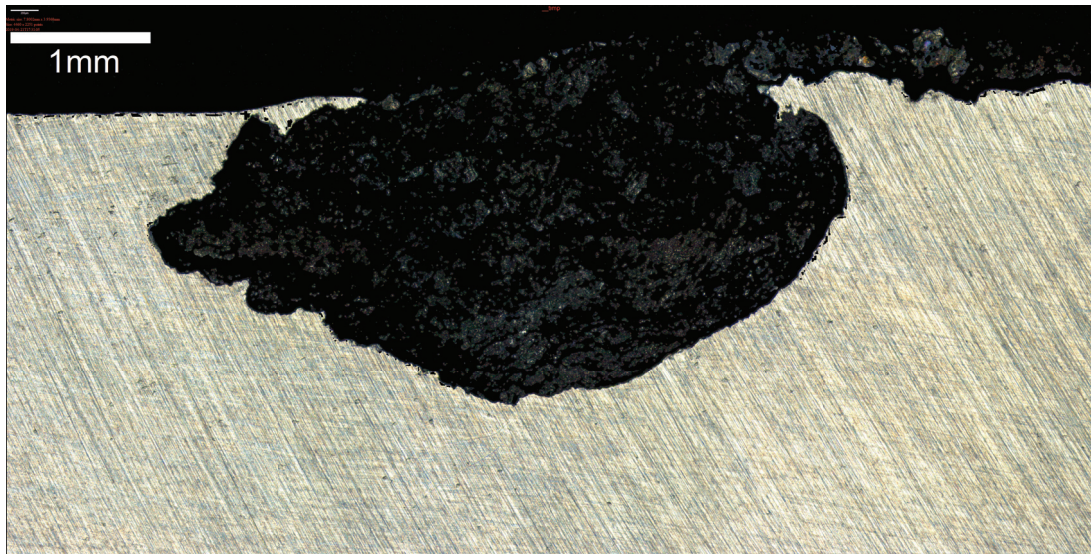
Figure 4.25: Cross-section of crevice corrosion attack on the TIG-welded, not pickled, coated Sample A which was polarized to +400 mV vs. Ag/AgCl, imaged by IFM.

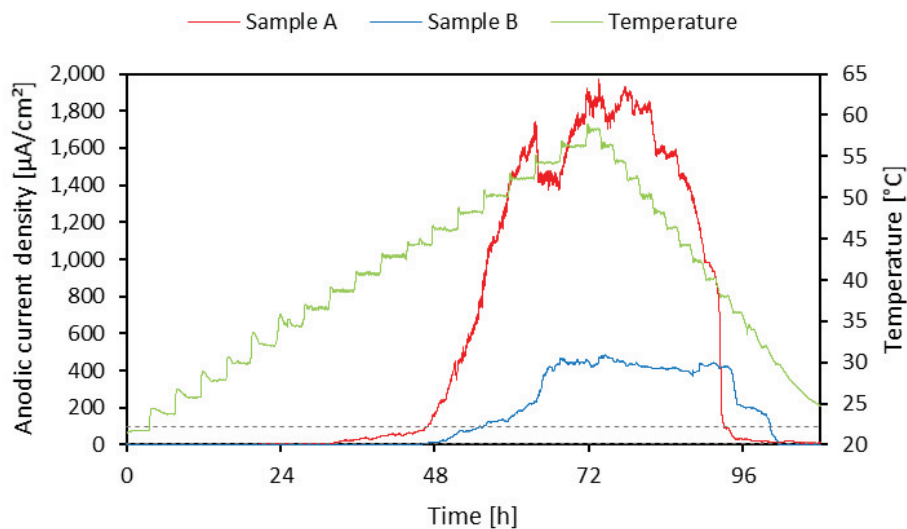
Figure 4.26: Anodic current density as a function of time and temperature for the TIG-welded, pickled, coated samples polarized to +400 mV vs. Ag/AgCl.

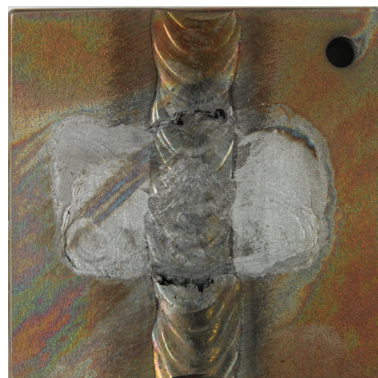
(b) Sample B.

Figure 4.27: Corrosion attacks on the TIG-welded, pickled, coated samples polarized to +400 mV vs. Ag/AgCl.

Figure 4.27a shows that Sample A experienced extensive crevice corrosion damage underneath the coating on top of the weld cap, as well as some damage on the HAZ and base material underneath the coating. Similar damage can be seen in Figure 4.27b where the crevice corrosion damage occurred on both coating edges on top of the weld cap, as well as in the HAZ and base material although to a lesser extent.

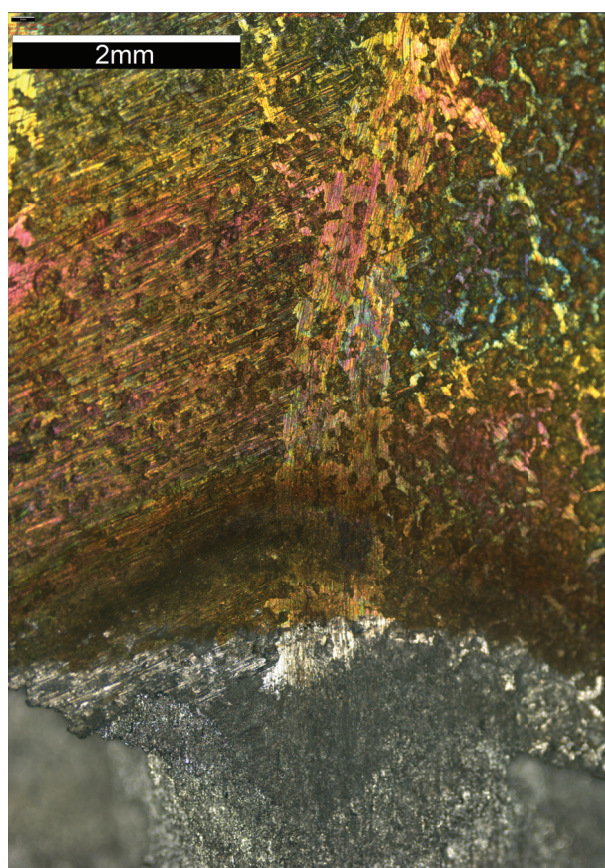
Figure 4.28: Scratch where corrosion initiated on the TIG-welded, pickled, coated Sample A which was polarized to +400 mV vs. Ag/AgCl, imaged by IFM.

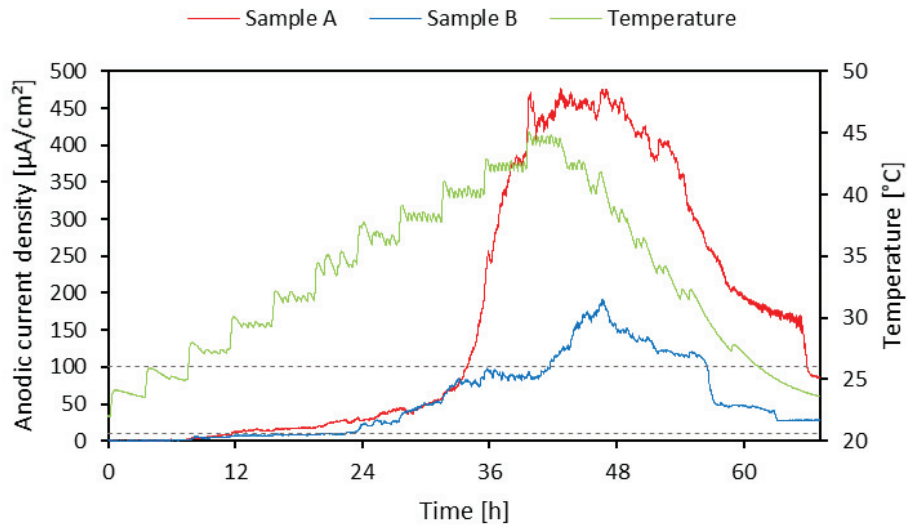
Figure 4.30: Anodic current density as a function of time and temperature for the laser-welded, not pickled, coated samples polarized to +400 mV vs. Ag/AgCl.

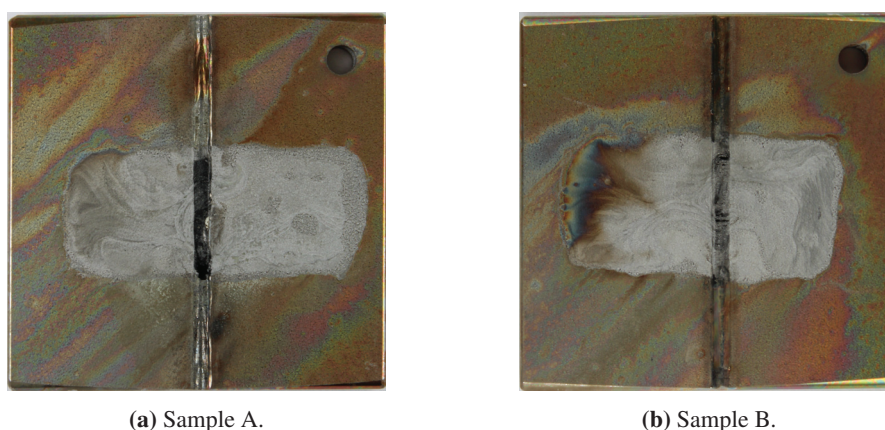
Figure 4.31: Corrosion attacks on the laser-welded, not pickled, coated samples polarized to +400 mV vs. Ag/AgCl.

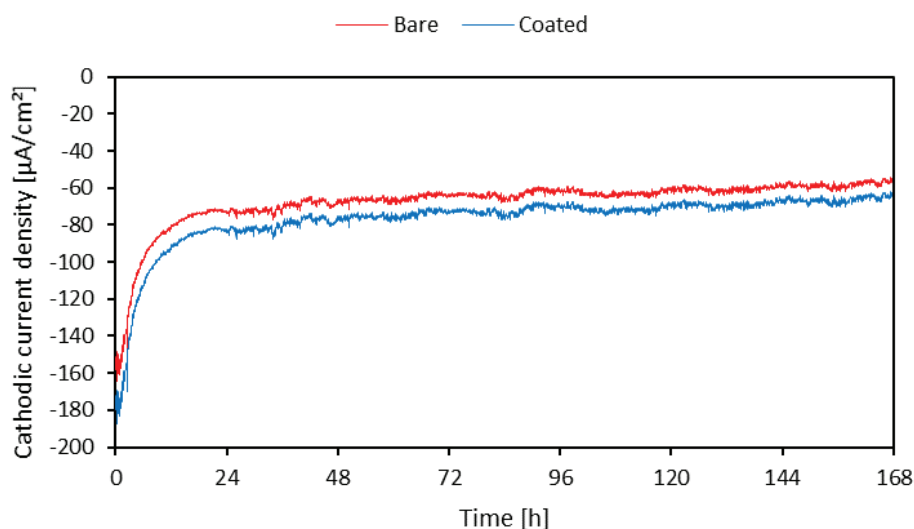
Figure 4.32: Cathodic current density as a function of time, expressed in hours, for the TIG-welded, pickled, bare and coated samples polarized to -1100 mV vs. Ag/AgCl for a week before critical corrosion testing.

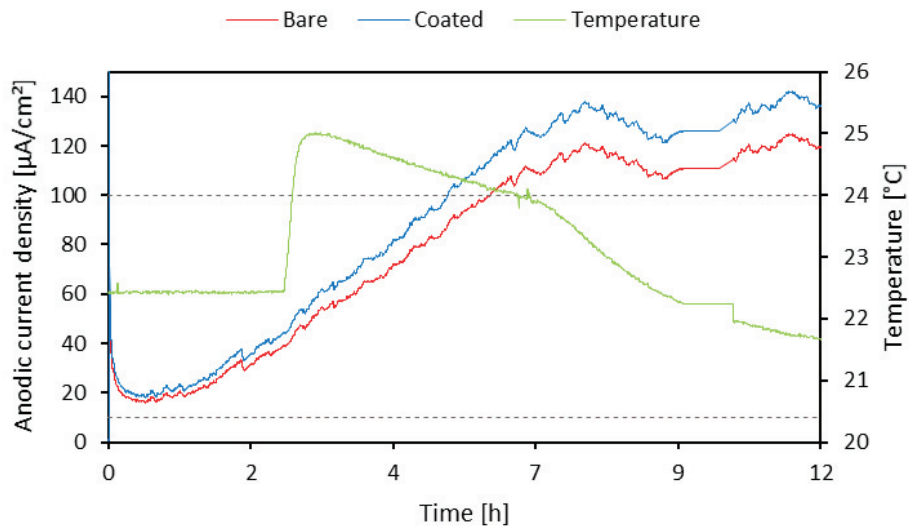
Figure 4.33: Anodic current density as a function of time and temperature for the TIG-welded, pickled, bare and coated samples while being polarized to +400 mV vs. Ag/AgCl after one week of cathodic polarization.

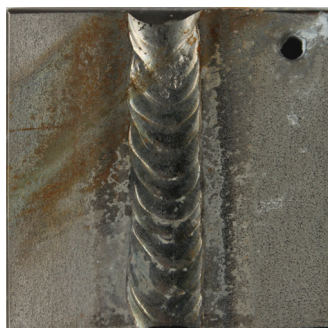
(a) Front side of bare sample.

Figure 4.34: Corrosion attacks and calcareous deposits on the TIG-welded, pickled, bare and coated samples polarized to +400 mV vs. Ag/AgCl after one week of cathodic polarization.

the anodic current density of the samples never reached zero, including the beginning of the anodic polarization where the sample had just been exposed at OCP for an hour. In addition, after one week of cathodic polarization, all samples had developed a fair amount of calcareous deposits throughout the sample surfaces. The corrosion damage on the samples can be observed in Figure 4.34 and some of the calcareous deposits are pointed out in Figure 4.34c.

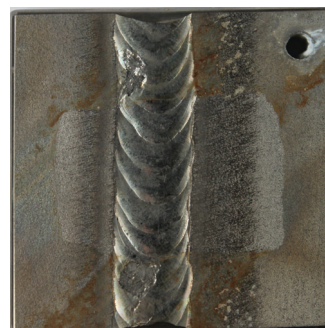
(b) Front side of coated sample.

It can be seen in Figure 4.34b that the coated sample has two major corrosion attacks, one of them outside the coating at the top of the weld area and another which is adjacent to the coating but that propagated outside of the coating. The corrosion attack adjacent to the coating was then analyzed in the IFM, as shown in Figure 4.36, where it was determined that this corrosion damage reached a depth of 0.19 mm.

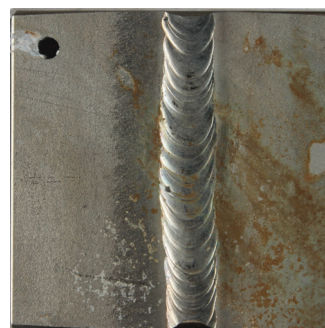
(d) Back side of coated sample.

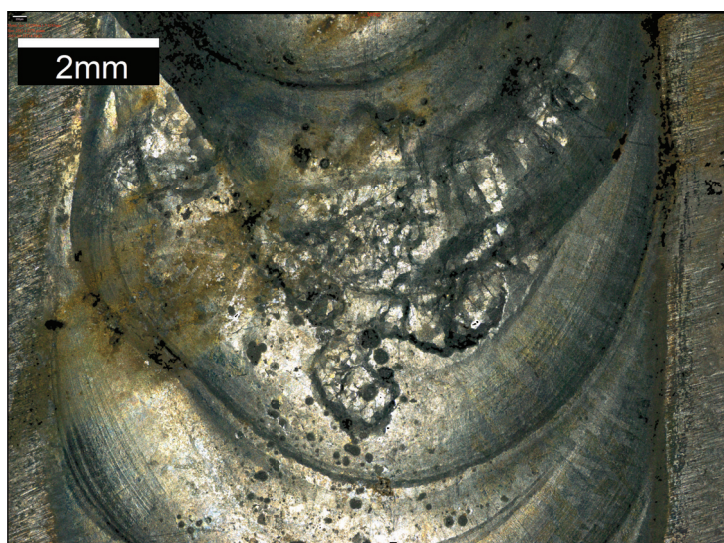
Figure 4.35: Corrosion attack in the form of pitting on the TIG-welded, pickled, not coated sample which was polarized to +400 mV vs. Ag/AgCl after one week of cathodic polarization, imaged by IFM.

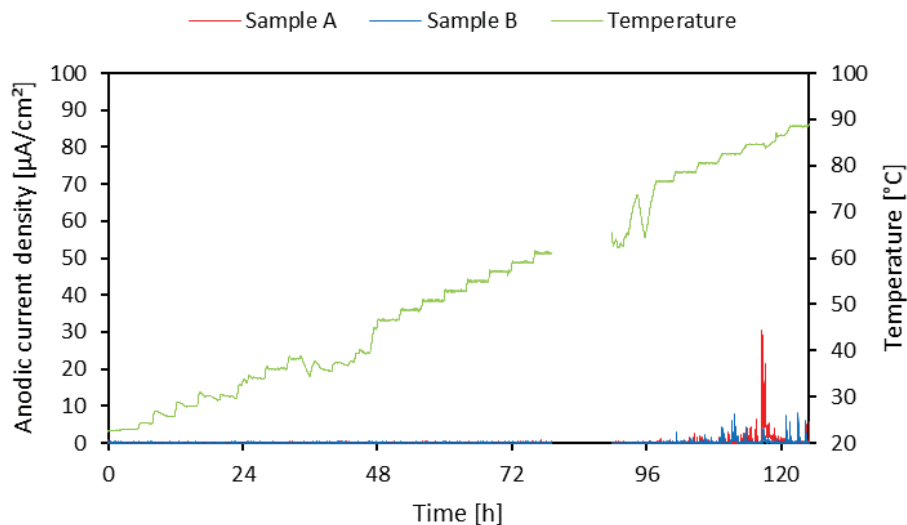
Figure 4.37: Anodic current density as a function of time and temperature for the base material, not pickled pickled, samples polarized to +400 mV vs. Ag/AgCl.

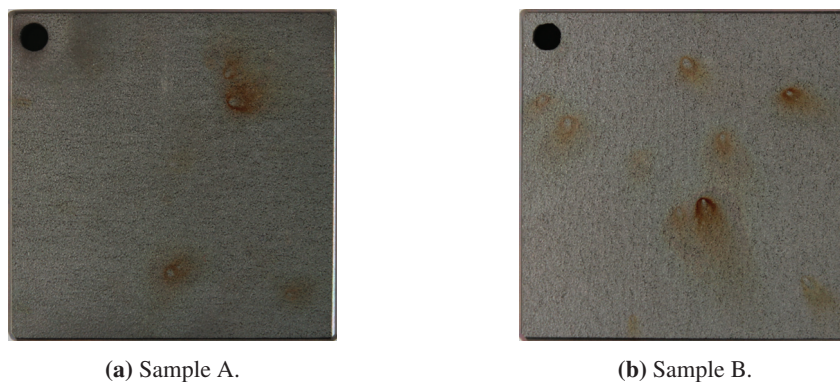
Figure 4.38: Superficial corrosion attacks on the base material polarized to +400 mV vs. Ag/AgCl.

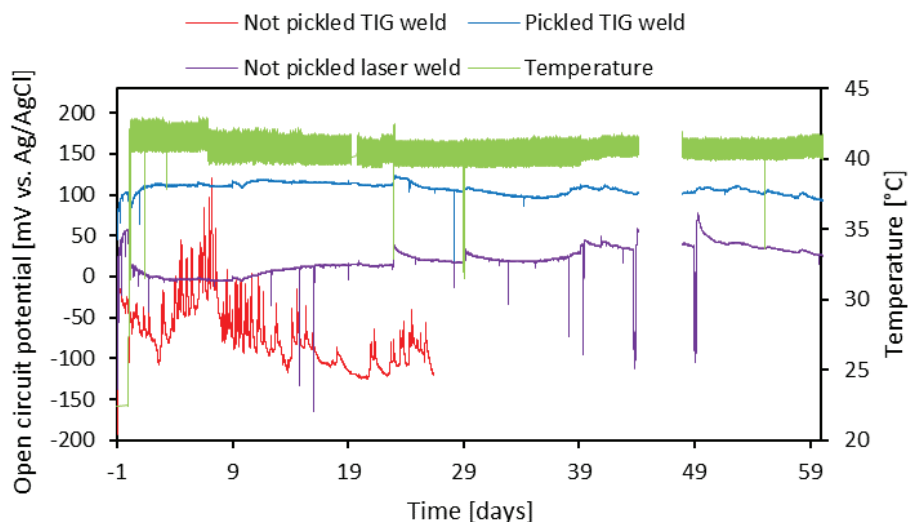
Figure 4.39: Open circuit potential development as a function of time and temperature, expressed in days and degrees Celsius respectively, for all the coated samples exposed at OCP during the long-term exposure test.

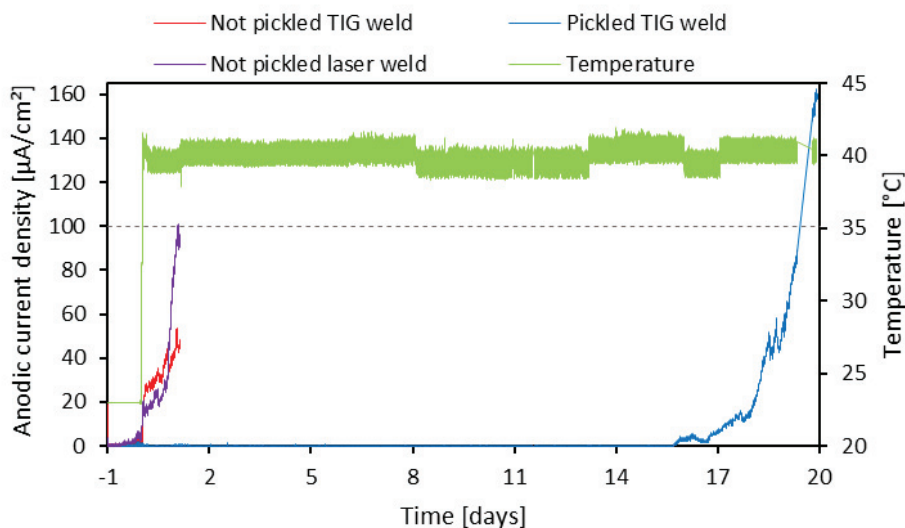
Figure 4.40: Anodic current density as a function of time and temperature for all the coated samples polarized to +400 mV vs. Ag/AgCl during the long-term exposure test.

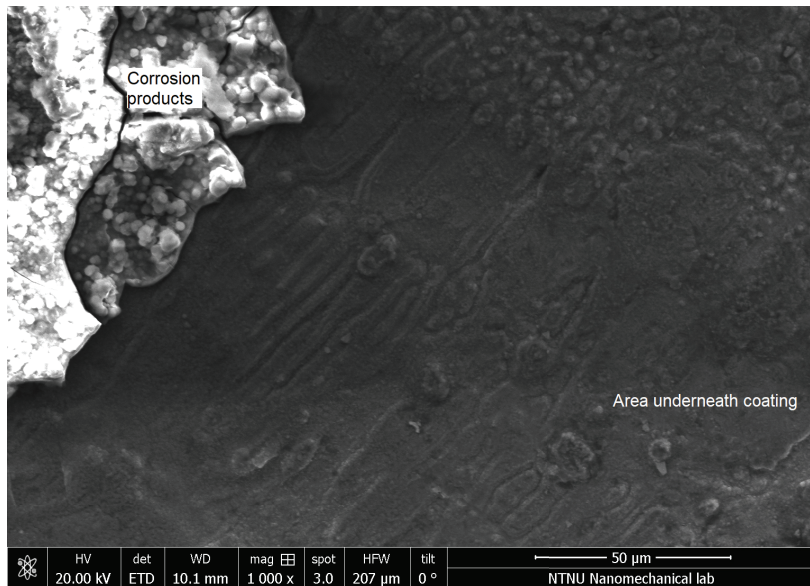
Figure 4.41: SEM image of the TIG-welded, not pickled, coated Sample A exposed at OCP showing the area where the coating edge used to be next to the corrosion products at 1000X magnification.

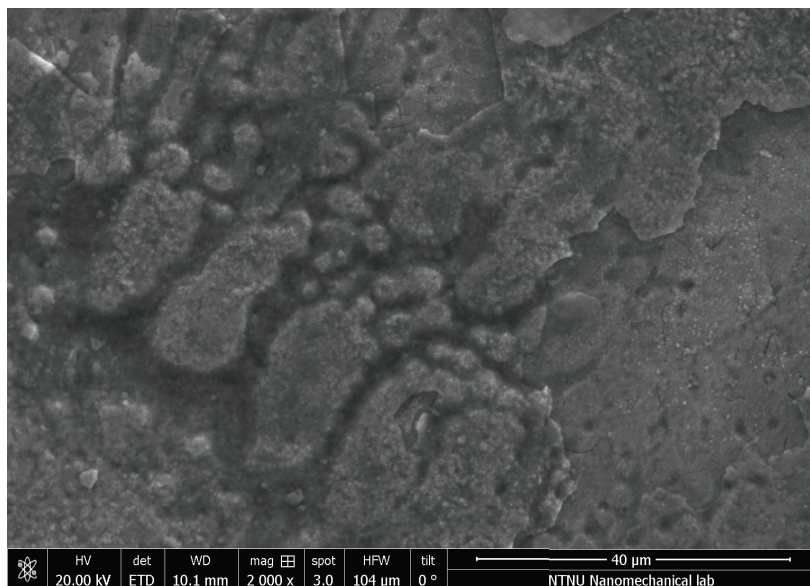
Figure 4.42: SEM image of the TIG-welded, not pickled, coated Sample A exposed at OCP showing the area underneath the coating close to the coating edge at 2000X magnification.
