Critical temperature of welded 25Cr duplex stainless steel in seawater

Master's thesis in Chemical Engineering and Biotechnology

The Norwegian Public Roads Administration (NPRA) is planning to build the world's longest pontoon bridge to cross Bjørnafjorden as a part of the project Coastal Highway Route E39. One of the favored design alternatives involves carbon steel pontoons with a 25Cr super duplex stainless steel (SDSS) section surrounding the pontoon in the splash zone. It is important that the right materials are used in the bridge to fulfill its required lifetime of 100 years. Although SDSS is a strong material with excellent corrosion resistance, its temperature limits in seawater are still a subject of debate. In addition, other design specifications such as welding, coatings and cathodic protection (CP) further challenge the material in this environment.

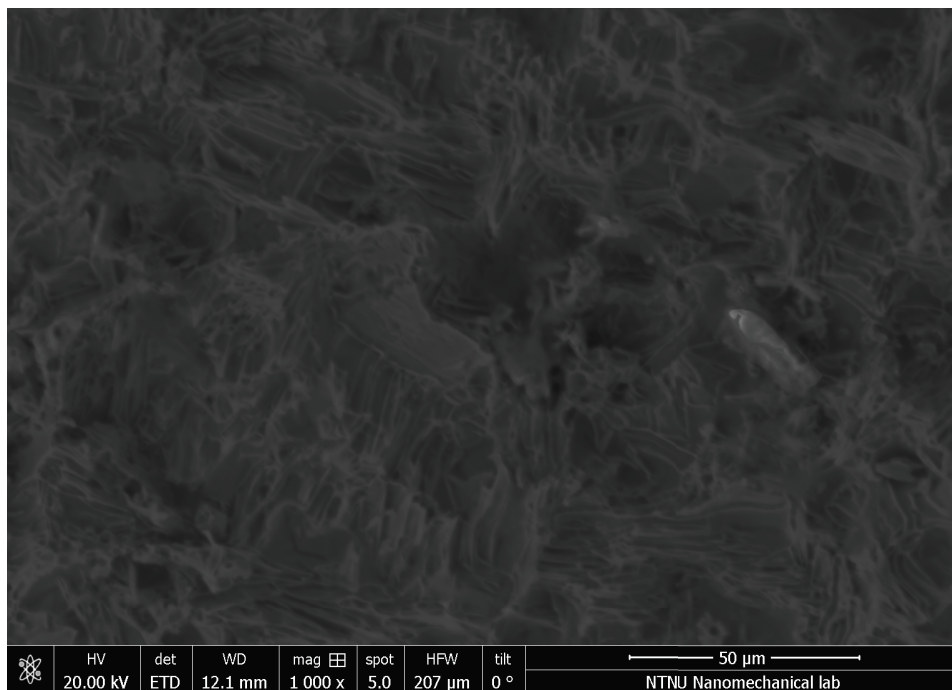
Figure 4.50: SEM image of the inside of the pit outside of the coating of the TIG-welded, not pickled, coated Sample A.

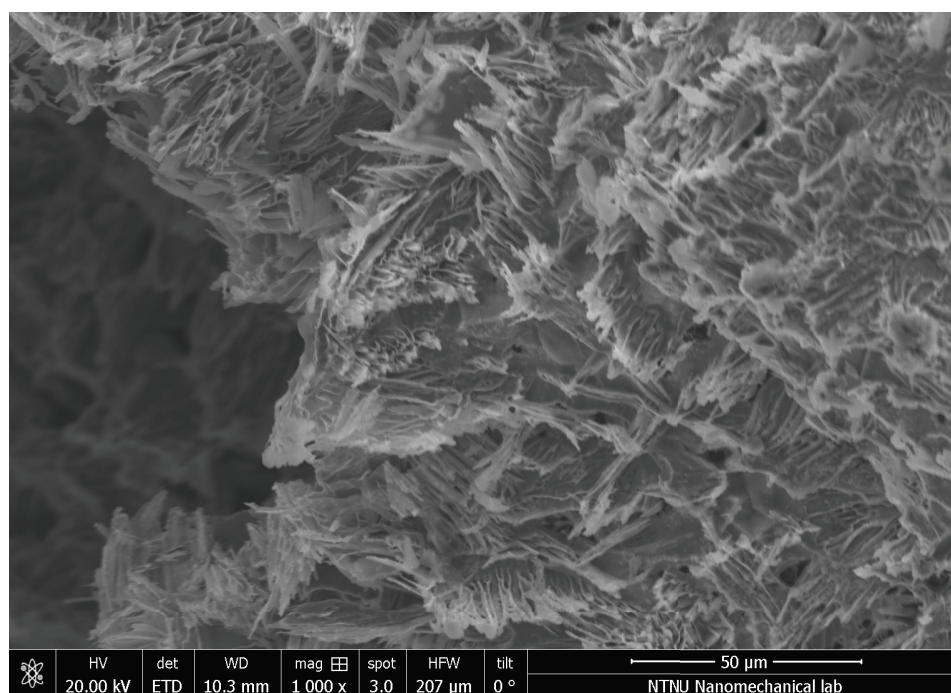
Figure 4.51: SEM image of the corroded area underneath of the coating of the TIG-welded, not pickled, coated Sample A TIG-welded, not pickled, not coated Sample A which was polarized to +400 mV vs. Ag/AgCl.

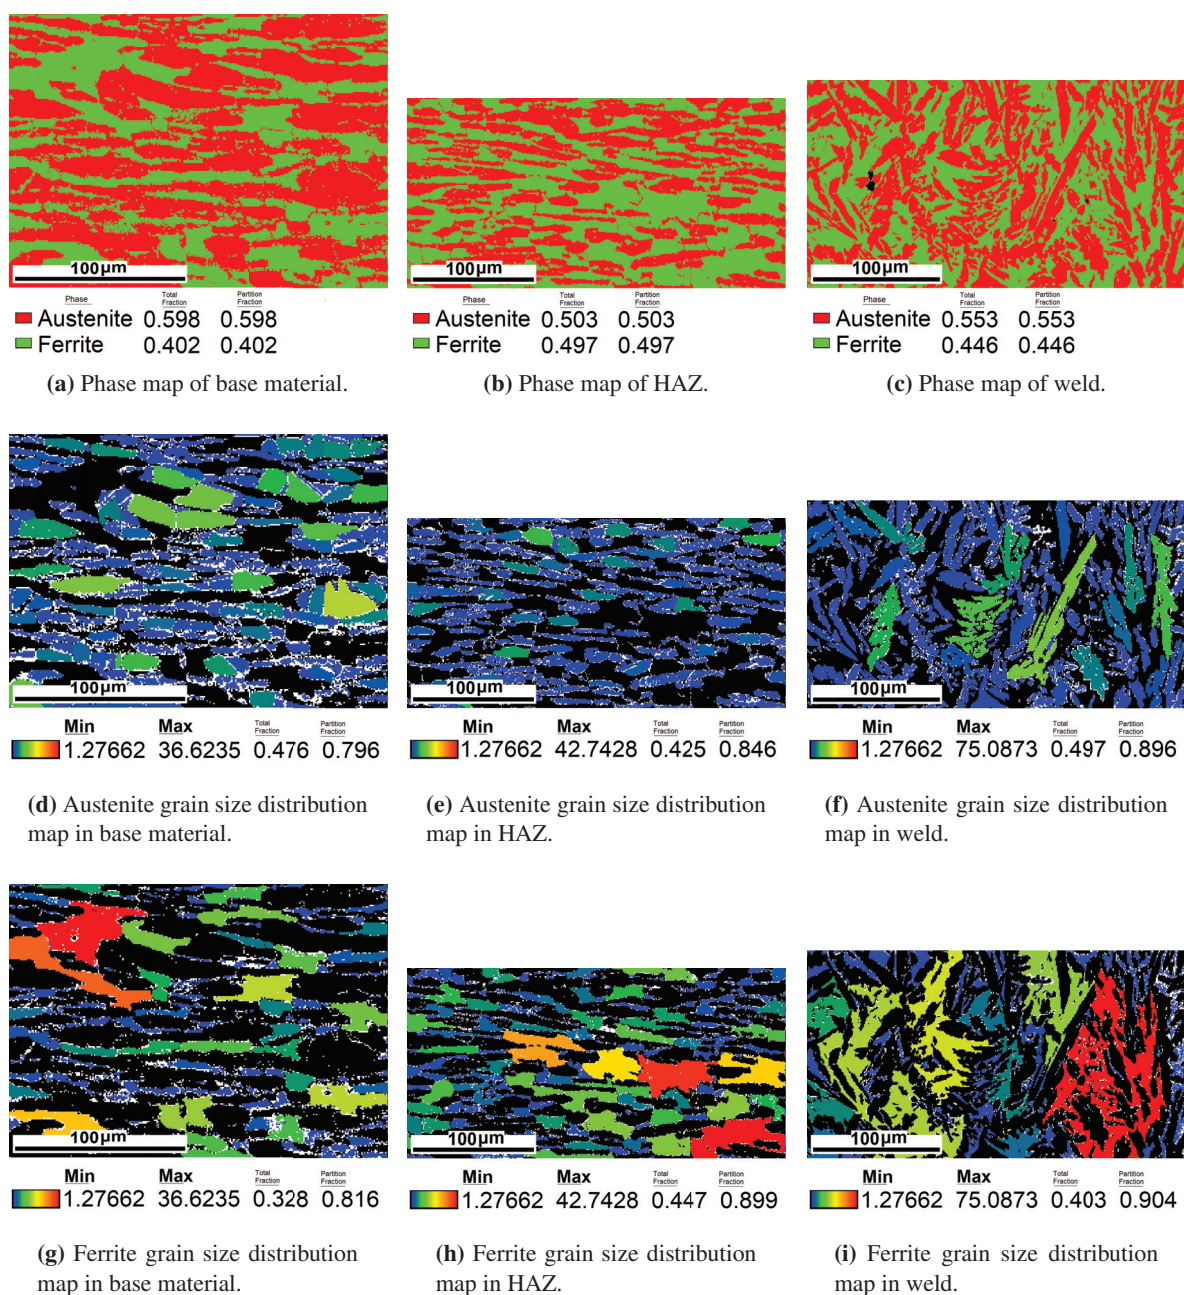
Figure 4.56: Phase and grain size maps for the different phases in the cross-section of a TIG-welded pickled sample at 200X magnification analyzed by EBSD.

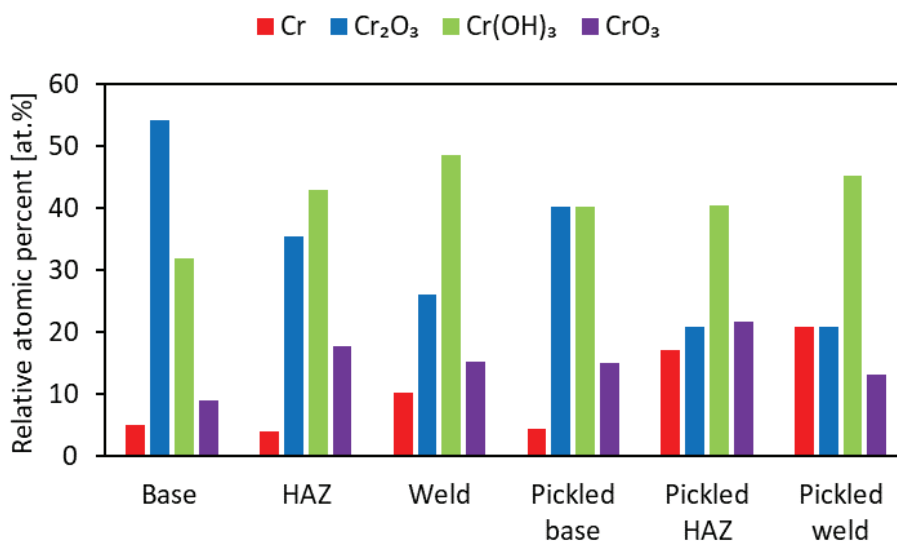
Figure 4.57: Amount of Cr and its oxides and hydroxide, expressed as the relative atomic percent, found at the base material, HAZ and weld of TIG-welded pickled and not pickled sample surfaces.

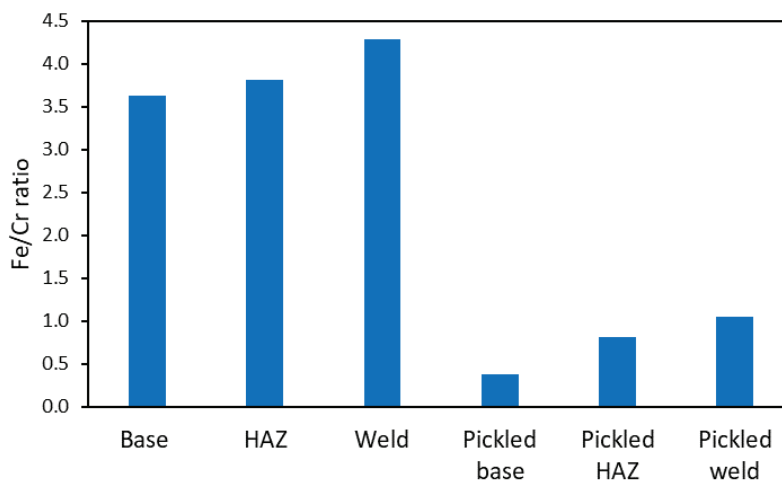
Figure 4.59: Fe/Cr ratio at the surface of the base material, HAZ and weld of TIG-welded pickled and not pickled samples.

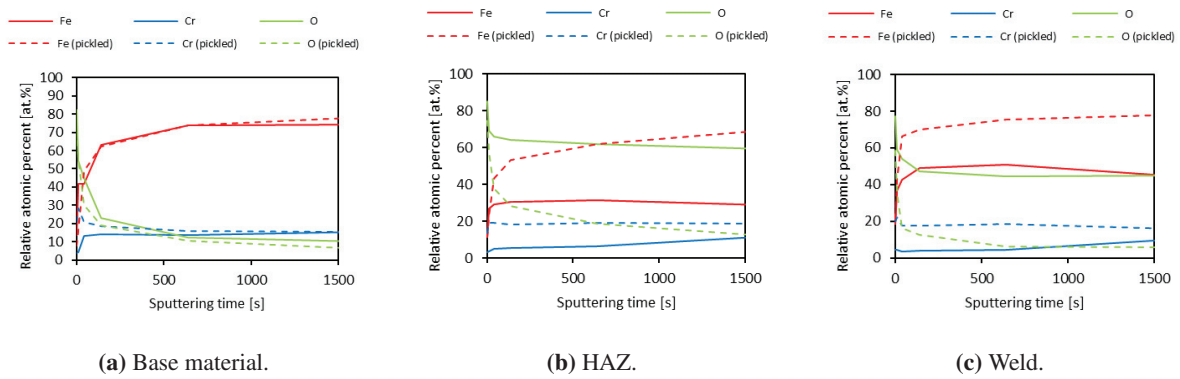
Figure 4.60: Relative atomic percent as a function of sputtering time, expressed in seconds, of Fe, Cr and O found in the base material, HAZ and weld of TIG-welded pickled and not pickled samples during depth profiling.

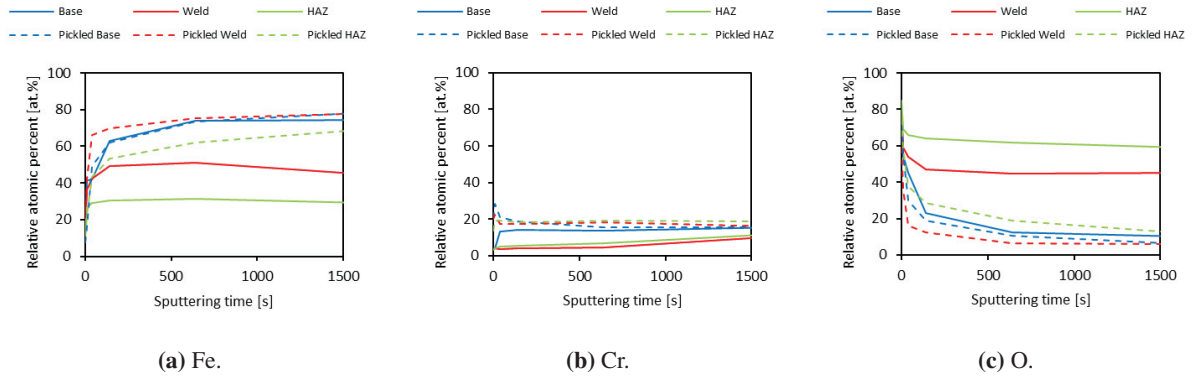
Figure D.1: Relative atomic percent of each element (Fe, Cr and O) as a function of sputtering time, expressed in seconds, in the base material, HAZ and weld of TIG-welded pickled and not pickled samples when sputtering the sample surfaces.
