# Effective ventilation solutions preventing sickbuilding syndrome in Norwegian schools

Master's thesis in Energy and Environmental Engineering

Norwegian University of Science and Technology  
Faculty of Engineering  
Department of Energy and Process Engineering

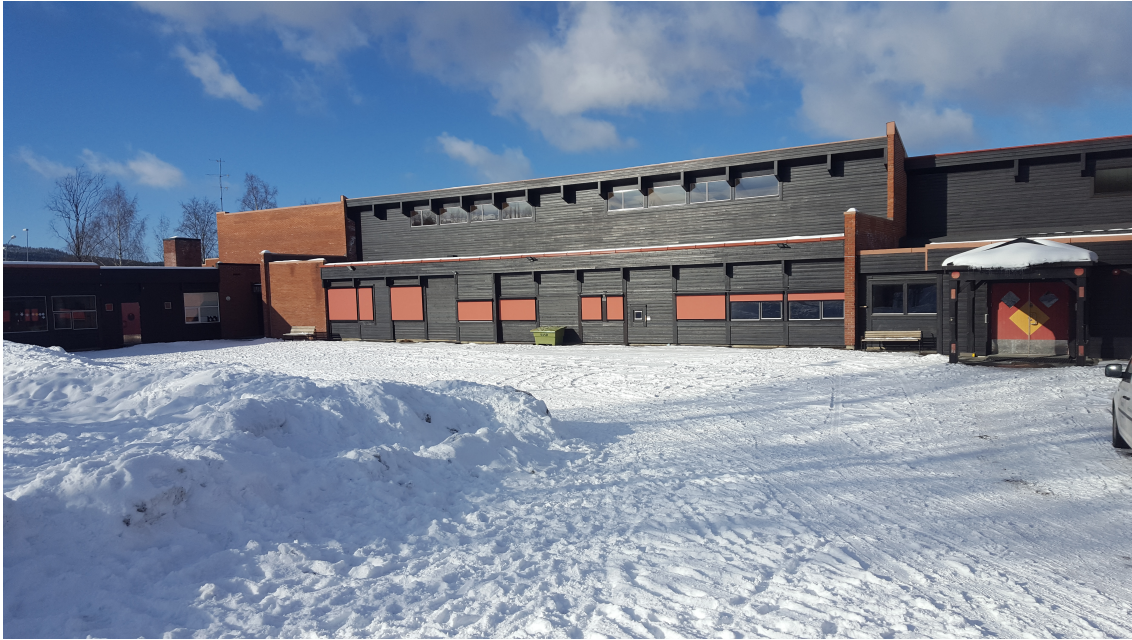
*Figure 4:* Picture of the administration section, wing F, at Sørborgen school. The After school program uses the wing seen on the left.

Some parts of the building have internal solar shading; others have external solar shading installed. Several sections have neither. The external solar shading can be seen in Figure 4. The new section has automatic external solar shading installed. The administration wing also had it installed as part of the refurbishment.

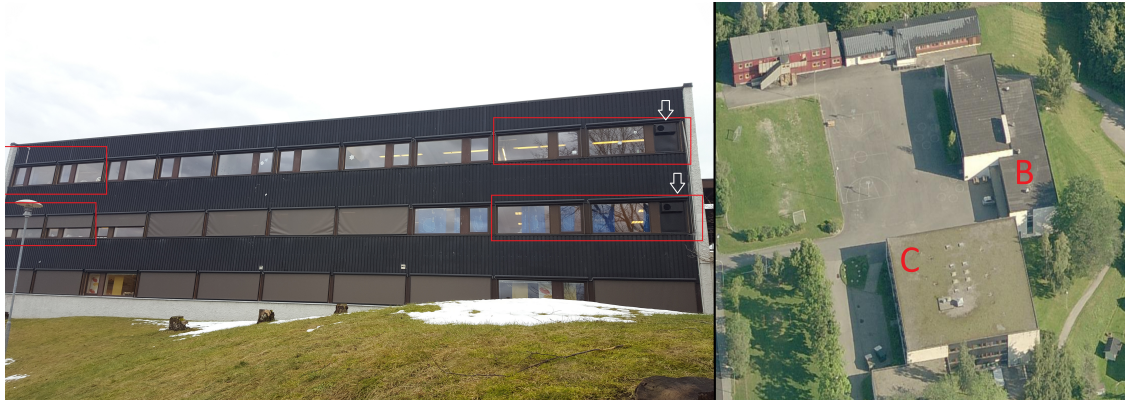
Figure 5: Picture of the east facing wall on building C on the left. On the right a air photo of Sunnland (Photo credit, right: gulesider.no)..

The four rooms that were chosen at Sunnland are all located on the east side of building C. Room 104 and Room 108 are on the first floor. Room 203 and 207 are on the second floor. Room 203 is directly above Room 104 in the northern corner. Room 108 is below Room 207 in the southern corner on the eastern wall. In Figure 5 the four classrooms are marked by red squares. White arrows pinpoint the air intake for the classroom ventilation units in Room 104 and Room 203. As seen, the external solar shading is in use on roughly half the classrooms. It is installed on every window on the east side of building C. The picture to the left shows several larger trees that provided shade to several classrooms. This picture is taken is from earliest 2014 as the old pavilion

still stands in the top right corner. This structure burned to the ground in December 2014 [5]. It has later been rebuild to TEK-17 standard. Several of the trees seen in the leftmost picture are seen cut down in the picture to the right from 2019. Four tree stubs are clearly visible in the right picture in Figure 5. The basement level is not used by the school. A school nursing station is located there. The technical rooms for the building are also in the basement.

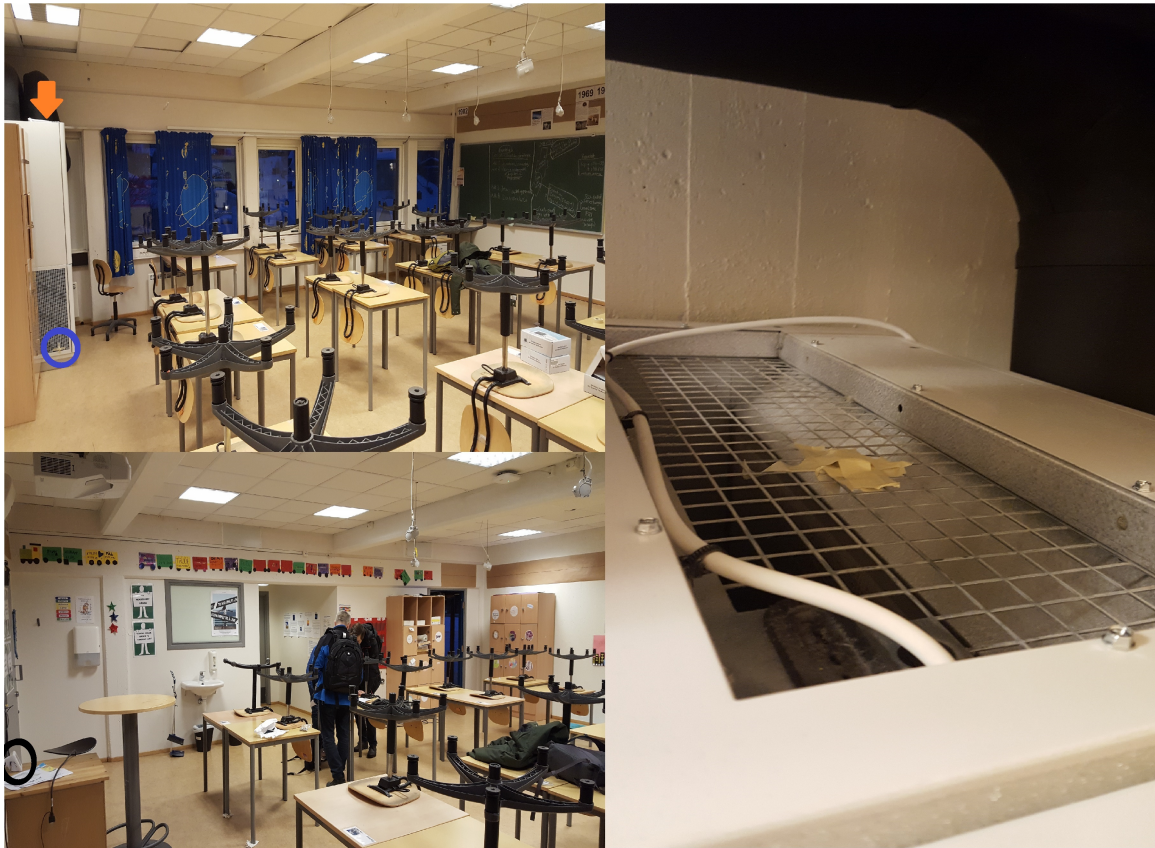
Figure 7: Pictures from Room 104. The supply air iButton is marked by a blue circle in the top left picture, the extract air iButton is indicated by an orange arrow. The ELMA monitor is marked by a black circle in the bottom left picture.

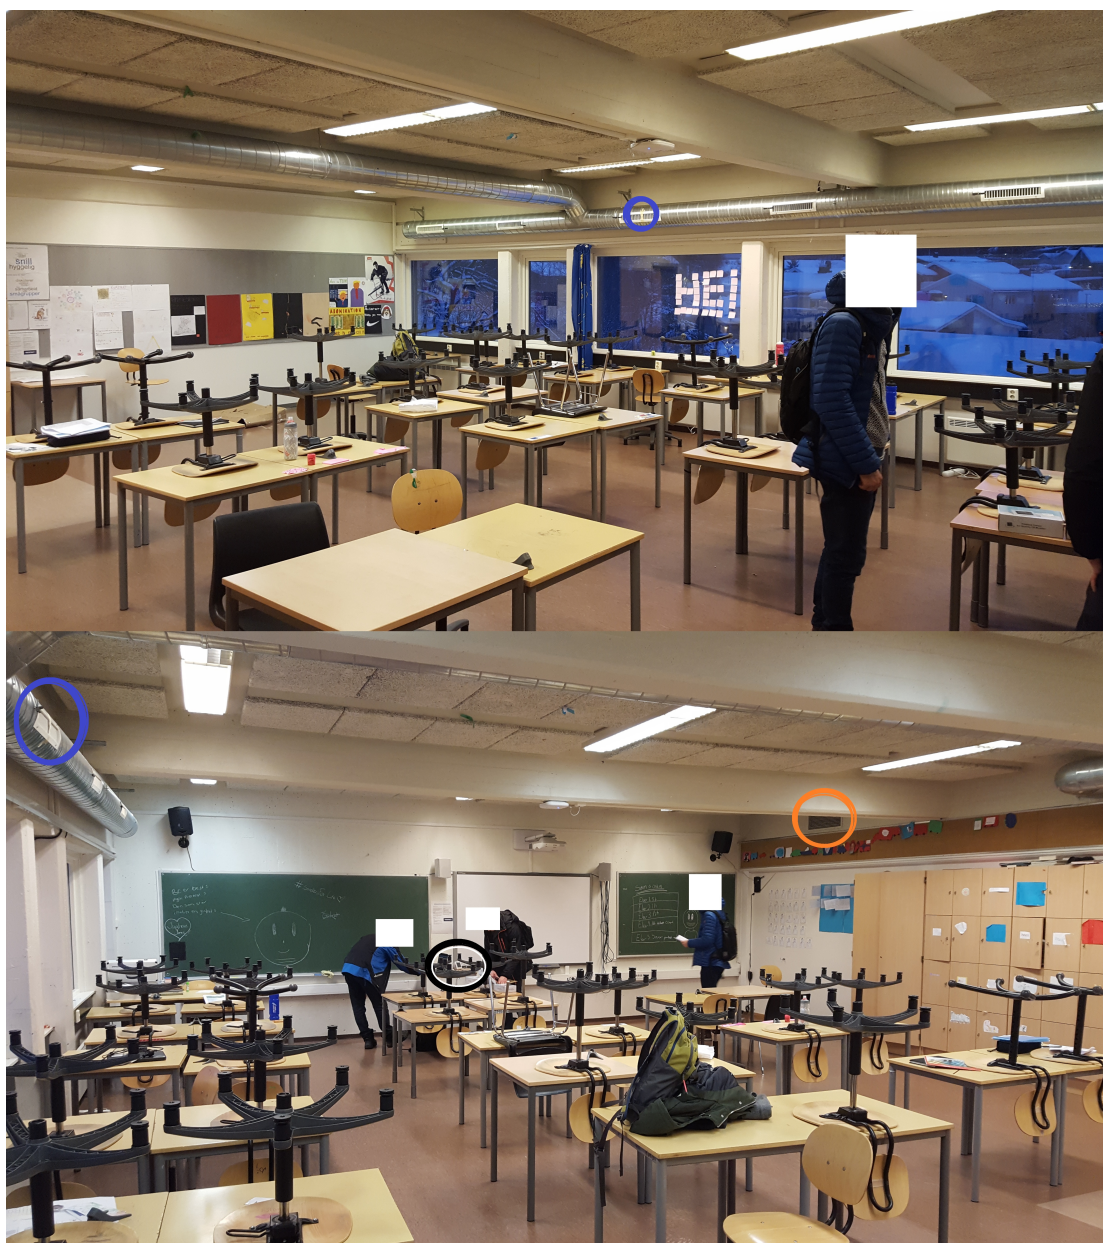
Figure 8: Pictures from Room 108. The supply air iButton is marked by a blue circle on both pictures, the extract air iButton is indicated by an orange circle and the ELMA monitor by a black circle on the bottom picture.

Room 108 is the largest ordinary classroom at Sunnland with 88.8 m<sup>2</sup>. There are 28 student desks. The room uses the central ventilation system. In Figure 8 the modified duct system is clearly seen. The fresh air duct runs across the classroom before splitting into two arms running over the windows. The original fresh air outlet placement is almost seen in the bottom picture in the top right corner.

This room has three windows that can be opened. All the windows have external solar shading. However, in the pictures in Figure 8 one can see the lack of curtains. There is one curtain, that covers only one of the smaller windows.

The iButtons were placed within the grills of the fresh and extract air ducts. The ELMA monitor was placed in front of the classroom by the blackboard.

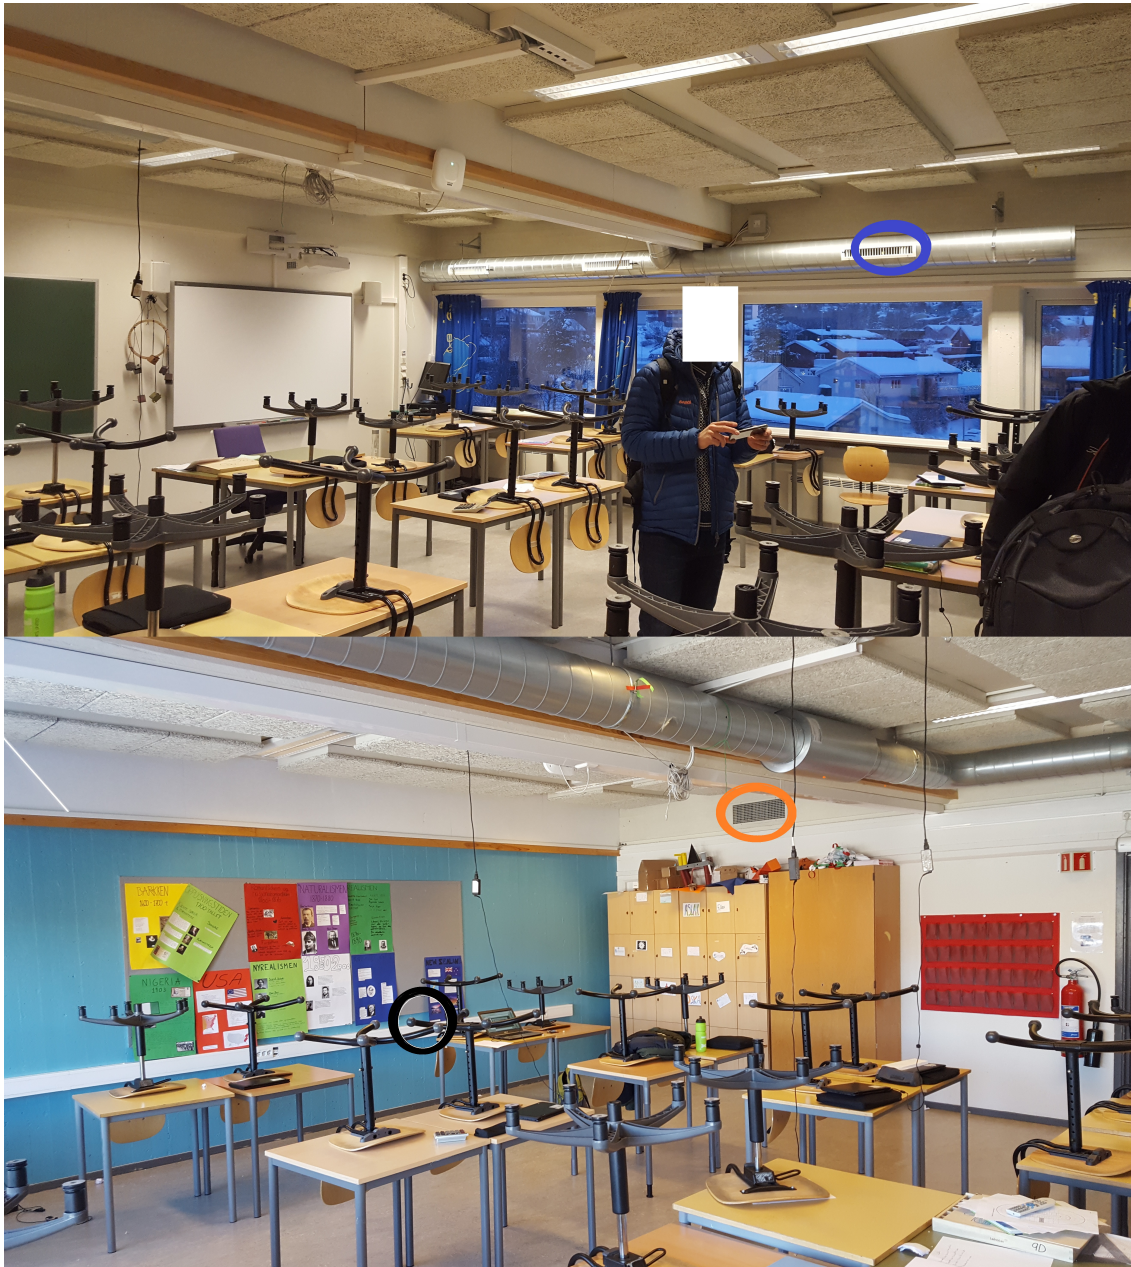
Figure 9: Pictures from Room 207. The supply air iButton is marked by a blue circle, the extract air iButton is indicated by an orange circle and the ELMA monitor by a black circle. The ELMA monitor had been removed before the bottom picture was taken.

The ELMA monitor was placed on the cable tray running across the back wall. It was taped to the wall and cable tray to immobilize it. The height of the ELMA monitor is roughly the same as the student desks. This means that it is in the lower breathing zone of the students. The ventilation holes of the ELMA device was not covered in tape. The iButtons were placed in the extract and fresh air grills. They are marked with orange and blue circles in Figure 9. It is also seen a lack of curtains to completely cover all the windows.

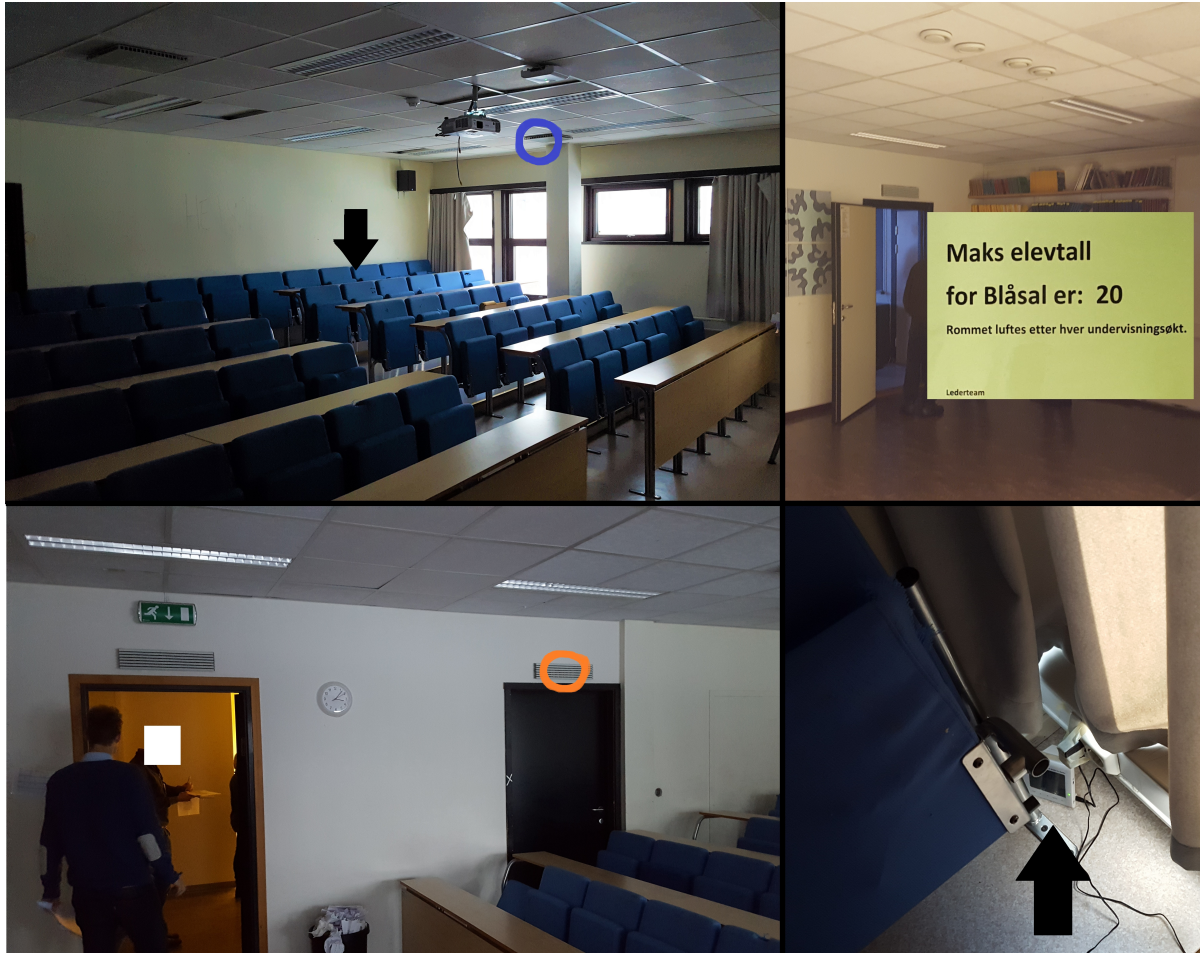
Figure 12: Pictures from the Room Blåsal. The top right picture is taken from outside the room towards the entrance door. The green screen was the poster pinned on the door. The blue circles shows the location of the supply air iButton and the orange circle show the extract air iButton. The black arrows show the placement of the ELMA monitor at the start and end of the field study.

The ELMA monitor was placed under a seat on the back row. It was placed, as far as the power cord allowed, towards the center of the room. This ended up being roughly under the fourth chair from the right. The position is indicated by an black arrow in Figure 12. This was to move it away from the windows that were used to vent

out the room. When the gear was collected the ELMA monitor had been moved right under the window as seen in the bottom right picture in Figure 12, indicated by a black arrow. The placement of the iButtons are indicated by a blue and an orange circle in the pictures to the left in Figure 12.

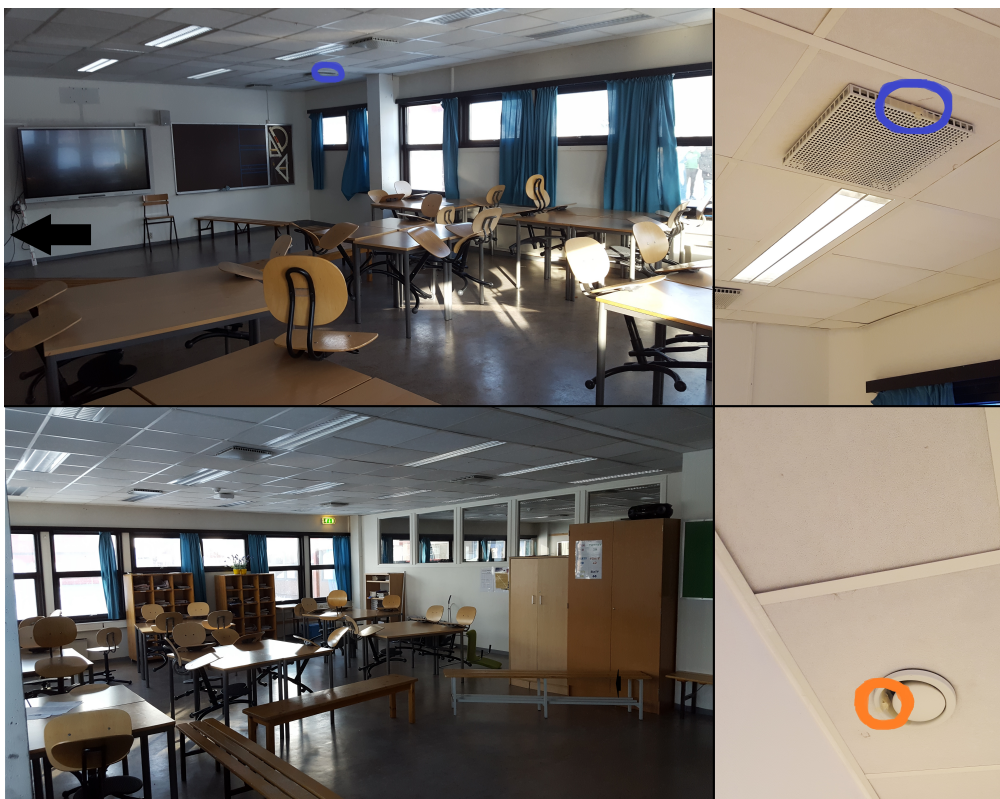
Figure 13: Four pictures from Room 321A at Stabbursmoen. The fresh air iButton is marked with a blue circle and the extract air iButton by an orange circle. The black arrow point to the placement of the ELMA monitor.

There is placed a free standing electrical convection fan heater on the floor near the emergency exit seen in the bottom picture in Figure 13. An interesting observation is that there is only one extract vent inside the room. There are several more right outside the entrance. The entrance do not have a door. The door marked on the floor plan (Figure 11) is not in use.

The ELMA device was placed in a corner on a desk in front of the classroom to the left of the television seen in Figure 13. The fresh air iButton was placed right onto the grill of the fresh air diffuser. The extract air iButtons were placed right inside of the lip of the extract vent. Both iButtons were fastened by freezing tape. The taping can be seen in the two leftmost pictures in Figure 13.

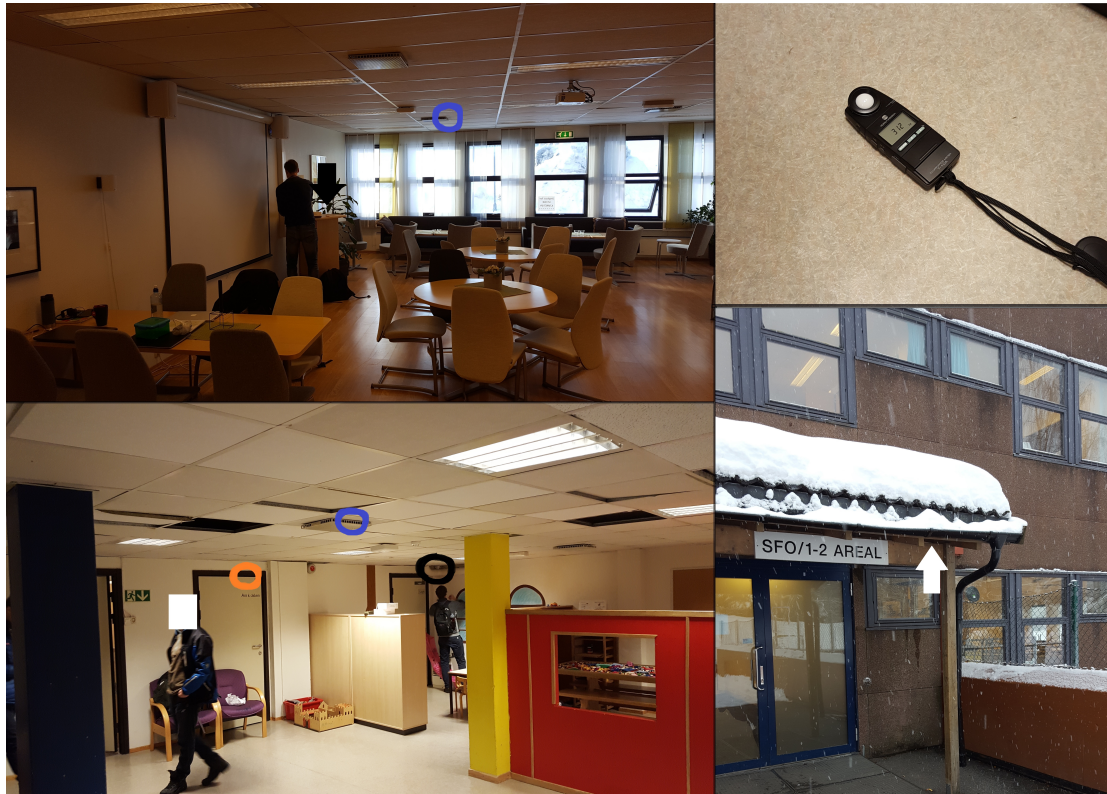
Figure 14: Four pictures from Stabbursmoen. The top left is from the Teacher's lounge, the black arrow shows the location of the ELMA monitor, beneath that is a picture from the SFO-room. The supply air iButtons are marked by the blue circles. The extract air iButton is marked by an orange circle. The top right show a light measurement done from the SFO room. The Bottom right picture shows where the iButton located outside was mounted, indicated by a white arrow.

The room did not have an extract vent, so the iButton was placed in the gap between the frame and the top of the door leading to the neighboring room. It was secured by tape. The neighboring room is 213 on the floor plan. The other iButton was taped in a similar way to the fresh air vent grill in room 321A. The ELMA monitor and iButtons placement can be seen in the bottom left picture in Figure 14.

The ELMA was placed on a heightened table. This should ensure that it is within the breathing zone of a sitting adult. In the top left picture in Figure 14 the ELMA was put on the table the person is standing by. The fresh air iButton was taped to the ventilation grill closest to the ELMA monitor. It is marked by a blue circle in the same picture. Four extract vents were located in the back of the room. The extract air button was placed in one of them. Both iButtons were taped and placed similar to approach seen in Figure 13 for room 321A.

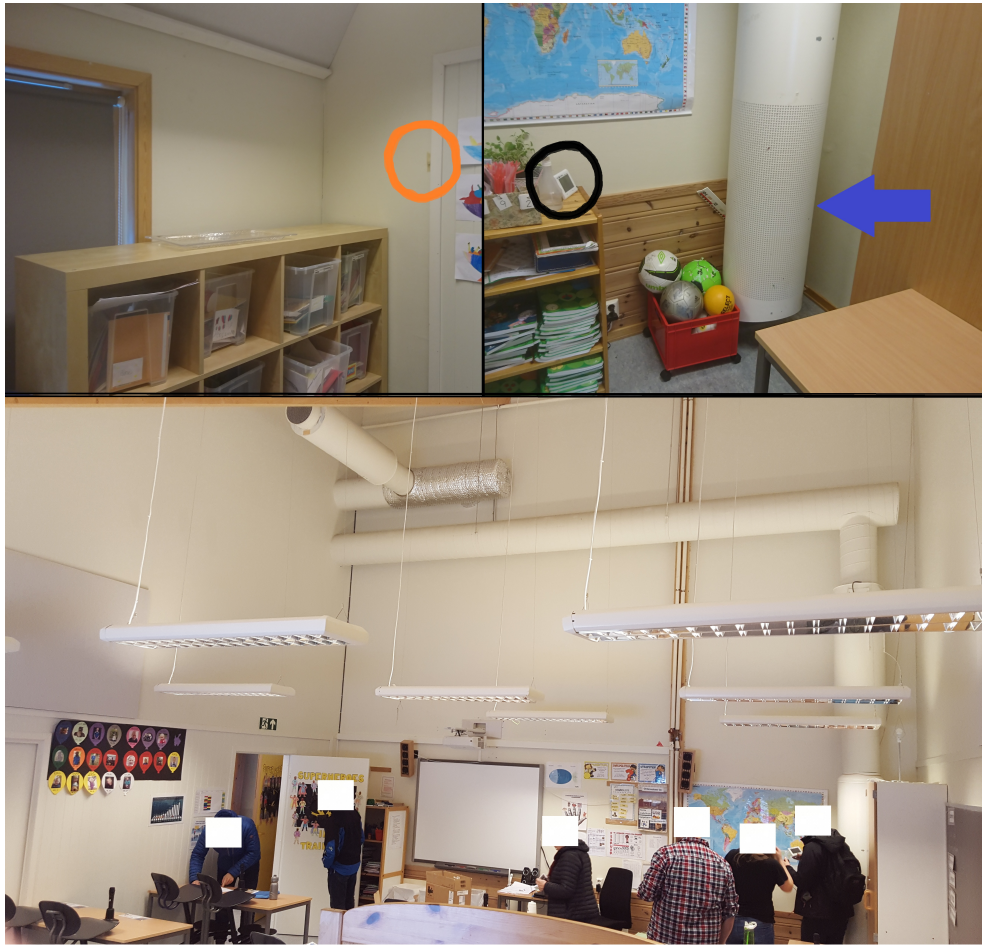
Figure 16: The top left picture shows the "extract" air iButton, marked with an orange circle, taped on wall in the back of the classroom. The top right picture shows the positioning of the ELMA monitor (black circle) and the displacement vent with the supply air iButton taped on the backside, indicated by a blue arrow. (Credit top pictures: "Skoler på vent")

Room 0217 is located in wing E, commonly called the yellow area by the school staff. The room uses displacement ventilation. The ELMA monitor was placed on top of a bookshelf right next to the fresh air vent. It was noted that the placement was to close to the fresh air outlet, but there was not any other viable options without an extensions power cord, except on a student desk or on the floor. The placement could affect the results and therefore not give an accurate representation of the real conditions. The fresh air iButton was placed on the backside of the displacement diffuser, but still over the air holes. In Figure 16 the ELMA monitors position is marked with a black circle, the extract air iButton is marked by an orange circle and the supply air iButtons placement is indicated by the blue arrow. The supply air iButton was taped to the backside of the displacement diffuser. The top right picture in Figure 16 is taken from the right corner seen in the bottom picture.

The extract inlet was located several meters high above floor height. The room has a sloping roof that ends in a two storey height. The extract vents were inaccessible without a ladder. The principle of thermal layers would ensure that the temperature closer to the roof would be higher than the occupant zone. Since the vents at that height would be far above the occupancy zone it was decided to place the "extract" iButton lower. It was taped on the wall behind the desk furthest away from the fresh air outlet. It was taped roughly 1.8 m above the floor. In Figure 16, the extract air iButton was placed further back on the left wall in the bottom picture.

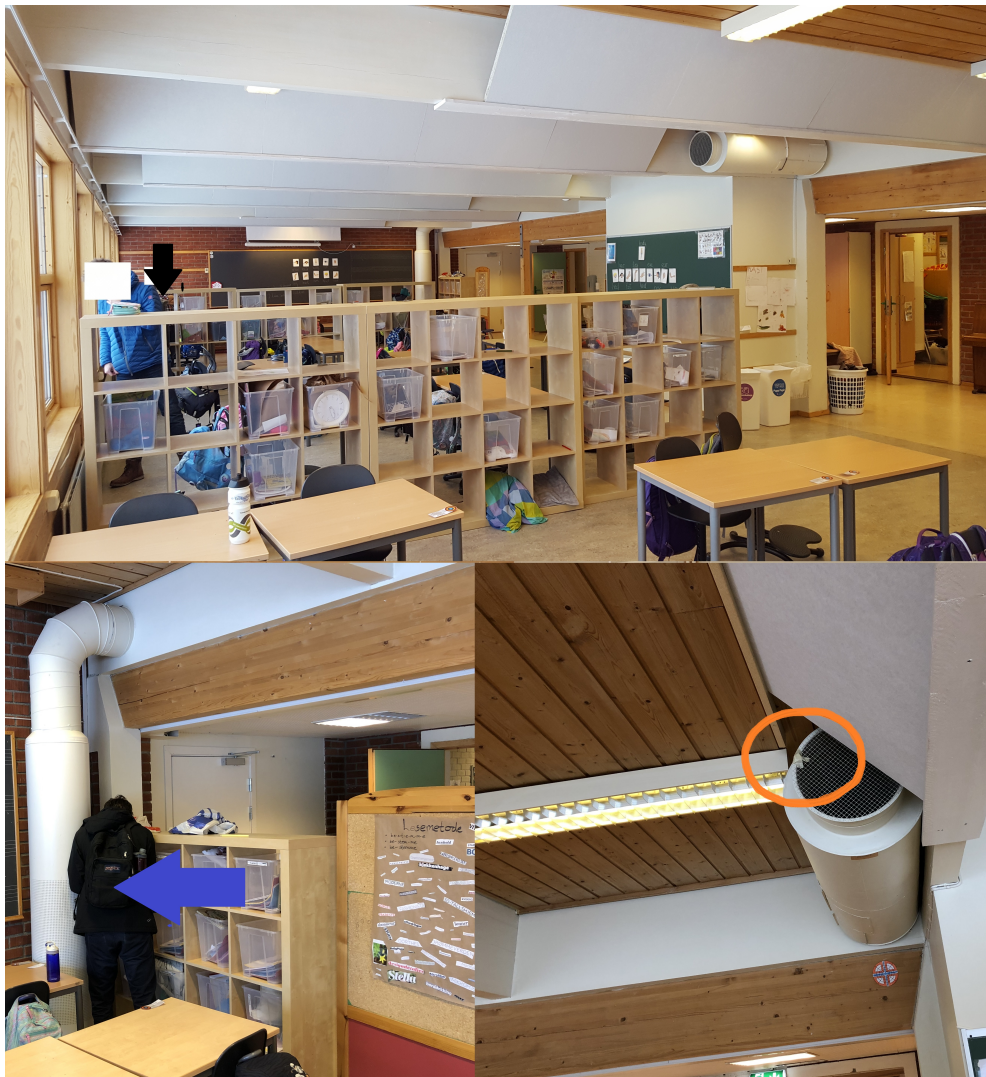
Figure 17: The ELMA monitors position is indicated by the a black arrow. It was placed in the second row of open shelves seen in the top picture. The displacement diffuser with the supply air iButton is seen in the back of the top picture and in the bottom left picture. The supply air iButton was hidden behind the diffuser indicated by the blue arrow. The orange circle marks the extract air iButton. (Credit bottom pictures: "Skoler på vent")

The ELMA monitor was placed in a open shelf separating the room into sections. The shelf is seen as the second row of shelves in the top picture in 17. The shelf walls would shield it from any direct sunlight. The iButtons were placed right onto the fresh air outlet and extract inlet. They were fastened by tape. The room has two fresh air diffusers on different sides of the classroom. It also has two extract vents close to each other in the center of the room. The iButtons were placed on the southern part of the classroom indicated by the blue arrow in Figure 17. It was taped on the backside of the displacement vent, but still over the ventilating holes. The top picture in Figure 17 shows most of Room 0222. The fresh air iButton was mounted on the backside of

the diffuser seen in the far back of the room. The extract air iButton was fastened to a hidden, but identical vent to the one seen in front of the column, just on the opposite side. Its exact location can be seen in the bottom left picture in Figure 17.

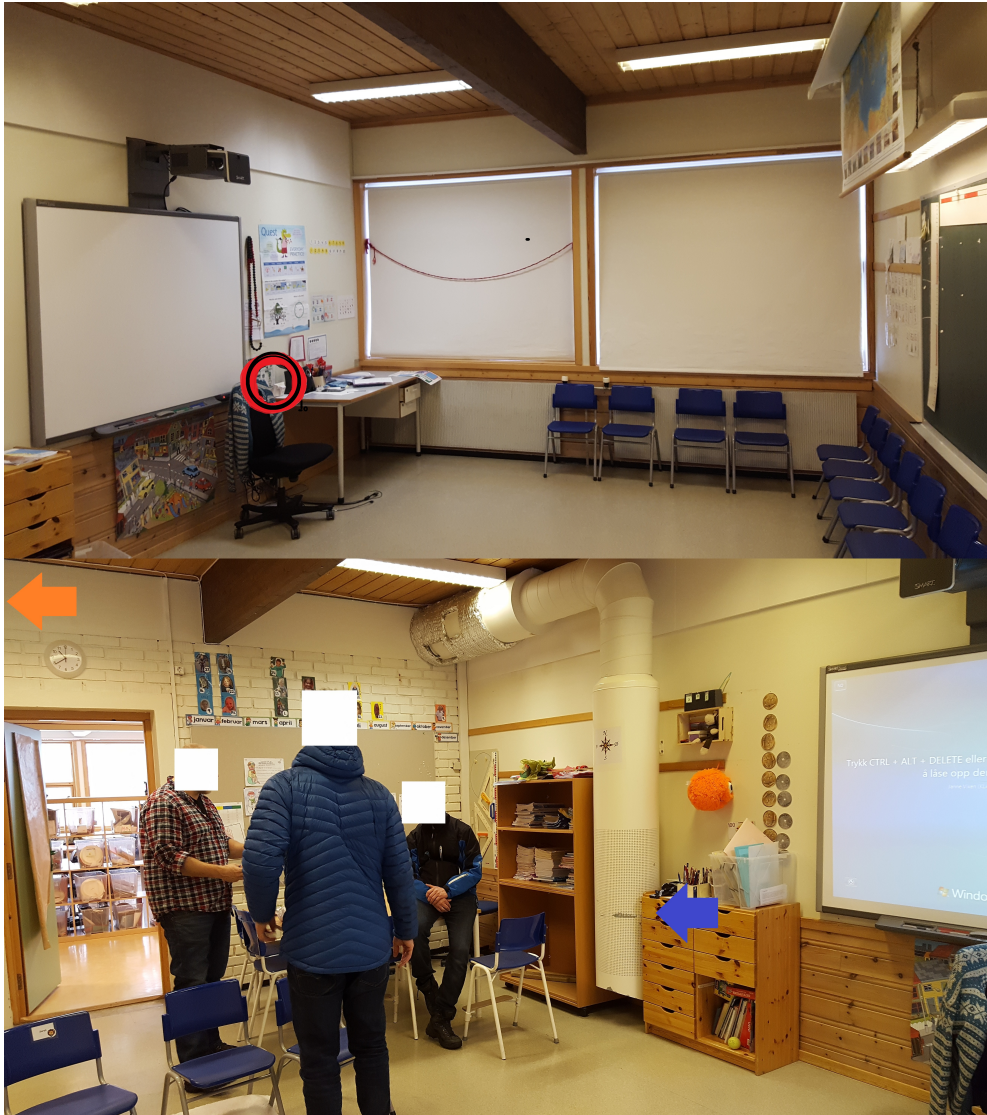
*Figure 18:* Pictures from Room 0273. The extract vent is not visible, but is located to the right of the door close to the ceiling. The ELMA monitors placement is shown by the red and black circle. The supply and extract air arrows placement are indicated by a blue and an orange arrow respectively.

Room 0273 is a home area for one of the classes that uses Room 0222 as a work area. It is a small room, but also uses displacement ventilation. The fresh air diffuser is partly covered up by furniture. The shelves are clearly seen in Figure 18. In the same figure one can see the thick white roll-up curtains deployed.

air iButton was placed directly on the air outlet. The extract iButton was taped on the underside of the extract duct just on the inside of the air inlet. In Figure 18 the placement of the ELMA monitor is shown with a black and red circle. The supply iButton was mounted on the backside of the displacement vent shown in the bottom picture, indicated by a blue arrow. The extract vent is not visible in the pictures, but was located in the opposite corner on the same wall, indicated by an orange arrow. The intake reached roughly the same distance into the room as the fresh air duct.

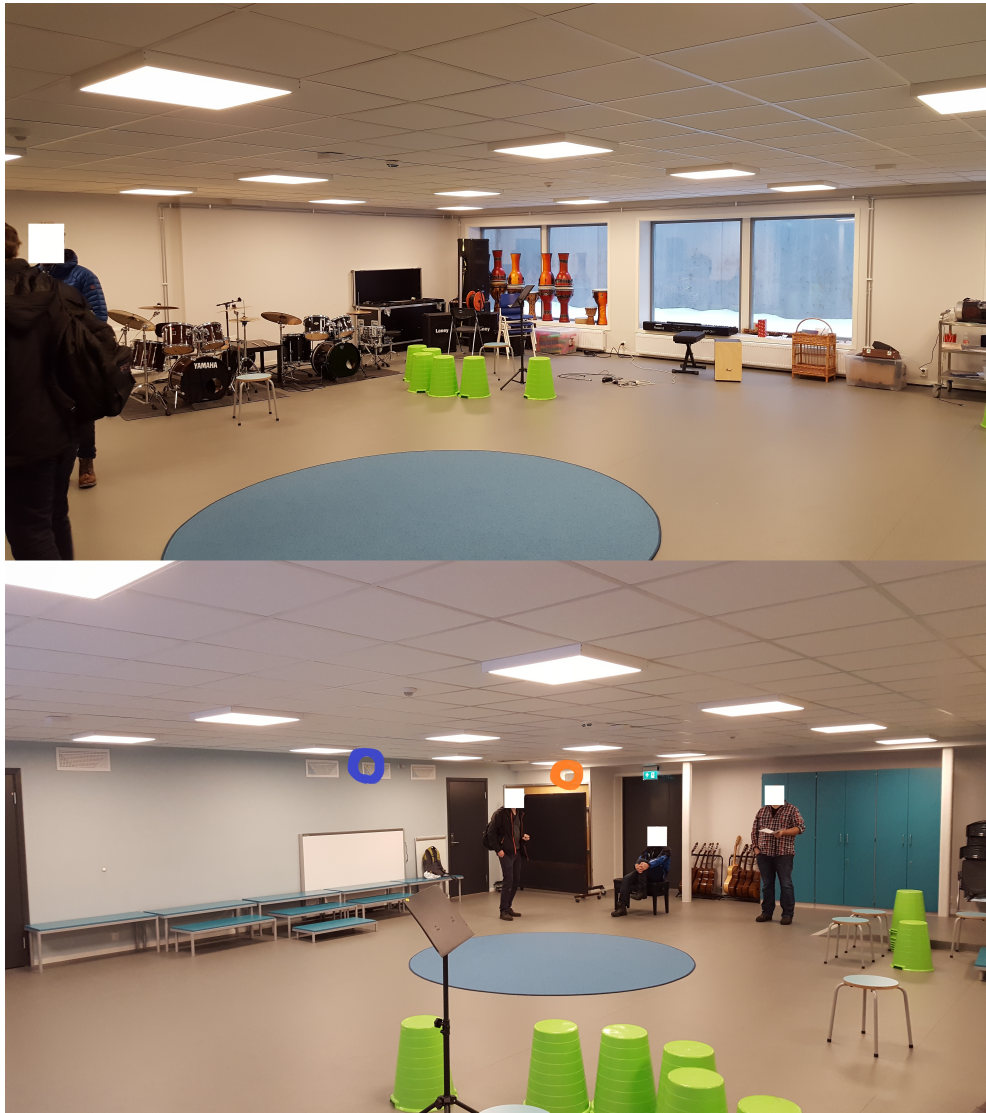
Figure 19: Pictures from the Music room. The extract vent inlet is partly hidden behind the blackboard.

but is now connected to the new structure built in 2018. It has four fresh air diffusers, all located all on the eastern wall. One of the iButtons was taped directly onto the second from the right. The only extract vent is located on the northern wall, close to the northeastern corner. Both iButtons are marked by a blue and orange circle in the bottom picture in Figure 19. The ELMA monitor was placed on a table in the northwestern corner. It is shown with a black dot on the edge of the floor plan in Figure 15. However, it is placed a level below what is shown in the figure.

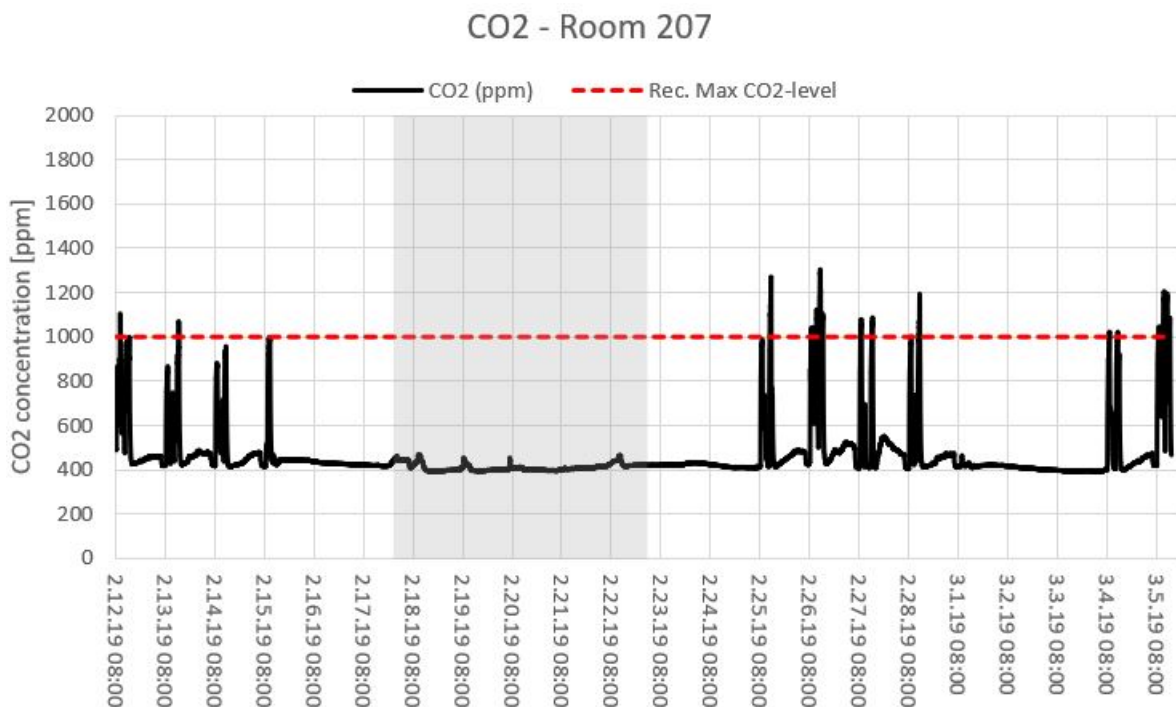
Figure 36: CO<sub>2</sub> concentration measured in Room 207 from Feb. 12. to Mar. 05.

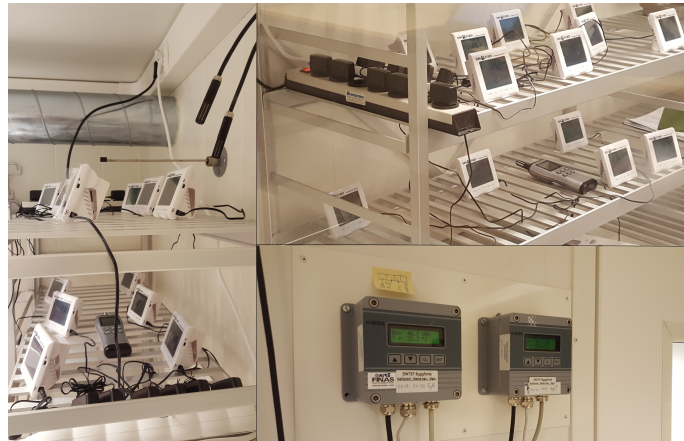
Figure 1: The picture to the left shows the setup for Room 2. The two black rods are the permanent room sensors. The top right picture shows the setup in Room 1. The bottom right picture illustrates the two permanent sensors in Room 1.

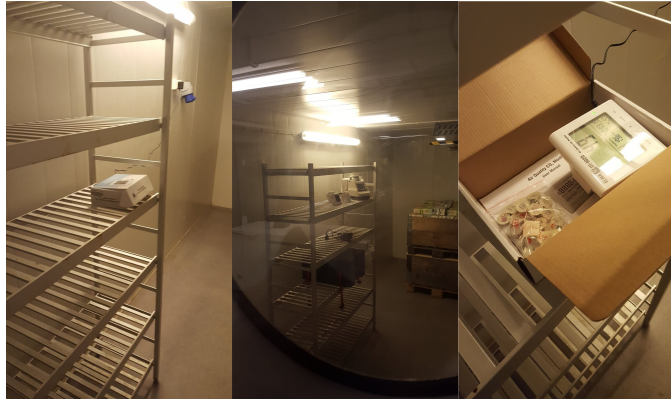
Figure 2: The leftmost picture shows the setup during the first session in the coldroom. The rightmost picture shows the cardboard seen in the leftmost picture. In the middle picture the setup for the second test session in the coldroom is shown. The large device seen is the Pegasor monitor.

The ELMA 10 and all the iButtons used were placed inside a small cardboard box and left in a coldroom at the laboratory at EPT from Friday afternoon on the 15. March and over the weekend to Monday morning. The test room was to well insulated so the temperature did not reach upwards of 16 degrees during the weekend. The experiment was therefore repeated in the following week under more constant conditions. During the second experiment a Pegasor indoor climate monitor was also placed inside the coldroom. It was placed side-by-side of the other instruments. Figure 2 shows the setup for both the first and second test series.

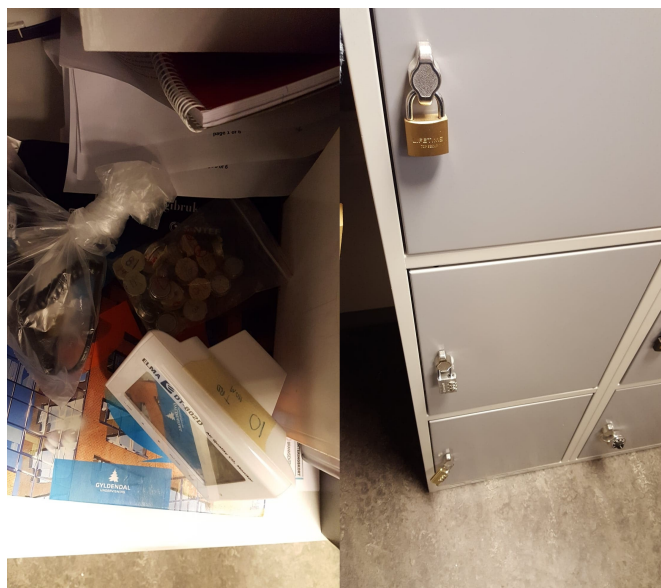
Figure 3: The picture to the left shows the iButtons and ELMA 10 inside the locker. As seen they were placed on top of a thick book that insulated them from the metal. The locker was closed and locked as seen in the picture to the right.

Lastly all the iButtons were placed inside a student's locker in a study room with the ELMA 10 monitor. The goal of this test was to find any significant changes in the iButtons at a higher temperature. Figure 3 shows the setup in the study room. The second locker from the floor further to the right was the one used. The ELMA 10 monitor is clearly visible in the picture to the left in Figure 3. The iButtons are more hidden, but are seen in the plastic bag just behind the ELMA 10.
