Hydrogen susceptibility of an interstitial equimolar high-entropy alloy revealed by in-situ electrochemical microcantilever bending test

Abstract: Hydrogen effect on an interstitial CoCrFeMnNi high-entropy alloy was investigated by micro-cantilever bending tests with pre-notched {111} plane as a case study. Results showed sharp mode I cracks on (001) plane bisecting two {111} planes in hydrogen-charged cantilevers, which was explained by hydrogen-assisted defects formation and hydrogen pins dislocation motion.

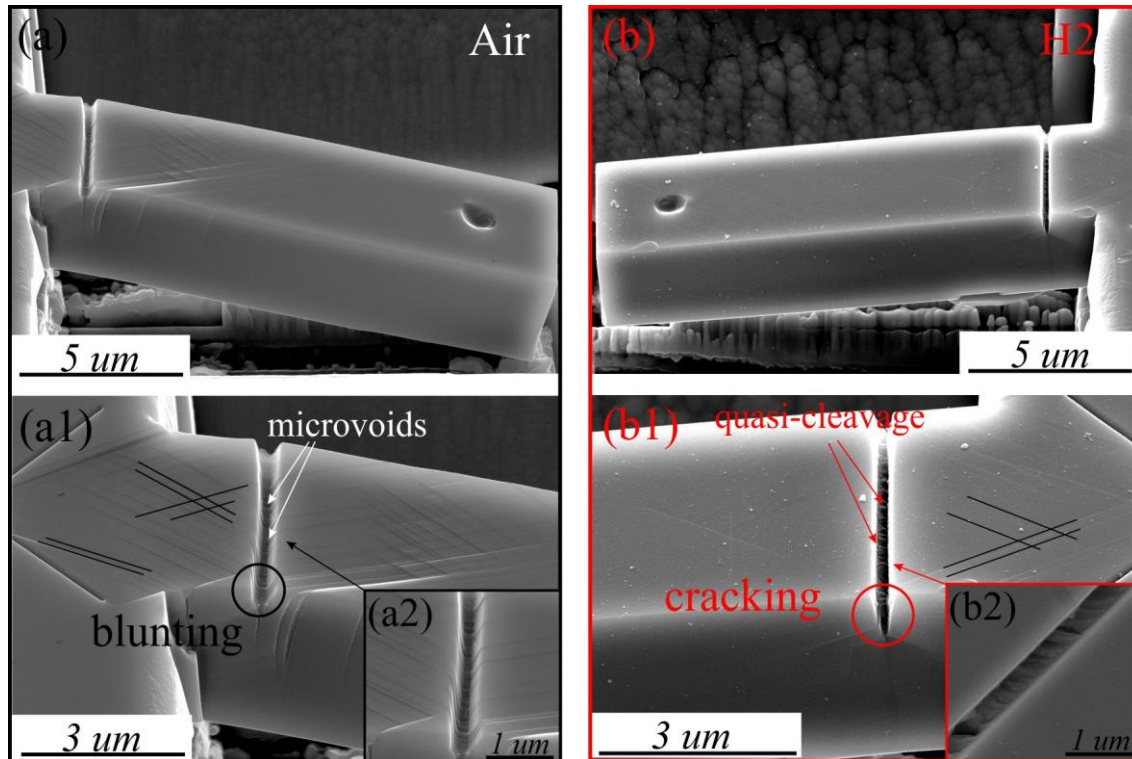
Fig. 2 (a), (a1) Secondary electron (SE) images showing deformation behavior of beams bent in air, and (b), (b1) in H2 charging condition; (a2) and (b2) magnified notch area in (a1) and (b1) after bending.

Fig. 2 shows the micrographs of beams after bending at different conditions. To study the most noticeable effect of hydrogen, we chose H₂ charging condition for the following discussion. In Fig. 2 (a1), abundant slip lines (marked by black lines) on the beam surface bent in air elucidate a large amount of plasticity was generated during deformation. According to Schmid's law, dislocation slips on (111), (11 $\bar{1}$), and (1 $\bar{1}$ 1) slip planes with an equal Schmid value of 0.272 were activated to compensate the plastic deformation, which is reflected by the slip traces on beam surface in Fig. 2 (a1). Here we use Schmid's law by assuming that on the top layer of the beams, uniaxial tensile stress dominated at the beginning of bending [25]. Notch blunting with a tip opening angle of 52.7° in air indicates a superior ductility and a high resistance to cracking of the studied interstitial HEA. The formation of microvoids at the crack tip, as pointed out by the white arrows in Fig. 2 (a1) and the magnified notch area in Fig. 2 (a2), elucidates a typical ductile fracture mode. On the contrary, beams bent in H₂ condition had entirely different cracking behavior. Fig. 2 (b1) shows a sharp cracking of the notch plane (marked in red circle) with a smaller crack-tip opening angle of 27.2°. It is worth noting that the number of slip lines in Fig. 2 (b1) was remarkably reduced compared to that in Fig. 2 (a1), which indicates that the cracking process consumed part of the plasticity. And rugged fracture surfaces on the cracking plane shows a quasi-cleavage fracture behavior (Fig. 2 (b1)-(b2)). It is worth mentioning that due to the effect of beam size and the space limitation beneath the beams, it was unable to obtain fracture surfaces in the current tests. Optimization will be made in the following studies.

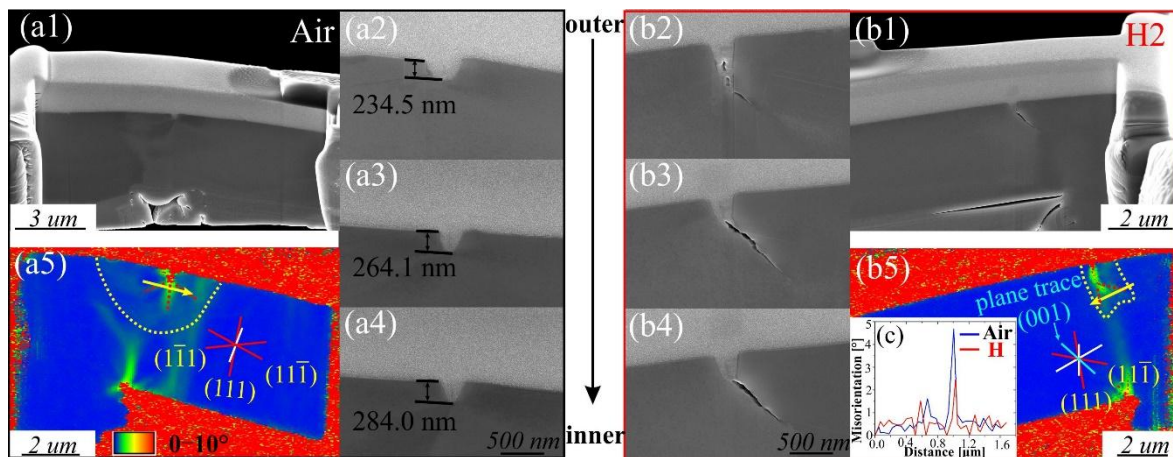
Fig. 3 SE images of beams cross-sections showing details of the cracking behavior (a1-a4) in air and (b1-b4) in H2 condition; (a5), (b5) KAM maps of two beams obtained from t-EBSD; and (c) misorientation data obtained close to the notch cracking.

Fig. 3 shows the detailed characterization of beam cross sections after bending. Notch blunting is observed in the hydrogen-free condition (Fig. 3 (a1)-(a4)). At regions close to the beam surface, where plane stress condition prevails and plastic flow is relatively easy, the blunted notch shows a depth of 234.5 nm (Fig. 2 (a2)). This observation is consistent with the micrographs shown in Fig. 2 (a)-(a1). The notch crack becomes steep with an increase in depth of about 50 nm from beam surface (Fig. 3 (a2)) to the interior (Fig. 3 (a4)). In the central part of the beam, the notch tip sensed triaxial stress in a plane strain condition. And the more pronounced blunting behavior in the plane strain condition is caused by the difficulty of plastic flow and an enhanced stress concentration at the notch tip. Fig. 3 (a5) shows the Kernel Average Misorientation (KAM) map of the beam bent in air obtained from t-EBSD. Crystallographic misorientations beneath the notch tip indicates high geometrically necessary dislocation (GND) densities in three directions (marked with red dotted lines), which corresponds to the $\{111\}$ slip traces marked in red. A large plastic zone is highlighted by the yellow dotted line. In comparison, hydrogen-assisted cracking happened on beams bent in H2 condition. In the plane stress condition, cracking propagated along the notch plane, followed by a deviation of the crack path into a non-specific-slip-plane (Fig. 3 (b2)). Fig. 3 (b3) shows the transition morphology of the crack from the surface to the middle region of the beam, i.e. cracking followed the notch plane for merely 80 nm then deviated as a sharp crack. In the plane strain condition, cracking deviated directly beneath the notch tip (Fig. 3 (b4)). Such variation in the cracking behavior on the beam surface and the center region is dependent on the local stress state. On the beam surface, the notch tip sensed less constraint from

the material, thus hydrogen-assisted cracking grew parallel to the notch plane. In comparison, the notch crack in the center region of the beam sensed a triaxial stress and cracking accordingly. KAM map in Fig. 3 (b5) shows a confined plastic zone compared to Fig. 3 (a5). Dislocation activities dominant in two slip planes, i.e., $(11\bar{1})$ and (111) (marked with red dotted lines). The resultant crack bisecting those two planes is aligned with (001) plane trace. Additionally, Fig. 3 (c) shows a reduced GND density in presence of hydrogen by measuring the crystallographic misorientations beneath the notch crack tip, which are highlighted by the yellow arrows in Fig. 3 (a5) and (b5). Further dislocation analyses on beam cross sections were performed with TEM. Bright-field images (Fig. 4 (a) and (b)) in two test conditions are consistent with the t-EBSD results. Deformation in air induced a large amount of plasticity below the blunted notch, and the high density of dislocations expand through the whole beam (Fig. 4 (a)). It is difficult to figure out dislocation structures since massive dislocations interact and tangle after deformation. Despite this, three slip bands can be clearly observed, which correspond to the active slip planes in Fig. 3 (a5). By contrast, hydrogen leads to a reduced and more localized plastic zone at the cracking area in Fig. 4 (b), which is consistent with the KAM map shown in Fig. 3 (b5). The two slip bands with high dislocation densities at the notch tip correspond to $(11\bar{1})$ and (111) plane traces, respectively.

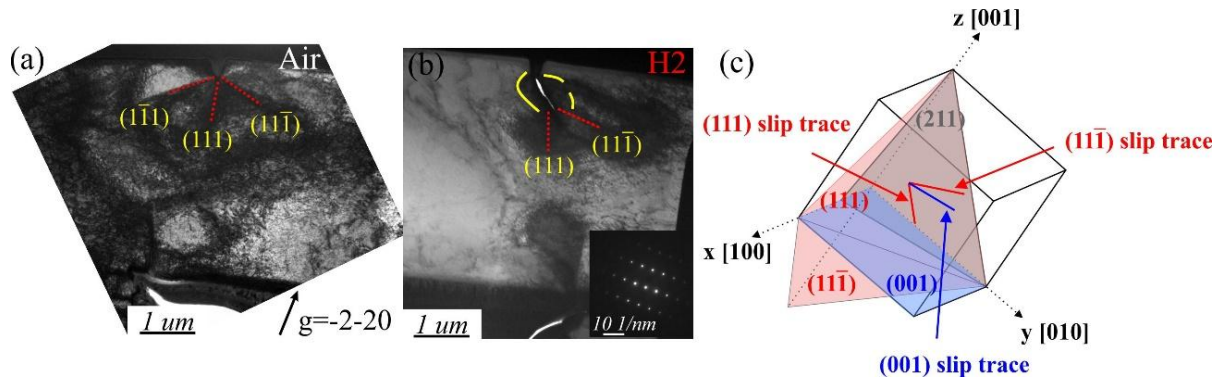
Fig. 4 Bright-field TEM micrographs showing dislocation morphologies of cantilevers bent in (a) air and (b) H2 condition; (c) a schematic showing the relation between the activated $\{111\}$ slip planes and the (001) crack plane.

Based on the above results, the cracking behavior of the interstitial HEA is highly influenced by introducing hydrogen. In the hydrogen-free condition, when the plastic deformation began, the notch tip acted as a stress concentrator and dislocation nucleation started on the slip planes that reached the critical resolved shear stress. Dislocations generated at the notch tip continuously move away, which relieved the local stress effectively and the deformation process continued by notch blunting. All slip systems with the same Schmid factor were activated in the hydrogen-free beam to compensate the deformation process. As a result, a large plastic zone with a value of about $6.28 \mu\text{m}^2$ was observed. In contrast, when hydrogen was presented at the notch tip, we observed a sharp crack with a reduced plastic zone (about $2.83 \mu\text{m}^2$) instead of notch blunting. According to the “Defactant” model proposed by Kirchheim [26, 27], the formation energy of dislocations [24, 28] and vacancies was reduced by adding hydrogen. Dislocation nucleation and multiplication started upon plastic deformation. With hydrogen absorbed into the material and segregated to the dislocations, massive dislocation-dislocation and dislocation-hydrogen interactions were triggered at the notch tip. Also, the creation of strain-induced vacancies was enhanced by hydrogen atoms [29]. Hydrogen and hydrogen-vacancy clusters were proposed to effectively pin dislocations from movement [17, 19, 20, 30], as reflected by the reduced plastic zone at both sides of the crack. With further deformation, dislocations were unable to move away and local strain increased drastically due to pronounced dislocation interactions near the notch front. The local stress intensity gradually reached to the critical value for micro-cracks formation. As a result, the first micro-crack initiated, and the local deformation energy was released. The crack propagation was realized by operating multiple slips on alternating $(11\bar{1})$ and (111) planes, and a mode I crack on (001) plane was created bisecting two $\{111\}$ planes. In this way, the plastic deformation was continuously consumed by the cracking process. Also, the nucleation and growth of microvoids at slip-band interactions or other defects ahead of the crack tip further contribute to the crack growth and result in a small crack-tip opening angle [31]. A schematic summary is shown in Fig. 4 (c), where cracking happened along $\langle 110 \rangle$ direction on (001) plane. The projection of slip planes and crack plane on the beam cross-section is highlighted. The comparable resolved shear stress values for two intersecting conjugate $\{111\}$ planes were proposed to cause the decohesion bisecting slip planes [32]. However, due to the complex stress state and dislocation activities at the notch tip, the values of resolved shear stress on each active

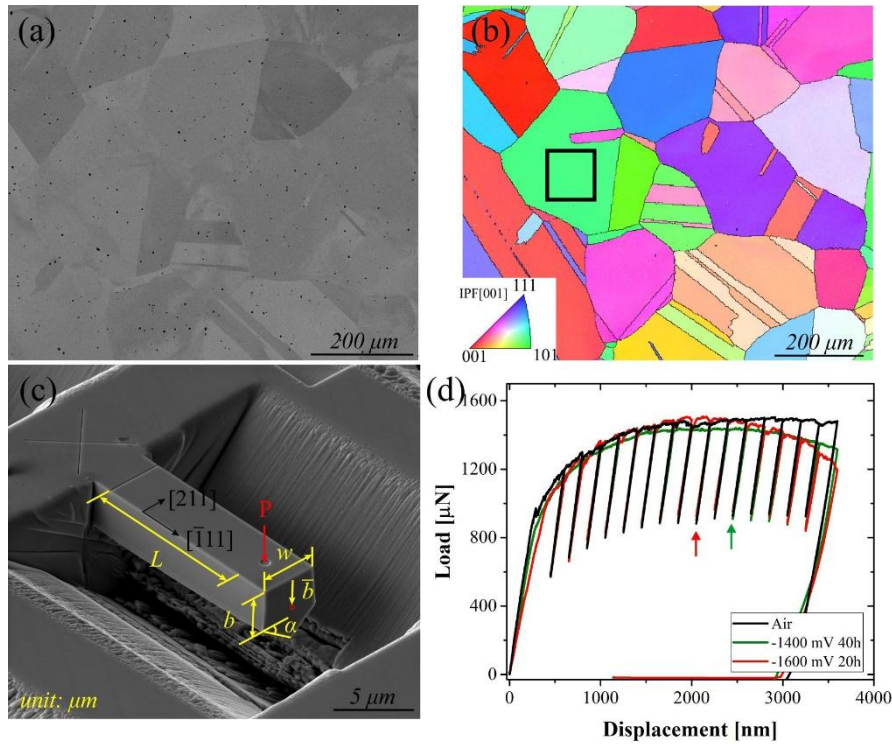
Fig. 1 (a) Back-scattered electron (BSE) micrograph of the studied interstitial HEA; (b) the corresponding inverse pole figure (IPF) map showing the selected grain orientation for milling cantilevers; (c) the characteristic dimensions of cantilevers; (d) load-displacement (L-D) curves of cantilevers bent in air and at two different hydrogen charging conditions, i.e., -1400 mV for 40 h (H1) and -1600 mV for 20 h (H2).

Fig. 1 (d) shows the representative load-displacement (L-D) curves obtained in air and at two charging conditions, i.e., H1 and H2. All beams exhibit linear elastic behavior in the first stage; the slight deviation in elastic properties could be caused by the small differentiation in beam geometries. Meanwhile, the absorption of hydrogen had no significant influence on yield strength (YS, defined as 0.2% offset stress). After reaching the yield points, L-D curves show similar plastic strain hardening regimes, and cantilever bent in air ~~reached-reaches~~ plateau till unloading at 3500 nm displacement, while the flow stresses of beams tested in H1 and H2 conditions ~~started start~~ decreasing gradually from the ~~loading-unloading cycles 11 and 911th and 9th of the loading-unloadign cycles~~, respectively, as marked by green and red arrows in Fig. 1 (d). The beam tested

in H1 condition ~~showsshowed~~ 8.4 % reduction in the flow stress compared to the maximum stress value. By further decreasing the charging potential to -1600 mV (H2 condition), which approximates to an increment of current density by one order of magnitude, a reduction of 20.5 % in flow stress ~~was is~~ observed.

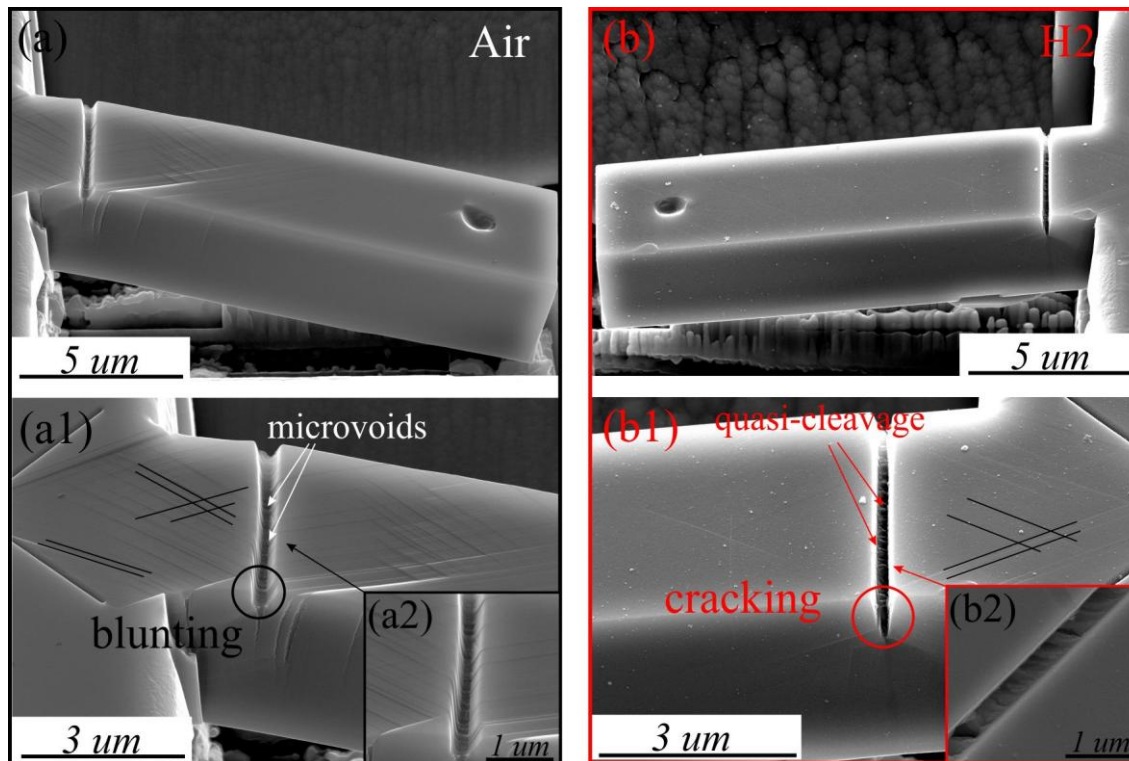
Fig. 2 (a), (a1) Secondary electron (SE) images showing deformation behavior of beams bent in air, and (b), (b1) in H2 charging condition; (a2) and (b2) magnified notch area in (a1) and (b1) after bending.

Fig. 2 shows the micrographs of beams after bending at different conditions. To study the most noticeable effect of hydrogen, we chose H2 charging condition ~~in for~~ the following discussion. In Fig. 2 (a1), abundant slip lines (marked by black lines) on the beam surface bent in air ~~elucidating~~ ~~elucidate~~ a large amount of plasticity was generated during deformation. According to Schmid's law, dislocation slips on (111), (11 $\bar{1}$), and (1 $\bar{1}$ 1) slip planes ~~with an equal Schmid value of 0.272~~ were activated to compensate the plastic deformation ~~with an equal Schmid value of 0.272~~, which is reflected by the slip traces on beam surface in Fig. 2 (a1). Here we use Schmid's law by assuming that on the top layer of the beams, uniaxial tensile stress dominated at the beginning of bending [25]. Notch blunting with a tip opening angle of 52.7° in ~~the~~ air indicates a superior ductility and a high resistance to cracking of the studied interstitial HEA. The formation of microvoids at the crack tip, as pointed out by the white arrows in Fig. 2 (a1) and the magnified notch area in Fig. 2 (a2), elucidates a typical ductile fracture mode. On the contrary, beams bent in H2 condition had entirely different cracking behavior. Fig. 2 (b1) shows a sharp cracking of the notch plane (marked in red circle) with a smaller crack-tip opening angle of 27.2°. It is worth noting that the number of slip lines in Fig. 2 (b1) was remarkably reduced compared to that in Fig. 2 (a1), which indicates that the cracking process consumed part of the plasticity. And rugged fracture surfaces on the cracking plane shows a quasi-cleavage fracture behavior (Fig. 2 (b1)-(b2)). It is worth mentioning that due to the effect of beam size and the space limitation beneath the beams, it was unable to obtain fracture surfaces in the current tests. Optimization will be made in the following studies.

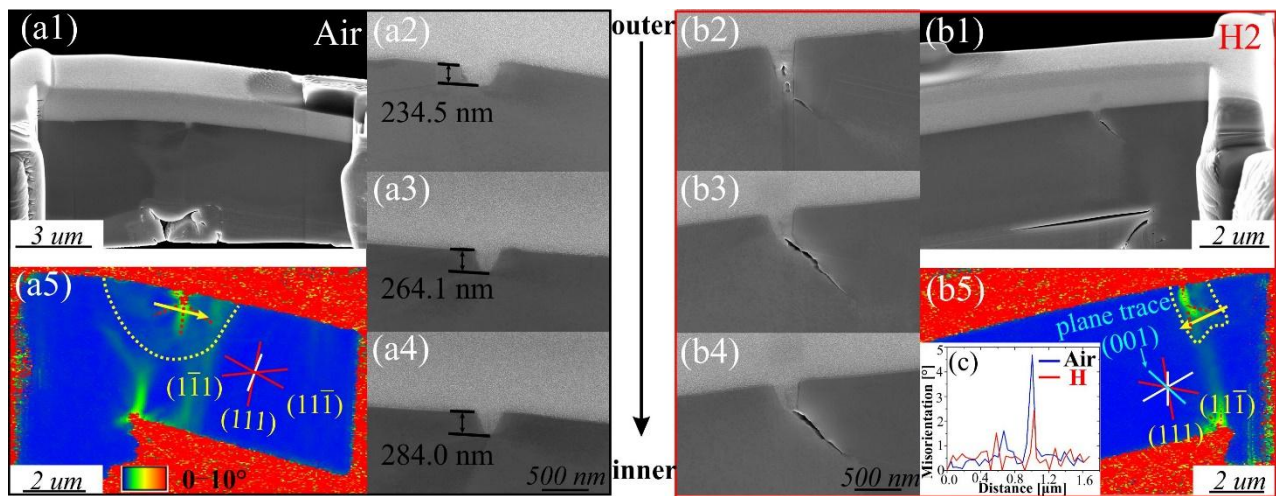
Fig. 3 SE images of beams cross-sections showing details of the cracking behavior (a1-a4) in air and (b1-b4) in H2 condition; (a5), (b5) KAM maps of two beams obtained from t-EBSD; and (c) misorientation data obtained close to the notch cracking.

Fig. 3 shows the detailed characterization of beam cross sections after bending. Notch blunting was-is observed in the hydrogen-free condition (Fig. 3 (a1)-(a4)). At regions close to the beam surface, where plane stress condition prevails and plastic flow is relatively easy, the blunted notch showed-shows a depth of 234.5 nm (Fig. 2 (a2)). This observation is consistent with the micrographs shown in Fig. 2 (a)-(a1). The notch crack became-becomes steep with an increase in depth of about 50 nm from beam surface (Fig. 3 (a2)) to the interior (Fig. 3 (a4)). In the central part of the beam, the notch tip sensed triaxial stress in a plane strain condition. And the more pronounced blunting behavior in the plane strain condition is caused by the difficulty of plastic flow and an enhanced stress concentration at the notch tip. Fig. 3 (a5) shows the Kernel Average Misorientation (KAM) map of the beam bent in air obtained from t-EBSD. Crystallographic misorientations beneath the notch tip indicated-indicates high geometrically necessary dislocation (GND) densities in three directions (marked with red dotted lines), which corresponds to the $\{111\}$ slip traces marked in red. A large plastic zone is highlighted by the yellow dotted line. In comparison, hydrogen-assisted cracking happened on beams bent in H2 condition. In the plane stress condition, cracking propagated along the notch plane, followed by a deviation of the crack path into a non-specific-slip-plane (Fig. 3 (b2)). Fig. 3 (b3) shows the transition morphology of the crack from the surface to the middle region of the beam, i.e. cracking followed the notch plane for merely 80 nm then deviated as a sharp crack. In the plane strain condition, cracking deviated directly beneath the notch tip (Fig. 3 (b4)). Such variation in the cracking behavior on the beam surface and the center region is dependent on the local stress state. On the beam surface,

the notch tip sensed less constraint from the material, thus hydrogen-assisted cracking grew parallel to the notch plane. In comparison, the notch crack in the center region of the beam sensed a triaxial stress and cracking accordingly. KAM map in Fig. 3 (b5) shows a confined plastic zone compared to Fig. 3 (a5). Dislocation activities dominant in two slip planes, i.e., $(1\bar{1}\bar{1})$ and (111) (marked with red dotted lines). The resultant crack bisecting those two planes is aligned with (001) plane trace. Additionally, Fig. 3 (c) shows a reduced GND density in presence of hydrogen by measuring the crystallographic misorientations beneath the notch crack tip, which are highlighted by the yellow arrows in Fig. 3 (a5) and (b5). Further dislocation ~~analysis-analyses~~ on beam cross sections ~~was-were~~ performed with TEM. Bright-field images (Fig. 4 (a) and (b)) in two test conditions are consistent with the t-EBSD results. Deformation in air induced a large amount of plasticity below the blunted notch, and the high density of dislocations expand through the whole beam (Fig. 4 (a)). It is difficult to figure out dislocation structures since massive dislocations interact and tangle after deformation. Despite this, three slip bands can be clearly observed, which ~~corresponds-correspond~~ to the active slip planes in Fig. 3 (a5). By contrast, hydrogen leads to a reduced and more localized plastic zone at the cracking area in Fig. 4 (b), which is consistent with the KAM map shown in Fig. 3 (b5). The two slip bands with high dislocation densities at the notch tip correspond to $(1\bar{1}\bar{1})$ and (111) plane traces, respectively.

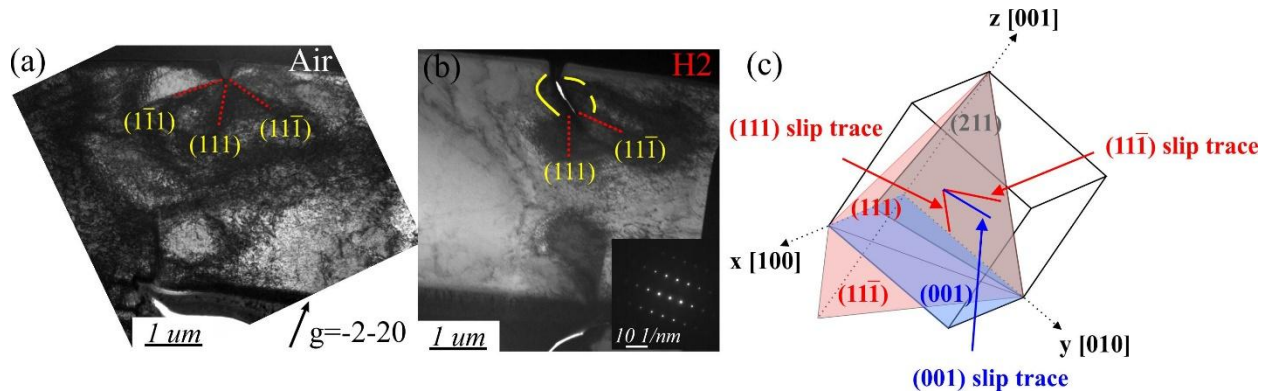
Fig. 4 Bright-field TEM micrographs showing dislocation morphologies of cantilevers bent in (a) air and (b) H₂ condition; (c) a schematic showing the relation between the activated {111} slip planes and the (001) crack plane.

Based on the above results, the cracking behavior of the interstitial HEA is highly **influence** **influenced** by introducing hydrogen. In the hydrogen-free condition, when the plastic deformation began, the notch tip acted as a stress concentrator and dislocation nucleation started on the slip planes that reached the critical resolved shear stress. Dislocations generated at the notch tip continuously move away, which relieved the local stress effectively and the deformation process continued by notch blunting. All slip systems with the same Schmid factor were activated in the hydrogen-free beam to compensate the deformation process. As a result, a large plastic zone with a value of about $6.28 \mu\text{m}^2$ was observed. In contrast, when hydrogen was **present** **presented** at the notch tip, we observed a sharp crack with a reduced plastic zone (about $2.83 \mu\text{m}^2$) instead of notch blunting. According to the “Defactant” model proposed by Kirchheim [26, 27], the formation energy **for-of** dislocations [24, 28] and vacancies was reduced by adding hydrogen. Dislocation nucleation and multiplication started upon plastic deformation. With hydrogen absorbed into the material and segregated to the dislocations, massive dislocation-dislocation and dislocation-hydrogen interactions were triggered at the notch tip. Also, the creation of strain-induced vacancies was enhanced by hydrogen atoms [29]. Hydrogen and hydrogen-vacancy clusters were proposed to effectively pin dislocations from movement [17, 19, 20, 30], as reflected by the reduced plastic zone at both sides of the crack. With further deformation, dislocations were unable to move away and local strain increased drastically due to pronounced dislocation interactions near the notch front. The local stress intensity gradually reached to the critical value for micro-cracks formation. As a result, the first micro-crack initiated, and the local deformation energy was released. The crack propagation was realized by operating multiple slips on alternating $(11\bar{1})$ and (111) planes, and a mode I crack on (001) plane was created bisecting two $\{111\}$ planes. In this way, the plastic deformation was continuously consumed by the cracking process. Also, the nucleation and growth of microvoids at slip-band interactions or other defects ahead of the crack tip further **contributes-contribute** to the crack growth and **results-result** in a small crack-tip opening angle [31]. A schematic summary is shown in Fig. 4 (c), where cracking happened along $\langle 110 \rangle$ direction on (001) plane. The projection of slip planes and crack plane on the beam cross-section is highlighted. The comparable resolved shear stress values for two intersecting conjugate $\{111\}$ planes **was-were** proposed to cause the decohesion bisecting
