Salt efflorescence in historic wooden buildings

Keywords: Wooden buildings, Wood degradation, Efflorescence, Subflorescence, Wood preservation, Archaeological wood, Flame retardants, Tutton's compounds, Alums

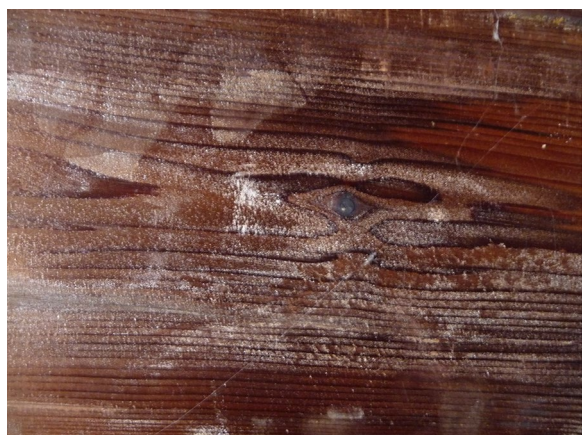
Efflorescence in Aspaas House occurs on certain areas on walls and ceilings in the 2nd and 3rd floor but is absent at the ground floor. In Tronshart House, efflorescence is coating the entire southern wall in the attic and also appears on the upper quarter of the wall below, in the ground floor. Efflorescence location excludes the possibility of salt transfer from the ground by water infiltration. The crystal deposit is not compact but appears as a pattern of isolated crystalline formations (Fig. 2). This morphology is typical of efflorescence growth [20].

Fig. 2 Efflorescence on the ceiling of Aspaas House in the second floor

The most likely cause of efflorescence seems to be water leakage at a not-recorded date, probably due to roof damage. Leaking water penetrated the wood and dissolved the salts inside forming a salt solution contained within a thin layer at the surface. Subsequent water evaporation and salt crystallization occurred after stopping the water leakage.

Removal of the efflorescence would be beneficial for the aspect, and to reduce health hazards and risks of wood degradation. Some of the cleaning techniques reviewed in [7] appear suitable in this case. The simplest one is the mechanical procedure using vacuum cleaners fitted with HEPA filters. As the efflorescence shows poor adhesion to the wood, it could be removed in this way but the salts incorporated in the wood will persist. Removal of both efflorescence and incorporated salts could be achieved by the vacuum washing process [51, 52]. This approach is more costly and laborious but such a deep-cleaning treatment eliminates the risk of efflorescence return and wood degradation under the effect of incorporated salts.

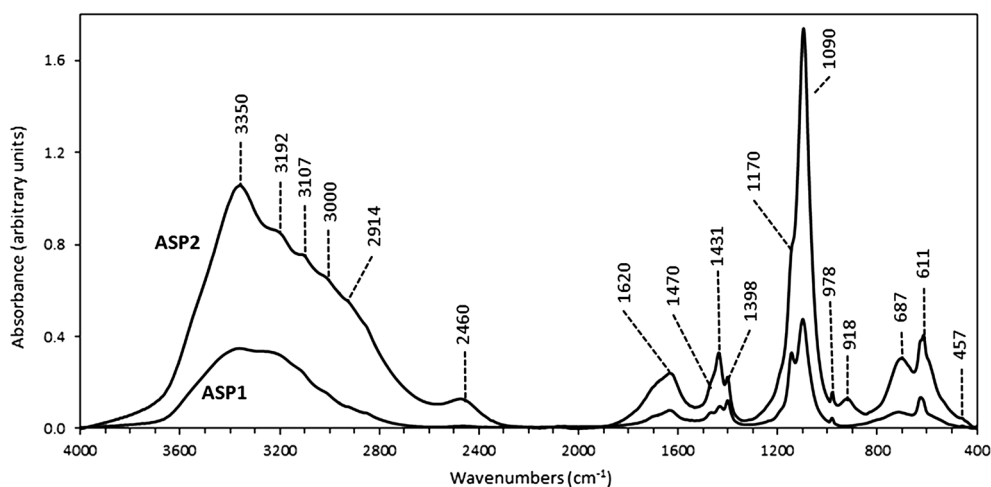
The investigated efflorescence samples display similar bands (Fig. 3) which suggest similar chemical compositions as far as molecular species are concerned. Further data interpretation was conducted using the guidelines in [22–24].

Fig. 3 Infrared spectra of the ASP1 and ASP2 specimens

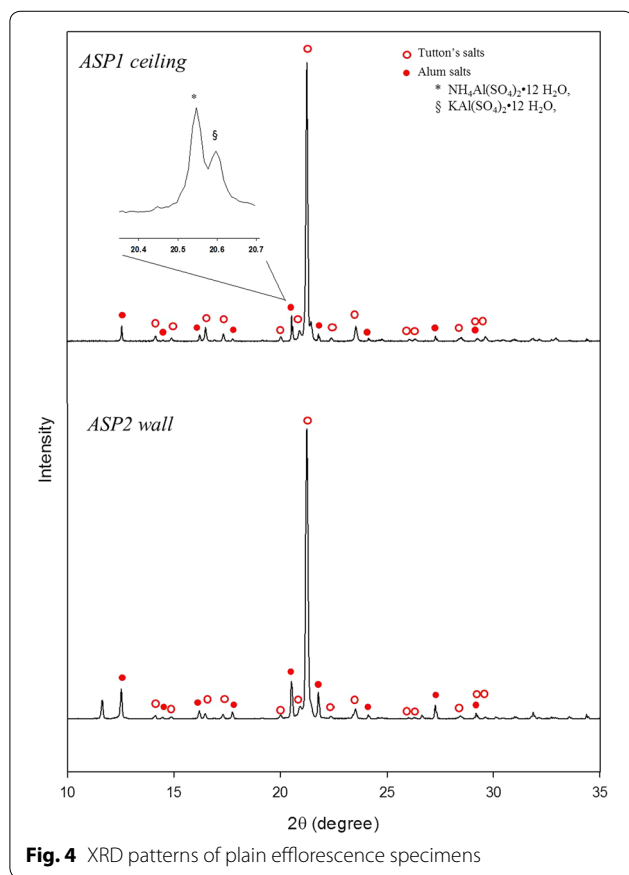
XRD patterns (Fig. 4) indicate the presence of two classes of double sulfate salts already mentioned, namely alums and Tutton's salts. Two alums, namely potassium alum and tschermigite (ammonium alum) were identified in both samples. They can be distinguished by the fine structure details in the diffraction pattern at 2θ about 20° as shown in the expanded view in Fig. 4.

Fig. 4 XRD patterns of plain efflorescence specimens

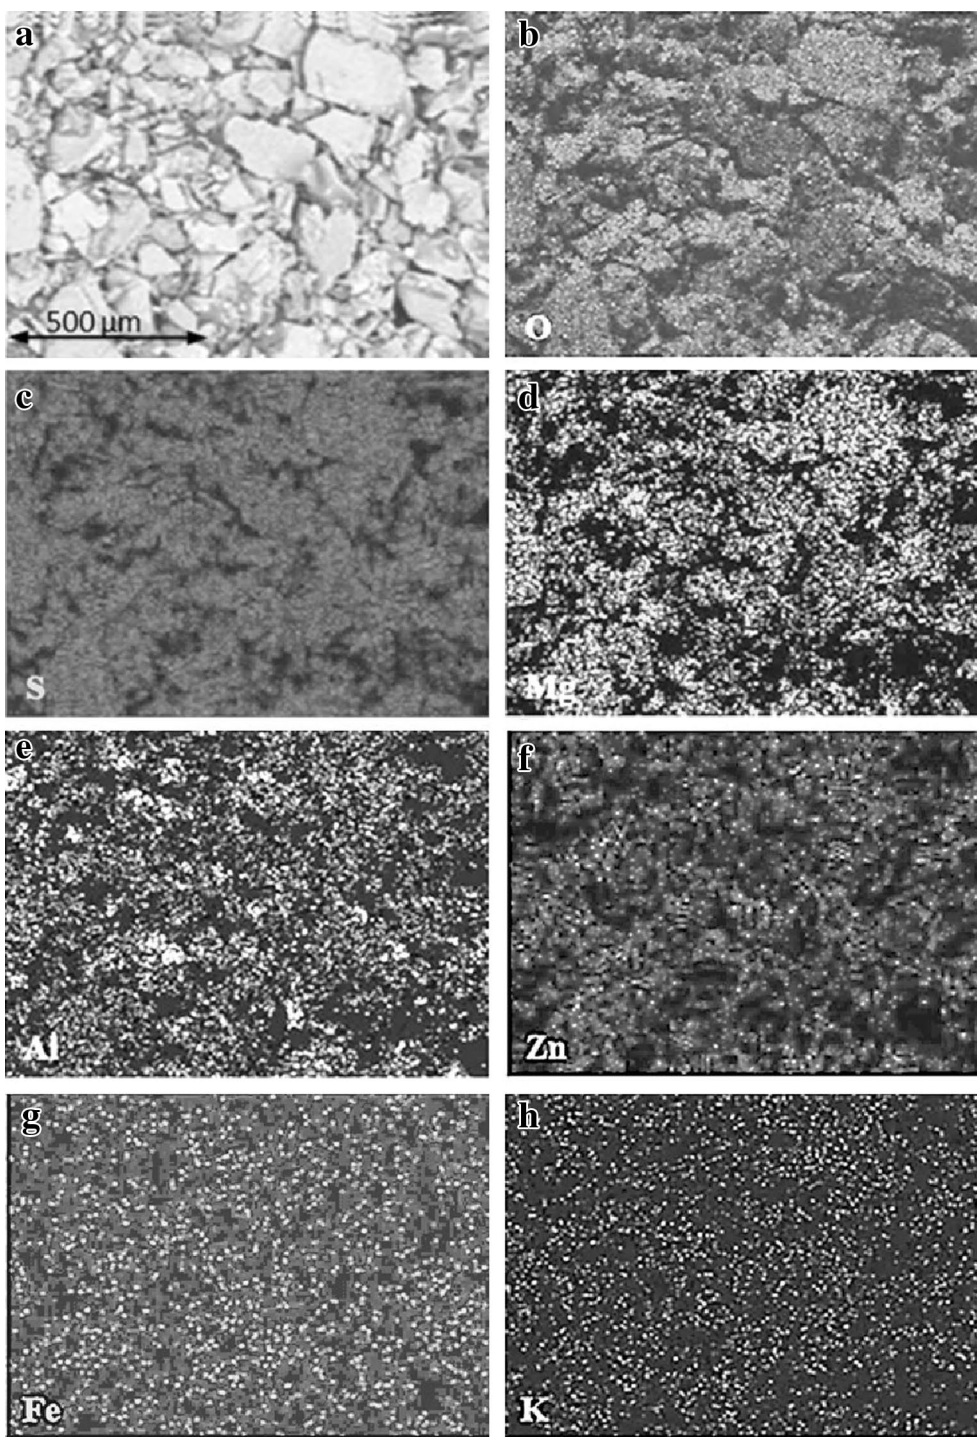
Figure 5a displays a BSE image of efflorescence. In agreement with optical microscopy observations, it proves that the efflorescence consists of crystals of sub-millimeter size. Next images in Fig. 5 display the mapping of elements within the ASP1 specimen. Both oxygen and sulfur maps (Fig. 5b, c respectively) match very well the BSE image (Fig. 5a) proving an abundant occurrence and an even distribution of these elements within the efflorescence material. Other major elements, such as magnesium (d) and aluminium (e) display a similar trend. Less abundant elements (Zn, Fe, and K) are also uniformly spread within the specimen.

Fig. 5 EPMA elemental mapping for the ASP1 specimen. **a** BSE image. **b–h** mapping of elements indicated on each picture

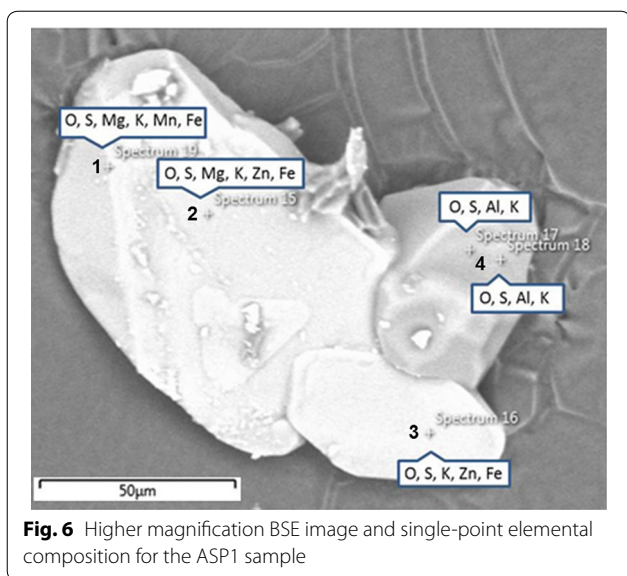
At a 10 times higher magnification, the distribution of the elements appears less even, as shown in Fig. 6. An interpretation of data in this figure can be done in the light of the FT-IR and XRD data above. Thus, sulfur and oxygen, which are present in the form of the sulfate ion, are found at each spot. At spots 1, 2, and 3, divalent metal ions (Mg^{2+} , Zn^{2+} , Fe^{2+} , and Mn^{2+}) are accompanied by the monovalent potassium cation which suggests that Tutton's salt occurs at each point. So, the lowest crystal is formed of zinc and iron Tutton's salts whereas at the upper part of the figure, magnesium Tutton's salt is mixed with similar salts of zinc and iron. Manganese seems to have been concentrated as a co-cation in magnesium-based Tutton's salts (spot 1) due to the similarity of ionic radii of the two ions [34]. Most probably, each of the above crystals is a mixed Tutton's salt crystal containing at least two different divalent cations. Since iron accompanies divalent cations, it can be inferred that it is present as the iron (II) ion. As far as the spots 4 are concerned, the elemental composition suggests that the pertinent

Fig. 6 Higher magnification BSE image and single-point elemental composition for the ASP1 sample

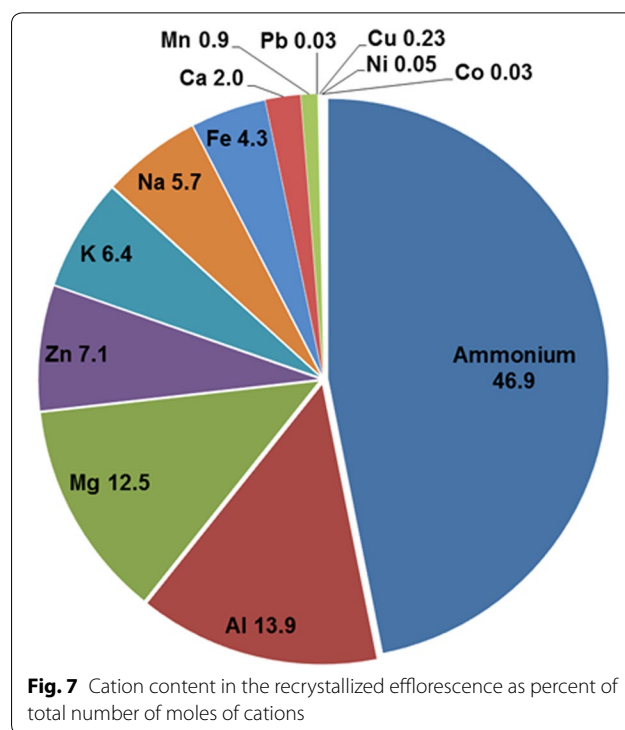
In order to look for possible stoichiometric relationships, the cation content was recalculated in terms of mole percent with respect to the total number of moles of cations in the specimen. The results (Fig. 7) prove that ammonium accounts for about half of the total number of moles of cations. Next come aluminium and magnesium that are present in about similar mole

Fig. 7 Cation content in the recrystallized efflorescence as percent of total number of moles of cations
