**Hydraulic and structural evaluation of
rockfill dam behavior when exposed to
throughflow and overtopping
scenarios**

Doctoral Thesis

Department of Civil and Environmental Engineering

NTNU
Norwegian University of
Science and Technology
Faculty of Engineering

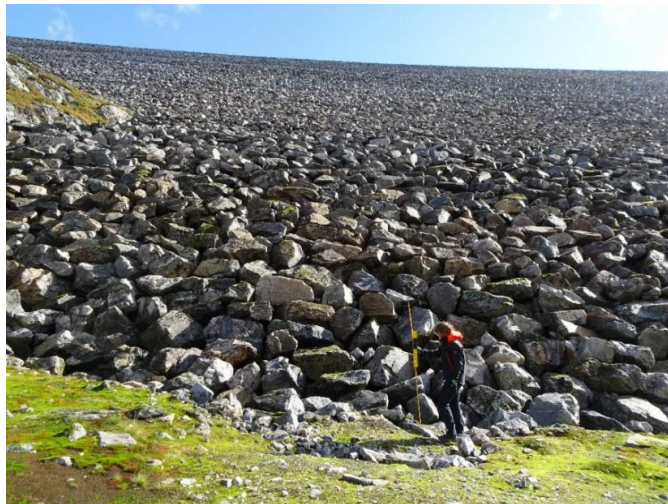
Figure 2. Placed riprap constructed on the downstream slope of dam Oddatjørn, which is a 142 m high rockfill dam constructed in Suldal, Norway (Photo: GHR Ravindra, NTNU).

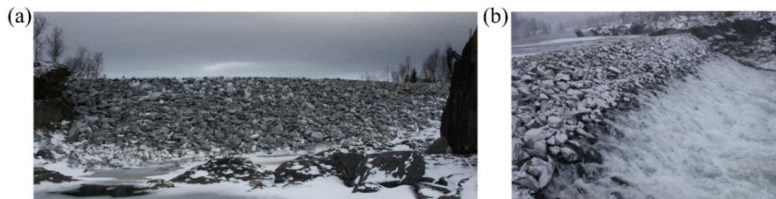
Figure 9. (a) Image of the test rockfill embankment (M1) from the test site downstream of Røssvatn, southern Norway prior to testing; (b) Image of the test dam during testing (Image courtesy: EBL Kompetanse (2006) and published in Ravindra et al., 2019b).

The 6 m high homogenous rockfill embankment was constructed in a channel with mean top width of 42.8 m as part of the IMPACT project (EBL Kompetanse, 2006). The cross-sectional geometric outline consisted of crest and bottom widths of 2 m and 20 m respectively with upstream and downstream inclinations of $S = 1:1.5$ (V: H). The inclination of the embankment side slope was chosen in accordance with Norwegian rockfill dam construction practice (e.g. NVE, 2012). The abutment profiles at the test location were steep resulting in a trapezoidal channel cross-section. The rockfill embankment of volume $V_E \approx 2000 \text{ m}^3$ was constructed of uniformly graded rockfill material with median stone size of $d_{50} = 350 \text{ mm}$. During embankment construction, a set of four piezometers (P₁ to P₄) were installed within the downstream embankment structure at an elevation of 2 m from the channel bottom at a spacing of 4 m along the flow direction for throughflow depth measurements. Images from the test site depicting the test embankment prior to and during testing are presented in Figures 9(a) and 9(b) respectively. Reference is made to *Paper IV* presented within this thesis for detailed information regarding the large-scale experimental setup from the IMPACT study.

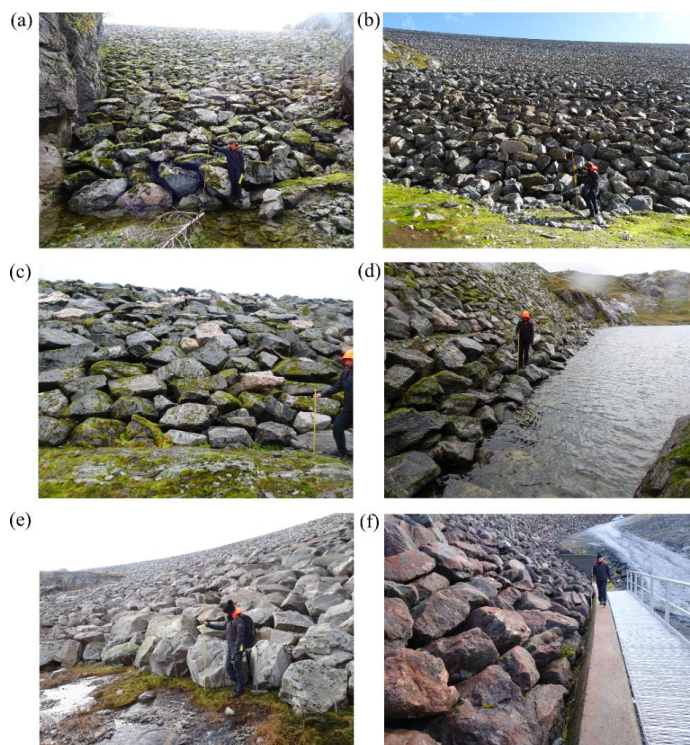
Figure 15. Depiction of existing conditions of placed riprap toe sections. Category 1 at dams (a) Fjellhaugvatn dam (b) Oddatjørn dam and (c) Skjerjevatnet main dam. Category 2 at (d) Skjerjevatnet main dam. Category 4 at (e) Storvass dam. Category 5 at (f) Akersvass dam (Adopted from Ravindra et al., 2019a).

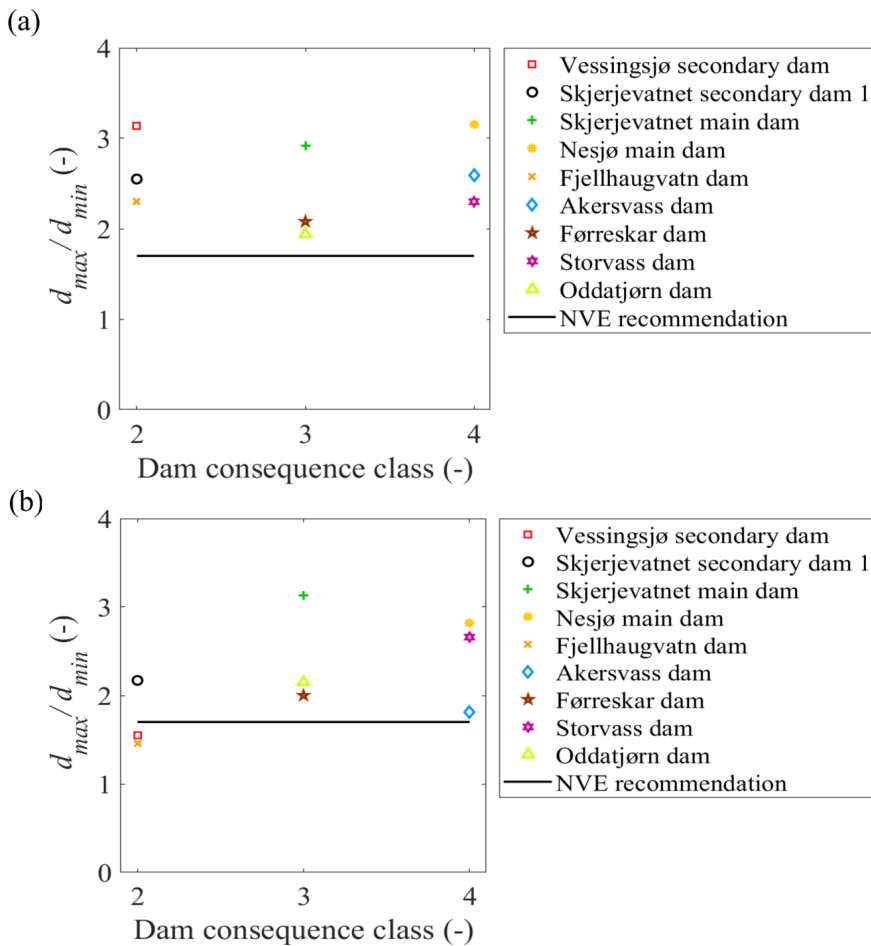
Figure 4. Panel a present plots depicting the ratio of the maximum to minimum stone diameters for the riprap stones for all the surveyed dams. Panel b presents the ratio of the maximum to minimum stone diameter for the toe stones for all the surveyed dams.

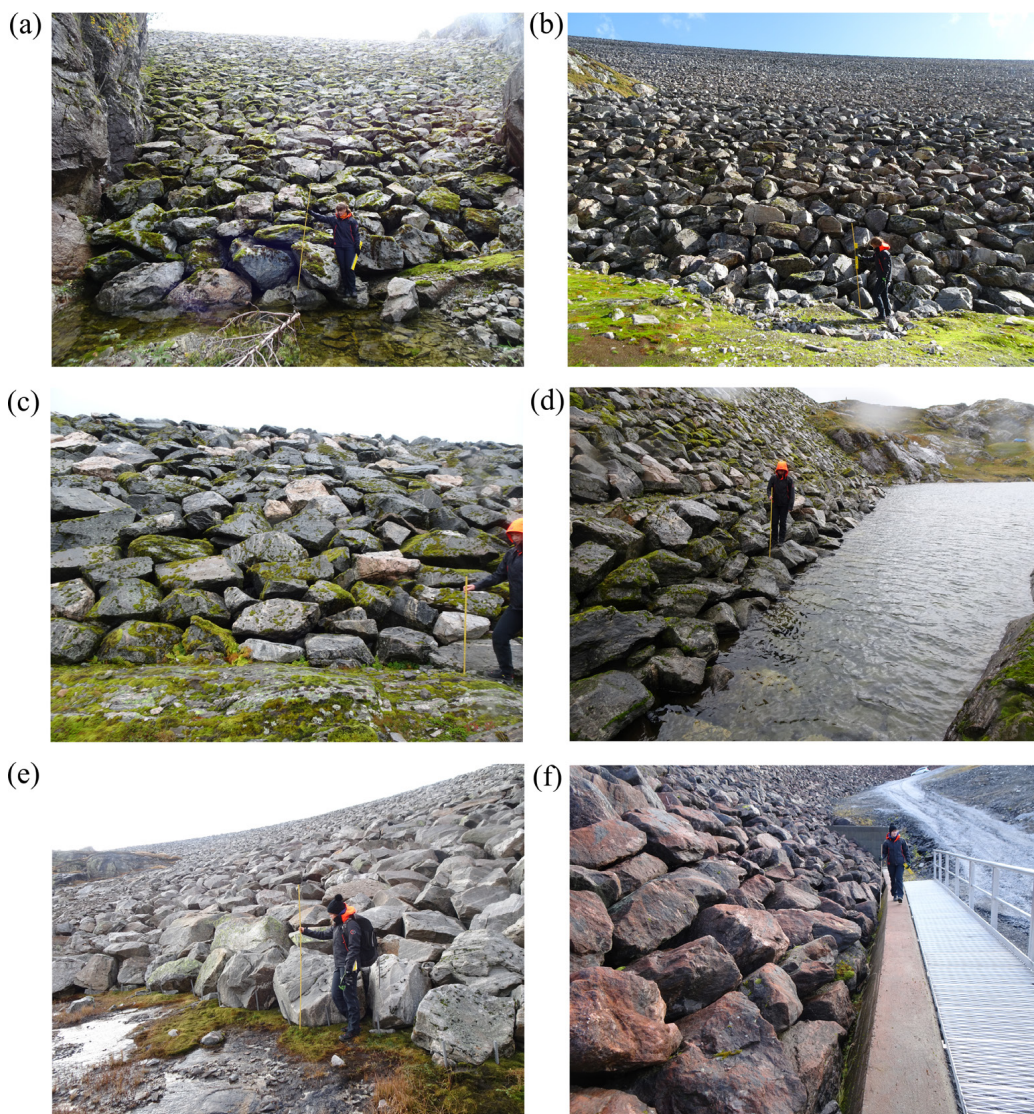
Figure 7. Depiction of existing conditions of placed riprap toe sections. Category 1 at dams (a) Fjellhaugvatn dam (b) Oddatjørn dam and (c) Skjerjevatnet main dam. Category 2 at (d) Skjerjevatnet main dam. Category 4 at (e) Storvass dam. Category 5 at (f) Akersvass dam.

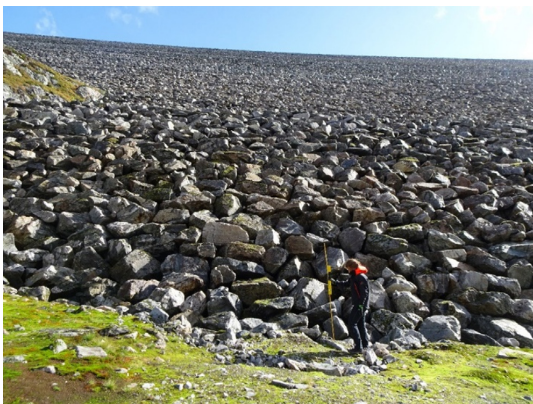
Fig. 1. Placed riprap constructed on Dam Oddatjørn, Suldal, Norway.

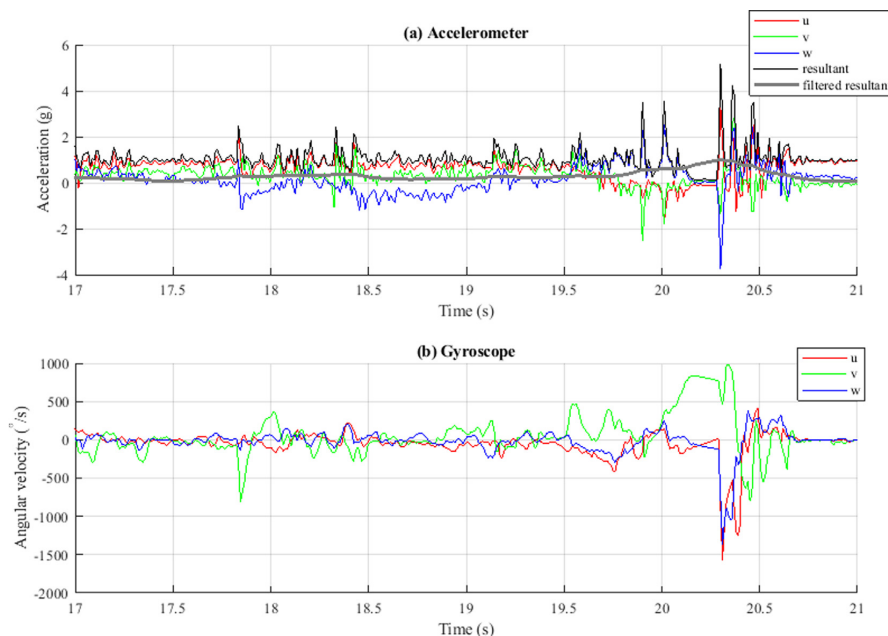
Fig. 6. Detailed plots of (a) accelerometer and (b) gyroscope measurements from the Smartstone placed at the riprap crest (S_0) from test P05 during total riprap collapse (Phase E).

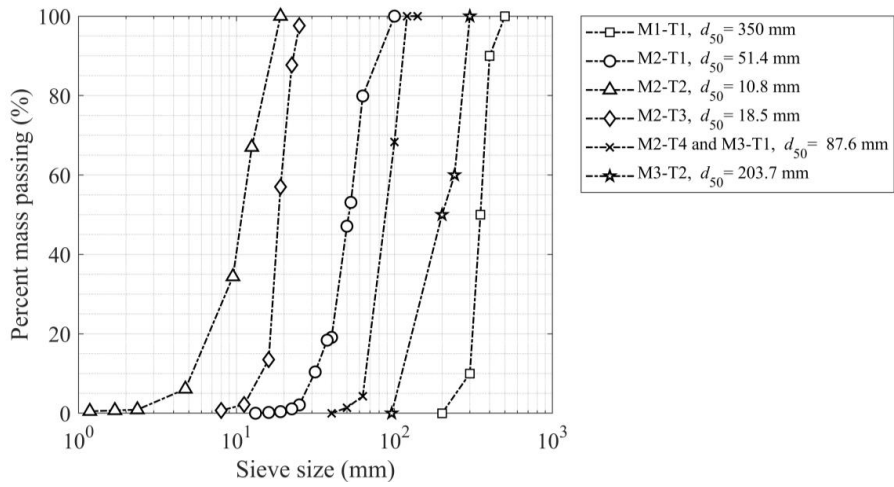
Figure 7 Particle size distribution curves for the materials employed for construction of different test dam models.
