# Back calculation of the Sørkjosen's landslide USING PLAXIS

**Marianna Kalogeropoulou**

Geotechnics and Geohazards

Submission date: June 2020

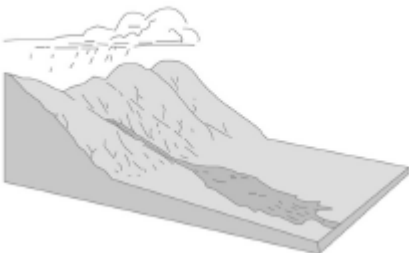
Figure 6: Debris flow

On the other side, debris and earth flows are easily recognized as they run in bigger distances and they are intense due to high cohesive material content. They are a fast mass movement in which a combination of uncompacted soil, rock, organic elements, air, and water is flowing in a downwards surface. Debris flow are mainly caused by the high water flows due to extreme precipitation on the rapid snow melting which erodes and mobilize the loose material or the rock in steep slopes.

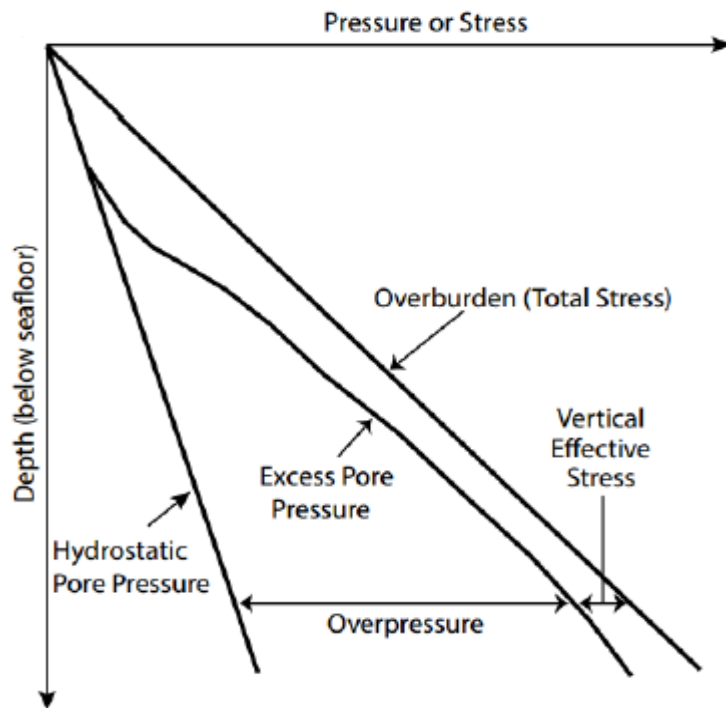
Figure 9: Example of how the pore pressure can increase with depth and reduce the effective stresses (Talling et.al,2014).

A decisive factor for stability is the pore pressure distribution on the slope. Increase in pore pressure leads to reduced effective stresses, see Figure 9. When the pore pressure becomes so large that it carries all the overlying weight, then a failure will occur.

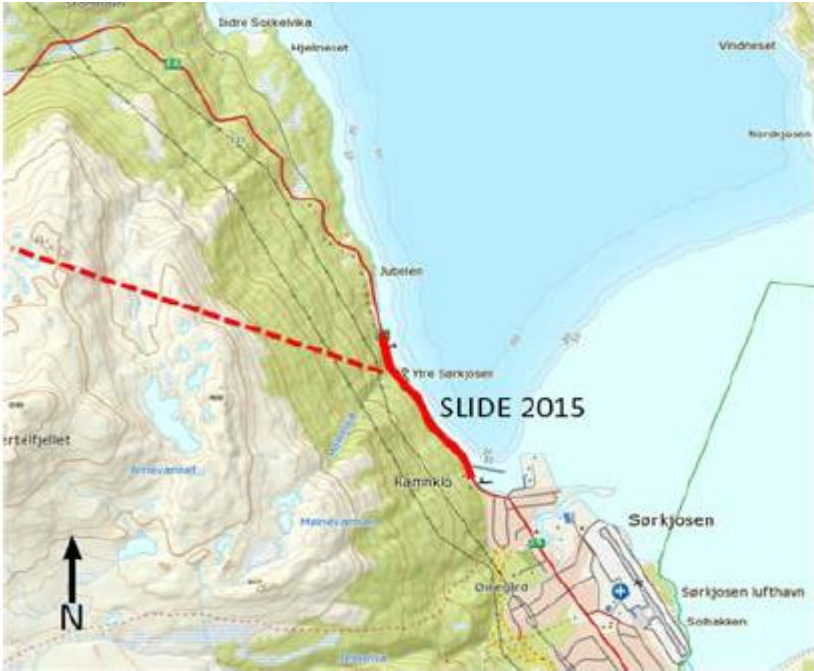
Figure 18: The 2015 slide sent the shoreline marked by a solid line into the fjord. The dotted line was a rock tunnel under construction.

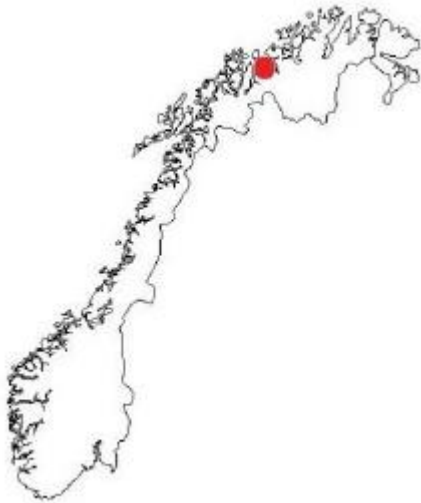
Figure 19: Sørkjosen area.

A shoreline landslide of between 1,1 and 1,4 million m<sup>3</sup> took place close to the village Sørkjosen in Northern Norway during the night of the 9<sup>th</sup> to the 10<sup>th</sup> May 2015 (see location in figure 18 and 19). The shoreline was destroyed over more than one kilometer. In the north a warehouse slumped into the sea whereas in the south a pier sank in the fjord, destroying a harbor. A small tsunami was triggered in the fjord. No casualties were encountered, but the landslide closed the main road, E6, connecting North and South Norway. After the landslide, the traffic had to take 700 km detour through Finland to get across.

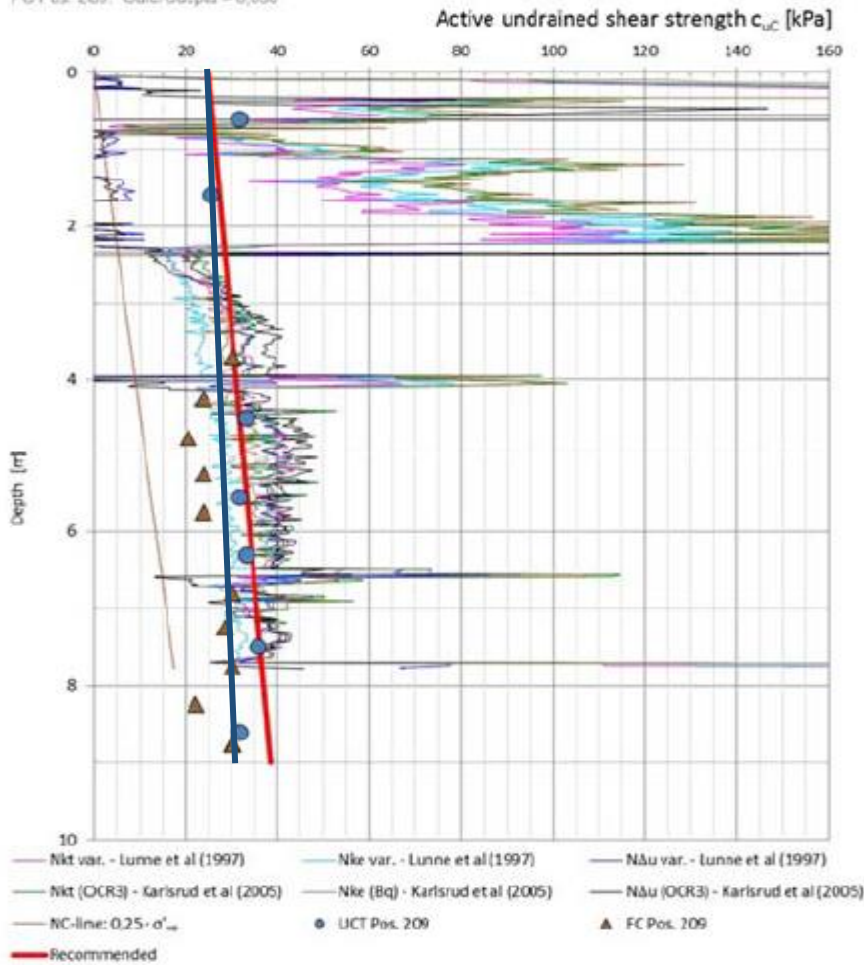
Anisotropy factors used for scaling in figure:  
 UCT Pos. 209:  $c_{uc}/c_{ucplu} = 0,630$   
 FC Pos. 209:  $c_{uc}/c_{ucplu} = 0,630$

Figure 21: Undrained active shear strength results from soil investigations performed after the slide within the evacuated scar (modified in order to include the  $s_u$  used in this paper (blue line)). The failure surface corresponds to the top of the clay layer now covered by landslide debris. (Nordal S, L'Heureux J. 2016)

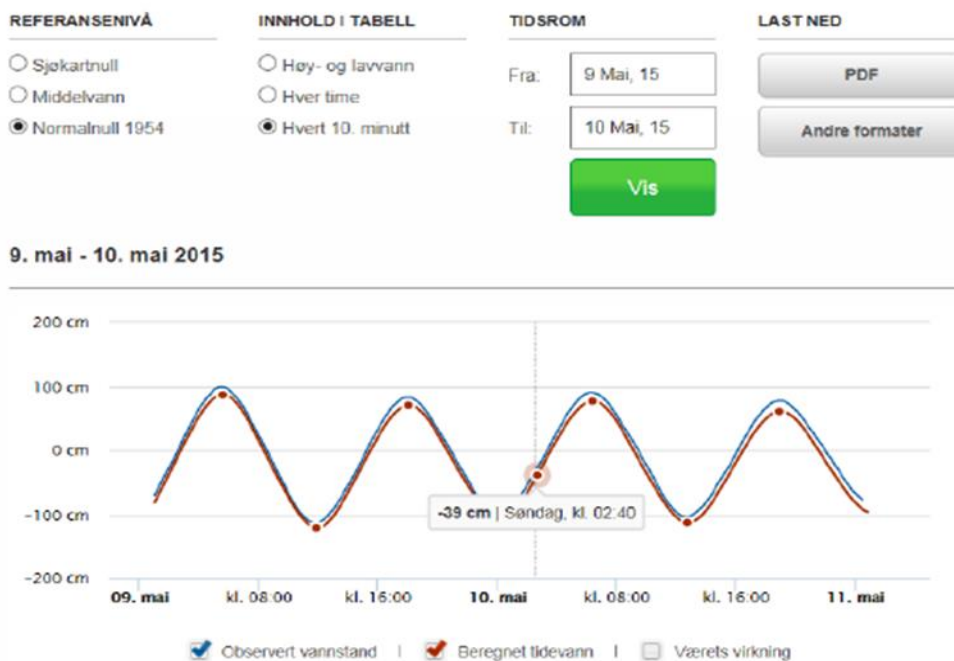
Figure 26: Calculated and observed tides for Sørkjosen (from Sehavnivå.no).

NVE (Norwegian Water Resources and Energy Directorate) notified on May 9, 2015 at 09.52 danger of flooding with level of care 2 in Troms and Finnmark. The avalanche occurred after the low tide, which was 43pprox.. at midnight. In Sørkjosen there is a tidal difference of 2 – 3 meters. The avalanche occurred 43pprox.. kl. 02.40 night to 10 May with an observed water level of 39 cm below normal 1954. Low tide occurred at 00.00 night to 10 May with an observed water level of 99 cm below normal zero 1954, see Figure 11. Naval chart zero (LAT) is set at 182 cm below normal zero 1954. Thus, it was not uncommonly low tide in the time before the avalanche.

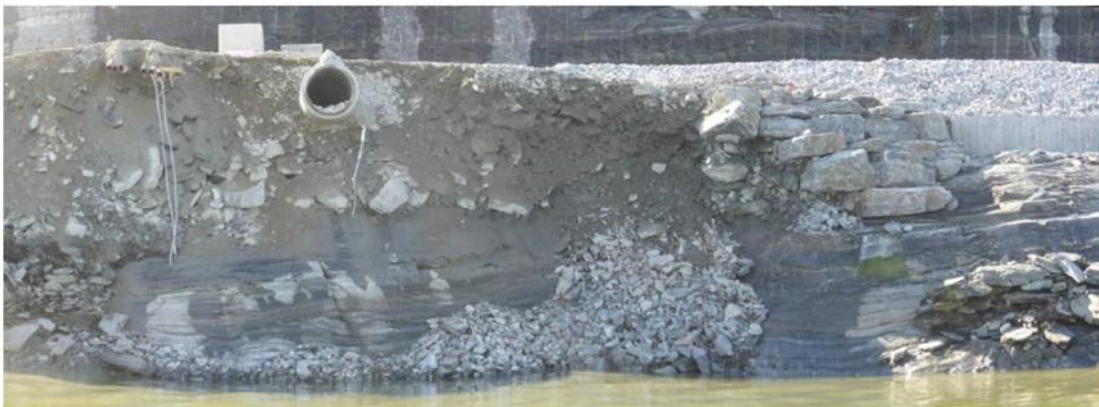
Figure 28: A photo from the seaside shortly after the landslide. Shows the northern part of the area where the pier reached land and the cuttings that passed through the road and the landfill. (Photo: Norut, ISBN 978-82-7492-305-8 report).

There was significant rainfall in the afternoon of May 9 and witnesses told of large amounts of water in the mountain cut, in the ditches along this and in the ditches under the road. The cuttings were laid between October 13 and November 14, 2014. A cutting was laid through the road 45 approx. at el. 10890 and went out into the sea through the new filling. Figure 27 shows the plug run after the landslide. The extent of the old filling at the foot of the pier is shown in the cones in Figure 28.

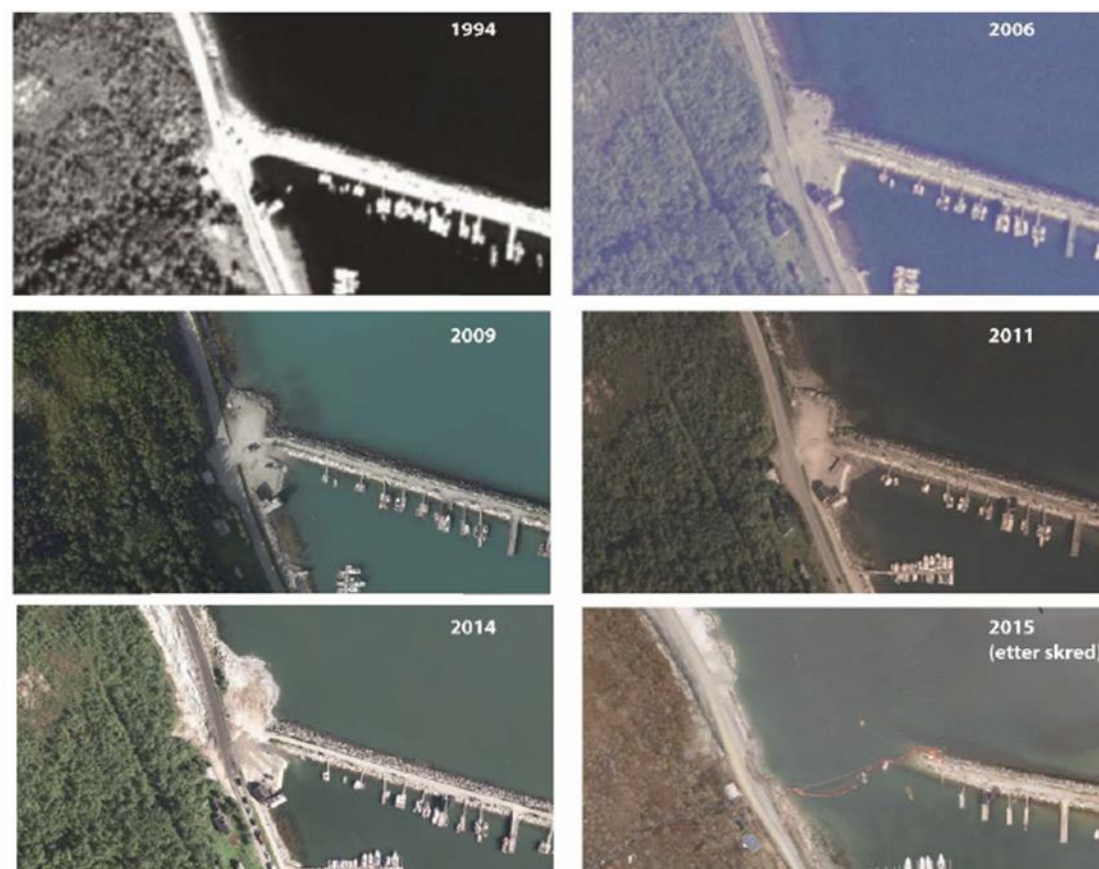
Figure 29: Orthophotos of the pier at Sørkjosen in the period 1994-2015 illustrate filling in over time, as well as the situation after the slide. (Nordal.S, L'Heureux.J, Skotheim. A, 2016)

The pier at Sørkjosen was built in 1977. In autumn 2014, a landfill was laid on the pier at the part for exits to the local road and the marina parking lot, using rocks from the mountainside further north along the E6. This work was completed in November 2014. Orthophotos from the molo area show that there have been fillings in various phases in this area during the period 1994-2014 (Figure 29). An overview of the filling at the parking lot is presented in Figure 30. The top of the filling at the parking lot is on the cot 46 approx.. 4 m, while the outer part of the pier to the east lies at the foot 3m.

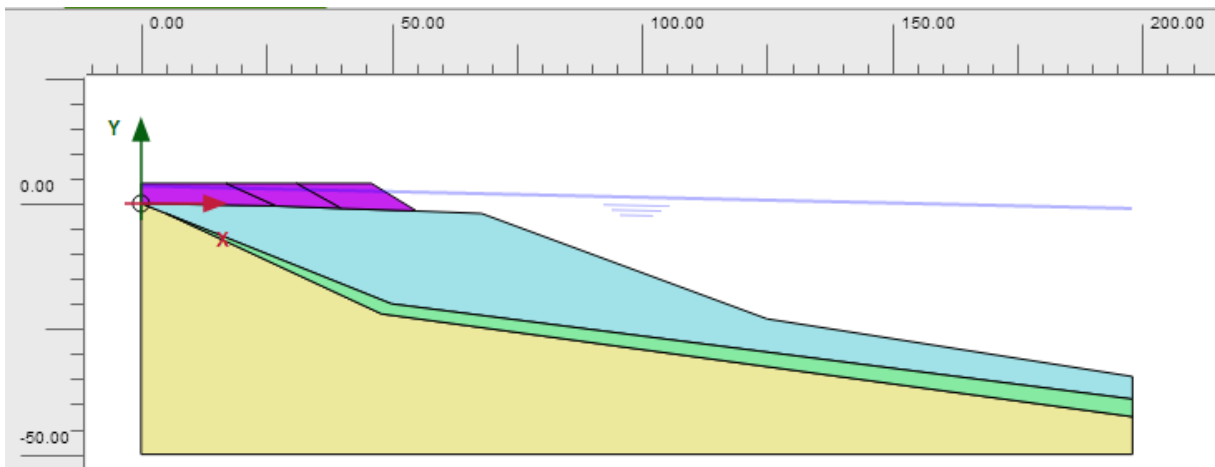
Figure 31: Plaxis model (profile 31)

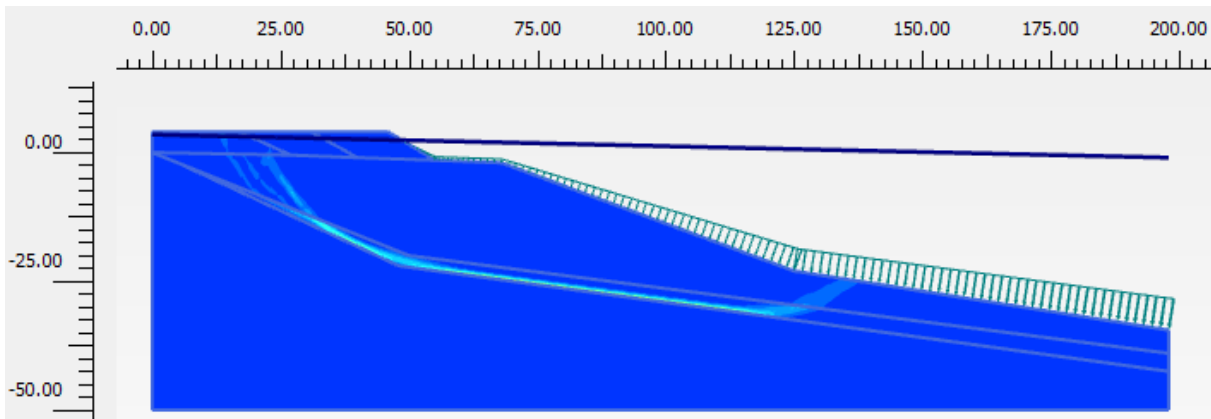
Figure 39: Failure mechanism for constant  $s_u$  equal to 33 kpa.

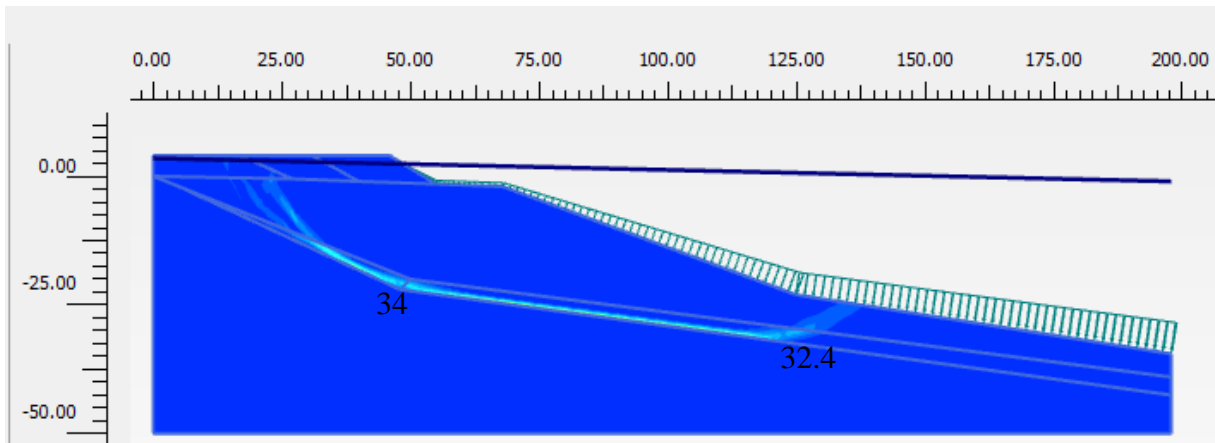
Figure 40: Failure mechanism for varying  $s_u$  in the lower clay layer. The undrained shear strength values are presented on the failure surface (unit kpa).
