Management of a High Arctic River

Erosion and Sediment Transport in Longyearlva,
Svalbard

Master's thesis in Arctic Geology

May 2021

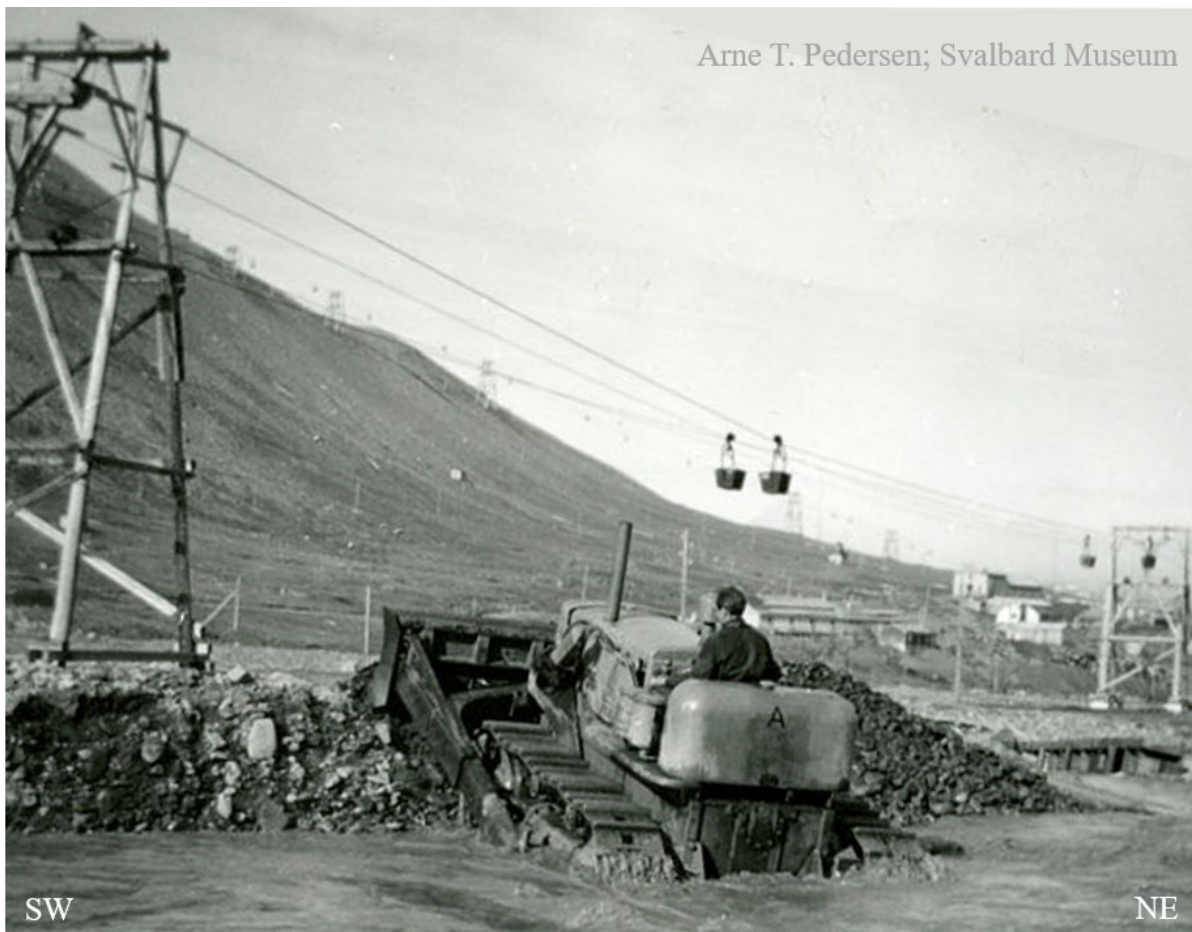
Figure 8: Crucial use of bulldozers to protect infrastructure along Longyearelva river dates to the 1950's (Pedersen and Svalbard Museum 1960). In this case is a bulldozer is used to keep the river from eroding the fundamentals of the cableway ramps used for transporting coal from the mines to the harbour.

The gradual expansion of infrastructure on the valley floor required extensive usage of bulldozers to control the river and protect infrastructure, such as the cableway-ramps, see Figure 8 (Pedersen and Svalbard Museum, 1960; Hoseth and Daae, 1996; Bjordal and Hoseth, 2017). SNSK increased the usage of bulldozers following a large flood in 1964 and planned a sedimentation dam next to Nybyen after consultations from NVE over the following years; however, the plans were never commenced (Hoseth and Daae, 1996). SNSK and NVE considered more permanent solutions for flooding mitigation again in 1989, but the usage of bulldozers continued (Øvereng, 1989; Hoseth and Daae, 1996). Elvsetta area was investigated for the development of residential and commercial buildings as early as the 1980 and '90s (Lied and Hestnes, 1986; Gregersen, 1995; Hoseth and Daae, 1996). Preliminary flooding calculations and plans for controlling the river were initiated in the mid-90s (Hoseth and Daae, 1996; Sværd, 1996). However, it would take another 20 years before the plans were put into action.

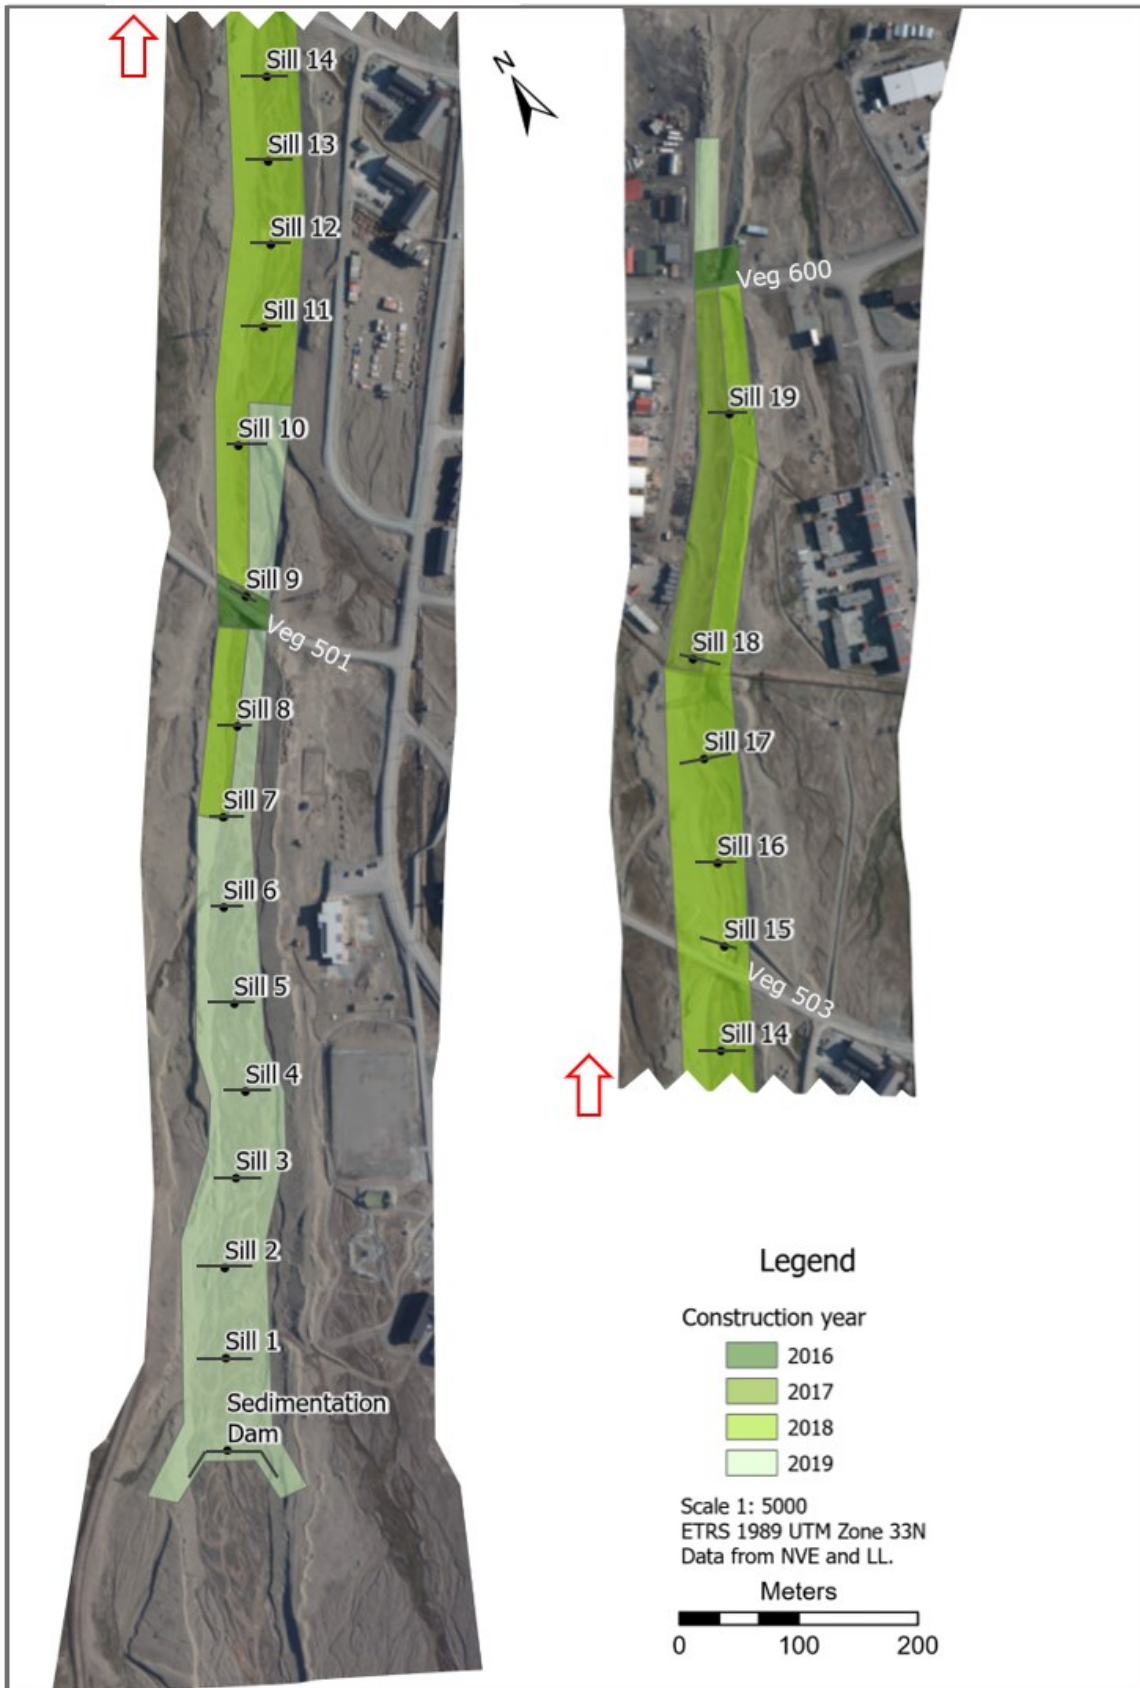
Figure 9: Timeline for construction work (building sills and riprap) in the river by NVE since 2016 and placements of all the sills and the sedimentation dam. Riprap is continuous on both sides from the sedimentation dam to Veg 600.

and a sedimentation dam should be built between Huset and the school (*Figure 1*) to control the sediment supply (see *Figure 9*). Shutting off the sediment supply could lead to channel degradation, and sills were therefore built. Construction work was completed in 2019, and the assessment of the mitigation is hence an essential part of this thesis. The different measurements and specific constructions are further explained in Chapter 2.6 *Hydrological engineering and scour protection*.

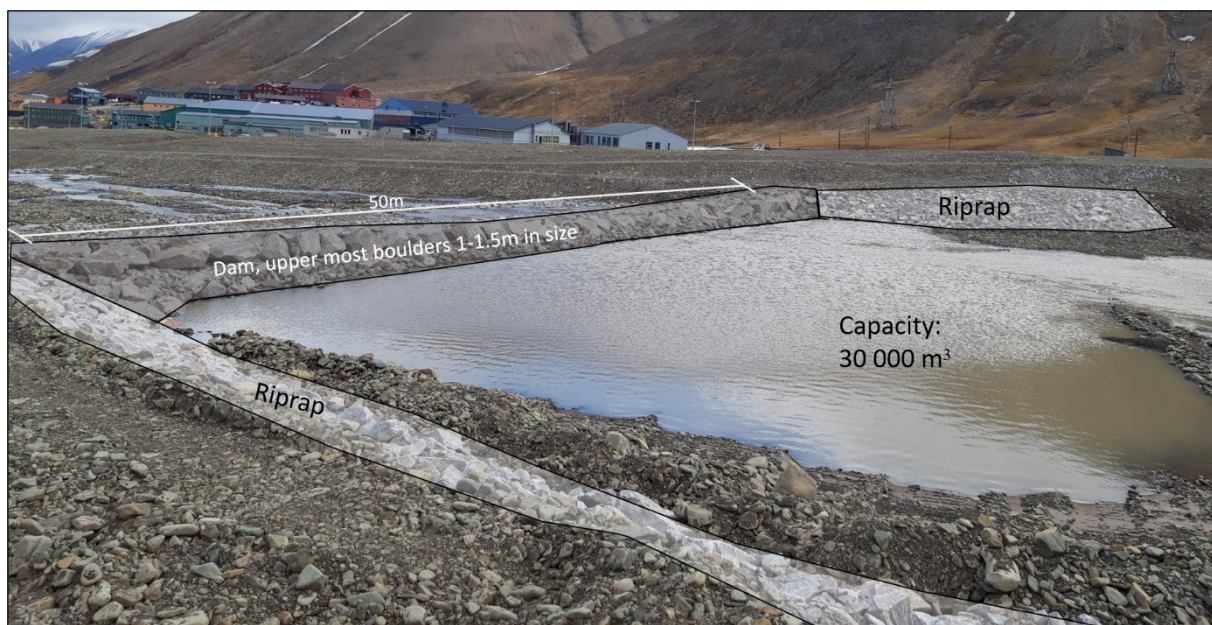
Figure 14: Annotated picture of the Sedimentation dam, riprap on both flanks to avoid undercutting. The dam consists of large boulders of blasted granitic gneiss, with an apron of smaller boulders downstream. The large boulders allow water to percolate through, while reducing the energy and allow bedload to settle.

A sedimentation dam or pool aims to obstruct further bedload in the channel (Fergus et al., 2010). By constructing a dam and thereby decrease the energy of the water, bedload will start to accumulate. The capacity of the dam will inevitably decline, and maintenance (excavation) depends on the accumulation rate (Fergus et al., 2010). Maintenance is mentioned in the building plan by Bjordal and Hoseth (2017), although a detailed schedule is missing due to uncertain accumulation rates.

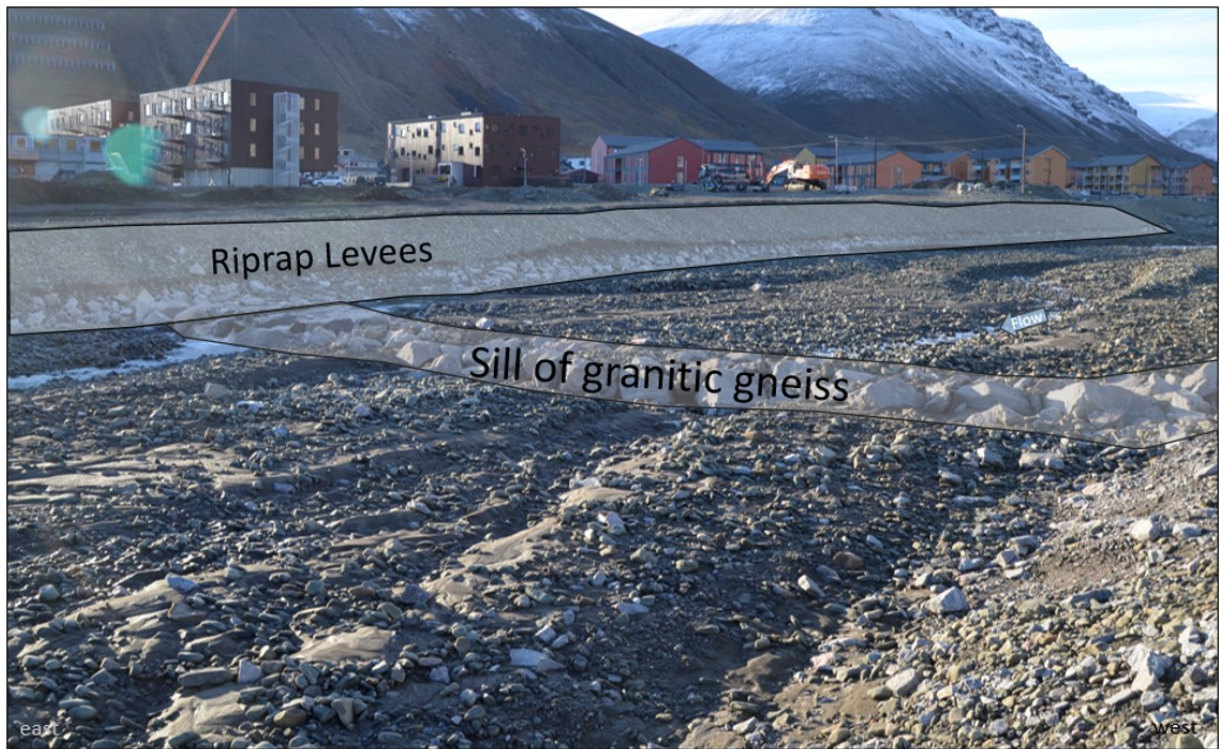
Figure 15: Annotated picture of a section of Longyearlva, illustrating riprap and one of many sills across the channel to prevent channel degradation. The sill is constructed of blaster granitic gneiss, placed in a 1m deep and 3m wide ditch, as shown in the schematic illustration. Tote that the riprapped levees are on both sides of the riverbed from the sedimentation dam to Veg 600.

Fergus et al. (2010) suggest sills across the channel to decrease bedload and prevent channel degradation. A sill is a barrier built across the channel to avoid bedload and scouring on the channel floor by holding the channel bed in place. Sills can be assembled in a variety of geometries, straight across perpendicular to the flow direction or V-shaped facing both upstream and downstream. Placement should be in areas where increased erosion is expected, such as under bridges or other sections where the channel width is decreasing. The placement of each boulder is critical to ensure effective interlocking and to avoid scouring of the foundation.

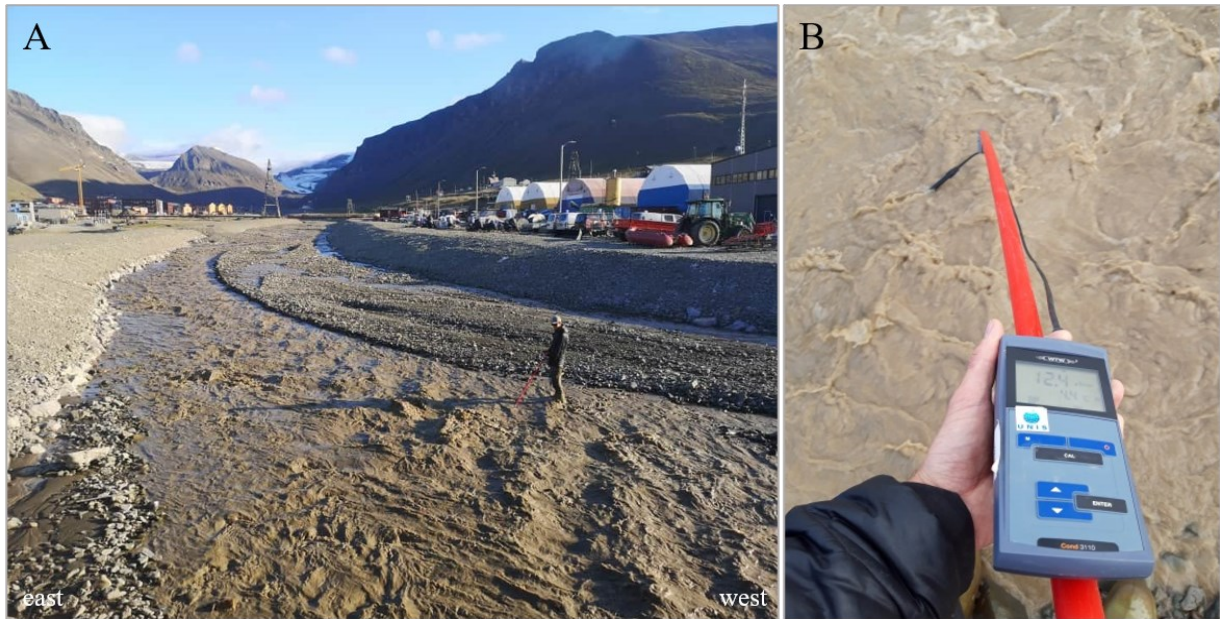
Figure 17: Measuring discharge. **A)** The writer recording electrical conductivity (EC) in the river after a slug injection of diluted salt. **B)** To avoid the EC-meter from flapping and catching air in turbulent water, it was attached to a plastic rod and securely submerged.

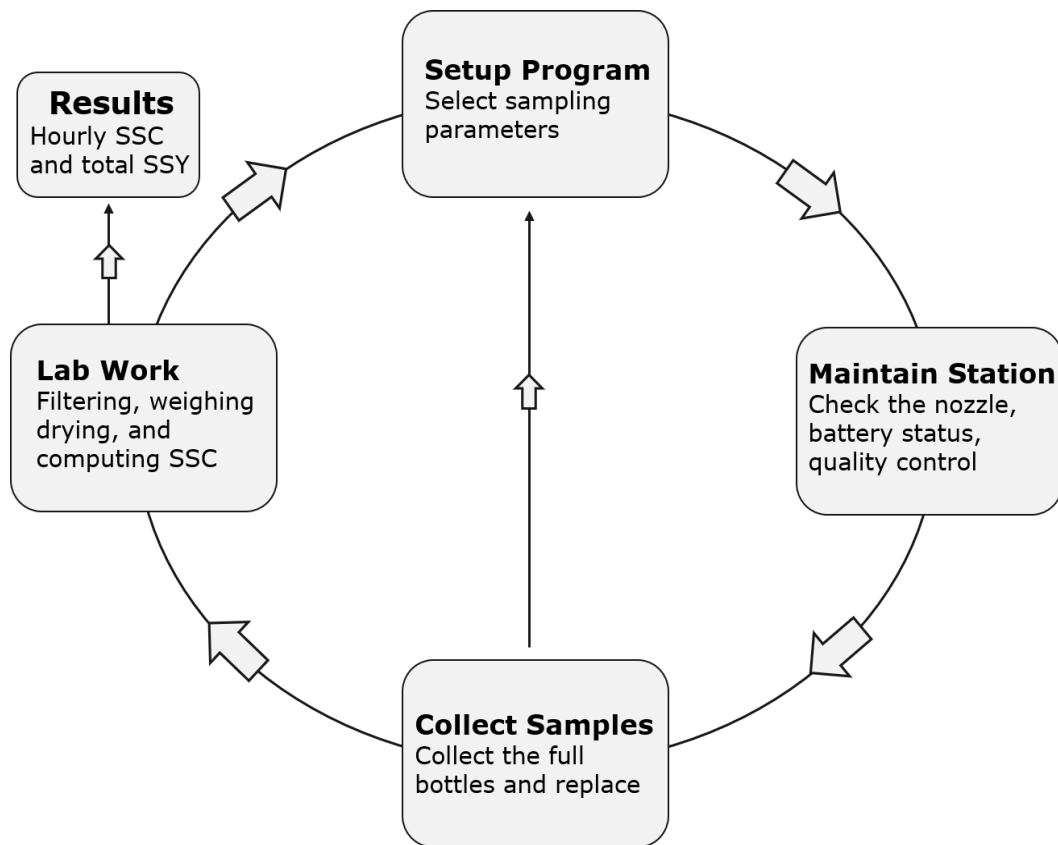
Figure 18: Workflow for collecting and calculation of suspended sediment concentration (SSC) and suspended sediment yield (SSY) in Longyearelva.

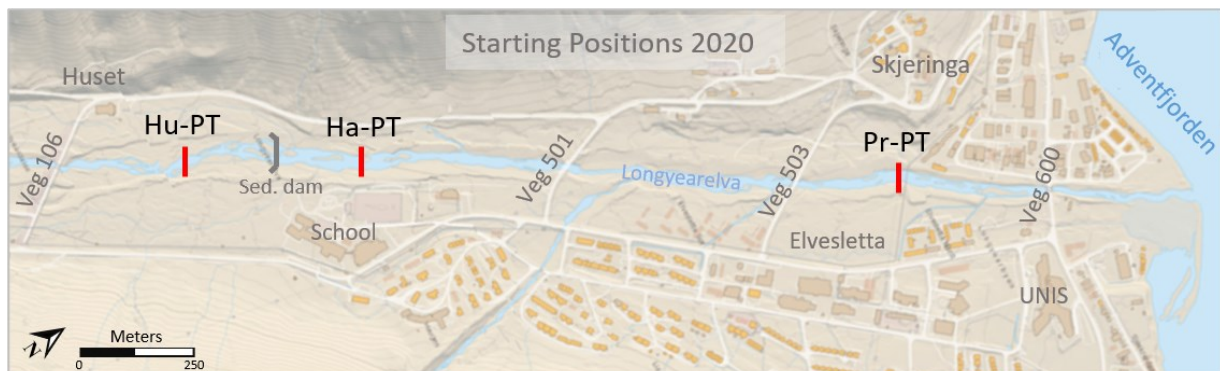
Figure 19: Initial starting position for the colored passive tracers (pt) for bedload measurements in Longyearvelva. Huset-pt (Hu-pt), Hallen-pt (Ha-pt), and Polarriggen-pt (Pr-pt).

The tracers were grouped and placed into three sections along the river, fifteen from Class 1 and 10 from the remaining classes, in total forty-five tracers in each section. The different starting positions were named: Huset (Hu-pt), Hallen (Ha-pt), and Polarriggen (Pr-pt), see *Figure 19*.

Hu-pt is located upstream of the sedimentation dam, thus outside the part of the river with permanent flooding mitigation. This section would be closer to the natural, braided river system, although bulldozers have reworked it regularly (Bjordal and Høseth, 2017). The Ha-pt starting position was chosen because of an increased inclination of the channel between the sedimentation dam and Veg 501. This section holds the most recent constructions of flooding mitigation, see *Figure 9*. The third starting position (Pr-pt) is located closer to the outlet into Adventfjorden and situated where the construction of the flooding mitigation started in 2016 (*Figure 9*).

Coloured passive tracers were placed in the fluvial channel (see *Figure 19*) to monitor bedload and evaluate the discharge threshold for bedload transport and erosion in the Longyareelva river, see *Figure 29*.

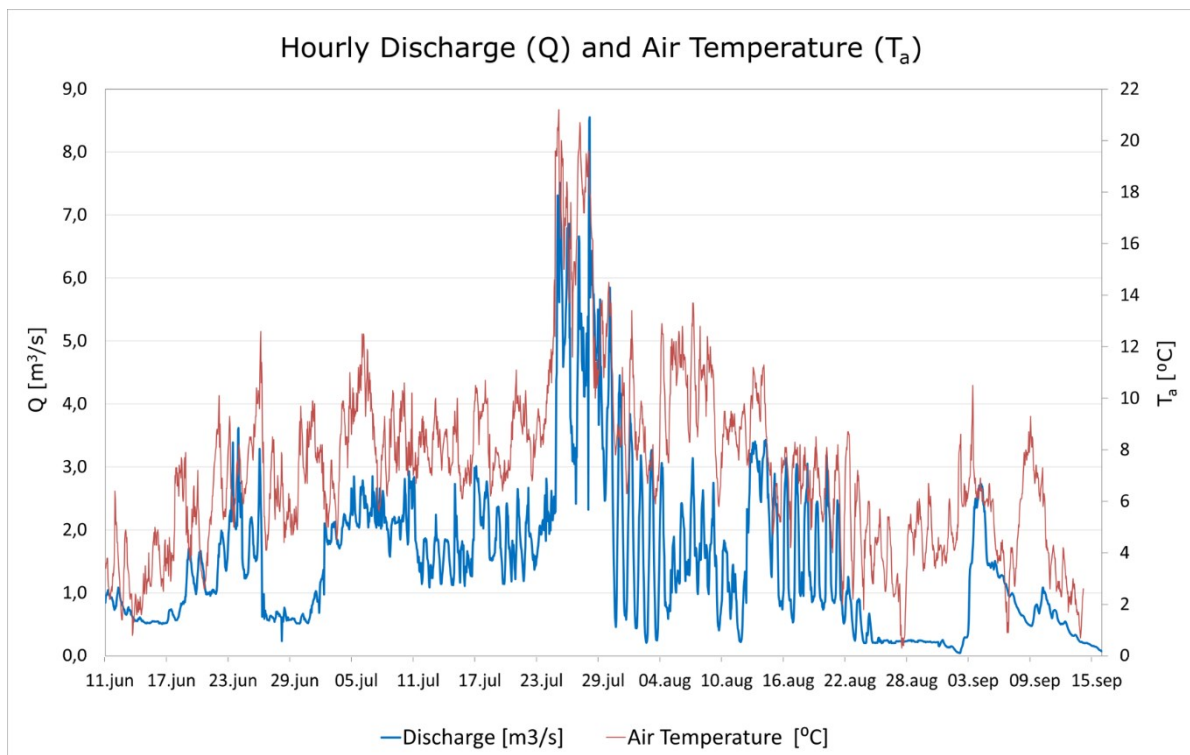
Figure 23: Hydrograph from the monitoring period, June 11th to September 15th. Hourly resolution displays the diurnal fluctuations throughout the summer, particularly in mid-July and August. Hourly air temperature data from Svalbard Airport meteorological station (MET, 2021).

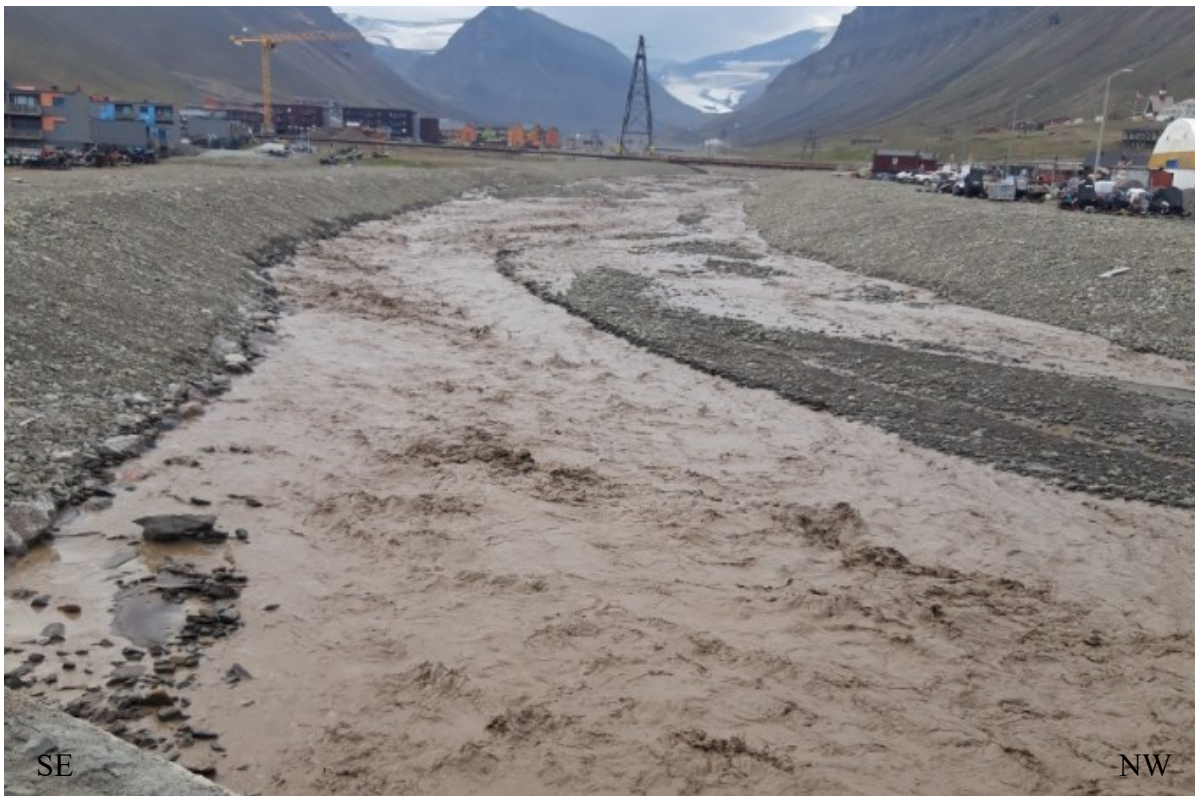
Figure 26: Mid-day on July 25th, discharge 5.6m³/s. The highest suspended sediment concentration was measured later that day: 24.1g/l and 7.3m³/s at 4:00 pm.

SSC varied from low sediment transport and clear waters, in strong contrast to periods of high SSC when the water was dark brown and untransparent, as in *Figure 26*. 254 SSC samples were acquired from June 12th to August 31st and used for SSY computations. The average SSC for the 2020 monitoring period was 1.9g/l and a total SSY of 41 050t, which implies a specific SSY of 1866t/day/km² for the Longyearlva catchment. Plotting the SSC samples against the corresponding computed discharge reveals a correlation with $R^2 = 0.58$.

The highest SSC correlates with the rising limb of the hydrograph in the Late July Flooding. Highest SSC was 24.1g/l recorded at 5:00 pm on July 25th, and the corresponding discharge was 5.6m³/s, see *Figure 26* and *Figure 27*. July 25th also produced the highest specific SSY, at 252t/day/km² for the catchment. A total of 5594t of suspended sediment was exhausted that day, illustrated in *Figure 28*. July 28th was a close runner-up, with 248t/day/km², and an SSY of 5411t, despite a lower SSC (14.2g/l at 5:00 pm, and 5.7m³/s), see *Figure 28*. The Late July Flooding event generated 57% of the total SSY for the monitoring period in 2020.

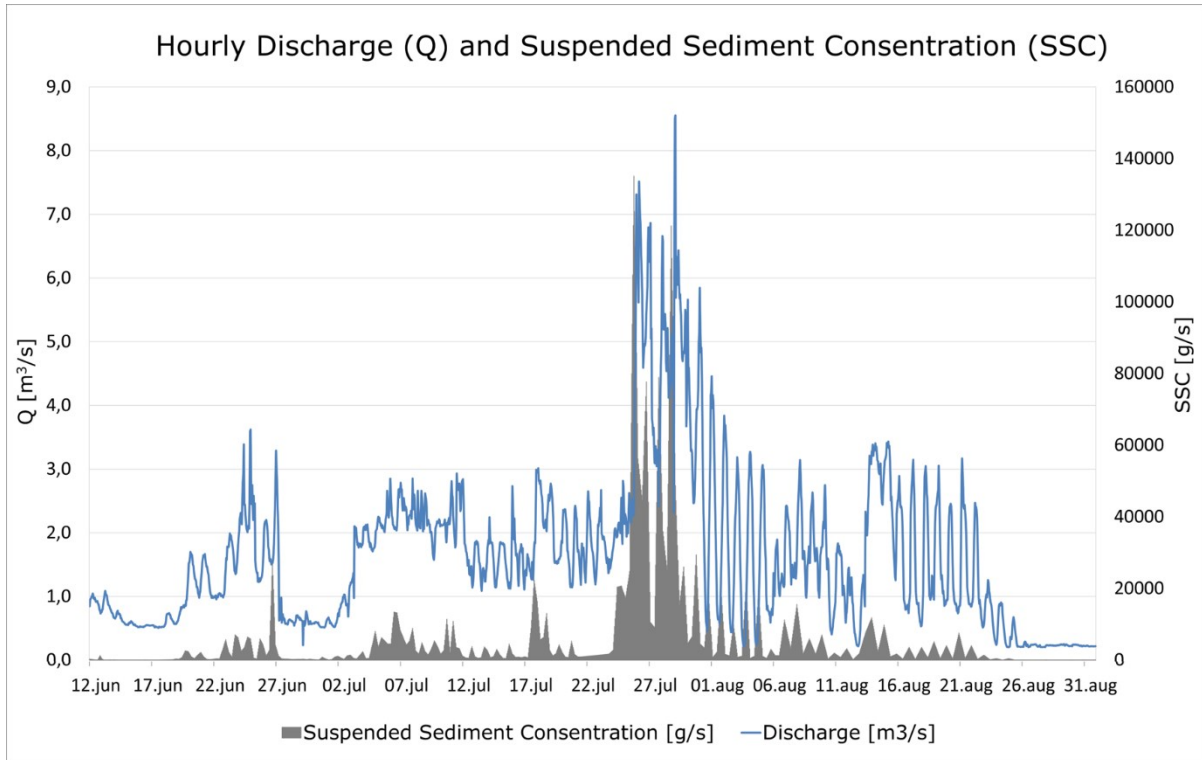
Figure 27: Hourly discharge and suspended sediment concentration (SSC). Highest SSC on July 25th, 24.1g/l. Average SSC during the monitoring period was 1.9g/l.

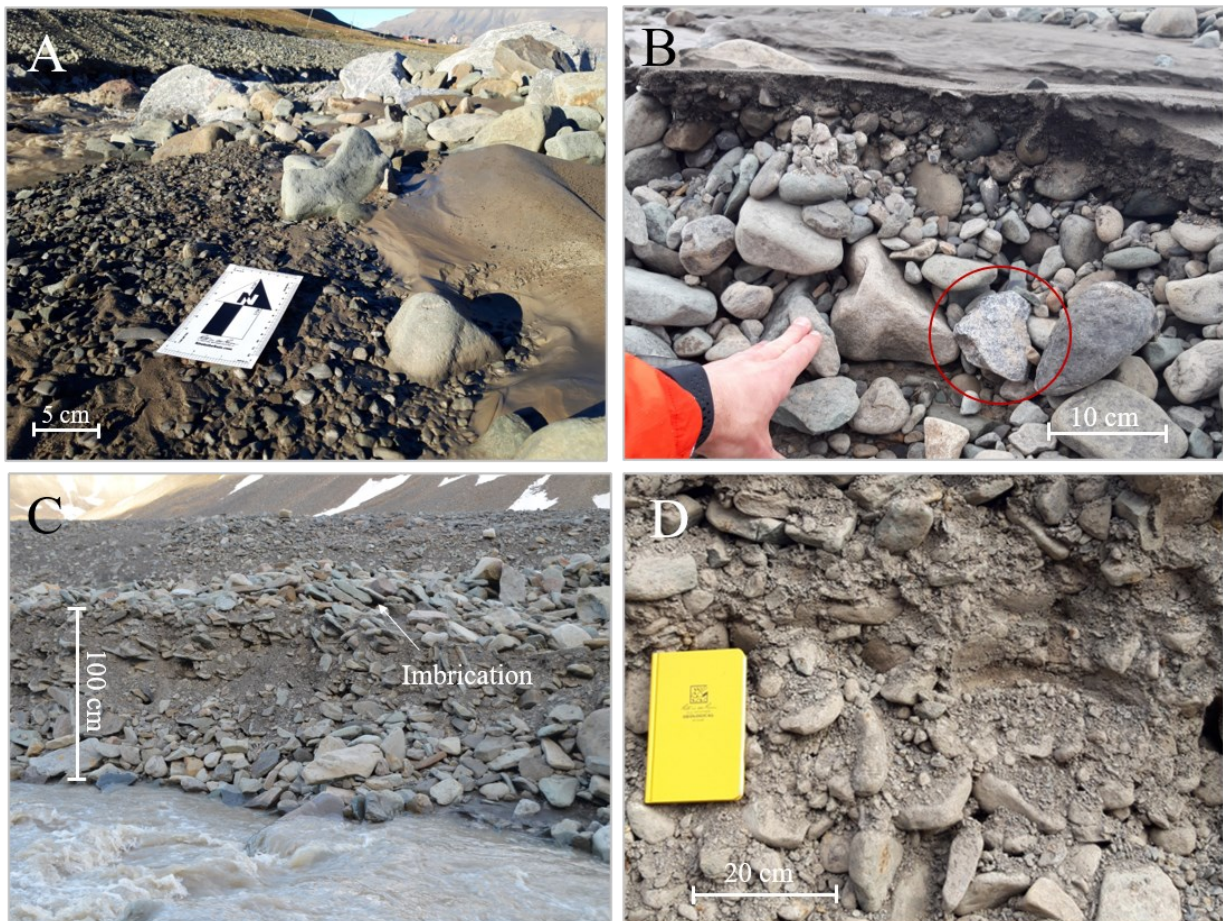
Figure 34: Fluvial sediments and qualitative grain size distribution in Longyearelva. **A**) Sand, gravel, cobble, and small boulders. Large boulders of granitic gneiss. **B**) Fines (silt and sand) on top, coarsening downwards to gravel and cobbles, note the small cobble of granitic gneiss highlighted in the red circle. **C**) Imbrication of cobbles and boulders in proximity to the Longyearbreen moraine. **D**) A wide range of mixed sediments from sand to boulders, unsorted, exposed in a 1.5m high, several meters long erosive scarp on the eastern side of the channel between Veg106 and the sedimentation dam.

The sediments in the glaciofluvial system vary in size, from silt, sand, gravel, to boulders, illustrated in *Figure 34* and *Figure 35 C-D*. The deposits are rounded to subrounded sand- and siltstone, cubic, and disc shape reflecting the local geology of the CTB. Besides the local lithology, angular cobbles and small boulders (<500mm) of granitic gneiss used for riprap and sills are entrained and mixed in the glaciofluvial sediments, see *Figure 34B*. Sorted sediments in the constructed fluvial channel were observed and documented in *Figure 34A-B*. Imbrication of disk-shaped cobbles and boulders was documented in the Longyearbreen meltwater stream, ~200m downstream from the moraine (*Figure 34C*). The sediments in *Figure 34D* are unsorted and exposed in a 1.5m high and several meters long fluvial erosion scarp on the eastern levee between the sedimentation dam and Veg106. The channel between the sedimentation dam and Veg 106 is wider than the channel from the dam and downstream. More lateral migration and braided streams were documented in the broader section, see *Figure 35A* and *B*.

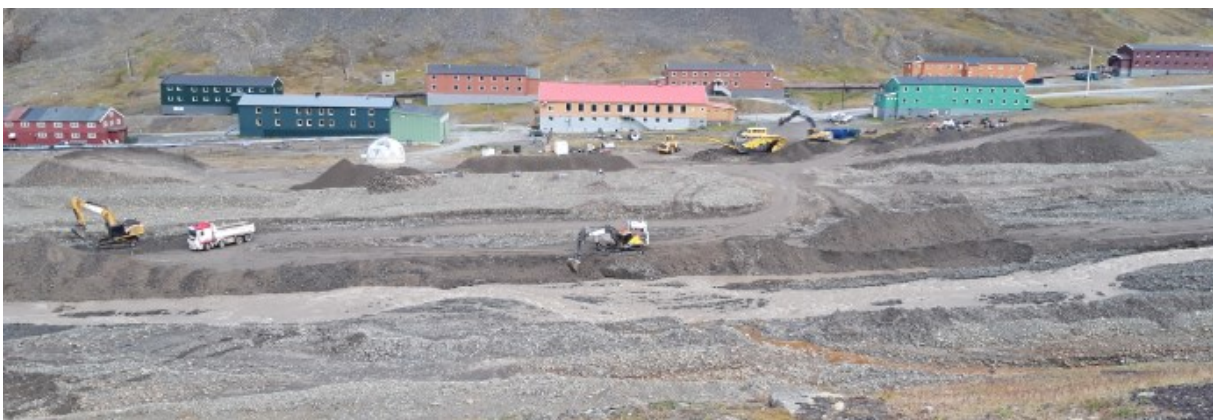
Figure 36: Excavation of fluvial sediments next to Nybyen, deepening the channel to keep the river from migrating. The material is intended to be used in the construction of landslide mitigation in Lia. Picture from August 10th.

The fluvial sediments between Nybyen and Veg106 were excavated and reworked from August 4th and for the rest of the monitoring period, see *Figure 36*. This part of the river was therefore excluded from the fluvial morphological mapping.

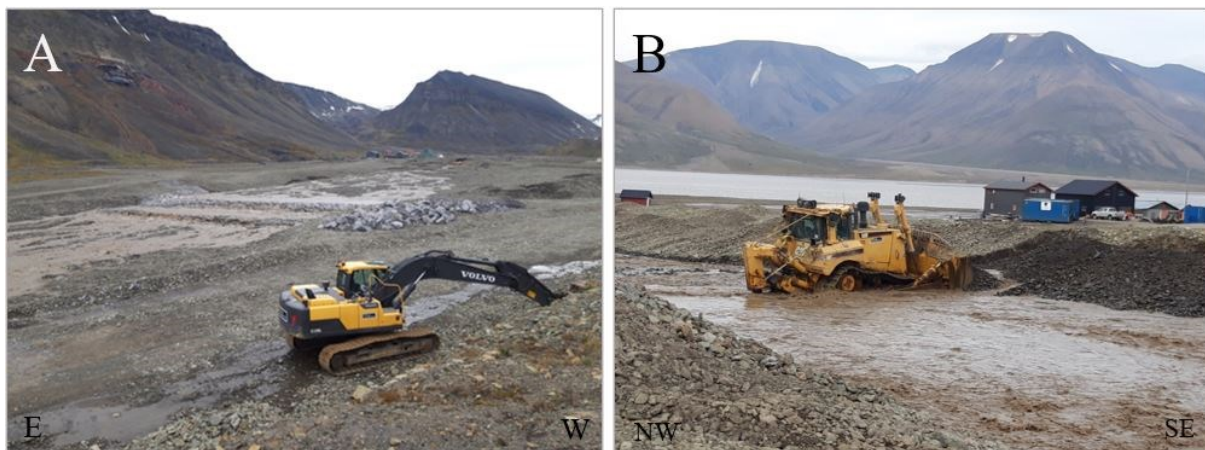
Figure 37: Immediate maintenance had to be done during floods. **A)** After the first minor flooding on June 24th, an excavator was used to reassemble damaged sills. **B)** July 27th, discharge $6.2\text{m}^3/\text{s}$. Bulldozer performing critical maintenance downstream Veg 600 to keep the river from eroding the levees and threatening to flood the red pump-house.

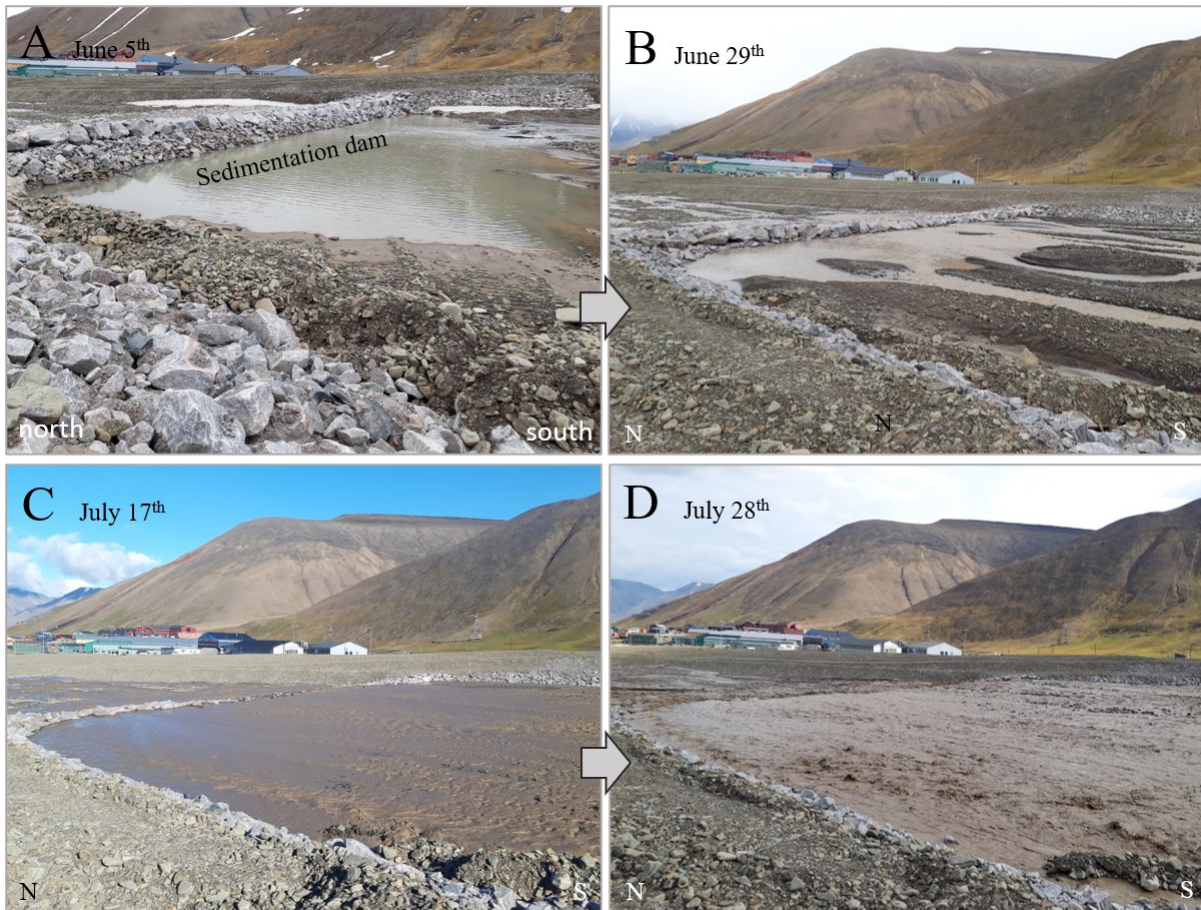
Figure 45: Gradually filling of the sedimentation dam during the summer. **A)** June 5th, first day of monitoring. Notice larger boulders on top of the weir, the crest is 100cm above the water surface at the time. **B)** June 29th, discharge 0.6m³/s. Water level now 60cm below the weir crest, and bars has developed upstream. **C)** July 17th, discharge 3.0m³/s. Considerable volumes of sediments accumulated, water in full width of the dam, overflowing in the middle. **D)** July 28th, discharge 6.7m³/s. Weir overflowing in full width, accumulated sediments filling the whole dam, 30 000m³, and bedload has started to accumulate on the apron. Longitudinal bars of sediments can be observed in the middle of the dam.
