Characterizing the damage mechanisms of orthopedic joint prostheses

Master's thesis in Materials Science and Engineering

Norwegian University of Science and Technology
Faculty of Natural Sciences
Department of Materials Science and Engineering

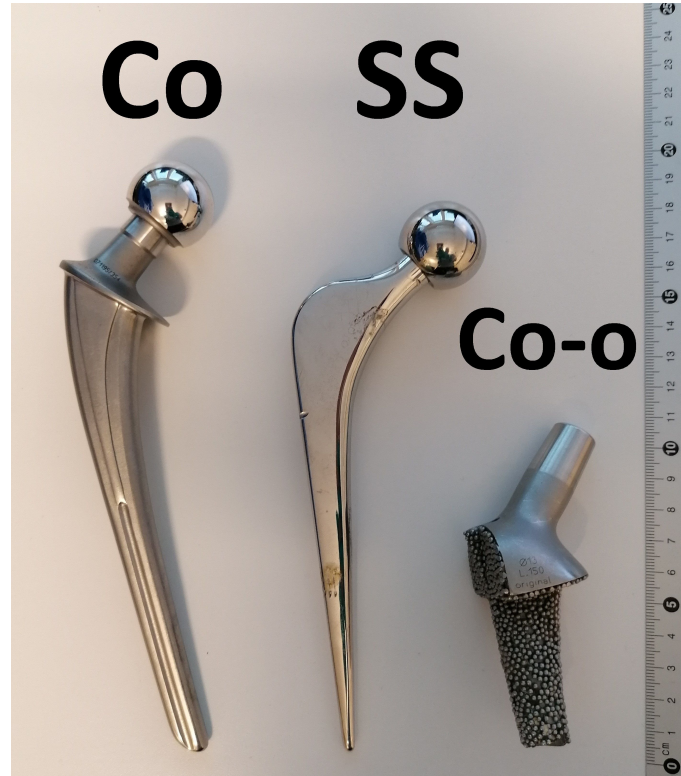
The materials examined in this thesis were used hip joint prostheses. The materials were three metal components made from two CoCrMo alloys and one stainless steel alloy. The prosthesis made from stainless steel will be referred to as *prosthesis SS*. The alloys made from CoCrMo will be referred to as *prosthesis Co* and *prosthesis Co-o*, where *-o* represents the spheres on the stem. All prostheses can be seen in Figure 11 below. The deviation in length seen for prosthesis Co-o is due to a fracture at the stem.

Figure 11: The prostheses examined in this thesis

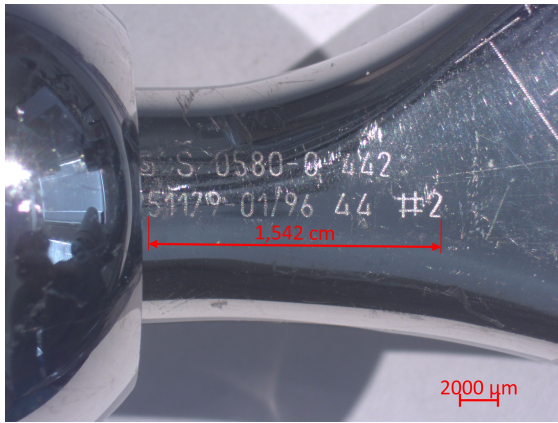
Prosthesis SS had serial numbers *BG S 0580-0-442* and *U251179-01/96 44 #2* on the neck. Figure 25 below shows these. In addition to the serial numbers, there were identical symbols on both sides of the top of the stem. The symbols are shown in Figure 26 below. All horizontal lines were about 9 mm long and the distances between the vertical lines and the edge of the prosthesis were about 3.1, 7.3 and 11.4 mm on both sides of the prosthesis.

Figure 25: Prosthesis SS
Markings on side 1 of the neck

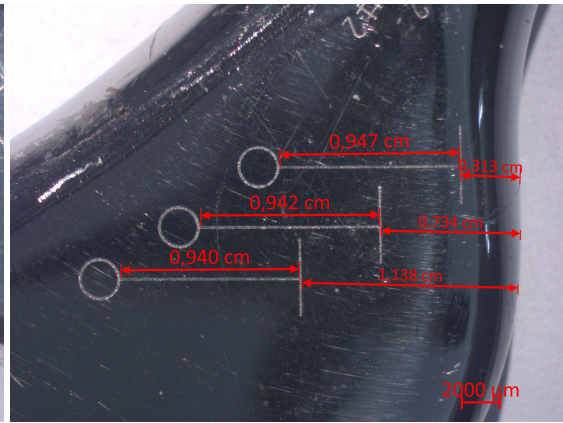
Figure 26: Prosthesis SS
Symbols on side 2 of the stem

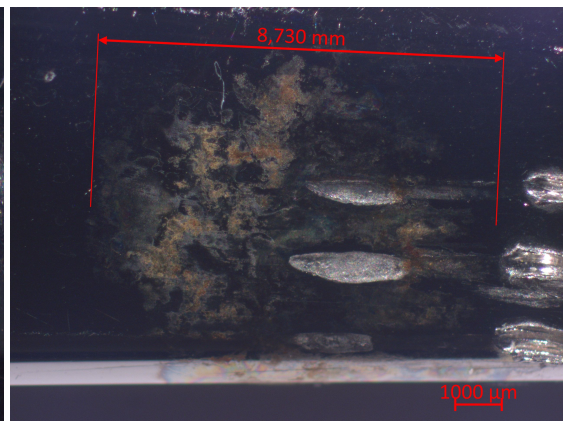
Figure 28: Prosthesis SS
Discoloration on side 1 of the stem

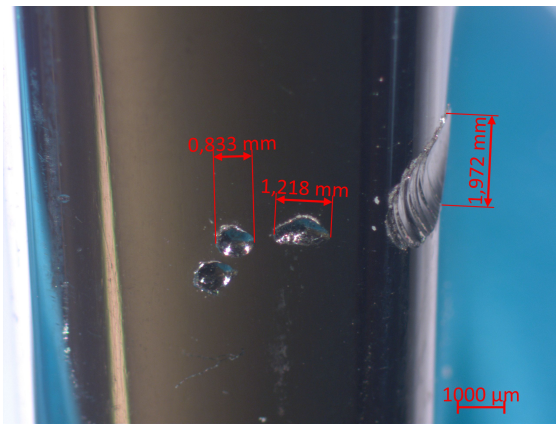
Deep notches were also found on side 1 of the neck close to the head, on the back of the stem and on side 1 of the stem. Figure 29 and Figure 30 below show some of these notches.

Figure 29: Prosthesis SS
Notches on the back of the stem

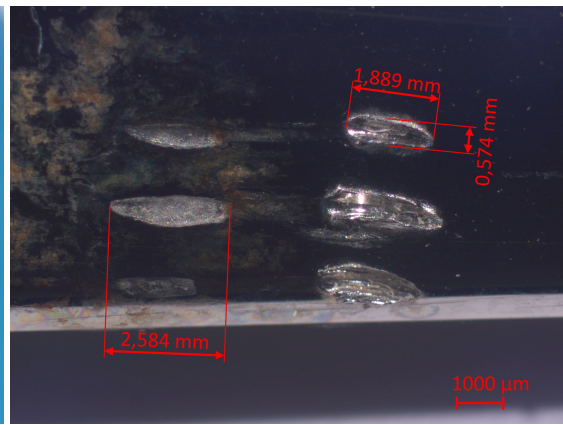
Figure 30: Prosthesis SS
Notches on side 1 of the stem

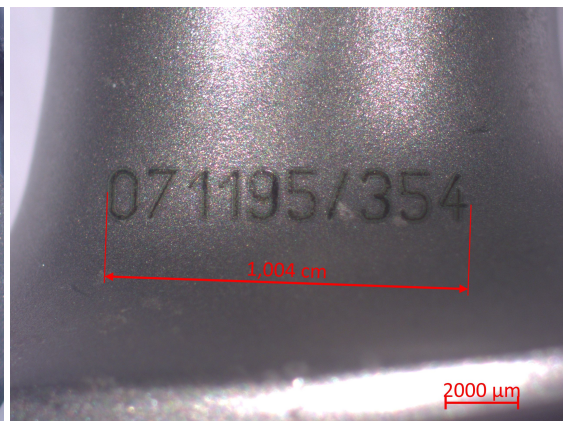
Figure 32: Prosthesis Co
Markings on side 1 of the neck

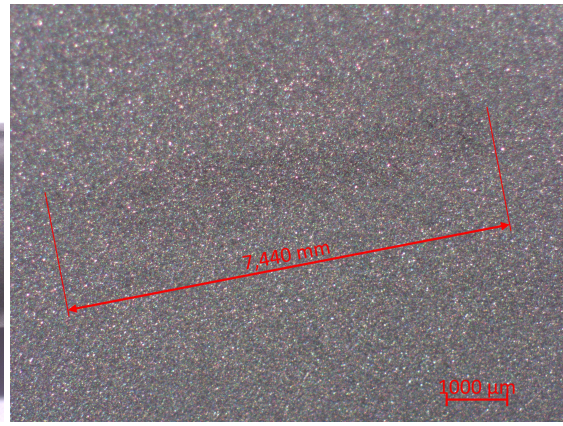
Figure 34: Prosthesis Co
Discoloration on side 2 of the stem

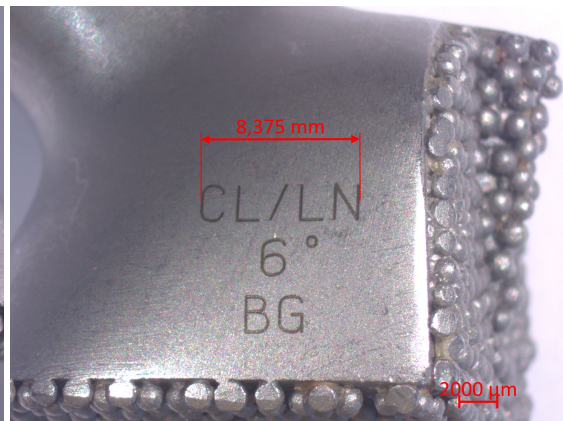
Figure 36: Prosthesis Co-o
Markings on side 2 of the neck

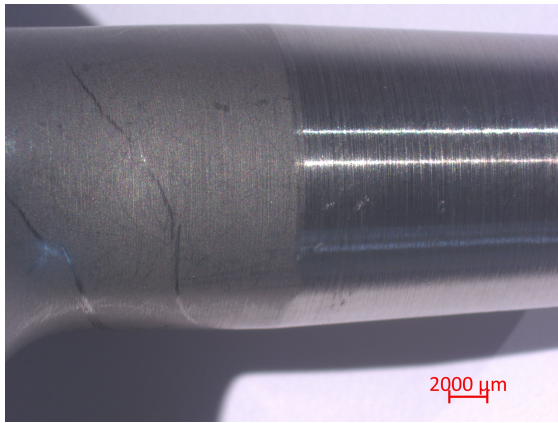
For prosthesis Co-o, the femoral head was not part of the provided sample. The area where the head used to be had a more shiny appearance, which can be seen in Figure 37 below. The same image displays some of the superficial scratch marks on the neck section of the prosthesis. Some discoloration could be found on the top of the neck and on side 1 of the neck, close to the bottom of the more shiny part. This is shown in Figure 38 below.

Figure 37: Prosthesis Co-o
Difference in surface reflection

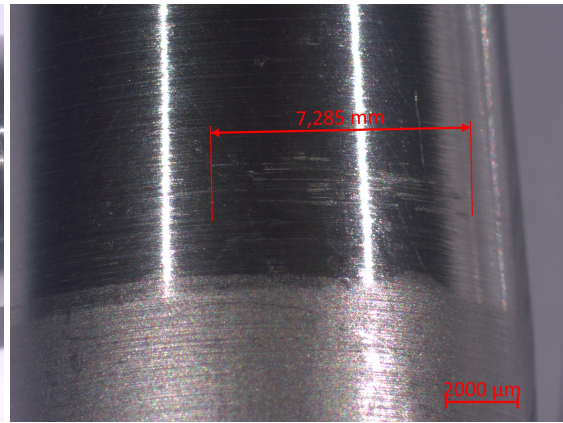
Figure 38: Prosthesis Co-o
Discoloration on side 1 of the neck

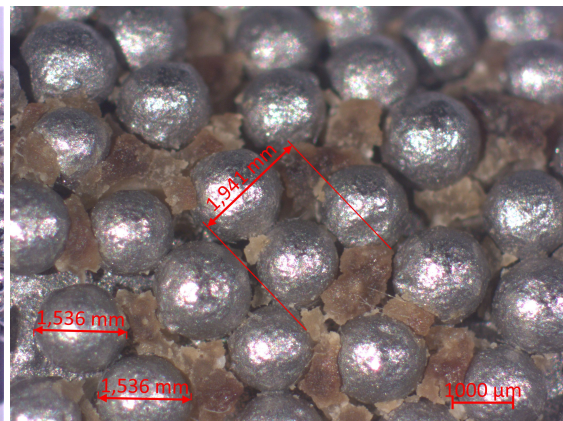
Figure 40: Prosthesis Co-o
Closeup of the brown layer

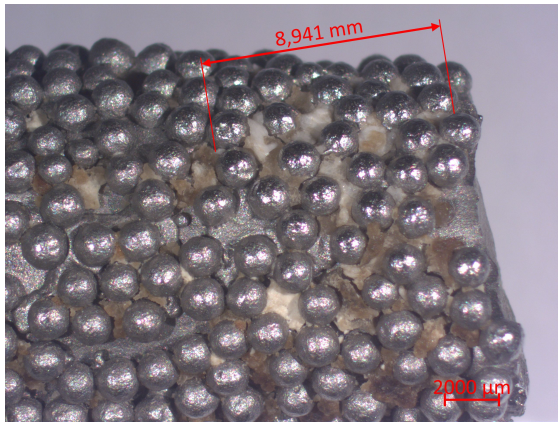
The other layer was white and is shown in Figure 41 and Figure 42 below. This layer was found near the fracture on the backside and both sides of the stem, covering the end close to the fracture. There was also white layer at the front of the stem, close to the neck area.

Figure 41: Prosthesis Co-o
White layer on the back of the stem

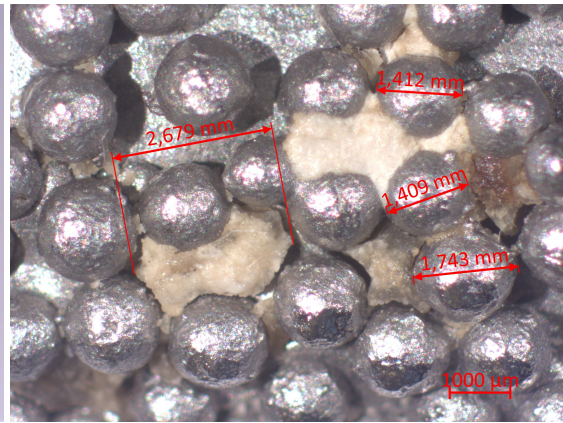
Figure 42: Prosthesis Co-o
Closeup of the white layer

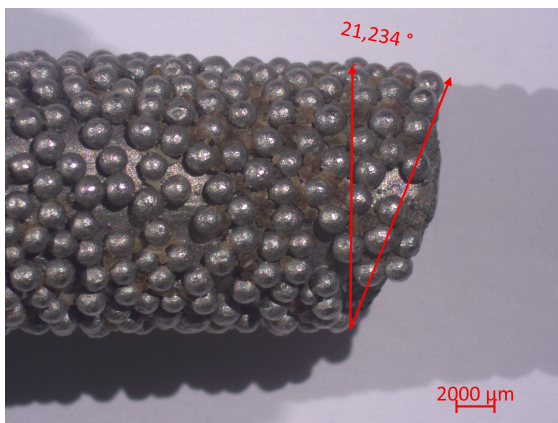
Neither prosthesis Co nor prosthesis SS displayed any external fractures. Prosthesis Co-o had a fracture about 4 cm from the edge of the neck. The fracture occurred at an angle of about 21 degrees and is shown in Figure 43 below. On side 1 of the prosthesis, the fracture had chipped off a piece from the stem edge. This is shown in Figure 44 below. Figures 43 and 44 are macroscope images.

Figure 43: Prosthesis Co-o
The fracture from the front part of the stem

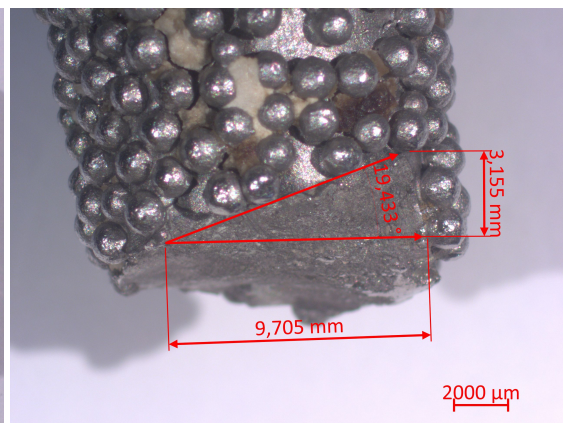
Figure 44: Prosthesis Co-o
The fracture from side 1 of the stem

Figure 44 above was situated at the opposite end of the initiation site. The red square in Figure 45 indicates where the SEM images in Figure 46 and Figure 47 later in this section were taken.

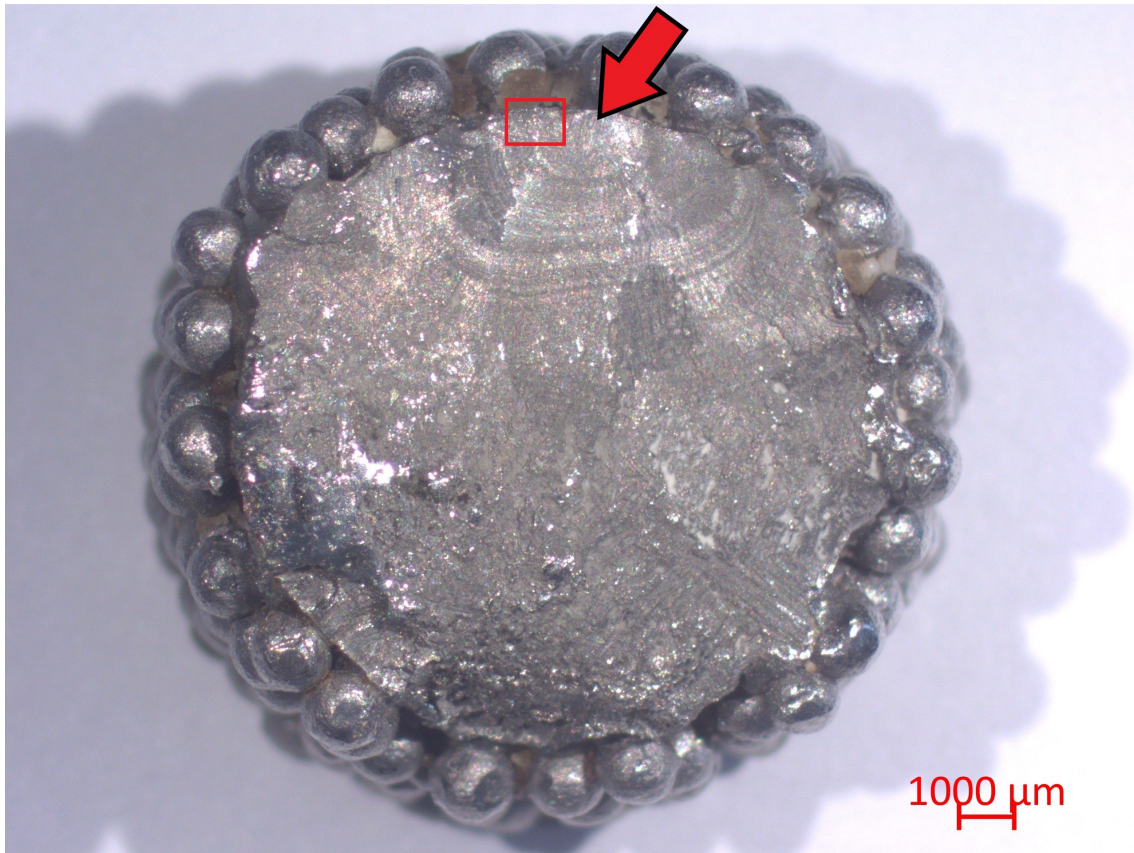
Figure 45: The fracture surface of prosthesis Co-o

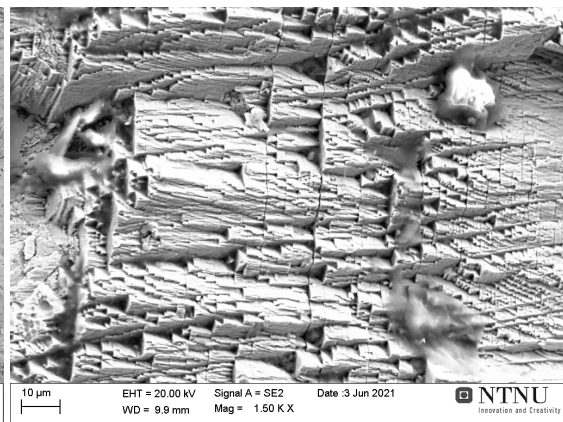
Figure 47: Prosthesis Co-o
Vertical lines

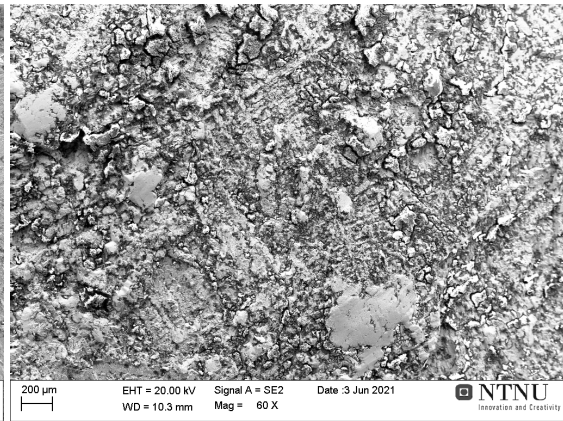
Figure 49: Prosthesis Co-o
Opposite side from the initiation site

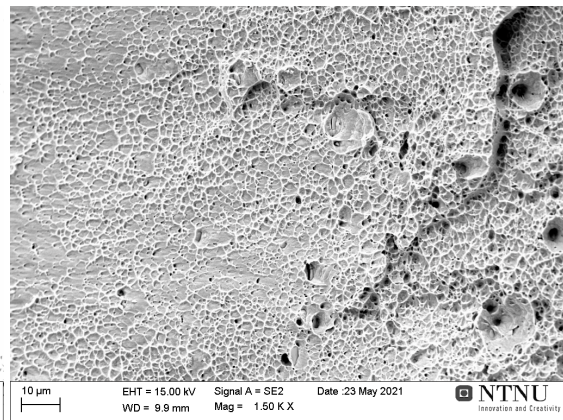
Figure 51: Prosthesis SS
Closeup of the tensile fracture surface

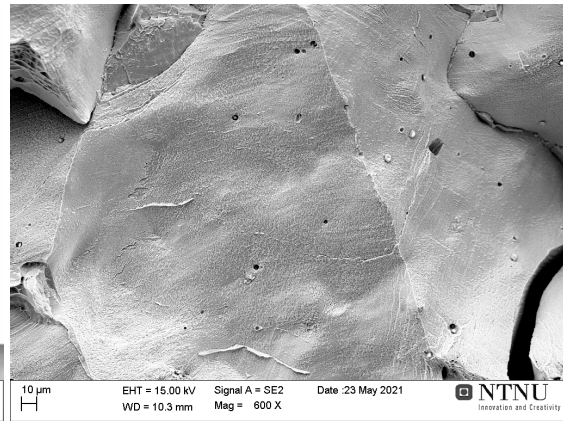
Figure 53: Prosthesis Co
Closeup of the tensile fracture surface

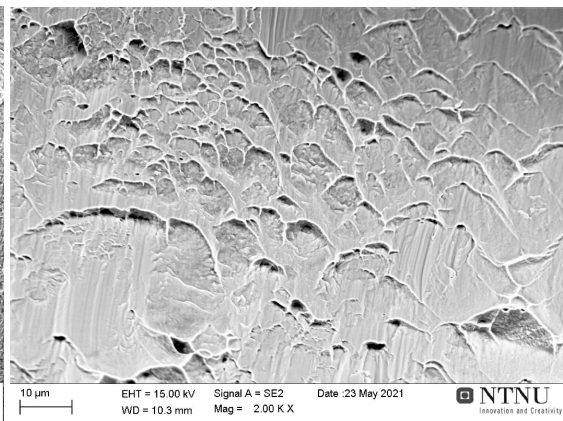
Figure 55: Prosthesis Co
Fracture surface with dimples

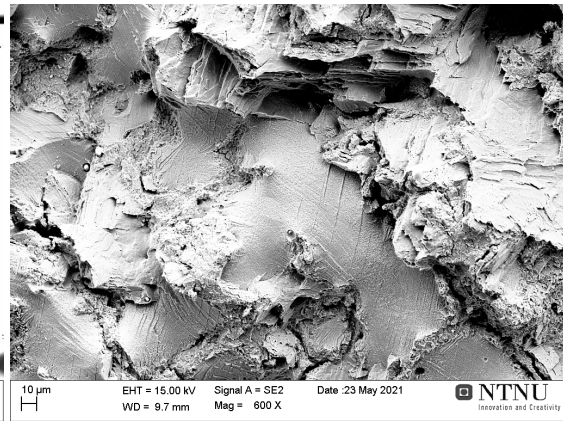
Figure 57: Prosthesis Co-o
Closeup of the tensile fracture surface

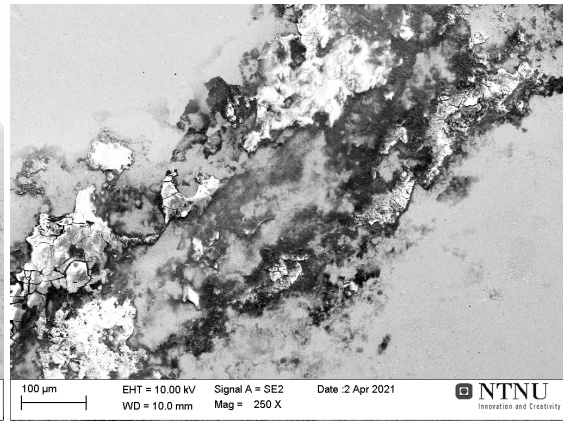
Figure 65: Prosthesis SS
Closeup of the layer

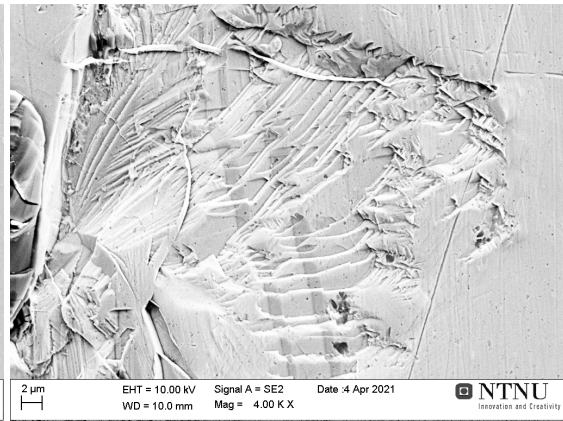
Figure 69: Prosthesis SS
Closeup of the crater on the stem

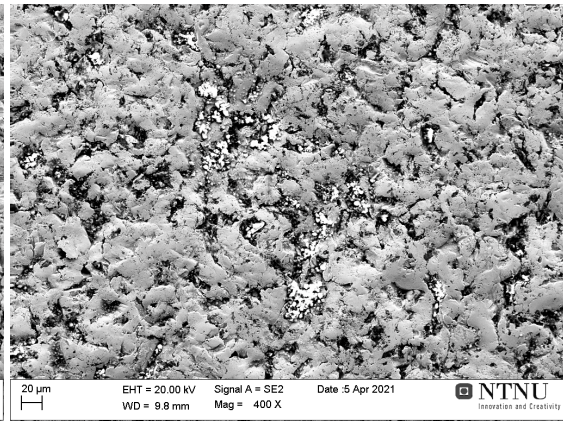
Figure 73: Prosthesis Co
Layer on the stem

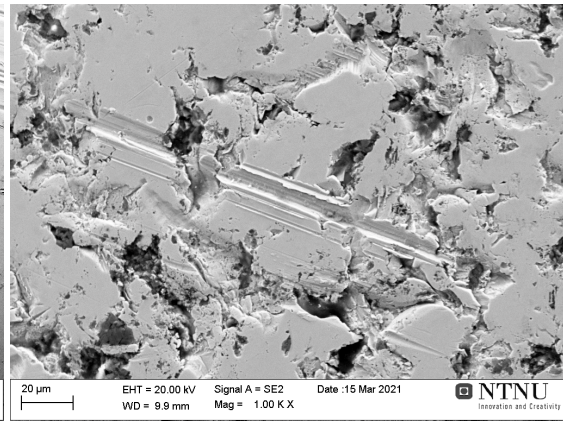
Figure 77: Prosthesis Co
Scratch on the stem

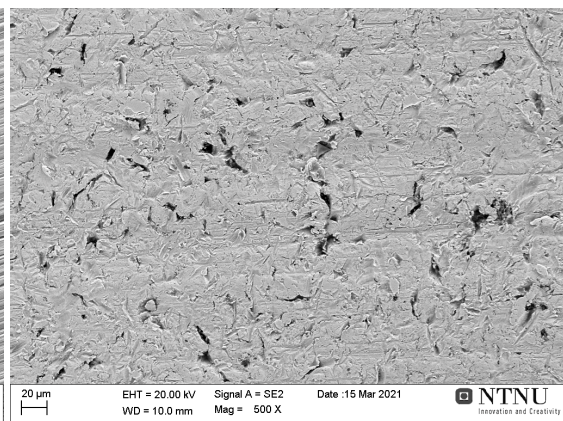
Figure 79: Prosthesis Co-o
Bottom, less shiny part of the neck

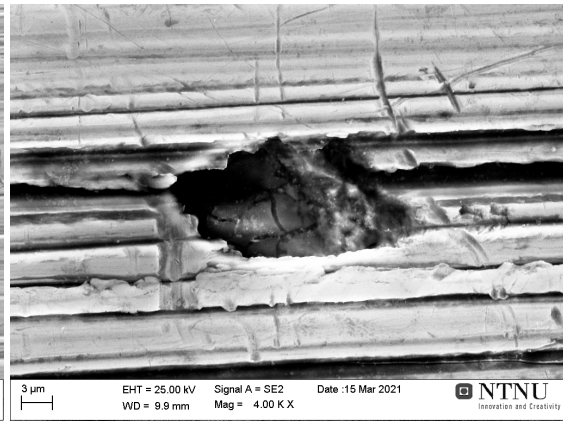
Figure 81: Prosthesis Co-o
Sub surface particle

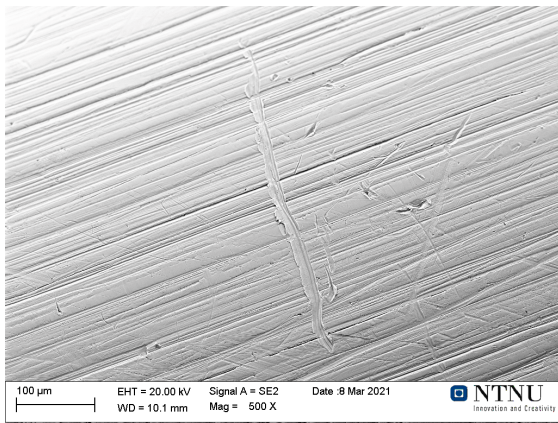
All over the neck of the prosthesis were also superficial surface scratches. This can be seen in Figure 84 below. A thick layer covered large parts of the stem in between the particles. This type of layer covered large sections of the front part of the stem, and could also be found frequently on side 1, side 2 and the back. Parts of these layers were cracked. An example of such a layer can be seen in Figure 85 below.

Figure 84: Prosthesis Co-o
Scratches

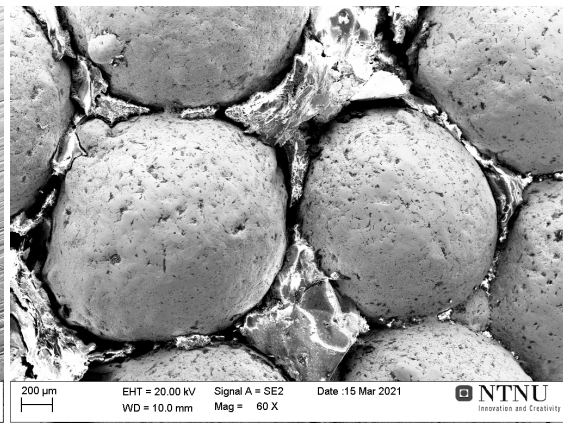
Figure 85: Prosthesis Co-o
Thick layer

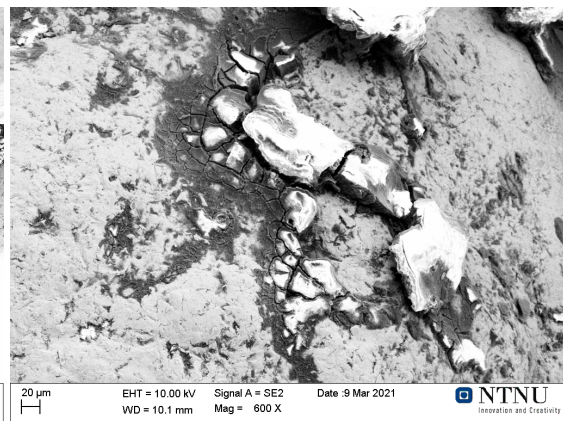
Figure 87: Prosthesis Co-o
Discoloration and layer on the spheres

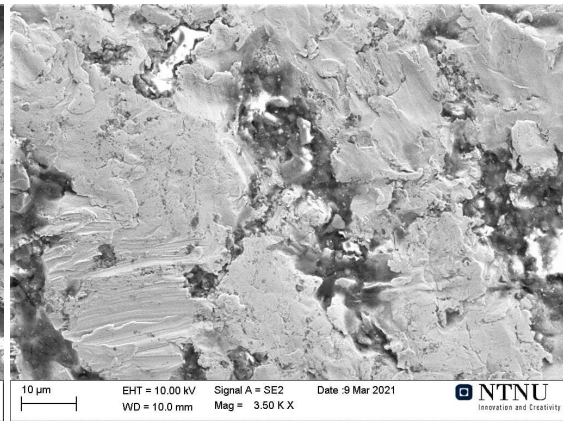
Figure 89: Prosthesis Co-o
Crater

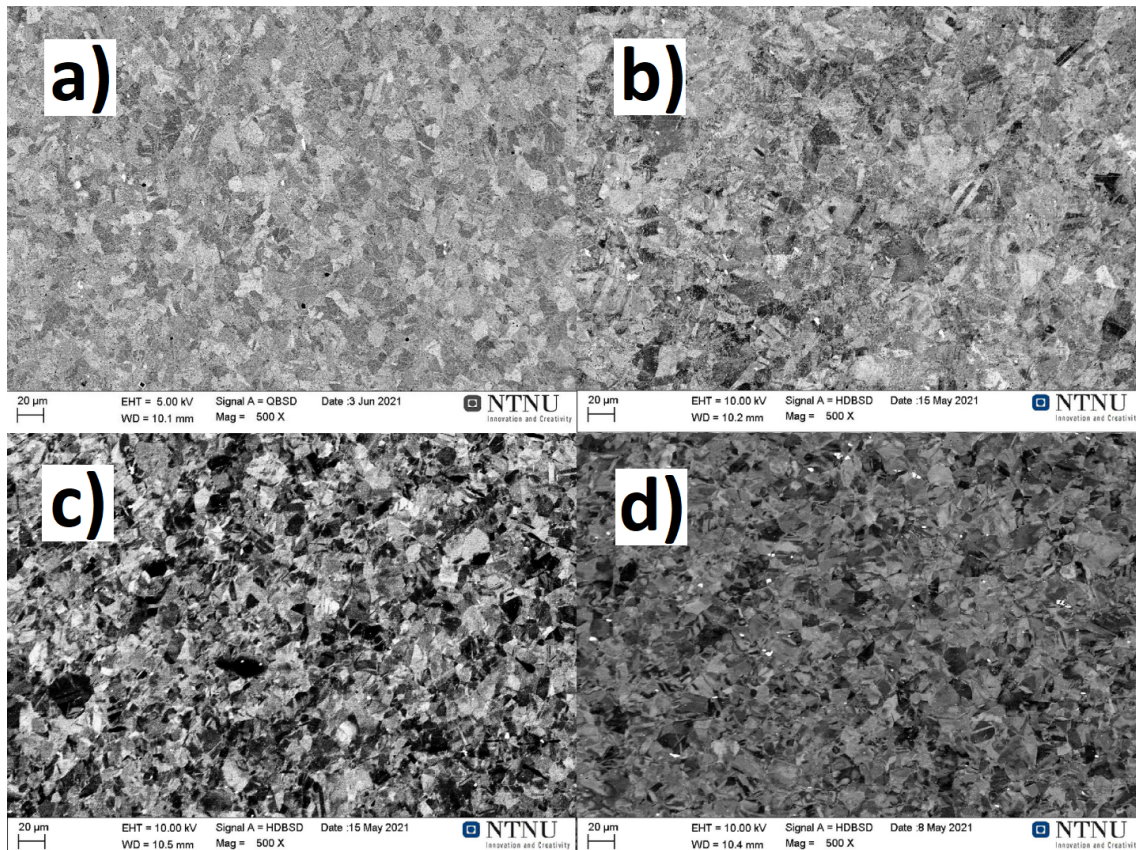
The grain structures for prosthesis SS, found by BSE analysis, are presented in Figure 92 below. The grain size was larger for the neck, section b) in Figure 92, than for the stem sections. There was no clear difference in grain size between the perpendicularly and parallel cut stem sections. Lines indicative of twins can be seen in all sections of Figure 92.

Figure 92: BSE images of Prosthesis SS

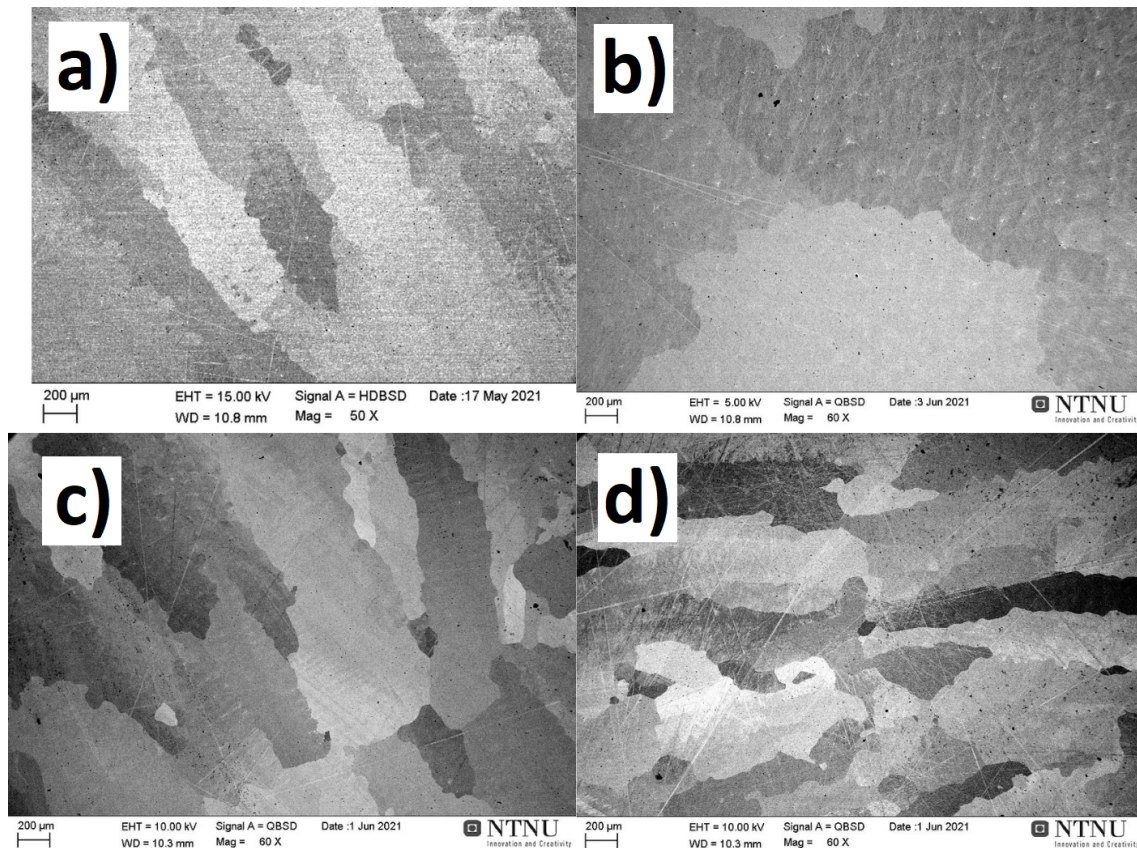
The grain structures for prosthesis Co, found by BSE analysis, are presented in Figure 96 below. The grain sizes were overall quite large, with most grains approaching or exceeding a millimeter each in their longest direction. The grains of the neck had a more rounded shape than the grains of sections a), c) and d) in Figure 96.

Figure 96: BSE images of Prosthesis Co
a) Head b) Neck c) Stem, perpendicularly cut d) Stem, parallel cut

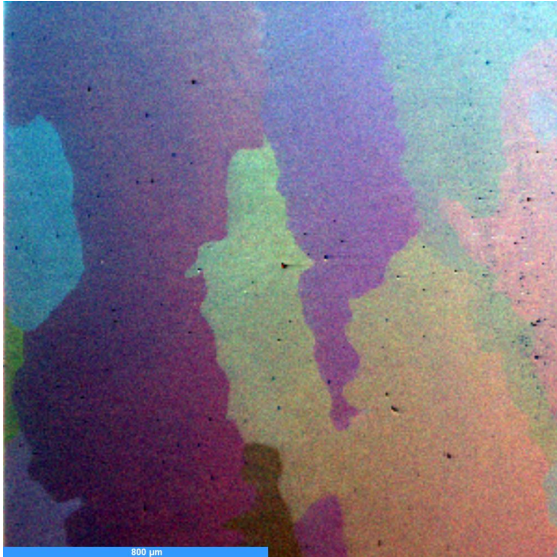
The orientation contrast images from the EBSD scanning process also showed the grain structure of the stem sections clearly. These images are shown in Figure 102 and Figure 103 below. A manual estimate of the grain size along the diagonal of the image gave an approximate grain size of 0.8 mm for the perpendicularly cut sample and 0.2 mm for the parallel cut sample.

Figure 102: Prosthesis Co Stem, perpendicularly cut

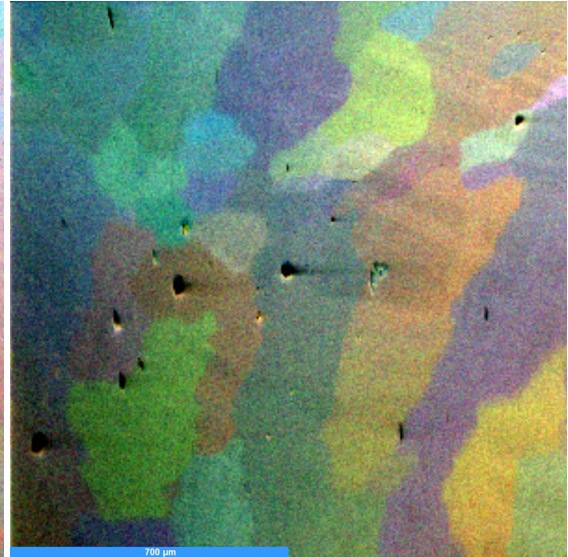
Figure 103: Prosthesis Co Stem, parallel cut

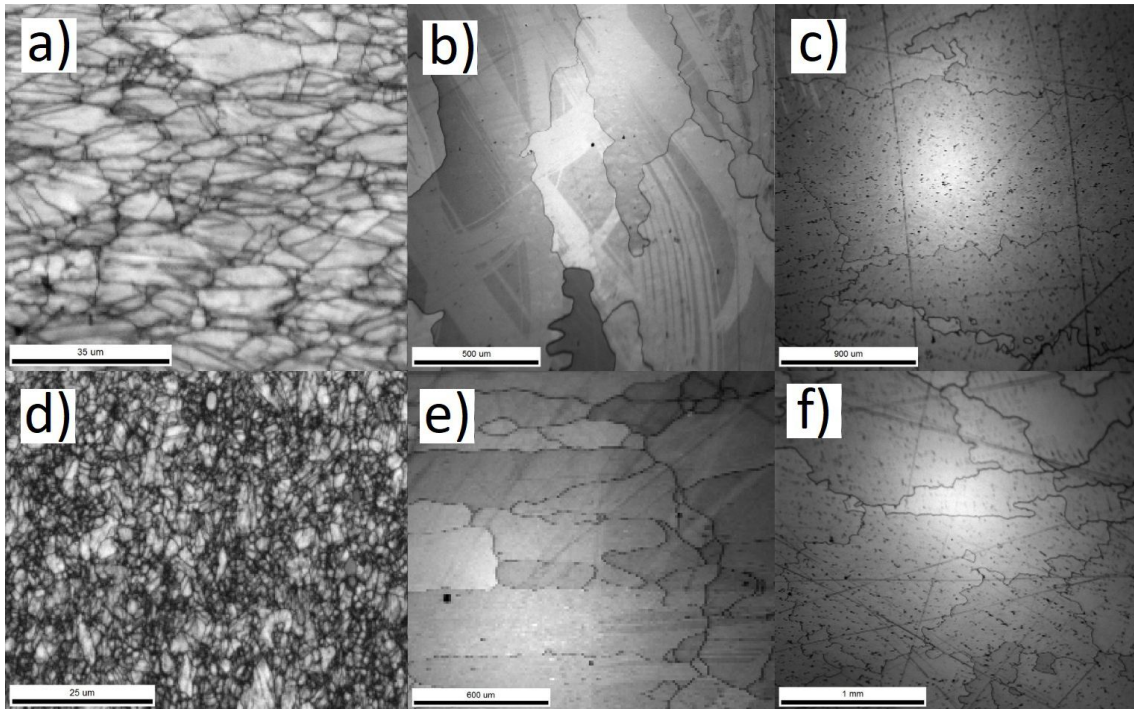
Figure 122: Top row shows the perpendicular cut and bottom row shows the parallel cut a) and d) are from prosthesis SS, b) and e) are from prosthesis Co, c) and f) are from prosthesis Co-o

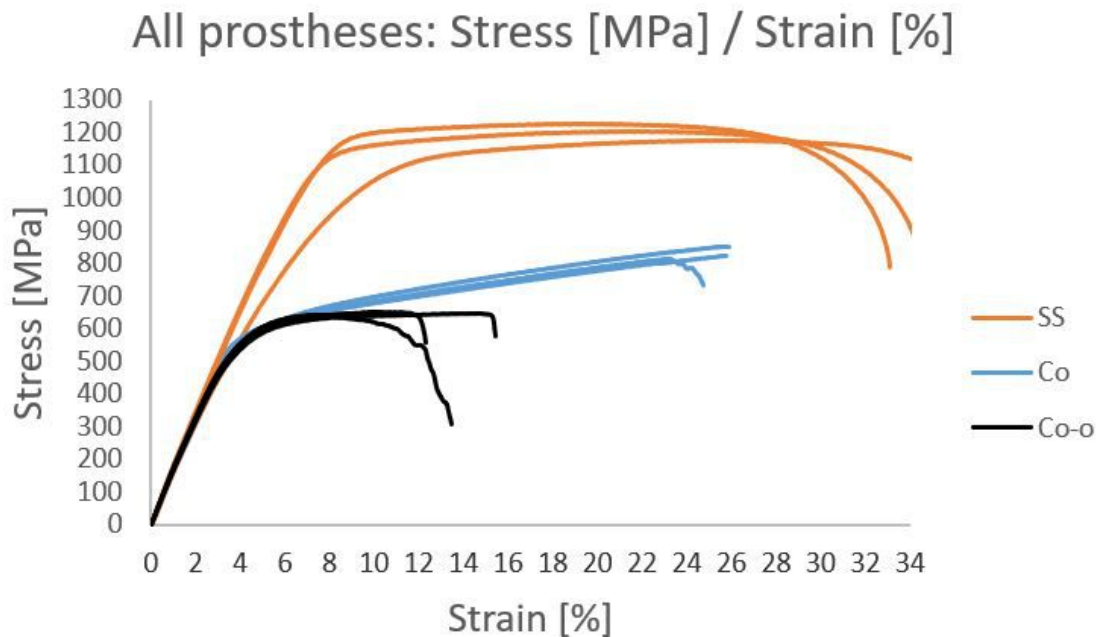
Figure 123: Engineering stress versus engineering strain in percentage

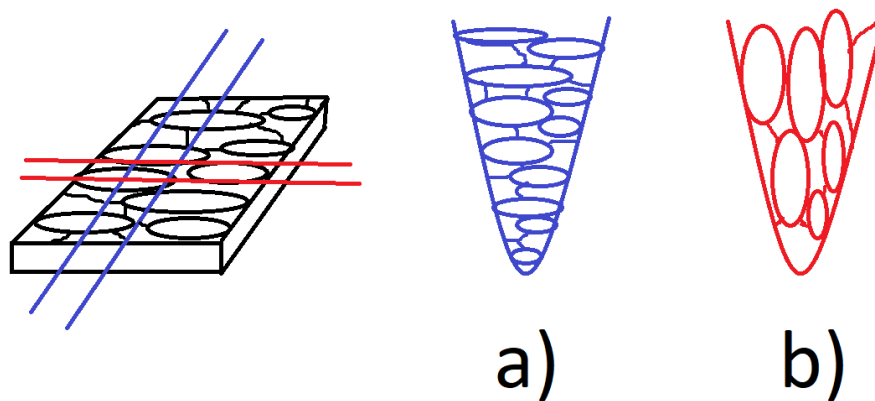
Figure 124: Illustration of resultant grain structures when cutting a material with elongated grains
