Effect of cracks in concrete after 25 years - Data report

STATENS VEGVESENS RAPPORTER

Nr. 374

Tobias Danner, Andres Belda Revert, Mette Rica Geiker (NTNU)

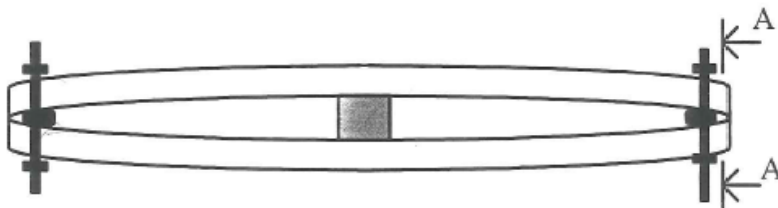
Figure 1: Illustration of coupling of 2 beams together in 3-point bending mode [12]

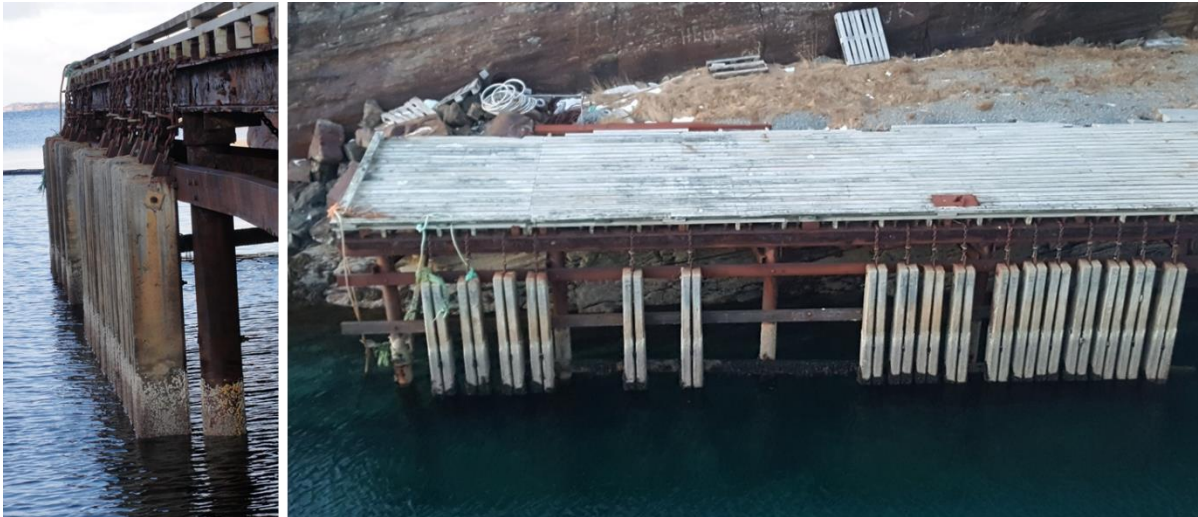
Figure 3: Field Station Sandnessjøen showing the concrete beams exposed to tidal water (14th March 2018 – Photo: Tobias Danner)

The beams are mounted from a quay near Sandnessjøen (Figure 2, Figure 3 and Figure 4). The mean water level is about at the middle of the beams and the tidal changes are between ± 0.5 to ± 1.4 m [13]. Information on temperature and precipitation can be obtained from yr.no and no.climate-data.org, respectively. In 2017 the minimum and maximum temperatures were -10 and 24°C, and the average temperature during the coldest and warmest month was -2 and 16°C. The monthly precipitation was 100-267 mm.

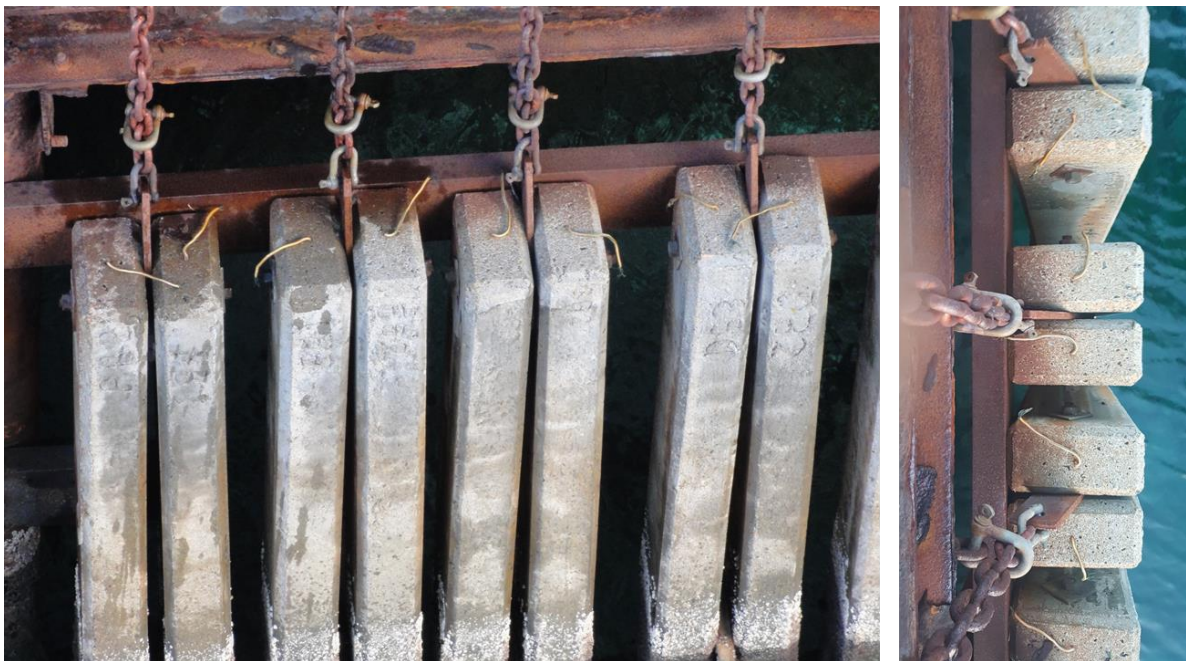
Figure 4: Concrete beams (concrete P, E, B and D from left to right) mounted from the ferry quay at the Field Station Sandnessjøen (14th March.2018 – Photo: Tobias Danner)

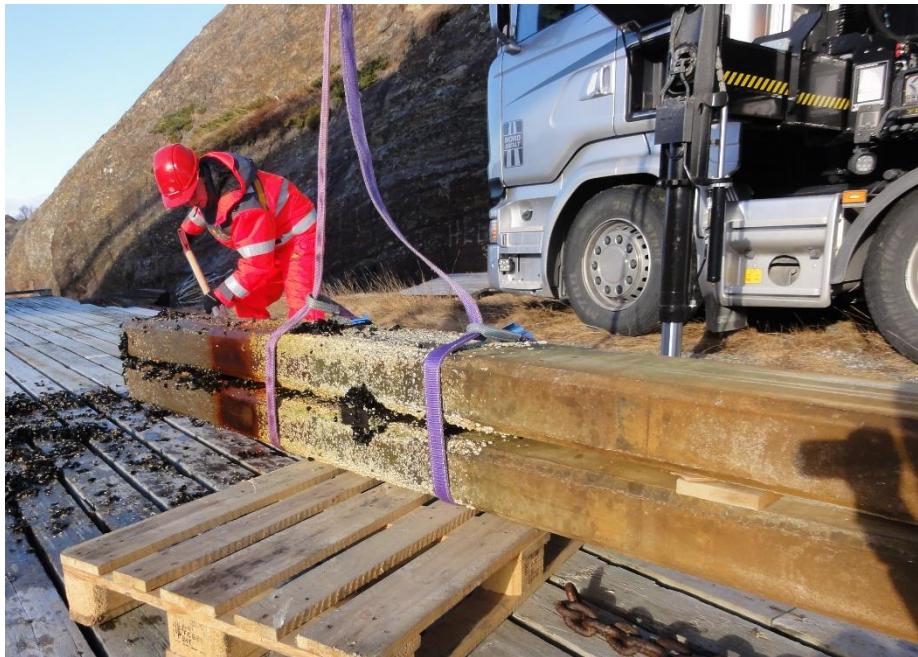
Figure 5: Removal of a pair of concrete beams and preliminary surface cleaning (14th March.2018 – Photo: Tobias Danner)

The 14th March 2018 between 09:00-11:00 a.m, three pairs of beams (concrete B, E and F; original marking BB1 and BB2, EB1 and EB2, FB1 and FB2) were taken out of the water with a crane. (Figure 5). Shells were partly removed from the concrete surface directly after lifting the beams out of the water. The beams were packed tightly in thick plastic foil (Figure 6) and transported to Trondheim the same day. The concrete beams were transported on an open truck and arrived in Trondheim around 19:00 the 14th March. The following day, the concrete beams were cleaned and moved into the laboratory.

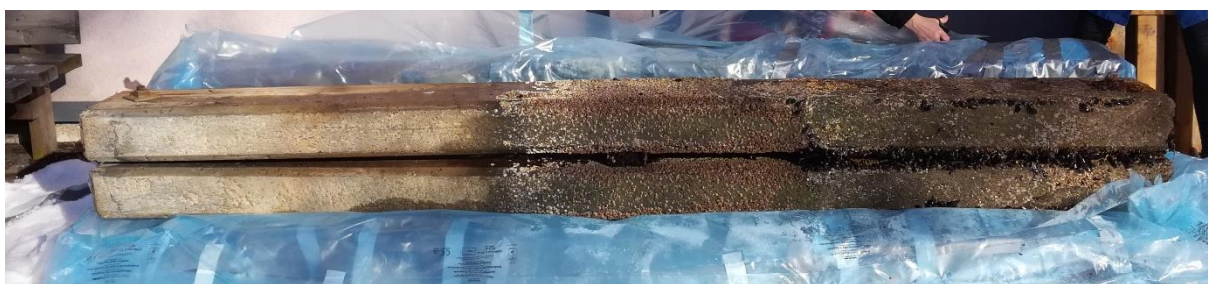
Figure 10: Pair of loaded concrete beams as received at NTNU before cleaning the surface, submerged part of the beam to the right (15th March 2018 – Photo: Ragnhild Moastuen)

Before moving the pairs of concrete beams in the laboratory, the concrete surfaces were cleaned outside. A pair of concrete beams before cleaning (as received at NTNU) is shown in Figure 10. The tidal and submerged zone are visible to the right in Figure 10 by shells covering the concrete surface. The concrete surface in the atmospheric zone was free of shells and algae. Remaining shells and algae were scratched off the surface with a big spatula before cleaning the concrete beams with water using a pressure washer (Figure 11).

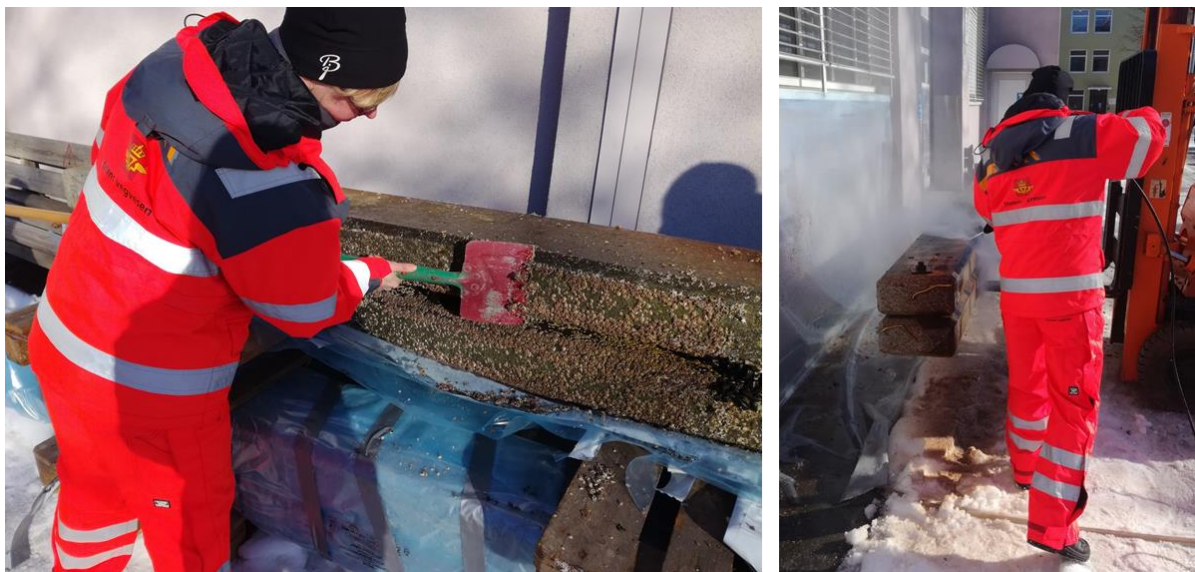
Figure 11: Surface cleaning of concrete beams. Left: Scratching of shells and algae; Right: Washing with pressure washer (15th March 2018 – Photo: Ragnhild Moastuen)

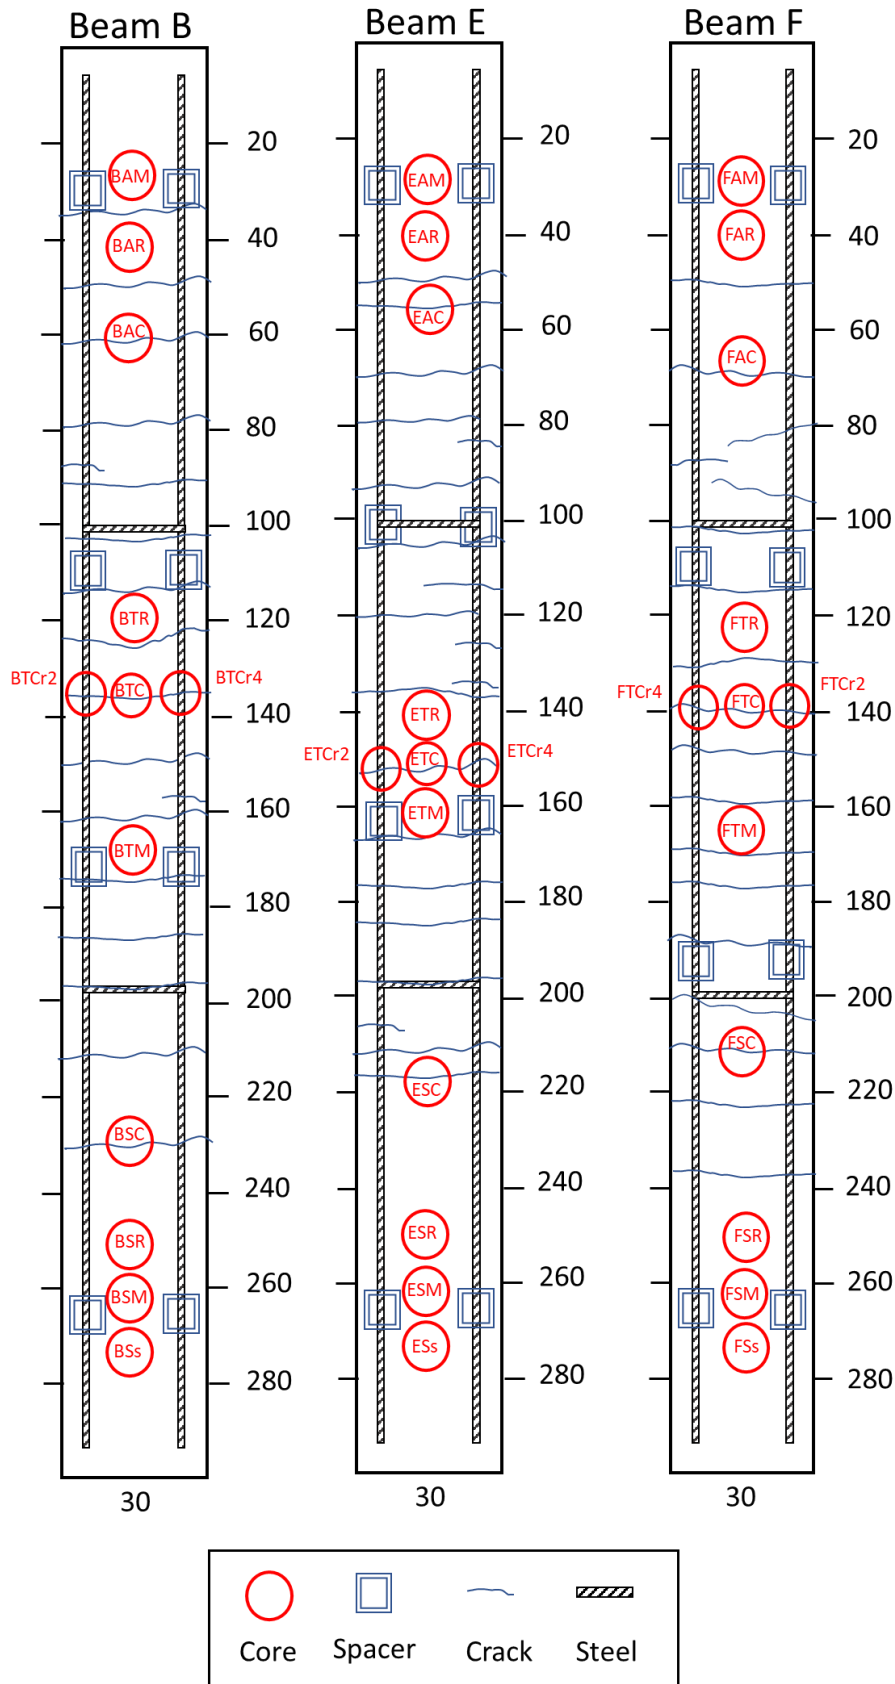
Figure 12: Location of concrete cores taken from Beam B, Beam E and Beam F. Note different orientation of Beam F at the ferry quay. Results of the visual inspection of the concrete beams is given in Chapter 5.1. Distance from the top in cm, width in cm

Concrete cores with and without cracks were drilled between the reinforcement in all exposure zones. In addition, concrete cores were drilled with reinforcement in the tidal zone. The location of the drilled cores is illustrated in Figure 12. Table 4, Table 5 and Table 6 give an overview of the concrete cores taken from Beam B, Beam E and Beam F. An explanation of the core IDs is given in Table 3. Pictures of the core locations are given in Appendix 2. In between the different investigations, the concrete cores were packed tightly in plastic and stored in a 5°C room.

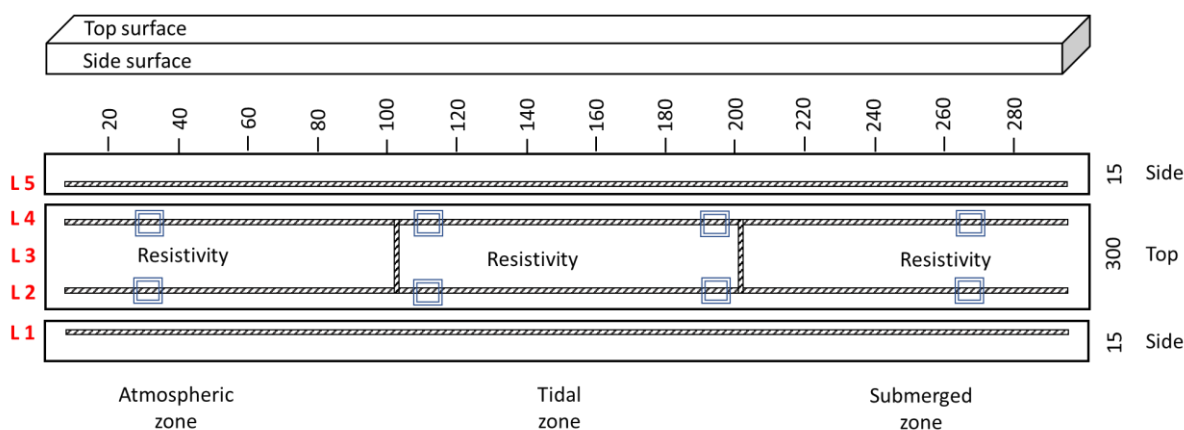
Figure 13: Template for crack mapping and experimental approach. Specific measurements were performed along five lines (L1-L5) on the side and top surface of the concrete beams. Measures in cm

Five parallel lines were drawn over the whole length of the concrete beams in longitudinal direction (L1, L2, L3, L4, L5 in Figure 13). Line 2 and Line 4 were drawn above the reinforcement on the top surface of the beams. Line 3 was drawn in the middle of the top surface between the reinforcement of the beams. Line 1 and Line 5 were drawn above the reinforcement on the side surfaces of the concrete beams. The bottom side of the beams was not investigated. Crack width and half-cell potential was measured along lines L1-L5 as described in Chapter 5.1 and 5.3. Resistivity measurements were only taken on the top surface in between the reinforcement (Chapter 5.4). All results will be presented with the atmospheric zone on the left in case of horizontal oriented figures or top in case of vertical oriented figures.

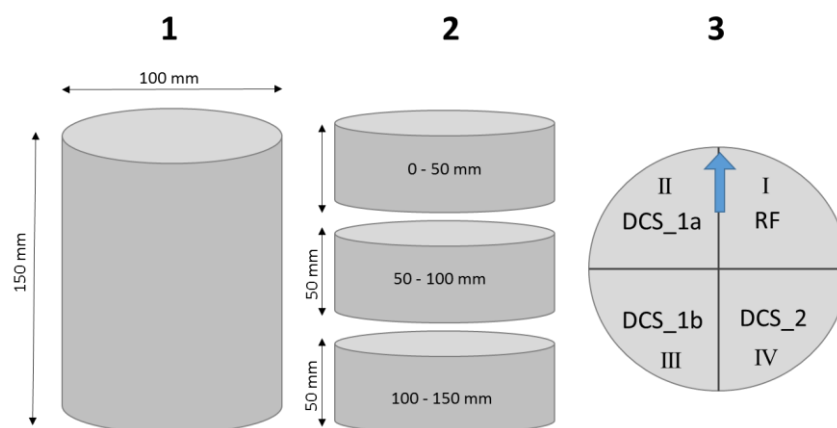
Figure 14: Principle drawing of utilization of concrete cores for moisture measurements. 1: Concrete cores of 100 mm diameter and 150 mm length; 2: Splitting of concrete cores in 3 layers (0-50 mm, 50-100 mm, 100-150 mm), 3: Splitting of each layer in 4 parts for DCS and RH (in figure RF) measurements

1. Splitting of concrete cores
2. Weighing of samples directly after splitting
3. Submersion in water and weighing in air after 7 and 21 days and in water after 7 days
4. Drying at 105 °C for 7 days
5. Submersion in water and weighing in air after 7 and 21 days and in water after 7 days
6. Submersion in pressure tank (50 mbar) for 2 days
7. Drying at 105 °C and weighing after 7 days

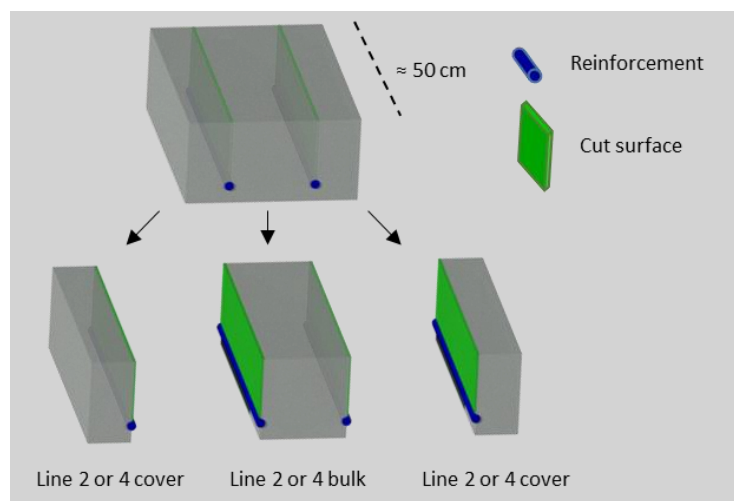
Figure 15: Illustration of cutting and removing the concrete cover for determination of extent of reinforcement corrosion

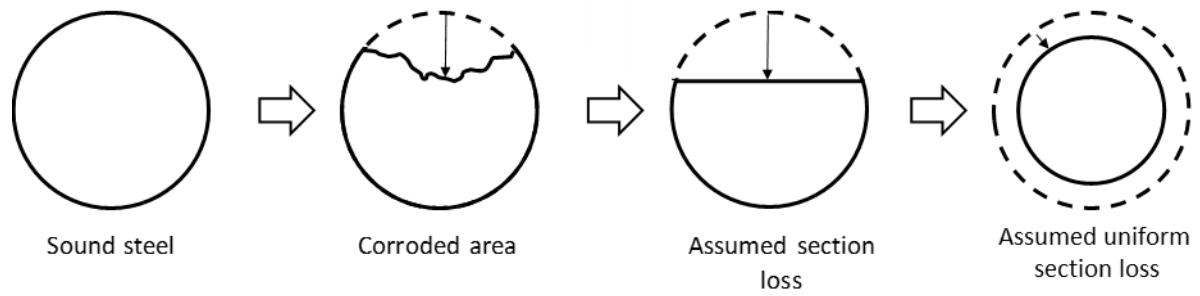
Figure 16: Cross section of rebar. Illustration of calculation of cross section loss based on measured maximum pit depth

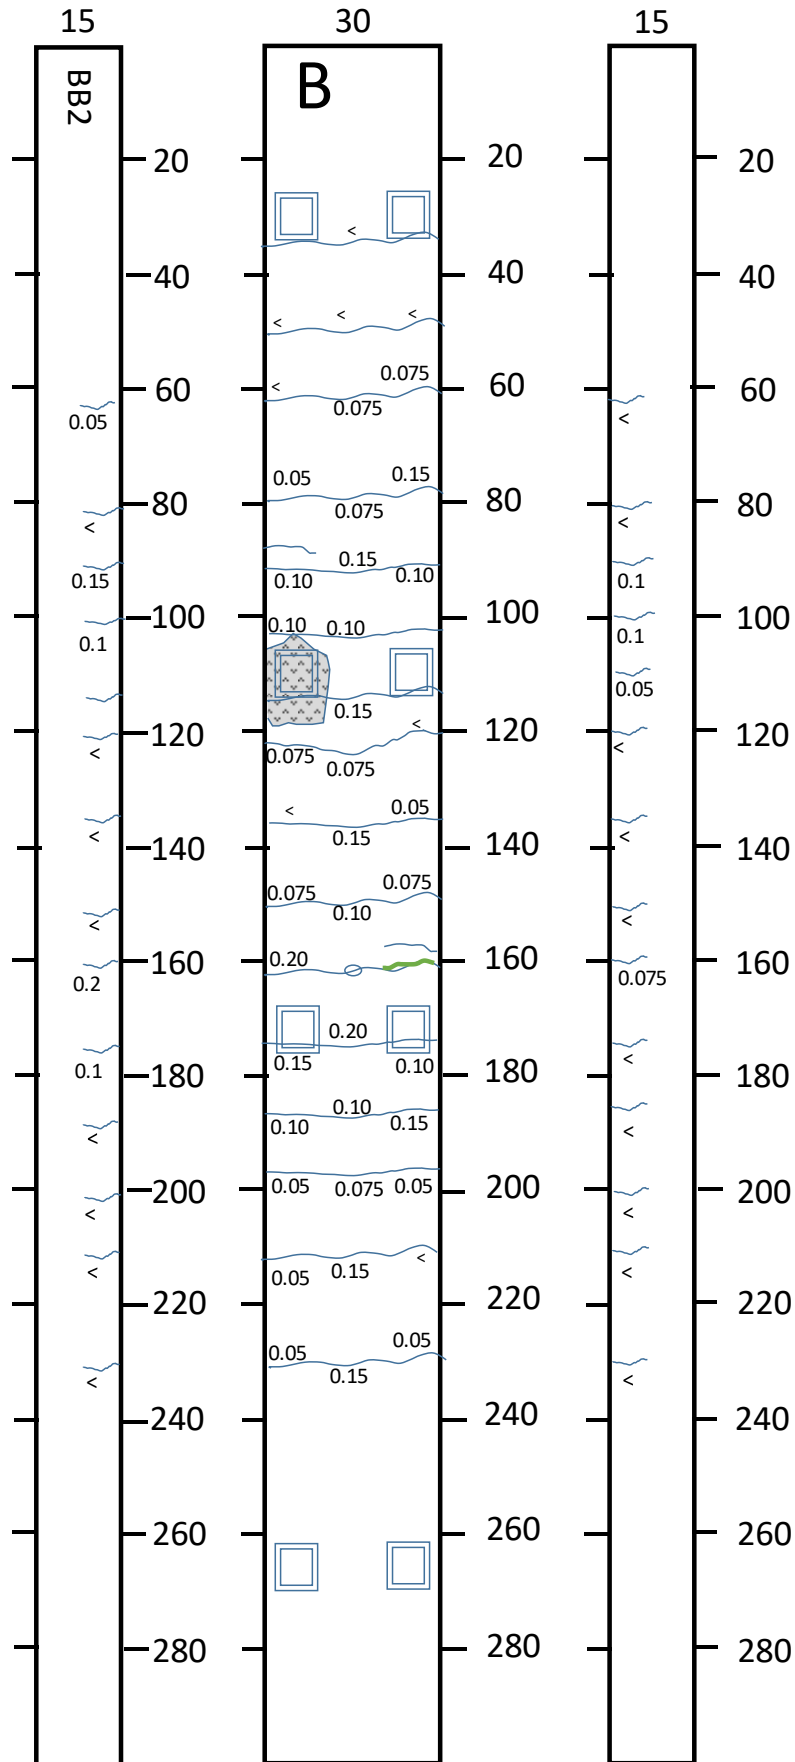
Figure 19: Crack map of Beam B (atmospheric zone at top). Distance from top in cm; crack width in mm. Legend in Figure 18

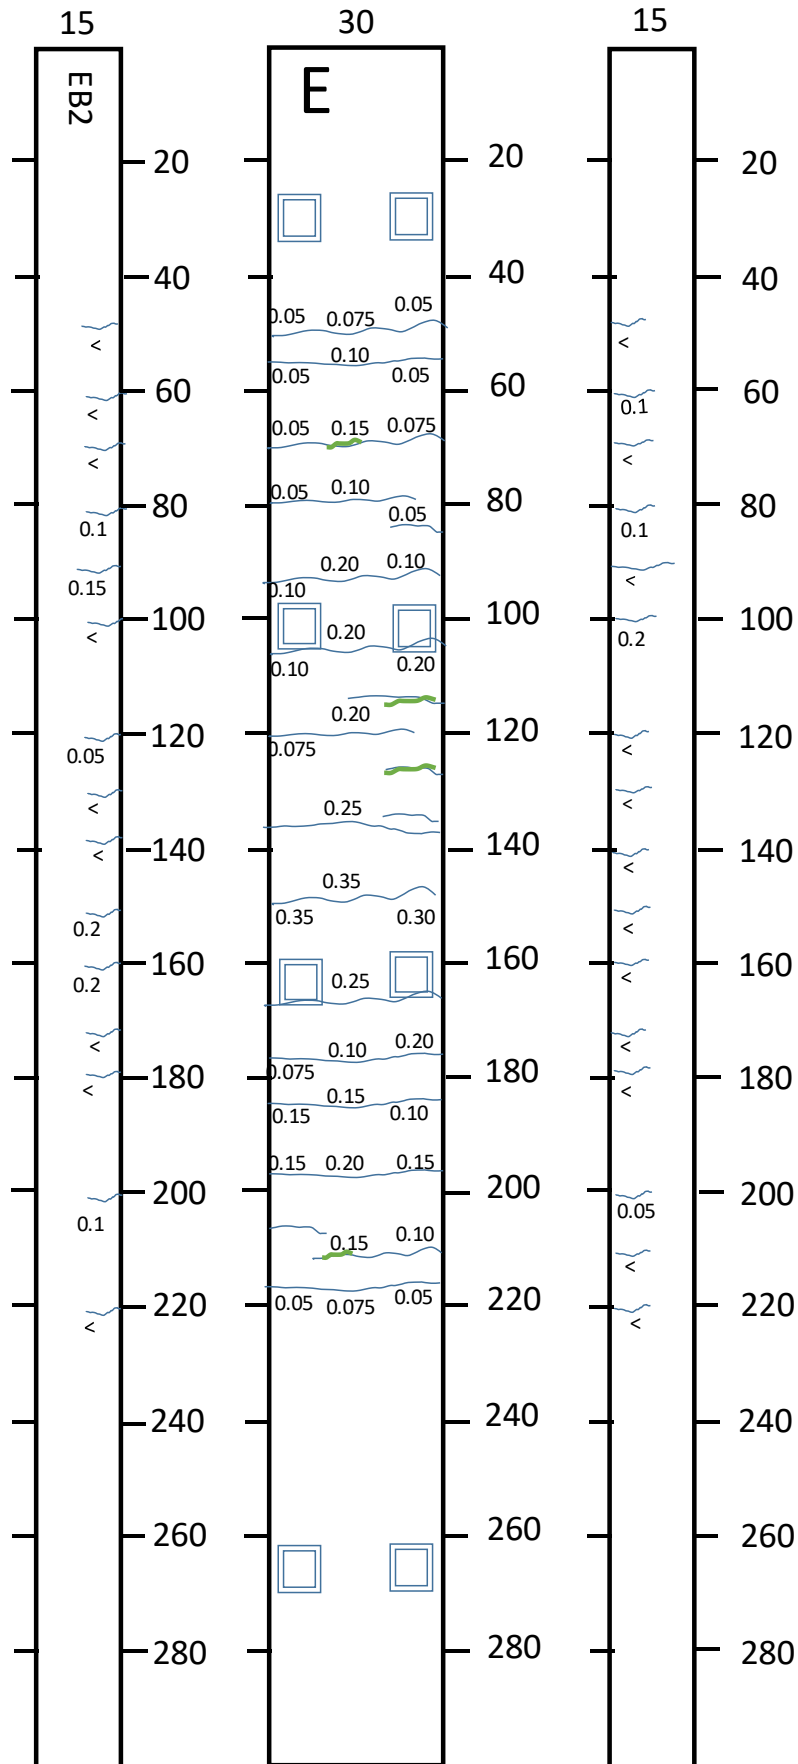
Figure 20: Crack map of Beam E (atmospheric zone at top). Distance from top in cm; crack width in mm. Legend in Figure 18

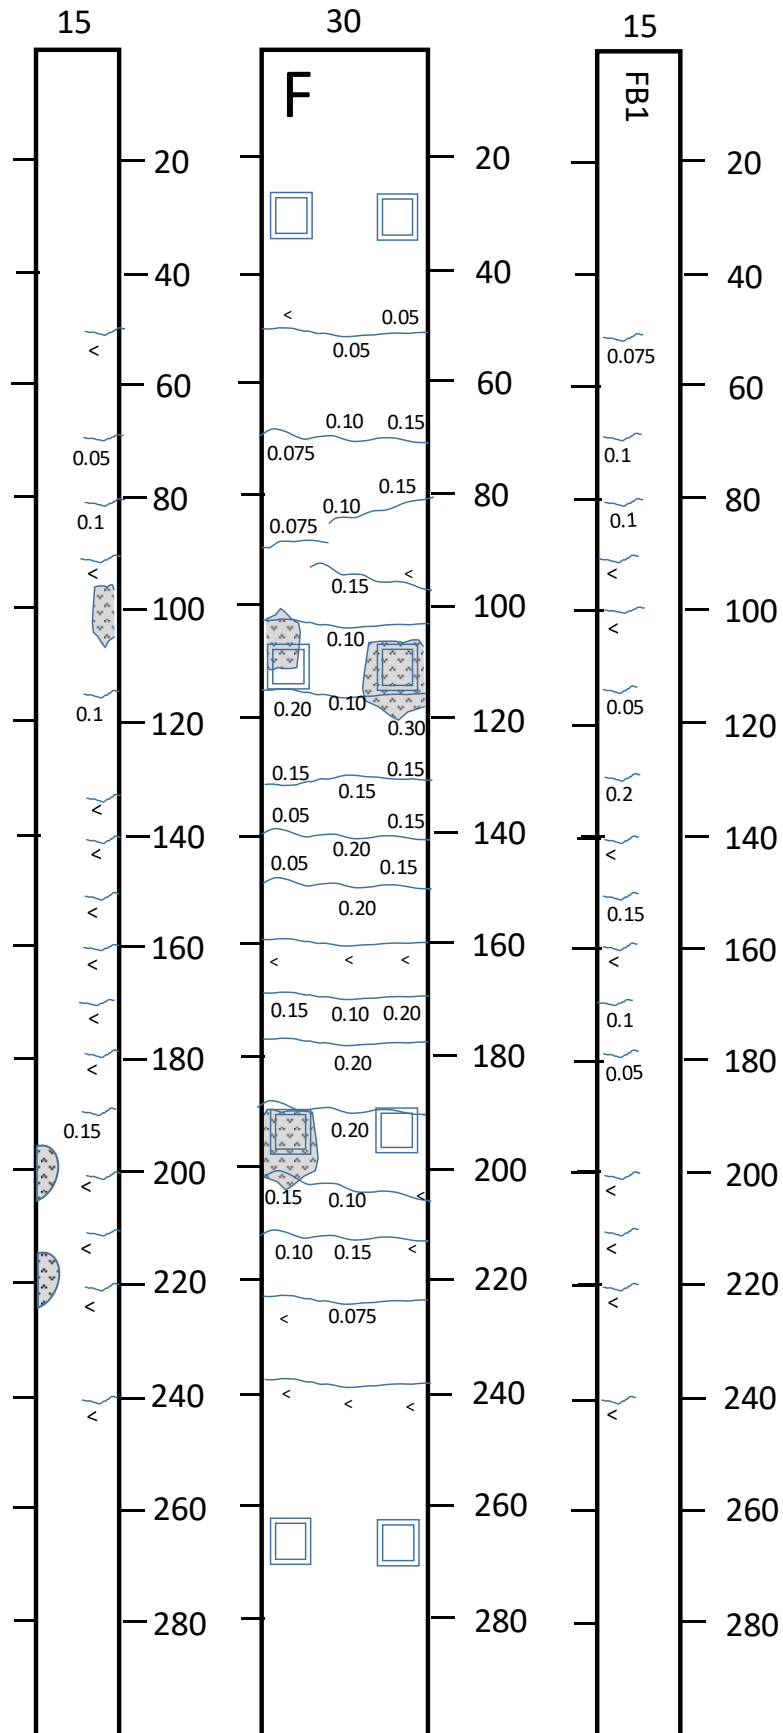
Figure 21: Crack map of Beam F (atmospheric zone at top). Distance from top in cm; crack width in mm. Note: different orientation on ferry quay (see Figure 7). Legend in Figure 18

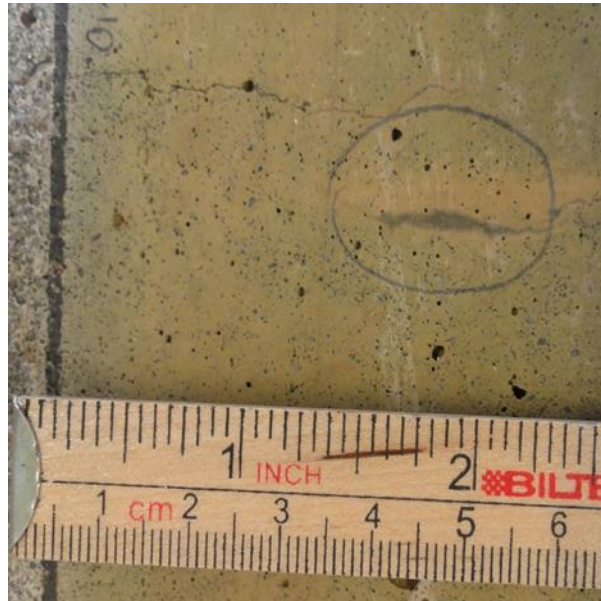
Figure 22: Example of a partly closed crack mouth (marked with grey circle) next to an open crack on the surface of Beam E. Location: 80 cm

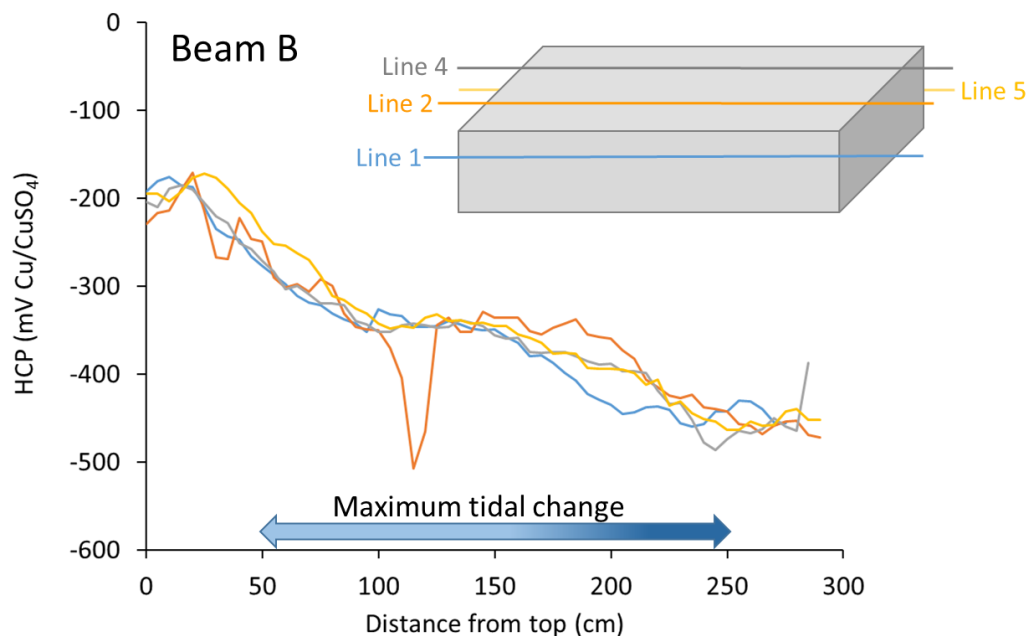
Figure 23: Half-cell potential (HCP) on the sides (Line 1 and Line 5) and top surface (Line 2 and Line 4) of Beam B. Measurements were performed with a wheel electrode above the reinforcement

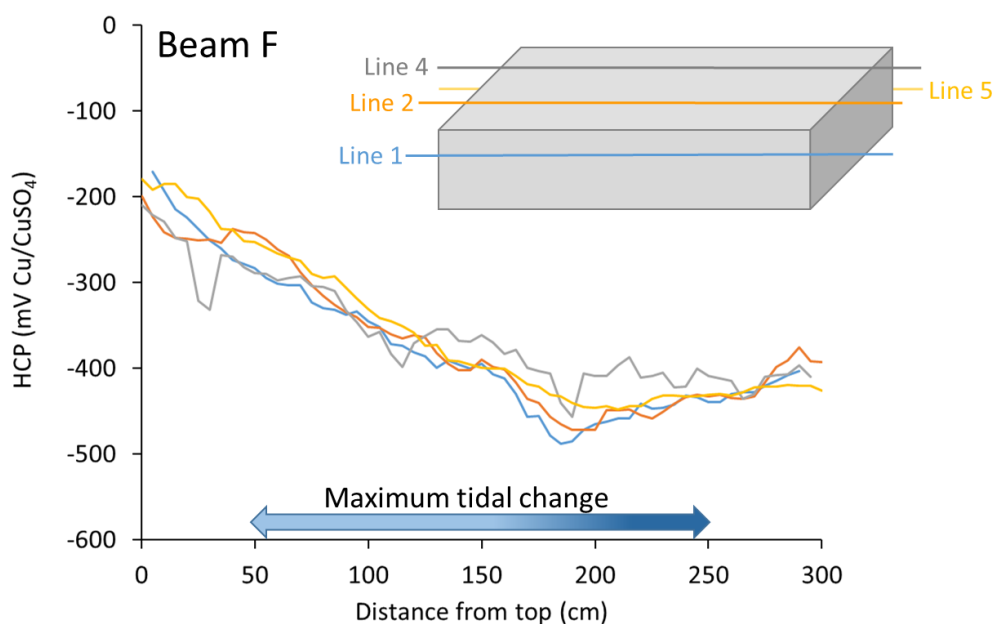
Figure 25: Half-cell potential (HCP) on the sides (Line 1 and Line 5) and top surface (Line 2 and Line 4) of Beam F. Measurements were performed with a wheel electrode above the reinforcement

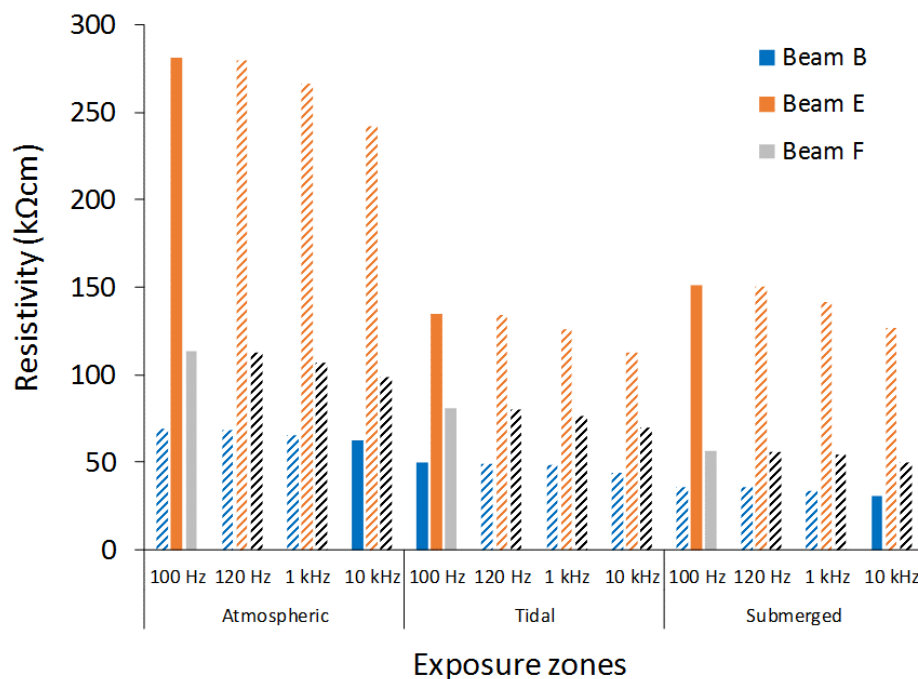
Figure 27: Resistivity measurements performed at 5°C on concrete cores BAC, EAC, FAC (atmospheric), BTC, ETC, FTC (tidal) and BSC, ESC, FSC (submerged). Measurements performed by Solveig Myklebust and Ragnhild Moastuen (Master thesis, 2018). The results obtained with lowest phase angle are solid

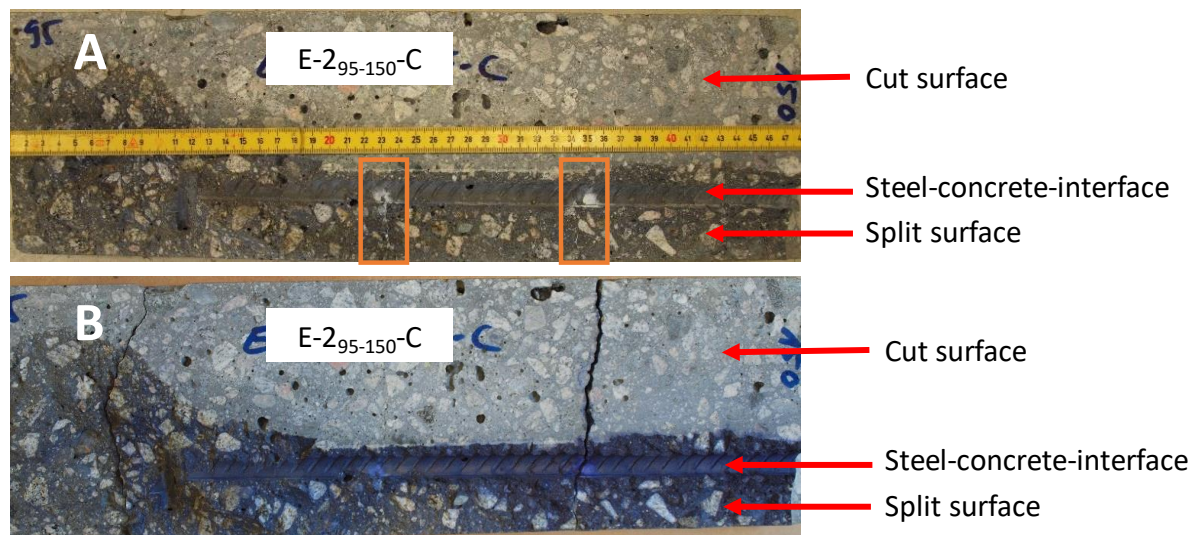
Figure 28: A: Beam E, position 95-150 cm along Line 2 shortly after cutting cover (light colour) and shortly after splitting the remaining part of the concrete (dark colour). Note the white precipitate at the steel-concrete interface and in the cracks (orange rectangles) B: same sample sprayed with thymolphthalein. The large crack in Figure B developed after cutting and splitting the concrete beam. Note: Top face down.

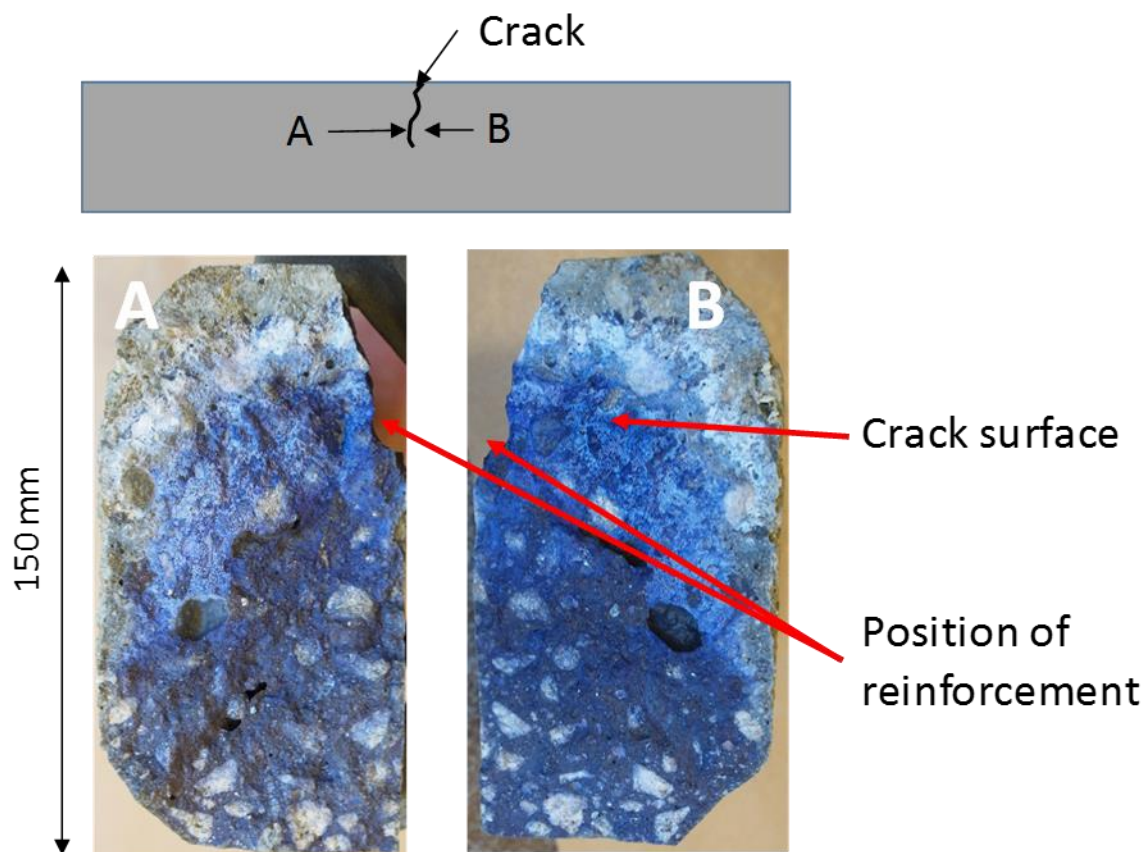
Figure 29: Sample split open at crack and crack surfaces sprayed with thymolphthalein (Beam E, position 180 cm, Line 2 (crack width 0.15 mm)). The white colour on the surface was present before spraying. A and B represent the two surfaces of the same crack. Note: Top face up

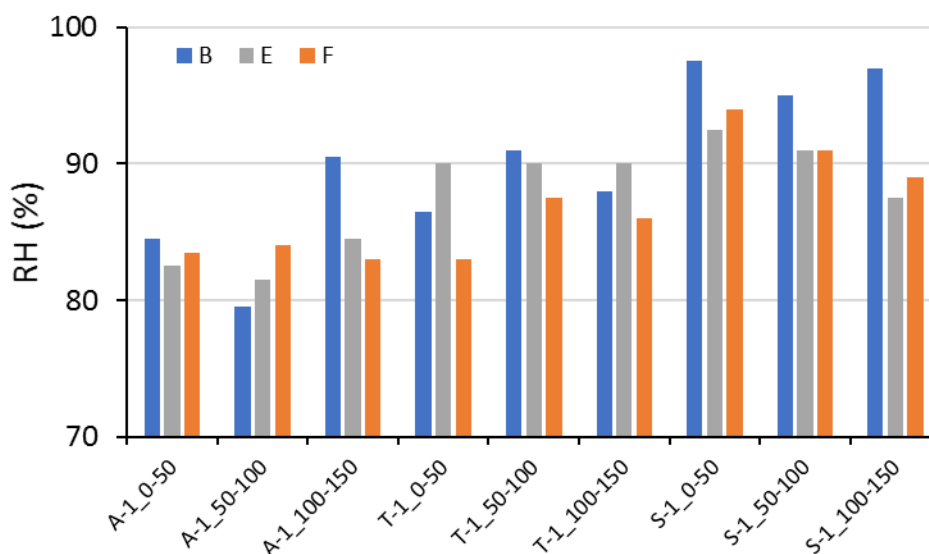
Figure 30: Relative humidity (RH) of concrete cores taken from beams B, E and F (A: Atmospheric, T: Tidal, S: Submerged)

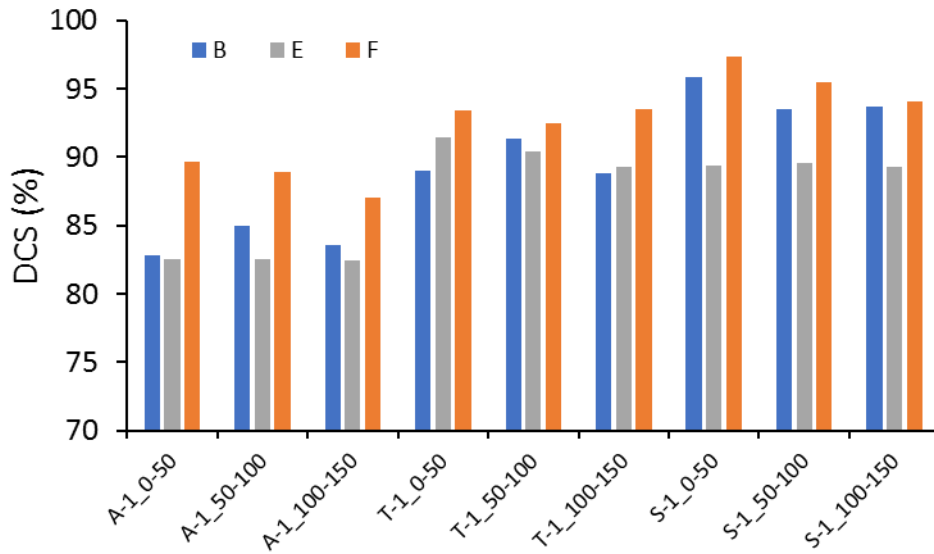
Figure 31: Degree of capillary suction (DCS) of concrete cores taken from Beam B, E and F (A: Atmospheric, T: Tidal, S: Submerged). Results based on 21 days submersion in water and 7 days drying at 105°C

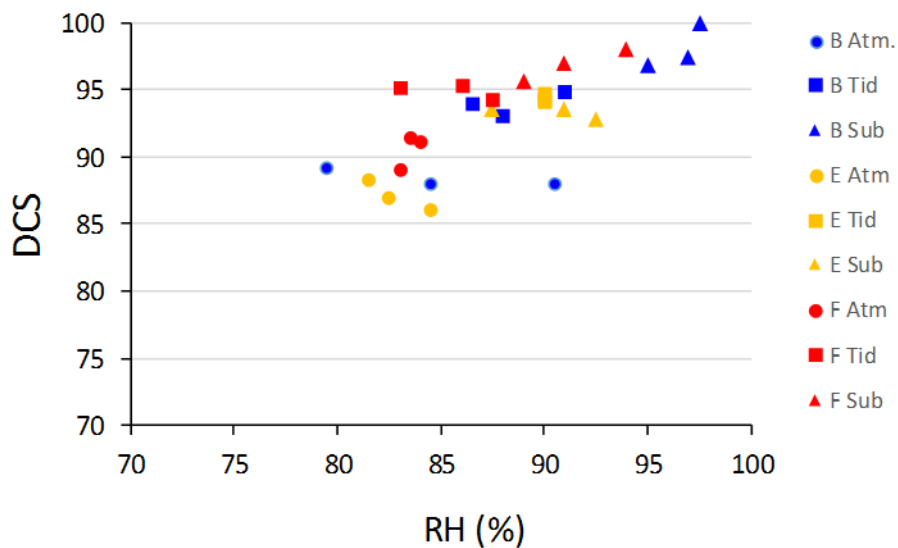
Figure 32: Degree of capillary suction (DCS) versus relative humidity (RH) of concrete cores taken from beams B, E and F taking in all three exposure zones (Atm: Atmospheric, Tid: Tidal, Sub: Submerged). DCS based on 21 days submersion in water and 7 days drying at 105°C

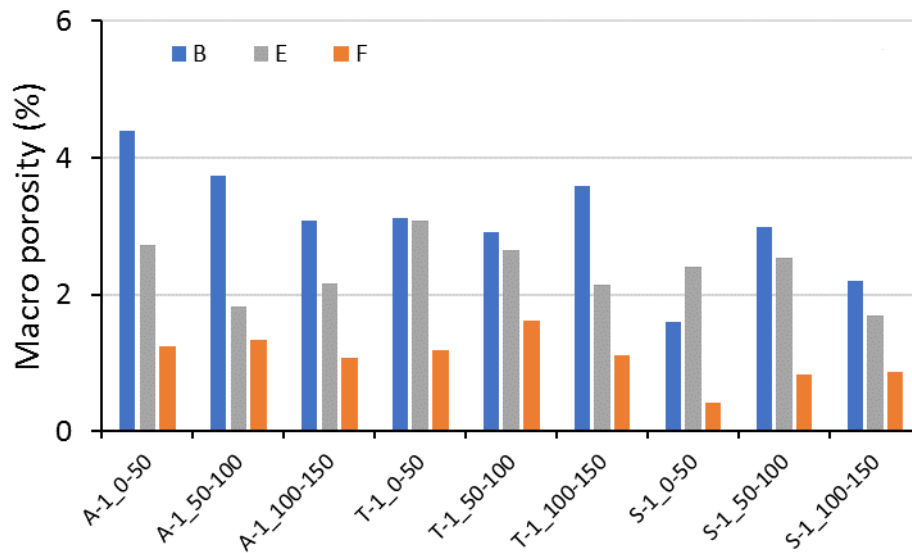
Figure 33: Macro porosity of concrete cores taken from beams B, E and F (A: Atmospheric, T: Tidal, S: Submerged). Results based on 21 days submersion in water, 7 days drying at 105°C and 2 days pressure saturation

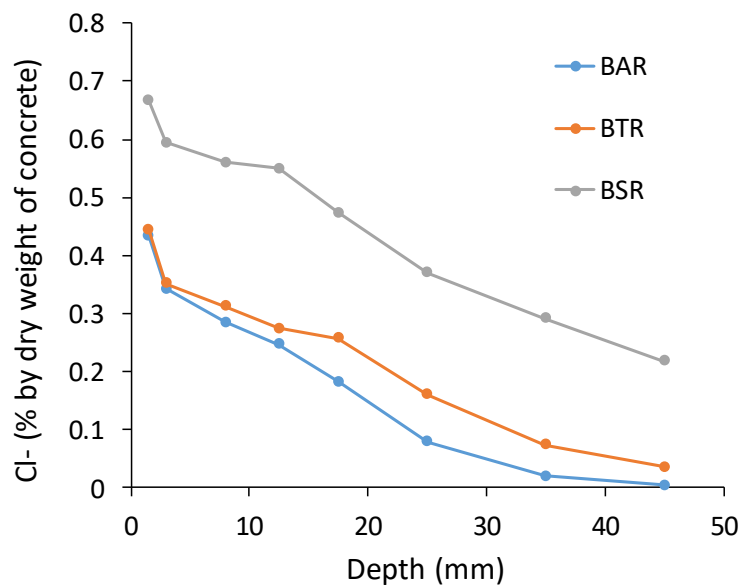
Figure 35: Chloride profiles of cores from Beam B determined by potentiometric titration; BAR (atmospheric), BTR (tidal) and BSR (submerged)

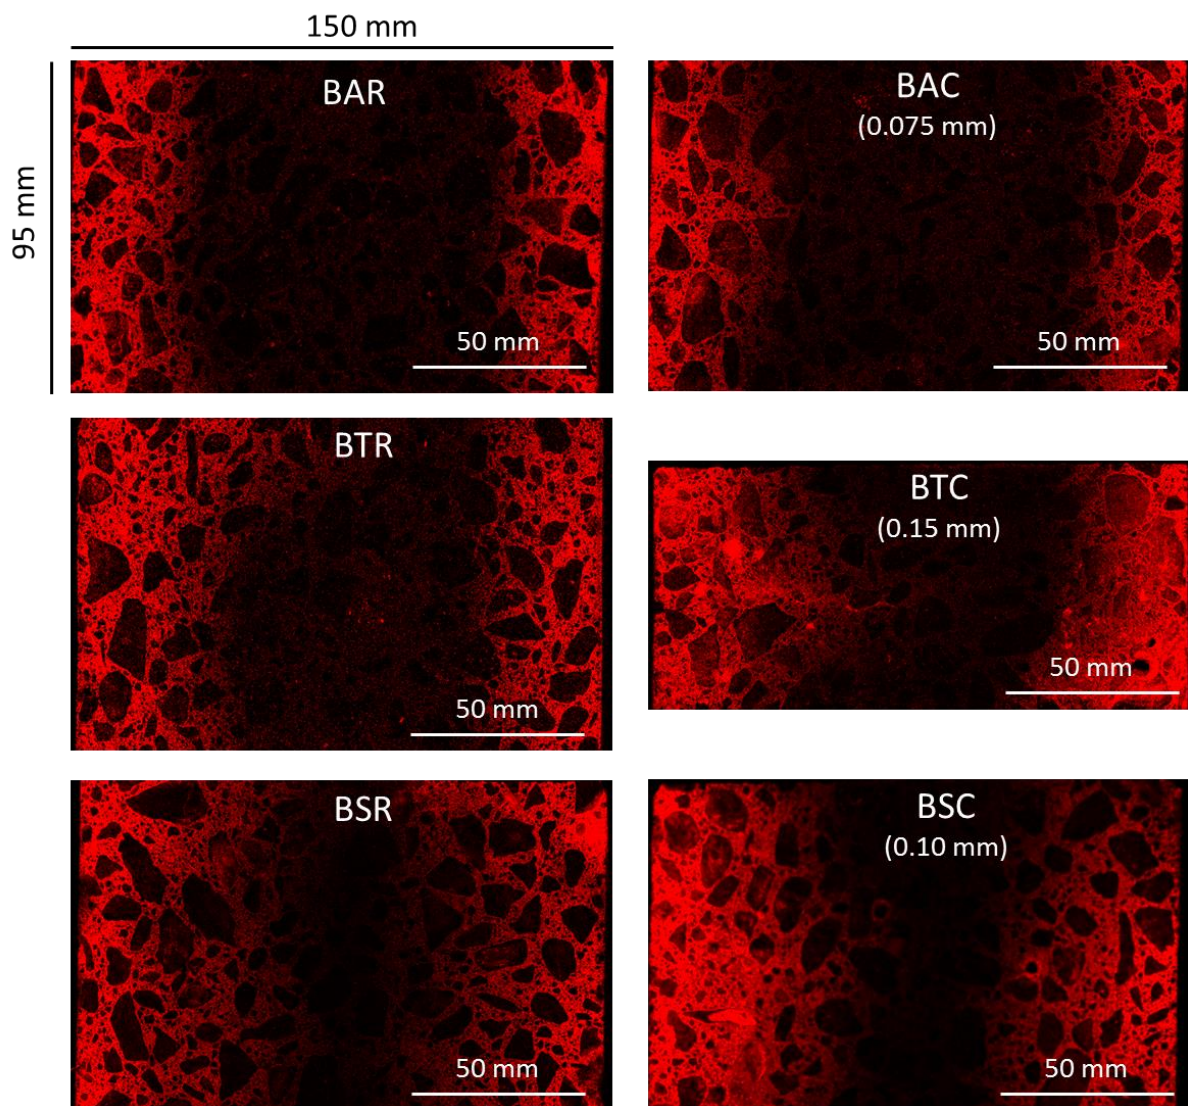
Figure 38: μ -XRF chloride maps of reference cores (BAR, BTR, BSR) and cores with cracks (BAC, BTC, BSC) from the three exposure zones of Beam B. Surface crack width indicated in brackets. Each picture is normalized to the highest measured intensity within the picture. The mapping area was slightly larger than the whole width of the core causing black stripes on the left and right side in some maps

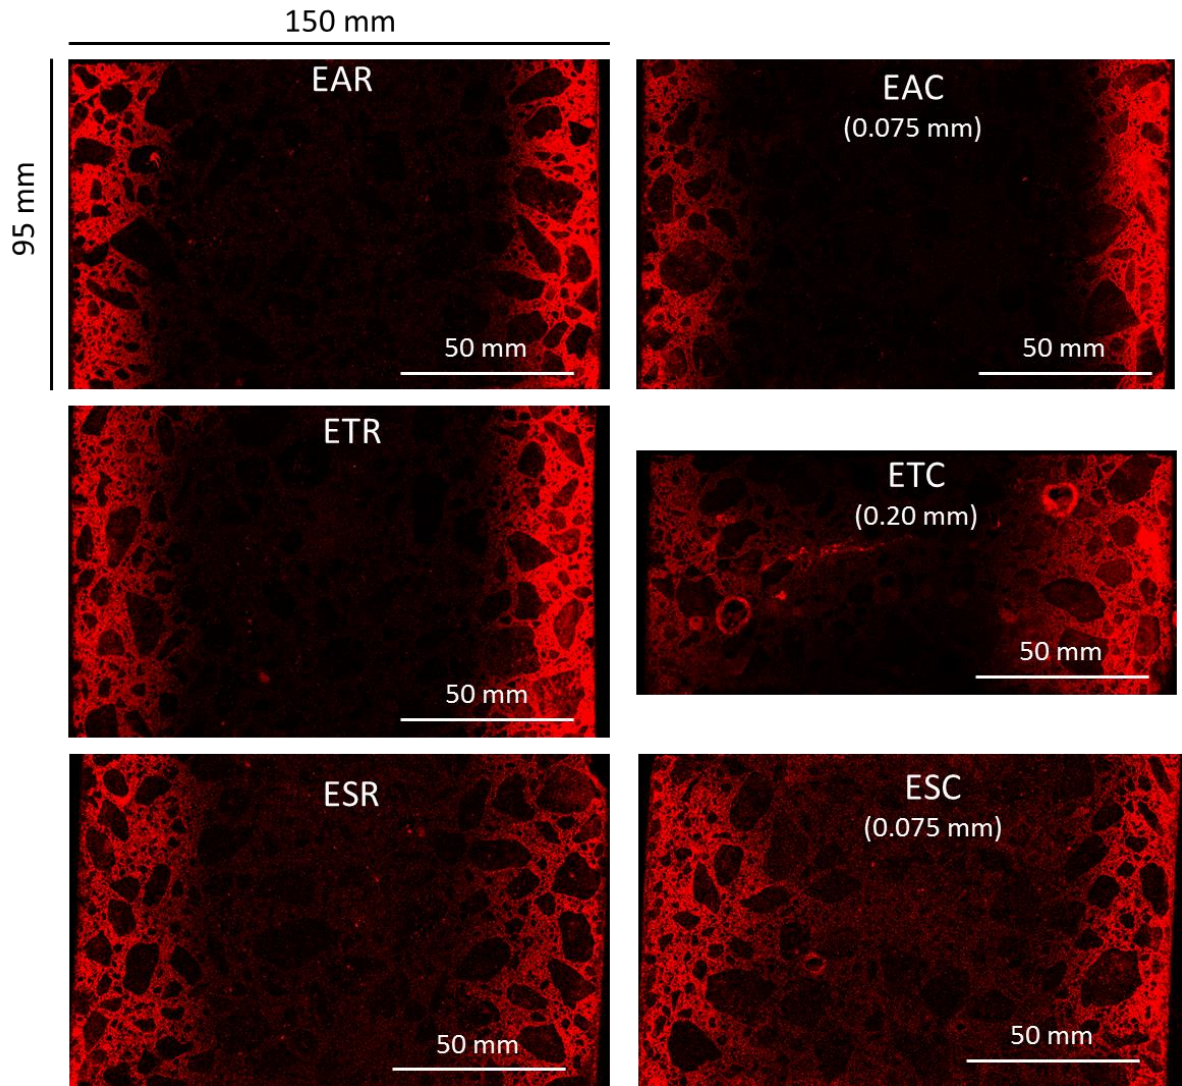
Figure 39: μ -XRF chloride maps of reference cores (EAR, ETR, ESR) and cores with cracks (EAC, ETC, ESC) from the three exposure zones of Beam E. Surface crack width indicated in brackets. Each picture is normalized to the highest measured intensity within the picture. The mapping area was slightly larger than the whole width of the core causing black stripes on the left and right side in some maps
