Effect of cracks in concrete after 25 years - Data report

STATENS VEGVESENS RAPPORTER

Nr. 374

Tobias Danner, Andres Belda Revert, Mette Rica Geiker (NTNU)

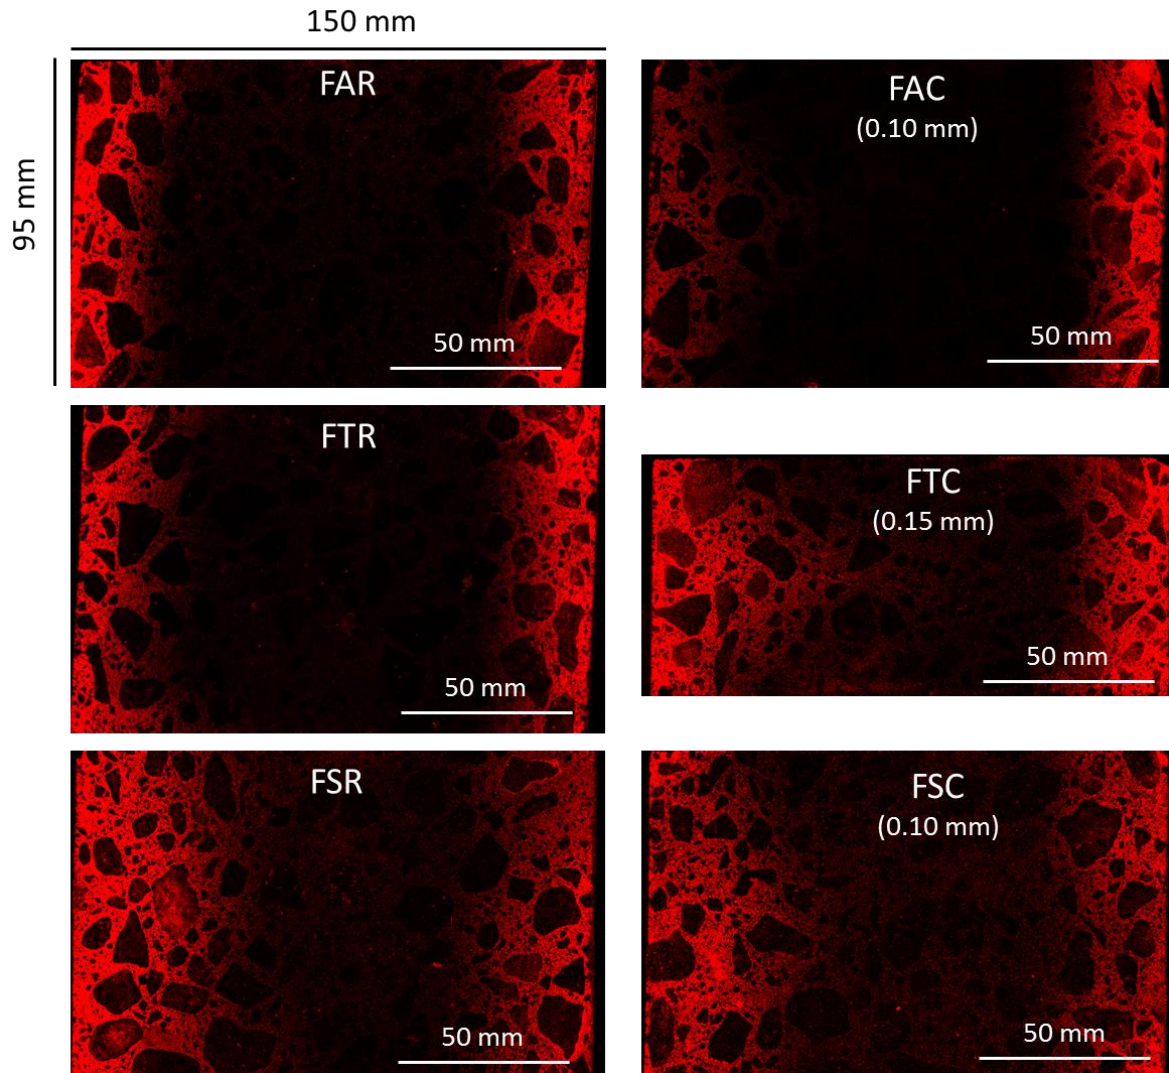
Figure 40: μ -XRF chloride maps of reference cores (FAR, FTR, FSR) and cores with cracks (FAC, FTC, FSC) from the three exposure zones of Beam F. Surface crack width indicated in brackets. Each picture is normalized to the highest measured intensity within the picture. The mapping area was slightly larger than the whole width of the core causing black stripes on the left and right side in some maps

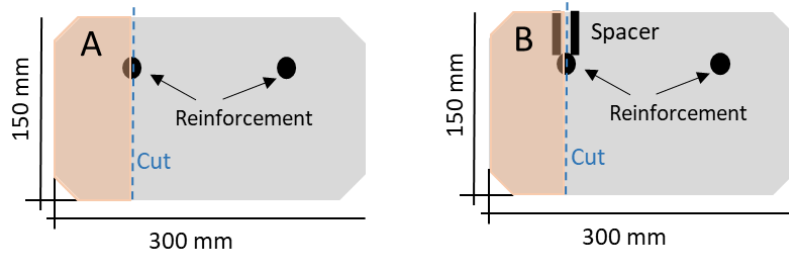
Figure 41: Illustration of the origin of the concrete slices with spacers cut from the concrete beams

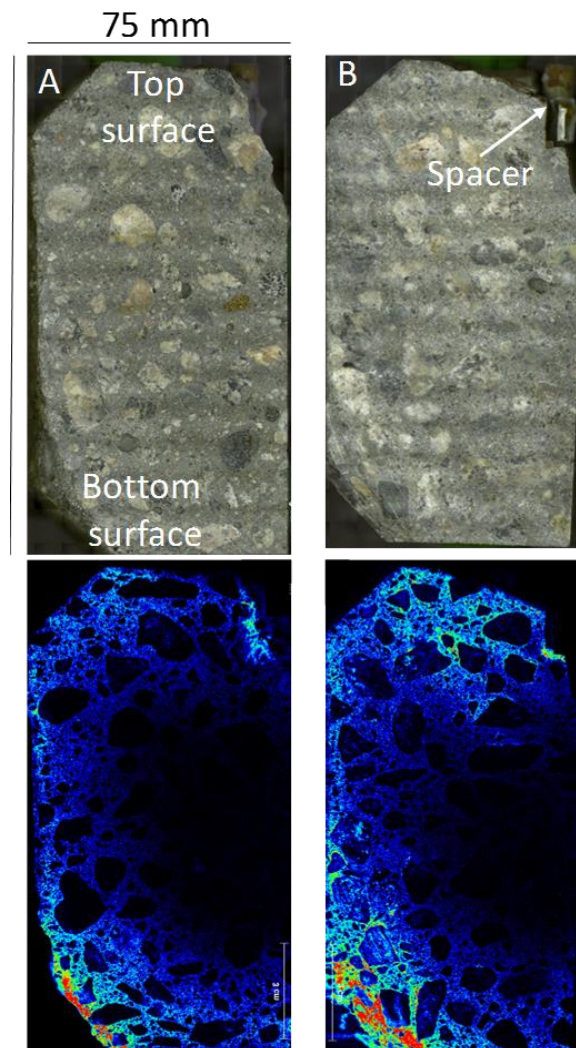
Figure 42: Chloride ingress in concrete Beam B at a spacer in the tidal zone (location 110 mm, Line 4). A: reference slice 2 cm from the spacer, B: slice cut through the centre of the spacer

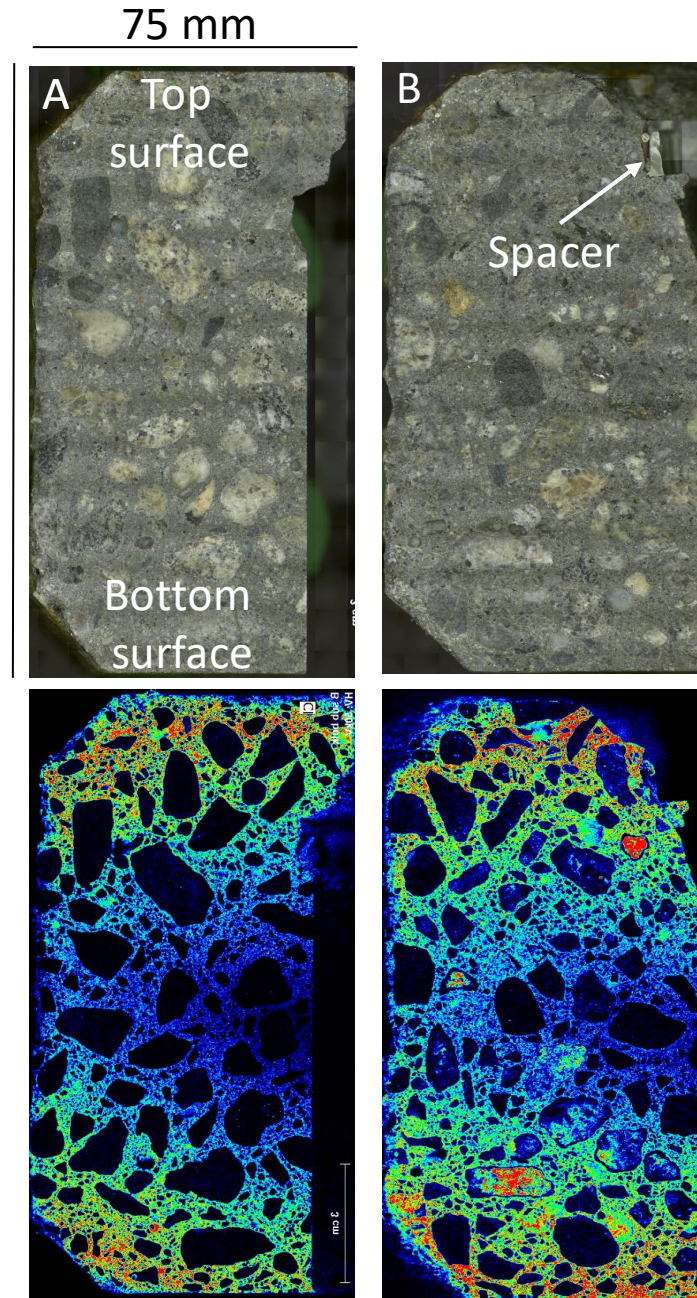
Figure 43: Chloride ingress in concrete Beam B at a spacer in the submerged zone (location 270 mm, Line 4). A: reference slice 3 cm from the spacer, B: slice cut through the middle of the spacer

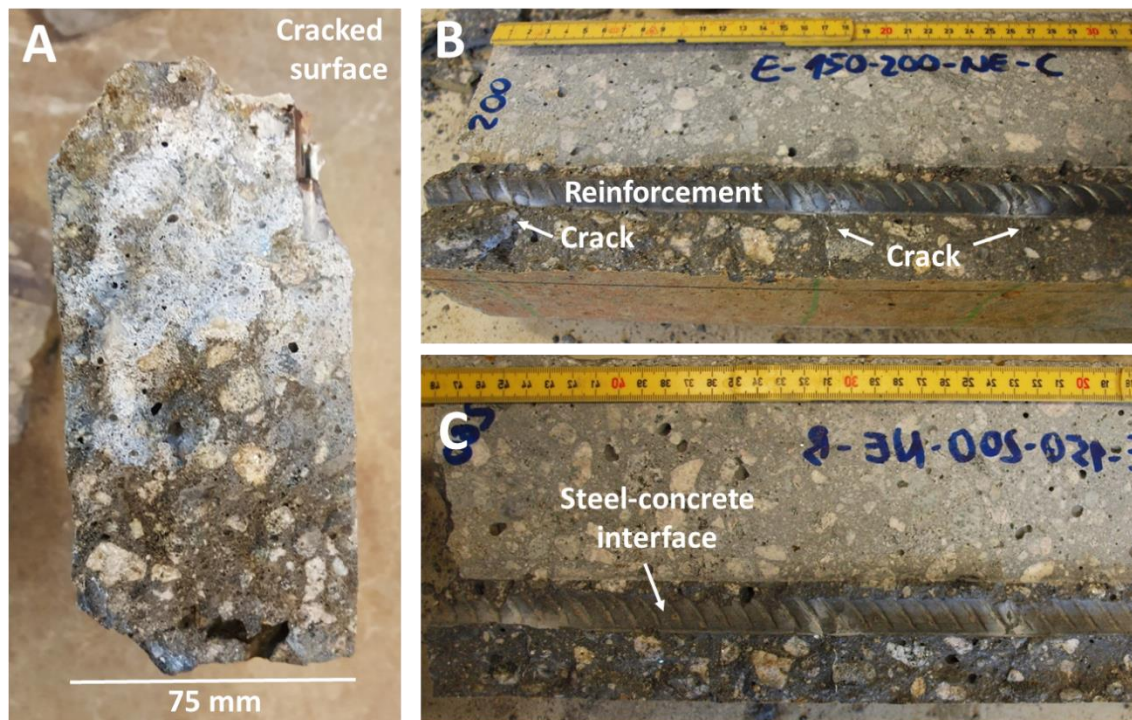
Figure 44: A: White precipitate on crack surface from Beam B, crack located at 100 cm (sample split along the crack); B and C: Beam E, white precipitate on the reinforcement and at the steel-concrete interface (after removing reinforcement) near cracks, section 150-200 cm

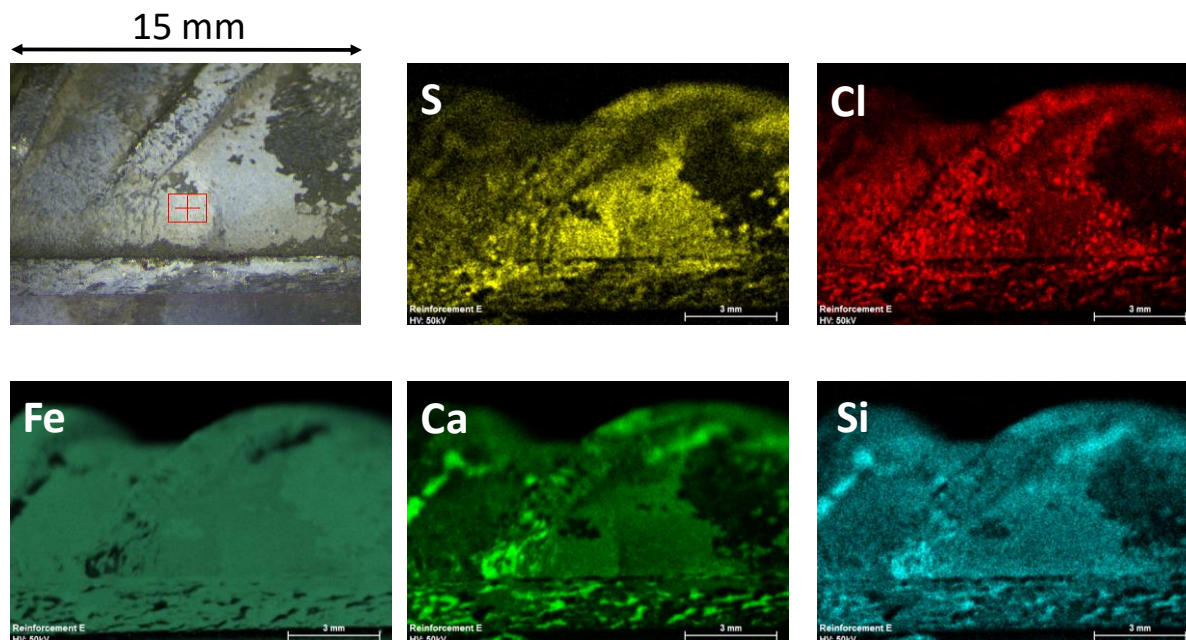
Figure 45: μ -XRF map of white precipitate found on the surface of the reinforcement near a crack of Beam E at around 180 cm. Red square in the upper left picture indicates the focus point of the X-ray beam

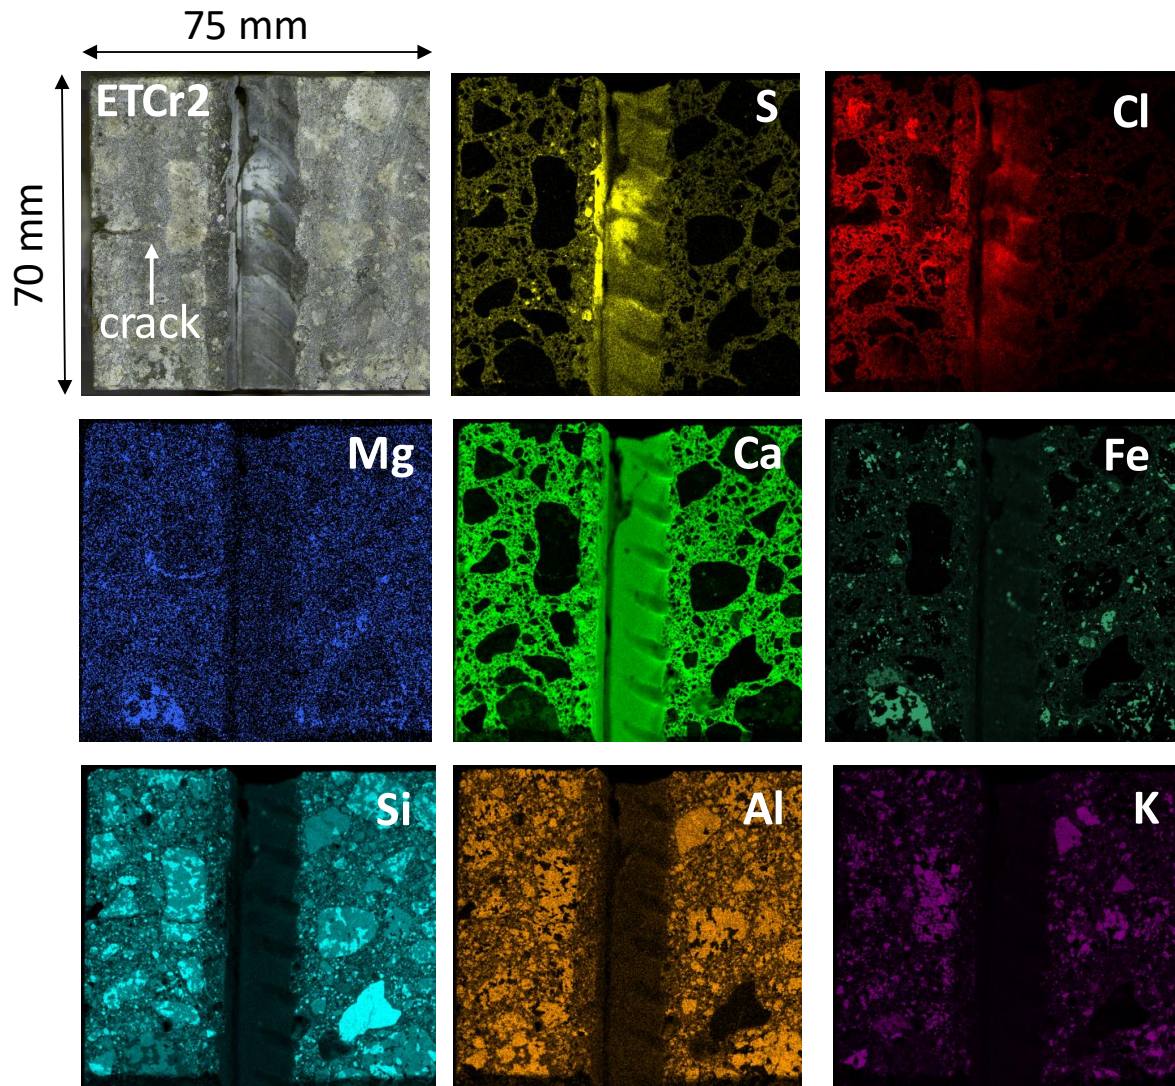
Figure 46: Overview picture of the mapped area of core ETCr2 containing both a crack and reinforcement, and elemental mapping of S, Cl, Mg, Ca, Fe, Si, Al and K

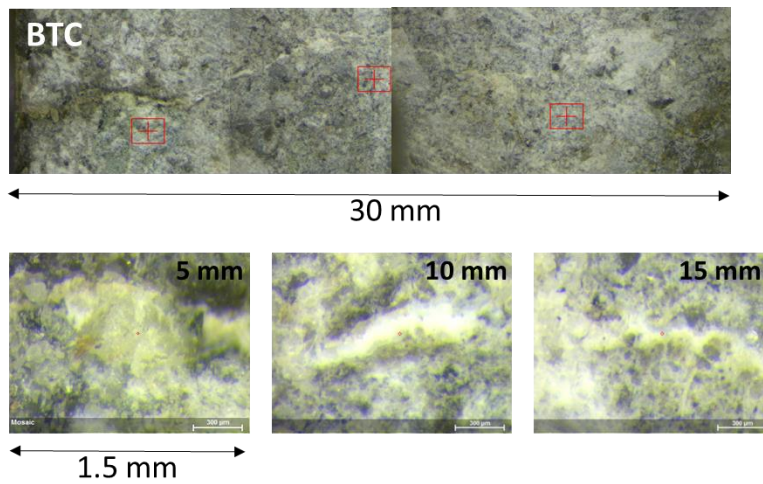
Figure 47: Crack in core BTC. Overview of crack (upper part; 10x magnification) and crack pictures at selected crack depths (lower part; 100x magnification). (The red squares indicate the potential position of the X-ray beam in case of point analysis and is not relevant here)

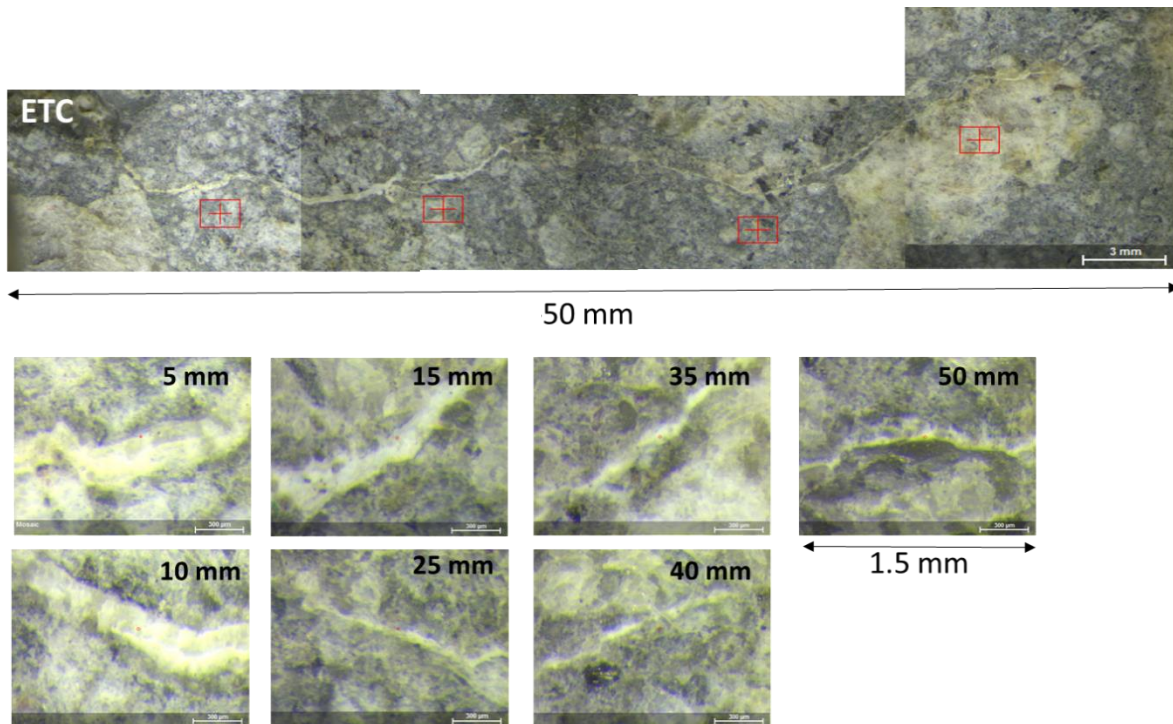
Figure 48: Crack in core ETC. Overview of crack (upper part; 10x magnification) and crack pictures at selected crack depths (lower part; 100x magnification). (The red squares indicate the potential position of the X-ray beam in case of point analysis and is not relevant here)

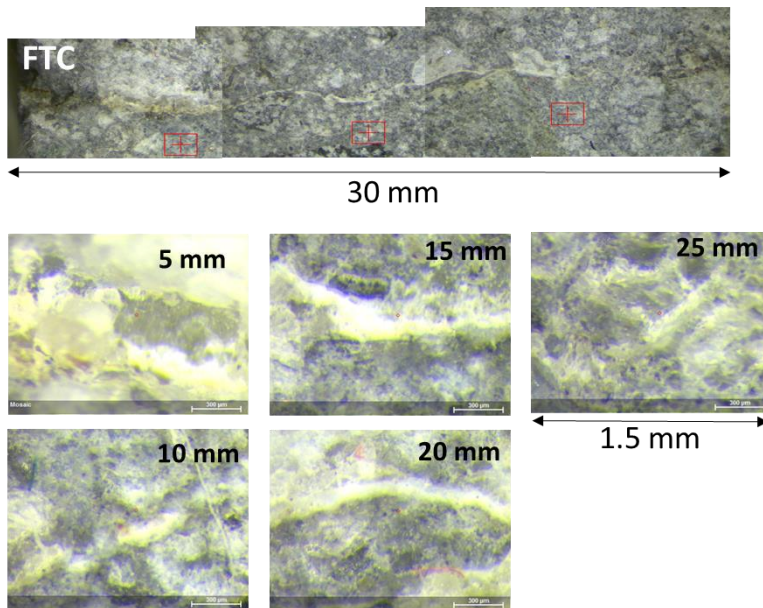
Figure 49: Crack in core FTC. Overview of crack (upper part; 10x magnification) and crack pictures at selected crack depths (lower part; 100x magnification). (The red squares indicate the potential position of the X-ray beam in case of point analysis and is not relevant here)

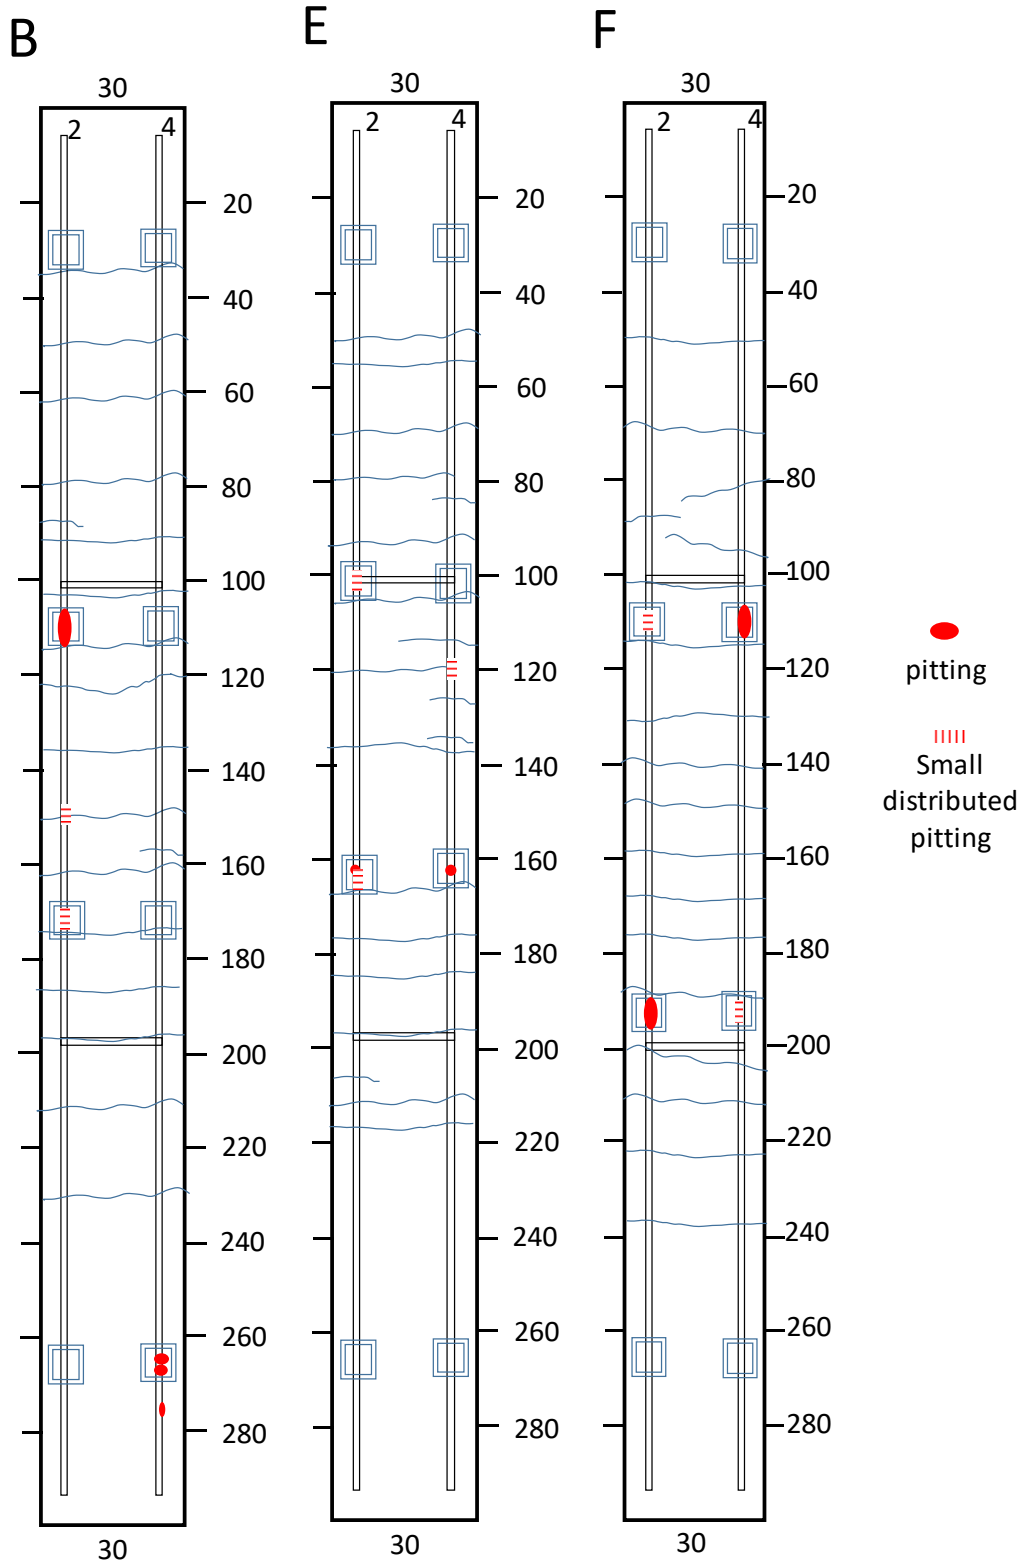
Figure 51: Corrosion maps of Beam B, Beam E and Beam F with scale in cm. (Note: different orientation of Beam F on the ferry quay; Line 2 directed towards ferry quay, see Figure 7)

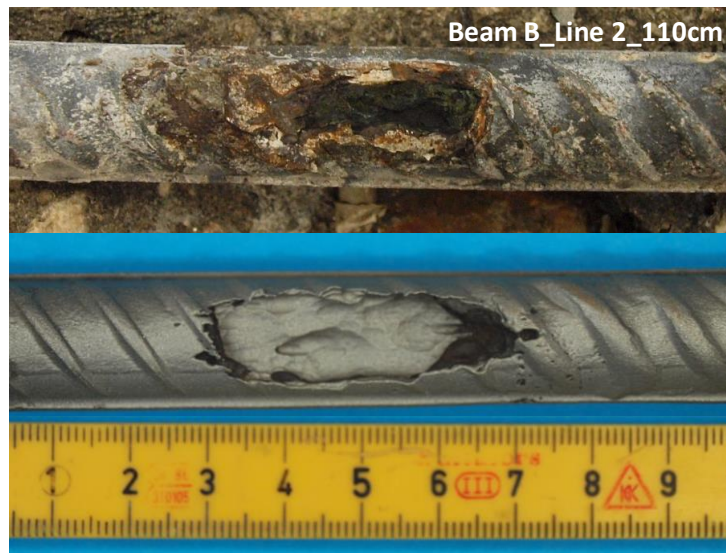
Figure 52: Severe pitting corrosion at a spacer in the tidal zone of Beam B. Location at around 110 cm at Line 2

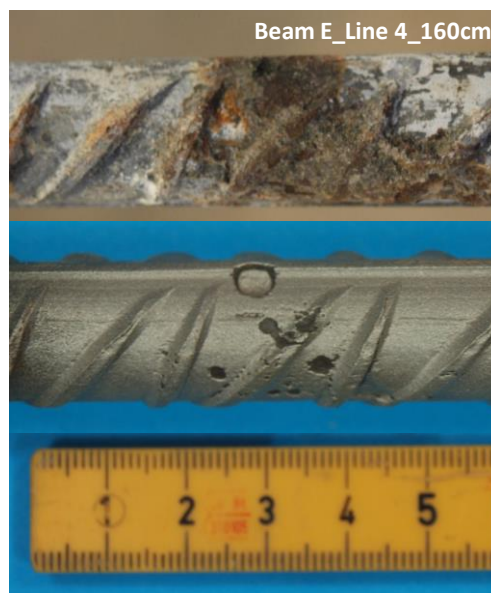
Figure 53: Distributed pitting at a spacer in the tidal zone of Beam E. Location at around 160 cm at Line 2

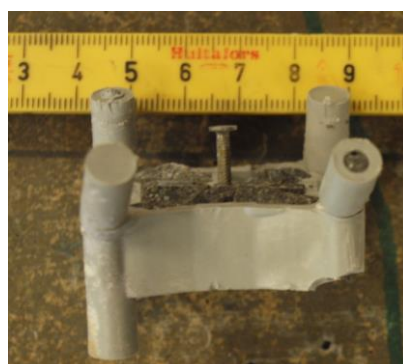
legs towards both formwork and reinforcement (Figure 54). The spacers appear to have been fixed to the formwork with a metal nail positioned in the centre of the spacer (Figure 54) or through one of the legs (Appendix 4). An apparent imprint of the head of such a nail was observed on one rebar indicating galvanic corrosion of the rebar (Figure 53). It is hypothesized that more severe corrosion at other spacers was initiated by galvanic corrosion. Sustained corrosion development might have been supported by more rapid ingress of aggressive substances in the vicinity of the plastic spacer [31] and later by spalling of the concrete cover. Visual inspection of the concrete confined in a spacer showed a paste rich, but well compacted concrete (see Appendix 10).

Figure 54: Representative plastic spacer removed from Beam B showing a nail in the middle with potential contact to the reinforcement steel

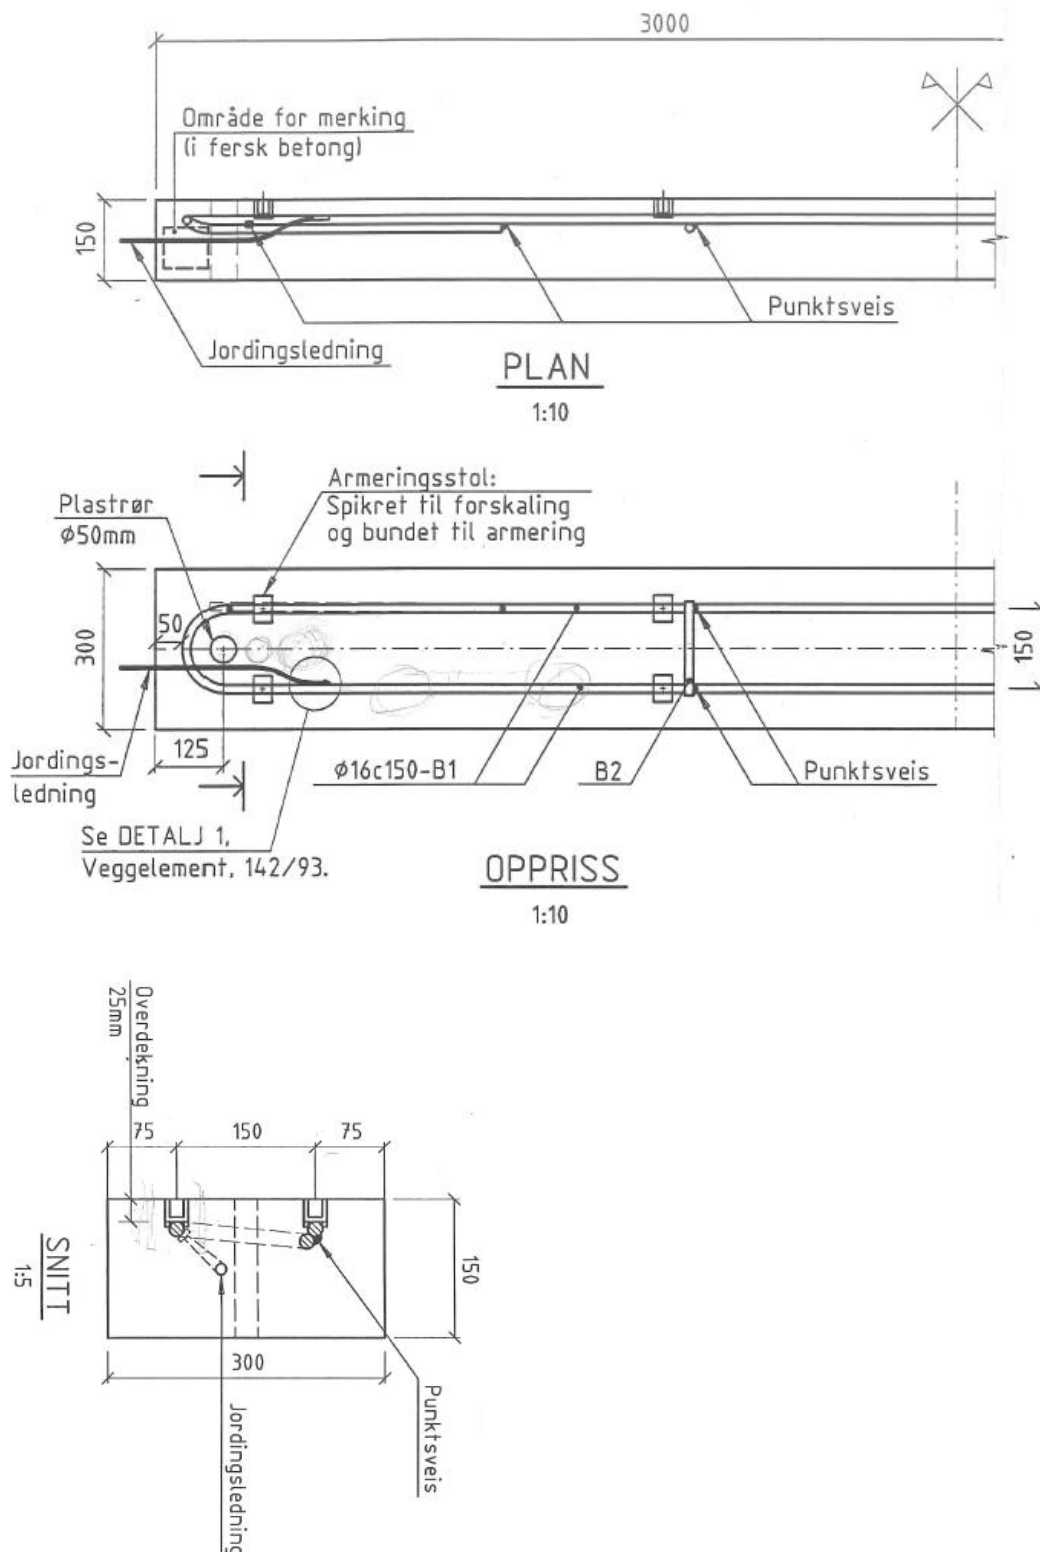
Figure 1: Constructional drawing of the concrete beams. From Holtmon J.P. & Isaksen H.R., "Utvikling av kloridbestandig betong - Rapport fra produksjon av prøveelementer", Vegdirektoratet, Bruavdeling, 1994

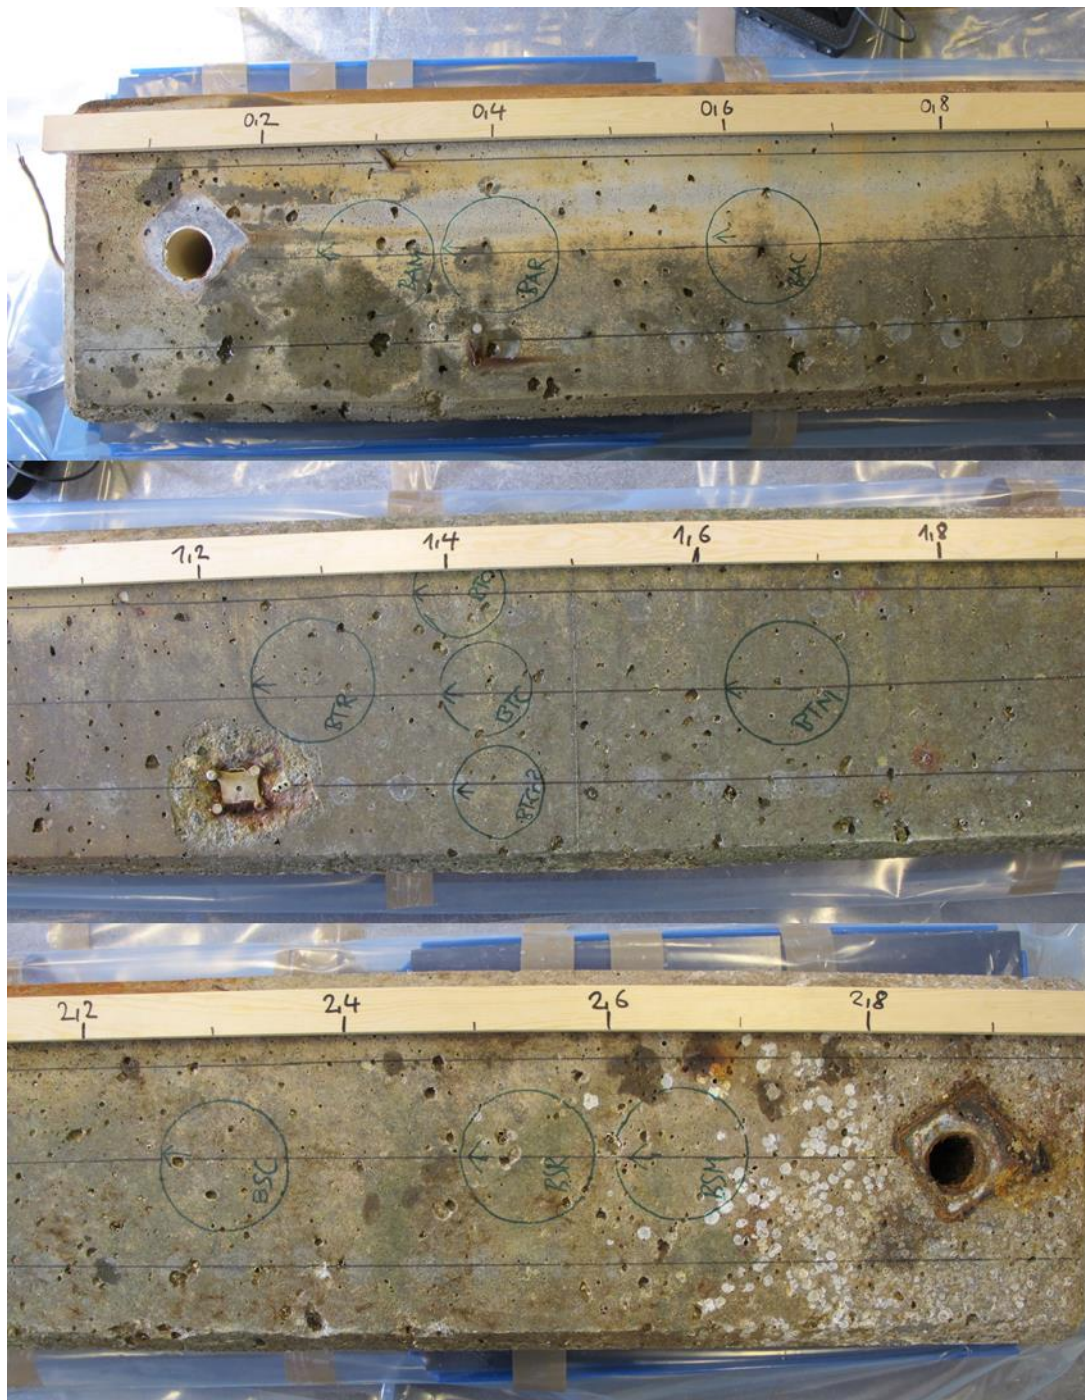
Figure 2: Location of concrete cores taken from Beam B, distance in meters (Photos: Eva Rodum)

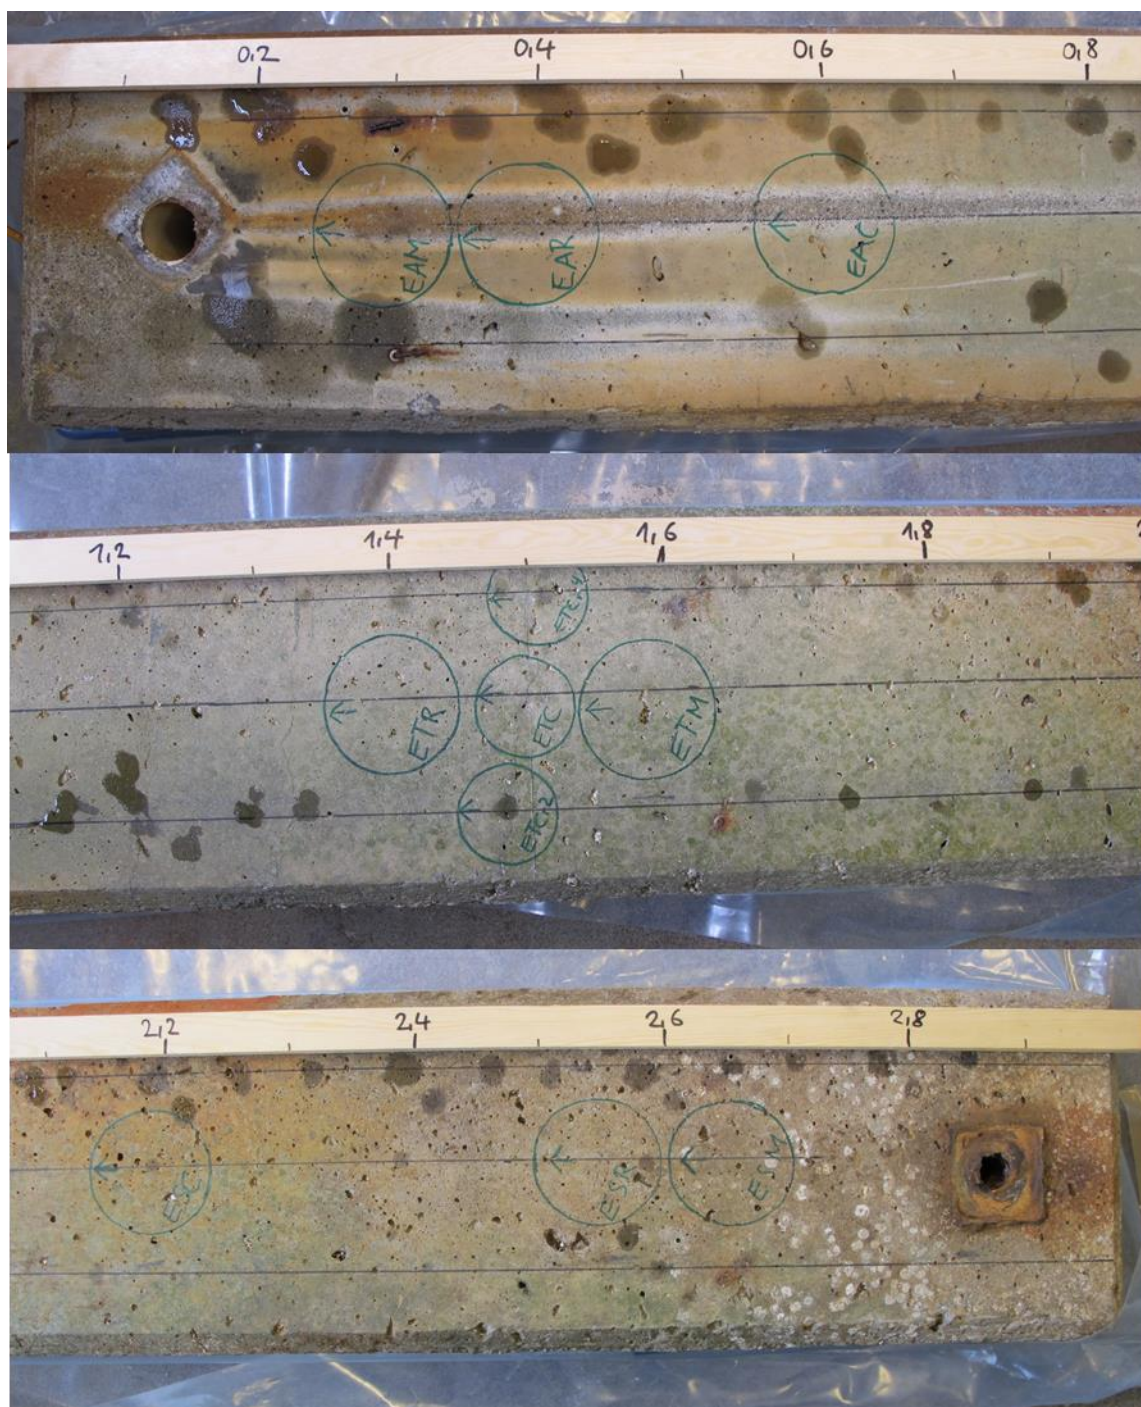
Figure 3: Location of concrete cores taken from Beam E, distance in meters (Photos: Eva Rodum)

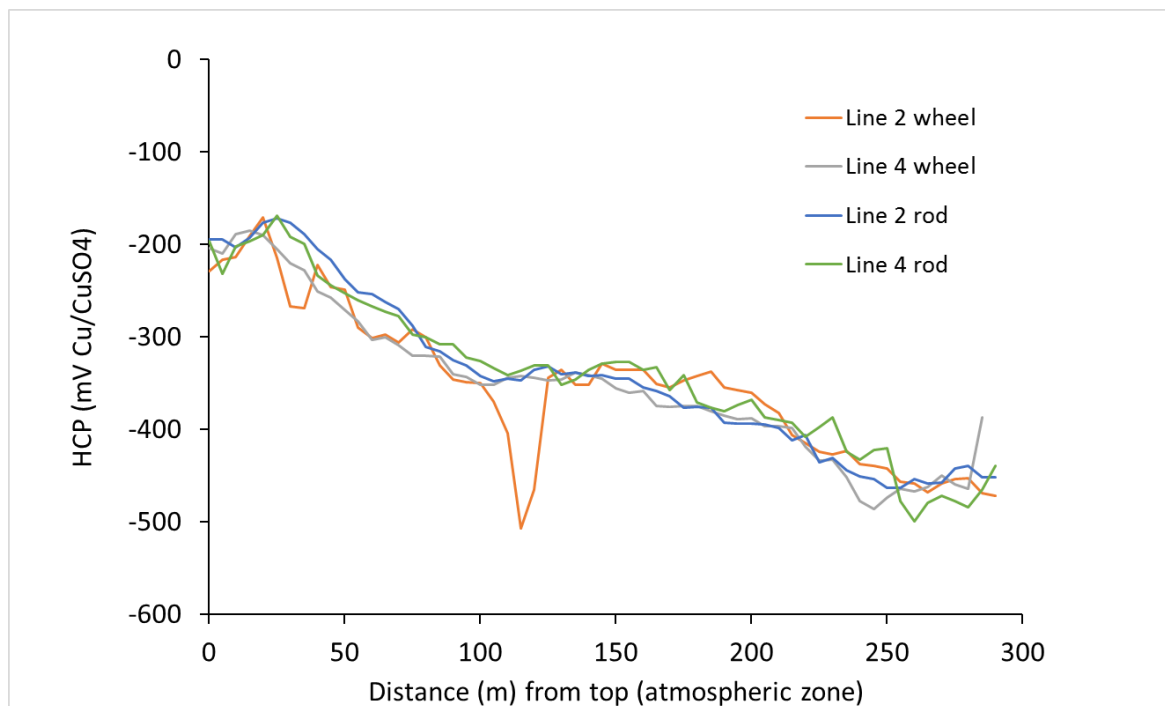
Figure 8: Comparison of half-cell potential (HCP) measured with the wheel and rod electrode along Line 2 and Line 4 on Beam B

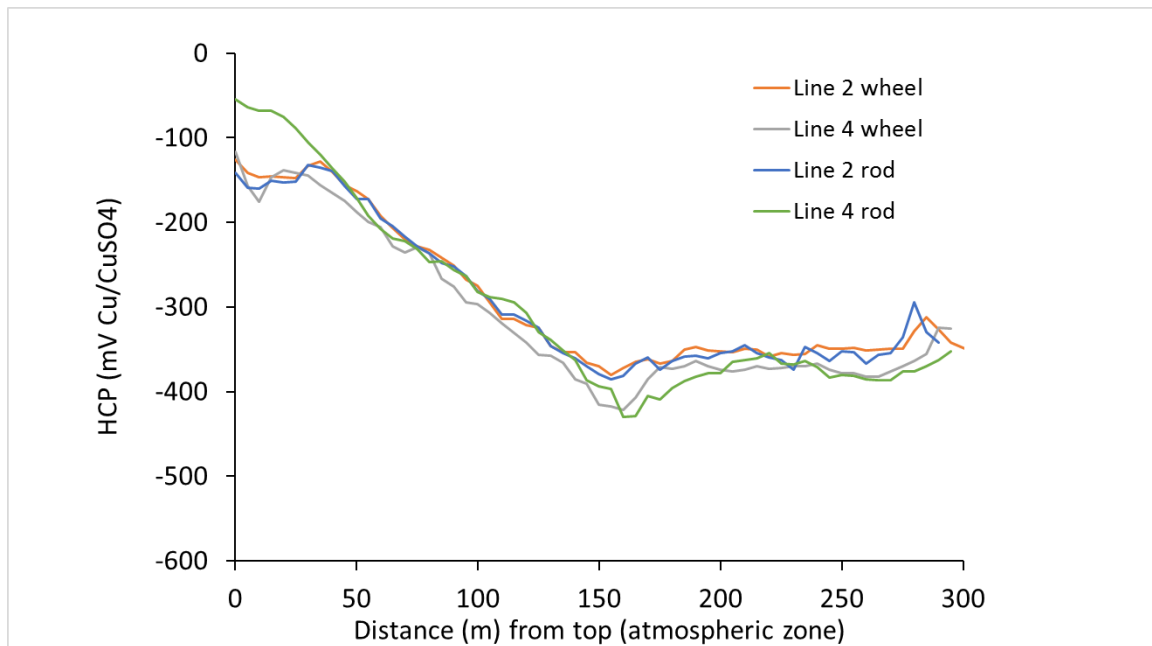
Figure 9: Comparison of half-cell potential (HCP) measured with the wheel and rod electrode along Line 2 and Line 4 on Beam E

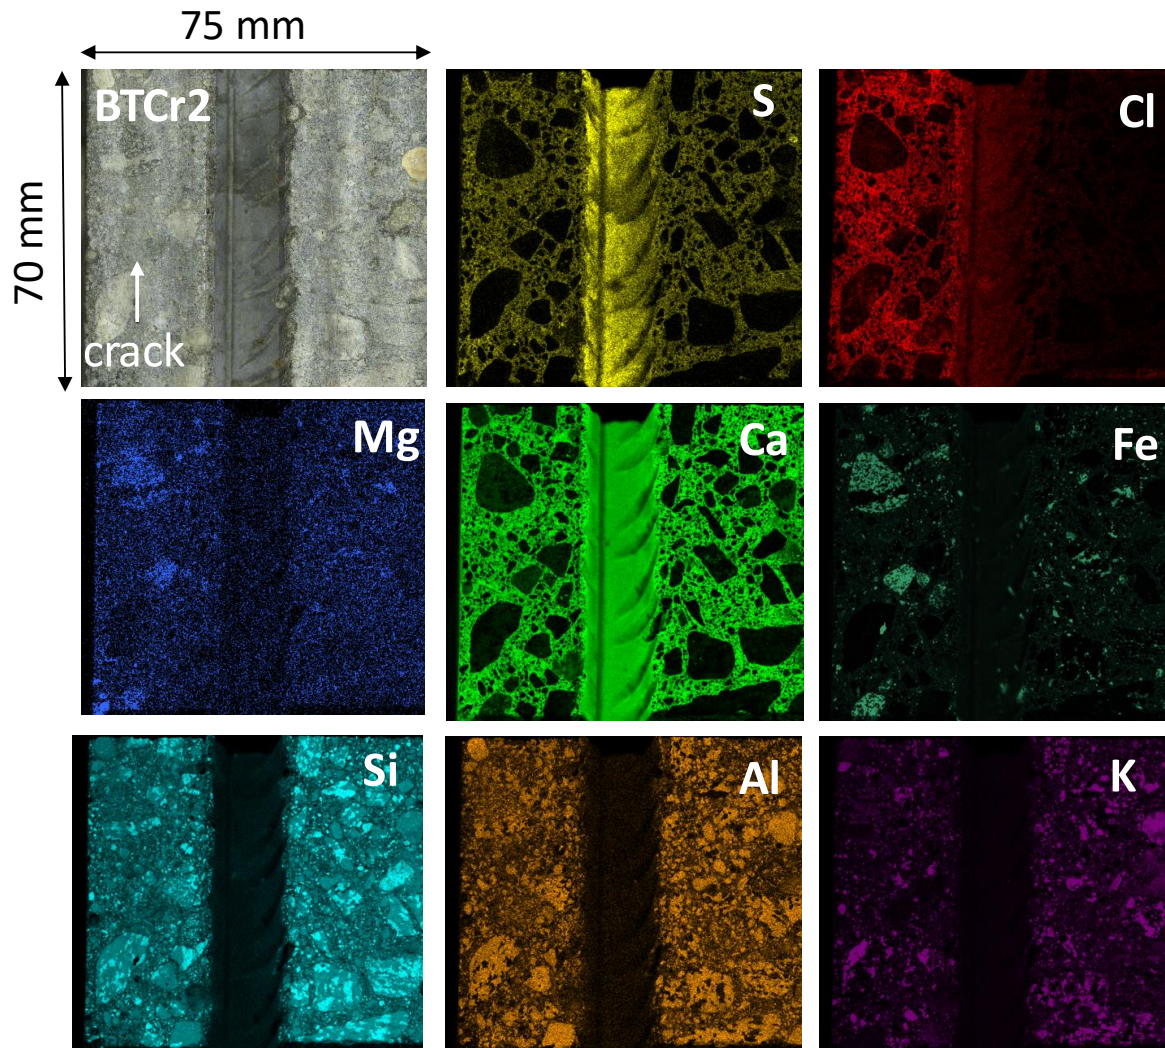
Figure 17: μ -XRF elemental mapping (S, Cl, Mg, Ca, Fe, Si, Al and K) of core BTCr2

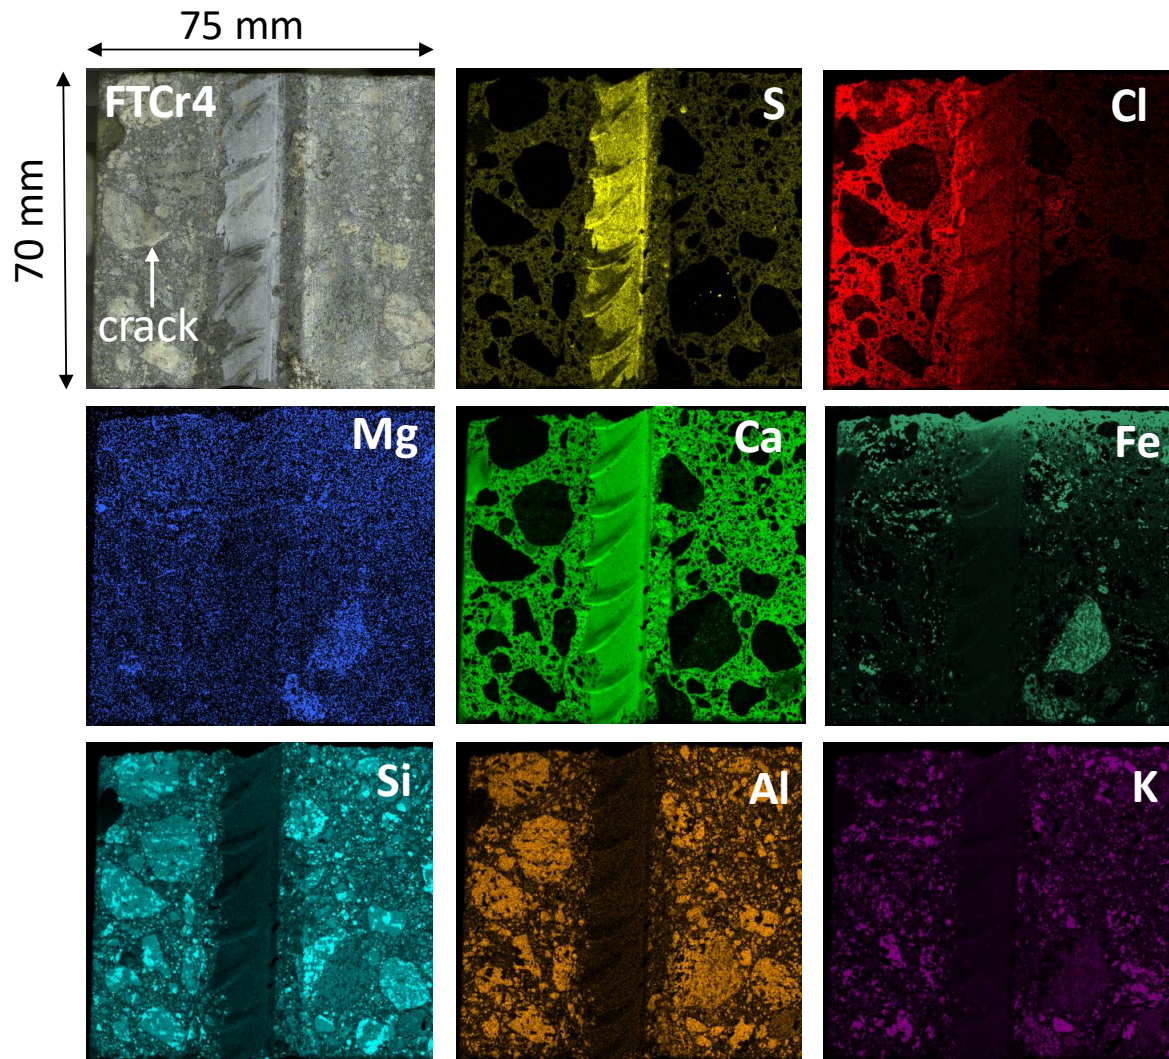
Figure 21: μ -XRF elemental mapping (S, Cl, Mg, Ca, Fe, Si, Al and K) of core FTCr4

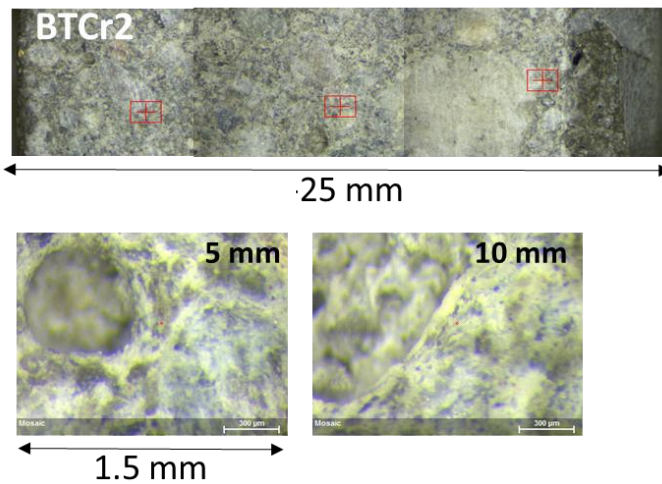
Figure 23: Overview picture and detailed pictures at different crack depth of the crack in core BTCr2

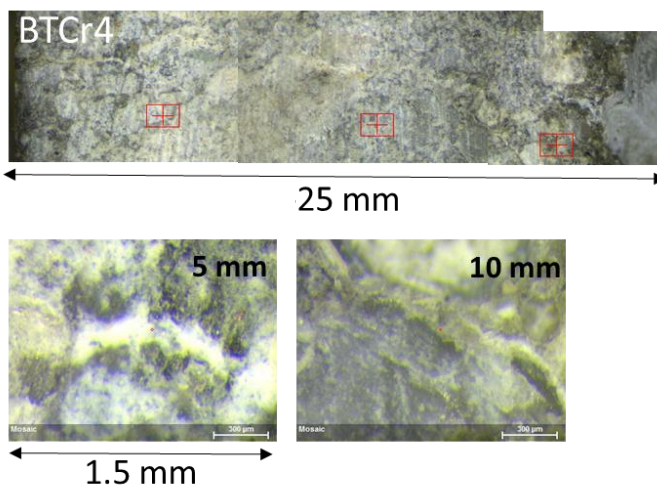
Figure 24: Overview picture and detailed pictures at different crack depth of the crack in core BTCr4

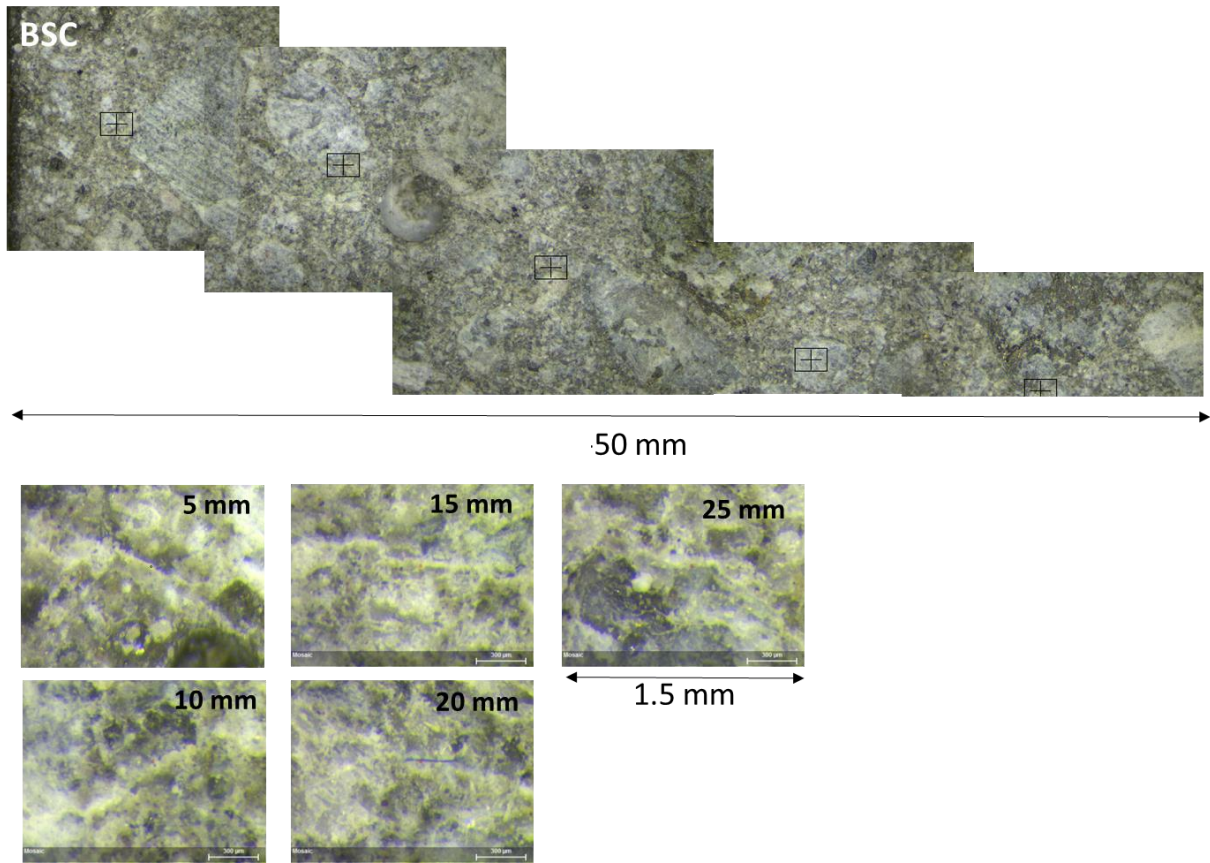
Figure 25: Overview picture and detailed pictures at different crack depth of the crack in core BSC

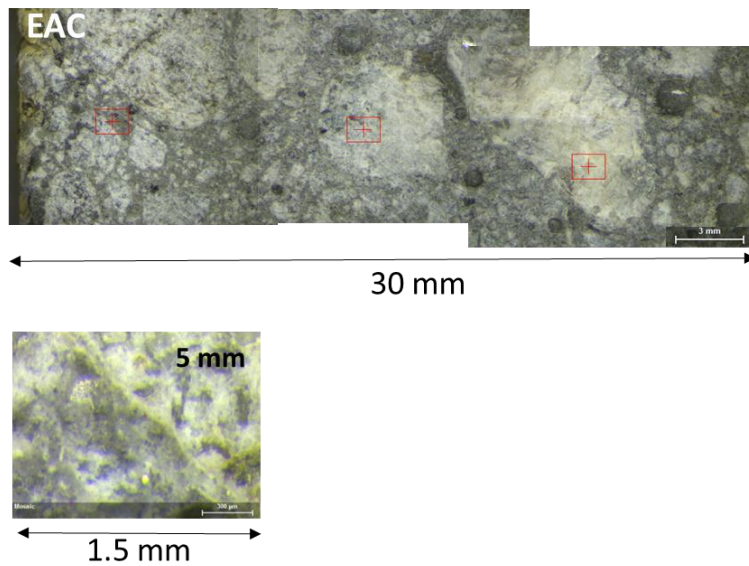
Figure 26: Overview picture and detailed pictures at different crack depth of the crack in core EAC

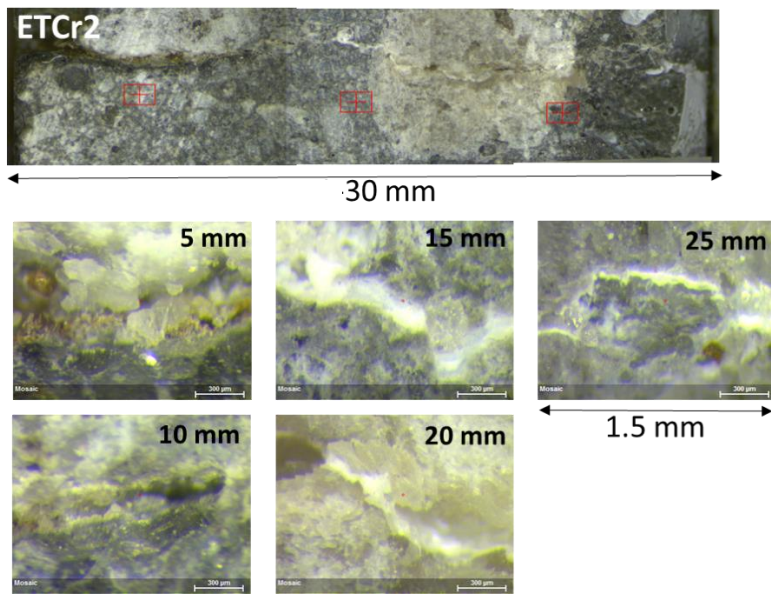
Figure 27: Overview picture and detailed pictures at different crack depth of the crack in core ETCr2

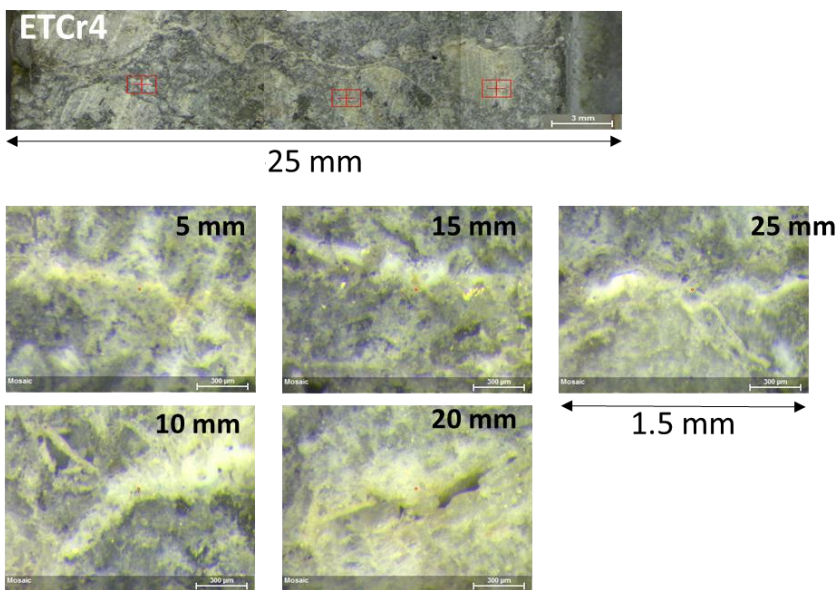
Figure 28: Overview picture and detailed pictures at different crack depth of the crack in core ETCr4
