Effect of cracks in concrete after 25 years - Data report

STATENS VEGVESENS RAPPORTER

Nr. 374

Tobias Danner, Andres Belda Revert, Mette Rica Geiker (NTNU)

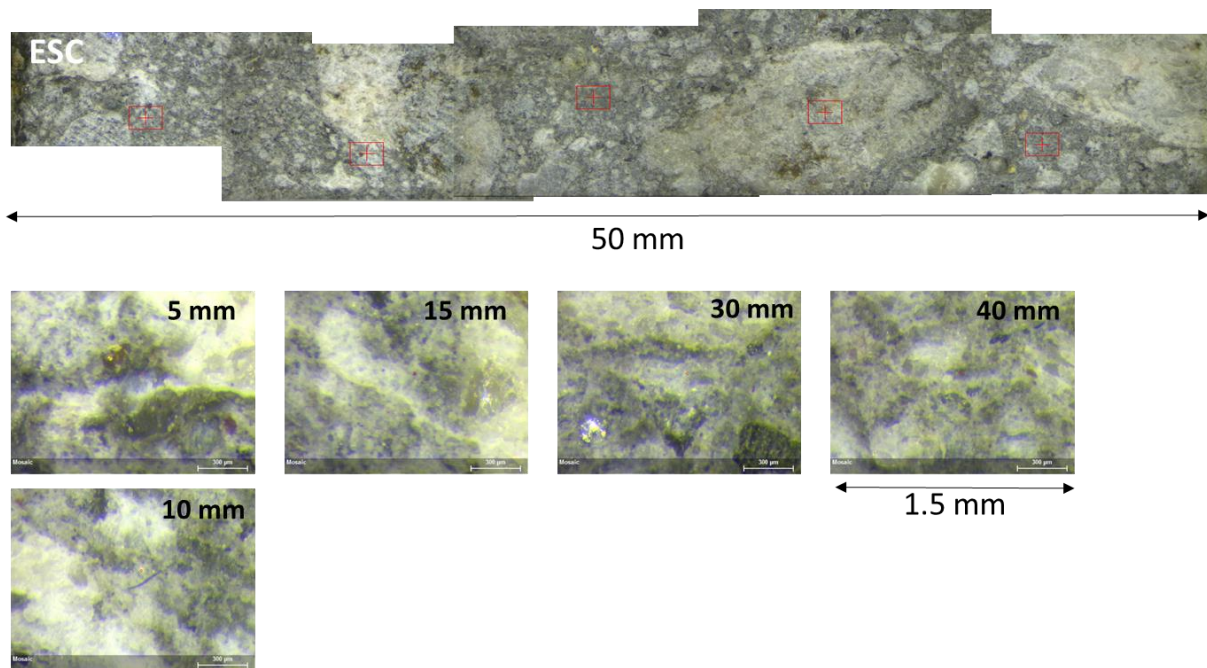
Figure 29: Overview picture and detailed pictures at different crack depth of the crack in core ESC

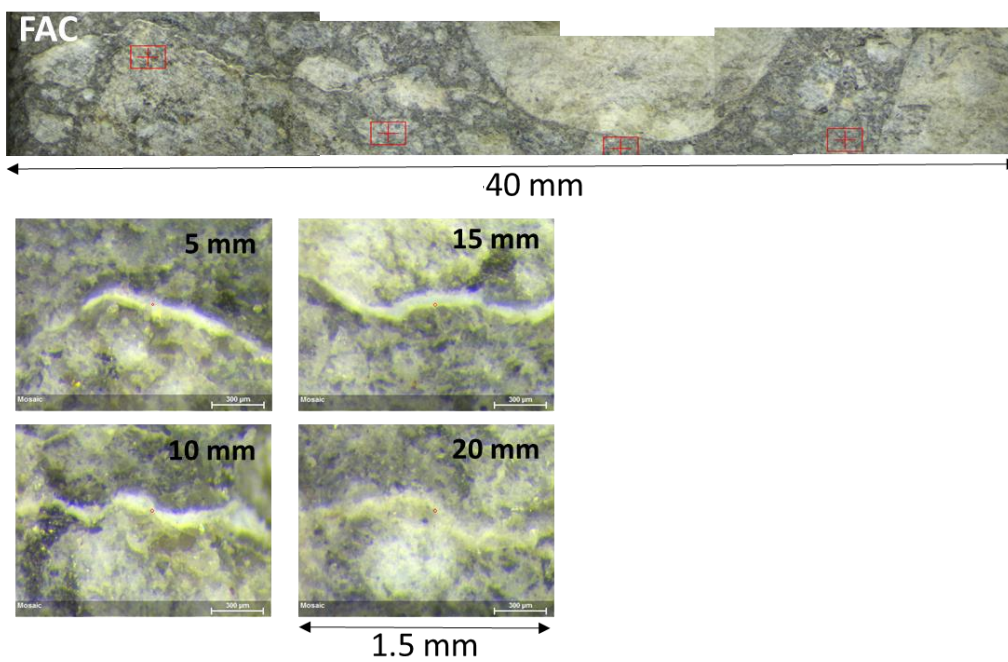
Figure 30: Overview picture and detailed pictures at different crack depth of the crack in core FAC

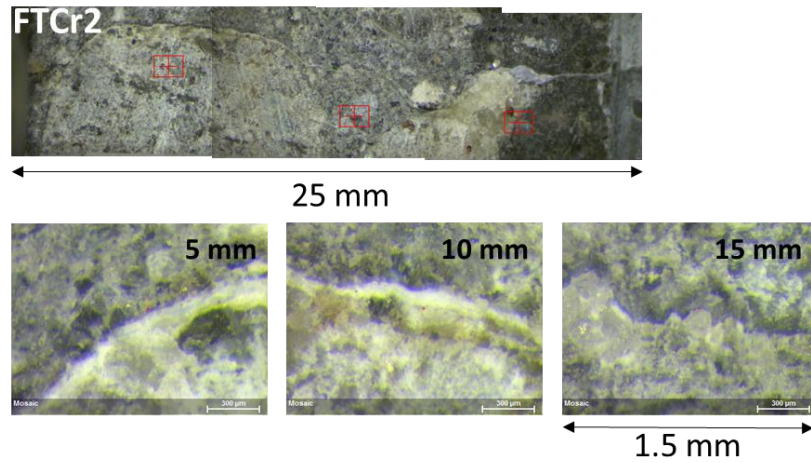
Figure 31: Overview picture and detailed pictures at different crack depth of the crack in core FTCr2

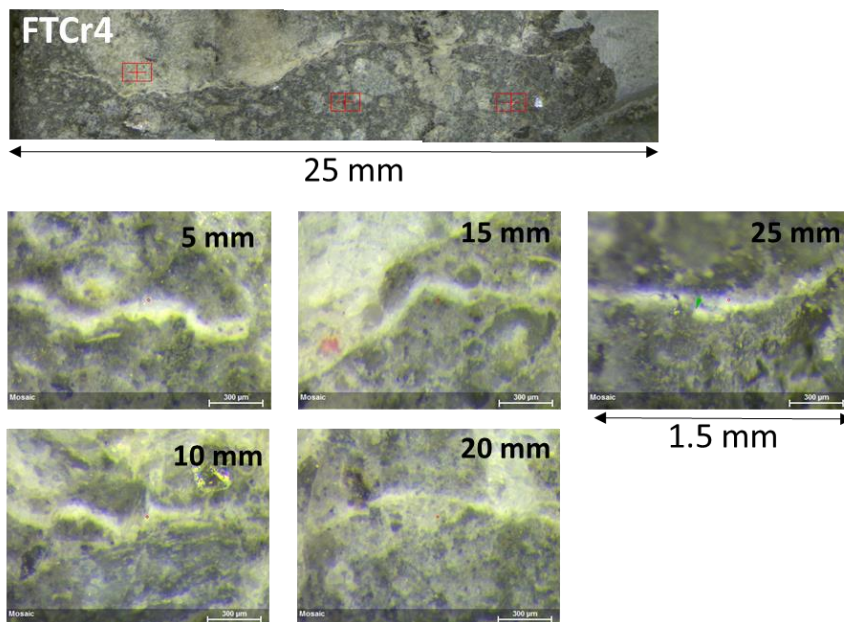
Figure 32: Overview picture and detailed pictures at different crack depth of the crack in core FTCr4

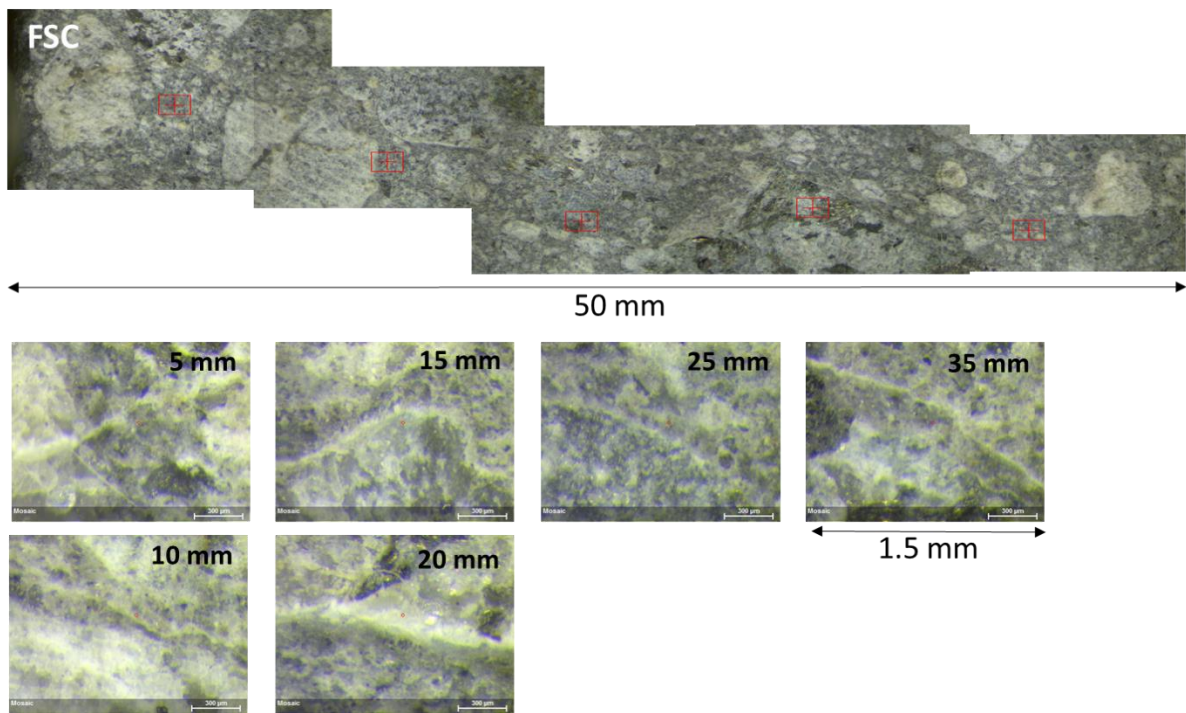
Figure 33: Overview picture and detailed pictures at different crack depth of the crack in core FSC

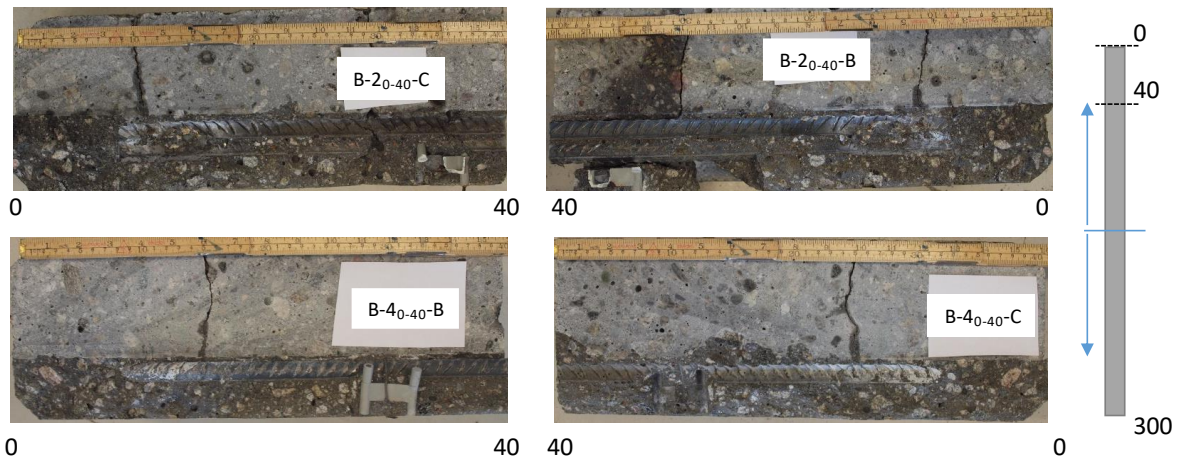
Figure 35: Steel-concrete interface of beam B section 0 to 40 cm. The large visible crack was due to the mounting of the pair of concrete beams. Near the crack white precipitate was observed at the steel-concrete interface

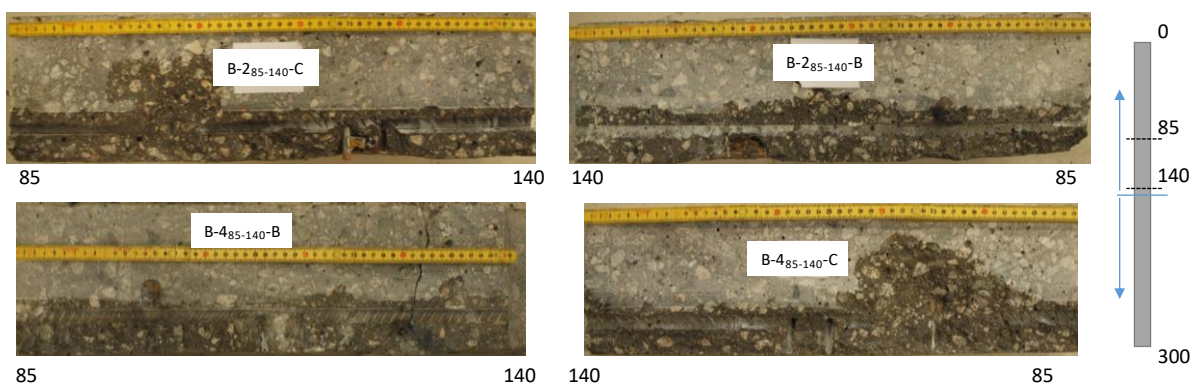
Figure 37: Steel-concrete interface of beam B section 85 to 140 cm. White precipitate at the steel-concrete interface near cracks. Localized corrosion at the spacer

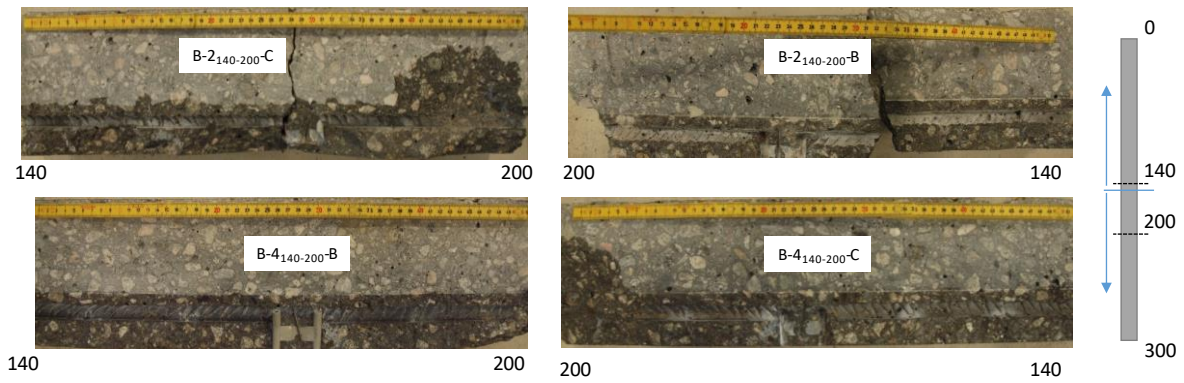
Figure 38: Steel-concrete interface of beam B section 140 to 200 cm. White precipitate at the cracks and spread over the steel-concrete interface. Localized corrosion at the spacer

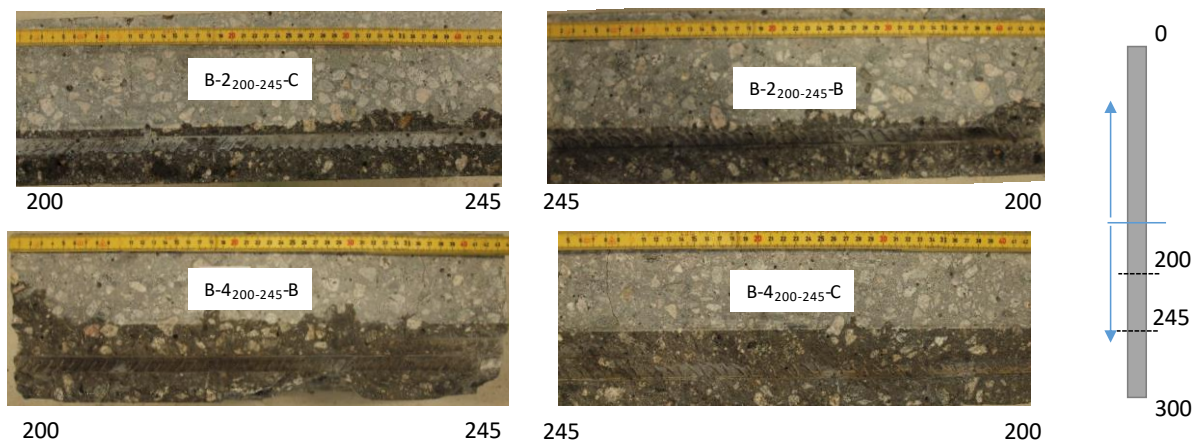
Figure 39: Steel-concrete interface of beam B section 200 to 245 cm. White precipitate at the cracks and spread over the steel-concrete interface

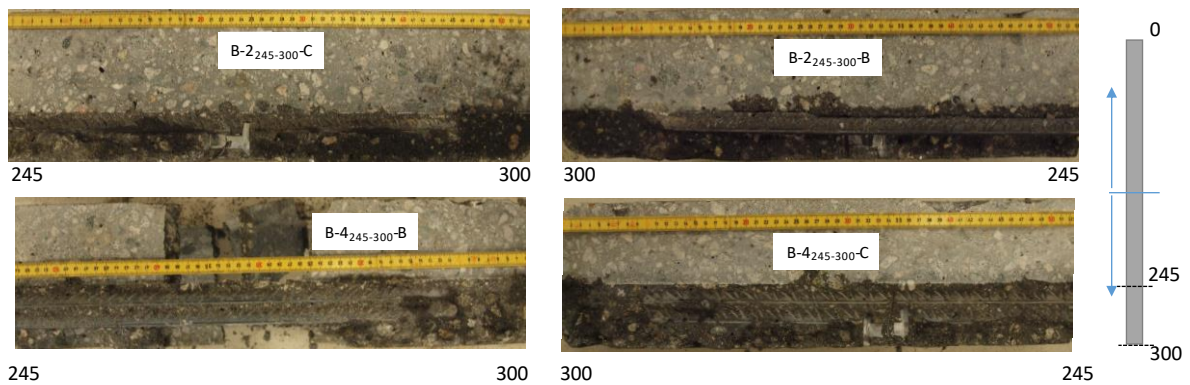
Figure 40: Steel-concrete interface of beam B section 245 to 300 cm. Localized corrosion at the spacer and distributed pitting 10 cm away from spacer

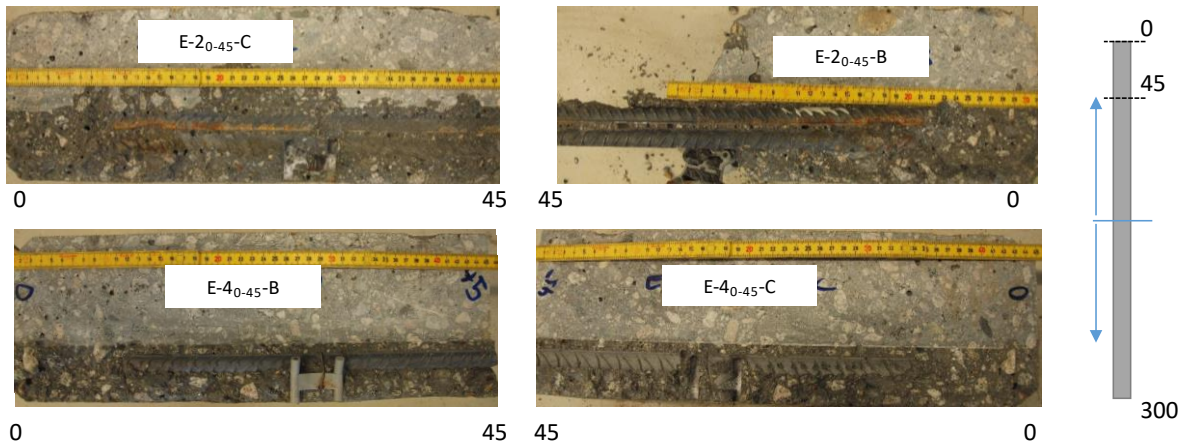
Figure 41: Steel-concrete interface of beam E section 0 to 45 cm. Superficial rust.

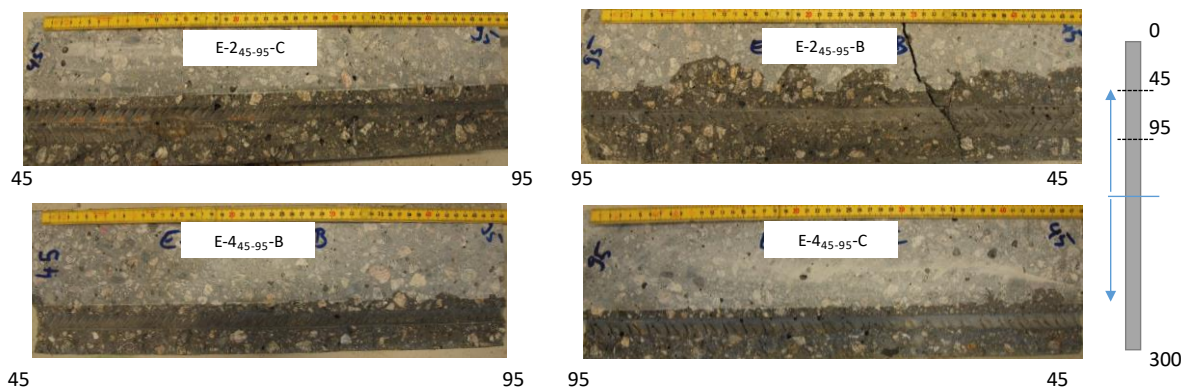
Figure 42: Steel-concrete interface of beam E section 45 to 95 cm. White precipitate at the cracks and spread over the steel-concrete interface. Superficial rust

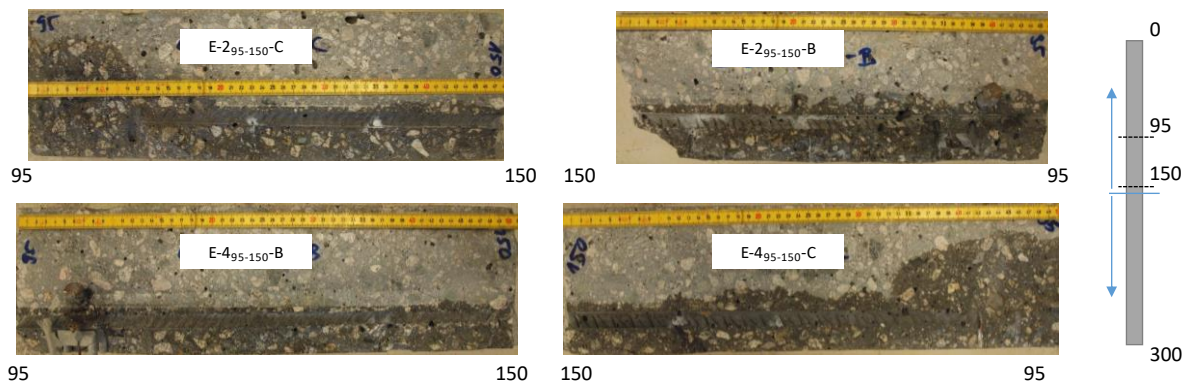
Figure 43: Steel-concrete interface of beam E section 95 to 150 cm. White precipitate at the cracks and spread over the steel-concrete interface. Localized corrosion at the spacer and a crack

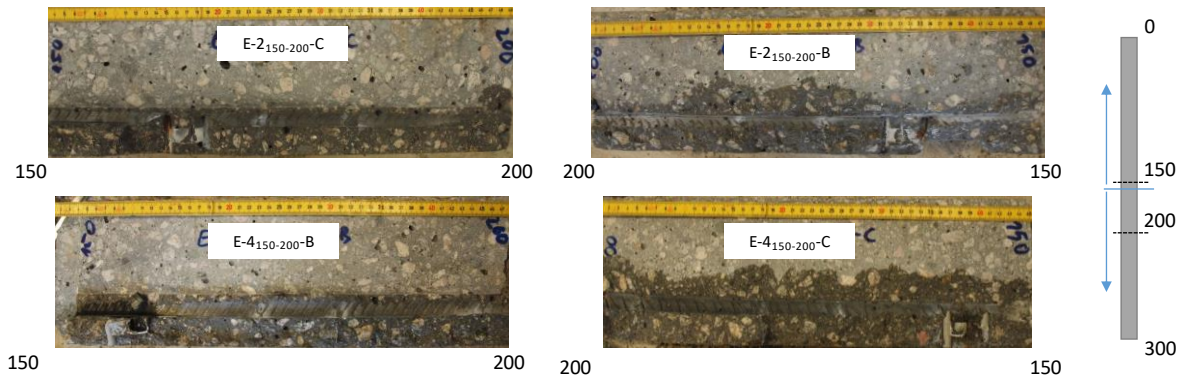
Figure 44: Steel-concrete interface of beam E section 150 to 200 cm. White precipitate at the cracks and spread over the steel-concrete interface. Localized corrosion at the spacer

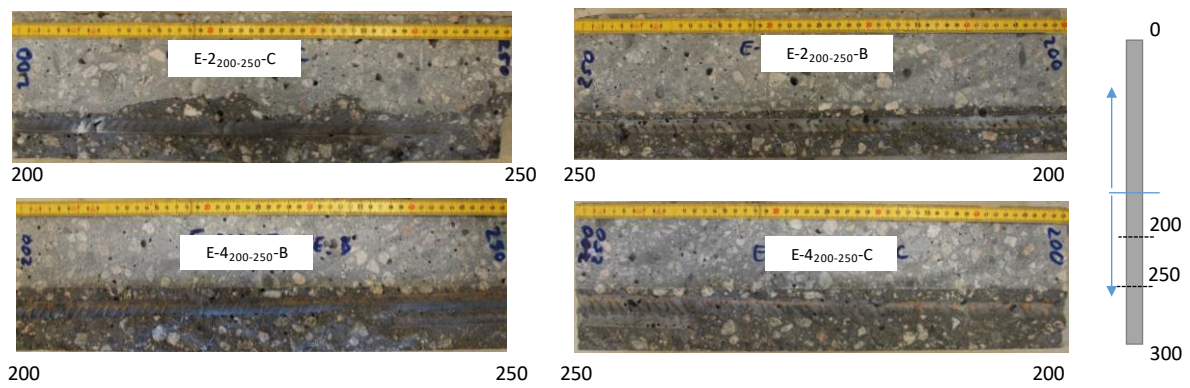
Figure 45: Steel-concrete interface of beam E section 200 to 250 cm. White precipitate at the cracks and spread over the steel-concrete interface. Superficial rust

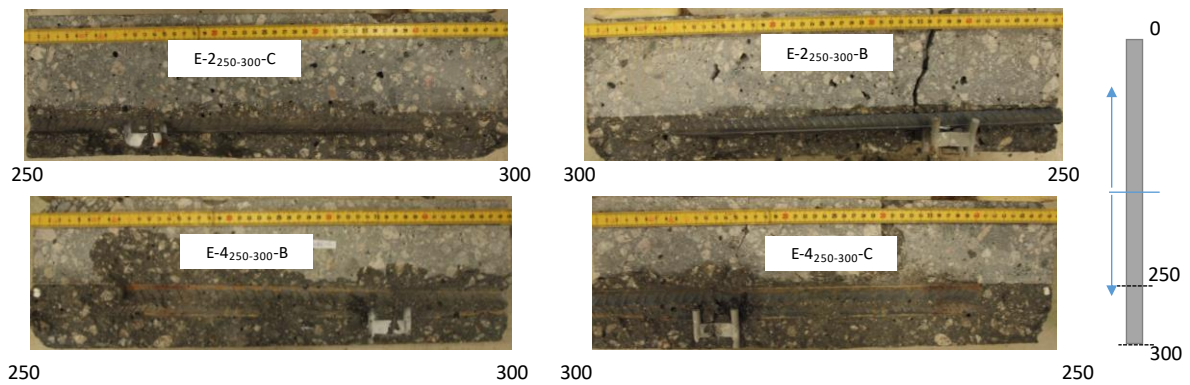
Figure 46: Steel-concrete interface of beam B section 250 to 300 cm. Superficial rust

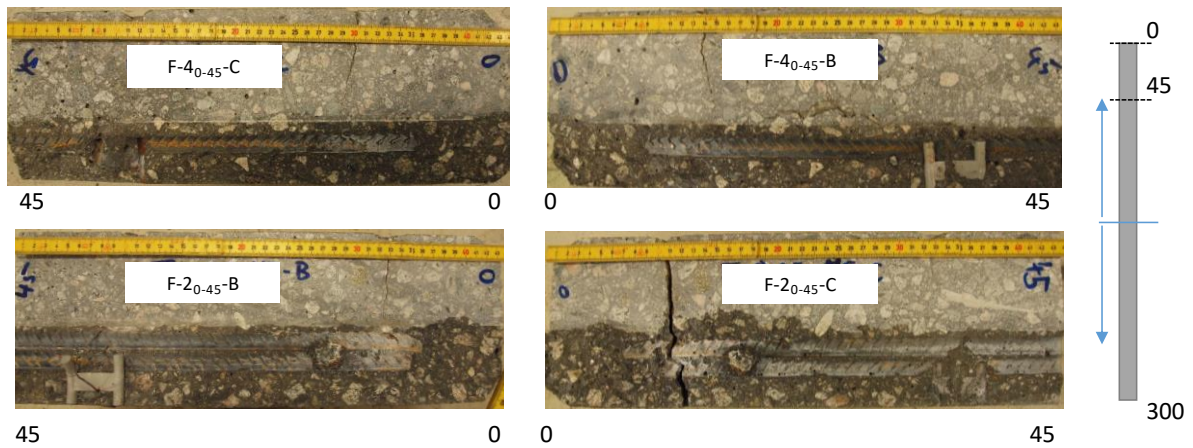
Figure 47: Steel-concrete interface of beam F section 0 to 45 cm. Crack close to the hanging-screw which presented white precipitate and spread on steel-concrete interface. Superficial rust

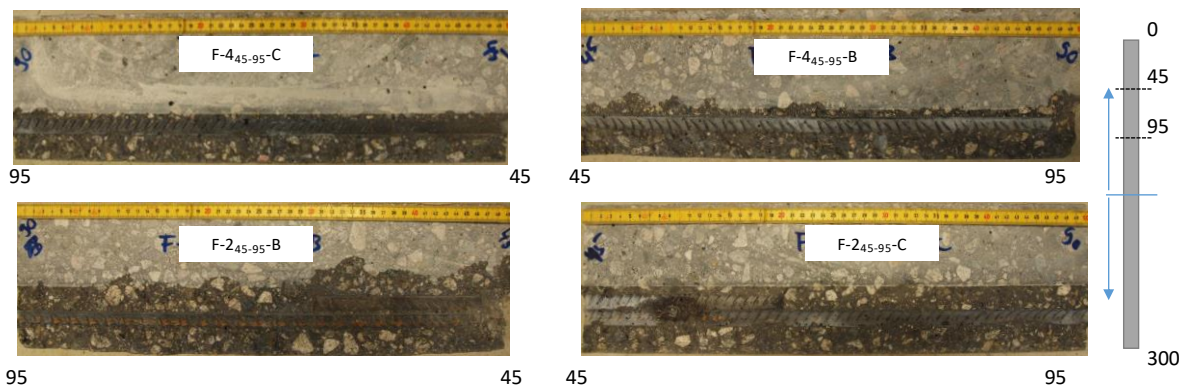
Figure 48: Steel-concrete interface of beam F section 40 to 95 cm White precipitate at the cracks and spread over the steel-concrete interface. Superficial rust

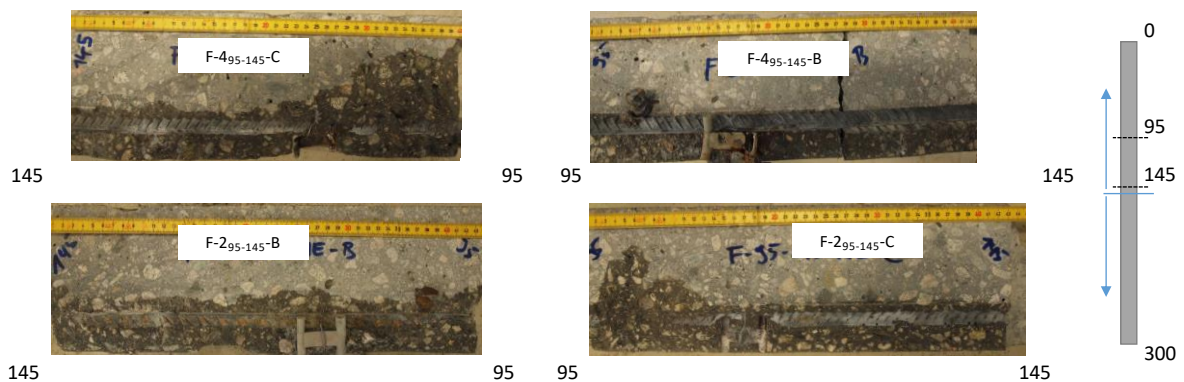
Figure 49: Steel-concrete interface of beam B section 95 to 145 cm. White precipitate at the cracks and spread over the steel-concrete interface. Superficial corrosion. Localized corrosion at the spacer

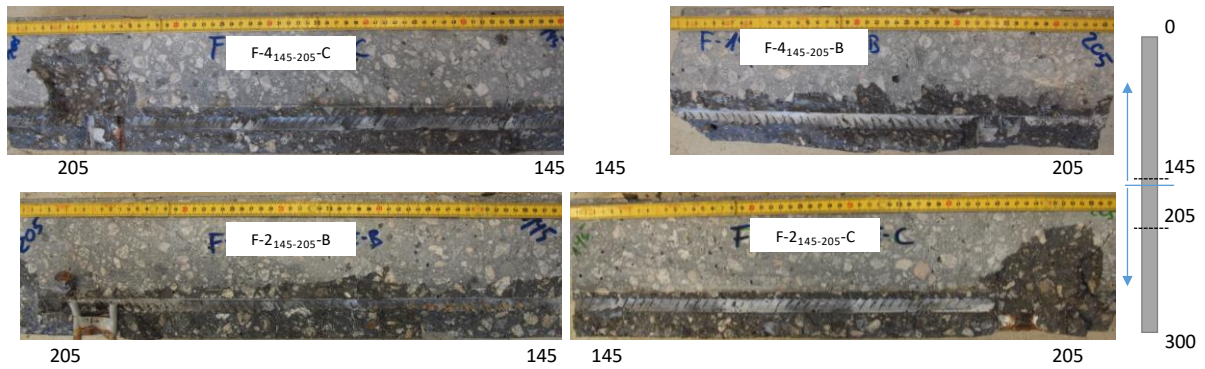
Figure 50: Steel-concrete interface of beam F section 145 to 205 cm. White precipitate at the cracks and spread over the steel-concrete interface. Localized corrosion at the spacer

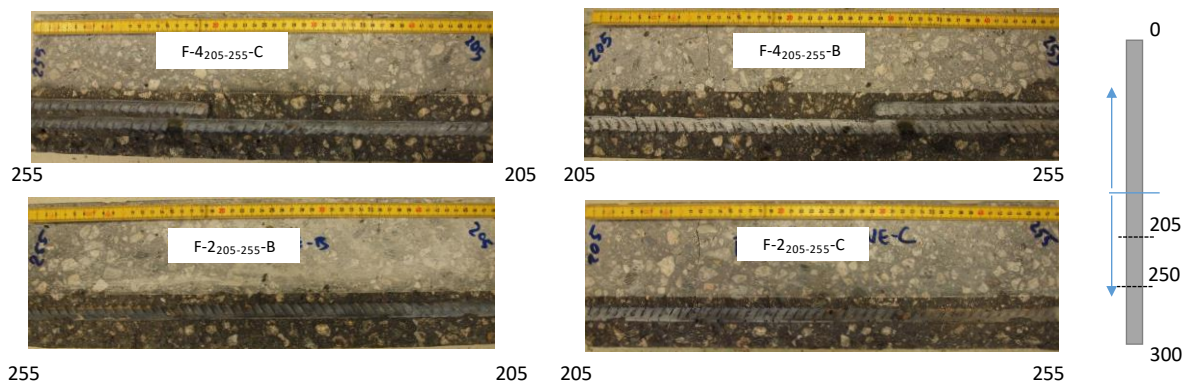
Figure 51: Steel-concrete interface of beam F section 205 to 255 cm. White precipitate at the cracks and spread over the steel-concrete interface. Superficial rust

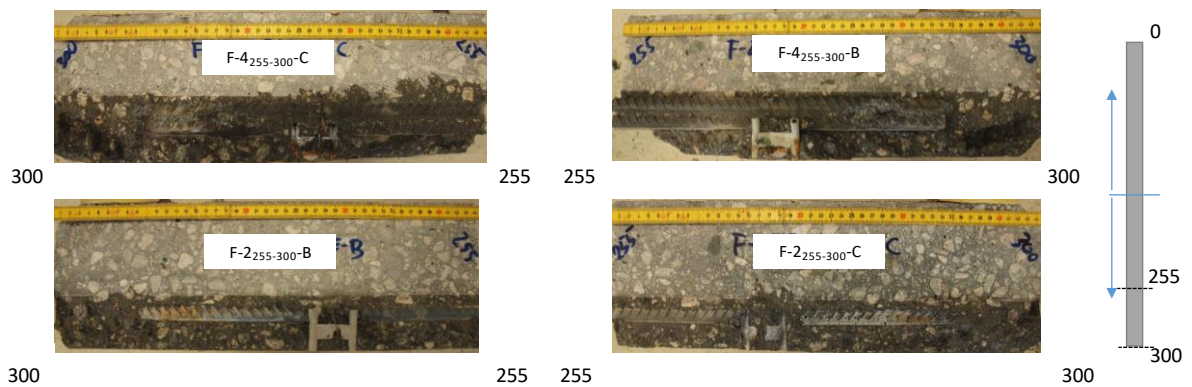
Figure 52: Steel-concrete interface of beam B section 245 to 300 cm. White precipitate at the cracks and spread over the steel-concrete interface. Superficial rust
