Evaluation of Strain Hardened Austenitic Corrosion Resistant Alloys' Susceptibility to Hydrogen Induced Stress Cracking (HISC)

Master's thesis in Materials science and engineering

Norwegian University of Science and Technology
Faculty of Engineering
Department of Mechanical and Industrial Engineering

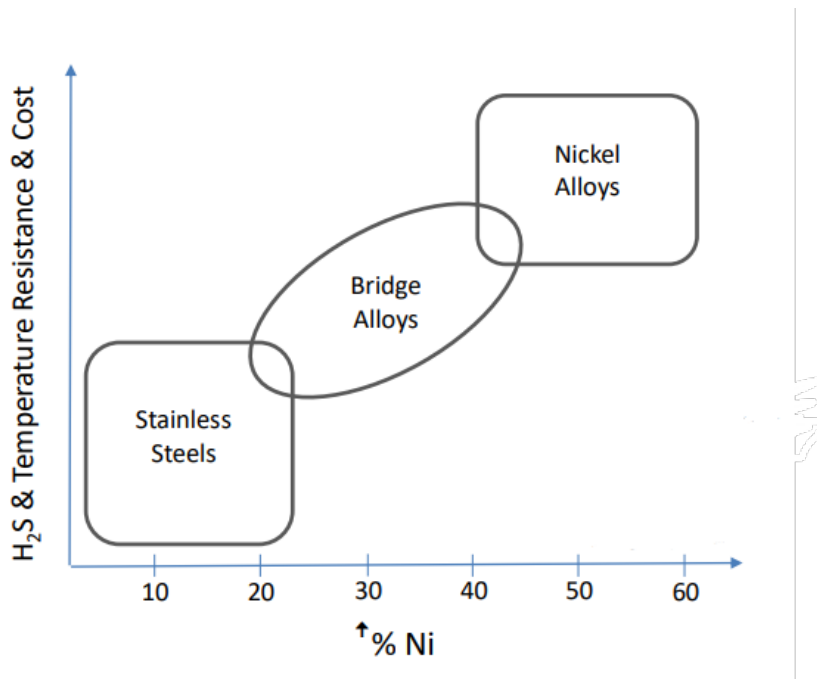
Figure 1.1.1: Illustration describing the positioning of bridge alloys in terms of nickel content compared to traditional nickel alloy grades and stainless steel [1].

As a result, a category of alloys classified as the "bridge alloys" are being considered as a potential substitution. A category consisting of alloys filling the gap between traditional stainless steel and high strength nickel alloys, Figure 1.1.1. The basis for this consideration are cost optimization due to the lower content of nickel, microstructure cleanliness and phase stability potentially increasing the HE resistance. Thereby, in recent times the focus have been shifted towards strain hardened nickel alloys being the focus alloys of this thesis work.

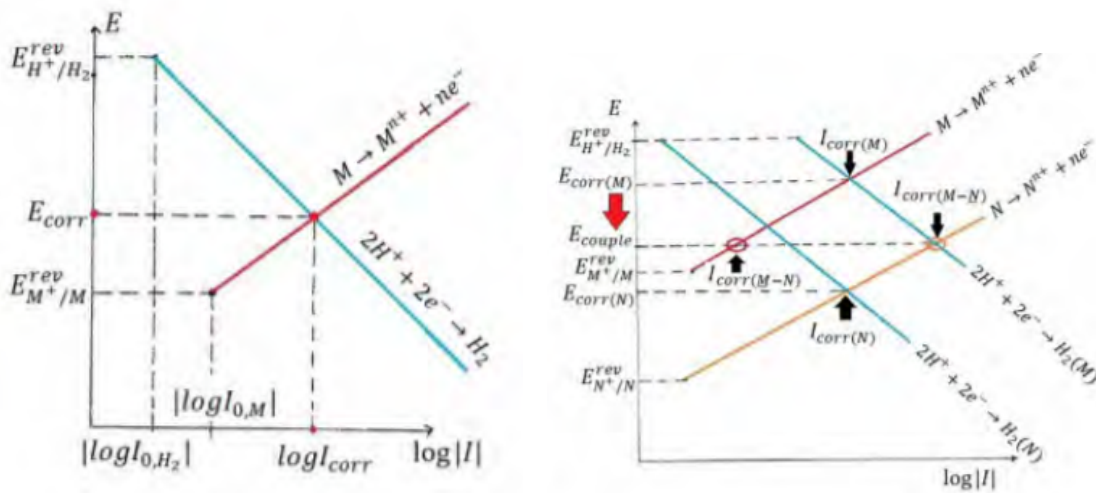
(a) Evans diagram for a single metal with HER as the dominating reduction reaction. (b) Evans diagram describing a galvanic coupling of two metals with their respective HER as the dominating reduction reactions.

The electrode potential is usually far from the reversible potentials for any of the reactions occurring on a metal surface [3, 2]. According to charge conservation and mixed potential theory, in order to avoid the accumulation of charge on a freely-immersed electrode the sum of all of oxidation currents must be equal to the sum of all of reduction currents [4]. Any electrode immersed in an electrolyte will naturally achieve a potential referred to as open circuit potential (OCP) or corrosion potential (E_{corr}), which fulfills this requirement. By comparing the E_{corr} to a metals calculated $E_{\text{electrode}}^{\text{rev}}$ the possibility of corrosion and corrosion rate can be assessed. In Figure 2.1.1a the red and blue line represents the anodic

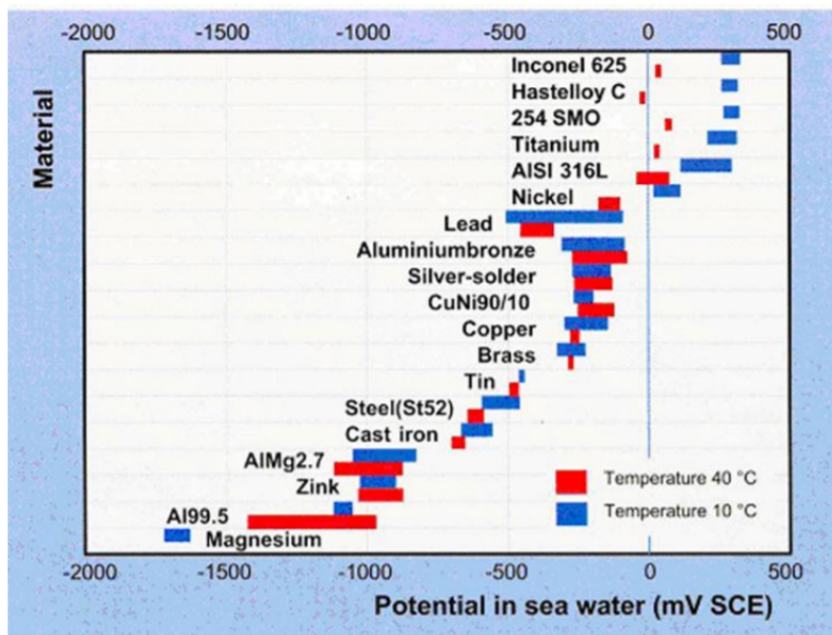
Figure 2.1.3: Galvanic series for different alloys with saturated calomel electrode (SCE) as reference electrode.

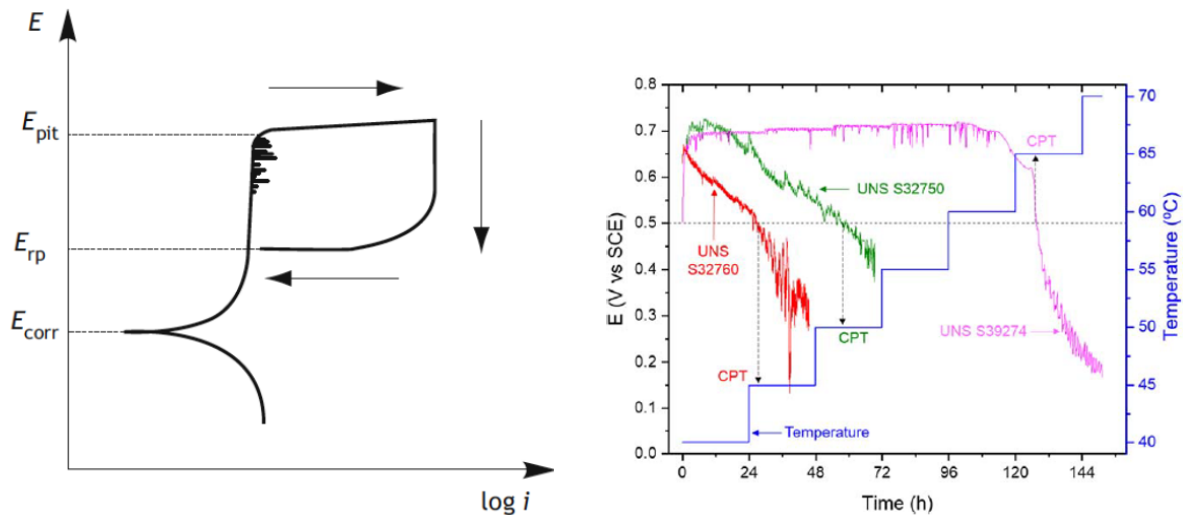
(a) Typical polarization curve for an active-passive metal illustrating different regions of determination of corrosion-, pitting- and repassivation potential [10]. (b) Typical potential development and incremental temperature increase as a function of time for 25%Cr super duplex stainless steel (SDSS) alloys in 6% $FeCl_3$ [11].

Different test methods depending on parameters in focus can be conducted to assess a metal's susceptibility to localized corrosion. More specifically, in order to obtain important parameters such as the repassivation potential (E_{rp}), passive current density (i_{pass}), E_{corr} and E_{pit} cyclic potentiodynamic polarization according to ASTM G61 standard can be conducted. Whereas in order to determine CPT certain test methods according to ASTM G48 would be the viable options. The latter standard is used to determine both pitting and crevice resistance of CRAs in chloride containing environment by immersion in a 6% $FeCl_3$ solution. The standard is classified into six test methods based on how temperature adjustments are conducted during testing. The test can either be conducted by a fixed test temperature or adjusted in intervals. In Figure 2.2.1 typical potential development for both ASTM G61 and G48 Method C is illustrated.

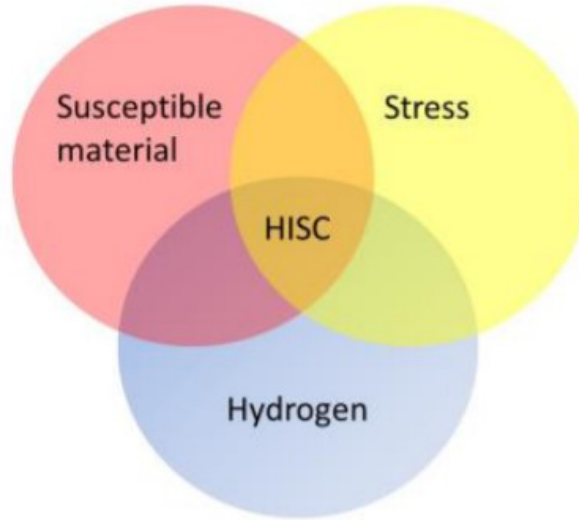
Figure 2.3.1: Illustration showing the three main factors needed to initiate HISC [12].

load case consisting of local stress and strain levels above the materials threshold, Figure 2.3.1. HISC has been a serious challenge for several alloys that initially have been viewed as the ideal material selection for typical oil and gas applications and consequently their respective offshore environments [12, 13]. As the three elements have to be in place simultaneously to initiate HISC, the path to determine the full overview of the causes resulting in HE can therefore be challenging. Especially the environment and material susceptibility for both PH and strain hardened nickel alloys, as the main drivers are to be described in detail in the following.

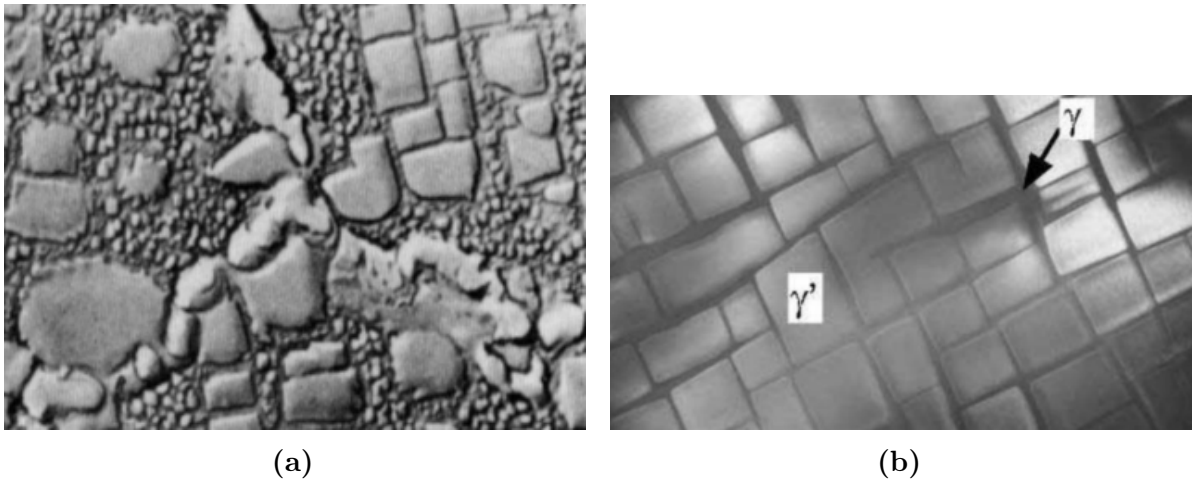
Figure 2.3.2: Traditional microstructure to a PH nickel alloy with precipitates on 2.3.2a) grain boundaries and as dispersed phases in the nickel matrix and 2.3.2b) γ' as homogeneous distributed phases in the nickel matrix [16].

The influence of both the microstructure and alloy elements on the materials behavior towards HE is of utmost importance. PH nickel alloys have different precipitates in the shape of phases existing on the grain boundaries and as their own dispersed phases in a high-nickel matrix integrated in the microstructure, Figure 2.3.2 [15, 16] . The precipitate gamma prime (γ') consist of $Ni_3(Al, Ti)$ with a face-centered cubic structure (FCC) in the nickel matrix and provides notable strengthening to the alloy. Both the particle size of γ' and the volume of γ' phase relative to the nickel matrix leads to an increase in mechanical strength and hardness of the alloy. The amount of γ' formed during processing is a function of alloy elements such as aluminum, titanium and niobium. Although, a supersaturation of Ti and Nb can lead to a transformation of γ' . Ti-rich metastable γ' can transform to the eta phase (η) consisting of Ni_3Ti with a hexagonal close-packed phase (HCP) structure. While excessive Nb leads to a transformation of γ' to γ'' and the η phase with a body centered tetragonal crystal (BCT) structure consisting of Ni_3Nb . Both γ' and γ'' would be present simultaneously at peak hardness [13].

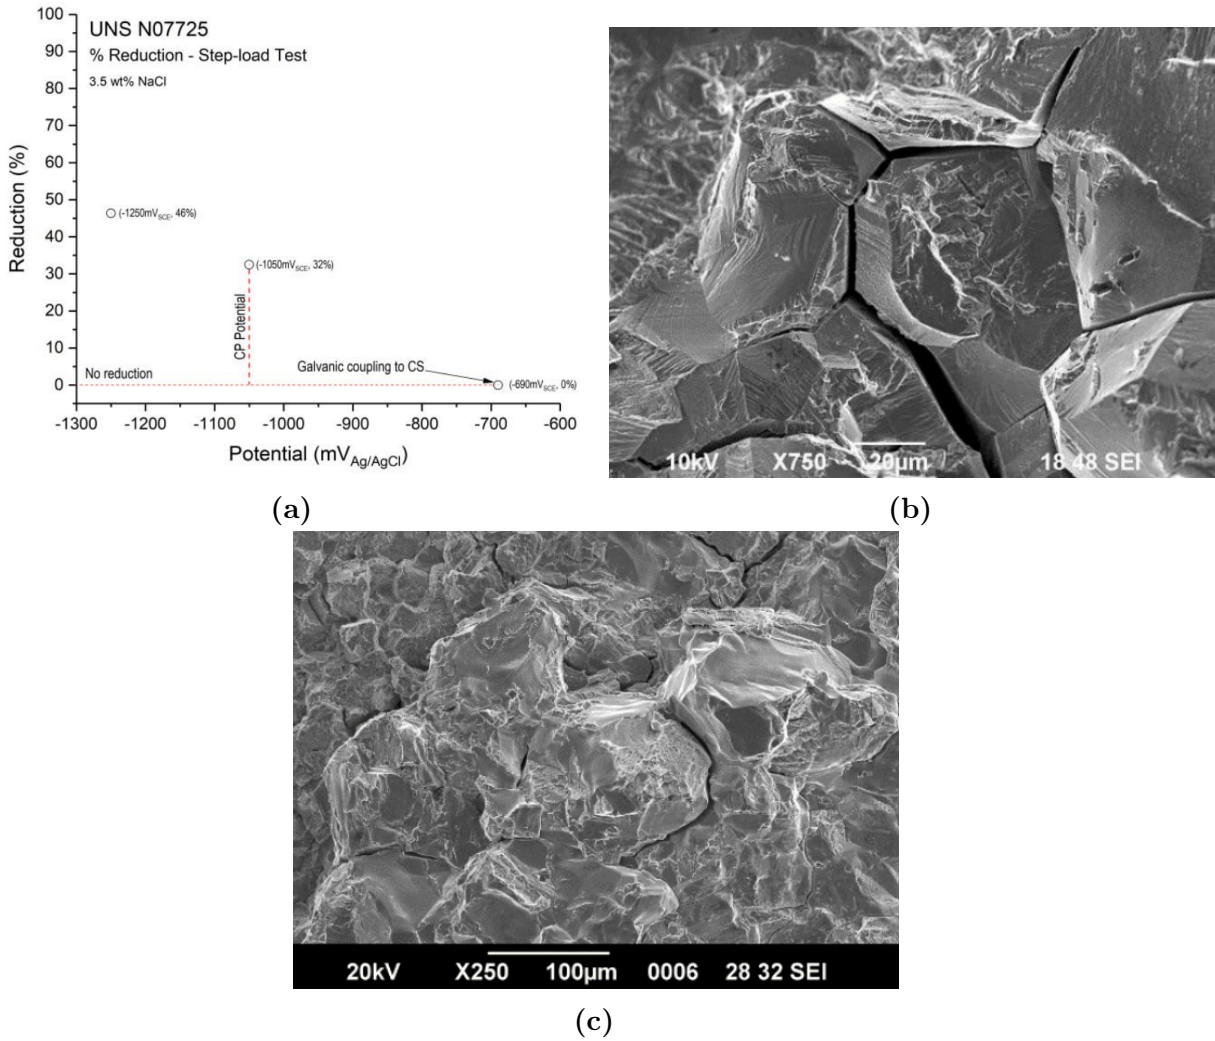
Figure 2.3.3: Results obtained by Qvale et al.[19] describing the effect of a decrease in potential resulting in fracture loss and intergranular cracking of UNS NO7725.

While in the case of UNS N07725, an extensive root cause investigation of a subsea failure involving metallic seals revealed that the brittle nature of the fracture surface indicated environmental assisted cracking (EAC). Further investigation through experimental work conducted by Qvale et al. [19] led to discovering that the presence of full grain boundary decoration σ -phase assisted the crack initiation and propagation and reducing the overall fracture resistance of the alloy. In order to determine the effect of the interaction between atomic hydrogen and σ -phase on the mechanical performance of the alloy, a correlation between reduction in fracture load and in situ hydrogen charging in means of incremental step loading was obtained, Figure 2.3.3a. The correlation is clear, revealing that as the applied potential decreases the reduction in fracture load increases indicating that as the alloy is coupled to CP, the probability of HISC increases. The interaction between atomic hydrogen and σ /matrix interface is also being revealed in the fractography study showing intergranular cleavage in the fracture surface, Figures 2.3.3b

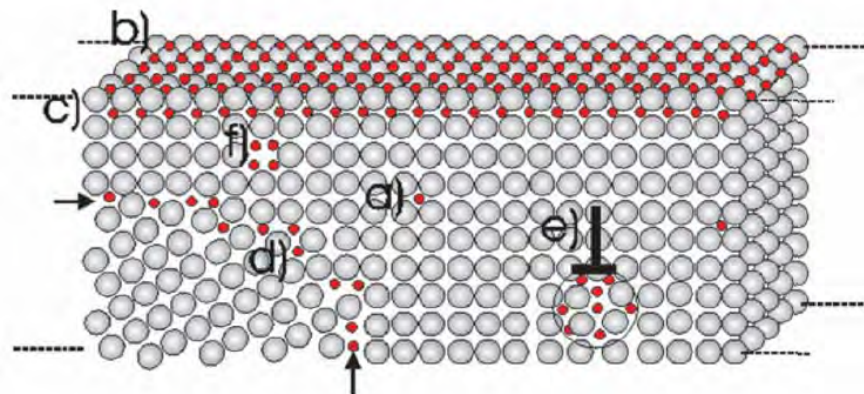
Figure 2.3.4: Schematic presentation of defects in metal and accumulation of hydrogen atoms. Where a) trap sites for hydrogen in the surface, b) in the subsurface and c) lattice sites. At e) representing a edge dislocation hydrogen segregation is expected, d) being the grain boundaries and f) for vacancies [24].

A summary of hydrogen interaction with the different defects mentioned above can be described according by Figure 2.3.4

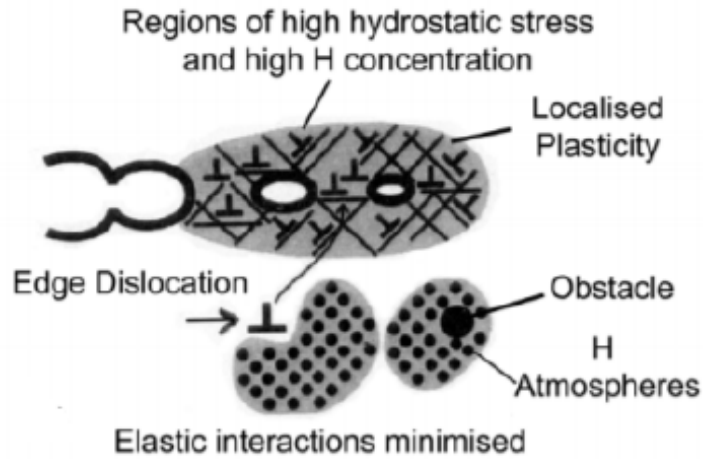
Figure 2.3.6: Schematic illustration of the HELP mechanism including a microvoid coalescence process with plasticity localized and located in regions with high hydrogen concentration [22].

Investigations through in situ transmission electron microscopy (TEM) have revealed an increase in dislocation mobility in the presence of hydrogen. According to these observations, stationary dislocations gained motion and an increased velocity when hydrogen was introduced [22].

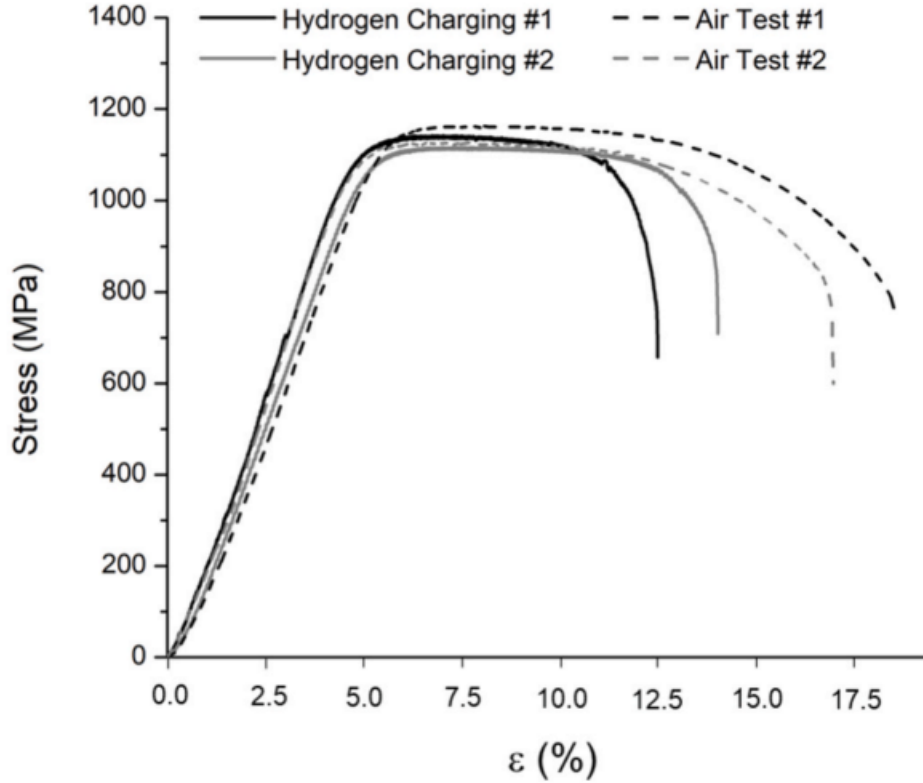
Figure 2.4.2: Typical stress-strain behavior for SSRT carried out in air and during in-situ hydrogen charging [21].

SSRT is a test method where the main objective is to investigate the materials susceptibility to EAC. The method is performed by applying constant strain to the sample and parameters such as failure loading, temperature, elongation (%EL) and time can be measured. In order to assess the susceptibility to EAC the testing can be executed by simulating different environments. During the mechanical evaluation environments such as air, liquid environments (seawater, fresh water) and galvanic conditions (sacrificial anodes) are possible to simulate. Heimseter [26] performed SSRT while cathodically polarizing the samples to $-1100 \text{ mV}_{Ag/AgCl}$ in 3.5 wt% NaCl solution. During this work, the testing was carried out according to ASTM G129, NACE TM0198 and ASTM F1624 which covers the procedures for SSRT, specimen design and strain rate, respectively [26]. Typical stress-strain behaviour of metals in air and in-situ hydrogen charging during SSRT are illustrated in Figure 2.4.2.

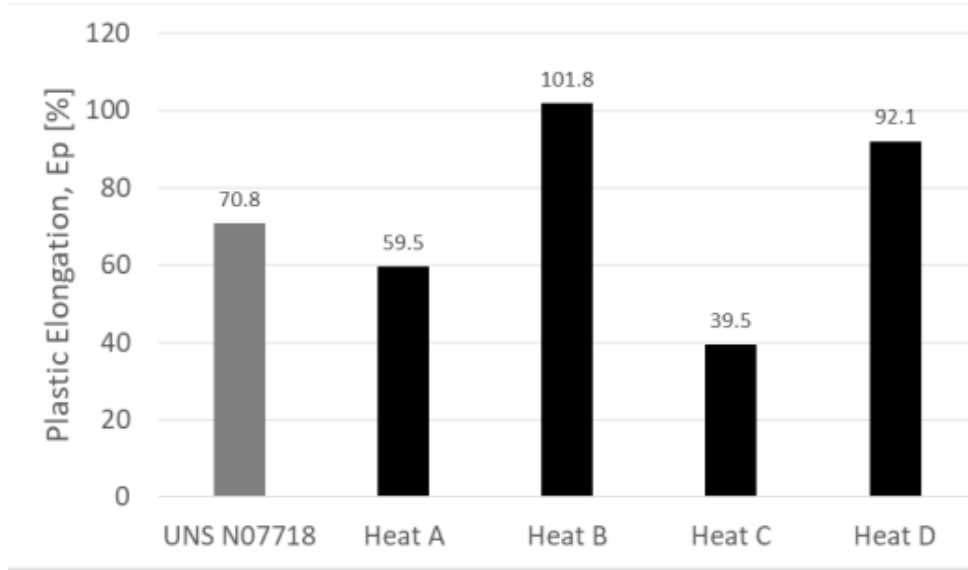
Figure 2.7.1: Plastic Elongation ratio of model alloys in comparison to production heat of Alloy UNS N07718 [27].

factor to increasing HE resistance is also being confirmed according to Heat D reaching a plastic elongation ratio of 92.1%.

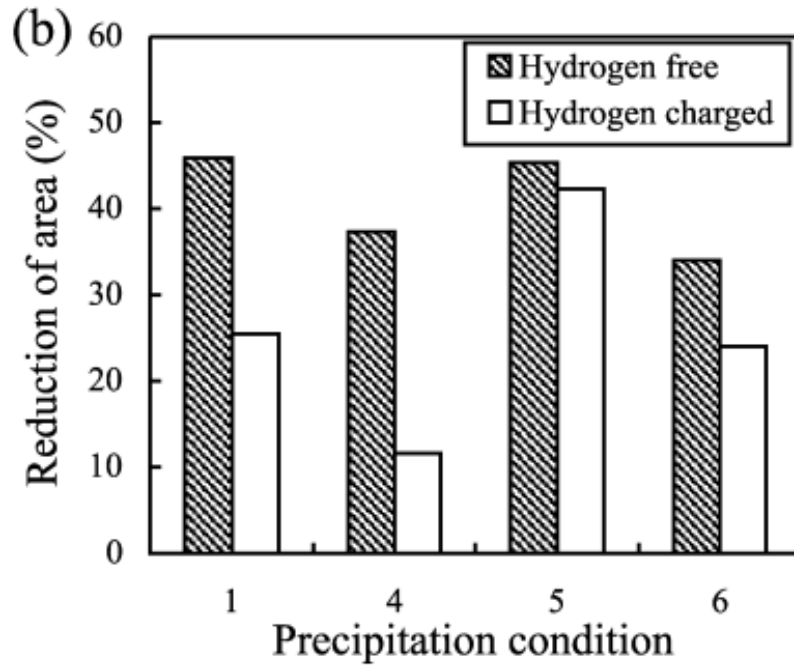
Figure 2.7.2: %RA for different precipitations conditions of UNS N07718 [17] .

It appears from the Figure 2.7.2 that the heat 1 and 5 with δ -free modified microstructures had much larger %RAs despite being hydrogen charged indicating low degree of embrittlement. Furthermore, in terms of loss in %RA the δ -free annealed alloy suffered a loss of 6.83% being relatively low compared to the conventionally annealed specimen which suffered a loss of 44.3%. The δ -free aged specimen experienced a loss of 29.41%, whereas the conventionally aged specimen with the relatively highest loss of 68.90%. It was from the results obtained concluded that the large decrease in HE sensitivity was due to the presence of δ -phase as grain boundary decoration. It was believed by the authors that the loss in %RAs for the delta free specimens was similarly to Bothina et al.[27] due to the γ'/γ'' -ratios [17].

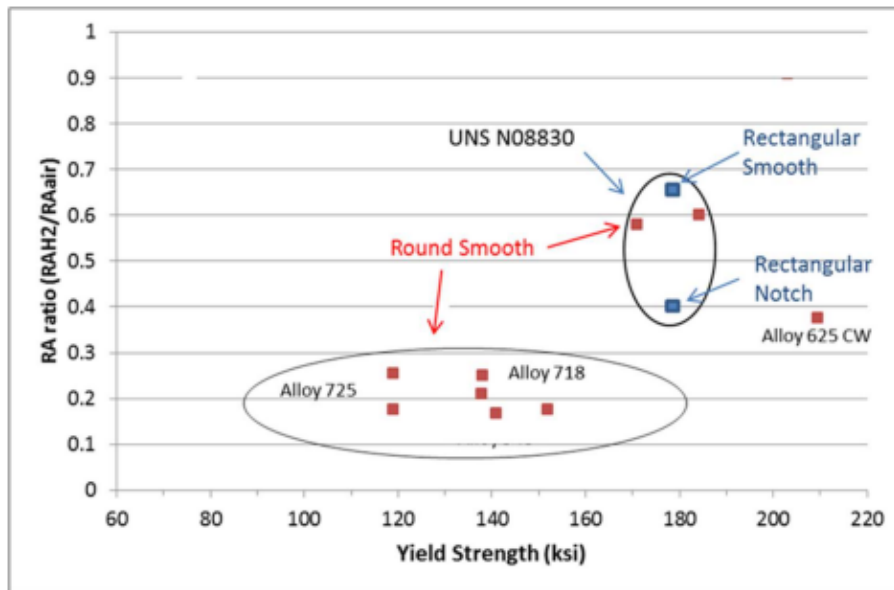
Figure 2.7.4: Relationship between %RA ratios and yield strength for selected PH and strain hardened nickel alloys [30].

Similar work on UNS N08830 has also been carried out by Stefansson et.al [30] through SSRT. However, the pre-charging procedure was similar to Heimseter [26] described in section ??, and a higher strain rate of $1 \cdot 10^{-6} s^{-1}$ was used. The latter was only the case for specimens with rectangular cross section. During this study, susceptibility to HE of both smooth and notched specimens were investigated. It was revealed from SSRT that the ductility of notched samples were reduced by half compared to the smooth samples both in air and during in-situ hydrogen charging. The latter is due to the notch providing a pre-crack. However, it appears from the SSRT that the smooth specimen during this study compared to the results obtained by Burille et al.[21] had an RAR of 55.2% which also seem to have performed well. The authors calculated an elongation ratio of 85% which also has met the acceptance criterion defined by Bothina et al.[27]. An comparison of the RARs for UNS N08830 with different specimen geometries to UNS N07725 and UNS N07718 along with cold worked Alloy 625 have been provided in Figure 2.7.4. It appears that the PH nickel alloys have the lowest RARs, indicating highest degree of embrittlement and high sensitivity to HISC.

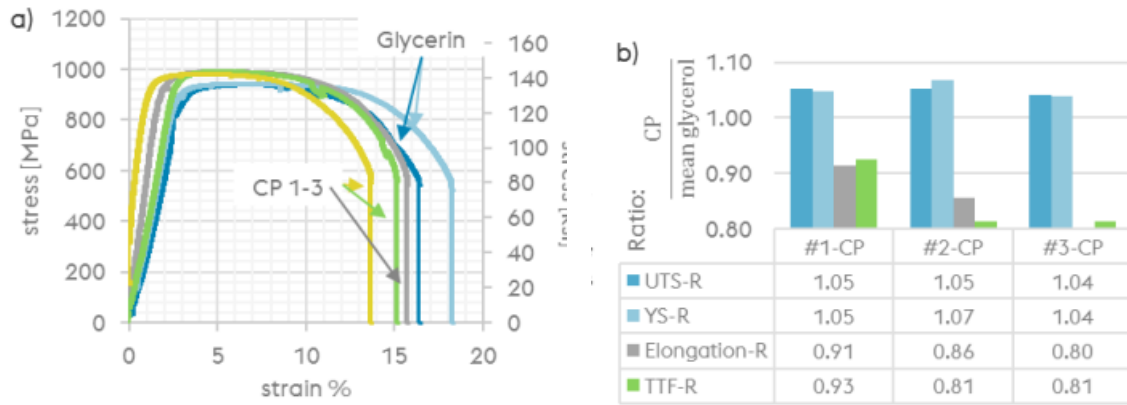
(a) Stress-strain behavior of CW A975 obtained from SSRT in glycerin as reference environment and during in-situ hydrogen charging at 40 °C [31]. (b) Mechanical ratios comparing the uncharged and hydrogen charged specimens.

The A975 alloy is a super austenitic stainless steel in CW condition which commonly has been used for drilling application due to the combination of high fatigue life and strength combined with the increased pitting resistance. By the experimental work carried out by Chitwood et al. [31], the susceptibility to HISC of A975 was investigated by the means of SSRT. The testing procedure were carried out in accordance with NACE TM0198. The results obtained from the experimental work carried out by the authors are provided in Figure 2.7.5. Two tests in glycerin has been used as reference when comparing to in-situ hydrogen charged specimens. In Figure 2.7.5b, key mechanical properties along with plastic elongation ratio and time to fracture ratio have been provided. In comparison to the uncharged specimens, all three tests conducted during in-situ hydrogen charging reveals an increase in YS and UTS ratios considering the CP and air environments, which may be due to hydrogen diffusion into the dislocation cores. The time to fracture and elongation ratios indicates that the alloy managed to maintain more than 80% of its ductility during in-situ hydrogen charging. It was concluded by the authors that the alloy possessed excellent resistance to HE.

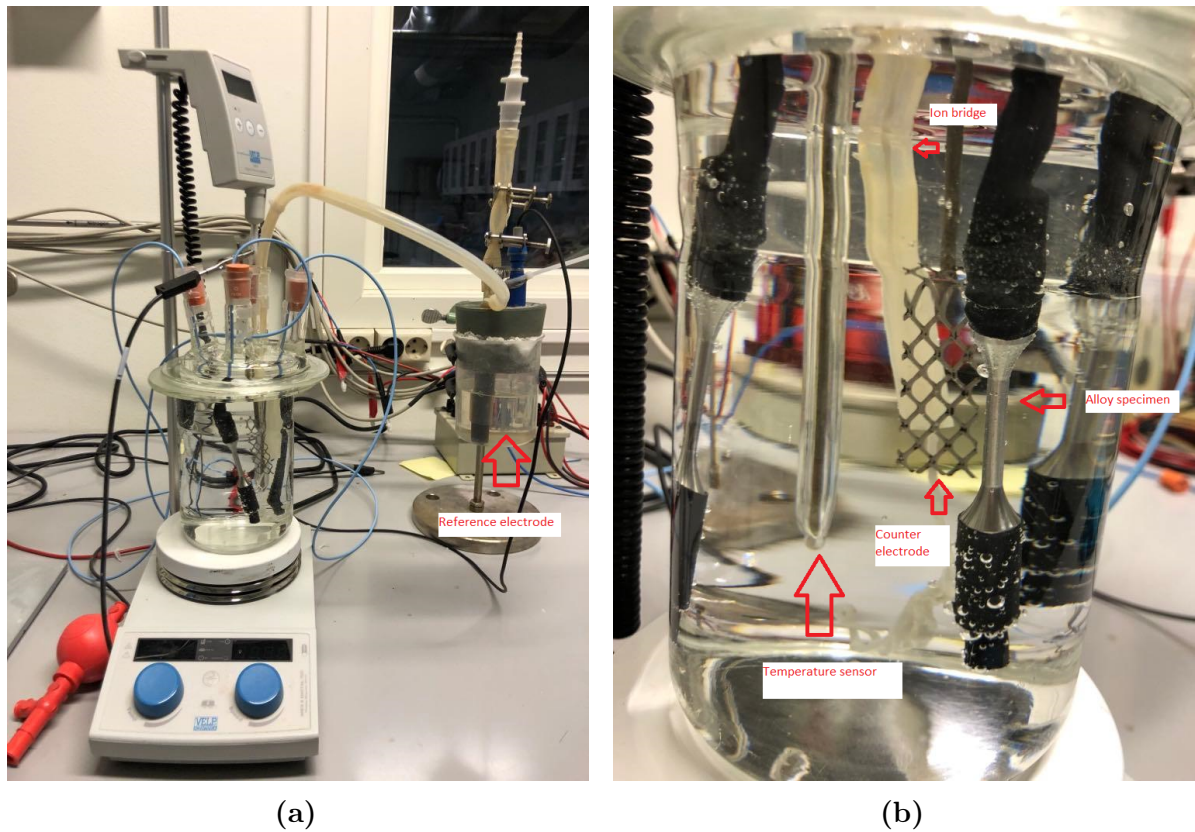
Figure 3.5.1: Experimental setup of hydrogen pre-charging at 80°C

During this project, multiple samples from the different alloys have been pre-charged simultaneously. The experimental setup has been consisting of the respective samples placed in the glass autoclave with an Pt counter electrode, temperature sensor and the ion-bridge connecting the separately positioned reference electrode Ag/AgCl, Figure 3.5.1. The reference electrode was immersed in KCl solution. The latter solution was prepared by dissolving KCl (170 g) in distilled water (500 mL). The separate positioning of the reference electrode is to avoid potential damage to the ion membrane of the reference electrode due to the elevated temperature. The content of the glass autoclave was connected to a potentiostat which contributed to the cathodic polarization to $-1100 \text{ mV}_{Ag/AgCl}$ ensuring the presence of hydrogen in the samples. The procedure was inspected everyday during the procedure run in case of removal of air bubbles accumulated in the ion bridge. After a complete pre-charging, the samples were taken out of the glass autoclave where the tubing was removed before being rinsed with distilled water and ethanol. The samples were stored in a freezer with a temperature of -20°C to eliminate the diffusion rate of hydrogen out of the charged samples.

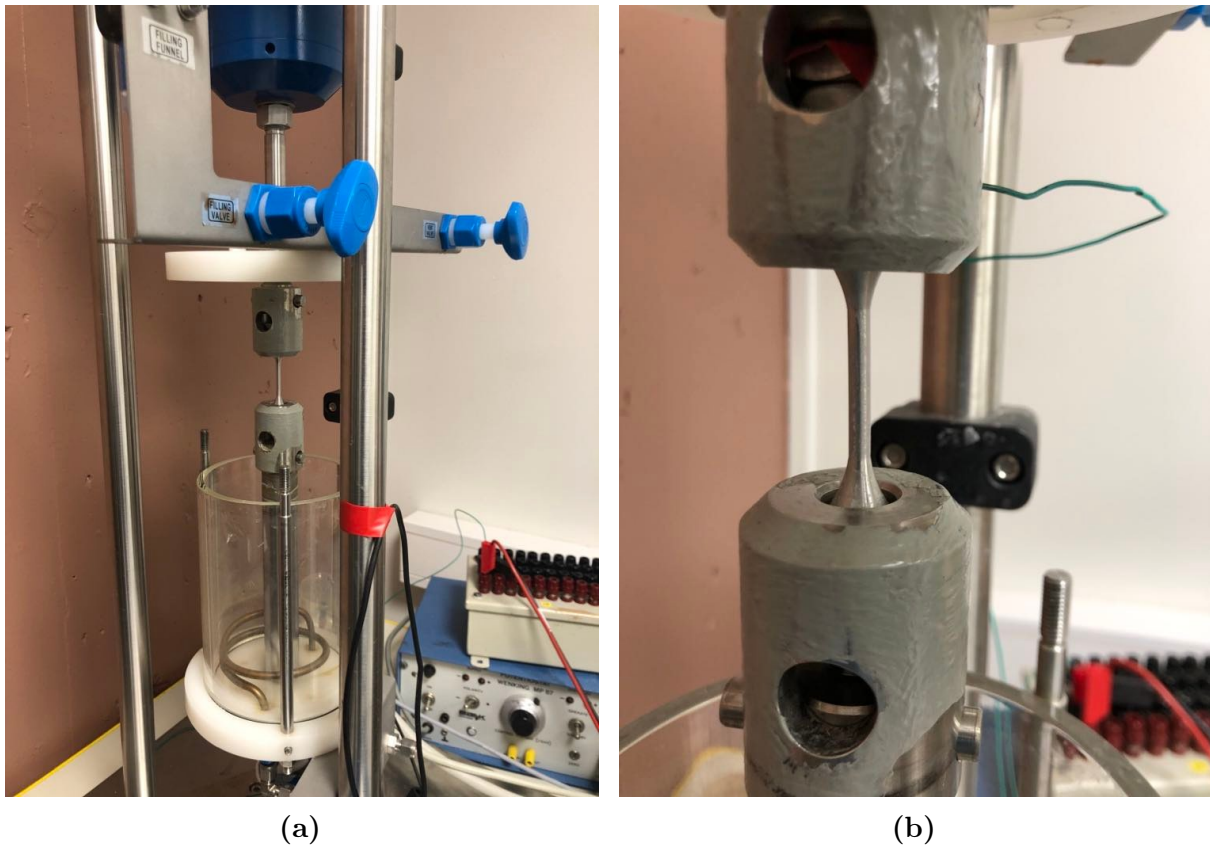
Figure 3.6.2: Experimental setup of SSRT in air environment.

and force are zeroed by determining a start position before the logging starts. As failure occurred, the fractured sample was taken out and stored in a plastic bag at RT.

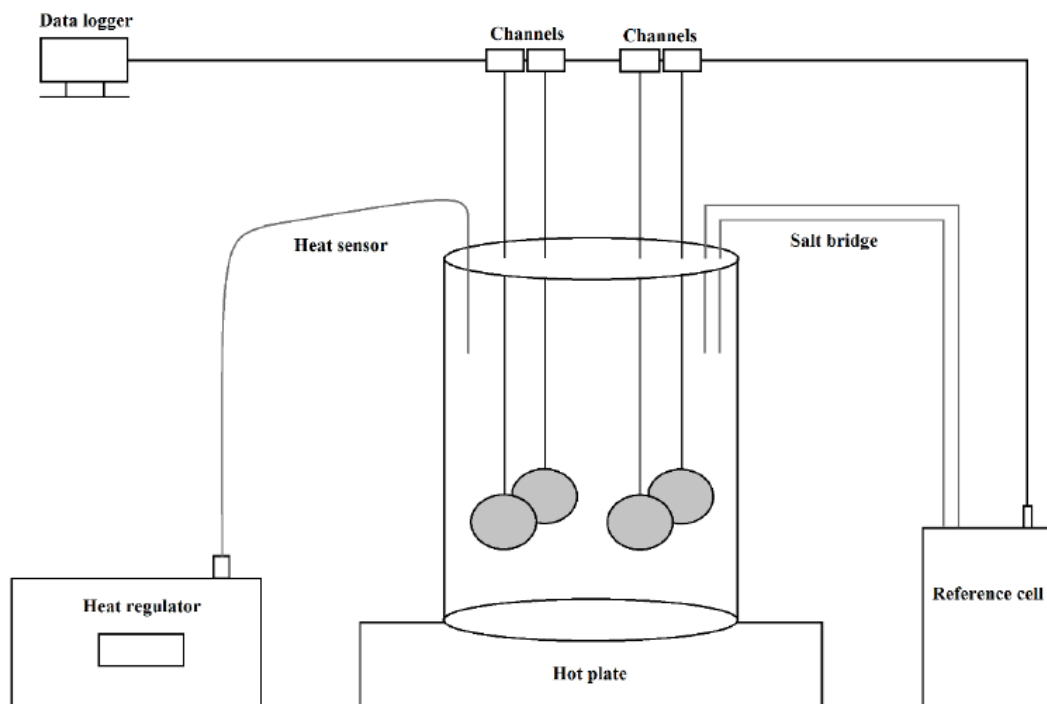
Figure 3.9.2: Illustration of experimental setup for ASTM G48 Method C [34].

The experimental setup was organized by placing the prepared electrolyte on a heating element in which a temperature sensor and the salt bridge were inserted. The samples were connected to the reference electrode and to their respective channels which logged the development of OCP during test duration, before being immersed into the electrolyte. The electrical connection was achieved by attaching a Pt wire through the holes in samples and clamped with the channel wires, Figure 3.9.2. The starting temperature for each test run was set to 50°C. Until any pitting was observed, the temperature was incrementally increased by 5°C every 12. hour. The experiment was to be stopped if the samples would experience a permanent potential drop below +450 mV_{Ag/AgCl} or if the sample would not experience any pitting even at a temperature of 85°C for a duration of 12 hours or more. Pitting initiation was defined at this potential drop and further temperature increase is not recommended according to the standard. After end of test, the samples were to be removed from the solution and cleaned with distilled water and ethanol. The cleaned samples would finally be weighed in order to determine any weight difference.

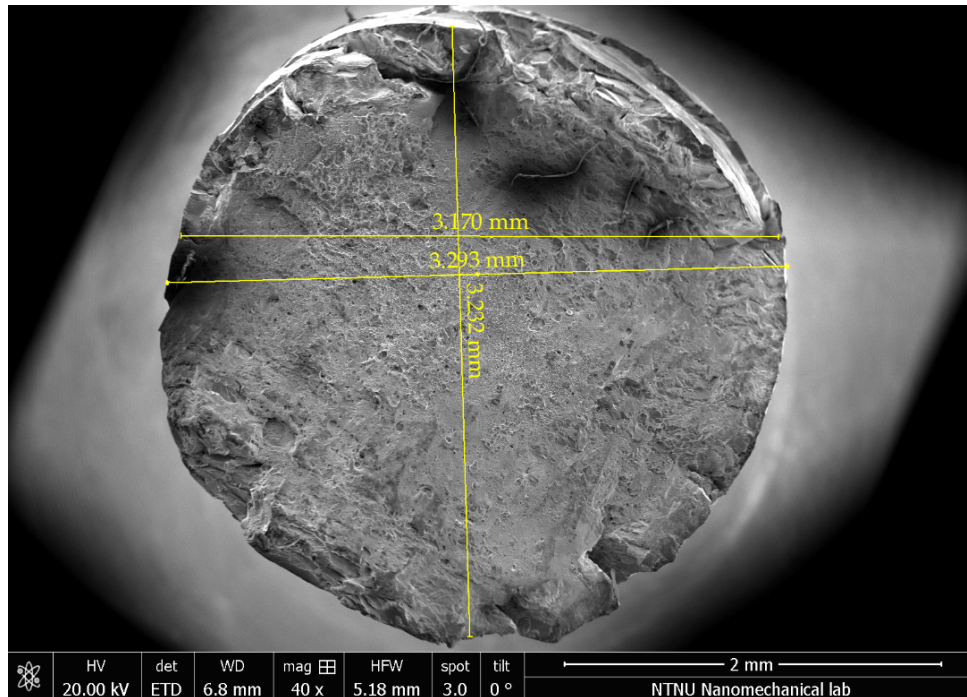
Figure 3.10.1: Measurements of average diameter of cross section in SEM post fracture.

post fracture was calculated using mean diameter of the cross section determined in SEM, Figure 3.10.1.

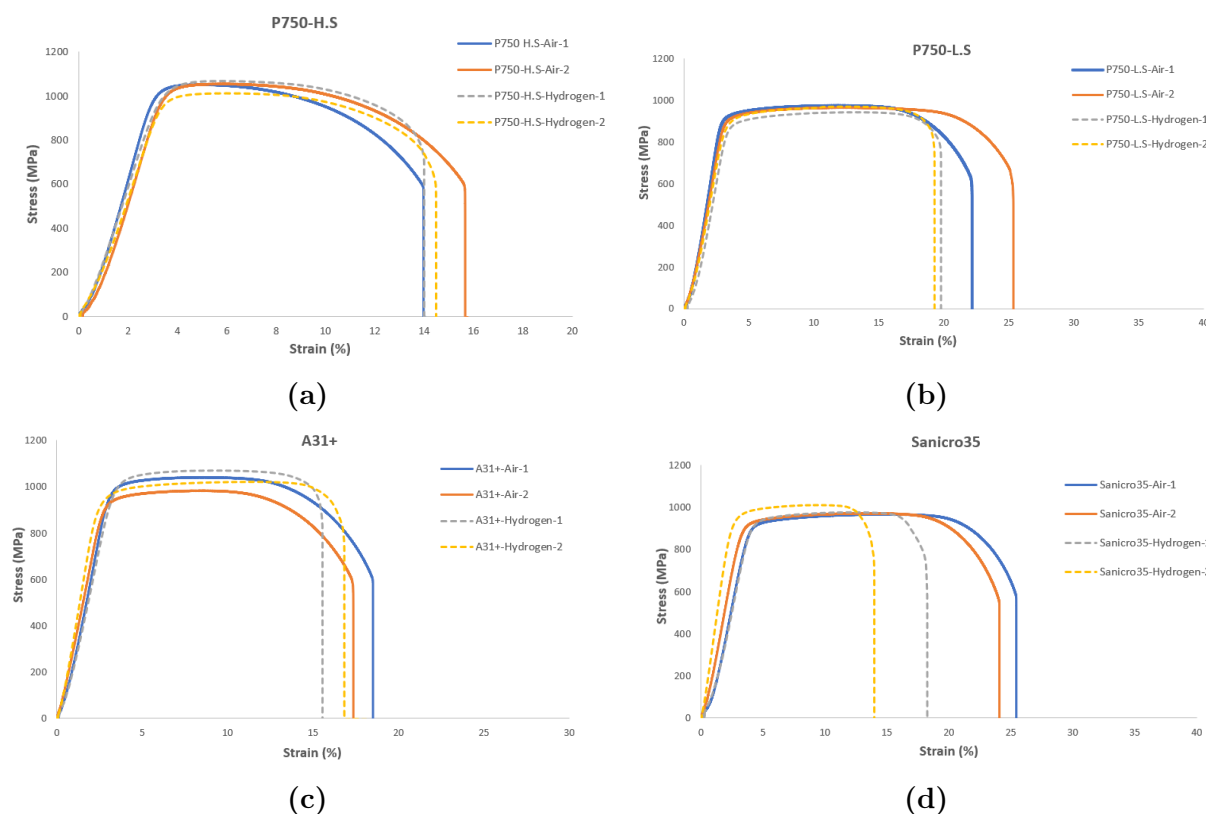
Figure 4.2.1: Stress-strain behaviour obtained from SSRT in air and in-situ hydrogen charging for P750-H.S, P750-L.S, A31+ and Sanicro35.

According to the stress-strain curves obtained from SSRT in Figure 4.2.1, it clearly appears that the alloys Sanicro35 and P750-L.S in Figures 4.2.1d and 4.2.1b respectively, have experienced relatively the largest loss in fracture strain. According to Table 4.2.1, both Sanicro35 and P750-L.S experienced a loss in fracture strain of 8.65% and 4.19% respectively, from in-situ hydrogen charging. The same pattern in terms of a decrease is also occurring in %EL and YS/FS-ratio for both alloys. In contrast, the loss in fracture strain from in-situ hydrogen charging for P750-H.S and A31+ have been 0.35% and 1.7%, respectively. Only a minimal decrease in terms of %EL and YS/FS-ratio has occurred for the latter alloys in comparison to P750-L.S and Sanicro35.

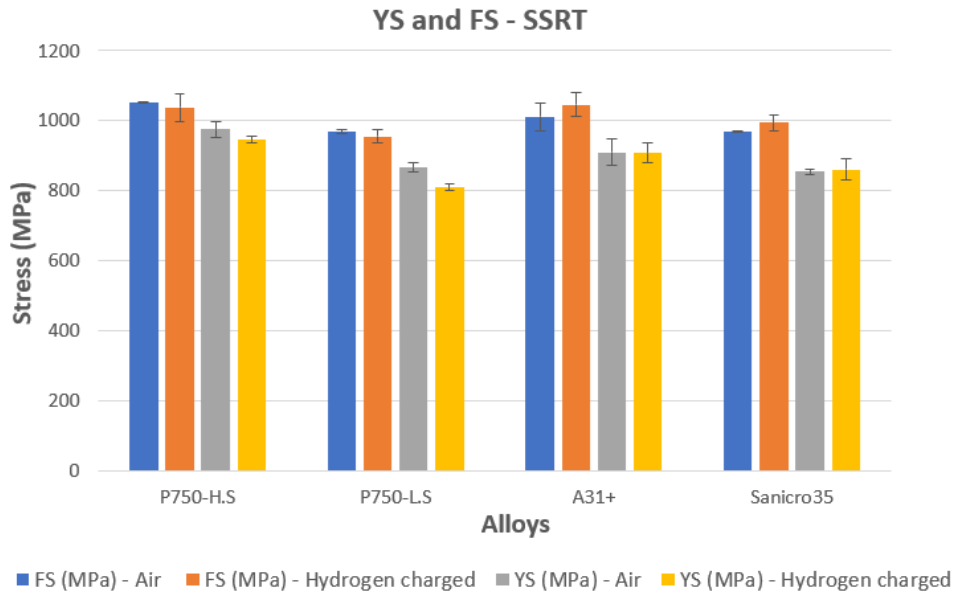
Figure 4.2.2: YS and FS from SSRT in air and from in-situ hydrogen charging.

For both P750-H.S and P750-L.S the variations in YS and FS when tested in air and from in-situ hydrogen charging are relatively small according to Figure 4.2.2 and Table 4.2.1. P750-H.S experienced a decrease of 29 MPa and 13.5 MPa in terms of YS and FS, respectively. While for P750-L.S the loss in YS and FS was 57 MPa and 14 MPa, respectively. However, in the case of A31+ and Sanicro35 a slight increase in FS from in-situ hydrogen charging occurred indicating a hardening effect for both alloys. The YS for the latter alloys from in-situ hydrogen charging experienced a minimal change. Due to these observations and as described in 2.5, the degree of susceptibility to HE will be measured according to parameters describing the mechanical ductility loss and degree of embrittlement.

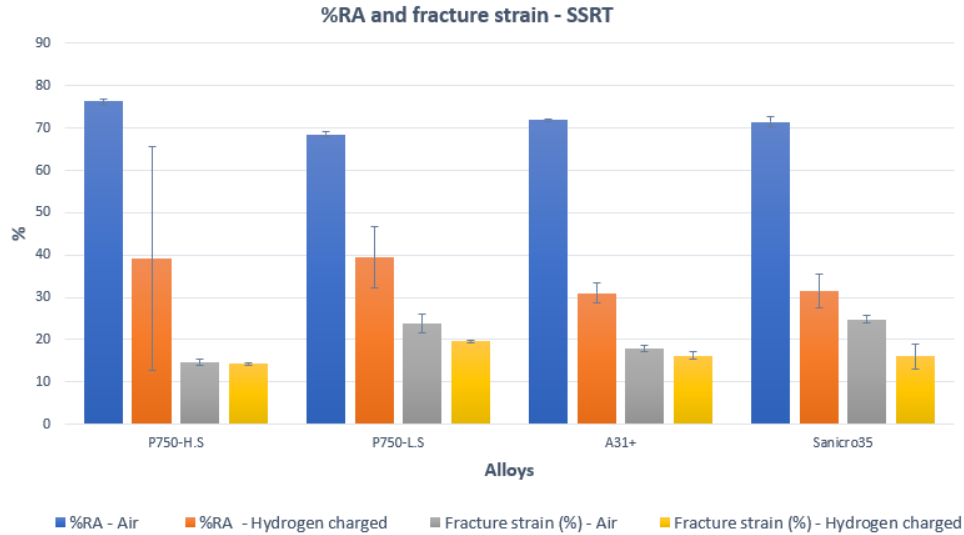
Figure 4.2.3: %RA and fracture strain obtained from SSRT in air and in-situ hydrogen charging.

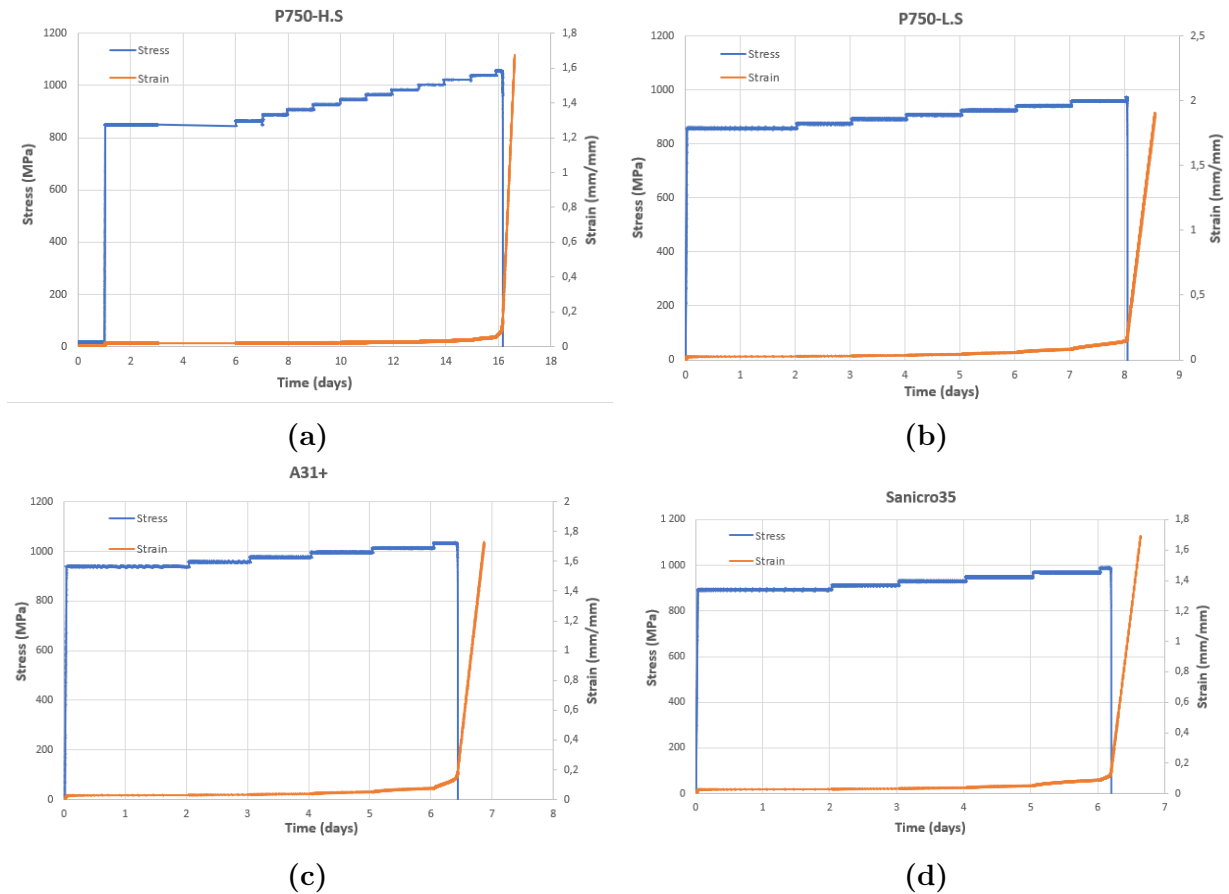
Figure 4.3.1: Stress-strain behaviour as a function of time obtained from SCL-testing during in-situ hydrogen charging for P750-H.S, P750-L.S, A31+ and Sanicro35.

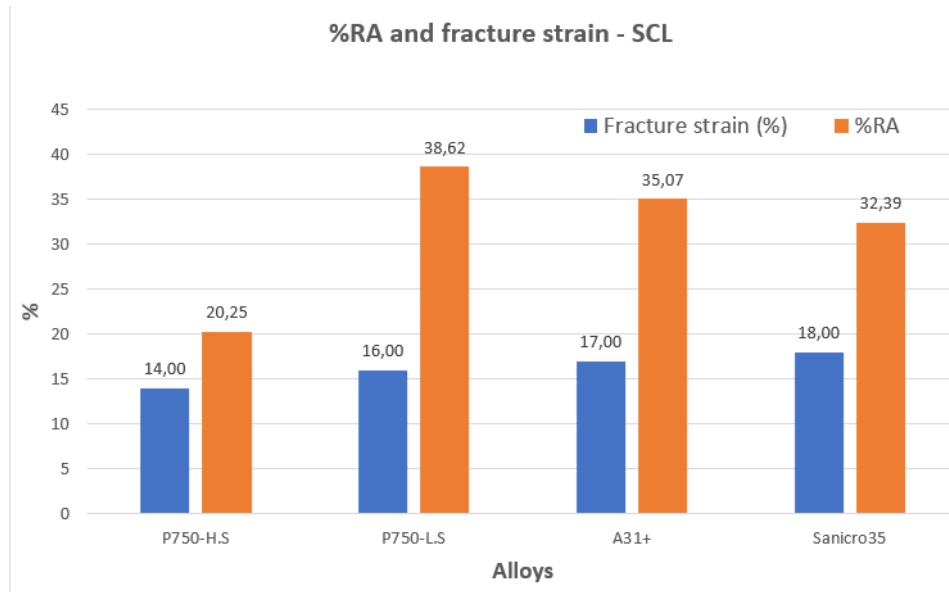
Figure 4.3.2: %RA and fracture strain obtained from in-situ hydrogen charging in SCL.

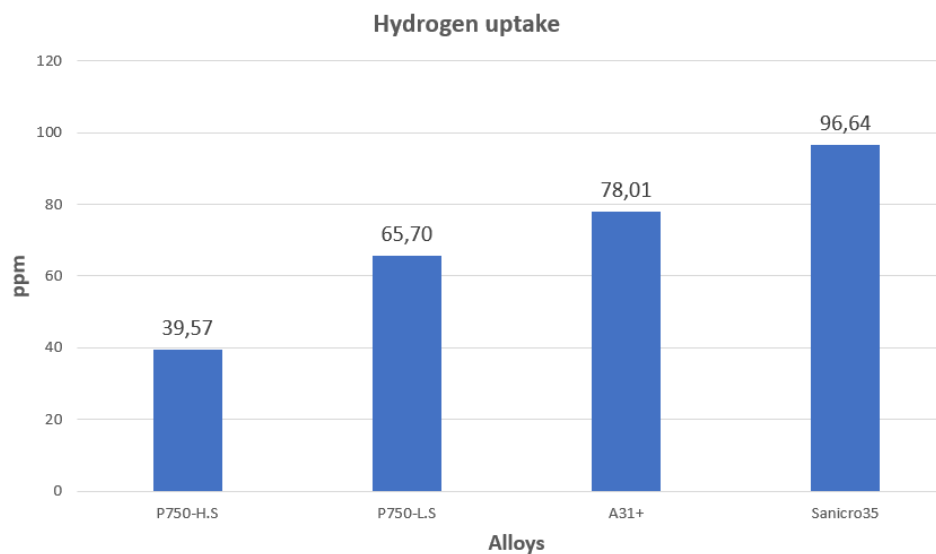
Figure 4.5.1: Hydrogen uptake in P750-H.S, P750-L.S, A31+ and Sanicro35 post SCL-test.

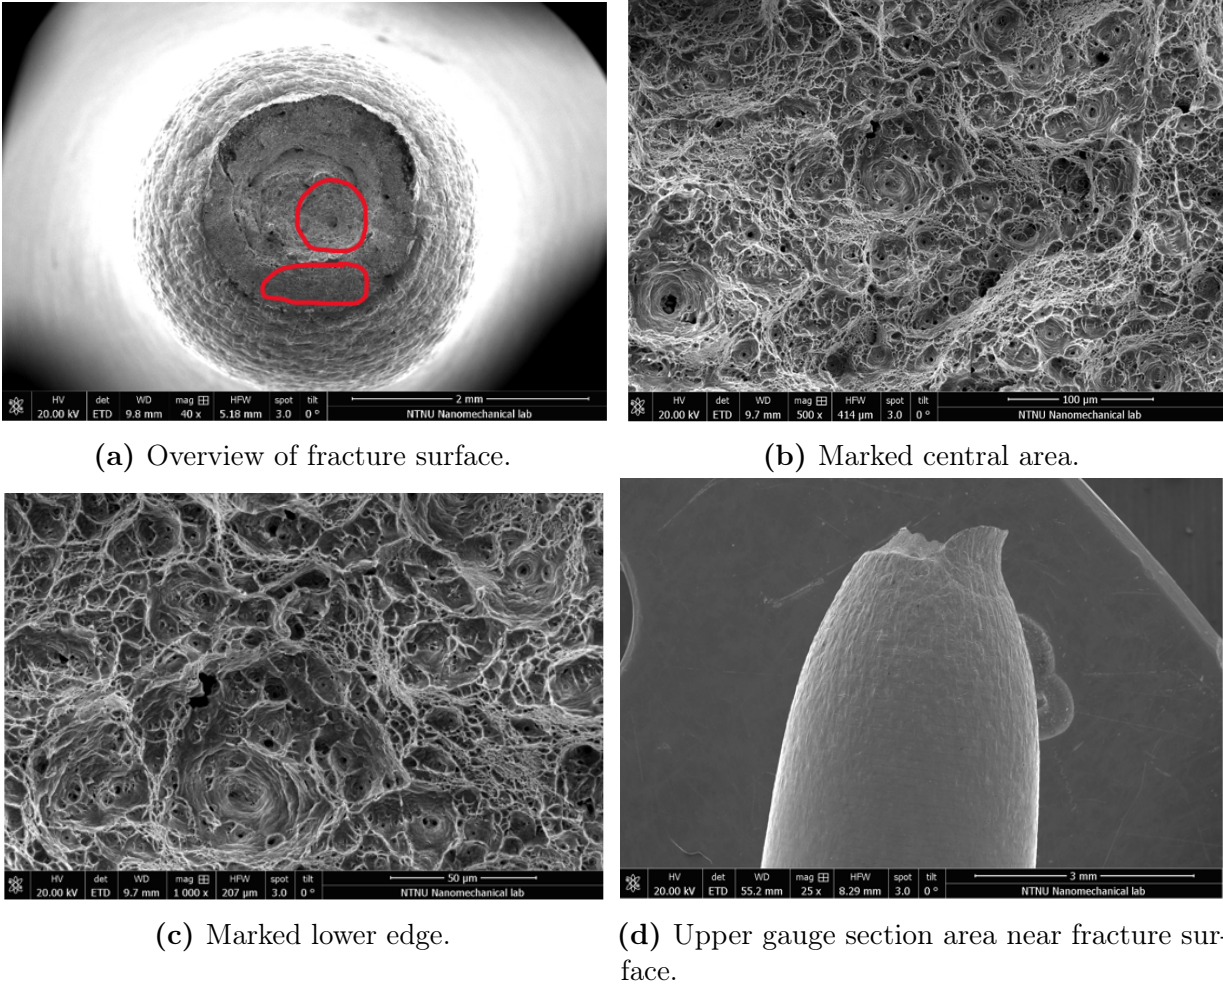
Figure 4.6.1: Fracture surface overview of P750-H.S from SSRT in air environment.
