Evaluation of Strain Hardened Austenitic Corrosion Resistant Alloys' Susceptibility to Hydrogen Induced Stress Cracking (HISC)

Master's thesis in Materials science and engineering

Norwegian University of Science and Technology
Faculty of Engineering
Department of Mechanical and Industrial Engineering

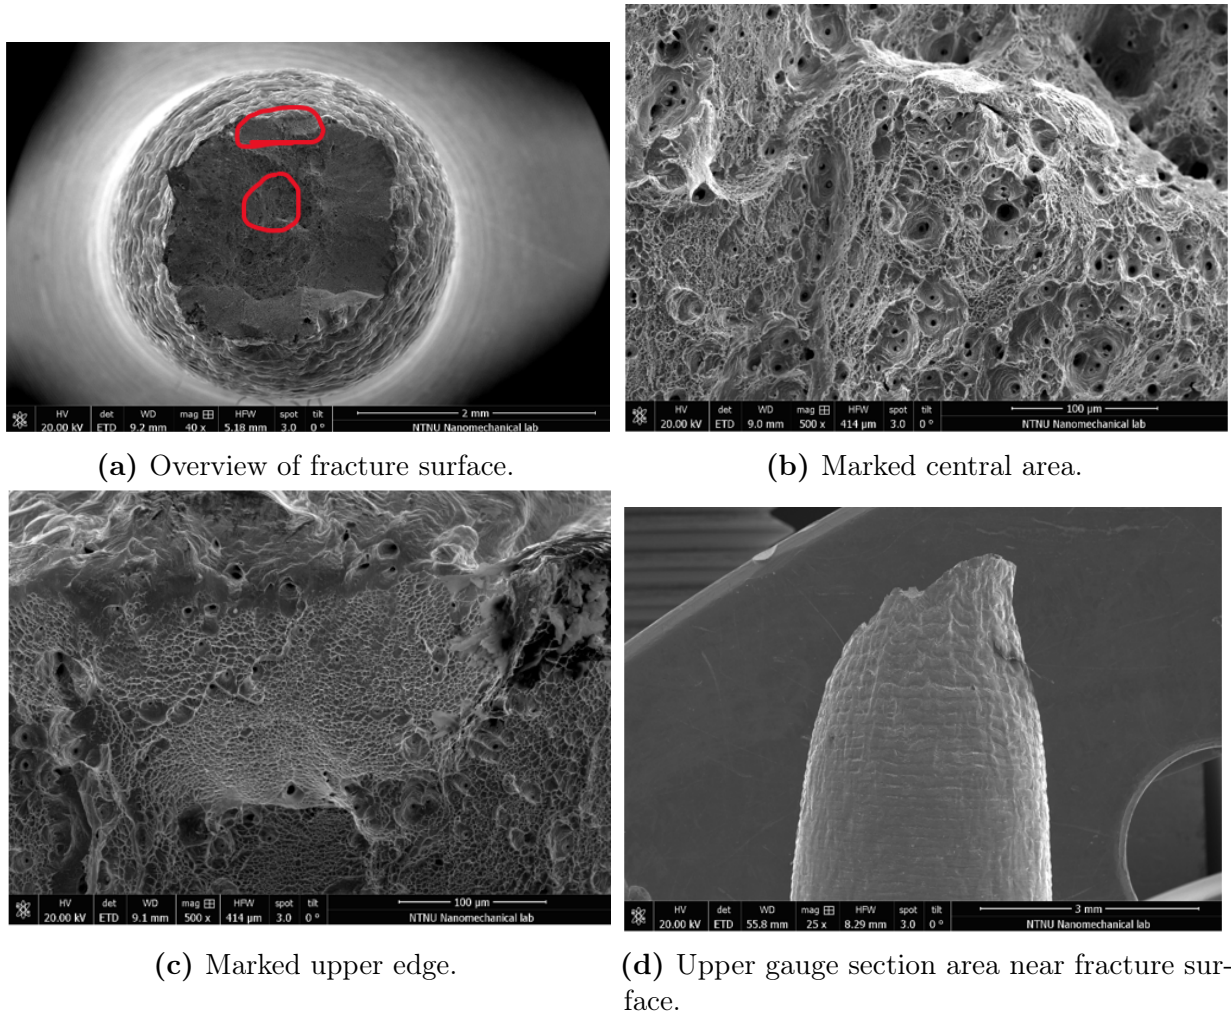
Figure 4.6.4: Fracture surface overview of Sanicro35 from SSRT in air environment.

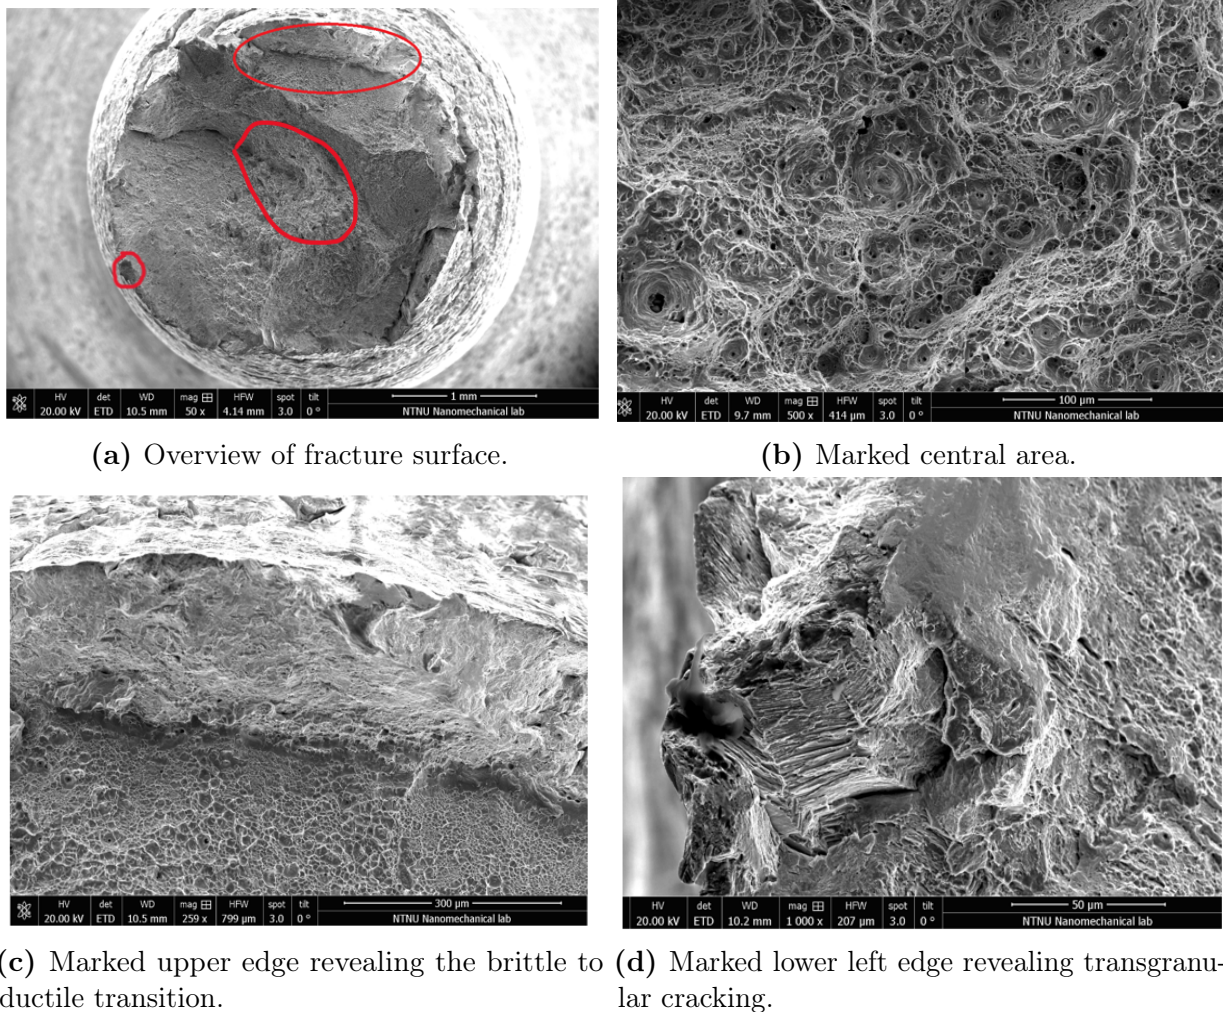
Figure 4.6.5: Overview of fracture surfaces for P750-H.S from in-situ hydrogen charging in SSRT.

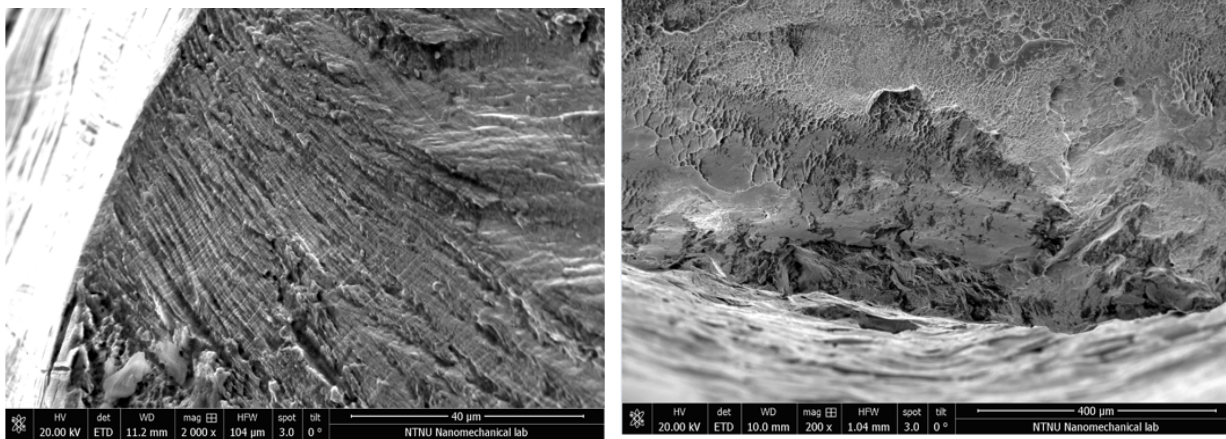
(c) Marked lower ledge revealing transgranular cracking.

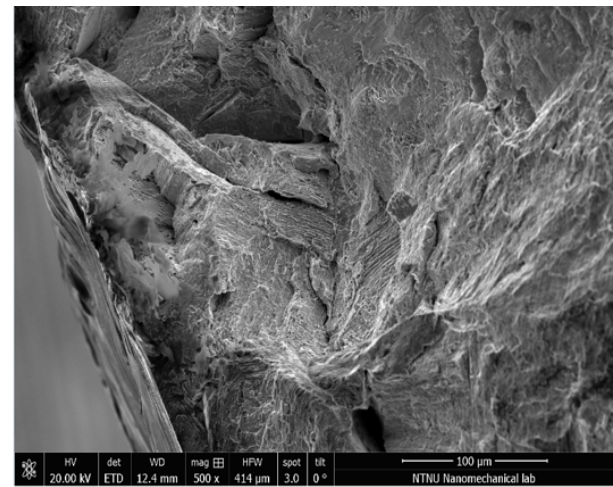
(d) Marked left edge revealing transgranular cracking.

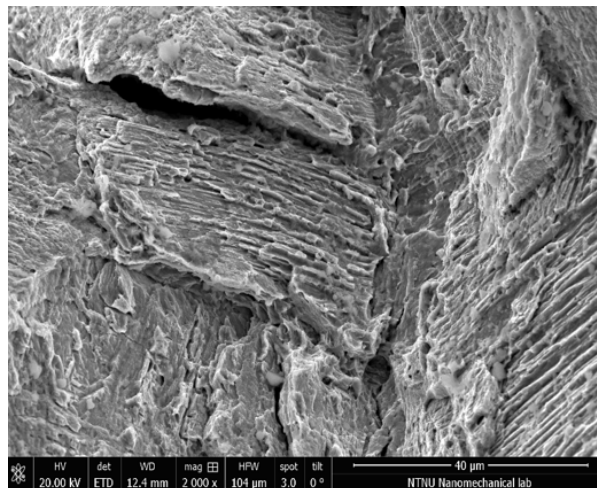
(e) Marked left edge revealing transgranular cracking with 2000X magnification.

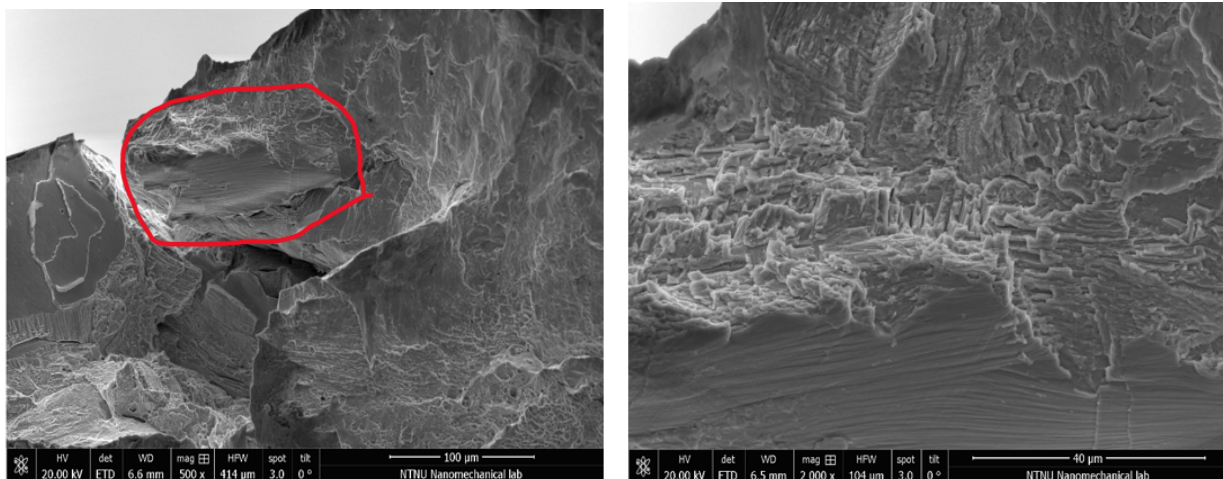
(c) Marked left ledge revealing transgranular cracking.

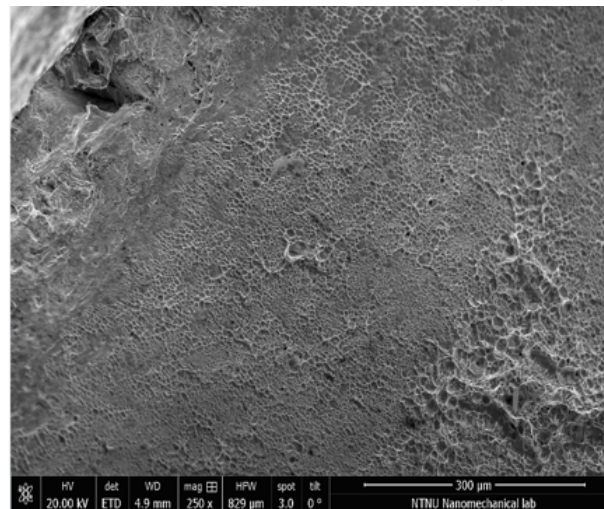
(c) Marked upper edge revealing the brittle to ductile transition.

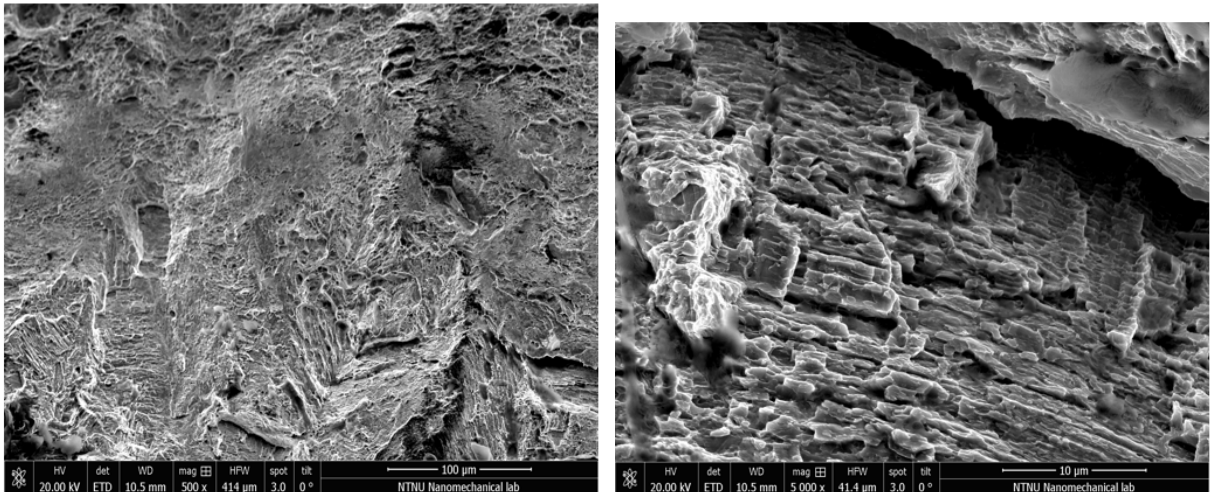
(c) Marked lower edge revealing the transgranular cracking.

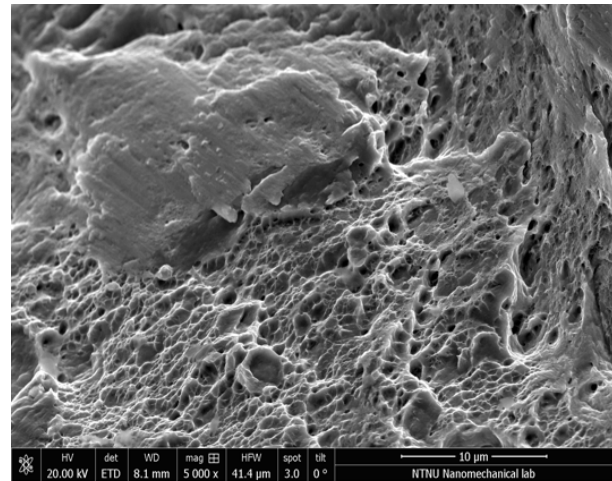
(d) Marked right edge with a 5000X magnification revealing a brittle flat facet.

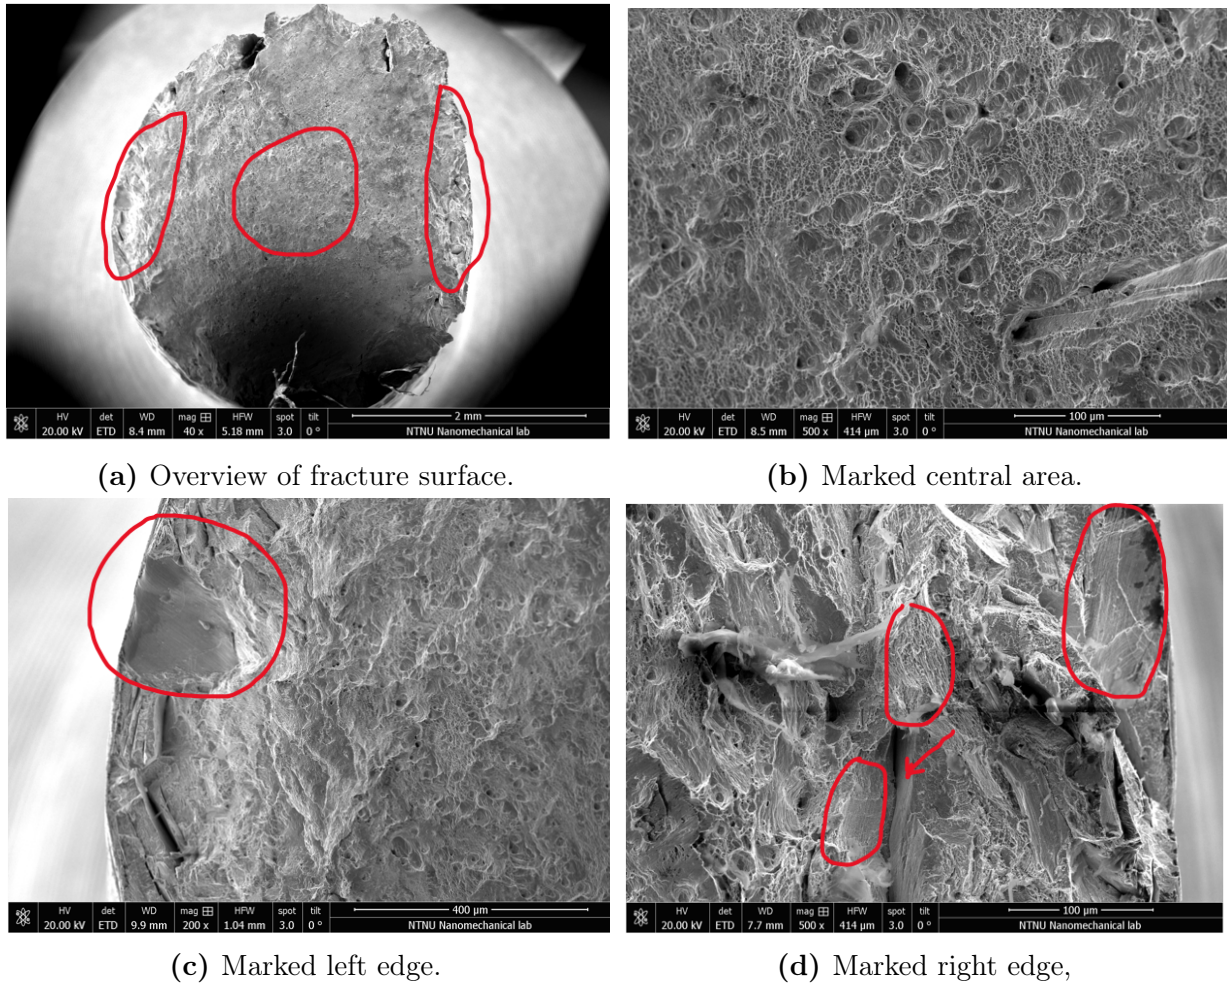
Figure 4.6.12: Overview of fracture surfaces for Sanicro35 from in-situ hydrogen charging in SCL.

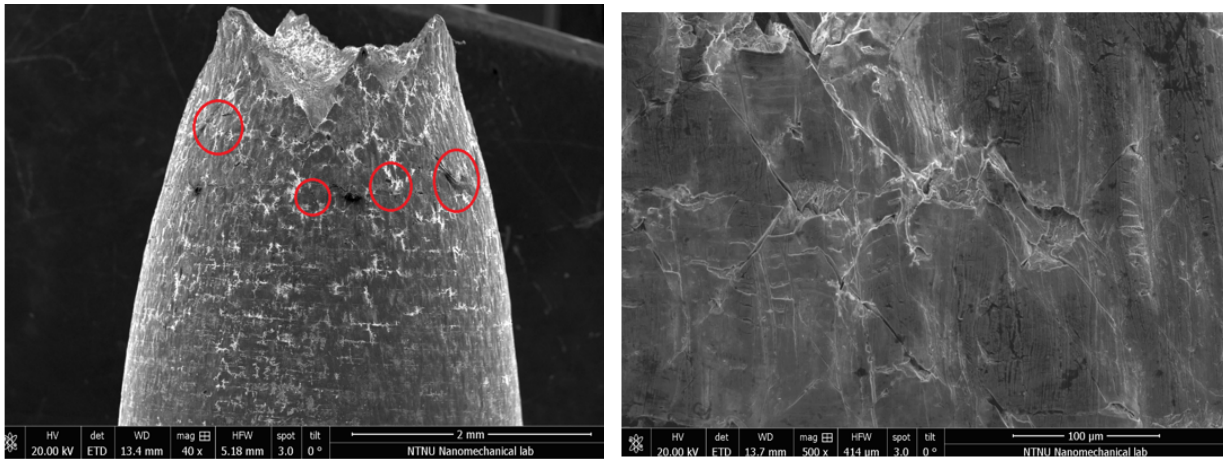
(a) Overview of secondary cracks near fracture surface.

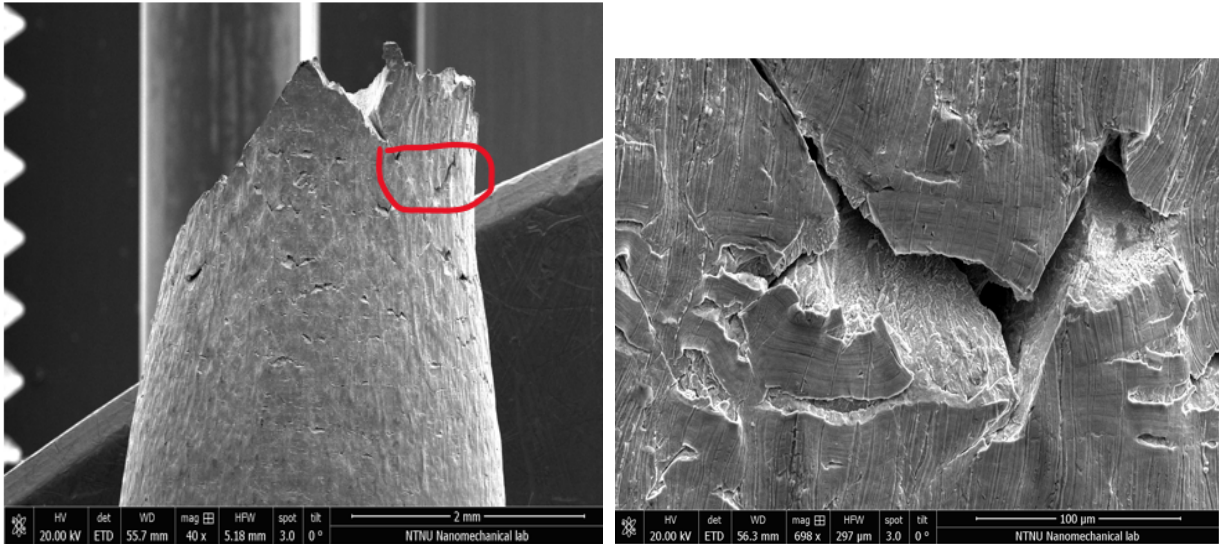
(a) Overview of secondary cracks near fracture surface.

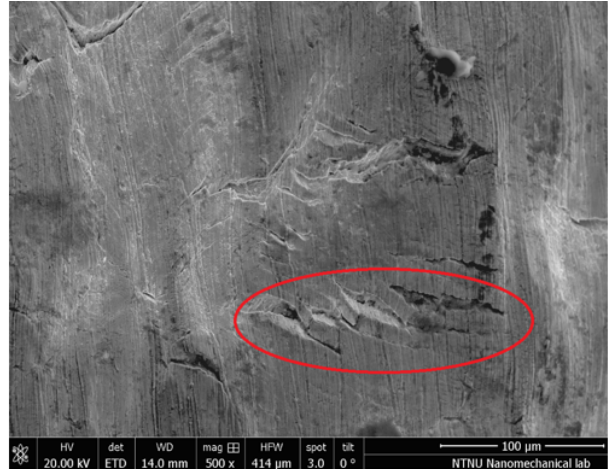
(b) Secondary crack in marked area.

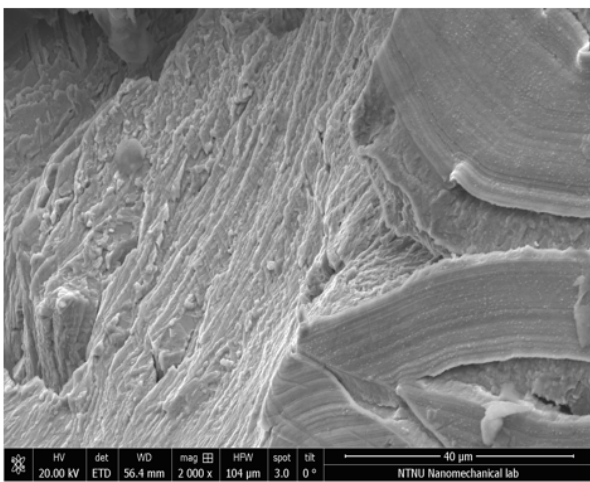
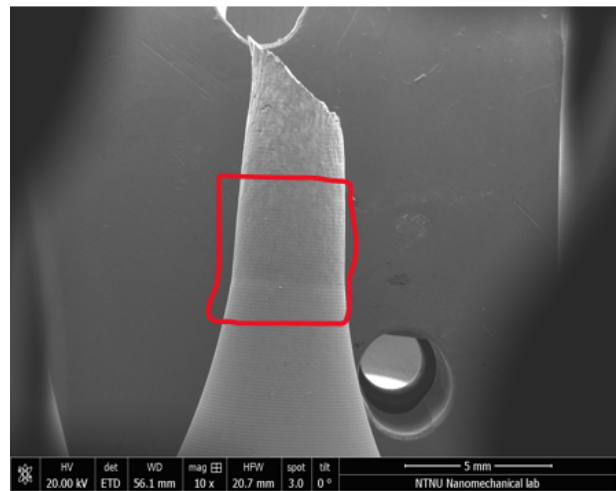
(c) Fracture surface of secondary crack in marked area with 2000X magnification. (d) Overview of gauge section.

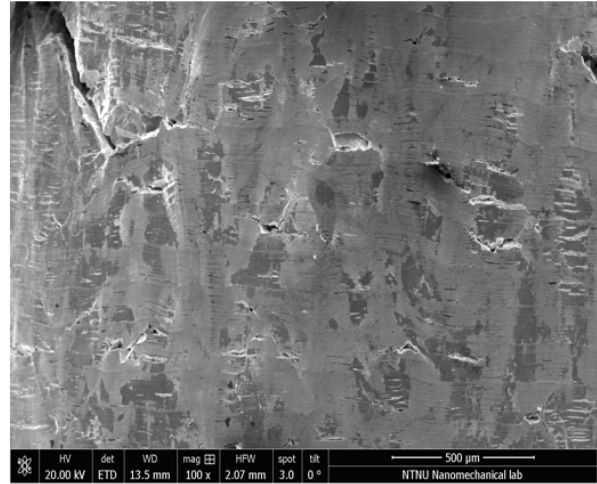
(b) Secondary cracks in marked area.

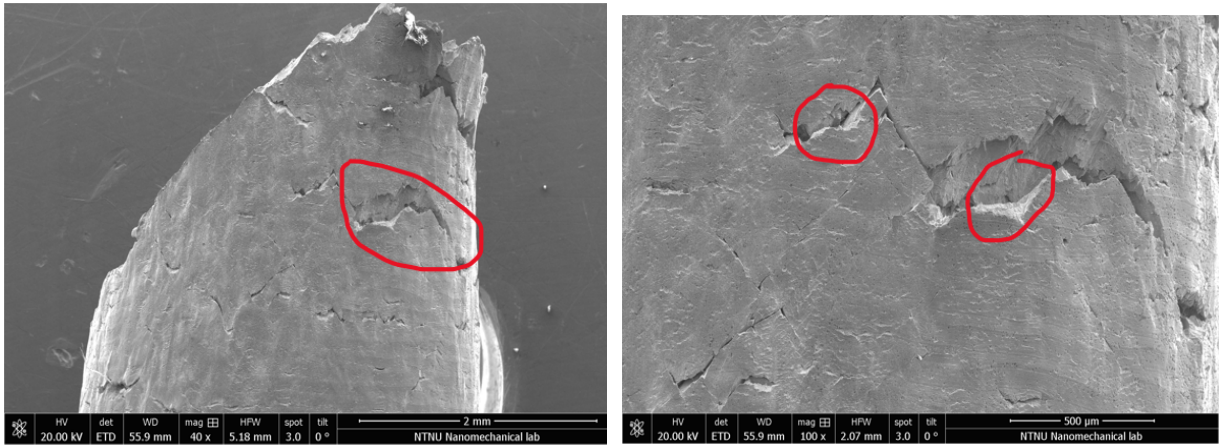
(a) Overview of secondary cracking near fracture surface. (b) Fracture surface of secondary crack in marked area.

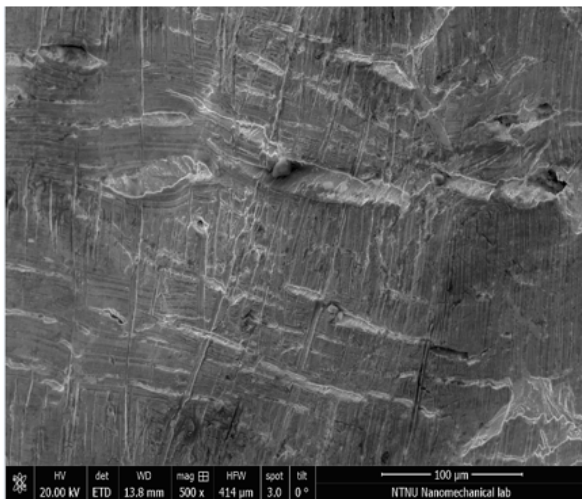
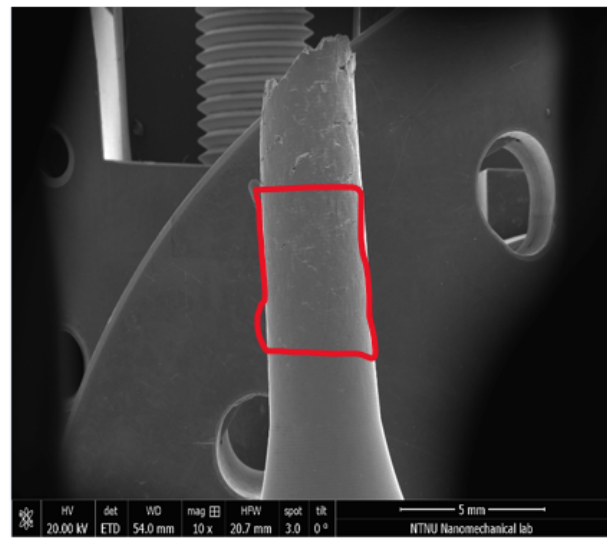
(c) Fracture surface of secondary crack in marked area with 500X magnification

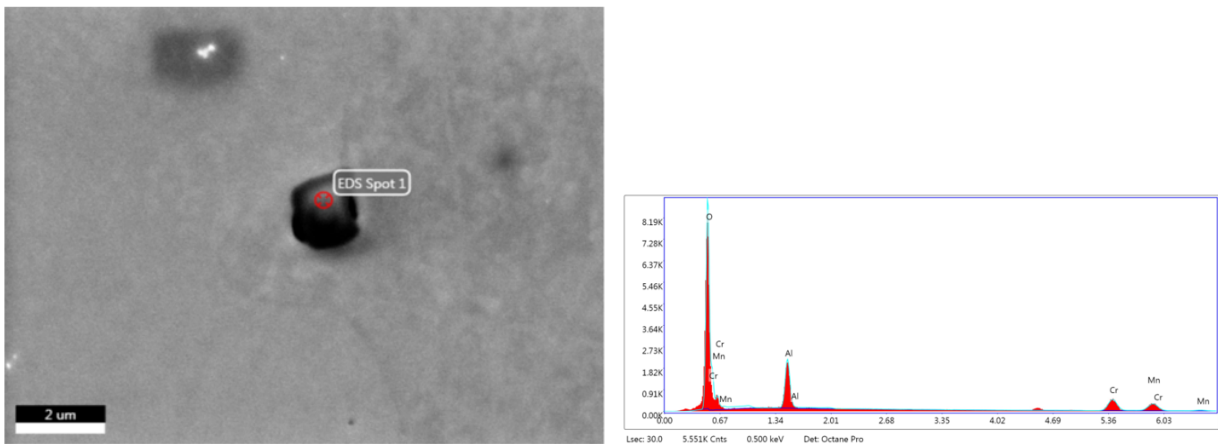
(c) Detected inclusion in microstructure. (d) Chemical assessment of detected inclusion.

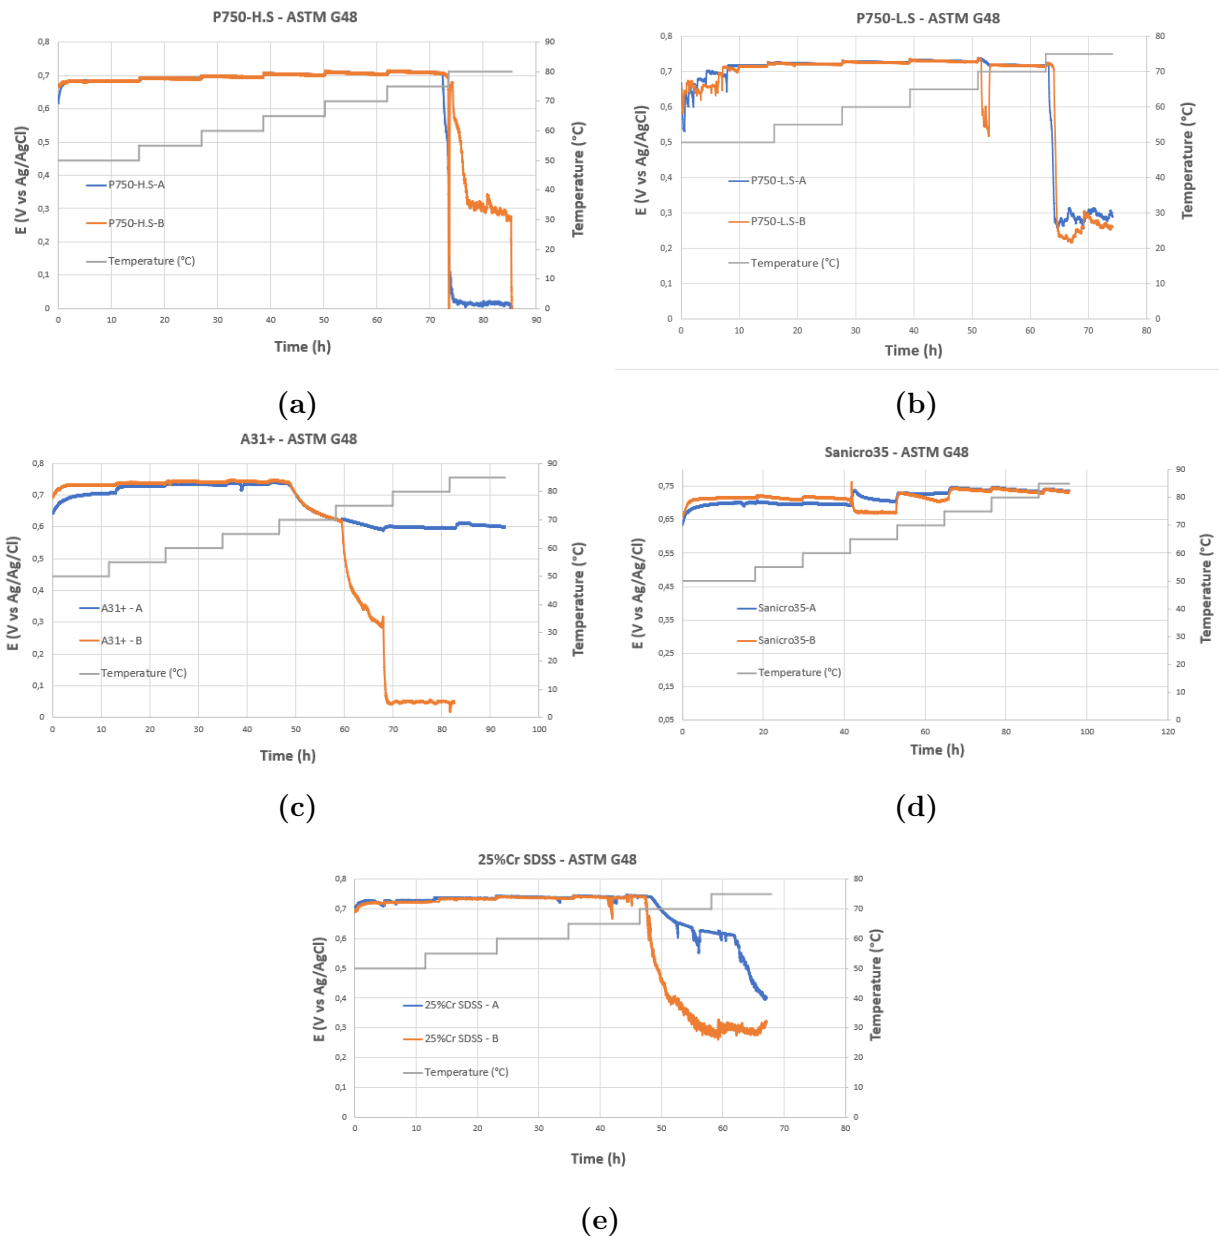
Figure 4.8.1: Potential development and temperature increase as a function of time for alloys investigated by ASTM G48 Method C.

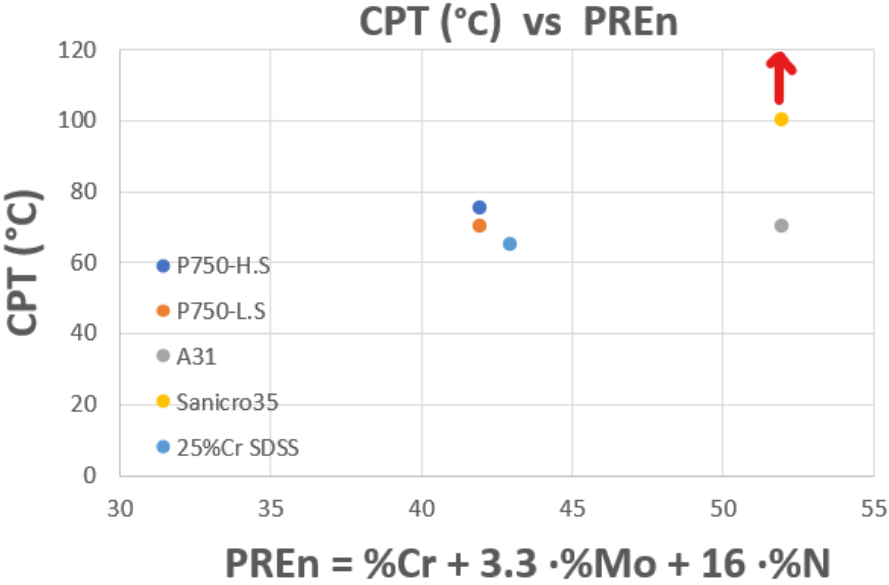
Figure 5.6.1: Correlation between CPT and PREn for alloys investigated.

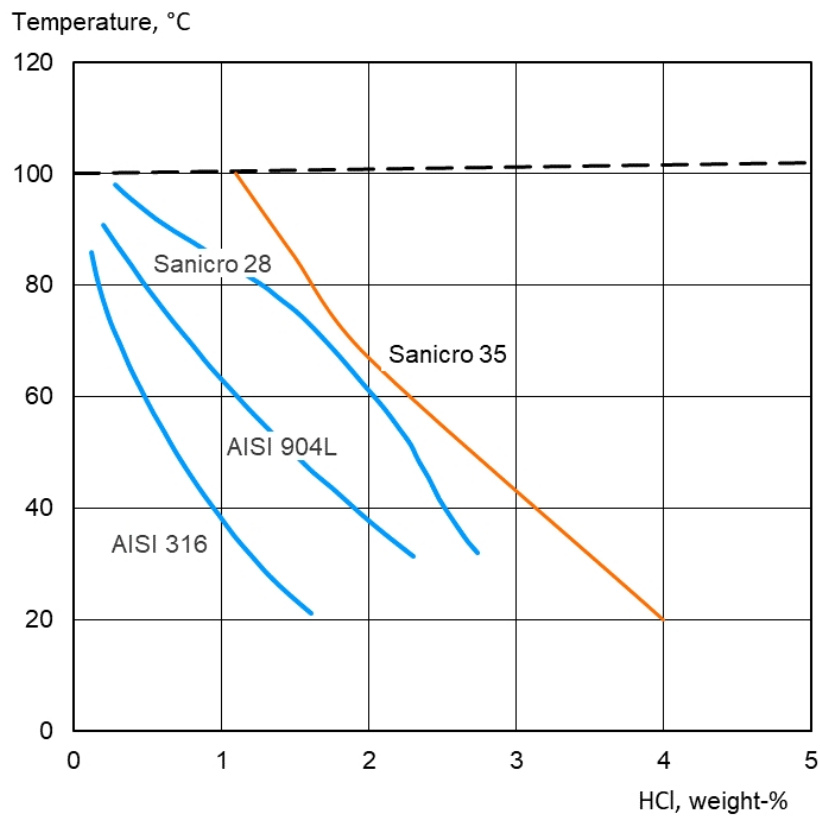
Figure 1. Isocorrosion in hydrochloric acid. The curves represent a corrosion rate of 0.1 mm/year.

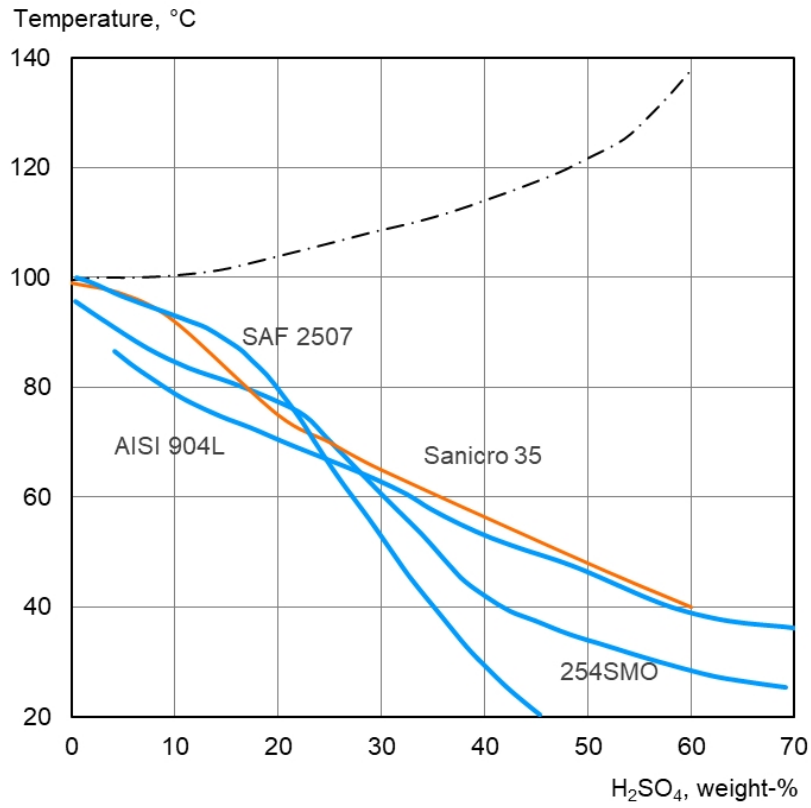
Figure 2. Isocorrosion in naturally aerated sulfuric acid. The curves represent a corrosion rate of 0.1 mm/year.

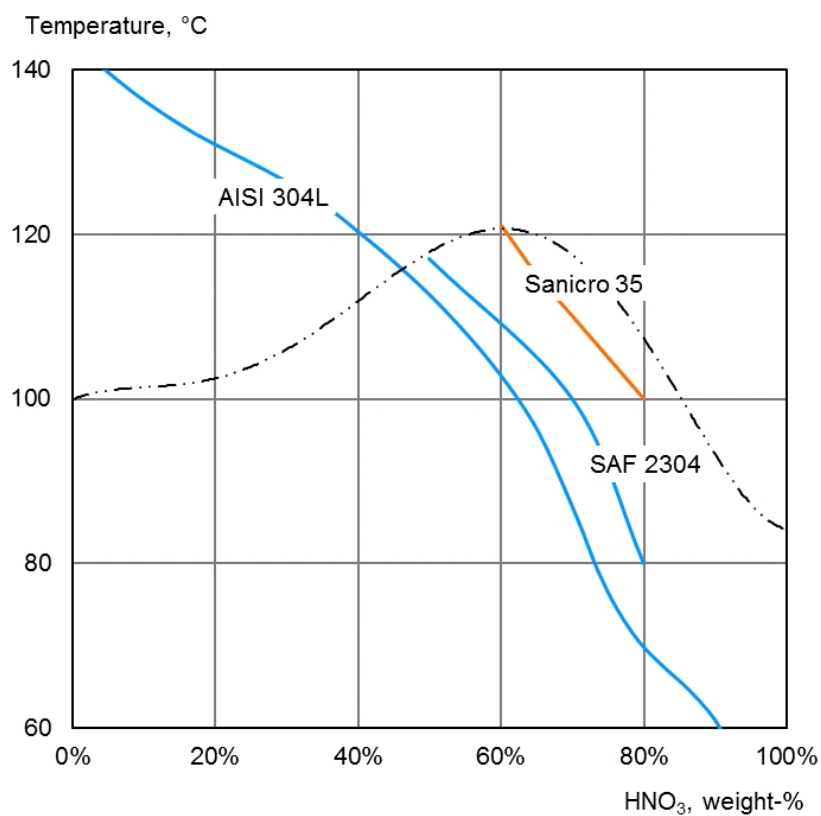
Figure 3. Isocorrosion in nitric acid. The curves represent a corrosion rate of 0.1 mm/year.
