# Analysing the Main Standards for Climate-Induced Mechanical Risk in Heritage Wooden Structures: The Case of the Ringebu and Heddal Stave Churches (Norway)

**Citation:** Califano, A.; Baiesi, M.; Bertolin, C. Analysing the Main Standards for Climate-Induced Mechanical Risk in Heritage Wooden Structures: The Case of the Ringebu and Heddal Stave Churches (Norway). *Atmosphere* **2022**, *13*, 791. <https://doi.org/10.3390/atmos13050791>

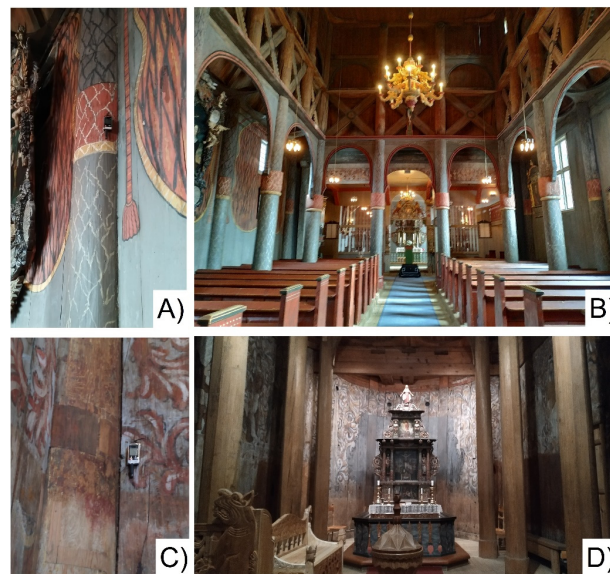
**Figure A1.** Indoor of Ringebu (B) and Heddal (D) stave churches: wooden building assets and altars are visible. The sensors positioned in Ringebu (A) and Heddal (C) are shown as well.
