Template for architectural and energy advice for retrofitting heavyweight non-residential heritage buildings in Norway

A trial demo using an ARV (Climate Positive Circular Communities) project case as reference

Master's thesis in Sustainable Architecture

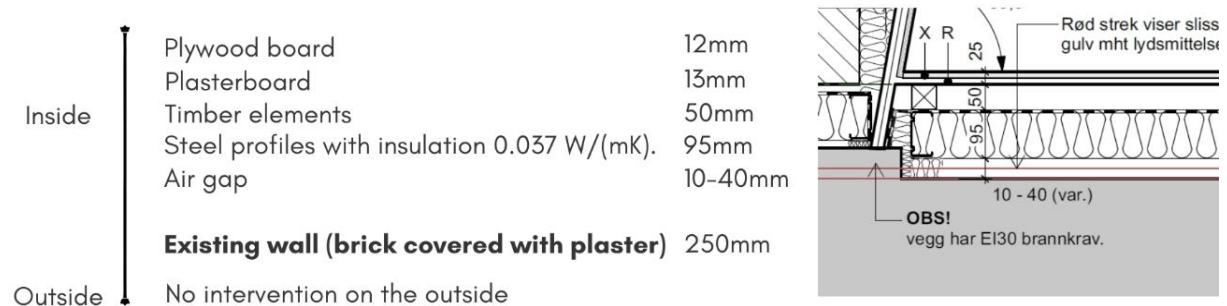
Previous U-value	After intervention U-value
0.30 W/(m ² K)	0.21 W/(m ² K)

Figure 15 Technical detail external wall of the intervention at Voldsløkka school (Taken from ARK documents from Voldsløkka school project)

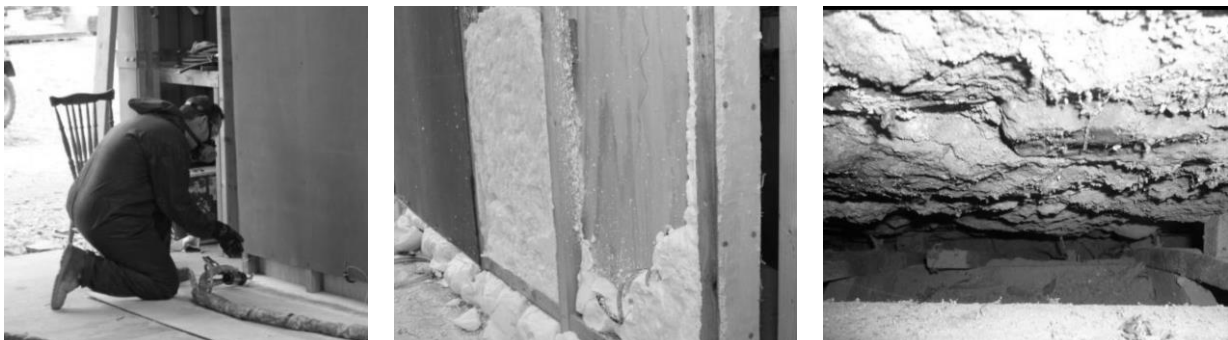
The brick heritage building in question was intervened with a cavity insulation measure. The insulation material is a water blown foam. This type of interventions diminishes the risk of damaging delicate structures, since the foam expands equally and also gives breathability to the interior, controlling the moisture. Since is it done from the inside, the exterior wall can be kept with its original features [73].

Figure 18 Example of cavity insulation of an 18th century house in Scotland. (Taken from Visual documentation process of historic building refurbishment "Improving energy efficiency by insulating wall cavity")

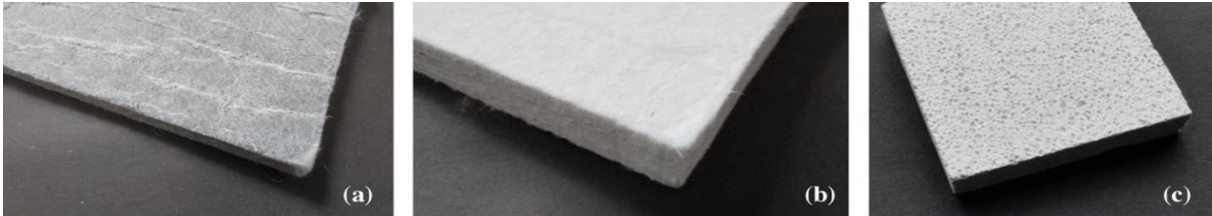
Figure 19 Available aerogel (a) Spaceloft blanket, (b) Heck AERO board, (c) Fixit 222 render (Taken from Aerogel materials for heritage buildings: Materials, properties, and case studies)

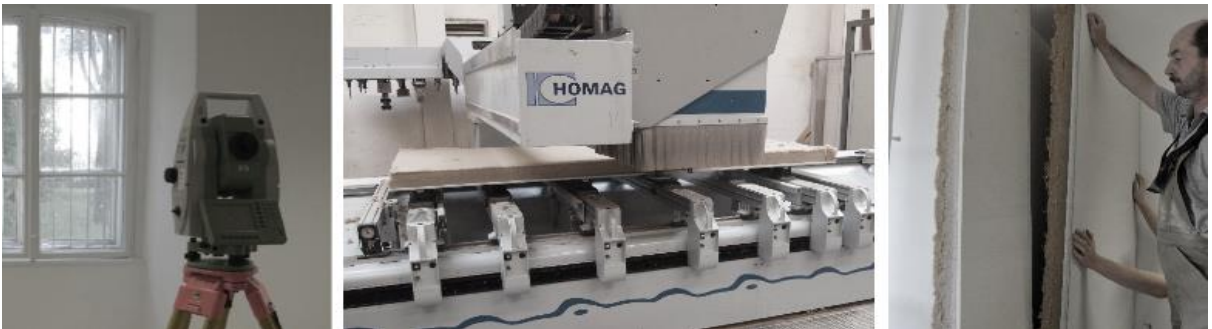
Figure 20 Process of rehabilitation of a wall with wood-fibre insulation (Taken from Developing of an Internal Insulation System made of wood-fibre boards for energy-efficient retrofitting of heritage buildings in Vienna)

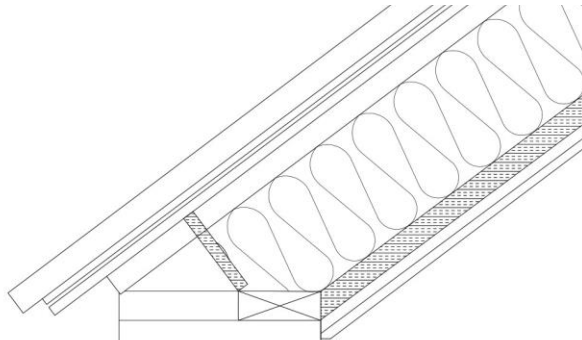
Standing seam metal roof	12 mm
Self-adhered membrane	
TREATED Roof sheeting	15 mm
Vapor barrier in Polyethylene (PE) foil	
Insulation Baffle	36 mm
RE-USED Insulation	300 mm
RE-USED rigid insulation	30 mm
Gypsum board	12 mm

Figure 23 Technical detail of the roof intervention at Skur 38 (Taken and adapted from shared information in FutureBuilt webpage of Skur 38 intervention)

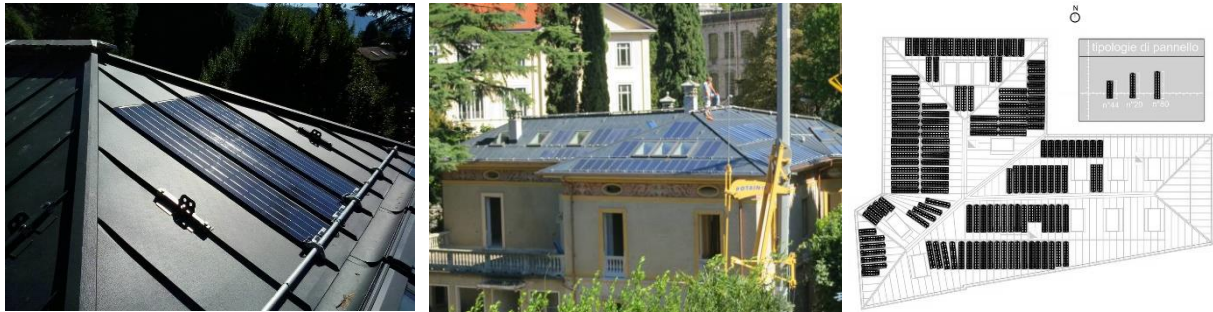
Figure 25 Solar panels implementation in Villa Castelli (Bellano), Italy. (Taken from *Historic Building Energy Retrofit Atlas – HiBERAtlas*)

As a general rule for the heritage aspects, for the current archetype (roof with external heritage protection), solar panels should not be visible from the ground, otherwise, they should merge with the existing roofing in terms of symmetry, colour matching, coplanarity and others [90]. If an intervention as such is pertinent, then it needs to be analysed together with its energy generation potential and other design and economic matters to be implemented.

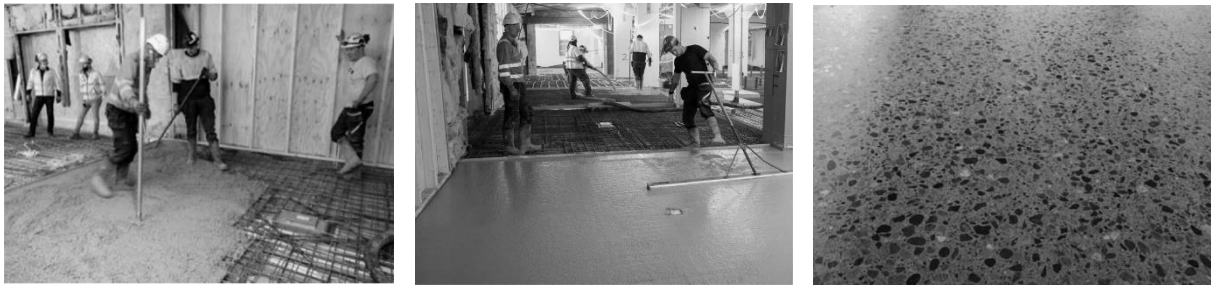
In Skur 38 an innovative material was used. Clay-based concrete. A lower embodied emission material (FutureCEM) compared to traditional concrete (36% emission savings), where burnt clay replaces some of the clinker [96]. Being the first building in Norway to use such material, evidence that despite the building being protected, elements as the ground floor, that in this case are not, can be more manageable and have deeper and more impactful renovations. The new material is complemented with two traditional EPS insulation boards [97].

Figure 30 Visual documentation of Skur 38 intervention to the ground floor

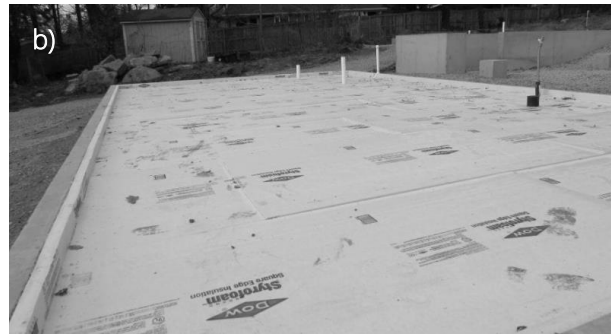
Figure 32 a) Technical detail of a usual upgrading of a concrete slab with insulation (Taken from Housing Retrofit: Ground floor insulation) b) Image of an insulation installation in a former garage to become a habitable space. (Taken from How to Insulate an Existing Concrete Slab <https://todayshomeowner.com/insulation/guides/how-to-insulate-an-existing-concrete-slab/>)

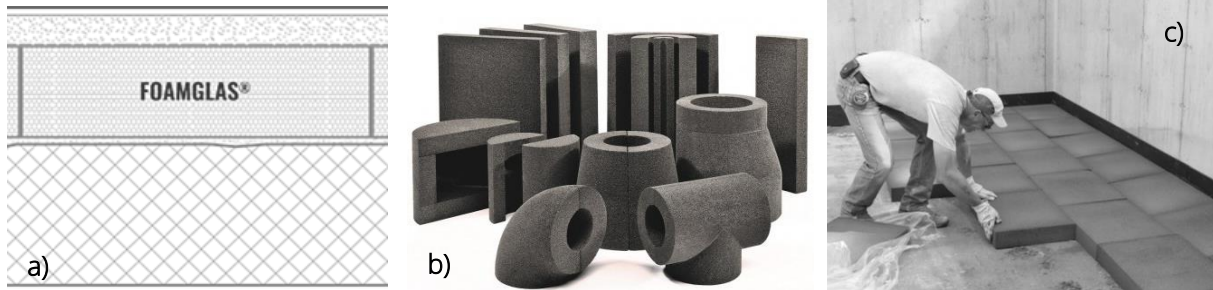
Figure 33 a and b) Foam glass installation and visual appearance of it (Taken from Foamglas <https://www.foamglas.com/en/references/netherlands/walterboscomplex-apeldoorn>) c) Example of installation of Foam glass (Taken from On the Jobsite with Foamglas <https://www.greenbuildingadvisor.com/article/on-the-jobsite-with-foamglas>)

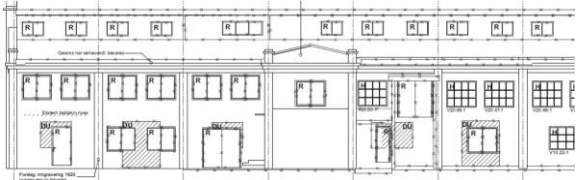
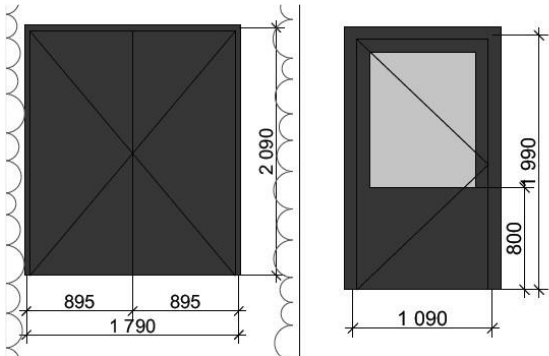
Previous U-value	After intervention U-value
Not mentioned	Doors: 1.20 W/(m ² K)
<p>New exterior doors</p> <p>Different types of doors Wood Wood + Glass</p>

Figure 36 Typologies of doors and their replacement in the façade at Skur 38 intervention (Taken from ARK documents from Voldsløkka school project)

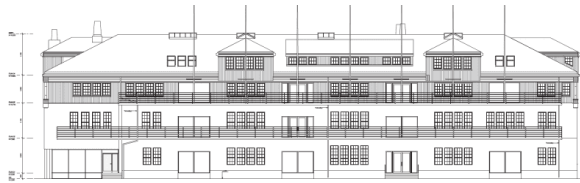
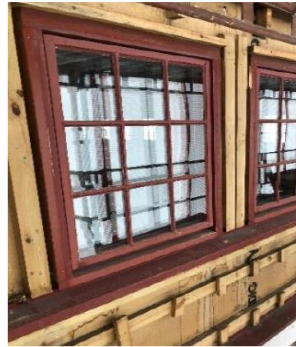
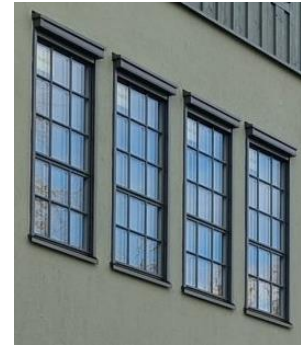
Figure 37 Intervention on the façade of Skur 38, with previous windows and the new installation. (Taken from FutureBuilt Skur 38 <https://www.futurebuilt.no/Forbildeprosjekter?municipal%5B%5D=oslo#>)
