# Corrosion of AISI 316L in Fish Processing Facilities

The Effect of Operational Conditions,  
Maintenance Procedures, and Biofilm

Master's thesis in Mechanical Engineering

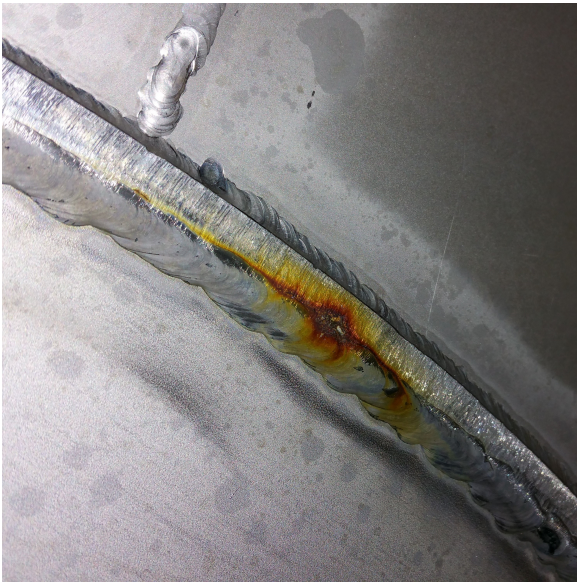
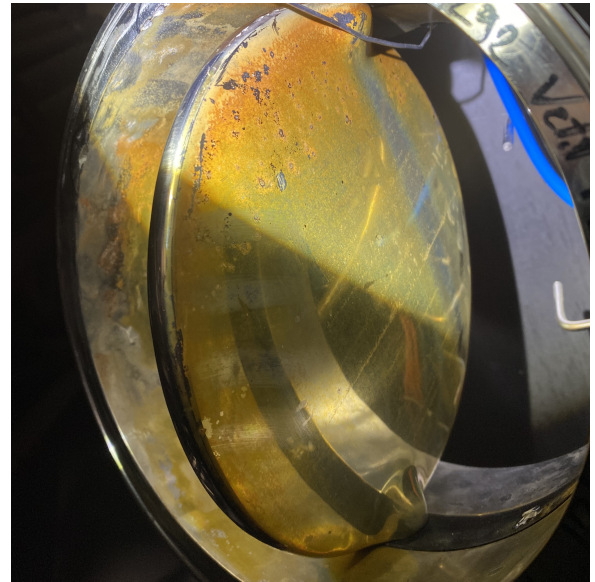
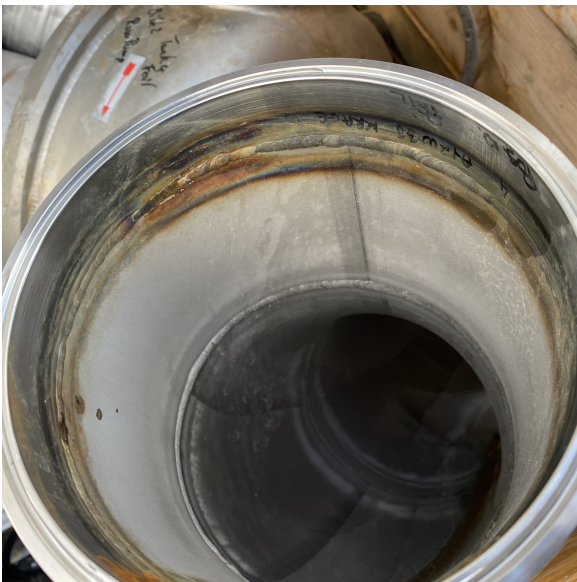
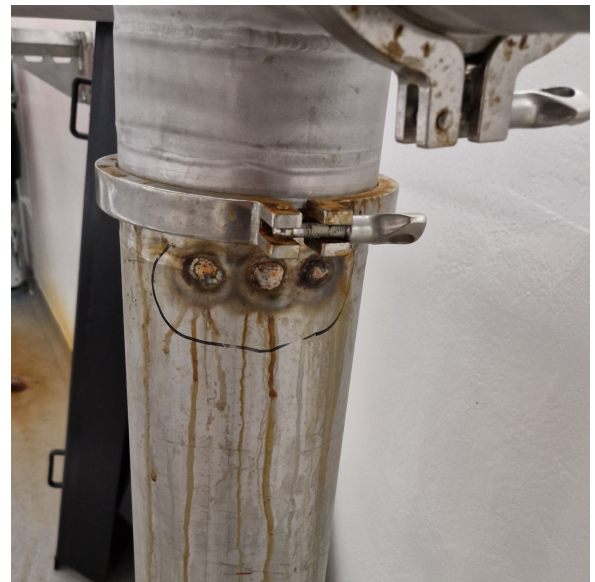
**Figure 1.3.:** Corrosion damages in different facilities.

(a) Weld pitting at Mowi Ulvan

(b) Valve corrosion at InnovaNor

(c) Internal weld corrosion at InnovaNor

(d) Pitting repairs at InnovaNor

Table 1.1 shows some of the numerous instances of corrosion-related failures in these facilities discovered during the pre-study to this project [1]. Some of these failures are also shown in Figure 1.3. It's worth noting that since pitting corrosion is prevalent in most of the facilities, it's likely that conditions are also suitable for crevice corrosion, as explained in subsection 2.2.3. Interestingly, findings of crevice corrosion were only uncovered during the survey of visited facilities, implying that there could be an underreporting of this corrosion mechanism by the facilities themselves, and a lack of knowledge about this corrosion mechanism.

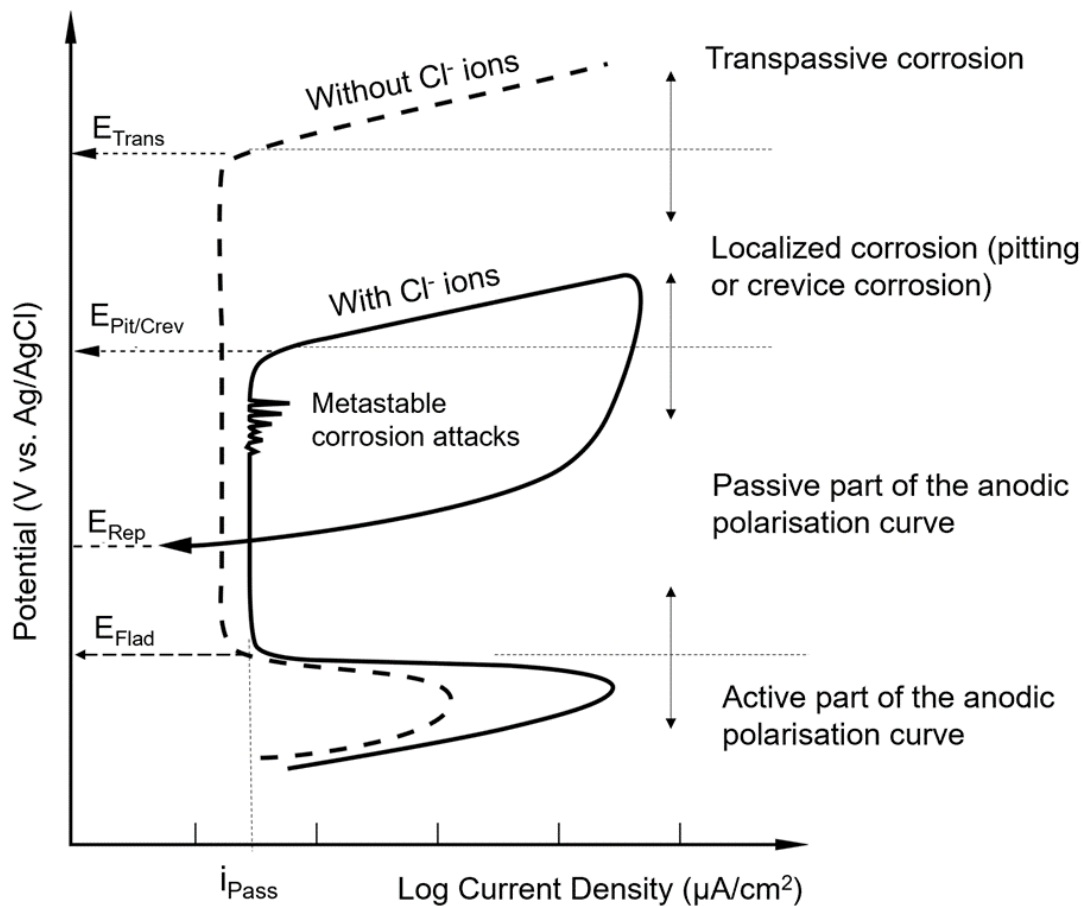
**Figure 2.1.:** Evans diagram showing corrosion rate compared to potential for chloride-containing and non-chloride-containing environments.

The conditions in which the passive film can form are illustrated in Figure 2.1 where the potential is the given potential of the metal in the electrolyte, and the corrosion current is the rate of the anodic reaction, which is explained further in section 2.2.

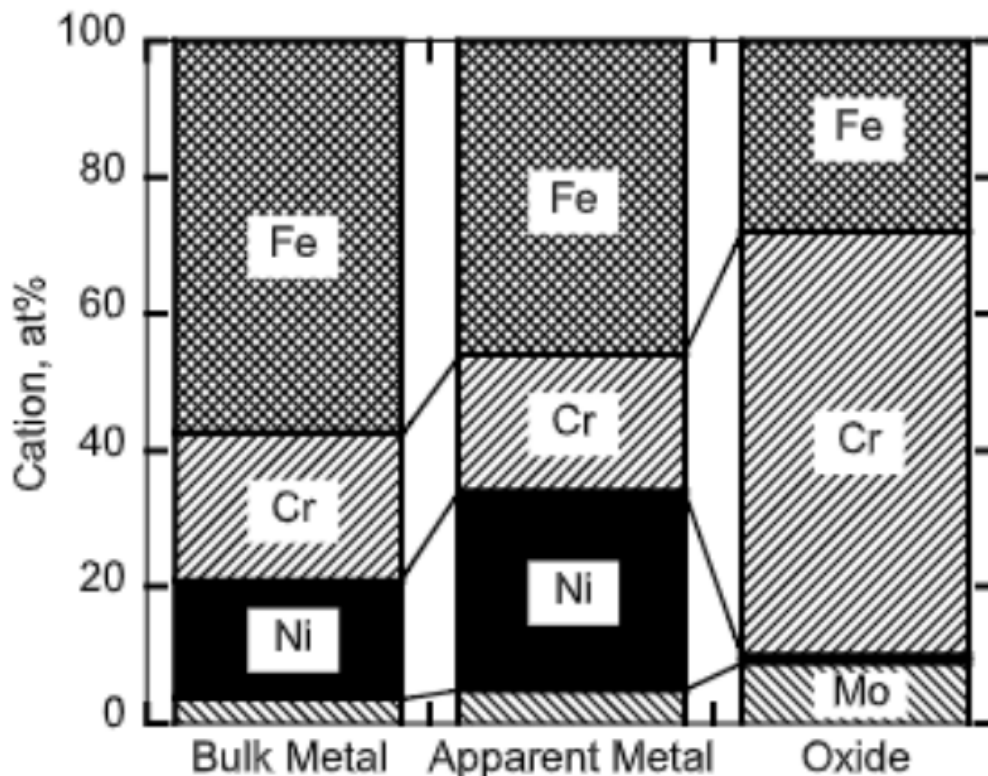
**Figure 2.2.:** Alloy composition in bulk metal and passive film [10].

The composition and structure of the passive film formed on austenitic steels vary depending on the pH of the electrolyte. The passive film will normally consist of an outer hydroxide layer and an inner oxide layer, mainly consisting of iron, chromium, and molybdenum, where molybdenum will occur in different oxidation states in the oxide and hydroxide layer [10]. The metal right under the oxide layer will appear to have a higher concentration of nickel since it will not contribute to the formation of the passive film, and stay dissolved in the austenitic structure. This mechanism is illustrated in Figure 2.2.

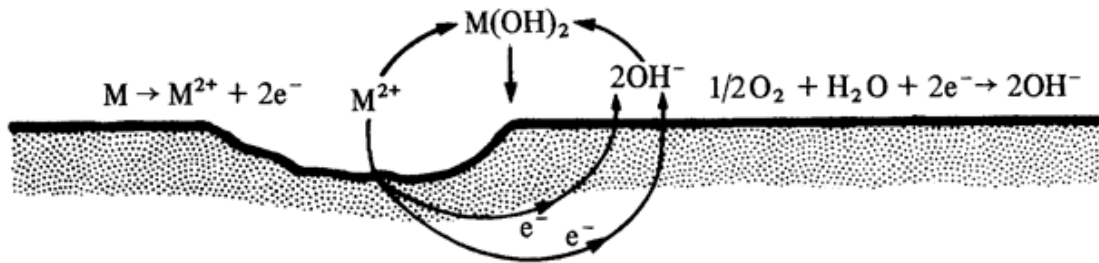
**Figure 2.3.:** Mechanism of corrosion in aqueous solution [34].

Figure 2.3 illustrates how corrosion in general occur in an oxygen-rich environment, where the oxidation of a bivalent metal is the anodic reaction letting metal ions into solution, while oxygen reduction occurs at the surface of the metal, producing hydroxide, which in turn react with the metal ions forming metal hydroxide, completing the electrical circuit by mitigating the buildup of charges.

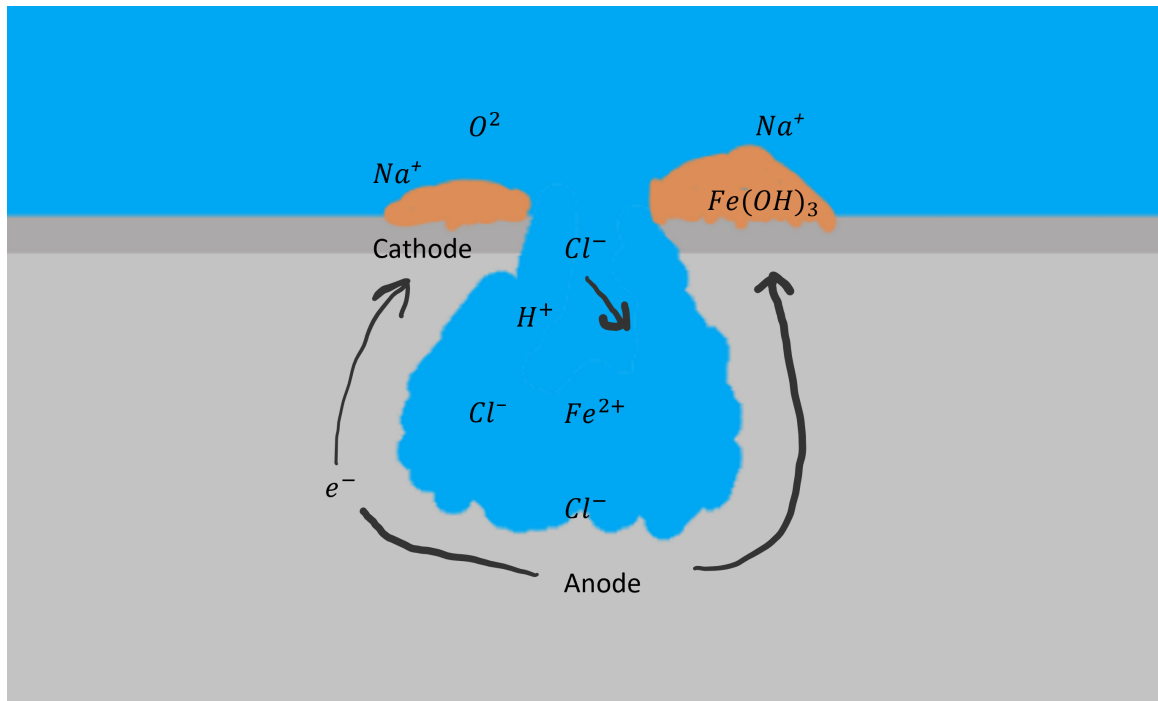
**Figure 2.5.:** Mechanism of pitting corrosion [1].

The localized corrosion can penetrate constructions at a much faster rate than general corrosion [39], and can in facilities cause spontaneous leaks in piping systems.

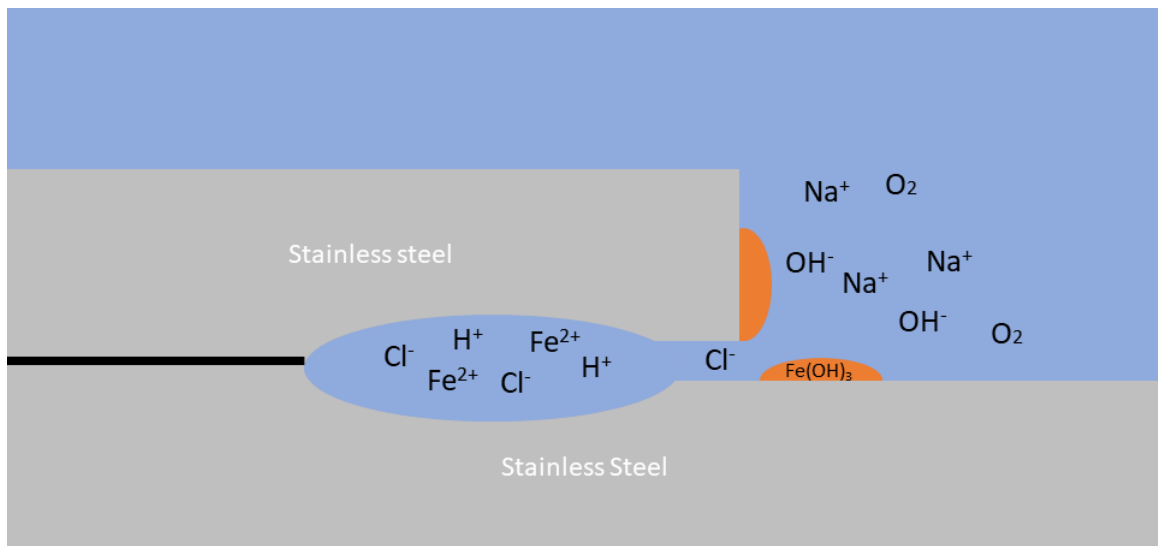
**Figure 2.6.:** Mechanism of crevice corrosion [1].

Crevice corrosion follows a similar mechanism as pitting corrosion, but it occurs in small gaps or crevices within the construction. As with pitting, to initiate crevice corrosion, a certain potential  $E_{crev}$  must be reached. Whereas in pitting, an initial region with oxygen depletion has to be formed, in crevice corrosion, the gap acts like the initial pit and allows oxygen depletion to occur. This will in turn create similar conditions as in the pit, although at a larger scale. This mechanism is shown in Figure 2.6 for a crevice between two stainless steel plates. However, non-metallic components like rubber gaskets and any other object that can form small gaps between itself and a metal substrate can cause crevice corrosion initiation [34]. An important note is that crevices will have a capillary effect, which can cause small gaps exposed to a humid, chloride-containing environment to accumulate water and similarly initiate corrosion even though there is little exchange of ions with an external electrolyte.

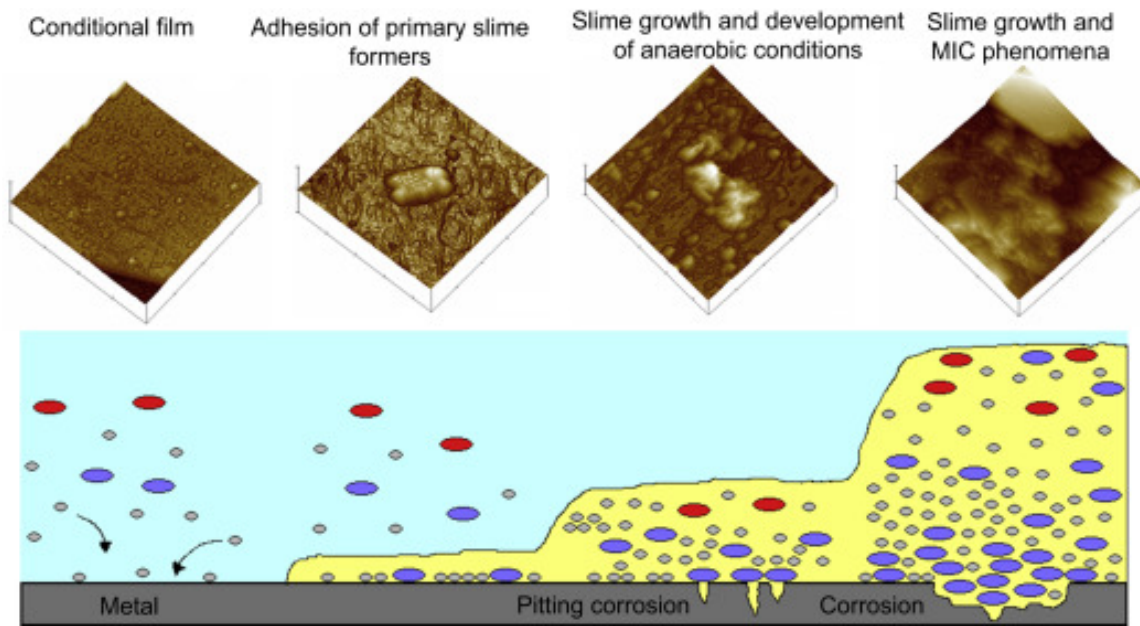
Figure 2.7.: Evolution of biofilm, and initiation of MIC [40].

Other factors like the change in pH under the biofilm and the fact that the biofilm acts like a physical barrier to the bulk solution can also be enabling factors in the increase of the OCP. As described in subsection 2.2.2, in order to begin pitting, the metal has to exceed  $E_{pit}$ . Hence the formation of biofilm can cause the initiation of pitting corrosion even though the conditions in the bulk solution would not facilitate this. The evolution of the stages from initiation to fully developed MIC can be seen in Figure 2.7, where the buildup of different bacteria and the encapsulation in EPS is shown together with Scanning Electron Microscopy (SEM) images of the corresponding stage. This illustration does not show which reactions occur under the biofilm since this can vary depending on what bacteria are present in the film [40].

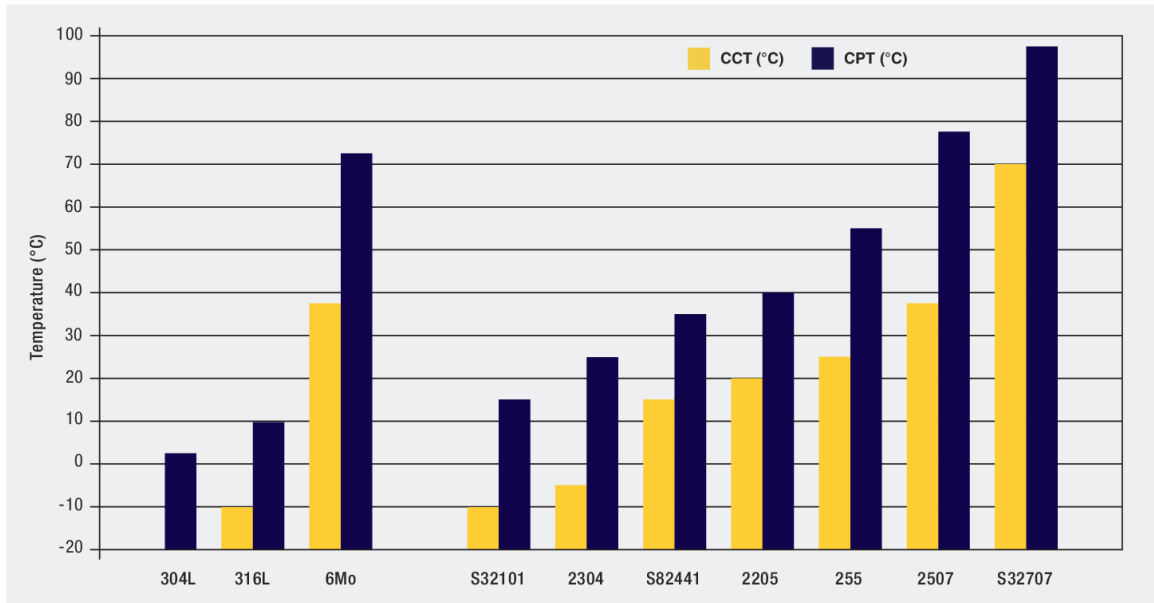
**Figure 2.9.:** Critical Pitting and Crevice corrosion temperature of selected stainless steel alloys (evaluated in 6% ferric chloride by ASTM G 48) [11].

General metal dissolution does not normally occur on AISI 316 in seawater since it will normally be passivated. However, if the temperature is high enough, pitting or crevice corrosion may occur, which in turn can cause active corrosion. The temperature at which stable pitting may occur is referred to as the metals Critical Pitting Temperature (CPT). A similar temperature relation is found as the Critical Crevice corrosion Temperature (CCT), and this is lower than the CPT. Due to the semi-random nature of pitting corrosion, it is challenging to predict the CPT and CCT for a specific situation.

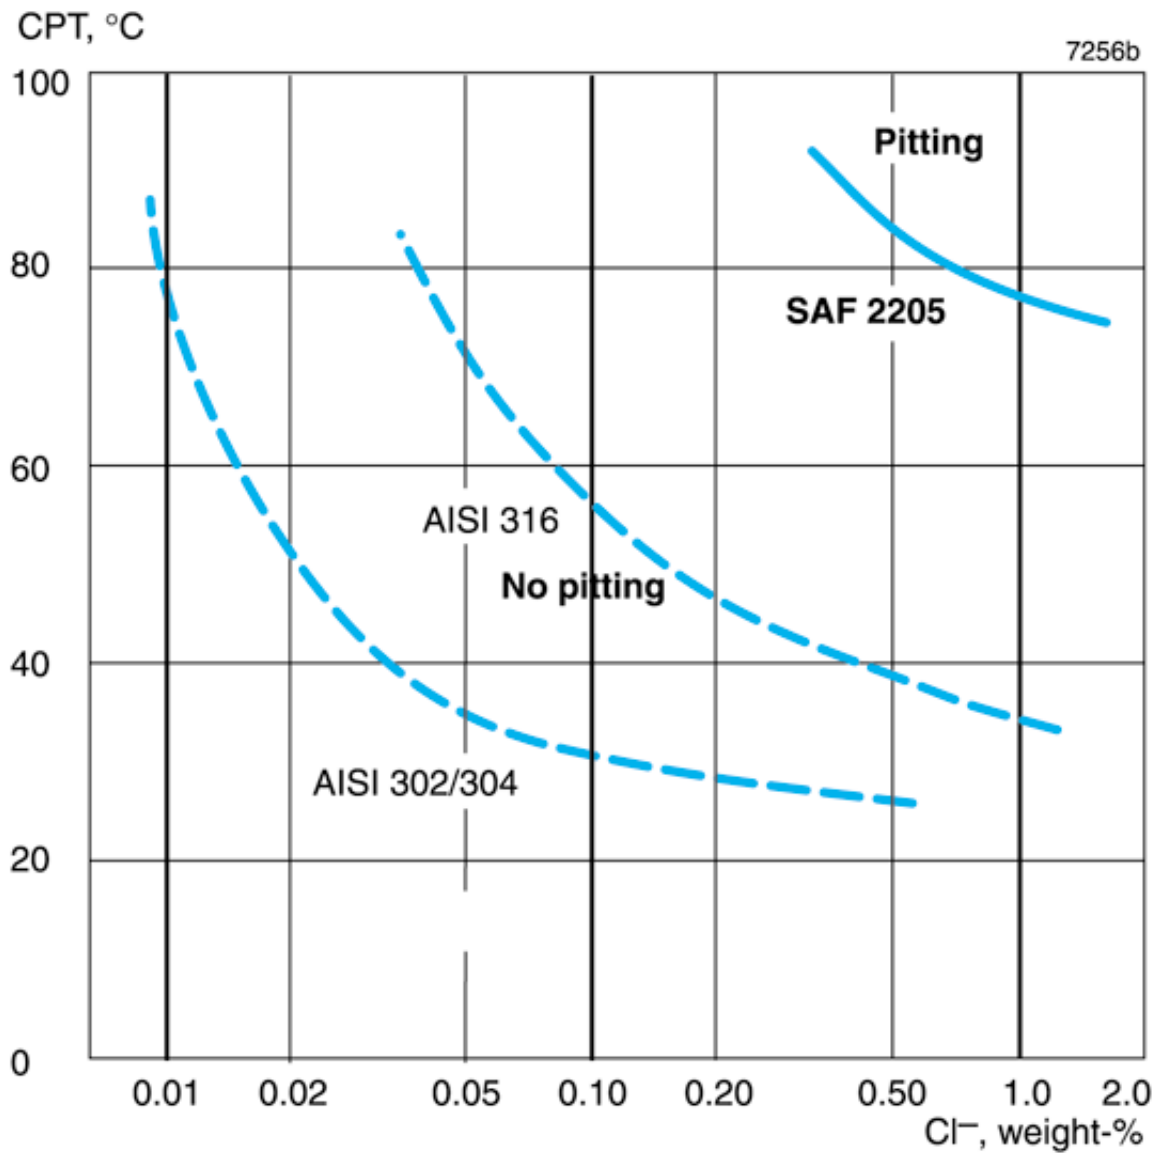
Figure 2.10.: CPT of selected stainless steel alloys in different Cl concentration [48].

as many chemical reactions will happen faster at elevated temperatures.

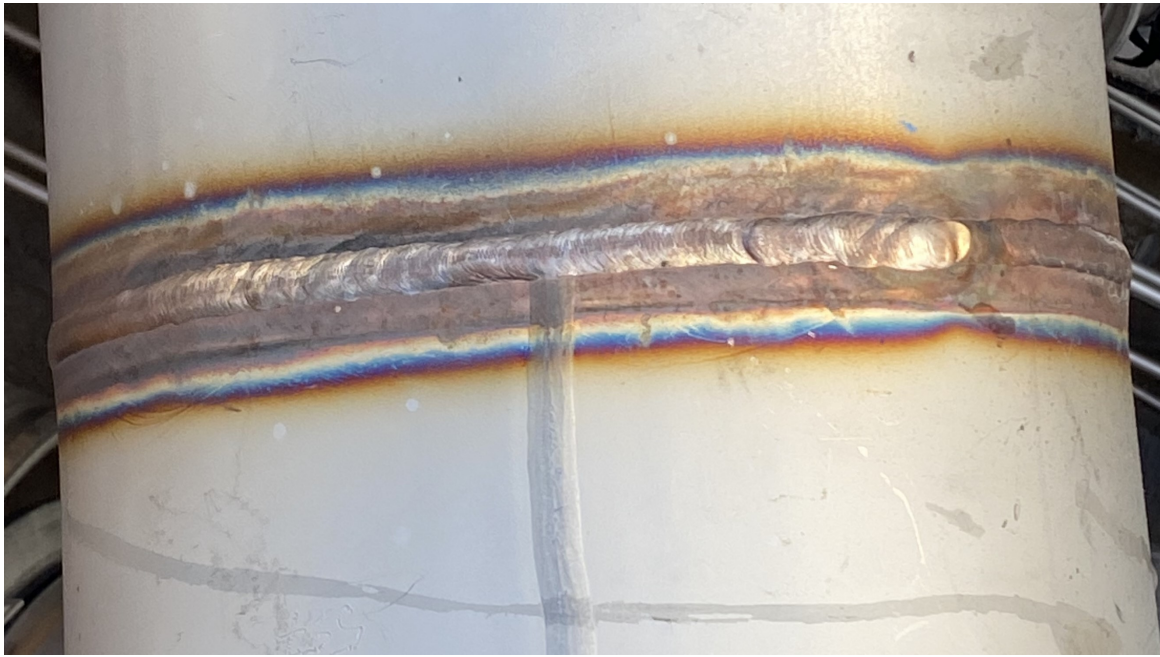
**Figure 2.11.:** Poor weld of AISI 316L piping at InnovaNor, with significant discolouration. The vertical seam is properly welded and post-treated, with no signs of discolouration.

An example of improper weld procedures is seen in Figure 2.11, where visible discolouration is seen. This corresponds well with the example weld in Figure 2.12.e) or f). A weld with sufficient shielding would have little to no discolouration, as seen in Figure 2.12.a. This resembles the vertical weld seen in the bottom half of Figure 2.11.

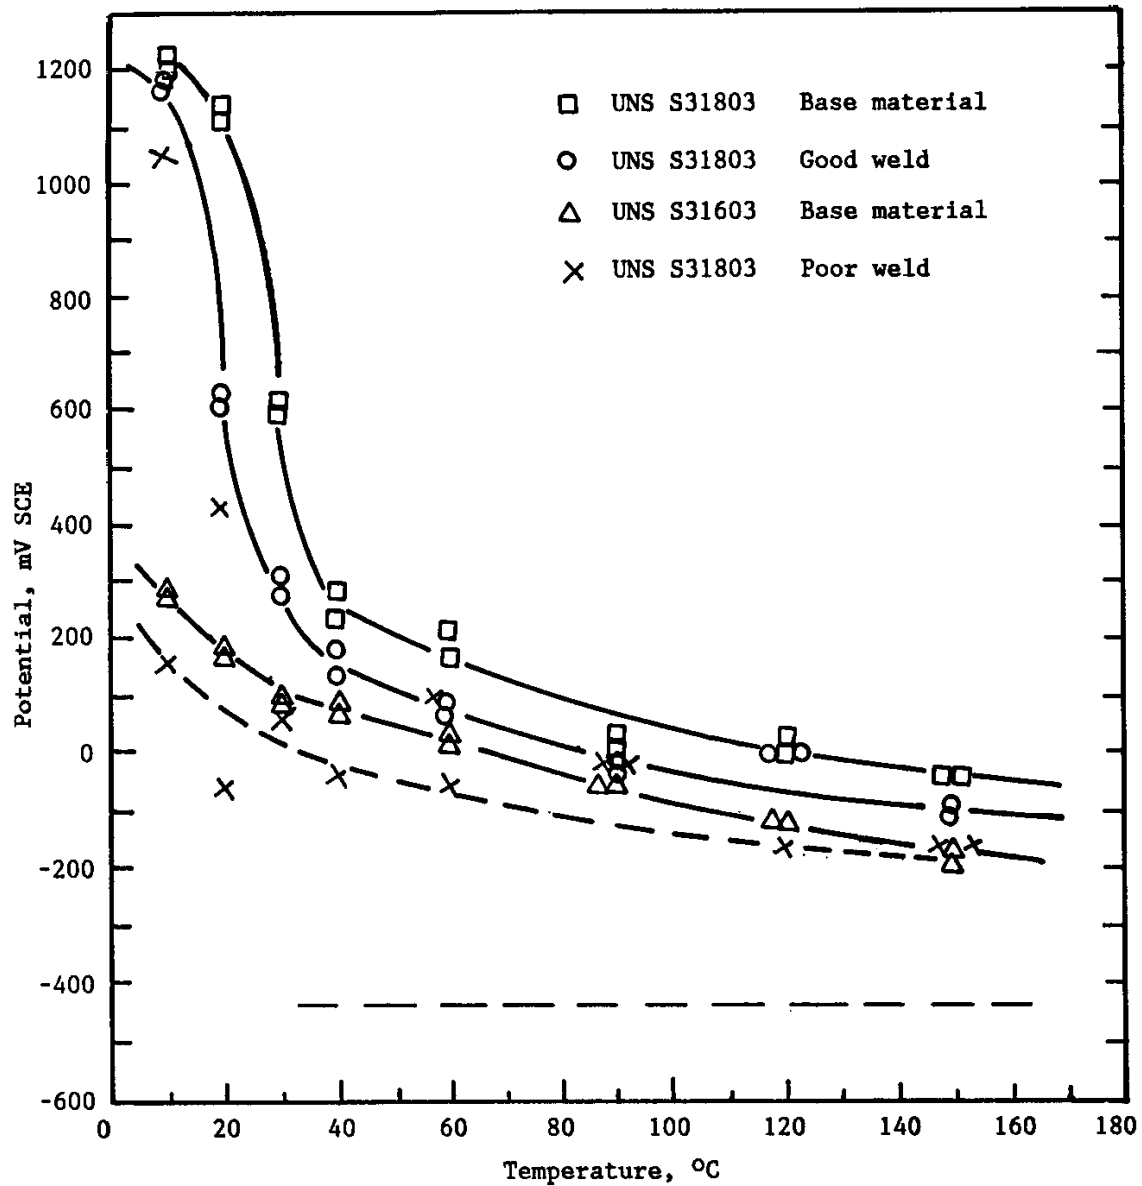
**Figure 2.13.:** Critical potential vs temperature determined by use of long duration tests in 3% NaCl at 2.5 bar CO<sub>2</sub> for base material of UNS S31803 and base material of UNS S31603 (AISI 316L) and good and poor quality welds of UNS S31803. [55]

Figure 2.13, show the relation between temperature and the potential at which pitting can occur on different alloys and weld qualities. At lower temperatures,  $E_{crev}$  is drastically lowered on a poor weld compared to a good weld. Though different from AISI 316L, the trend does still apply.

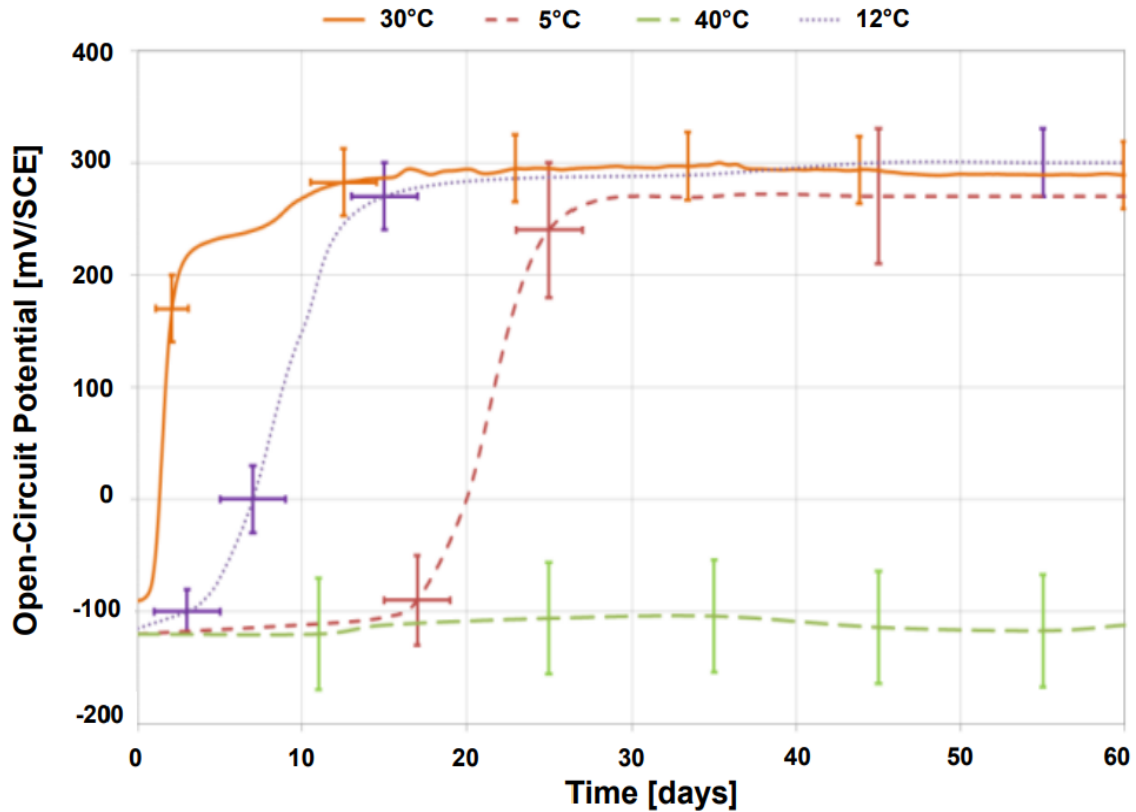
**Figure 2.14.:** Open Circuit Potential development at different temperatures, due to biofilm formation. No ennoblement indicates that no biofilm is formed [56].

As seen in subsection 2.2.4, biofilm formation will affect the OCP evolution of AISI 316L, which in turn can cause the onset of pitting or crevice corrosion. The rate at which this biofilm forms, hence changing the OCP, is highly dependent on temperature. This effect can be seen in Figure 2.14, where the fastest biofilm formation occurs at 30°, with decreasing speed at lower temperatures due to a longer incubation time of the film. At 40°C, the biofilm no longer forms, and no ennoblement is seen. These exact temperature relations will be dependent on location in the world [56]. Light level can also affect the onset of biofilm [41].

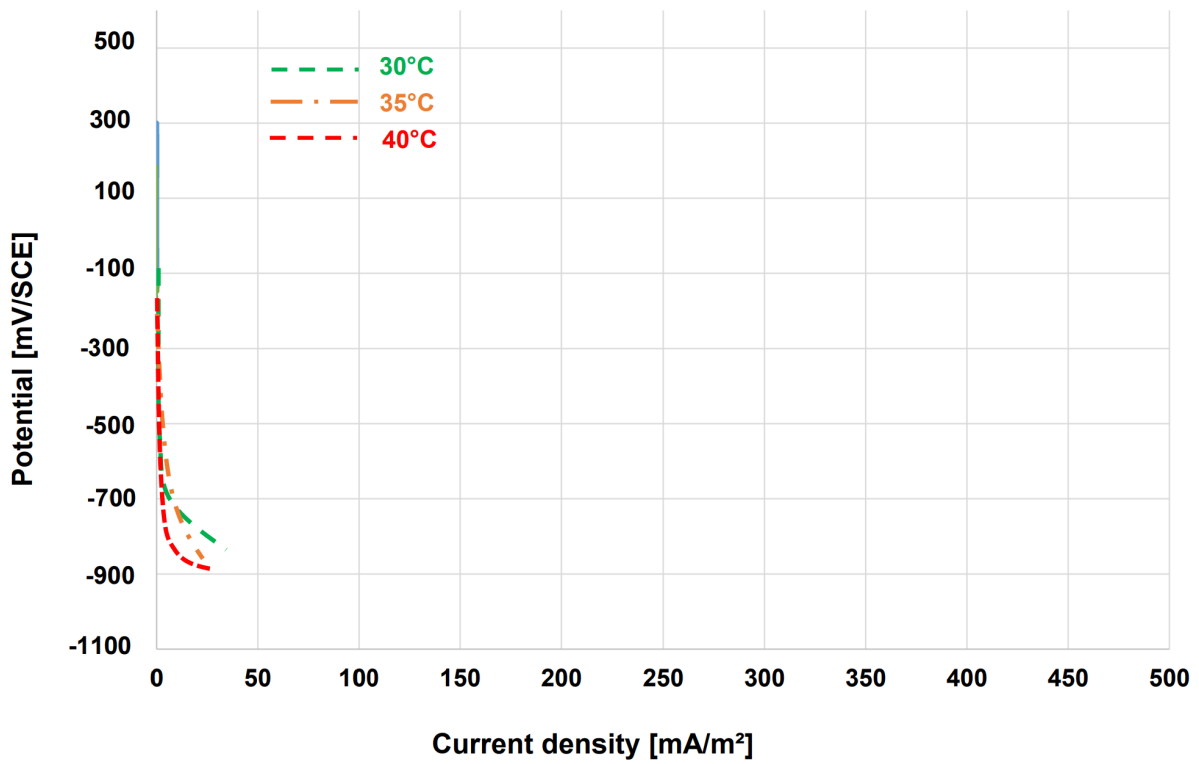
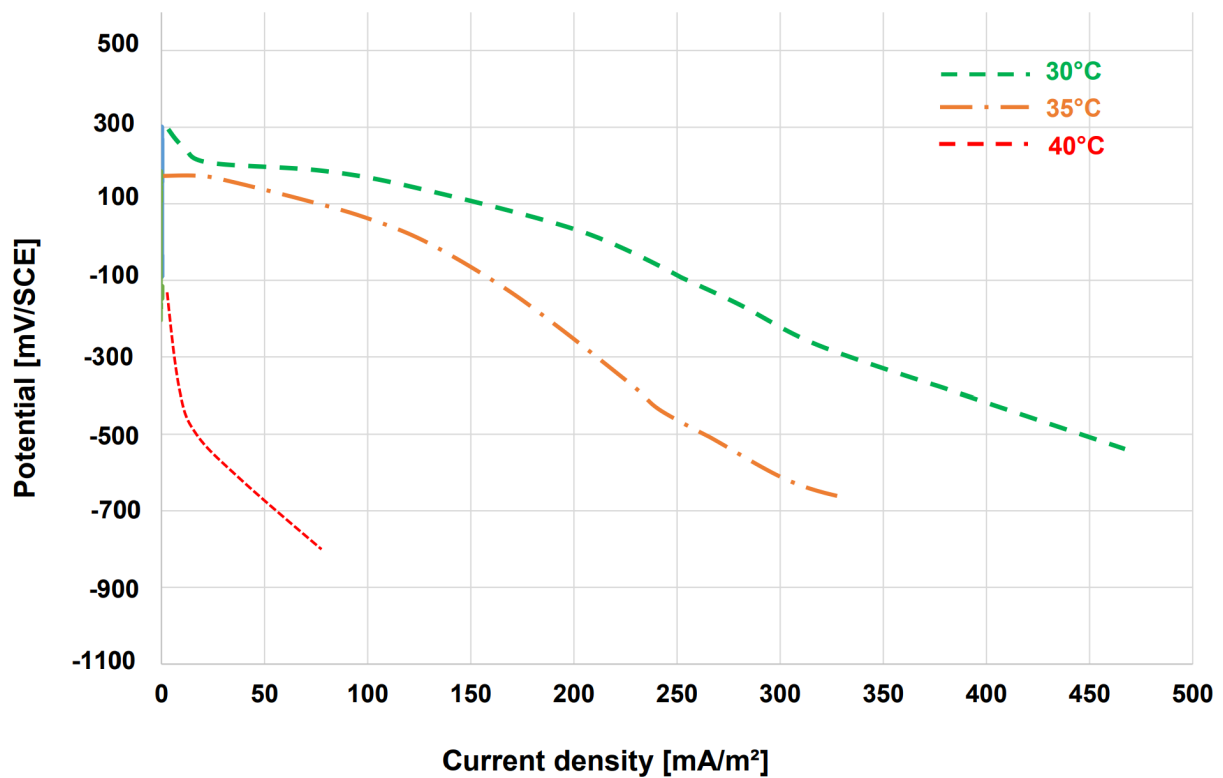
By connecting samples of 25Cr SDSS to a sacrificial anode through a shunt resistor, and measuring the cathodic current, pseudo-polarization curves were made by Larche et al [56]. These curves, seen in Figure 2.15, show the cathodic current demand of the stainless steel drastically increases with the onset of biofilm, indicating the initiation of pitting. It is important to note that this current reduction is specific for 25Cr SDSS as lower alloyed metals can initiate pitting at these temperatures without the onset of biofilm. The trend is nevertheless relatable to current demand with and without the onset of biofilm in regard to pitting corrosion.

(a) Cathodic current before biofilm formation

(b) Cathodic current after biofilm formation

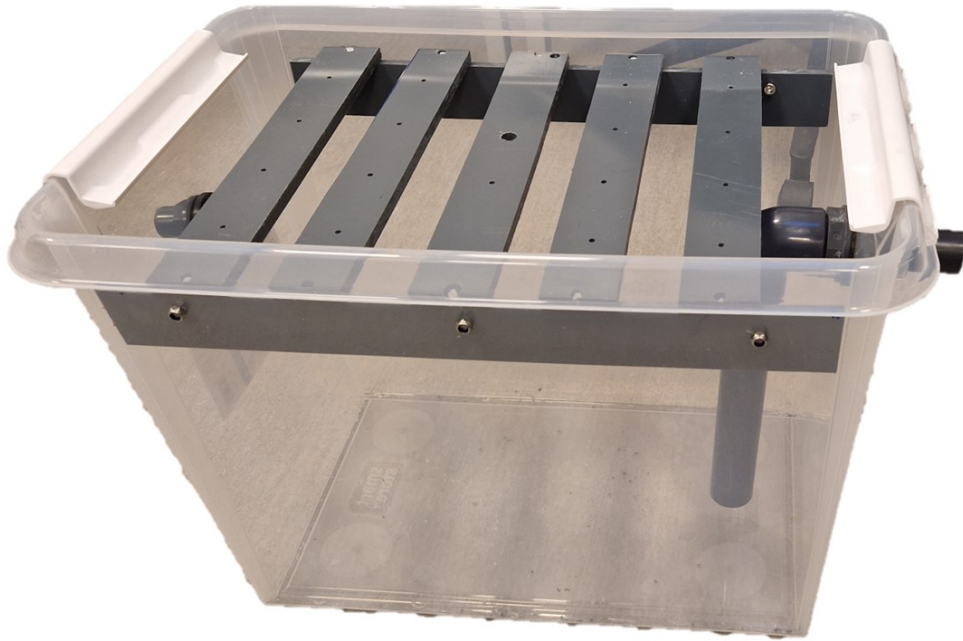
**Figure 3.1.:** Test chamber during the design stage.

To hold all the samples in place, a mount was designed consisting of two girders along the length of the box, with overlaying beams to hold the samples, reference electrode

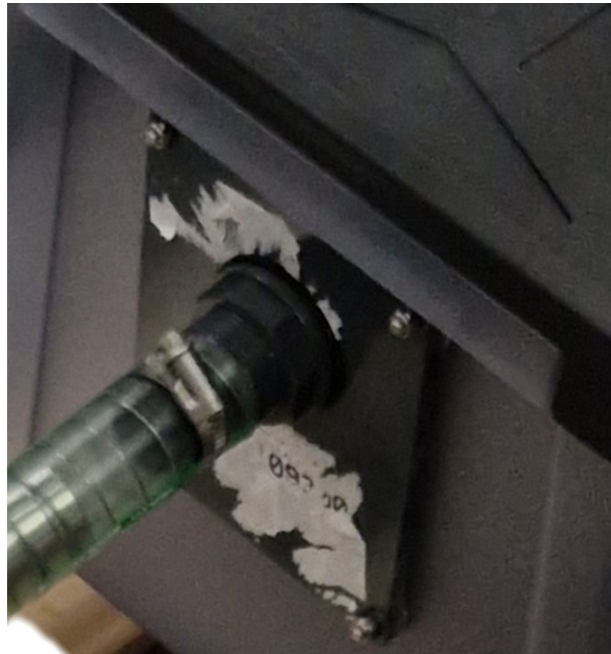
**Figure 3.3.:** Support for the inlet valve assembly, constructed and implemented for the setup at InnovaNor.

A slot is cut into the side of the box to facilitate cable routing out of the box, as seen in Figure 3.2. After mounting the first samples on Frøya, it became clear that stronger support for the inlet was beneficial due to the heavy inlet valve assembly. To accommodate this, an extra plate of PVC is mounted to the outside of the box to stiffen the wall, seen in Figure 3.3. This plate is fastened with four M6 bolts and the holes sealed with silicone.

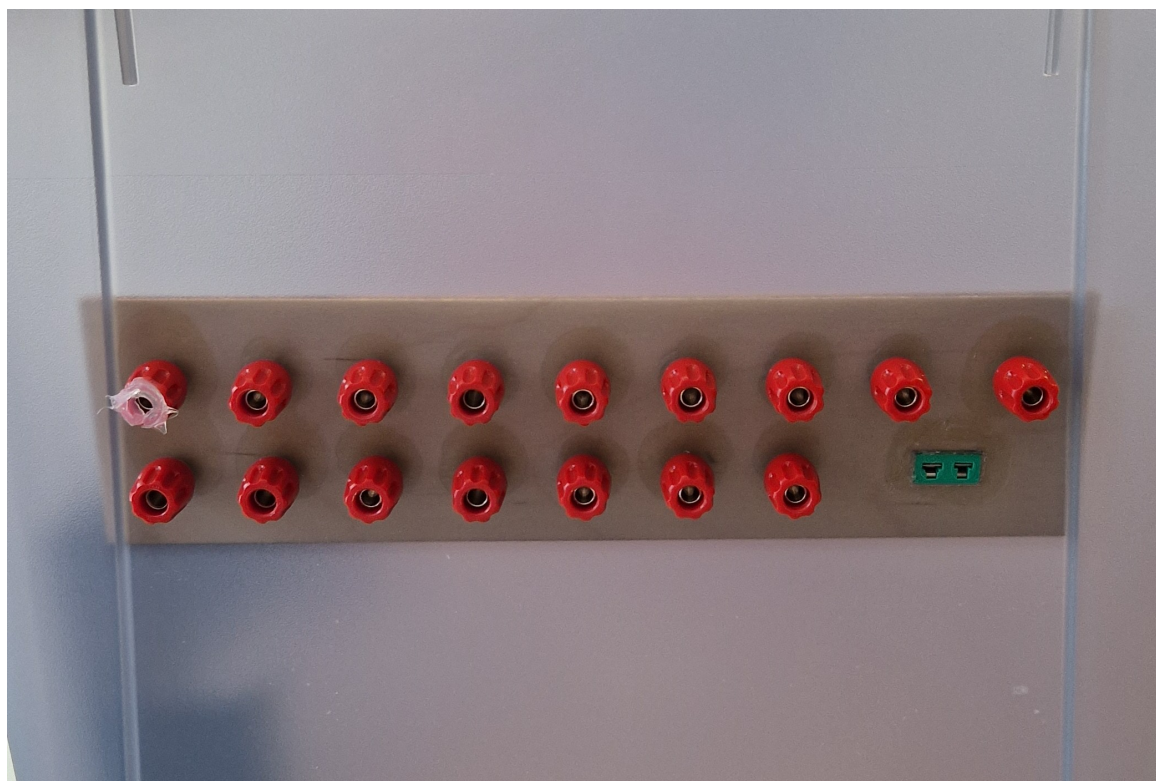
**Figure 3.4.:** Signal cable interface for the electronics cabinet, Allowing for 15 samples, 1 reference electrode, and a thermocouple to be connected.

The electronics cabinet is designed to withstand humid conditions as well as direct splashes of water, while providing a safe and stable environment for the datalogger and allowing it to monitor the samples. This cabinet is built with an IP44 rated box, which is splash proof. All holes in the box walls are sealed with silicone to provide a watertight seal. The most noticeable feature on the electronics cabinet is the input for all the samples, seen in Figure 3.4. These banana connectors are mounted to the side wall of the box, with an additional laser-cut plywood support behind to relieve some strain from the wall of the box. This piece of plywood also serves the purpose as a drill guide when boring the holes in the box. All banana plugs eventually got a seal like the one in the upper left corner, to seal the interface between the male and female plug. The rectangular thermocouple connector is also sealed with silicone to make the connection waterproof. Cables like the one shown in Figure 3.5a are used to connect the samples to the Electronics cabinet. These are prepared with one male banana plug connector for the cabinet, and one ring-formed cable lug to connect to the sample.

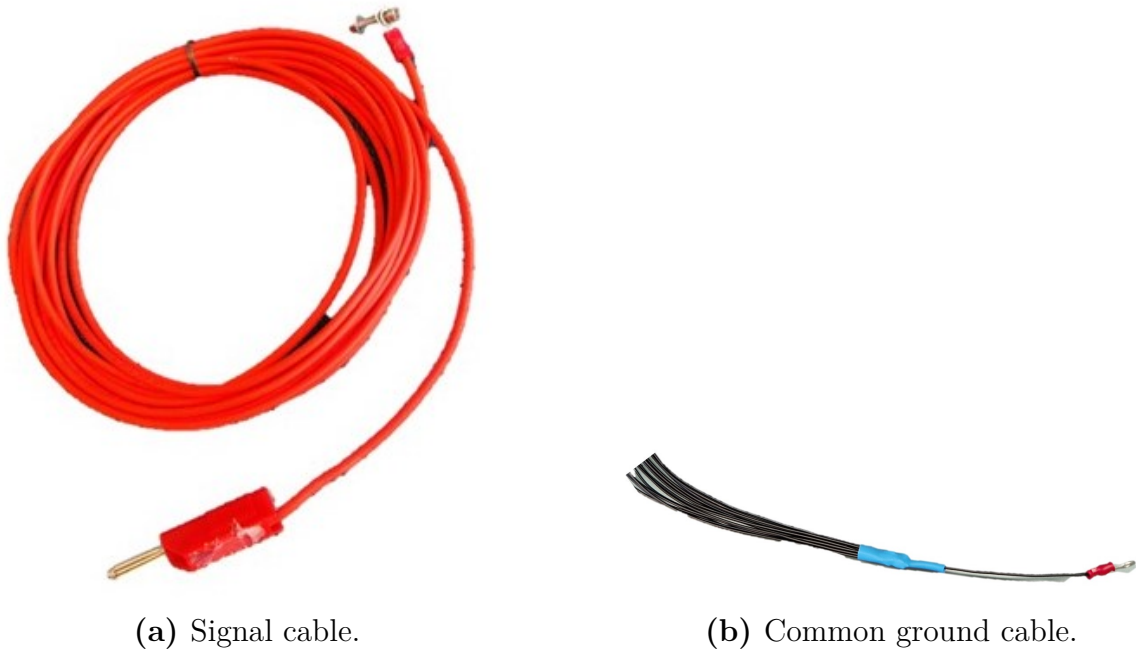
**Figure 3.5.:** Custom cables made for the test setup. The signal cables are terminated with banana plugs and ring-formed cable lugs. The Common ground is soldered with 15 cables to 1, to connect all samples to the same reference.

In order to make the thermocouples used in the test setup waterproof, their exposed sensor tips were coated with polyurethane, as seen in Figure 3.6.

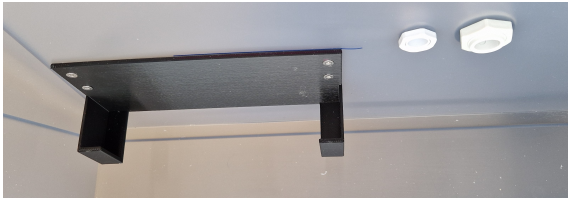
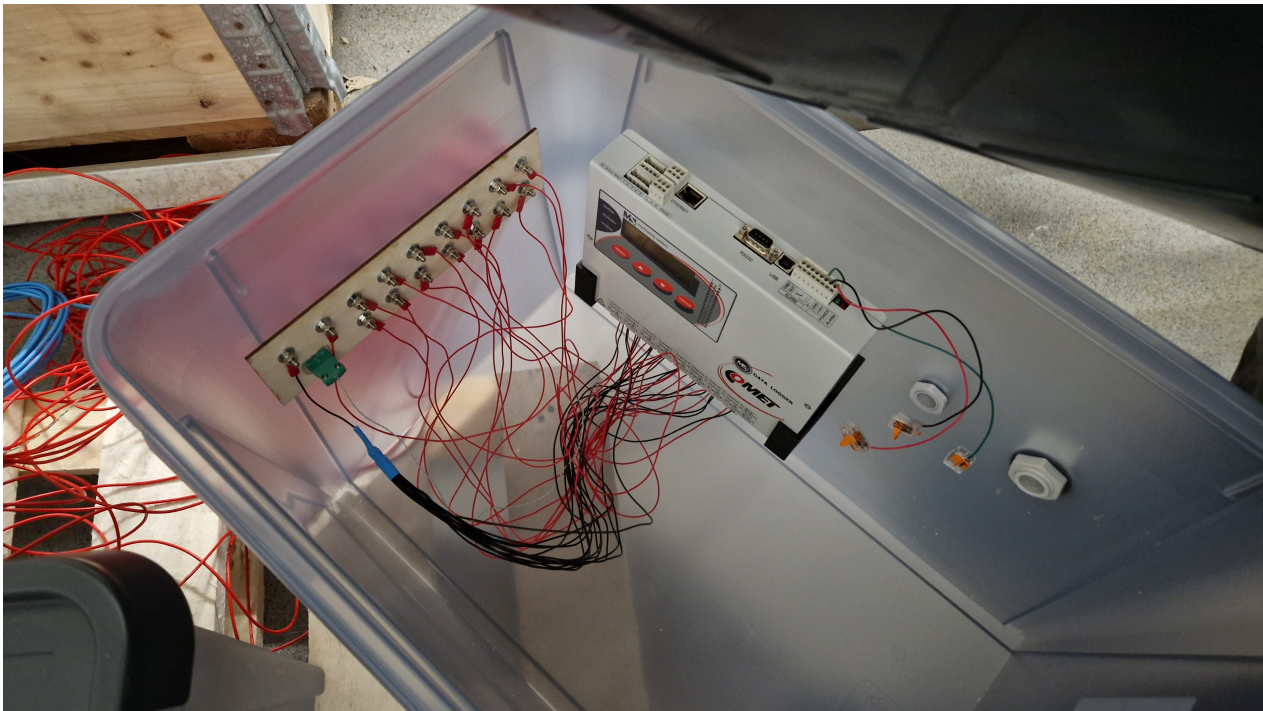
In an effort to minimize the humidity inside, small bags of silica gel were placed in the electronics cabinet during installation.

(a) 3D-printed logger holder.

(b) Cable glands.

(c) Mounted datalogger.

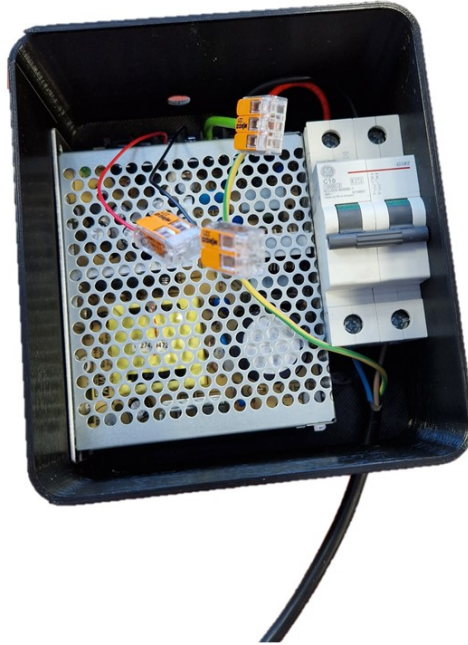
**Figure 3.8.:** Powersupply for the data logger, with integrated circuit breaker in order to protect the system should a short circuit occur.

The PC and PSU are mounted in dry locations separate from the rest of the setup, with power and Ethernet cables brought to the data logger. This is to protect the electronics of the PC from moisture, as well as making sure the electronics do not overheat, as they could if placed in the enclosed box together with the data logger.

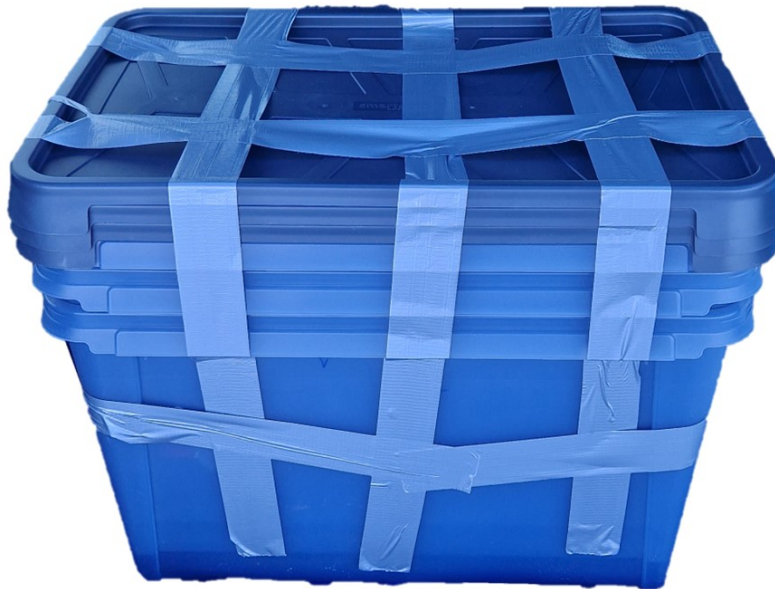
**Figure 3.9.:** The HEMOS system packed for transport to InnovaNor.

One important aspect of the HEMOS is that it can be mounted in remote locations, and subsequently needs to be transported there. One criterion for the setup was to be able to transport it within the footprint of one case. This is done by making all internal structures of the Test chamber removable so that the other cases can stack within, as seen in Figure 3.9. The electronics cabinet must have all external features removable for the same reason. When stacked, the inner case holds all the electronics, PC, PSU, samples and equipment needed, so that everything can be shipped as one package. This makes shipping and transportation easier, at the cost of longer assembly time at the test location. Whether the HEMOS should be transported as one unit or pre-assembled, has to be decided on a time-to-time basis depending on the transportation method and efficacy.

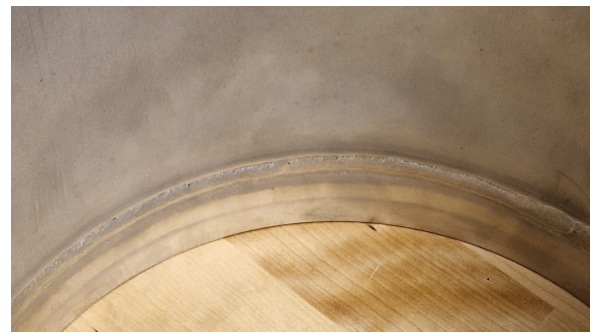
(b) Inside of pipe

**Figure 4.1.:** Pipe flange cut into the good weld samples.

The good weld samples were cut from a piping section where both the inside and outside of the weld had sufficient gas coverage, and no weld discolouration was present, as seen in Figure 4.1.

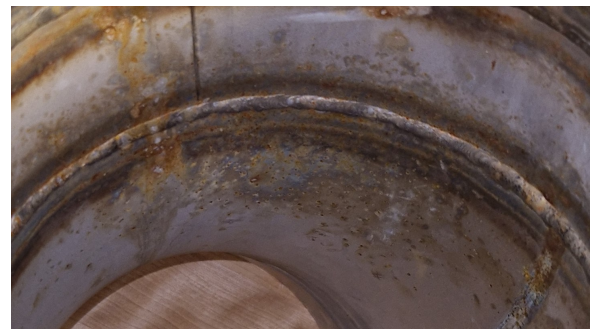
(b) Inside of pipe

**Figure 4.2.:** Pipe weld cut into the bad weld samples. The weld appears good from the outside, but has bad discolouration and oxide precipitates on the inside.

The bad weld samples were cut from a piping section where the outside of the weld appeared to have had sufficient gas coverage, while the inside of the pipe had sputtering, and bad oxidation and discolouration in the HAZ, Figure 4.2.

Wrong filler material, and improper weld procedures during construction or maintenance create welds susceptible to severe pitting attacks. Difficulties in monitoring and inspecting the backside of welds can be contributing factors, as some welds appear to be good on the outside while still being oxidized inside the pipe, like the ones seen in Figure 4.2.

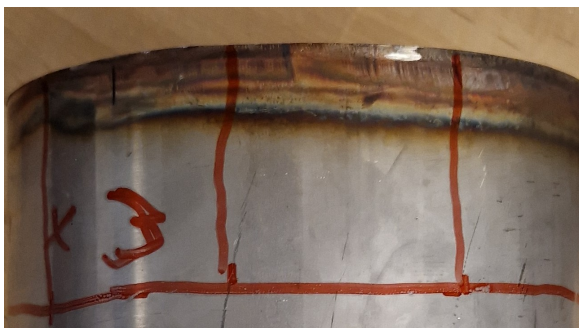
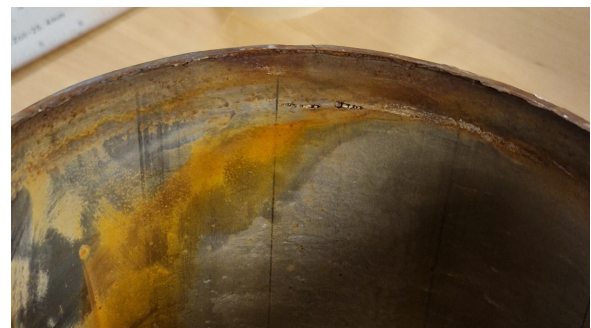
**Figure 4.3.:** Pipe section from which the pitted weld samples were cut. the weld zone is badly discoloured, with pitting attacks on the inside.

The pitted weld samples were cut from a piping section where there were severe pitting attacks in the weld zone, seen in Figure 4.3b, and holes through the pipe. The samples were made from sections of this weld without any visible pits or holes.

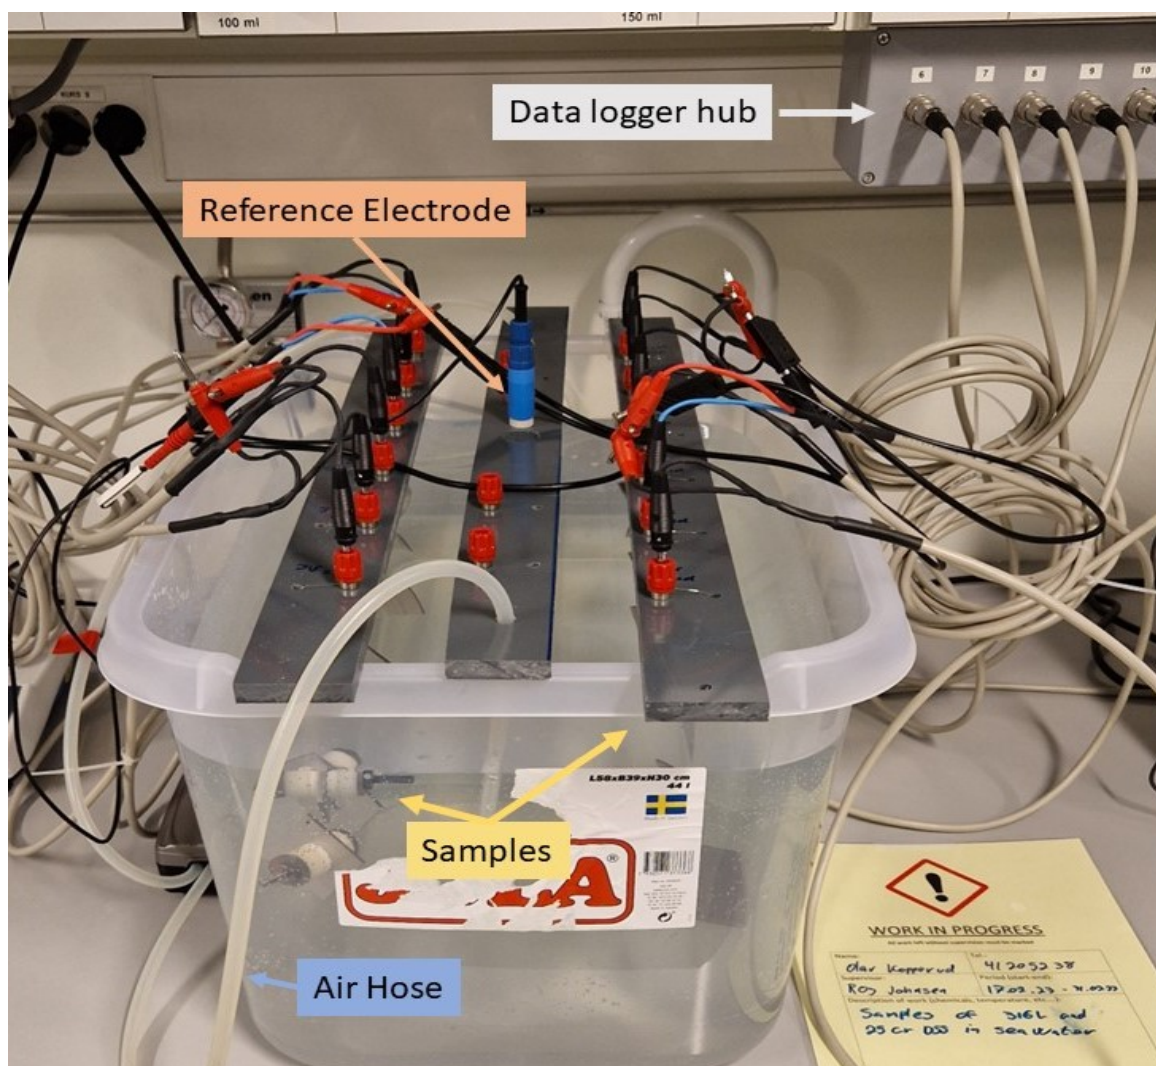
**Figure 4.4.:** OCP setup at the Corrosion Lab. The samples are immersed, and connected to the data logger through the data logger hub.

During the experiment, a crack was discovered in the test chamber, and the setup needed to be moved to another chamber to avoid leaks. This, together with a power outage, might have affected the data recorded.
