# Corrosion of AISI 316L in Fish Processing Facilities

The Effect of Operational Conditions,  
Maintenance Procedures, and Biofilm

Master's thesis in Mechanical Engineering

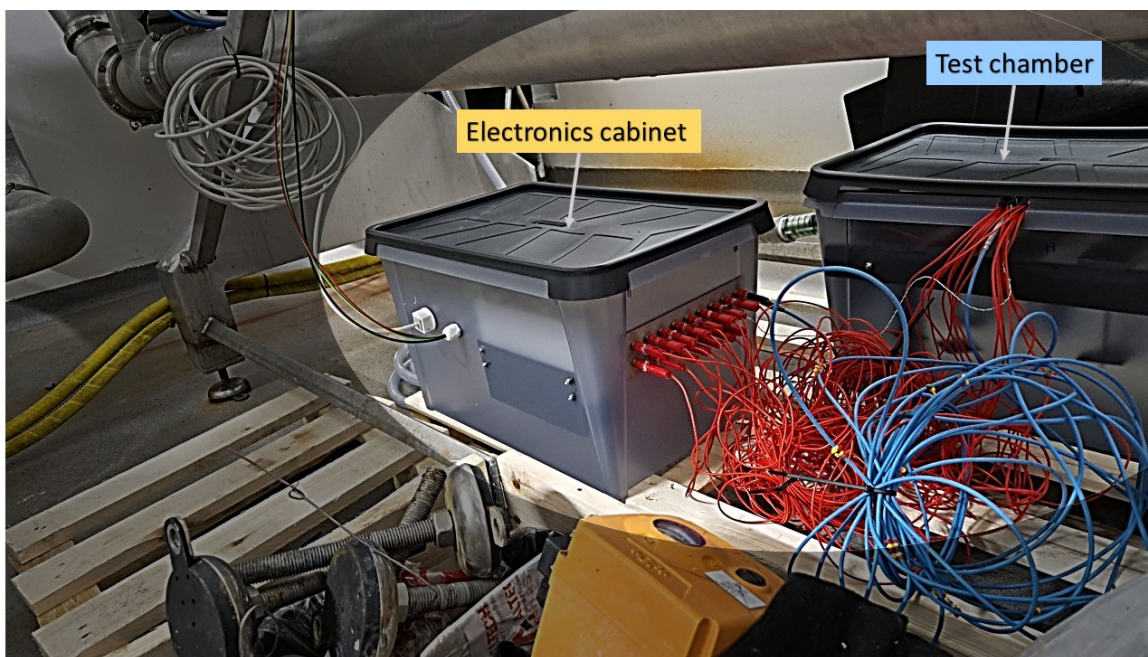
**Figure 4.6.:** HEMOS setup at InnovaNor - Senja. The system is mounted in the room with the RSW cooler.

The HEMOS at Senja, seen in Figure 4.6, was mounted at the beginning of March 2023 after implementing a few design modifications based on the experiences from Frøya. In addition to making a functioning test setup, this setup had to be easily transportable and have some redundancy in case something was to break during transportation. The HEMOS was shipped with Nor-Lines from Trondheim to Finnsnes, while personnel transport was with a plane to Tromsø and a ferry to Finnsnes. The last part of the trip went by car to the facility, and the mounting of the test setup began. The redundancy turned out to be important, as the electronics cabinet was cracked during shipping and had to be remade. Luckily, an extra case was shipped, and a new cabinet was made within an hour.

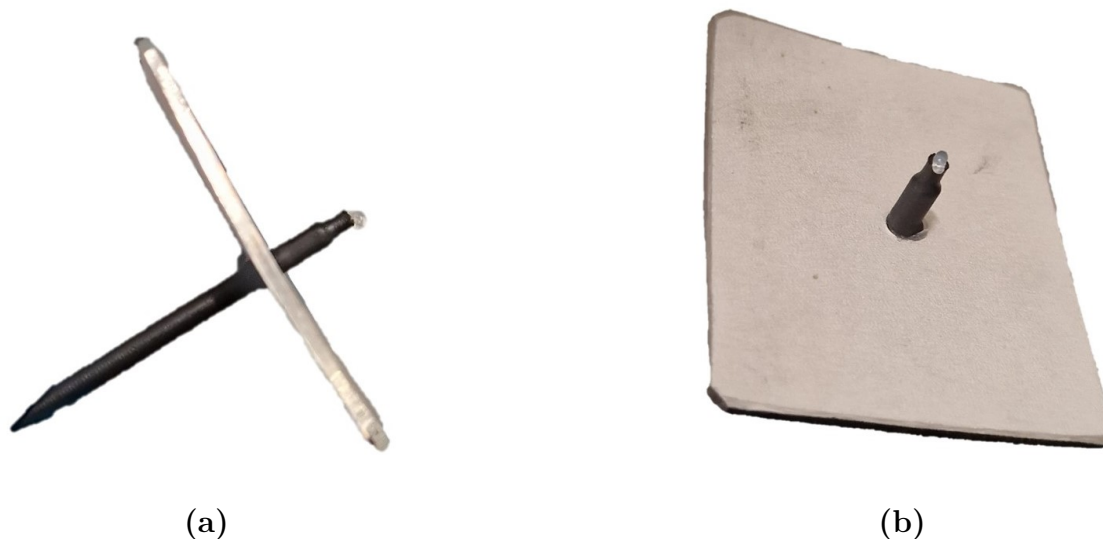
**Figure 4.7.:** Specimen mounting on threaded rods. Heat shrink tubing and silicone were used to shield the threaded rod, and the connection between the sample and rod.

As with Frøya, the samples were cleaned with soap and ethanol before departure and packed in plastic bags. These samples were threaded with M3 threads and mounted using A4 grade (AISI 316) threaded rods. These rods were cut from longer pieces of threaded rod and covered in heat shrink tubing to protect them from direct water contact. When mounting, the test specimen was threaded onto the rod, and the exposed tip was covered with heat shrink and silicone, as seen in Figure 4.7. This was done to prevent a potential initiation of crevice corrosion and subsequent erroneous measurements.

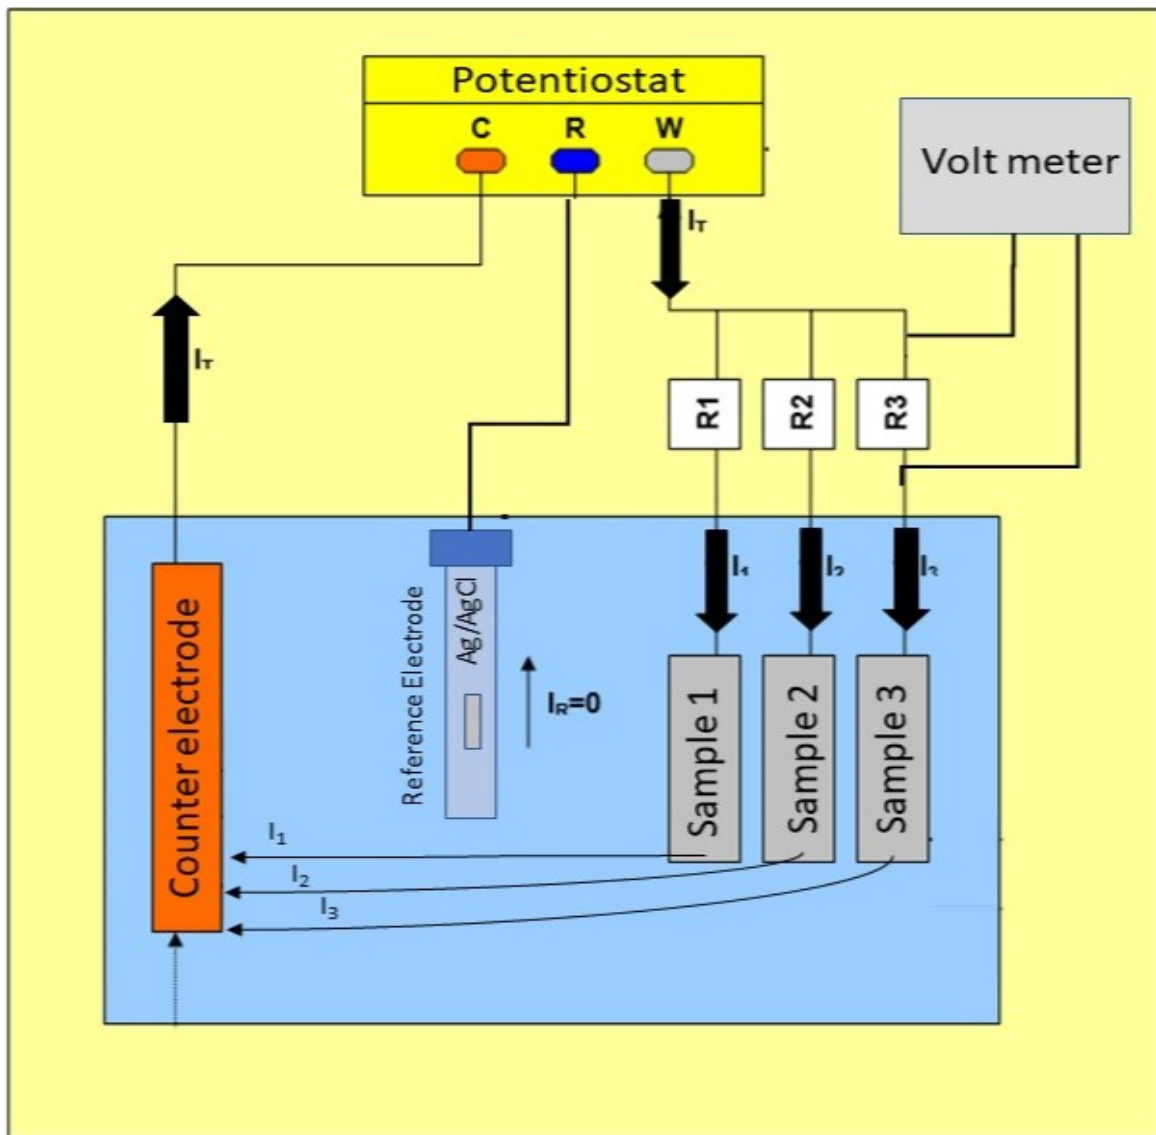
Figure 4.8.: Schematics of the Potentiostatic Test Setup.

The shunt resistors used were 1 Ohm resistors, making the potential drop measured in Volts identical to the current in Ampere. An increase in this current indicates the initiation of crevice or pitting corrosion, which is verified by observing the formation of corrosion product and discolouration of the water. When initiation was observed,

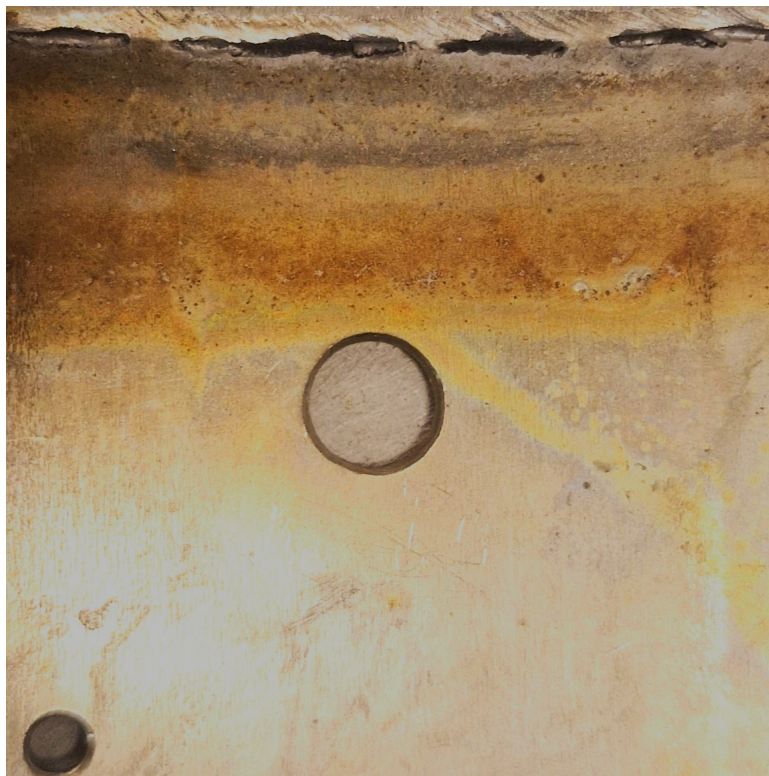
**Figure 4.9.:** One of the samples scanned by SEM and analyzed by EDS. This is the sample exposed to the potentiostatic test at 400mV 2°C.

These tests were performed on samples that were subject to severe corrosion damage during the potentiostatic tests. One of which is the sample seen in Figure 4.9.

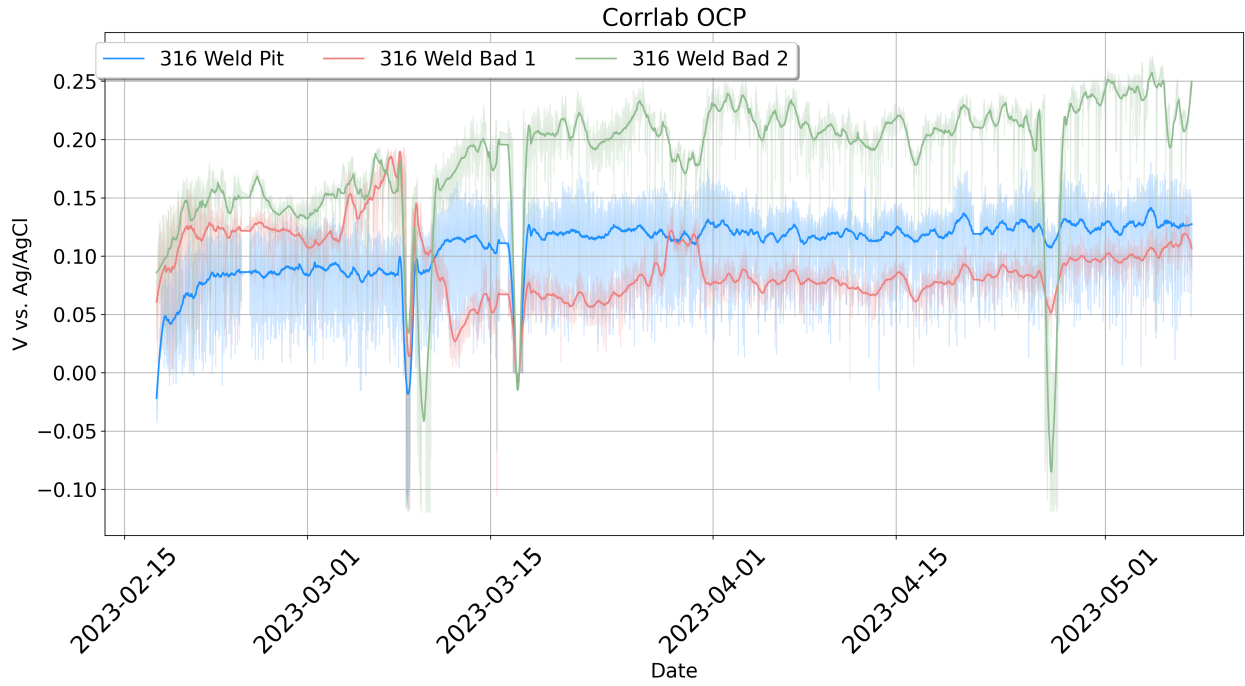
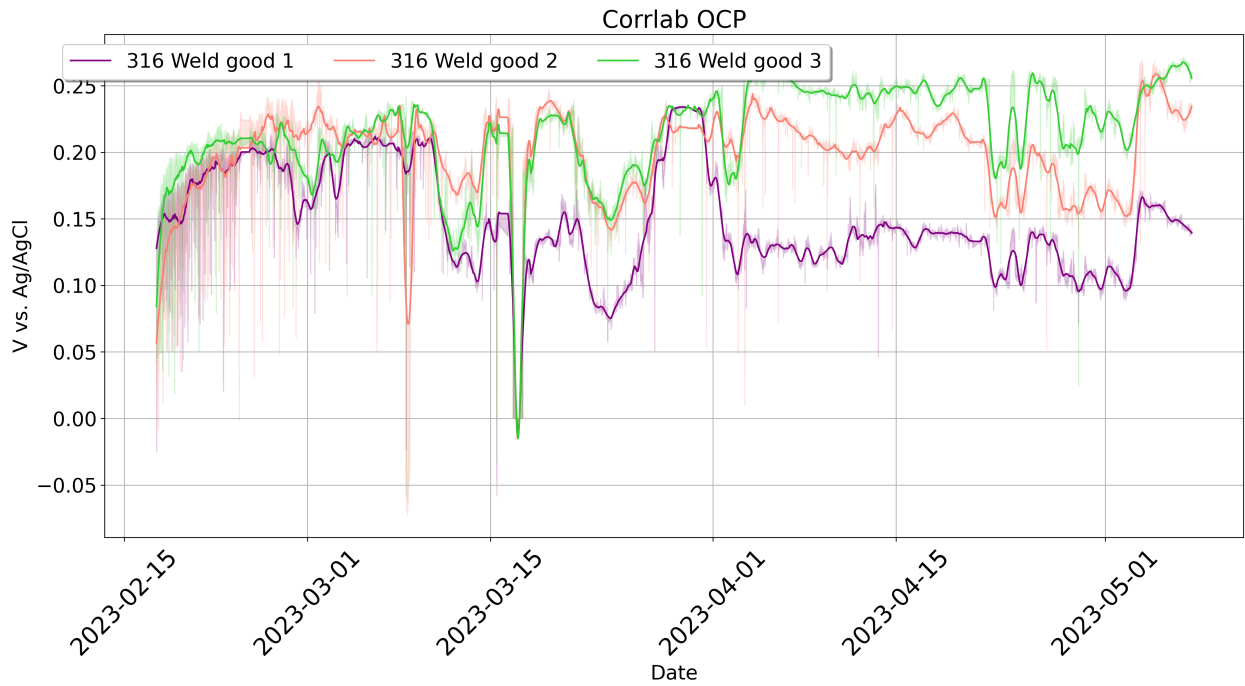
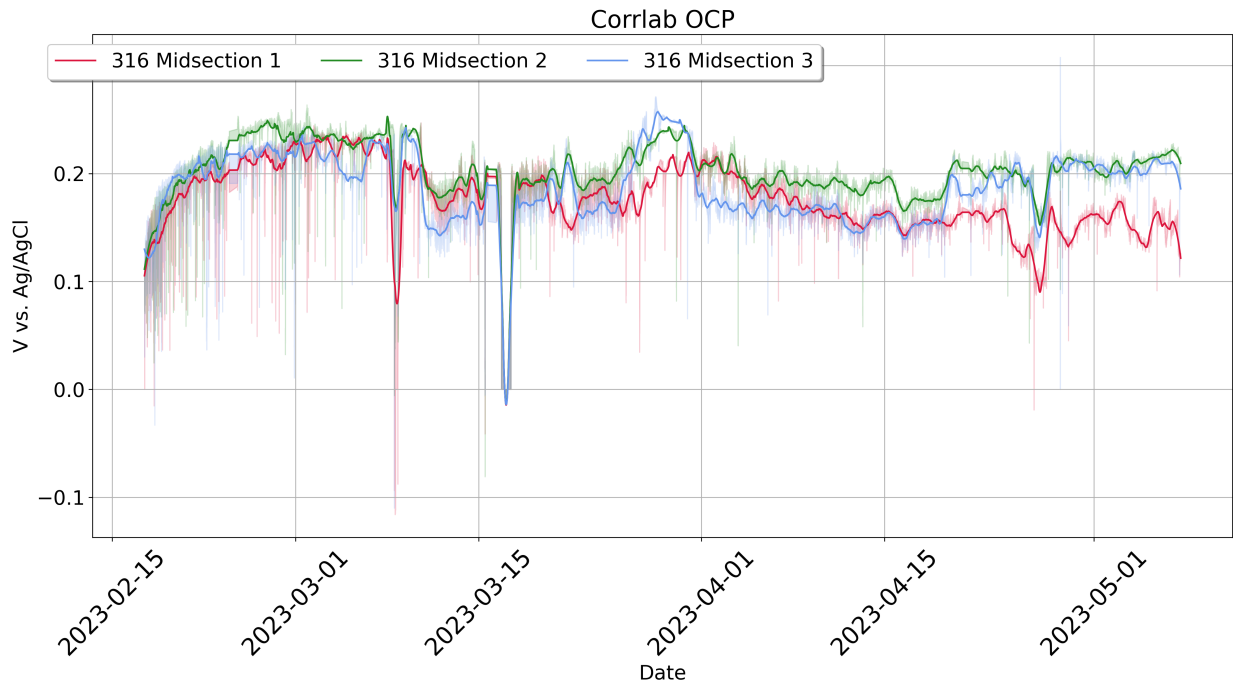
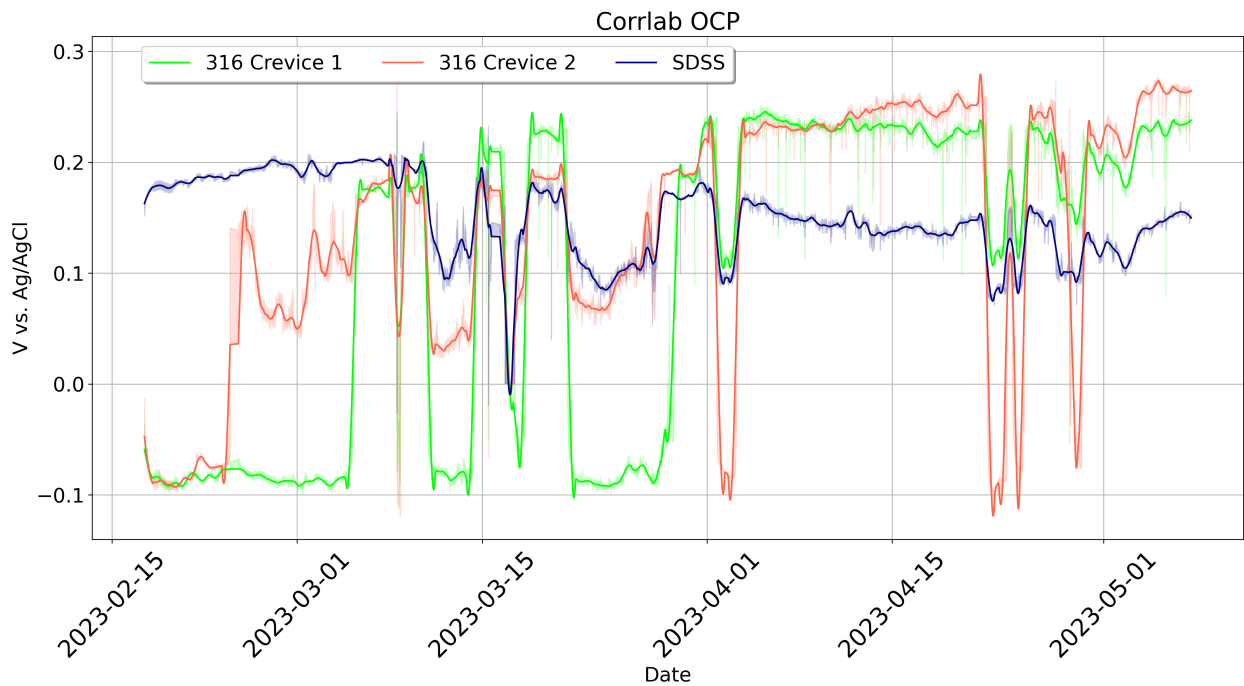
**Figure 5.1.:** OCP data from the test performed at the Corrosion lab - NTNU.

(a) OCP evolution of pitted and bad weld specimens.

(b) OCP evolution of good weld specimens.

(c) OCP evolution of AISI 316L piping mid-section specimens.

(d) OCP evolution of AISI 316L crevice and 25Cr SDSS specimens.

The crevice samples seen in figs. 5.2a and 5.2b, clearly have initiated crevice corrosion, which is relatable to Figure 5.1d. The biofilm similar to the one seen in Figure 5.2e, was present on all samples. After cleaning the samples from this biofilm, it was clear that the 25Cr SDSS sample, Figure 5.2d, was more or less unaffected by the exposure. Both the AISI 316L midsection, and Good weld sample had some minor signs of pit initiation, seen as small brown spots in figs. 5.2c and 5.2f. The other samples from this setup can be seen in Figure B.1

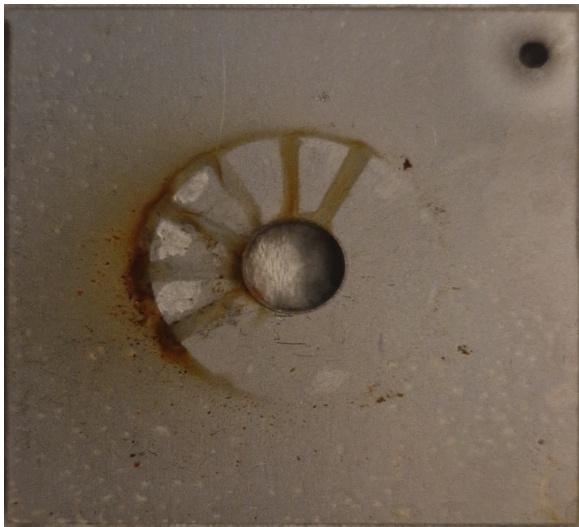
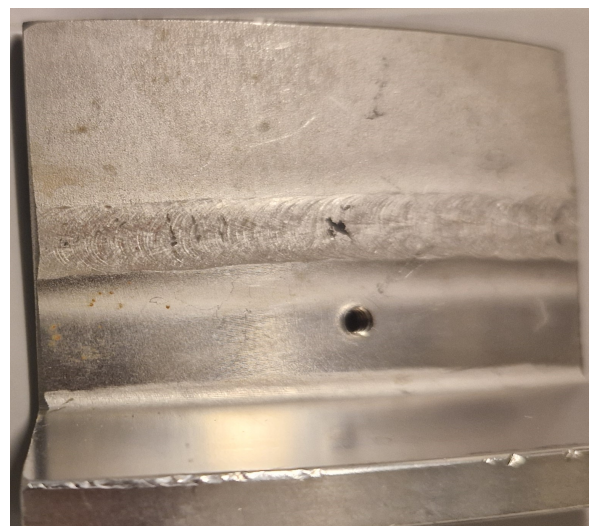
(a) 316 Crevice 1.

(e) Biofilm formation on good weld.

(f) Good Weld.

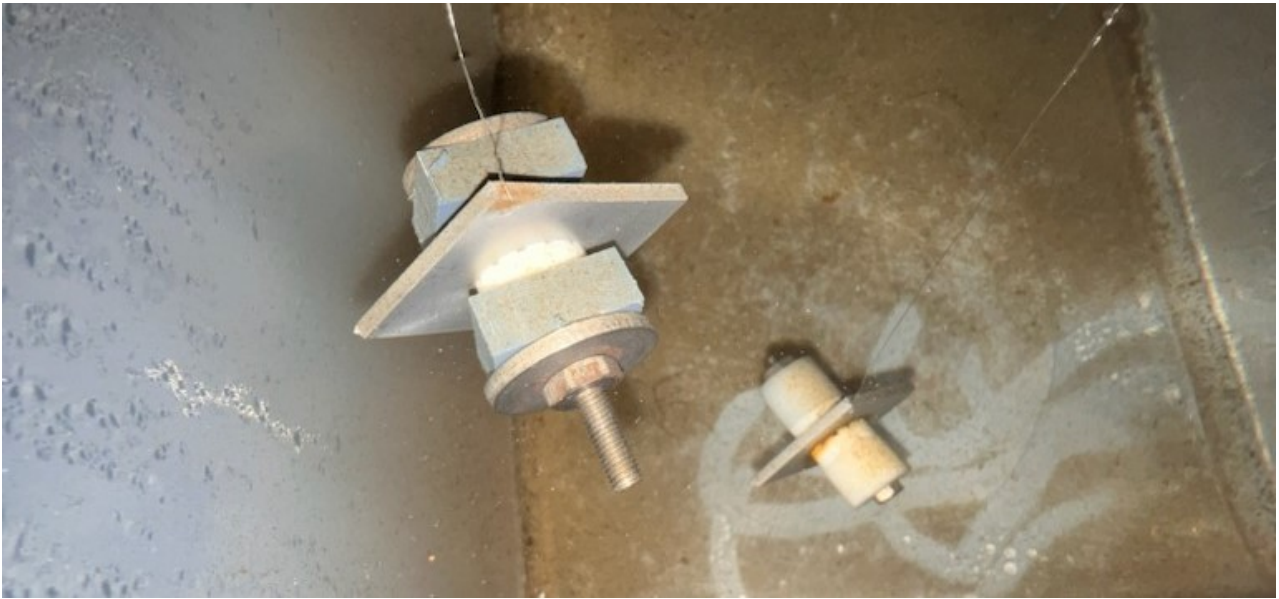
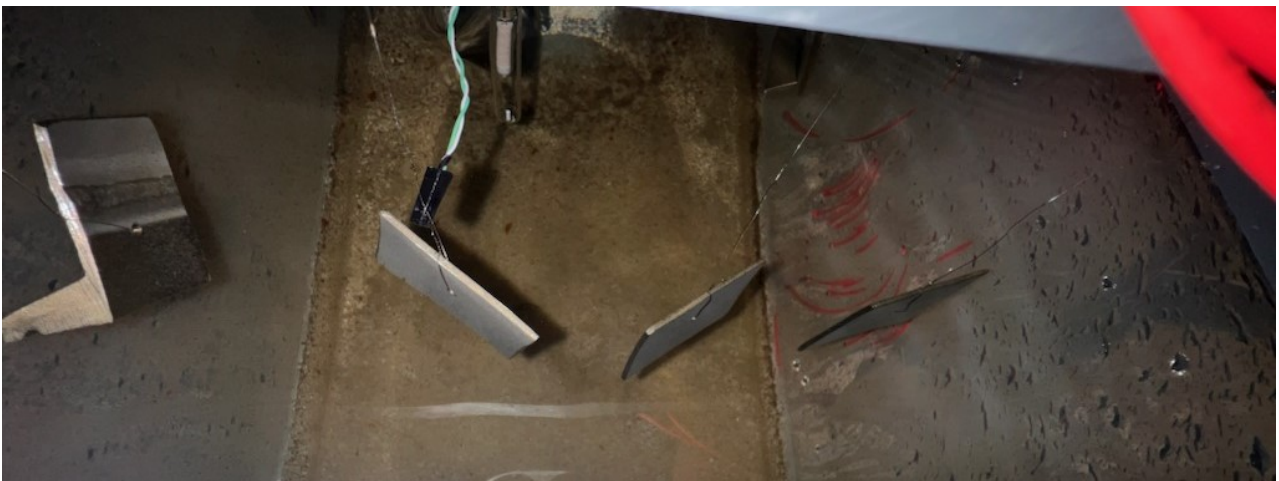
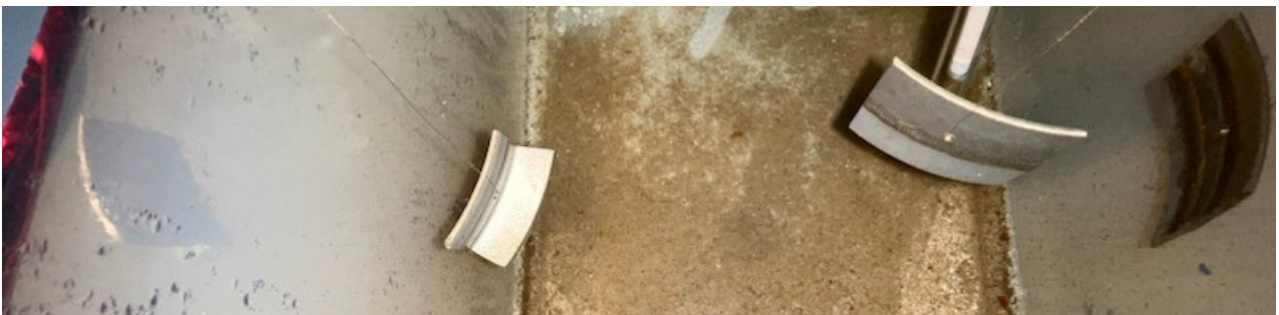
**Figure 5.3.:** Samples at InnovaMar - Frøya, after three months of exposure in the HEMOS.

(a) Corrosion on crevice samples.

(b) Free surface AISI 316L samples.

(c) Welded samples without visible corrosion.

Observations made by personnel at the facility, together with pictures of the setup after three months of exposure, show visible biofilm formation in the test chamber, Figure 5.3. Visible corrosion was seen on the crevice samples, Figure 5.3a, but no other samples showed visible signs of corrosion product, seen in part in Figure 5.3b and Figure 5.3c.

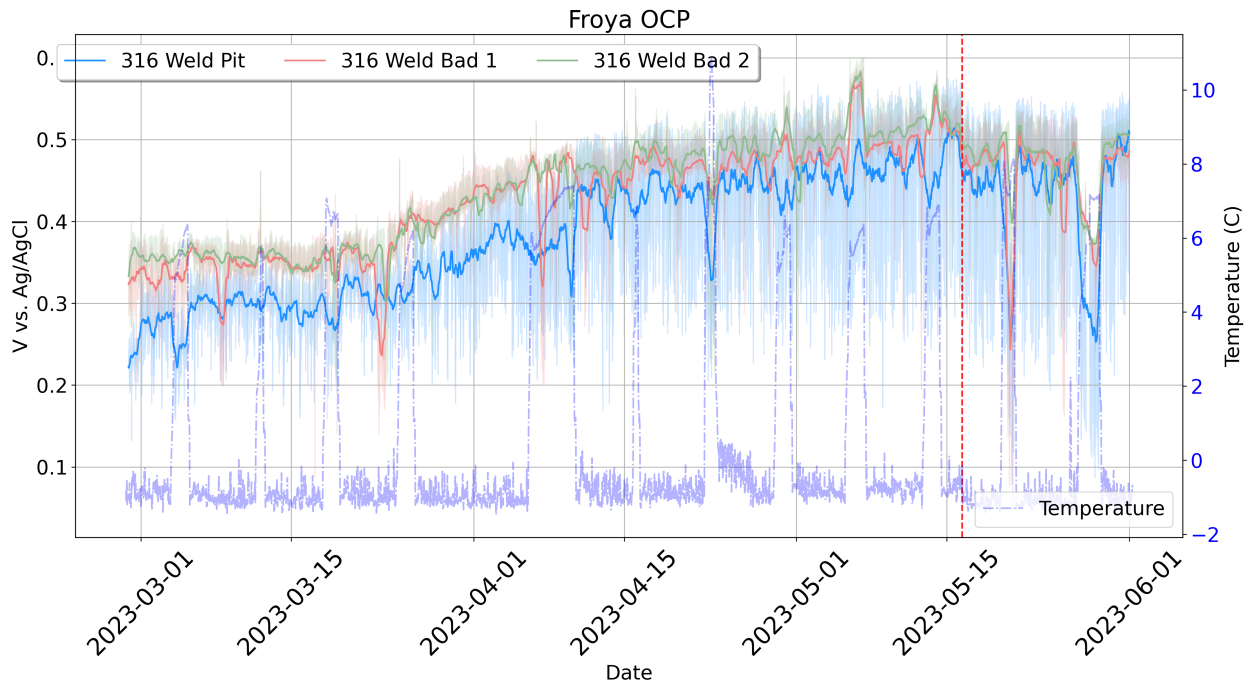
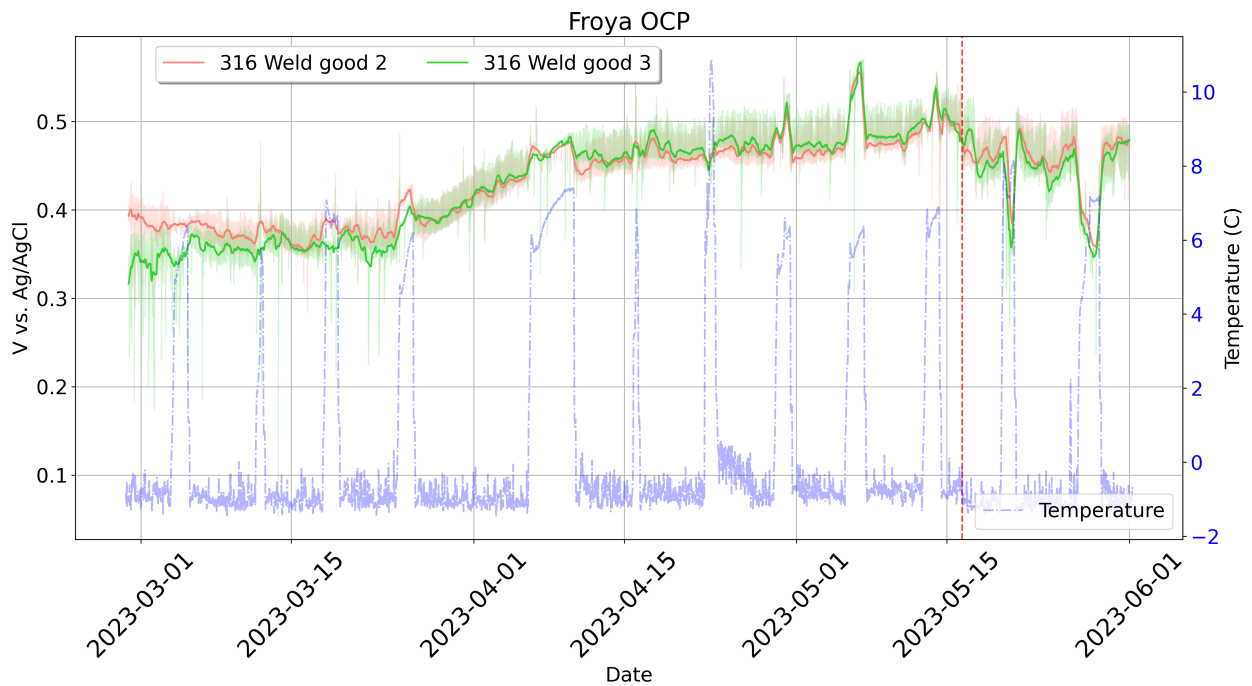
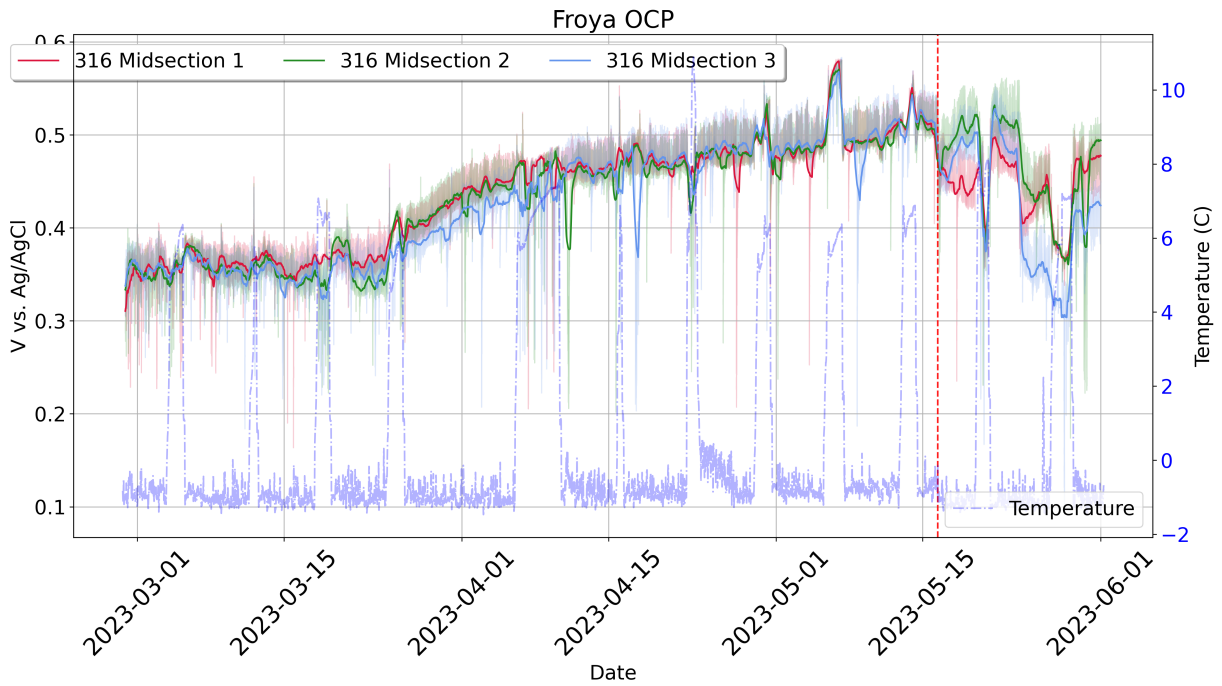
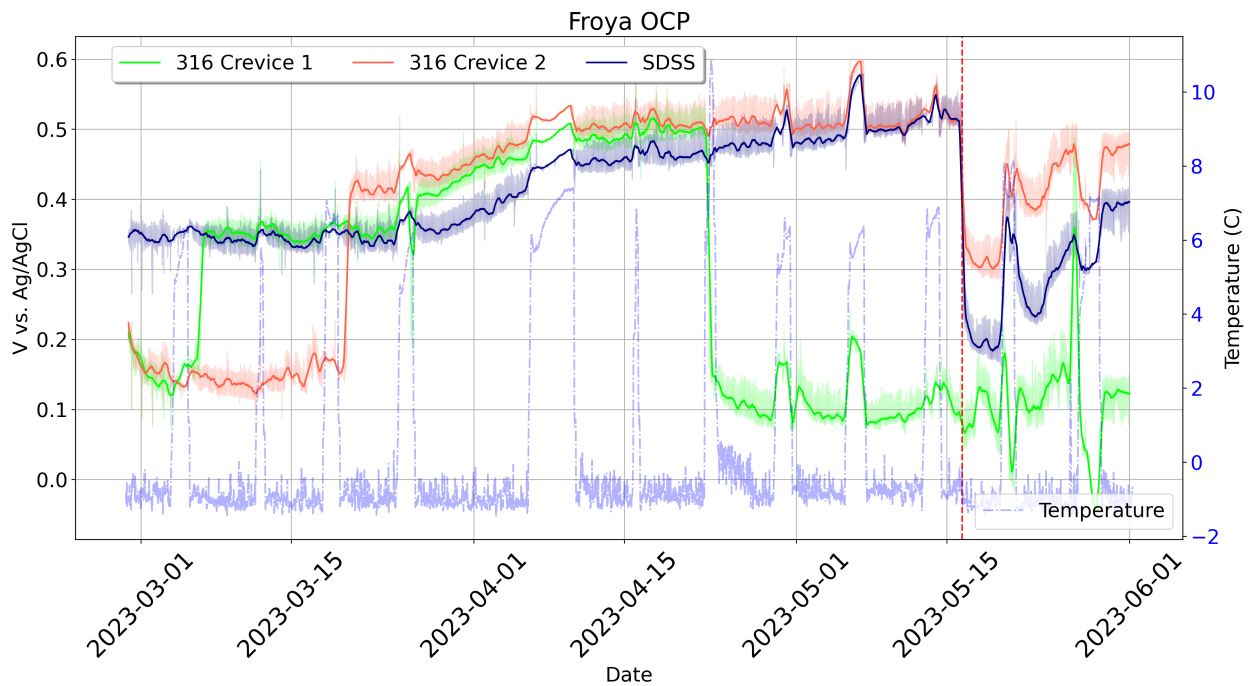
(a) OCP evolution of pitted and bad weld specimens.

(b) OCP evolution of good weld specimens.

(c) OCP evolution of AISI 316L piping mid-section specimens.

(d) OCP evolution of AISI 316L Crevice and 25Cr SDSS specimens.

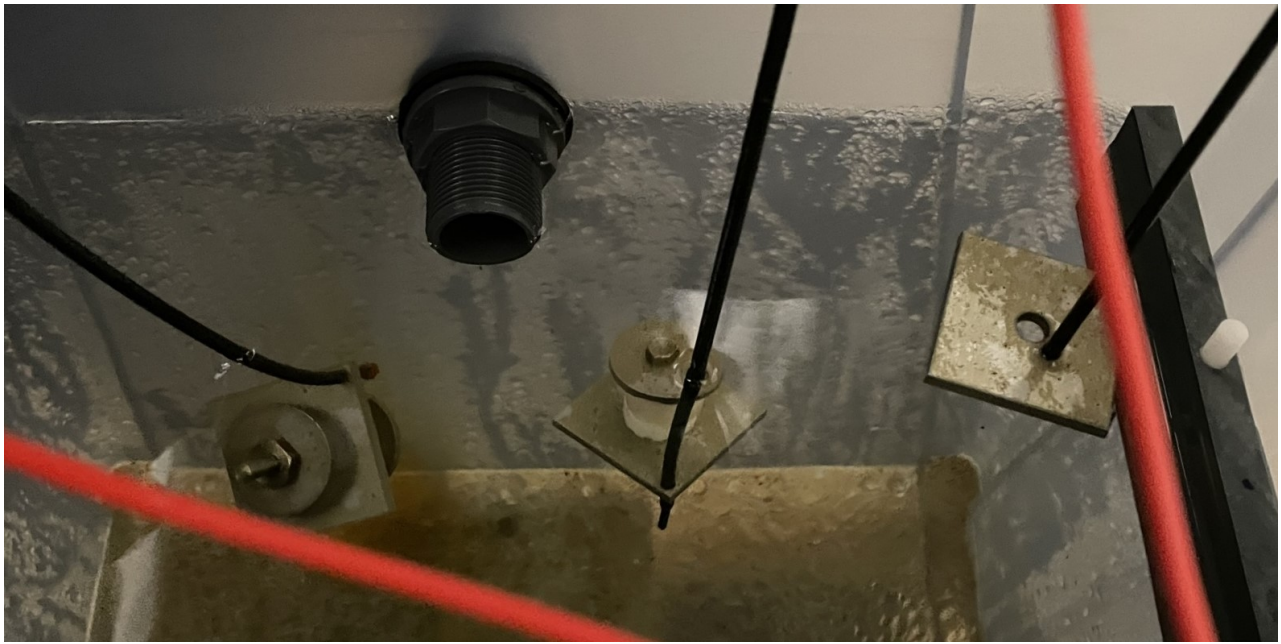
**Figure 5.5.:** Samples at InnovaNor - Senja after three months exposure in the HEMOS.

(a) Crevice samples and 25Cr SDSS.

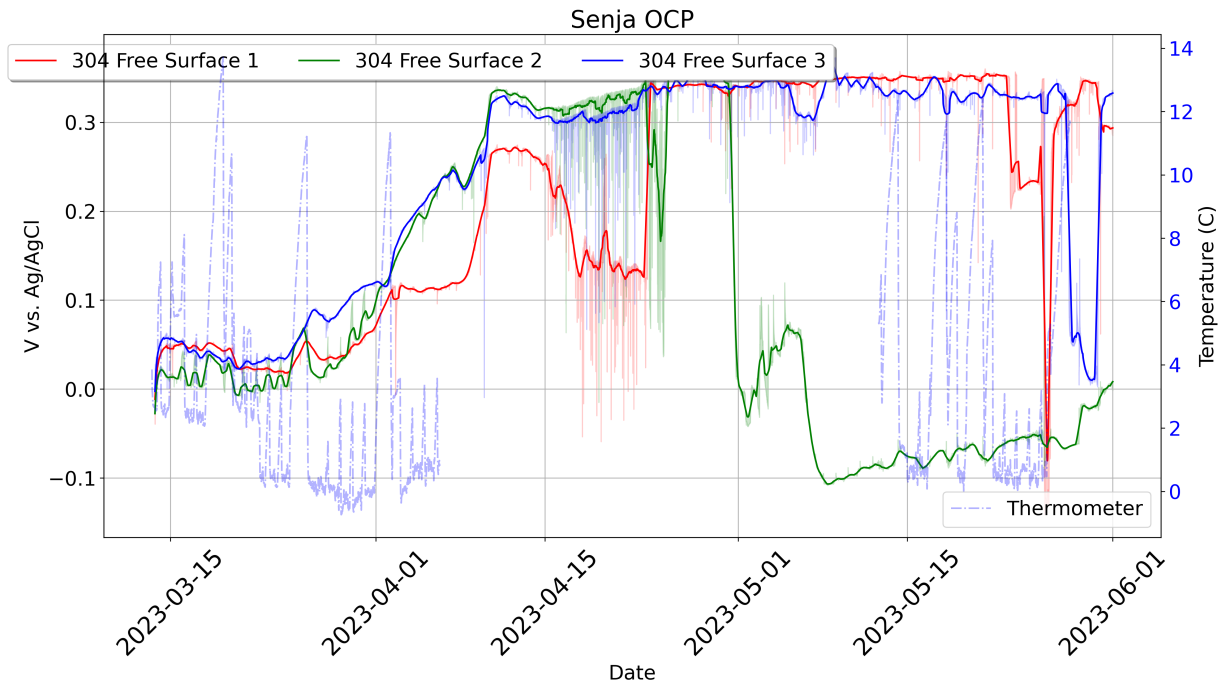
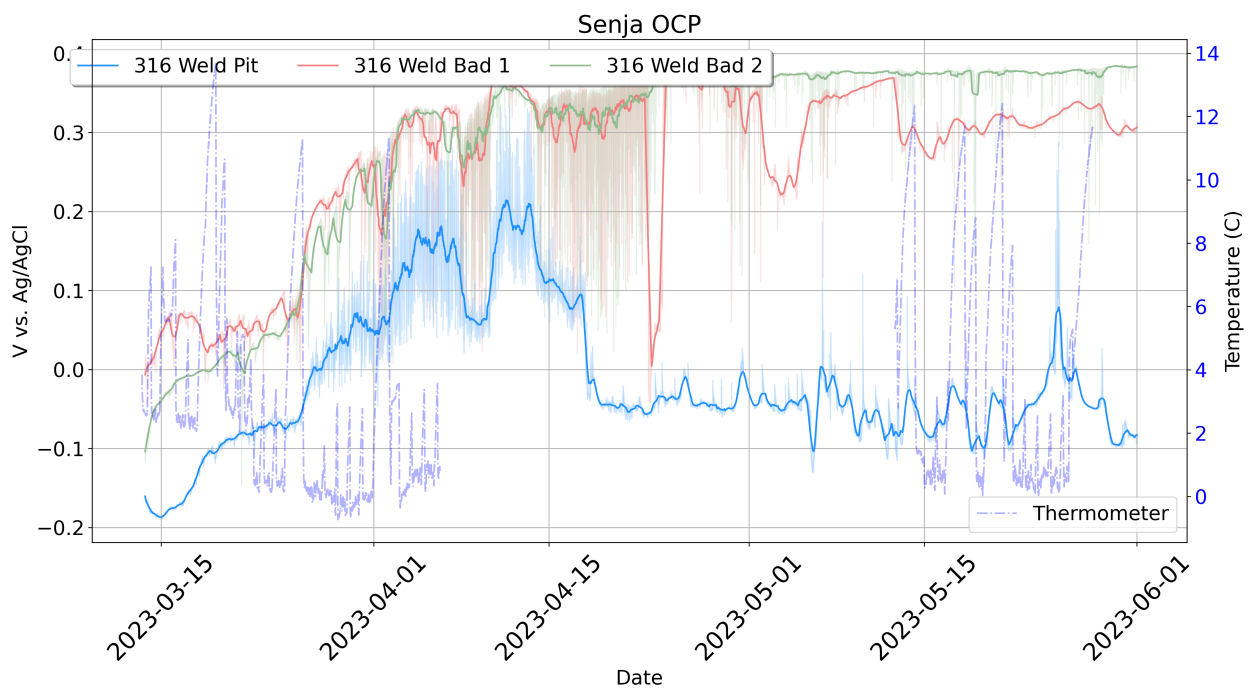
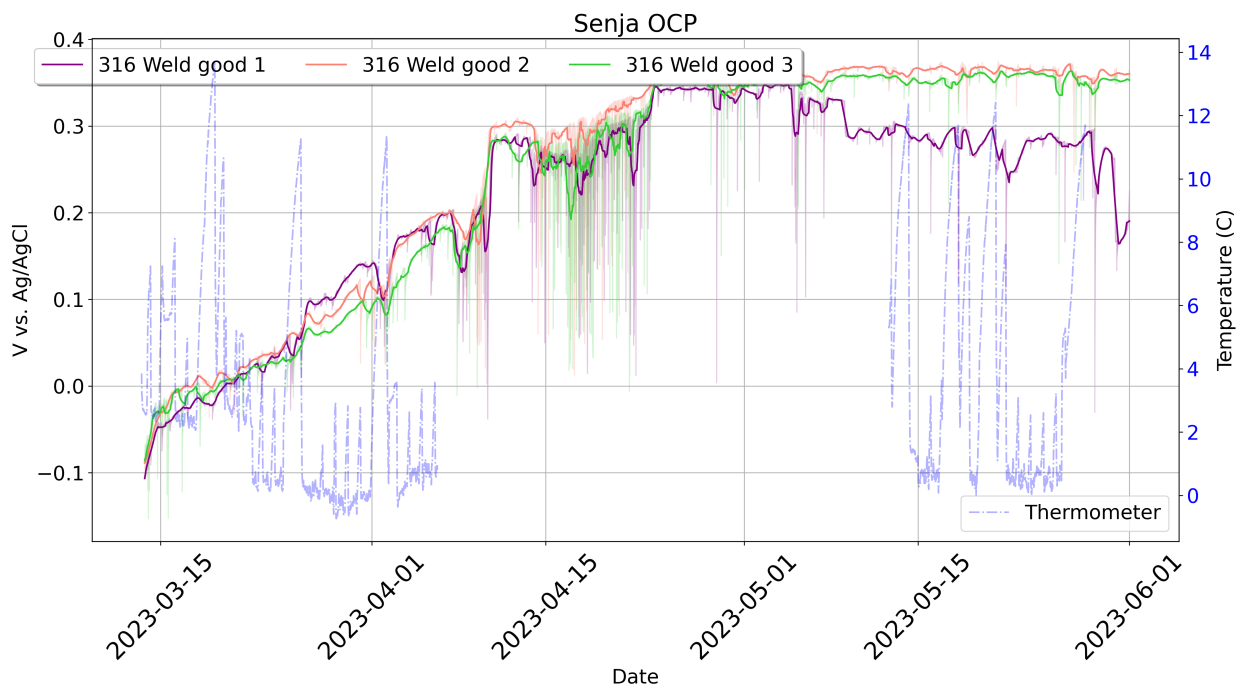
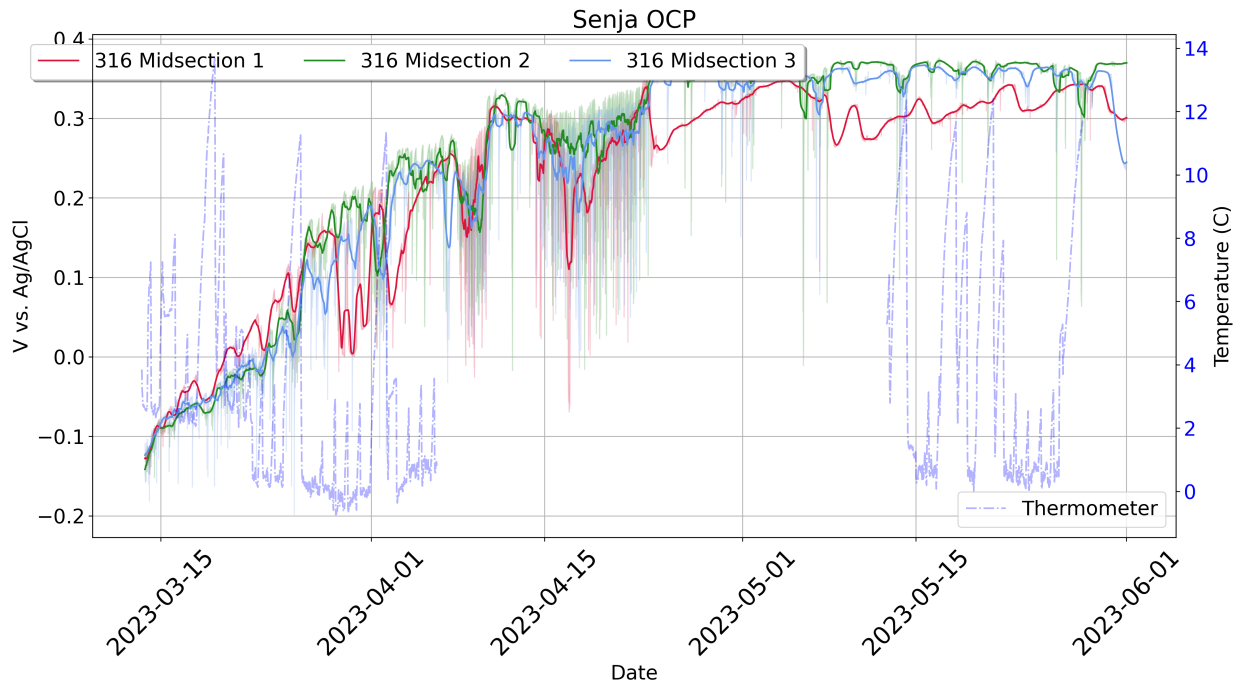
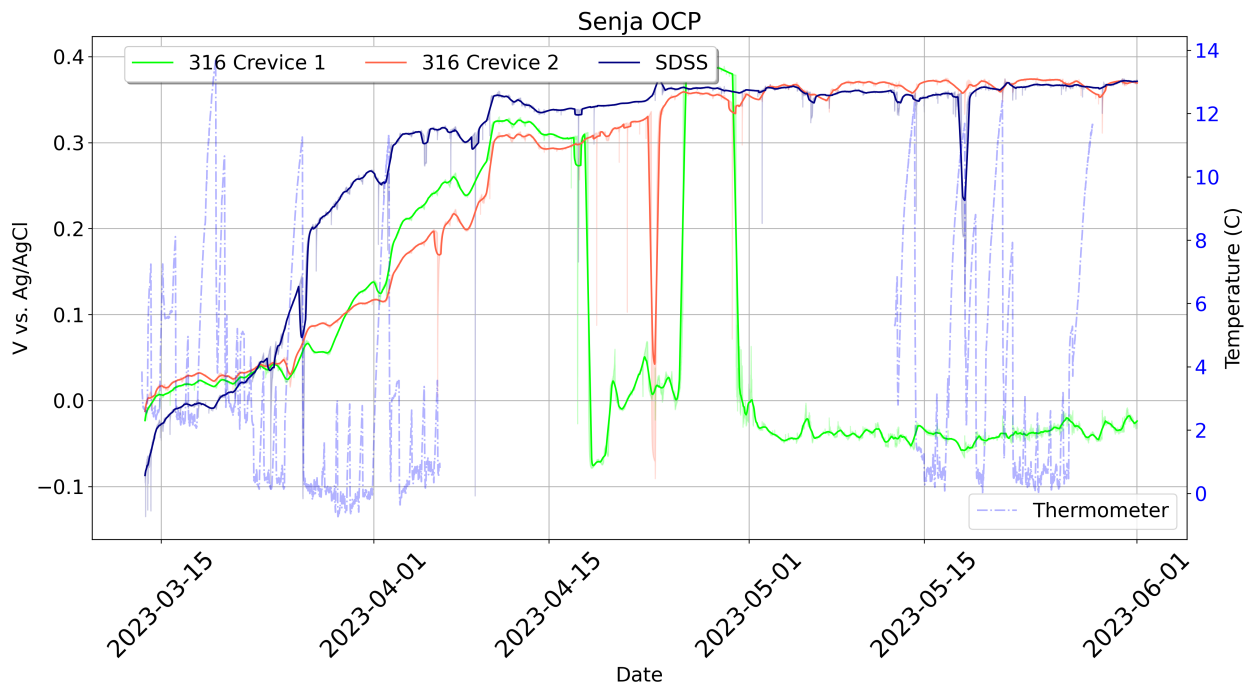
(a) OCP evolution of AISI 304L specimens.

(b) OCP evolution of pitted and bad weld specimens.

(c) OCP evolution of good weld specimens.

(d) OCP evolution of AISI 316L piping mid-section specimens.

(e) OCP evolution of AISI 316L crevice and 25Cr SDSS specimens.

The temperature measurement for the first week is a bit off due to a wrong setting in the data logger. This was updated remotely and provided accurate temperature readings afterwards. Temperature data was lost between the 5th of April and 12th of May due to a faulty temperature probe. The replacement probe failed on the 28th of May, and was not replaced before the end of the testing period.

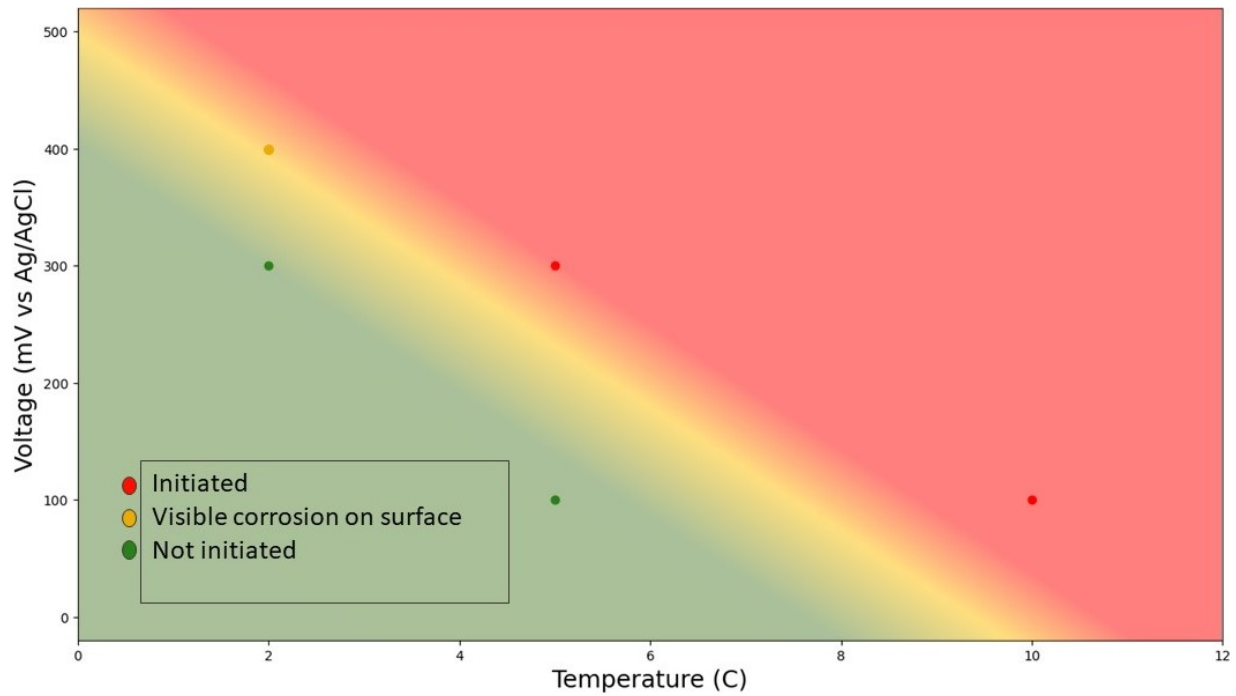
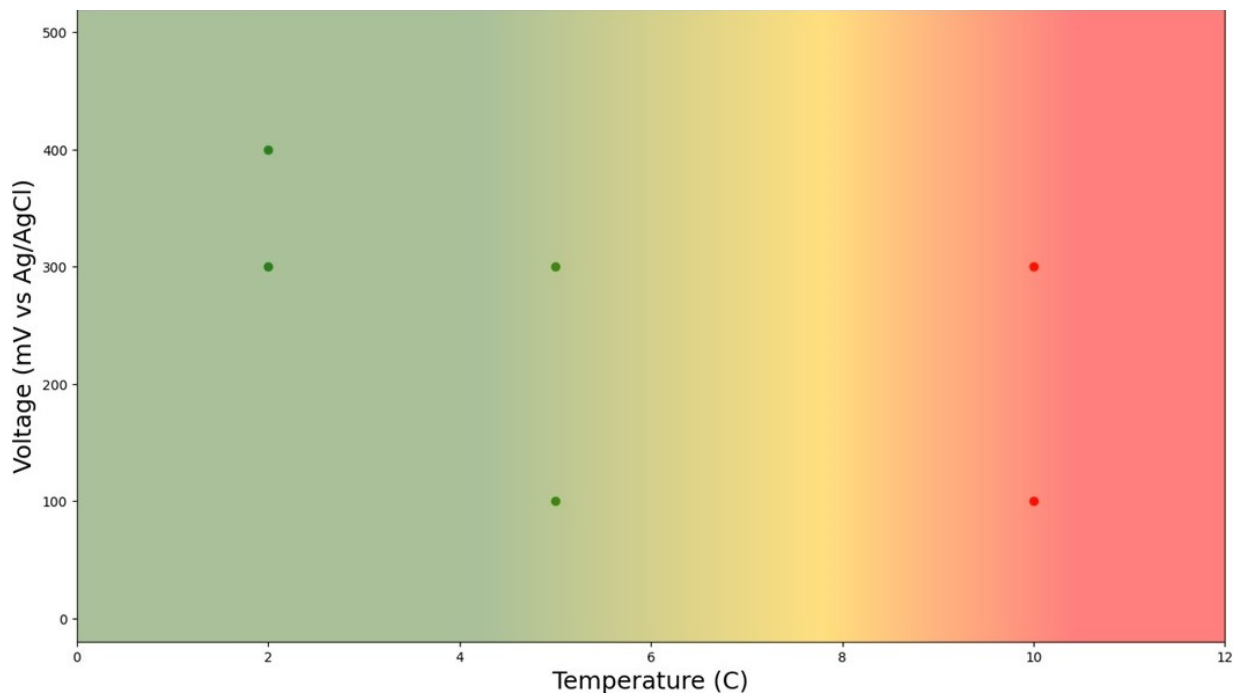
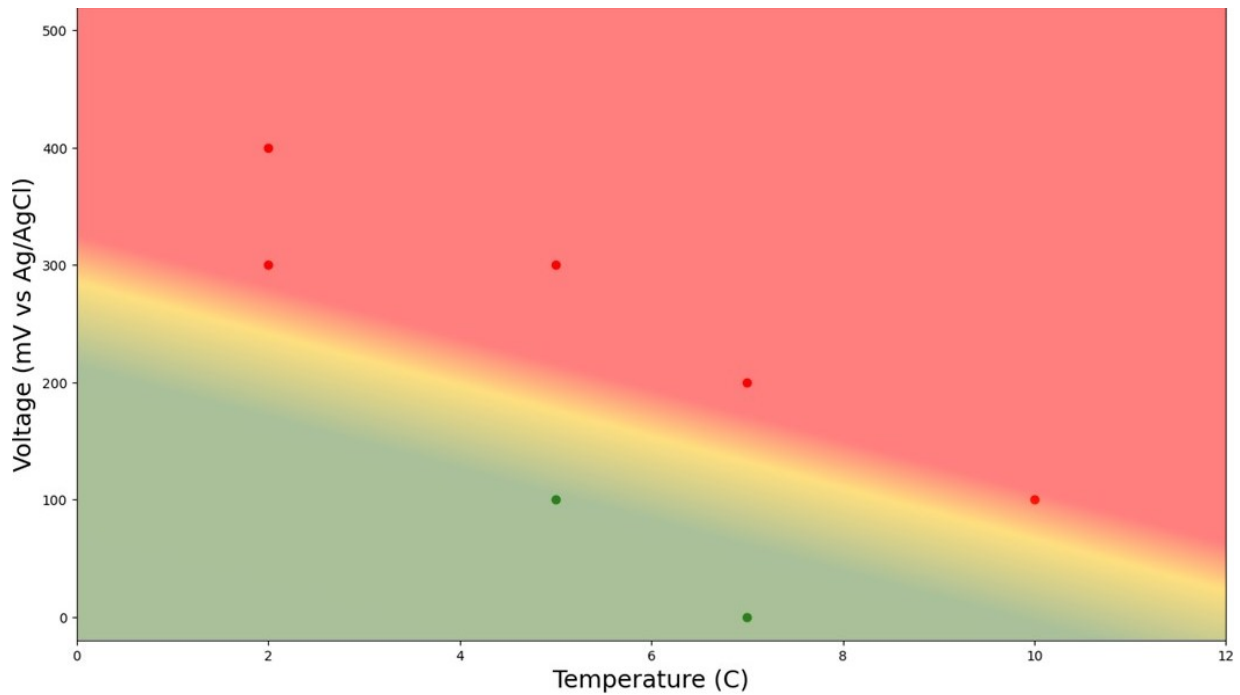
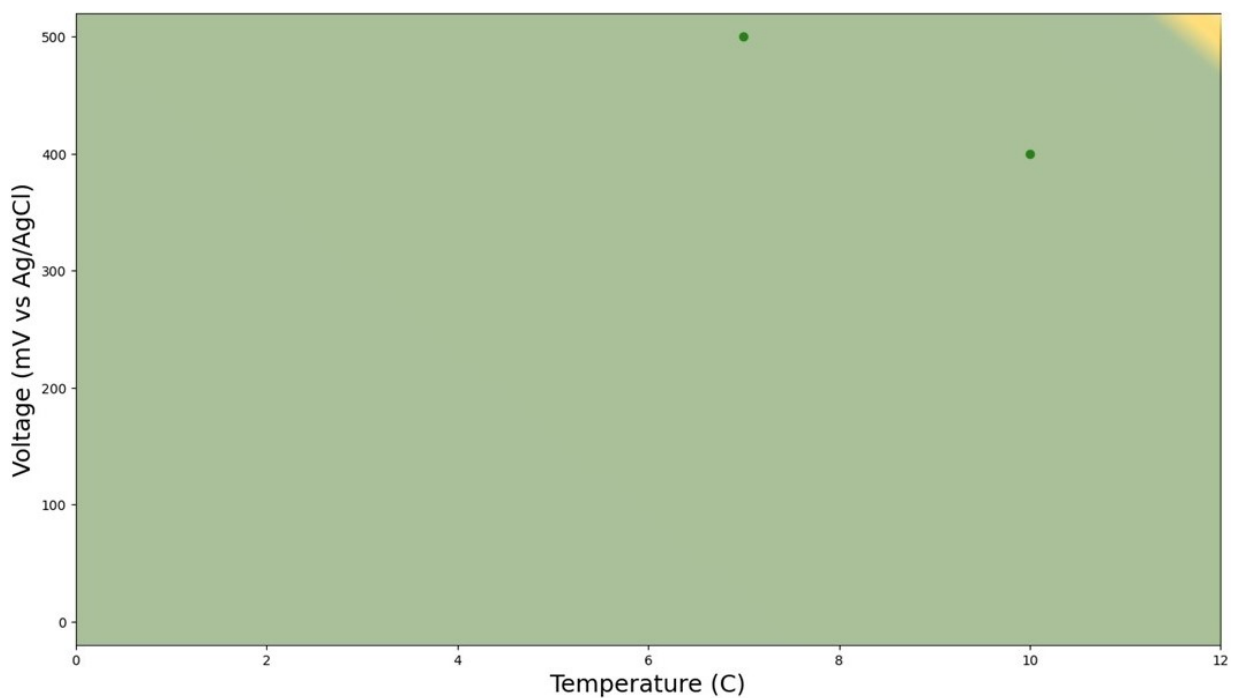
(a) Temperature-Potential dependency on crevice corrosion initiation of AISI 304L.

(b) Temperature-Potential dependency on crevice corrosion initiation of AISI 316L.

(c) Temperature-Potential dependency on initiation of pitting corrosion on previously pitted AISI 316L weld samples.

(d) Temperature-Potential dependency on pitting corrosion initiation of free surface AISI 316L.
