# Corrosion of AISI 316L in Fish Processing Facilities

The Effect of Operational Conditions,  
Maintenance Procedures, and Biofilm

Master's thesis in Mechanical Engineering

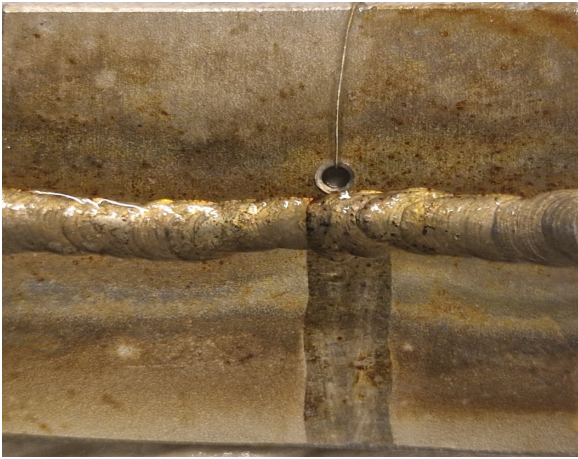
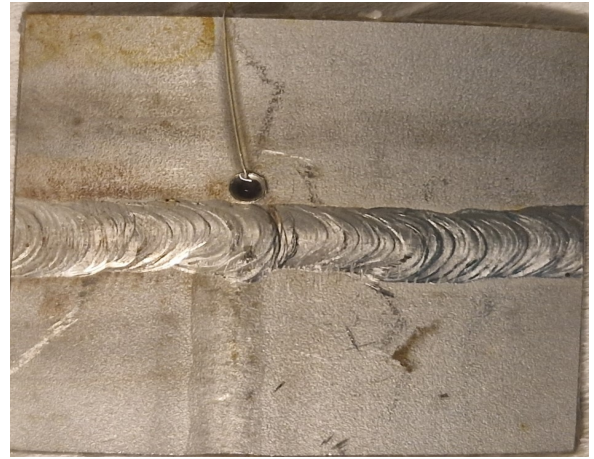
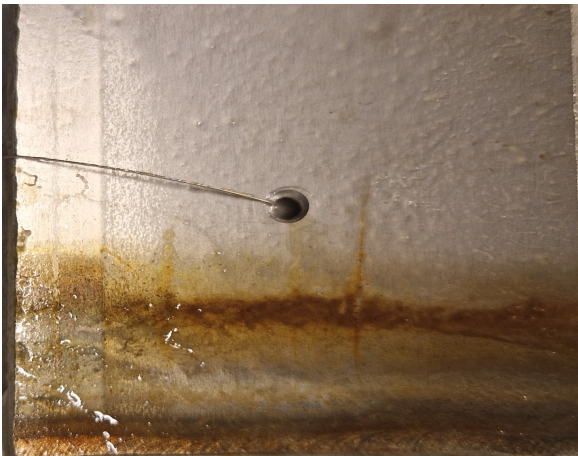
**Figure B.1.:** Welded samples from OCP setup at the Corrosion Lab.

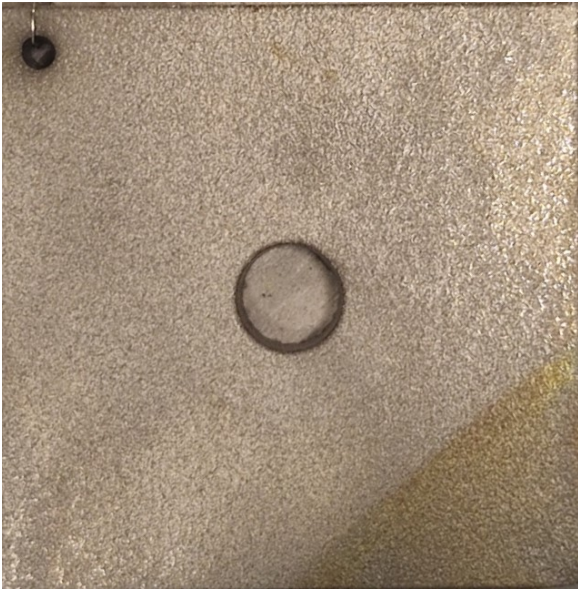
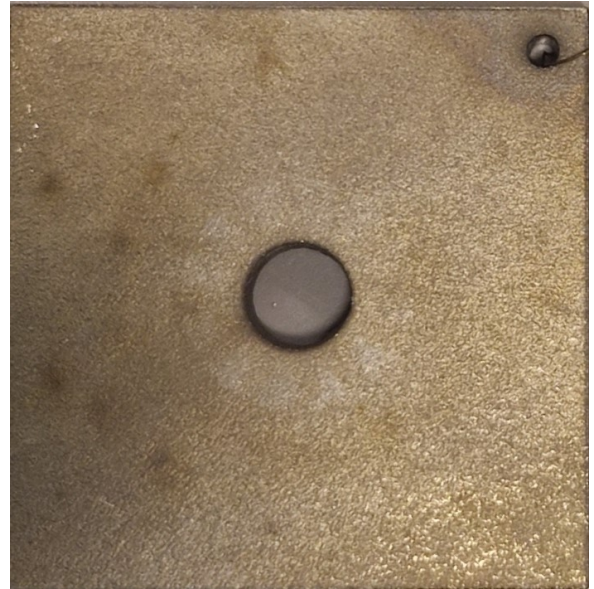
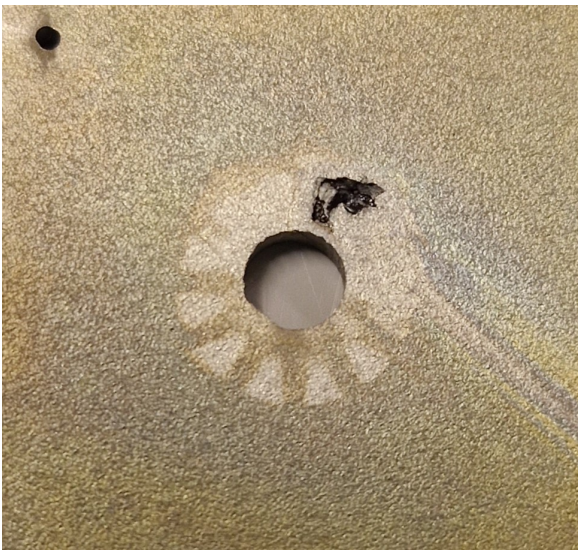
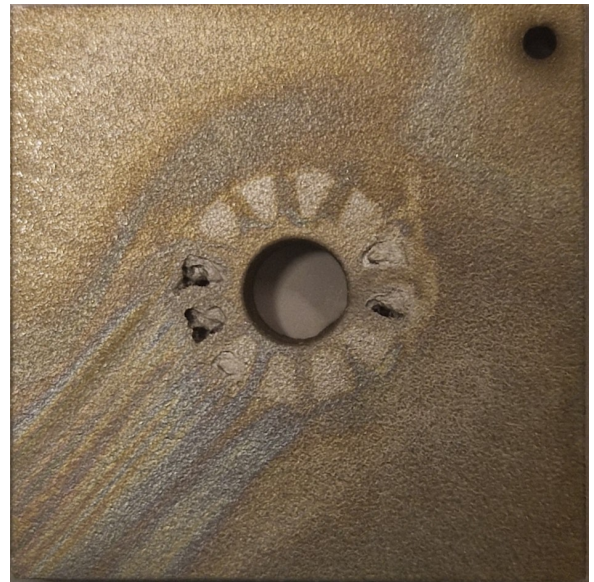
**Figure B.2.:** 304L Crevice samples.

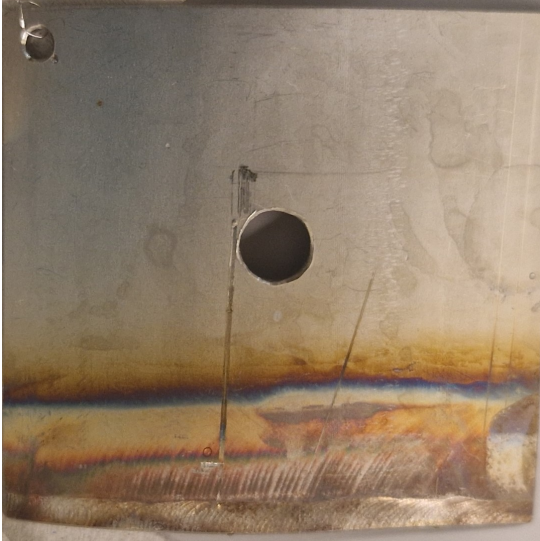
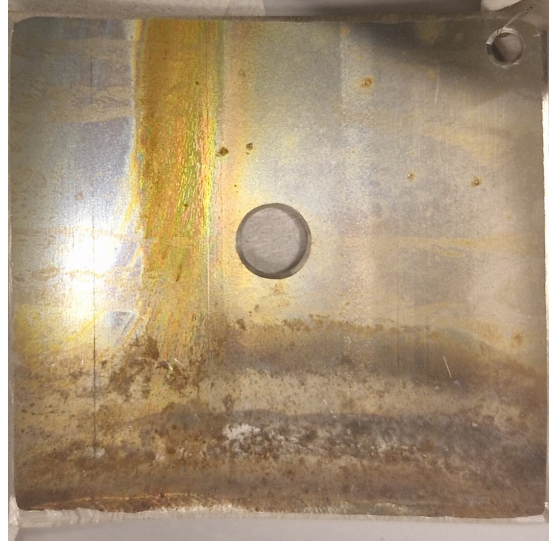
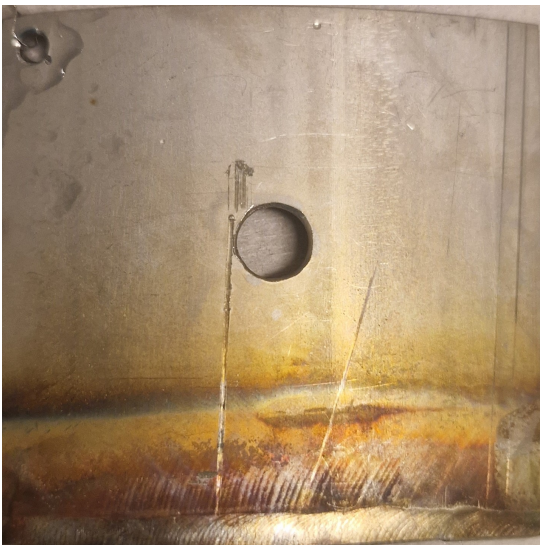
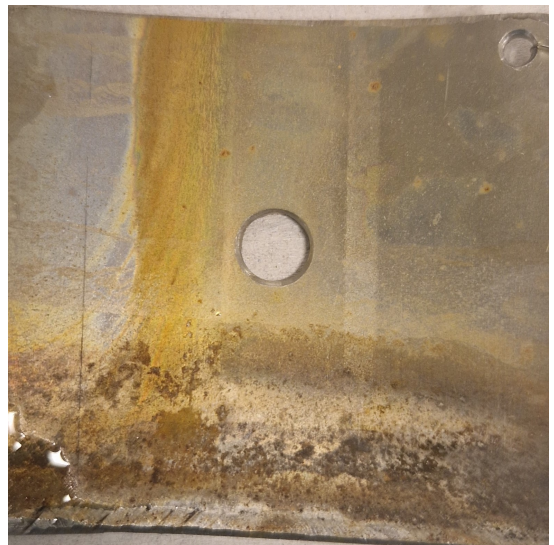
**Figure B.3.:** Pitted AISI 316L weld samples, 300mV at 2°C.
