Climate aging of miscellaneous wood surfaces and their characterization by Fourier transform infrared radiation spectroscopy

Master's thesis in Civil and Environmental Engineering

June 2023

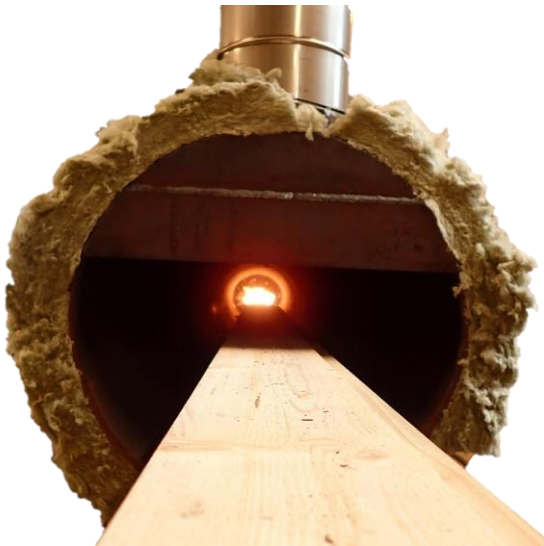
The charring took place in a furnace of steel, see Fig. 2, with the dimensions 5000 mm x 400 mm x 10 mm (length x diameter x thickness). The device has a roller on the bottom of the furnace to facilitate continuous board feed, and two propane torches on top. The torches have an output of 55 kW each and are placed at the end of the steel pipe. It is estimated 40 mm between the top surface of the panels and the torches. The processing speed was set at 6 meters per minute, which roughly corresponds to a processing time in the furnace right under one minute per panel. After heat modification the panels got brushed and water sprayed by a high-pressure washer. The last operation was to remove surface water with a leaf blower before storing the samples.

Fig. 2. A wood panel through the thermally insulated steel pipe gets charred at the end.

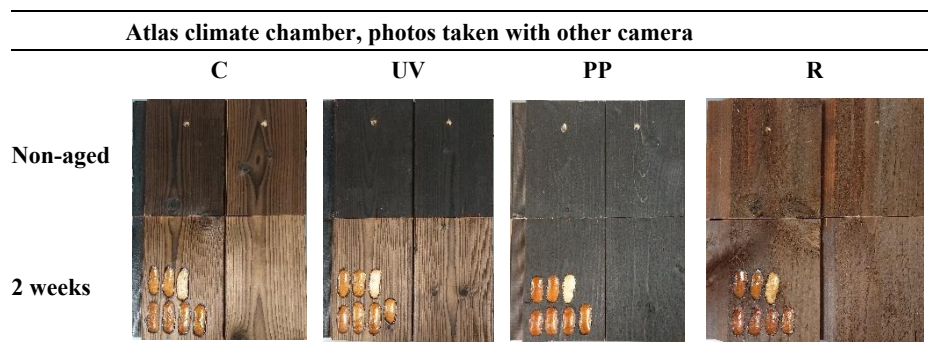
As mentioned in the above, samples weathered in the Atlas climate chamber depict similar color changes as samples weathered in the vertical climate simulator, with higher color stability for primed and painted and royal-impregnated wood. Even though the vertical climate simulator include exposure to UV radiation for four and a half weeks, and the Atlas climate chamber only two weeks with solar radiation lamp, there is a clear color change for the samples weathered in the climate chamber as well. A possible explanation for this might be due to the stronger solar radiation in the Atlas chamber. Furthermore, Fig. 5 shows the sampling of the small specimens of the wooden claddings that were analyzed with FTIR spectroscopy. The color change in the sampling area is due to degradation of the fast-setting two component adhesive (Casco Strong Epoxy Rapid) which were used to protect the sampling area.

Fig. 5. Samples before and after weathering in Atlas climate chamber taken with phone camera of charred wood (C), charred wood with UV resistant wood stain (UV), primed and painted wood (PP), and royal-impregnated wood (R). The upper samples are the non-aged references. The lower samples show marks after sampling of the specimens used in the FTIR analysis.

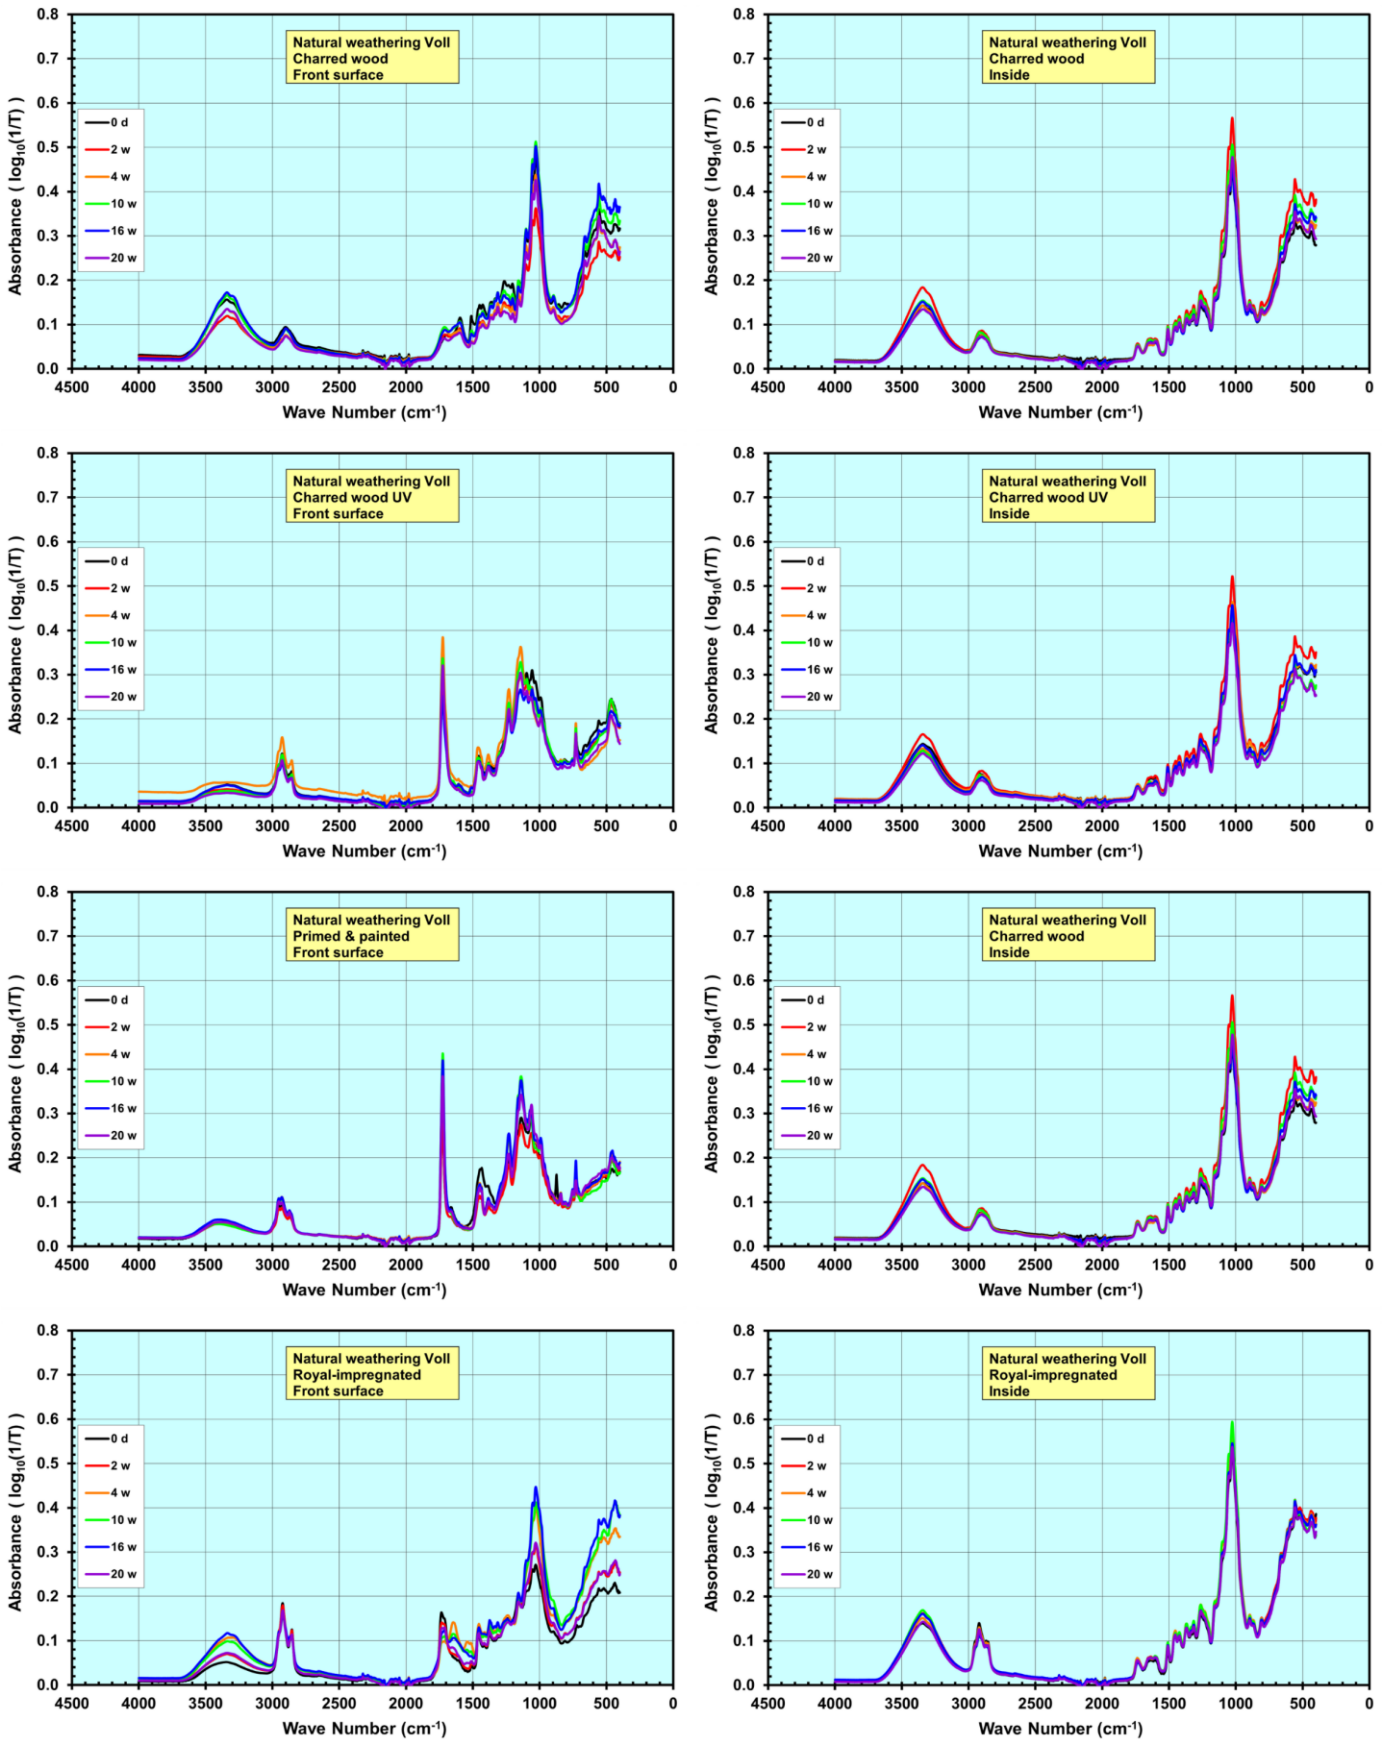
FTIR absorbance versus wave number for the four different samples subjected to natural climate aging at Voll are shown in Fig. 8. The natural weathering experiments may capture factors that are challenging to induce in artificial climate aging such as particulate matter, salts, combination of various factors, etc. Common for the inside of the claddings is lack of correlation between rising absorbance intensities with increased time of aging, same results as for the vertical climate simulator and Atlas climate chamber.

Analyzes at the front surface at wave number 1059 cm^{-1} , C-O stretching of cellulose, depicts an absorbance peak for all the claddings, but there are no clear connections between peak changes with increased aging time. The same is valid for wave number 1508 cm^{-1} , C=C aromatic band, lignin, except for primed and painted wood where no peak exists. In contrast to weathering tests in the vertical climate simulator and the Atlas climate chamber, an absorbance peak still appears at all aging times at wave number 1508 cm^{-1} for charred wood. This may be due to slower aging when weathering in natural outdoor conditions, as expected. At wave number 1729 cm^{-1} , claddings treated with UV stain and primer and paint, portray a sharp peak. However, no obvious correlations to aging times are observed for either these ones or the other cladding types. Analyzes at wave number 1595 cm^{-1} , aromatic ring of lignin, do not show a peak for the claddings except for charred wood. This may be due to the treatments hiding this peak for the wood front surfaces.

Fig. 8. FTIR absorbance versus wave number for the four different samples subjected to natural climate aging at Voll, including both front surface and inside of the samples.

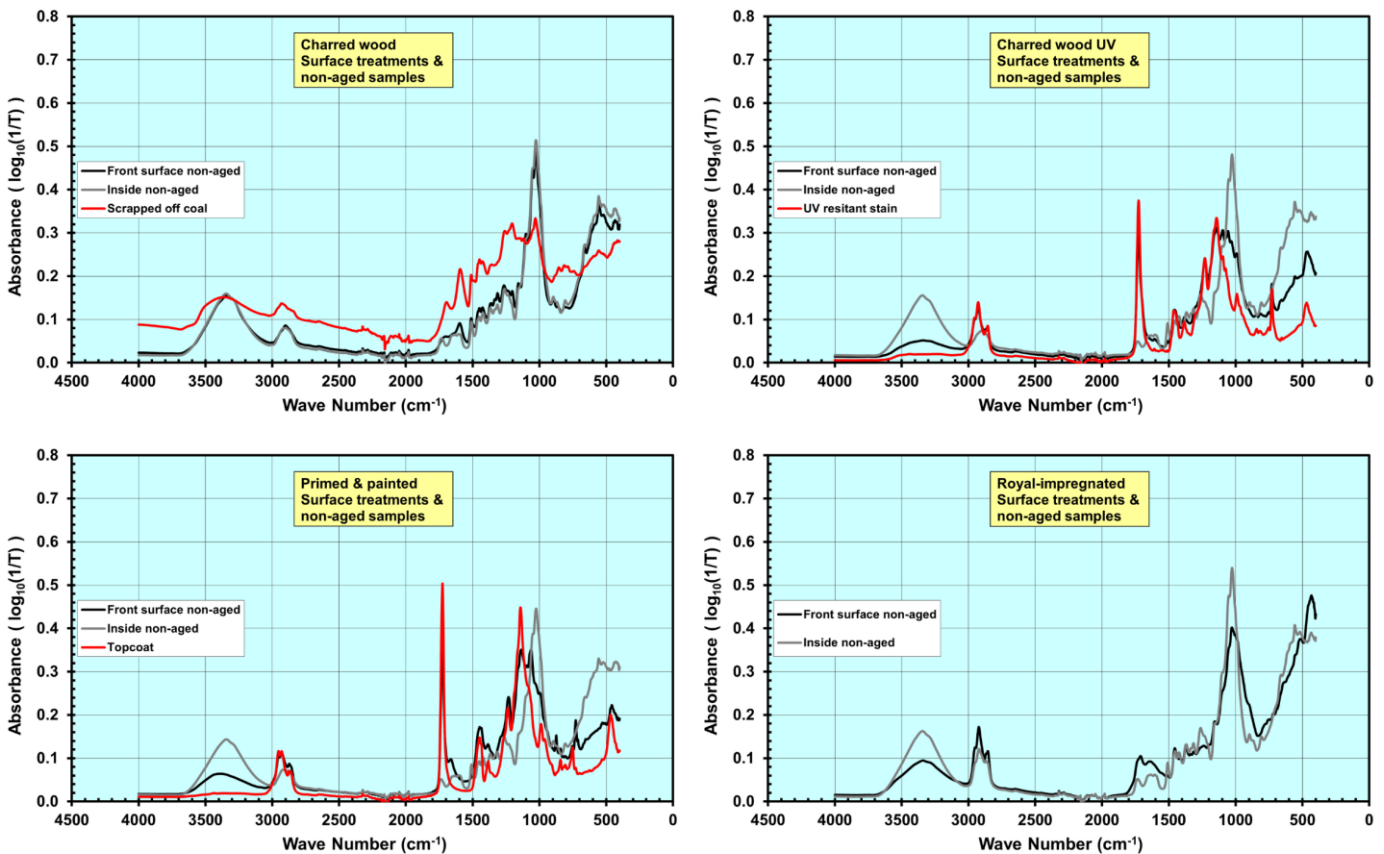
FTIR absorbance spectra versus wave number for the wooden claddings and treatments before aging are shown in Fig. 9. Note that the figure with the royal-impregnated wood do not have any spectrum of the treatment, as it was not possible to obtain the treatment of royal-impregnation cladding from the supplier or elsewhere within the timeframe of the investigations. Nevertheless, what can be observed from Fig. 9 is a similarity between the absorbance peaks on the front surface and inside of the wood, which is as expected since the impregnation penetrates the wood. Further, there are many common peaks between charcoal (scraped off charred wood before the brushing and washing process) and charred wood. This may be due to content of wood fibres in the charcoal. Wood fibres were found in some specimens when examined with a light microscope. Pure charcoal consists of carbon bonds and thus different from the more complex FTIR spectra which would arise from the multitude of different chemical bonds in wooden samples.

An interesting finding is that for charcoal the FTIR absorbance peak at 1795 cm^{-1} is more than doubled from 0.09 to 0.22 compared to the non-aged reference. This is also shown for multiple wave numbers in same plot. Probably, the uncertainties mentioned in chapter 3.3.1 *Artificial weathering experiments – Vertical climate simulator* may occur here as well, especially quantitative uncertainties (height of absorbance peak). If this is the case, the difference may be explained by the varying contact between the ATR diamond crystal and the sample, due to differences in the composition of the charcoal (sharpened charcoal fiber) and the charred wooden cladding. On the other side, it may also be due to differences in the amount of chemical bonds.

For cladding treated with primer and paint, many common peaks appear for the treatment itself and cladding with treatment, as expected. However, a greater difference was expected between the front surface and the inside of the wood due to the primer and paint are applied as a topcoat and hence do not penetrate so far into the wood like e.g. the impregnation. Noteworthy, previous results showed that e.g. peaks representing lignin were not visible, indicating that the treatment covers sufficiently the primed and painted wood.

Fig 9. FTIR absorbance versus wave number of different surface treatments. Note that it was not possible to obtain the treatment of royal-impregnated cladding from the supplier.

A peak at wave number 1508 cm^{-1} represents aromatic C=C bands (Srinivas & Pandey, 2012). When looking at charred wood, this absorbance peak reduces with increased time of aging, and almost disappears after 16 weeks. The decrease in the intensity of peak 1508 cm^{-1} indicates degradation of the aromatic C=C band. Srinivas and Pandey (2012) reported a rapid decrease in the intensity of lignin associated absorption band during photodegradation, which almost disappeared. Kymäläinen et al. (2020) also reported degradation of the aromatic C=C band, as well as formation of oxidized lignin structures and new carbonyl groups at around 1729 and 1508 cm^{-1} after aging. For the other claddings a peak at 1508 cm^{-1} barely exists or does not exist at all and may be due to the treatments covering the wood structure. At wave number 1729 cm^{-1} all the claddings show a peak, but no changes with increased time of aging. The peak is curved for charred wood and royal-impregnated wood, and sharp for charred wood with UV stain and primed and painted wood due to the treatment as shown in Fig. 9.

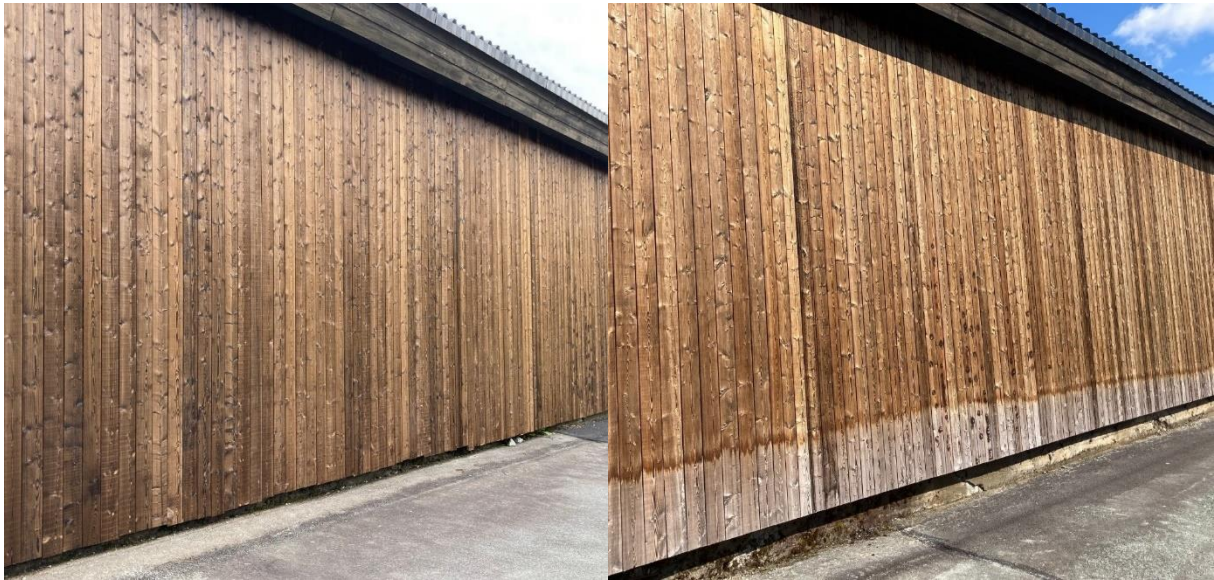
Fig. B1. Left: The test wall when installing 8th of June 2022. The edges were cut right after the picture was taken. Right: Picture of the test wall taken 28th of April 2023 showing a color change along the edge.

The observed difference in color may be due to rain, with a clear color change 55 cm above the cladding. The distance between the ground and the cladding is approximately 25-30 cm, which may exclude the suspect of the spurt of water [B1]. On the other hand, it seems that the color change has a connection to lack of roof gutter, which causes rain from the roof to drips onto the lower part of the wall and gets soaked whenever it rains. In addition, the eaves (overhang of 35 cm) do not cover sufficiently when wind-driven rain appears so the degradation along the edge becomes even higher.

This experiment shows that charred wood may be more susceptible to weathering by rain than the result in the article shows. This indicates that both UV radiation and rain may change the visual appearance of charred wood, in addition to the orientation of the wall together with the climate. However, further studies are needed to gain more knowledge of the performance of charred wooden claddings.
