# Rain resistance of open-joint facade claddings – Experiences from laboratory measurements **FREE**

Stig Geving

*AIP Conf. Proc.* 2918, 020019 (2023)

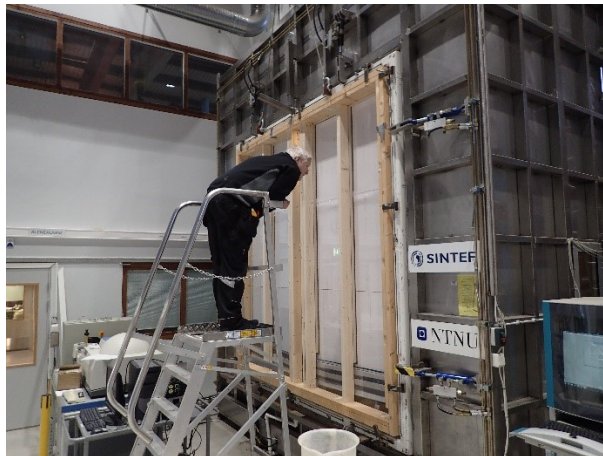
**FIGURE 1.** The test wall installed in the driving rain apparatus undergoing visual inspection for rain penetration. The rear of the wall is facing to the laboratory.

The test sections were sprayed with water 10 min before measuring the volume of leakage water to avoid water absorption at the board surfaces disturbing the measurements. The water leaked through the two horizontal joints were collected at the bottom of the wall section by metal ducts at two locations, one taped to the rear of the façade board and one taped to the outer surface of the wind barrier (polycarbonate board). The metal ducts were mounted with slope to one side of the test section, where the water was drained by plastic tubes to closed collection trays. The measurements were performed for 60 s and were not repeated. The leakage patterns were observed through the transparent polycarbonate board during testing as shown in Fig. 1.

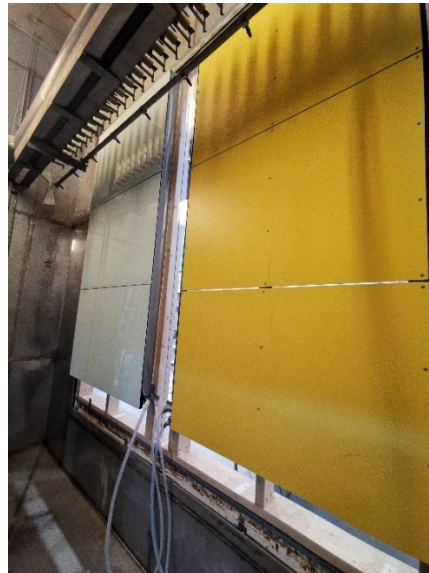
The driving rain cabinet was originally set up to test the driving rain tightness according to NS-EN 1027:2016. However, the present test was not entirely tested according to the standard. The cabinet had a spraying system with several horizontally positioned water spray nozzles at a distance of 400 mm as shown in Fig. 4. The nozzles were vertically adjusted and had two inclinations. The nozzles were permanently mounted at a distance of 150 mm above the upper horizontal joint and 200 mm from the external surface of the cladding, and at an inclination of 24° to the horizontal. Although most of the water impinged over the upper horizontal joint, a small volume of water directly impinged on the joint. The bottom horizontal joint only received water that flowed down the board above. This means that it is only in connection with the upper joint that raindrops can penetrate directly to the wind barrier (polycarbonate board). Each nozzle yielded 2 L/min that impinged on the test object in a circular area. This provided 5 L/min per meter, or 6 L/min per test section.

**FIGURE 4.** Test wall observed from the inside of the driving rain cabinet. The water spray nozzles can be observed at the top.

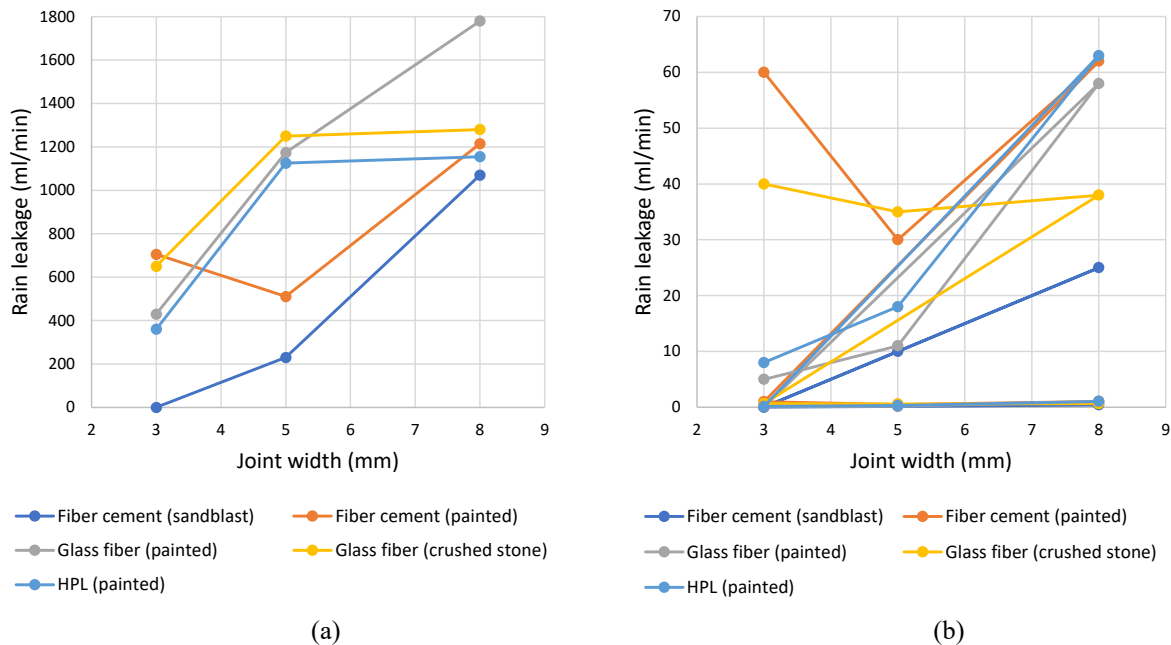
The results of rain leakage as a function of board material, surface, and joint width are shown in Fig. 5. The average rain leakage measured at the rear of the façade board (for the test set shown in Fig. 5) in % of the total amount of water striking the test section (6000 mL/min) was 7, 14, and 22 % for the joint widths of 3, 5, and 8 mm, respectively. The leakage spans for the entire test set from 0% (for sandblasted fibre cement) to 30% (for painted glass fibre).

**FIGURE 5.** The measurement of rain leakage through the façade board. (a) Rear of the façade board, (b) Outer surface of the wind barrier (polycarbonate board).

The rain leakage increased with an increase in the joint width. A joint width of 3 mm was optimum according to Fig. 5(a). However, observations demonstrated that water filled the joint for a long period of time after the test, which increased the risk of discoloration and microbial growth. With 3 mm joint the possibility for water filling the entire joint during a rain incident is very high, and the assumption of pressure equalization of the air gap might become invalid. Therefore, the pressure difference over the façade board might lead to higher leakage rates in the case of

3 mm joint width than shown in Fig. 5(a). With that background, the optimal joint width is probably around 5 mm, which verify previous investigations and recommendations [7].

The fibre cement boards, particularly the sandblasted type, had the lowest total leakage at a joint width of 5 mm. The difference was probably due to the different values of roughness/smoothness of surfaces at the exterior face and/or at the edges. The surface at the exterior face affected the run-off speed, or the path (concentrated flows or evenly distributed) of water running down the façade. However, it was difficult to determine if the application of a rough exterior surface (as for instance the sandblasted fiber cement) was advantageous because the very rough surface of glass fibre board with crushed stone exhibited the highest leakage at a joint width of 5 mm. It is therefore to be expected that the surface at the board edges, and how it interacts with the surface tension of the rainwater, plays an important role in how the water flows past the horizontal joint. However, the difference between the various boards at a joint width of 8 mm was not distinct.

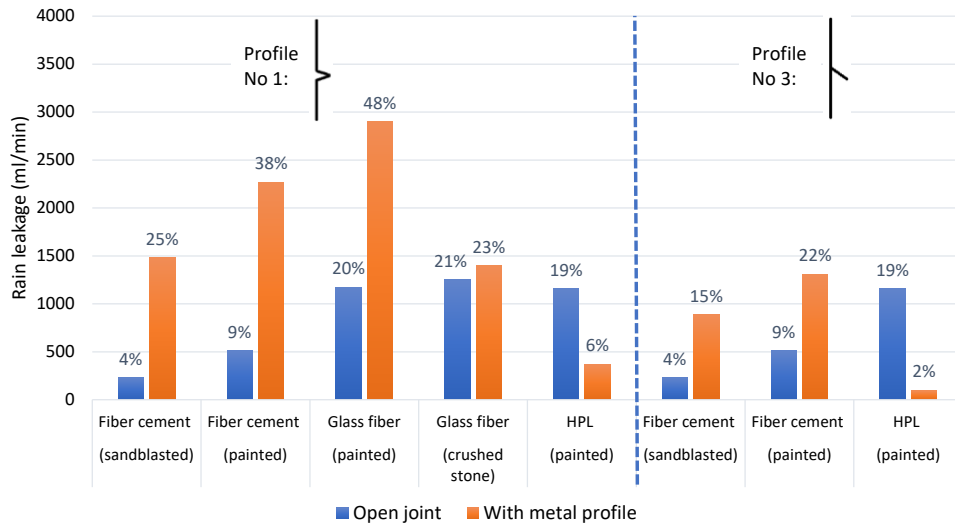
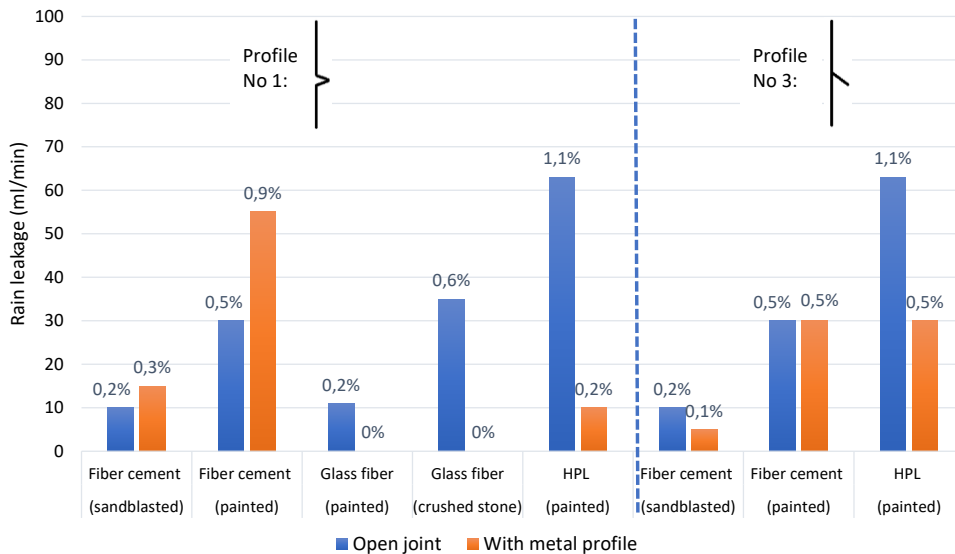
**FIGURE 6.** Rain leakage with and without metal profiles. The joint width recommended by the producer for the “open joint” is used as a comparison, i.e., 5 mm for fibre cement and glass fibre, and 8 mm for HPL. Note: Profile No. 3 was not tested for the glass fibre boards. The rain leakage is represented as a percentage of the total amount of spray water (6000 mL/min) hitting the façade. (a) Back side of façade board, (b) Outside of wind barrier (polycarbonate board).

Metal profile No. 2 was tested for the two variants of glass fibre boards and rain leakage through the façade boards was not observed, i.e., the rain leakage was effectively reduced by 100%. The profile was adopted specifically for façade boards with a thickness of 6 mm as were the thickness of the glass fibre boards. However, the remaining two profiles were significantly less effective. The measurement results of these two profiles were compared with that of the results with open joints (as shown in Fig. 5), refer Fig. 6. The total rain leakage (rear of the façade board + at wind barrier) increased for all tests. However, the HPL-boards exhibited a decrease in the rain leakage from 19% to 2 – 6%. In the case of profile No. 1, the total rain leakage increased 4 – 6 times for the fibre cement boards and up to 2 times for the glass fibre boards. The total rain leakage reached 48% of the volume of the sprayed water at the façade for one of the cases. In the case of profile No. 3, the total rain leakage increased 2 – 4 times for the fibre cement boards. A minimum of 97 – 100% of the total rain leakage for the cases with profile No. 1 and No. 3 were run-off on the rear of the façade board. An exception applied for HPL board with profile No 3, wherein significantly low total rain leakage (130 mL/min) was observed, and only 77% were run-off on the back side of the façade board.

One possible explanation for the increase in the rain leakage while using profile No 1 and No. 3 is that the metal profiles did not offer reliable tightening such as rubber gaskets between the metal and board material. In addition, the profiles were not fastened between the vertical battens. Since they have a limited stiffness, it is impossible to achieve effective compression between the facade panel and profile. In between the vertical battens giving some compression, a distance of a few mm could be present between the board and profile. It seems that the profiles were disrupting the normal run-off past the horizontal joint in the absence of reliable tightening, which led to the increased seepage of water behind the façade board. A possible reason to why the profiles had a good tightening effect for the HPL-boards, could be due to the fact that the joint width used for these boards are 5 mm instead of 8 mm, giving possibly a tighter connection between the profile and the boards. Additionally, the difference between the surface properties of the HPL-boards and the other type of boards probably resulted in different run-off pattern on the exterior surface.

The metal profiles protected the wind barrier from the direct impact of raindrops through the joints, but minor water leakage at the wind barrier (less than 1% of the total rain leakage) was observed. This was probably due to leakage water running down the vertical battens and thereby reaching the wind barrier. The rain leakage at the wind barrier with and without metal profiles is shown in Fig. 6(b). It can be observed that three test series out of eight test series exhibited higher or equal rain leakage for metal profiles compared with that of open joints. It should be noted that these three test series consisted of fibre cement boards. In the case of glass fibre or HPL boards, a high reduction of rain leakage was observed at the wind barrier while using metal profiles, particularly for glass fibre boards with profile No. 1 wherein rain leakage did not reach the wind barrier.
