The Challenge of Rehabilitating Relocated Listed Heritage Buildings: Requirements, Current Standards and Opportunities

Master's thesis in Civil and Environmental Engineering

Norwegian University of Science and Technology
Faculty of Engineering
Department of Civil and Environmental Engineering

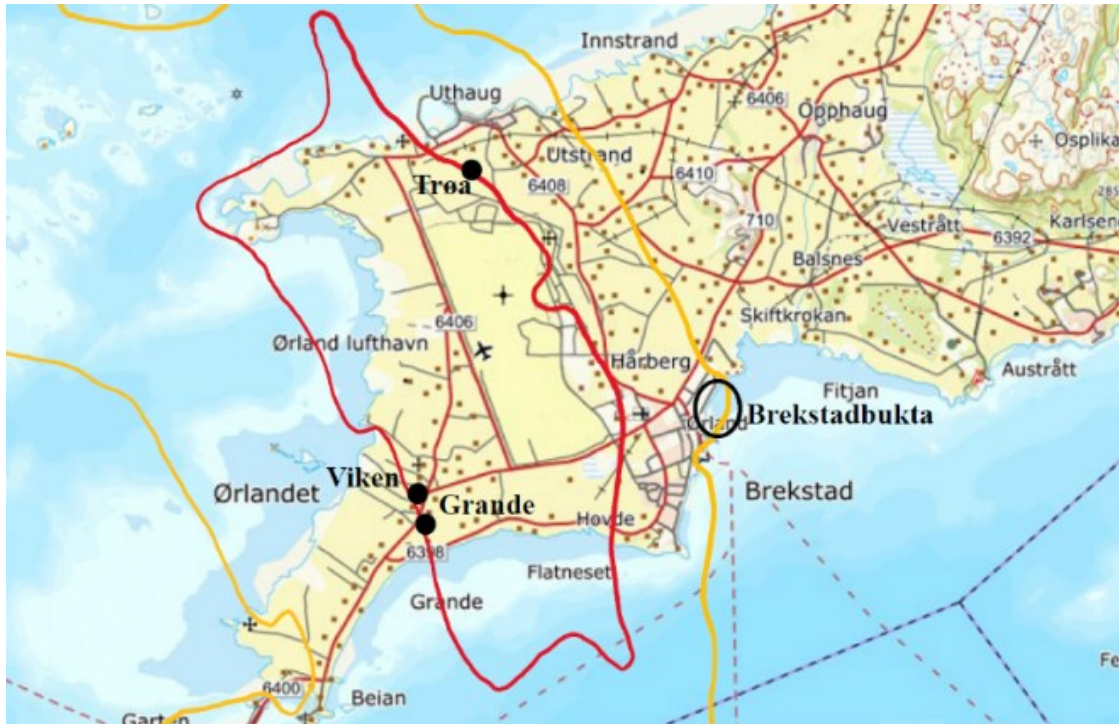
Figure 2.1: Part of Ørland Municipality, showing Ørlandet and Brekstad. The red line represents the red noise zone, and the yellow line represents the yellow noise zone. The current location of the three assessed farmhouses (Trøa, Grande and Viken) and the recently designated Brekstad Bay area are also indicated. Drawn on the map from norgeskart.no.

Ørland Municipality is located at Fosenhalvøya in Trøndelag County (Haugen, 2023). Most of the population in Ørland Municipality lives near the northern coastline, in Brekstad and on the outer west peninsula, called Ørlandet. Ørlandet is a flat area characterized by agriculture and a military airport. In 2012 it was decided to establish a main combat aircraft base at Ørlandet for The Royal Norwegian Airforce (The defence sector’s properties, 2014). This development will not only expand the existing base but also bring new aeroplanes. The increased noise levels from these aeroplanes will have an impact on the environment, including potential harm to both people and animals living in the area. As a result, The Norwegian Defence Estates Agency has designated a “red zone” around the base that will be most affected by noise, see Figure 2.1.

Today, the three selected farmhouses are rurally located at some distance from the coast. Trøa is located near Uthaug, north of Ørlandet, while both Grande and Viken are situated in the southern part of Ørlandet, see Figure 2.1. In the new residential area, the buildings' orientations and climate stresses will change. For instance, the proposed site for Viken is situated along the coast, resulting in significant alterations in the weather exposure the building will be subjected to. The farmhouse will be rotated approximately 220° based on cardinal directions (north being 0° and east being 90° etc.). Trøa will be somewhat protected from climate stresses by surrounding buildings, and the proposed orientation remains roughly the same. Grande will be situated farthest away from the coast but close to the road, causing issues concerning noise. Grande will be rotated about 50° from its original orientation. Figure 2.2 show the new placement of the buildings in Brekstad Bay.

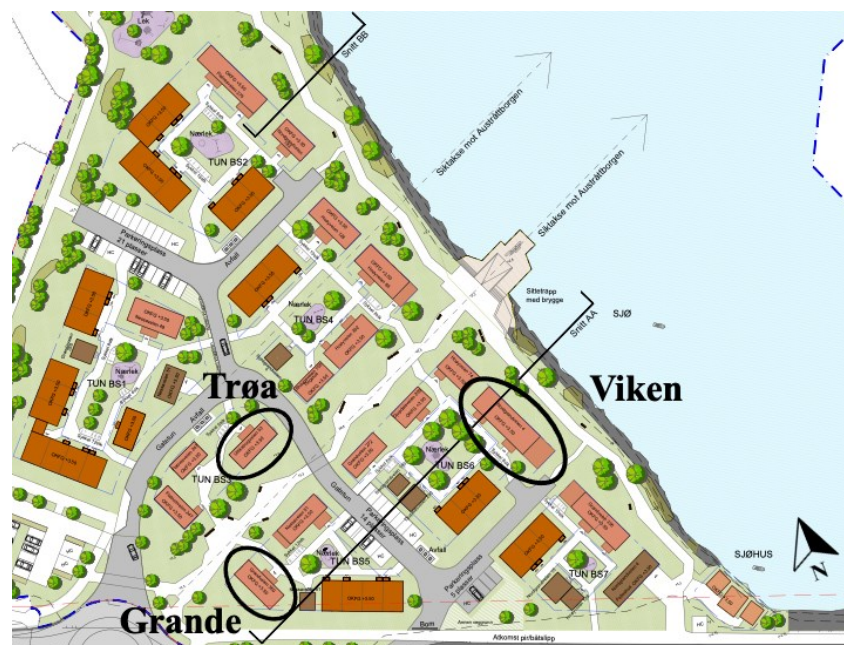
Figure 2.2: Placement of Trøa, Grande and Viken in Brekstad Bay (Brekstadbukta). Drawn on site plan received from Ørland Municipality.

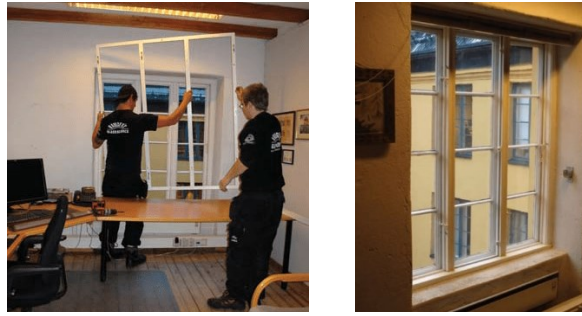
Figure 3.1: Installation of a secondary glazing improving the window's U-value from 4.6 W/(m²K) to 1.6 W/(m²K). Photo: Marte Boro (Directorate for Cultural Heritage, n.d.).

Original windows in old buildings contribute to a large part of the building's energy losses due to their low thermal performance, thermal bridging and air leakage (Homb & Uvsløkk, 2012). Hence, energy savings can be achieved by restoring or replacing the building's fenestration. Total windows replacement is currently the most applied fenestration upgrade, also in historic buildings, even though other options exist (Litti et al., 2018). This is partly due to technical simplicity, affordability and high energy-saving potential, but also window products producers and suppliers influence this through compelling lobbying activity. Furthermore, it is noticeable that total windows replacement is not always the only and better solution for fenestration renovation. Restoration and/or installation of internal secondary glazing may lead to similar or more energy savings, according to Litti et al. (2018). Moreover, windows replacement is not always compatible with preservation of heritage buildings and their cultural value. This is applicable for the case in Ørland Municipality, where there are regulatory requirements about preserving the exterior façades, something that must be accounted for when considering fenestration renovation. The original windows in listed buildings are an important part of building history and traditional craftsmanship (Korsaksel & Stige, 2014). Also, there are multiple reasons to preserve old windows, e.g., historic cultural value, lifetime and quality, economy, and environmental considerations. Figure 3.1 shows an example of an old window which is improved with an energy-efficient secondary glazing.

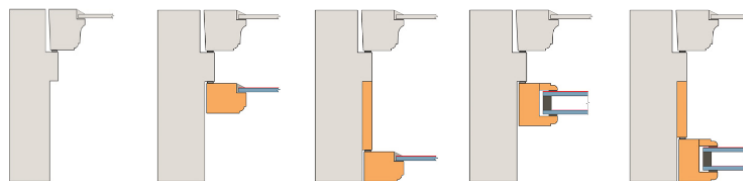
Figure 3.2: Possible solutions for upgrading an old single-glazed window with an internal storm window of single or double glaze (Homb & Uvsløkk, 2012).

Homb and Uvsløkk (2012) investigated the performance of an old heritage window upgraded with a secondary glazing with various configurations of panes and positions. Four different solutions were tested: single and double glazing, each with a cavity between the panes of 74 mm and 174 mm, see Figure 3.2. The research included both calculations and measurements in the laboratory, e.g., thermal transmittance (U-value), air tightness and soundproofing. The best results were obtained in both positions with a double-glazed windowpane.

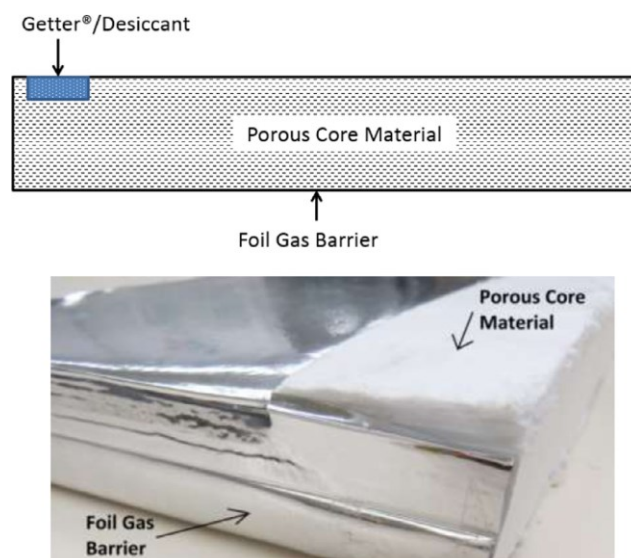
Figure 4.1: VIP components (Molletti et al., 2018).

A vacuum insulation panel (VIP) is formed of a core of porous material enclosed by an airtight foil, from which the air is pumped out forming a vacuum (SINTEF 573.344, 2020). VIPs have very low thermal conductivity, in fact, the insulation performance is 5-10 times better, dependent on ageing, compared to conventional thermal insulation (Kalnæs & Jelle, 2014). This technology represents one of the most up-and-coming building insulation materials for commercialization today. Information about the construction of VIPs, and different types, can be found in Kalnæs and Jelle (2014). Figure 4.1 displays the components of a VIP.

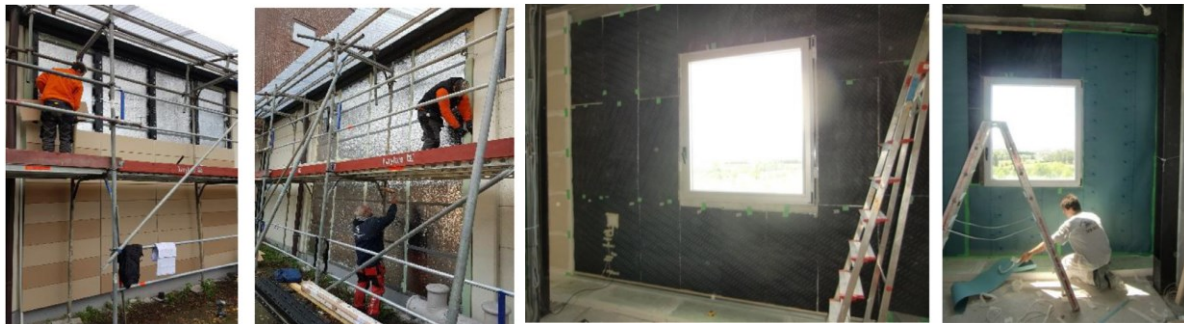
Figure 4.2: External ventilated façade retrofitting with VIPs in Malmö (two left photos) and internal installation of VIPs in KUBIK by Tecnalia (two right photos) (Uriarte et al., 2019).

Throughout their studies, Uriarte et al. (2019) discovered that one of the main issues to make the installation process fast and smooth are the VIPs' tolerances. Nevertheless, the use of VIPs seems promising with regards to space heating energy savings, with a reduction of 23 % and 36 % in the respective study. Sallée et al. (2014) studied the use of VIPs for internal thermal insulation in existing buildings with façades with high architectural character, as an alternative to external thermal insulation systems. They found that the use of VIPs can yield a 30 % reduction of the whole U-value, while external thermal insulation systems can give a reduction of 50 %. This study was carried out on a mock-up of a connection between an external wall and a partition wall both made of concrete. A study conducted by Sveipe et al. (2011) investigated the use of VIPs for retrofitting half-timber frames, both on the cold (exterior) and warm (interior) side. The study concludes that "timber frame buildings thermally insulated with 100 mm mineral wool, might be retrofitted at the exterior side by adding 30 mm VIPs in a continuous layer", based on the results from the experiments, the simulations, and the condensation controls (Sveipe et al., 2011). On the other hand, the condensation calculations highlighted the importance of preventing puncturing of the VIPs and to account for the VIPs' qualities in aged conditions. The solution with VIPs for interior retrofitting showed the best results concerning moisture, i.e., no condensation occurred during the test. Examples of VIPs used for external and internal insulation are shown in Figure 4.2.

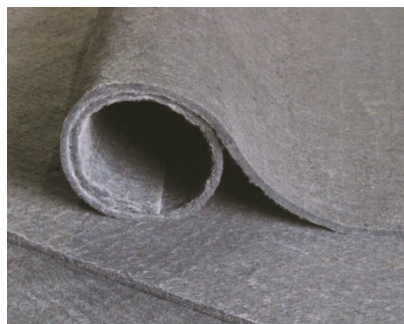
Figure 4.3: Spaceloft® Aerogel insulation blanket developed by Aspen Aerogels, Inc. (Glava AS, 2013).

There are three different types of aerogels: silica, carbon and alumina, whereas silica is the most common (Cuce et al., 2014). Silica aerogel can be used in both opaque and translucent building parts, e.g., roofs, walls and windows (Baetens et al., 2011; Cuce et al., 2014). The process of creating aerogels is described thoroughly by Baetens et al. (2011) and Cuce et al. (2014). Aerogels come in different product types, e.g., blankets (see Figure 4.3), render and boards (Ganobjak et al., 2020). Due to low thermal conductivity, the products are slim and ideal when space saving is crucial (Cuce et al., 2014). By using aerogel materials instead of conventional thermal insulation materials, a given insulation performance is achievable with about half the thickness (Ganobjak et al., 2020). Hence, aerogel materials may be suitable for the rehabilitation of cultural heritage buildings. Furthermore, this was investigated by Ganobjak et al. (2020) with respect to a historic building's authenticity, integrity, reversibility and compatibility. The projects presented in the mentioned article are mainly quarry and brick walls retrofitted with exterior aerogel render. Ganobjak et al. (2020) conclude that heritage requirements, as well as a decrease in energy demand, can be obtained with aerogel-based insulation for retrofitting preserved heritage buildings. However, additional insulation can cause moisture problems, especially internal thermal insulation must be carefully evaluated. Elshazli et al. (2022) performed full-scale experimental tests to study the performance of aerogel insulation blankets used as internal insulation in a student residential apartment. The study showed a reduction in energy usage by 23 % and 38 % for single and double layers of aerogel, respectively. Anyhow, Elshazli et al. (2022) emphasizes that type of building, type of building envelope and thickness, type of thermal insulation, and windows and configurations will affect the energy-saving percentages. More studies about building retrofit with aerogel have been conducted by (Cuce & Cuce, 2016; Ibrahim et al., 2015; Koebel et al., 2012; Koh et al., 2022).

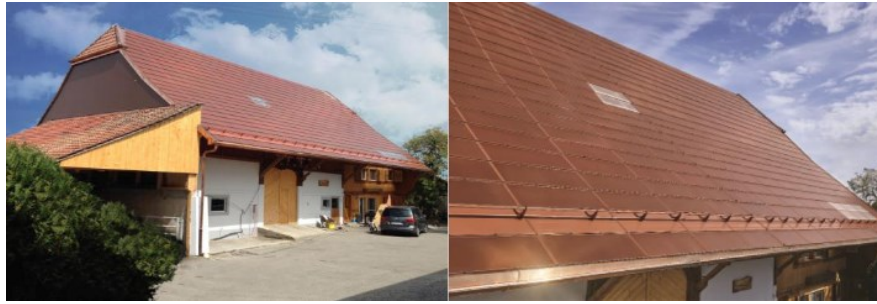
Figure 5.1: Rural farmhouse in Switzerland from 1859 with terracotta coloured BIPV (right picture). The left photo shows the building before the energy upgrade. Photos from (Polo López et al., 2020).

Pelle et al. (2020) find in their study that integration of BIPV in historic buildings consists of three integration levels: (i) aesthetic integration, i.e., the capability to include PV in a building's architectonic rules; (ii) technological/functional integration, i.e., the PV system's potential to substitute traditional building components; and (iii) energy integration, i.e., the PV's ability to efficiently integrate to the applicable energy system to maximise self-consumption and contribute to the implementation of energy-efficient communities. To visualize this; during an energy upgrade of an 1859 rural farmhouse in Switzerland (Figure 5.1), terracotta-coloured PV modules were used to meet requirements (Polo López et al., 2021). These solar panels are integrated in the building, and they have anti-reflective glass, cover a 250 m² area and produce 16 500 kWh per year.

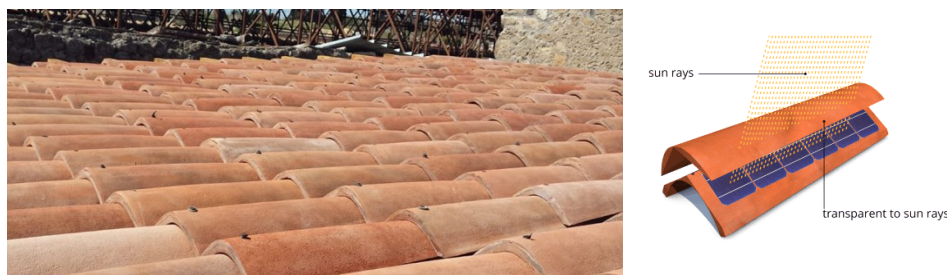
Figure 5.2: Dyaqua Invisible Solar terracotta roofing tile (Dyaqua, n.d.).

The Italian company Dyaqua Invisible Solar has taken it one step further and recently launched an invisible solar roofing tile that realistically resembles a traditional terracotta roofing tile (Dyaqua, n.d.), as shown in Figure 5.2. The PV cells are hidden underneath a low molecular polymeric compound surface which is opaque to human eyes, but transparent for sun rays. These tiles have a peak power of 7.5 Wp and weigh 2 kg per tile. The same company are also developing PVs that realistically look like other building materials, such as wood, stone and concrete, see Figure 5.3, which can be applied to roofs, walls and pavements. However, the three last-mentioned products are not on the market yet. Still, they are worth a mention to show where the development of PV technology is headed. Such realistic PV tiles could be of great importance for the integration and acceptance of PV in general, and especially for cultural heritage buildings and areas.

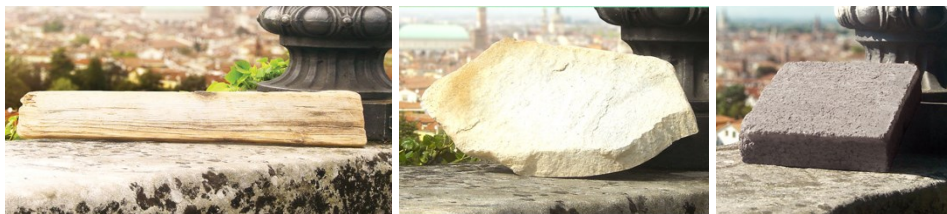
Figure 5.3: PV-technology under development from Dyaqua (Dyaqua, n.d.). PV with realistic-looking wood (left), stone (middle) and concrete (right) surface.

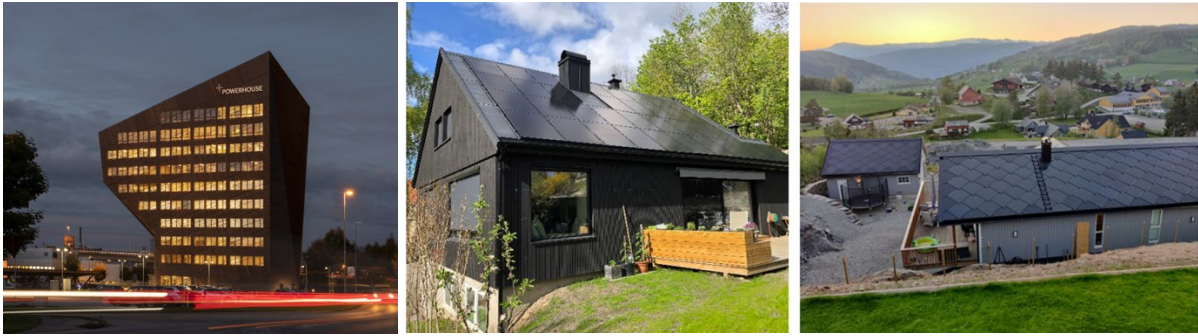
Figure 5.4: Powerhouse Telemark (left) (Powerhouse, n.d.). Two Norwegian houses with BIPV roofs (middle and right) (Bunkholt et al., 2021).

Over the past few years, the accumulated capacity of solar power plants has increased in Norway (Kvalbein & Stensrud Marstein, 2018). Typical for Norway is to apply the PV panels to existing buildings as BAPV, and not installed as ground-mounted systems or BIPV. Nevertheless, the country has a growing interest for BIPV (Bunkholt et al., 2021), and they are highly applicable due to low temperatures and low sun angle, especially on south-facing façades (Kvalbein & Stensrud Marstein, 2018). However, there are few agreed-upon and recommended solutions for building structures with BIPV, and this is not included in the “SINTEF Building Research Design Guides” (Byggforskserien) (Bunkholt et al., 2021), which is an important national information channel, knowledge base and quality standard used by builders, contractors, engineers, and architects (*SINTEF Information*, n.d.). Still, BIPV can be found in several Norwegian buildings, e.g., Powerhouse Brattørkaia, Telemark and Kjørbo (Powerhouse, n.d.), ZEB Laboratory in Trondheim (ZEB Laboratory, 2022), and several others shown in (Bunkholt et al., 2021; Kvalbein & Stensrud Marstein, 2018). Some of the aforementioned buildings with BIPV are depicted in Figure 5.4.

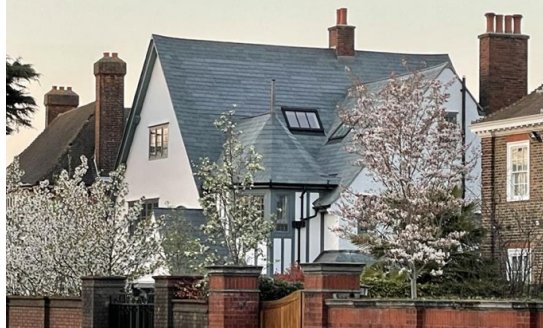
Figure 5.5: PV Slates from GB-Sol (GB-Sol, 2023).

British company GB-Sol offers a product called PV Slate, which looks like slate stones (GB-Sol, 2022). They claim the PVs will work seamlessly with natural slates, see Figure 5.5. This could be an option for Ørlandet to satisfy regulations; incorporating both natural slate and PV slate. The PV slates come in different shades, are lightweight compared to natural slate, and have an output of 132-138 Wp/m² depending on dimension. Alternatively, they could be used on the entirety of the roof, as they offer edge-to-edge solutions.

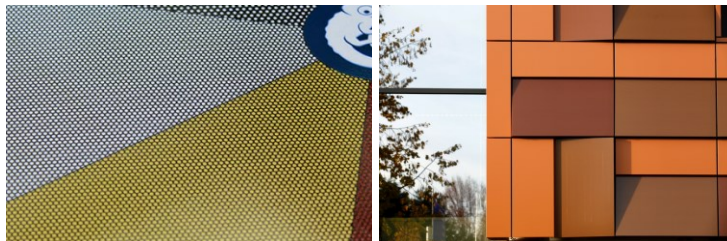
Figure 5.6: Hexagon coloured pattern on ColorBlast PVs (left). Kuijpers - Helmond with ColorBlast PVs in orange shades from a distance, appearing as homogenous colours (right). Both images are retrieved from (SolarLab, n.d.).

The Dutch manufacturer Kameleon Solar offer coloured PV, called ColorBlast, with a variety of 4000+ colours, and customizable shapes and glass finishes (Kameleon Solar, n.d.-b). The output is colour dependant, but they have the potential to reach 168 Wp/m². In addition, they offer several other types of PVs, e.g., with design/image print, as well as metallic and matte surfaces. However, these have a lower output between max 150-168 Wp/m². Kameleon Solar uses metric patterns of hexagons to create a homogenous colour/image from a distance, while allowing light to pass through the gaps. This is beneficial as colour works as a shade for solar radiation. See Figure 5.6. For Trøa, Grande and Viken, a green PV could, for instance, resemble a turf roof (permitted roofing material), alternatively a turf-print could be applicable. Furthermore, woodprint PVs could be incorporated into the façades.

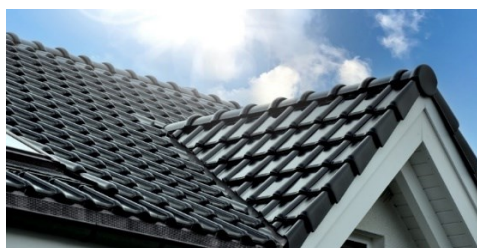
Figure 5.7: Alegra 10 Wevolt solar roofing tiles by Wienerberger (Wienerberger, 2023b).

Wienerberger is a Dutch manufacturer producing PVs which resemble roofing tiles, named Alegra 10 Wevolt solar roof tile (Wienerberger, 2022). Regular roofing tiles are not permitted according to regulatory requirements; however, Alegra 10 Wevolt solar roof tiles are still considered an applicable option as they do not appear as PVs, but rather standard roofing tiles as shown in Figure 5.7. These solar roofing tiles are combined with a traditional ceramic roofing tile, making them easy and flexible to lay (Wienerberger, 2023a). They have an output of 106 Wp/m². Further BIPV options are presented in Table 5.1.

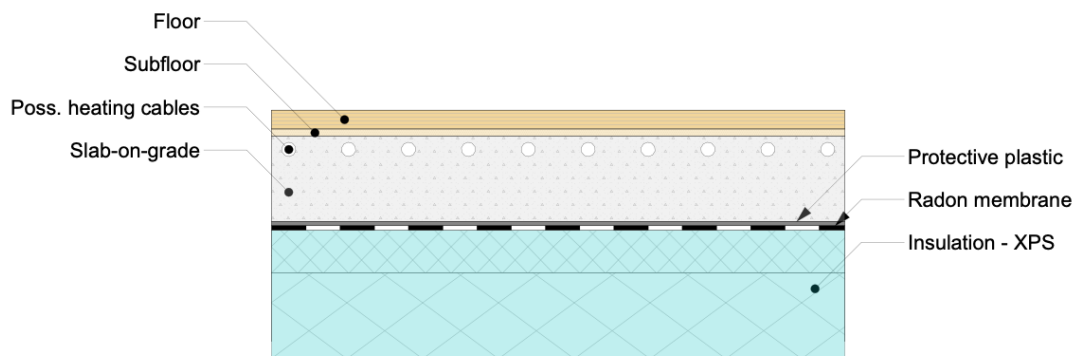
Figure 6.1: Illustration of suggested new floor composition.

As addressed in Chapter 3.1, a new slab-on-grade foundation with a concrete stem wall is the best option for the new foundation and floor construction for the three buildings. Considering the high moisture levels present at the coast, XPS has been identified as the most suitable thermal insulation material. Furthermore, insulation thickness is not a concern due to the foundation being remade and ample space being available in the ground. Figure 6.1 illustrates the composition of the floor construction.

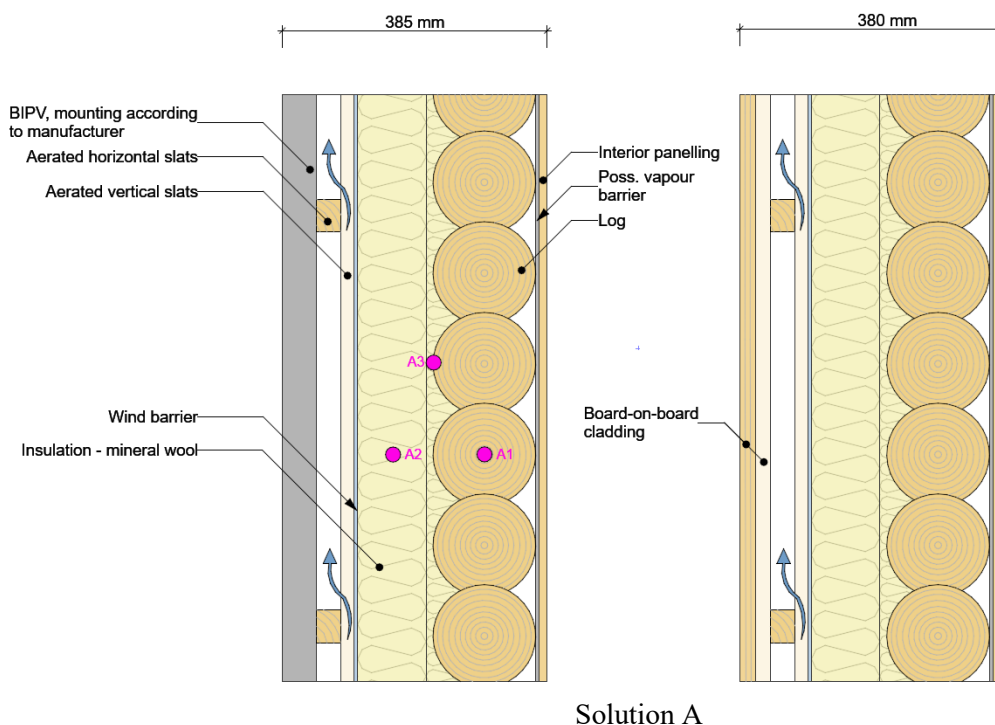
Solution A

Figure 6.2 presents a solution of a wall construction externally post-insulated with 150 mm mineral wool (solution A), which gives a U-value of 0.26 W/(m²K). The mineral wool is placed in a framework and fills the gaps in the logs. While obtaining an adequate U-value, the drawback of solution A is a total thickness of ca. 385 mm which will affect the eaves and window placement in the wall, and consequently the building's architectural appearance. Moreover, deeper window posts also result in less daylight inside. WUFI revealed that the centre of the logs (A1) will dry out well with this solution, see Figure 6.6. In the centre of the mineral wool (A2), the graph (Figure 6.7) demonstrates that the relative humidity (RH) fluctuates stably and gradually downward sloping. The peaks are during autumn and the troughs are during spring, meaning the insulation dries out during winter. In the junction between the mineral wool and the logs (A3), Figure 6.8, solution A displays the best results out of all the solutions (A-F). Adding a vapour barrier gives slightly better results over time in all positions, than without vapour barrier, i.e., using a vapour barrier results in lower RH in solution A.

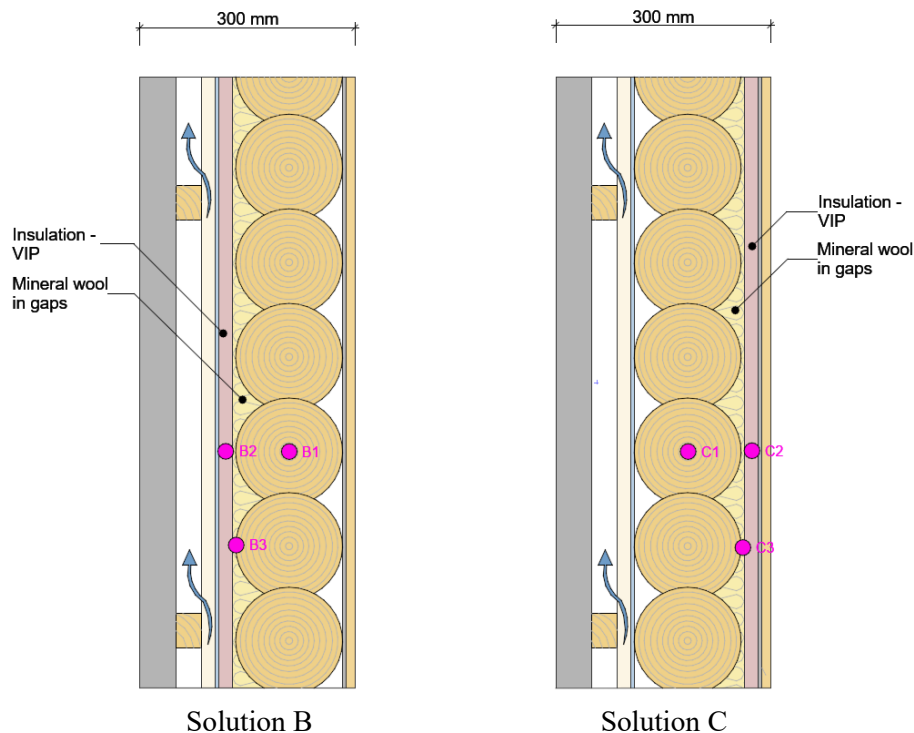
Figure 6.3: Wall construction post-insulated with external VIP (B), and internal VIP (C). Monitor positions and names for WUFI simulations are shown as pink dots.

Figure 6.3 illustrates how to post-insulate with 20 mm VIP externally (solution B) and internally (solution C). VIP results in a slimmer construction than mineral wool, approximately a total thickness of 300 mm. The VIPs are connected to the logs in a 23-36 mm framework, where the log gaps are filled with up to 50 mm mineral wool. Both external and internal VIP will provide a U-value of 0.25 W/(m²K). In both centre log (B1, C1, Figure 6.6) and the junction between logs and insulation (B3, C3, Figure 6.8), the VIP solutions causes a rather high relative humidity in the wall. Solution B with vapour barrier hardly decreases from 80 % RH over 7 years in the log-centre and increases somewhat in the junction. This is because VIP is vapour diffusion tight and works as a vapour barrier, resulting in a vapour tight layer on both sides of the log. Therefore, post-insulating externally with VIP (solution B) cannot be combined with a vapour barrier since the moisture will be “trapped” inside the construction. An RH of 80 % together with the right temperature (25-30 °C) could cause mould growth and rot in the logs (SINTEF 701.401, 2005). However, solution B without vapour barrier will give the logs an opportunity to dry out more. Solution C, both with and without vapour barrier also decreases marginally from 80 % RH over seven years in both the centre log (Figure 6.6) and the junction between logs and insulation (Figure 6.8), i.e., this is not a good solution.

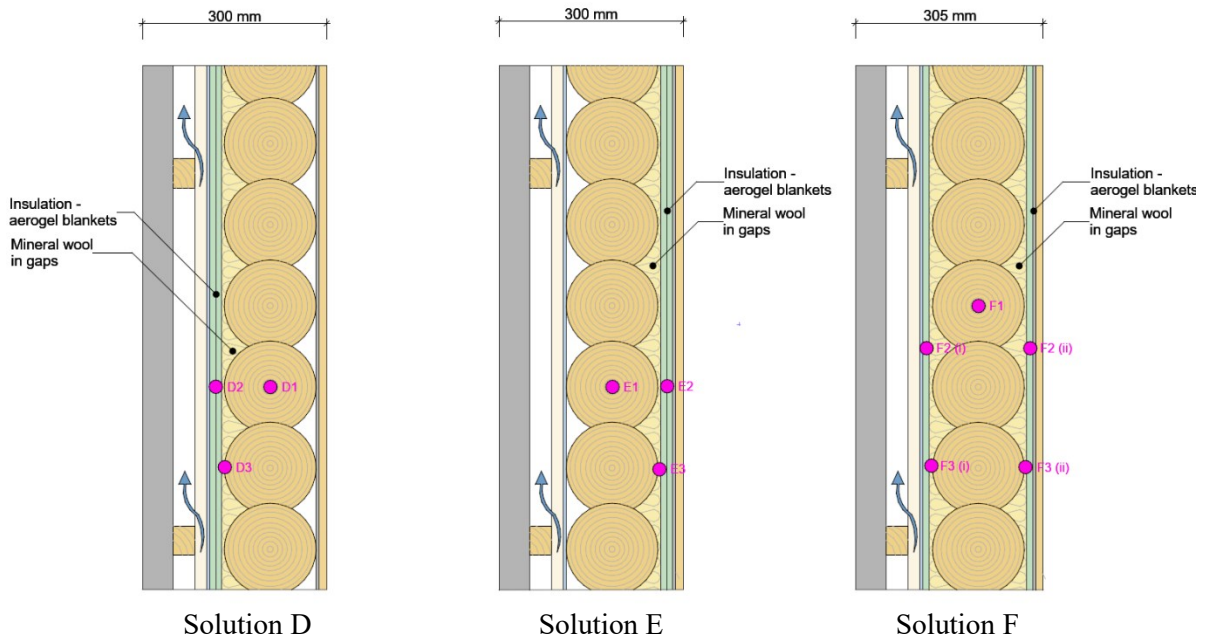
Figure 6.4: Wall construction post-insulated with external aerogel insulation (D), internal aerogel insulation (E), and both (F). Monitor positions and names for WUFI simulations are shown as pink dots.

Measurements from the log centre (Figure 6.6) and between the logs and the insulation (Figure 6.8) shows that external aerogel gives the best result out of the three solutions. Both with and without vapour barrier result in low RH in the log, but over time the solution with vapour barrier will be the best by decreasing the most. Combined external and internal aerogel gives tolerable results by reducing the RH in the centre log (F1, Figure 6.6) both with and without vapour barrier. In the junction between logs and insulation (F2 (i) and (ii), Figure 6.8) the solution with vapour barrier gives more RH on the internal side than the external. It is the opposite case for the solution without vapour barrier. Also, the RH is higher. Internal aerogel insulation gives a relatively high RH both with and without vapour barrier in the log centre (E1, Figure 6.6) and the junction between logs and insulation (E3, Figure 6.8), but somewhat lower RH without vapour barrier. In the centre of the insulation (Figure 6.7), the internal aerogel in solution F has the lowest RH when combined with a vapour barrier, but the appurtenant external insulation contains more moisture. Solution E with a vapour barrier has the second-lowest RH, while the same solution without a vapour barrier is higher. Solution D has approximately the same high RH with and without vapour barrier.

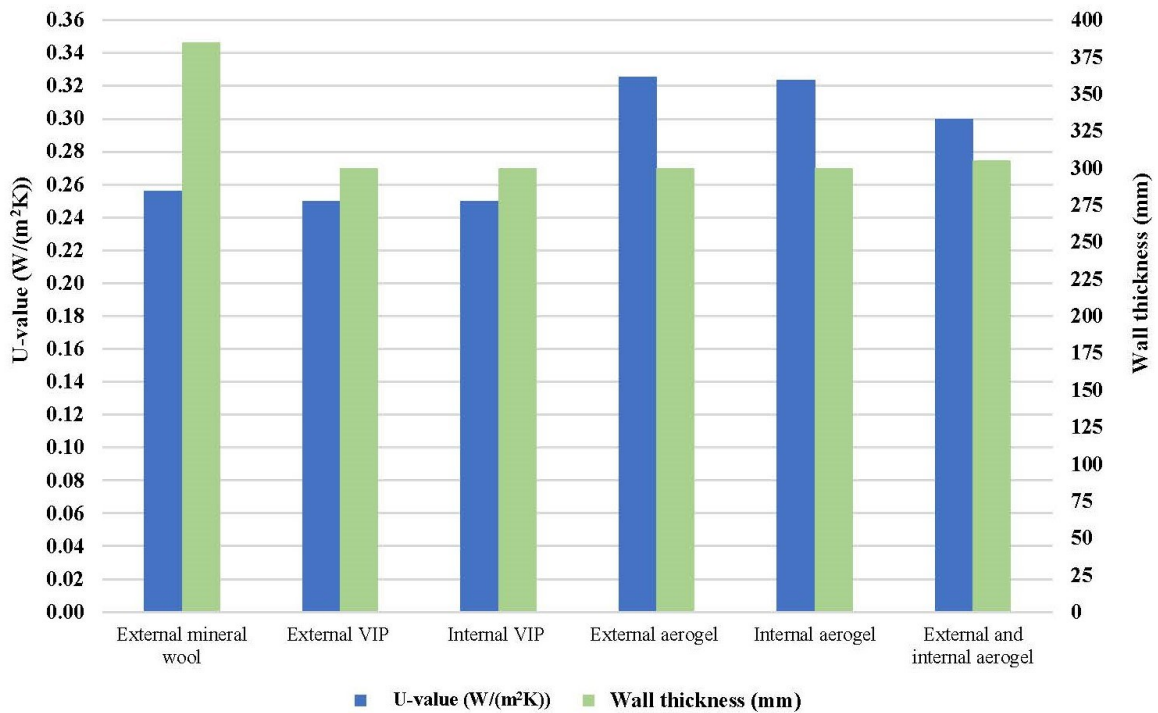
U-values simulated in THERM and total thicknesses for different wall solutions.

Figure 6.5: U-values simulated in THERM and total thicknesses for different wall solution.

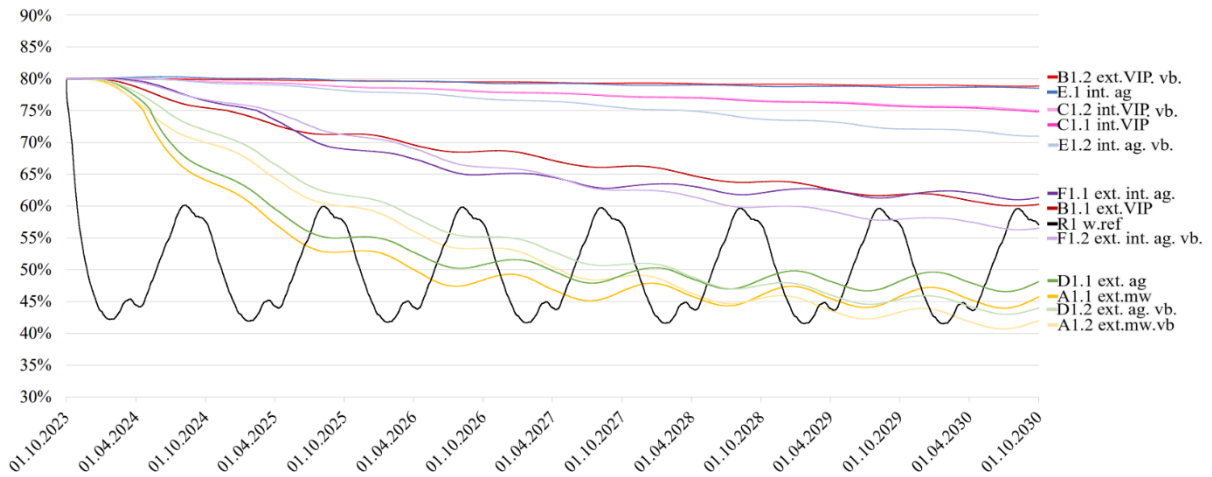
Relative humidity (%) for external wall measured in centre log

VIP. vb.: Solution C internal VIP with vapour barrier; D1.1. ext. ag.: Solution D external aerogel; D1.2. ext. ag. vb.: Solution D external aerogel with vapour barrier; E1. 1. int. ag.: Solution E internal aerogel; E1.2. int. ag. vb.: Solution E internal aerogel with vapour barrier; F1.1. ext. int. ag.: Solution F external and internal aerogel; F1.2. ext. int. ag. vb.: Solution F external and internal aerogel with vapour barrier; R1. w. ref.: Wall reference measured on interior surface.

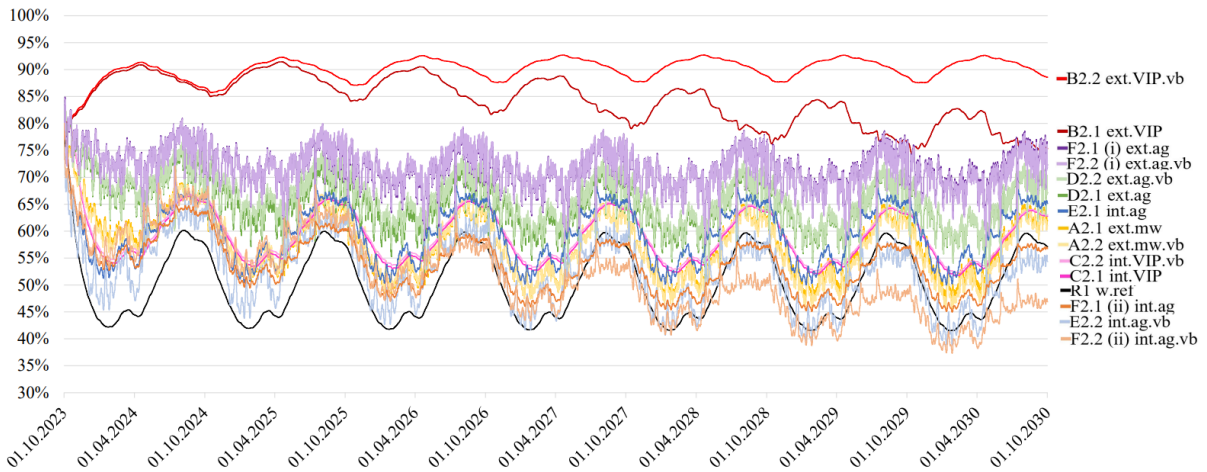
Relative humidity (%) for external wall measured in centre insulation

A2.1. ext. mw.: Solution A external mineral wool; A2.2. ext. mw. vb.: Solution A external mineral wool with vapour barrier; B2.1. ext. VIP.: Solution B external VIP; B2.2. ext. VIP. vb.: Solution B external VIP with vapour barrier; C2.1. int. VIP: Solution C internal VIP; C2.2. int. VIP. vb.: Solution C internal VIP with vapour barrier; D2.1. ext. ag.: Solution D external aerogel; D2.2. ext. ag. vb.: Solution D external aerogel with vapour barrier; E2.1. int. ag.: Solution E internal aerogel; E2.2. int. ag. vb.: Solution E internal aerogel with vapour barrier; F2.1. (i) ext. ag.: Solution F external aerogel; F2.2. (i) ext. ag. vb.: Solution F external aerogel with vapour barrier; F2.1. (ii) int. ag.: Solution F internal aerogel; F2.2. (ii) int. ag. vb.: Solution F internal aerogel with vapour barrier; R1. w. ref.: Wall reference measured on interior surface.

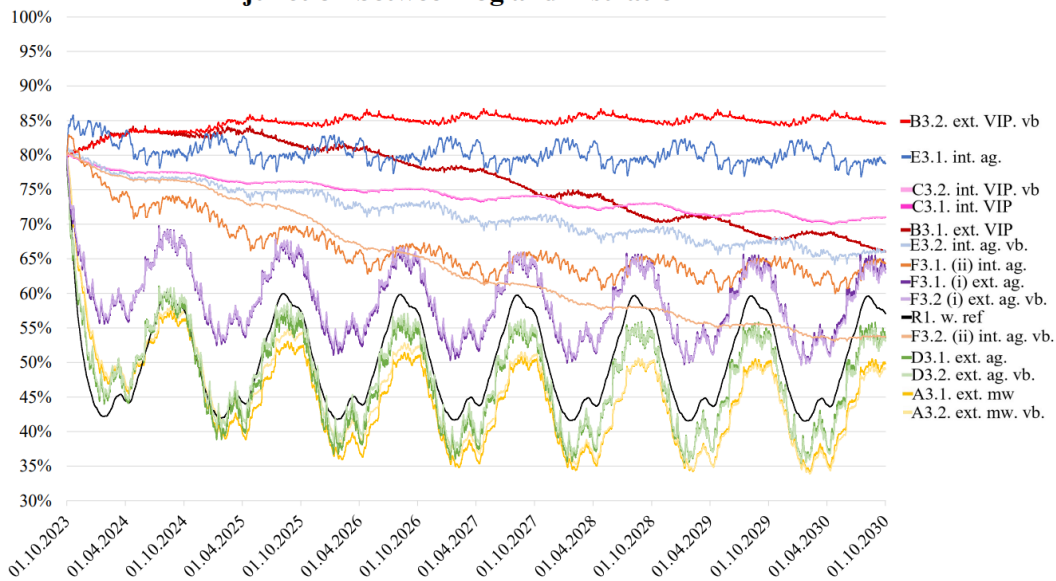
Relative humidity (%) for external wall measured in junction between log and insulation

A3.1. ext. mw.: Solution A external mineral wool; A3.2. ext. mw. vb.: Solution A external mineral wool with vapour barrier; B3.1. ext. VIP.: Solution B external VIP; B3.2. ext. VIP. Vb.: Solution B external VIP with vapour barrier; C3.1. int. VIP.: Solution C internal VIP; C3.2. int. VIP. Vb.: Solution C internal VIP with vapour barrier; D3.1. ext. ag.: Solution D external aerogel; D3.2. ext. ag. vb.: Solution D external aerogel with vapour barrier; E3.1. int. ag.: Solution E internal aerogel; E3.2. int. ag. vb.: Solution E internal aerogel with vapour barrier; F3.1. (i) ext. ag.: Solution F external aerogel; F3.1. (ii) int. ag.: Solution F internal aerogel; F3.2. (i) ext. ag. vb.: Solution F external aerogel with vapour barrier; F3.2. (ii) int. ag. vb.: Solution F internal aerogel with vapour barrier; R1. w. ref.: Wall reference measured on interior surface.

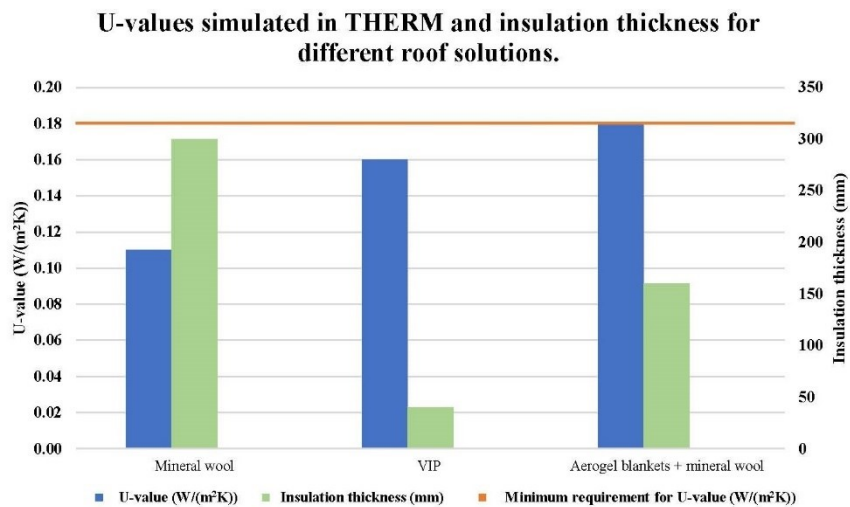
Figure 6.10: U-values and insulation thickness for three different roof solutions for post-insulation above the joists against the cold attic simulated in THERM.

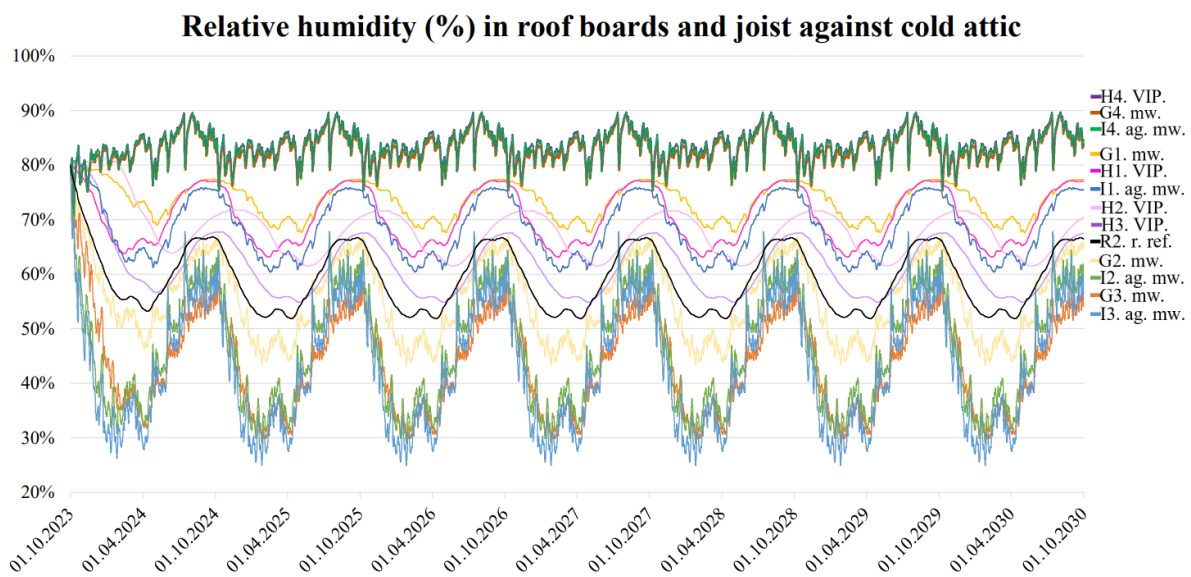
G1-4. mw.: Solution G, monitor position 1-4, mineral wool; H1-4. VIP.: Solution H, monitor position 1-4, VIP; I1-4. ag. mw.: Solution I, monitor position 1-4, aerogel and mineral wool; R2. r. ref.: Roof reference measured on interior panelled ceiling.

A vapour barrier is necessary underneath the insulation to prevent warm and humid air from entering the insulation. Although the VIP itself is vapour tight, a vapour barrier is also included in this alternative to ensure a consistently air and vapour tight layer, especially in the joints between the VIPs. Figure 6.11 shows the relative humidity (RH) in four measuring points for each solution. On the underside of the roof boards, i.e., in measuring points G4, H4 and I4, the RH is alarmingly high (> 80 %) in all the suggested solutions. The post-insulation will cause cooler temperatures and consequently a higher RH in the attic. Moreover, the underside of the roof boards is likely cooler than the air in the attic, and the RH is even higher here. With the right temperature, for example during the summer, this can cause rot and mould growth. To avoid this, it is crucial with sufficient aeration in the attic to lower the RH. The remaining measuring points have lower RH that fluctuates evenly through the simulated years with peaks during the autumn and troughs during the spring. The moisture levels are increasing from the interior side to the attic side of the joists, but the RH is never higher than 80 %.

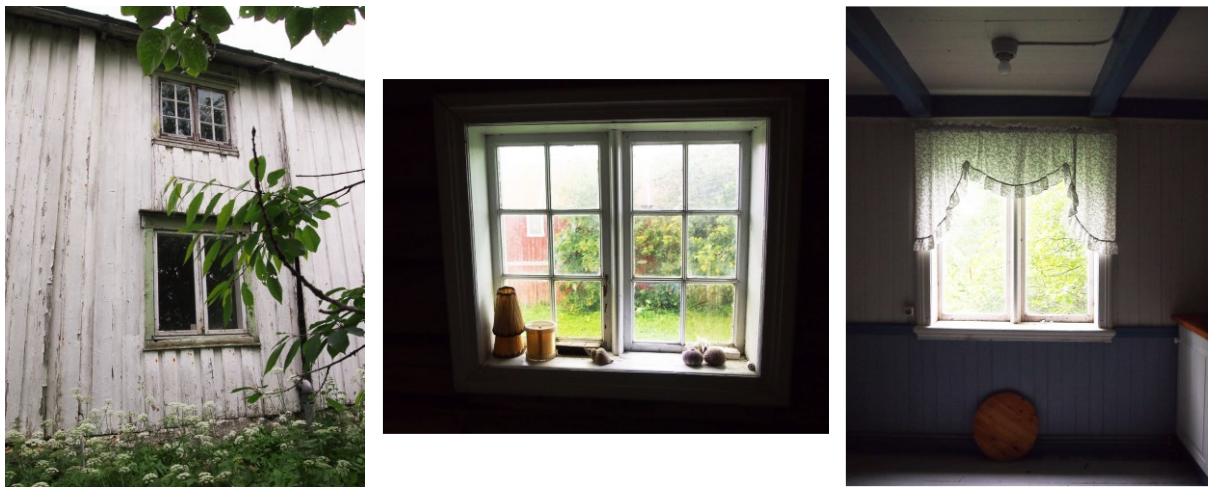
Figure 6.12: The pictures show an old original slatted window on the first floor and a newer two-section window on ground floor. Photos: (Taftø Petersen, 2015).

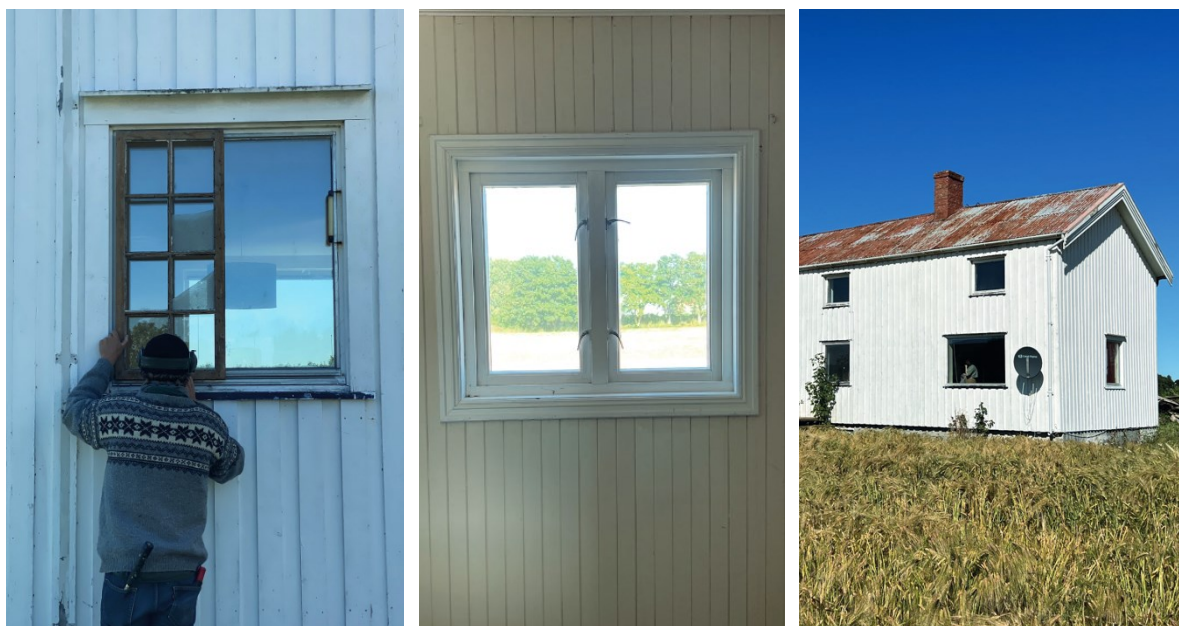
Figure 6.13: Left: Old slatted window found at the farm held over an awning window. Middle: two-section casement window. Right: Awning windows on the southwest and southeast façades. Photos: (Hesthol Løvik et al., 2022).

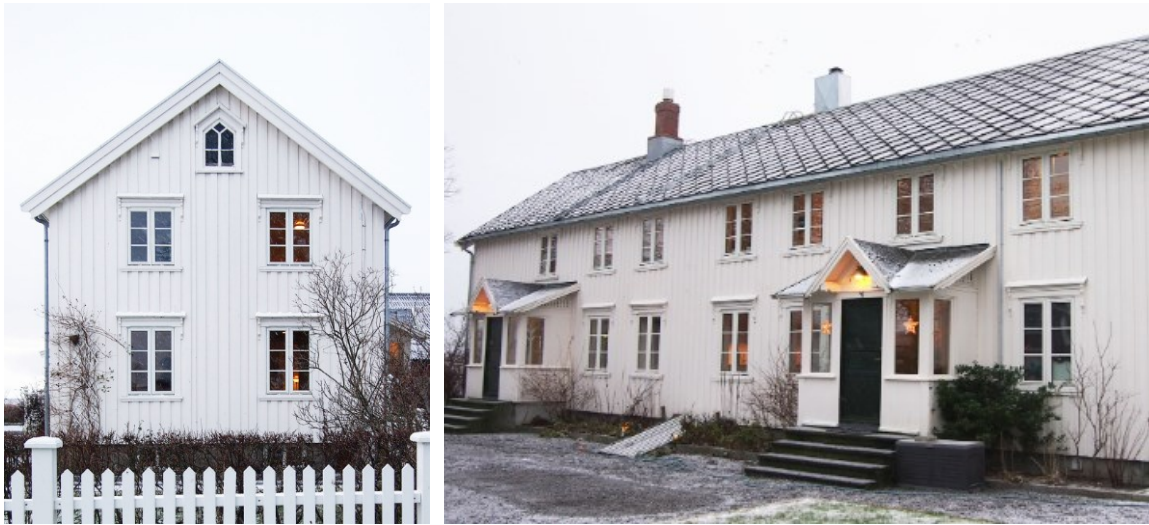
Figure 6.14: The east (left) and north (right) façade of Viken illustrating the current windows (Taftø Petersen & Johansen, 2015).

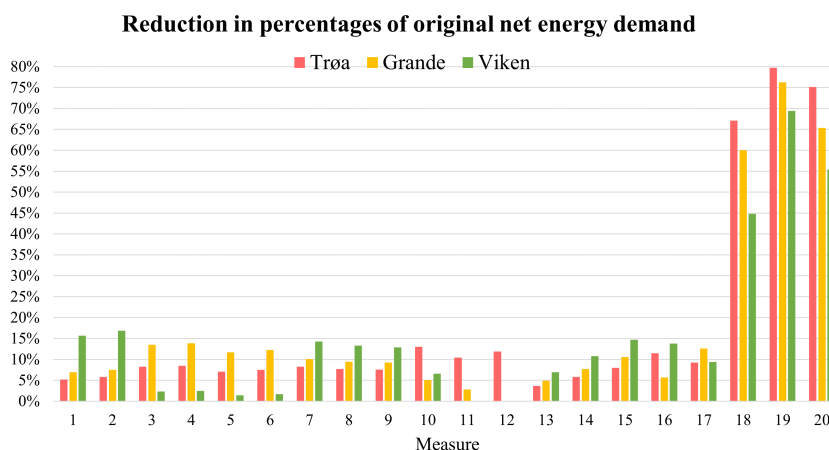
Figure 6.15: Reduction in percentages of original net energy demand for all three buildings.

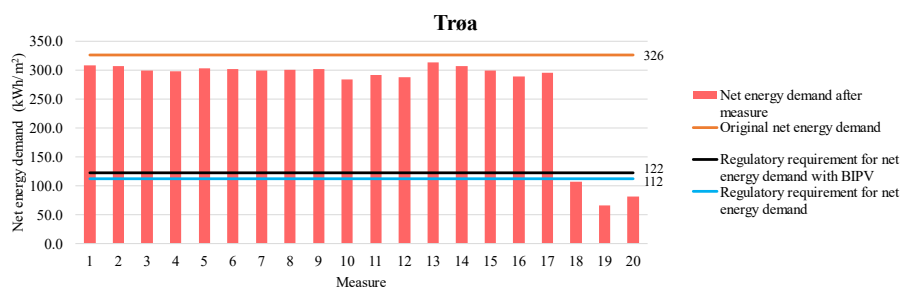
Figure 6.16: Trøa's net energy demand after each individual measure and the combined measures, as well as original net energy demand and regulatory requirement for net energy demand with and without BIPV.

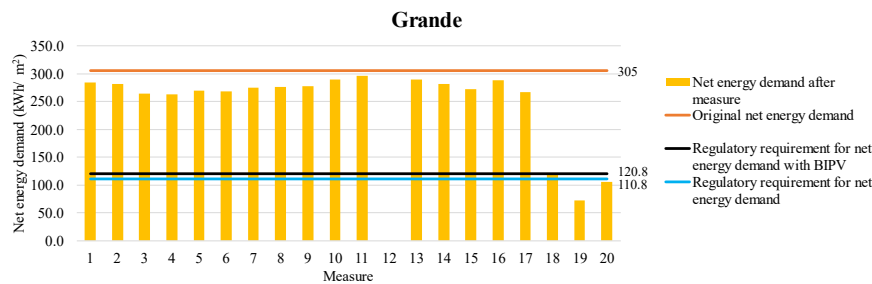
Figure 6.17: Grande's net energy demand after each individual measure and the combined measures, as well as original net energy demand and regulatory requirement for net energy demand with and without BIPV.

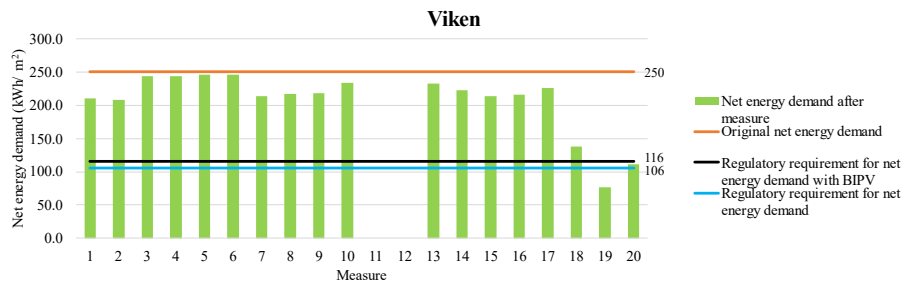
Figure 6.18: Viken's net energy demand after each individual measure and the combined measures, as well as original net energy demand and regulatory requirement for net energy demand with and without BIPV.

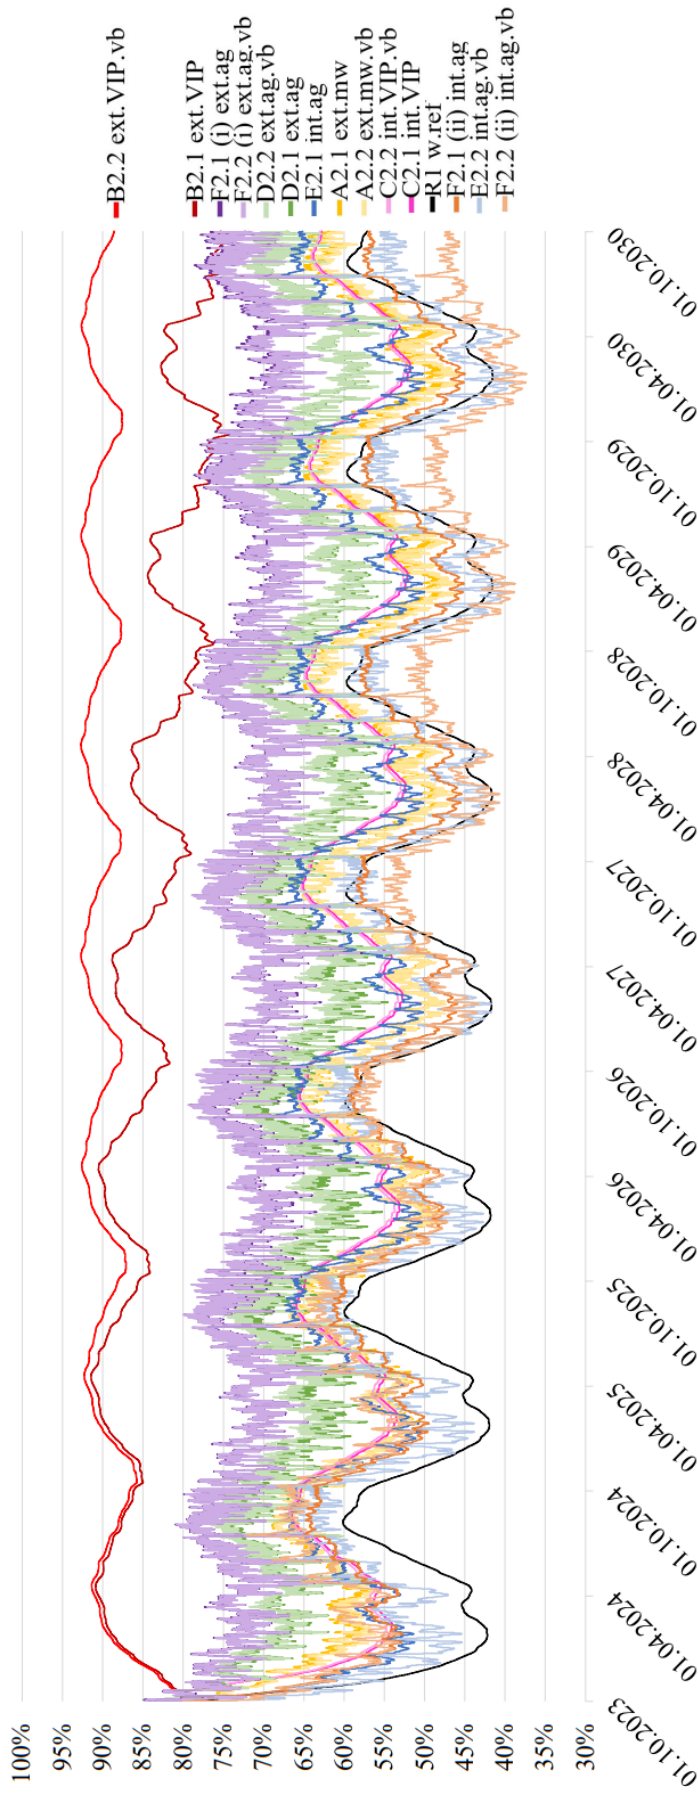
A2.1. ext. mw.: Solution A external mineral wool; A2.2. ext. mw. vb.: Solution A external mineral wool with vapour barrier; B2.1. ext. VIP.: Solution B external VIP; B2.2. ext. VIP. vb.: Solution B external VIP with vapour barrier; C2.1. int. VIP: Solution C internal VIP; C2.2 int. VIP. vb.: Solution C internal VIP with vapour barrier; D2.1. ext. ag.: Solution D external aerogel; D2.2. ext. ag. vb.: Solution D external aerogel with vapour barrier; E2.1. int. ag.: Solution E internal aerogel; E2.2. int. ag. vb.: Solution E internal aerogel with vapour barrier; F2.1. (i) ext. ag.: Solution F external aerogel; F2.2. (i) ext. ag. vb.: Solution F external aerogel with vapour barrier; F2.1. (ii) int. ag.: Solution F internal aerogel with vapour barrier; R1. w. ref.: Wall reference measured on interior surface.
