The Challenge of Rehabilitating Relocated Listed Heritage Buildings: Requirements, Current Standards and Opportunities

Master's thesis in Civil and Environmental Engineering

Norwegian University of Science and Technology
Faculty of Engineering
Department of Civil and Environmental Engineering

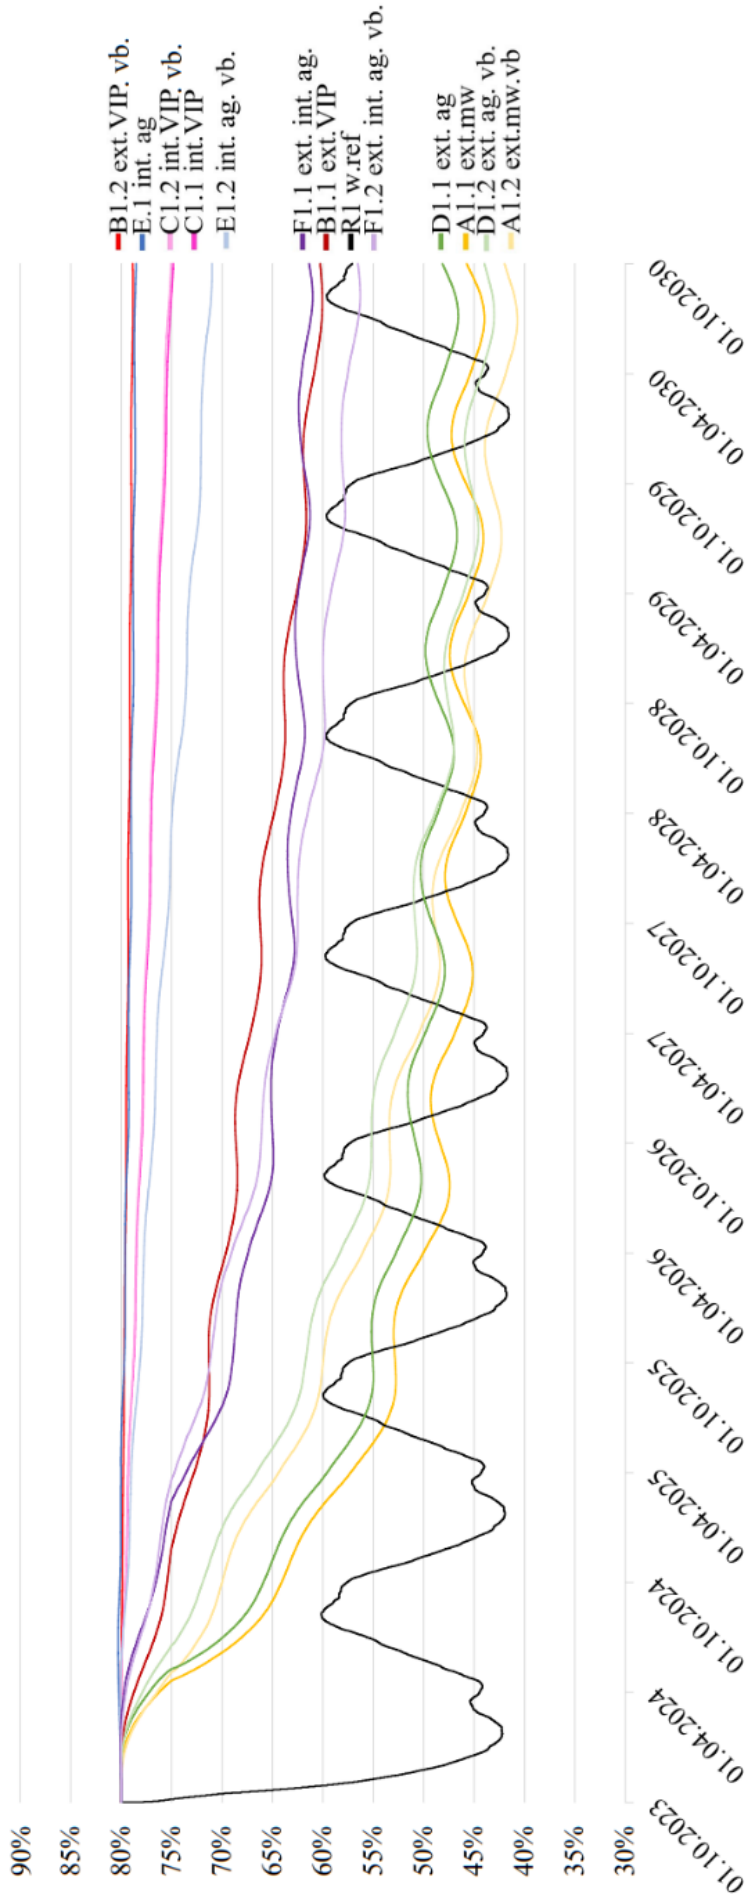
A1.1. ext. mw.: Solution A external mineral wool; A1.2. ext. mw. vb.: Solution A external mineral wool with vapour barrier; BI.1. ext. VIP.: Solution B external VIP; BI.2. ext. VIP. vb.: Solution B external VIP with vapour barrier; CI.1. int. VIP: Solution C internal VIP; CI.2 int. VIP. vb.: Solution C internal VIP with vapour barrier; DI.1. ext. ag. vb.: Solution D external aerogel; DI.2. ext. ag. vb.: Solution D external aerogel with vapour barrier; EI.1. int. ag.: Solution E internal aerogel; EI.2. int. ag. vb.: Solution E internal aerogel with vapour barrier; FI.1. ext. int. ag.: Solution F external and internal aerogel; FI.2. ext. int. ag. vb.: Solution F external and internal aerogel with vapour barrier; RI. w. ref.: Wall reference measured on interior surface.

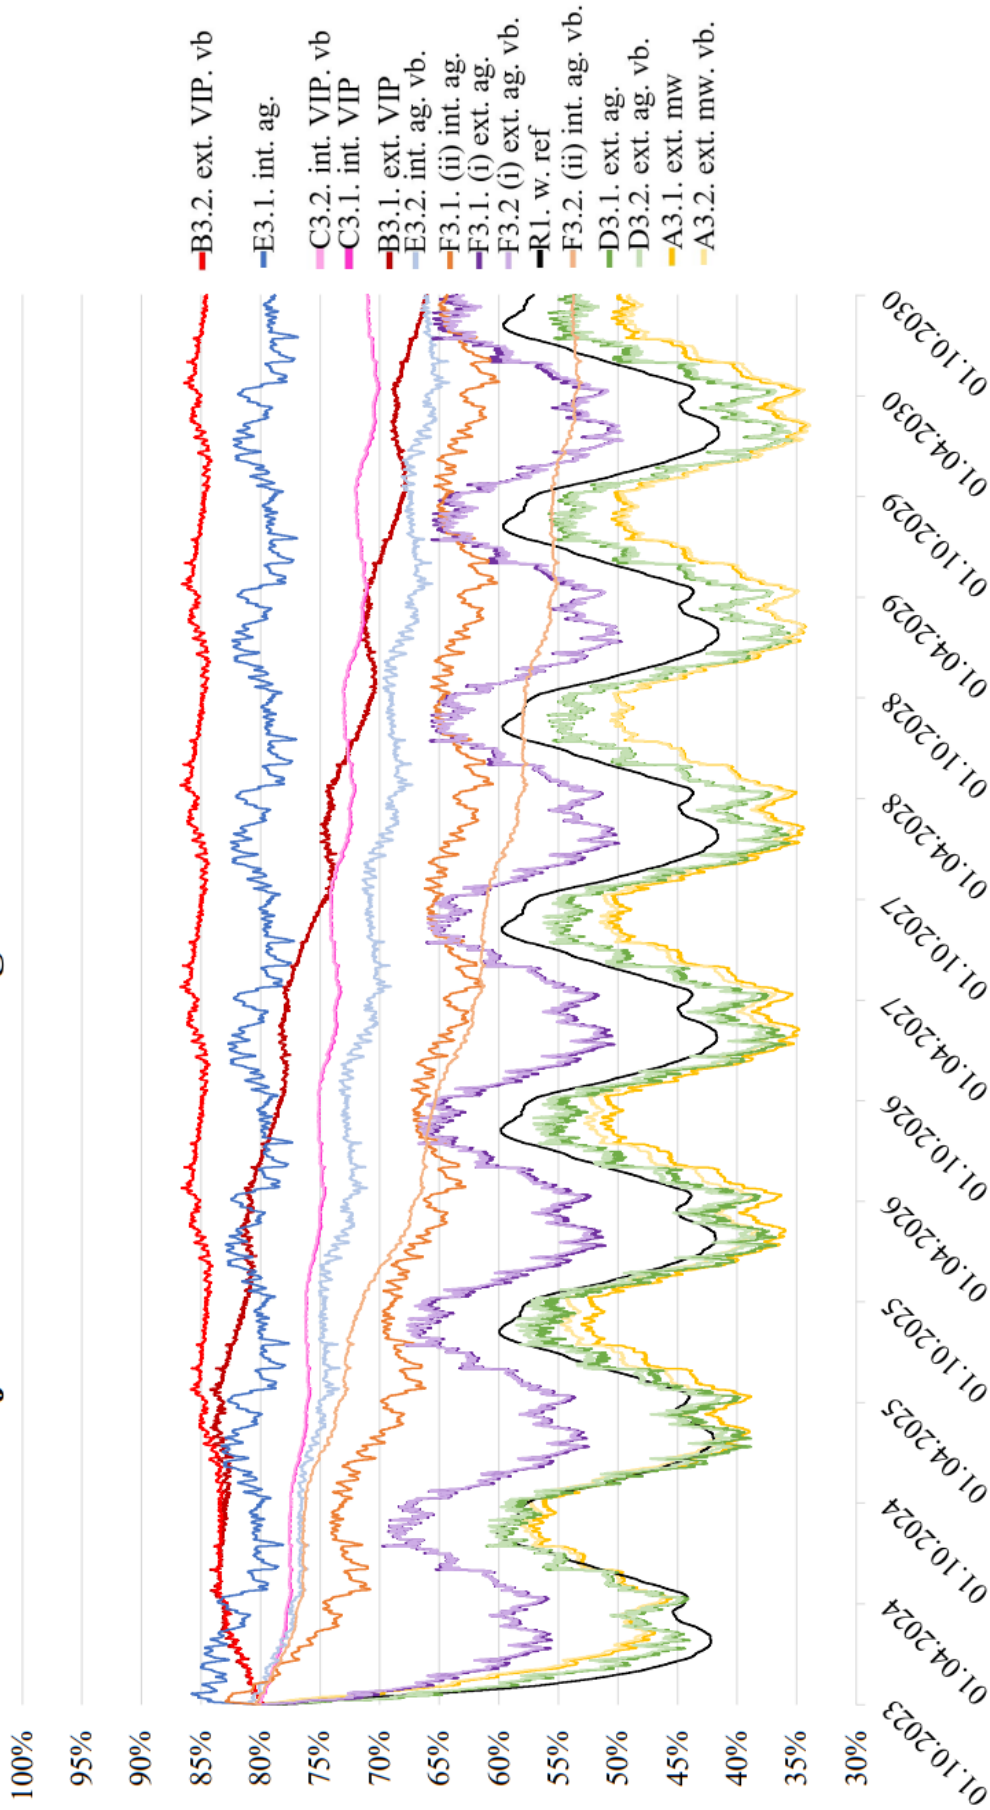
A3.1. ext. mw.: Solution A external mineral wool; A3.2. ext. mw. vb.: Solution A external mineral wool with vapour barrier; B3.1. ext. VIP.: Solution B external VIP; B3.2 ext. VIP. Vb.: Solution B external VIP with vapour barrier; C3.1. int. VIP.: Solution C internal VIP; C3.2. int. VIP. Vb.: Solution C internal VIP with vapour barrier; D3.1. ext. ag.: Solution D external aerogel; D3.2 ext. ag. vb.: Solution D external aerogel with vapour barrier; E3.1 int. ag.: Solution E internal aerogel; E3.2. int. ag. vb.: Solution E internal aerogel with vapour barrier; F3.1. (i) ext. ag.: Solution F external aerogel; F3.1. (ii) int. ag.: Solution F internal aerogel; F3.2 (i) ext. ag. vb.: Solution F external aerogel with vapour barrier; F3.2. (ii) int. ag. vb.: Solution F internal aerogel with vapour barrier; R1. w. ref.: Wall reference measured on interior surface.

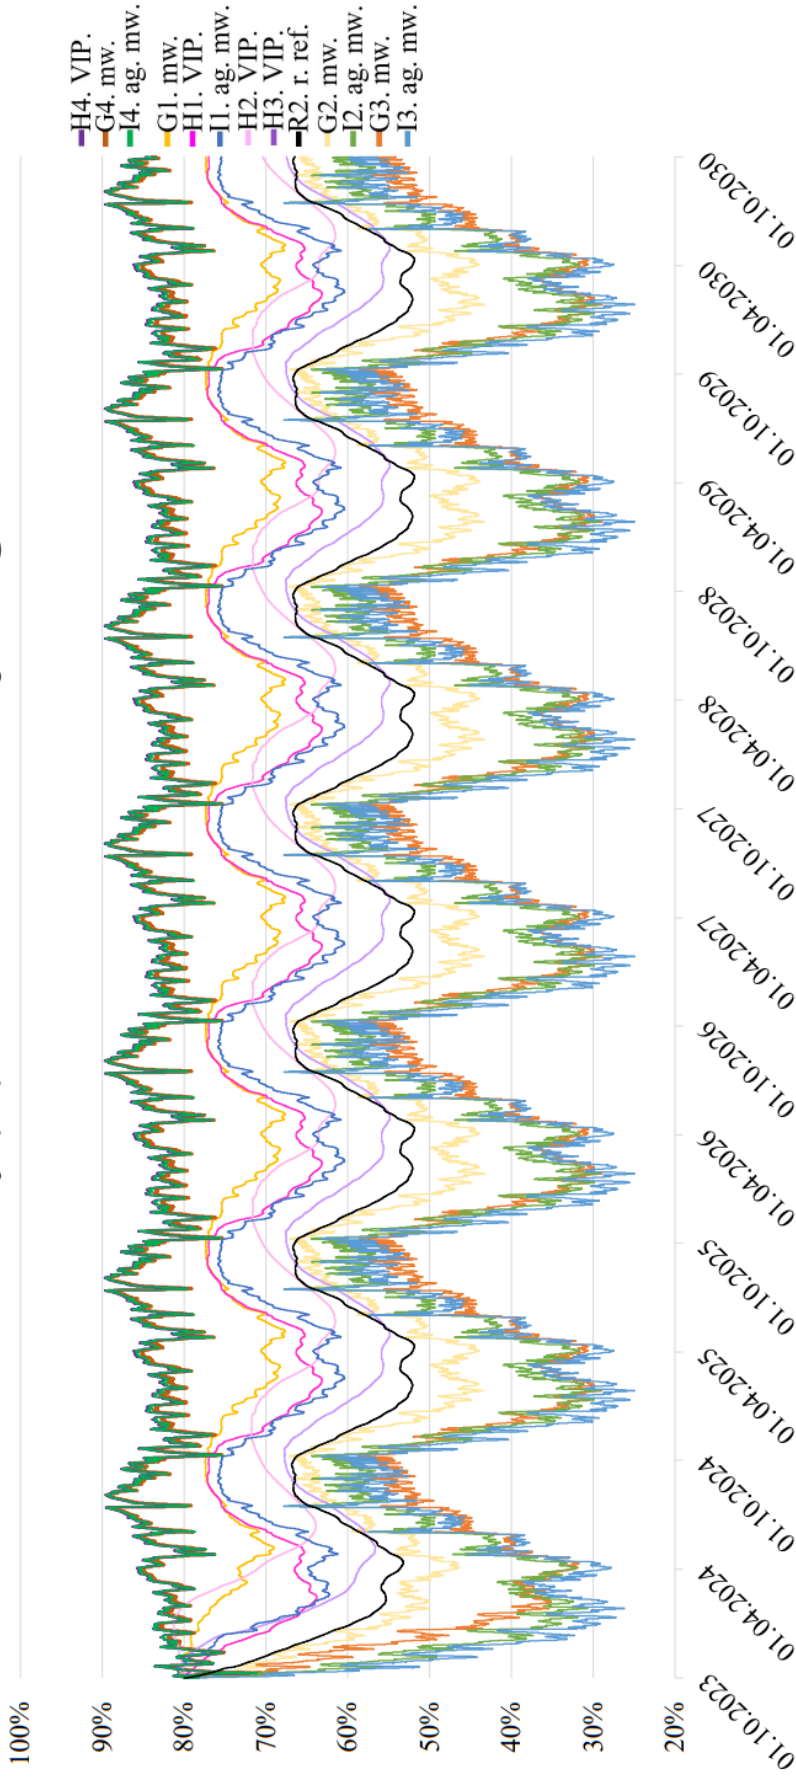
G1-4. mw.: Solution G, monitor position 1-4, mineral wool; H1-4. VIP.: Solution H, monitor position 1-4, VIP; I1-4. ag. mw.: Solution I, monitor position 1-4, aerogel and mineral wool; R2. r. ref.: Roof reference measured on interior panelled ceiling.

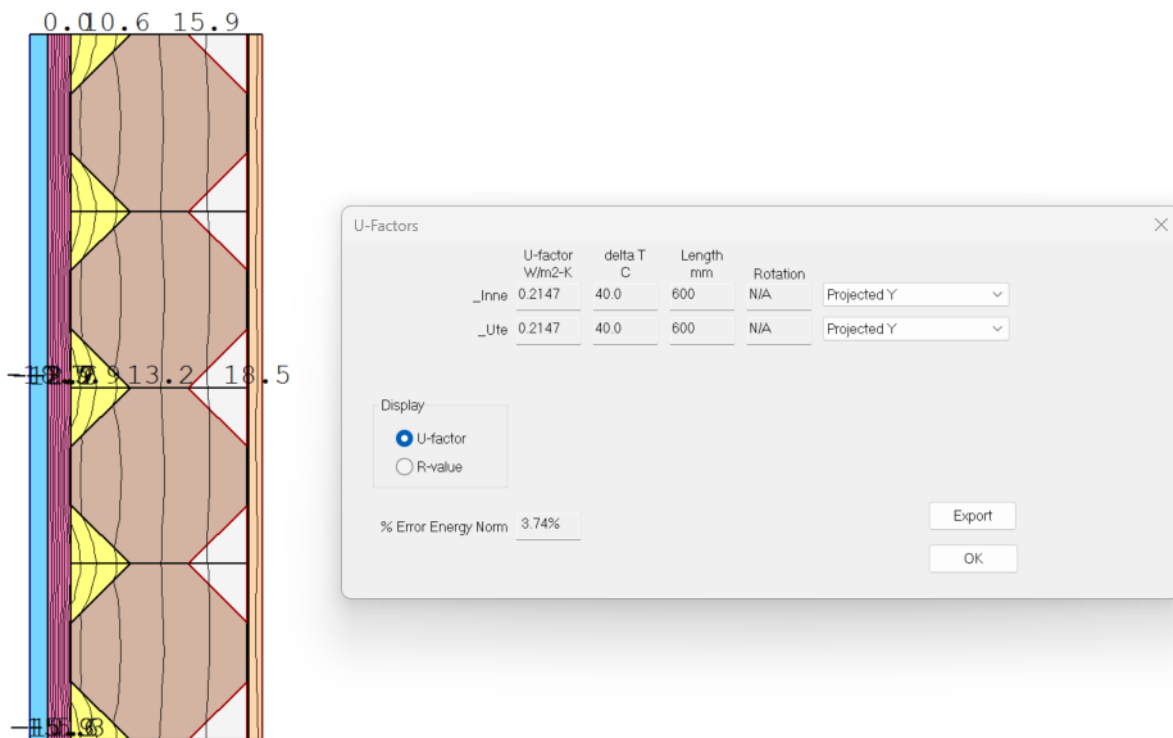
Figure C1: Excerpt from THERM that shows an illustration of the simulated wall and the results for Option 1 for simulation in THERM.

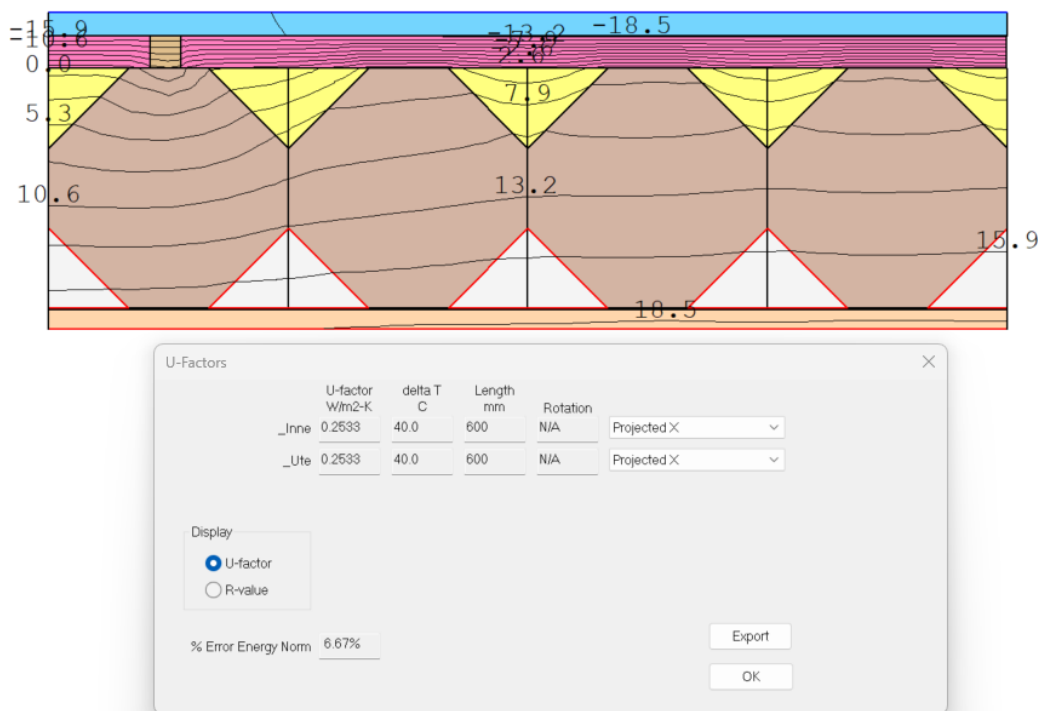
Figure C3: Excerpt from THERM that shows an illustration of the simulated wall and the results for Option 3 for simulation in THERM.

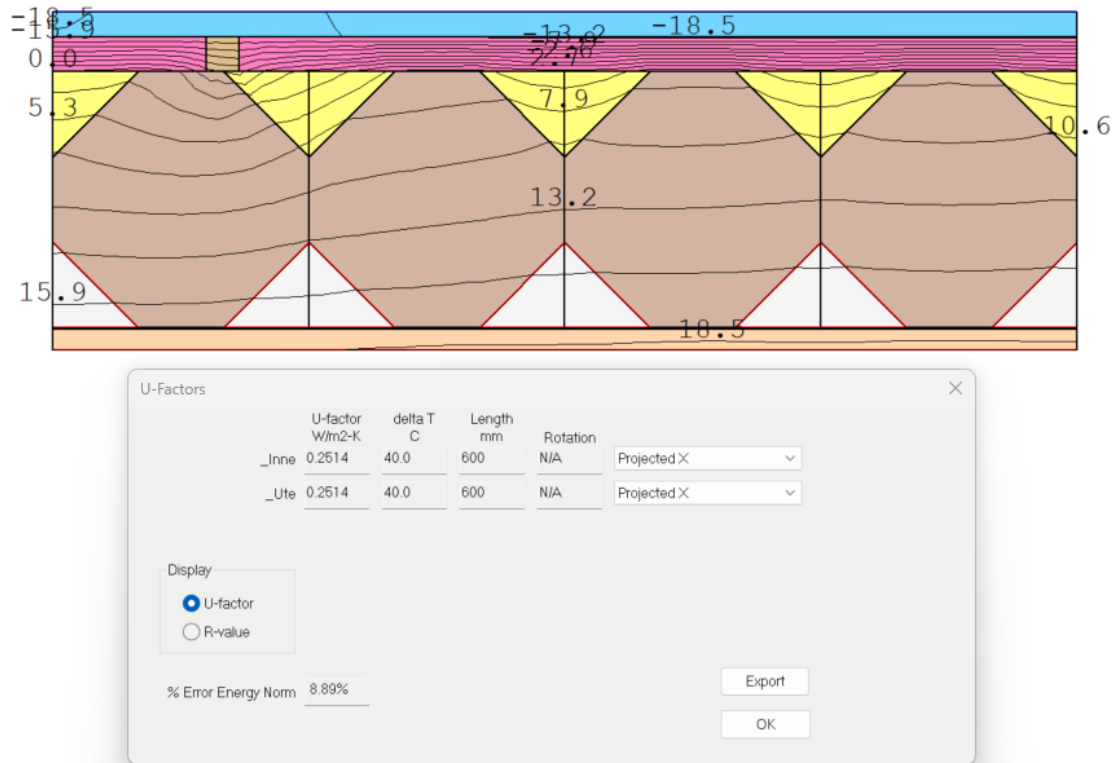
Figure C4: Excerpt from THERM that shows an illustration of the simulated wall and the results for Option 4 for simulation in THERM.
