# Watertight insertion of heavy sliding doors in exterior walls

Erlend Andenæs<sup>1\*</sup>, Torill Raugstad<sup>1</sup>, Jonas Strid<sup>1</sup>, Lars Gullbrekken<sup>2</sup>, Tore Kvande<sup>1</sup>

**Abstract** The joints around heavy terrace doors are considered a weak point in rain-exposed façades, as it is vulnerable to defects in design and construction. The insertion process of heavy sliding doors is a notable challenge. Design recommendations from manufacturers as well as national advisory agencies are currently lacking. This paper presents a full-scale laboratory study on the water tightness of heavy sliding doors with joints waterproofed according to five different solutions. The door assembly is mounted in a pressurized cabinet with water spray nozzles to simulate wind-driven rain. The interior side of the joint around the door is monitored for moisture leaks at steadily increasing pressure levels. It was found that leaks most often occur in the corners of the frame. Sealant mounted before the door itself was hoisted in place tended to be twisted or distorted as the door was adjusted in the frame, spoiling the waterproofing. A common feature of the most watertight so

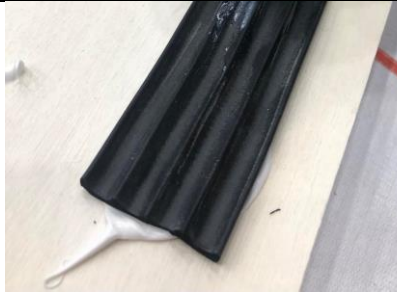
Test no.	Weather-proofing of bottom joint	Illustration of bottom joint sealant	Weather-proofing of side/top joints	Other notes
1	Neoprene gasket, attached using double-sided tape

The first test was performed with a neoprene gasket in the bottom joint of the door, with the top and side joints covered with tape. This solution is recommended by the SINTEF Building Research design guidelines for exterior doors [15]. Sealing the corners was found to be difficult using this strategy, and injection of liquid sealant was required to close visible openings in the assembly. A qualitative airtightness test using smoke revealed multiple air leaks even afterwards. The watertightness test revealed leaks in the corners of the assembly already at a pressure level of 50 Pa. The test was aborted after the pressure had reached 200 Pa.

Disassembly after the test revealed that the neoprene gasket had not adequately covered the corners of the frame, and that the liquid sealant injected after mounting had failed to seal the observed holes. The neoprene gasket had also been twisted by the insertion of the door, ripping it free of the double-sided tape that attached it to the sole plate. During the watertightness test, leaks had been observed in this location.

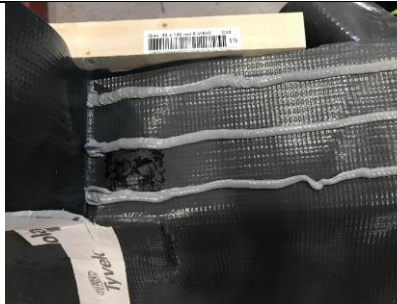
Wind barrier tape  Additional liquid sealant in corners	Initial airtightness test performed before water tightness test
2	Liquid sealant, three parallel lines

This test was similar to Test 1, but the neoprene gasket was replaced with three lines of liquid sealant. The solution was found in design recommendations by a major building material supplier. Additional sealant and tape were used to seal the corners of the door frame. However, the corners once again proved to be the weakest point of the assembly. Water penetration in the corners occurred at 200 Pa, but the test was continued until a pressure level of 600 Pa to provoke leaks in different locations than those observed in Test 1.

Post-test disassembly showed that the weight of the door had squeezed the liquid sealant completely flat, to the point it resembled a layer of paint on the PVC substrate. Much of the sealant was squeezed out of the joint entirely. Water leakage through the sealant was observed at 450 Pa.

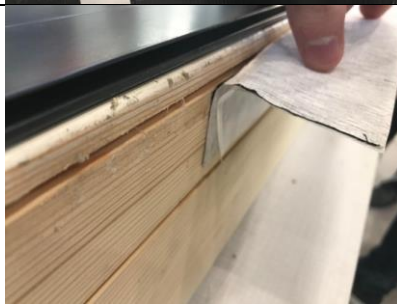
Wind barrier tape	
3	Flexible adhesive sealing strip

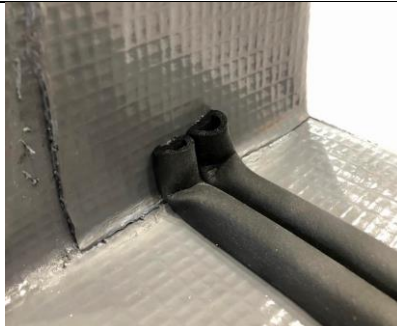
Flexible adhesive sealing strip	Wind barrier mounted on sole plate instead of PVC membrane (to fasten sealing strip)
4	EPDM rubber gasket

This test largely resembled Test 1, but with liquid sealant along the top and side edges instead of tape. The gasket was also different; a double D-profile of EPDM rubber. This gasket features adhesive on the rear side, making it possible to adhere directly to the PVC membrane on the sole plate and up about 2 cm in the corners. The liquid sealant was allowed to harden over a weekend prior to the tests.

However, leakage again initiated quickly in the corners, at pressure levels as low as 100 Pa for the lower corners. Leakage occurred in the upper left corner at 150 Pa. The test was continued to a pressure level of 600 Pa. No leaks occurred elsewhere than in the corners throughout the test. The setup was not disassembled after the test. Close inspection of the joints indicated that the sealant had kept the joints dry along the edges.

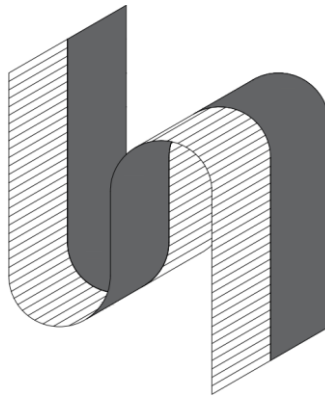
Figure 3: Flexible adhesive sealing strip. Note the adhesive on alternate sides of the strip.

A flexible adhesive sealing strip was attached around the door frame before insertion. The solution was developed as part of the research project “Verkøykasse for klimatilpassning av boliger” (“A toolbox for climate adaptation of dwellings”). The sealing strip consists of a 100 mm wide breather membrane substrate, covered in butyl adhesive on alternate sides as illustrated in Figure 3. One side of the substrate is folded like an accordion and features flexible adhesive. Thus, it can be stretched to fit around corners, then attached to the outer frame like tape once the door is inserted. It was necessary to fix a piece of wind barrier along the sole plate for this test, as the butyl glue is not able to adhere directly to the PVC membrane.

The test was continued beyond the threshold for recommendation since the solution appeared completely watertight at 600 Pa. Water leakage was observed along the top joint at a pressure level of 1050 Pa. Leaks occurred in the outer frame of the assembly at lower pressure levels, but these are outside the test specimen and thus the scope of the study. The leak along the top joint occurred between the door frame and the adhesive.

Disassembly revealed that the adhesive strip had moved slightly relative to the door frame, presumably due to the high static pressure. Had the pressure been sustained for a longer time, more substantial leaks might have occurred as the strip could have been torn loose. However, this is not a major concern for the operation of the door, as such high static pressures do not occur for long in nature.
