Article

Exploring Vulnerability Indicators: Tourist Impact on Cultural Heritage Sites in High Arctic Svalbard

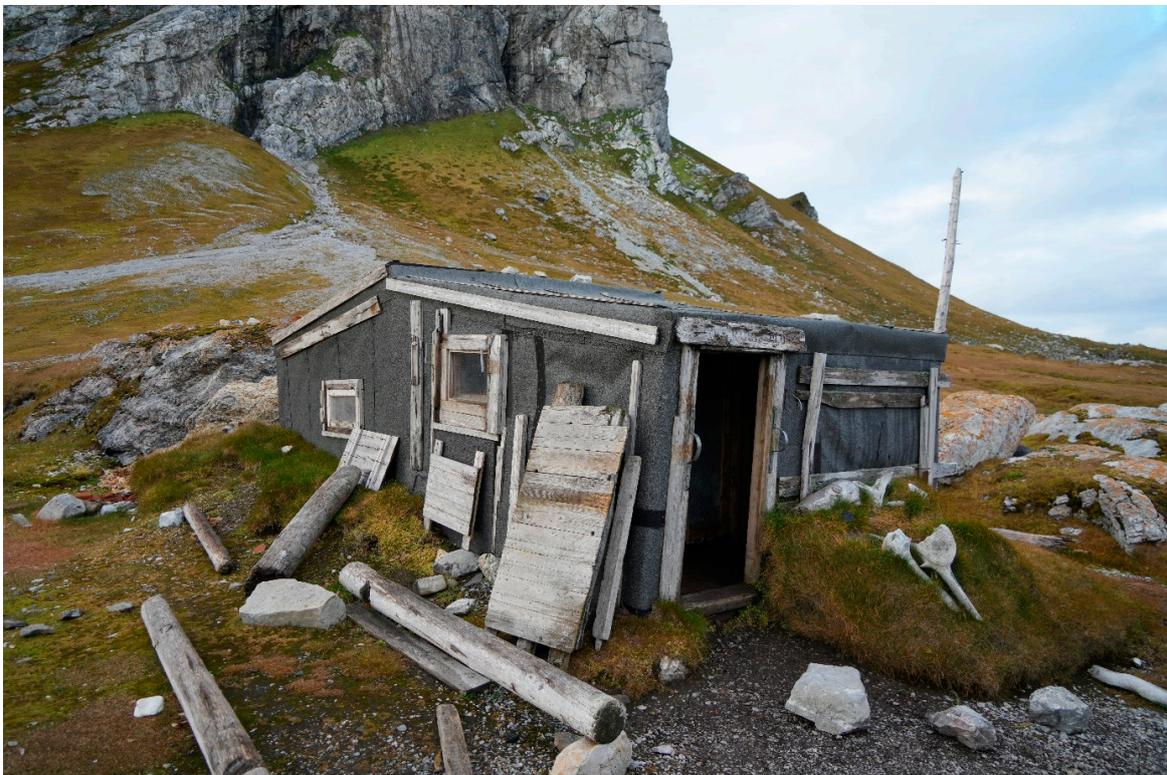
Figure 2. Gnålodden at Hornsund on southwest Spitsbergen in Svalbard was the southernmost case site. The small hunter's cabin, which was erected sometime before 1935, is automatically protected and signifies a historic site. This cabin is a highly typical cultural heritage site in the archipelago. Photo: Anne-Cathrine Flyen.

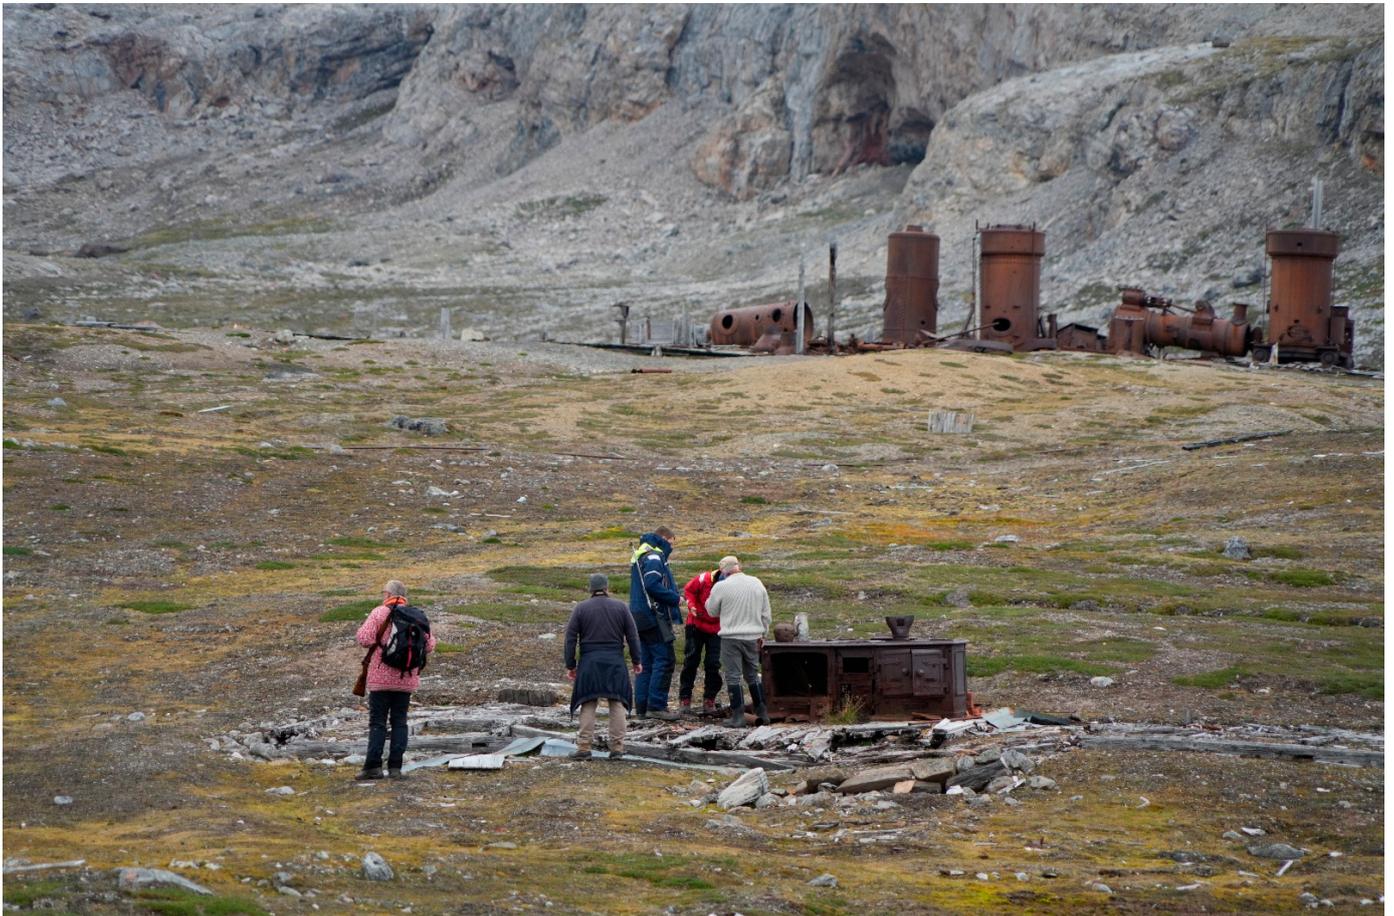
Figure 3. Historic remains from the protected marble mine settlement London at Blomstrandhalvøya in Kongsfjorden. Visitors are closely looking at the historic remains, inadvertently destroying the remaining surrounding wooden floor. Photo: Anne-Cathrine Flyen.

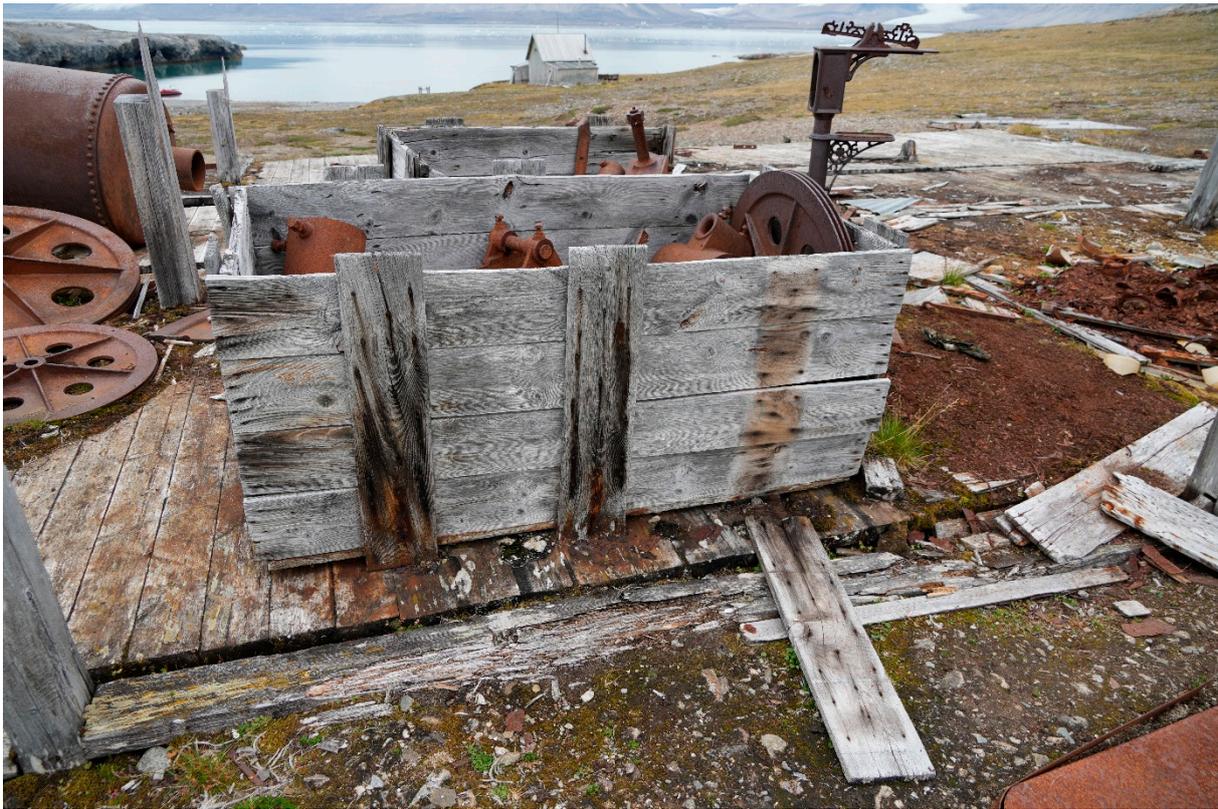
Figure 4. Historic remains from the protected marble mine settlement London at Blomstrandhalvøya in Kongsfjorden. Visitors trampled on the remaining wooden floor, destroying the wood. Photo: Anne-Cathrine Flyen.

London in Kongsfjorden, north-western Spitsbergen	Buildings: poor condition and resistance to wear Ruins: poor condition and resistance to wear The standing buildings are in relatively good condition and can withstand foot traffic. However, the ruins are extensively deteriorated, and the wood crumbles upon stepping. Several of the machines within the cultural setting are placed on a wooden floor, which is the only remaining part of the garage where the machines were housed. The wood in the floor is severely degraded and collapses under pressure/when stepped on.	Standing buildings: good legibility Ruins and machinery: difficult legibility The site comprises several standing buildings. These are simple and not grand monuments, and it may not be immediately intuitive that they are protected. However, it is relatively easy to document them as historical structures. But the site also includes several ruins and low remnants of buildings, and these are not easily perceived as protected structures. Similarly, there is preserved machinery that appears to be abandoned scrap.	Easy accessibility: The site is visited by cruise ships and locals from the research community in Ny-Ålesund. It is located on the west coast of Spitsbergen. However, once you arrive at the site, the cultural relics are close to the landing point.	Buildings: moderate number of objects Ruins: many objects Parts of the cultural environment feature numerous small components and objects, especially within the ruins. Here, various items capture attention and curiosity, leading tourists/visitors to venture closer, including onto the wooden floor, to examine these details more closely.

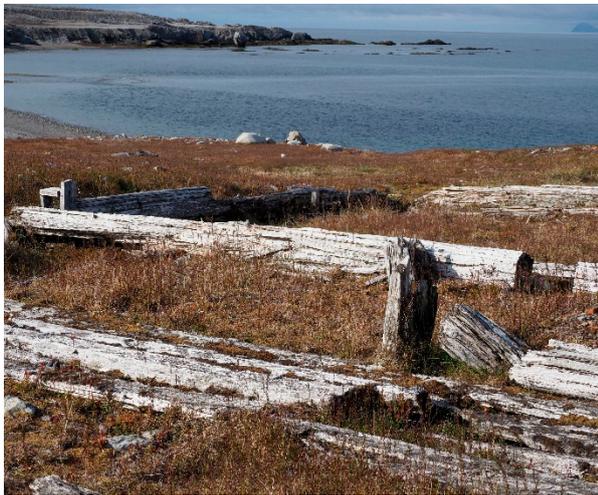
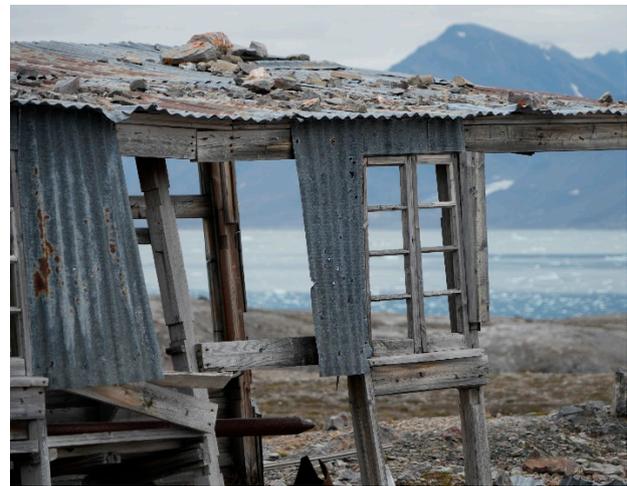
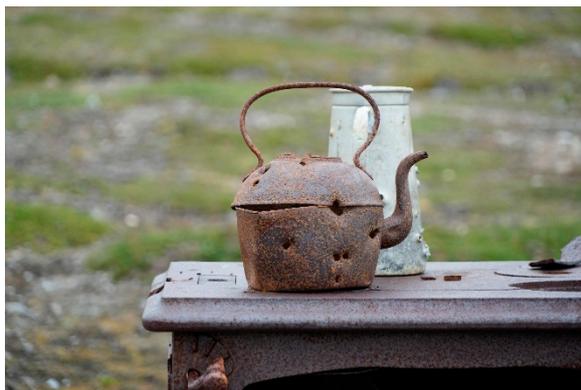
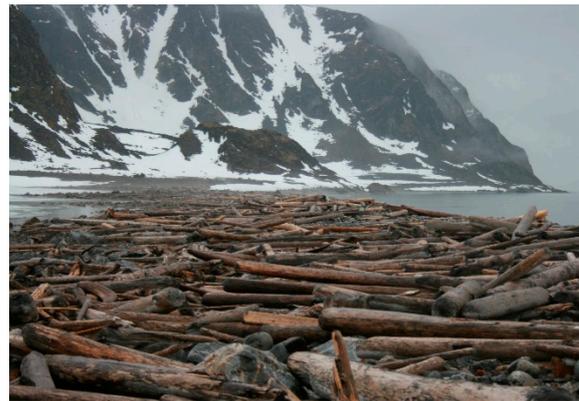
Figure 5. The figure portrays the vulnerability indicators, which consist of four primary parameters for characterising a cultural heritage site's vulnerability to visitors, as deduced from fieldwork. Top-left describes "Legibility", which pertains to the extent that it is apparent that the observed location is a cultural heritage site. Top-right illustrates "Physical condition", which is evaluated in the context of the cultural heritage site's capacity to endure the impact or pressure caused by visitor activities, such as foot traffic, tactile interaction, and overall engagement. Bottom-left illustrates "Quantity & quality of Objects", which quantifies the intricacy or number of objects situated on or in the vicinity of the cultural heritage site. Finally, bottom-right shows "Accessibility", which measures the ease, difficulty, or level of discomfort involved in reaching the cultural heritage site. All photographs: Anne-Cathrine Flyen.

Physical condition/degree of deterioration: gauges the cultural heritage's resilience to foot traffic. A physically deteriorated site is less resilient to foot traffic compared with one that is intact. For instance, deteriorated wood is less tolerant of foot traffic than a fully standing structure.

Legibility: This characterises how easy or difficult it is for visitors to comprehend what they are seeing and recognise that it is a protected cultural heritage site. Without understanding what they are observing, accidental damage becomes more likely.

Accessibility: This describes how easy or difficult it is to approach the cultural heritage site or environment. If it is not feasible to access or if the path is muddy, challenging, or unsafe, the likelihood of causing damage diminishes.

Quantity and quality of objects: This accounts for the abundance of details and objects in a location, encompassing the number of objects, loose building components, or material fragments present. A multitude of intact objects attracts attention, prompting individuals to approach for a closer look, potentially leading to souvenir collection. Moreover, the likelihood of trampling loose objects and scattered materials increases with their abundance.
