# Histories of Architectural Conservation

Five Case Studies On The Treatment of Norwegian  
Vernacular Heritage Buildings Circa 1920-1980

Thesis for the degree of Philosophiae Doctor

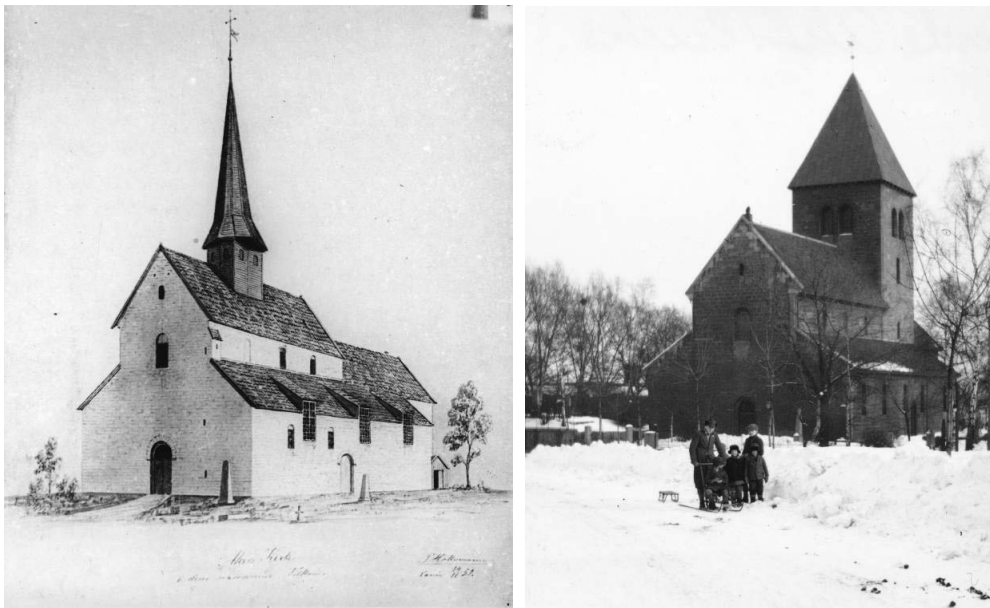
Figure 1-2: Old Aker church in Oslo before (left) and after the restoration (right). The restoration was completed in 1861 according to the design by Schirmer and von Hanno. Survey by P. Holtermann 1852, and undated photograph. (Riksantikvaren archive)

1-2]. Schirmer had designed a new church in its place and argued for the demolition of the medieval stone structure. He had already established himself as architect for the Nidaros Cathedral restoration and thus had some standing in these matters. According to Schirmer the church, although old, carried no historic legacy and had no art-historical value, being “crude, dark and depressing on the Soul”, and would for the same reasons not be suitable as a protestant church room, nor did he consider that it could “be a pretty or in artistic respects a peculiar and remarkable ruin.”<sup>76</sup> Age was not considered a sufficient reason to preserve the church from the expert architect’s point of view when the monument did not hold relevant symbolic historical value, and was not pleasing to the eye. The archaeologist Nicolaysen however argued to preserve the church and succeeded in convincing *Fortidsminneforeningen*’s executive committee to intervene. His resolute stand in the matter contributed to his being elected president of the society in 1851. Aker church was later restored.

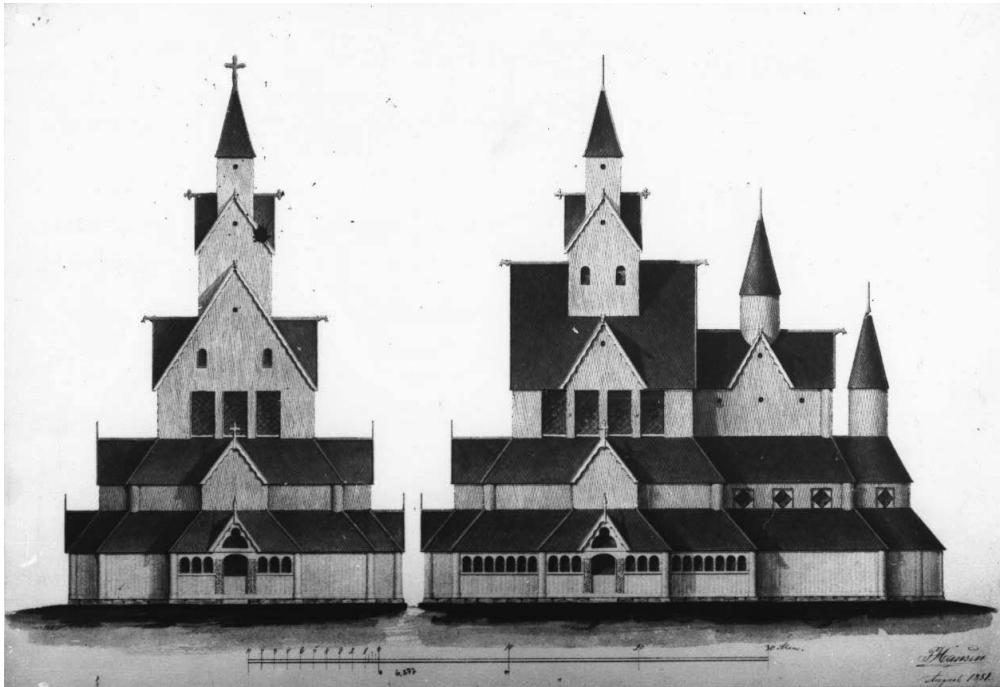
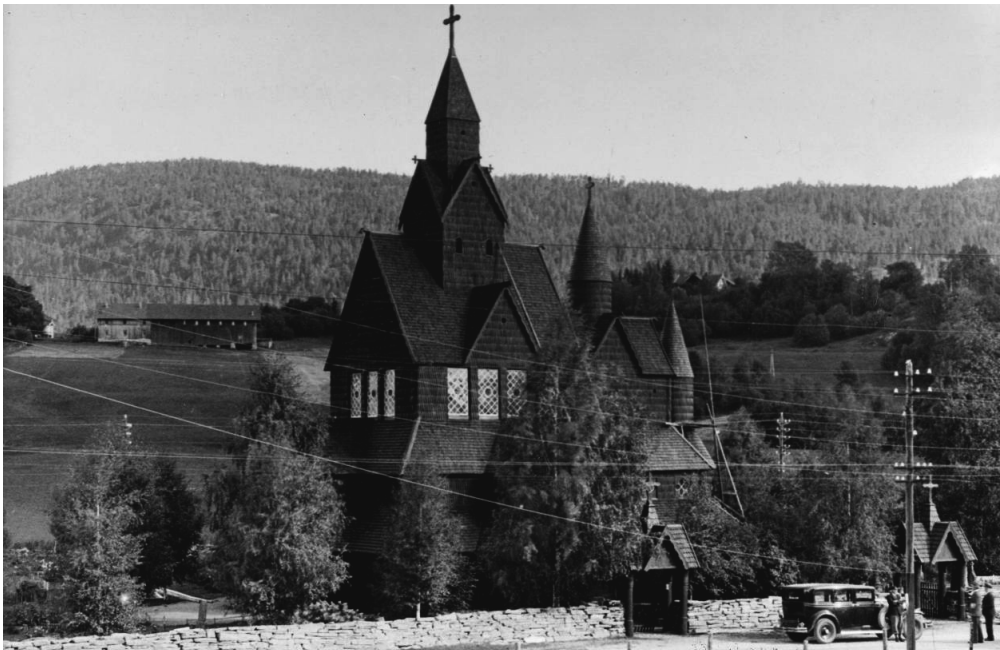
Figure 5-6: Heddal stave church, drawing by P. Hansen August 1851 (top) of the newly restored church, and photograph by Domenico Erdmann from 1934 or 1936. P. Hansen's drawing of the newly restored church was presented in Fortidsminneforeningen's annual publication of 1851. (Fortidsminneforeningen, Domenico Erdmann©Riksantikvaren, both Riksantikvaren archive)

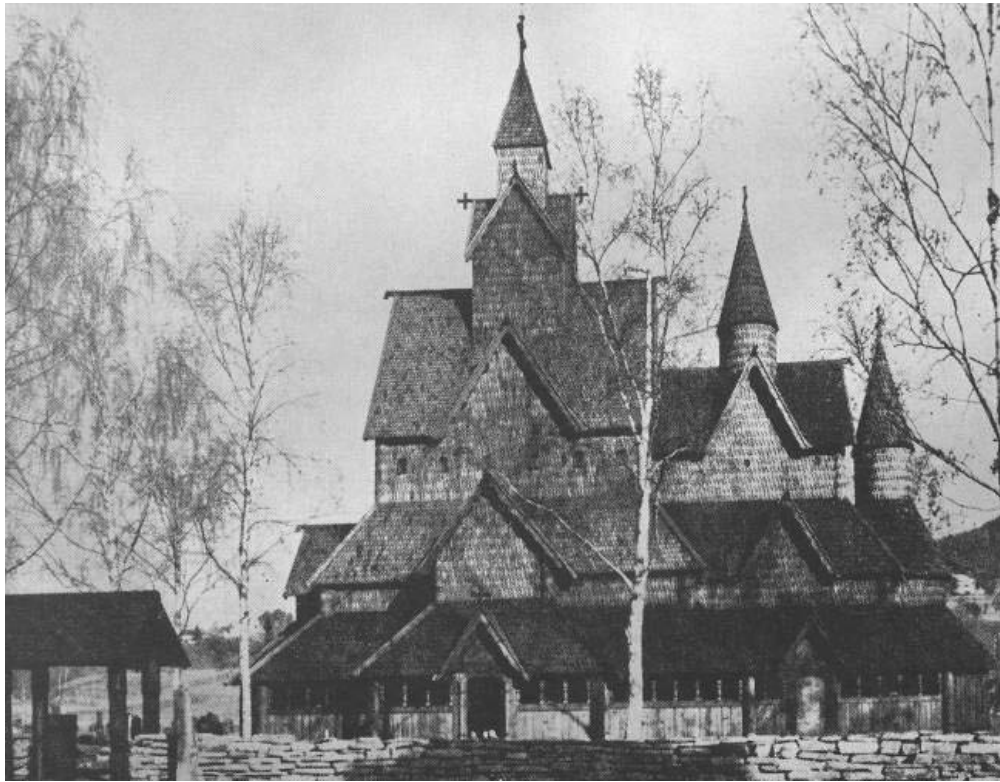
Figure 8: Heddal stave church after (top) Gudolf Blakstad's restoration in the late 1940s, presented in Fortidsminneforeningen Annal 1950. (Photograph unknown, Fortidsminneforeningen, Riksantikvaren archive)

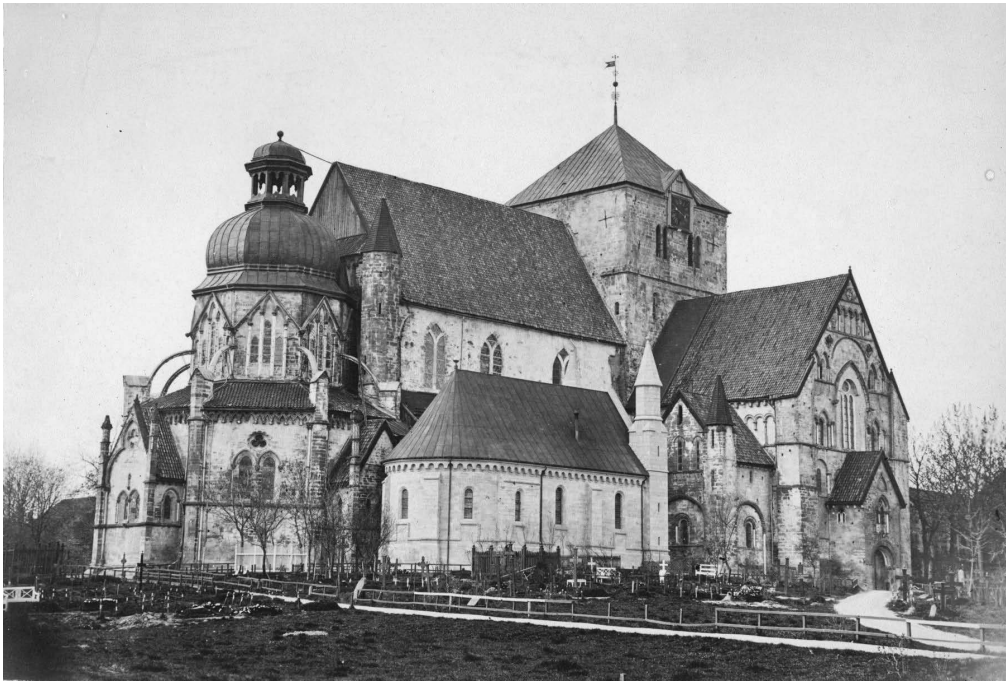
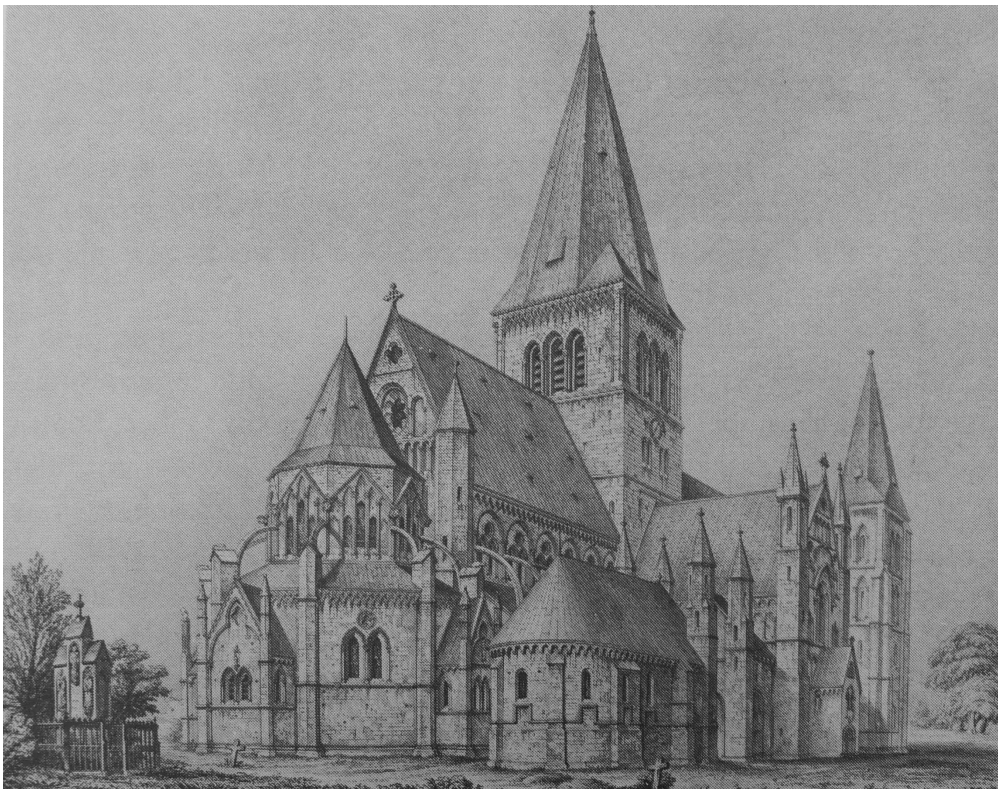
Figure 21-22: H.M. Schirmer’s first design for the restoration of Nidaros Cathedral’s nave, 1846 (left); Floor plans of English and French cathedrals and Norwegian churches (right), likely based on information Schirmer collected during a study trip to England and Normandy in 1843, taken to increase his knowledge of medieval ecclesiastic architecture in 1843.<sup>134</sup> The depicted cathedrals are, top row from left: St. Svithun in Winchester, Hereford, St. Ouen, St. Etienne, Bayeux. Nidaros Cathedral bottom left. The smallest floor plan is Hove church in Sogn. From *Kristkirken i Nidaros* by H.M. Schirmer 1885

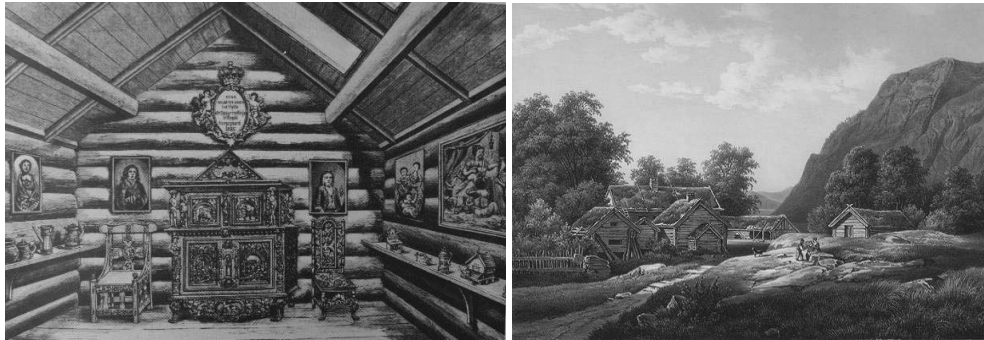
Figure 31-32: The Bredal storage building's interior (left), xylographic print circa 1885, fitted with skylights to provide daylight for the exhibition of the museum objects, illustration from the publication *Bygninger fra Norges Middelalder hvilke Hans Maj. Kong Oscar den Anden har ladet flytte til Bygdø Kongsgaard* published in 1888. Early depictions of Norwegian vernacular buildings by painters of the romantic era (II): Davigens Præstegaard i Nordfjord by Joachim Frich (right) from *Norge Fremstillet i Tegninger*, Chr. Tønsberg (1846-48). (Norsk Folkemuseum; and ©Digitalarkivet 2000)

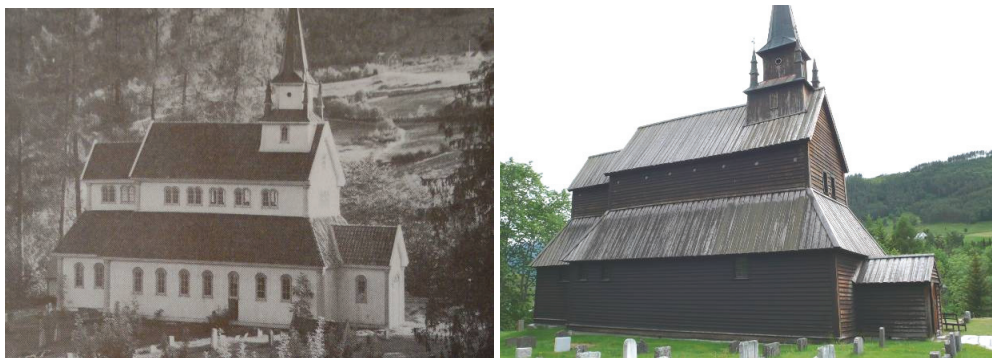
Figure 37-38: Kaupanger stave church after Stockfleth’s modernization in 1862 (left); in 2010 with the exterior it obtained from Kristian Bjerknæs’ restoration in 1952-64 (right). Bjerknæs based the new exterior on paintings and drawings from the early 19<sup>th</sup> century which showed that the church had been clad with wooden planks. The exterior work was carried out in 1964 in the second phase of the restoration.

In the 1950s and 60s a large number of churches were restored in Norway, to the point that the phenomenon later was characterized as "the wave of church restorations", with removal of Swiss Style and historicist elements as one common consequence.<sup>156</sup> In Kristian Bjercknes' restoration of Kaupanger stave church in the 1960s, the neo-gothic elements from the 19<sup>th</sup> century modernization were removed to cultivate the medieval character of the church. Original surfaces and elements were exposed. There was no model for the exterior, and Bjercknes designed a new and subdued wooden exterior which was completely free of ornaments, and which was considered more appropriate for the medieval church.<sup>157</sup> [Figure 37-38] Ethnologist Ragnar Pedersen writes: "even if the church restorations during these years were often justified with antiquarian terms, it must in retrospect be considered

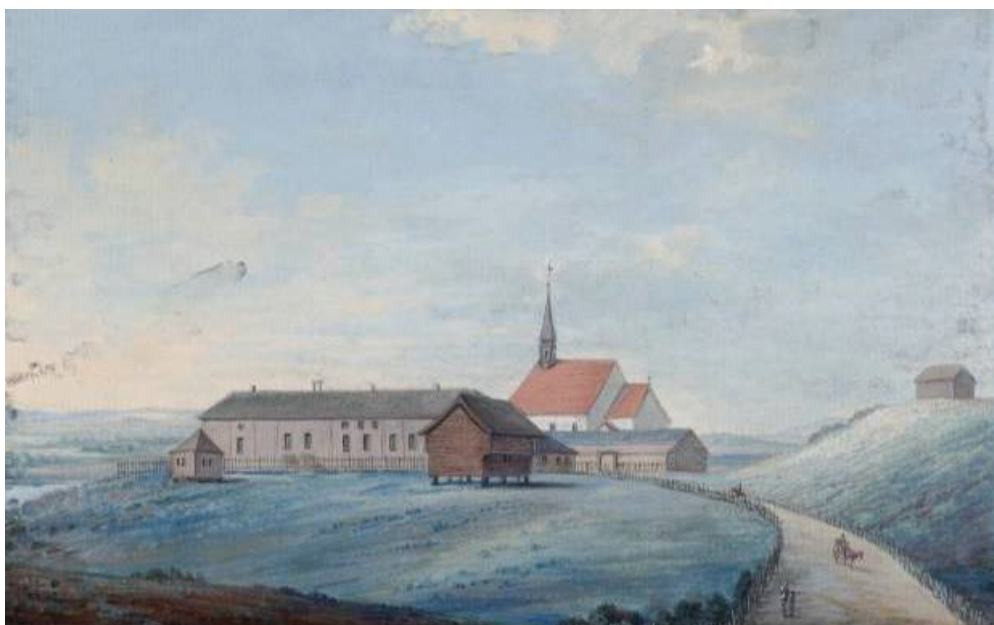
Figure 5: Melhus vicarage and Prestegårdslåna with the medieval Melhus church. In 1733, it was reported that the church was in good condition, and that it was owned by the vicar.<sup>11</sup> In 1756 the vicar was chided for neglecting the church.<sup>12</sup> In 1873 the Melhus church was again reported to be in excellent condition, with only a minor roof repair undertaken recently.<sup>13</sup> Two years later the condition was reported to be very bad, and that it had been so for many years, with unstable foundations on one side which had caused one wall to shift.<sup>14</sup> Architect Digre's commission for Prestegårdslåna in 1875 supposedly included an assessment of the church.<sup>15</sup> The medieval Melhus church was demolished in 1889. *Riksantikvar* Harry Fett wrote of the destruction of Norwegian medieval churches in general, using Melhus and Orkdalen churches in Trøndelag as examples: "We sacrifice millions to restore the cathedral, while at the same time the genuine heritage which we own in the same style is destroyed"<sup>16</sup>, "The cathedral" referred to being Nidaros Cathedral (see Chapter 2).

section of Prestegårdslåna today. The walls were notched timber, 13 metres in length.<sup>81</sup> No pictorial representations of Prestegårdslåna in this early stage are known. A painting from 1795 depicts Prestegårdslåna with a jamb-walled upper storey and hipped roof [Figure 5]. By this time it had been extended and clad; this happened in the 1740s and 50s.

The *roof and roofing material* of Prestegårdslåna changed over time. The types of roofing material can be documented fairly accurately, whereas the documentation on the history of the roof construction is not conclusive. The oldest known pictorial depiction of the Melhus church and vicar's farm, a painting by Meyer from 1795 or 1796, showed Prestegårdslåna as a one-and-a-half storey building with a hipped end roof; the slanting gable is clearly visible above the roof of the *bur*, or storage building [Figure 5]. 19<sup>th</sup> century photographs show Prestegårdslåna with a saddle roof; a hipped end roof is not mentioned in any known historical document; nor have marks been found in the fabric of the building showing that the upper storey was elevated. Hipped end roofs were not unusual on 18<sup>th</sup> century buildings in the region; the closest example for Prestegårdslåna was the neighbouring property, comparable in age and standing.<sup>109</sup> The only document which mentions alterations to the roof construction of Prestegårdslåna is a letter which described how the walls in the west end were raised by two logs, and that new gables and new purlins were fitted in this section in 1798.<sup>110</sup> The same letter stated that Prestegårdslåna had been "fully repaired" (*satt i*

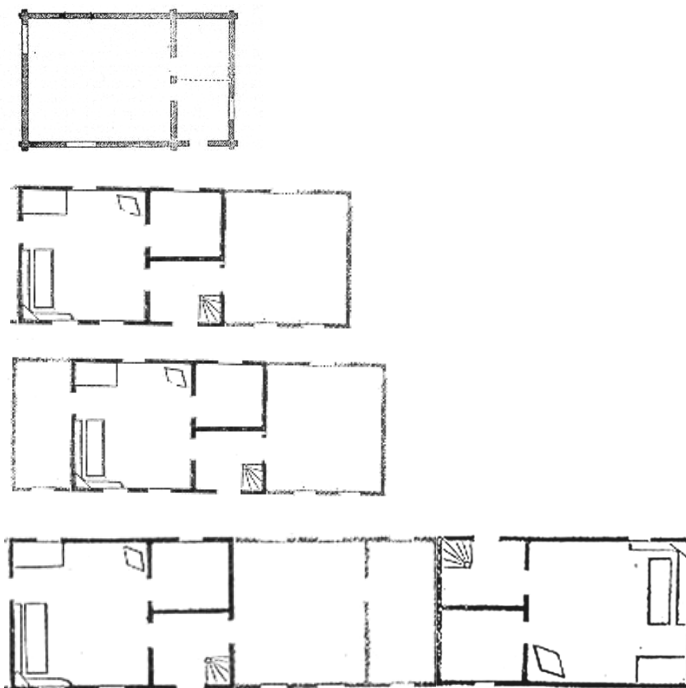
Figure 10: The development of the floor plan in Trøndelag vernacular according to Eilert Sundt. The three-room type, the paired room type with an added *nystue*; the paired room type with an added “long chamber” (*langkammers*), and lastly the double unit, where the addition was in fact a separate unit (for the older generation) with a separate entrance and, in this case, no internal connection. (Eilert Sundt, Digitalarkivet)

twos, symmetrically flanking entrance doors, which could be placed in the central axis of the building although this does not seem to have been a strict rule. In the *trønderlån* interior, the row of rooms was connected by equally positioned doors, creating an *en filade* effect. The size of the rooms varied according to the average length of the materials, and the rhythm of the façade was determined by this rather than by calculated, architectural symmetry. The classicism of the *trønderlån* exterior was underscored by architectural details in mouldings (dentil moulding, grooved pilasters and semi-columns, occasionally architraves, consoles, entablatures), always concentrated around windows and, especially, doorways. These classical features in the floor plan, façade and silhouette became deeply rooted in the traditional regional way of building. Halvor Vreim described the style of Trøndelag buildings (“*trønderstil*”) as harmonious, dignified, beautiful and balanced; the interiors well proportioned.<sup>40</sup>

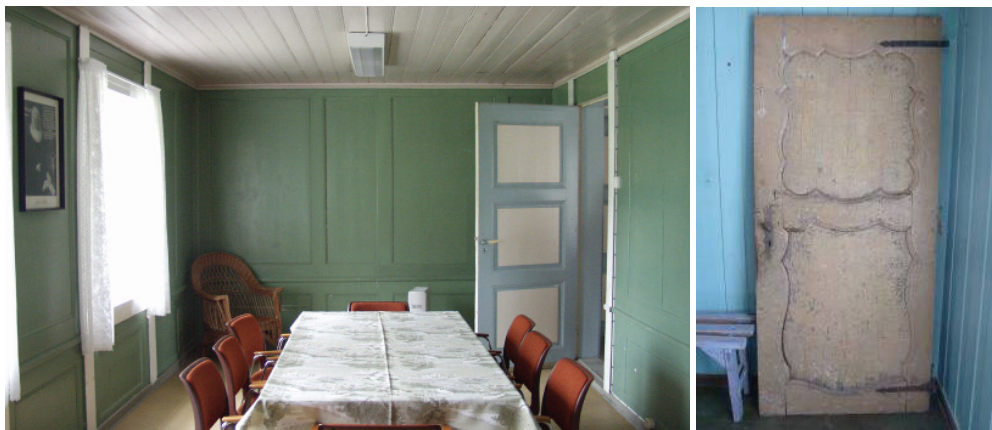
Figure 12-13. Lystersalen (left) in the oldest part of Prestegårdslåna, named after the vicar Christen Lyster who had this section built in the 1720s. Examination of the wall panels revealed their original colour as dark green<sup>111</sup>; an incision in the ceiling boards indicated a previous staircase at the far end of the room. This may have been removed in 1877, when the room according to written sources “extended”. The door (right) is the larger of two early 18<sup>th</sup> century doors found in the west end. Its likely origin is the oldest section of the building, maybe between *Hovdenstova* and *Bispekabinettet*. It was temporarily reused as an exterior door to a utilities building.<sup>112</sup> (Photograph NIKU 2003; MB 2009)

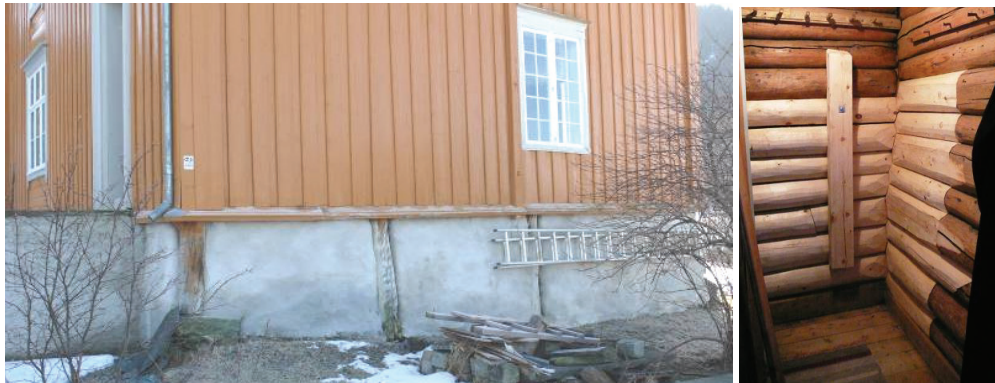
Figure 14-15: The west end, exterior (left) and section of wall in the upstairs clothes chamber (right) viewed from the interior (right). In 1758, only 14 years after the west end (with *Borgestuen* and *Størhuset*) was built, its foundations were considered so unsound that taking apart and reassembling this whole section was considered. In 1814 it was noted that the outer stairs (far left in left-hand photo) were timbered; today they are stone.<sup>113</sup> By the stairs to *Størhuset* a hole in the wall was observed in 1802, which would require “planks and nails”.<sup>114</sup> This hole was still there in 2000, when it was discovered that the entire log wall section had been subject to a serious fungal attack. In the clothes chamber (right) a fossilized fungus was found, likely produced by the leakage which was described in 1802. About 50% of the wall timber was renewed after the year 2000. (Photographs MB 2007)

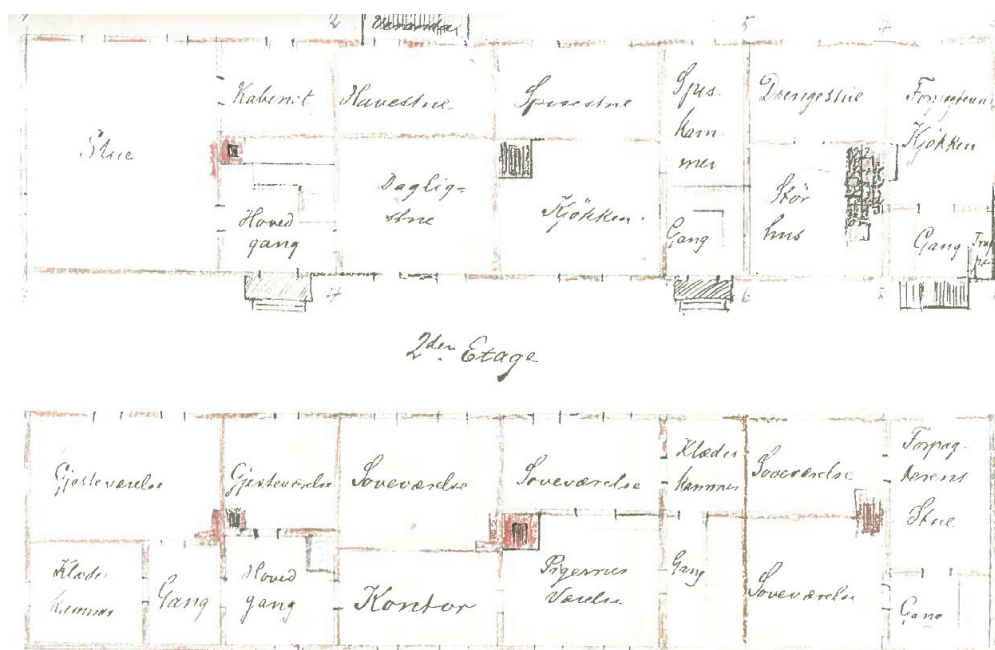
Figure 16: Floor plan of Prestegårdslåna from circa 1900.  
(Unsigned and undated drawing from *Prestearkivet*, reprinted in Moe, 2007)

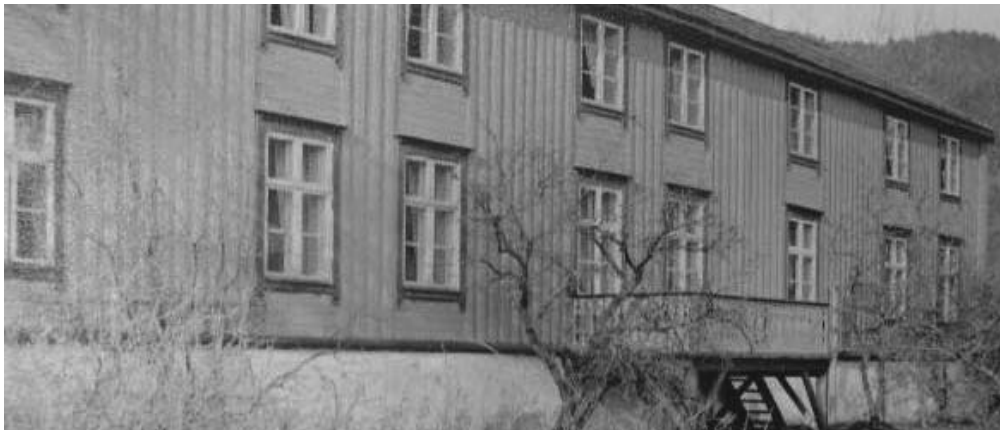
Figure 17: Prestegårdslåna after the 1877 modernization, south façade. The veranda was built in 1900. It was accessed from the main sitting room *Hovdenstova*. (Photo ©Riksantikvaren)

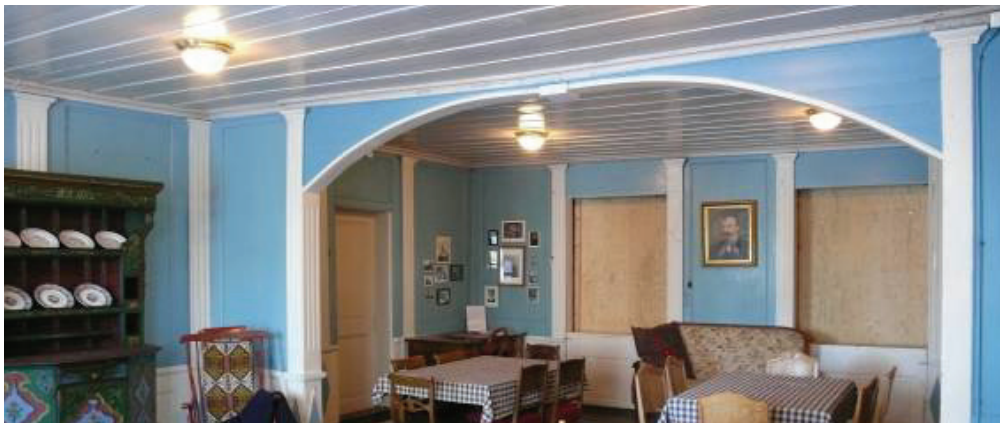
Figure 31: *Hovdenstova* where two rooms were joined during Vicar Anders Hovden's residency between 1910 and 1920. In 1929 the southern wall was fitted with new doors to the veranda which were disguised as windows to complete the image of a dadoed wall. The bottom panels can be removed, and the open space behind them filled with heat insulation material. (Photograph MB 2005)

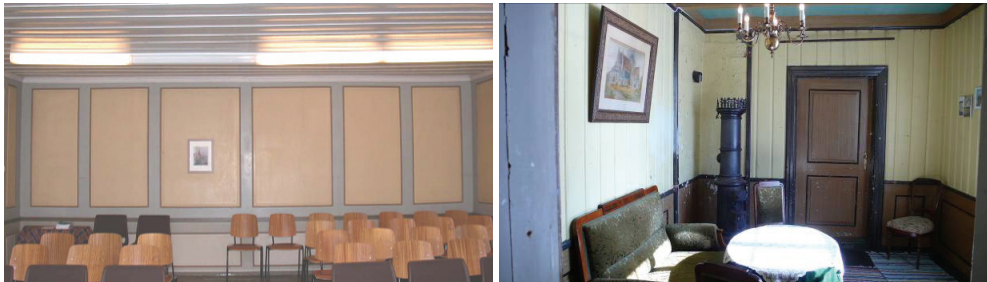
Figure 32-33. *Herrestuen* (left) was the congregation's responsibility until 1908. Originally with exposed timber walls, the room was frequently described as draughty. Panels were mounted during the first half of the 19<sup>th</sup> century, and the ceiling in 1877-78 when the whole building was modernized. The room was proposed to be divided but architect Tønseth argued against this. It was last painted in 1929 for Tønseth's restoration.<sup>252</sup> The bishop's chamber (right) was the shared responsibility of the vicar and the congregation during the 18<sup>th</sup> and early 19<sup>th</sup> century. Over time this room has had the function of bedroom, office, sitting room and kitchen. In 1922 Tønseth proposed to fit the doors leading onto the terrace here, but these plans were abandoned. (Photographs MBY 2005)

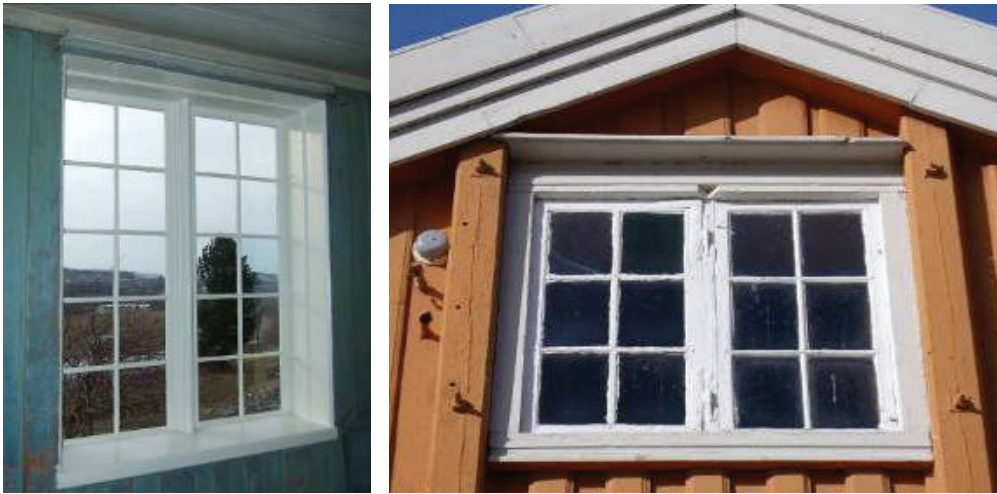
Figure 34-35: Only two 17<sup>th</sup> century windows are preserved in Prestegårdslåna's façades. The fire insurance valuation from 1868 described six different sizes of windows, including these two. The larger window (left) which has 20 panes, is placed in the west end gable wall, in *Borgestuen*. It was moved from *Herrestuen* and reused here in the 1878 modernization. Roar Tønseth used this window as a prototype for his restoration design. The smaller window has 12 panes and is placed in the loft section of the east end gable. Both windows are hinged on the mullion. The remaining windows in Prestegårdslåna are from 1878 or the 1929 restoration. (Photographs Kristine Kaasa Moe; MB 2009)

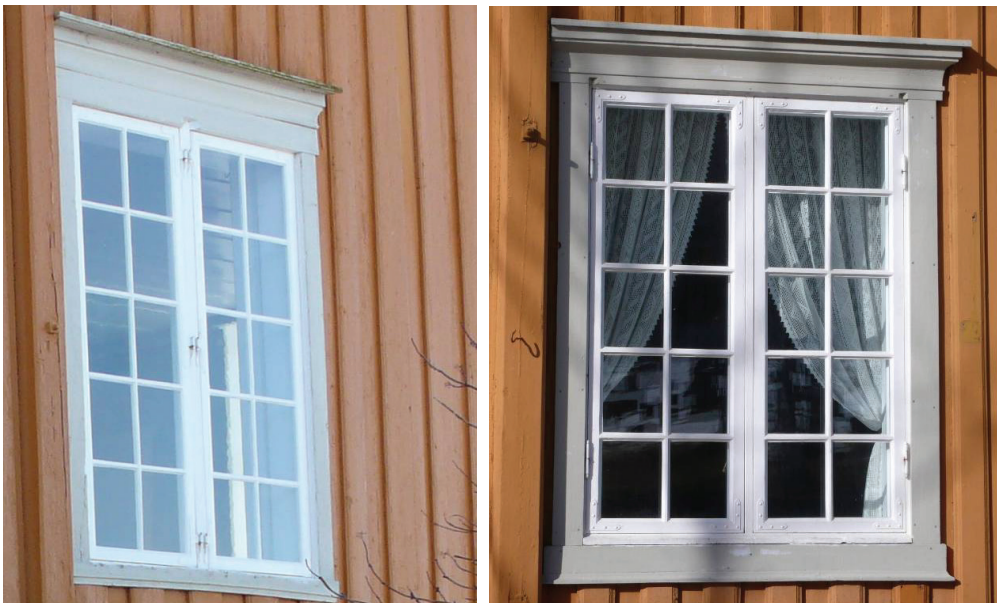
Figure 36-37: 18<sup>th</sup> century window in Prestegårdslåna in the west end gable (left), moved here from *Herrestuen* and reused in "*Almuestuen*" in connection with the modernization in 1877 and the only larger window from before 1877 is preserved in the building. Double glazed (*koble*) window from the 1929 restoration (right) designed by architect Roar Tønseth, likely modelled after "*Almuestuen*"'s. (Photographs MB 2009)

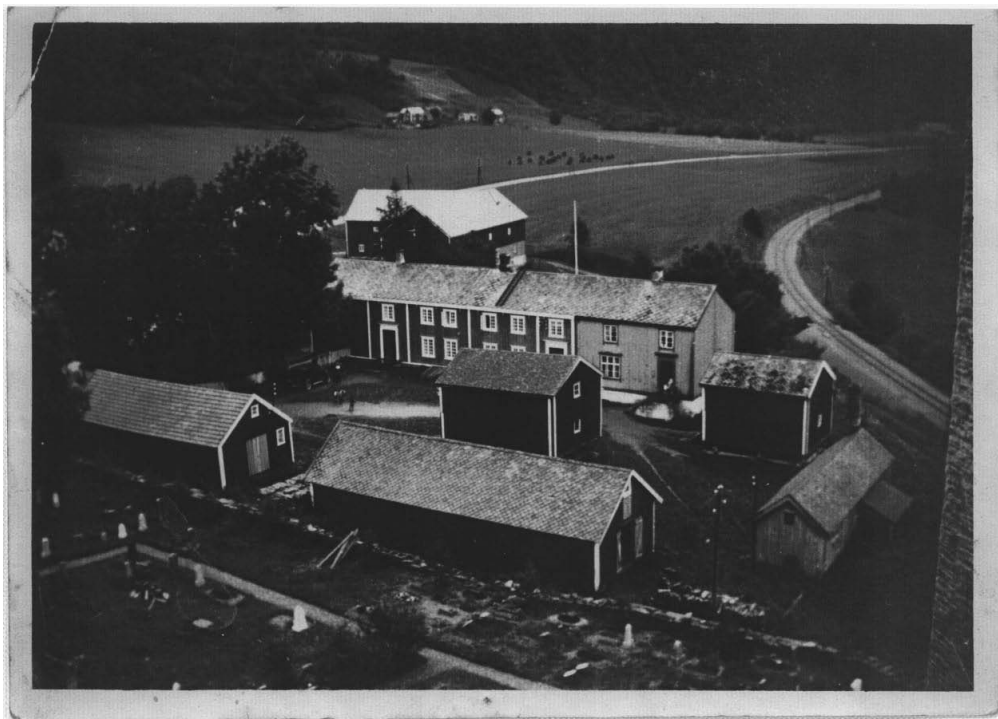
Figure 39: The north façade of Prestegårdslåna and the old farmyard photographed from the tower of Melhus church in 1937/38. The restored section was painted red, while the west end section which here is the right hand side of the building remained yellow, and retained its windows from 1877. The utilities buildings; wagon shed, wood shed (*rulle og -vedbu*), two storage buildings and drying house; were demolished after Melhus municipality took ownership of the vicarage in 1959. *Riksantikvaren* protested, but arguments that the buildings were too costly to maintain won. The new utilities building, in the background, replaced the older barn, cowshed and stable. In 1948 a new dwelling for the tenant farmer was built south of the utilities building.

painted, in a red colour; the west end section however was not and remained yellow. [Figure 39]

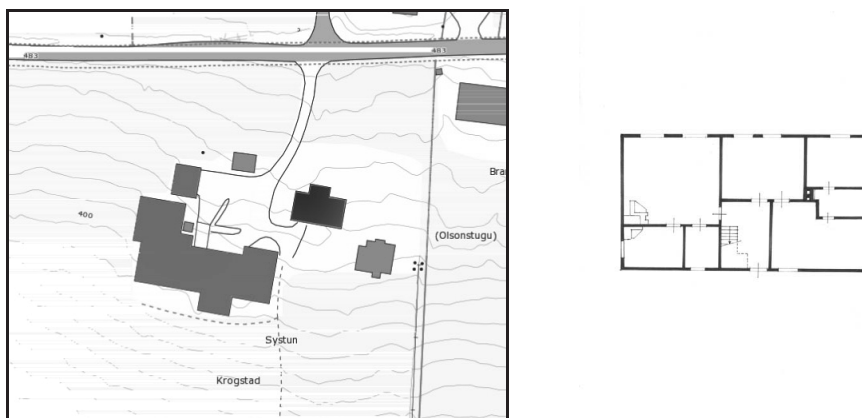
Figure 3-4: Krogstad site plan (left) and floor plan (right), (August Schmidt 2010)

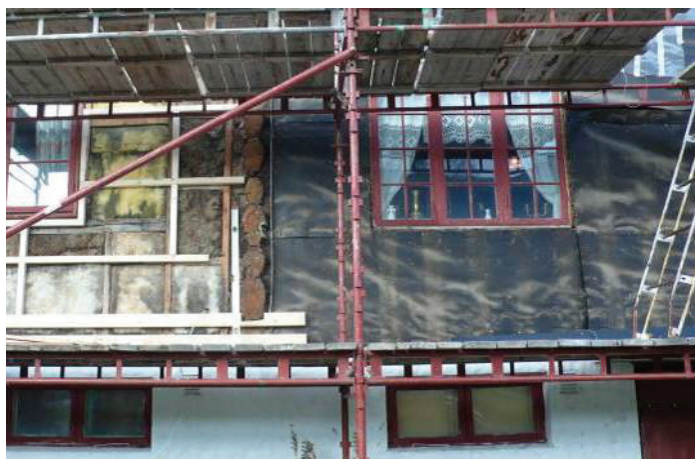
Figure 9: Krogstad søre, 2008. The boarding removed, exposing 1950s type wind-proofing on the 1811-section of the building. Vreim had strongly recommended that this section was to be left with exposed timber. Initially this was the case, but apparently not for long. (Photograph MB 2008)

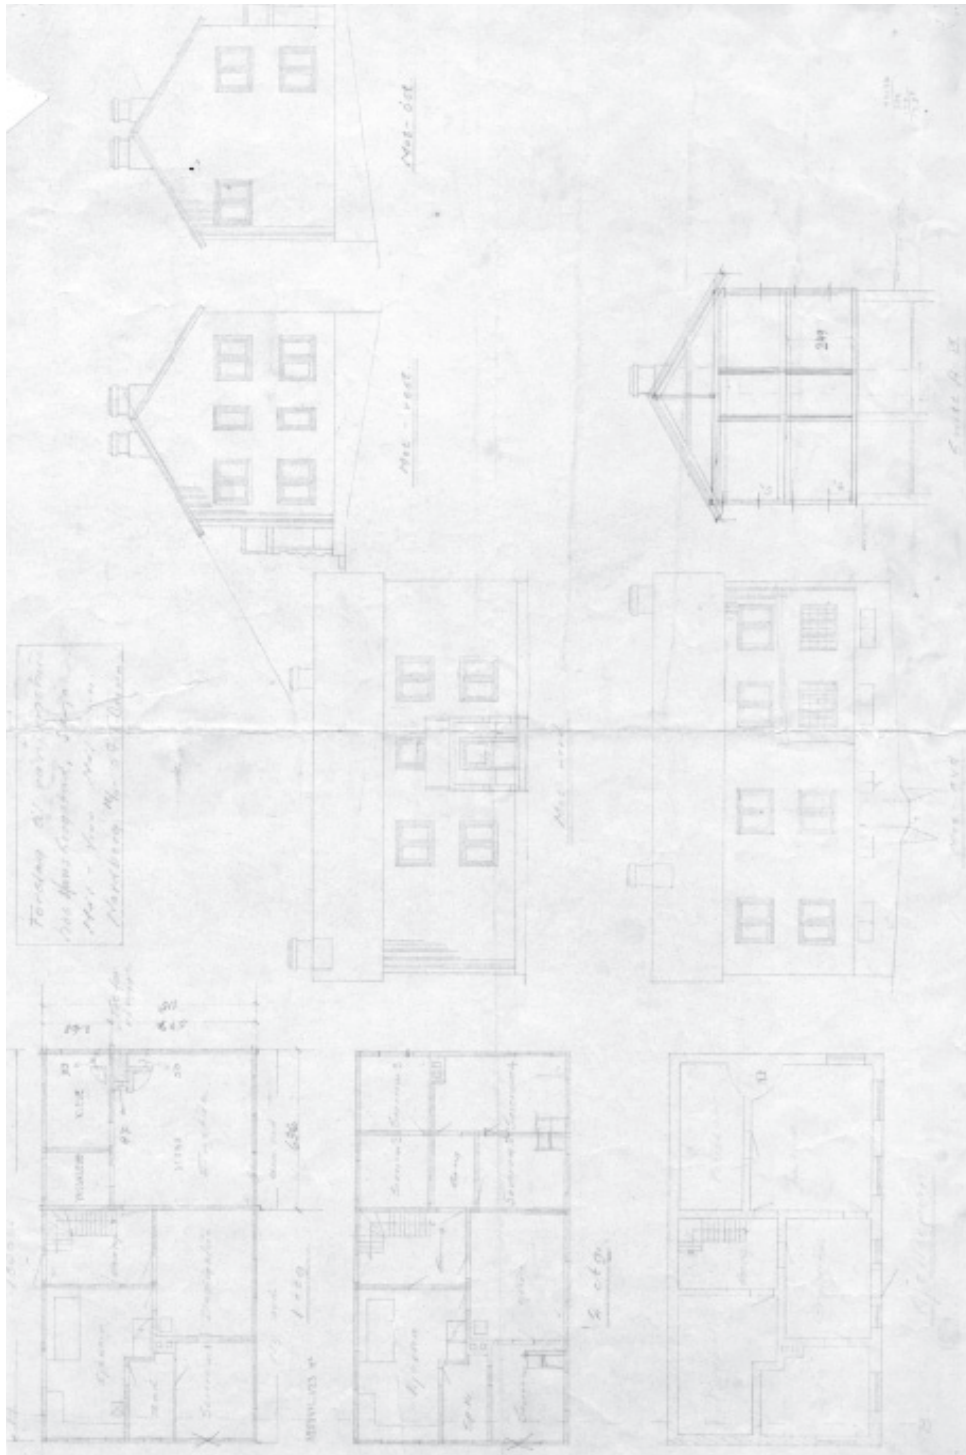
Figure 10: Krogstad, new house, first house concept, T. Bakken 16/11-1954, original scale 1:100. (Riksantikvaren archive)

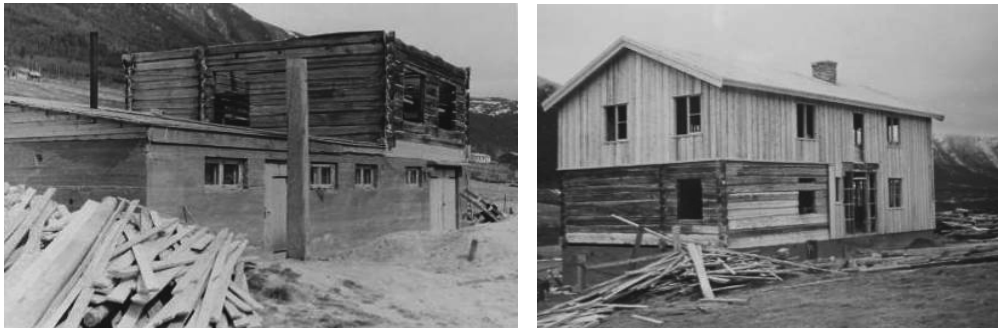
Figure 11-12: Krogstad under construction in 1956 showing the new cast concrete basement (left) with the garage doors and the notched case with the three rooms; and from the opposite angle (right) with the new addition and visible signs that the old construction was repaired with new sills and back wall logs fitted. (Photographs: Halvor Vreim ©Riksantikvaren)

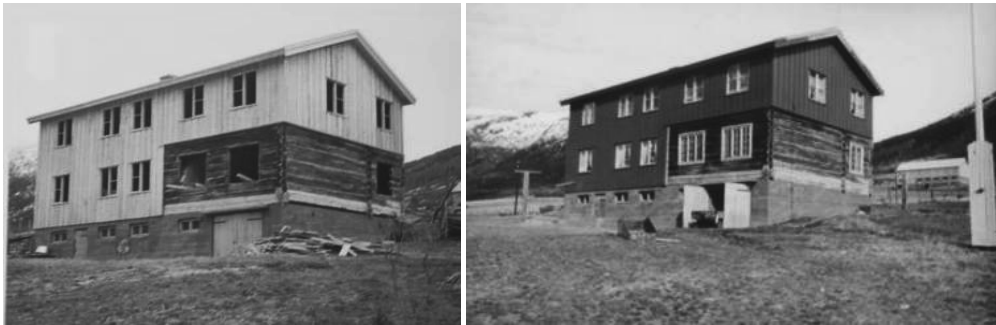
Figure 13-14: Krogstad in 1958. The new house envelopes the section from 1811, still under construction (left) and finished with windows and paint and a car in the new garage (right). Vreim initially rejected the plans to place the garage under the 1811 rooms; he also wanted the 1811 section left exposed, but it was clad shortly after the house was finished. His request that the whole house was given small-paned type casement windows was also ignored; the owner wanted a more modern window type and Vreim's preferred type ended up being used for the 1811-section only. (Photographs: Halvor Vreim ©Riksantikvaren)

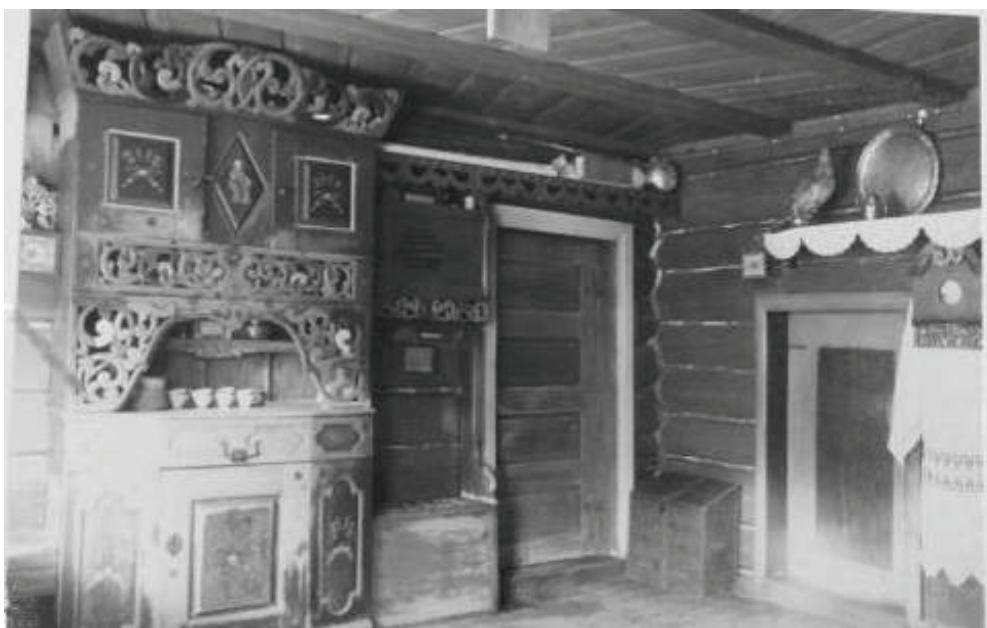
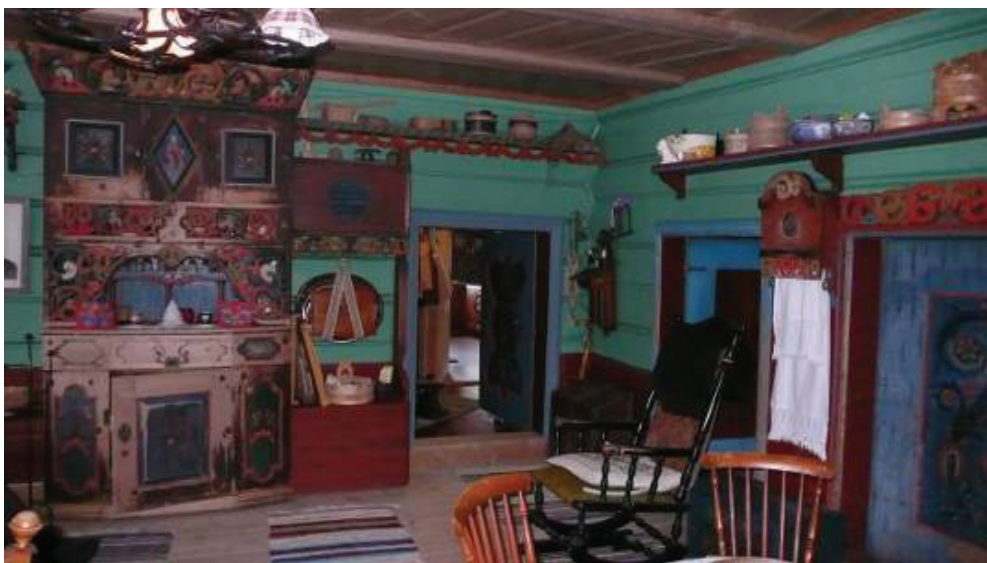
Figure 17-18. Interior of the *stugu* with cupboard, main entrance and door to the smaller chamber before (top) and after reconstruction. This section of the house was completely disassembled, rebuilt with *laftevatt* (fabric chinking) instead of moss between the timber logs. The interior was restored by a local painter on the instructions of *Riksantikvaren*'s restoration assistant Ola Quale. The wall paint, green, is from the late 1950s, based on the original colour. The doors and fixed furniture do not seem to have been touched. The rooms are an integral part of the house in 2008, but not in daily use. Right: (right). Photo Halvor Vreim ©Riksantikvaren (Archive B123). Photo MB 2008

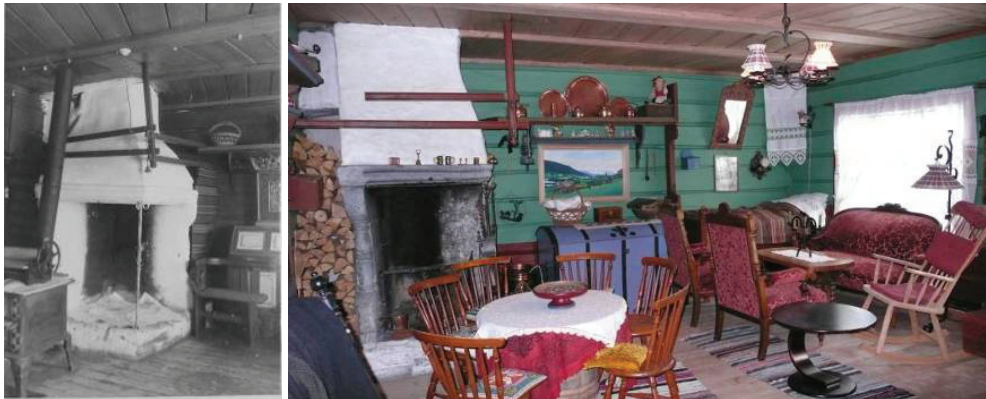
Figure 19-20. The old fireplace in the Krogstad *stugu* (left) and the new fireplace as it was reconstructed in 1956 (right). Vreim's specifications were: "Even if the new chimney is placed behind the fireplace, the fireplaces must not be altered upon reconstruction. This also relates to the character of the rendering of the overmantel. As much as possible of the old stone is to be re-used."<sup>121</sup> The photo of the room before the relocation shows that an iron stove had been fitted by the old open fireplace, with a hazardous stack penetrating the wooden ceiling. These furnishings were not included when the room was reconstructed; it was restored to a previous phase. In the right hand corner can be glimpsed the bed fixed to the wall, which was noted missing by Vreim upon his first visit, and reconstructed after the building was moved. Under this room the owner built his basement garage, with the entrance gates directly under the window. (Photographs: Halvor Vreim ©Riksantikvaren, and MB 2008)

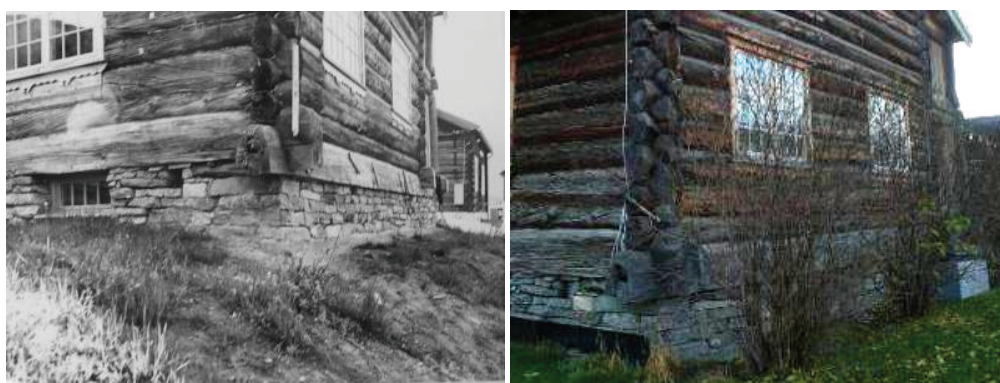
Figure 29-30: Stensgård relocated on new foundations, concrete underground and natural stone above, in 1978-80 (left) and in 2008. (Photograph unknown©Riksantikvaren and MB 2008)

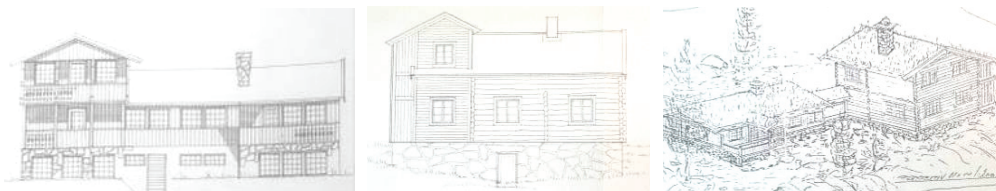
Figure 31-33: Adaptation architecture. Proposition for a new house in the farmyard at the Stensgård farm from 1981 by the housing firm Nøkkelhus (left). This solution involved demolishing an existing dwelling from 1892, neighbour of the listed building. The alternative presented in 1984 (centre) was to extend and rebuild the existing 1892-dwelling. The extension was designed in traditional *ramloft* style to fit with the historic farmyard and listed building, design by architect Horn April 4<sup>th</sup> 1984. The listed Stensgård building was newly repaired but not inhabited at the time when these plans were discussed. Proposal for an addition to Gammelstua from 2001 (right) endorsed in principle by the county conservation authorities. The signature on the drawing is illegible. (Riksantikvaren archive)

When the old Stensgård dwelling was repaired after decades of accelerating decay, there were no immediate plans to inhabit the building; instead the owners launched plans to build a new dwelling in the farmyard. In 1981 *Riksantikvaren* was consulted and rejected blueprints from prefabrication housing firm Nøkkelhus.<sup>165</sup> [Figure 31] New blueprints were

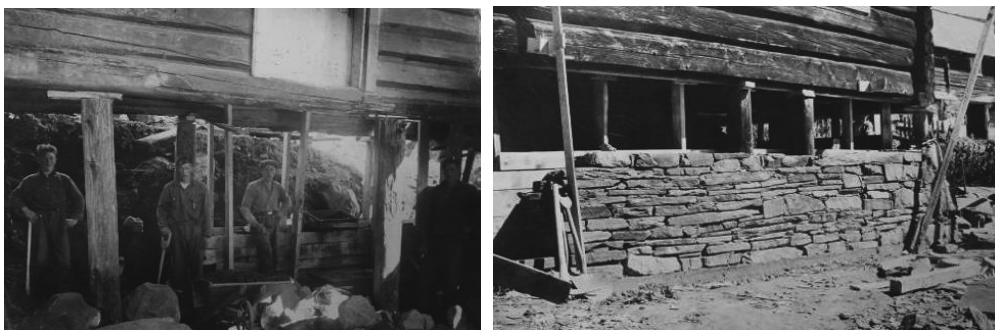
Figure 50-51: Søndre Stugu. "Ungdomsopplæring i arbeid" ("Youth training at work") State employment grants used to repair listed buildings. Work on the foundations of Søndre Stugu at Harildstad Søre in 1938 were prescribed and inspected by Halvor Vreim. (Photographs Halvor Vreim ©Riksantikvaren)

*Foundations* were the main target for the work done at Harildstad Søre in 1938. Both *Nordre* and *Nedre Stugu* had foundations which were in bad condition. Vreim suggested that these needed to be renewed with foundations extending down below the frost-line. *Søre Stugu* had sound foundations, but Vreim proposed that they be renewed all the same to accommodate a new brewing house for the owner. Vreim specified new foundations of cast concrete faced with a wall of natural stone: "...faced in the exterior with common irregular stone so as to achieve an appearance like it presently has."<sup>206</sup> The foundations of all three dwellings were renewed in 1938 under the supervision of Halvor Vreim. *Søre* and *Nordre Stugu* are described as being fitted with concrete and stone foundations; for *Nedre Stugu* we know that a new basement was made and the walls repaired, although no details are documented in the case file.<sup>207</sup> The foundations of *Søre Stugu* were repaired again in 1976, again as part of a state funded employment programme which targeted listed buildings. The year before, *Riksantikvaren* reported that the foundations and sills of *Søre Stugu* were in a

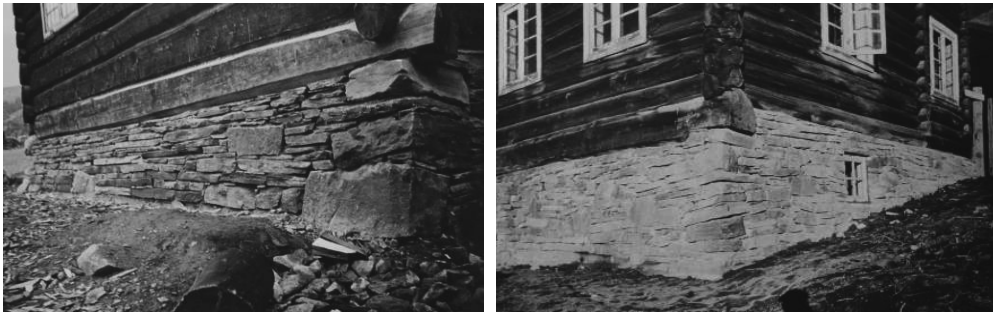
Figure 52-53: Nordre Stugu “The new foundations under the northern dwelling” (left) and Nedre Stugu (right) photographed by Vreim in 1939. On both buildings the foundations were repaired. The photo of Nordre Stugu was presented in the piece *Fortidsvern og ungdomsarbeid* in *Fortidsminneforeningen*’s 1939 annal with the caption “House lifted and provided with new foundations and bottom logs. The old stone re-used, but with reinforcements at the back.”<sup>208</sup> (Riksantikvaren archive)

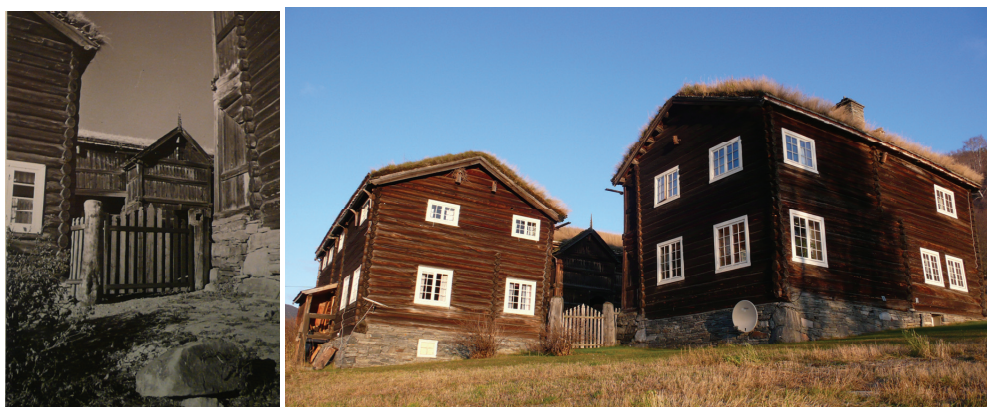
Figure 54-55: The farmyard in 1938 (left) and 2008 (right) with Nedre Stugu on the left hand side, the Nordre Stugu gallery centre and Søre Stugu to the right. The upstairs windows in Nedre Stugu were fitted after 1946. *Den Antikvariske Byggningsnemnd* was consulted on the matter. (Photograph Halvor Vreim 1938 ©Riksantikvaren and MB 2008)

previously uninhabited, were to be converted to living space. The proposal was to place two windows on the gable wall and one on the long wall facing southwest.<sup>226</sup> This was also done [Figure 54-55]. There is no indication that the conservation authorities objected or commented on this measure.

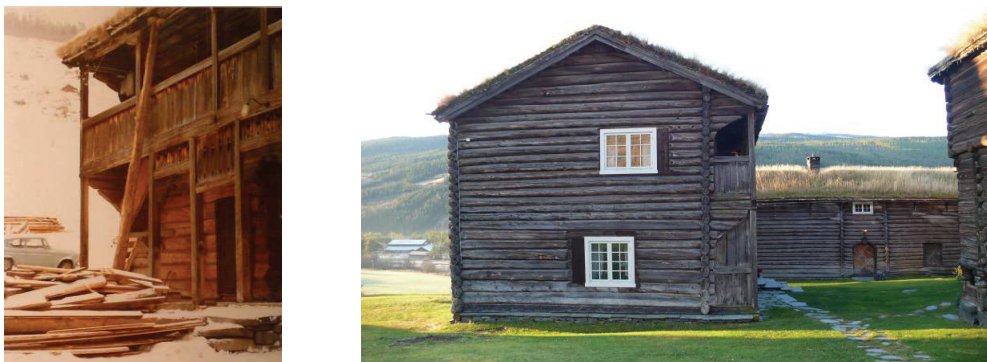
Figure 58-59. “Søre Harildstad Sørstua under restoration March 1976” (left), and in 2008 (right). The ground floors of Søre Stugu were replaced after a fungal attack in the northern section of the house. The gallery was partly dismantled and the sill replaced. The sill log was replaced in 1976. The surface of the new log has surface tracing of axe work and seems to have been tinted to blend in with the old wood. The windows were renewed in 1982. (Photographs unknown ©Riksantikvaren and MB 2008)
