# Histories of Architectural Conservation

Five Case Studies On The Treatment of Norwegian  
Vernacular Heritage Buildings Circa 1920-1980

Thesis for the degree of Philosophiae Doctor

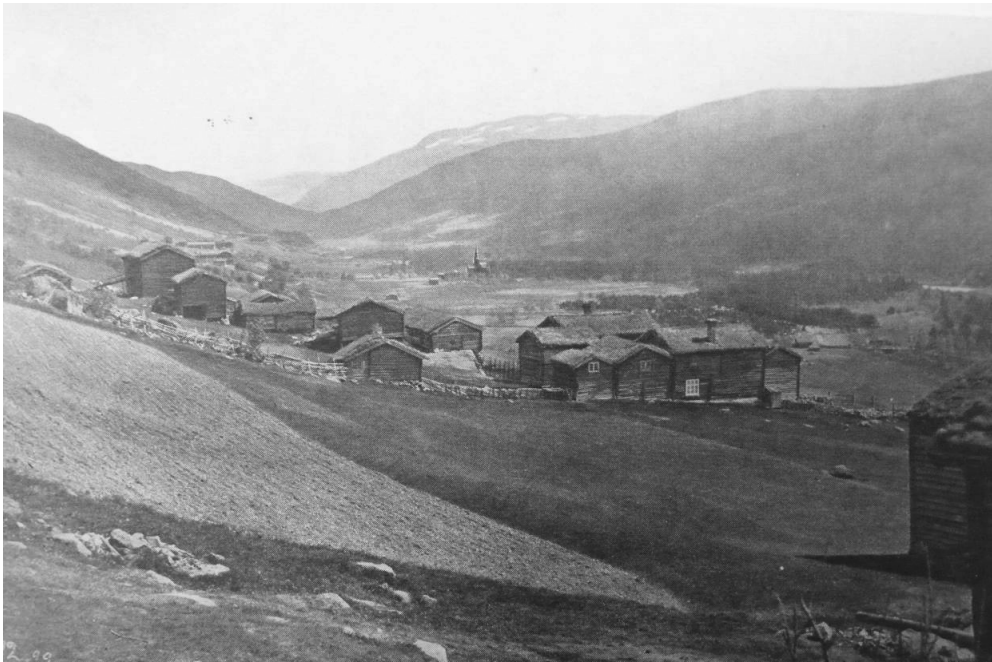
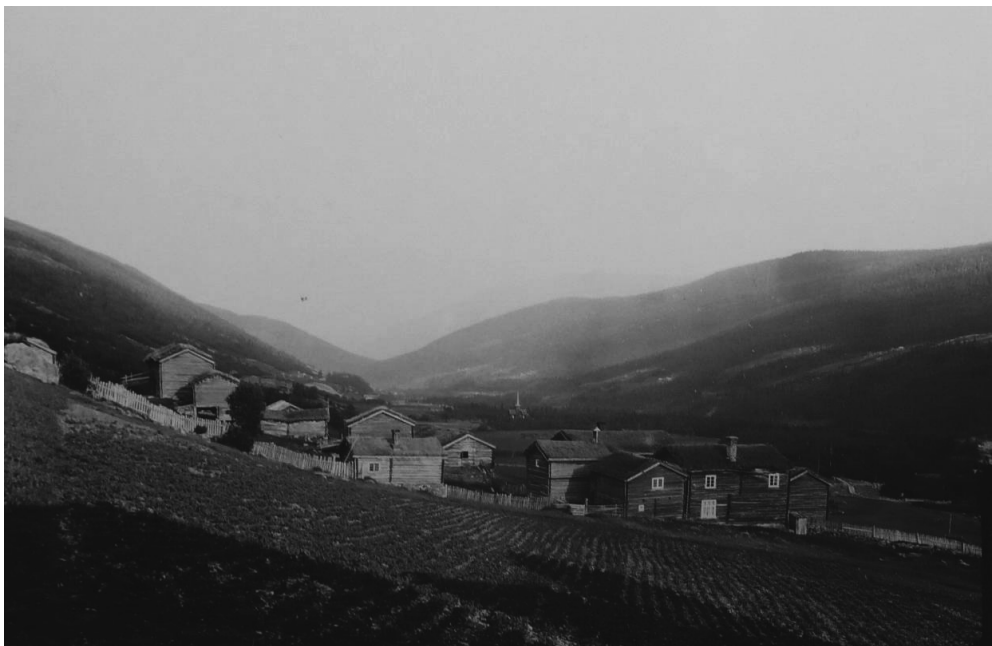
Figure 61-62: Søre Harildstad photographed from the north west in 1899 (top) and by Johan Meyer in the 1920s (bottom). During the interval between these photographs a smaller storage building disappeared. The *eldhus/karstuggu* was repositioned and rebuilt, the gable turned 90°. (Riksantikvaren archive)

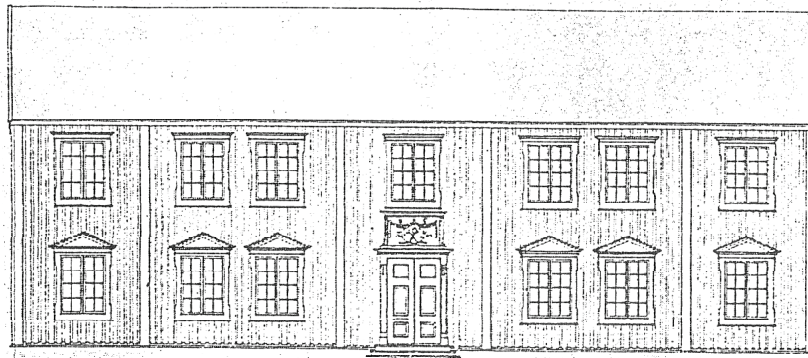
Figure 7-9. The monumental “Bergskrivergården” in Røros was stylistically restored back to its neoclassical origins following a design by the architect Tycho Castberg from the 1940s (top). Photograph of the building before the restoration, reprinted from Vreim’s 1942 article (bottom left), showing the building “done up” in the popular Swiss Style, before the restoration. “Bergskrivergården as it once was and at will be according to the restoration proposal by Tycho Castberg” Halvor Vreim wrote in his piece *Pleien av et Bybillede* (1944). Bergskrivergården in 2007 (bottom right). (Tycho Castberg, Riksantikvaren archive; photograph Unknown ©Riksantikvaren; MB 2007)

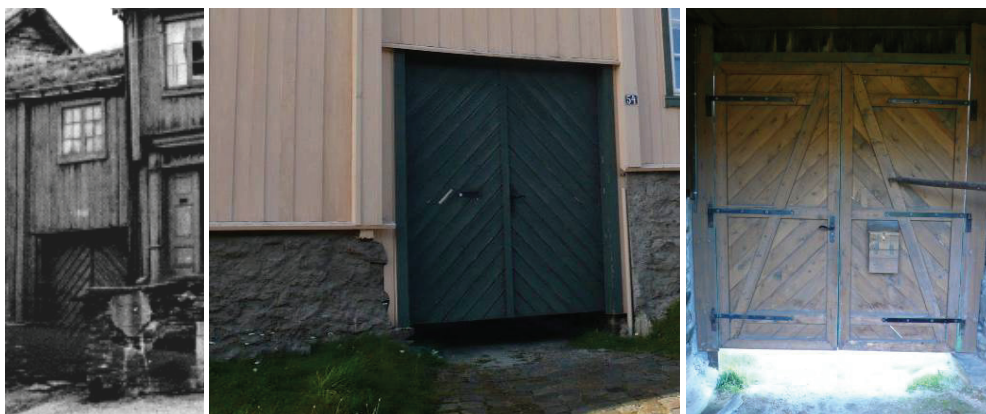
Figure 31-33 (previous page): Kjerkgata 54 foundations and gate entrance. Before the 1955 restoration the foundation walls had a rendered surface with a pattern traced to imitate ashlar, which was deteriorating as shown in the 1953 photograph (left, section). Ashlar patterned rendering was not approved of by Vreim who associated it with the late 19<sup>th</sup> century way of building not appropriate for the historic buildings of Røros (he commented on this in his piece *Pleien av et bybillede*). The owner repaired the foundations with modern cement *kulepuss*. This was also criticized by Vreim, who encouraged the owner to remove this and restore the foundations using a smoother lime-cement rendering, but to no avail. The gate was renewed and the gateway foundations repaired with no alteration to the design in 1973 with a *Riksantikvaren* grant. The gate in 2007, façade (centre) and from the viewpoint of the gateway (right). (Photograph Mby 2007)

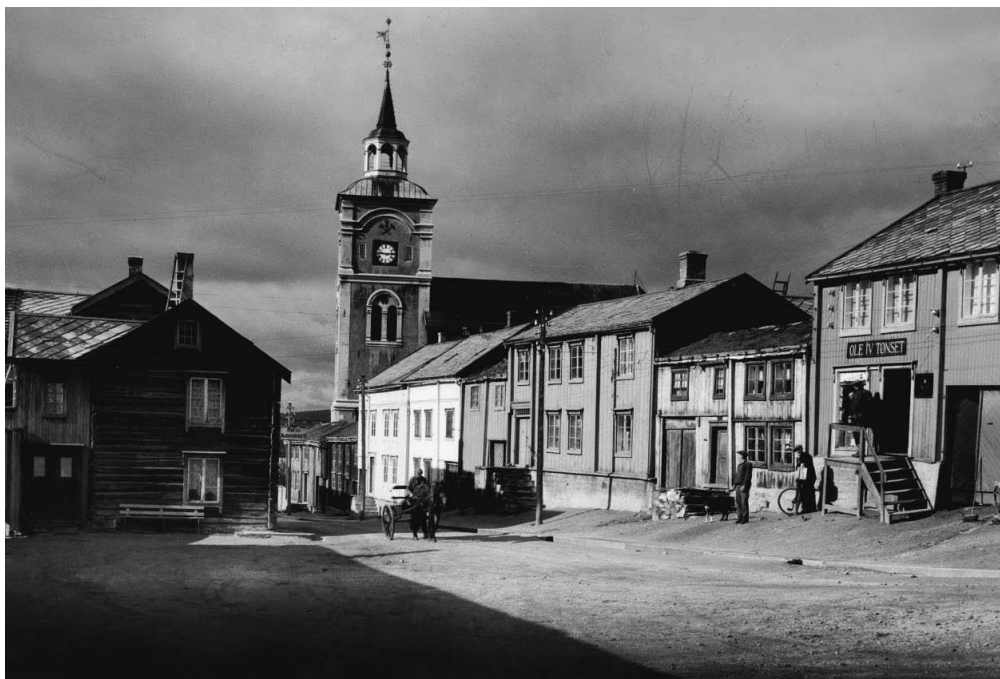
Figure 38: Sohlbergrekka, undated photograph. Kjerkgata 56 is the second building from the right, as it was before it was demolished and replaced with a larger house. (Photograph unknown ©Riksantikvaren)

Early photographs [Figure 38] show a building significantly lower in height than its neighbours Kjerkgata 54 and 58. The façade was clad with vertical cladding and a vertical casing between two sections. The ground floor comprised a gateway entrance, a street door to the house reached by low stone steps and two windows, and the upstairs storey four windows,

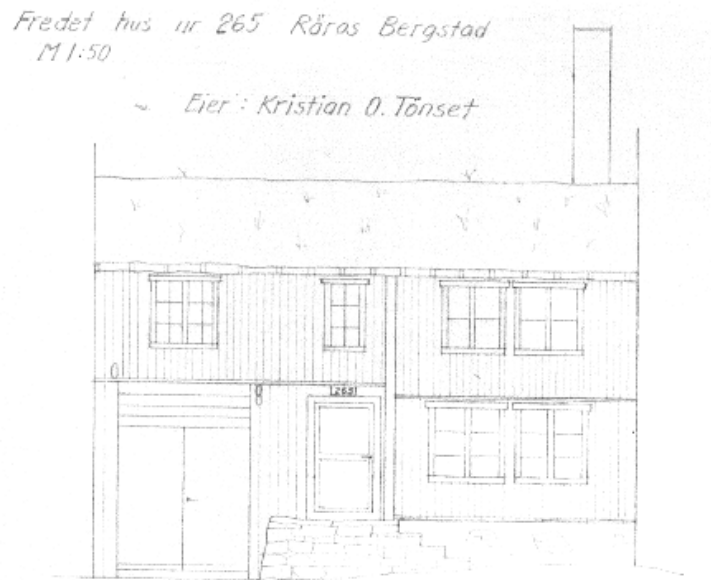
Figure 42: Kjerkgata 56. Survey signed MK (Magne Kverneng) 1949. (Røros municipal building archive.)

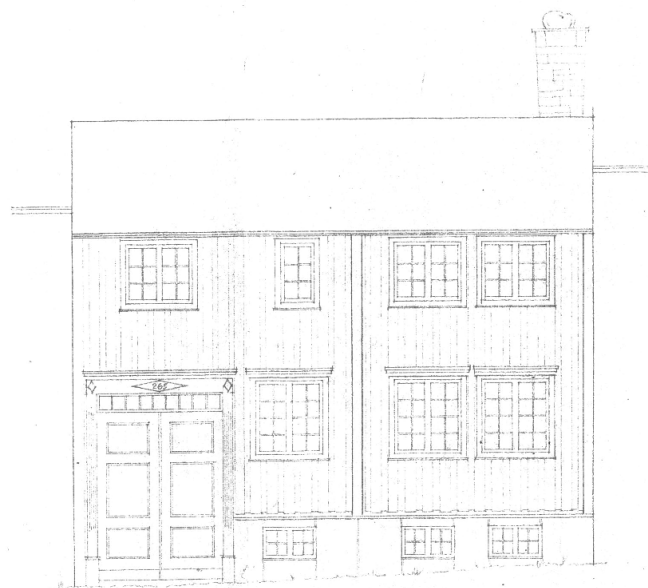
Figure 43: Kjerkgata 56, the new façade by architect Stensaas “Gård nr. 265, 25.2.1950”. Original scale 1:50. The eaves of the neighbouring buildings are marked in Stensaas’ blueprint, showing that both of the neighbouring buildings were taller than his proposal for Kjerkgata 56. When the building was constructed, however, the heights were increased so that Kjerkgata 56 is today taller than its neighbour Kjerkgata 54. This was not done according to Stensaas’ plan, in which he worked hard to keep the height to a minimum. (Røros municipal building archive.)

The architect had explained his intentions for the building design in letters to the municipal engineer, claiming that lifting the ground floor level would be “exceedingly difficult to achieve”, inquiring whether the indoor heights on the ground floor were 1.69 or 1.79 metres, and suggesting that plans for an extra bedroom over the kitchen extension were discarded, as this would make planning easier, the latter most likely a reference to the uneven roof planes of his solution [Figure 45].<sup>102</sup> The municipal engineer endorsed the owner’s plans and confirmed that draining surface water and packing snow were problematic for this property, and also argued for the necessity of an extra bedroom at the back of the house:

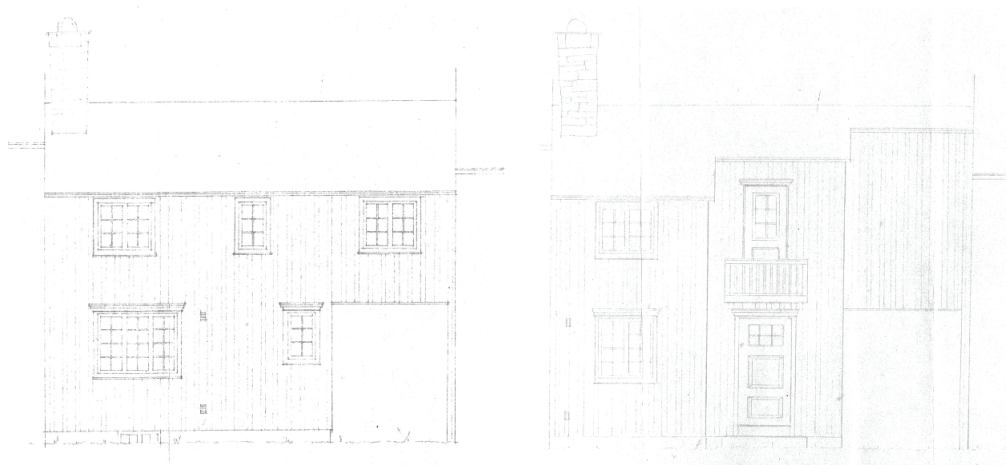
Figure 45-46: Kjerkgata 56, backyard façade, alternative plans for reconstruction. The altered proposition of 1952 was the basis for the reconstruction, although it became taller than Stensaas' plans proposed. Courtyard façade 25/2-1950 (left); courtyard façade 23/2-1952 (right); Architect Johan Stensaas. (Røros municipal building archive)

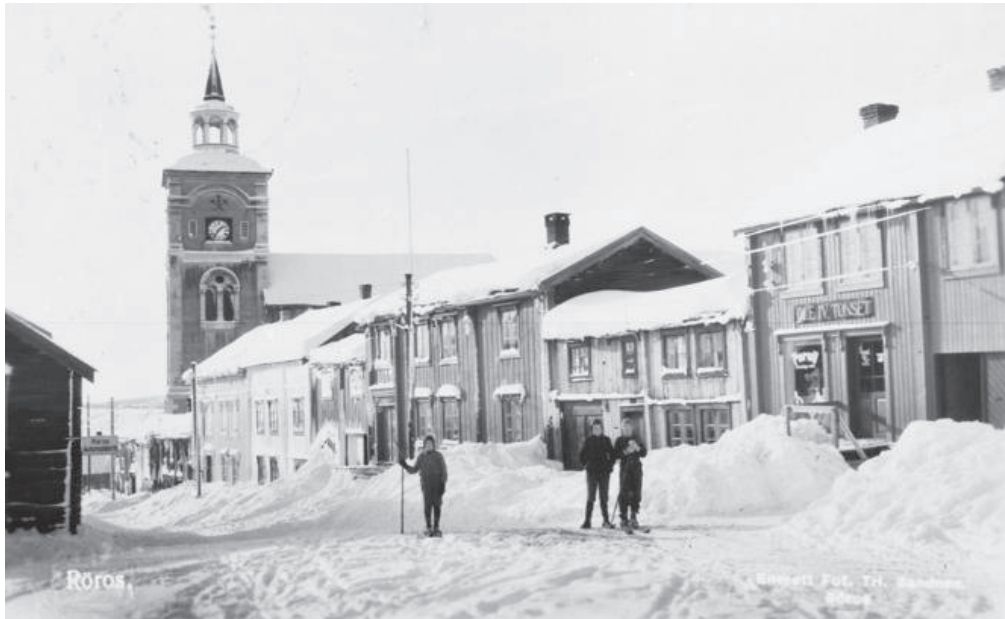
Figure 53: Solbergrekka, Kjerkgata 58 to the right with wooden front steps, which Vreim described as “tall free steps” in 1940. In 1948 a building permit was issued to close off the street gateway entrance in favour of larger shop premises. The photograph predates this façade alteration. (Photograph, undated ©Trøndelag Folkemuseum)

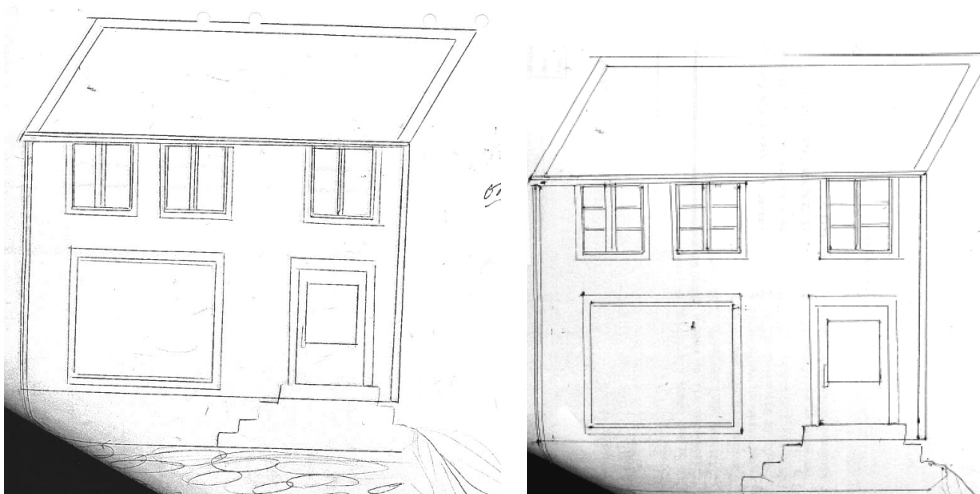
Figure 56-57: Kjerkgata 58, two alternatives for the upstairs windows in 1960. *Riksantikvaren* opted for the traditional design (right). (Røros municipal building archive)

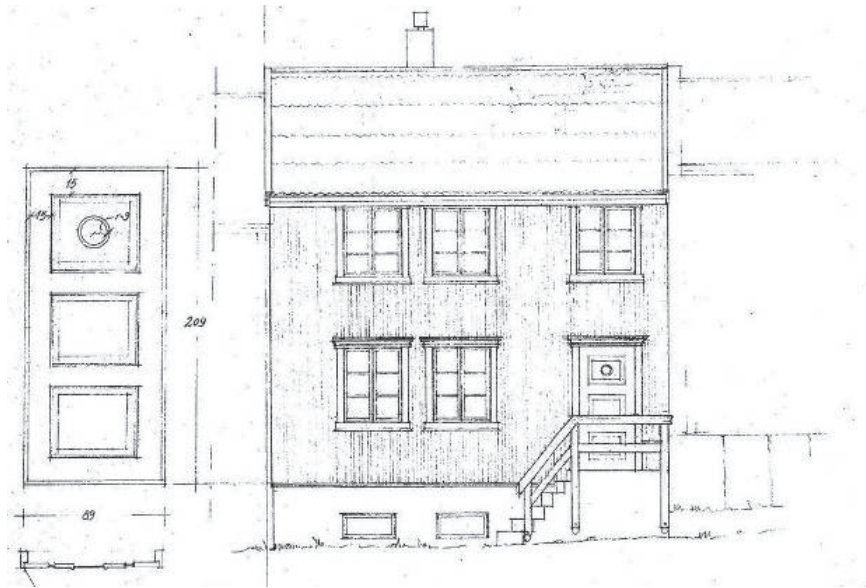
Figure 60: Design for the façade of Kjerkgata 58 by architect Seppo Heinonen, 1975, entrance door, original scale 1:20 (left) and street façade, original scale 1:50 (right). The design involved new windows and mouldings, a new entrance door and new steps and banister. (Riksantikvaren archive)

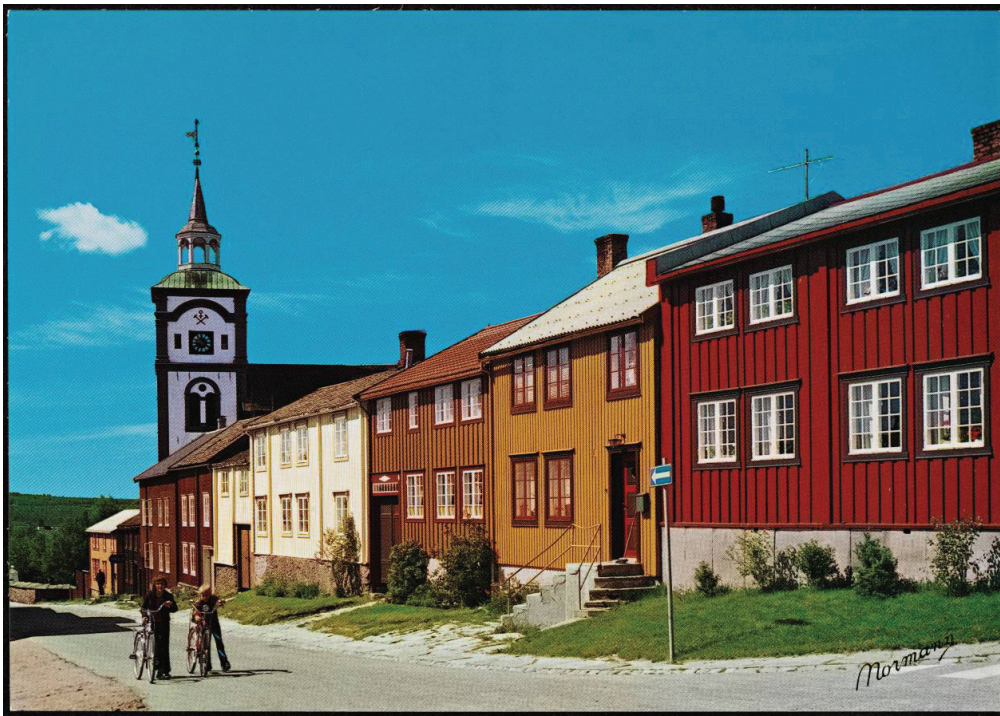
Figure 61: postcard from Røros, circa 1980? The façade of Kjerkgata 58 had been rebuilt according to Heinonen's design by this time (Photograph: Normann, postkort published by Normanns Kunstforlag, 1972/Owner: Nasjonalbiblioteket)

The conversion of the shop to an apartment, and thus the reversion or restoration of the building as a dwelling, was completed in the second half of the 1970s following a façade design by architect Seppo Heinonen [Figure 60]. The façade restoration was initiated by *Riksantikvaren* representatives and the committee for the European Architectural Year (*Komiteen for Arkitekturvernåret*). The architect’s stated intention was:

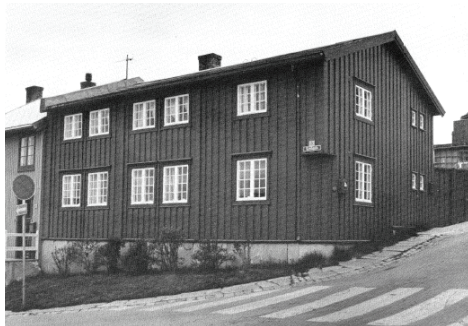
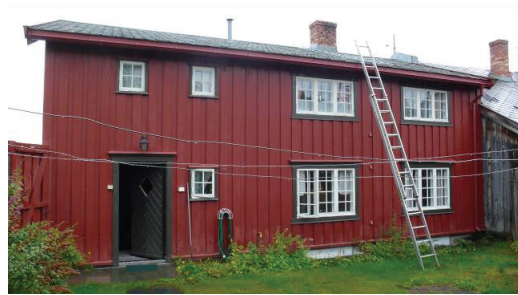
Figure 64-65: The street façade of Kjerkgata 60 as it was presented in the Riksantikvaren publication *Fredede hus og anlegg* in 1983 (left); courtyard façade (right). Photograph Anne Winterthun, Riksantikvaren, Riksantikvaren archive; MB 2007)

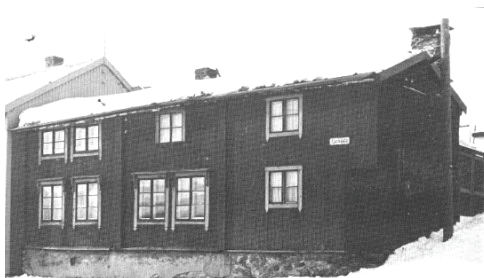
Figure 66-67: Kjerkgata 60, street façade (left) and courtyard façade (right) at the time of the 1954 modernization. These were the photographs Vreim requested Samordningsnemda to take in his letter of 11/2-1954. The façade had been rebuilt in two phases; the southern and centre sections between 1914 and 1924, the northern section after 1924; during the course of which the front entrance was removed, the walls clad with narrow boards and, out of the nine windows, seven changed to match the two larger windows on the ground floor of the southern section. (Photo by: unknown; Riksantikvaren archive)

The building was photographed again during the winter of 1954-1955 [Figure 66-67], from the street and the courtyard. This documentation reveals that the northern section by now had acquired cladding and new windows to match the rest of the building, the street façade now complete with the same type wooden cladding of narrow, phased (*avfaset*) boards and a total of nine similar type windows with Swiss Style mouldings (characterized by the clover motif and the saw-moulded consol carrying the water-board), rhythmically paired. All window mouldings were painted in a light contrasting colour, making them stand out clearly against the darker wall cladding. The photograph of the courtyard façade indicates that the windows here were of the same type. The street façade wall displayed vertical casings to indicate the underlying construction of three building sections, while the north end gable still seems to have exposed timber. Foundation walls were rendered, the saddle roof laid with sod or slag; with birch bark visible at the eaves. Two chimneys were visible, both on the courtyard side of the roof, the northern one in natural stone, and the southern one in brick. It is clearly visible that the façade wall of Kjerkgata 60 was not exactly aligned with its neighbour Kjerkgata 58 but set back by some 20-30 cm; it was also distinctly narrower and of lower height. Georg Eliassen made a survey of the building in 1945.<sup>152</sup>

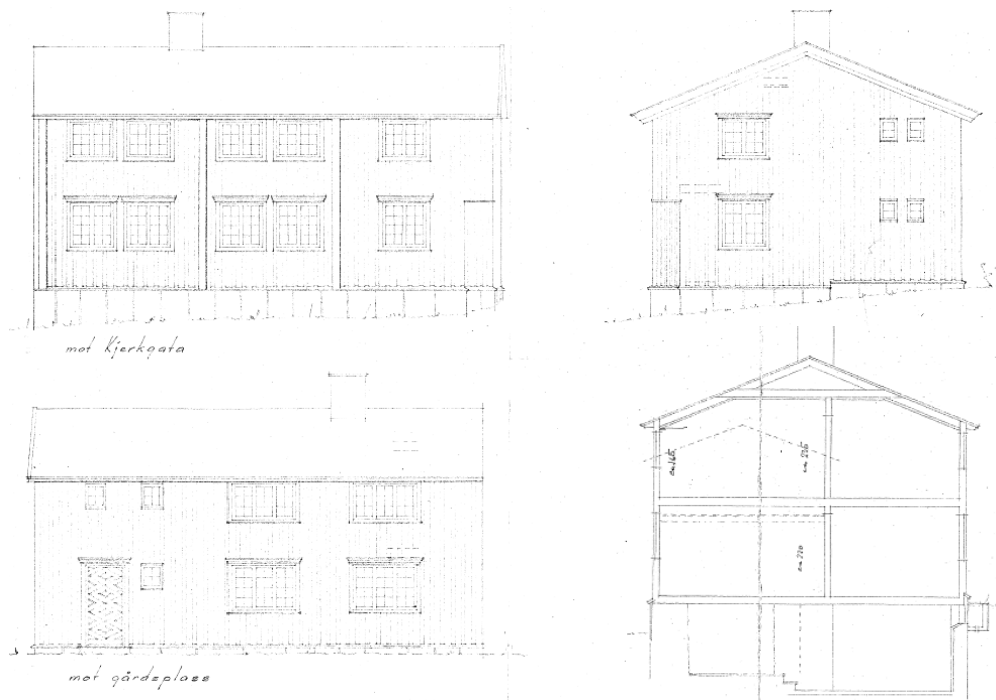
Figure 69-70: façade designs for Kjerkgata 60 (architect Stensaas referred to the plans as a “restoration” in his letter to *Riksantikvaren*): street façade (upper left) northern gable wall (upper right) courtyard façade (bottom left). Figure 70, the section (bottom right, inserted) showing the new house, and the outline of the old dwelling marked with dots. Architect Johan Stensaas 7/2-54. (Røros municipal building archive)

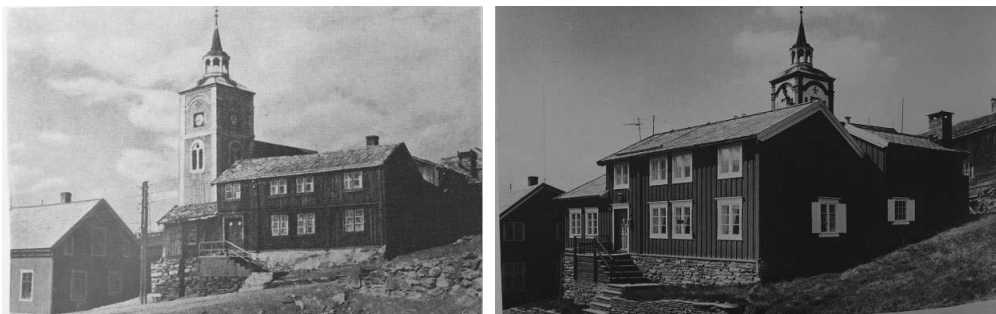
Figure 75-76: Mørkstugata 14 and 18 (Smed-Embretgården), before and after restoration of Mørkstugata 14, to the left in both photographs. This was listed in 1940 and demolished and replaced with a replica in 1952-53, by permission of the local building council. The cases of Mørkstugata 14 and Kjerkgata 54 gave rise to extensive correspondence between the local building authorities and *Riksantikvaren* on the management and treatment of listed buildings. Vreim called the new building 'an ugly and alien element in the Røros environment...', *Pleien av et bybillede*, 1944. Mørkstugata 18, centre-right in both photos, was according to *Fredede hus og anlegg*, restored and modernized according to plans by architect Erik Guldahl in 1956. (Photograph unknown ©Riksantikvaren)

The case here referred to was Mørkstugata 14 (*matrikkel* 49), a listed 18th century building which had been demolished in 1952 without DAB's knowledge.<sup>211</sup> [Figure 75-76] The building council later admitted having acted beyond their area of expertise in this case when reaching the following conclusion:

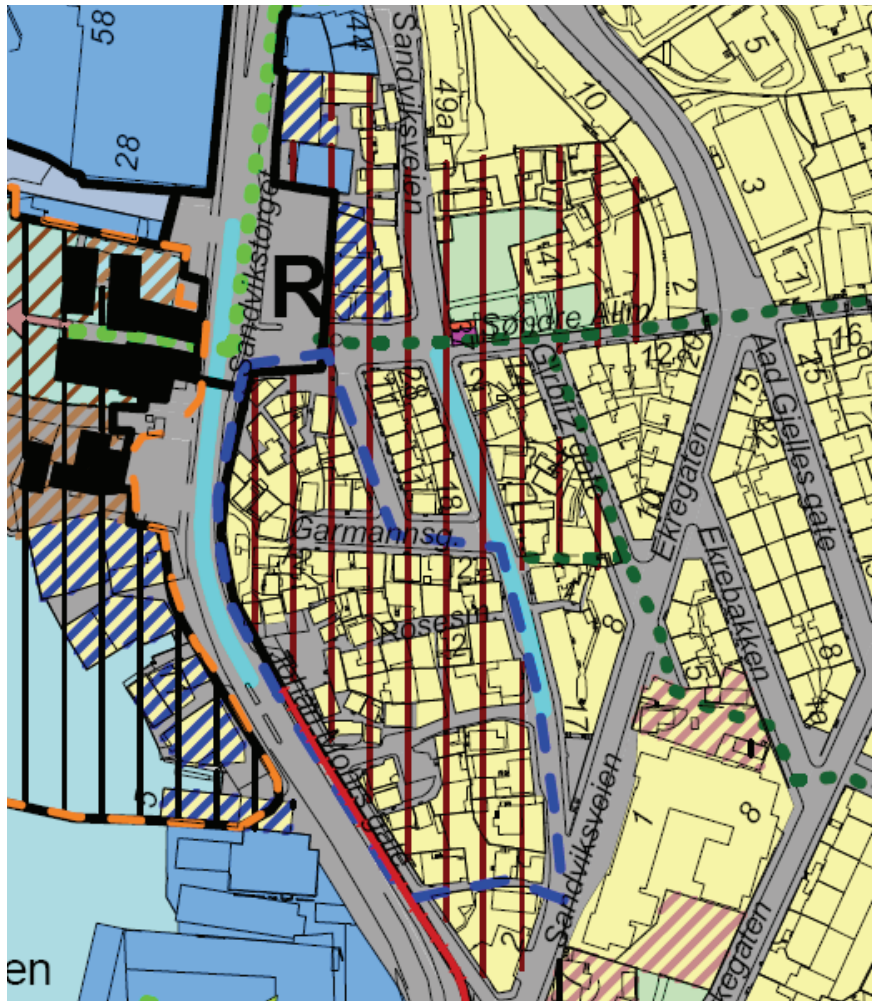
Figure 13: Area plan for Sandviken. Blue dotted line marks boundaries of the Fjæregrenden/Rosesmuggrenden conservation area, where the guidelines from 1958 are still valid. Horizontal stripes indicate a larger conservation area under § 25.6, 1978 Planning and Building Act, also incorporated in the area plan. (Bergen municipality)

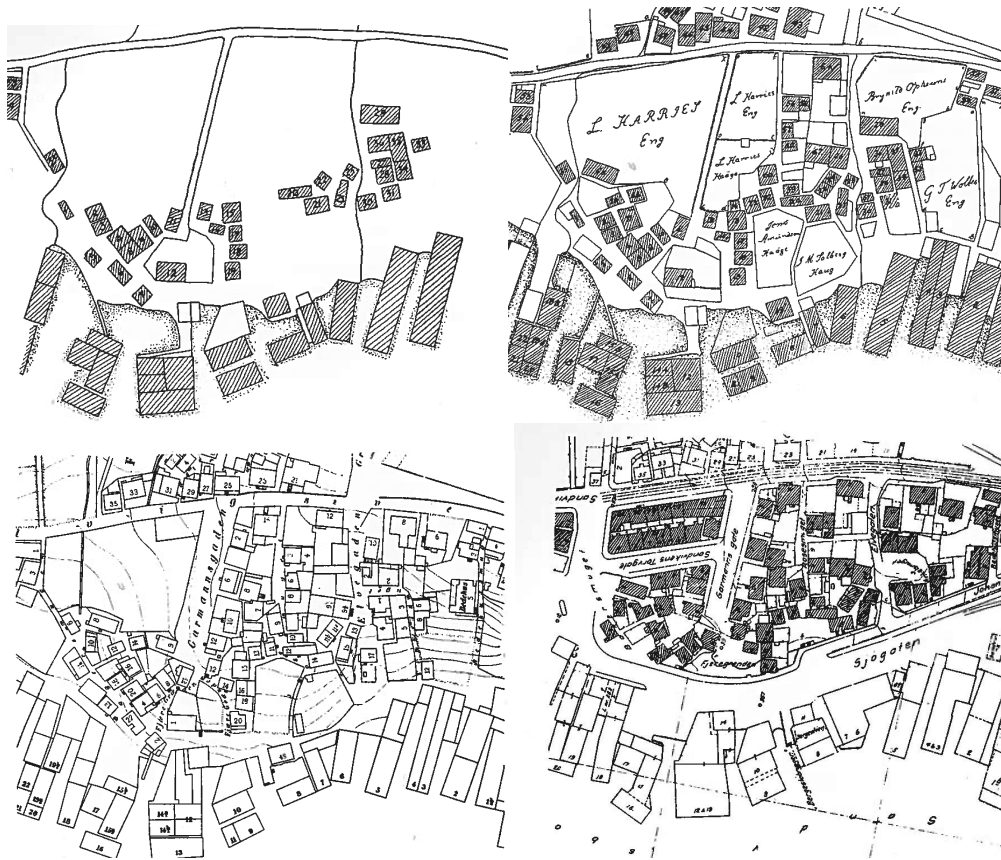
Figure 14-17: Fjæregrenden and Rosegrenden, historic area development: the 1760s (top left), 1819 (top right, detail of Aad Gjelles' map of Sandviken) and 1879 (bottom left) "Detail of the city map of 1879". The street which by 1879 had been planned and named Garmannsgate had been established as a thoroughfare in 1760. Elvegaten was established when the stream (*elv*) which previously ran here was piped. Rosesmuggrenden in 1956 (bottom right). Historically, buildings in Sandviken ranged from shoreline storage buildings, workers' housing and rope factories to fine country houses; a combination which according to Bjerknæs made Sandviken unique. "All in all one can say that in the whole country there is no match for Sandviken" Kristian Bjerknæs declared in 1955.<sup>97</sup> All maps published in Gamle Bergen Årbok, 1956. (©Gamle Bergen Museum)

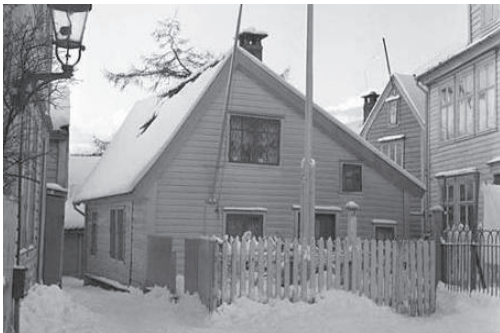
Figure 22-23. Left: Rosesmuget 9 Photograph Gustav Brosing 1959. Right: ground floor plan. (Photograph G. Brosing, UBB Billedsamling; unknown, Bergen municipal building archive)

The roof is asymmetrical, an indication that the house was rebuilt and extended; judging by the two juxtaposed cross-bar windows in the gable in Brosing's photograph from the 1950s this may have been done sometime during the late 19<sup>th</sup> century. These windows were later replaced with a single window without mullions. The ground floor today consists of two

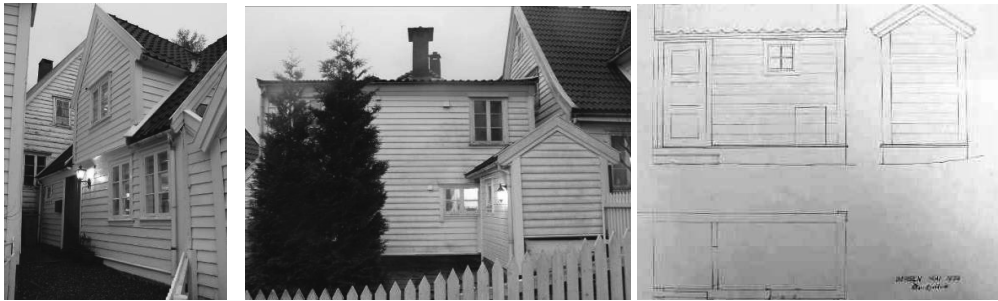
Figure 26-28: Fjæregrenden 16 façade from Fjæregrenden (left); and garden (centre); shed (right) designed by architect Olav Hjellevik, May 1959 original scale 1:20. (Photograph MB 2007; Gamle Bergen Museum archive)

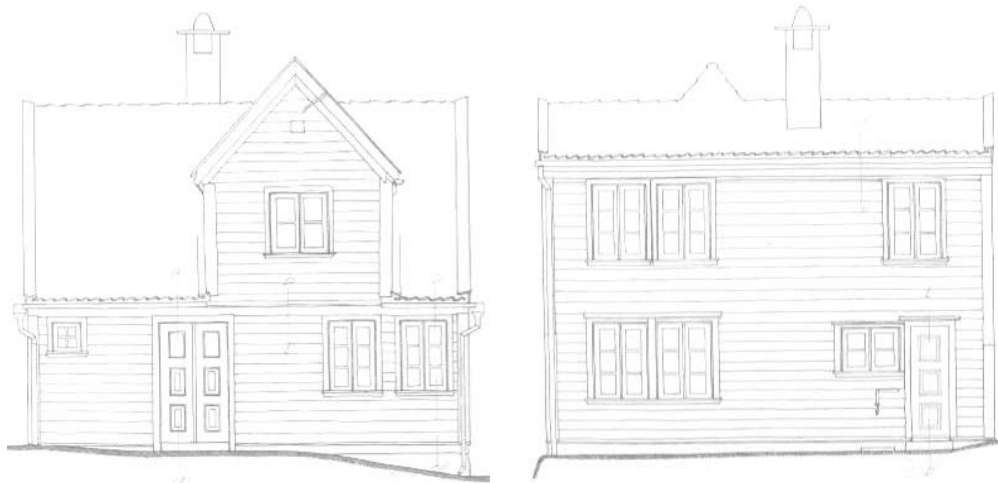
Figure 29-30: Fjæregrenden 16, north façade facing Fjæregrenden (left); south “garden façade” (right). Original scale 1:50, Gamle Bergen November 1943. (Gamle Bergen Museum archives)

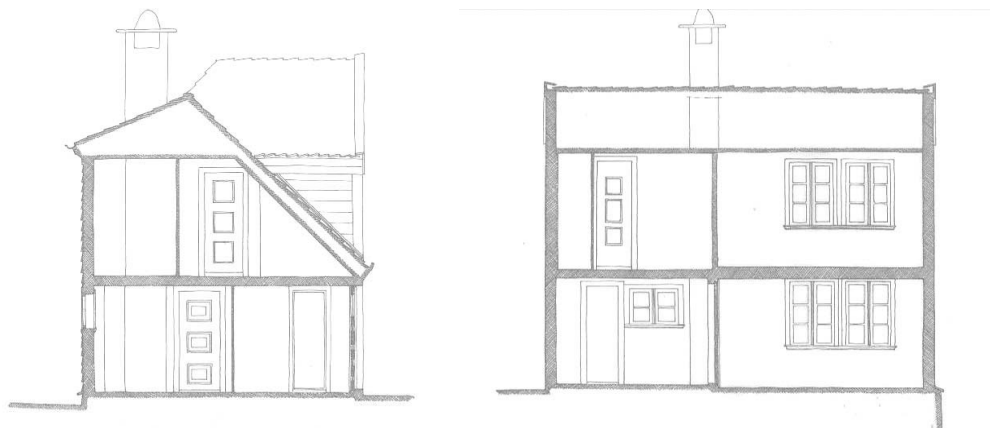
Figure 35-36: Fjæregrenden 16, section B-B (left) and A-A (right), Original scale 1:50. November 1943. (Gamle Bergen Museum archives)

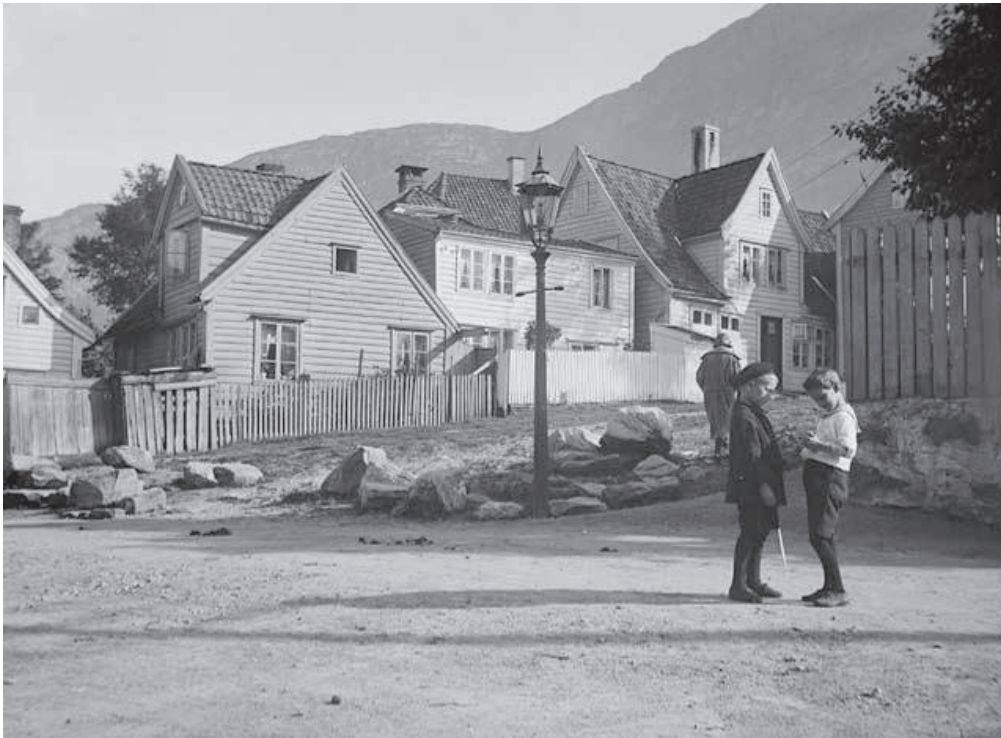
Figure 41. Rosesmuggrenden before Sjøgaten's expansion. From the left Fjæregrenden 20 (only partly in view; demolished), Fjæregrenden 18, Fjæregrenden 16 and Rosesmuget 15.(UBB Billedsamling)

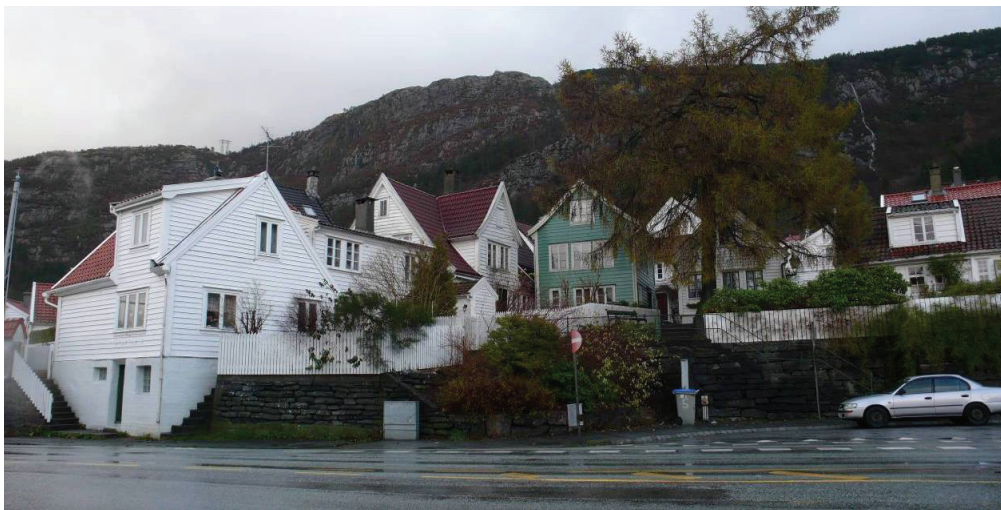
Figure 42. Rosesmuggrenden. Fjæregrenden 18 to the left. Its neighbour Fjæregrenden 20 was demolished with the extension of Sjøgate, leaving the west façade exposed to the street. New tall concrete foundations and steps were constructed to negotiate the difference in height. The arched dormer was reconstructed, the Empire Style windows replaced with a type associated with functionalism. All these alterations were performed before 1953, and before the municipal guidelines of the “conservation plan” were adopted. (Photograph MB 2005).

changed in 1953, two in the west façade and one in the gable. The windows which were replaced were, judging from the type, only 20 years of age. The owner described them as “completely rotted”.<sup>106</sup> The tall concrete foundation wall was constructed when Sjøgata was widened. With the exception of a plan for installing a shower which was approved in 1966<sup>107</sup>, no modifications to Fjæregrenden 18 are recorded to have been done *after* the municipal guidelines were ratified in 1958. The modifications of Fjæregrenden 18 were done at a time when the conservation area was in an early planning phase, exemplifying the type of modernizations the guidelines were intended to prevent.

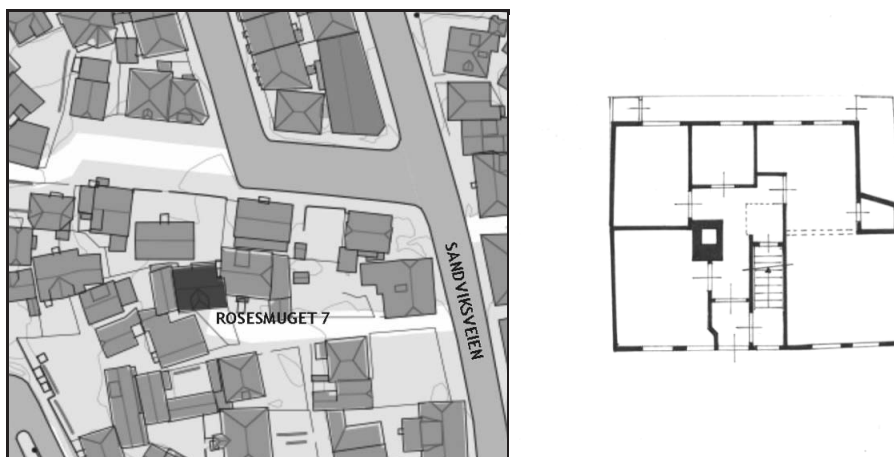
Figure 43-44: Rosesmuget 7 site plan (left) and floor plan (right), (August Schmidt 2010)

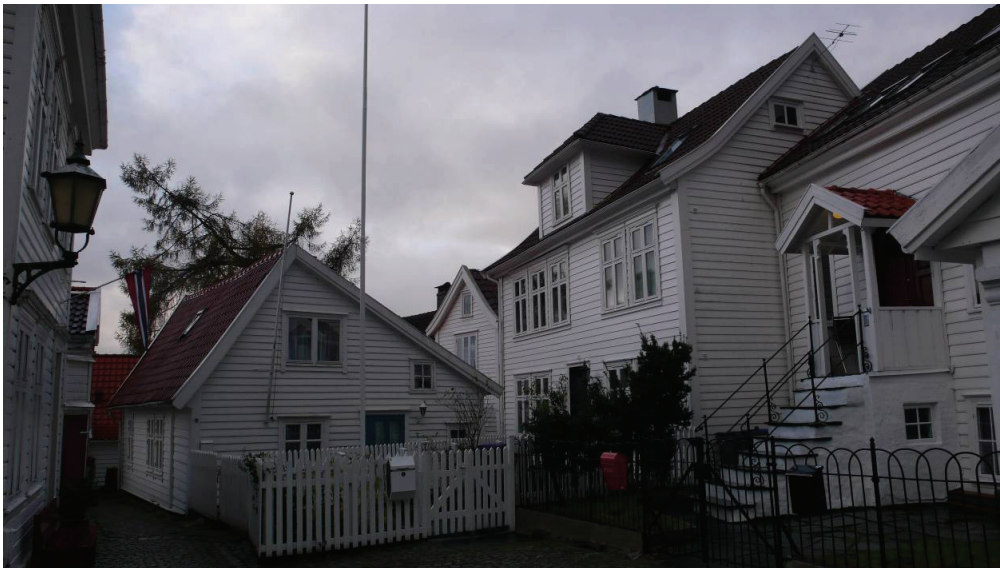
Figure 52: Rosesmuggrenden 9 (left), 7 (centre right) and Garmannsgate 8 (right). Rosesmuggrenden 7 underwent a comprehensive rehabilitation in 1987 which involved a complete renewal of the interior and transformed the building from a 19<sup>th</sup> century apartment building to a two-apartment building conforming to 1987 building standards. The red tile roof was replaced with a black concrete tiles of the brand “H-panne”. The main timber construction was preserved. Façade cladding and mouldings were renewed. The original windows had already been replaced with modified copies in 1978. (Photograph MB 2005)

The planned interior changes were not commented on by *Kulturavdelingen* except with regards to the conversion of the loft area, which was considered acceptable as long as no alterations to the roof or arch were made.<sup>113</sup> [Figure 46, 48, 50-52]. Building materials and rehabilitation methods are described in some detail in the specification from the contractor.<sup>114</sup> A range of modern materials were introduced with the rehabilitation of Rosesmuget 7.

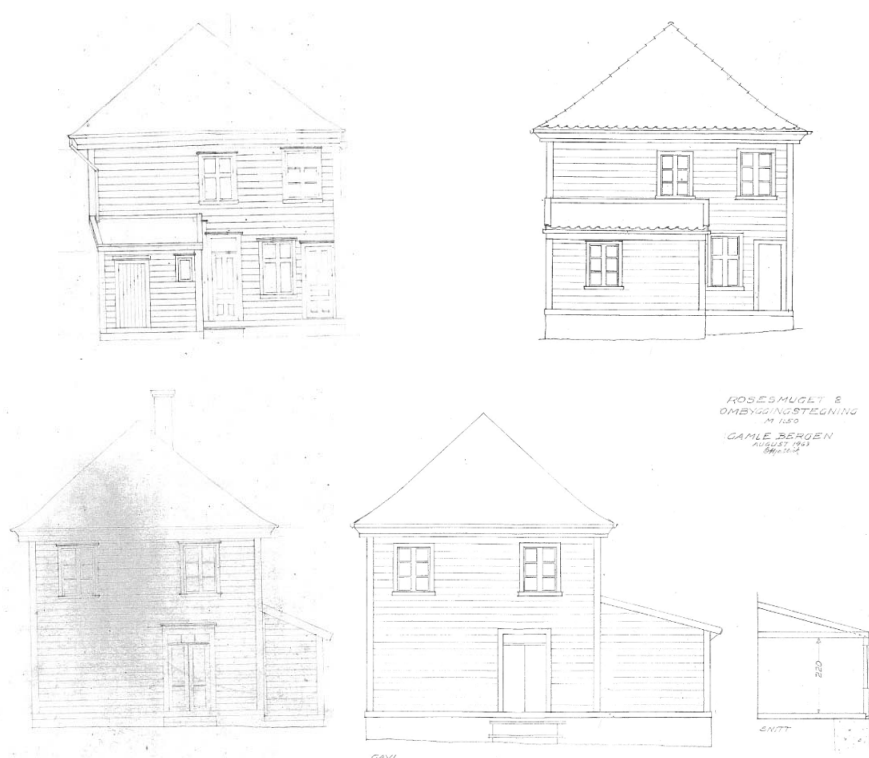
Figure 53: Rosesmuget 2. *Grenderådet* gave advice and helped design conversions and additions in Rosesmuggrenden conservation area. Rosesmuget 2, survey (left) and plan for addition/conversion of shed (right). Olav Hjellevik, Gamle Bergen Museum, august 1963. Original scale 1:50. (Gamle Bergen Museum archives)

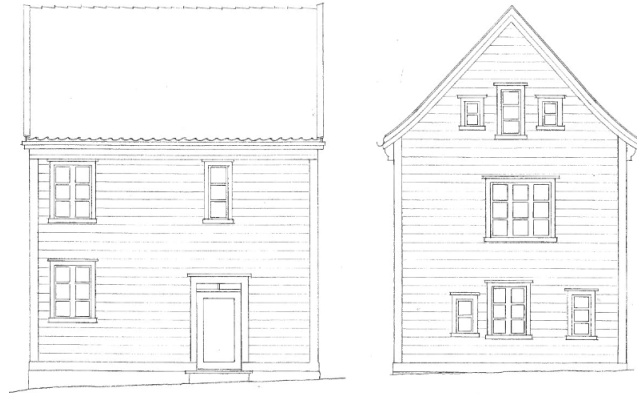
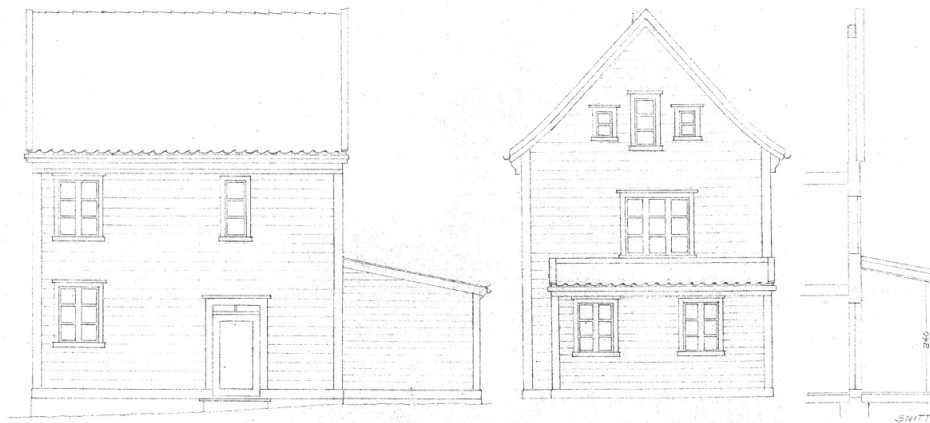
OPPMÅLINGSTEGNING FOR ROSESMUGET 13 M. 1:50

Figure 54: Rosesmuget 13. Survey (top) and façade design (centre) and plan (bottom) for conversion/addition for bathroom/W.C. and an extra bedroom. Olav Hjellevik, Gamle Bergen Museum, april 1960. Original scale 1:50. (Gamle Bergen Museum archives)

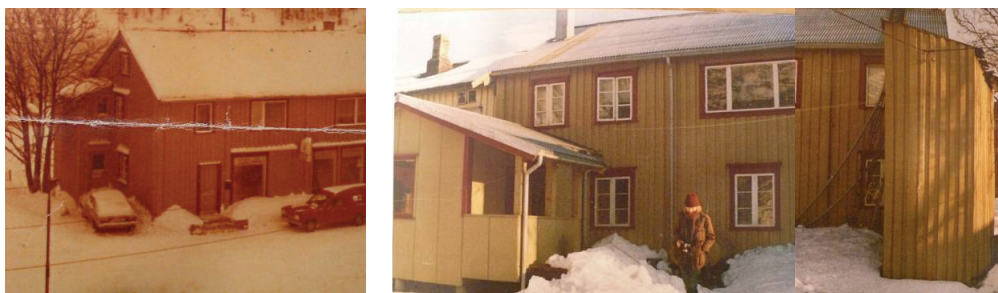
Figure 15-16: Sjøgata 41 in 1977, street and courtyard façades as they were in the 1960s and 1970s. The building still had some of its older windows intact; in the right hand photo an upstairs window is slightly open, showing that it was hinged on the mullion. In the photo: architect Dag Nilsen. (Vefsn municipal building archive)

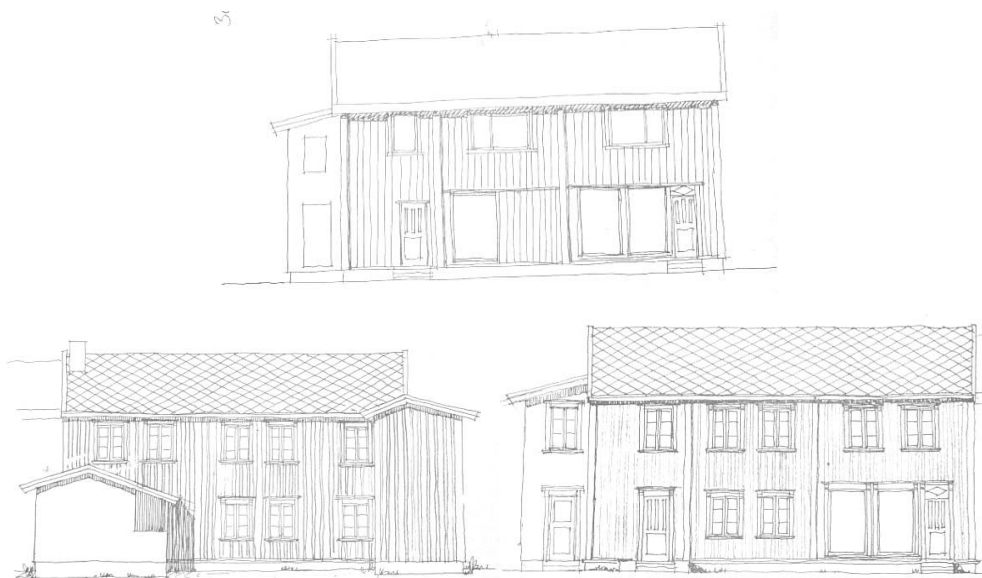
Figure 23-25: Sjøgata 41, survey of street façade 30.8.1977 (top); restoration plan for the backyard façade 29.3.78 (left) and street façade (right) by Bjørn Grimsby Arkitekt M.N.A.L in 1978. The restoration was based on a 1905 photograph and building parts in the façade which had not been altered during the 1960s modernization; (Vefsn municipal building archive)

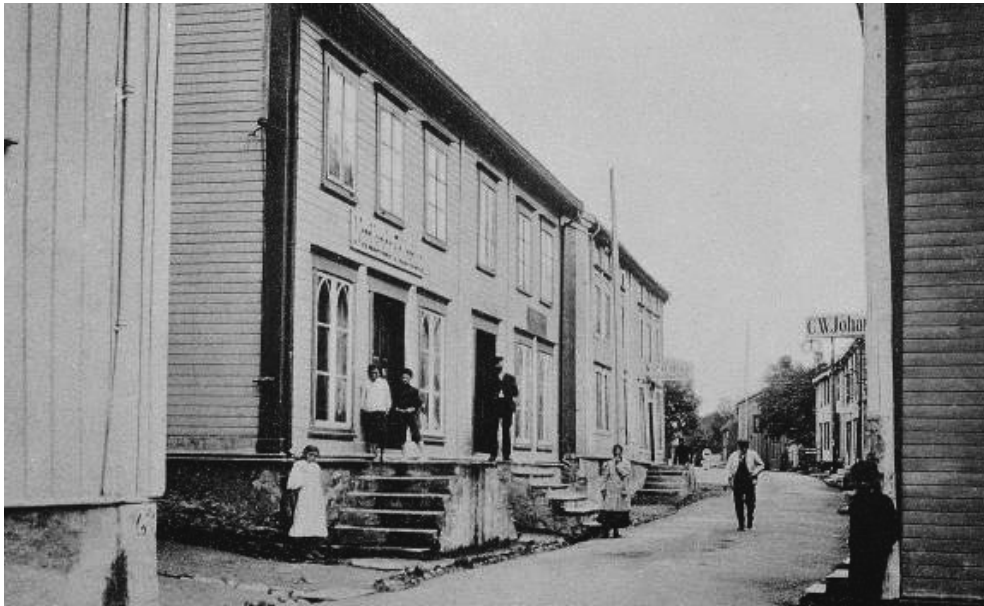
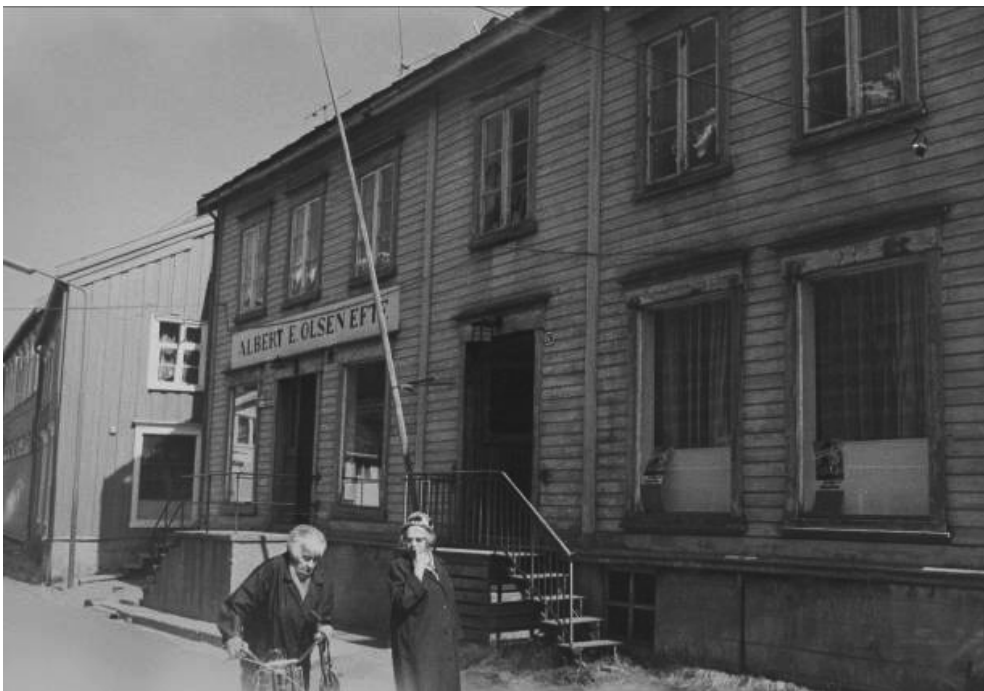
Figure 33-34: Sjøgata 26 circa 1910 (top) and 1968 (bottom). In the time interval between these photographs the shop front windows and staircases of number 26 were altered, and the neighbouring building (number 28, to the right of 26 on top photo) was demolished (before 1961<sup>85</sup>), the plot seized as parking space and never rebuilt. (Photographs Vefsn museum archive)

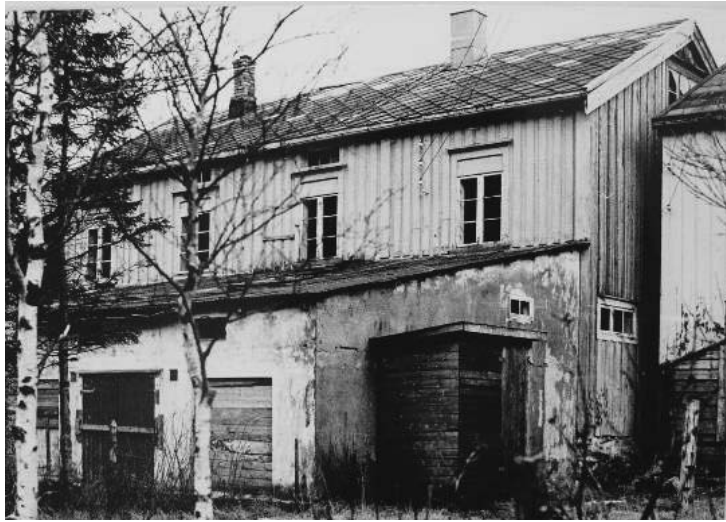
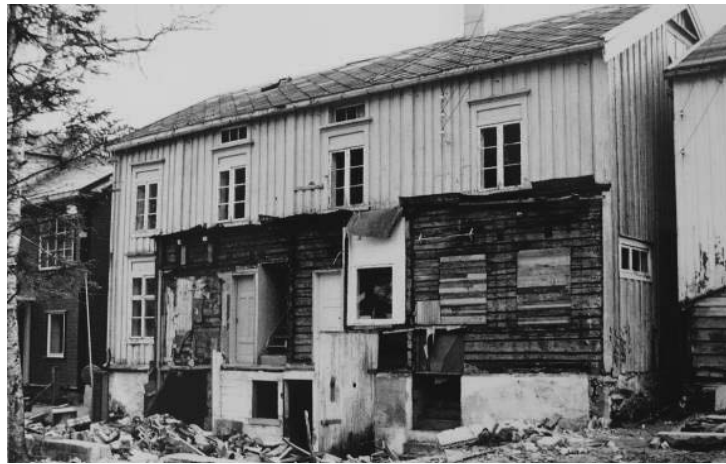
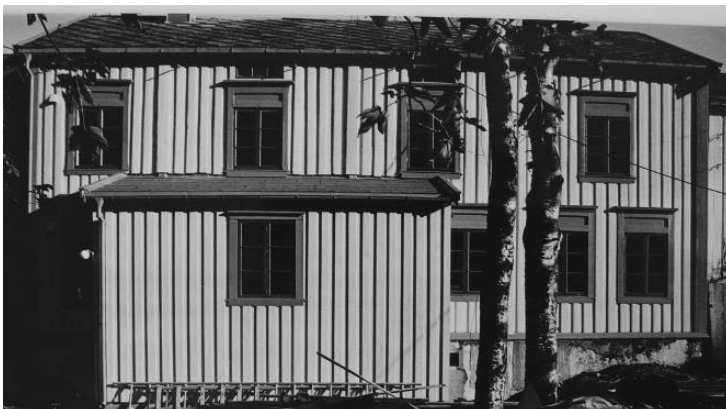
Figure 55-57: Sjøgata 37, backyard façade before regeneration (top); backyard façade after the secondary addition was removed (middle); new backyard addition in place (bottom). (Photographs: Dag Nilsen, Dag Nilsen private archive)
