**Geological, geomorphological and  
geophysical investigations of areas  
prone to clay slides: Examples  
from Buvika, Mid Norway**

Thesis for the degree philosophiae doctor

Trondheim, May 2007

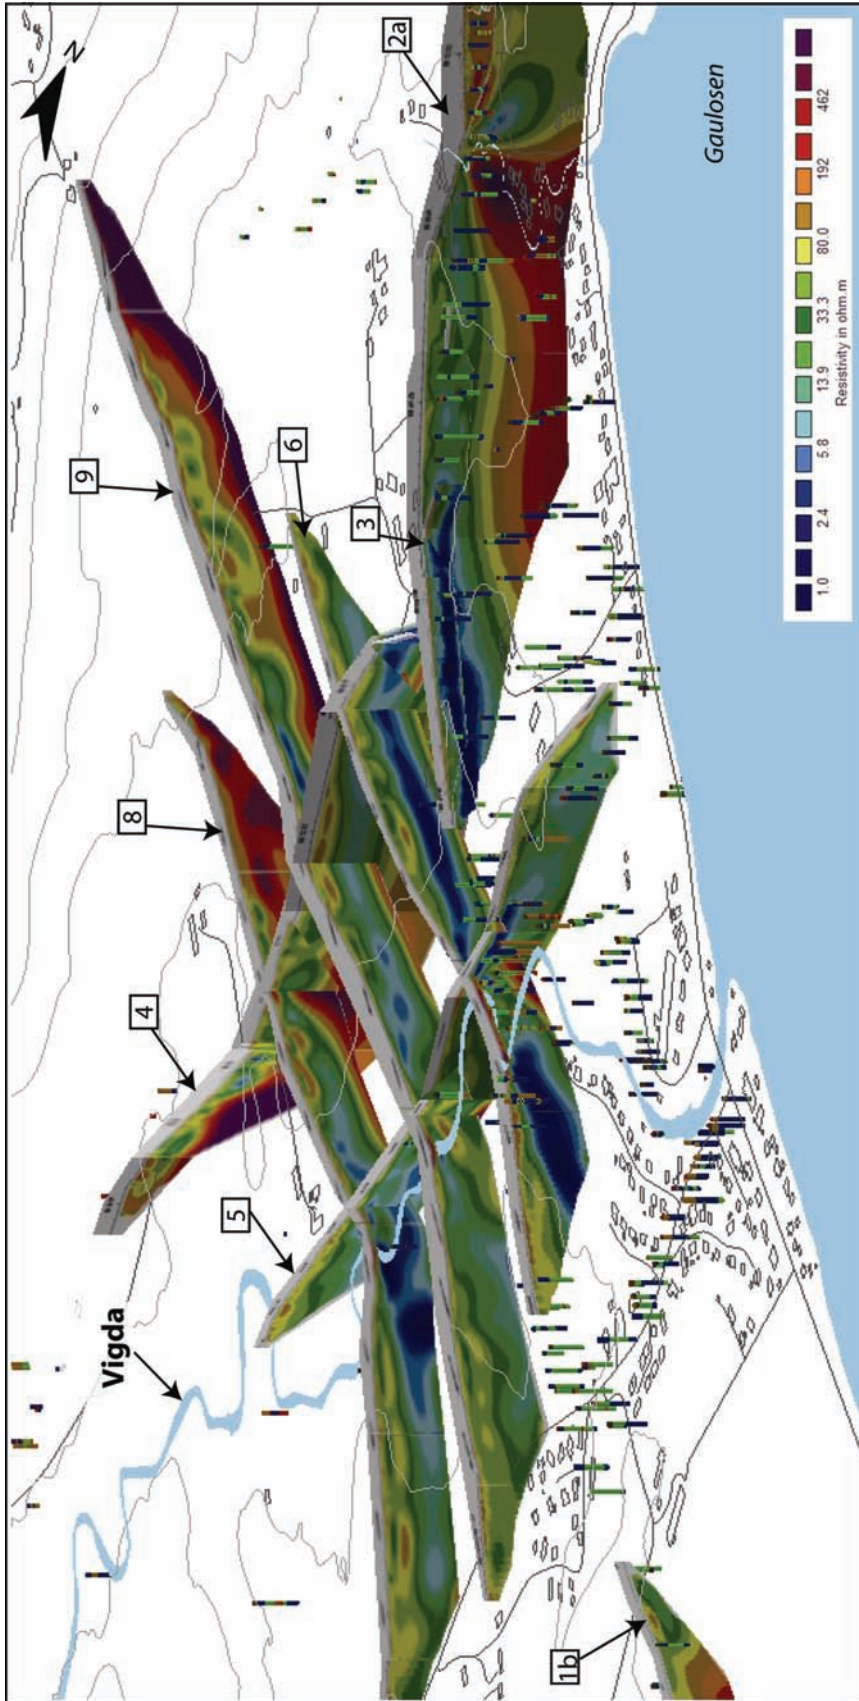
**Fig. 12.** Resistivity profiles visualised in ArcScene together with some interpreted geotechnical drilling profiles for comparison of the two methods (Data from Dalsegg *et al.* 2006 and Enclosure 3). For more on profile locations, see paper IV.

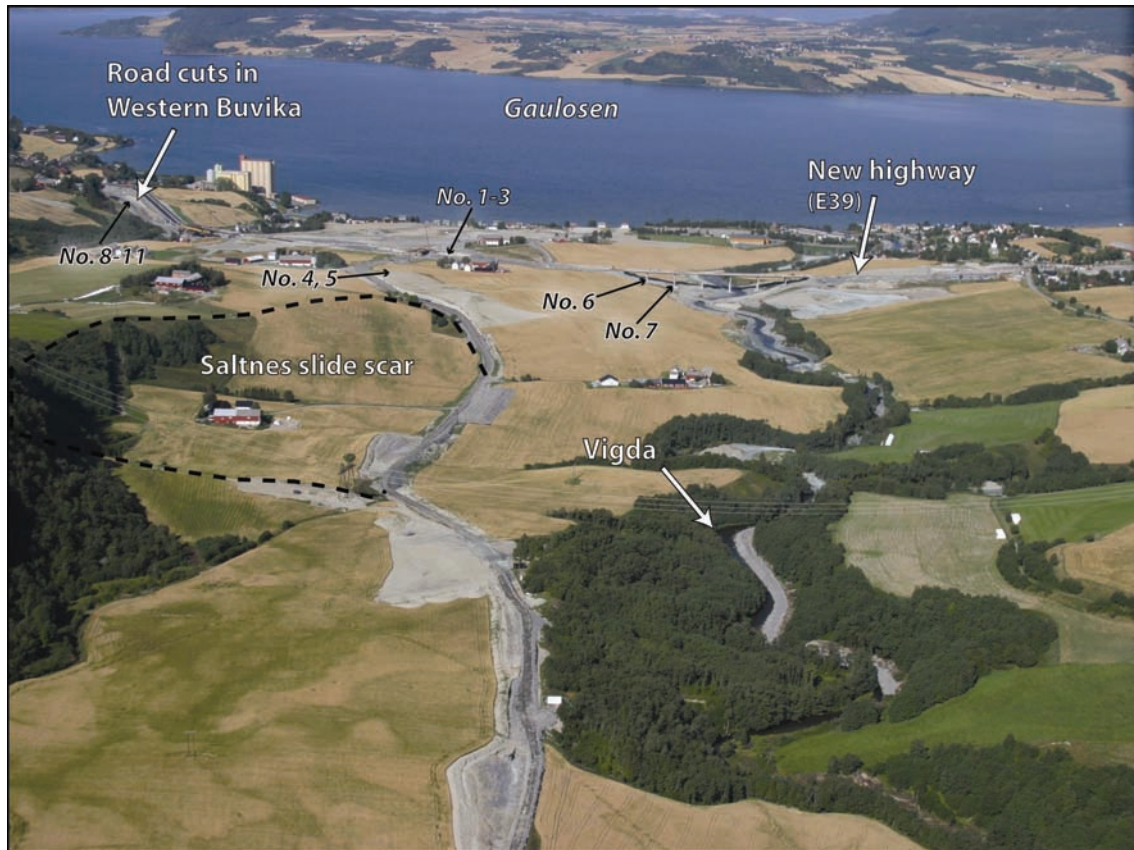
Fig. 2. Buvika seen towards the north. See Table 1 for  $^{14}\text{C}$ -ages from samples 1-11 (Photo: the Norwegian Water Resources and Energy Directorate, NVE).

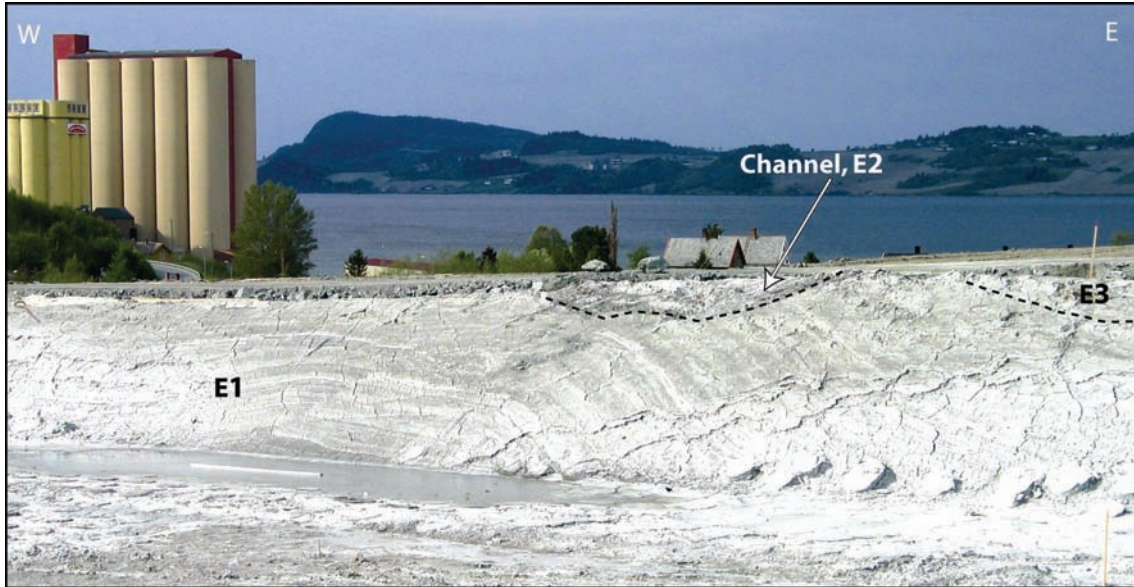
**Fig. 9** Large fold and a fault in laminated clay (Unit E1), filled channel (Unit E2) and traces of a slide scar filled with clay from cropland levelling (Unit E3) in Section E. Weathering of the exposures allows for the identification of the structures.

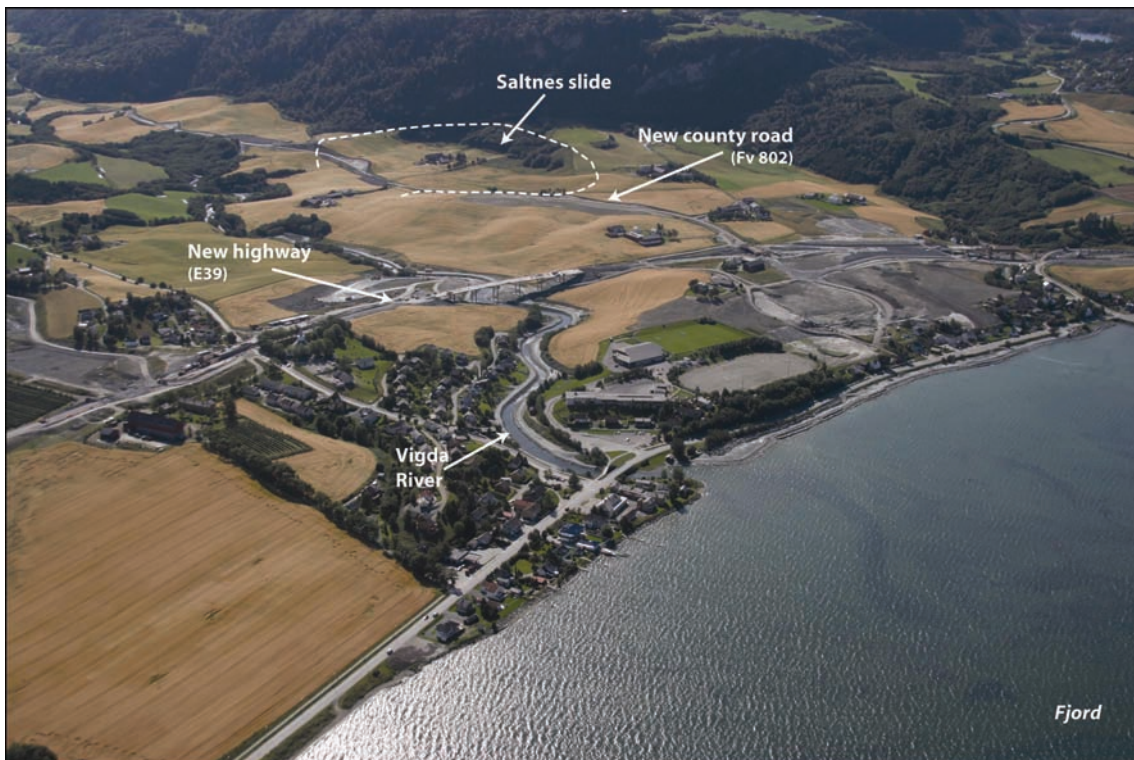
**Fig. 2.** Buvika during construction of highway E39. The photo is taken towards southwest (Photo: the Norwegian Water Resources and Energy Directorate, NVE).

Buvika is located in Skaun municipality, in Sør-Trøndelag County, Central Norway (Figs. 1, 2), about 25 km southwest of the city of Trondheim. Buvika is a small fjord-valley system surrounded by 300 to 400 m high bedrock hills, and is characterised by its undulating terrain with numerous ravines and slide scars.

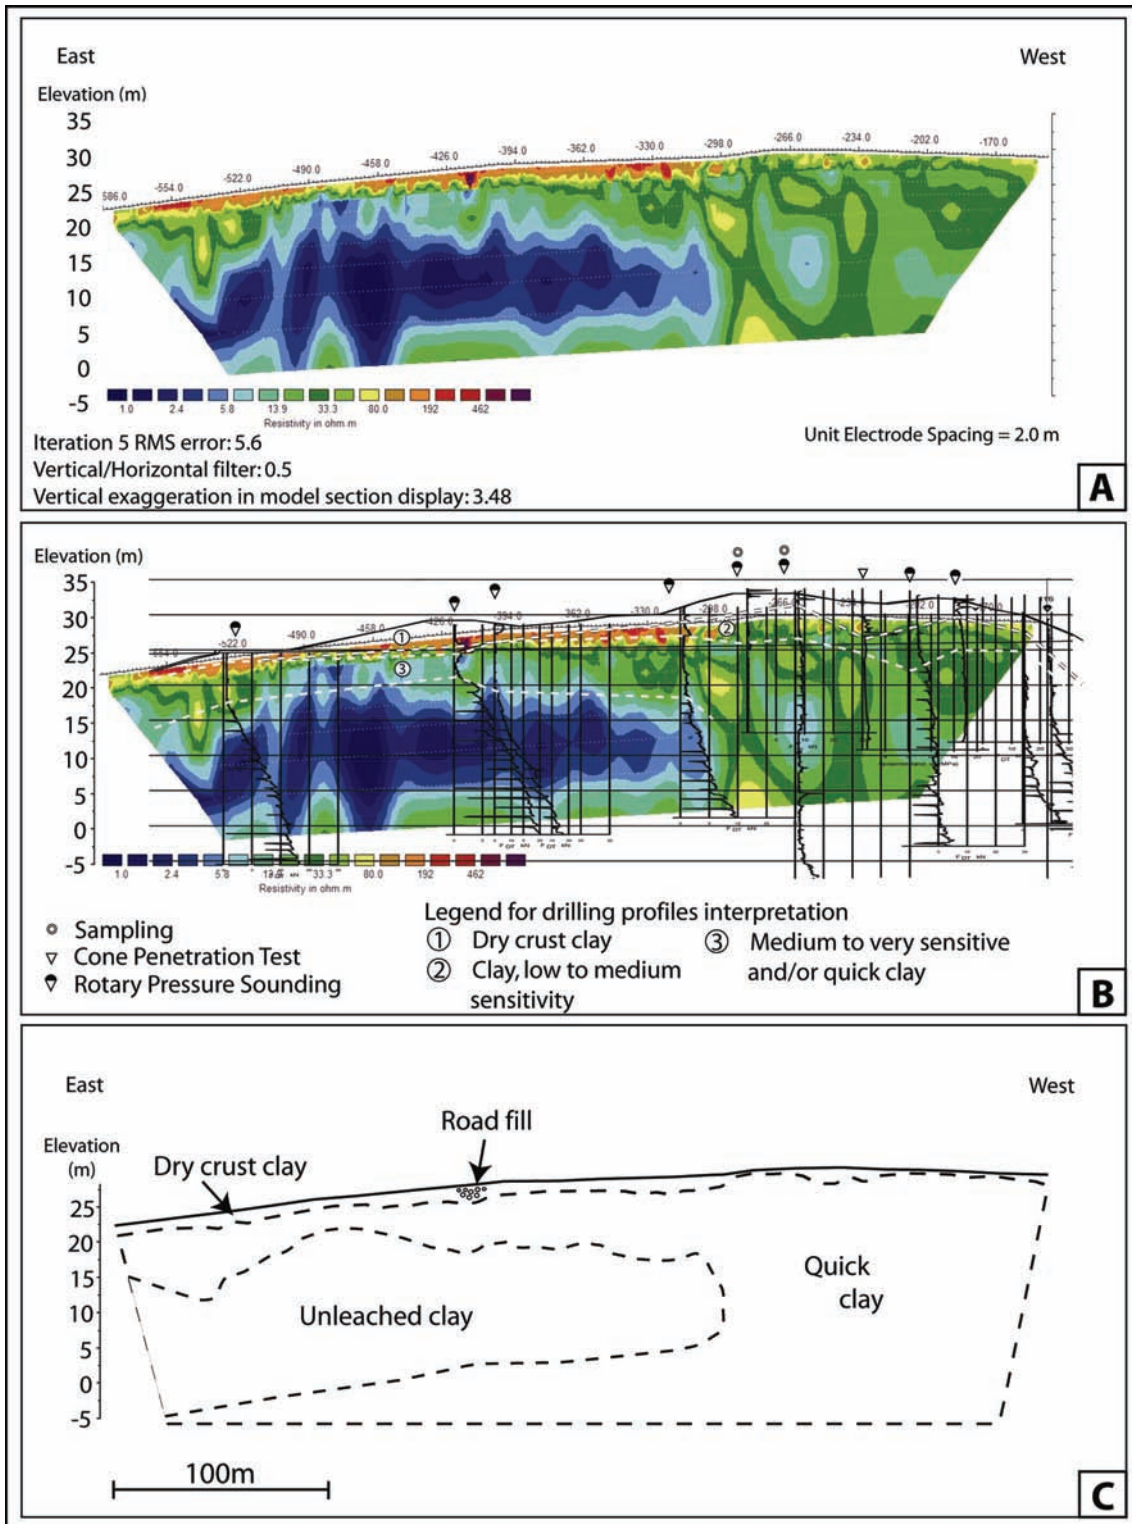
**Fig. 6.** Resistivity profile 3 (see Fig. 4 for location) (A), with geotechnical drilling profiles (drillings were carried out before surface sediment removal) (B), and interpretation (C). (Data from Berg and Hove 2001a; Engen and Jensen 2003; Dalsegg et al. 2006).

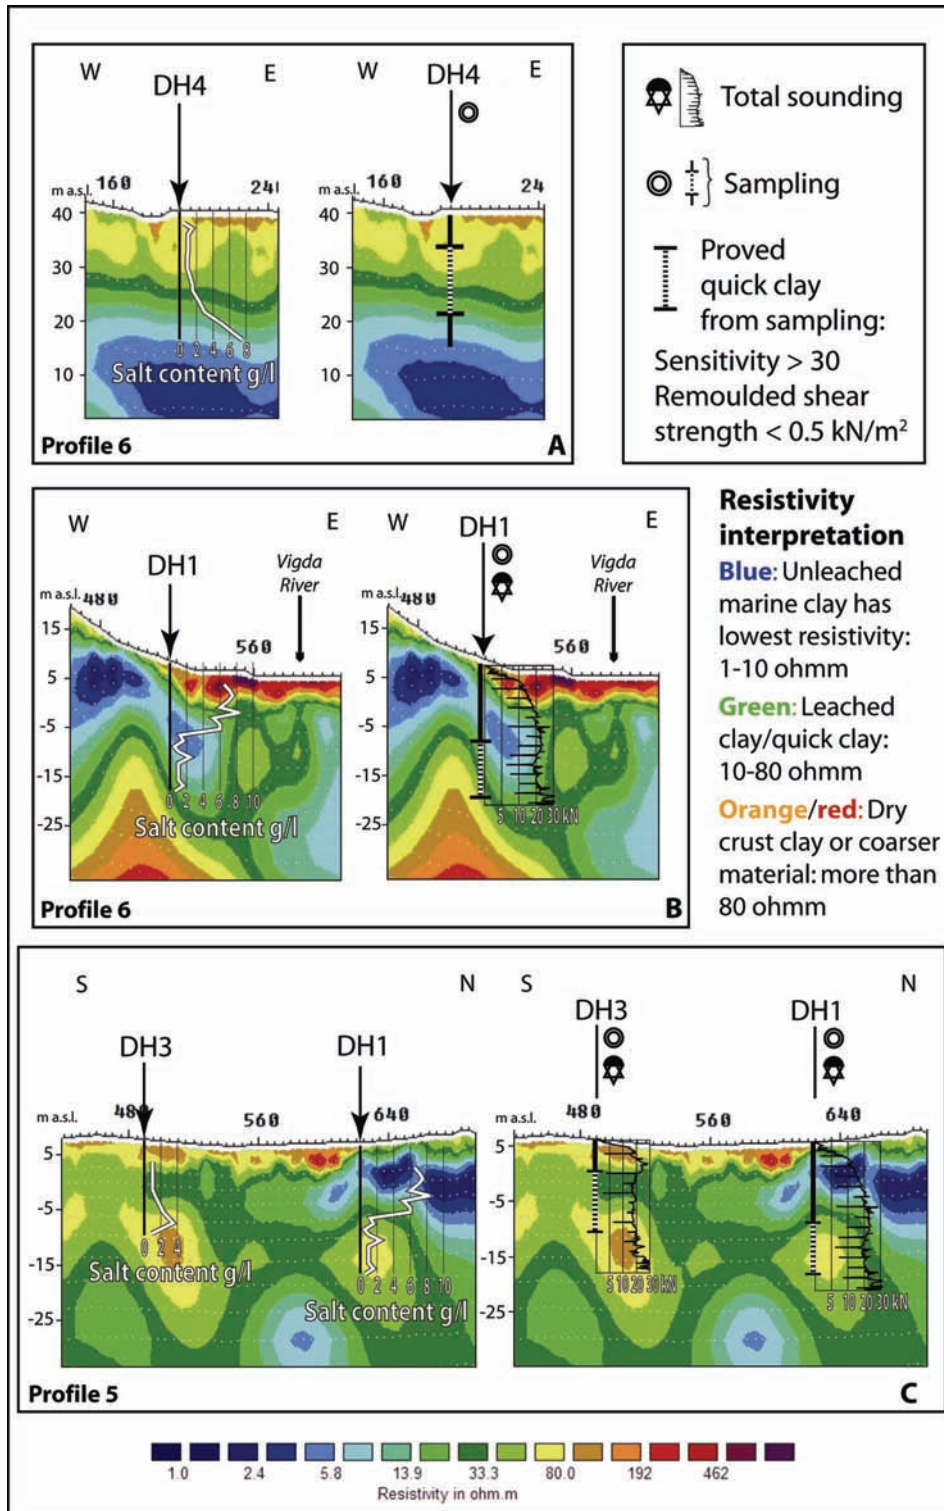
**Fig. 8.** Details on the resistivity profiles 5 and 6, total sounding, tested samples and pore water salt content (white curve) in drill holes DH1, DH3 and DH4. For drilling locations, see Fig. 4 (data from Helle 2004; Dalsegg et al. 2006).
