Runway Operability under Cold Weather Conditions

Tire-pavement friction creation by sand particles on iced pavements, and non-contacting detection of sand particles on pavements

NTNU
Norwegian University of
Science and Technology
Thesis for the degree of
philosophiae doctor
Faculty of Engineering Science and Technology
Department of Civil and Transport Engineering

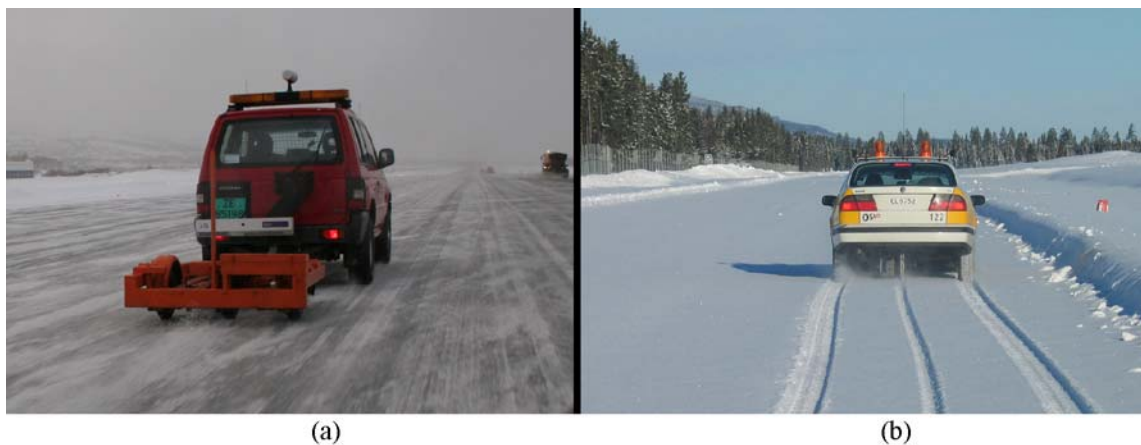
Figure 2-1. Two friction measurement devices used in Norway: (a) the Skiddometer BV-11 and (b) the Saab Friction Tester.

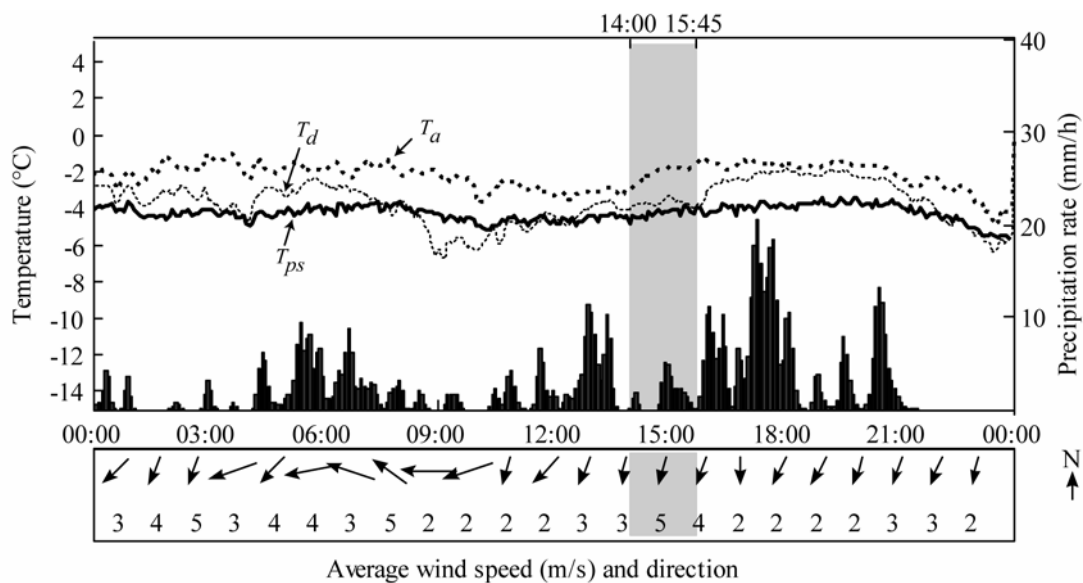
Figure 3-2. Example of a 24-hour meteogram.

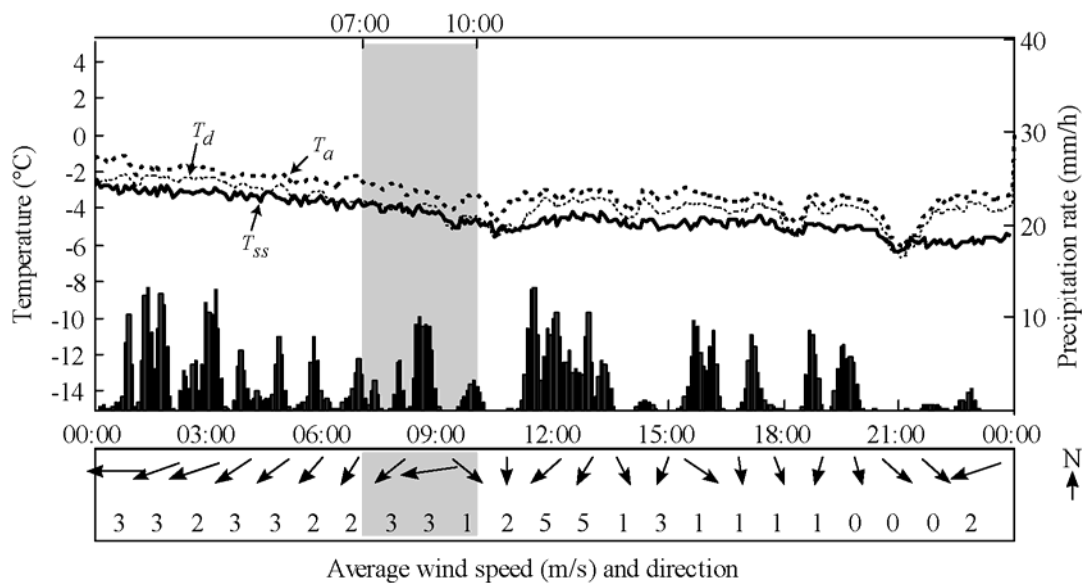
Figure 3-5. Meteorological data Tromsø Airport January 26, 2005.

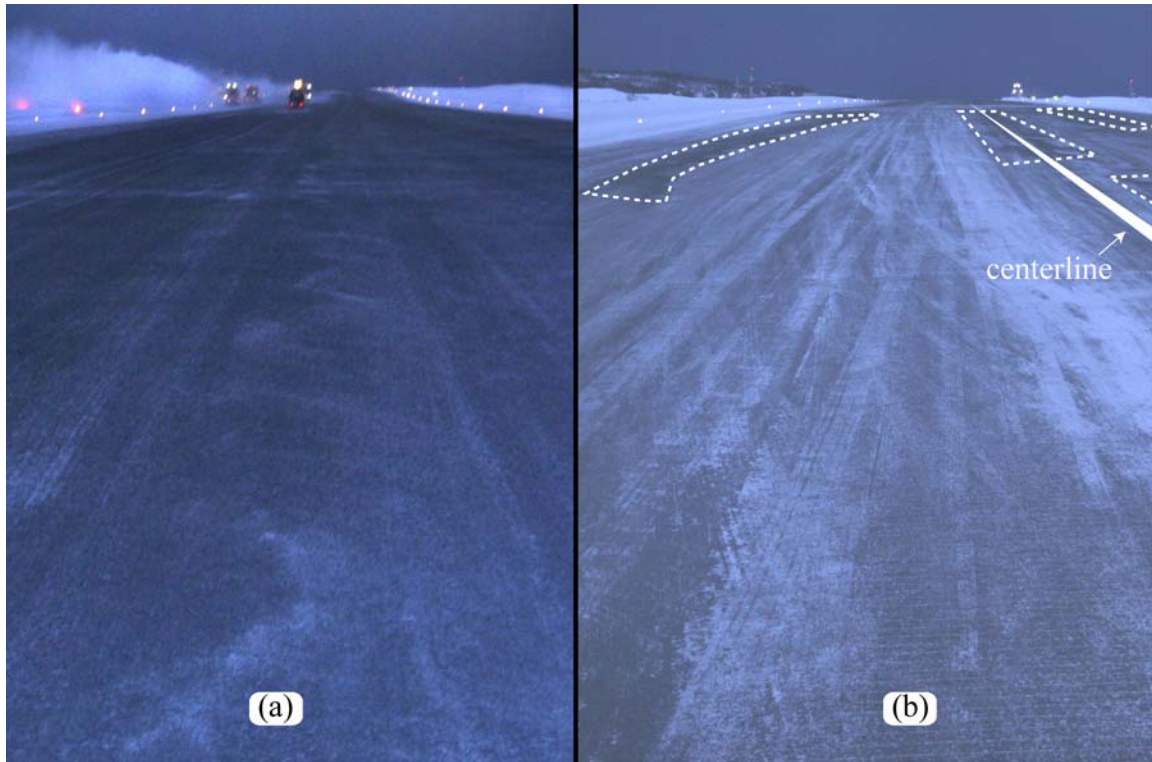
Figure 3-6. The runway surface conditions on January 26 (a) during friction measurements at 08:00 and (b) 11 minutes later, after three aircraft movements. The sand, initially uniformly distributed has been blown to the sides and towards the centreline. The regions with sand are indicated by dashed lines.

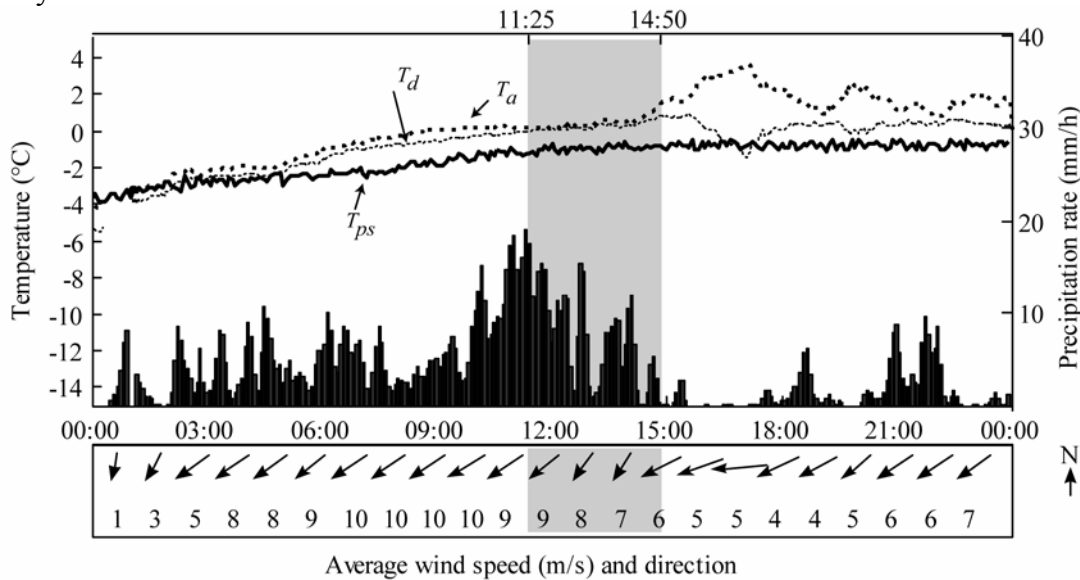
Figure 3-10. Meteorological data Tromsø Airport February 6, 2005.

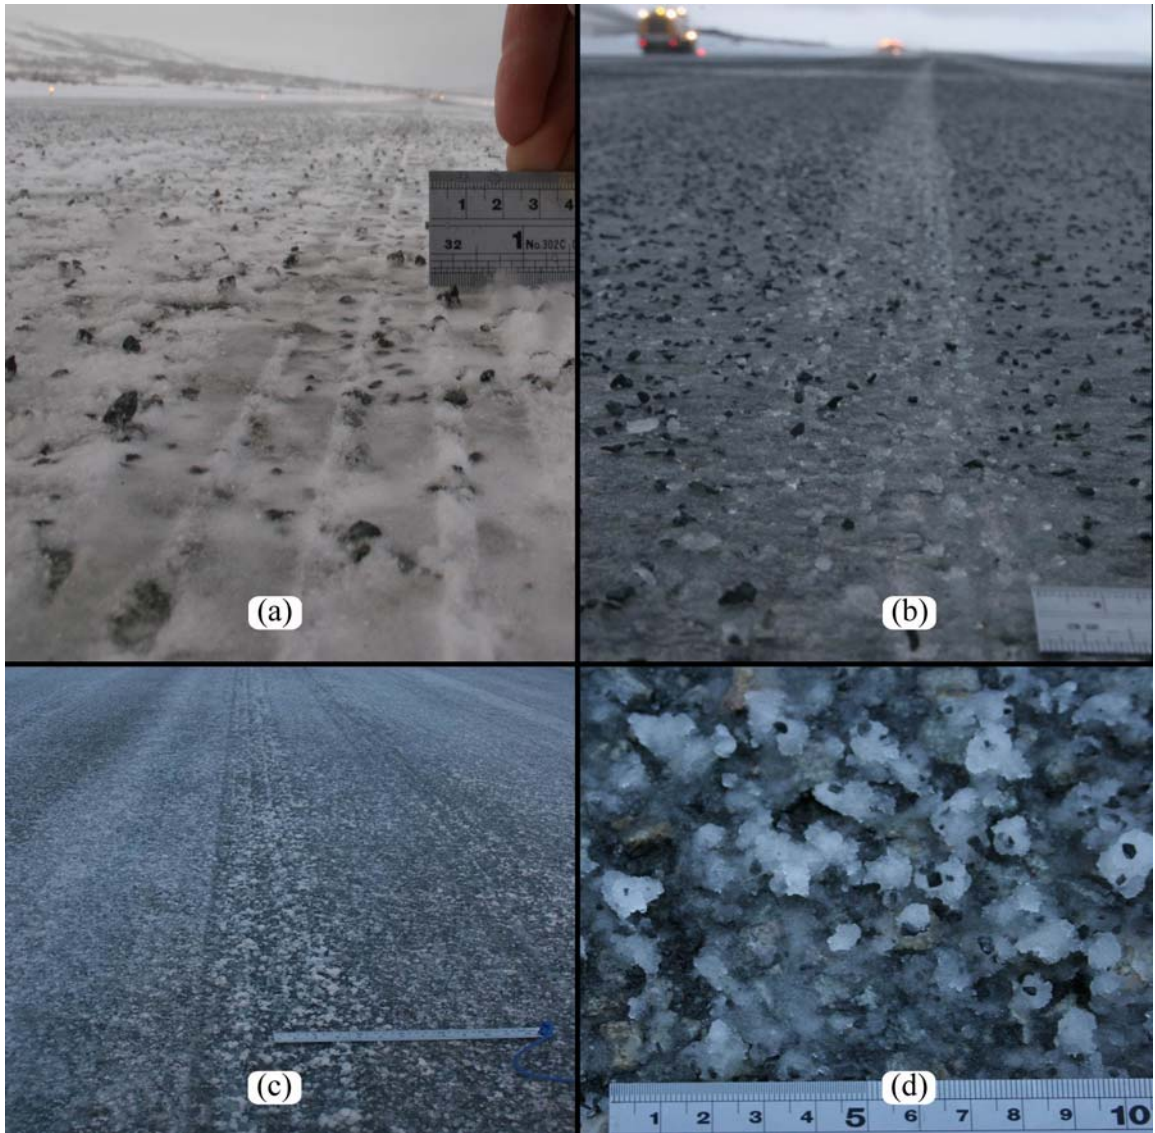
Figure 3-11. Tire tracks on the decaying contamination layer. (a) During the friction measurements at 11:42. The sand particles remained embedded in the track. (b) Friction measurement at 13:13. At this time, most particles broke loose together with ice fragments. (c) Fragmentation of the contamination layer by a landing Dash-8 at 13:21. (d) Detail of the fragmentation. Asphalt aggregates have become visible. Note that most fragmented pieces contain one or a few sand particles.

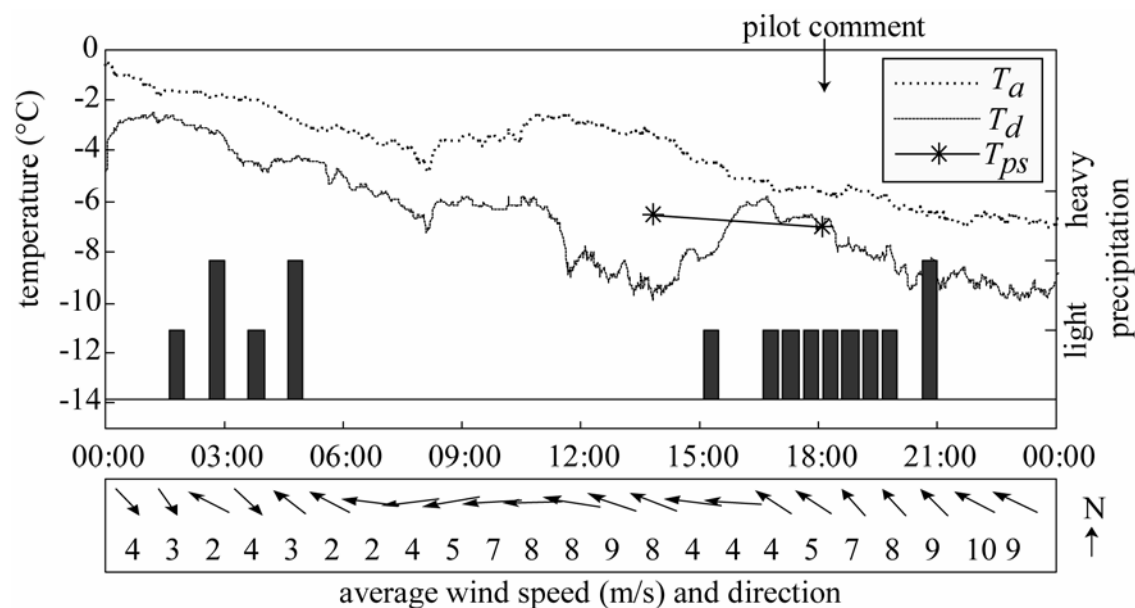
Figure 3-12. Meteorological data Kirkenes Airport February 24, 2005.

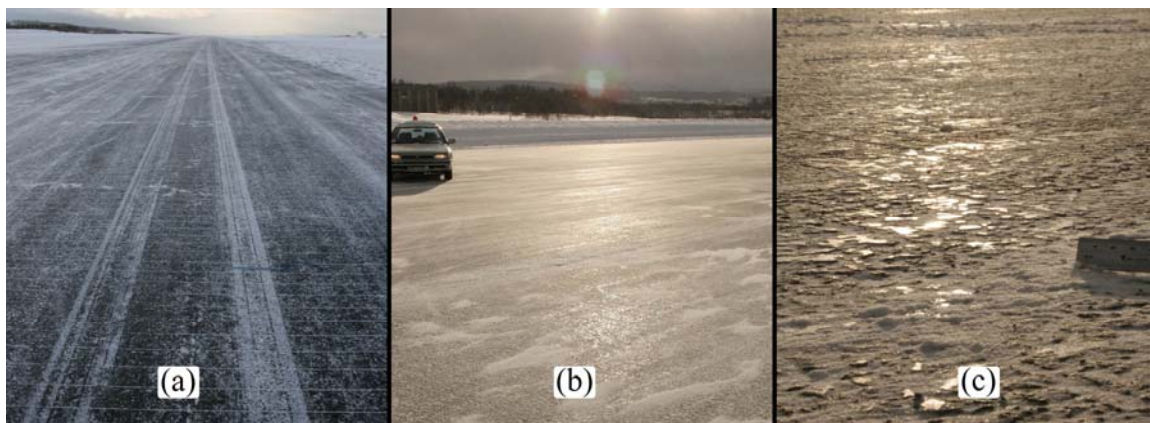
Figure 3-14. (a) Tracks of compacted snow resulted in spatial variability of the contamination. (b) The thin ice cover is visible by the reflected sunlight. (c) The asphalt texture is still visible and the top of the aggregates is covered with a thin layer of ice.

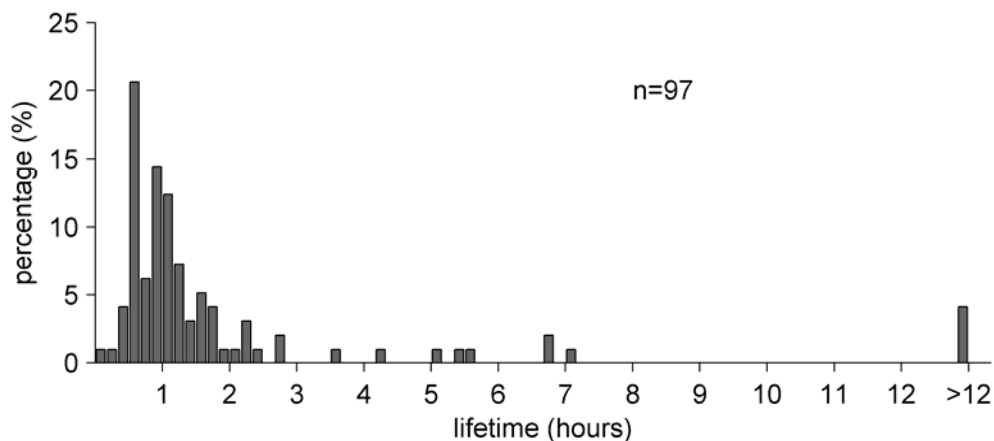
Figure 3-16. Distribution of report lifetime for runway status reports generated at Tromsø Airport between November 1, 2004 and March 31, 2005, when at least one runway section is described as “poor” or “unreliable”.

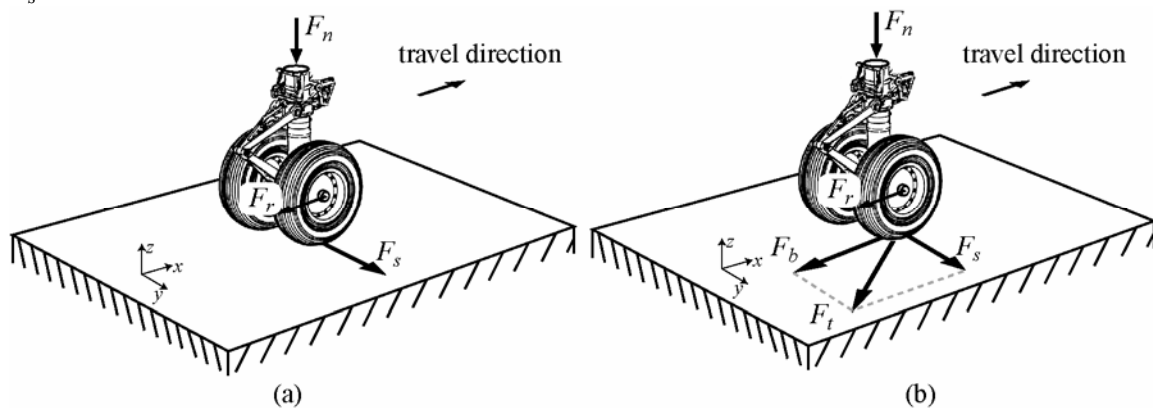
Figure 4-1 The main resistance forces acting on an aircraft tire: (a) during free-rolling, and (b) during braking.

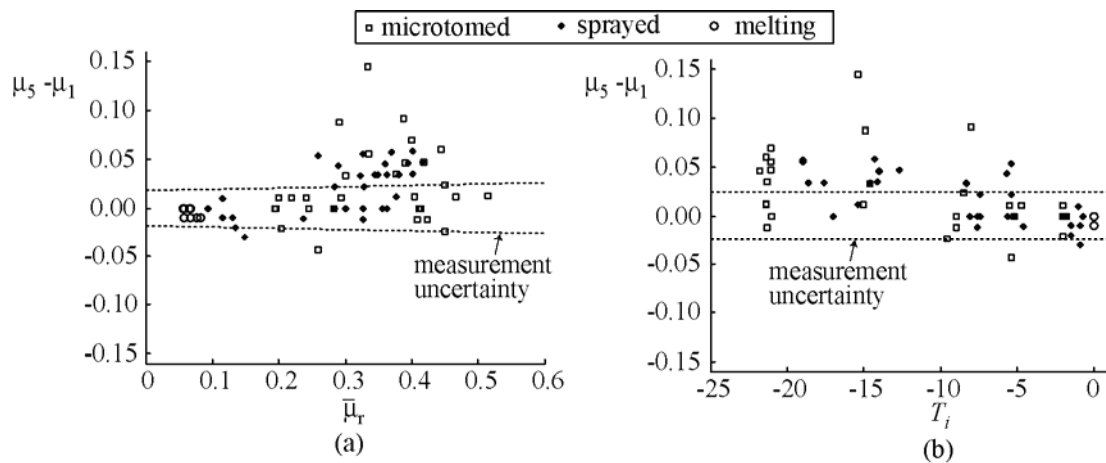
Figure 6-6. The difference between the last and the first measured friction coefficient in a run, plotted against (a) the run average friction coefficient and (b) the ice temperature.

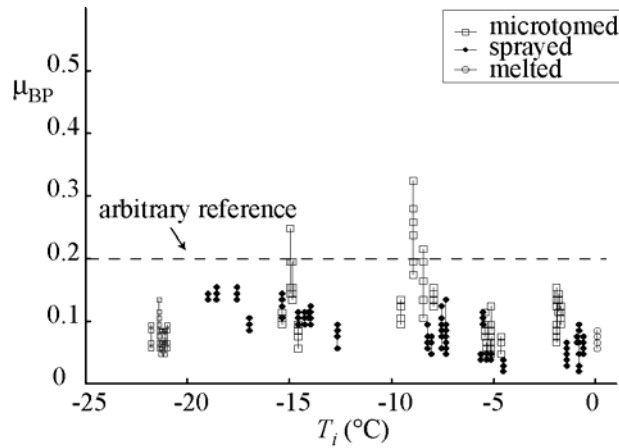
Figure 6-9. The friction coefficient versus ice temperature for rubber sliding on ice dusted with snow. Measurements of the same run are connected with vertical lines.

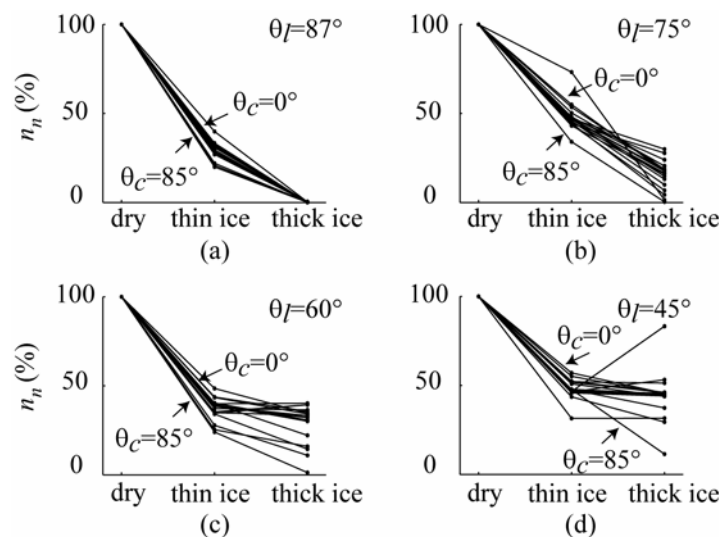
Figure 7-3. The normalized number of bright pixels for different surface conditions at four different laser angles: (a) $\theta_l = 87^\circ$, (b) $\theta_l = 75^\circ$, (c) $\theta_l = 60^\circ$, and (d) $\theta_l = 45^\circ$. Each graph shows the recordings at all camera angles ranging between 0° and 85° .

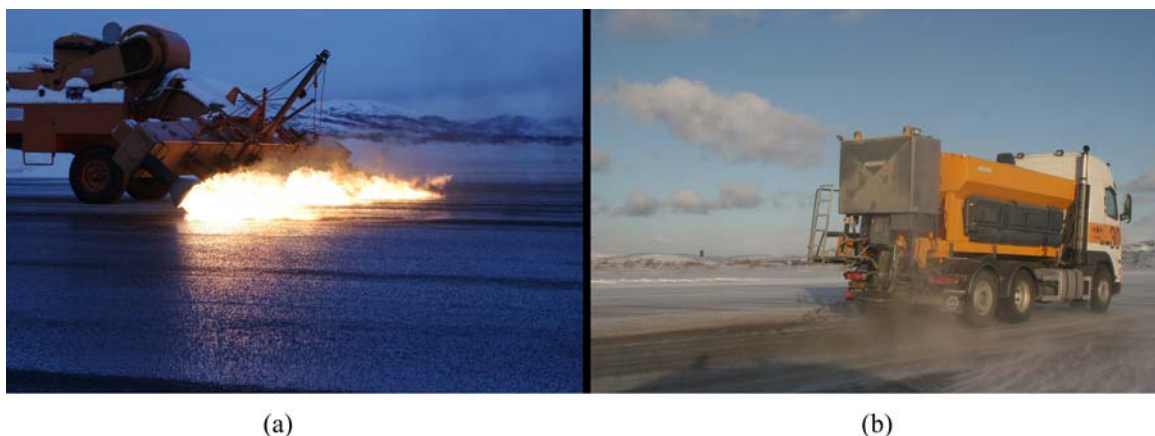
Figure 9-1. Traditional and modern methods of freeze bonded sanding. (a) The iced pavement is heated with open flames prior to the sanding operation. (b) A modern sand spreader that pre-wet the sand with hot water.

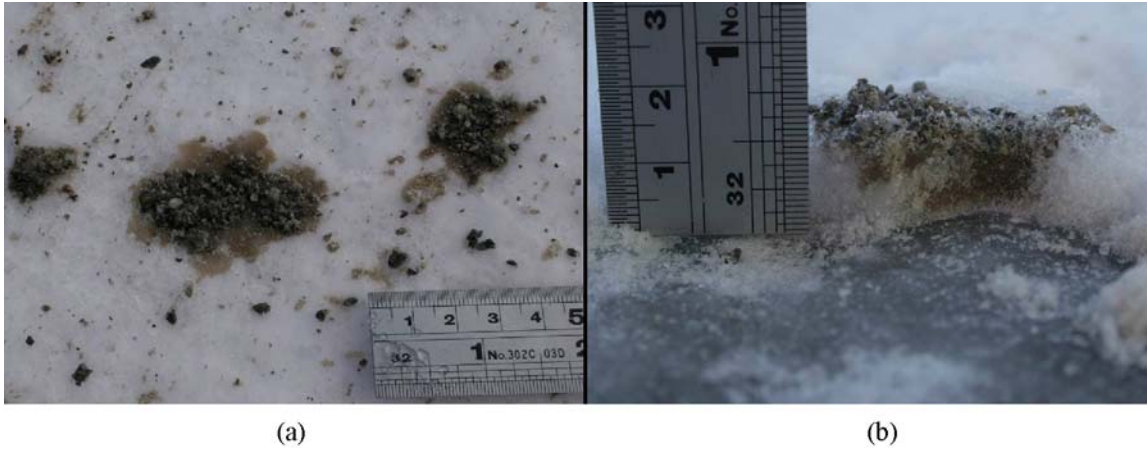
Figure 9-4. A top view (a) and side view (b) of warm pre-wetted sand that is applied on compacted snow.

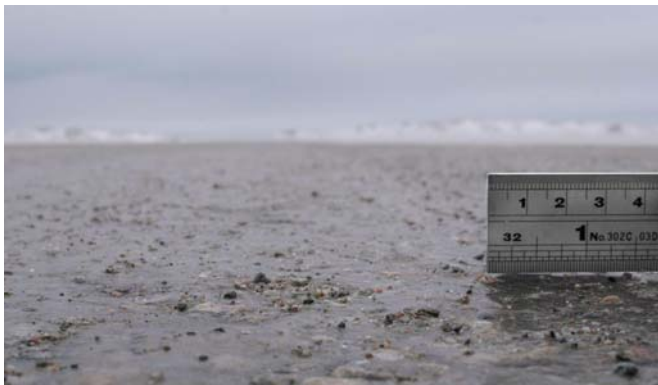
Figure 9-5. Example of an iced runway that is regularly treated with freeze bonded sand, four days after the last application.

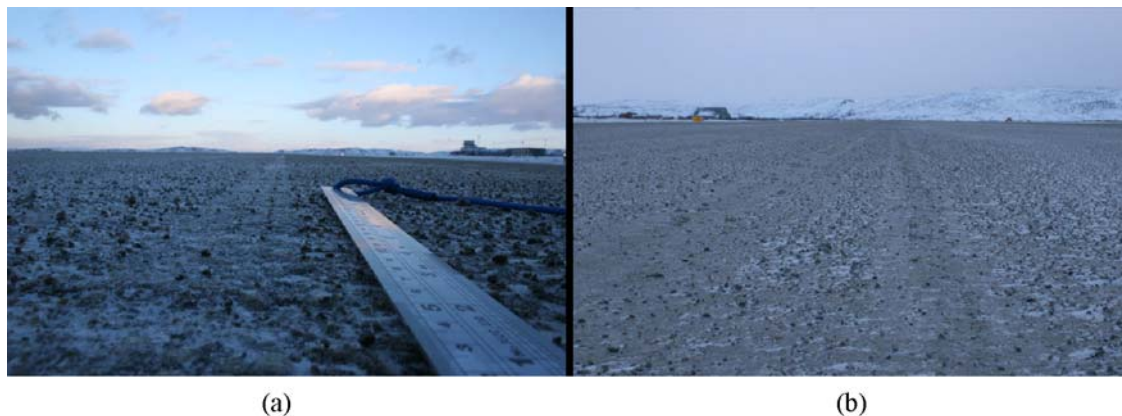
Figure 9-6. Tracks on newly applied freeze bonded sand. (a) The track from a BV-11 test tire. (b) The track of a Beach King Air 200. Both tracks show that large particles broke loose under the action of the tire.

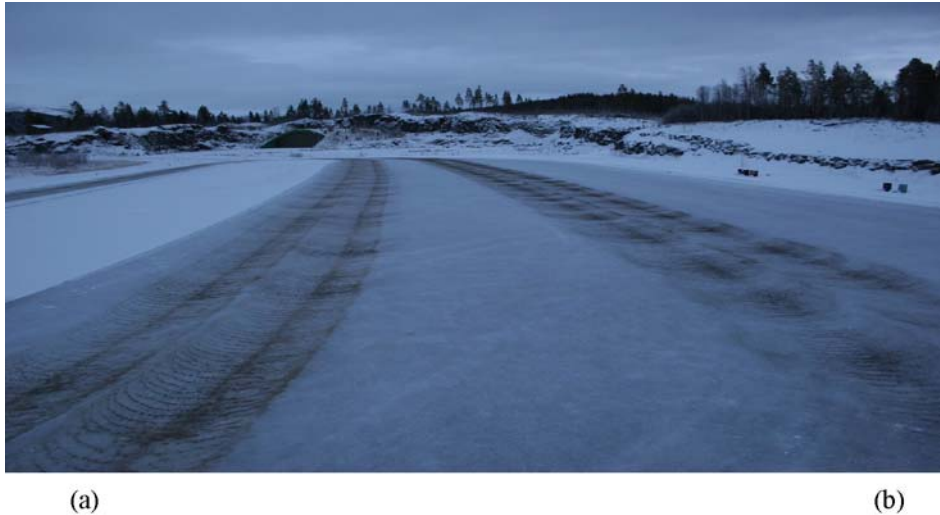
Figure 9-7. Overview of the test beds: (a) freeze bonded sand and (b) loose sand.
