# Coastal-sea-ice action on a breakwater in a microtidal inlet in Svalbard

Thesis for the degree of doctor philosophiae

Norwegian University of  
Science and Technology  
Faculty of Engineering Science and Technology  
Department of Civil and Transport Engineering

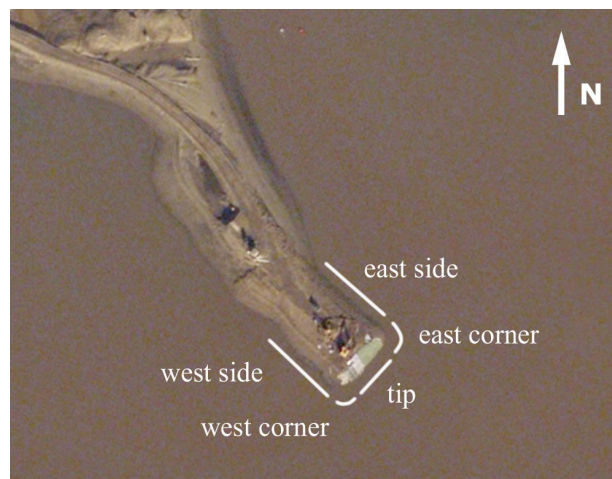
Figure 1: Orthophotography of Barryneset with the nomenclature of the different zones of the breakwater – Summer 2006

**Breakwater:** The different zones of the breakwater are named according to Figure 1.

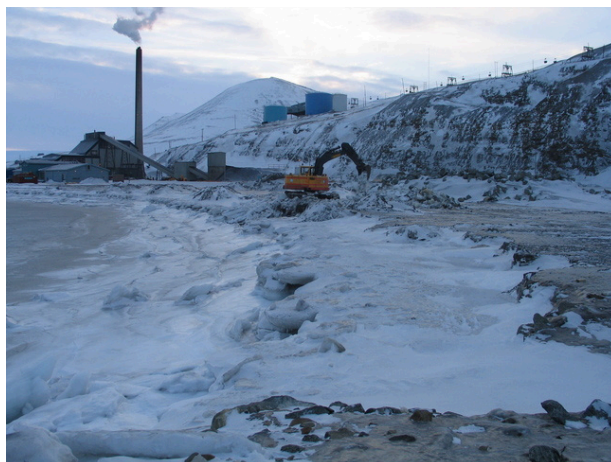
Figure 2.2: Winter ice foot on a gentle slope in the winter. Between the new and the old harbour of Longyearbyen – 2 March 2005

Different types of ice feet are shown in Figures 2.2, 2.4 and 2.3. Depending to a great extent on shore topography, the size of the ice foot may vary from a small strip of ice like (Figure 2.4) to estuary ice sheets several kilometres wide (Dionne, 1994). Kovacs et al. (1982) and Kovacs and Sodhi (1981) described a 15-m-high, up-to-over-100-m-wide ice foot at Fairway Rock in the Bering Strait, although it would be preferable to call it *pressure ridge* or—a more general term—*shorefast ice*. Both terms are used by George

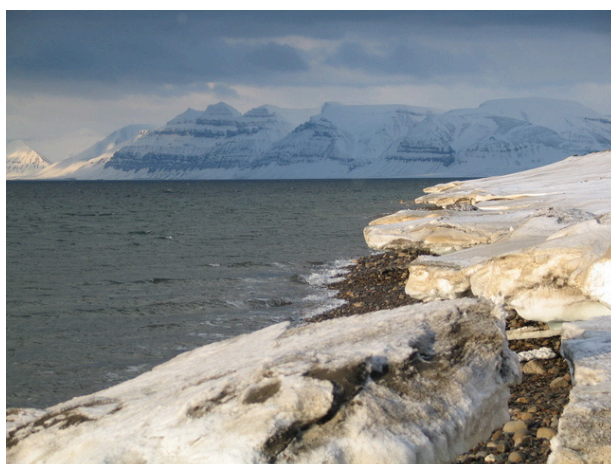
Figure 2.3: Ice foot on a gentle slope in the spring. Between Carolinedalen and Deltanaset, Isfjorden, Svalbard – 15 April 2006

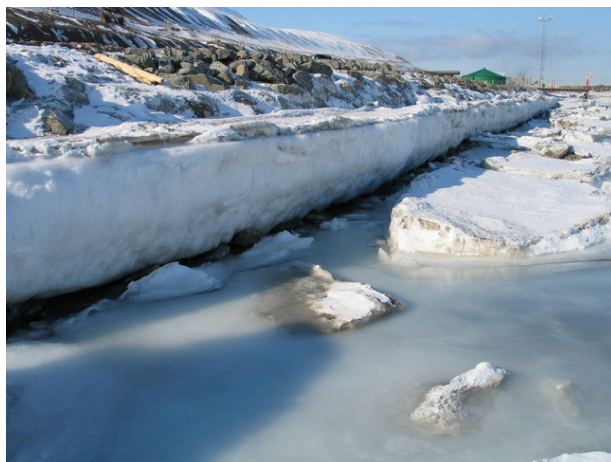
Figure 2.4: Ice foot on a steep slope in the winter. Port of Longyearbyen – 27 April 2005

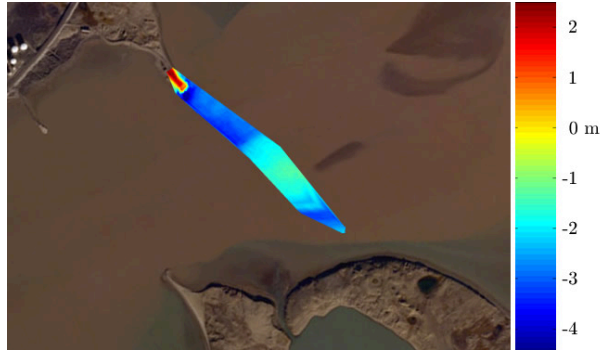
Figure 3.10: Seabed elevation map of Sveasundet – 25 July 2006 – Courtesy of Norges Geologiske Undersøkelser (NGU)

Sveasundet consists of two 4.5-m-deep canals separated by a 1-m-deep ridge. Close to Barryneset the water depth is 3 m +/- 20 % (Figures 3.10 and 3.11).

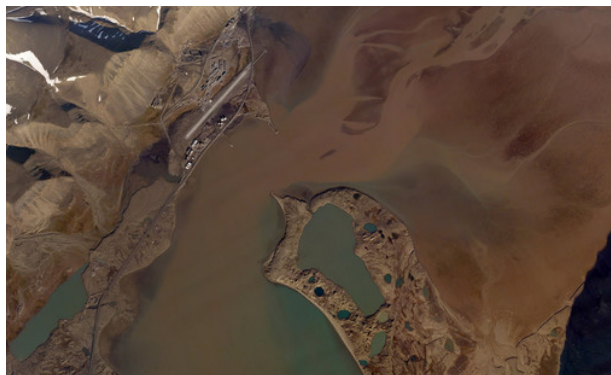
Figure 3.13: Orthophotography of the Svea area – Summer 2006

As seen in Figure 3.13, Kjellströmelva carries a high amount of sediments into Braganzavågen and Sveabukta.

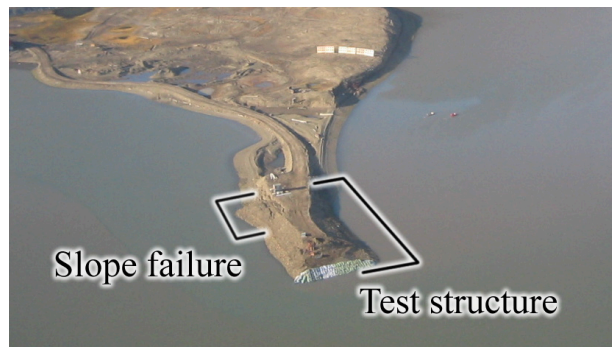
Figure 4.4: Aerial view of the breakwater – 30 August 2006

A slope failure occurred along the west side of the breakwater on 15 August 2006 (Figure 4.4). Due to a lack of seabed topography data elsewhere than along the 160°-line, it was difficult to model the failure with good precision. Andreassen's proposed model showed that the breakwater load caused a seabed failure, which, in turn, propagated to the breakwater (Røsvik Andreassen, 2006). It is reasonable to assume that the seabed was softer below the failed slope than elsewhere below the breakwater. This, combined with a gradual accumulation of masses at the toe, may have prevented the failure to spread to the whole embankment.

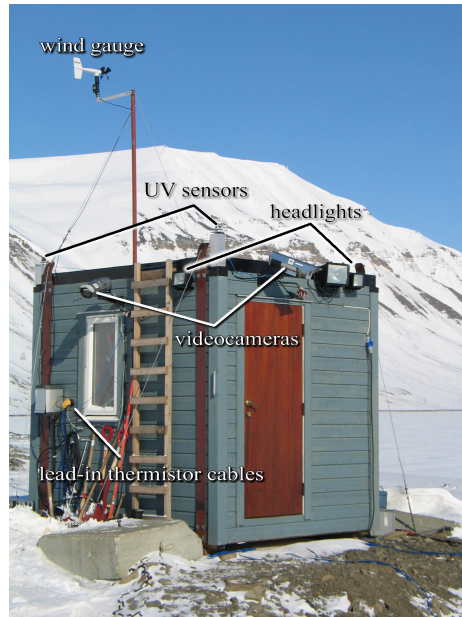
Figure 4.5: Measurement cabin – 5 May 2007 (week 18)

Barryneset and the DNMI station. Figure 4.5 shows the mast with the wind gauge.

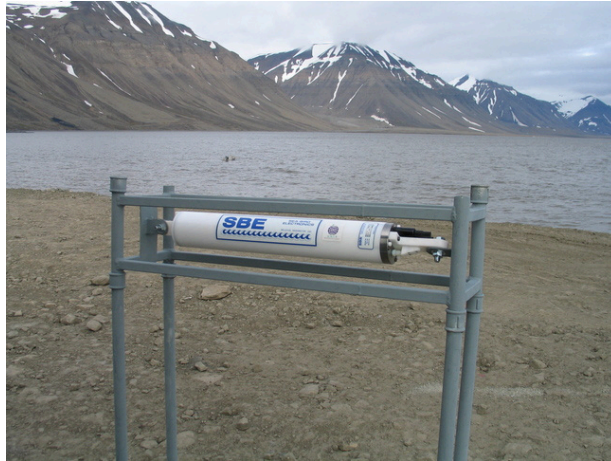
we mounted a tide and wave gauge (SBE 26 Plus from Seabird Electronics, Inc.) on a steel frame and installed the frame in a fixed position by pressing its 25-mm-in-diameter vertical legs into the soft seabed. It was necessary to install the gauge on the seabed since there was no pontoon close by. The instrument depth was  $-2.71$  m and its position  $8647026N - 541044E$  (measured with 20 m precision with a handheld GPS).

Figure 4.6: Tide gauge mounted on the steel frame

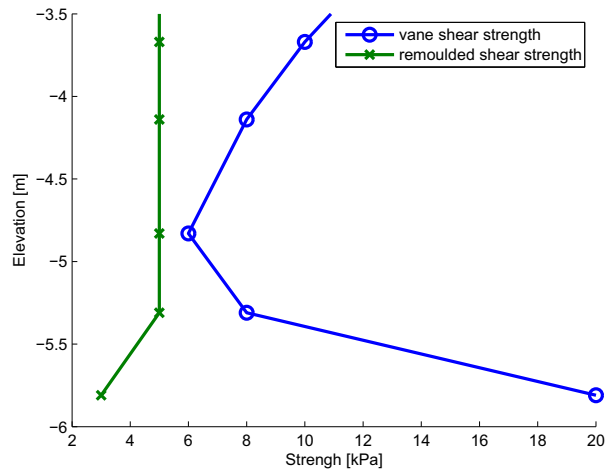
Figure 4.9: Results from a vane test 140 m seaward of Barryneset – the underlying data are found in Table A.4

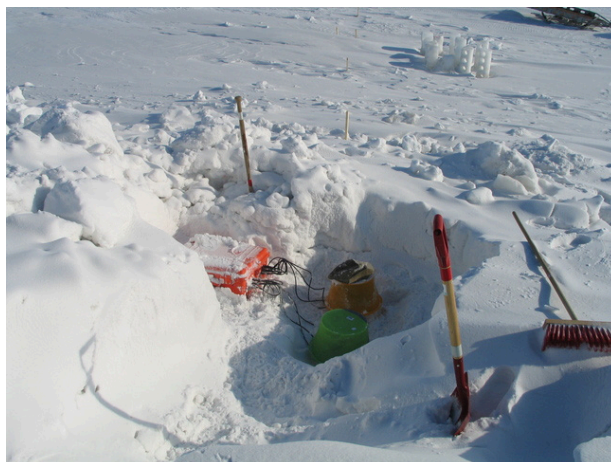
Figure 4.12: Set-up of the stress sensors. Datalogger in orange box – 26 April 2007 (week 17)

We installed the sensors in rosettes of three sensors each. The centre of the rosettes placed on each side of crack 2 were 30 cm from the crack and 18 cm below the ice top. In both rosettes, one sensor measured stresses perpendicular to the crack, and the angle between each sensor was  $120^\circ$  (Figures 4.12, 4.13, 4.14, 4.15). We froze another rosette in the free-floating ice, 2.6 km away from the breakwater, in the middle of Sveabukta (Barrault and Høyland, 2007).

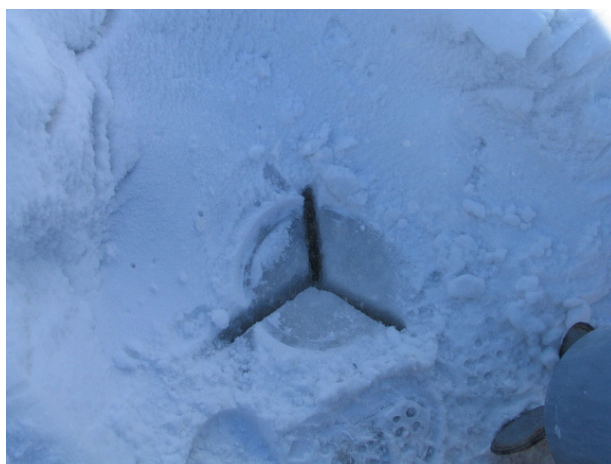
Figure 4.13: Slots in the ice for a stress-sensors rosette – 26 April 2007 (week 17)

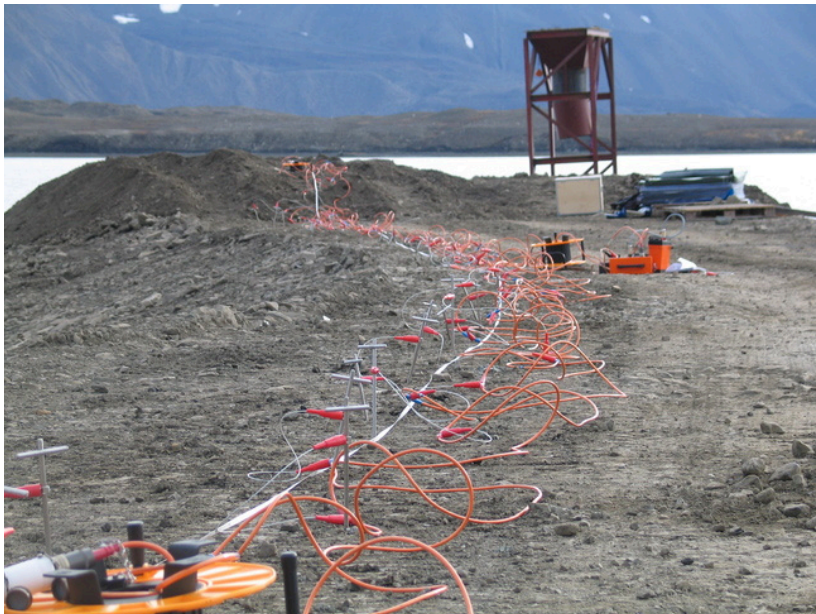
Figure 4.16: Measurement of ground resistivity – 2 September 2006

were inverted using a quasi-Newton optimisation method using the software RES2DINV (Geotomo Software Sdn. Bhd) (Loke and Barker, 1996). A full description of the method is found in Kristensen et al. (2009).

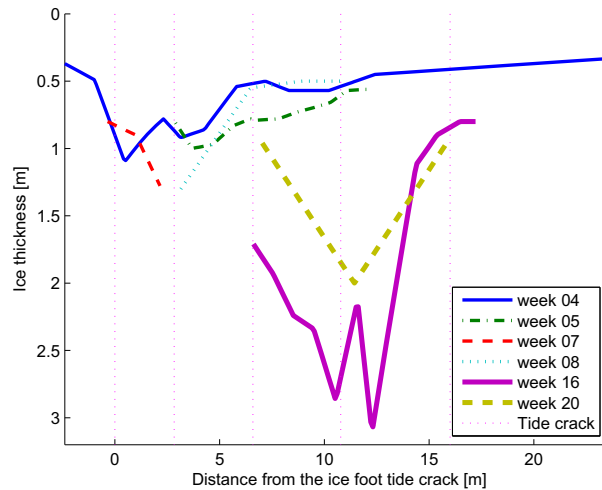
Figure 5.3: Ice thickness throughout the season. The tide cracks locations are indicated with vertical, dotted lines.

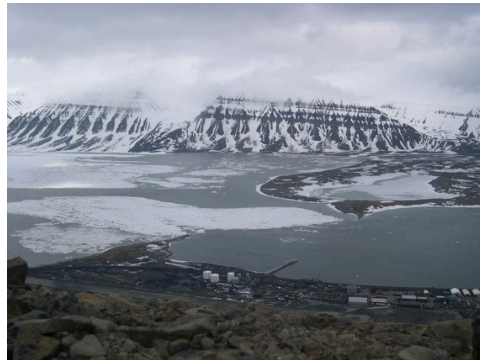
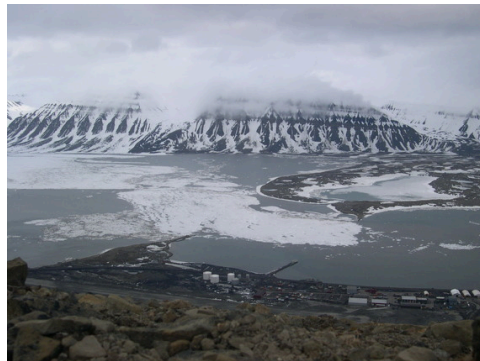
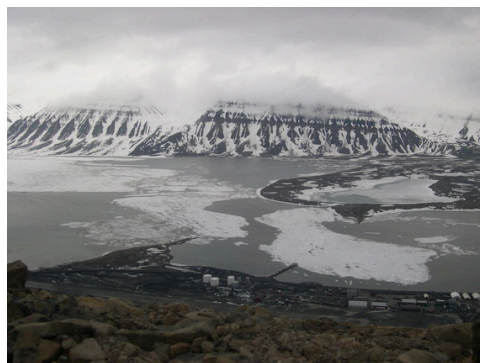
(a) time: 19:42

(b) time: 20:42

(c) time: 21:42

Figure 5.6: Big ice floe from Braganzavågen getting stuck in Sveasundet – 14 June 2006

The break-up mechanism was similar all three years: after the ice had been melting for several weeks, it started to break into individual cakes that drifted back and forth with the tide. After a few days, large chunks of the Braganzavågen ice cover broke loose. These floes, which were several hundred metres in diameter got stuck in Sveasundet due to their size and generated shore pile-ups (Section 5.5). Figure 5.6 shows a sequence of a floe getting stuck, rotating into Sveasundet and eventually cracking up.

As mentioned above, pile-up commonly occur during break-up. I do not know whether it occurred in 2005, but it occurred both in 2006 and 2007. Figure 5.8 shows the biggest pile-up I witnessed at Barryneset. It was caused by the event shown in Figure 5.6. Piled-up ice was about 30 cm thick and mostly rotten.

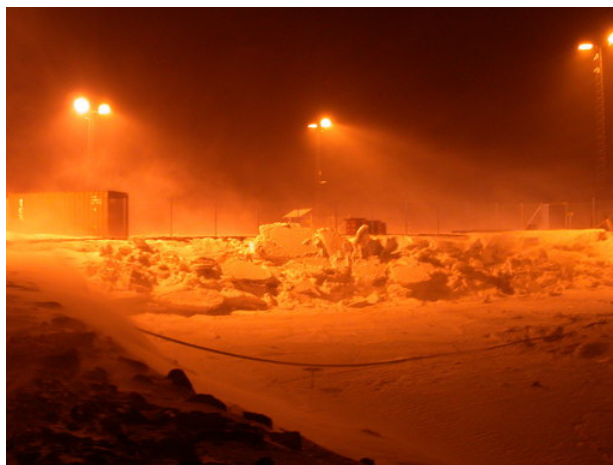
Figure 5.7: Ice pile-up on the east side of the harbour of Longyearbyen – December 2004  
– Picture: Per Olav Moslet

Ice encroachment is a major concern in ice engineering (Kovacs and Sodhi, 1980; Gawne, 1999). Figure 5.7 shows an event that happened in Longyearbyen in December 2004.

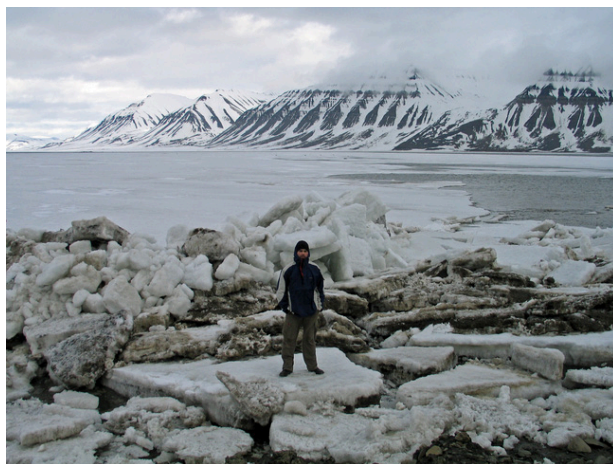
Figure 5.8: Pile-up at Barryneset – 14 June 2006

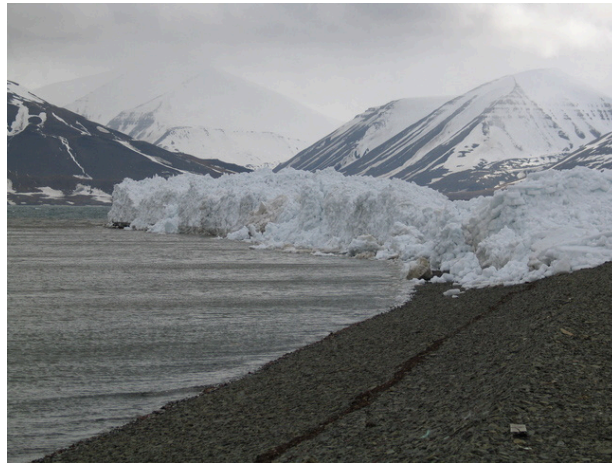
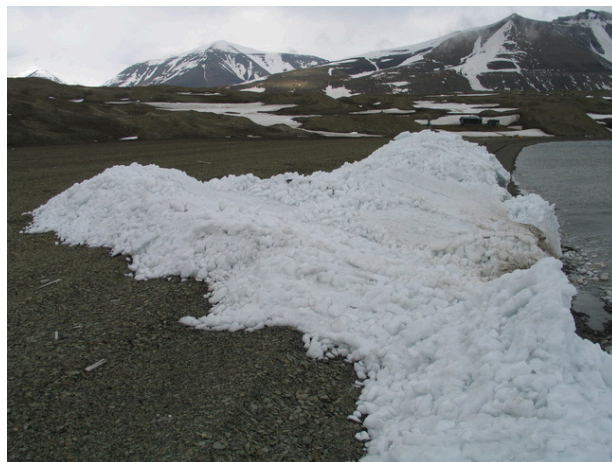
Figure 5.9: Pile-up on the shore of Damesbukta west of Kapp Amsterdam – 15 June 2006

Figure 5.10: Pile-up on the shore of Damesbukta west of Kapp Amsterdam – 15 June 2006

A few kilometres west of Kapp Amsterdam, in the bay north of Linderotneset a more sizeable pile-up occurred in 2006, following a 9-hour-long period of strong westerly winds ( $12 \text{ m s}^{-1}$ ). The pile-up was about 4 m high and went up to 30 m shoreward (Figures 5.9 and 5.10).

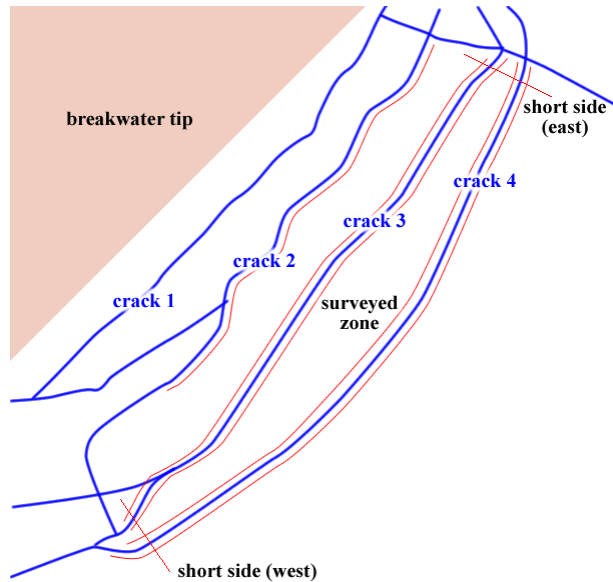
Figure 5.13: Cracks, in blue, and the 5 shore-parallel lines along which the elevation was measured, in red

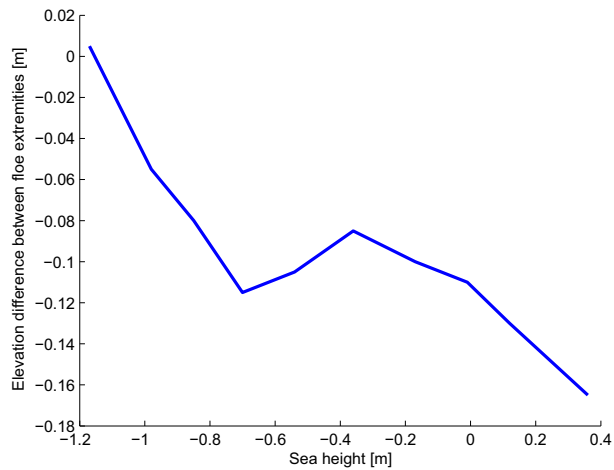
Figure 5.15: Shore-parallel tilting of the ice zone as a function of the sea height – 22 February 2007 (week 8)

Shore-parallel tilting also decreased almost linearly from 0, when the sea height was  $-1.17$  m, to  $-0.17$  m, when it was 0.36 m (Figure 5.15).

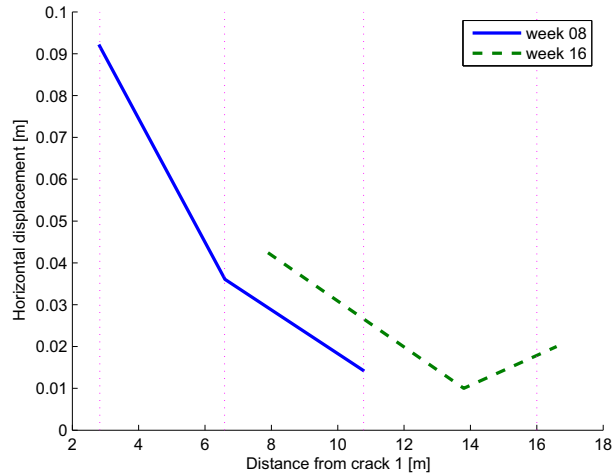
Figure 5.16: Horizontal tidal movement of the ice in the direction perpendicular to the breakwater – sea level variation: 0.9 m. The tide cracks locations are indicated with vertical, dotted lines.

In weeks 8 and 16, I monitored the horizontal tidal movement and observed that, perpendicularly to the shore, the ice was moving horizontally. Up to crack 4, the amplitude of the movement was decreasing with the distance from the shore (Figure 5.16). Between cracks 4 and 5, it was V-shaped, going from about 0.03 to 0.01 then 0.02 m. The largest measured horizontal displacement was 0.09 m. The corresponding sea level variation was 0.90 m.

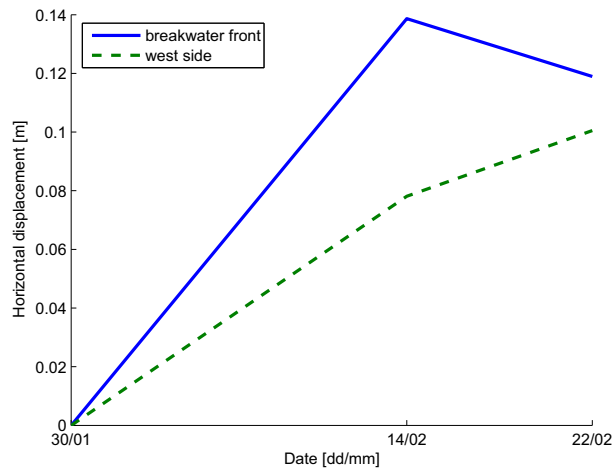
Figure 5.17: Movement of the ice surrounding the breakwater, rectified for horizontal tidal movement

for week 5 and a  $-2$  cm correction for week 8. As to the point on the west side, it was assumed that the effect of the tide was less than 1 cm. The rectified displacements are shown in Figure 5.17. There was around 0.1 m drift within two weeks. The ice in front of the breakwater drifted in the direction perpendicular to the shore while the ice on the west side drifted toward south. Unfortunately, I was not able to continue the measurements because the ice was flooded and the wood sticks disappeared into snow ice. The few measurements available suggest that the long-term horizontal movement of the ice was not negligible. Apparently, it was highest in the beginning of the ice cover period.

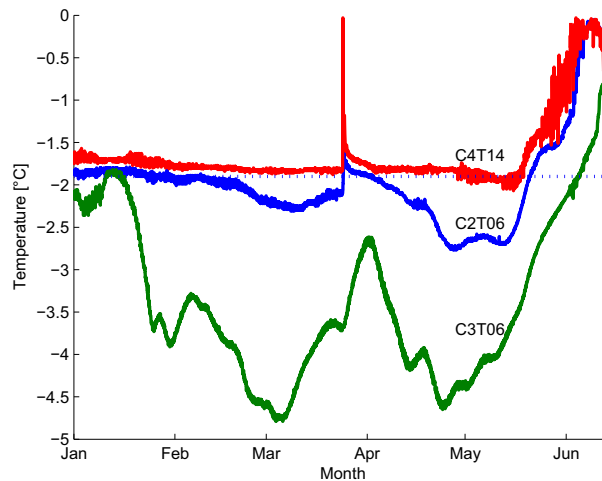
Figure 5.18: Temperatures recorded by thermistors C2T06 (altitude: 0.1 m), C3T06 (altitude: 0.3 m) and C4T14 (altitude:  $-1.8\text{ m}$ ) between 1 January and 15 June 2007. The dashed line corresponds to  $-1.9\text{ }^{\circ}\text{C}$  (sea water freezing temperature).

It seems reasonable to assume that the ice was frozen fast to the ground whenever the temperature at the ice–ground interface was below the freezing temperature of the water in Sveasundet, which is  $-1.9\text{ }^{\circ}\text{C}$ . During the winter of 2006–07 the temperature at C2T06 (altitude: 0.1 m) was lower than  $-1.9\text{ }^{\circ}\text{C}$  in periods, while it was constantly around  $-1.8\text{ }^{\circ}\text{C}$  at C4T14 (altitude:  $-1.8\text{ m}$ ) (Figure 5.18)—except for the surge in March (Section 5.1)—Figure 4.7 shows the position of the thermistors. Therefore, it is likely that the ice was frozen fast down to somewhere between C2T06 and C4T14, which corresponds approximately to the bottom of the fourth row of geosynthetic bags, at  $-1.0\text{ m}$  (Figure C.9), and down to C4T14, 2 m shorewards of crack 2, in the beginning of May. Figure B.95 confirms that the ice was frozen fast at least up to crack 1 at the end of the season. It was not frozen fast between crack 1 and crack 2 at that time, but it is possible that it had been so earlier and had melted off. Figure 5.11 confirms that the ice was not frozen fast seawards of crack 2.

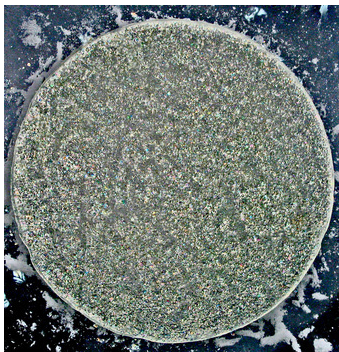
Figure 5.30: Pt1: vertical section — Depth: 0.16 m — Density:  $724 \text{ kg m}^{-3}$  — Structure: granular, very fine grains — Ice type: T2 (drained snow ice)

The ice structure is classified in Figures 5.30, 5.31, 5.32 and 5.33 according to the classifications found in Michel and Ramseier (1971) and Weeks and Ackley (1982).

In the coastal ice, due to the way the ice was formed, the size of the crystals compared to the diameter of the samples varied from very small (factor 100) to small (factor 10), as seen in Figures 5.30 and 5.33. Core Pt4-H3 contained ice formed directly from sea water while core Pt1-H1 contained ice formed by snow that was soaked with sea water at high tide. Because the brine was drained at low tide, the ice at Pt1-H1 was porous and had a low salinity.

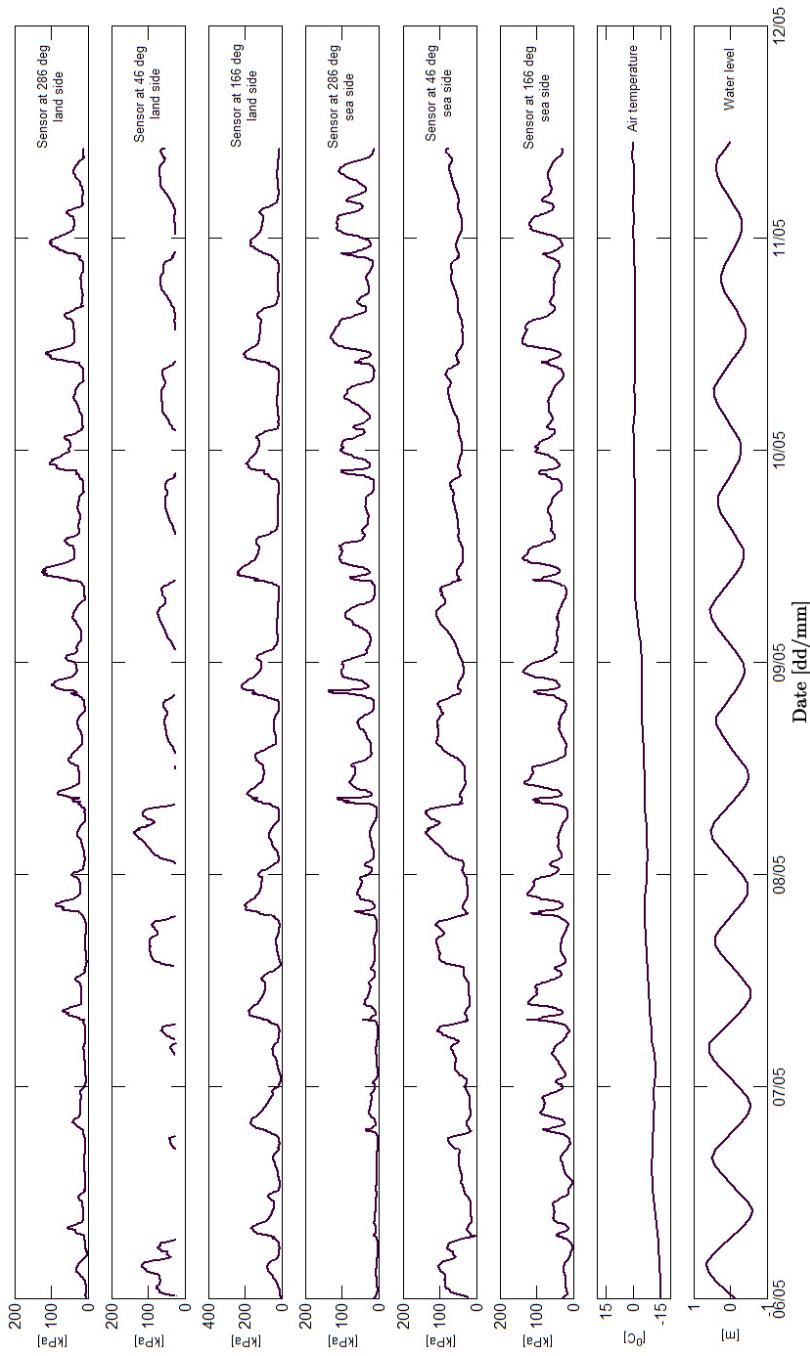
Figure 6.4: Air temperature, sea level and stress intensities in the two rosettes on both sides of the crack – full measurement period

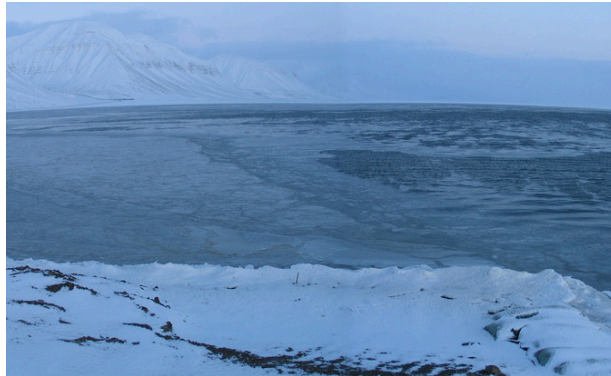
Figure B.2: Pancake ice to the left and strip of grease ice in the middle, looking toward the east corner – 27 October 2006 (week 43)

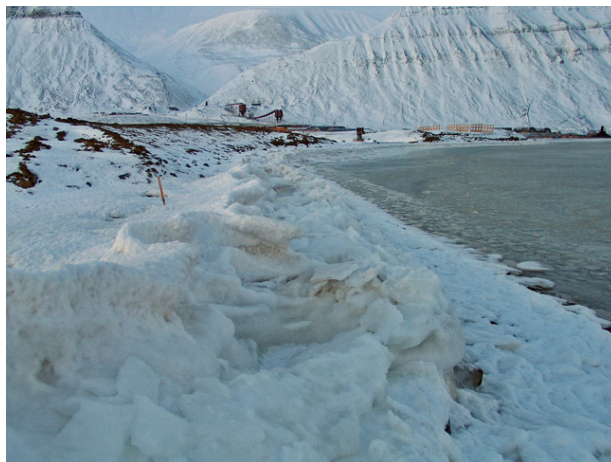
Figure B.3: Ice foot, east side, looking toward Svea, sea height =  $-0.1$  m — 27 October 2006 (week 43)

**Ice foot:** on the east side, deposited pancakes were stacked up into a berm (Figure B.3) and sea water spray was cementing them together. The pancakes were formed at the surface of the sea surrounding the breakwater. On the west side of the breakwater there was a stranded ice cake of 4.7 x 2.0 m (Figure B.4). Along the tip of the breakwater an ice cap had grown on the bags and was covering the second row of bags, i.e. a 40 cm-high zone above MHW (Figure B.5). Stranded cakes were integrated into this ice cap in the form of scattered lumps of ice.

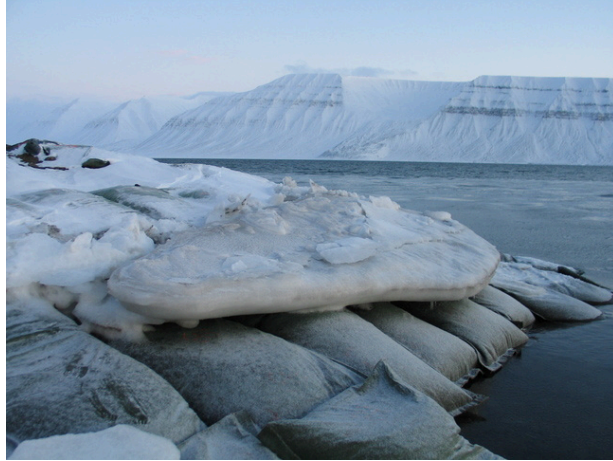
Figure B.4: Stranded ice cake, west side, looking toward Ispallen, sea height =  $-0.1$  m – 27 October 2006 (week 43)

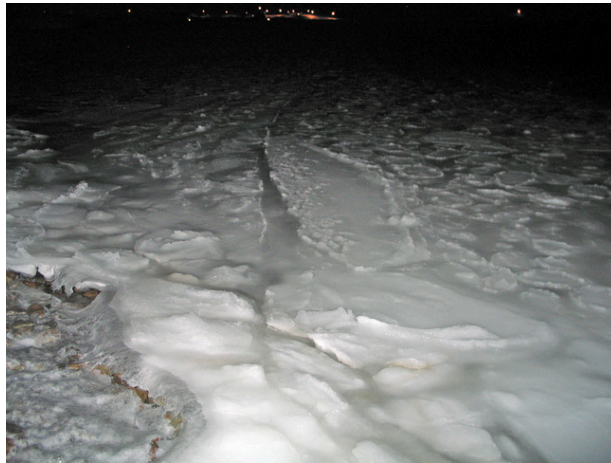
Figure B.8: Pancake ice, east side, looking toward Braganzavågen – 1 November 2006 (week 44)

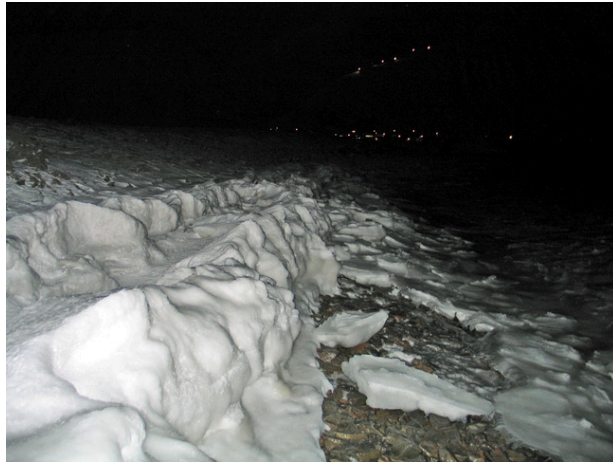
Figure B.9: Ice foot, east side, looking toward Svea, sea height =  $-0.5$  m — 1 November 2006 (week 44)

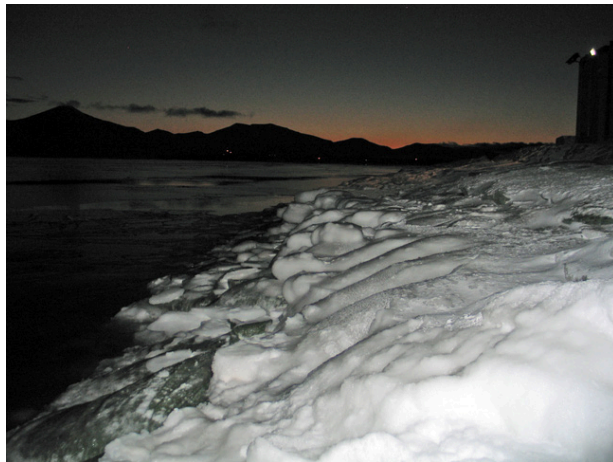
Figure B.10: Bags at the tip of the breakwater, looking toward west, sea height =  $-0.5$  m – 1 November 2006 (week 44)

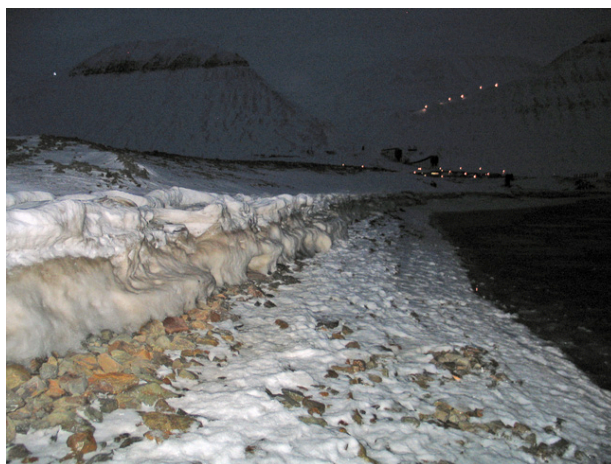
Figure B.12: Ice foot (left) and ice rubble (middle), east side, looking toward Svea, sea height =  $-0.3$  m – 8 November 2006 (week 45)

**Bags:** The amount of ice rubble, described in week 43, had increased, and it extended to the fourth row of bags.

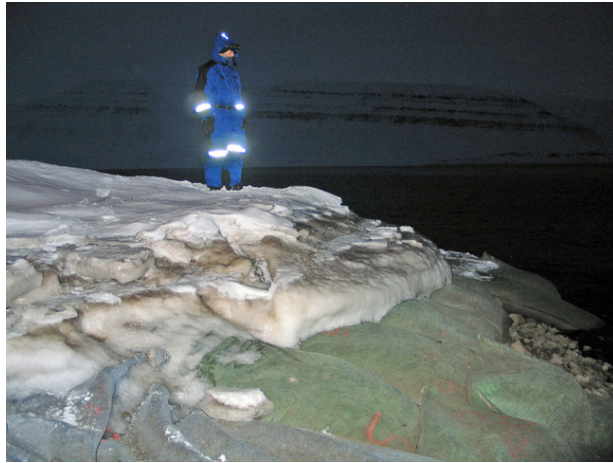
Figure B.13: Ice foot, west side, looking toward Ispallen, sea height =  $-0.3$  m – 8 November 2006 (week 45)

of spring tides when the ice foot was flooded on high tide. When snow was present, it became saturated and froze into snow ice during ebb, when it was above the water level. On the west side, the stranded ice cake was gradually being integrated in the ice foot (Figure B.13). The lower boundary of the ice cap along the tip of the breakwater has moved higher upwards as a result of mild weather (Figure B.14).

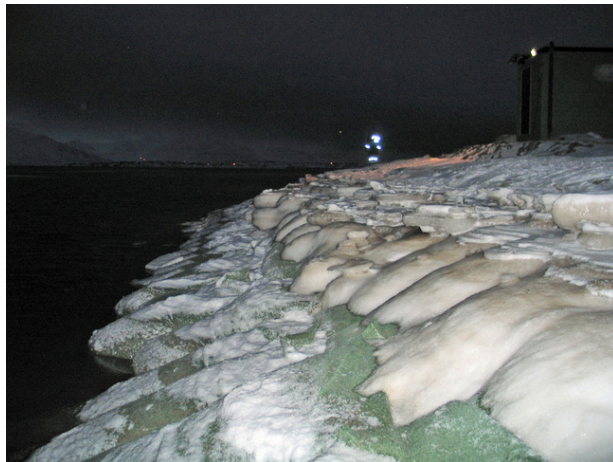
Figure B.14: Bags at the tip of the breakwater, looking toward west, sea height =  $-0.3$  m – 8 November 2006 (week 45)

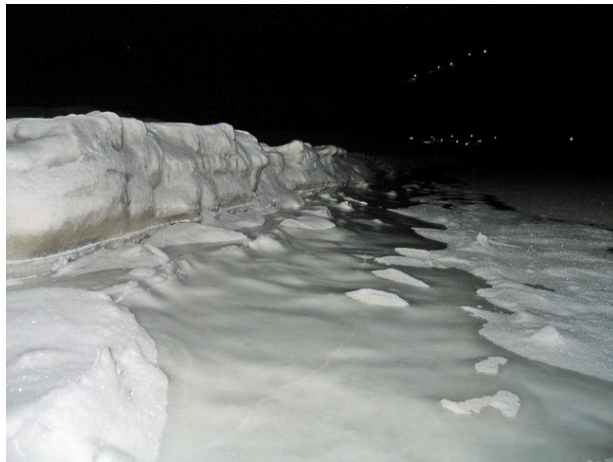
Figure B.17: Ice foot and shore ice, east side, looking toward Svea, sea height =  $-0.5$  m – 15 November 2006 (week 46)

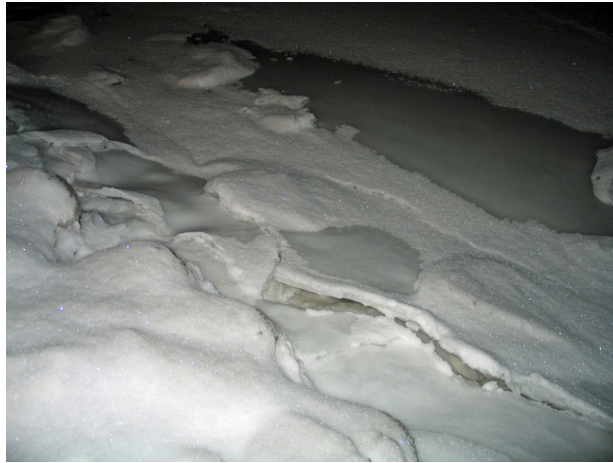
Figure B.18: Bending cracks in the sea ice due to the tide – 15 November 2006 (week 46)

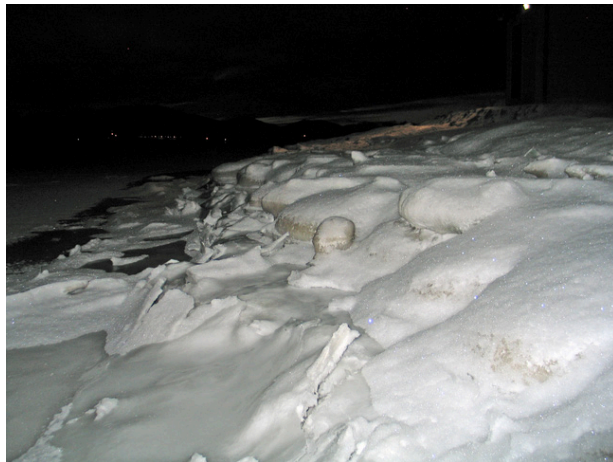
Figure B.19: Bags at the tip of the breakwater, looking toward west, sea height =  $-0.5$  m – 15 November 2006 (week 46)

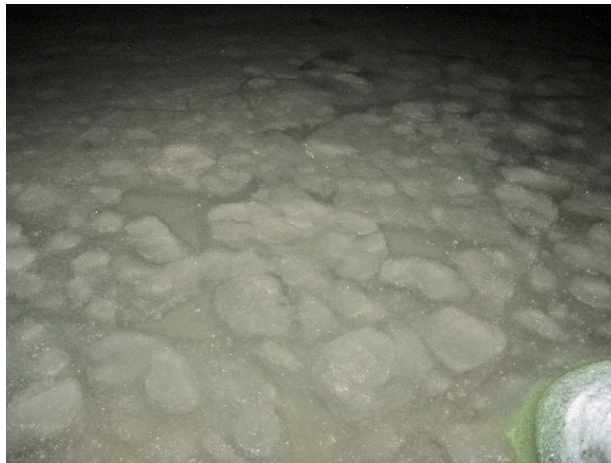
Figure B.21: Pancakes and frazil at the breakwater tip, looking toward south – 22 November 2006

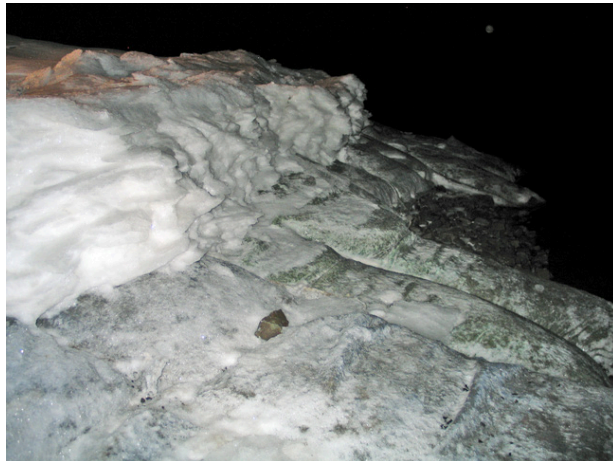
Figure B.23: Ice foot, west side, looking toward Ispallen, sea height =  $-0.7$  m – 22 November 2006 (week 47)

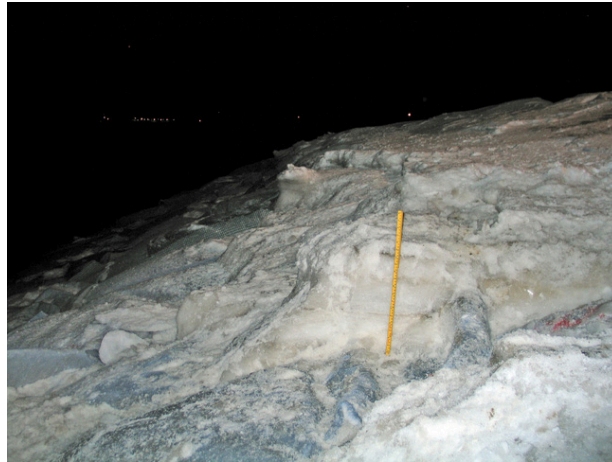
Figure B.24: Along the breakwater tip the ice foot was 40 cm high, looking toward Kapp Amsterdam, sea height =  $-0.6$  m – 23 November 2006 (week 47)

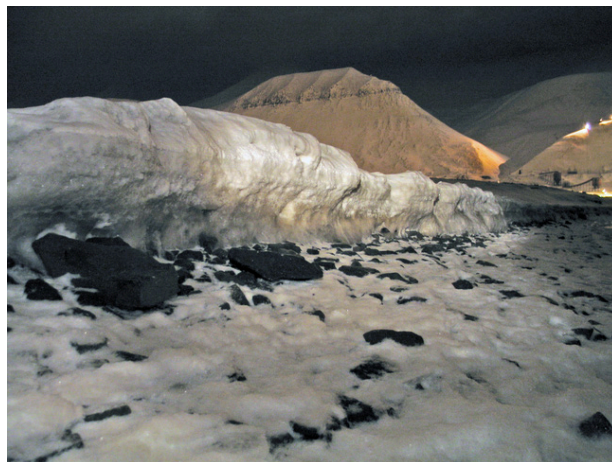
Figure B.25: On the east side the ice foot was 1 m high, looking toward Svea, sea height =  $-0.6$  m – 22 November 2006 (week 47)

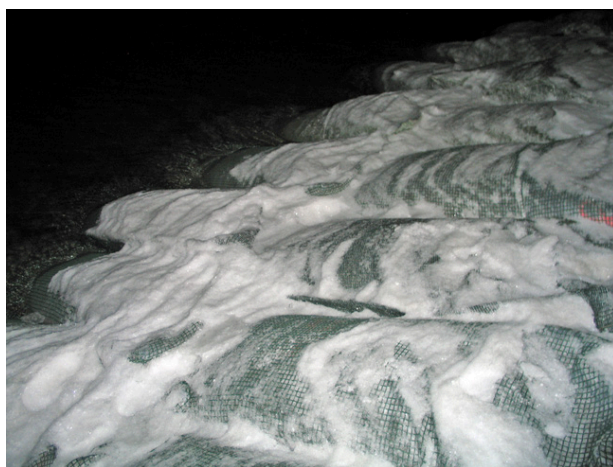
Figure B.27: Ice rubble on the bags, sea height =  $-0.6$  m – 22 November 2006 (week 47)

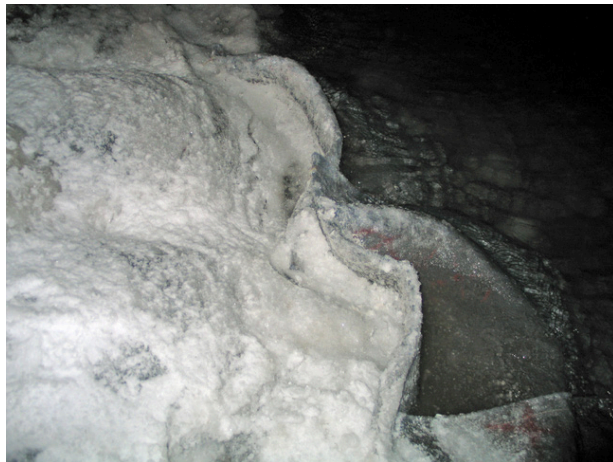
Figure B.29: Ice rubble accumulation beneath the bags tops – 22 November 2006 (week 47)

Since the bags were never perfectly full and the fill material settles with time, the top of the bags was loose and the ice rubble was accumulating beneath the top of some bags (Figure B.28).

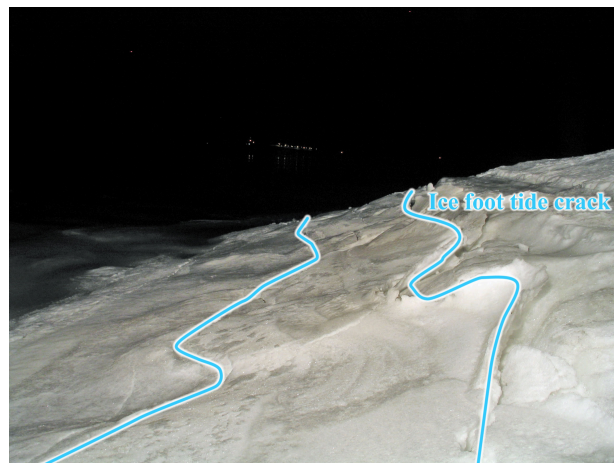
Figure B.33: Ice cover along the tip of the breakwater, sea height =  $-0.4$  m – In red: tide cracks – 20 December 2006 (week 51)

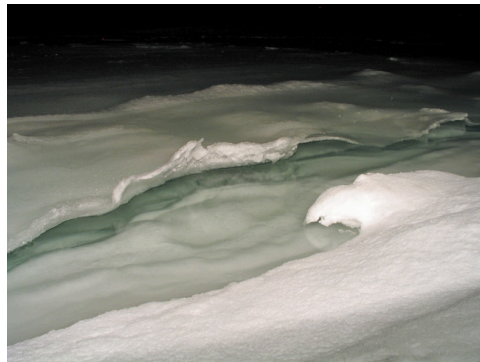
(c) sea height =  $0.5$  m

Figure B.34: Tidal movement, ice foot in the foreground, shore ice in the background – 19 December 2006 (week 51)

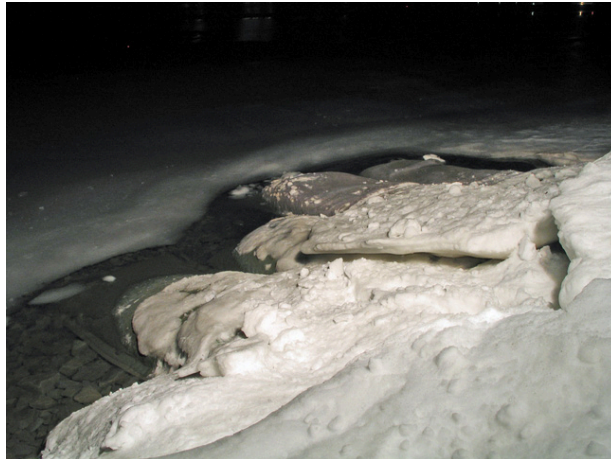
Figure B.38: Hole in the ice cover at the west side of the breakwater, sea height =  $-0.4$  m – 20 December 2006 (week 51)

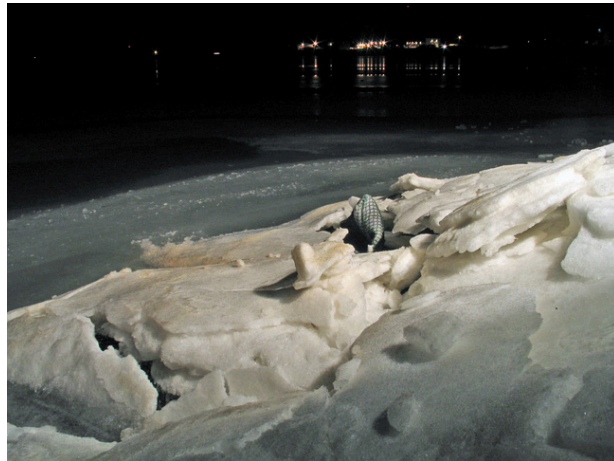
Figure B.39: Piled-up sea ice cakes at the west corner of the breakwater, sea height =  $-0.4$  m – 20 December 2006 (week 51)

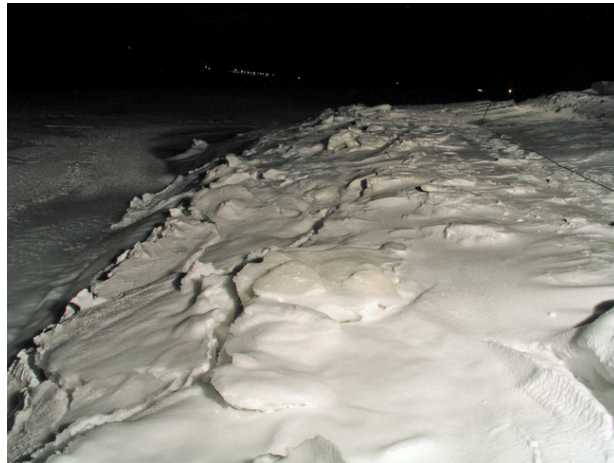
**Ice foot** (Figure B.41): with the shore ice growing, the transition with the ice foot was smoother.

Figure B.41: Ice foot at the breakwater tip, looking toward west, sea height =  $-0.5$  m – 30 December 2006 (week 52)

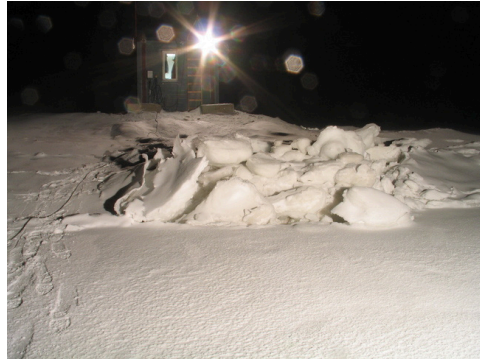
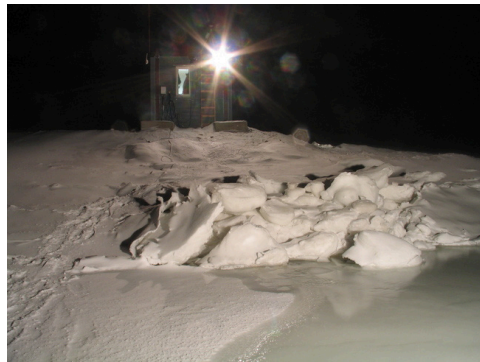
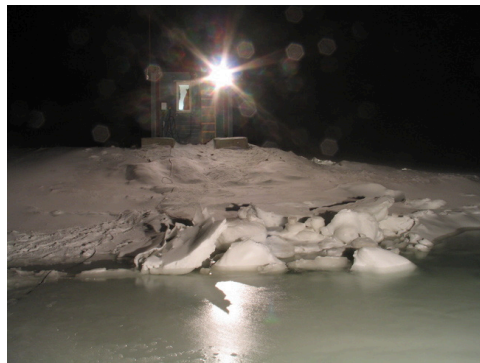
Figure B.43: Tidal movement, west side – 7 January 2007 (week 1)

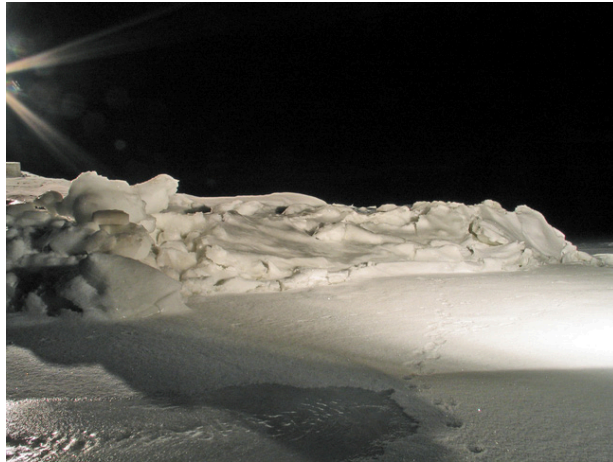
Figure B.44: Steep shore ice in the west breakwater corner, sea height =  $-0.7$  m – 5 January 2007 (week 1)

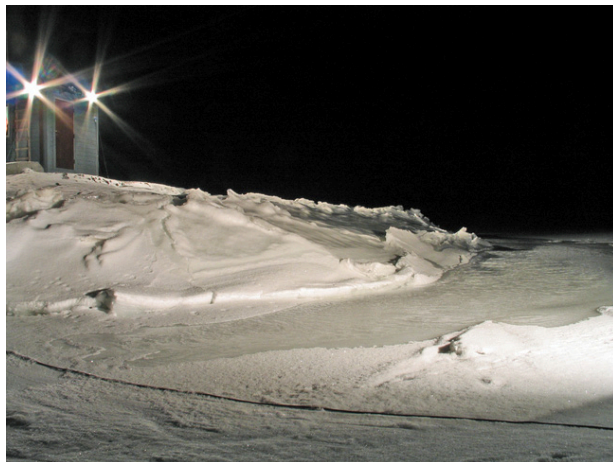
The sea ice was also flooded in front of the breakwater tip at high sea levels (Figure B.45). Because of the narrowness of the tide crack through which the surface water penetrates, some of it becomes trapped at low sea levels, and create surface water ponds (Figure B.45). The extent of surface water ponds changed every day. During the period of observations (5 to 7 January) the width of the water pond photographed in Figure B.45 varied between 2 and 5 m. Some of the surface water froze to the top of the sea ice layer and formed a growing layer of snow-ice.

Figure B.45: Pond of surface water along the tip of the breakwater, sea height =  $-0.7$  m – 5 January 2007 (week 1)

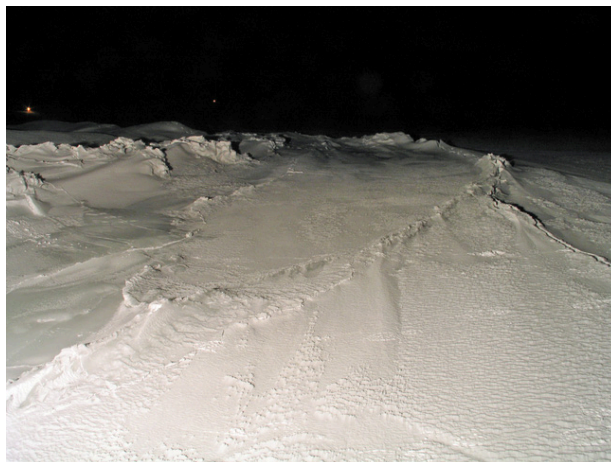
Figure B.53: Hinge zone without surface water (normal conditions), breakwater tip, looking toward the east corner, sea height = 0.3 m – 22 January 2007 (week 4)

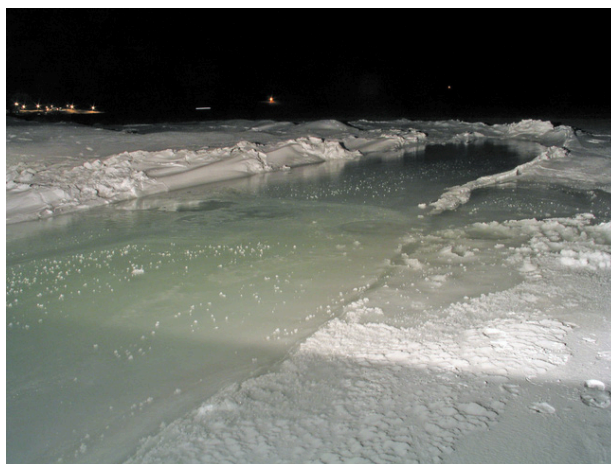
Figure B.54: Surface water on top of the hinge zone after holes were drilled, breakwater tip, looking toward the east corner, sea height = 0.5 m – 23 January 2007 (week 4)

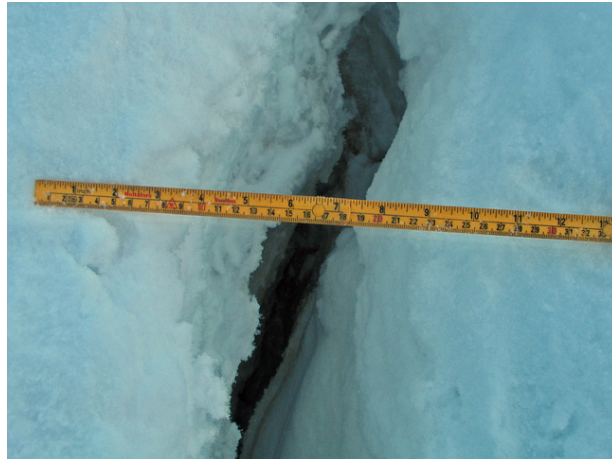
Figure B.58: Crack 1 opening at high tide (10-20 cm) – 22 February 2007 (week 8)

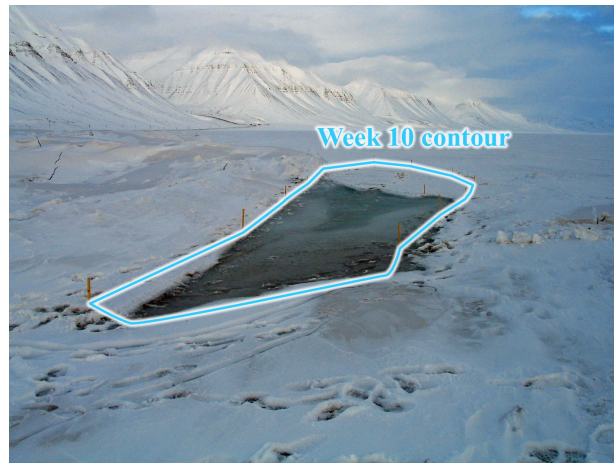
**Sea ice:** The pond of surface seawater was still present although it had shrunk (Figure B.64).

Figure B.64: Pond of surface seawater along the tip of the breakwater, sea height =  $-0.4$  m  
– 14 March 2007 (week 11)

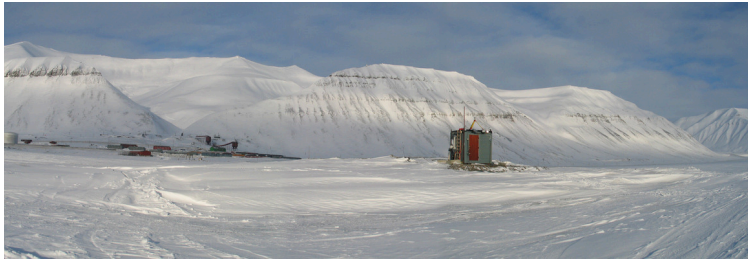
Figure B.66: Coastal ice along the tip of the breakwater, sea height =  $-0.1$  m – 27 March 2007 (week 13)

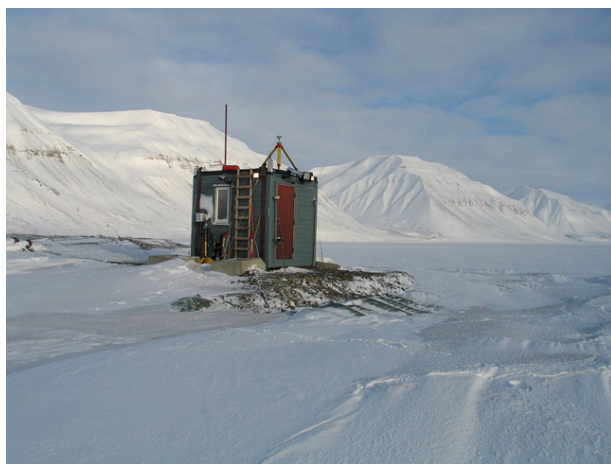
**Bags:** All but a few of the upper bags were covered either with snow or ice (Figure B.69).

Figure B.69: Backshore and cabin – 27 March 2007 (week 13)

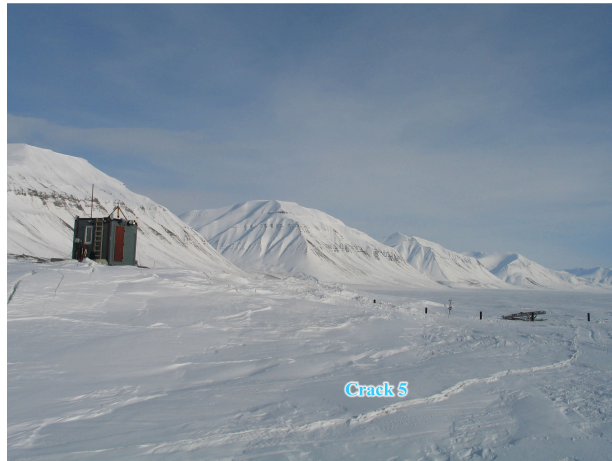
Figure B.72: New shore-parallel crack seaward of crack 4, sea height = -0.7 m – 18 April 2007 (week 16)

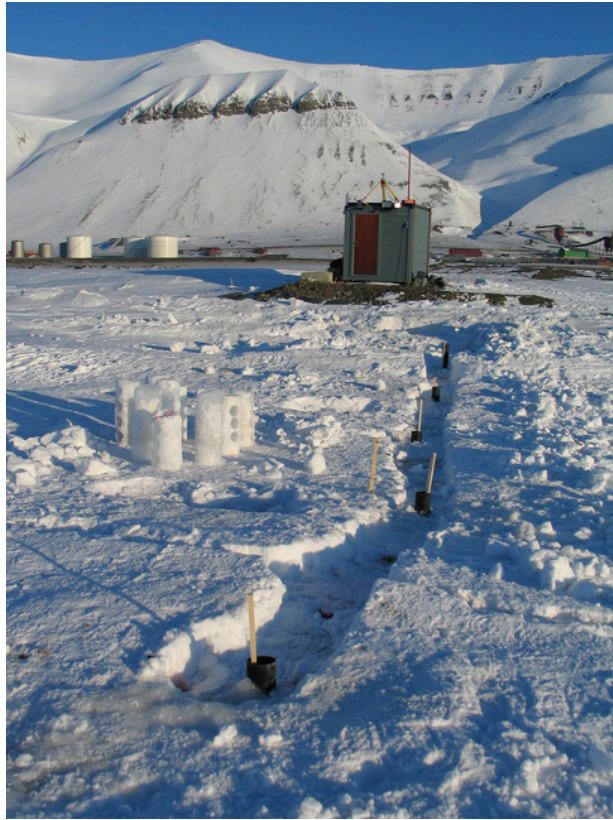
Figure B.73: Tubes placed around drilled holes avoid the sea water from flooding the ice when performing freeboard measurements in the hinge zone. In the foreground, tube 5. There is a tide crack between tube 5 and the next tube, tube 4. Ice core “graveyard”, on the left, from the coring campaign described in Section 4.2.11 – 21 April 2007 (week 16)
