# Coastal-sea-ice action on a breakwater in a microtidal inlet in Svalbard

Thesis for the degree of doctor philosophiae

Norwegian University of  
Science and Technology  
Faculty of Engineering Science and Technology  
Department of Civil and Transport Engineering

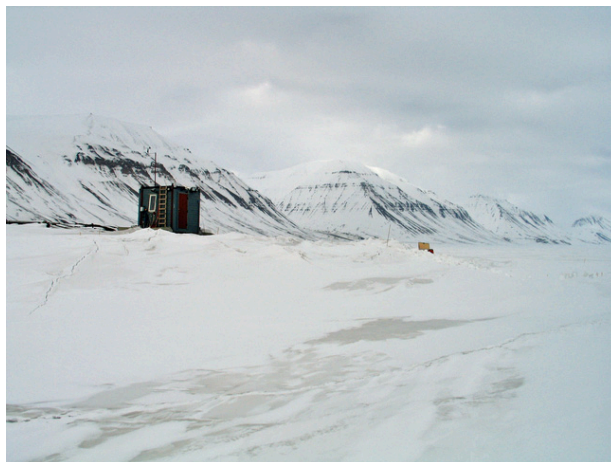
Figure B.76: Still winter: sea ice at the breakwater tip, sea height =  $-0.7$  m – 11 May 2007 (week 19)

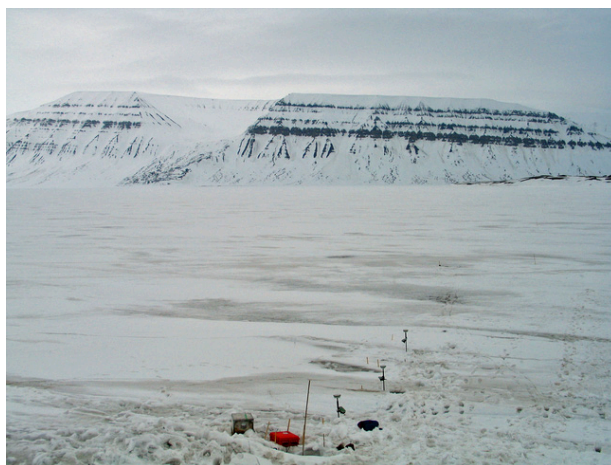
**Snow:** the snow started to melt around mid-May as can be seen by comparing Figures B.76 and B.77. By 18 May it was already quite rotten and the first ponds of melt-water started to form (Figures B.77). Ponds were observed on the west side of the breakwater but they were caused by sea water flooding at high sea levels (Figure B.77).

Figure B.77: The snow layer was rotting and the first meltwater ponds are starting to form. In the foreground the stress sensors with battery and logger. The three poles on the ice are DGPS rovers. The picture was taken from the cabin in the direction of Ispallen – 17 May 2007 (week 20)

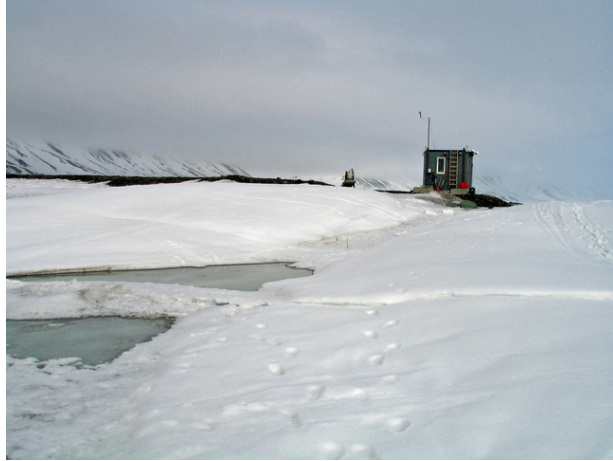
Figure B.78: Sea water ponds on the west side of the breakwater, sea height =  $-0.3$  m – 18 May 2007 (week 20)

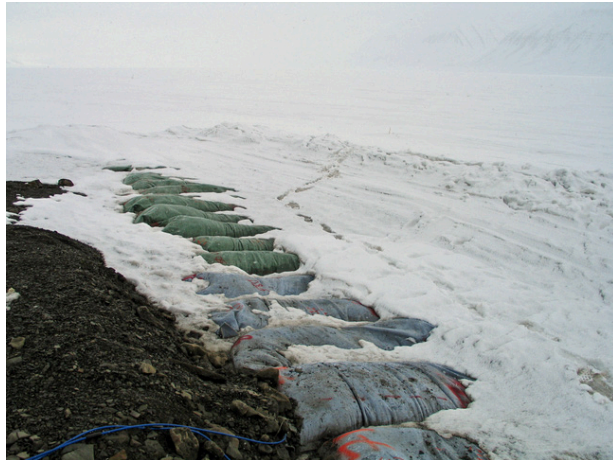
cover was slowly melting. By 17 May almost all the snow had melted from the upper row of bags (Figure B.79).

Figure B.79: The upper row of bags was almost free of snow – 17 May 2007 (week 20)

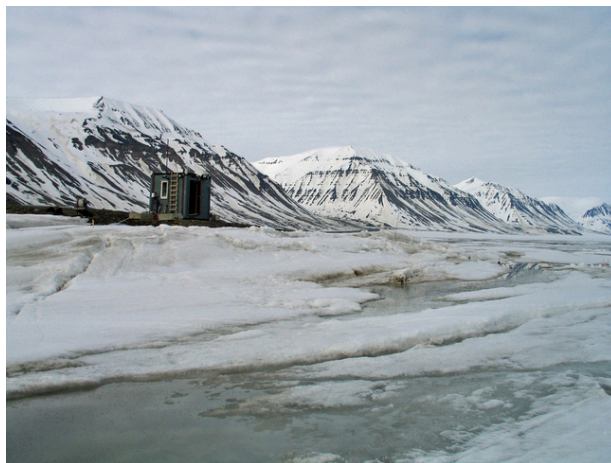
**Snow:** most of the snow on land had melted. There was still snow, albeit rotten, on the ice foot and the sea ice (Figures B.81 and B.82).

Figure B.81: Ice covered with rotten snow and meltwater at the tip of the breakwater, sea height =  $-0.3$  m – 22 May 2007 (week 21)

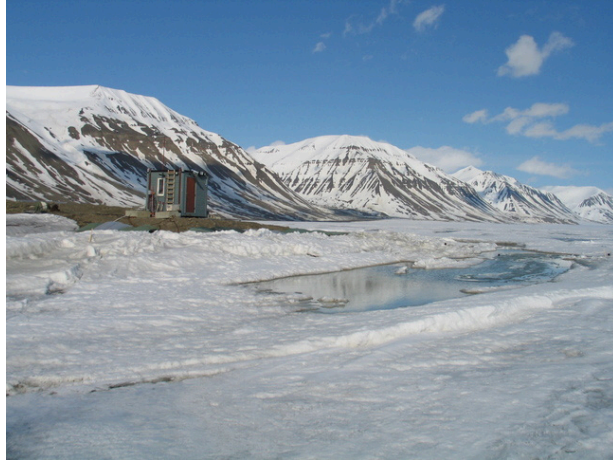
**Sea ice:** the water temperature is  $-0.1\text{ }^{\circ}\text{C}$  at the ice bottom and  $-0.3\text{ }^{\circ}\text{C}$  20 cm right below the ice. The appearance of the sea ice was similar to what it had been 10 days earlier (Figures B.84 and B.85).

Figure B.84: State of the ice at the tip of the breakwater. A tide crack is crossing the picture in the foreground. Sea height = 0.1 m – 31 May 2007 (week 22)

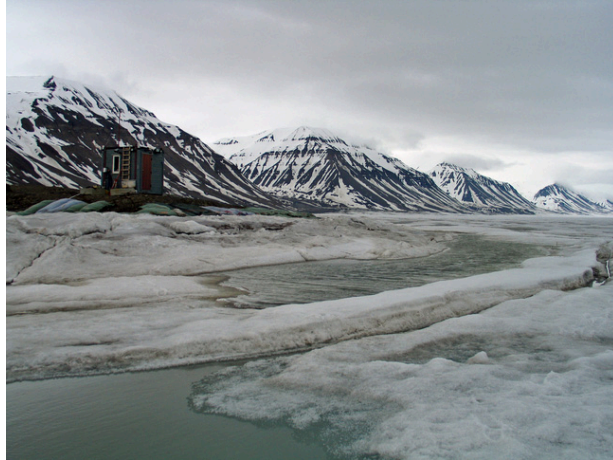
**Sea ice:** the sea ice 50 m away from the breakwater was 43 cm thick. The ice was melting up in situ from the top, the bottom and along the tide cracks, which were widening (Figure B.87). The meltwater ponds were continuing to develop and were merging into small lakes close to the shore (Figure B.88).

Figure B.87: State of the ice at the tip of the breakwater. The tide crack in the foreground was getting wider. Sea height =  $-0.7$  m – 8 June 2007 (week 23)

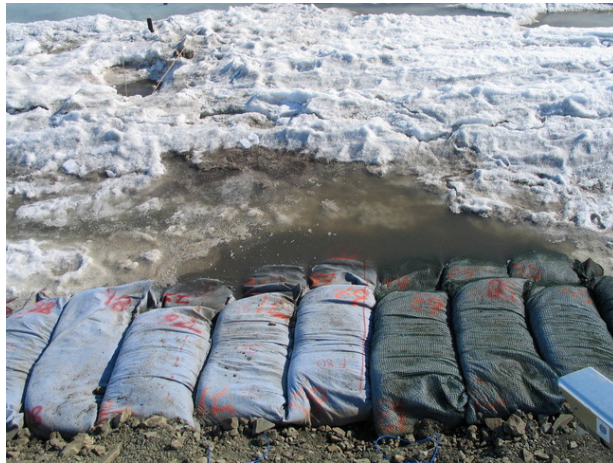
**Bags:** the snow was continuing to melt on the bags and a meltwater pond had formed on top of the ice foot (Figure B.89).

Figure B.89: Meltwater pond on top of the ice foot at the breakwater tip, picture taken from the roof of the cabin - 8 June 2007 (week 23)

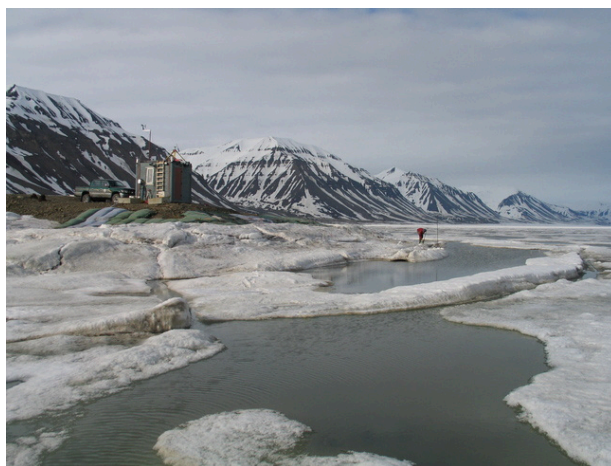
Figure B.91: State of the ice at the tip of the breakwater, sea height =  $-1.0$  m – 12 June 2007 (week 24)

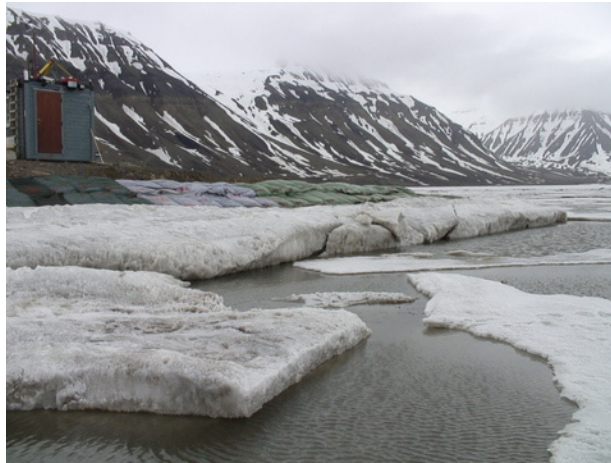
The ice seaward of tide crack 2 broke loose and drifted away during flow, at 10:05 (Figure B.92). Although the ice had broken up around the breakwater most of the ice in Sveasundet was still fast. The zone of unconsolidated ice extended along land in Braganzavågen and stopped at the west corner of the breakwater. Within that zone ice cakes were drifting back and forth with the tide. On the opposite side of Sveasundet a meltwater river was starting to form along Crednermorenen (Figure B.93).

Figure B.92: State of the ice at the tip of the breakwater, sea height =  $-0.8$  m – 13 June 2007 (week 24)

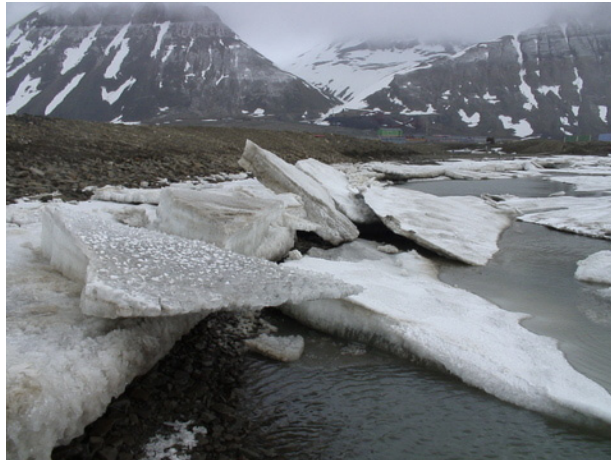
On the east side of the breakwater ice cakes were stranded on the ice foot at high tide (Figure B.94). The ice in the hinge zone was continuing to break apart from the ice foot. Figure B.95 shows the difference between the fixed ice foot (to the left) and the moving sea ice (in the middle). The moving sea ice was melting both from the top and from below.

Figure B.94: Stranded ice cakes, east side of the breakwater, sea height =  $-0.9$  m – 14 June 2007 (week 24)

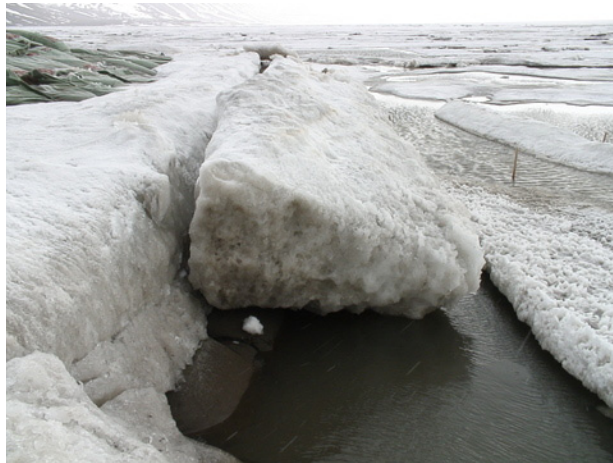
Figure B.95: Ice still attached to the breakwater and crack 1, sea height =  $-0.9$  m – 14 June 2007 (week 24)

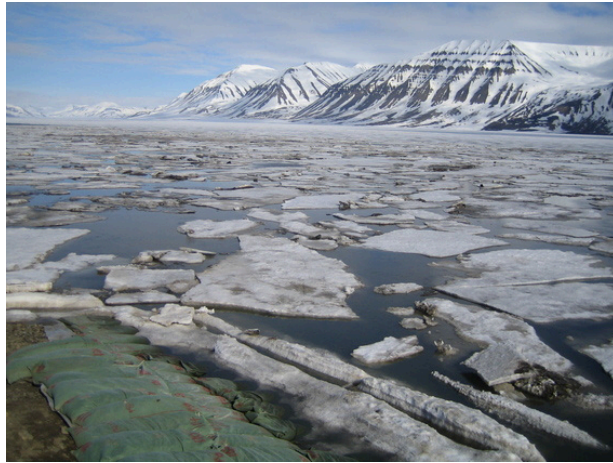
Figure B.97: Drift ice stuck in front of the breakwater during ebb, sea height =  $-0.5$  m – 15 June 2007 17:16 (week 24)

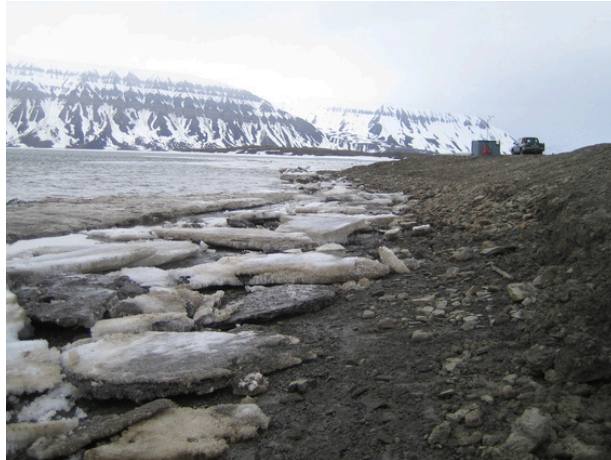
Figure B.99: Stranded ice blocks on the east side of the breakwater, sea height =  $-0.6$  m – 16 June 2007 (week 24)

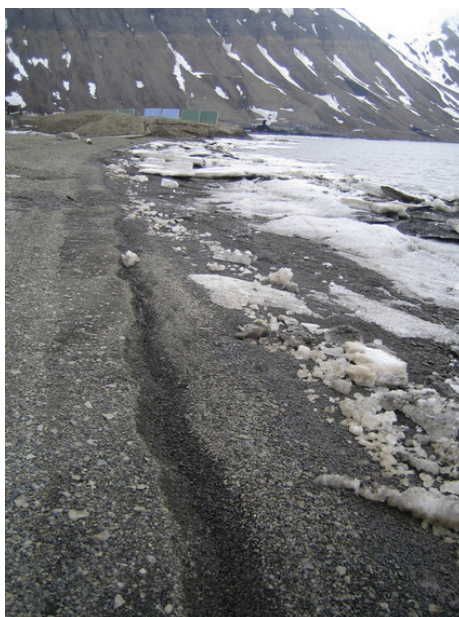
On the east side of the breakwater I observed a peculiar geomorphological feature in the form of a track left on the shore by the ice foot crack (Figure B.102). The track was levelled out after a few tidal cycles though.

Figure B.102: Track left by the ice foot crack on the shore – 16 June 2007 (week 24)

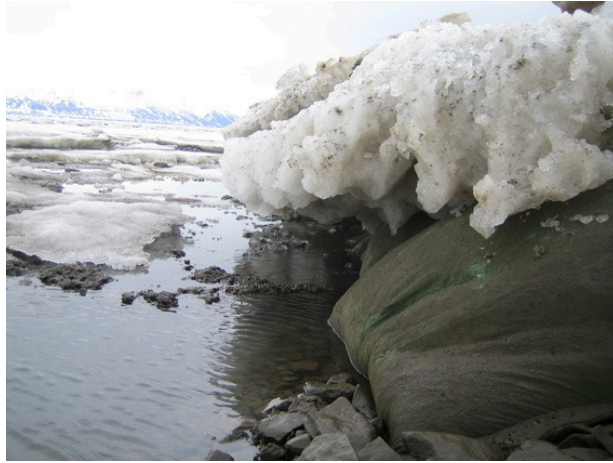
Figure B.103: Bags exposure following the melting of the ice foot, eastern part of the breakwater tip, sea height =  $-0.9$  m – 16 June 2007 (week 24)

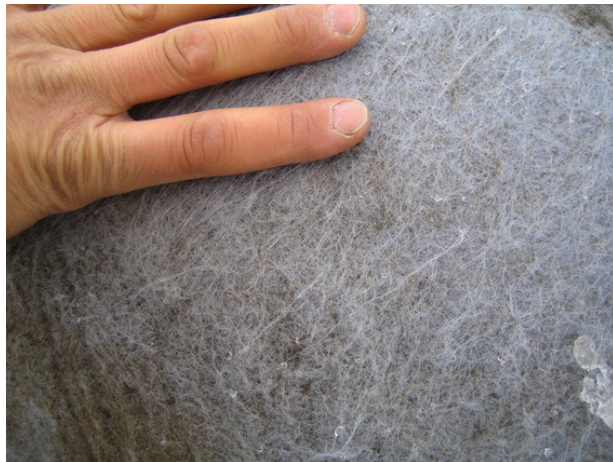
Figure B.104: Elongated fibres on the lower bags on the west side – 16 June 2007 (week 24)

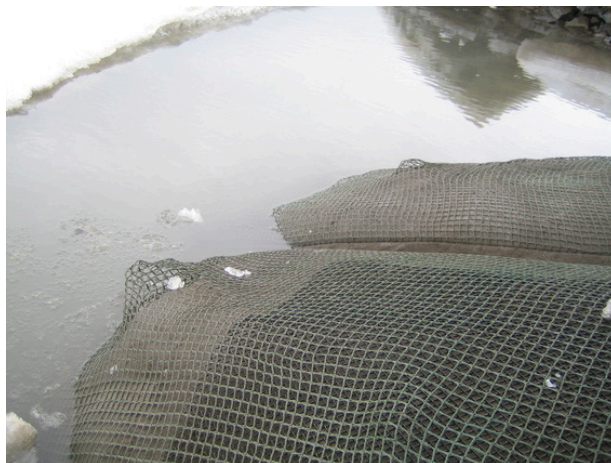
Figure B.106: Deformed protection net at the west corner of the breakwater – 16 June 2007 (week 24)

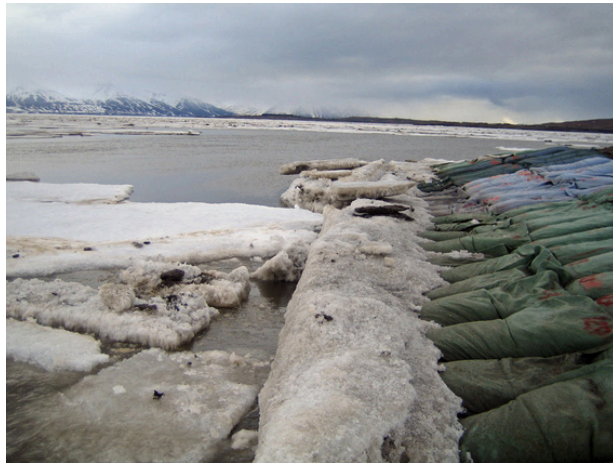
Figure B.107: Drift ice scouring against the lower bags at low tide, sea height =  $-0.6$  m – 16 June 2007 (week 24)

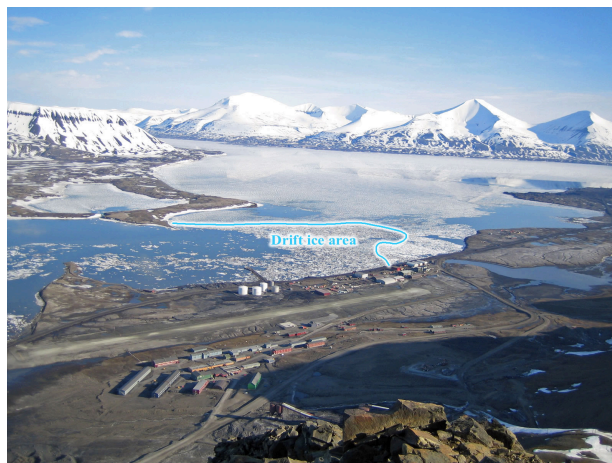
Figure B.108: View of Sveasundet and Braganzavågen from Liljevalchfjellet – 17 June 2007 (week 24)

During ebb the floating ice cakes moved further west for each tidal cycle as the ice was gradually breaking up toward west (Figure B.108). During flow the cakes moved back into Braganzavågen.

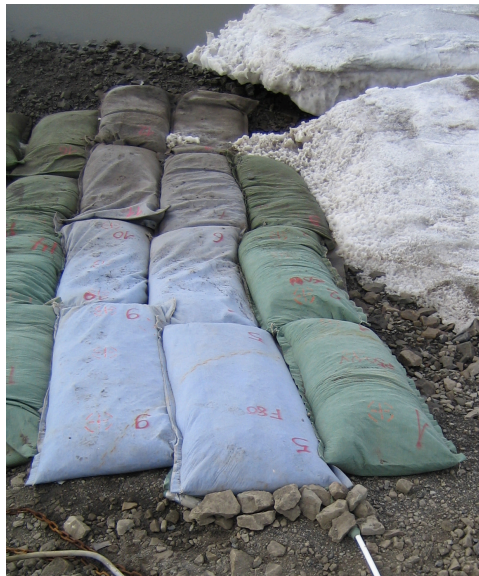
Figure B.109: Bags on the west side of the breakwater, sea height =  $-1.0$  m – 17 June 2007 (week 24)

On the west side of the breakwater the bags were completely ice-free (Figure B.109).

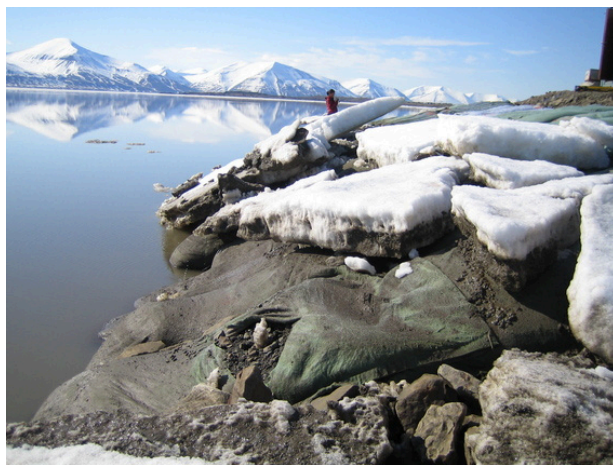
Figure B.113: Damage on bag #150 at the east corner of the breakwater, looking toward west, sea height =  $-1.0$  m – 18 June 2007 (week 25)

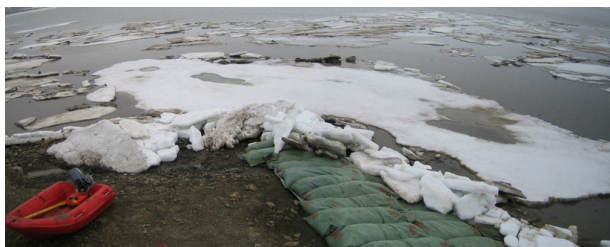
Figure B.115: Ice pile-up in the east corner of the breakwater, sea height =  $-0.8$  m – 19 June 2007 (week 25)

Drift ice had piled up at the east corner of the breakwater (Figure B.115). The weather was unfortunately foggy while the pile-up was taking place, therefore, it is not possible to use the pictures from the cameras on Liljevalchfjellet in the same manner as on 18 June. Pictures taken by one of the video cameras show, however, that the same type of mechanism was responsible for the pile-up and that it started at 06:24, which is 2 hours after high tide. The pictures in Figure B.118 were taken from the video camera and give an idea of how the ice piled up. The biggest piled-up cakes were about 3.6 x 1.2 m in horizontal dimensions and 30 cm in thickness.

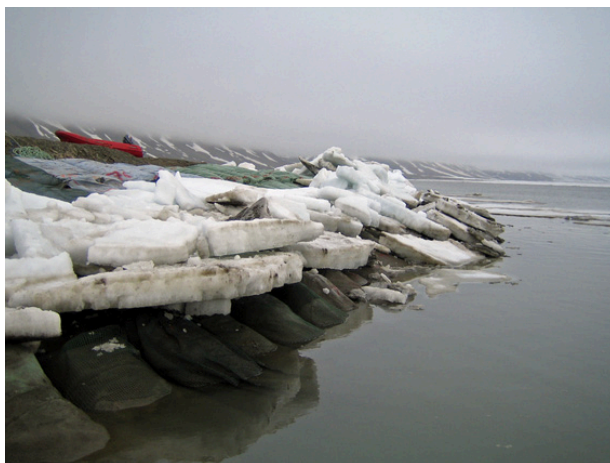
Figure B.116: Ice pile-up at the tip of the breakwater, sea height =  $-1.0$  m – 19 June 2007 (week 25)

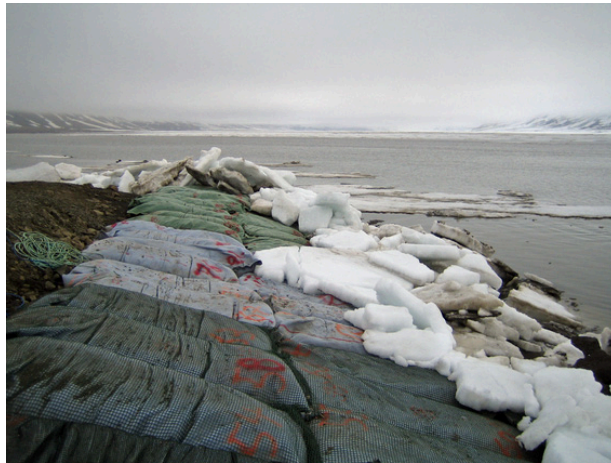
Figure B.117: Ice pile-up at the tip of the breakwater, sea height =  $-1.0$  m – 19 June 2007 (week 25)

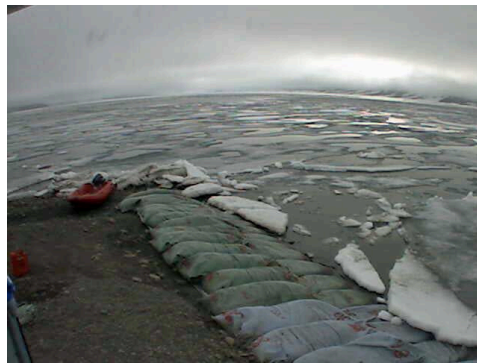
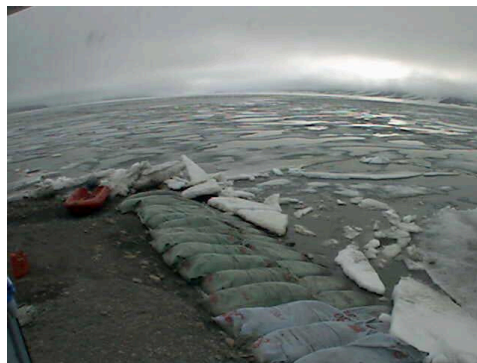
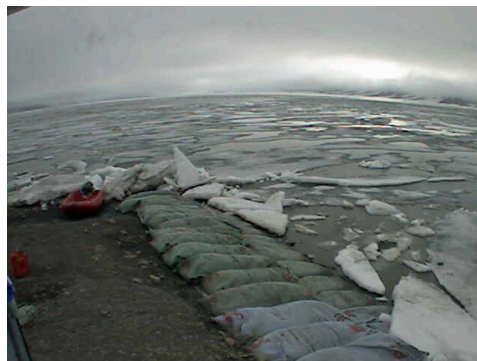
Figure B.118: Ice pile-up at the eastern corner of the breakwater, sea height = 0.0 m – 19 June 2007 (week 25)

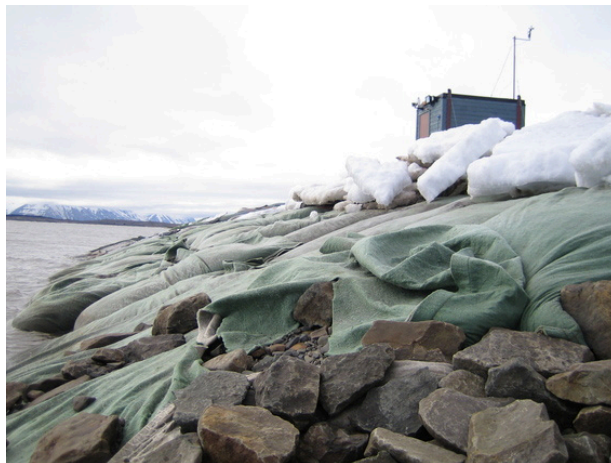
Figure B.119: Breakwater tip, looking toward west, sea height =  $-0.9$  m – 21 June 2007 (week 25)

The piled-up ice was washed away at high tide up to the top of the third row of bags (Figure B.119). During the pile-up bag #150 was damaged further, probably by stones displaced by the ice from the corner of the breakwater (Figure B.119).

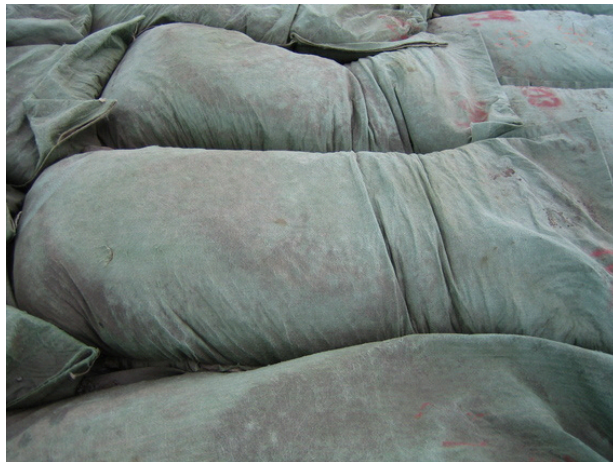
Figure B.121: Deformed bags in the third row – 21 June 2007 (week 25)

Masses in the bags from the lower row had moved from the center of the bags to their bottom under the action of the ice rotating along crack 1. Therefore, the bags had become peanut-shaped: both ends were thicker than the middle, the lowest one being the thickest. The shape was so pronounced that the fabric in the middle of the bag was stretched like a drumhead. Bags on the third row were deformed as well, albeit in a different manner: while the lowest bags were thinnest in the middle, the bags in the third row had more of a pear shape with the thickness linearly increasing from the top to the bottom.

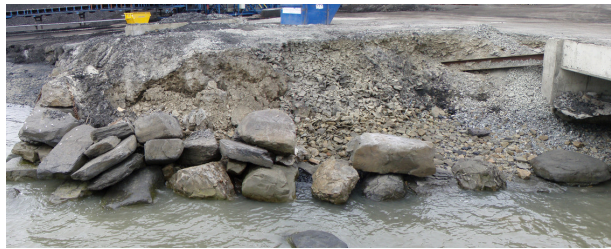
Figure C.1: Shore protection attempt with low-quality, local rocks at Kapp Amsterdam – 17 July 2007

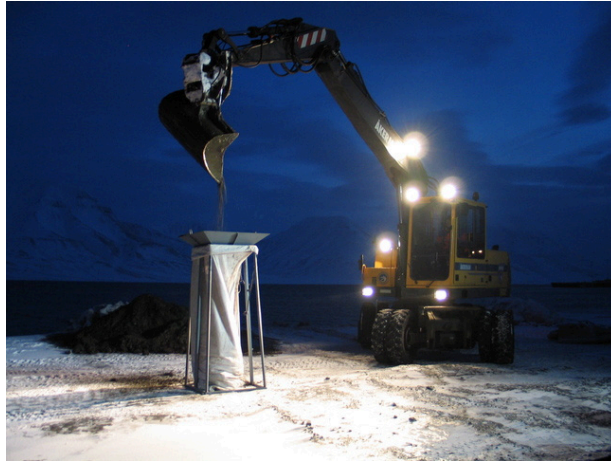
Figure C.3: Filling of a bag in Longyearbyen

The filling method needed improvement. It was difficult to remove the frame from the bag. It is also important to avoid sharp edges: the section of the funnel was square and its corners perforated some of the bags.

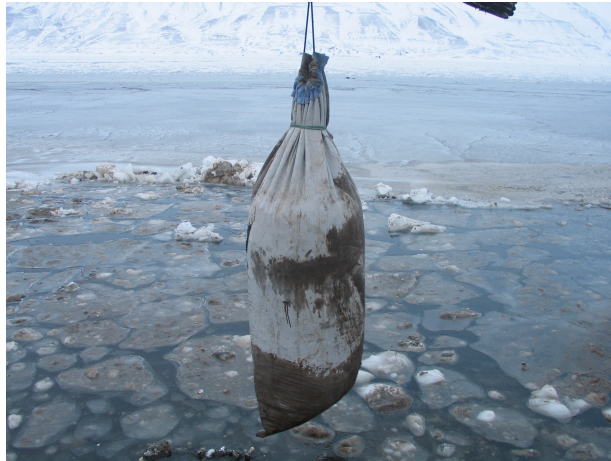
Figure C.4: Placement of a bag in Longyearbyen – 2 March 2005

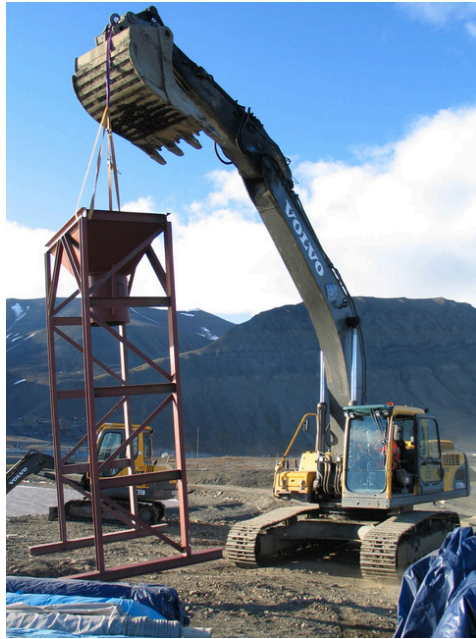
Figure C.7: Elevated funnel used to fill the bags at Barryneset

The masses were dumped from approximately 5 m above the ground. Therefore, the first load probably pinched the bottom of the bags, especially if it contained rocks. I never saw any damage with the naked eye, though.

Pinching also occurred higher up on the bag during filling. The box containing the bag was, in fact, too narrow. When vertical, the side closest to the excavator was below the funnel opening and the fabric was pinched between the top of that side panel and falling masses. In addition, when filled to the top, the bag was overflowing, like the belly of a fat person over his belt, which made it difficult to sew it at the top. The workaround we used was to tilt the box a little so that the masses would hit the opposite side instead. Since that side was longer, and its top above the bottom of the funnel, the masses were hitting

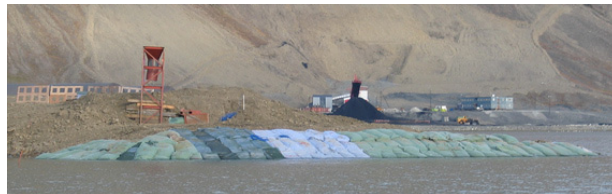
Figure C.8: View of the breakwater after installation of the geosynthetic bags

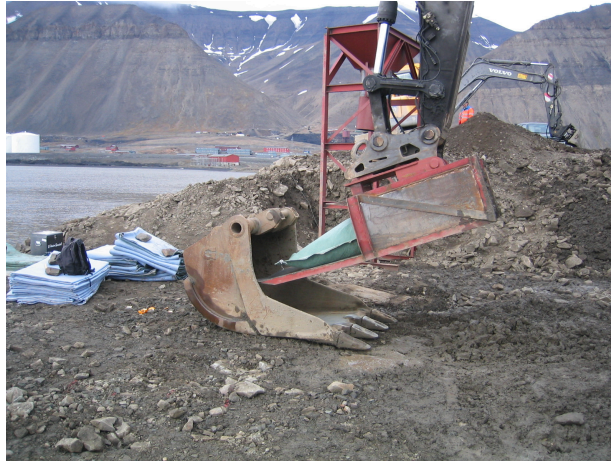
Figure C.11: Transferring a bag from the box to the bucket

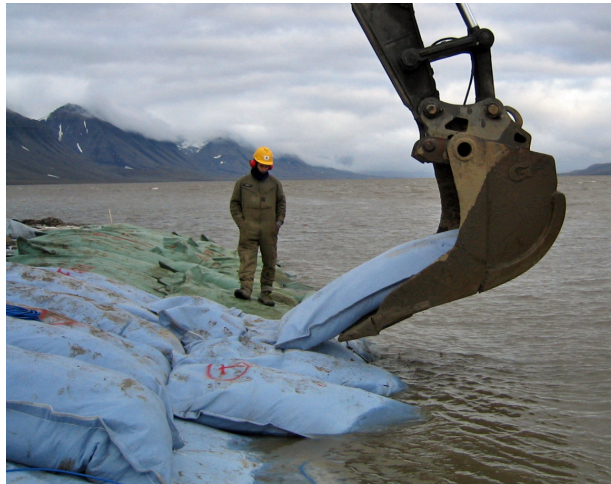
Figure C.12: Installation of a bag

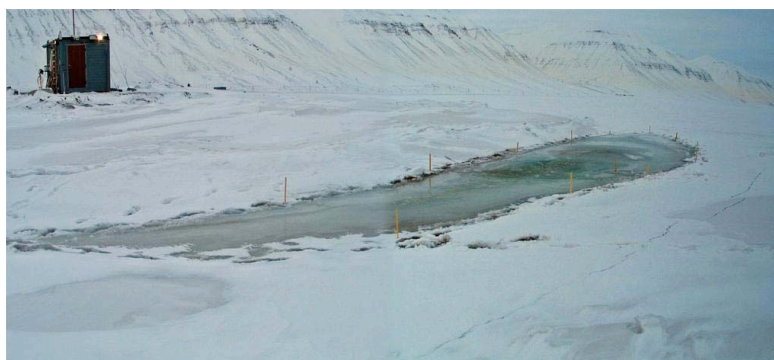
**Figure 2.** Pond of surface water close to shore that refreezes on top the coastal ice

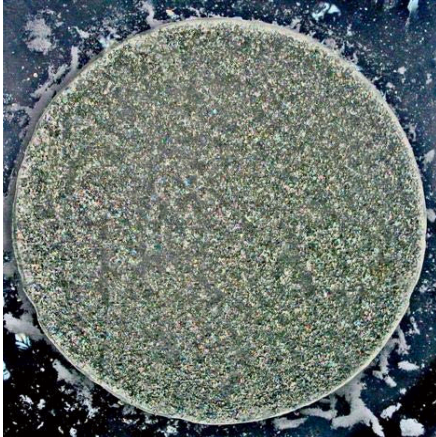
**Figure 3.** Vertical thin section of P1-H1

In the coastal ice the size of the crystals compared to the diameter of the samples varies from very small (factor 100) to small (factor 10) as seen in Figures 3 and 4. The unequal grain size originates from the ice formation. Core P1-H1 represents ice formed by snow that gets soaked in sea water at high tide. At low tide the brine is drained, and this causes the ice to be low-saline and very porous. Core P4-H3 represents ice formed directly from sea water.

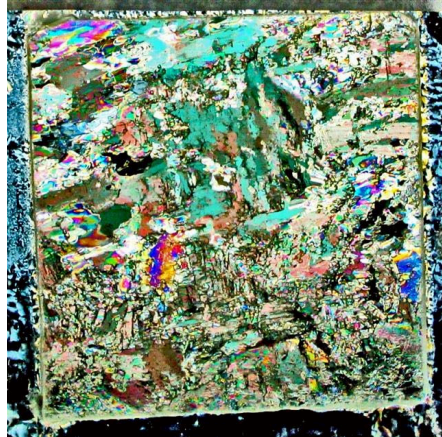
**Figure 4.** Horizontal thin section of P4-H3
