Improved Cycle Facility Design at Intersections

Miroslav Vasilev

Civil and Environmental Engineering

Submission date: June 2014

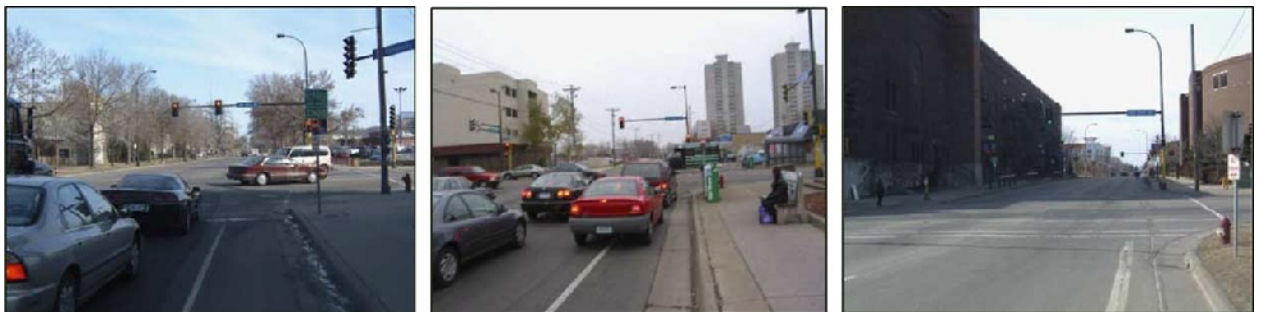
The group of ‘intersection inconsistencies’ consists of discontinuities where the bicycle lane is terminated because of a huge junction (Fig. 2). In such cases the cycle lane is usually on the right-hand side of the road but dissipates after the intersection because of many reasons such as automobile parking, a street with a different layout or not enough space.

Fig. 2. – Examples of intersection inconsistency²

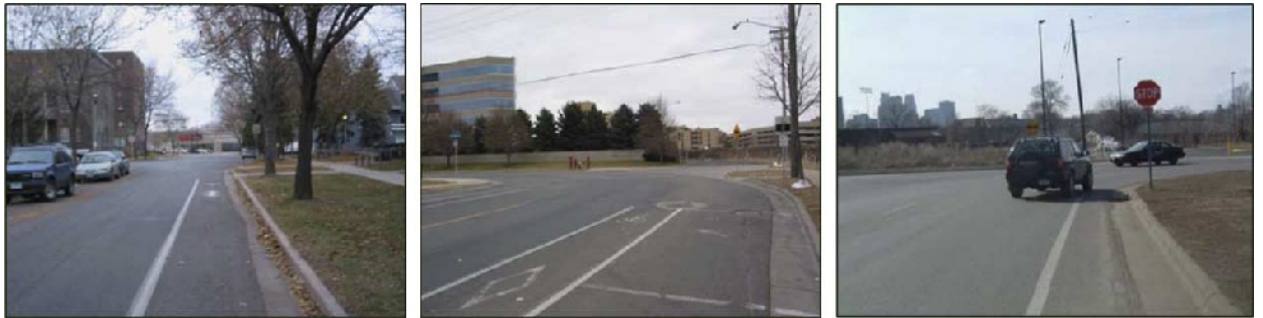
The third category – ‘lapsing lanes’ – are those that usually terminate under relatively favorable conditions and provide wide enough lanes to ride in mixed traffic (Fig. 3).

Fig. 3. – Examples of lapsing lanes³

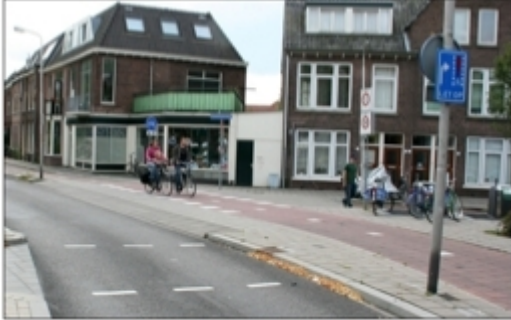
Exit Constructions are used at unsignalized priority intersections between an arterial street, with an outside parallel cycle track, and a local street. Exit Constructions are designed to provide a safer passage for cyclists and pedestrians over the side street without changing grade (Fig. 4). They are supposed to enforce lower speeds for traffic on the intersecting carriageway.

Fig. 4. – Exit Construction⁴

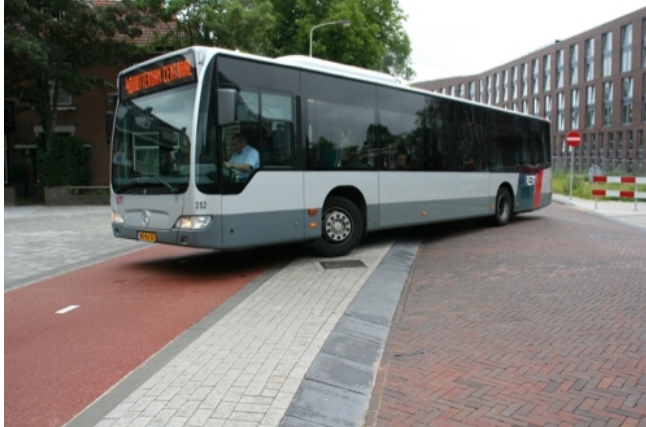
During their observation of raised crossings in the Netherlands, Furth et al (2011) noticed that buses were not impeded from normally passing through these facilities. In Delft Exit Construction style crossings with a grade of 25 percent are used on many bus routes (Fig. 6). To be able to go over it public transport buses should significantly reduce their speeds which has a positive effect on cyclists' safety.

Fig. 6 – A bus slows down to safely negotiate its way over an Exit Construction⁶

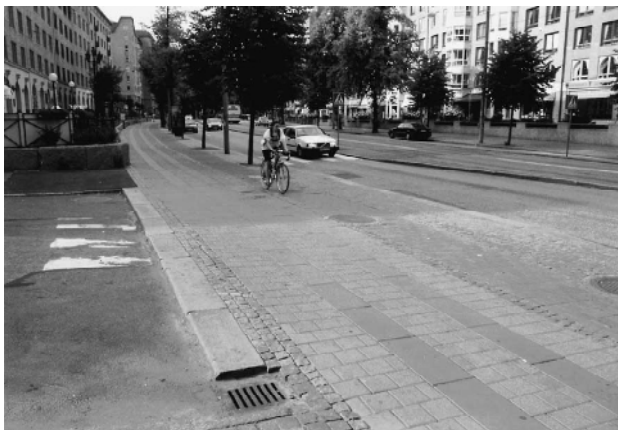
Gårder et al (1998) developed a before-and-after methodology to estimate the effect on cyclists' safety of raising urban cycle crossings by 4 to 12 cm. Four of all 44 reconstructed intersections in Gothenburg were studied in detail. All the cycle paths run parallel to arterial streets and the raised crossings were all across minor streets (Fig. 7). Before the implementation, bicycle paths had ended with short ramps or curb cuts at each cross street, and cyclists had used conventional crossings. Gårder et al used information on accidents from hospital-reported database for the period 1988-1996. Broad cycle flow counts were performed at two of the sites and at two control sites for two weeks before the implementation and two weeks after. Study of the safety perceptions of the cyclists at the intersections before and after the implementations was also undertaken. A survey on bicyclists' safety was sent to 22 experts from different countries. Video recordings were also applied to gather information on cyclists' behavior.

Fig. 7. – Raised crossing⁷

As a result of the before-and-after study it was found that 50 percent more cyclists used the paths after the implementation of the raised crossings. It was also found that the safety per bicyclist was improved by around 20 percent because of the increase in bicycle traffic and with another 10 to 50 percent due to the improved design. Application of statistical methods showed that the highest probable consequence of an elevated cycle crossing is a risk reduction of approximately 30 percent compared with the before situation with a standard cycle crossing.

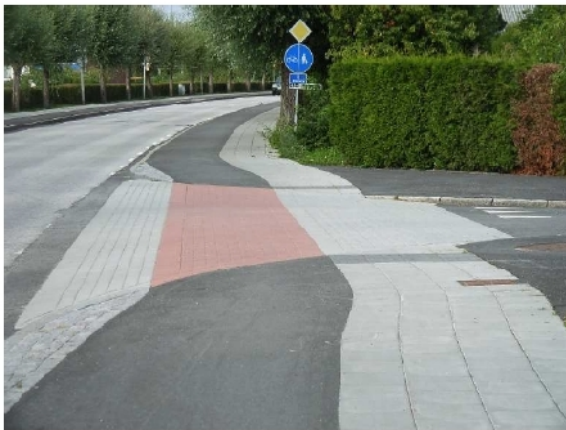
It was concluded that this kind of layout for crossings had the potential to improve cyclists' total traffic safety. One possible approach towards achieving the above was to visualize the right of way regulation – by traffic signs at the cycle paths, for example.

Fig. 8. – Colored and raised cycle crossing⁸

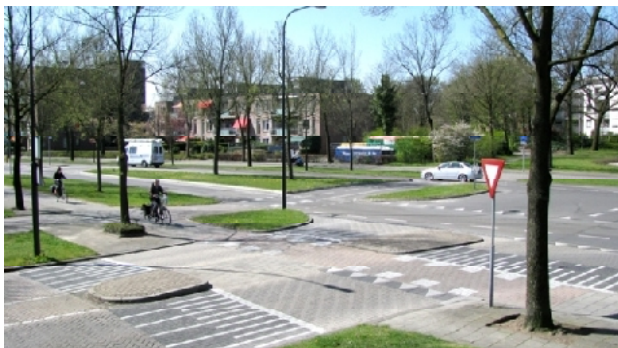
A study undertaken by Schepers et al (2011) examined the safety of cyclists at unsignalized priority intersections within urban areas. The main point of interest was the connection between the design features of the junctions and bicycle-motor vehicle crashes. During a four-year period of observation of the study intersections, 339 failure-to-give-way collisions with cyclists were registered. As a result of the study it was found that the most efficient way to enhance the safety of cyclists at intersections is the implementation of speed-reducing facilities for drivers leaving or entering the main road, such as raised crossings.

Fig. 9. – Well marked, reddish colored, raised bicycle crossing⁹

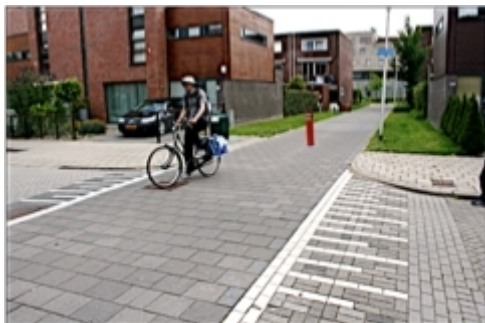
The other type of raised crossing is Speed Table (Fig. 10). They are flat-topped speed humps long enough for the entire wheelbase of a passenger car to rest on top. Speed Tables are applied when a cycle track or a pedestrian sidewalk intersects with a carriageway at a right angle. They are applied in order to lower motorists’ speeds on streets where cyclist and pedestrian movement occurs, regardless of who has right of way (Furth et al, 2011). Street markings are used to show the driver that there is elevation. Brick or other textured materials increase visibility, and may enhance safety and speed reduction. According to (Furth et al, 2011) in the Netherlands Speed Tables are applied even when the cyclists do not have priority on the cycle track just to enhance the safety of the self enforcing traffic calming.

Fig. 10. – Speed Table¹⁰

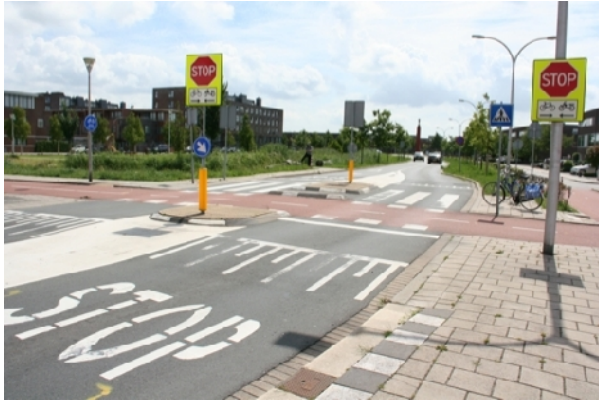
Fig. 11. – Speed Table in Delfgauw (a Dutch village)¹¹

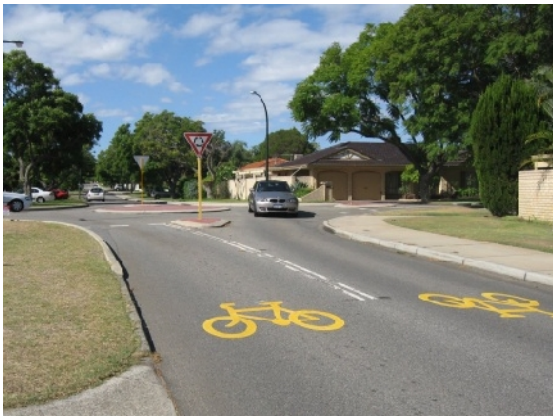
Another modification of this design solution is to add advisory pavement markings or 'sharrows' in the traffic lanes of the approaches and in the circulatory area of the roundabout to enhance mixing between the modes (Wilke et al, 2014). An example of this variation is shown in Figure 13. According to Wilke et al, there is strong evidence that such markings can be effective and are recommended where speeds are equitable. They have found that cycle lanes on the approaches should terminate some distance behind the holding line where speeds are low. It is advisable in such cases that the width of the approach lanes does not exceed 3.0 meters so that the drivers do not attempt to enter the roundabout alongside cyclists (Wilke et al, 2014).

Fig. 13. – Roundabout with advisory lane markings¹⁴

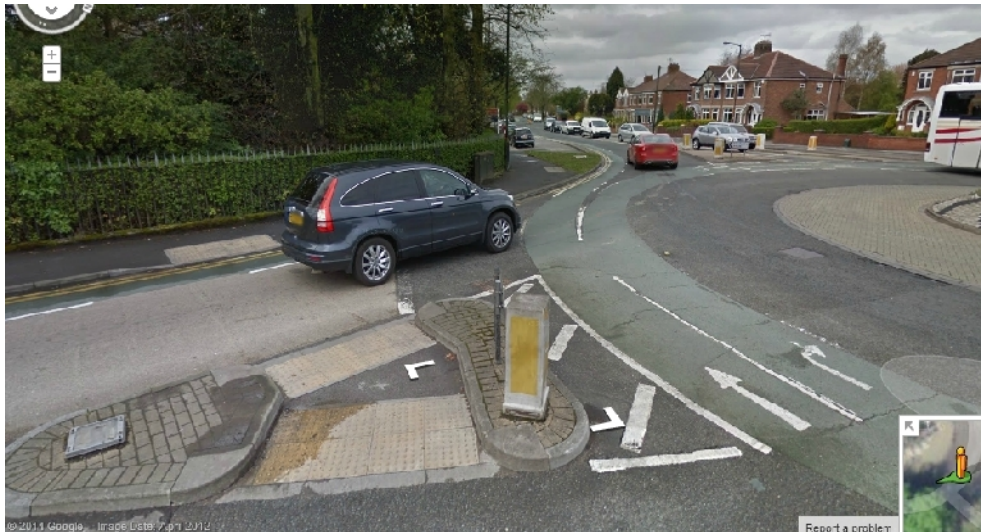
2003. Having in mind the design of this roundabout it can be hypothesized that placing cycle lanes in a roundabout should only be done if the geometry of the intersection is changed in a way that it reduces the speed of the motorized transport users.

Fig. 15. – Continental-style roundabout with cycle lanes at Heworth Green in York, UK

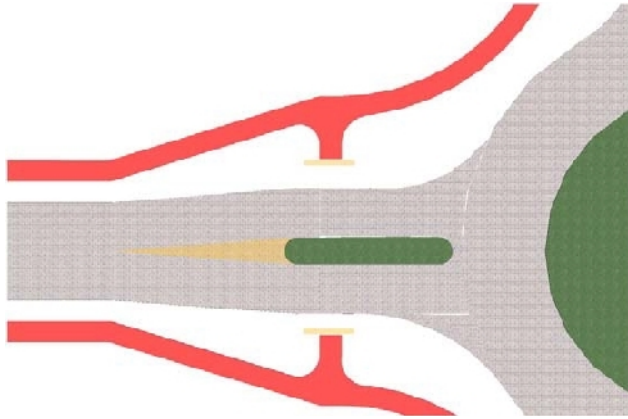
The fourth design solution for accommodating cyclists in roundabouts is called 'grade separated roundabout (Fig. 18). This design allows cyclists to pass under the approaches of the roundabout and thus avoiding any conflicts with the motorized traffic.

Fig. 18. – Roundabout with grade-separated cycle path¹⁹

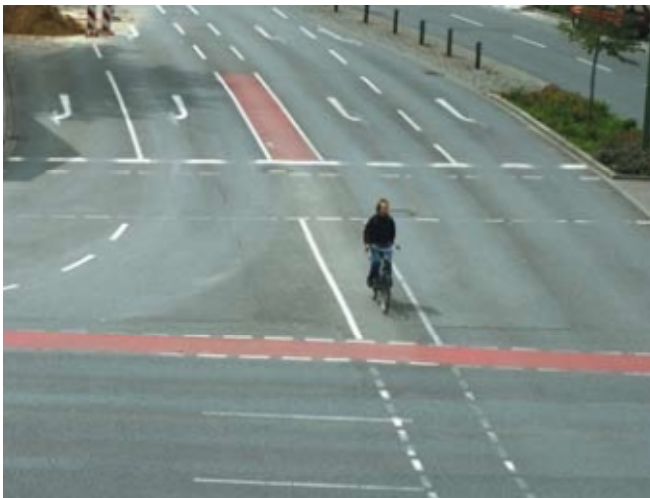
At huge junctions, on-street cycle lanes are dashed in order to lead cyclists through the intersection (Fischer et al, 2010). A dashed line is supposed to identify the zone of potential conflict from turning vehicles and straight-travelling riders (Faichney, 2002). This kind of pavement treatment was implemented for example in Osnabruck, Germany as it is shown in Figure 19.

Fig. 19. – Dashed cycle lane in Osnabruck, Germany²⁰

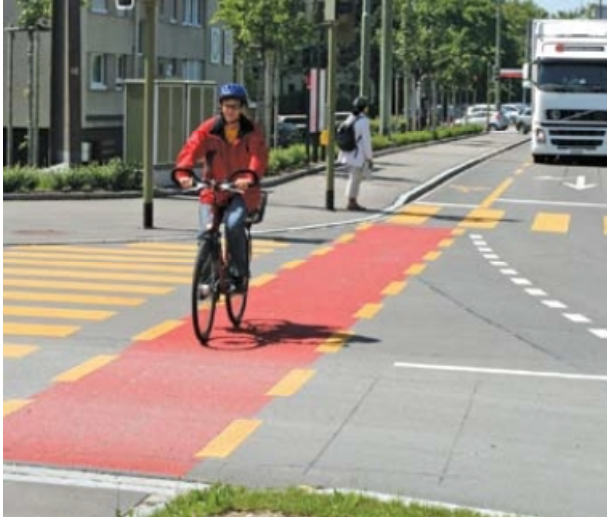
Fig. 20. – Colored bike lane²¹

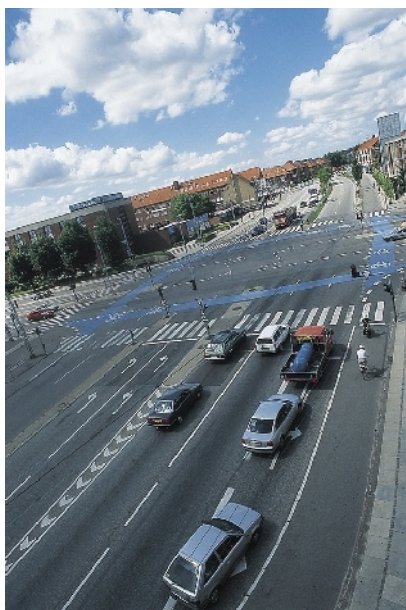
Fig. 21. – Intersection in Copenhagen with four blue cycle crossings²²

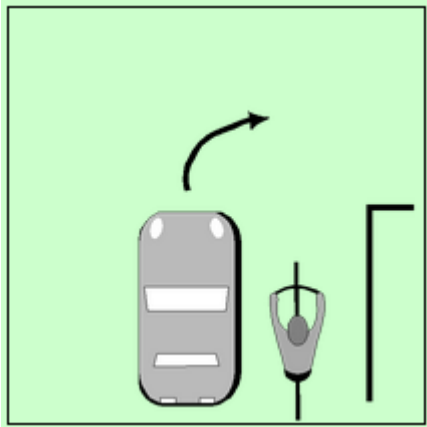
scenario where a bicyclist that wants to turn left at a junction provisioned with a bicycle lane tends not to merge to the left far enough in advance or at all. Another problem situation is when motorists turning right across a bicycle lane. In such cases drivers can improperly wait to allow bicyclists to overtake on their right and by doing so they cut off following vehicles and forming puzzling situation for cyclists. A bicycle lane encourages cyclists to overtake motorists on the right side and to go to the front of the queue. According to Wayne Pein (2000) this is very dangerous and leads to many right hook collisions (Fig. 24). Wide curb lanes also enable bicyclists passing on the right side, but it is not as formally regulated as with cycle lanes.

Fig. 24. – Right hook

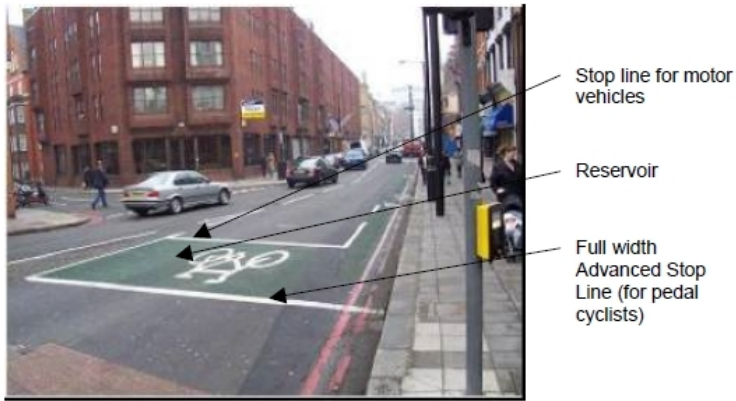
Their design is intended to place cyclists ahead of motorists during red signal allowing them to enhance their conspicuity being in the direct field of vision of drivers and to acquire a more comfortable position for taking turns. An additional stop line, dedicated to cyclists is situated right behind the crosswalk while the traditional stop line for motorists, is pulled back from the intersection. The area between the two stop lines is approximately 5 meters deep and is called an ASL reservoir (or a bike box) and is usually marked with a bike symbol on the pavement (Fig. 25). A feeder lane or a gate is provided for them to reach it when a queue of vehicles is formed. The pavement on the reservoir and the lead-in area is sometimes colored in green, red or blue to increase the attentiveness of the traffic users and to reduce the encroachment by motorists. When cyclists are ahead of the other traffic at red signal they are given the opportunity to leave the intersection first when the signal changes. This allows them to avoid the danger of being hit by right turning vehicles when moving straight ahead or by straight moving vehicles when turning left. This makes the solution extremely valuable where there are frequent turning conflicts. A solution, practiced a lot in the Netherlands, is to install a separate signalization for cyclists so that they can have earlier green signal. Another positive feature of positioning cyclists in front of the motorized vehicles is that riders are given the opportunity to wait without being directly exposed to the exhaust fumes.

Fig. 25. – Full width ASL²⁵

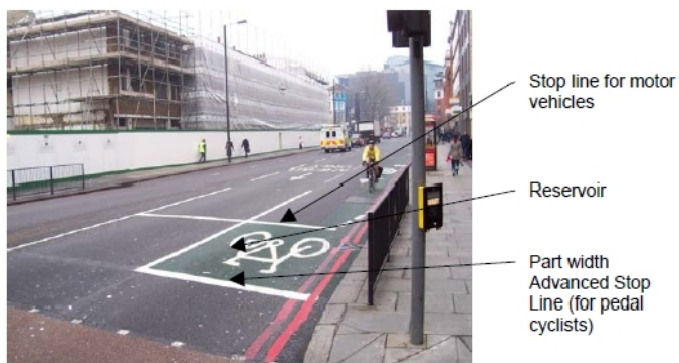
- Reduced encroachment of the area by vehicles;
- Reduction of the used space;
- Discouragement of bicyclists from taking risky maneuvers in the off-side of the carriageway when they are not necessary.

Fig. 26. - Part Width ASL²⁶

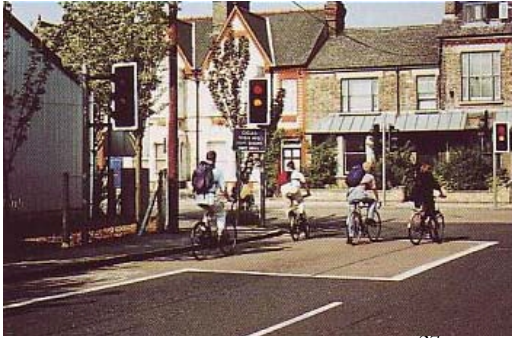
Fig. 27. – Mandatory feeder lane²⁷

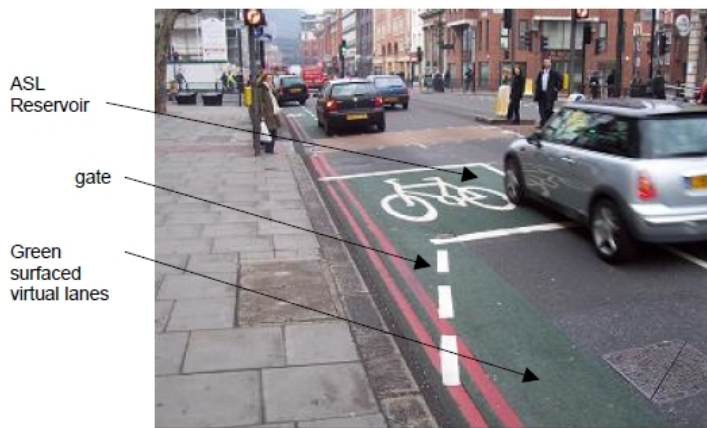
If the space is limited and a feeder lane can't be installed, a stub feeder lane or 'gate' can provide access into the ASL reservoir. Gates are diagonal access markings (Fig. 28).

Fig. 28. – A gate and a Virtual Cycle Lane²⁸

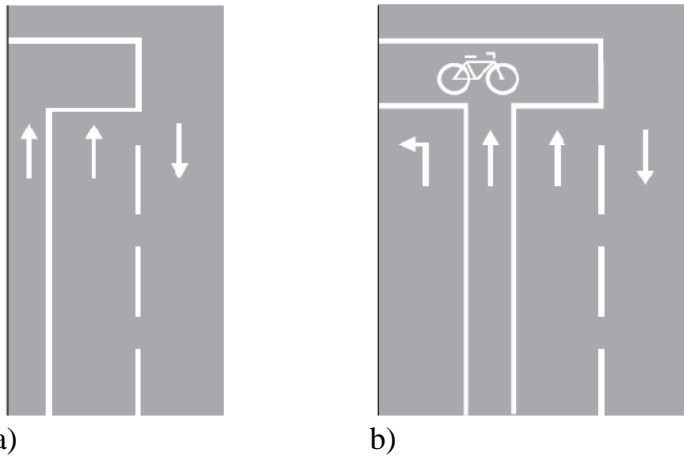
A study of the effect on capacity of Advanced Stop Lines, was undertaken by Wall et al (2003). A signal-controlled junction modeling computer program was utilized together with before-and-after video surveys. Five different theoretical before-and-after scenarios involving the installment of an ASL with either a nearside or a central cycle lane were studied (Fig. 30).

a) b)
 Fig. 30. – Two variations of Advanced Stop Lines: a) ASL with a nearside cycle lane, b) ASL with a central cycle lane³⁰

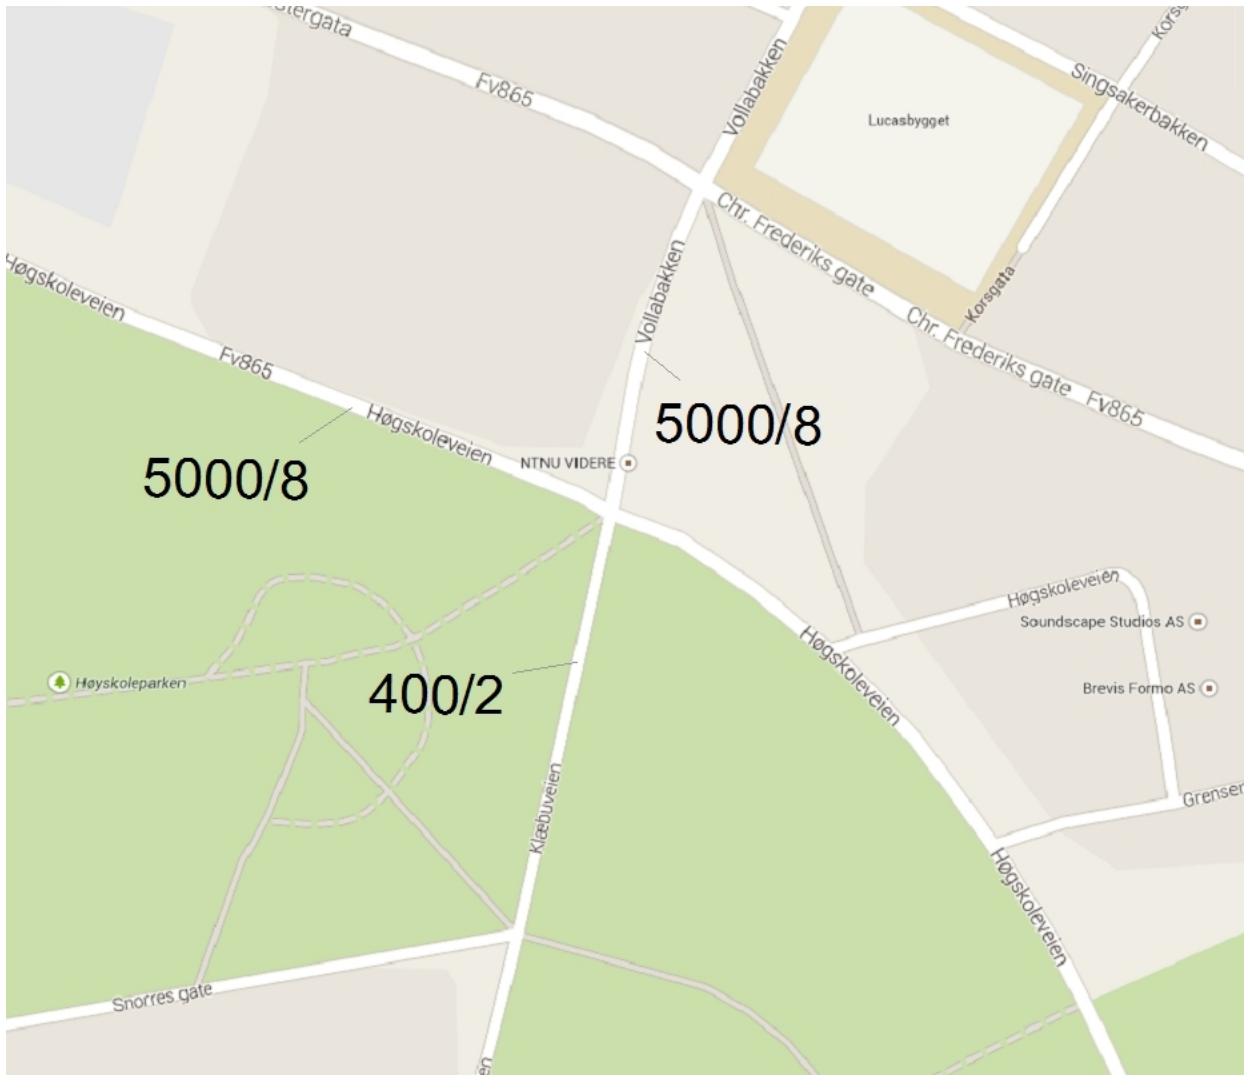
Fig. 63. AADT volumes on the regular intersection

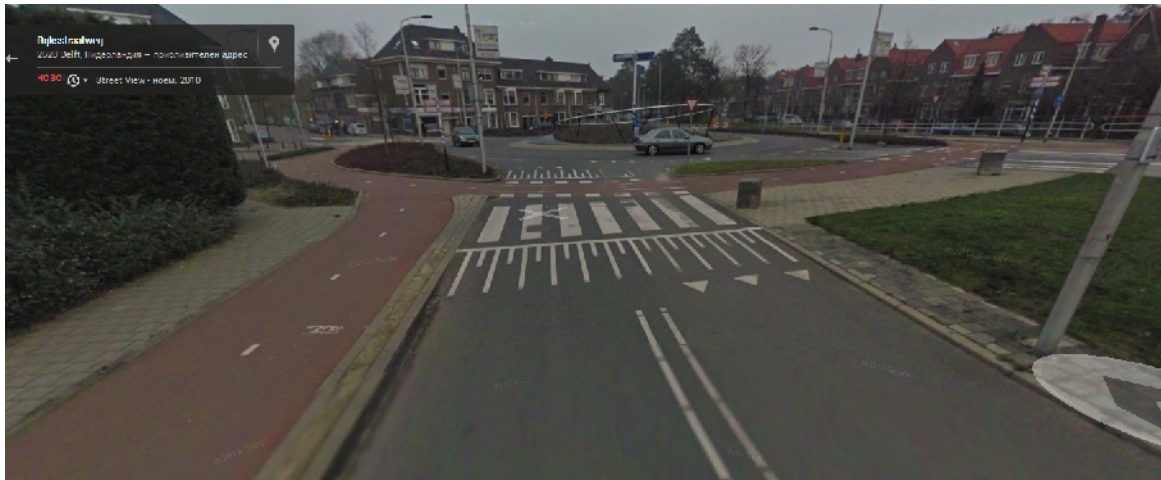
Fig. 74. Roundabout with a raised crossing in Delft, The Netherlands
