Railway Ballast Characteristics, Selection Criteria and Performance

Thesis for the degree of Philosophiae Doctor

Trondheim, September 2014

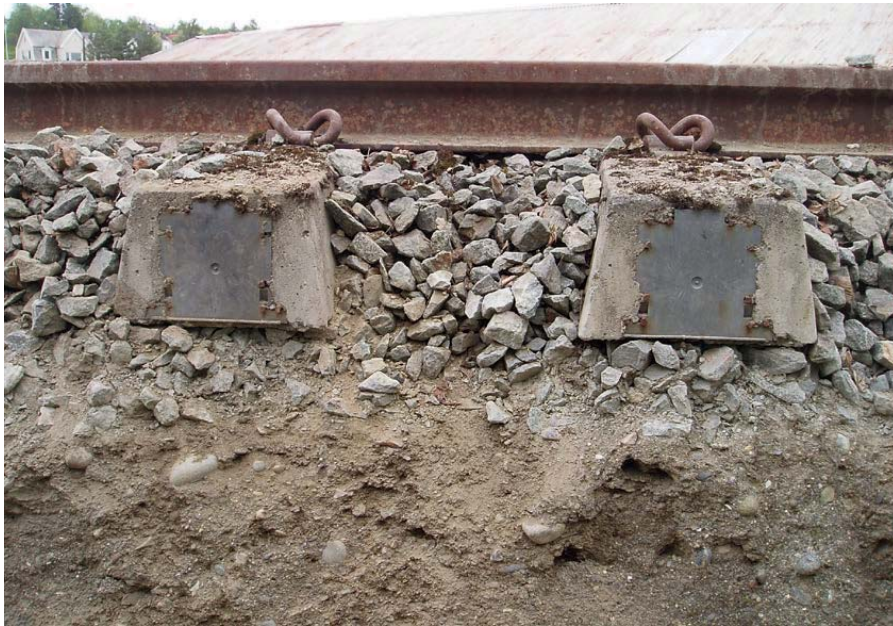
Figure 1.3. Fouled ballast on Stavne-Leangen Line near Trondheim.

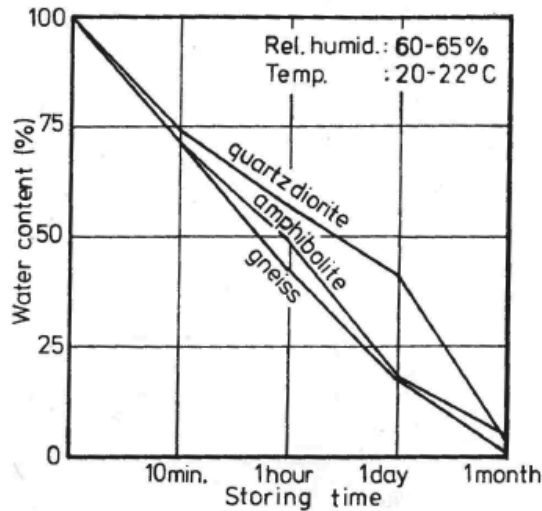
Figure 2.4 Water content in rock cores as a function of storing time in a laboratory environment with relative humidity of 60-65 % and temperature of 20-22 °C (Broch 1974).

Hence, in this project test sample materials prepared for dry state testing (the Los Angeles abrasion test, the Point Load test, the cyclic triaxial test and the full scale rail track model test) were all dried at room temperature. But this procedure requires that the storage time is longer than one day. An investigation conducted by Broch (1974) showed that necessary drying time to obtain 0 % water content is minimum one month (Figure 2.4).

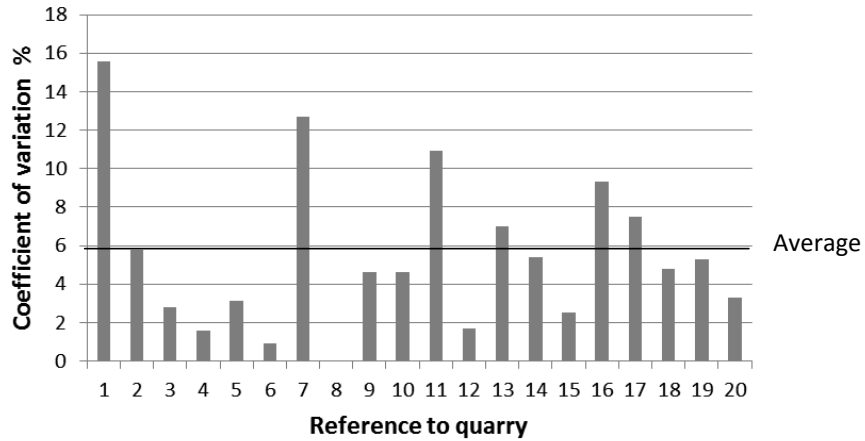
Figure 2.6 Coefficient of variation (COV) for Los Angeles abrasion values (modified after Cuelho et al. 2007).

Cuelho et al. (2007) examined 20 gravel aggregates according to ASTM C131-06 (maximum particle size less than 37.5 mm and sample weight 5000 g) and found that the average COV was 5.8 % with a variation range between 0.9 and 15.6 % as shown in Figure 2.6. Three or more (up to fifteen) repeated tests were conducted for the Los Angeles abrasion test, and average LAA value was 27.3 %.

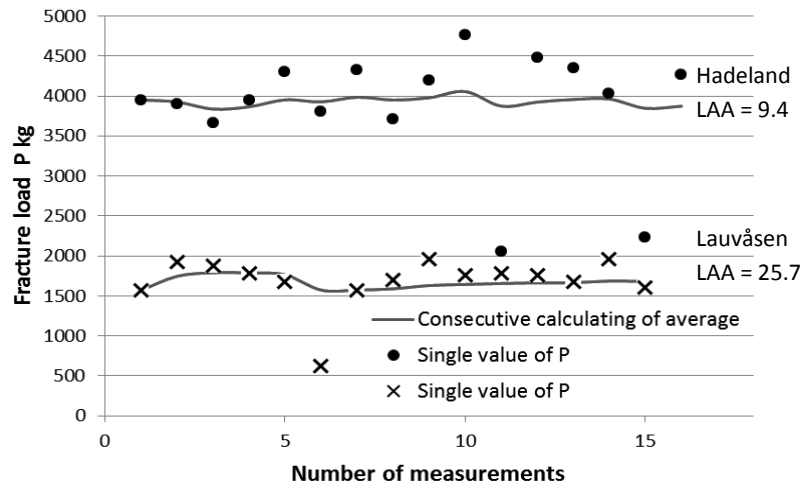
Figure 2.9 Example of calculation of arithmetic value of fracture load P for two rocks as a function of number of measurements. Core diameter D was 50 mm. LAA values relate to fraction 31.5-50 mm.

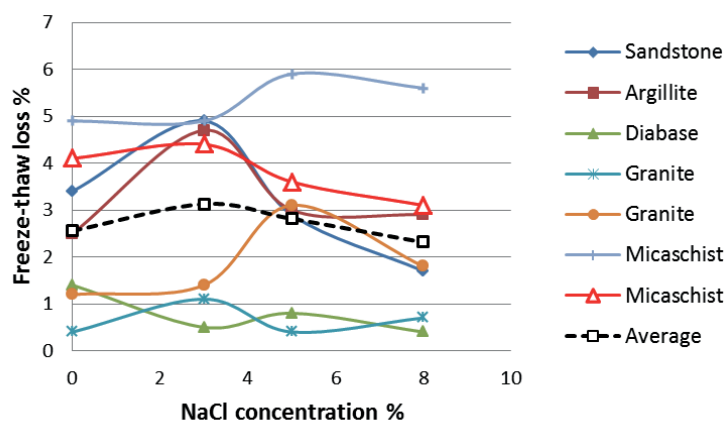
Figure 2.10 Correlation between sodium chloride concentration and freeze-thaw degradation (weight loss), modified after Verbech and Klieger 1957.

The freeze-thaw test with NaCl solution was conducted according to standard specification which says 1 % NaCl. However, an investigation by Verbech and Klieger (1957) on frost resistance for 25 rocks with test fraction 4.5/19.5 mm, ten freezing cycles (ten times 24 hours) and four different NaCl concentrations (0, 3, 5 and 8 %) found that the strongest impact from NaCl occurred with concentrations between about 2 and 6 % as shown in Figure 2.10.

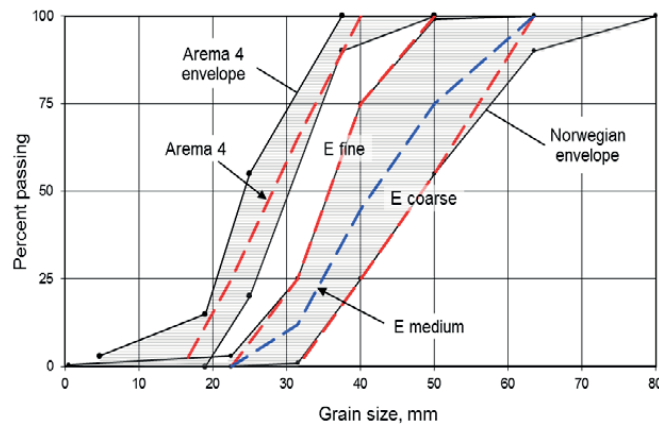
Figure 3.1. Ballast grading curves employed in the large scale triaxial tests and the full scale rail track model test.

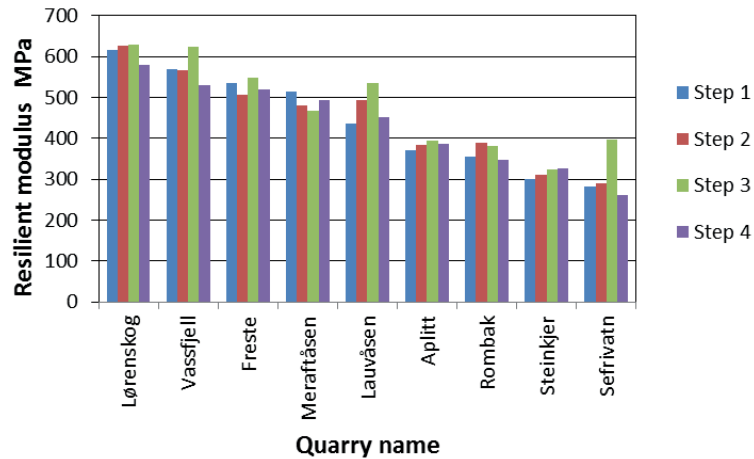
Figure 4.1 Elastic properties (dry state) to nine different rock types. Number of loadings are 1 million for each step.

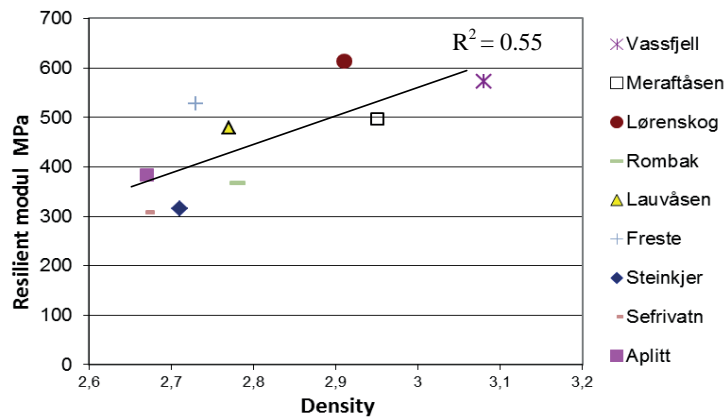
Figure 4.2 Relationship between ballast elastic property and rock density

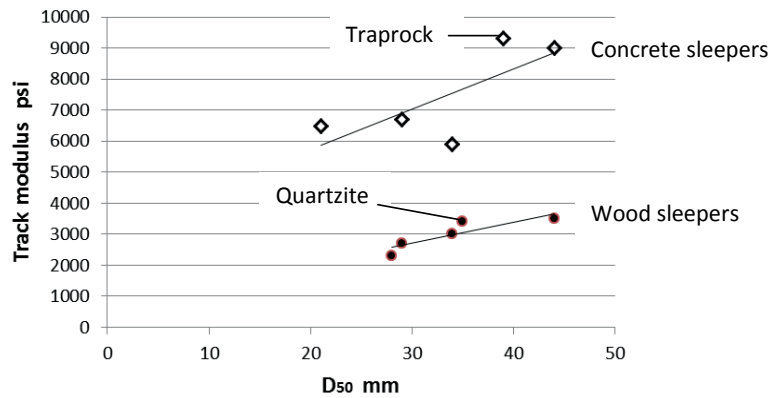
Figure 4.5 Variation in track modulus with ballast particle size. Regression coefficient R^2 for concrete sleepers is 0.55 and for wood sleepers 0.77. Test materials are different types of granite with two exceptions. 1 psi = 6.89 kPa. Modified after Bosserman 1981.

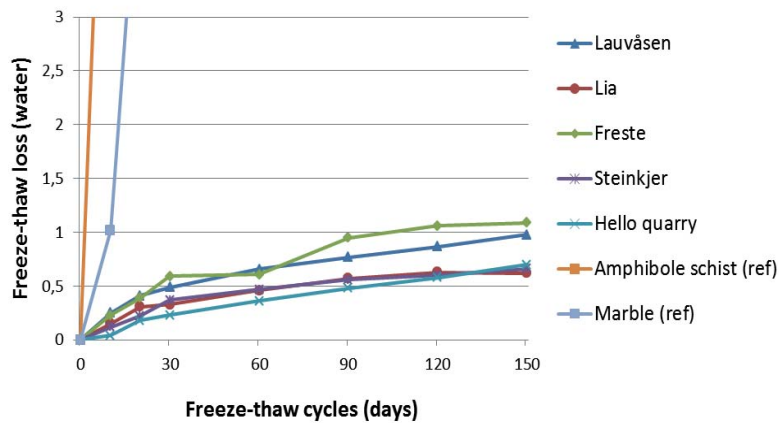
Figure 4.15 Example of long term recording of frost resistance of Norwegian rocks (water). Freeze-thaw loss in % of dry weight. Fraction 8/16 mm and 1 kg sample weight.

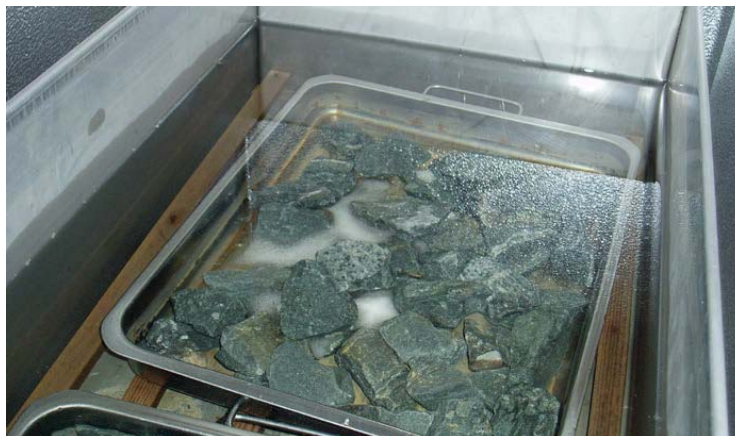
Figure 4.20 Thawing phase of the test. Test material was soaked in water during both freezing and thawing.

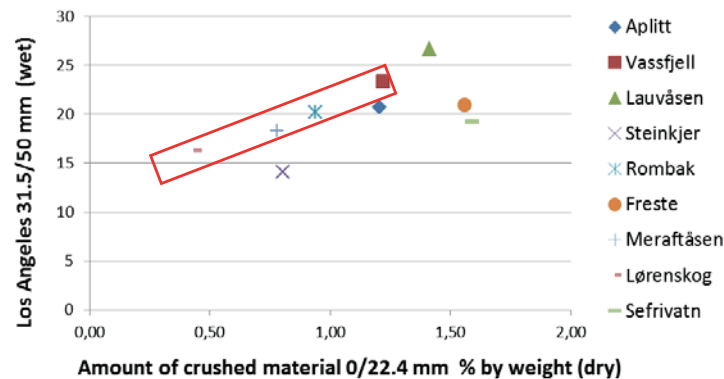
Figure 4.27 Total amount of crushed material from full scale model test (4x1 million loadings (dry state) related to mechanical strength ($LAA_{31.5/50 \text{ m wet}}$). $R^2=0.41$.

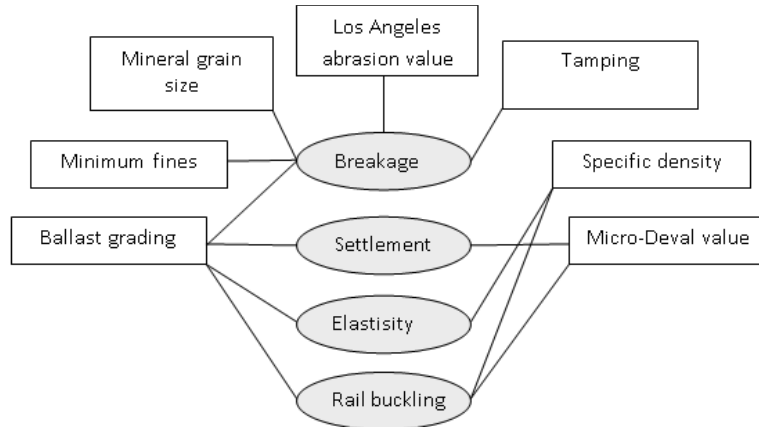
Figure 6.1. Impact from different variables on ballast breakage, track settlement, track stiffness and rail buckling

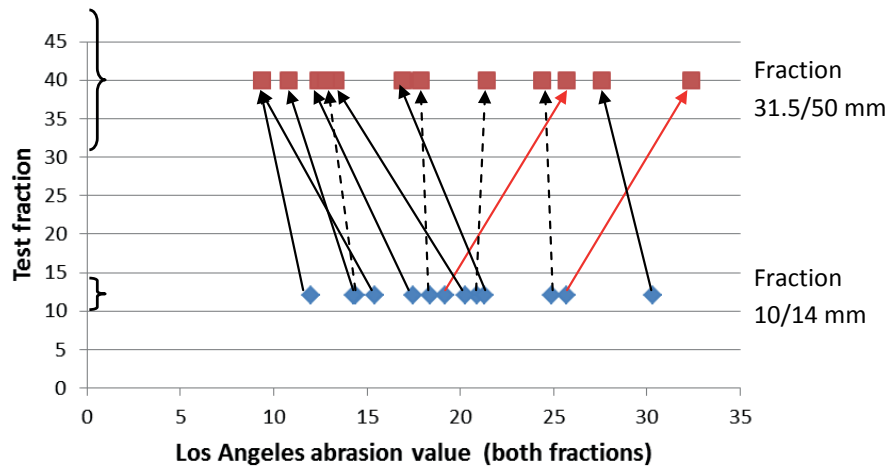
Figure 7.1 Los Angeles abrasion loss for a selection of rocks tested on fraction 10/14 mm and fraction 31.5/50 mm. Black lines marks decreasing values, dotted lines mark indifferent values and red lines mark increasing values when going from fraction 10/14 mm to fraction 31.5/50 mm

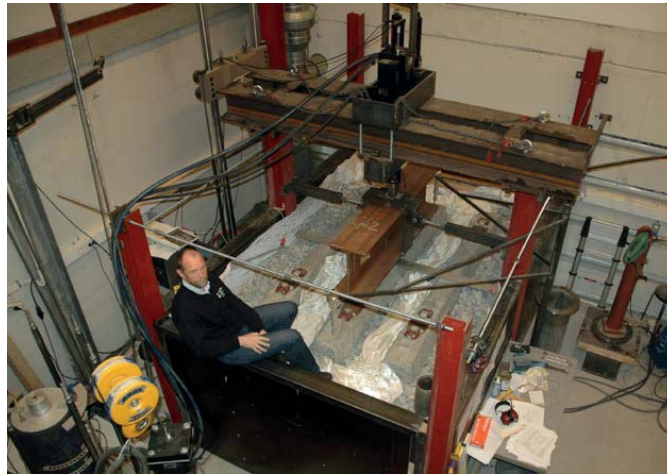
Figure 2: Full scale rail track model test setup for cyclic loading.
