Failure Mechanisms in Cutter Tools for Tunnel Boring

Jarand Nærland

Materials Science and Engineering

Submission date: June 2015

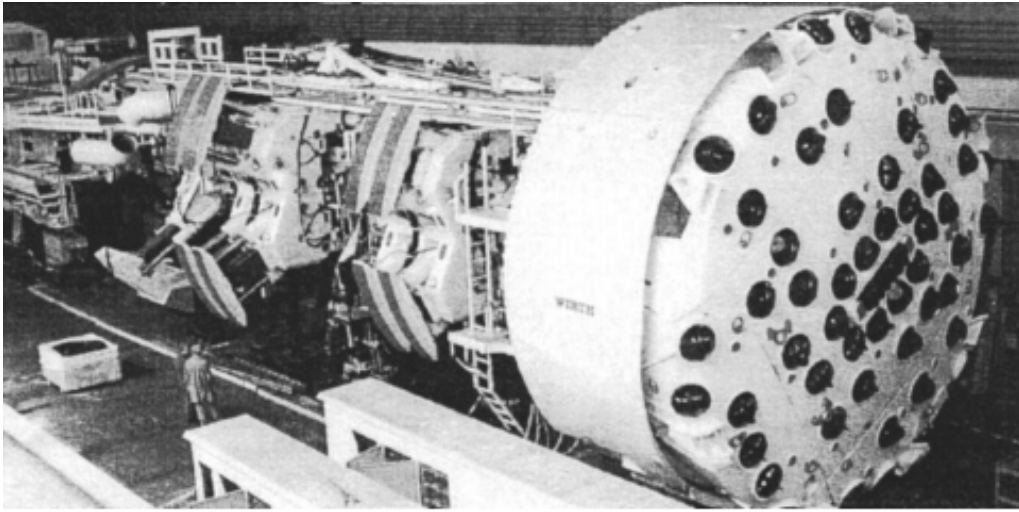
Figure 2.2: Gripper tunnel boring machine in factory [3].

of potentially several months. Modern machines are distinguished by which type of rock they excavate, namely soil and rock. A rock type gripper TBM is shown in Figure 2.2 for reference. This type of TBM does not build a concrete mantle, relying solely on the quality of the rock mass for stability. The research presented in this work will be based on hard rock TBMs similar to this machine.

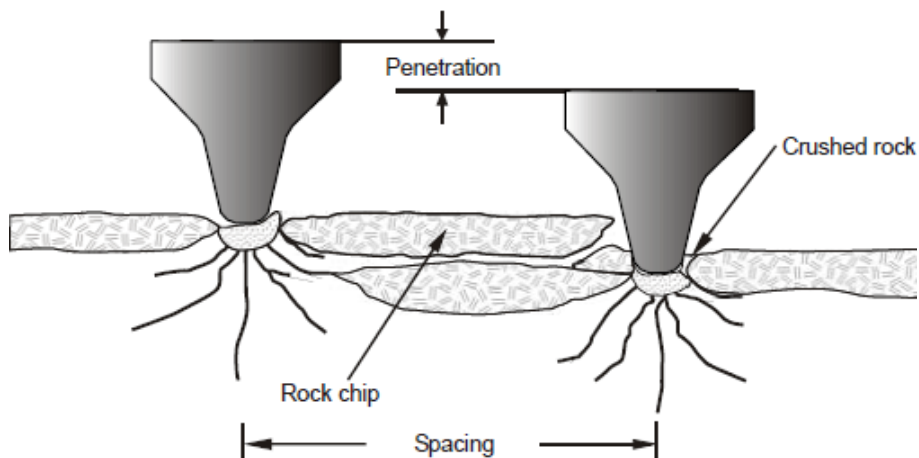
Figure 2.3: Rock chipping by cutter discs [4].

The TBM digs its way forward by pressing the cutter head towards the rock while rotating it [5]. Mounted on the cutter head are steel discs which roll and slide along the rock. Applied pressure acts both as a driving force for the rock grinding process and as a balance force to stabilize the surroundings. The contact pressure directly beneath the surface pulverize the rock forming grooves [4]. As seen in Figure 2.3, cracks form on the bottom of two neighbouring grooves and combine to cut off the wall between them. Debris is extracted by transport screws and conveyor belts.

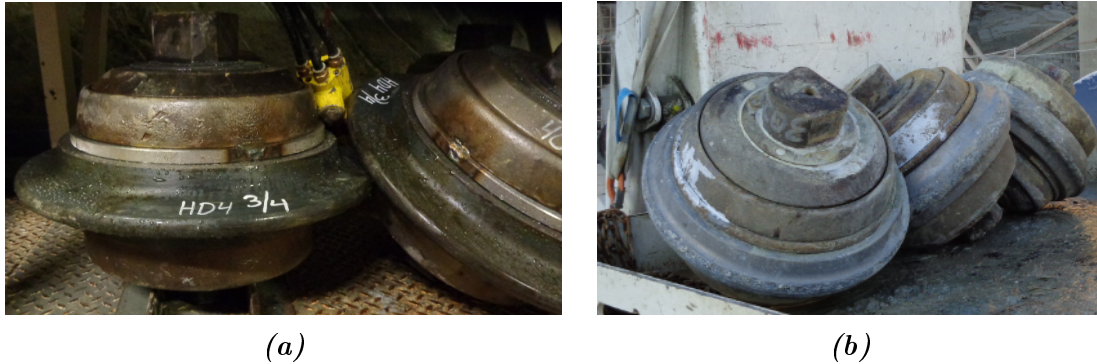
Figure 2.4: **a)** Cutters with new outer rings ready for use. **b)** Worn discs replaced due to general wear.

Figure 2.4a shows refurbished cutters ready for use. General wear is apparent in Figure 2.4b, showing cutters removed for refurbishing. The layout of a disc cutter is shown in Figure 2.5. Replacement of the rings occur either when the limit for allowable general wear is reached, or when special types of wear, namely chipping or blocking is discovered during inspection.

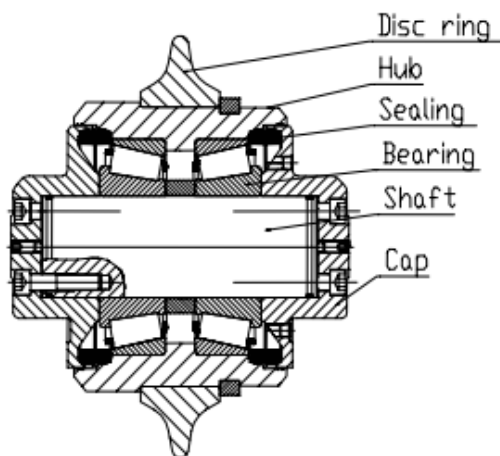
Figure 2.5: Typical cutter disc design [6].

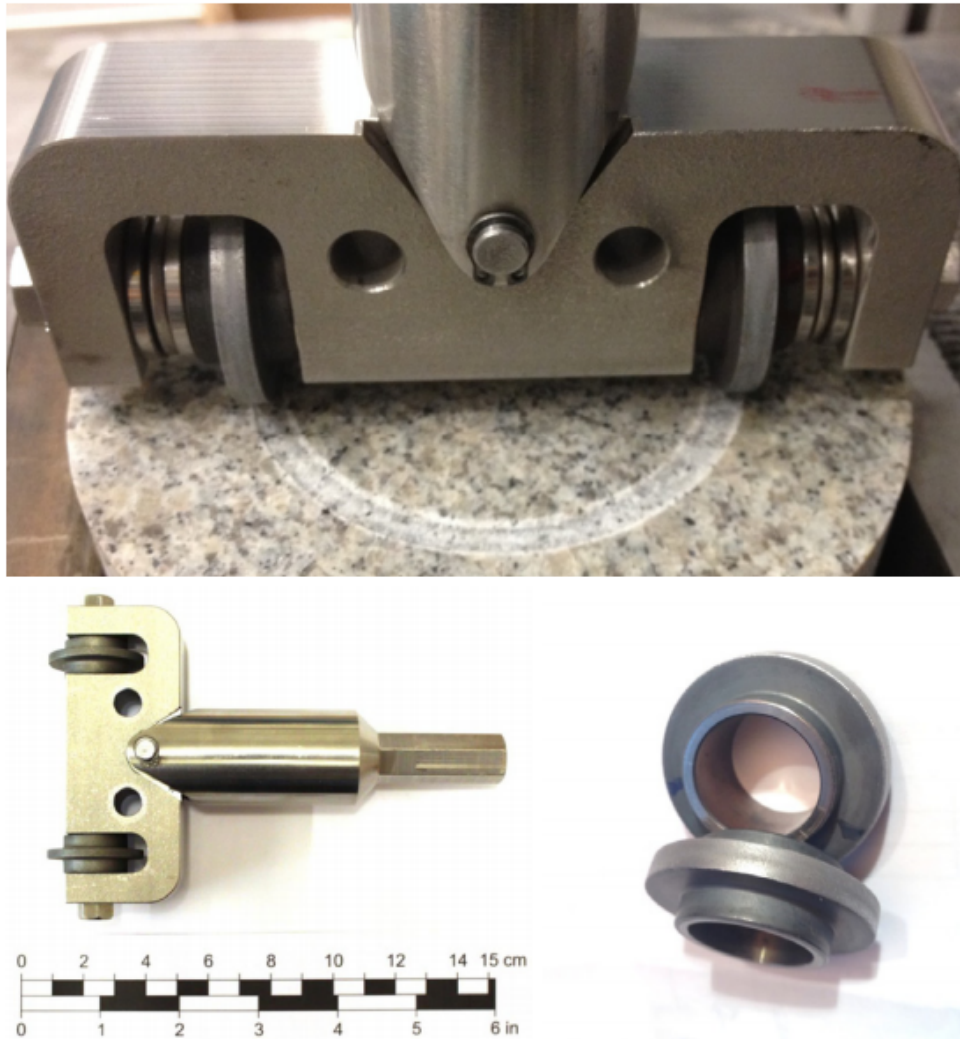
Figure 2.25: The RIAT tool and the mini-cutter rings [37].

Two of the most apparent weaknesses with the tests mentioned in 2.5.1 when used to predict wear in hard rock TBMs are the contact mode utilized and thus the wear mechanisms these modes reproduce. When ruling out chipping caused by knocks and fatigue, cutter disc wear is dominated by two-body abrasion. Soil grinding the metal sample, as tested with AVS, will produce wear by three-body abrasion. As mentioned in section 2.4.1, this wear mechanism is around ten times less efficient than two-body abrasion. The CERCHAR and LCPC tests initiate wear by two-body abrasion. In all three methods, the contact mode will be only sliding. During production, a combination of rolling and sliding will occur, with rolling as the dominant mode of contact. Had this not been the case, disc wear would have been significantly higher [4]. In order to overcome these challenges a novel characterization method for rock abrasiveness is currently under development at NTNU [36]. This method, called the Rolling Indentation Abrasion Test (RIAT), utilize mini cutter discs for wear measurements on hard rock samples in a rolling-sliding motion. Following this design, the discs are worn by two-body abrasion in what is assumed to be a predominantly rolling contact. The test configuration is seen in Figure 2.25 [37]. Preliminary results from the analysis of the RIAT discs are presented in this thesis.

Disc weight loss as well as penetration depth is measured to characterize the tool wear and effectiveness of cutting in different rock types. In addition to being a measurement for cutter disc lifetime, the test provides valuable insight into wear and penetration from varying operational parameters. Changes in the given parameters may occur as the method is currently under development.

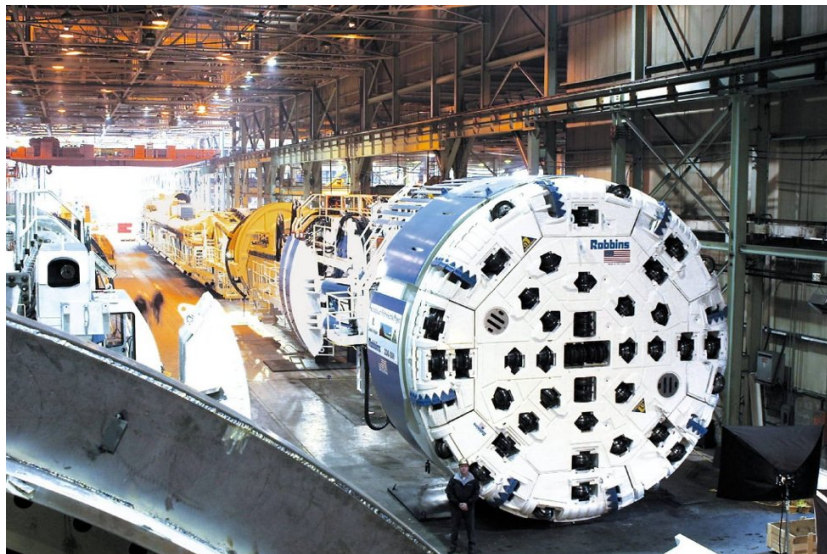
Figure 3.1: The TBM used in Røssåga. Photo provided by The Robbins Company [41].

The TBM used in Røssåga is called "Jern Erna" and shown in Figure 3.1. It is 7.23 m in diameter and will drill in total 7 km of tunnel as part of a hydro power plant for Statkraft [41]. Its cutter head houses 46 19" [48.3 cm] diameter discs.

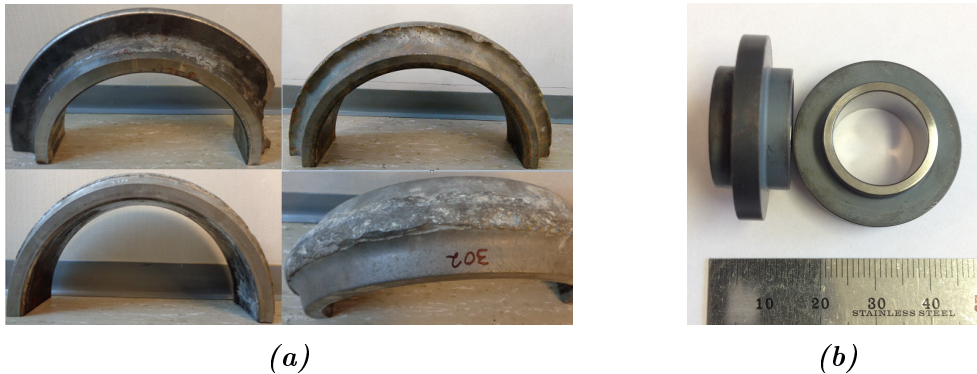
Figure 3.2: a) 19" samples from Røssåga. b) H13 mini-cutters for small scale testing.

The RIAT mini-cutters are 30 mm in diameter with a tip width of 4 mm. The distance between the two mini-cutters when placed in the tool is 60 mm. A thrust of 1250 N is provided to the tool while rotating at 40 rpm for 30 minutes. Mini-cutter weight loss and rock penetration depth is measured during testing. The mini-cutters were later examined for hardness, microstructure and deformation structure. The samples are made by H13 tool steel of composition given in table 3.2 [43]. They were machined and pre heated at 700 °C prior to annealing at 1020 °C. Tempering was performed twice for 2 hours at 600 °C.

The samples collected from Røssåga and a RIAT mini-cutter are shown in Figure 3.2a and Figure 3.2b respectively. Table 3.3 gives an overview of the different samples and the tests which were performed on them.

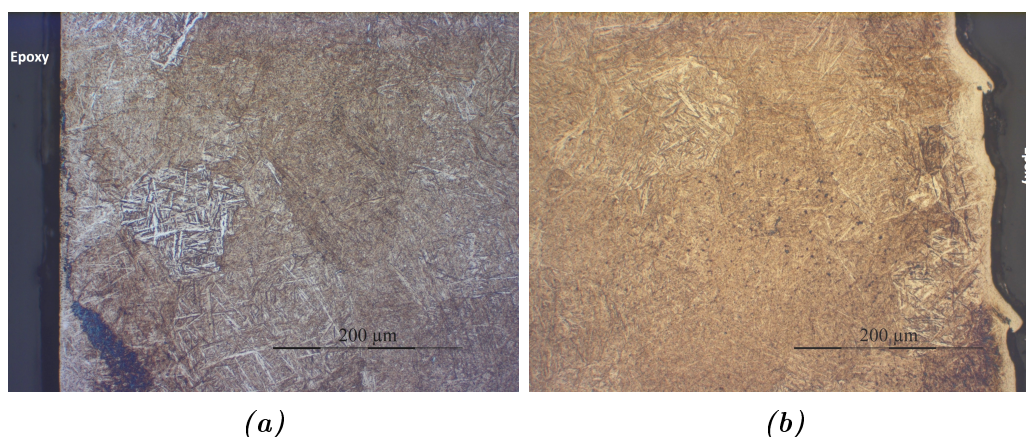
Figure 3.3: **a)** Microstructure of sample 314, left edge cut with *Discotom-2*. Etched with *Vilella's* reagent. 200X magnification. **b)** Sample 314, edge on right side cut with bandsaw. Etched with *Vilella's* reagent. 200X magnification.

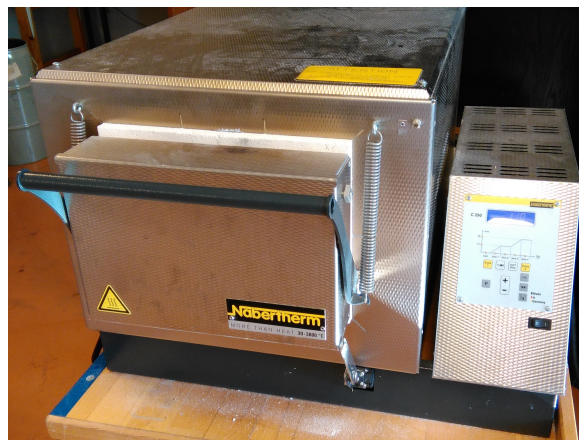
Figure 3.7: The Nabertherm N 17 furnace used for specimen tempering.

A tempering experiment was performed to identify the evolution of hardness as a function of time and temperature, without including deformation. Samples were cut from the unused disc, HD4. Tempering was performed at 200, 300, 400, 500, 600 and 700 °C. Three samples were used at each temperature, tempered for 1, 2 and 4 hours respectively. The furnace used was the Nabertherm N17 which is shown in Figure 3.7. No attempts were made to control the atmosphere inside the furnace. The effect of this is decarburization due to lower carbon concentration in the air than in the steel. This is also true during normal TBM operations and is therefore seen as a natural part of the experiment.

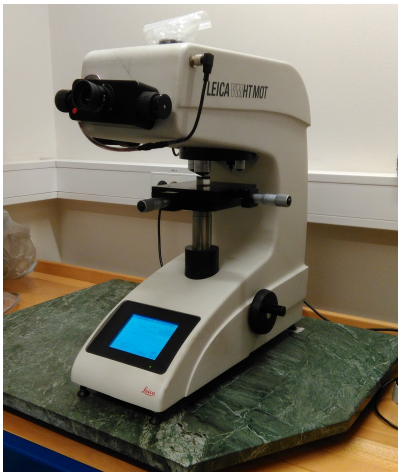
Figure 3.9: *Micro hardness indenter*

The *Leica VMHT MOT* micro hardness indenter shown in Figure 3.9 was used to measure hardness profiles of a RIAT mini-cutter. The process was similar to that described above and shown in Figure 3.8b, but for the distance from indentation to surface. This was registered manually by way of moving the specimen stage a known distance for each measurement. The measurements were performed with 0.025 kg_F, providing results in HV0.025

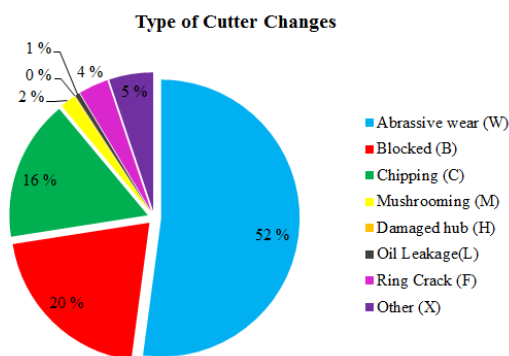
Figure 4.1: Overview of wear mechanisms on the Røssåga TBM.

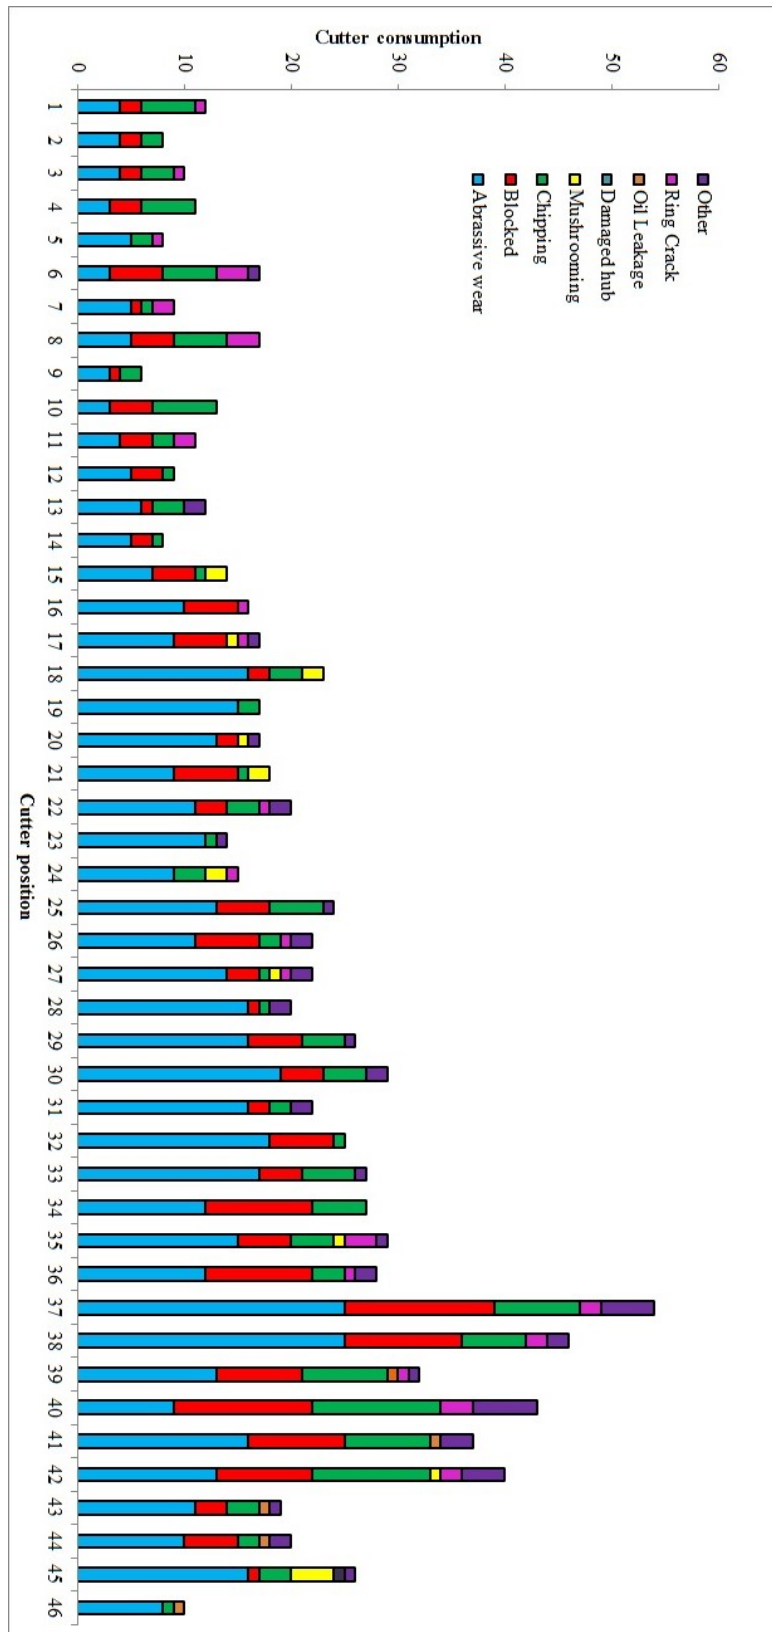
Figure 4.2: Reasons for cutter changes on all cutter head positions.

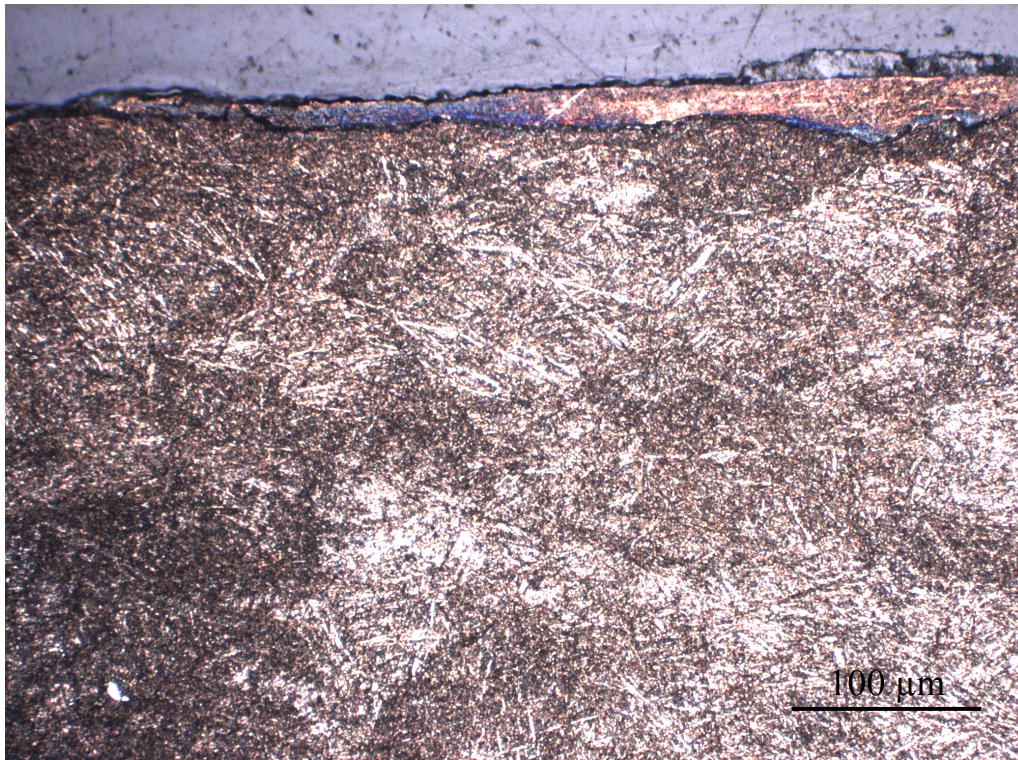
Figure 4.7: Optical image of cross section parallel to rolling direction of TBM cutter 314. 200X magnification.

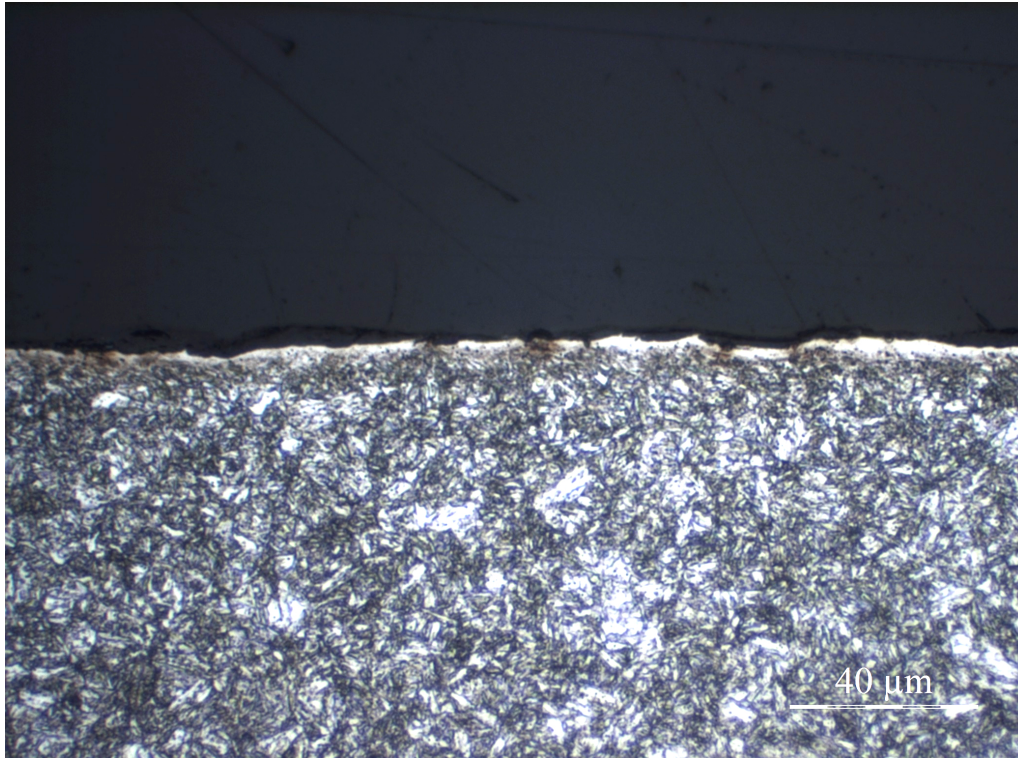
Figure 4.8: Optical image cross section parallel to rolling direction of RIAT mini-cutter 8, worn by quartzite. 500X magnification.

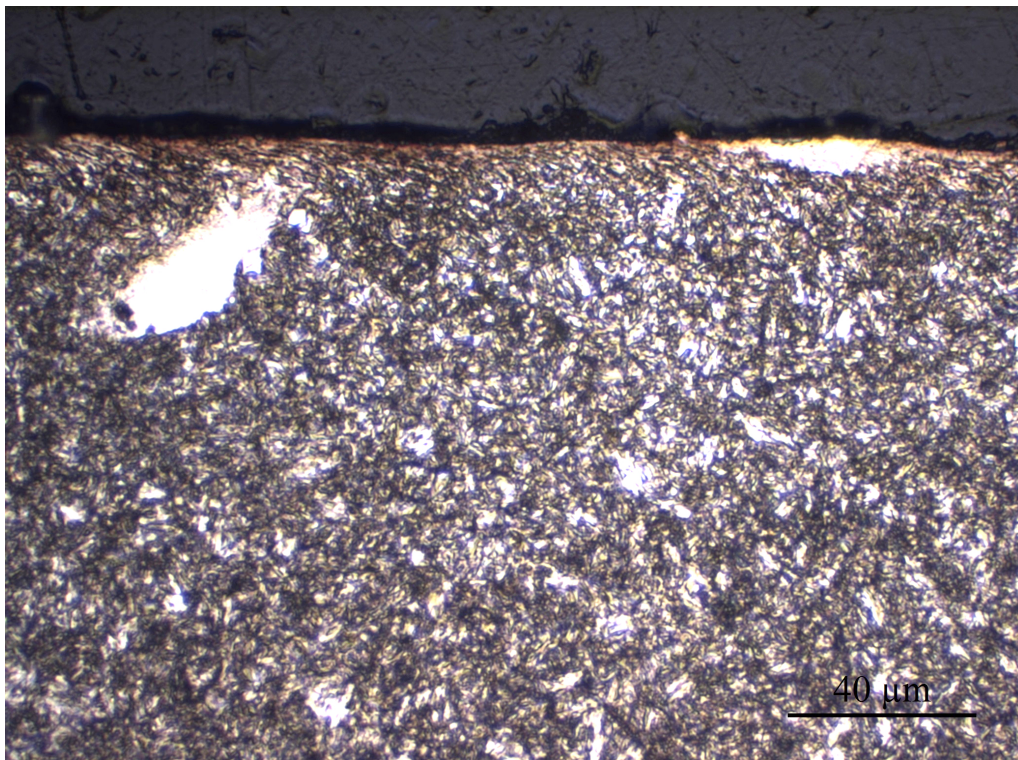
Figure 4.9: Optical image cross section parallel to rolling direction of RIAT mini-cutter 11, worn by quartzite. 500X magnification.

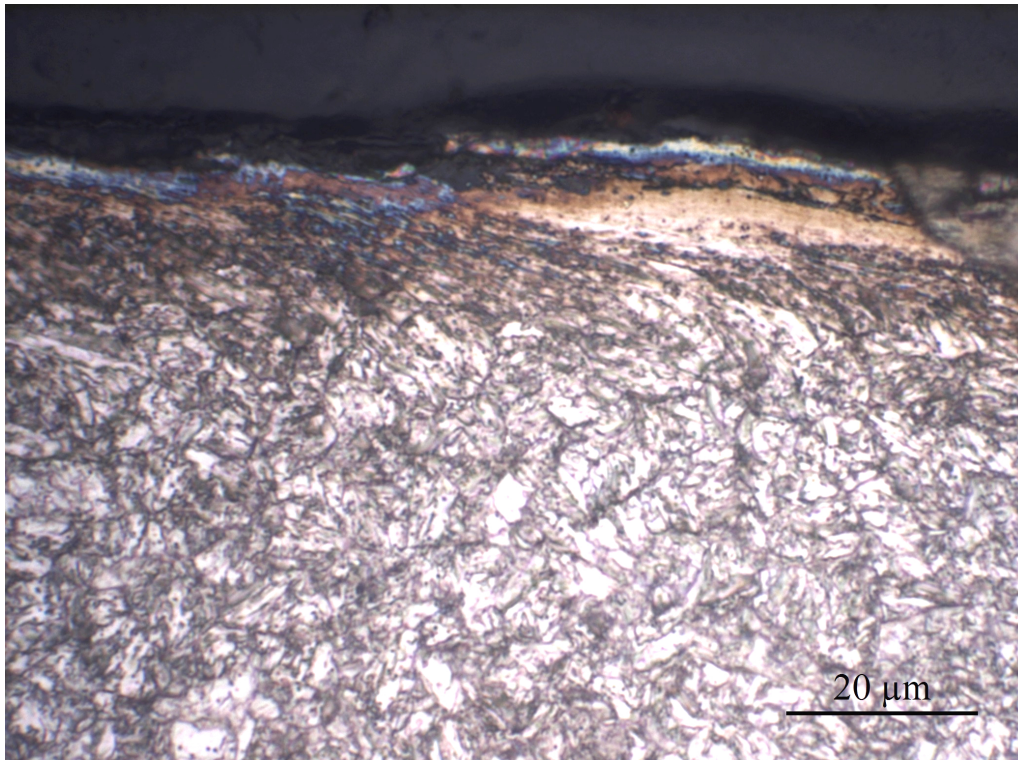
Figure 4.10: Optical image cross section parallel to rolling direction of RIAT mini-cutter 003, worn by granite. 1000X magnification.

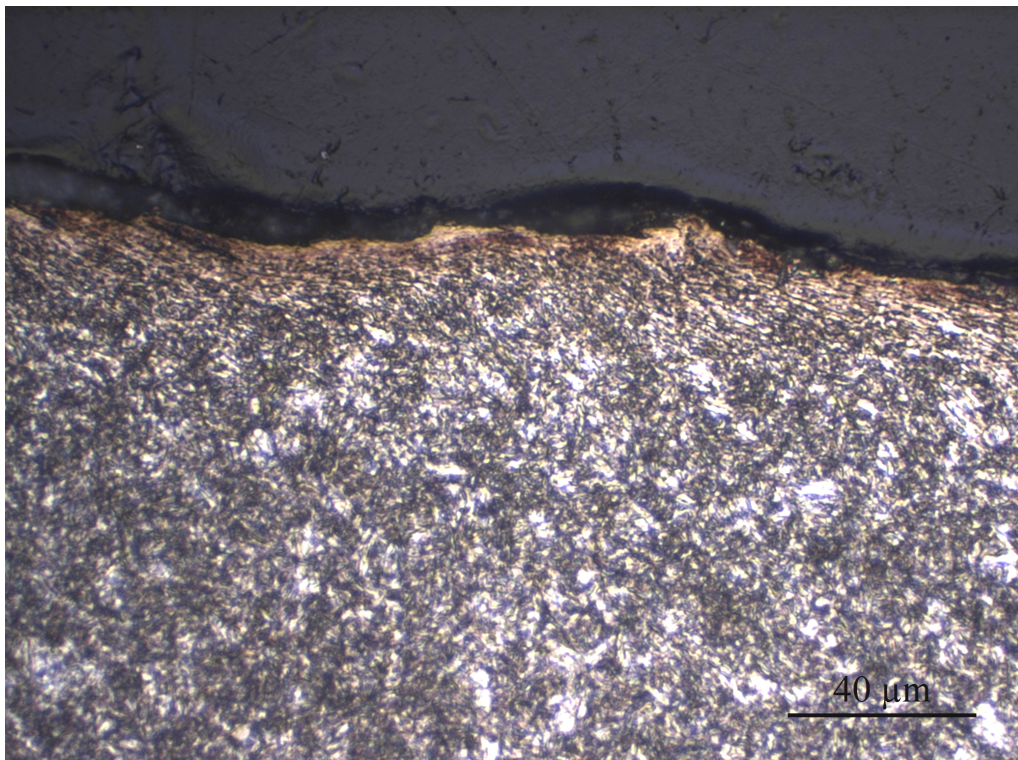
Figure 4.11: Optical image cross section parallel to rolling direction of RIAT mini-cutter 001, worn by Chinese basalt. 500X magnification.

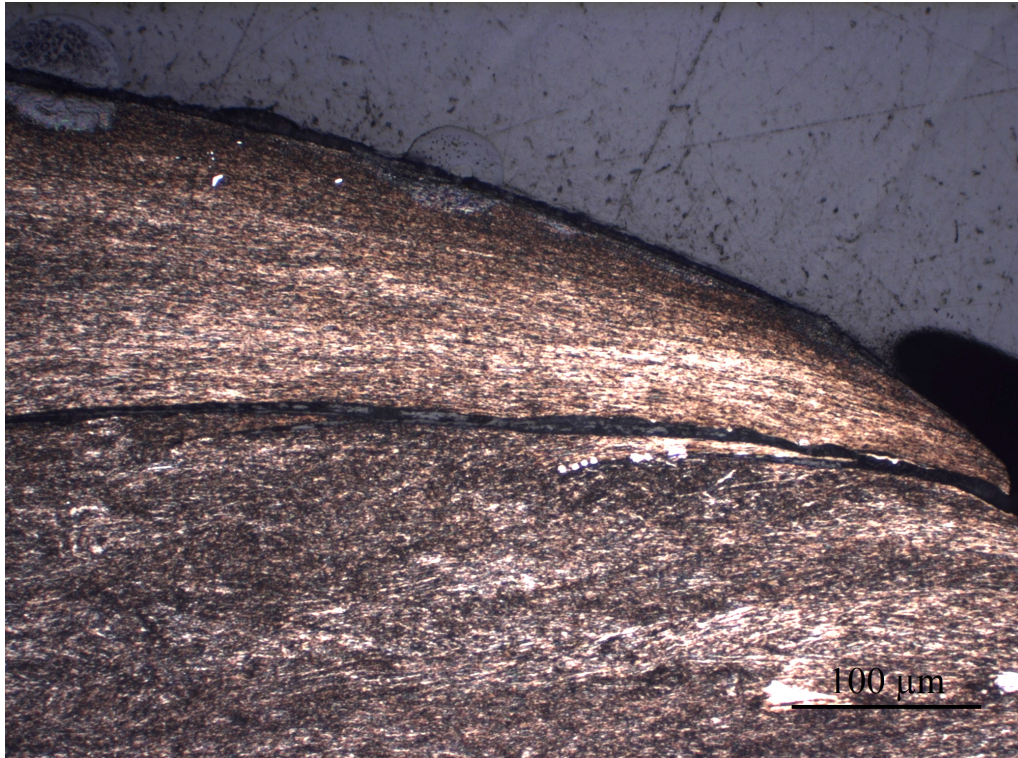
Figure 4.12: Crack growth in TBM cutter 302, transverse cross section. 200X magnification.

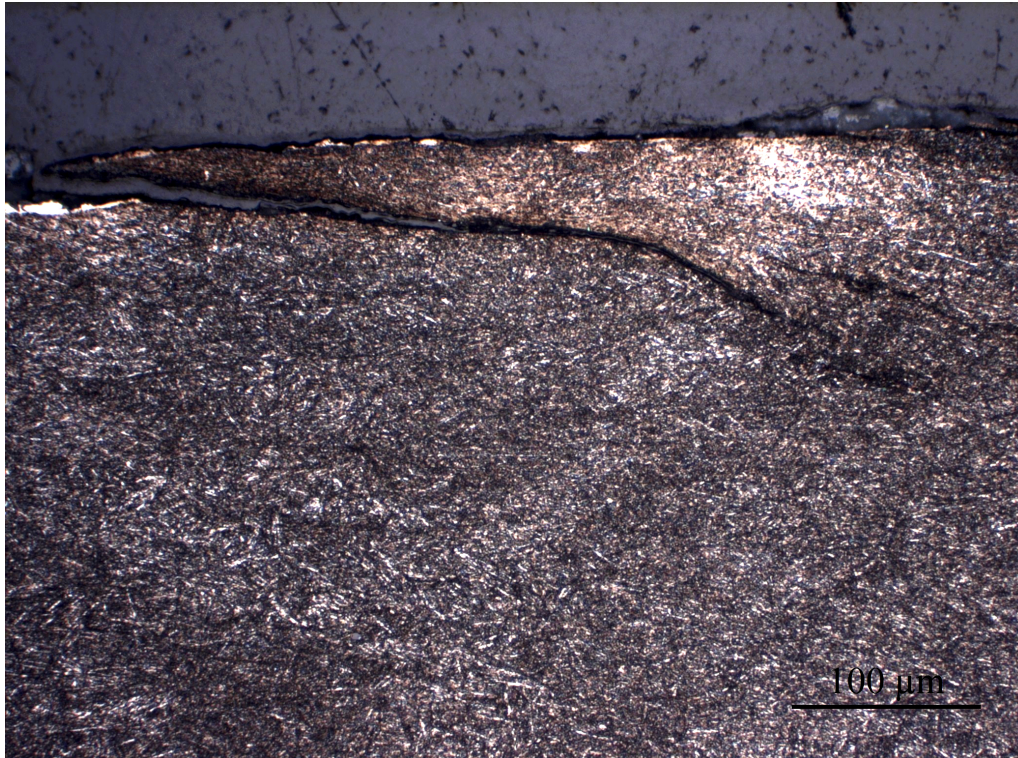
Figure 4.13: Crack growth in TBM cutter 302, parallel cross section. 200X magnification.

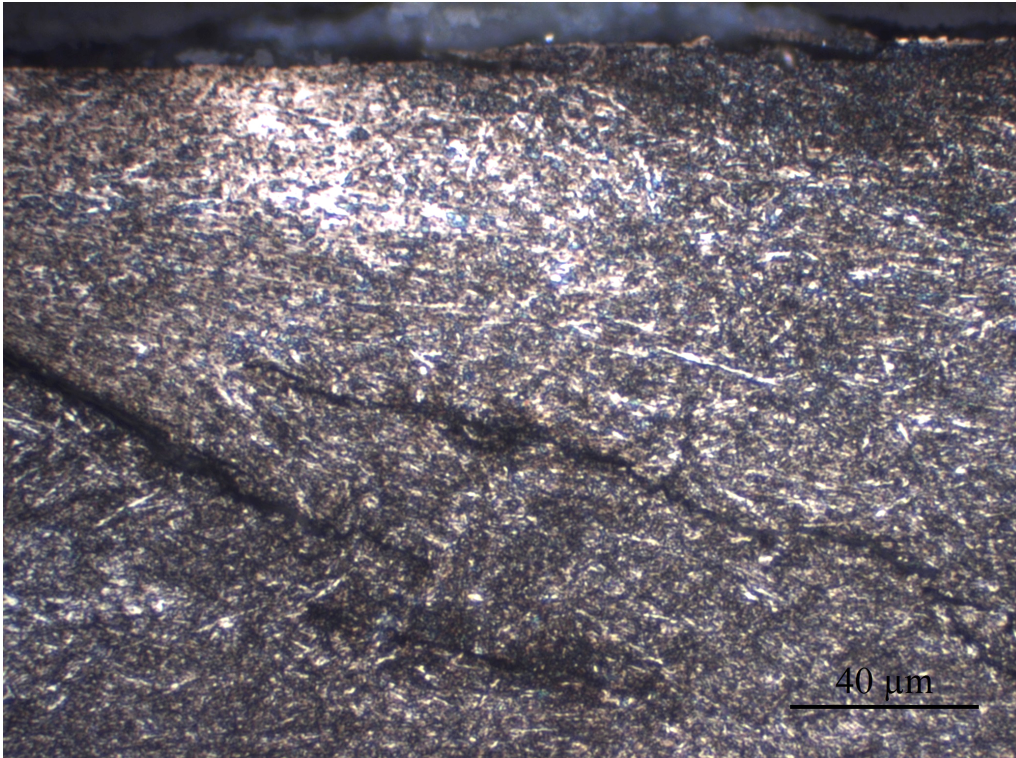
Figure 4.14: Crack growth in TBM cutter 302, parallel cross section. 500X magnification.

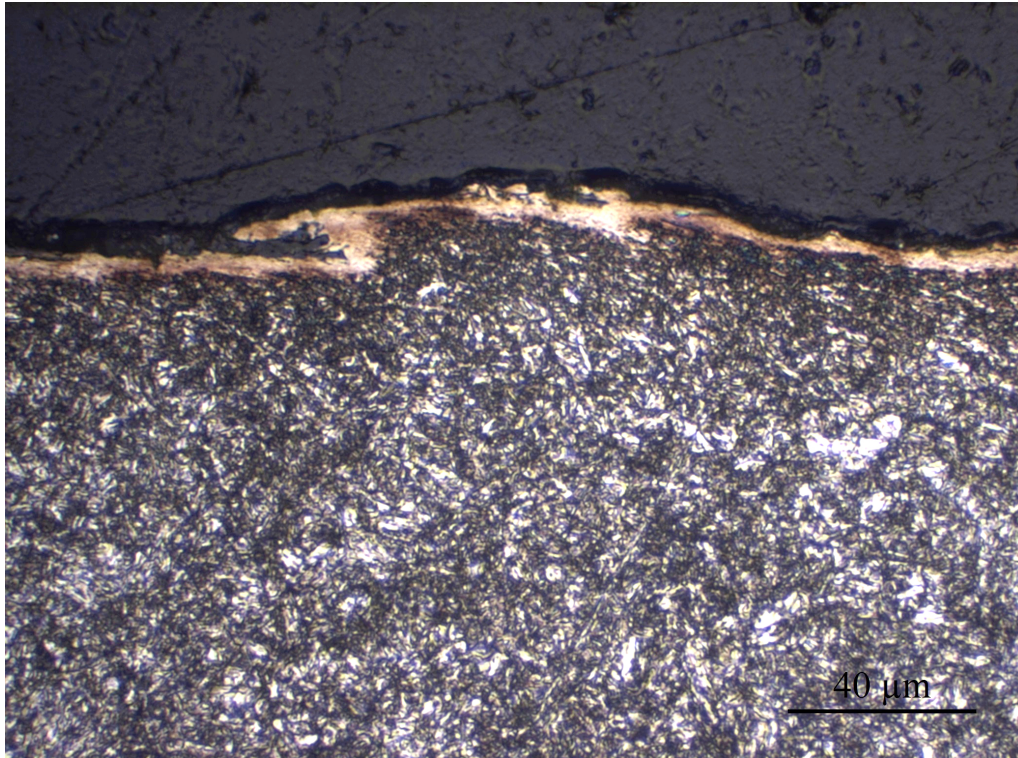
Figure 4.15: Folding in RIAT mini-cutter 002, worn by Chinese basalt, parallel cross section. 500X magnification.

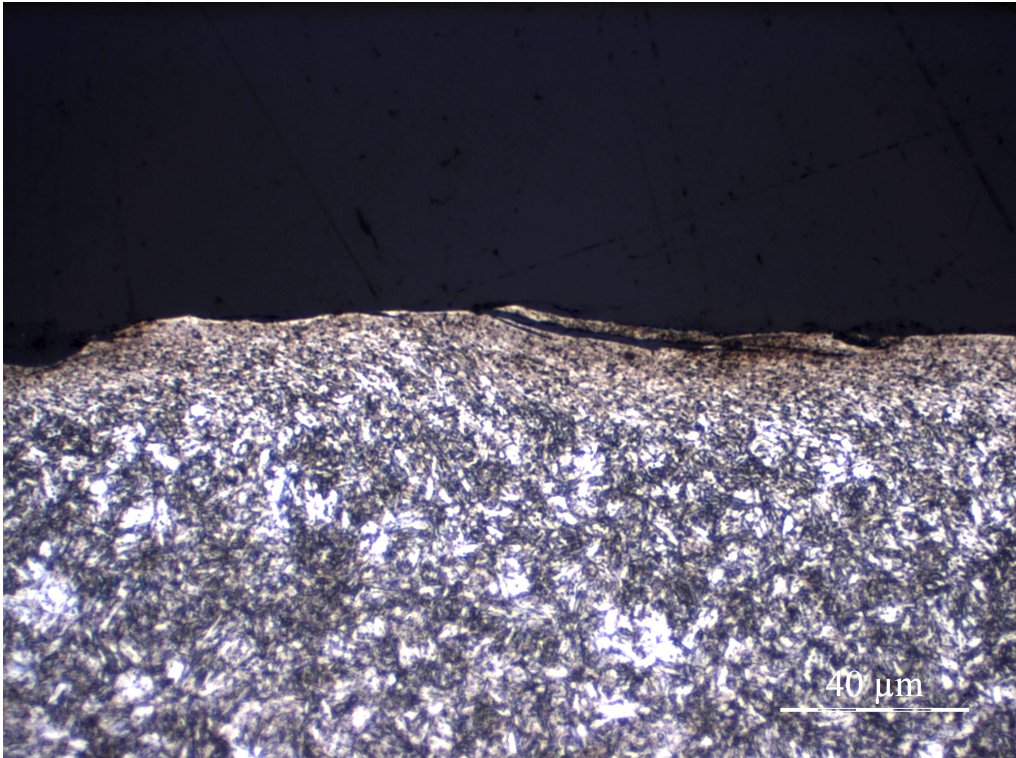
Figure 4.16: *Folding in RIAT mini-cutter 3, worn by Iddefjord granite, parallel cross section. 500X magnification.*

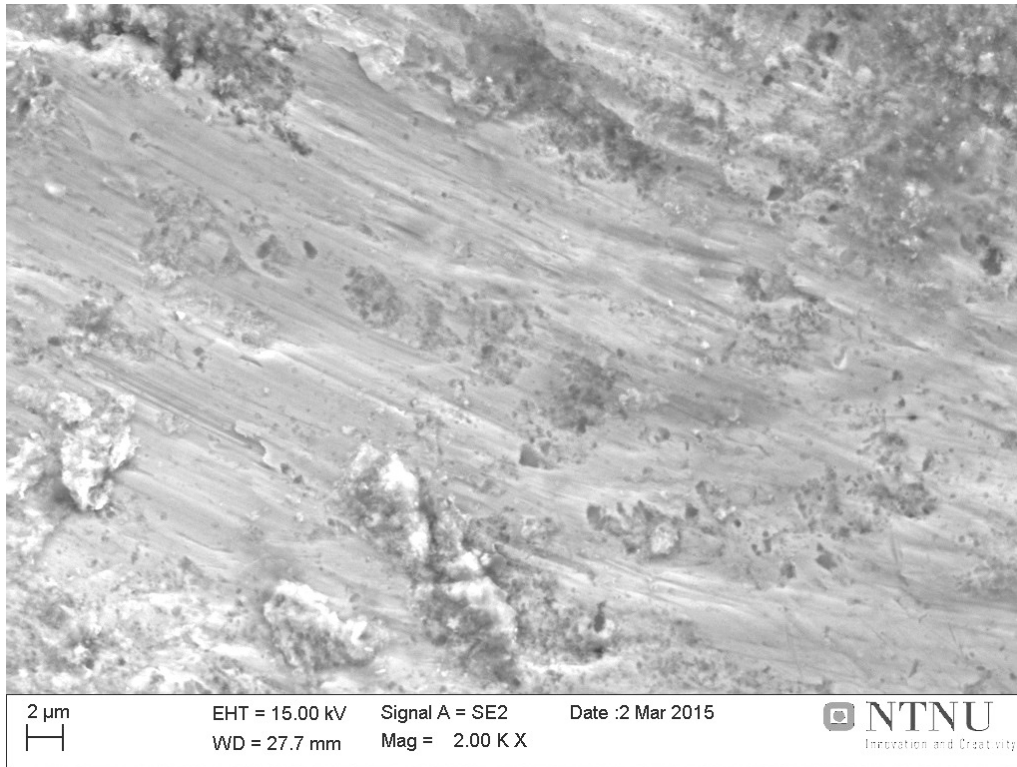
Figure 4.17: SEM image of a RIAT mini-cutter surface. Sample 4, worn by quartzite. Secondary electron signal.

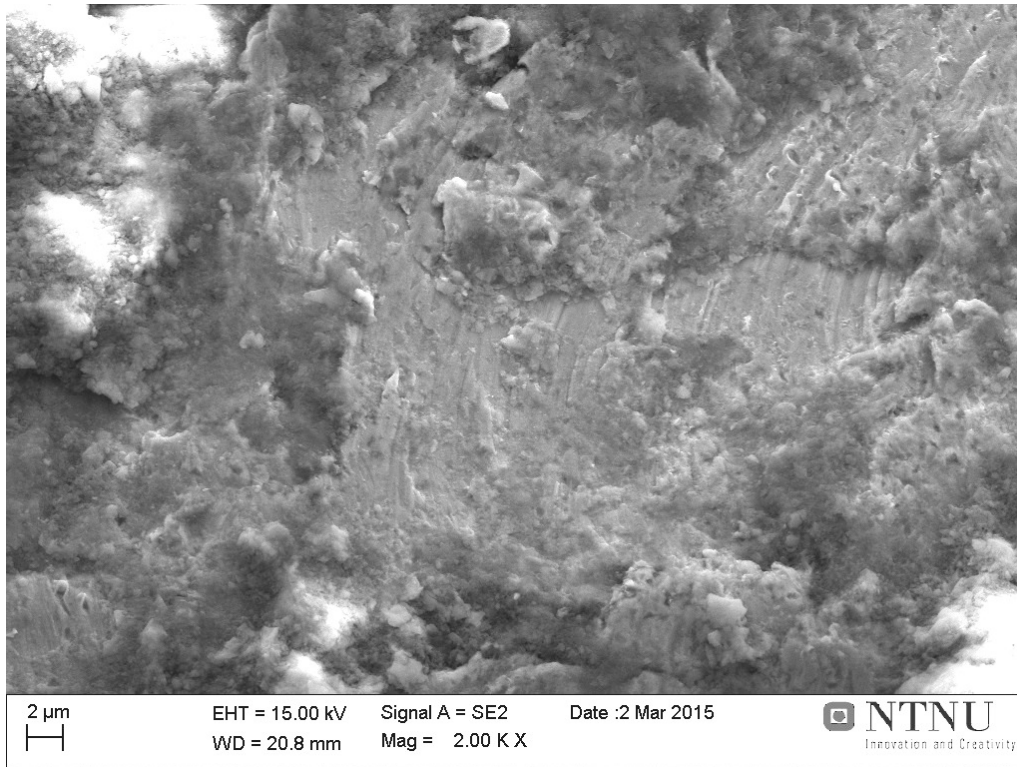
Figure 4.18: SEM image of a RIAT mini-cutter surface. Sample 6, worn by Iddefjord granite. Secondary electron signal.

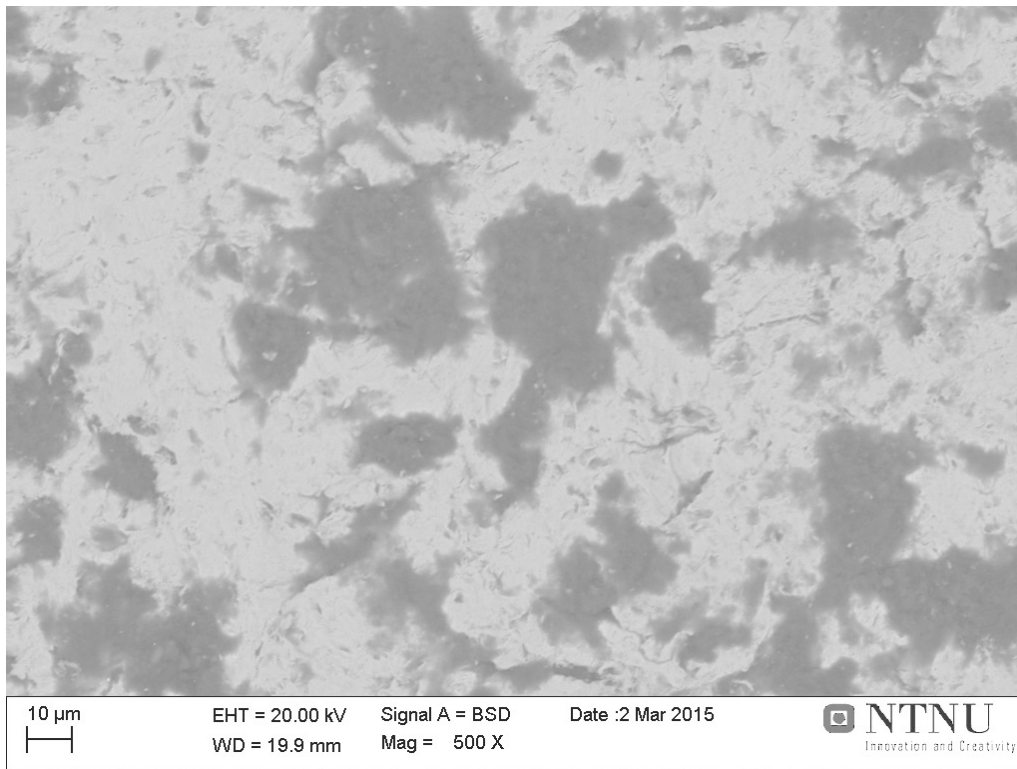
Figure 4.19: SEM image of wear surface of RIAT mini-cutter 3, worn by Iddefjord granite. BSE signal. Bright areas are steel, dark areas are rock debris.

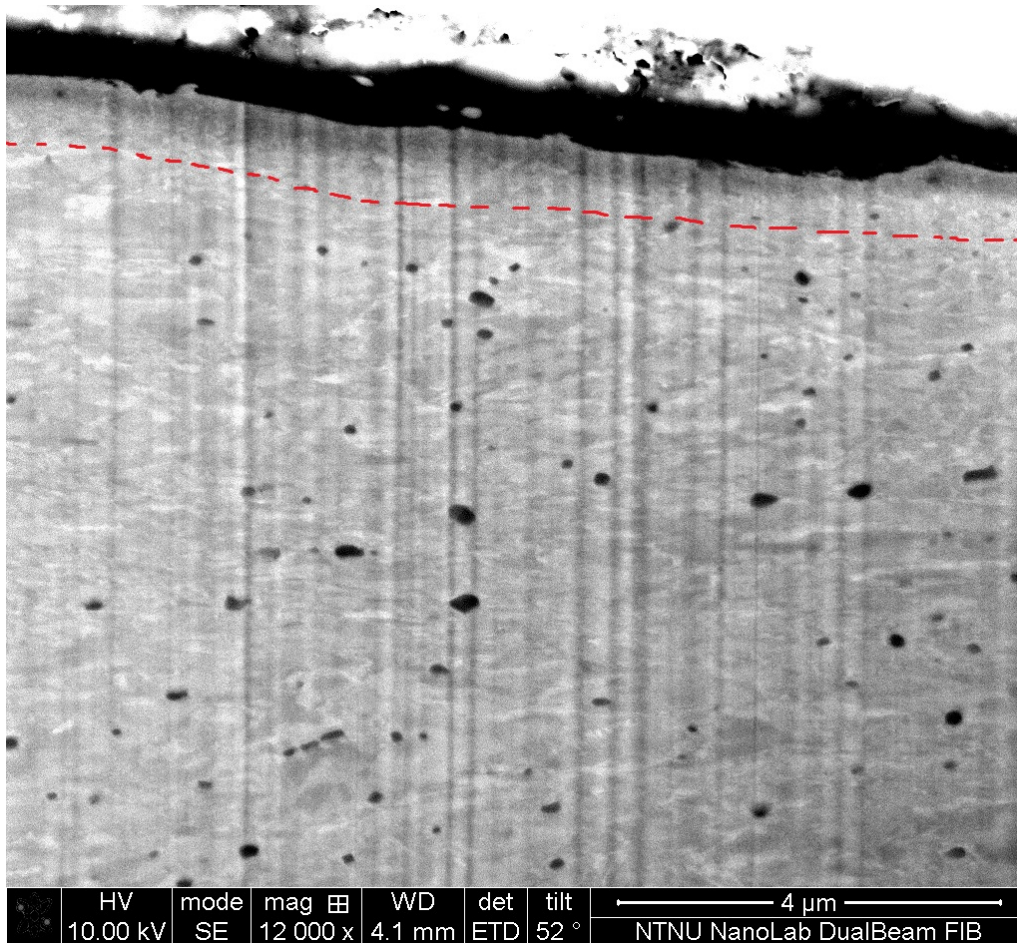
Figure 4.20: TBM cutter disc 314, transverse cut cross section. Dotted line imply border for nanocrystalline deformation layer.

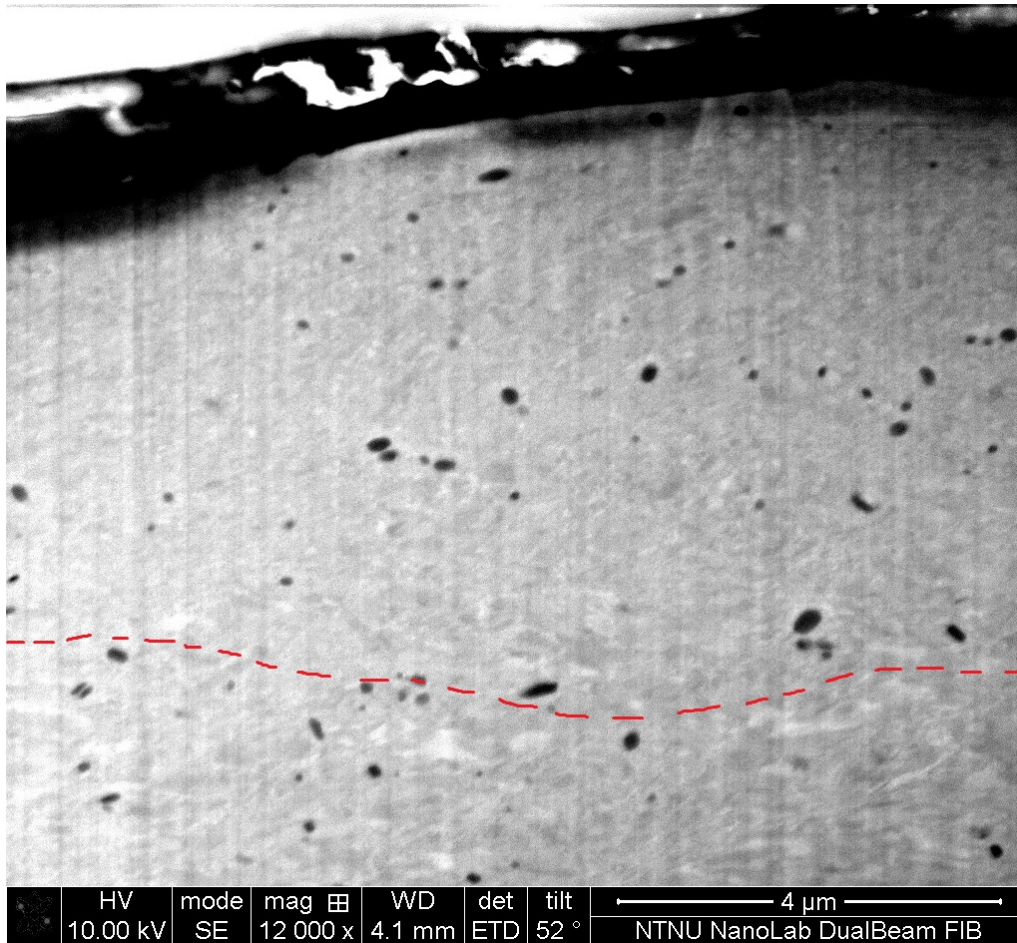
Figure 4.21: TBM cutter disc 302, transverse cut cross section. Dotted line imply border for nanocrystalline deformation layer.

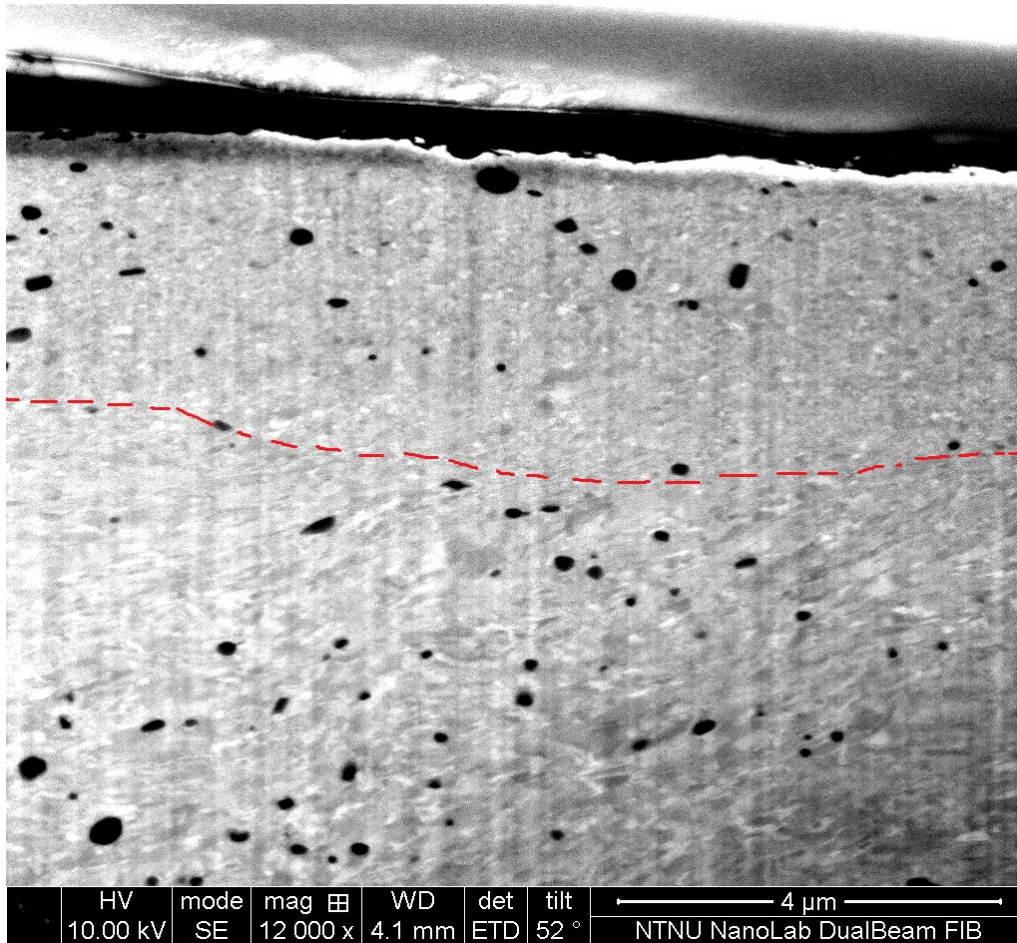
Figure 4.22: TBM cutter disc 302, parallel cut cross section. Dotted line imply border for nanocrystalline deformation layer.

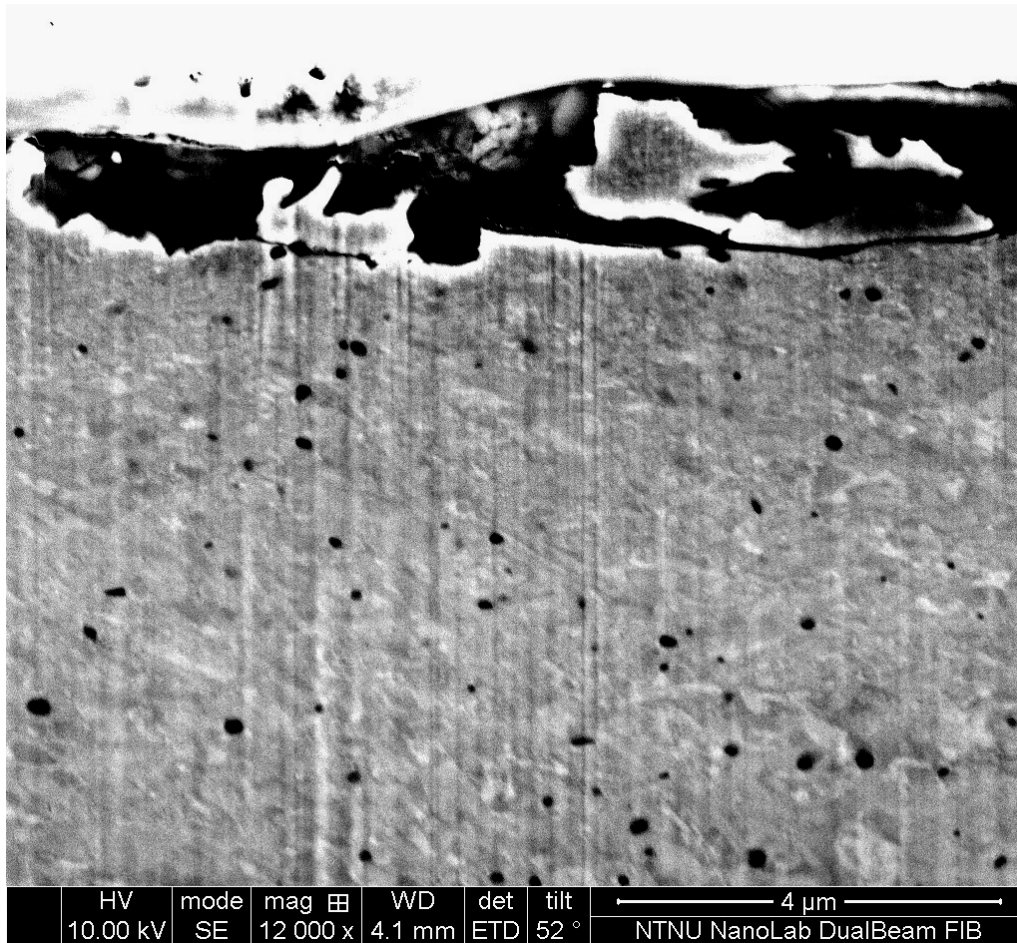
Figure 4.23: TBM cutter disc 140, parallel cut cross section. Dotted line imply border for nanocrystalline deformation layer.

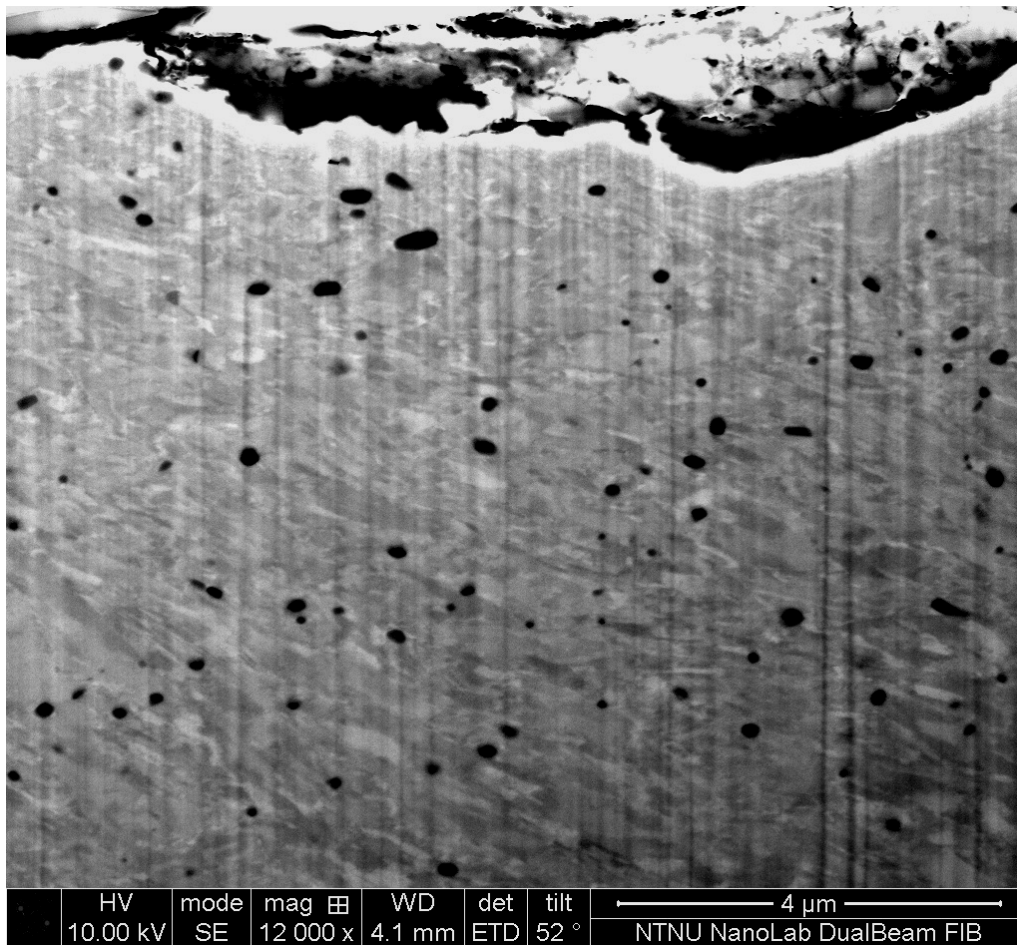
Figure 4.24: TBM cutter disc 140, transverse cut cross section.
