Failure Mechanisms in Cutter Tools for Tunnel Boring

Jarand Nærland

Materials Science and Engineering

Submission date: June 2015

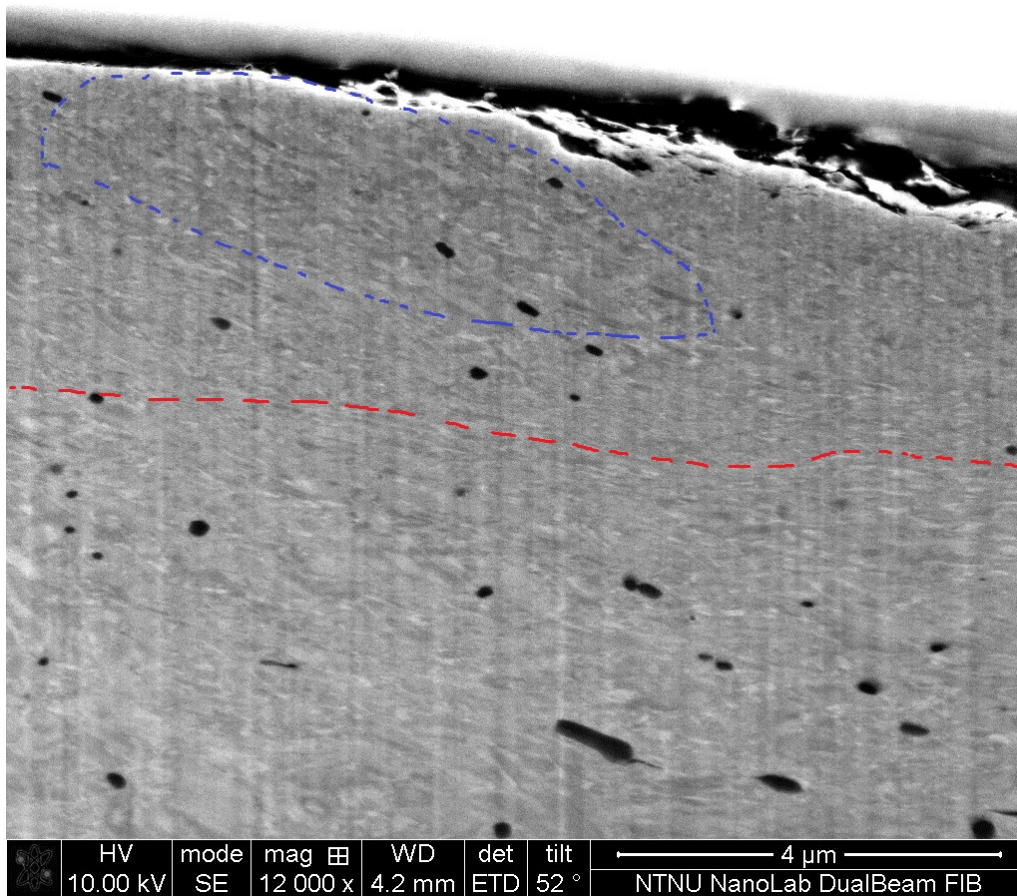
Figure 4.25: TBM cutter disc 383, transverse cut cross section. Dotted red line imply possible border for nanocrystalline deformation layer. Dotted blue line indicate area of possible grain growth.

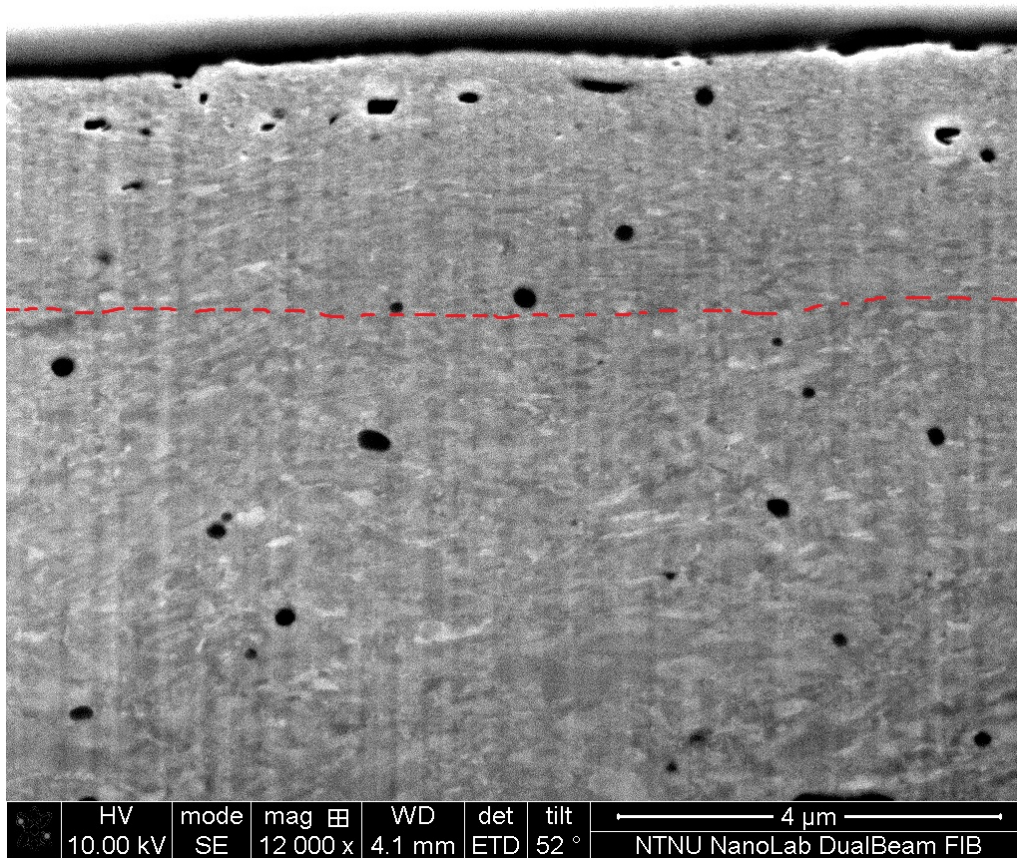
Figure 4.26: FIB cross section. Surface worn by Chinese basalt, sample 002, transverse cut cross section. Dotted line imply border for nanocrystalline deformation layer.

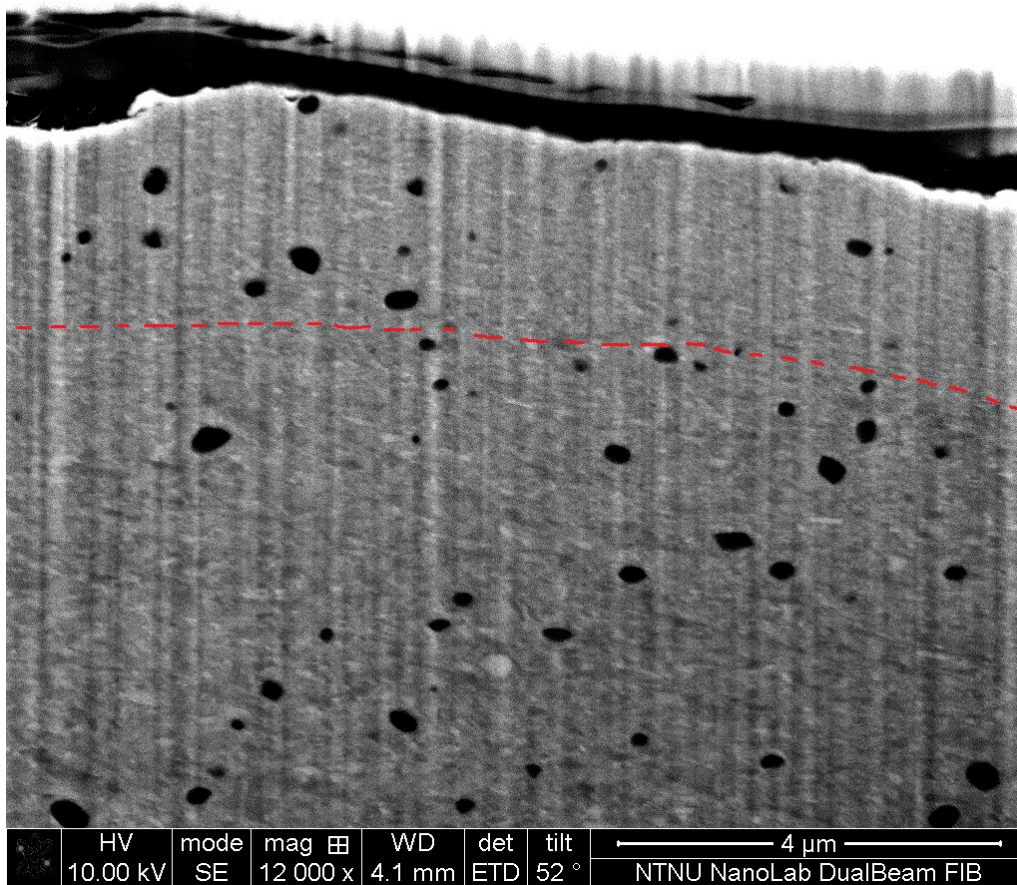
Figure 4.27: FIB image of RIAT mini-cutter 3, worn by Iddefjord granite. Fine grained area visible at the surface of the specimen. Dotted line imply possible border for nanocrystalline deformation layer.

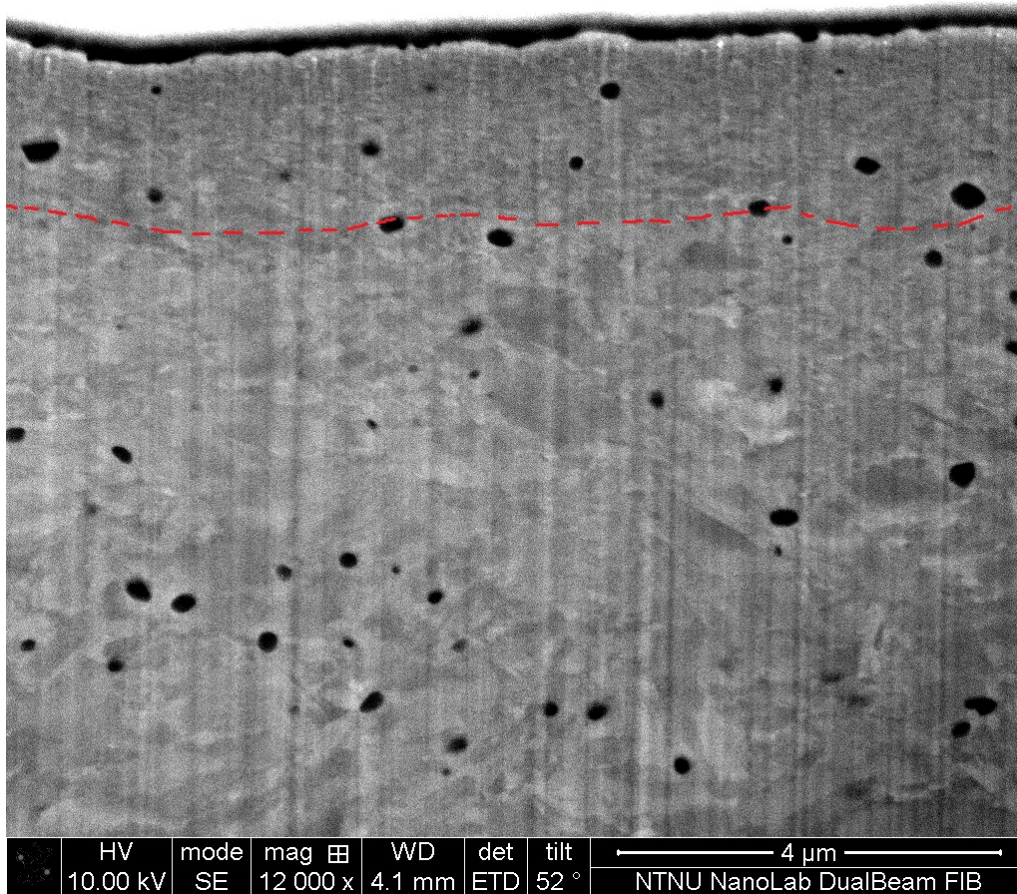
Figure 4.28: FIB cross section. Surface worn by Quartzite, sample 11, transverse cut cross section. Dotted line imply border for nanocrystalline deformation layer.

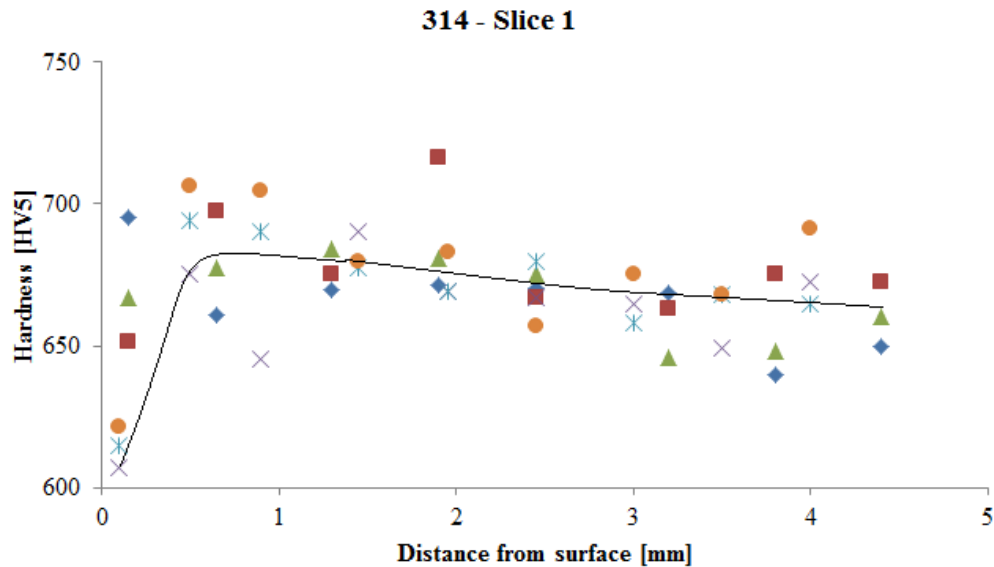
Figure 4.29: Vickers hardness profile of 314 disc, slice 1

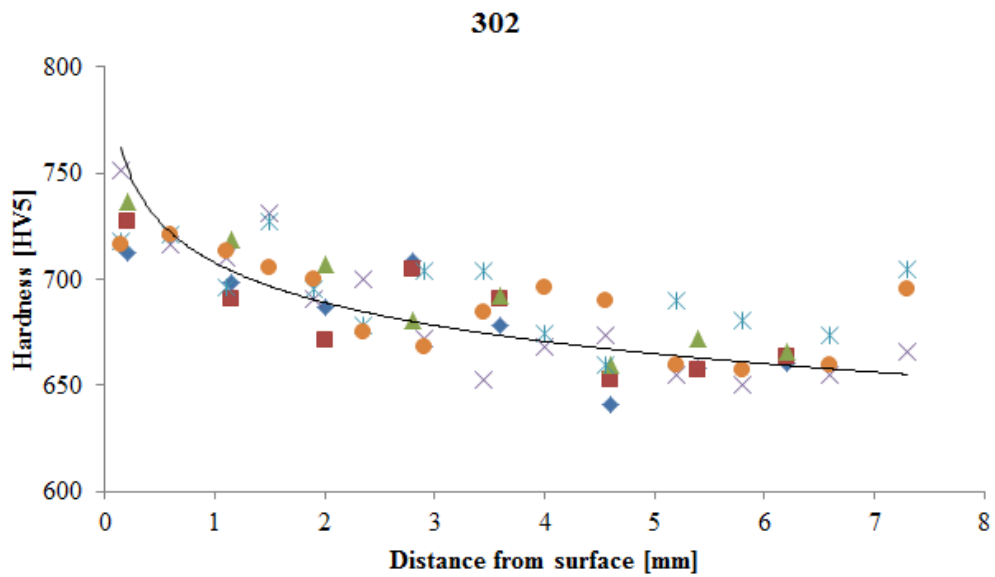
Figure 4.31: Vickers hardness profile of 302.

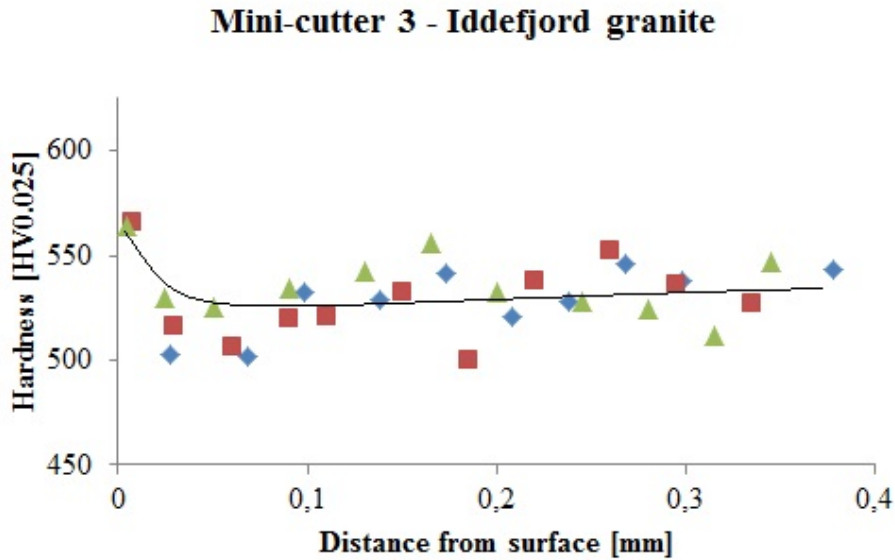
Figure 4.32: Vickers hardness profile of RIAT mini-cutter 3, worn by Iddefjord granite.

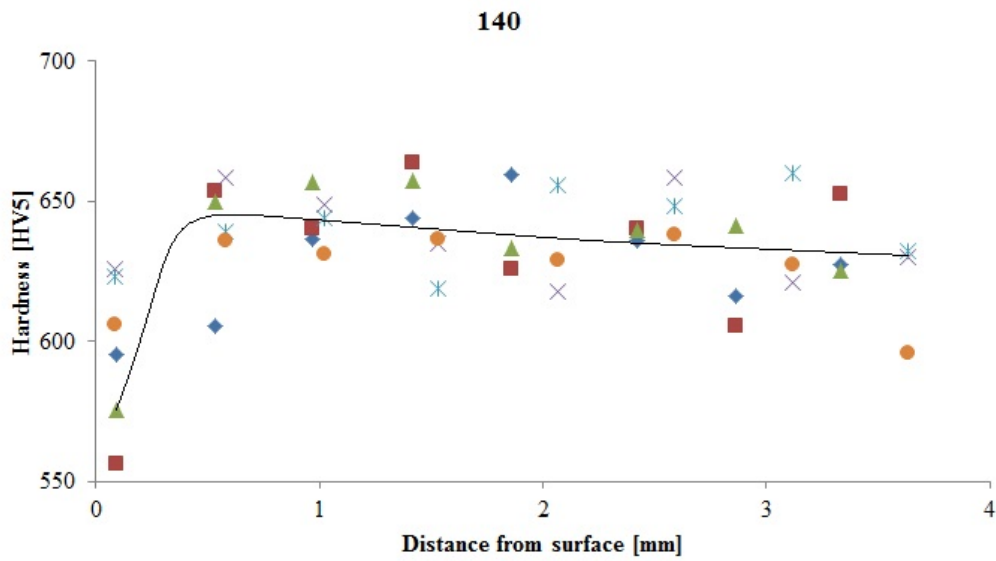
Figure 4.33: Vickers hardness profile of disc 140.

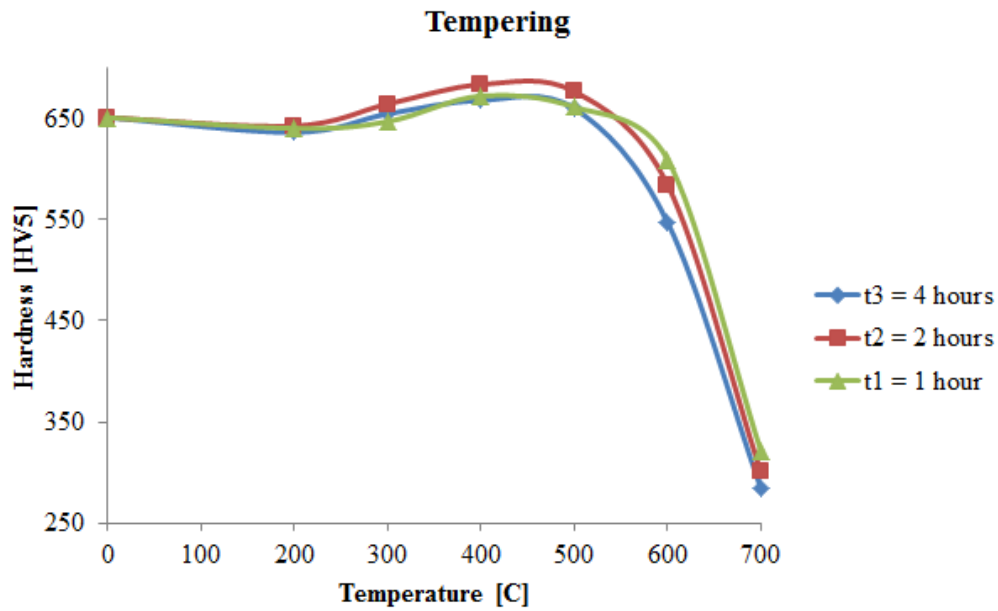
Figure 4.35: Hardness profile of cutter disc HD4 after 1, 2 and 4 hours of tempering.

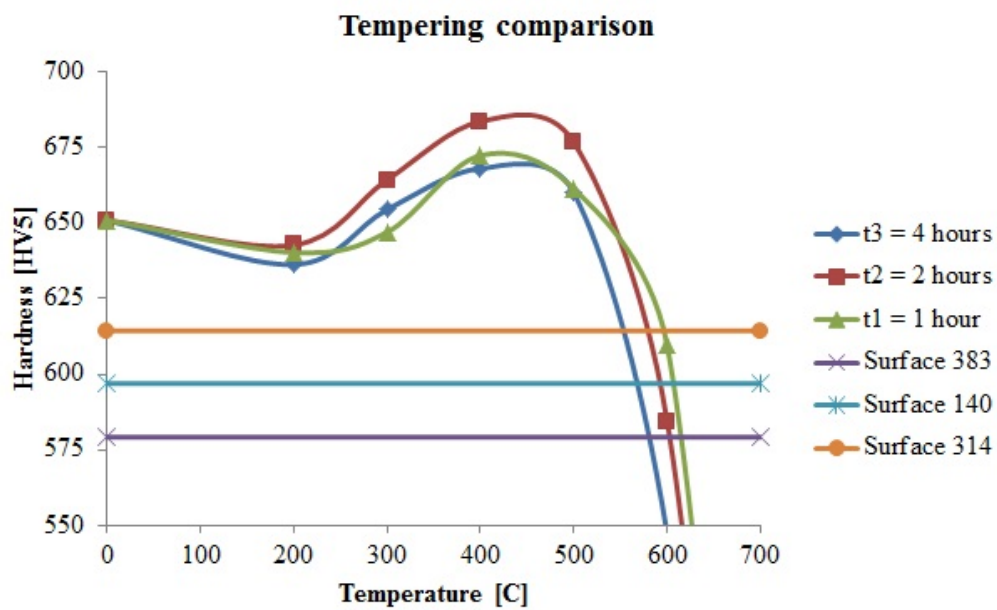
Figure 4.36: Hardness profile of cutter disc HD4 after 1, 2 and 4 hours of tempering. Horizontal lines indicate hardness at the wear surface of TBM cutters 140, 314 (slice 1) and 383.

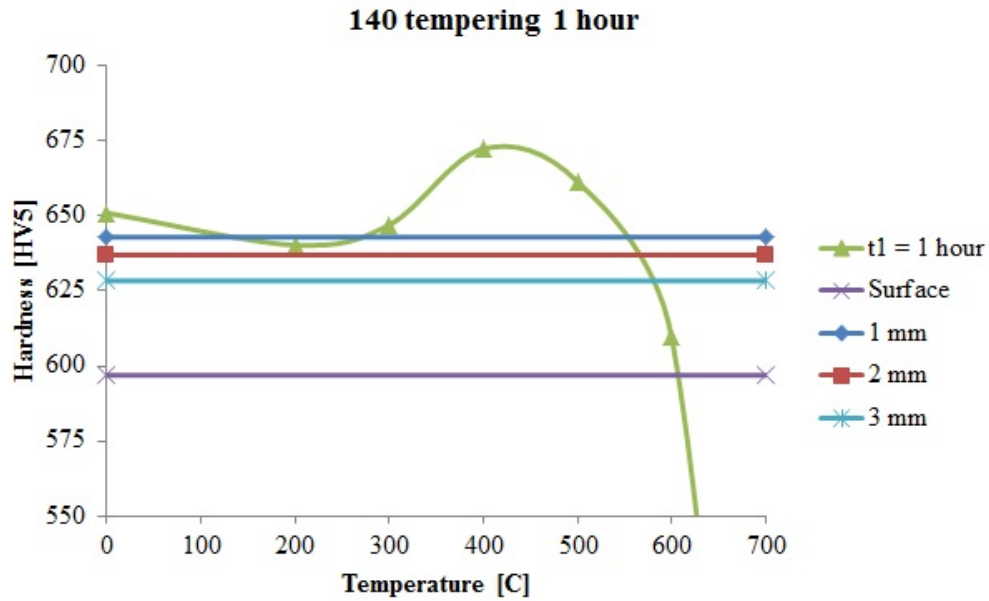
Figure 4.37: Hardness profile of cutter disc HD₄ after 1 hour of tempering. Horizontal lines indicate hardness at known distances from the wear surface of TBM cutter 140.

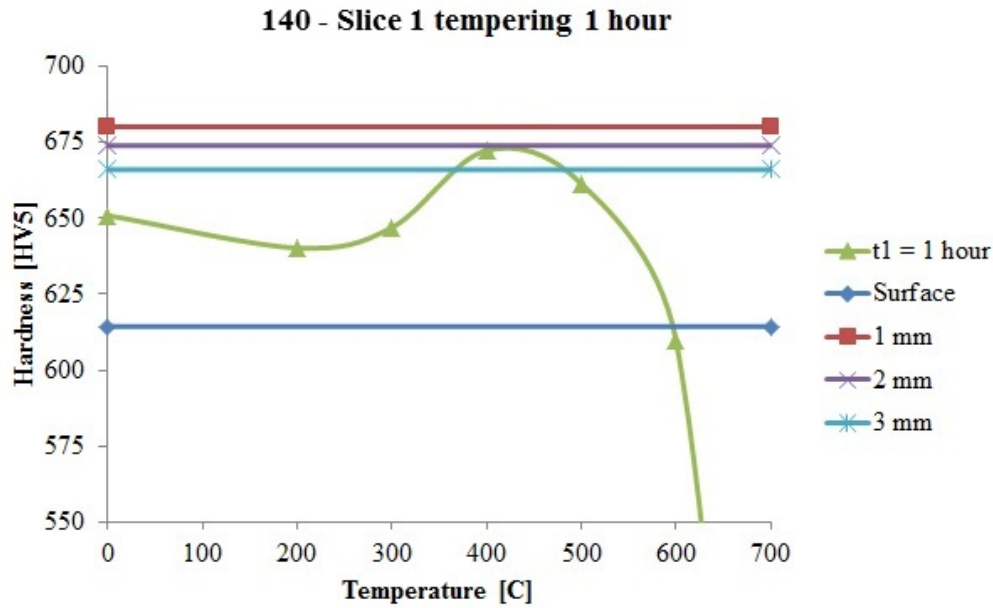
Figure 4.38: Hardness profile of cutter disc HD4 after 1 hour of tempering. Horizontal lines indicate hardness at known distances from the wear surface of TBM cutter 314, slice 1.

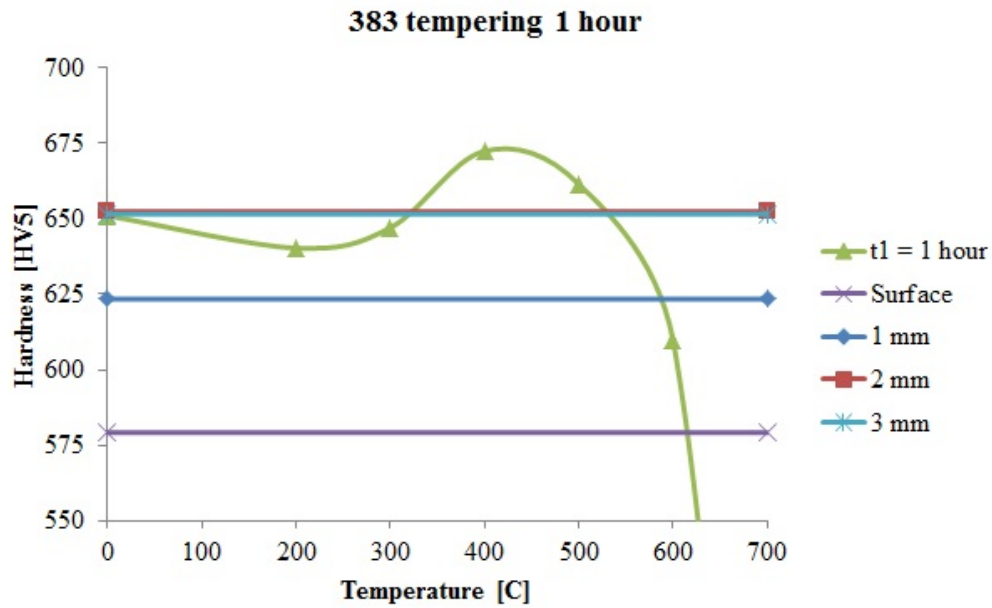
Figure 4.39: Hardness profile of cutter disc HD_4 after 1 hour of tempering. Horizontal lines indicate hardness at known distances from the wear surface of TBM cutter 383.

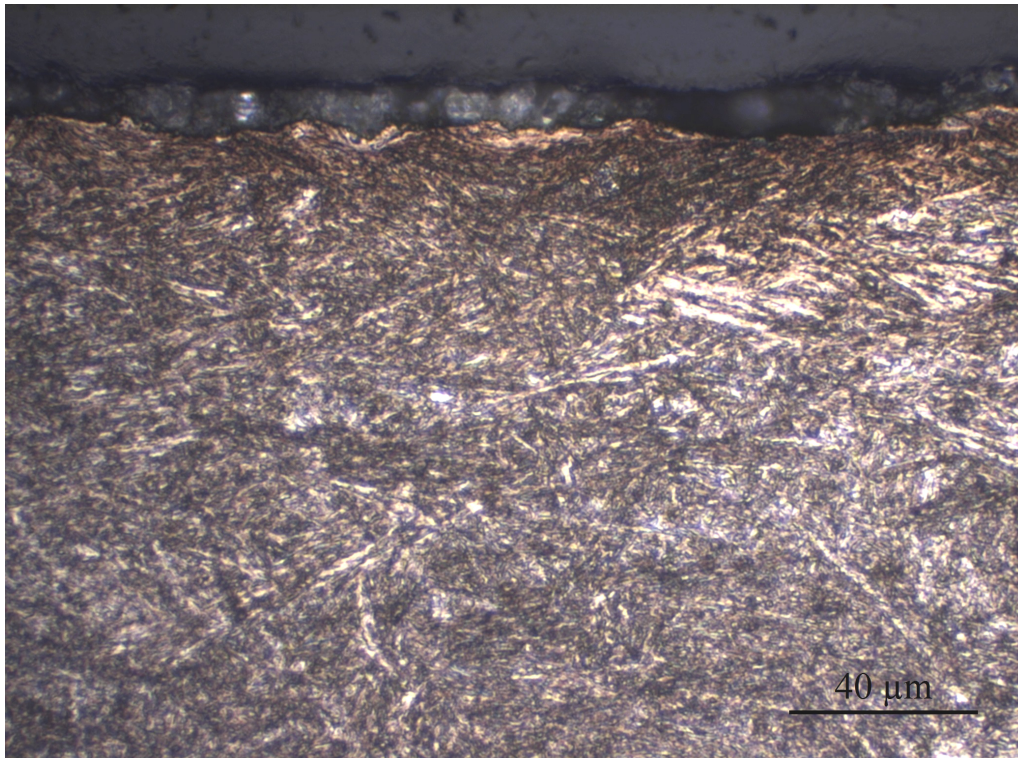
Figure D.1: Optical image of cross section in TBM cutter 140, transverse cut. No lamellar surface layer observed. Some deformation apparent, with no clear direction of orientation. 500X magnification.

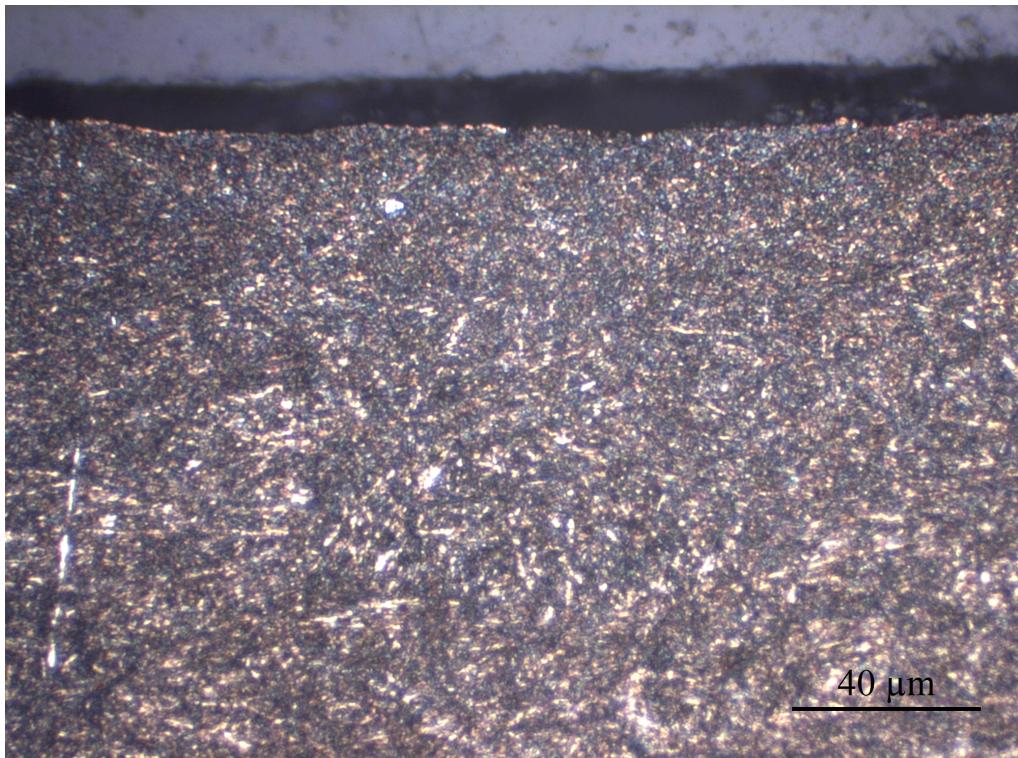
Figure D.2: Optical image of cross section in TBM cutter 302, transverse cut. No lamellar surface layer observed. Microstructure highly deformed, seen from lack of retained austenite (white phase). 500X magnification.

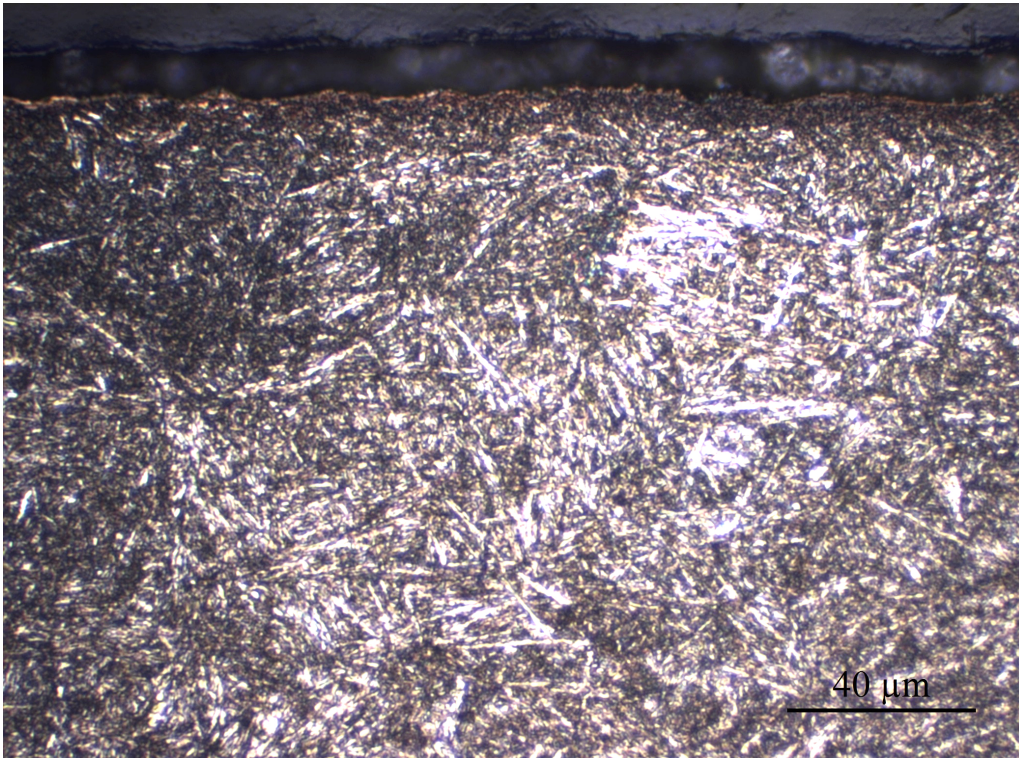
Figure D.3: Optical image of cross section in TBM cutter 383, transverse cut. No lamellar surface layer observed. Some deformation apparent at the surface. 500X magnification.

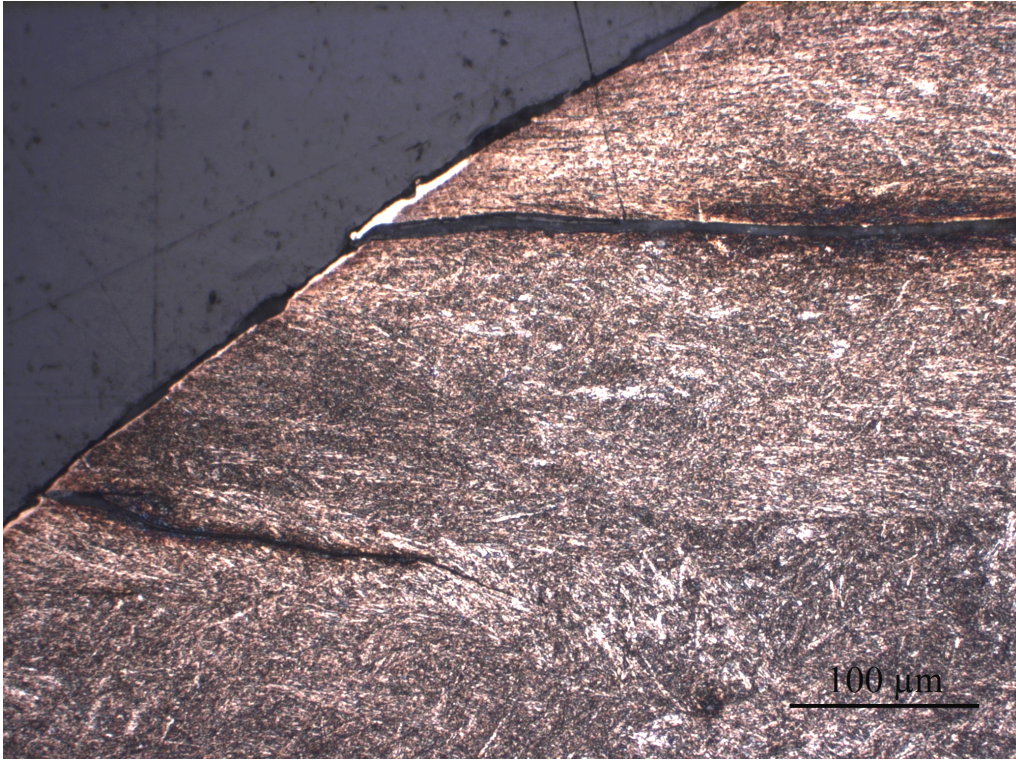
Figure D.4: Optical image of cross section in TBM cutter 314, parallel cut. Lamellar structure seen, with crack growth in parallel with the lamellae direction. Lamellar structure possibly caused by folding of asperities. 200X magnification.

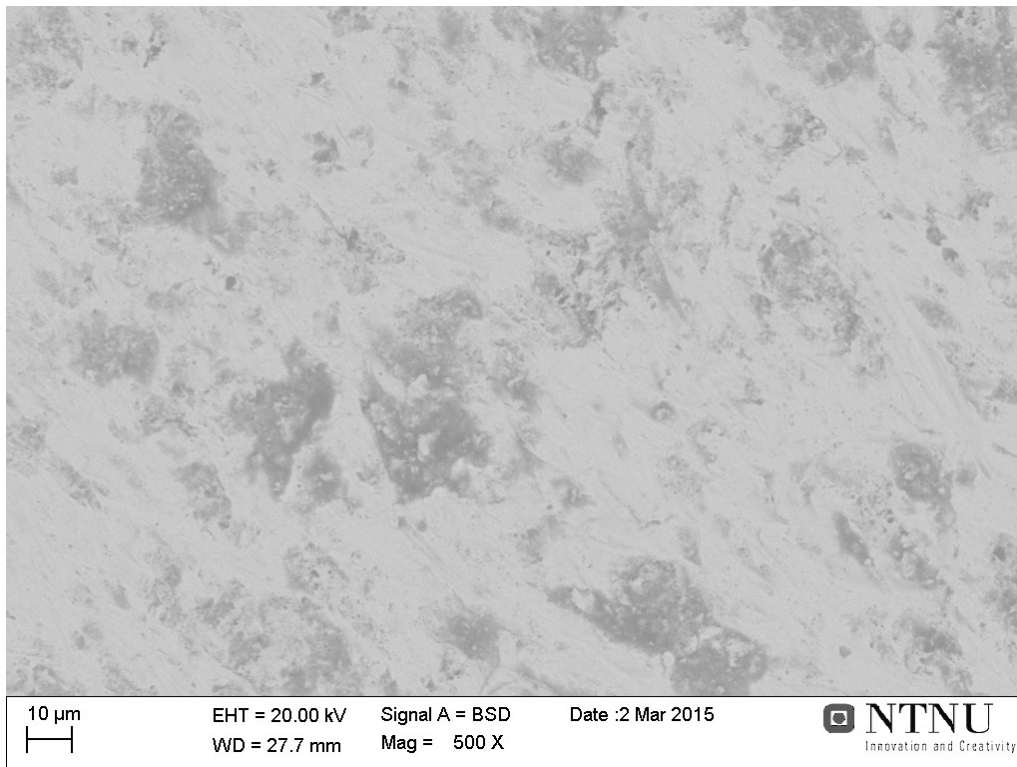
Figure D.5: SEM image of wear surface of RIAT mini-cutter 8, worn by quartzite. BSE signal. Bright areas are steel, dark areas are rock debris.

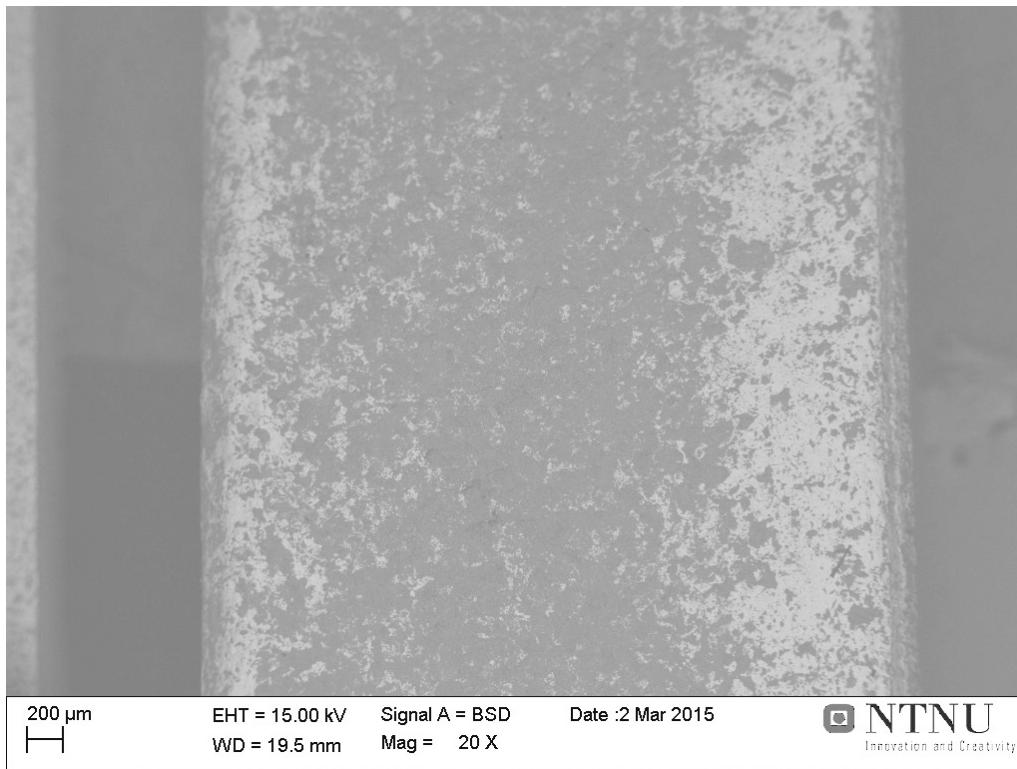
Figure D.6: SEM image of wear surface of RIAT mini-cutter 7, worn by basalt. BSE signal. Bright areas are steel, dark areas are rock debris.

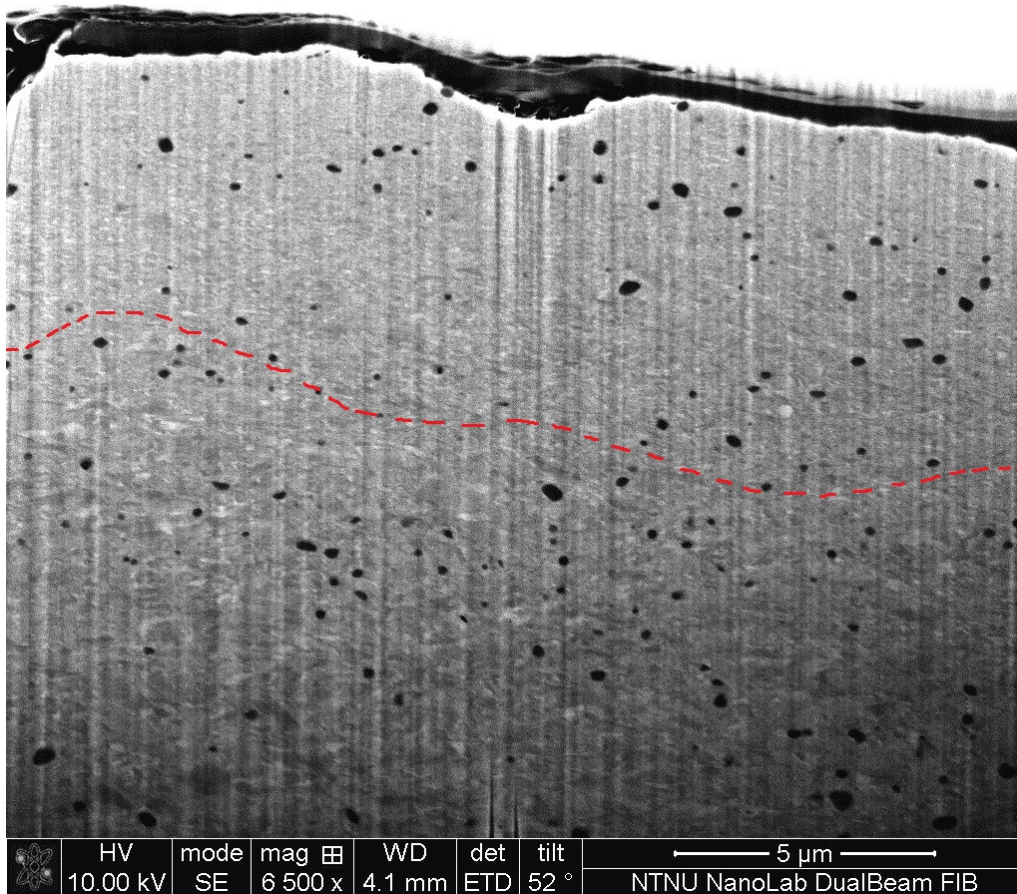
Figure D.7: FIB image of RIAT mini-cutter 3, worn by Iddefjord granite. Fine grained area visible at the surface of the specimen. Dotted line imply border for nanocrystalline deformation layer. Possible nanocrystalline layer approximately 5 - 7 μ m thick.

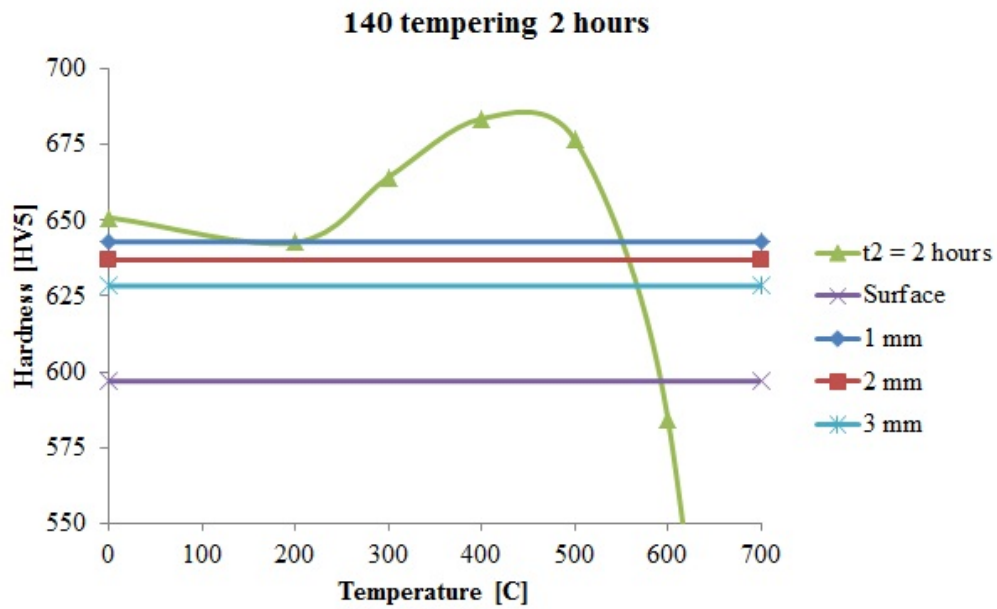
Figure E.1: Hardness profile of cutter disc HD₄ after 2 hours of tempering. Horizontal lines indicate hardness at known distances from the wear surface of TBM cutter 140.

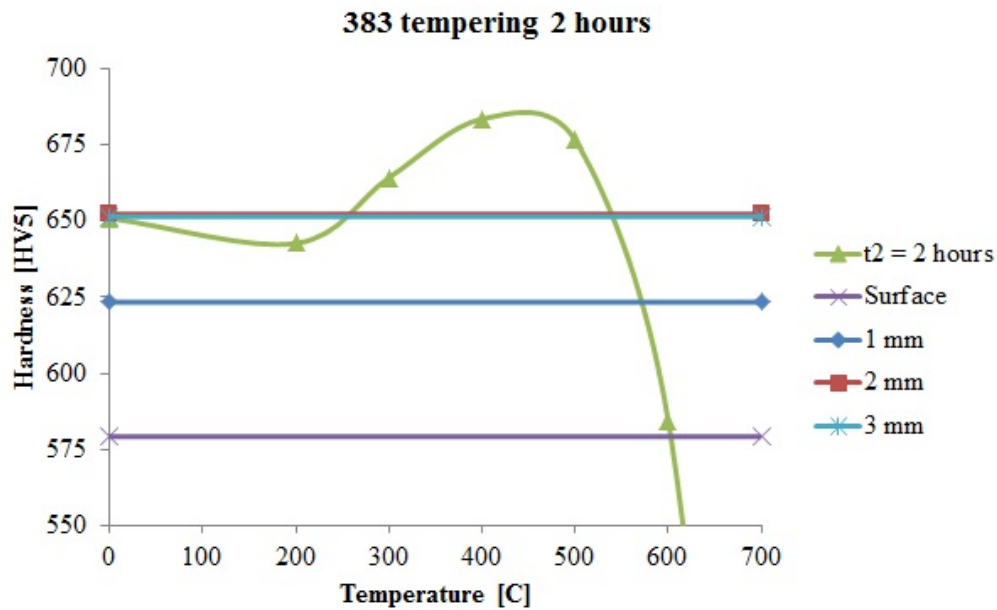
Figure E.2: Hardness profile of cutter disc HD_4 after 2 hours of tempering. Horizontal lines indicate hardness at known distances from the wear surface of TBM cutter 383.
