# Hydrogen Induced Stress Cracking of Inconel 718 under Cathodic Polarization

Effects of Hydrogen on the Initiation and  
Propagation of Cracks

Submission date: June 2015

Norwegian University of Science and Technology  
Department of Engineering Design and Materials

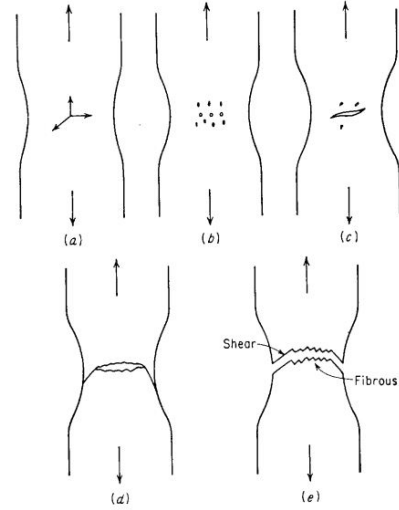
**Figure 2.2:** Formation of a cup-and-cone ductile fracture. Figure from Dieter [22].

Tensile fracture of a ductile metal will usually include plastic deformation until a necked region is formed. Many fine cavities, or microvoids, will form in this necked region. The preferred sites for void formation are inclusions and second phase particles [22]. As these microvoids elongate, they will merge and thereby contribute to crack growth by a process of microvoid coalescence. The crack will grow in a direction perpendicular to the load axis until it gets close to the surface, where it will start to propagate along shear planes at a 45° angle to the load axis. The result is a recognizable cup-and-cone fracture, the steps of which are shown in Figure 2.2. This process leads to a dimpled fracture surface, characteristic of a ductile fracture (as

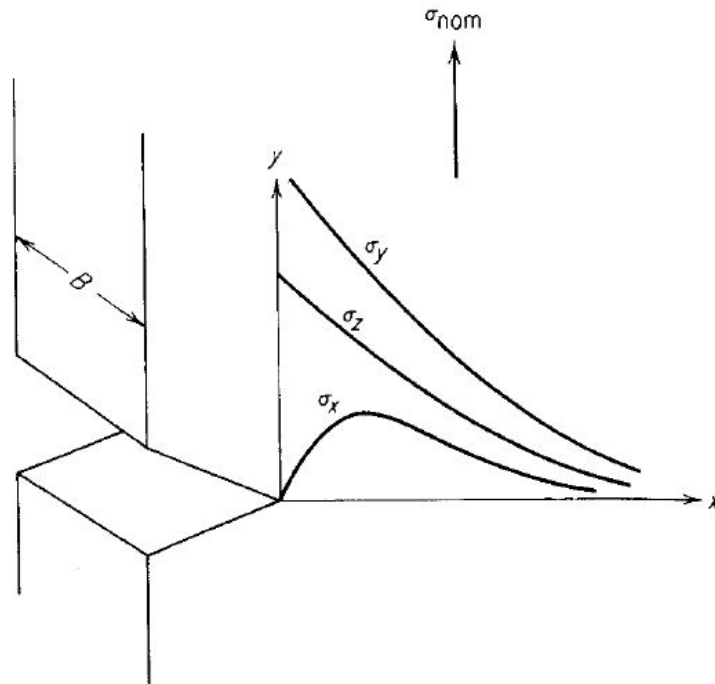
**Figure 2.6:** A representation of the elastic stress distribution at a notch during plane strain. The schematic is taken from Dieter [22].

In a notched specimen, the notch will create a local stress peak near the root of the notch, as illustrated by Figure 2.6. Still, the most important effect is the fact that it introduces a triaxial state of stress at the notch. In an un-notched tensile specimen, the longitudinal stress alone measures the yielding. The existence of transverse stresses raises the average value at which yielding occurs. Consequently, the nominal strength of a notched sample may be greater than the tensile strength of a smooth sample, and a “notch strengthening” effect in crystalline metals may be observed [22] [29]. Although, in a material sensitive to brittle fracture the increased tensile stresses can exceed the critical value for fracture before plastic yielding occurs [22]. A notch strengthening effect was observed in notched tensile specimens of Inconel 718 in project work performed by the author [9].

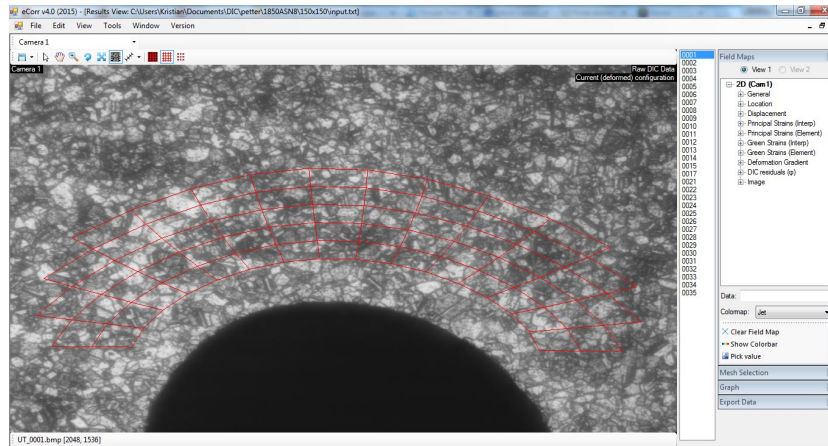
**Figure 2.13:** A mesh used for DIC analysis in the software *eCorr v4.0*. The mesh (in red) is laid over an image of a fine grained Inconel 718 sample that has been etched in order to achieve the desired contrast.

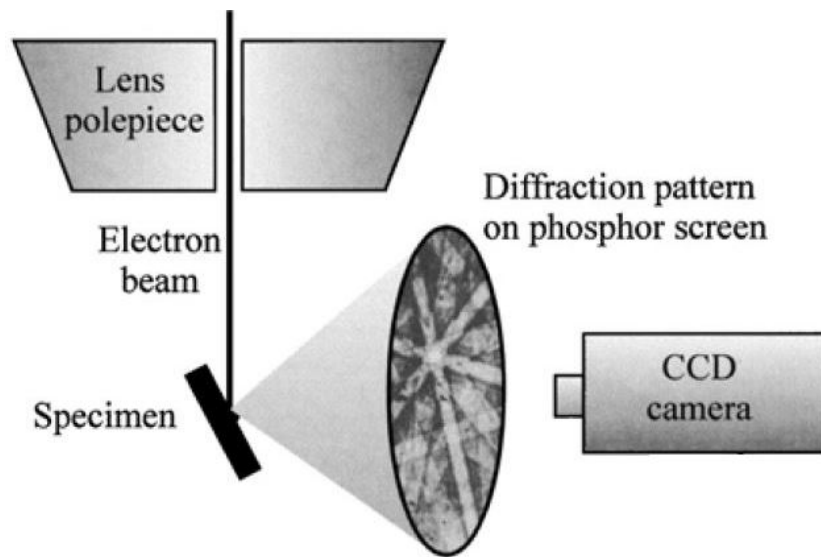
**Figure 2.16:** Illustration of the setup used to produce electron backscatter diffraction. A high energy beam of electrons hits the tilted specimen, creating an EBSD pattern when backscattered electrons hit the phosphor screen. Figure from Humphreys [62].

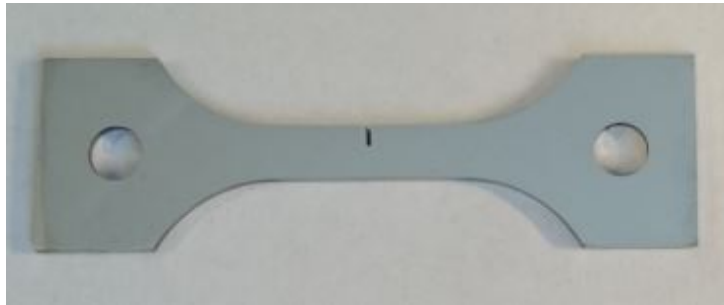
*Figure 3.4: Appearance of a sample after grinding and polishing.*

samples, as well the inside of the notch, were subjected to grinding with 800 and 1200 grit Struers SiC papers. Polishing was not possible in these areas. The samples were subjected to cleaning with soap and water, using a cotton swab, between each polishing step. Figure 3.4 displays a sample polished to 1  $\mu\text{m}$ . After grinding and polishing, the samples were etched for a duration of approximately 15 minutes in Kallings etch no. 2 [63] (constituted by 2 g  $\text{CuCl}_2$ , 50 ml HCl and 50 ml ethanol) in order to make the microstructure visible in optical microscope.

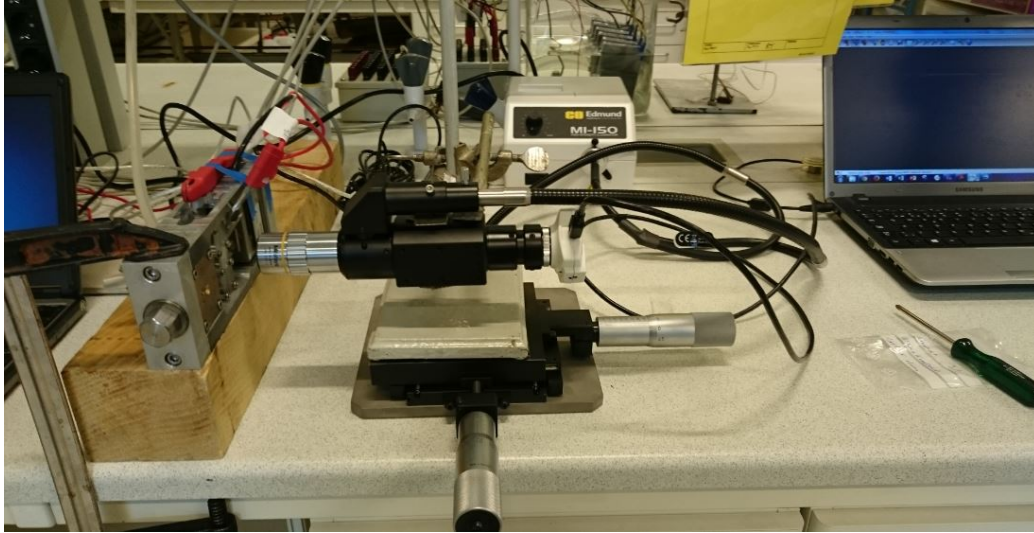
*Figure 3.6: Initial setup for the microscope showing the microscope connected to a 10X objective, digital camera, light source and micro movement stage. The digital camera is connected to a computer.*

The microscope consisted of a Mitutoyo<sup>TM</sup> video microscope unit with a Mitutoyo<sup>TM</sup> M PLAN APO 10X objective and was directly connected to a EO 3112C color LE USB digital camera and MI-15 illuminator light source. This gave a total magnification of approximately 160X. At first, the microscope was mounted on a x-y-micro movement stage, allowing fine focus of the image, as well as moving the microscope across the specimen surface in one direction (either sideways or up and down). The digital camera was connected to

a computer where images could be viewed and saved, using uEye Cockpit software from IDS Imaging Development Systems GmbH. This initial setup is displayed in Figure 3.6.

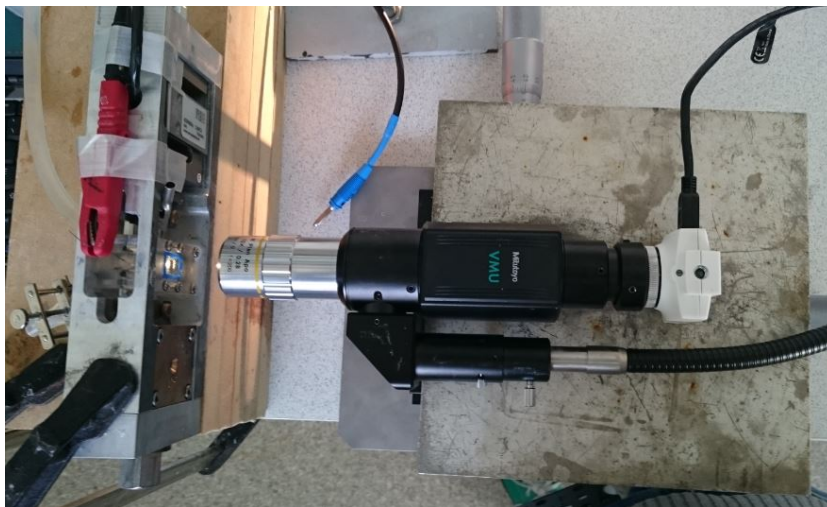
*Figure 3.8: Final setup viewed from above.*

After using the initial optical microscope setup for the first experiments, gradual improvements were made until arriving at the final setup used in this work. Part of the problem with the initial setup was that it was very sensitive to vibrations from movement and other adjacent experiments in the laboratory. It was also problematic that the microscope could only be moved in x and y directions, not in the z direction. To alleviate these problems, the microscope was fastened to a height-adjustable plate using screws, which in turn was fastened to the x-y-micro movement stage. This allowed movement in three directions, as well as reducing much of the vibrations. To further reduce the issues with vibrations, the whole setup was moved to a room separate from other experiments. The final setup is displayed in Figures 3.7 and 3.8.

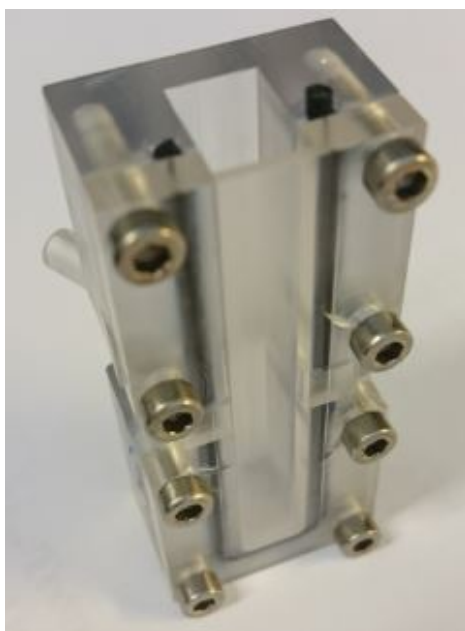
**Figure 3.9:** *The old design for the electrolyte chambers. The front panel is made from polycarbonate, polished to make the sample visible.*

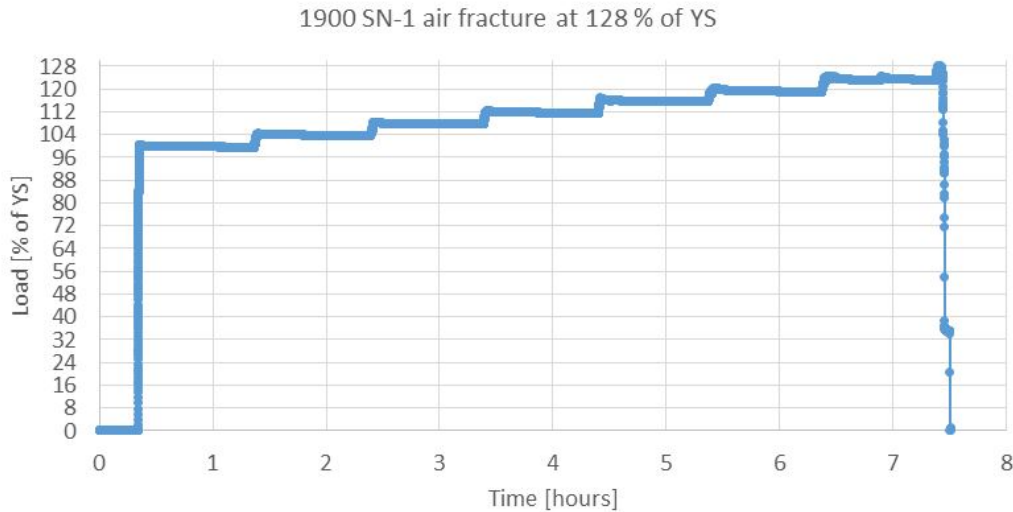
**Figure 3.12:** A graph illustrating the loading procedure of the tensile tests.

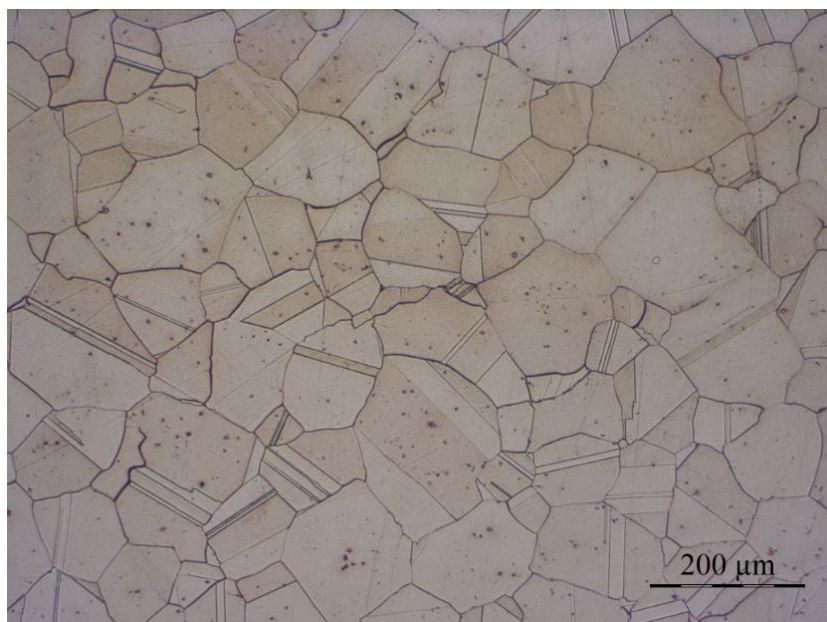
*Figure 4.1: Microstructure of the coarse grained P3A01-1900 material. 100X magnification in optical microscope.*

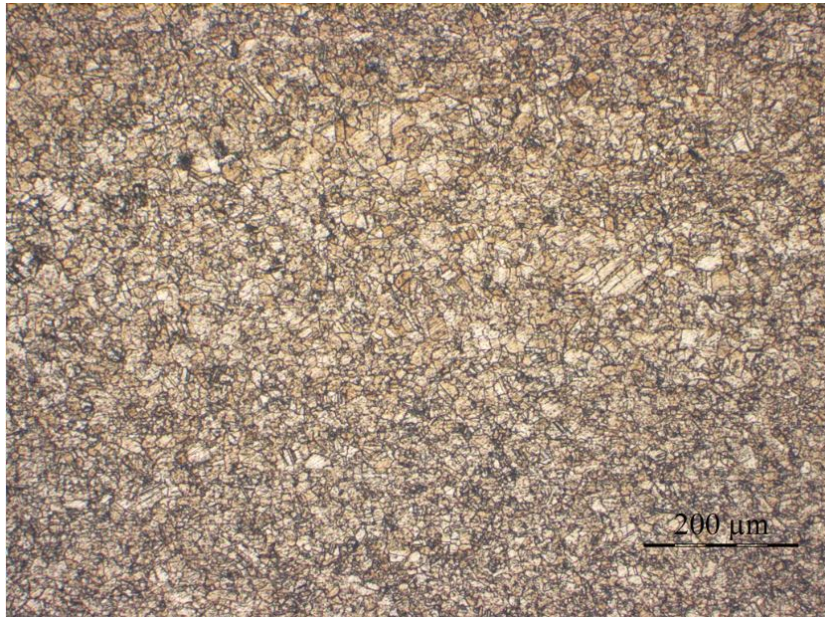
**Figure 4.2:** *Microstructure of the fine grained P3A01-1850B material. 100X magnification in optical microscope.*

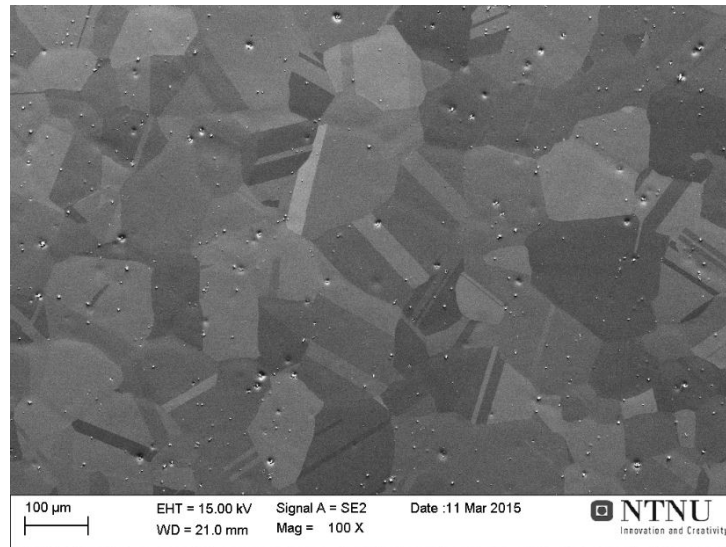
**Figure 4.3:** Microstructure of the coarse grained P3A01-1900 material in SEM. The particles are spherical. The electropolishing treatment has etched the areas around particles, giving the impression that the particles are placed in small dimples. 100X magnification.

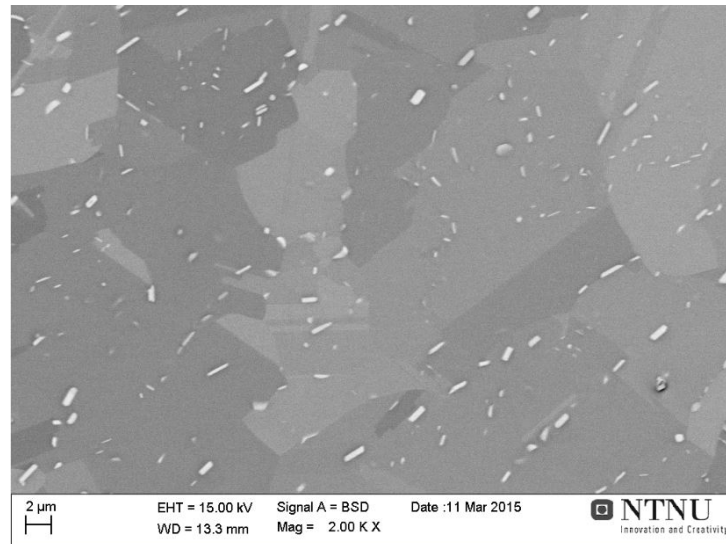
**Figure 4.4:** Microstructure of the fine grained P3A01-1850B material in SEM. The particles are rectangular and are scattered throughout the microstructure. 2000X magnification.

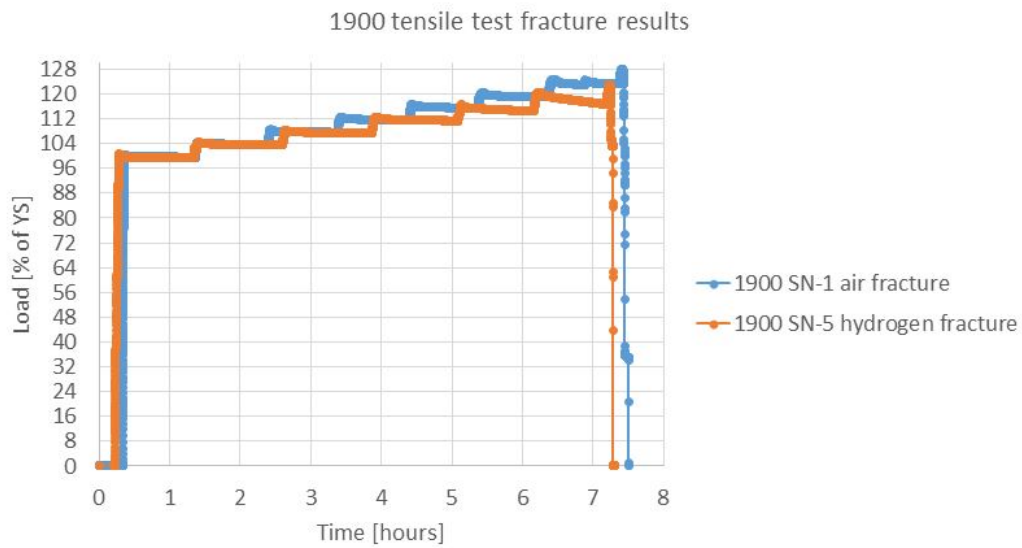
**Figure 4.9:** Tensile test results of the fracture tests of 1900 coarse grained material.

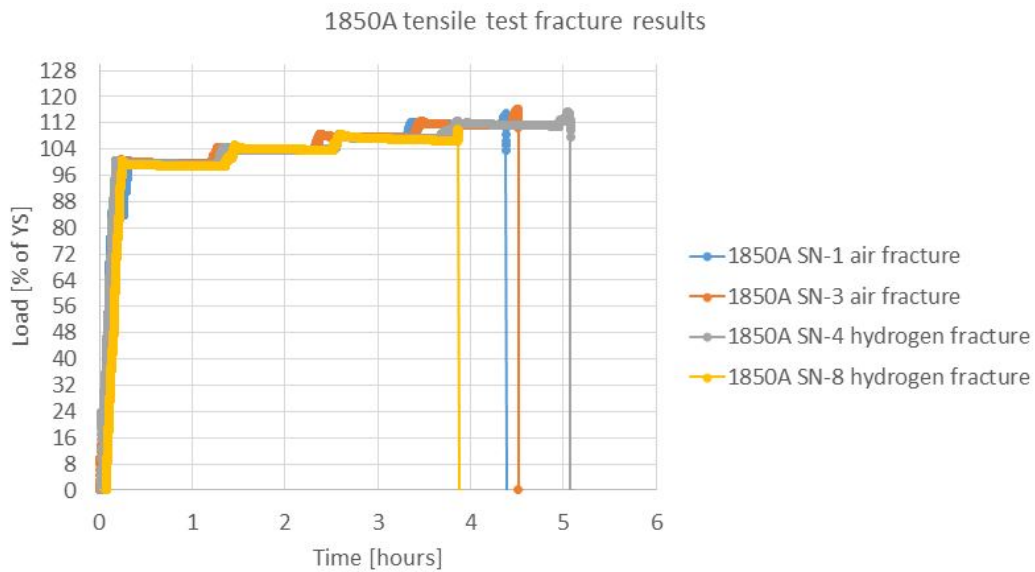
**Figure 4.10:** Tensile test results of the fracture tests of 1850A fine grained material.

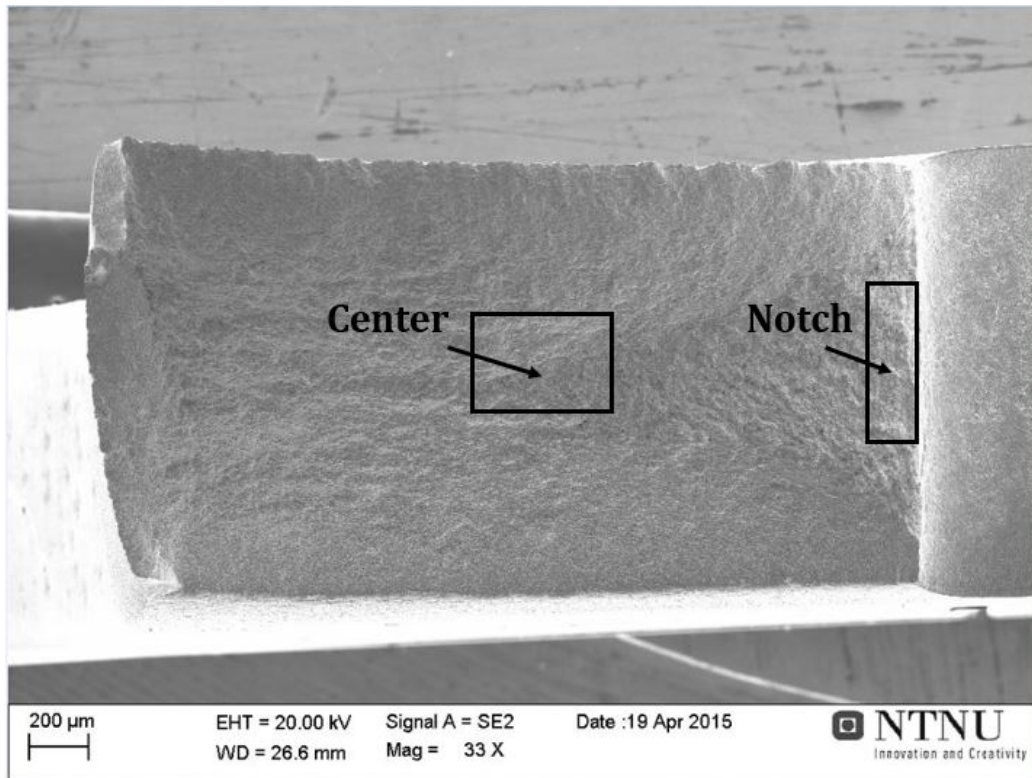
**Figure 4.13:** All fracture surfaces were examined in the same manner, capturing pictures from the notch area as well as the center. This is a map of the fracture surface of the fine grained 1850A SN-4 strained to fracture in Glycerol. 33X magnification.

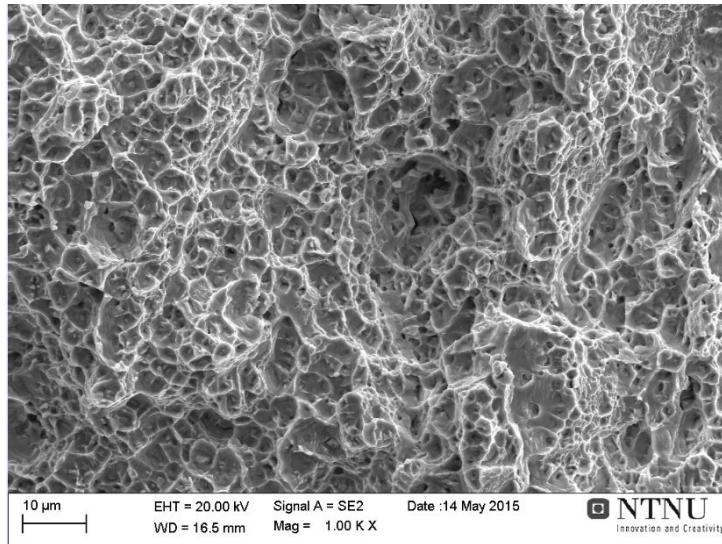
*Figure 4.14: Fine grained sample 1850A SN-1 exhibiting ductile fracture characteristics near the notch edge. 1000X magnification.*

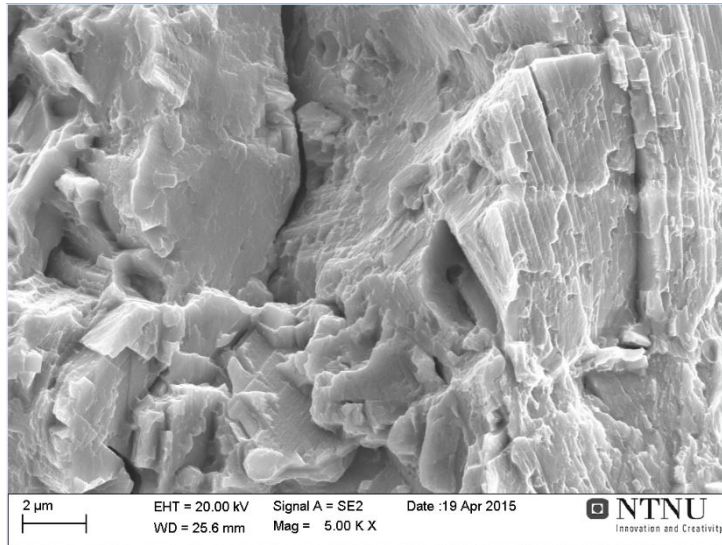
**Figure 4.15:** Fine grained sample 1850A SN-4 exhibiting brittle cleavage fracture characteristics near the notch edge. 5000X magnification.

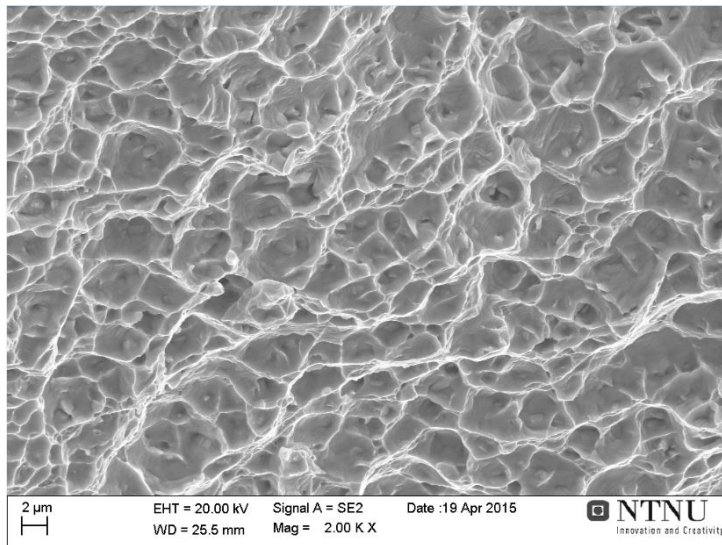
**Figure 4.16:** Fine grained sample 1850A SN-4 exhibiting ductile fracture characteristics near the center of the fracture surface. 2000X magnification.

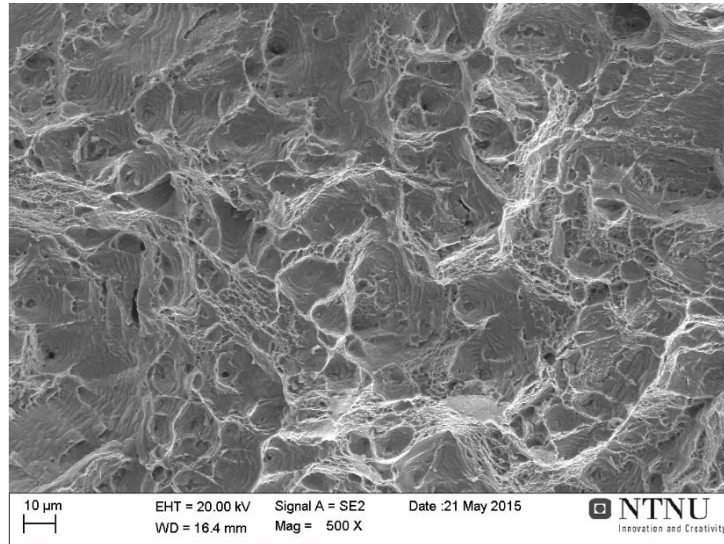
*Figure 4.17: Coarse grained sample 1900 SN-1 exhibiting ductile fracture characteristics near the notch edge. 500X magnification.*

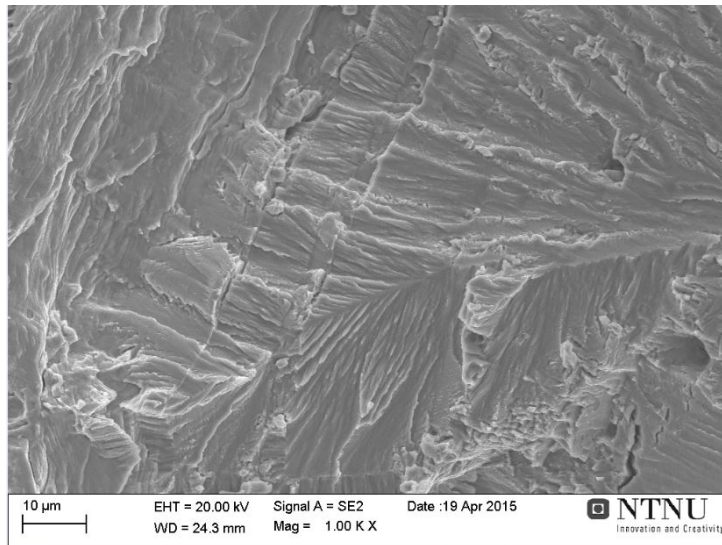
**Figure 4.18:** Coarse grained sample 1900 SN-5 exhibiting brittle cleavage fracture characteristics near the notch edge. 1000X magnification.

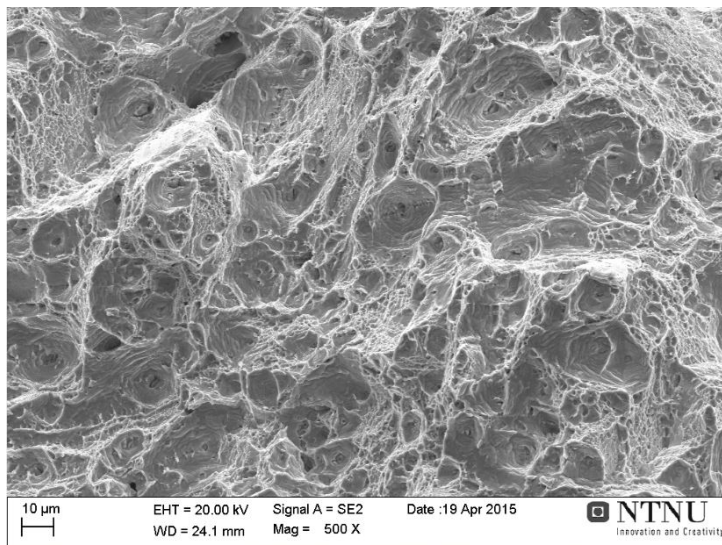
**Figure 4.19:** Coarse grained sample 1900 SN-5 exhibiting ductile fracture characteristics near the center of the fracture surface. 500X magnification.

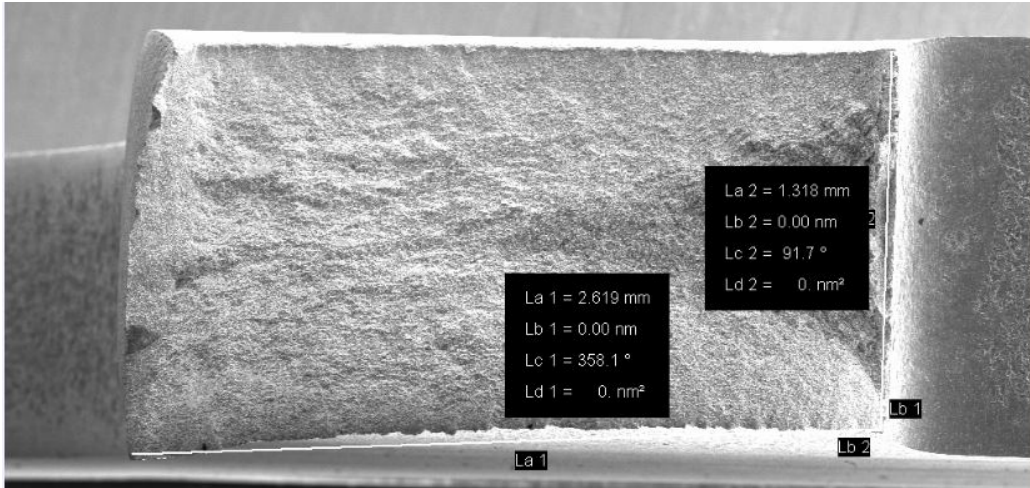
**Figure 4.20:** After fracture, the cross section area was measured by imaging the fracture surface directly from above in the SEM, then using the SEM software to measure the length of the sides.

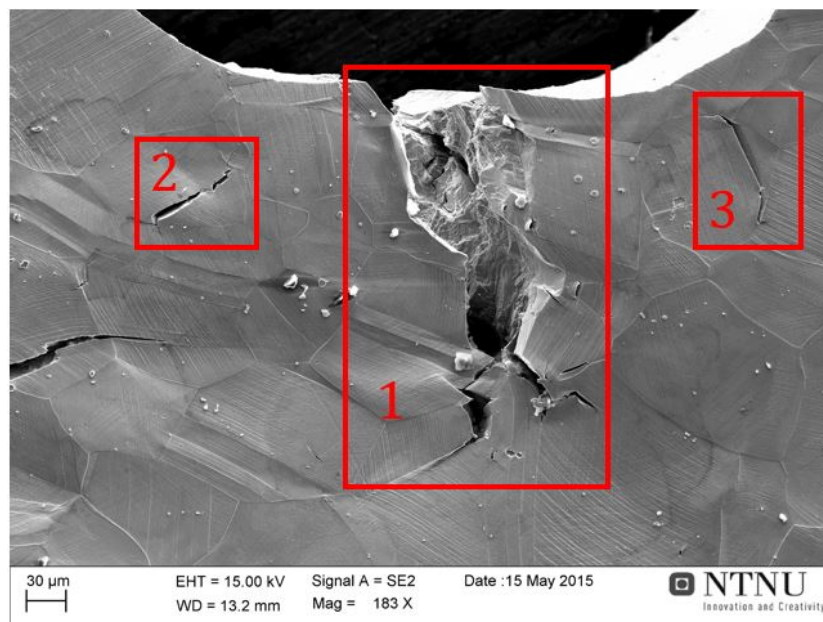
**Figure 4.21:** This picture illustrates the difference between a main crack and secondary cracks. The main crack is marked number 1; a crack propagating from the notch root, clearly on its way to failure. The cracks marked by numbers 2 and 3 are examples of secondary cracks; cracks initiating in the microstructure around the main crack. 183X magnification.

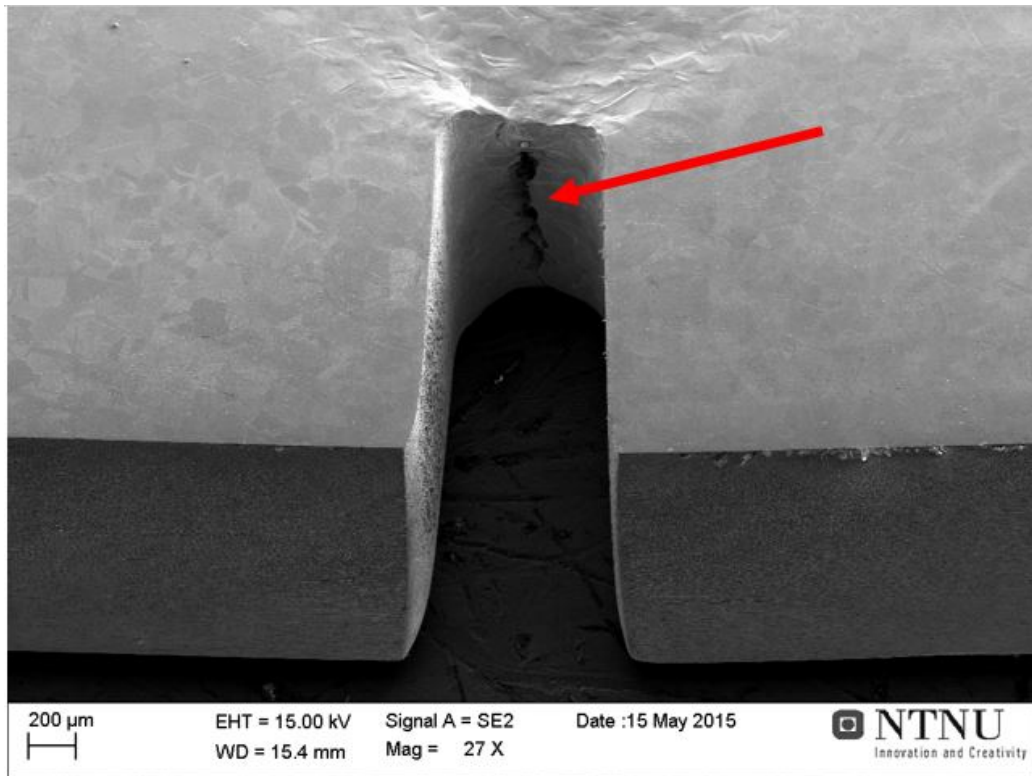
**Figure 4.22:** An example of a main crack propagating from the notch root. All samples exhibited main cracks that propagated from inside the notch. However, they had not always reached the sides of the sample when the experiment was stopped. 27X magnification.

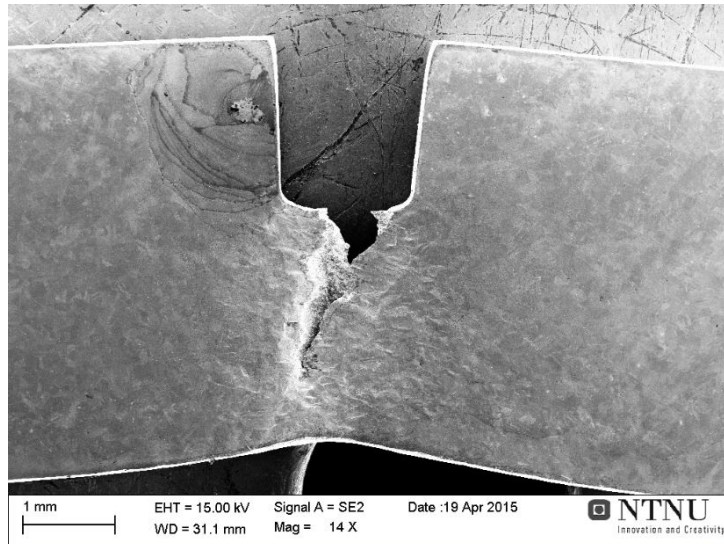
*Figure 4.24: Coarse grained sample 1900 SN-1 strained until a large crack appeared. Except from the main crack, no cracking could be seen on the surface of the sample. 14X magnification.*

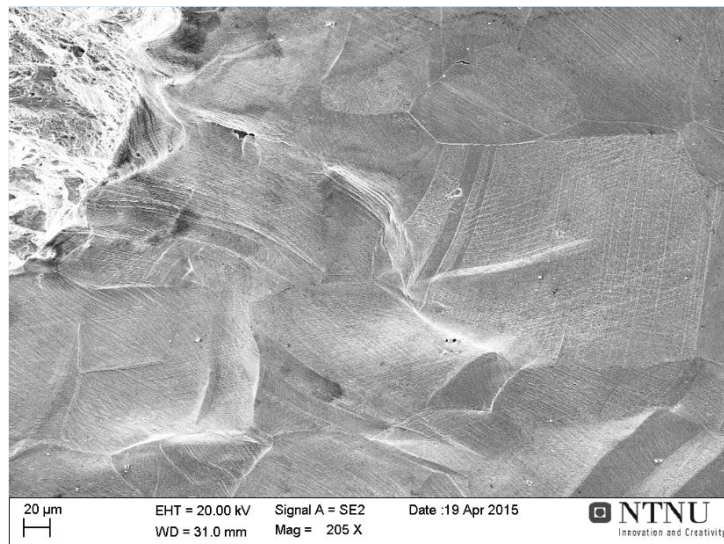
*Figure 4.25: A closer look at the microstructure next to the main crack, revealing no visible secondary cracking in this sample tested in air. Part of the fracture surface can be seen in the upper left corner of the picture. 205X magnification.*

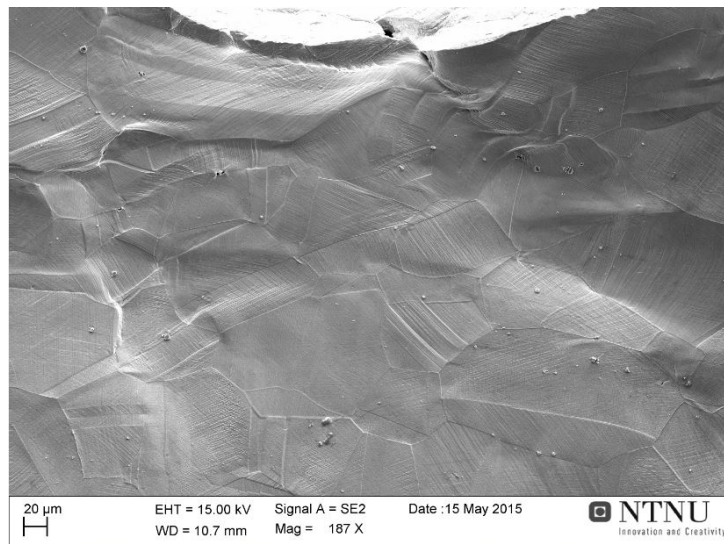
**Figure 4.26:** Coarse grained sample 1900 SN-4 re-loaded to 127 % of YS in air. Other than the main crack, no cracking could be seen on the surface of the sample. 187X magnification.

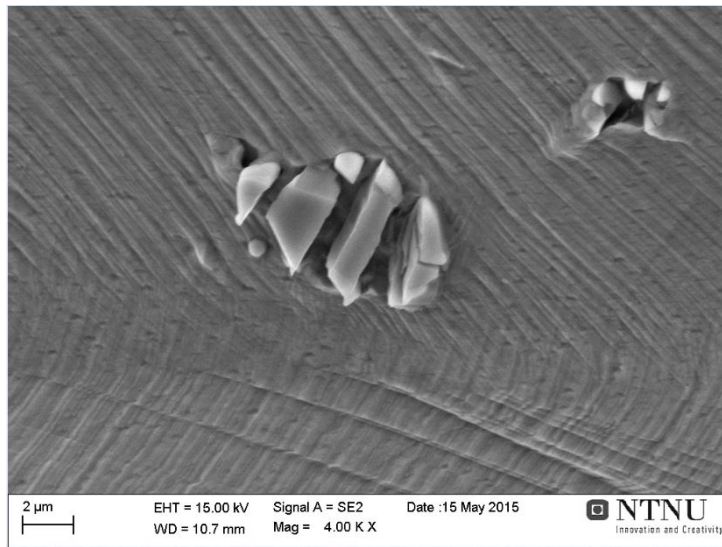
**Figure 4.27:** Some cracked particles could be observed in sample 1900 SN-4 re-loaded to 127 % of YS in air. 4000X magnification.

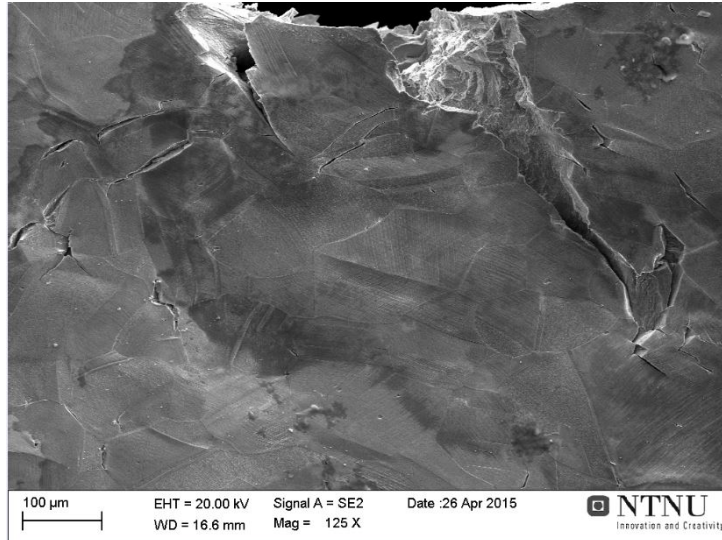
*Figure 4.28: Two large main cracks were found on this side of the sample. Several secondary cracks can also be seen in the picture of coarse grained sample 1900 SN-2, which was stopped at 120 % of YS. 125X magnification.*

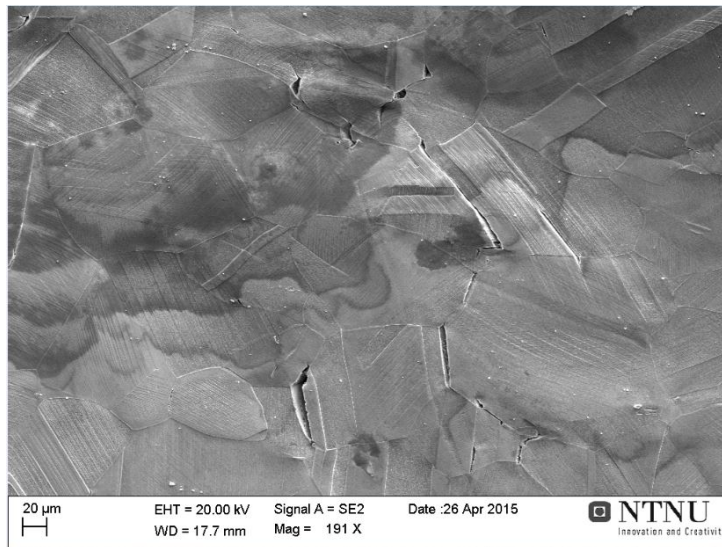
**Figure 4.29:** Picture showing several secondary cracks initiated at twins and grain boundaries in coarse grained sample 1900 SN-2, which was stopped at 120 % of YS. The picture is taken from the lower left area under the notch. 191X magnification.

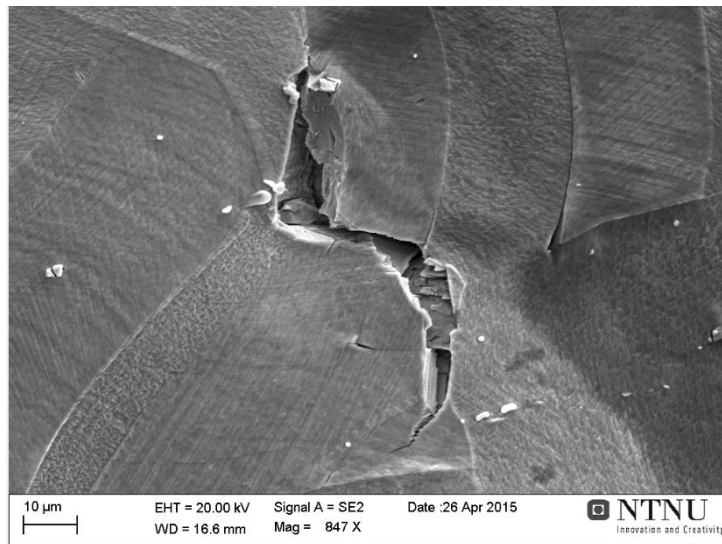
**Figure 4.30:** Close-up of a crack initiated at a twin boundary in coarse grained sample 1900 SN-2, which was stopped at 120 % of YS. The picture is taken from the lower middle area under the notch. 847X magnification.

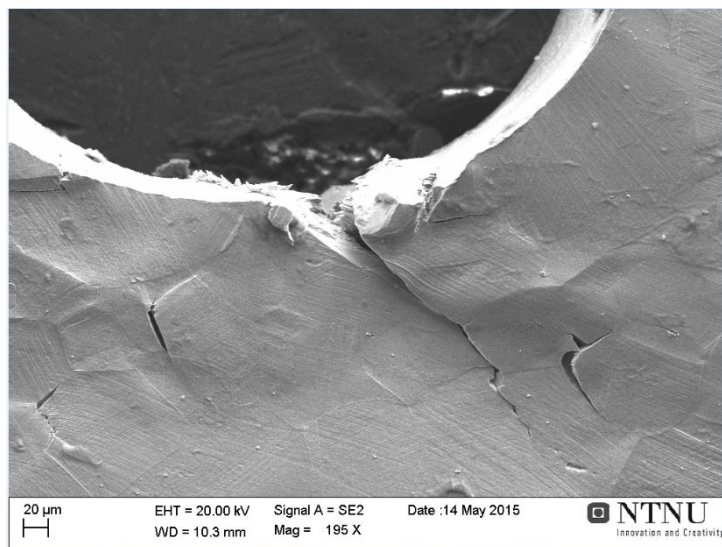
**Figure 4.31:** Picture showing several secondary cracks initiated adjacent to the main crack in coarse grained sample 1900 SN-3, which was stopped at 120 % of YS and polarized in 3.5 % NaCl. 195X magnification.

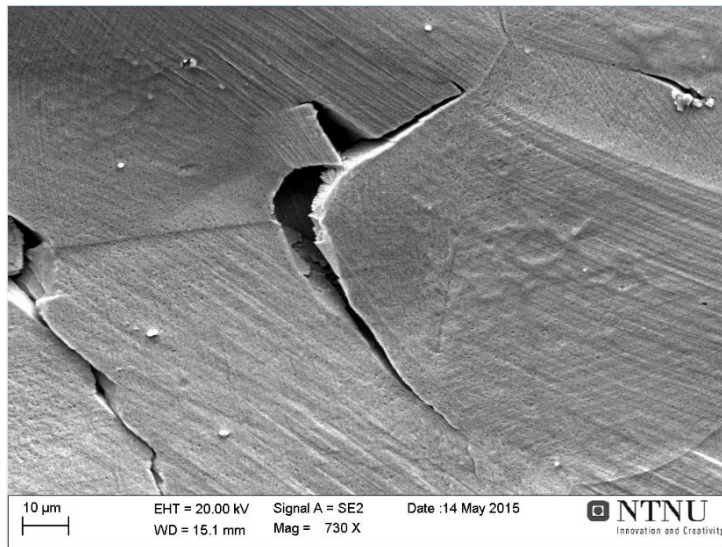
**Figure 4.32:** Close-up of a crack initiated at a grain boundary in coarse grained sample 1900 SN-3, which was stopped at 120 % of YS and polarized in 3.5 % NaCl. The picture is taken from the lower right area under the notch. 730X magnification.

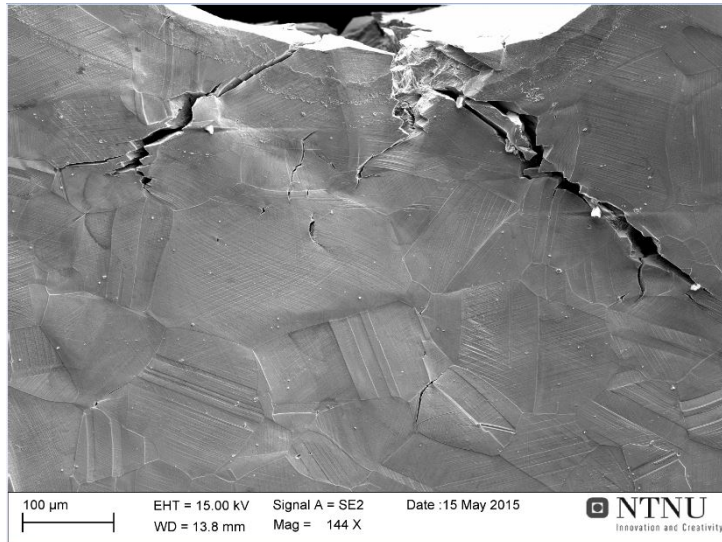
*Figure 4.33:* Picture showing several secondary cracks initiated adjacent to the main crack in coarse grained sample 1900 SN-6, which was stopped at 122 % of YS. 144X magnification.

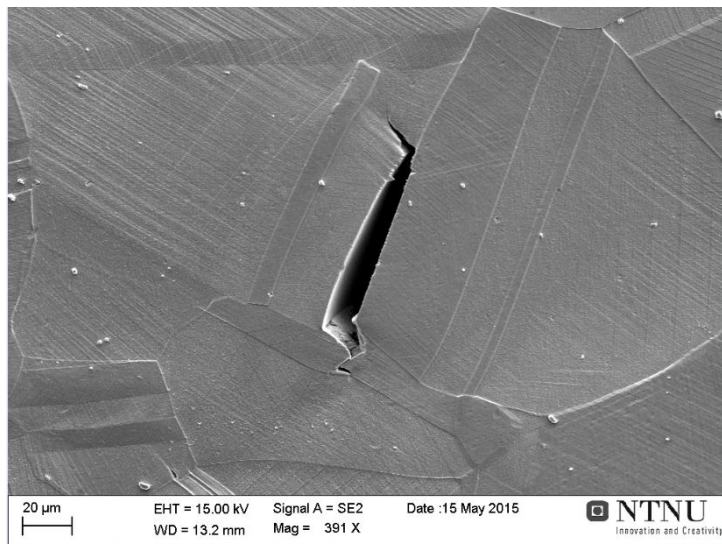
*Figure 4.34:* Picture showing a secondary crack initiated at a twin boundary in coarse grained sample 1900 SN-6, which was stopped at 122 % of YS. 391X magnification.

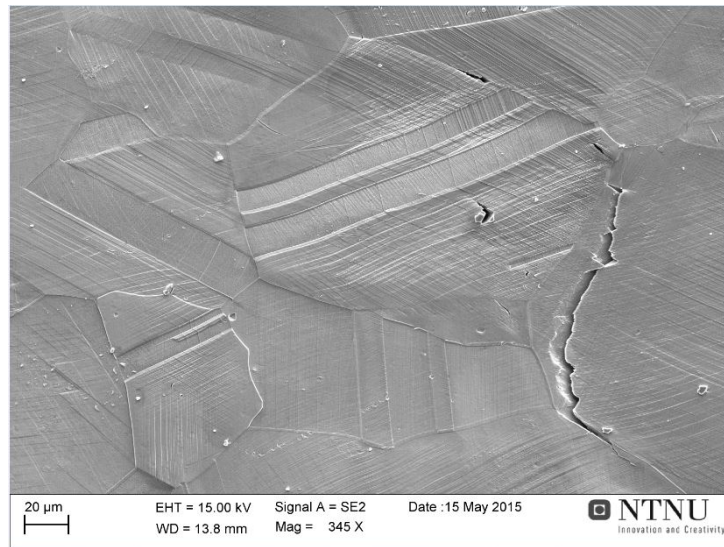
**Figure 4.35:** Close-up of a crack that seemed to have initiated at a grain boundary corner, and propagated inside the grain, in coarse grained sample 1900 SN-6. The picture is taken from the lower right area under the notch. 345X magnification.

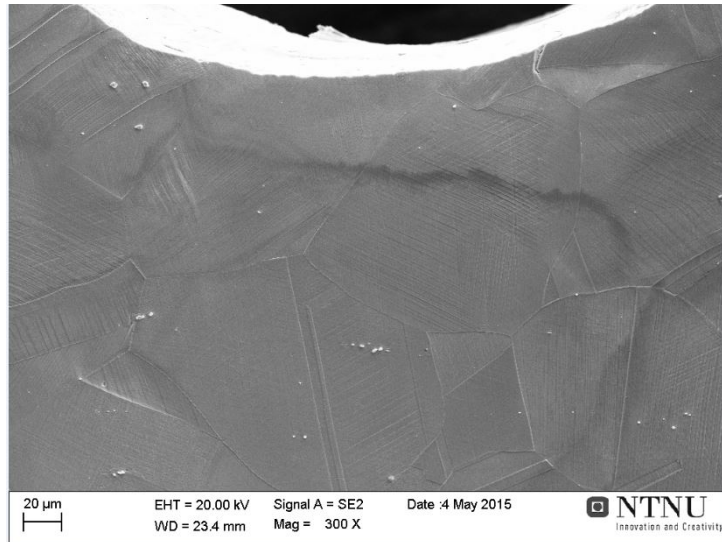
*Figure 4.36: No significant cracking is visible in coarse grained sample 1900 SN-7, which was stopped at 116 % of YS. 300X magnification.*

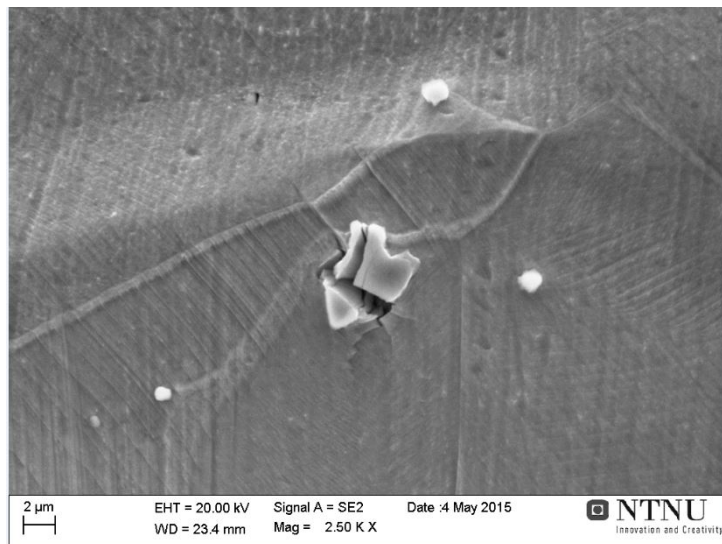
*Figure 4.37: Close-up of a cracked particle in coarse grained sample 1900 SN-7, which was stopped at 116 % of YS. 2500X magnification.*

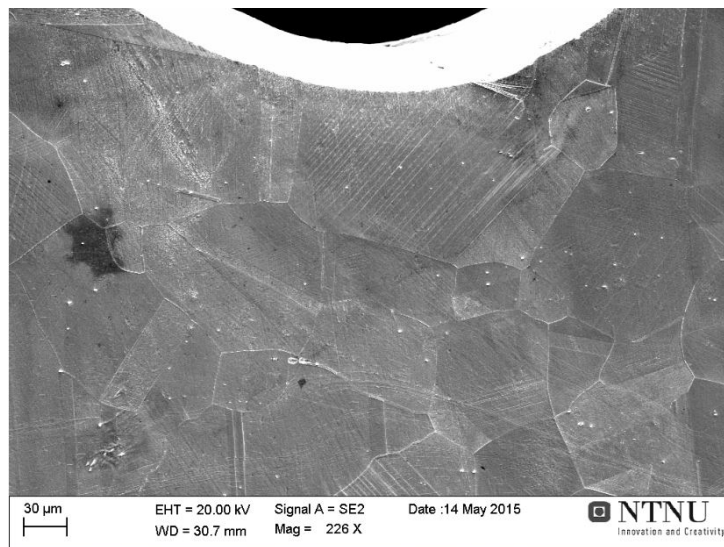
**Figure 4.38:** No cracking is visible in coarse grained sample 1900 SN-8, which was stopped at 112 % of YS. 226X magnification.

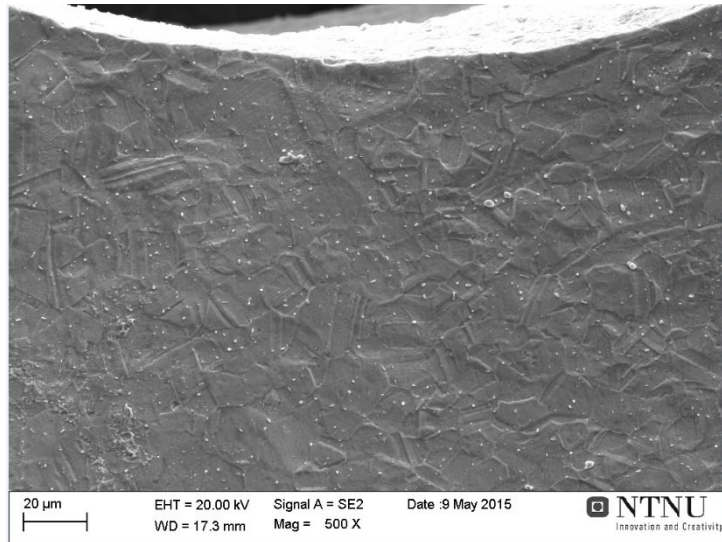
**Figure 4.40:** No secondary cracking was observed in the fine grained sample 1850A SN-6 that was stopped at 115 % of YS in air. 500X magnification.

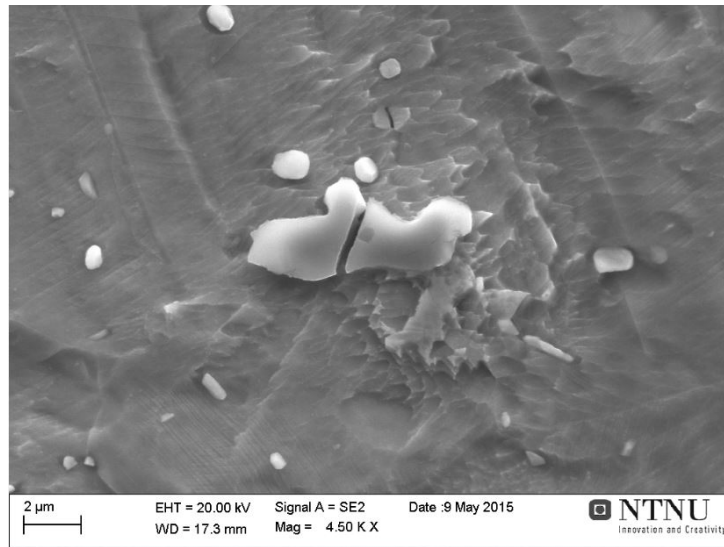
**Figure 4.41:** Image of a cracked particle in the fine grained sample 1850A SN-6 that was stopped at 115 % of YS in air. This particle was examined by EDS, where elevated Ti- and N-content was found. 4500X magnification.

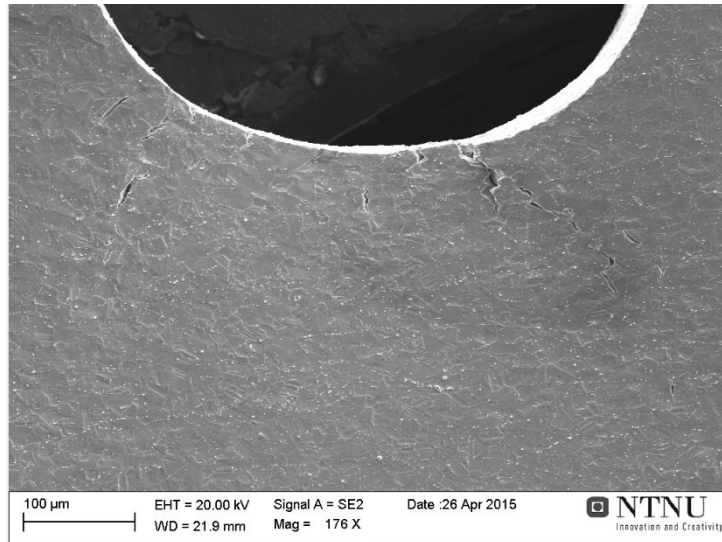
*Figure 4.42: Secondary cracks, especially evident at 45 degree angles to the notch root, were observed in the fine grained sample 1850A SN-2 that was stopped at 113 % of YS in Glycerol. 176X magnification.*

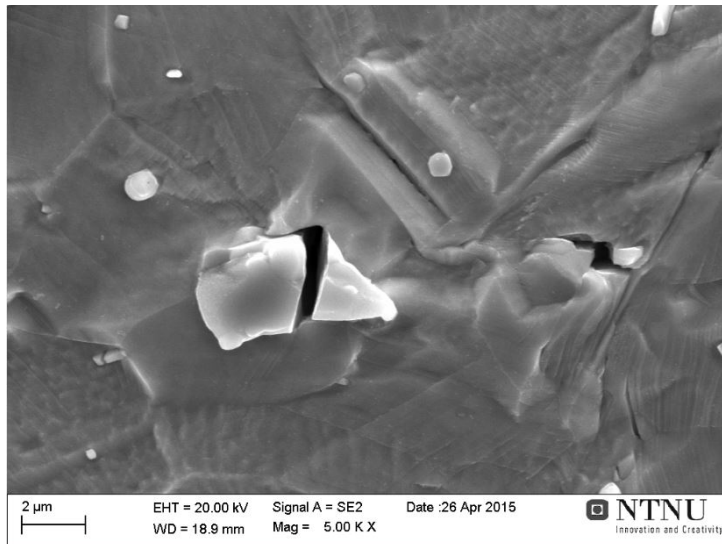
*Figure 4.43: Image of a cracked particle in the fine grained sample 1850A SN-2 that was stopped at 113 % of YS in Glycerol. 5000X magnification.*

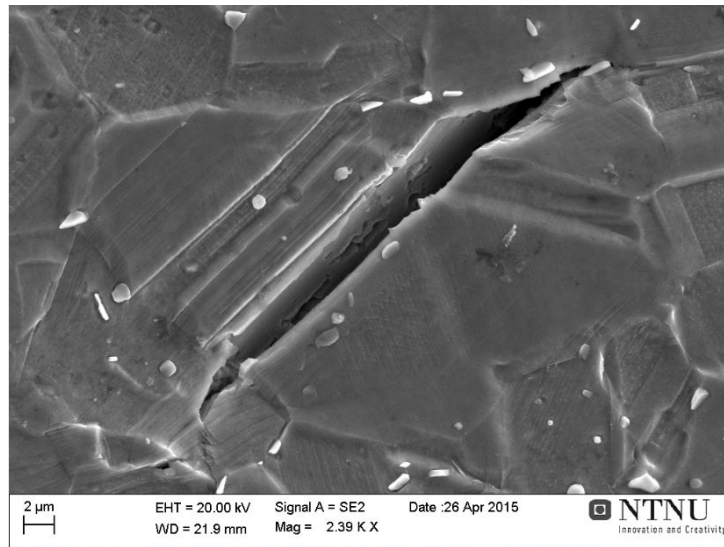
**Figure 4.44:** Cracking at a twin boundary in the fine grained sample 1850A SN-2 that was stopped at 113 % of YS in Glycerol. 55X magnification. 2390X magnification.
