# Hydrogen Induced Stress Cracking of Inconel 718 under Cathodic Polarization

Effects of Hydrogen on the Initiation and  
Propagation of Cracks

Submission date: June 2015

Norwegian University of Science and Technology  
Department of Engineering Design and Materials

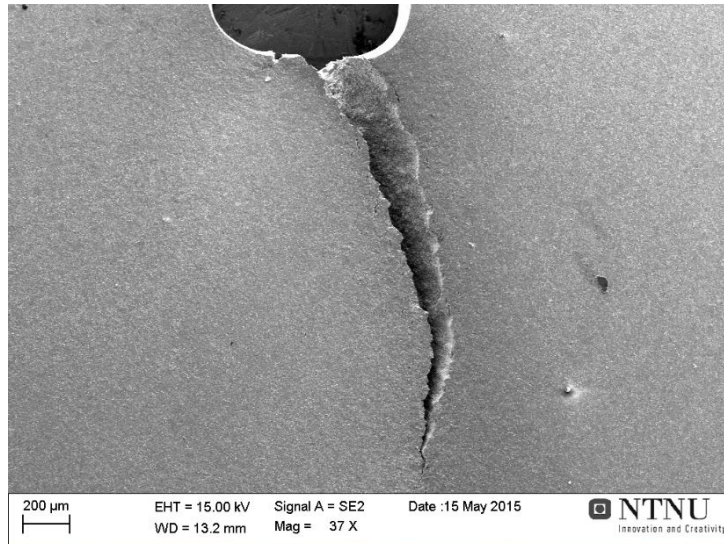
*Figure 4.45:* A large main crack was observed in the fine grained sample 1850A SN-5 that was stopped at 112 % of YS in Glycerol. 37X magnification.

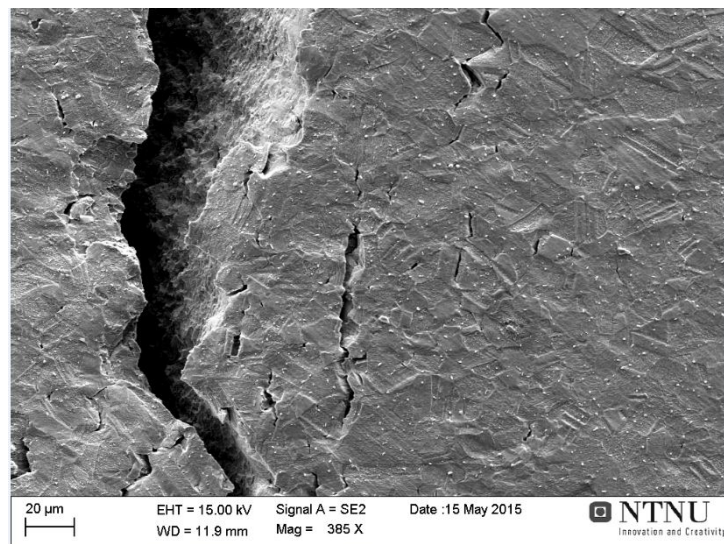
*Figure 4.46:* Secondary cracking was observed in the area adjacent to the main crack in the fine grained sample 1850A SN-5 that was stopped at 112 % of YS in Glycerol. 385X magnification.

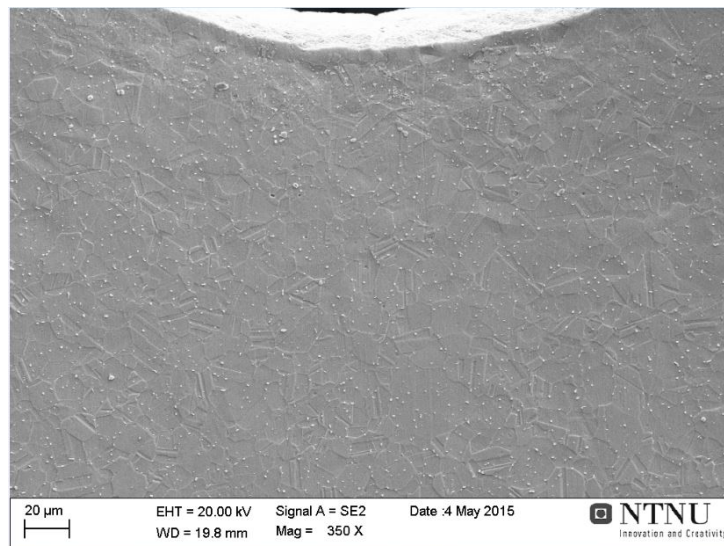
**Figure 4.47:** No surface cracking was found in the fine grained sample 1850A SN-7 that was stopped at 108 % of YS in Glycerol. 350X magnification.

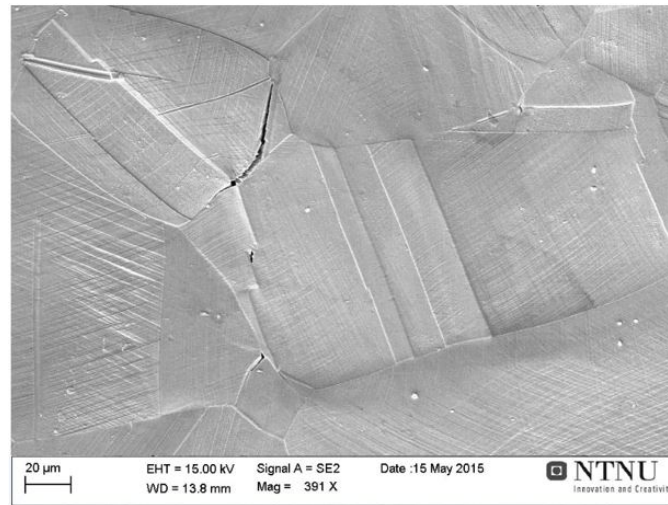
**Figure 4.48:** A SEM image of coarse grained sample 1900 SN-6, loaded to 122 % of YS in Glycerol. A crack can be seen along a grain boundary. 391X magnification.

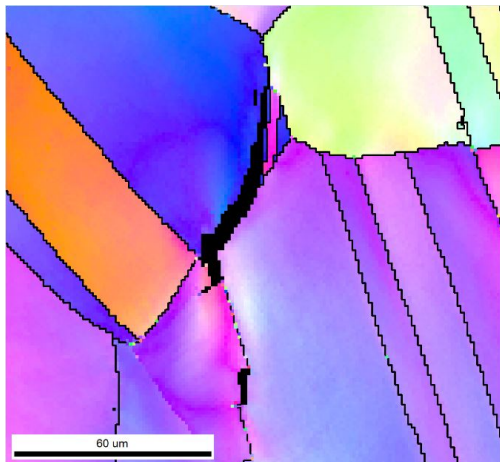
**Figure 4.49:** A grain map from sample 1900 SN-6; the same area as in Figure 4.48. 681X magnification.

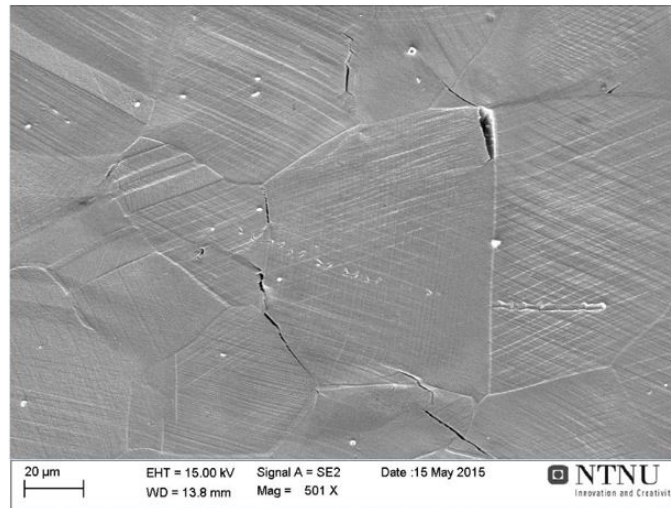
**Figure 4.51:** A SEM image of sample 1900 SN-6. Cracks can be seen at the corners of grain boundaries. 501X magnification.

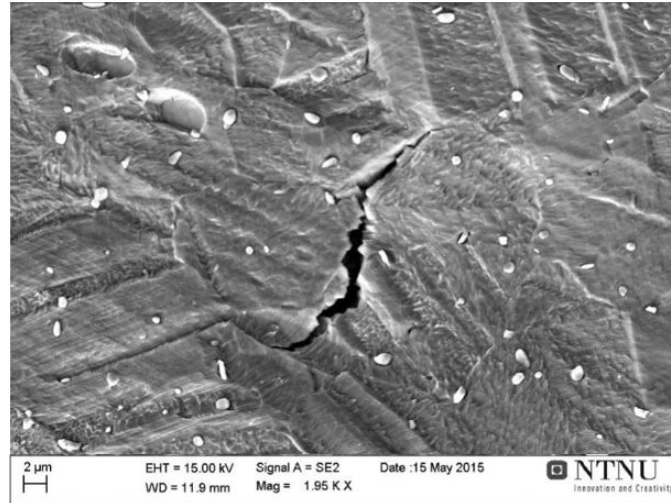
**Figure 4.54:** A SEM image of sample 1850A SN-5, loaded to 112 % of YS in Glycerol. A crack has propagated through several grains. 1950X magnification.

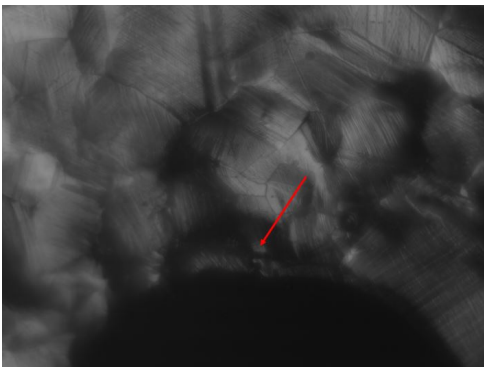
**Figure 4.61:** A crack has initiated at the notch root. 1310 MPa load (118 % of YS). 160X magnification.

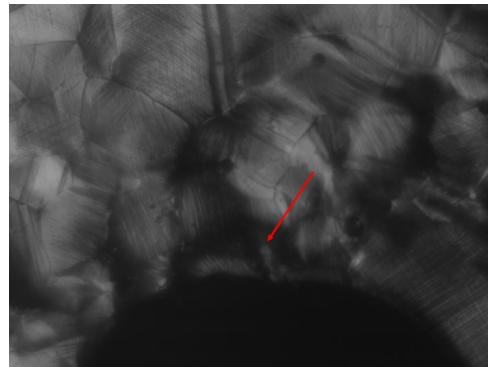
**Figure 4.62:** The crack can be seen propagating at the notch root. 1322 MPa load (119.0 % of YS). 160X magnification.

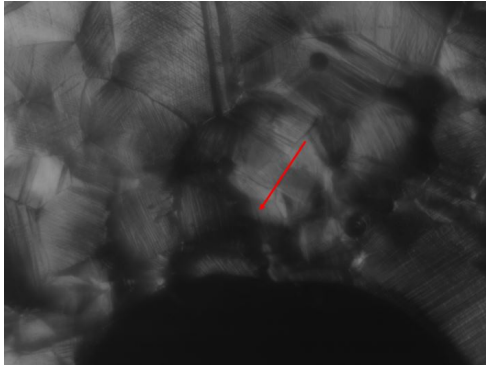
**Figure 4.63:** The crack can be seen propagating further at the notch root. 1327 MPa load (119.5 % of YS). 160X magnification.

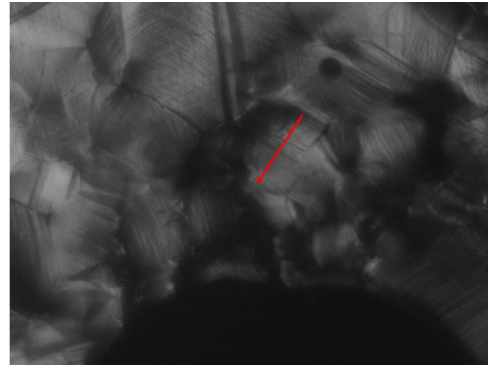
**Figure 4.64:** The experiment was stopped when the crack was discovered. 1329 MPa load (119.7 % of YS). 160X magnification.

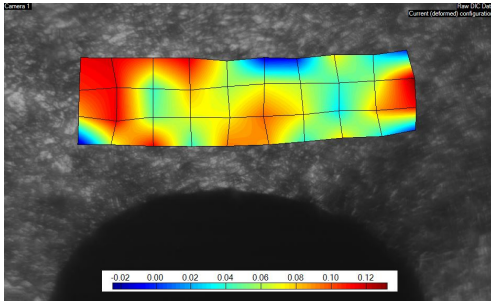
**Figure 4.75:** 1850A SN-8 in Glycerol at 1349 MPa load (104 % of YS). The DIC software has lost track of the microstructure, leading to breakdown of the strain map. 160X magnification.
