Guro Grøneng  
**Stability Analyses of the Åknes Rock  
Slope, Western Norway**

# Stability Analyses of the Åknes Rock Slope, Western Norway

Thesis for the degree of philosophiae doctor

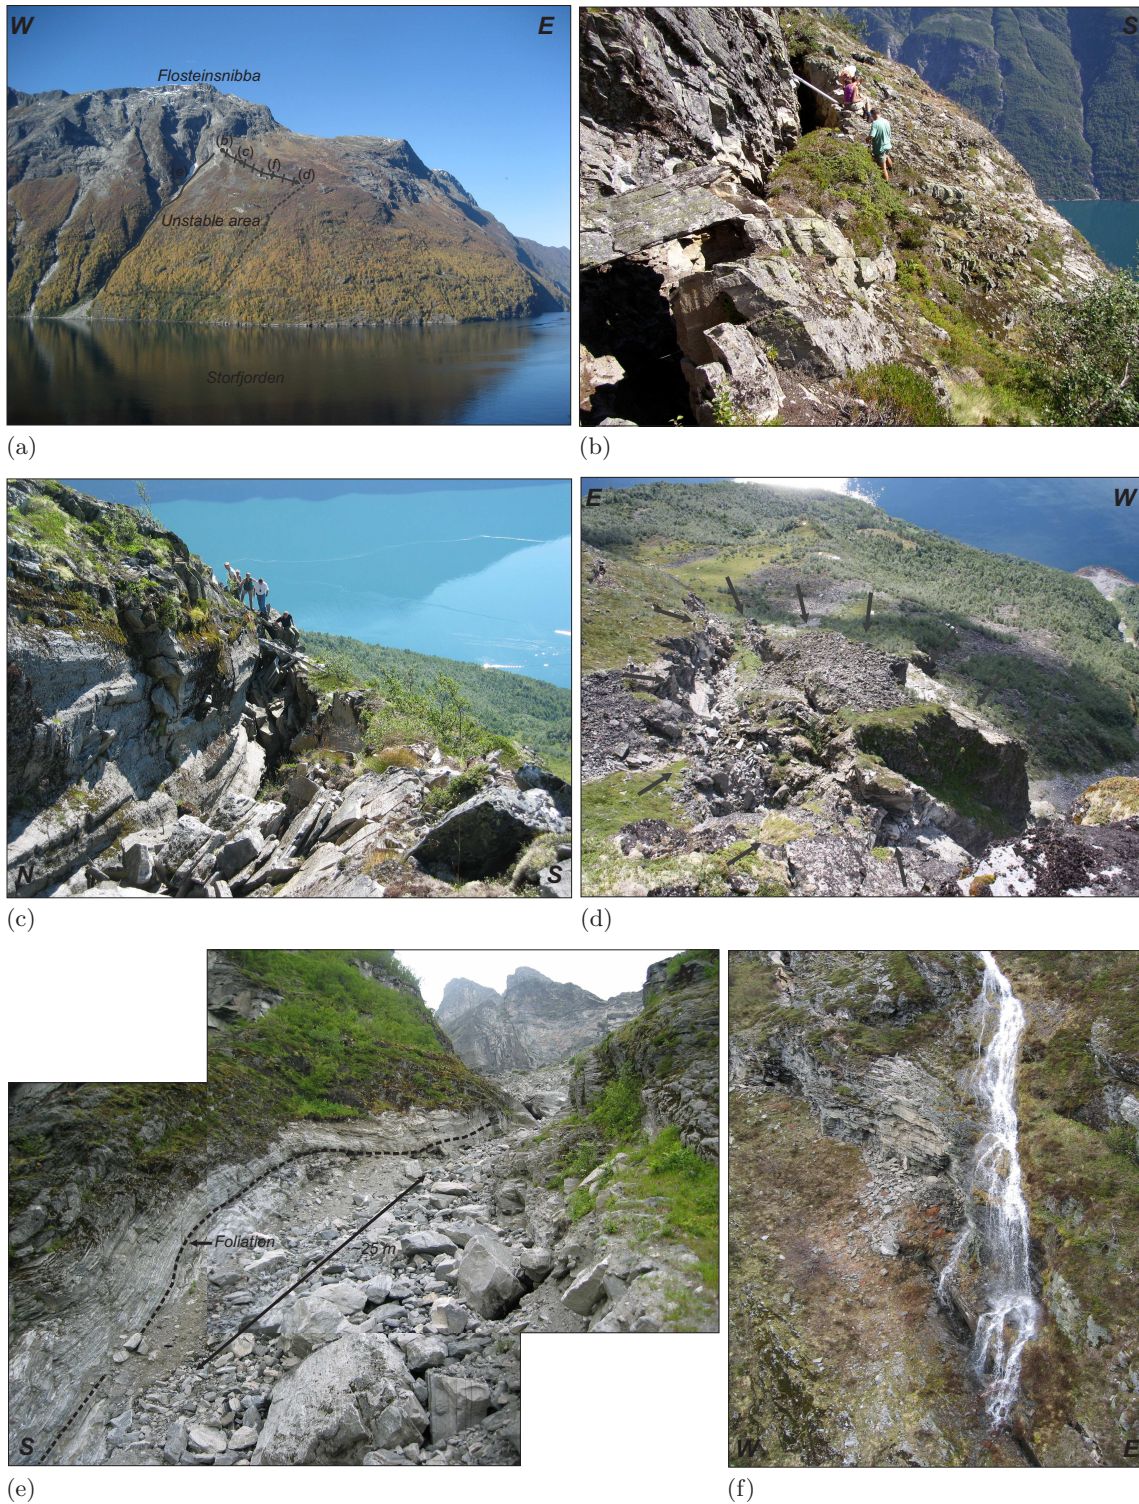
Figure 4: a) Åknes rockslide area, with photo locations b) Back scarp opening in the eastern part (0.5-1 m) c) Back scarp opening in the western part (2-3 m) d) Relieved graben structure located in the western end of the back scarp e) Foliation in the area f) Water infiltrating the back scarp in spring.

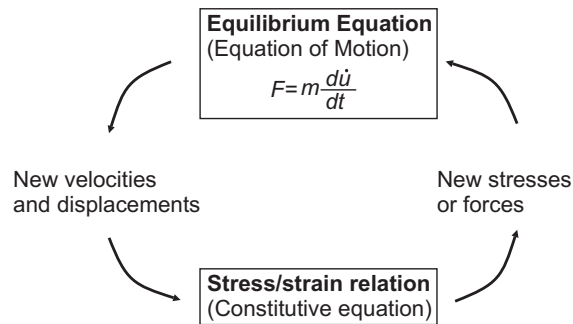
Figure 13: Explicit time marching calculation cycle (from *Itasca* (2002)).

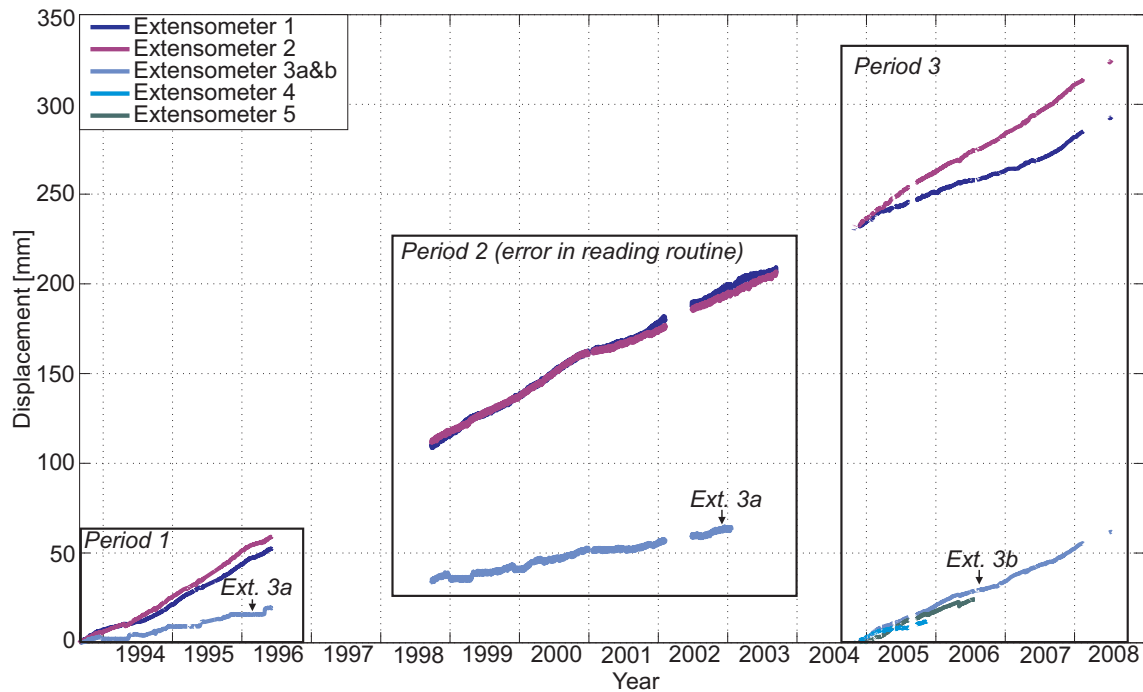
Figure 18: Extensometer records from the back scarp since August 1993.

A total of twelve “events”, where expansion or contraction of the back scarp has been recorded by more than one extensometer, have been analysed in detail with respect to meteorology and groundwater levels (where available). The paper concludes that the relative stability of the upper area at Åknes is highly affected by the groundwater level. Large fluctuations in groundwater levels in spring and early summer (due to varying feeding of the groundwater from snowmelt in addition to precipitation), causes the largest net

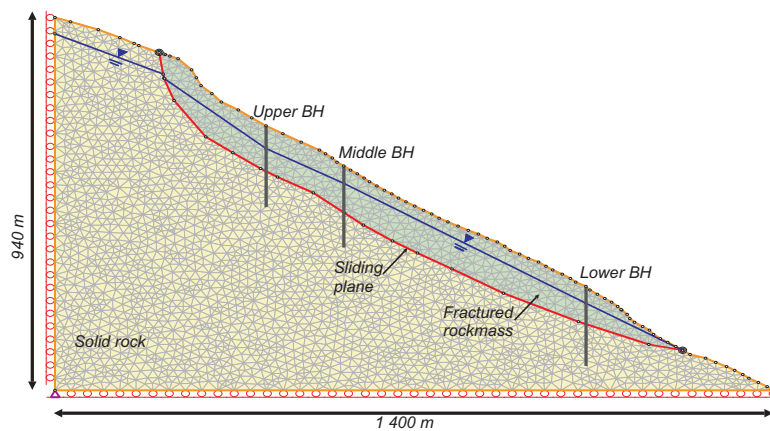
Figure 22: Model in *Phase*<sup>2</sup> with a sliding plane located at an average depth of 110 m below the surface.

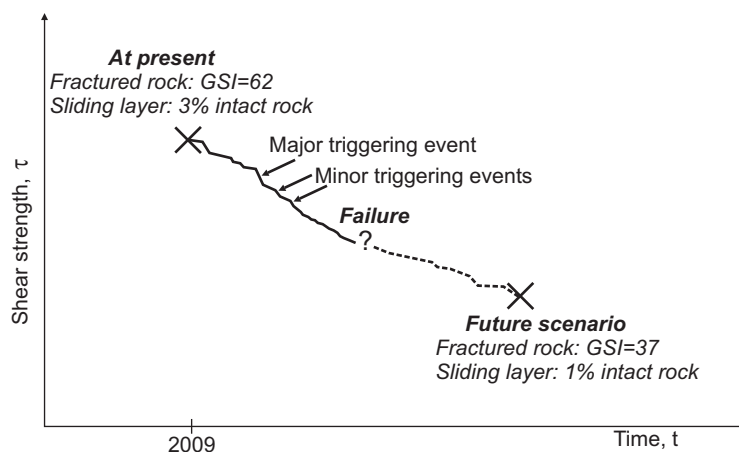
Figure 24: Illustration of how a gradual decrease in shear strength from the situation at present at Åknes might lead to slope failure, based on analyses in this thesis.

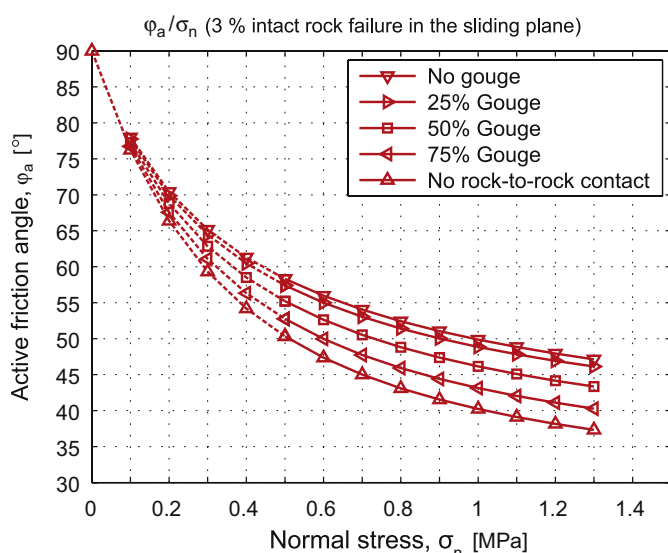
Fig. 14. Active friction angle versus normal stress for 3% intact rock failure in the sliding plane.

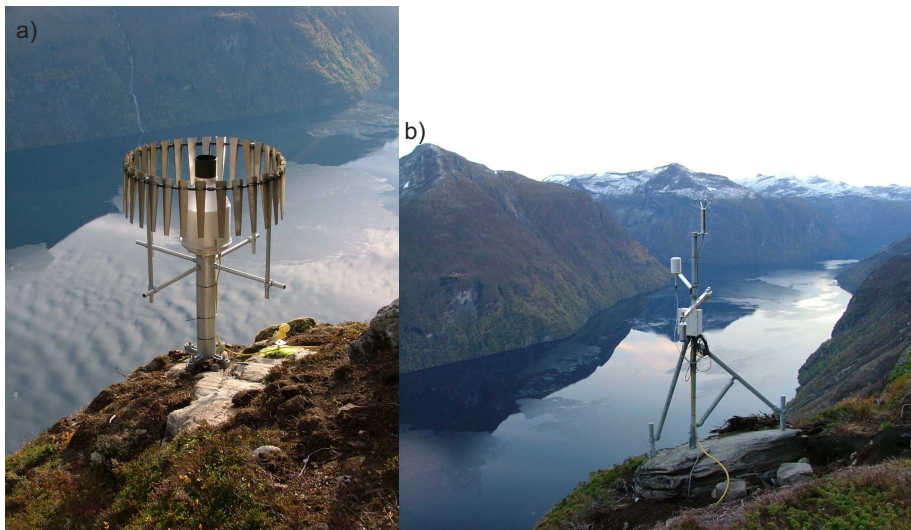
**Fig. 3** Meteorological station at Åknes at 900 m a.s.l. operational from 11 November 2004. a) Precipitation gauge (Oscillating string T-200 B from Geonor) b) Meteorological mast monitoring air temp/humidity (Combinationsensor HMP45A from Vaisala), soil temperature (Thermistor 107 from Campbell), wind speed/direction (Windobserver II from GILL), radiation (Combinationsensor CNR1 from Kipp&Zonen), and snow depth (Ultrasoundsensor SR50 from Campbell). The measuring frequency is 5 sec for all instruments except for the snow depth sensor, for which it is 15 min.

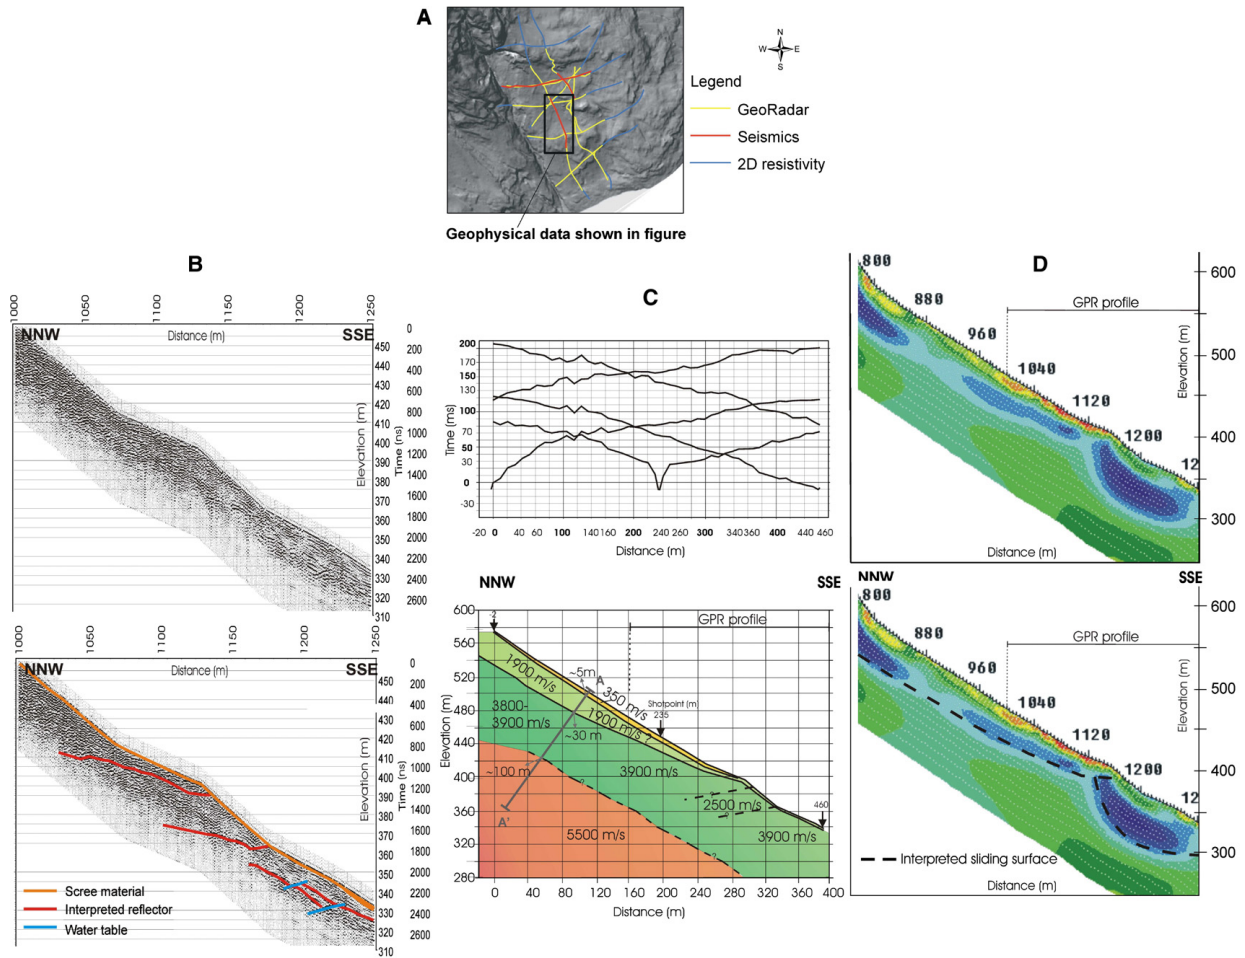
**Fig. 7.** Geophysical data from Åknes. A) Map showing all the geophysical profiles collected in the rockslide area. The presented profiles b–d are only a selected section of a profile. Profile c and d are the same section, c. 450 m long, while b is 250 m long and its location is marked in profile d. B) GPR profile with NNW–SSE orientation and approximate 35 m depth penetration. Above, profile without interpretations, below; profile showing shallow, undulating structures, interpreted to be foliation-parallel layers that crop out at the slope surface (marked with red lines). C) Refraction seismic; above travel time (ms) vs. distance (m) for first arrival P-wave traces. Below, schematic profile showing four layers with increasing velocities with depth. A–A' is line of cross section for thickness estimates. D) 2D resistivity profile, measured with Wenner configuration, showing layers with different resistivity. Above, profile without interpretation, below; profile showing an undulating resistivity contrast, interpreted as a sliding surface at the bottom of the low resistivity (blue) layer marked with black dashed lines. The profile has the same location as the seismic line (c).
