Testing for frost formation in exhaust pipes when releasing safetyvalve.

The goal for the test is to show if there is any tendency to blocking or buildup of CO₂ frost formations during release of 60 bar pressure relief valve.

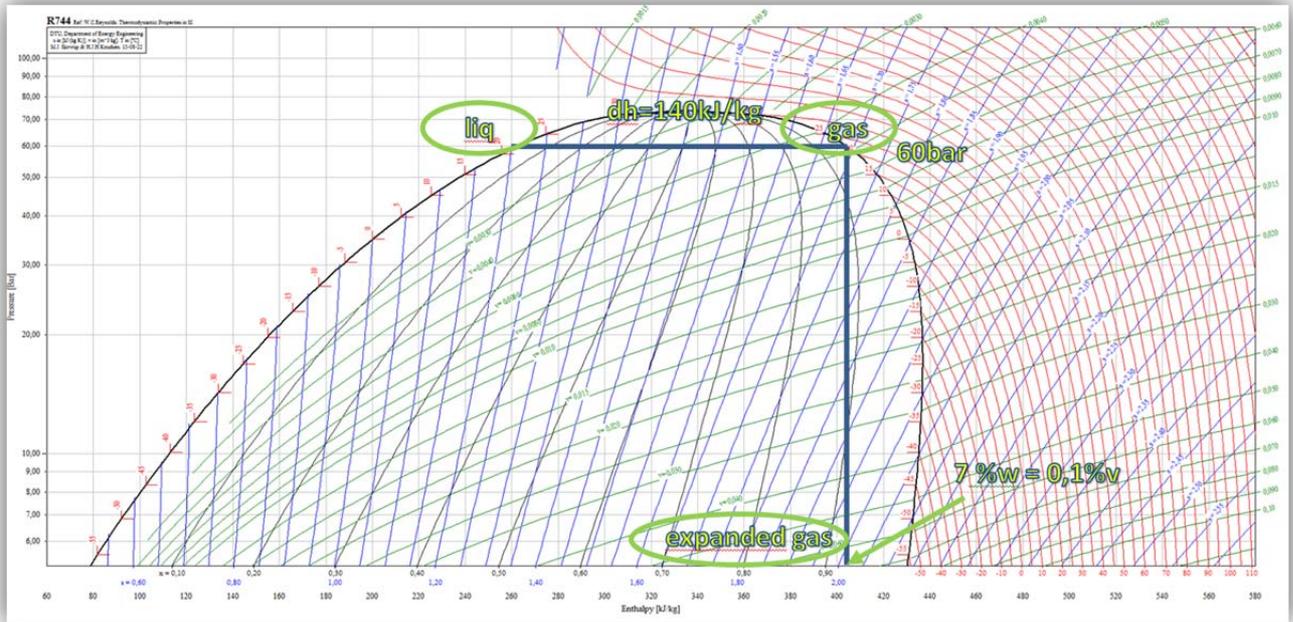
Figure 1: States of CO2 during heating and expansion.
 Heating process: transfer from “liq” to “gas” phase.
 Expanding process: transfer from “gas” go “expanded gas” phase.

The released gas contains as expected some amount of snow. This is the thermodynamic consequence when expanding 60bar gas through a safetyvalve, where the expansion develops a volumenfraction of the snow of 0,1%. The massfraction of snow is 7%.

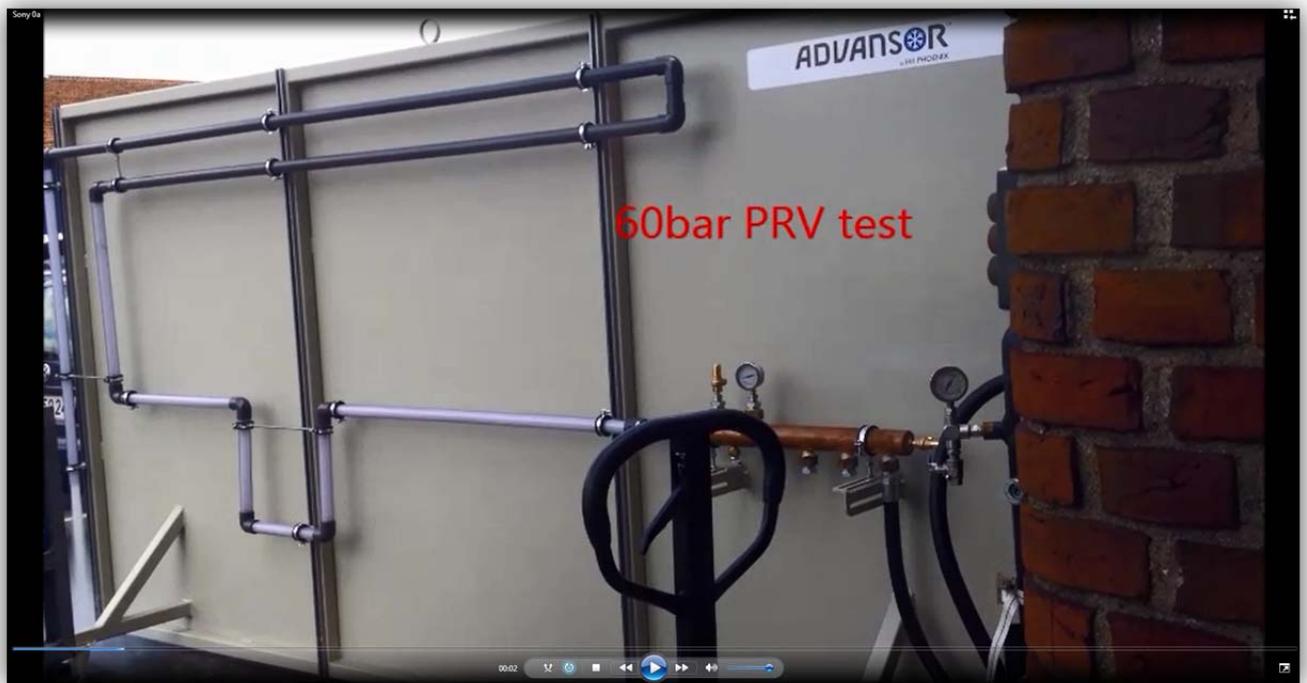
Figure 2: Picture of flow through pipe during PRV release.

The very high velocity of the gas flow seems to eliminate the possible buildup of snow in the system, and hence the snow does not block the pipes or fittings.

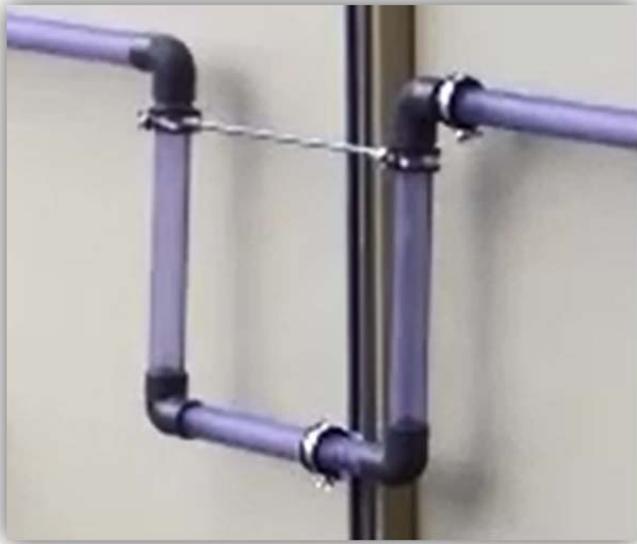
Figure 3: No trace of stocked frost formation in the pipes after relief of PRV.

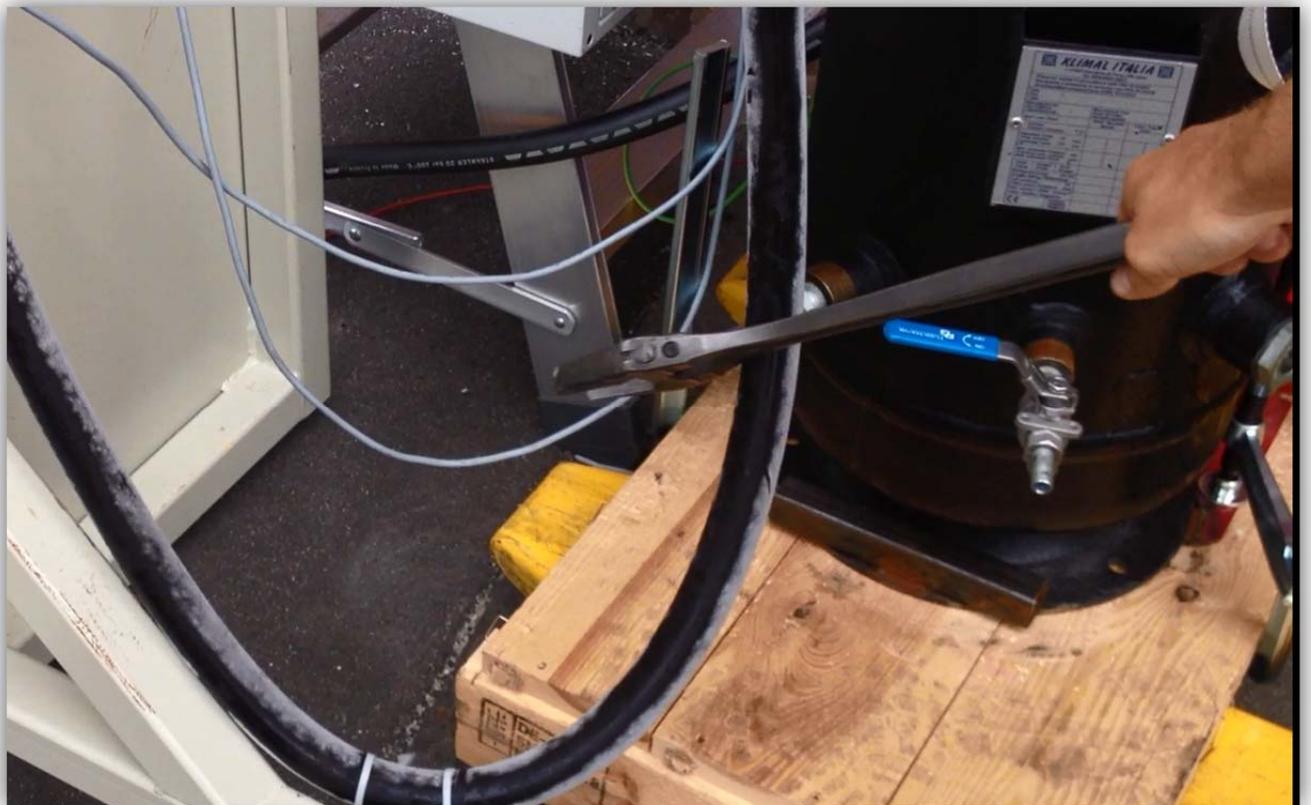
Figure 4: Hose is still flexible after relief of PRV and not fragile.

The flexible hoses get very cold during the release, but do not get fragile.
