# Base Station Security Experiments Using USRP

Master of Science in Communication Technology

Submission date: June 2015

Norwegian University of Science and Technology  
Department of Telematics

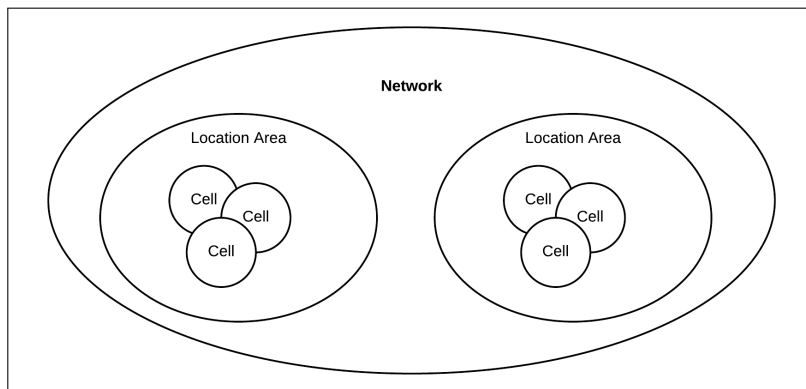
**Figure 2.3:** Topology of a GSM network

The topology of a GSM network is illustrated in Figure 2.3.

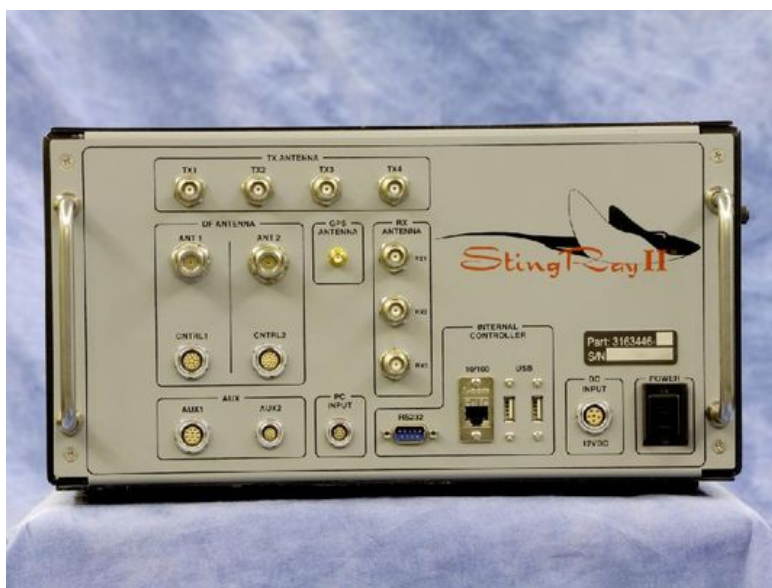
IMSI-catchers are devices used to perform active man-in-the-middle (MITM) attacks against GSM. An IMSI-catcher is a false BTS. The device behaves as a BTS, but is not part of the infrastructure of a real PLMN. It broadcasts messages that are interpreted as legitimate GSM messages, and the device operates on a frequency allocated for GSM that MSs can interpret. IMSI-catchers exploit the fact that there is no authentication of the network in GSM. MSs will simply camp on the cell that broadcast correct MCC and MNC values and satisfies the conditions described in Section 2.6, whether it is a legitimate cell or not.

**Figure 2.8:** The IMSI-catcher Stingray II, produced by Harris Corp. The image is from [31].

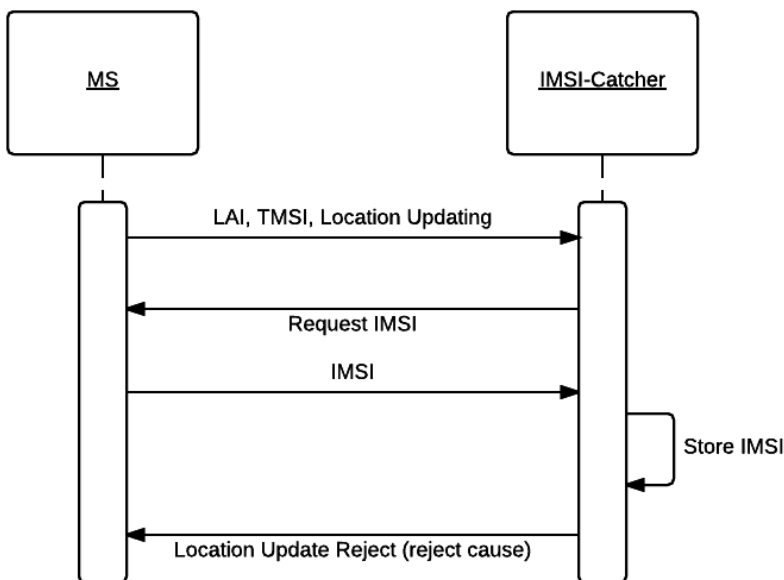
The message sequence chart in Figure 2.9 explains how a simple IMSI-catcher is catching IMSIs. The MS initiates a location update procedure with the IMSI-catcher. The IMSI-catcher requests the IMSI of the MS, and then sends a location update reject message. The IMSI-catcher has obtained the IMSI and the MS reselects to a valid cell nearby.

**Figure 2.9:** Message sequence chart of catching IMSIs with IMSI-catcher

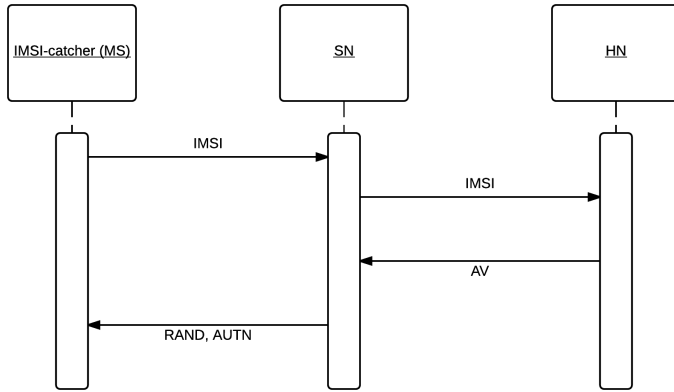
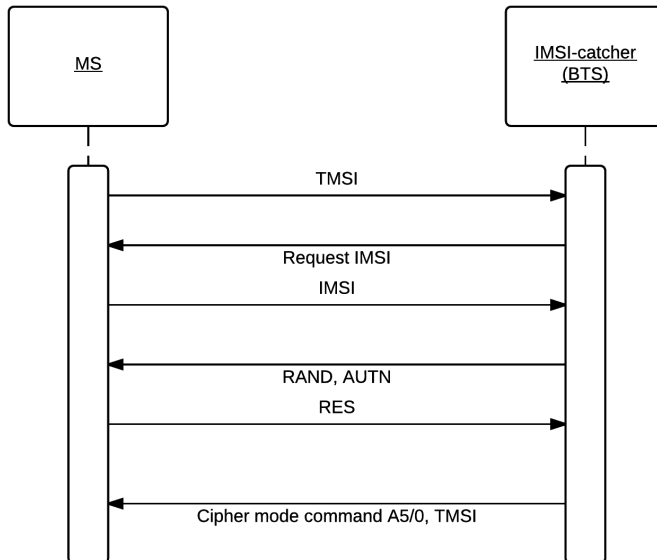
(a) Step 2

(b) Step 3

The attack consists of three steps. First the TMSI or the IMSI of the target has to be found. Then the IMSI-catcher impersonates the victim towards a legitimate BTS. The attacker will then receive AUTN and RAND from the network. Subsequently, the attacker will masquerade as a GSM BTS and send AUTN and RAND to the victim, which then will compute SRES. The IMSI-catcher will then turn off encryption, and forward messages to the legitimate network by the use of a SIM card at the IMSI-catcher.

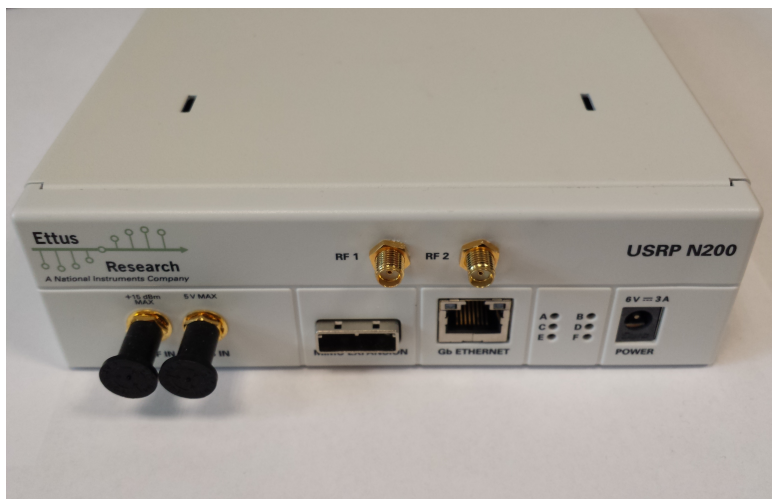
**Figure 3.1:** The USRP N200

The USRP N200 is a device of the USRP family, that in total consists of 10 different SDR devices. The devices are manufactured and developed by Ettus Research<sup>1</sup> which is a daughter company of National Instruments. Ettus Research is at the time of writing the world's leading supplier of SDRs[41].

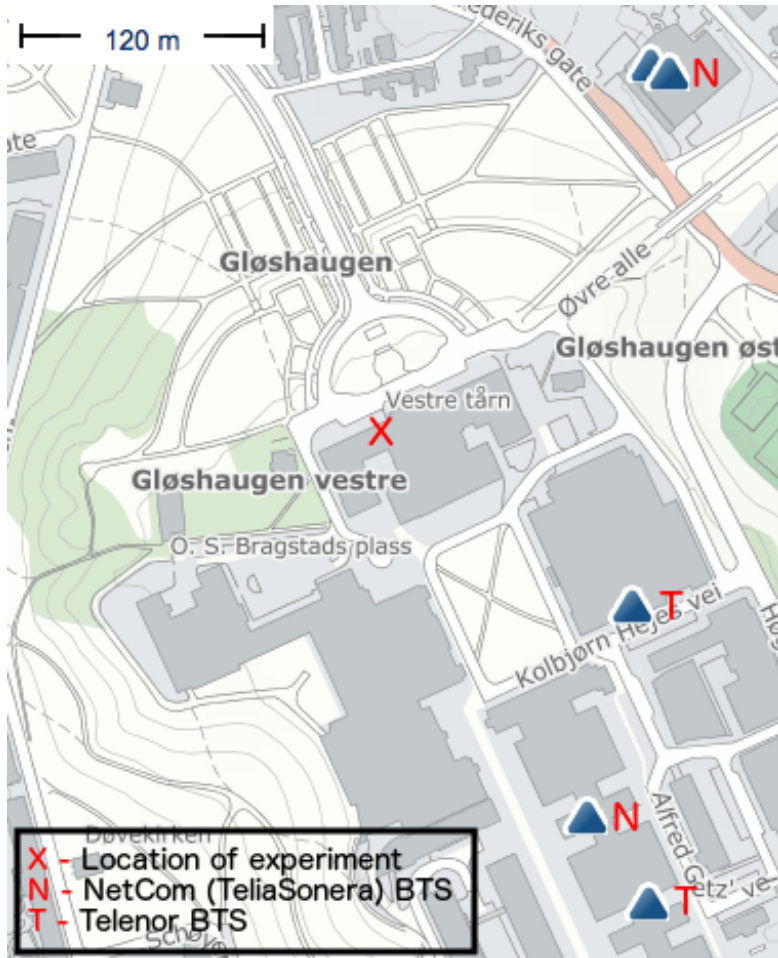
**Figure 3.3:** Map over the closest GSM BTSs to the location of the experiment. 'N' represents NetCom BTS, 'T' represents Telenor BTS and 'X' represents the location of where the experiment was conducted. Edited map from <http://www.finnsenderen.no/>[44].

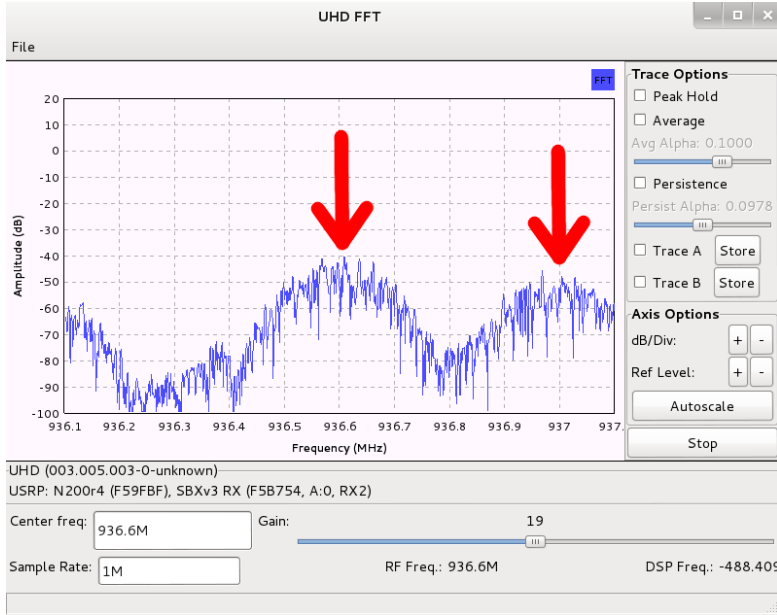
**Figure 3.5:** Output from *uhd\_fft -f 936.6M*.

Figure 3.5 shows the output of *uhd\_fft -f 936.6M*. The red arrows point at BTSs observed in this plot, one at 936.6 MHz and one at 937 MHz. The RxL from the one broadcasting on 936.6 MHz was strongest out of all the NetCom BTSs observed, thus it was chosen to listen for NetCom system information messages on this frequency. This frequency corresponds to ARFCN 8. The measured RxL from this BTS was approximately -40 dBm at the location of the experiment, as can be observed from Figure 3.5.

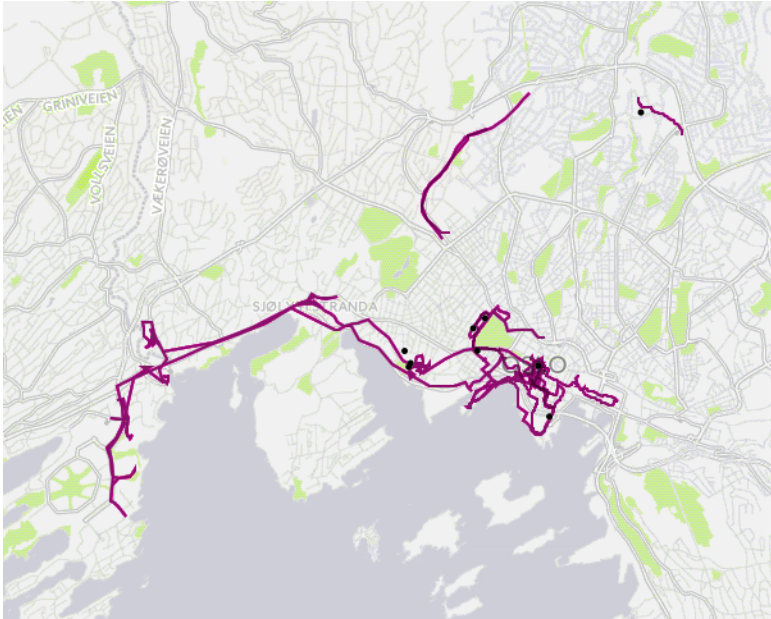
The investigation with the Network Guard device resulted in a significant amount of data of how the BTSs in Oslo were configured. Several observations of the configuration of the networks in Oslo can be made by analyzing the data. The observations are based on all the data acquired by Aftenposten from the three first surveys, i.e. in total 42109 distinct measurements. The observations made in this section are used in further analysis of the anomalies Aftenposten detected in Section 5.6. The route traversed with the Network Guard device is shown in Figure 5.3.

**Figure 5.3:** The route traversed with the Network Guard device in Oslo. Modified map from [54].

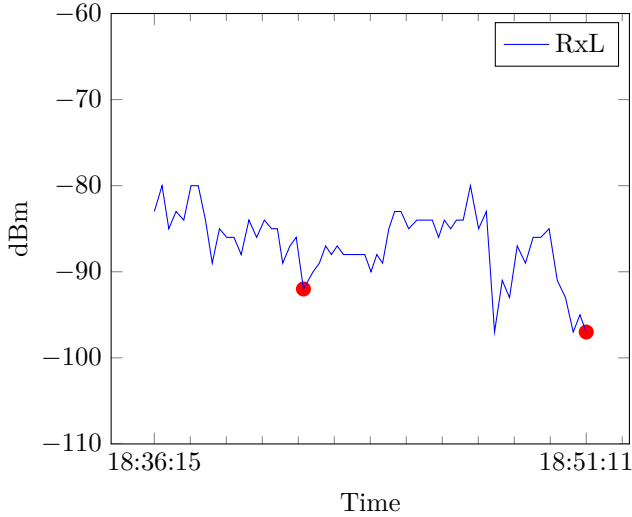
**Figure 5.14:** RxL from cell 3107 the 09.12.2014 between 18:36:15 and 18:51:11. The red points represents the time LAC changes were observed.

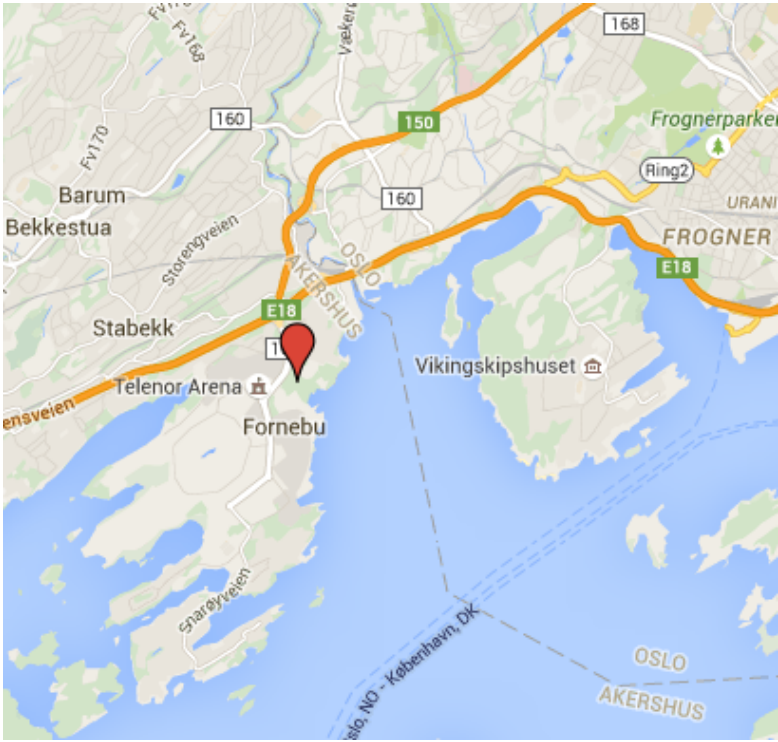
During a mobile survey the 03.12.2014, cell 2174 on Telenor's network was observed changing LAC. Alarm 3 in Table 5.3 was raised. Delma graded the alarm to "HIGH" severity. The geographical location of where the LAC change occurred is shown in Figure 5.22

**Figure 5.22:** Geographical location of LAC change on cell 2174.
