Holmestrand Underground Railway Station - Analysis of Groundwater Inflow and Methods for Water Sealing

Earth Sciences and Petroleum Engineering

Submission date: May 2012

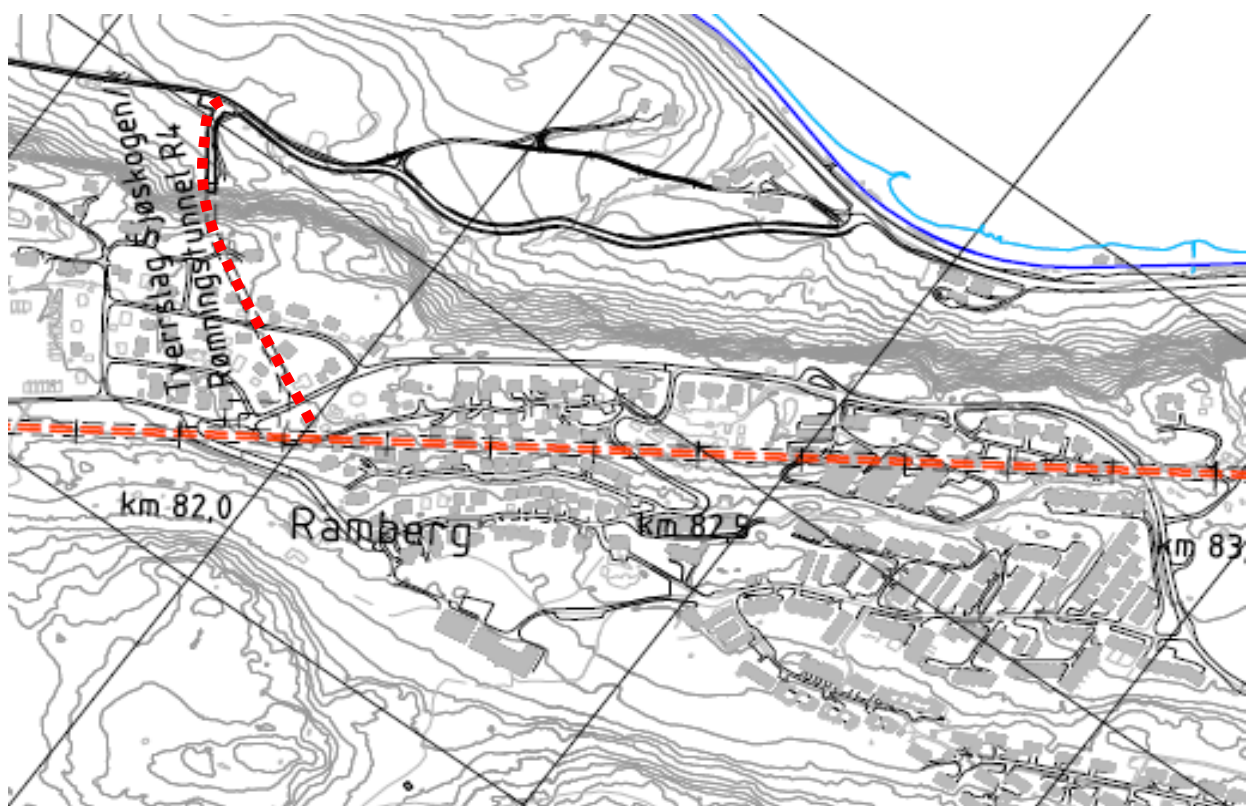
Figure 3. Location and sketch of the R4 escape tunnel and the main tunnel part of the Sjøskogen project (red dotted lines). (Jernbaneverket 2011)

Constituting the Sjøskogen tunnel project are the main tunnel part itself and an entrance tunnel which will later on serve as an escape tunnel, named R4. The location of this project can be seen on figure 3. The inflow criterion for both the R4 tunnel and the main tunnel part is $5 - 10 \frac{L}{\frac{min}{100 m}}$. (Jernbaneverket 2011) Appendix A shows an engineering geological length profile of the site, while appendix B contains an engineering geological map of the surroundings.

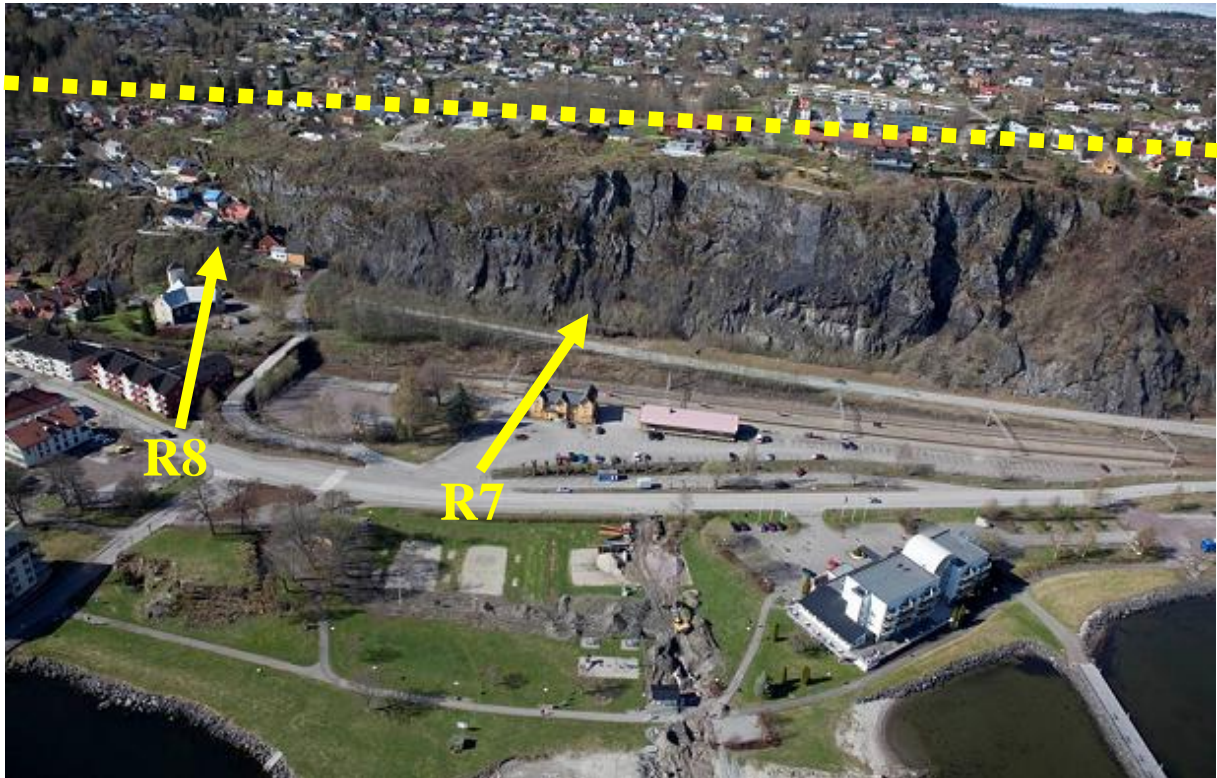
Figure 5. An aerial overview of the current railway station with the entrance tunnels, R7 and R8 (yellow arrows) and the approximate tunnel line (yellow dotted line). (Sagen 2011)

An overview of the Holmestrand plateau with the location of the entrance tunnel to the station hall and the approximate tunnel line traversing below the plateau can be seen on figure 5. Appendix E displays an engineering geological length profile of the station hall and appendix F shows an engineering geological map over the surroundings of the station hall.

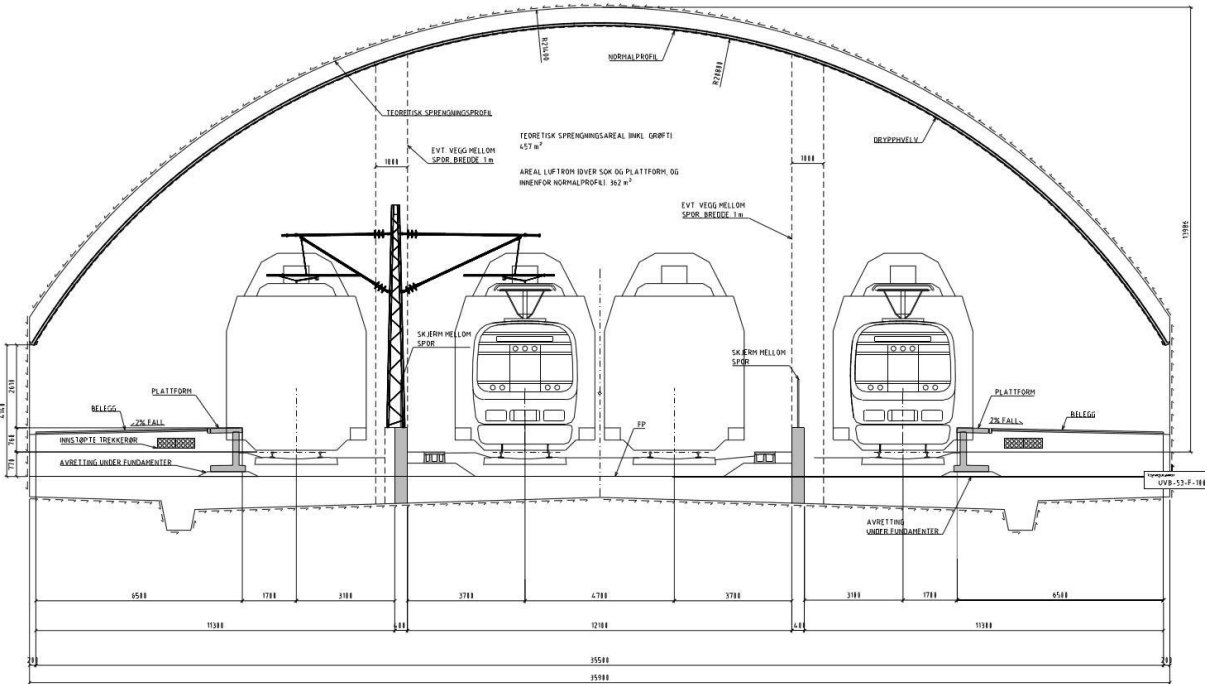
Figure 6. A sketch of the cross-section of the station hall. (Sagen 2011)

A sketch of the cross-section of the station hall can be seen on figure 6.

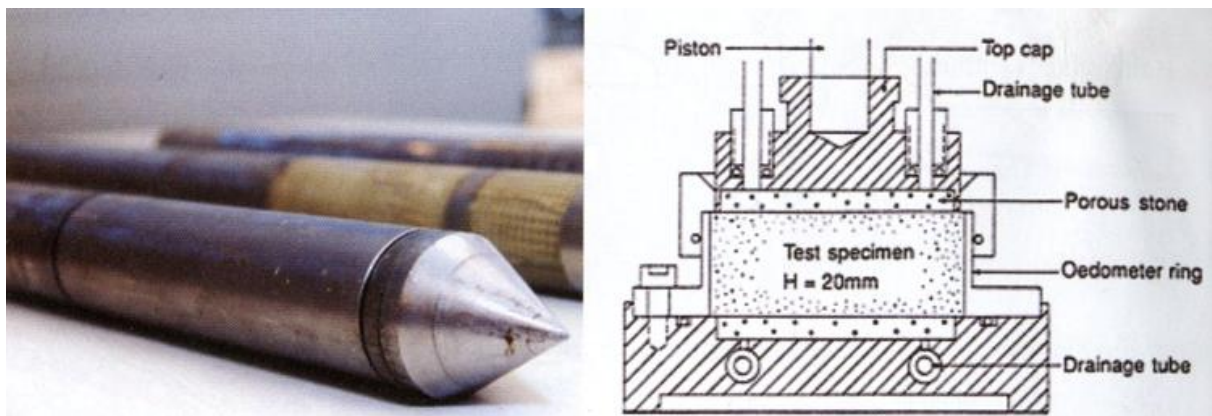
Figure 10. CPTU cylinder (left) and oedometer test (right). (Langford, Kveldsvik et al. 2011)

As a support test, the oedometer has been utilised. In such a test pressure is exerted vertically on the test specimen, under drained conditions. The vertical stress is measured, as is the pore pressure, the latter measured at the bottom of the sample. From this test, it is possible to determine p'_c , permeability and general compression abilities. (Langford, Kveldsvik et al. 2011)

Figure 10 displays both the CPTU and the oedometer equipment, respectively.

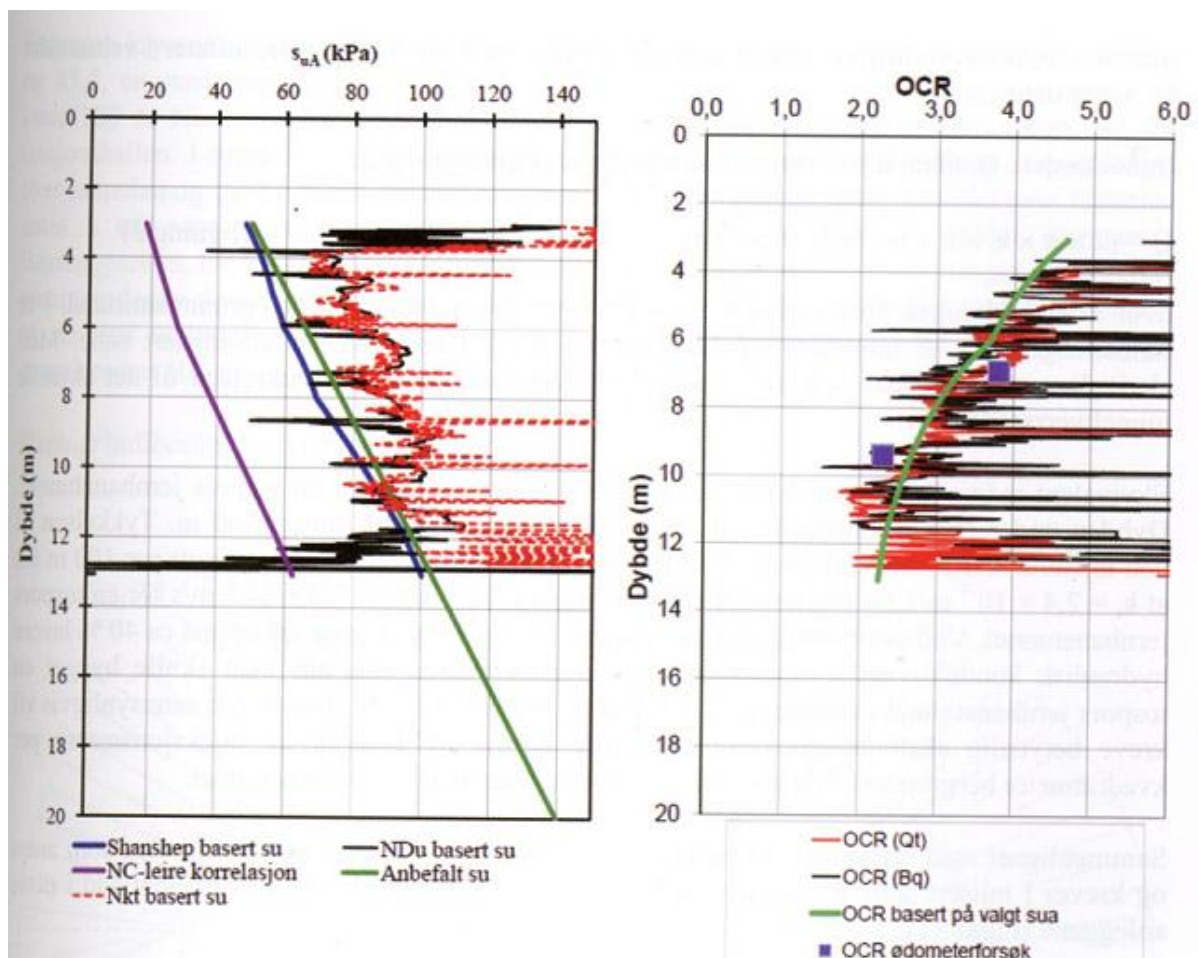
Figure 11. Results from the CPTU measurements above the station hall; s_{ua} (left diagram) and OCR (right diagram) as functions of depth. (Langford, Kveldsvik et al. 2011)

Figure 11 shows results from several boreholes in which the CPTU and oedometer tests have been executed.

the clay measured is clearly pressured in the past, showing a difference of 20 – 30 KPa. The green, linear line is the recommended value of s_{ua} .

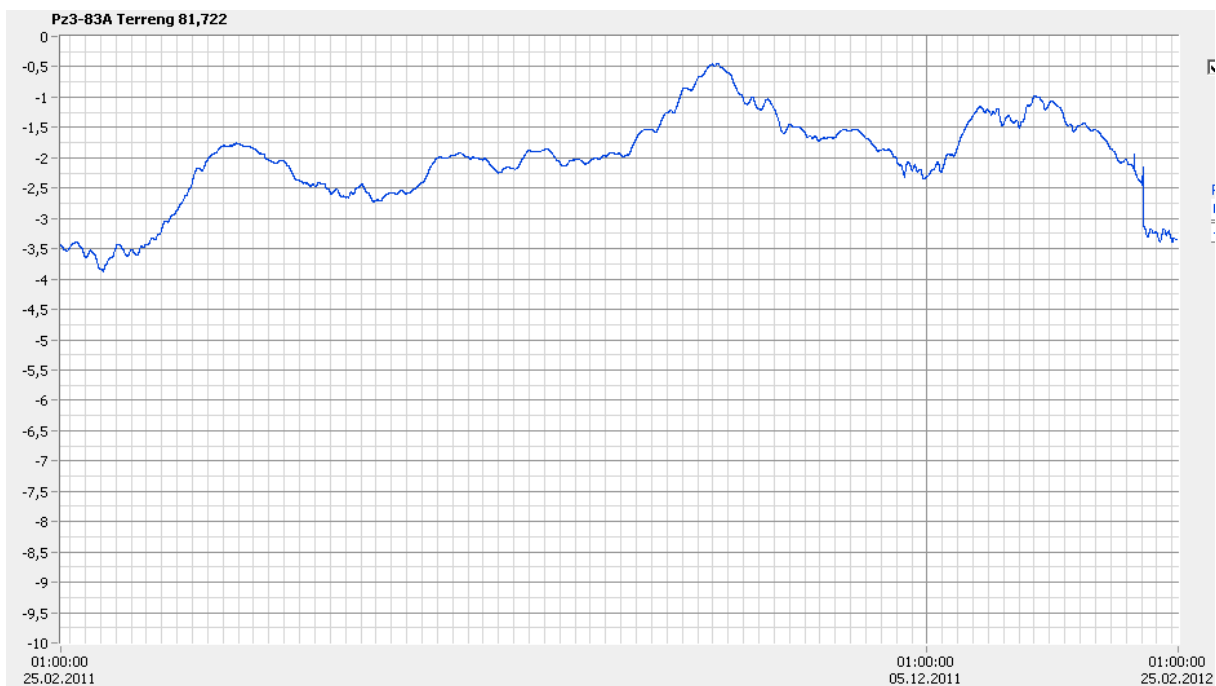
Figure 14. Piezometer measurements for Pz 3–83A. Measurements range from 25.02.11 – 25.02.12. (Jernbaneverket 2011)

Pore pressure variations over one year have been logged and are presented for piezometers Pz 3–83A, Pz 5C, Pz 670A in figures 14 through 16. Note that the tunnel excavation works at the time of registering have been going on for approximately 2 months. Unfortunately, due to technical reasons, it is not possible to obtain data from the piezometer measurements solely prior to the excavation works.

Locally, the most natural cause of groundwater fluctuation is precipitation, which can clearly be seen in the diagrams. Initially after the start of the measuring period the groundwater table increases in all diagrams, with different intensity. This is most likely related to the spring thaw where snow and ice melt and cause water to penetrate into the ground. Precipitation falling as rain will also increase the groundwater level.

Tiny, local peaks are found throughout the graphs in the different holes over the years. These are probably related to local geological differences. Pz 670A differs significantly more from the other holes in the one-year period but still follows the trend with the peaks and bottoms of the groundwater level. Pz 5C is the hole having most variations, however this is probably due to natural reasons and not the tunnel excavation works.

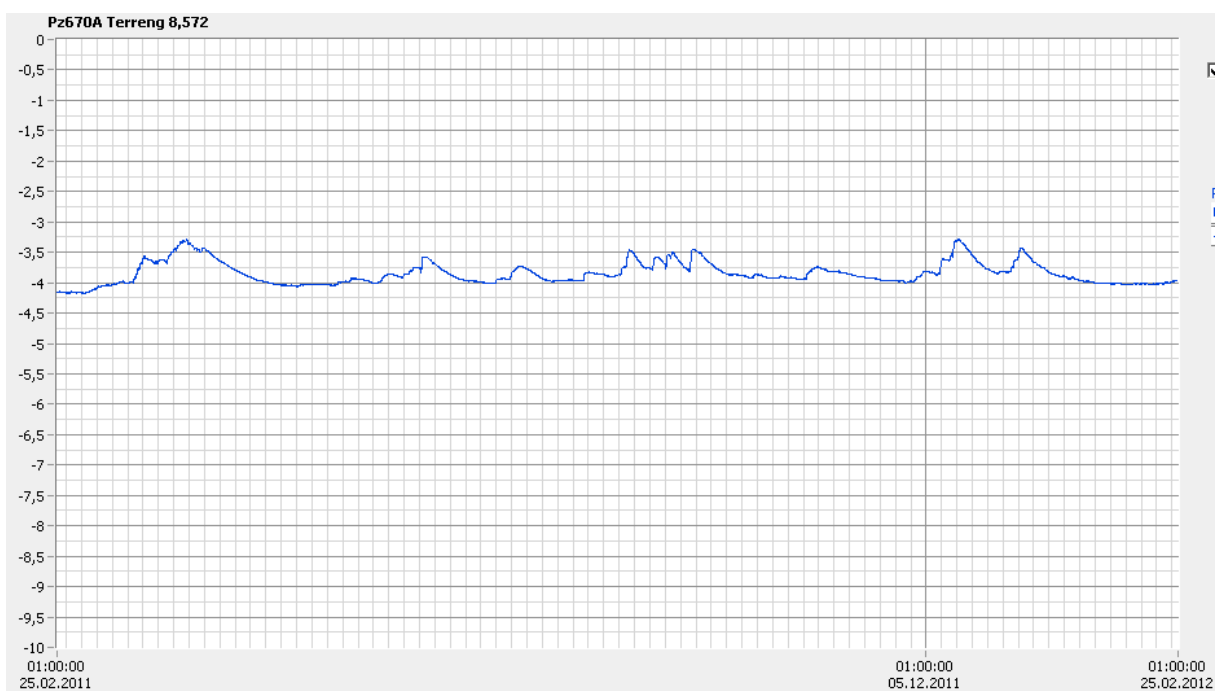
Figure 15. Piezometer measurements for Pz 670A. Measurements range from 25.02.11 – 25.02.12. (Jernbaneverket 2011)

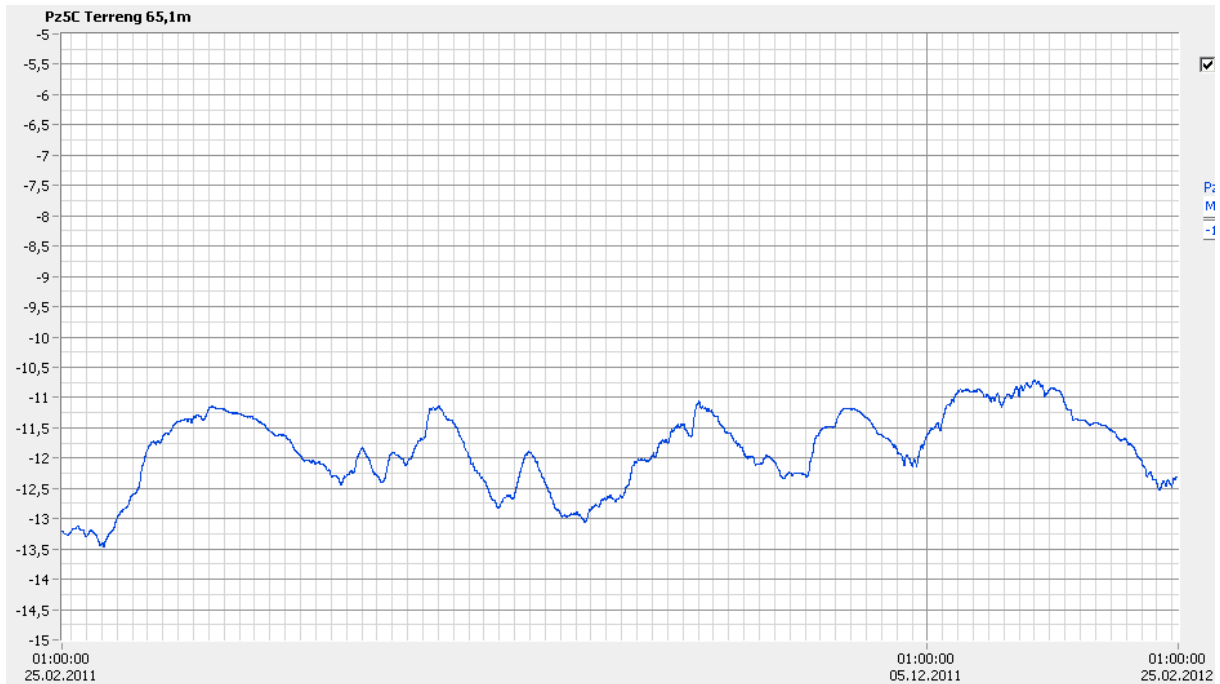
Figure 16. Piezometer measurements for Pz 5C. Measurements range from 25.02.11 – 25.02.12. (Jernbaneverket 2011)

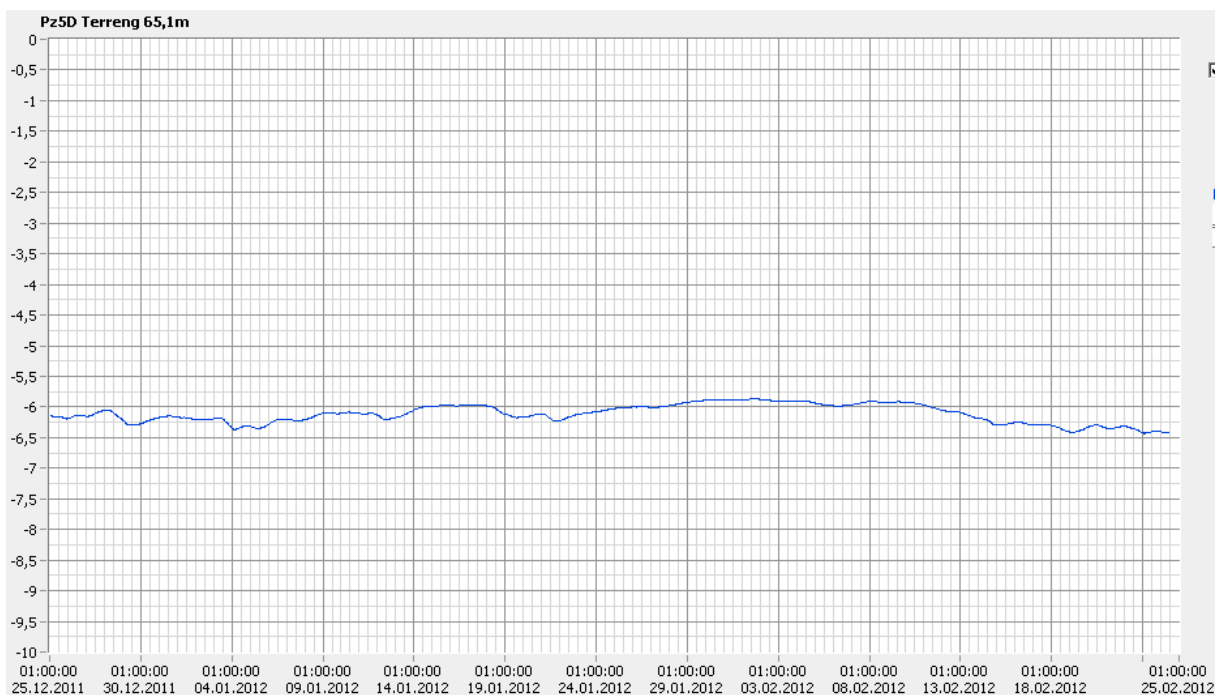
Figure 17. Piezometer measurements for Pz 5D. Measurements range from 25.12.11 – 25.02.12. (Jernbaneverket 2011)

Results from the latest 2 months at the time of writing for Pz 5D, Pz 3–83B and Pz 670B are graphically presented in figures 17 through 19.

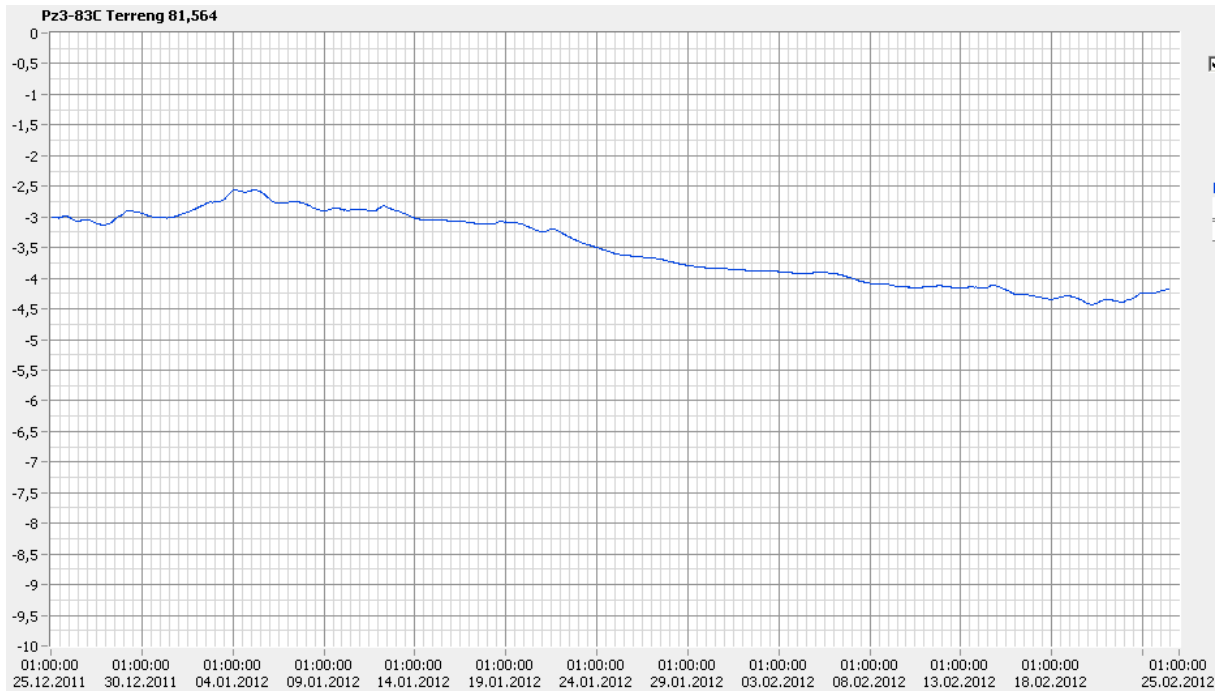
Figure 18. Piezometer measurements for Pz 3–83B. Measurements range from 25.12.11 – 25.02.12. (Jernbaneverket 2011)

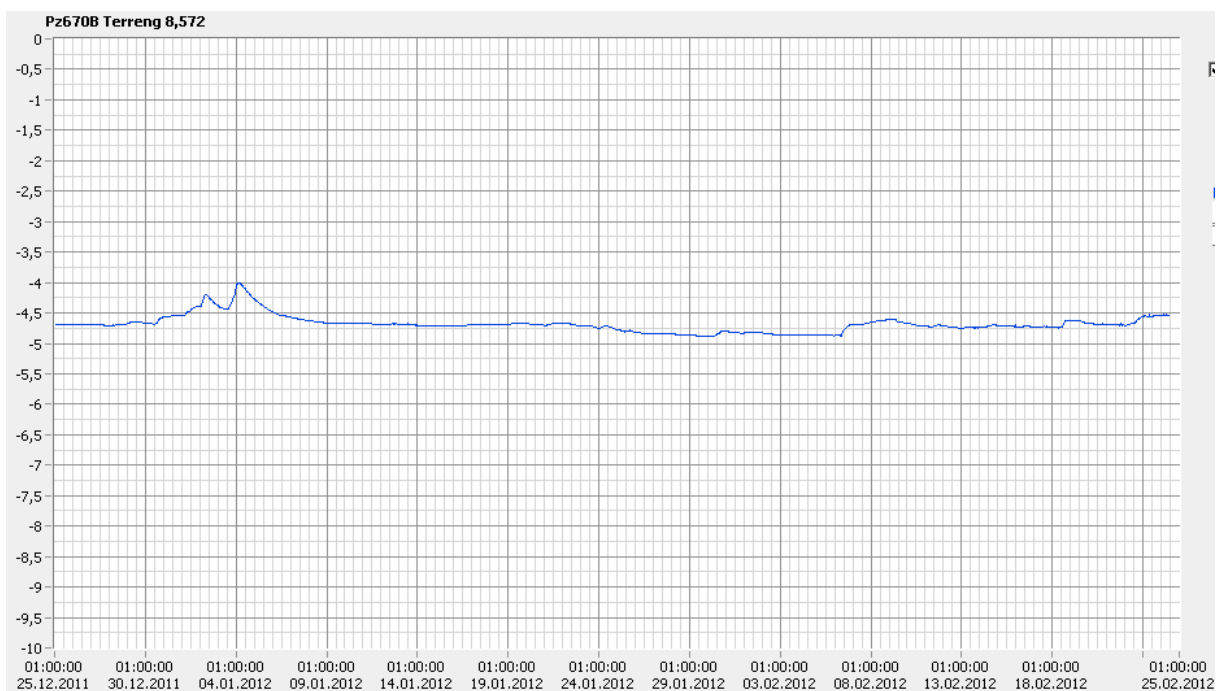
Figure 19. Piezometer measurements for Pz 670B. Measurements range from 25.12.11 – 25.02.12. (Jernbaneverket 2011)

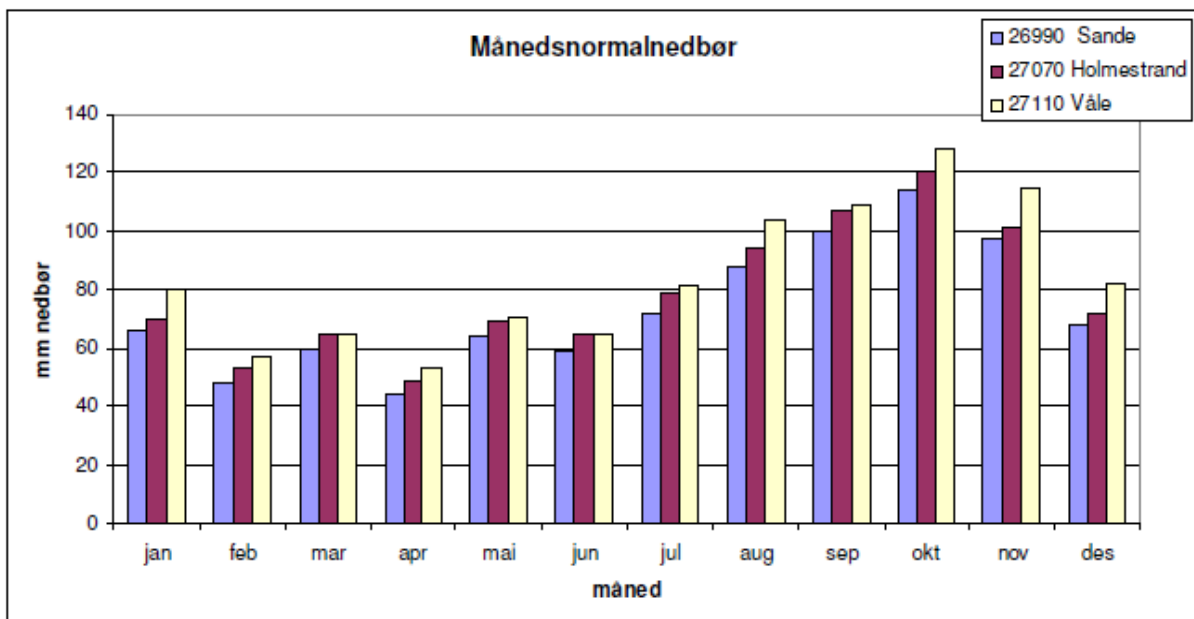
Figure 21. Diagram showing the annual precipitation in the Holmestrand area (red columns). (Multiconsult 2008)

The most important and significant source of groundwater in the Holmestrand area is precipitation. Parts of the groundwater is being evaporated, this is due to several reasons such as topography, temperature, air moisture, wind and wind direction, etc. The annual evaporation in the Oslo graben is around 50%. (Multiconsult 2008) Also, permeability in the soils and in the rock mass, magazine properties of the soils and the rock mass and other water sources like creeks, rivers, lakes are parameters which determine the groundwater behaviour. (Hognestad, Fagermo et al. 2010) There have been completed precipitation measurements at the closest meteorological stations to Holmestrand. In figure 21, these are presented.

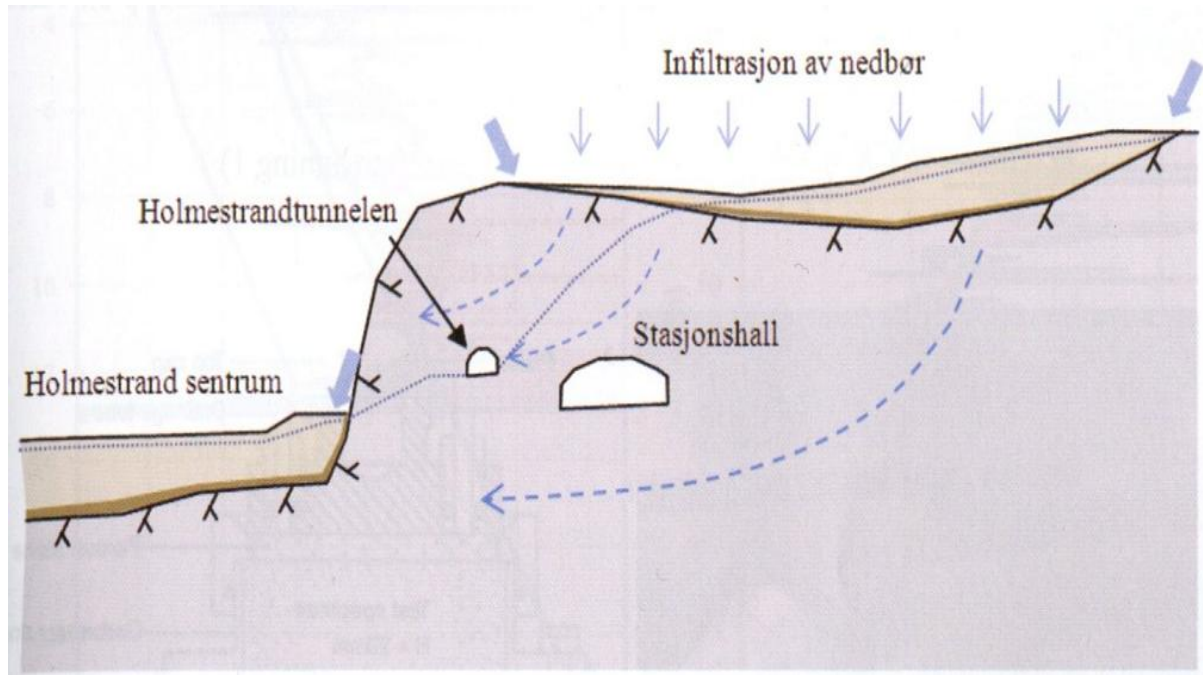
Figure 23. The drainage situation at the Holmestrand plateau. (Langford, Kveldsvik et al. 2011)

It is assumed that the Holmestrand plateau is naturally drained and that the groundwater table has been leveled down to the tunnel floor of the Holmestrand tunnel. This is because the tunnel has not been grouted. This assumption has also been confirmed by several measurements taken at the plateau, west of the town centre of Holmestrand. (Langford, Kveldsvik et al. 2011) A sketch of how the drainage functions interact can be seen on figure 23.

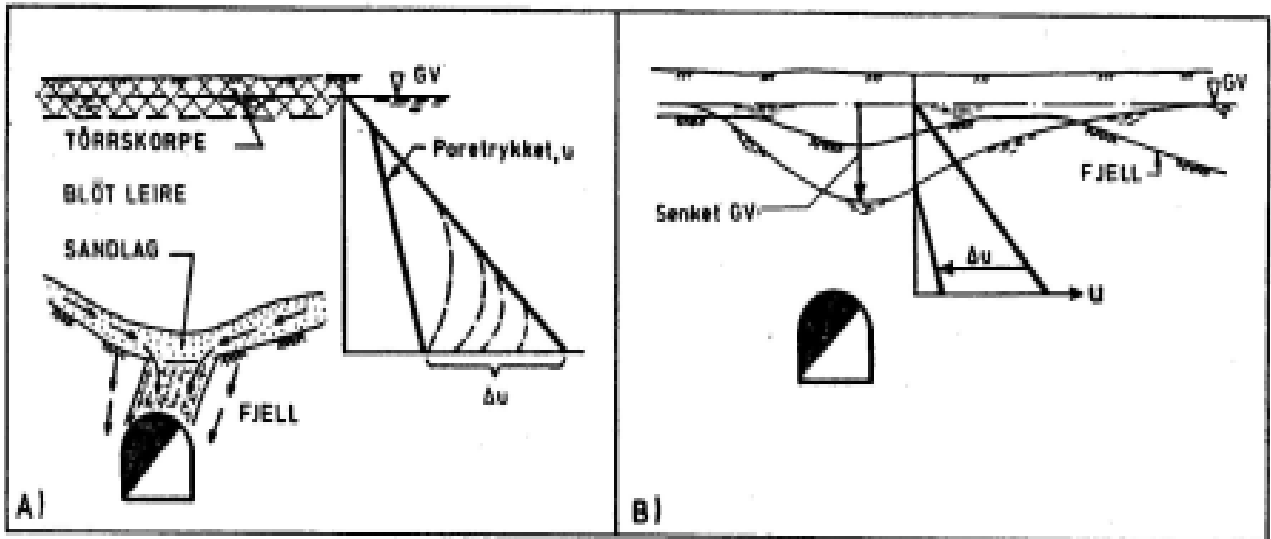
Figure 24. The effect of tunnelling below soil masses and the effect on the groundwater level. (Karlsud, Erikstad et al. 2003)

Figure 24 shows the effect of tunneling below soil masses.

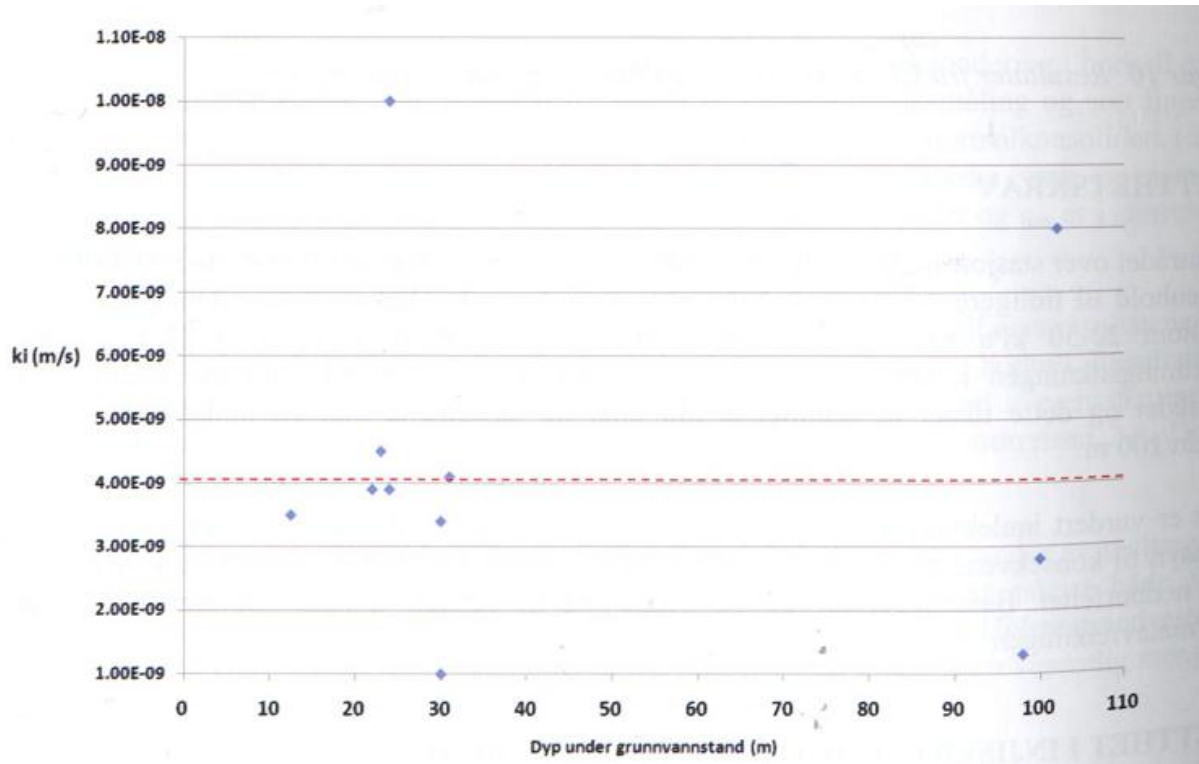
Figure 25. Hydraulic conductivity values in the grouted zone for various newly constructed tunnels. The red dotted line indicates the average. (Langford, Kveldsvik et al. 2011)

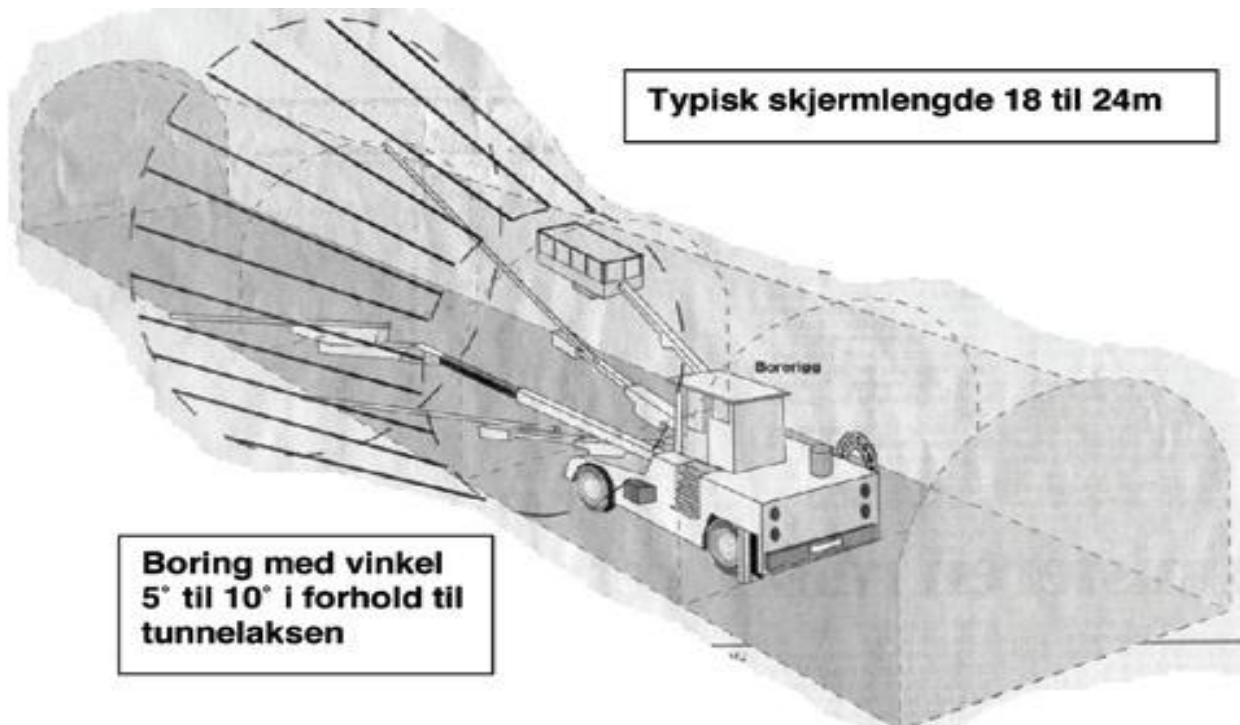
Figure 26. A sketch of the drilling of a grouting fan in a tunnel. (Hognestad, Fagermo et al. 2010)

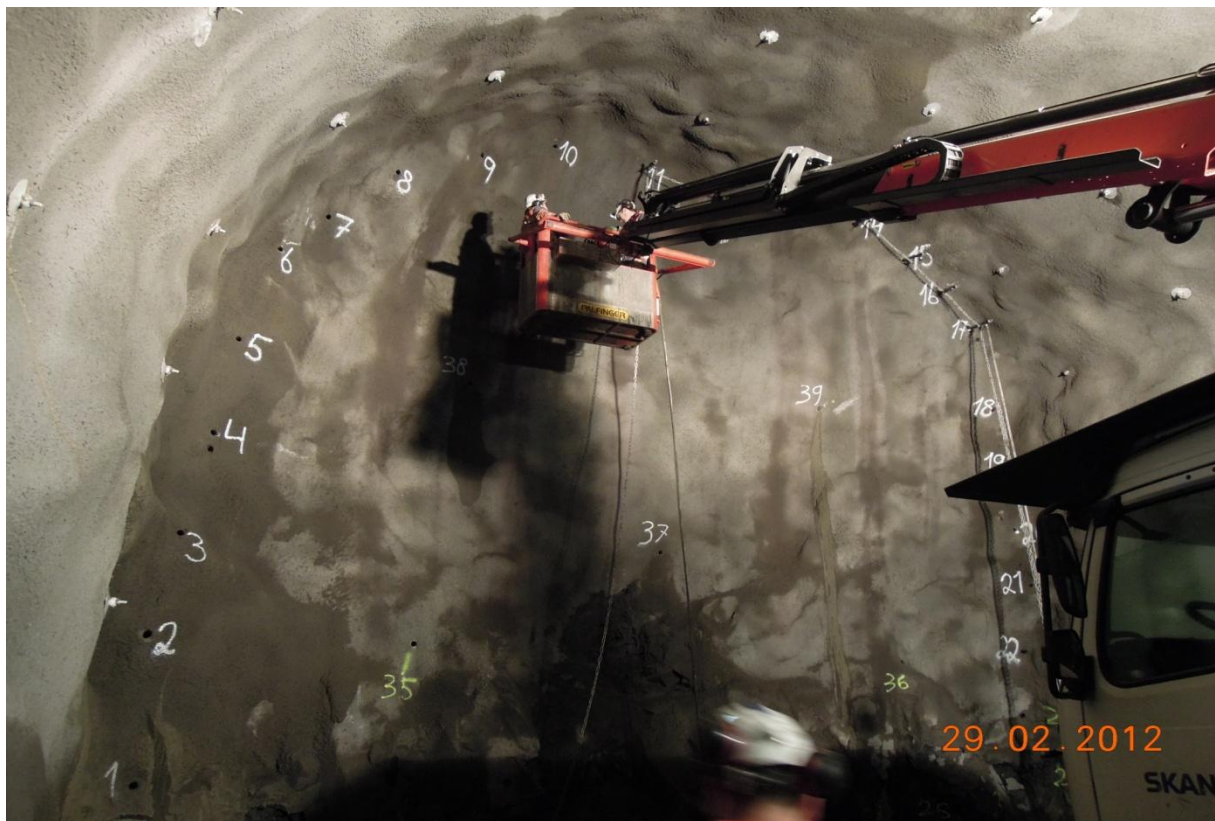
Figure 27. Grouting rods being inserted at the tunnel face in the R7 entrance tunnel.

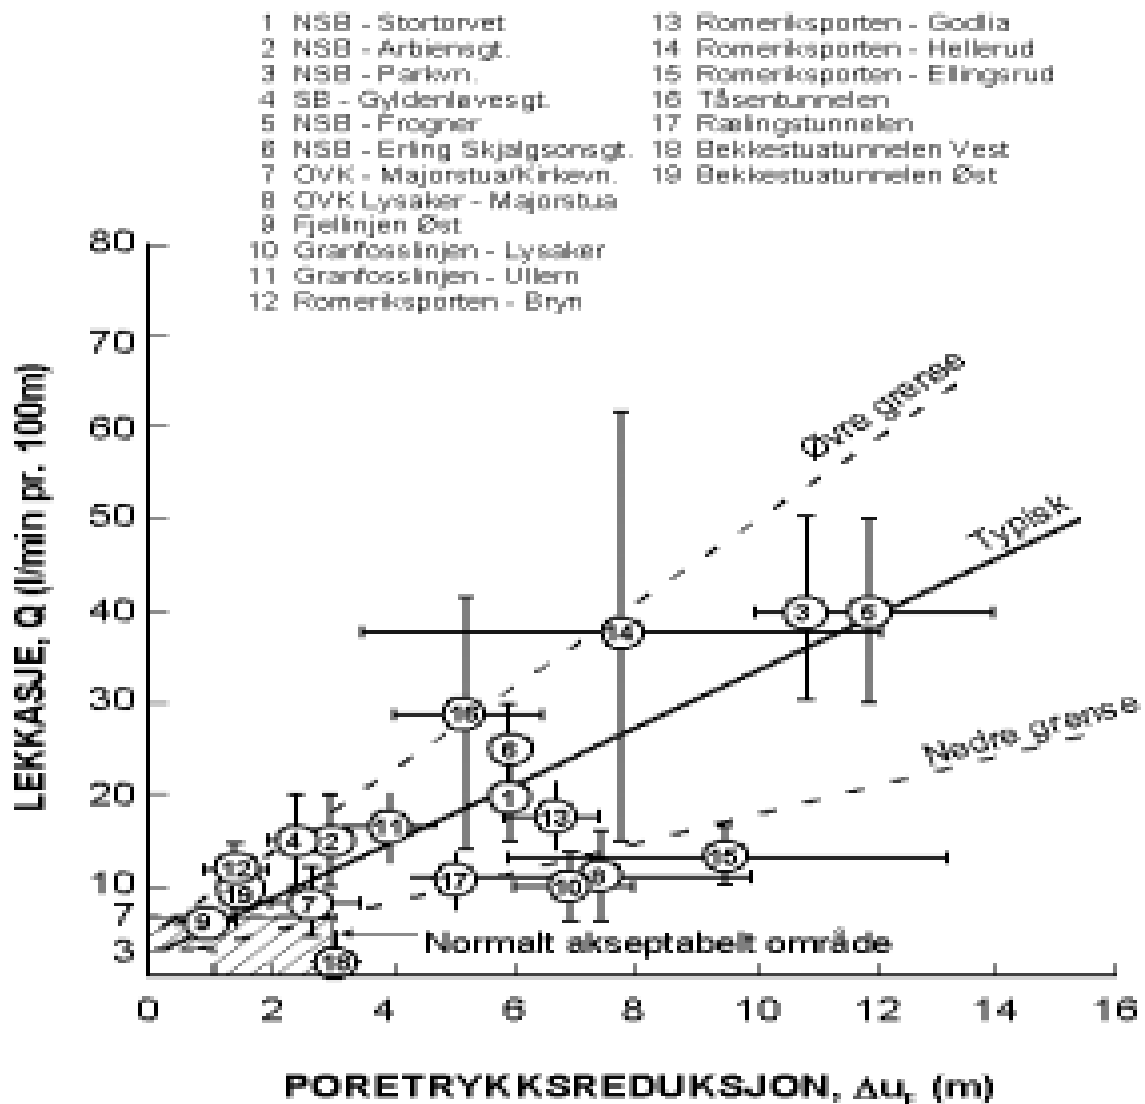
Figure 28. A statistic model showing the relation between inflow and pore pressure reduction. (Karlsud, Erikstad et al. 2003)

When studying figure 28, the "normal acceptable area" is within the range of $3 - 7 \frac{L}{\frac{min}{100 m}}$. This means pore pressure reductions of 1 – 3 m which further lead to subsidence at several cm. This is usually acceptable at most cases and since there have been revealed no great risks of harming any installations at the surface of the Holmestrand plateau, the inflow criterion is at times when geological conditions are satisfactory being allowed to fluctuate between 5 – 10 $\frac{L}{\frac{min}{100 m}}$. As seen, such is the case at the Sjøskogen tunnels and partially the R13 entrance tunnel at Snekkestad.

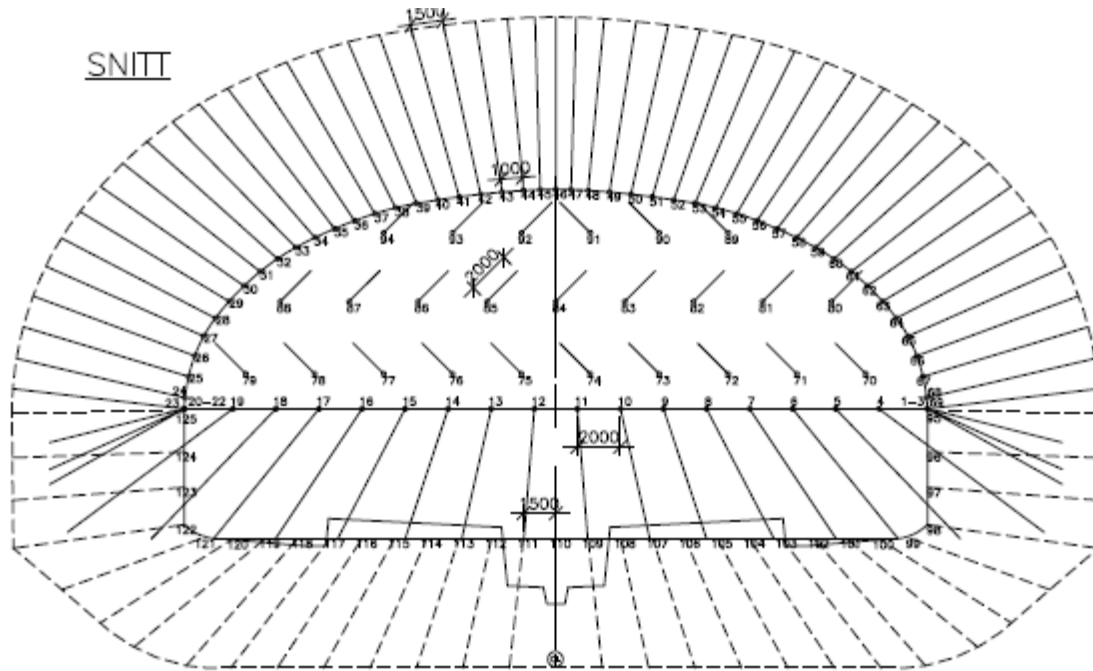
Figure 29. The basic hole distributions for pre-grouting fans in the station hall. Holes are drilled from the top of the cross-section and then around the entire tunnel profile. Prior to blasting out the lower part, holes are drilled around this as well. (Jernbaneverket 2011)

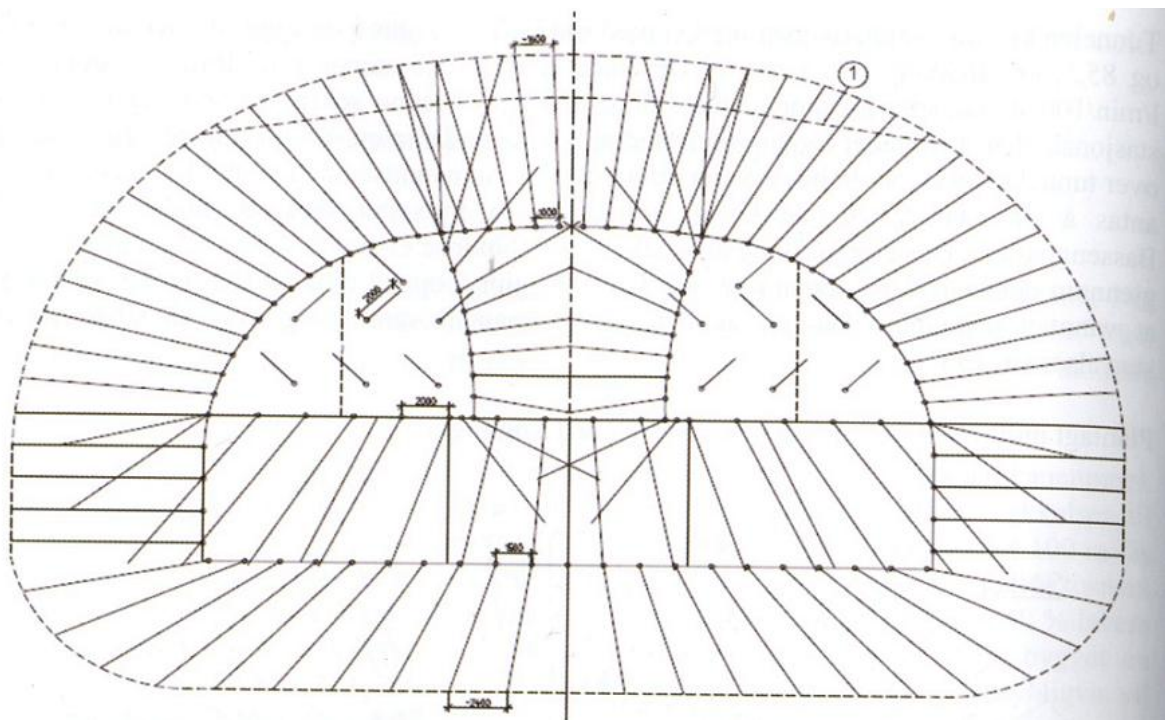
Figure 30. Sketch of the grouting scenario at a weakness zone. Holes are drilled in the tunnel and partially in the rock mass which later is to taken out before each of the partial cross-sections are excavated. (Langford, Kveldsvik et al. 2011)

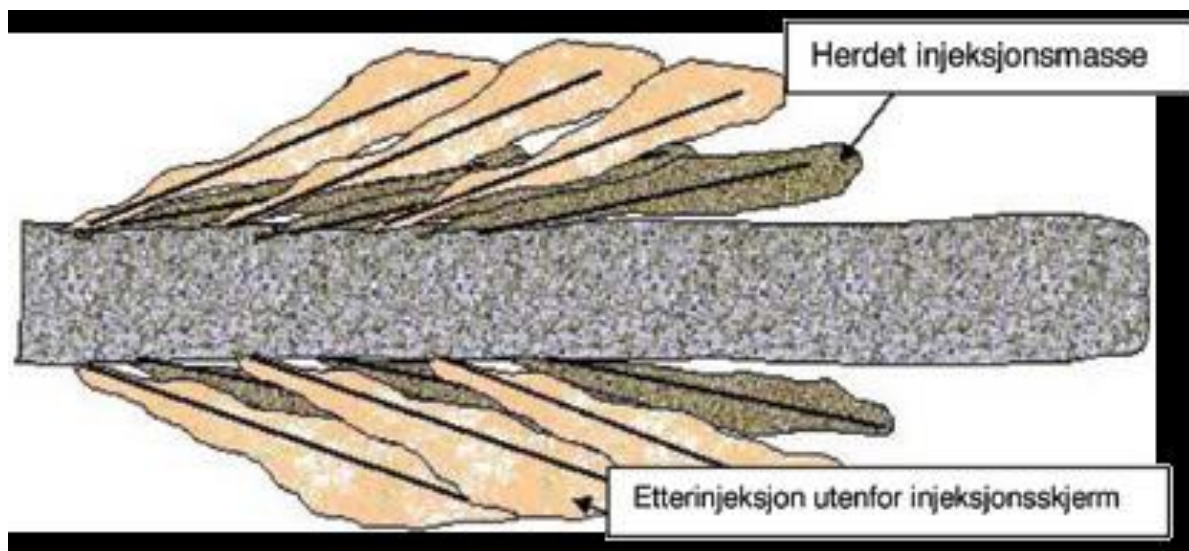
Figure 31. During the performance of post-grouting over a vast surface, holes are drilled in the opposite direction of the holes of the pre-grouting fan. Dark slabs show the hardened pre-grouting fan while the beige slabs indicate the post-grouting. (Hognestad, Fagermo et al. 2010)

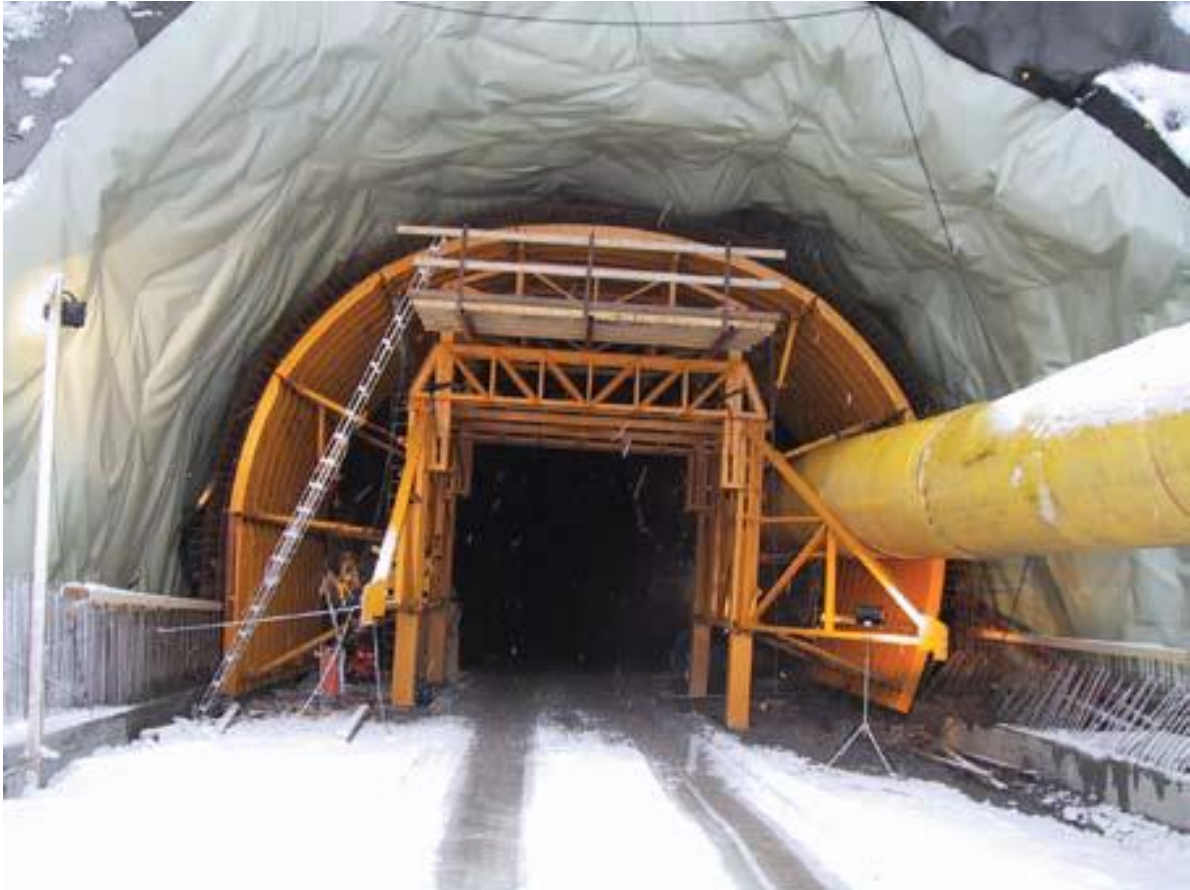
Figure 32. A shield used for concrete lining in the entrance tunnel to the Melkøya tunnel. (Sve, Elvøy et al. 2008)

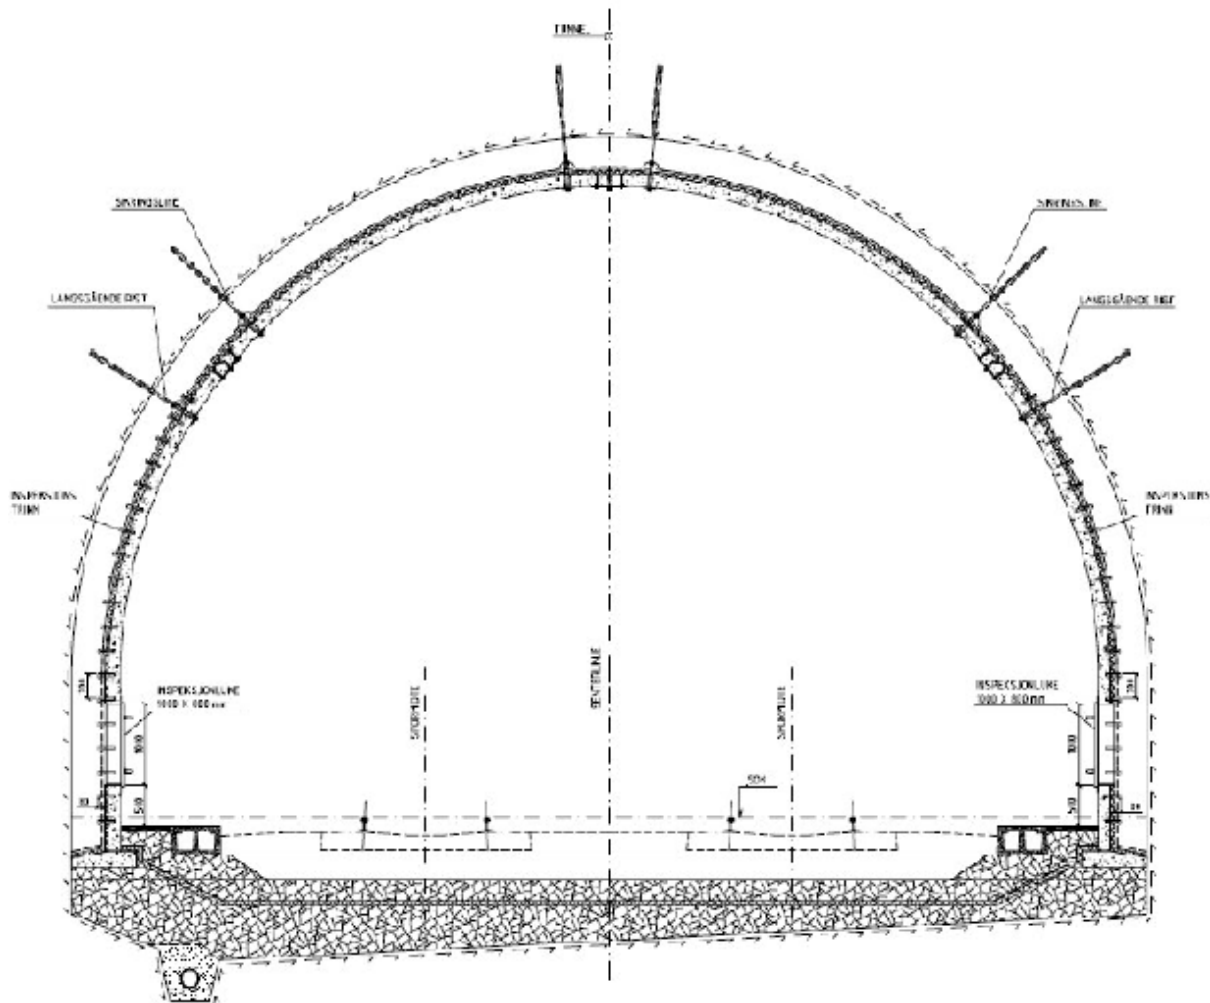
Figure 33. Sketch of a common water and frost profile for the station hall. At the bottom of either side there are inspection shafts, with safety lines behind the vault. (Multiconsult 2008)
