Holmestrand Underground Railway Station - Analysis of Groundwater Inflow and Methods for Water Sealing

Earth Sciences and Petroleum Engineering

Submission date: May 2012

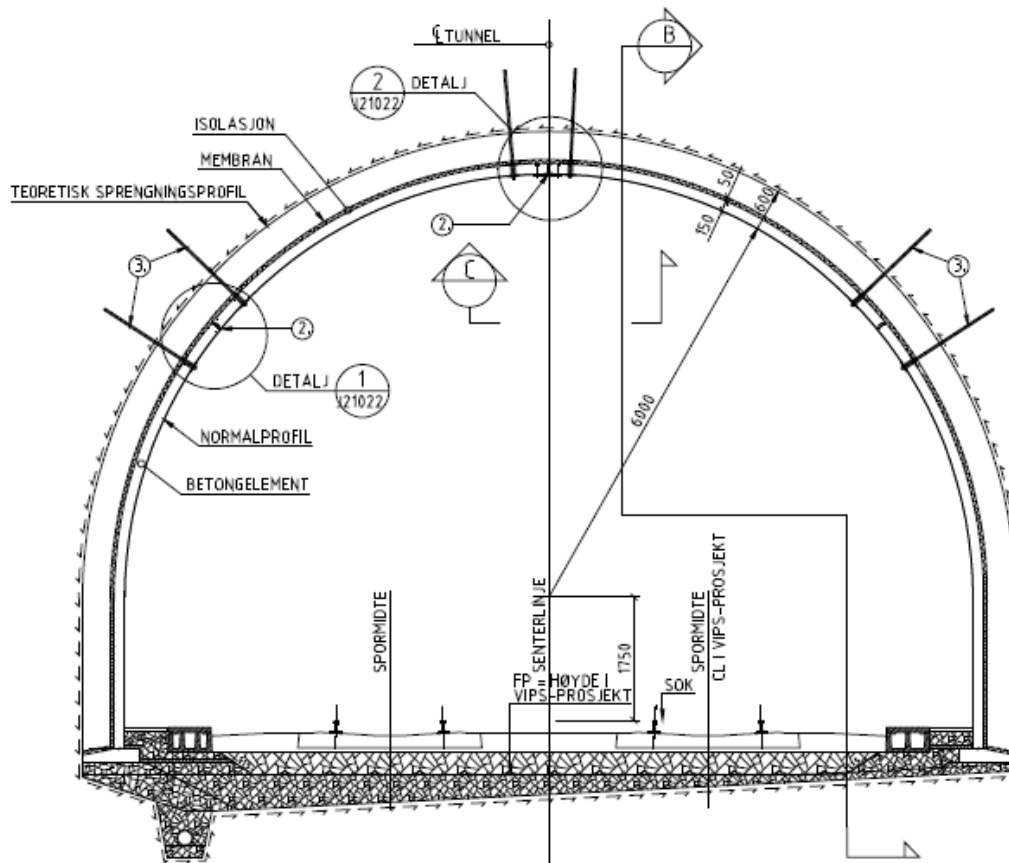
Figure 35. Sketch of the water and frost protection method using the concrete elements. (Multiconsult 2008)

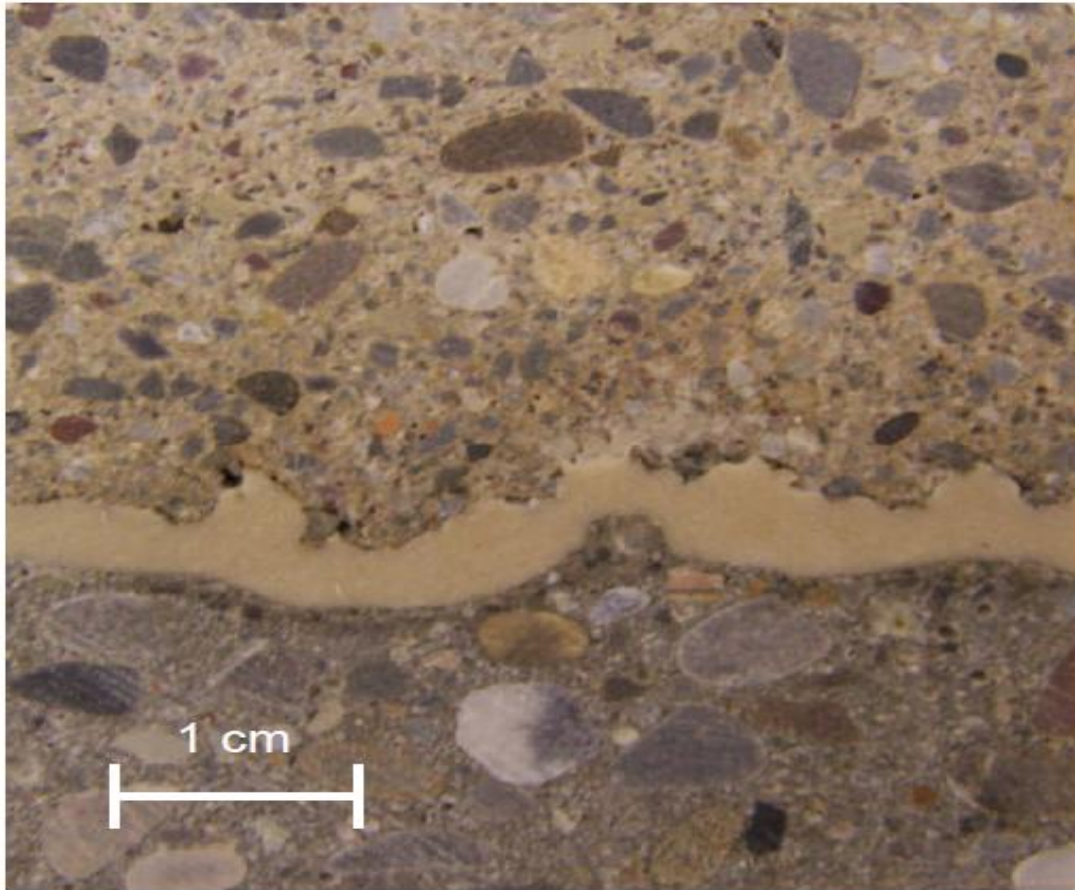
Figure 36. Photograph of the sprayed membrane sandwich structure. The upper part shows the rock support layer of shotcrete, the lower part is the inner lining. The membrane, in the middle, bonds chemically and mechanically to either side of the shotcrete. (Holter, Nermoen et al. 2011)

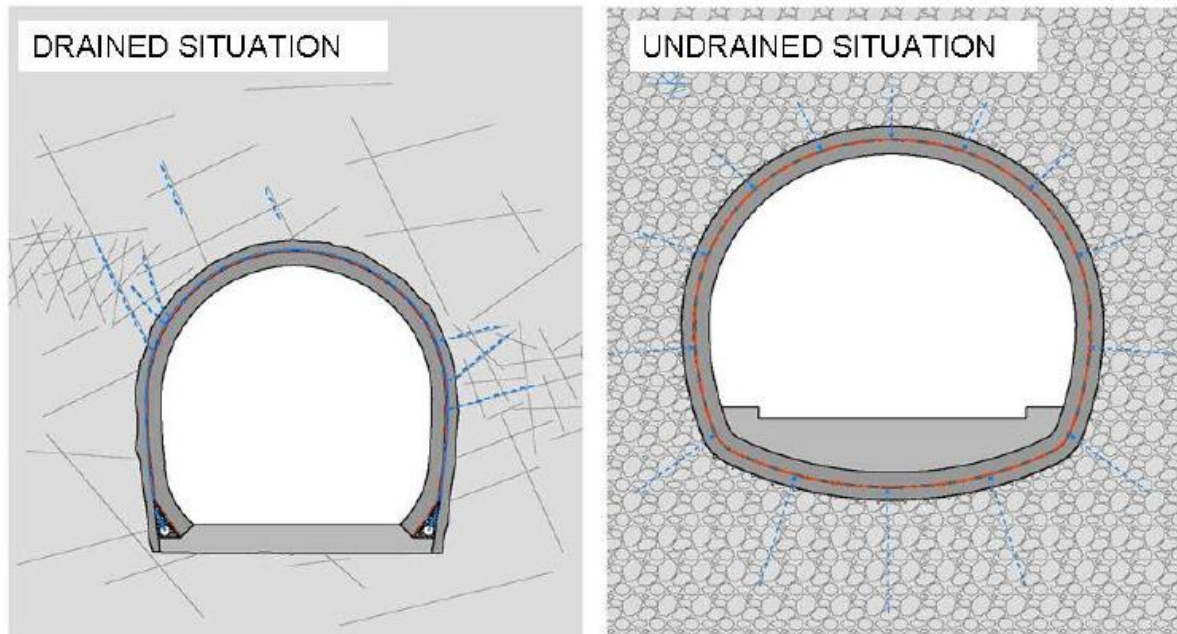
Figure 37. A sketch of a drained and undrained situation, and the securing application of both of the cases. (Holter, Nermoen et al. 2011)

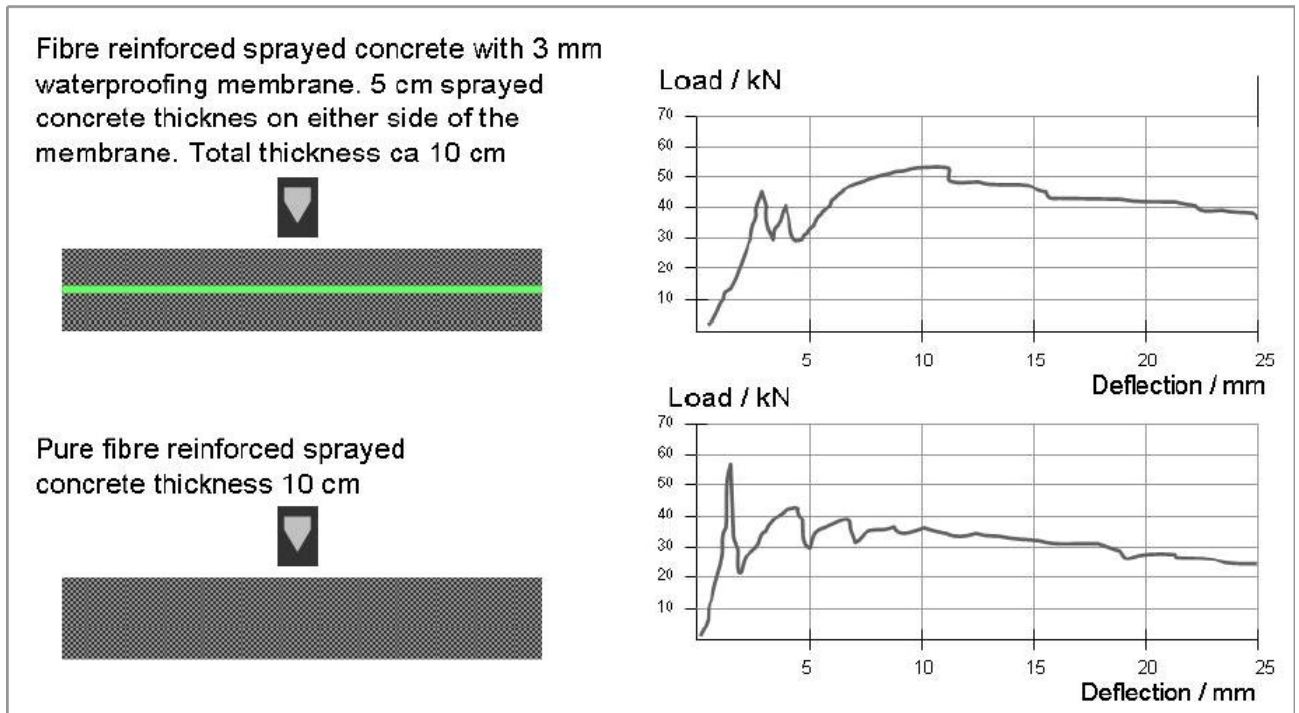
Figure 38. The results from the tests. In total, three samples of pure fibre reinforced concrete and the composite structure were tested. (Holter, Neramoen et al. 2011)

Figure 38 shows the results of these tests.

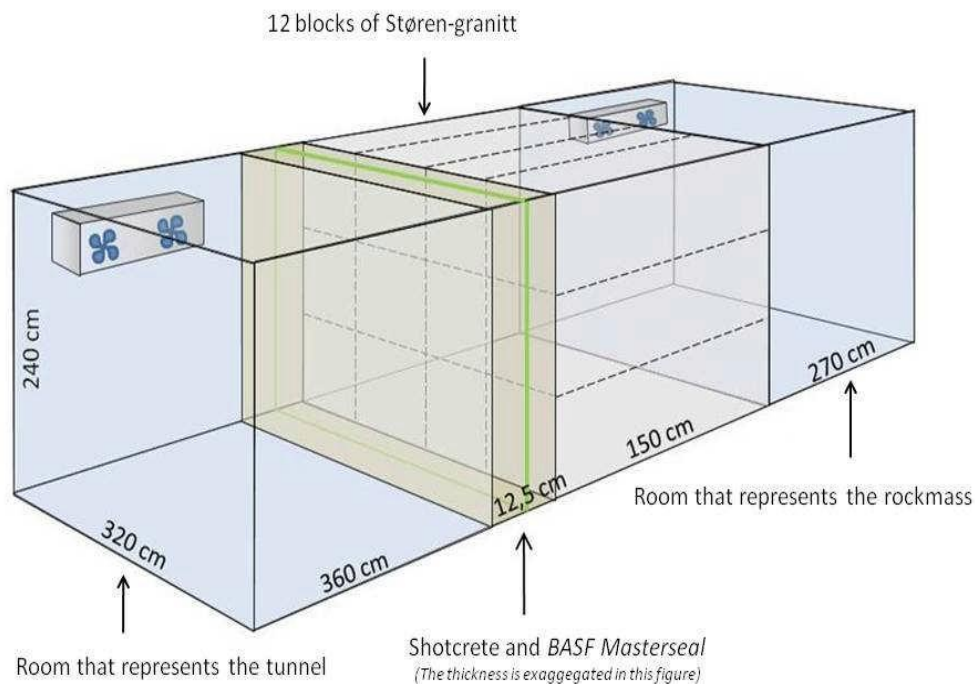
Figure 39. Sketch of the frost laboratory of SINTEF containing all rooms. (Holter and Neramoen 2011)

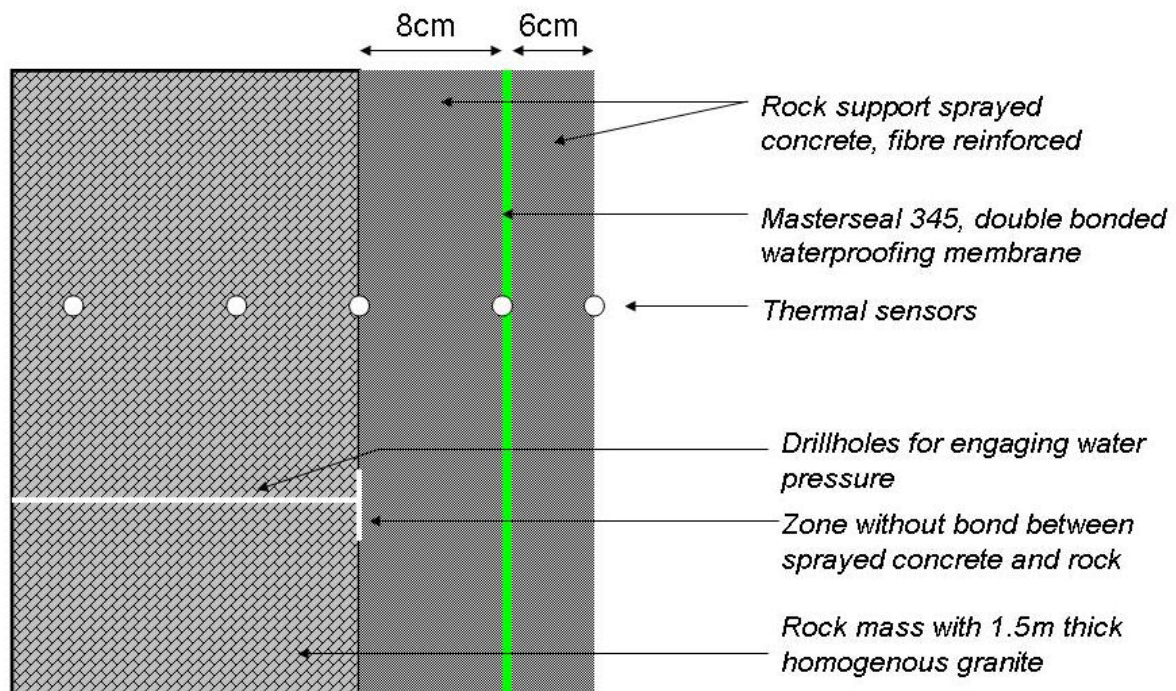
Figure 40. Sketch of the BASF masterseal 345 membrane and shotcrete package installed on the rock mass. (Holter and Neramoen 2011)

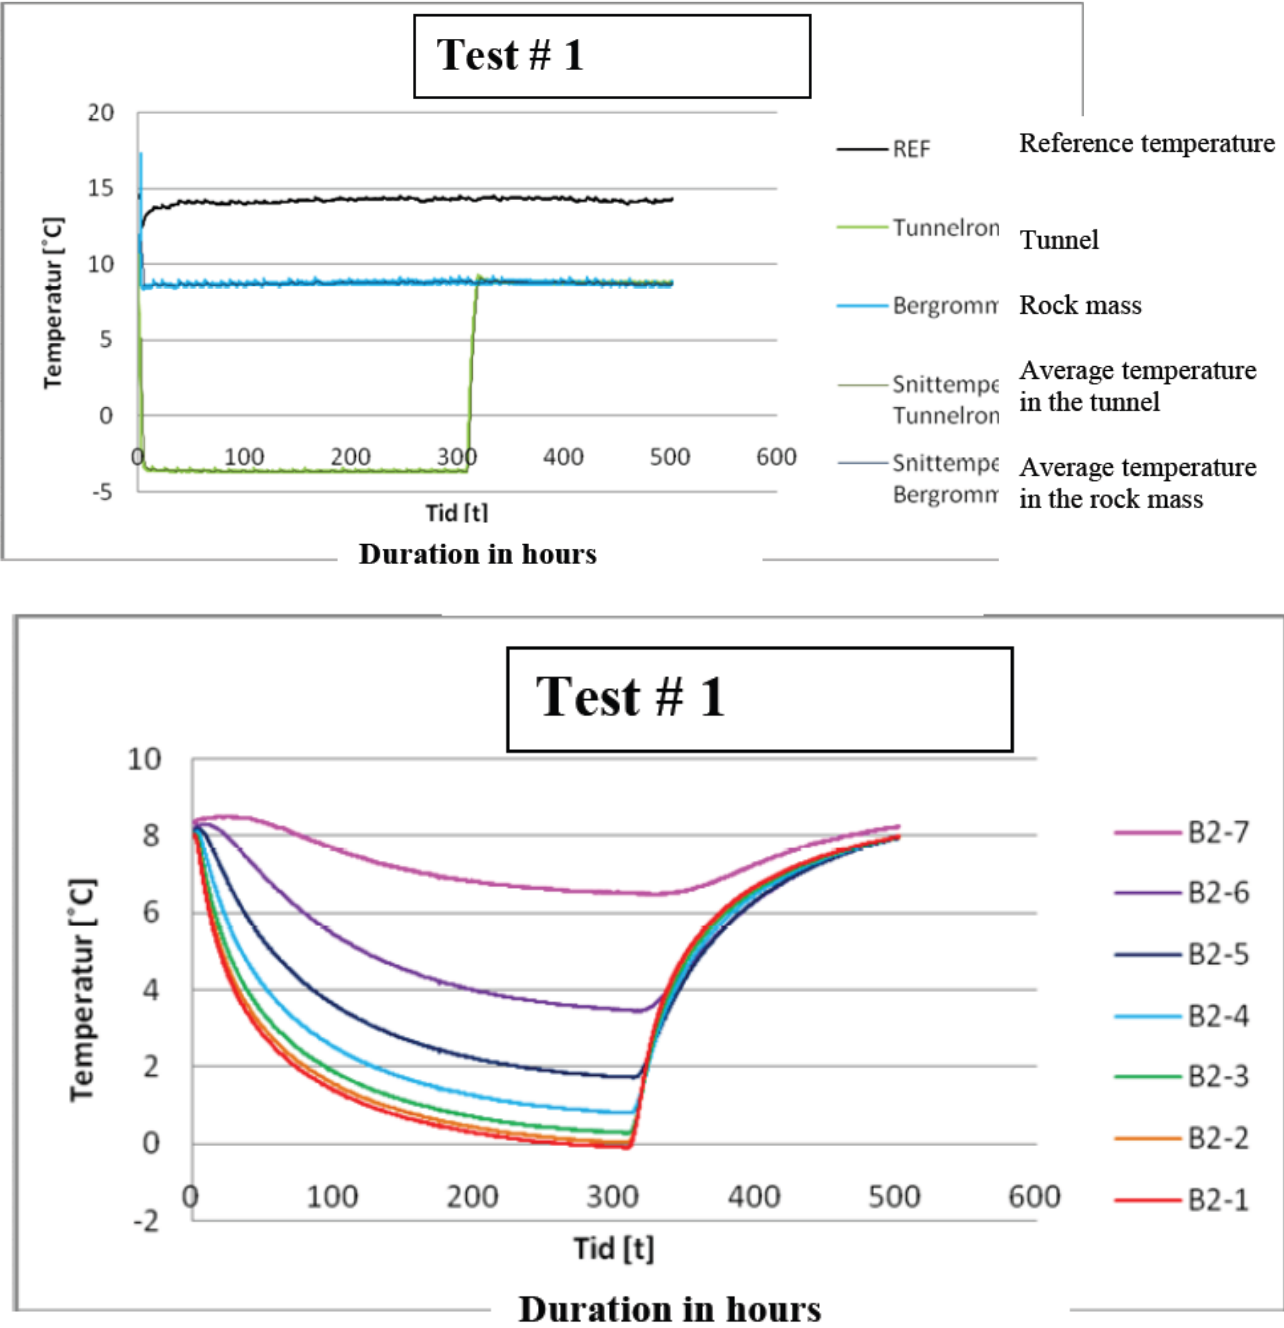
Figure 41. Results from the first test with the temperature in the tunnel room plotted in the upper diagram, and the temperature in the rock mass plotted in the lower diagram. (Holter, Neramoen et al. 2011)

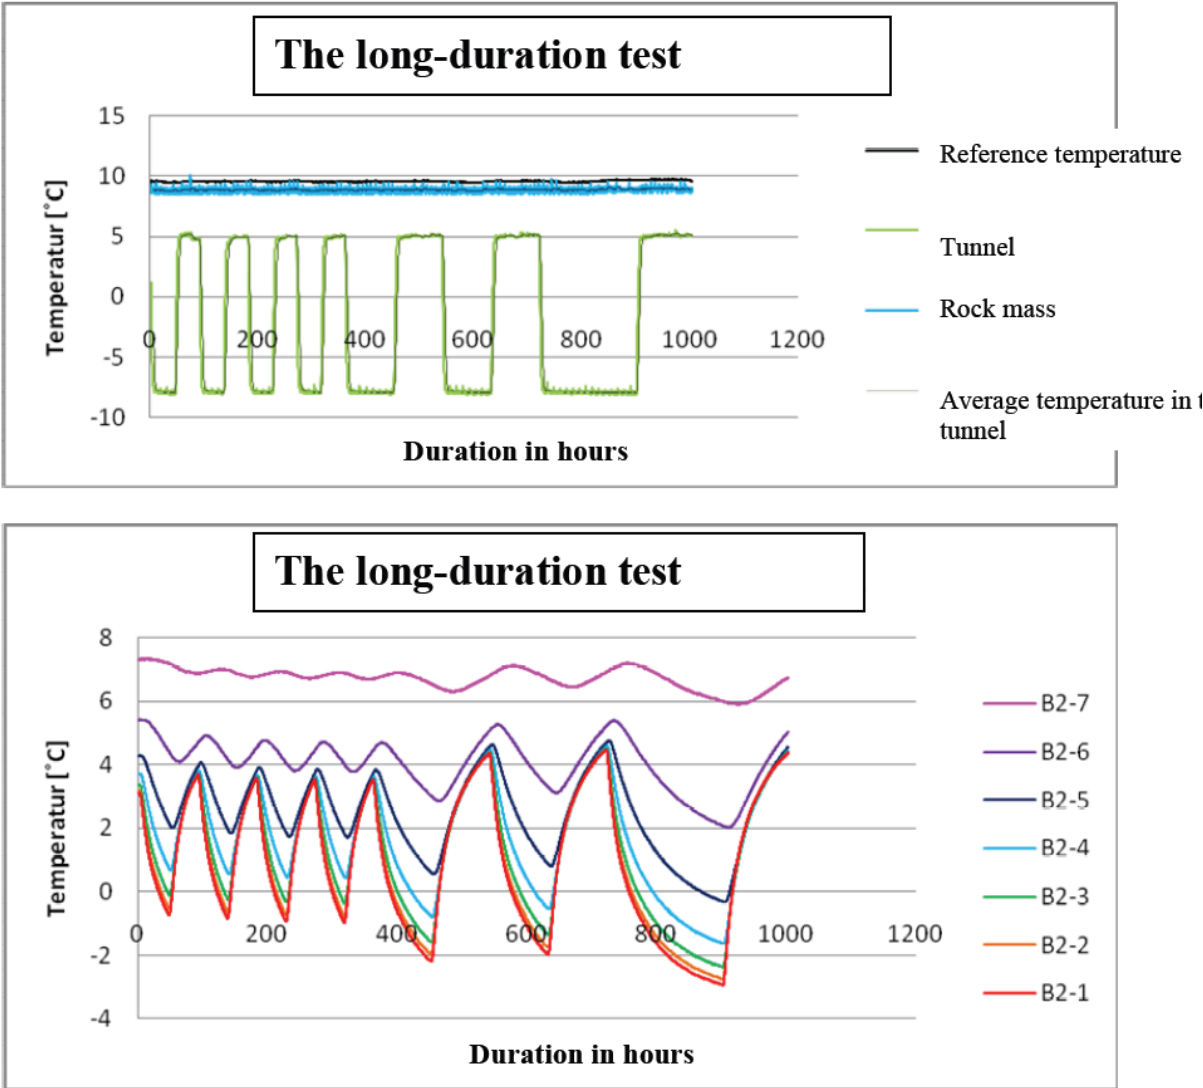
Figure 42. The results from the long-term test, with the temperatures in the tunnel room in the upper diagram, and the lower diagram representing the temperature in the rock mass. (Holter, Nermoen et al. 2011)

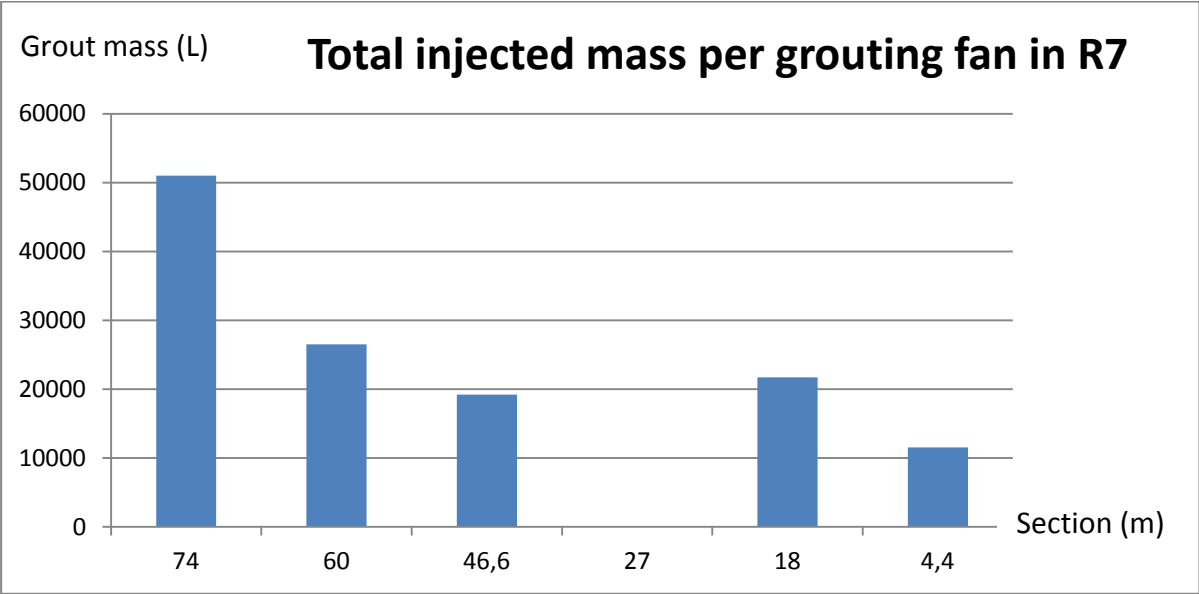
Figure 44. The total amounts of grouting mass per grouting fan in R7.

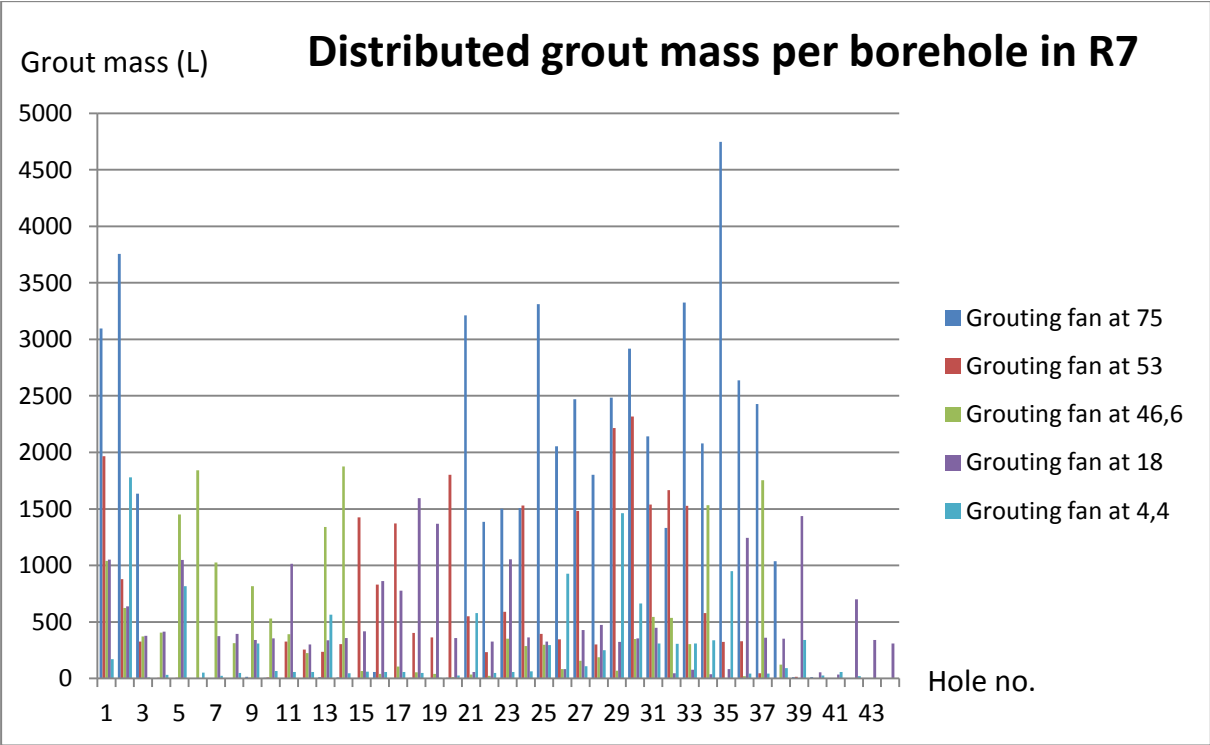
Figure 46. Distributed amounts of injected mass per borehole per grouting fan in R7.

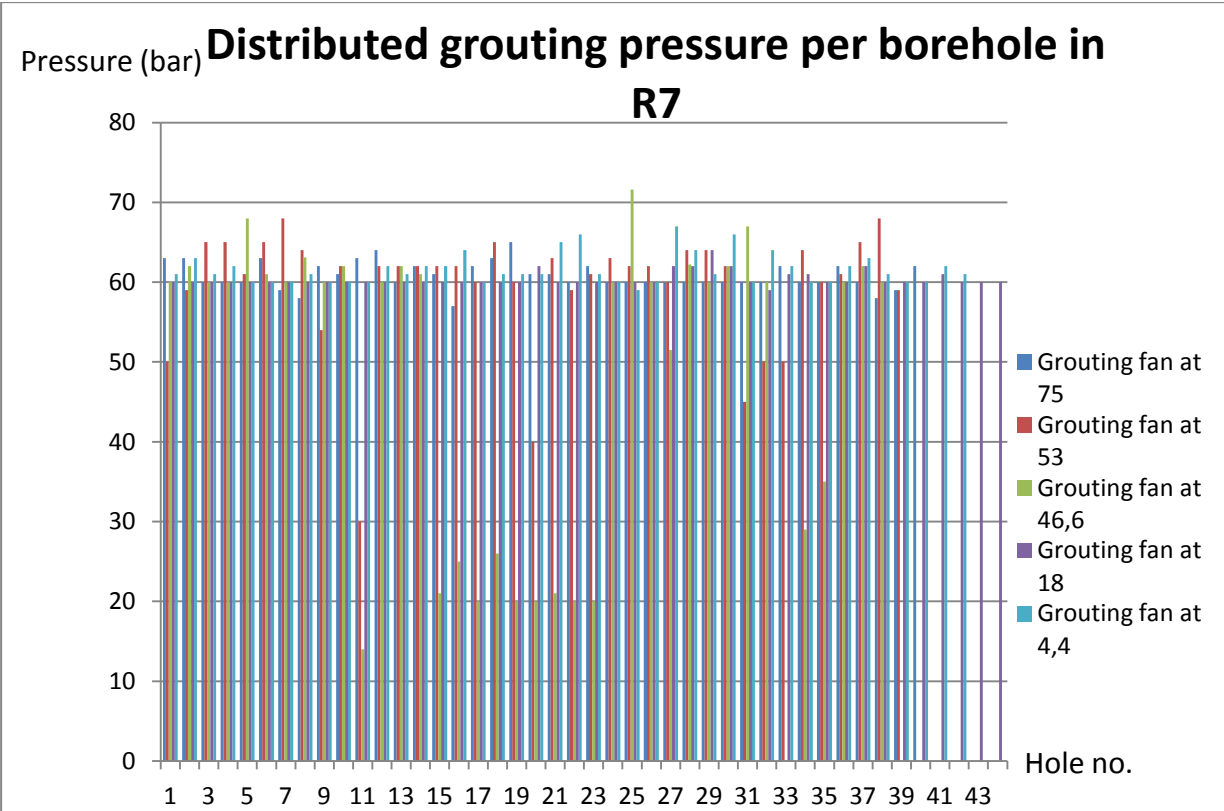
Figure 47. Distributed amounts of grouting pressure per borehole per grouting fan in R7.

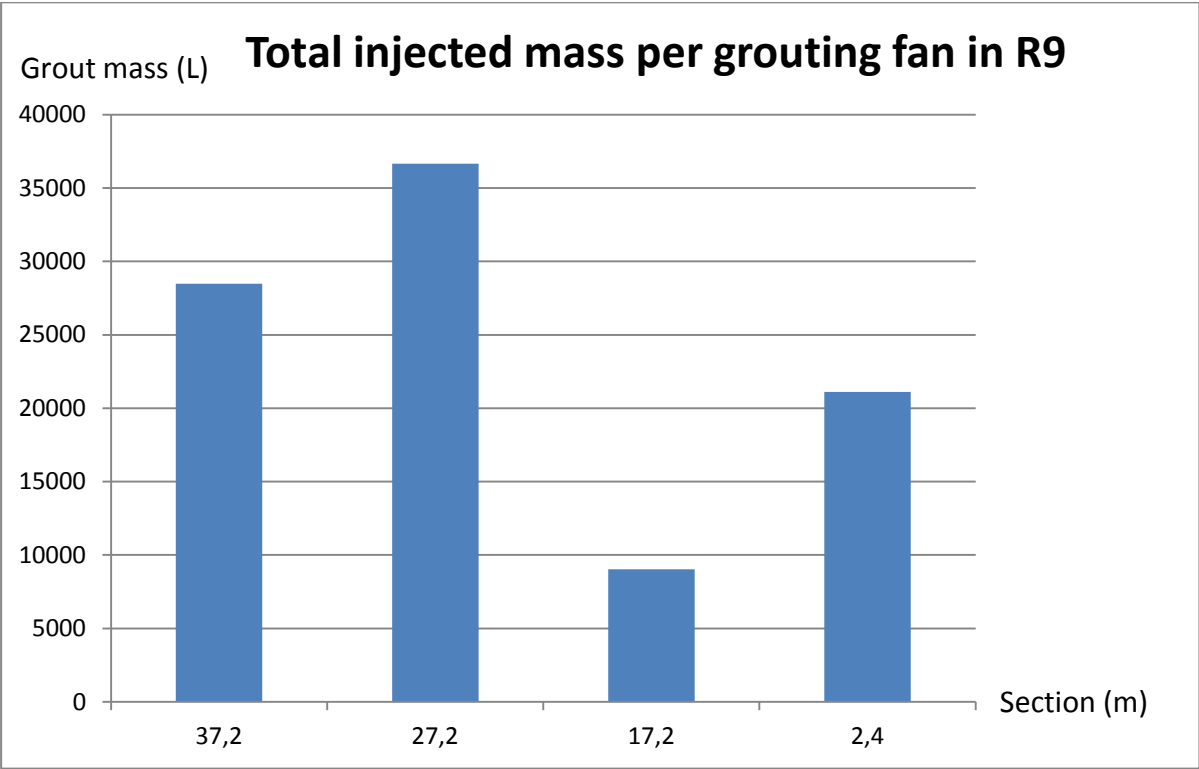
Figure 48. Total amounts of injected grout mass per grouting fan in R9.

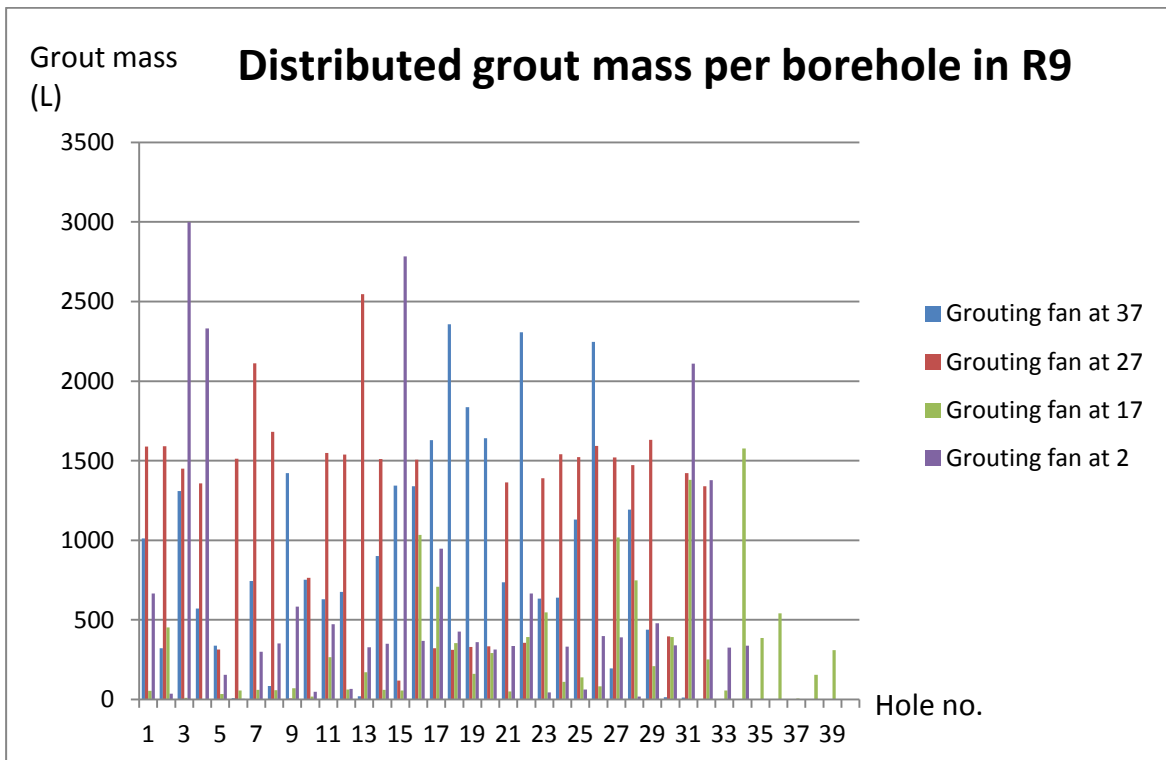
Figure 50. Distributed amounts of injected grout mass per borehole per grouting fan in R9.

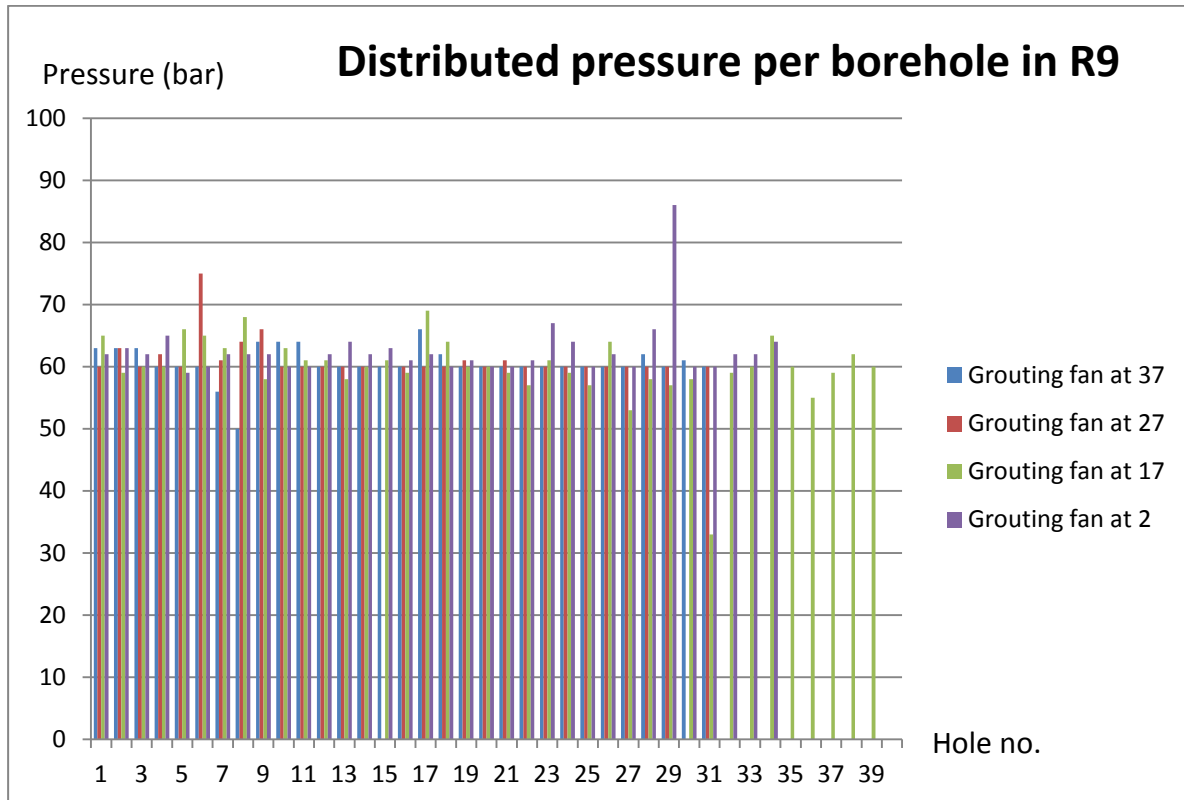
Figure 51. Distributed grouting pressure per borehole per grouting fan in R9.

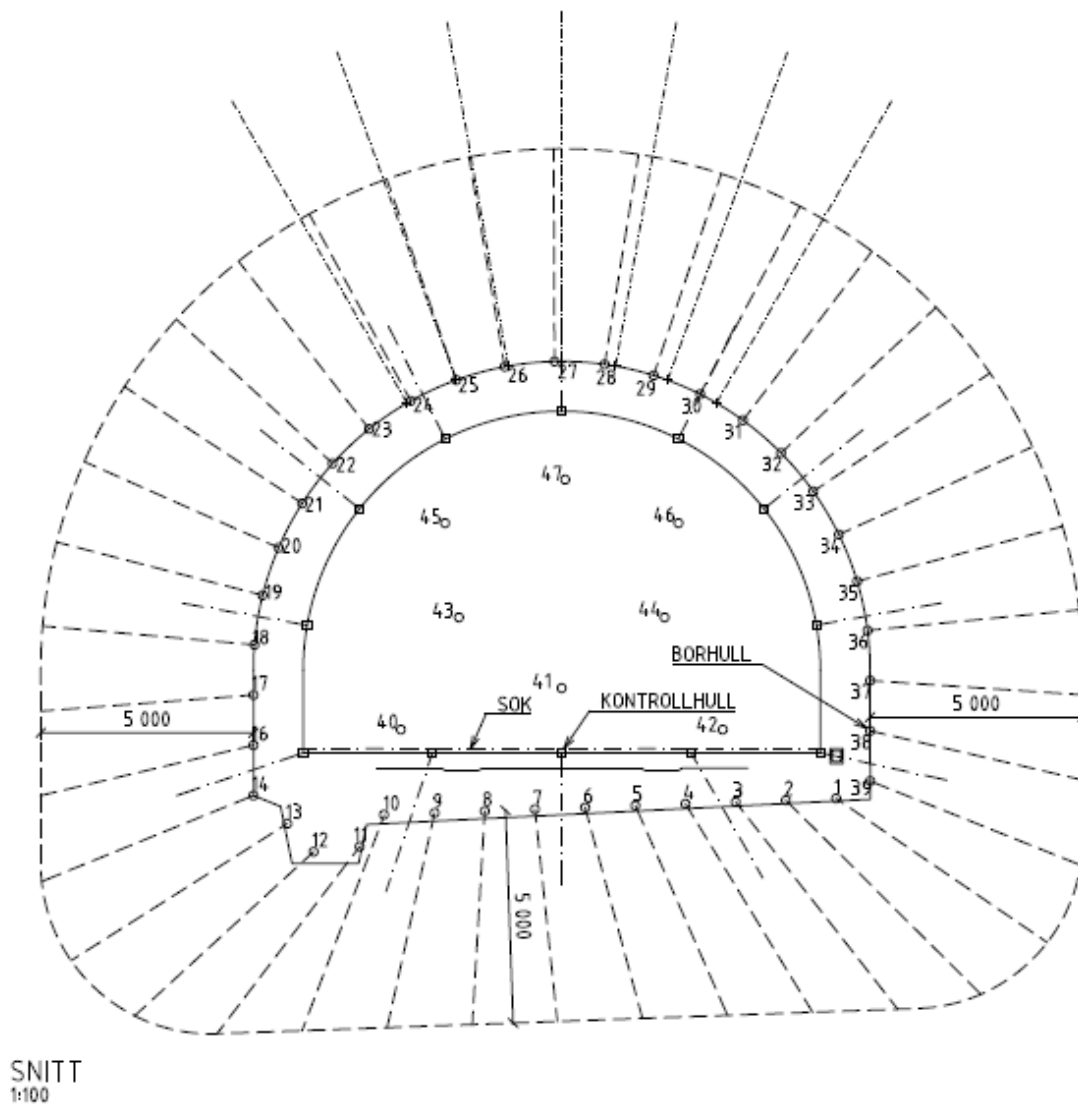
Figure 53. The pre-grouting fan for the main tunnel at Sjøskogen. (Jernbaneverket 2011)

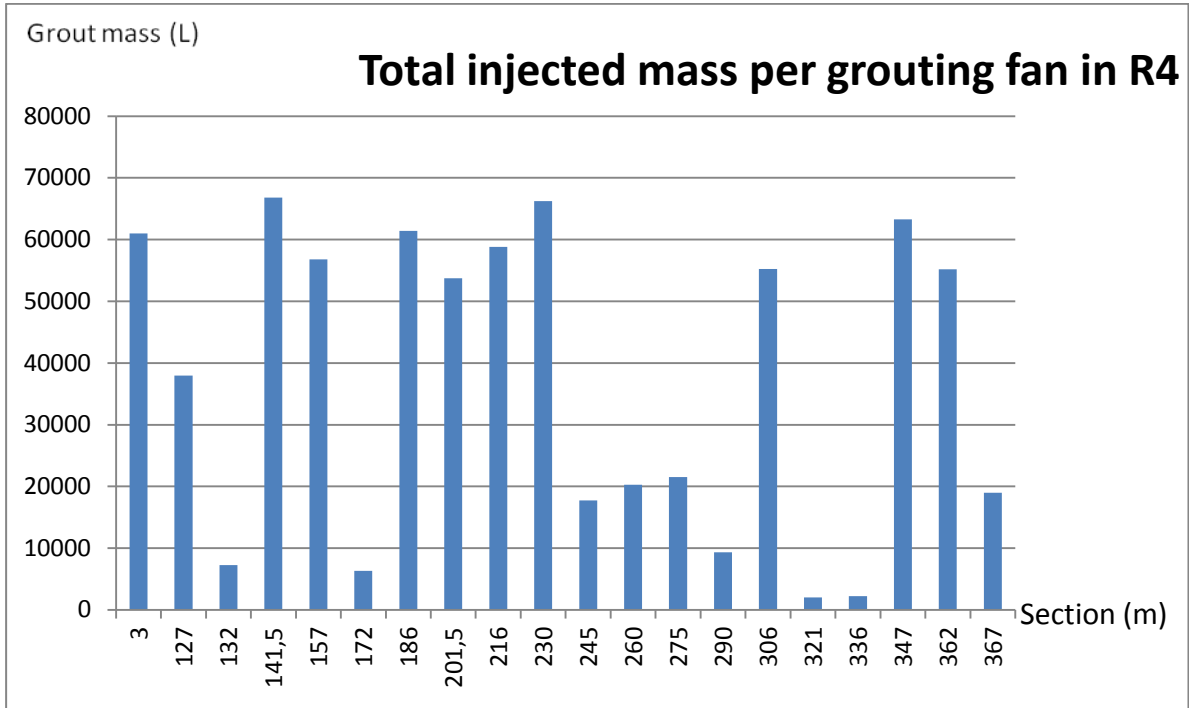
Figure 54. Total amount of grout mass per grouting fan in the R4 entrance tunnel.

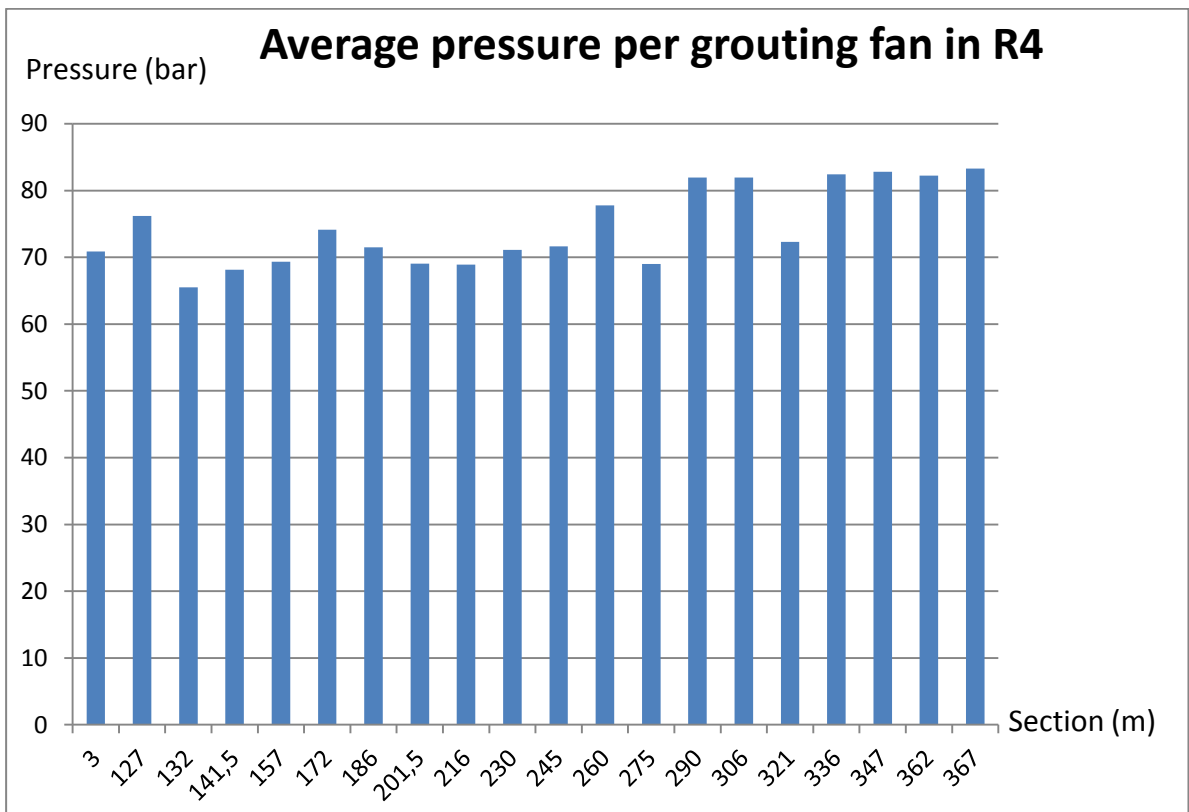
Figure 55. The average pressure per grouting fan in the R4 entrance tunnel.

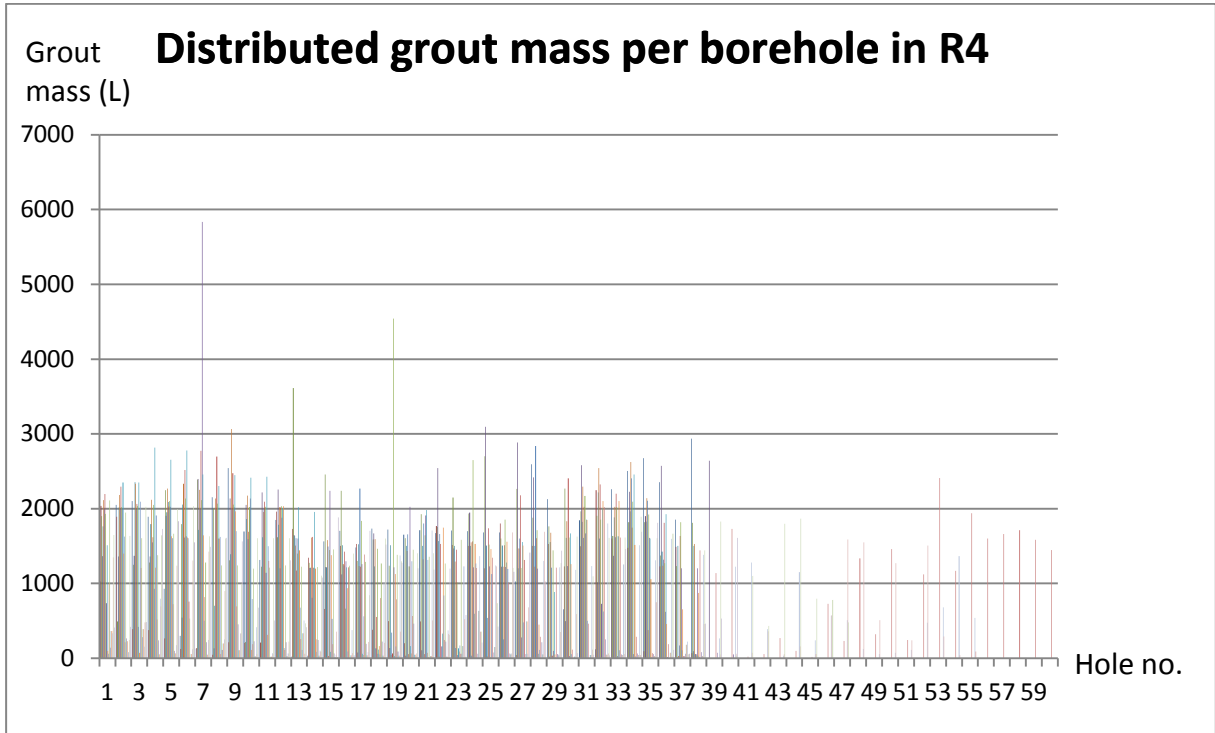
Figure 56. Grout mass per borehole per grouting fan in R4.

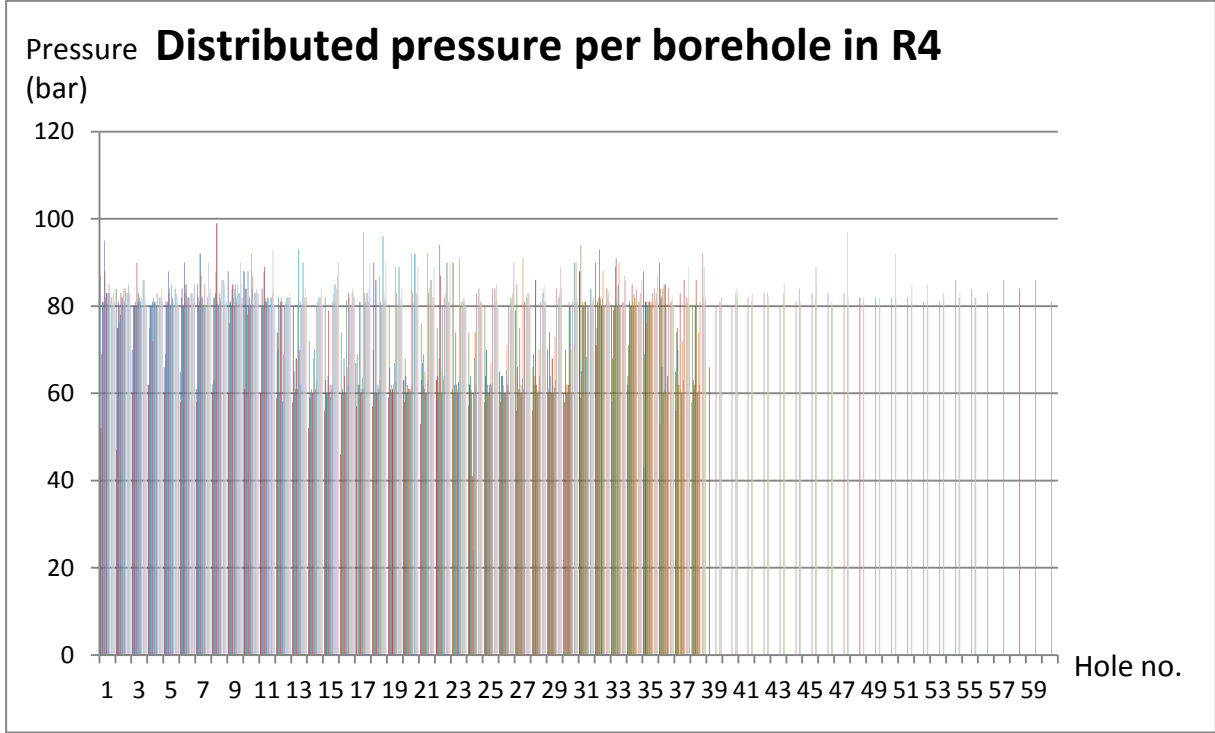
Figure 57. Grouting pressure per borehole per grouting fan in R4.

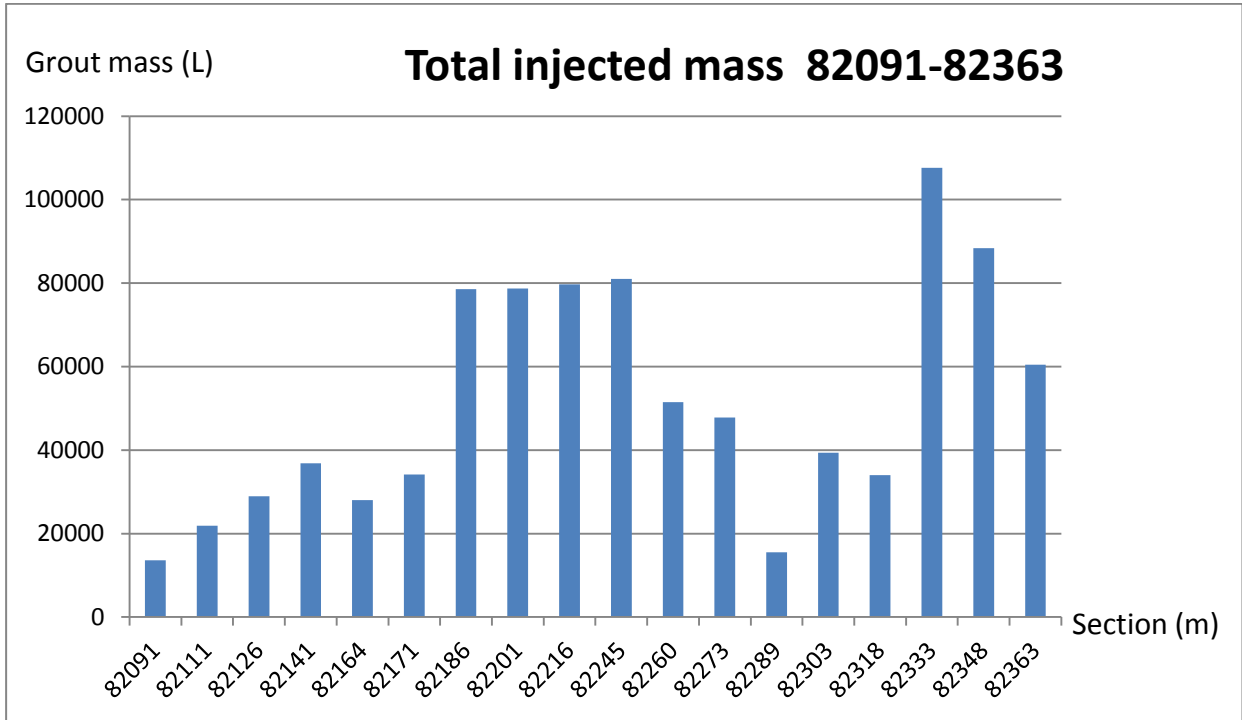
Figure 58. Total amount of injected grout mass per grouting fan in the main tunnel at Sjøskogen from section 82091 – 82363.

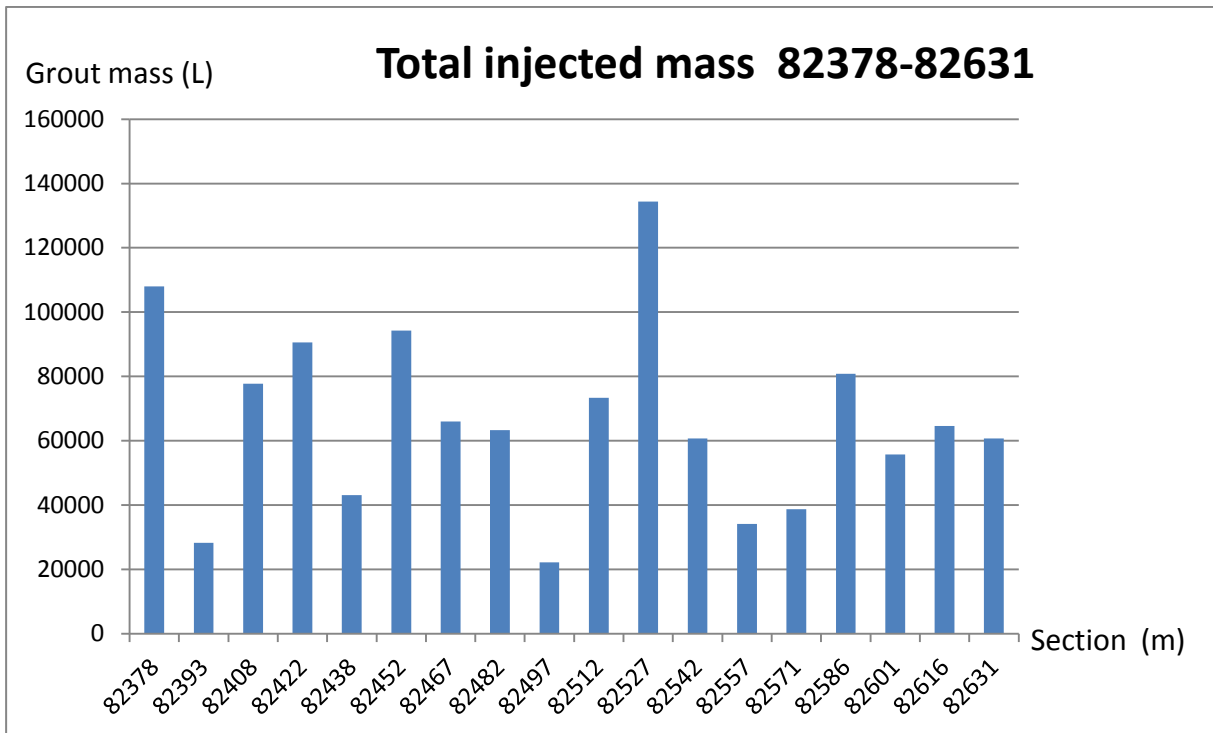
Figure 59. Total amount of injected grout mass per grouting fan in the main tunnel at Sjøskogen from section 82378 – 82631.

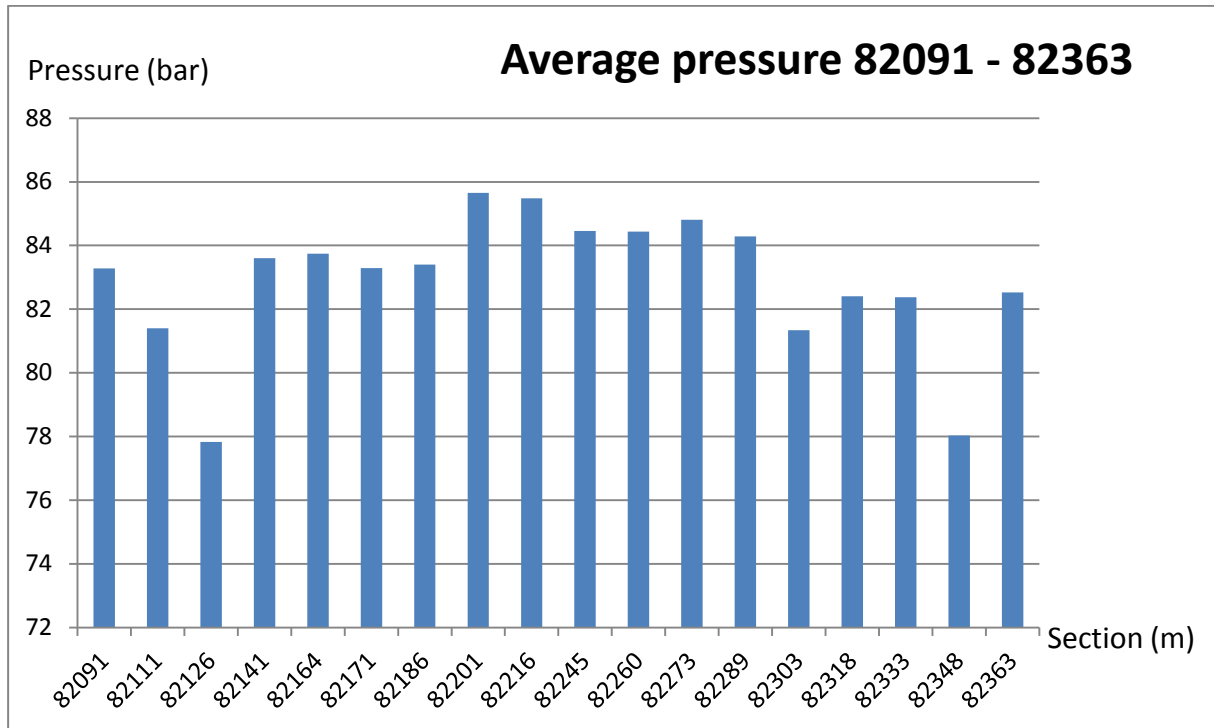
Figure 60. The average pressure per grouting fan in the main tunnel at Sjøskogen from section 82091 – 82363.

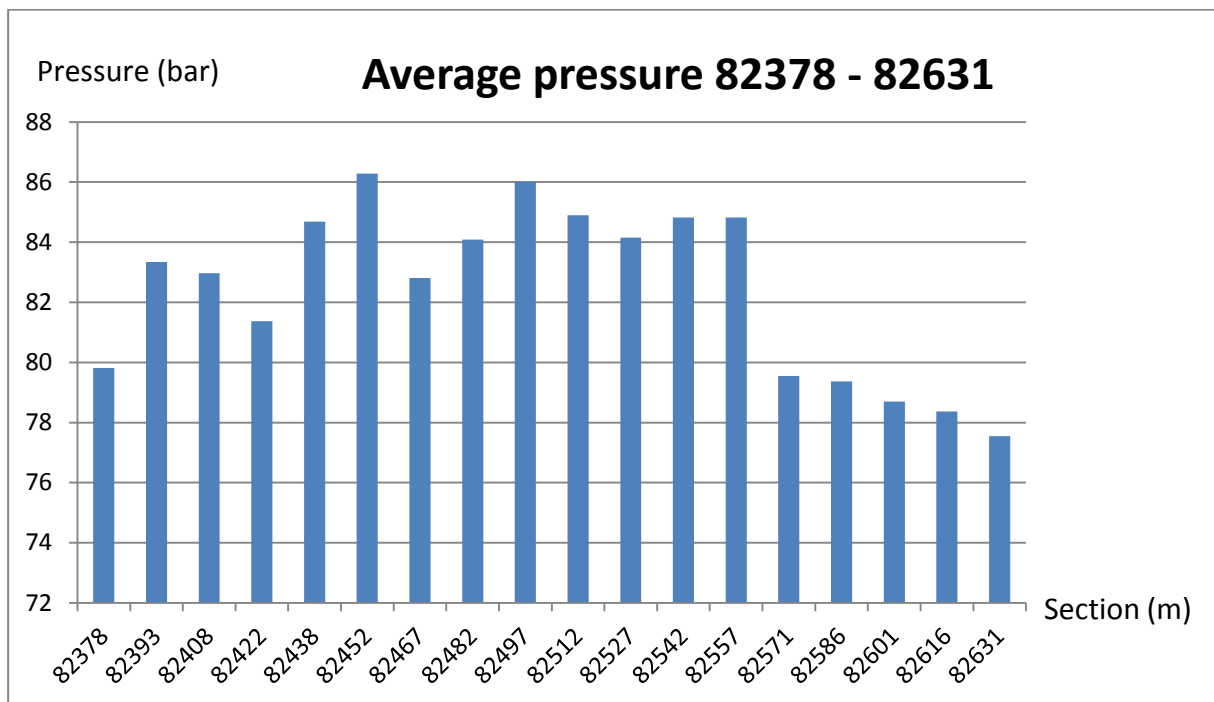
Figure 61. The average pressure per grouting fan in the main tunnel at Sjøskogen from section 82378 – 82631.

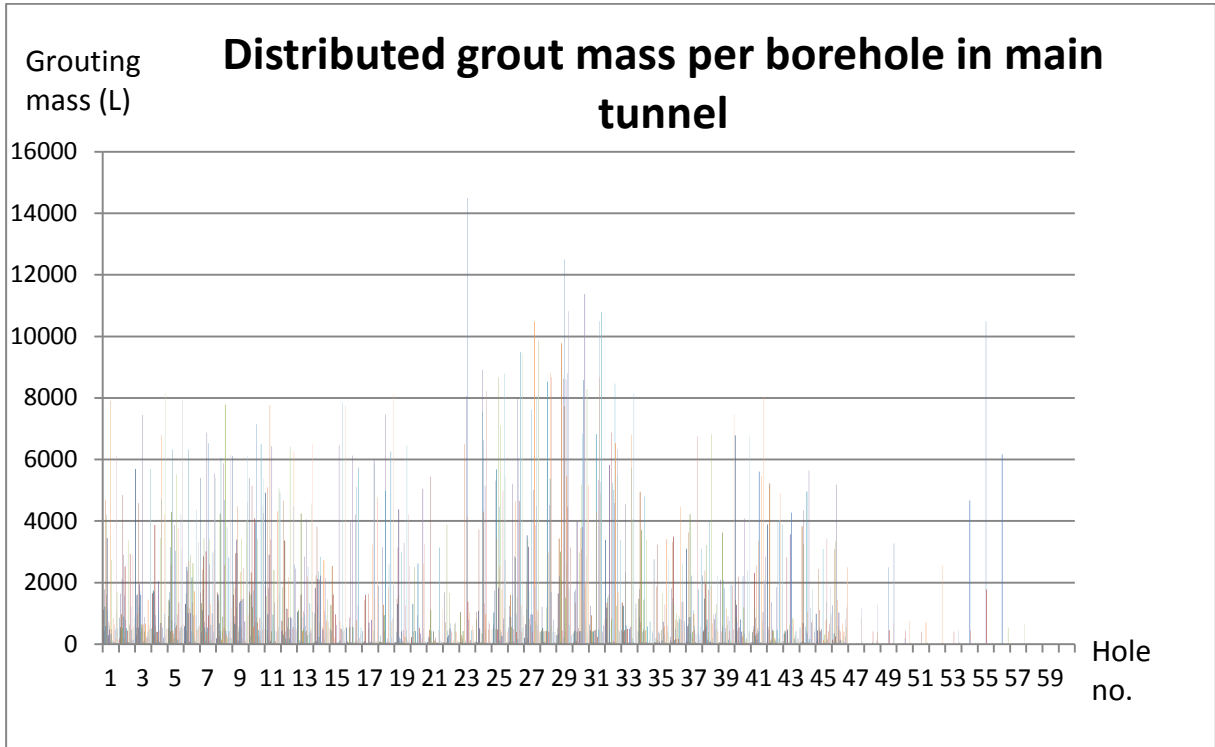
Figure 62. Injected grout mass per borehole per grouting fan in the main tunnel at Sjøskogen.
