Holmestrand Underground Railway Station - Analysis of Groundwater Inflow and Methods for Water Sealing

Earth Sciences and Petroleum Engineering

Submission date: May 2012

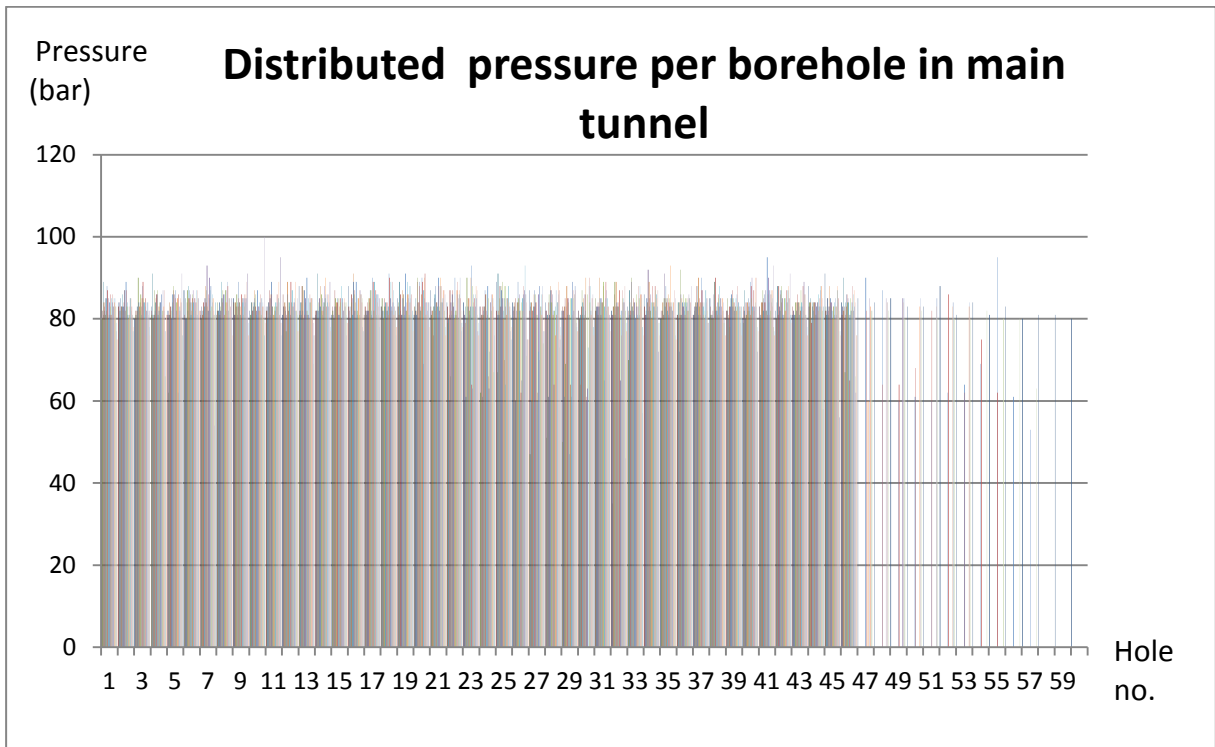
Figure 63. Grouting pressure per borehole per grouting fan in the main tunnel at Sjøskogen.

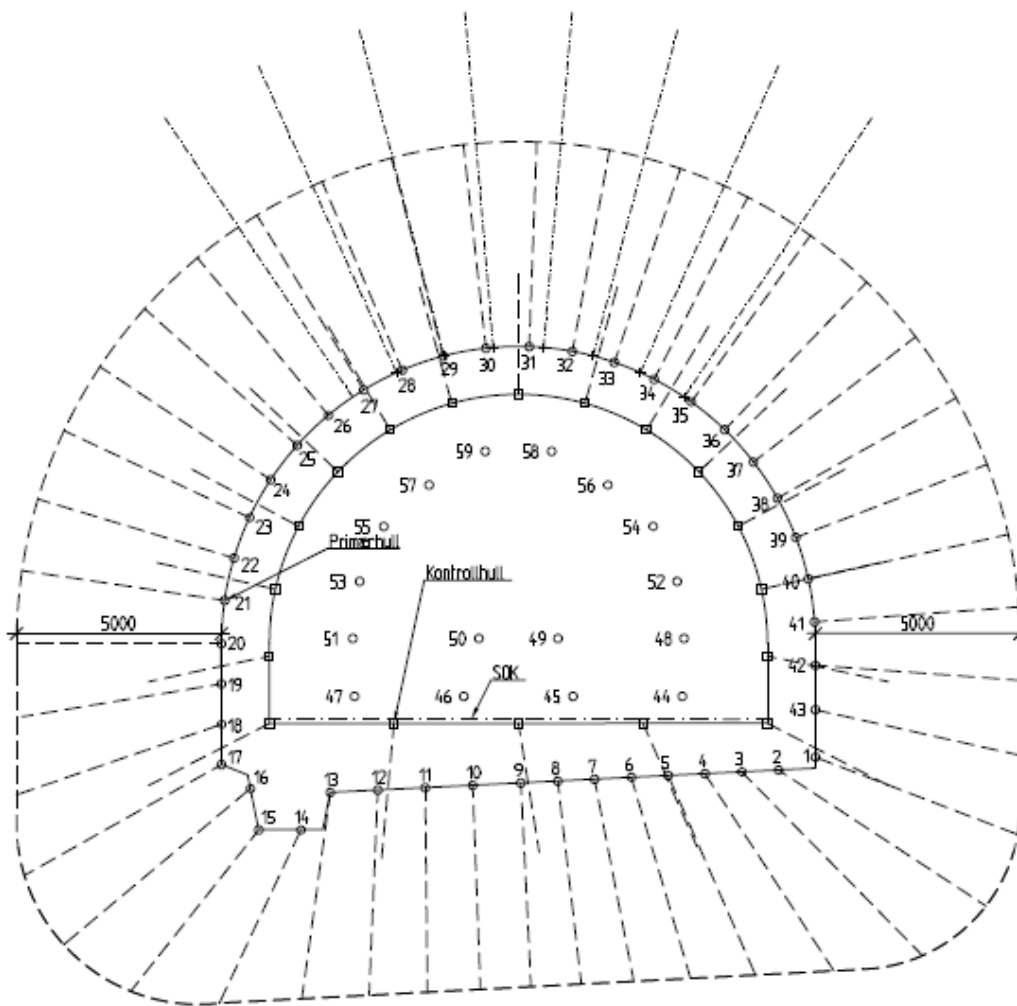
Figure 65. Sketch of the pre-grouting fan for the main tunnel at Snekkestad. (Jernbaneverket 2011)

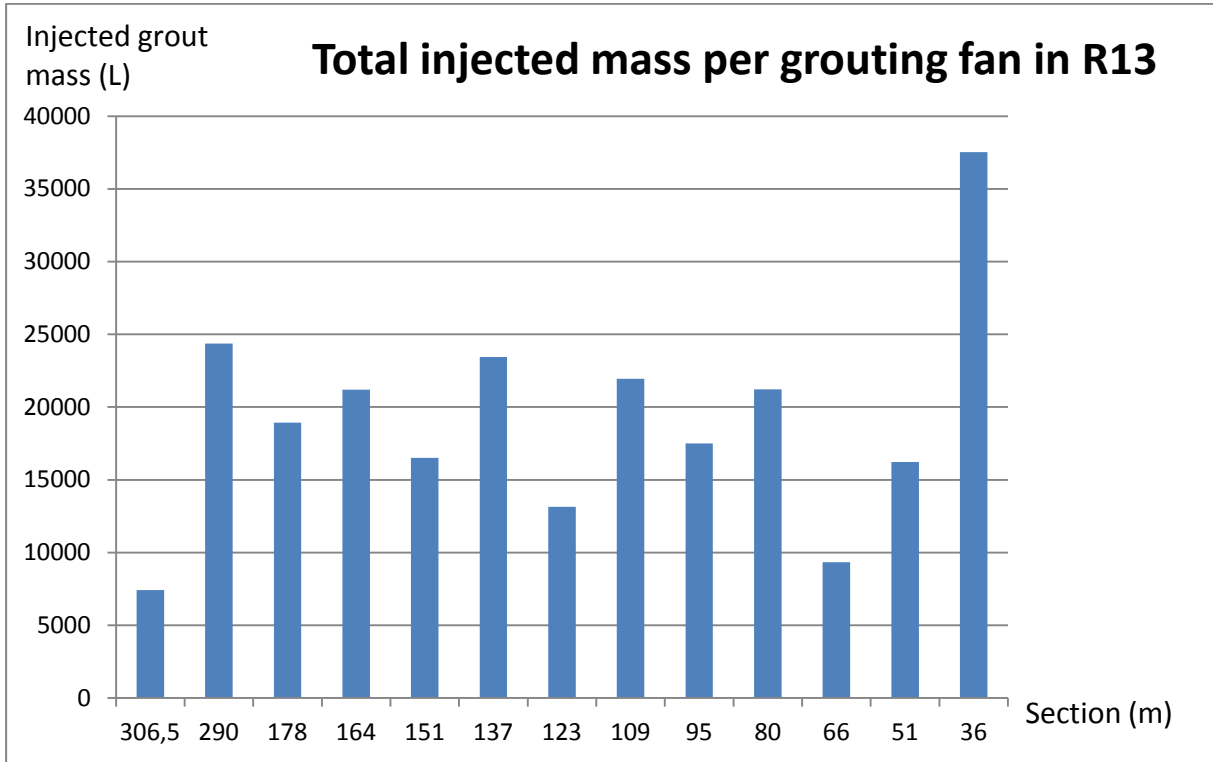
Figure 66. Total amount of grout mass per grouting fan in R13.

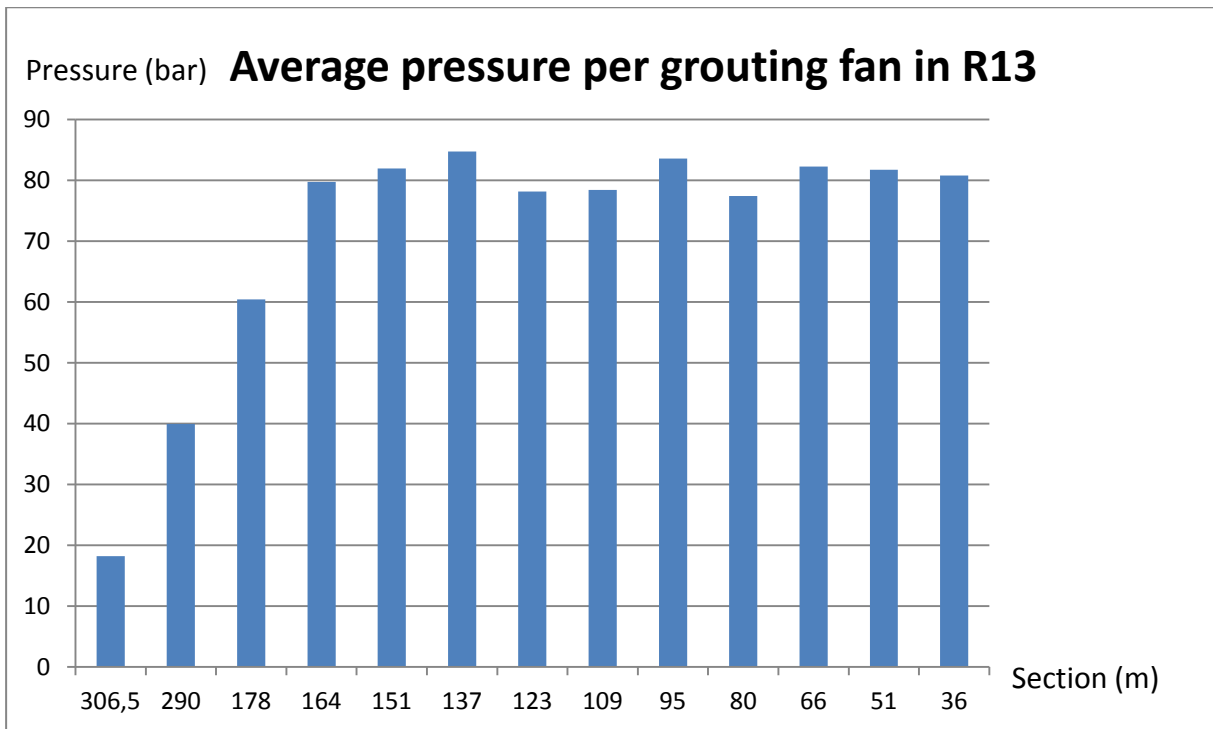
Figure 67. Average grouting pressure per grouting fan in R13.

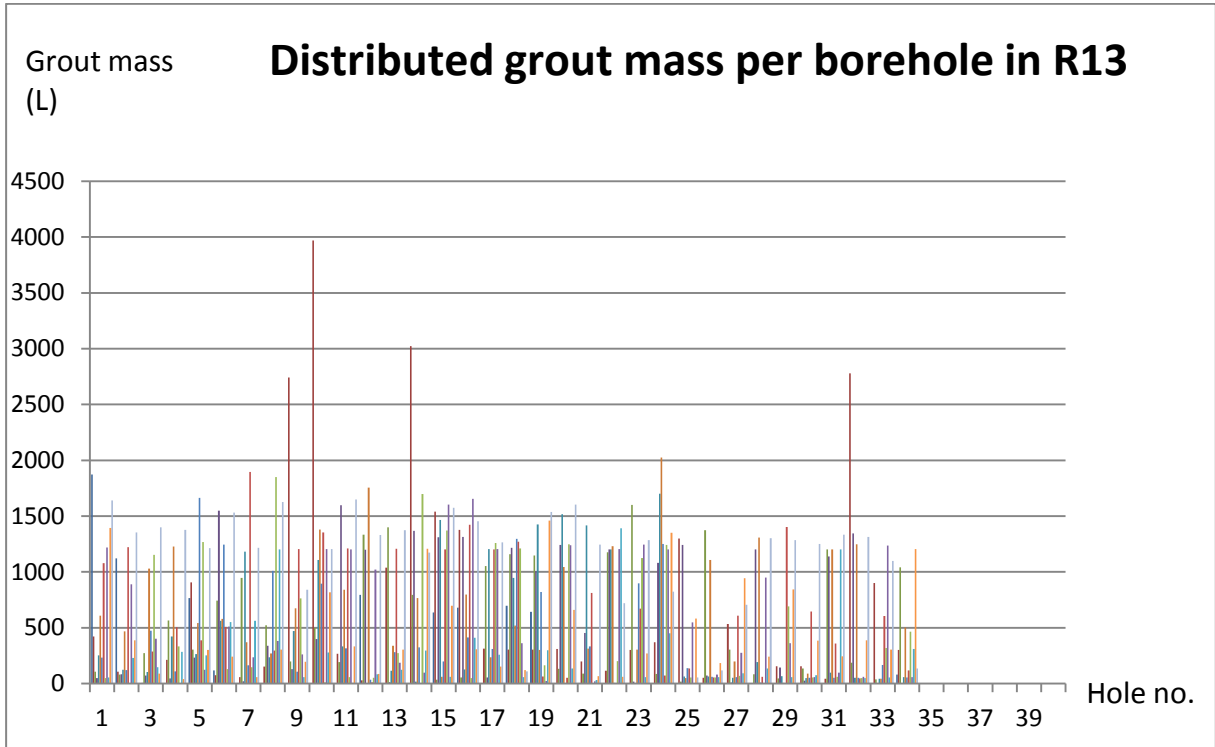
Figure 68. Distributed grout mass per borehole per grouting fan in R13.

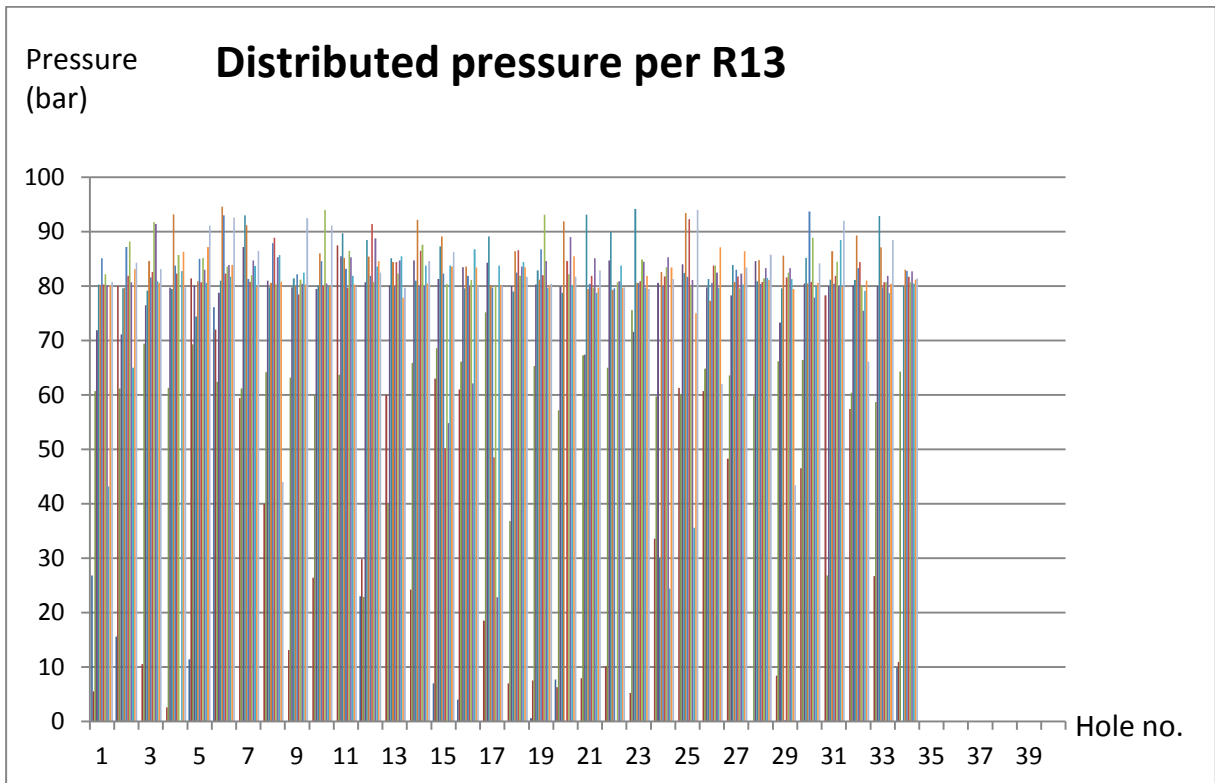
Figure 69. Distributed grouting pressure per borehole per grouting fan in R13.

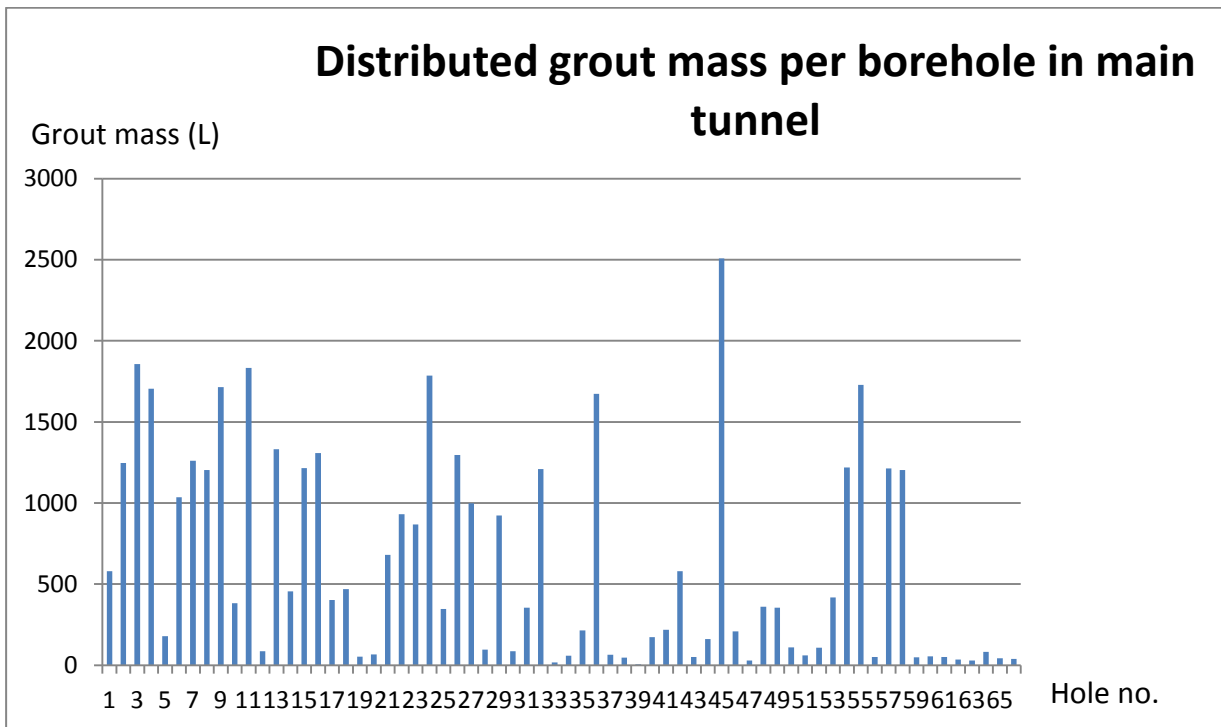
Figure 72. Distributed amounts of grout mass per borehole for the grouting fan in the main tunnel at Snekkestad.

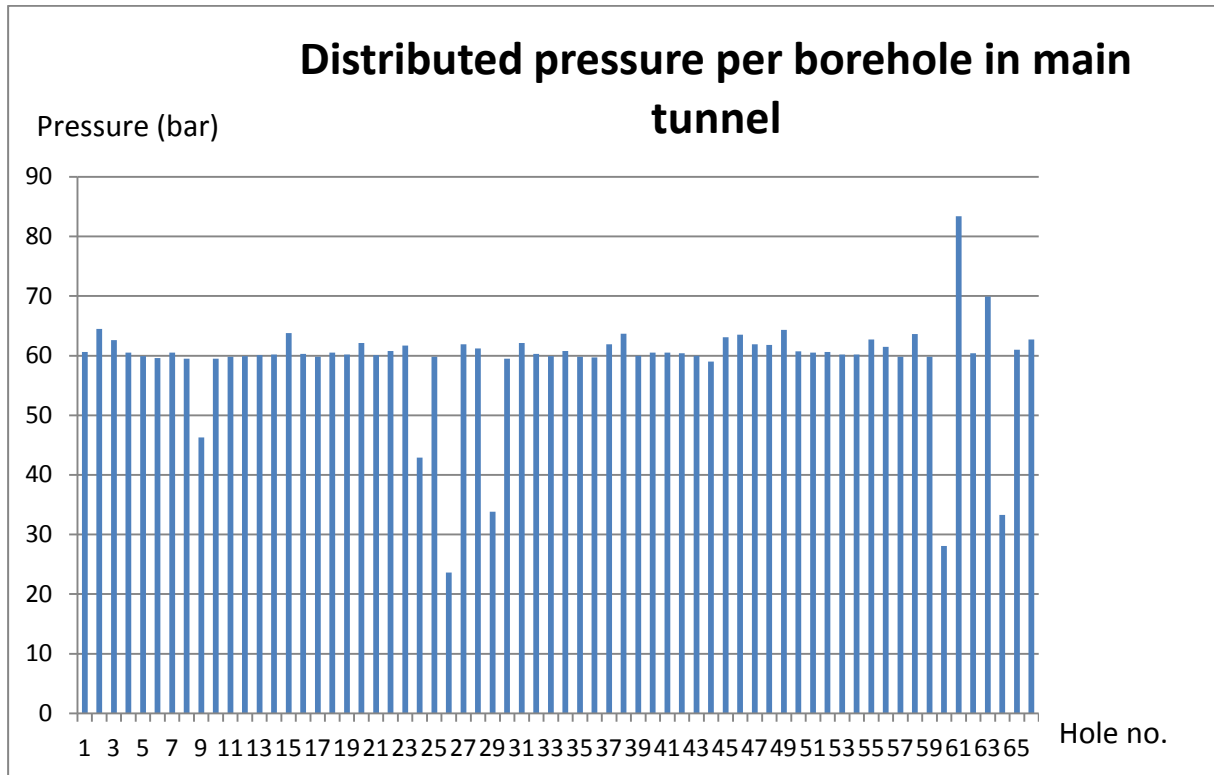
Figure 73. Distributed grouting pressure per borehole for the grouting fan in the main tunnel at Snekkestad.

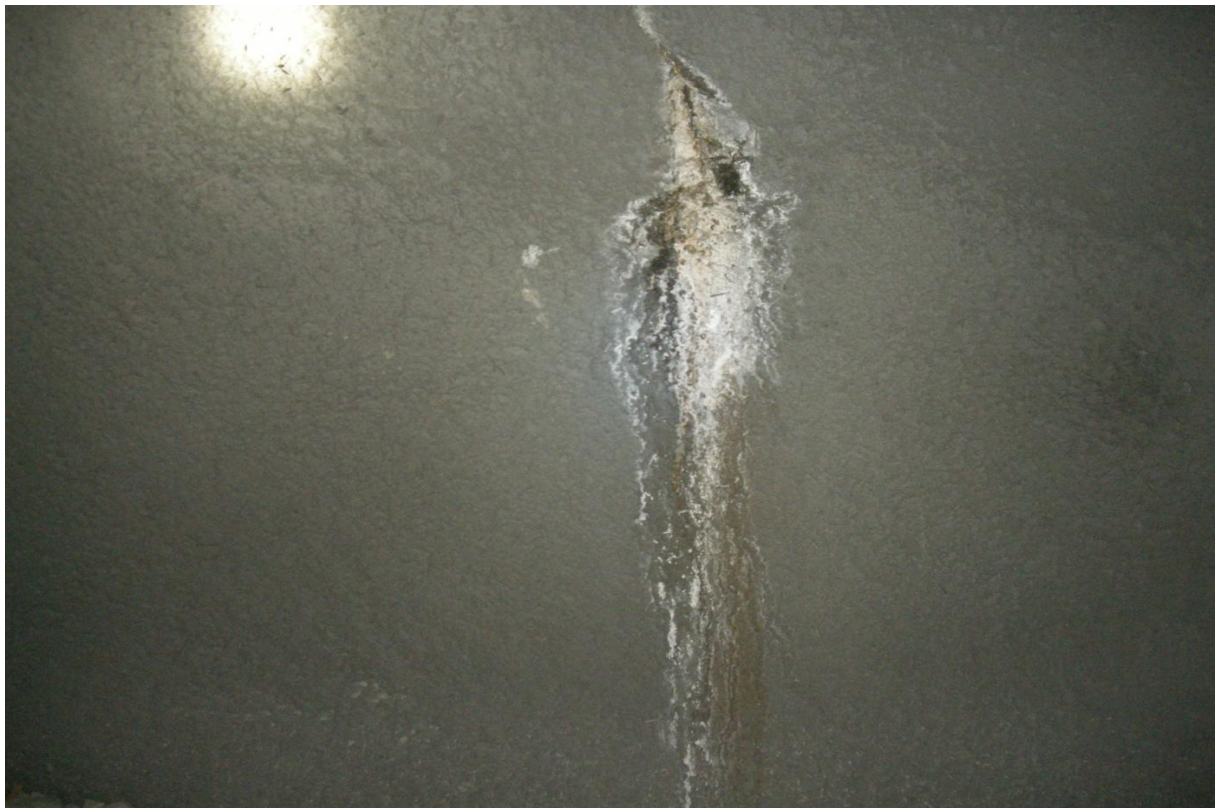
Figure 74. Photograph of a seepage point on the surface of the outer layer of the shotcrete in the Gevingåsen tunnel, at 26.01.12.
