Distributed Sacrificial Cathodic Protection

A New Cost Effective Solution to Prevent
Corrosion on Subsea Structures

Geir Quale

**MASTER THESIS SPRING 2016
FOR
STUD. TECHN. GEIR QUALE**

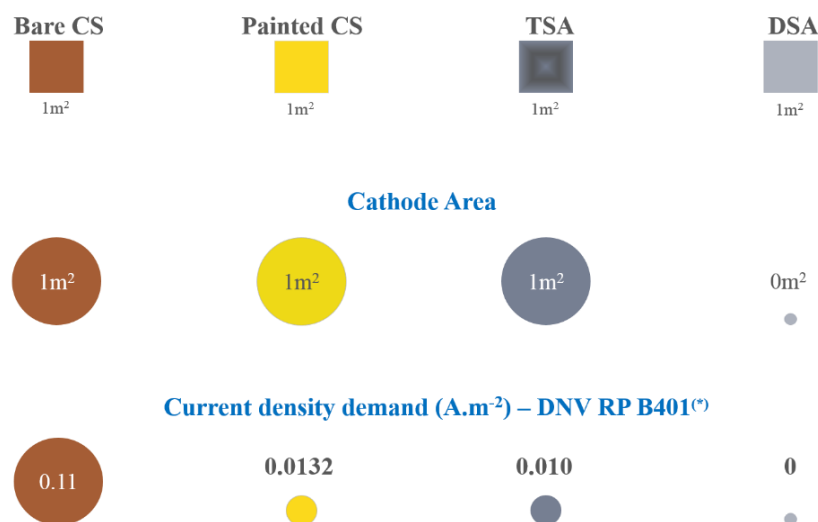
Figure 1 Current density demand for bare carbon steel (CS), painted CS with coating damage and TSA according to DNV [7], in addition to theoretical behavior of DSA connected to conventional sacrificial anodes [8].

In GE's calculations, CP for coating damages are achieved by conventional anodes alone and not from the coating itself. This means that even larger weight- and cost savings can be possible if the DSA surfaces are included in the calculations. As TSA has proven adequate for tension legs and risers under splash zone environments, DSA should theoretically be superior due to its low corrosion potential providing effective polarization to defects at a higher degree than TSA. Figure 1, illustrates the main benefits (theoretically) by applying DSA compared to other CP strategies.

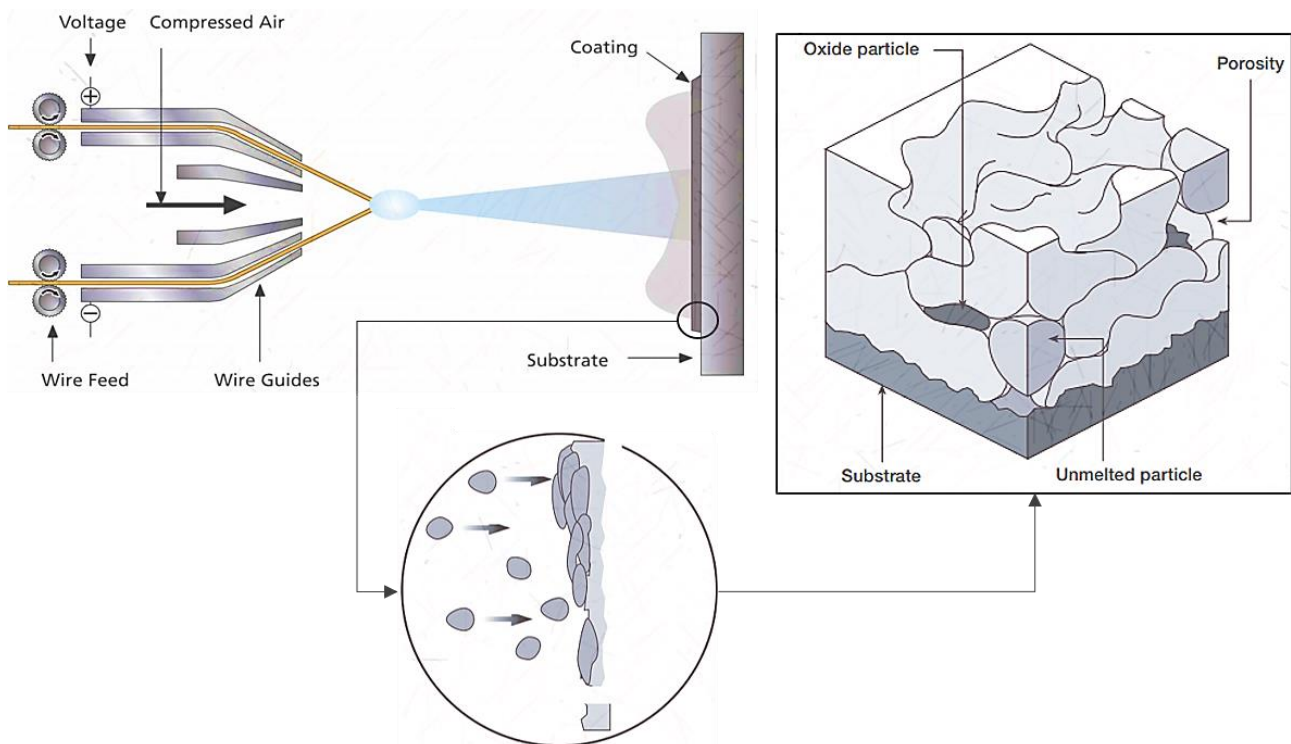
Figure 2 Principle of thermal spraying [13].

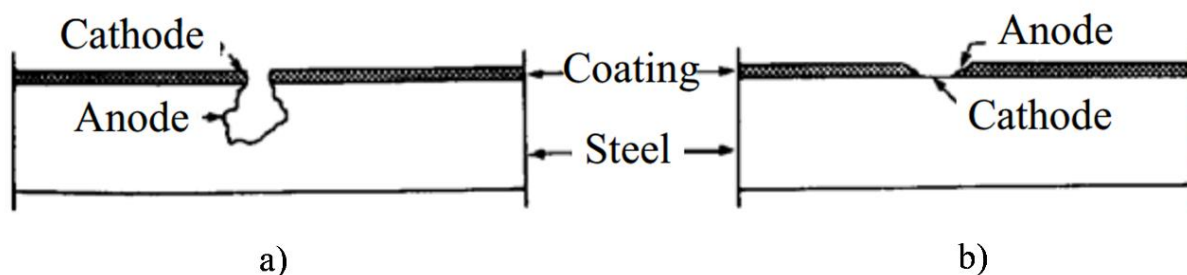
Figure 3 Localization of corrosion at a defect in a metal coating on steel, a) cathodic coating, b) anodic coating [17].

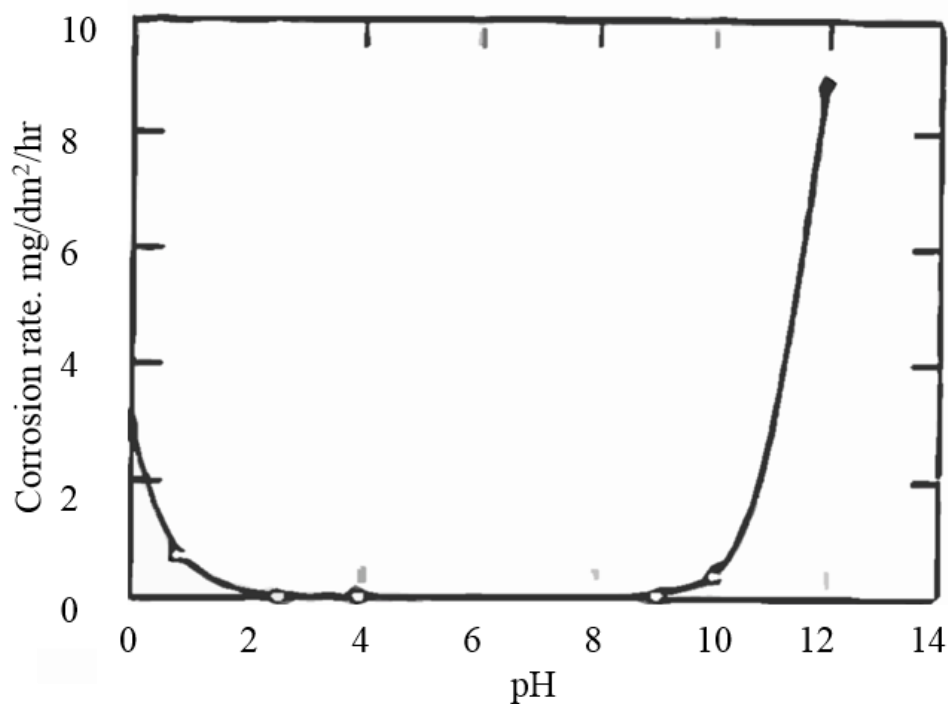
Figure 5 The corrosion rate as a function of pH [19].

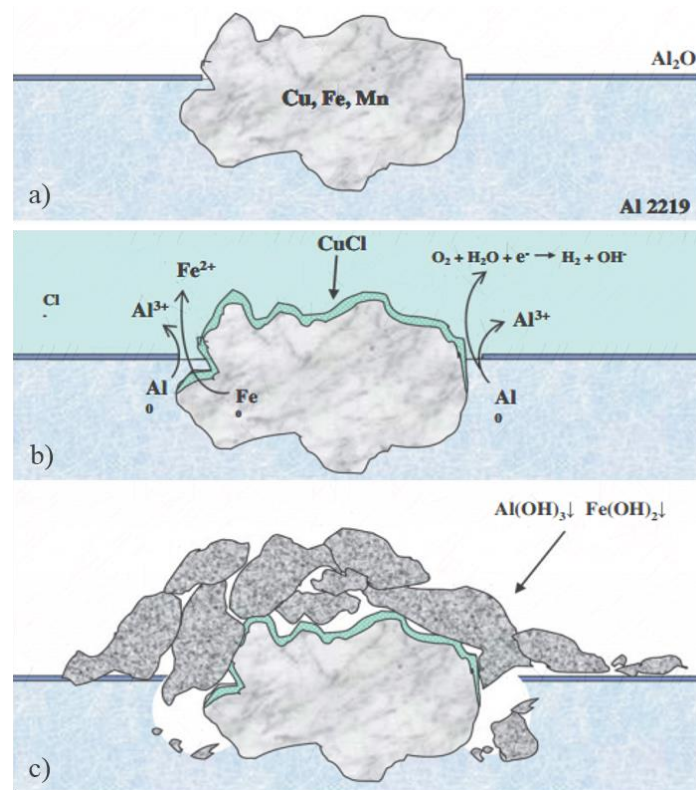
Figure 6 Illustration of (a) an intermetallic particle covered by an oxide layer, (b) corrosion process when immersed in seawater and (c) corrosion deposits after long exposure time [28].

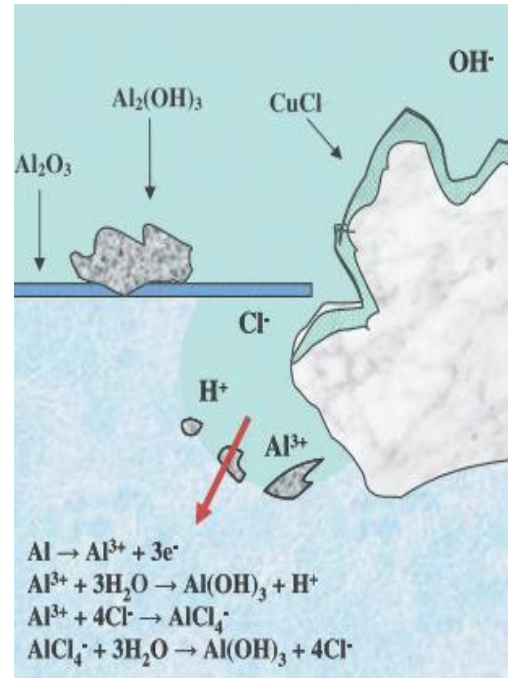
Figure 7 Reactions to maintain equilibrium inside the pit [27].

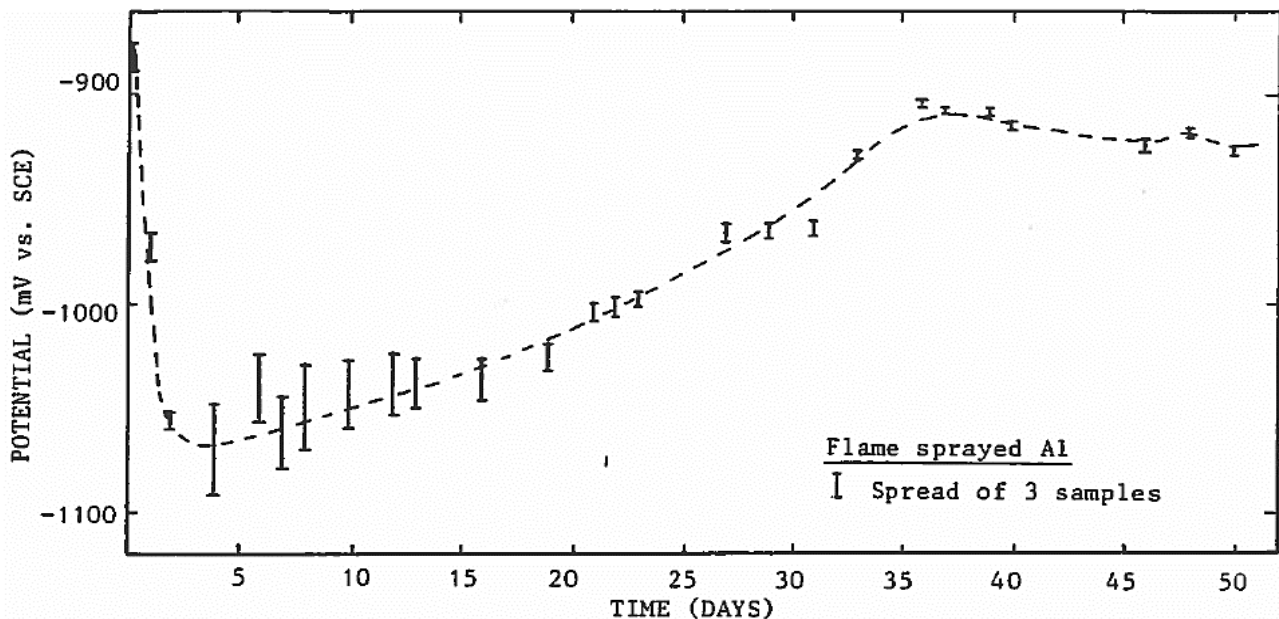
Figure 8 Corrosion potential of flame sprayed aluminum over time [19].

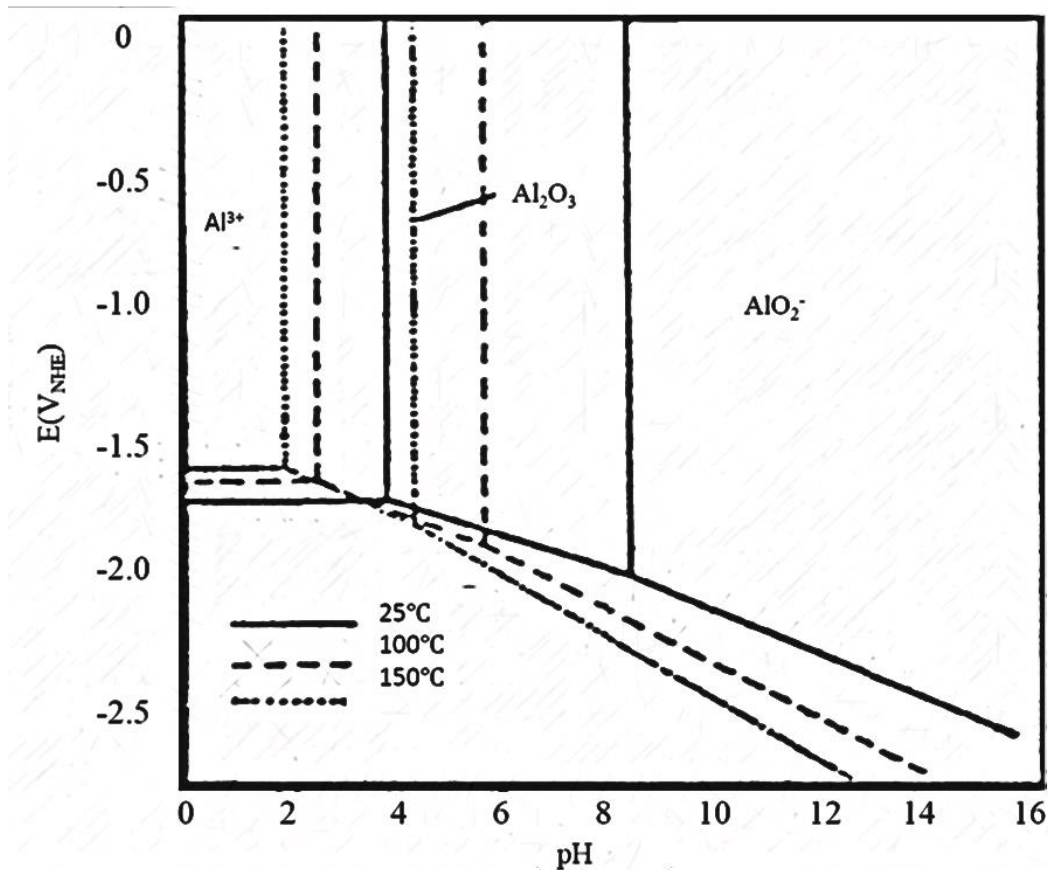
**Figure 9** Effect of temperature on the passivity of aluminum in water [22]

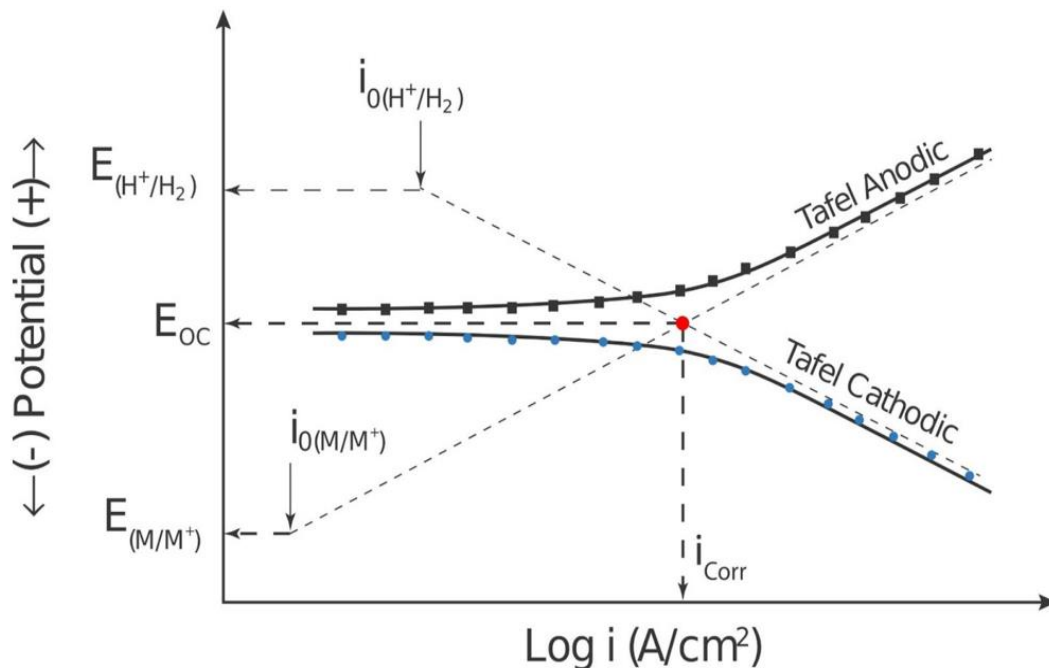
Figure 10 Polarization curves and Overvoltage Curves (Tafel lines) [34].

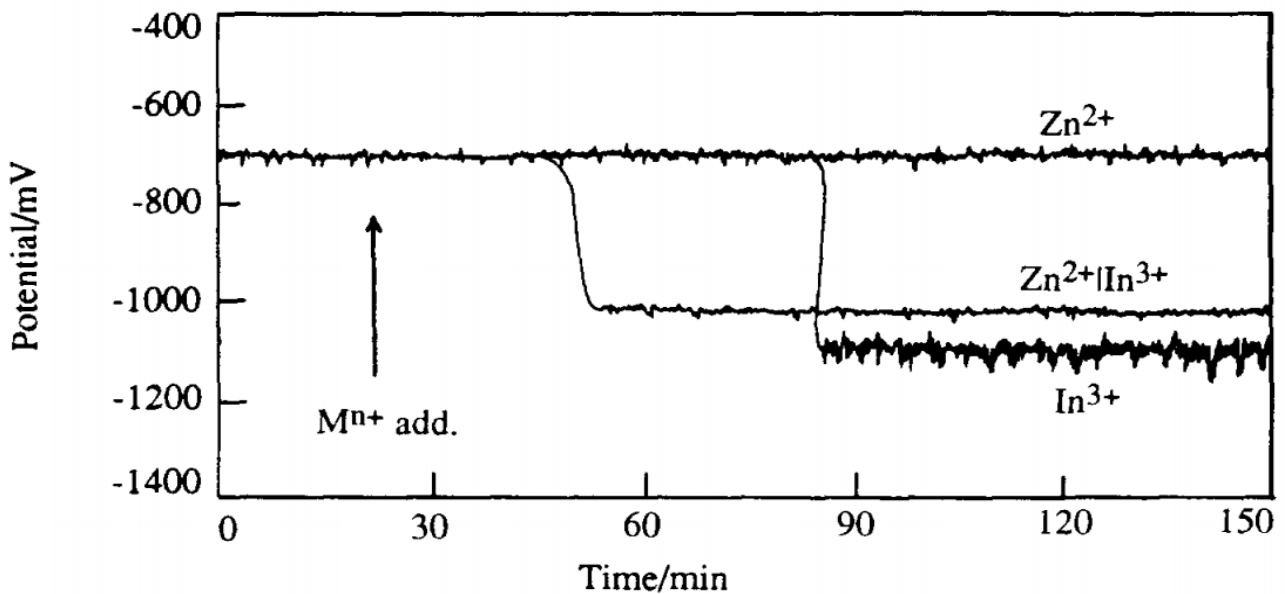
Figure 13 Open circuit potential-time plot for pure aluminum recorded in 0.5M NaCl solution on addition of 0.01 M $ZnSO_4$; 0.005 M $In_2(SO_4)_3$; 0.005 M $ZnSO_4$ and 0.0025 M $In_2(SO_4)_3$ solution following a 25-min immersion period. The time of activator addition is shown by the arrow. A more effective attack occurs when addition of Zn, destabilizes the oxide film [39].

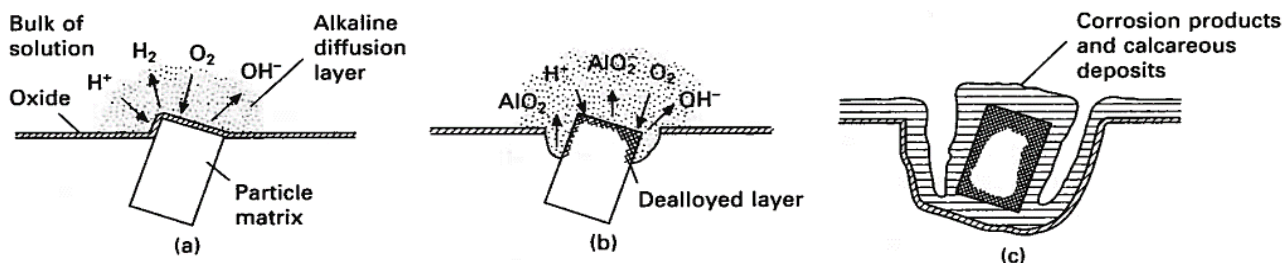
Figure 14 Schematic description of the mechanism of cathodic protection of aluminum alloys in seawater. (a) Development of alkaline diffusion layer. (b) Pitting corrosion around the intermetallic particles and (c) repassivation of the surface [23].

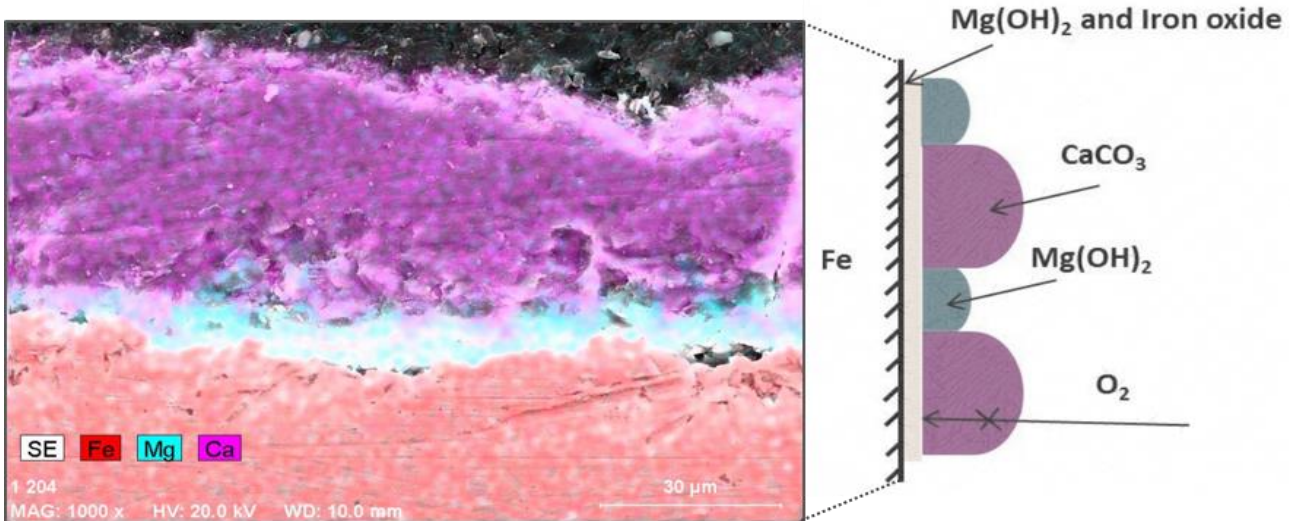
Figure 15 SEM micrograph and corresponding EDX element distribution maps for Mg and Ca, cross-section of calcareous, showing a thin film of $Mg(OH)_2$ deposits between $CaCO_3$ [49].

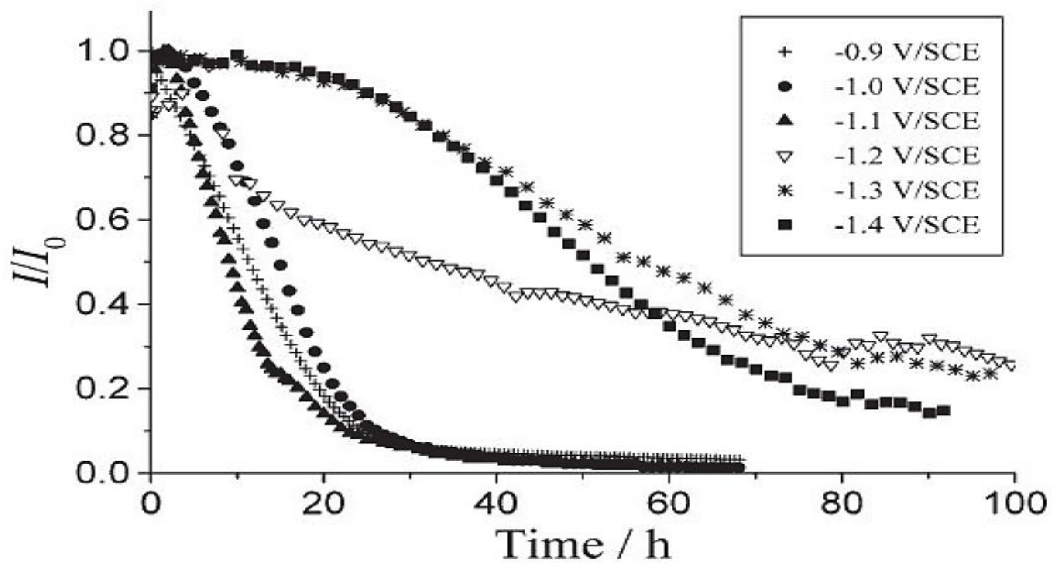
Figure 16 The effect of potential on the deposition at 600 rpm on a steel surface in artificial seawater. The steep curve represents $CaCO_3$ deposition while at -1.2 VS SCE the curve has an initial stage before decreasing which represents $Mg(OH)_2$ [44].

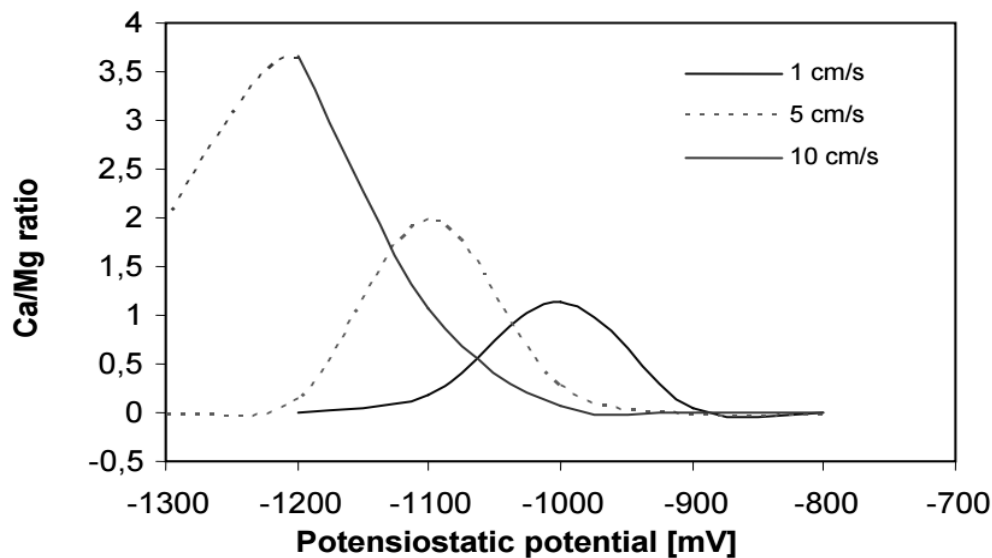
Figure 17 Ca/Mg ratio for calcareous deposit as a function of applied potential and flow rate [48].

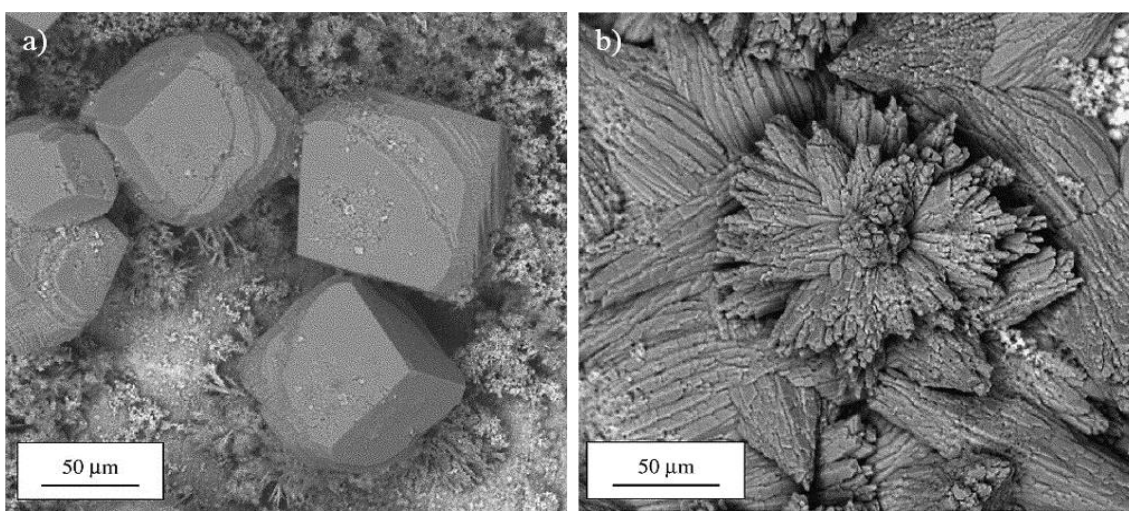
Figure 18 Calcareous deposit on steel surface: a) calcite precipitates formed during immersion for 21 days in a Mg^{2+} -free solution and b) aragonite deposits during 21 days in a Mg^{2+} -containing solution [53].

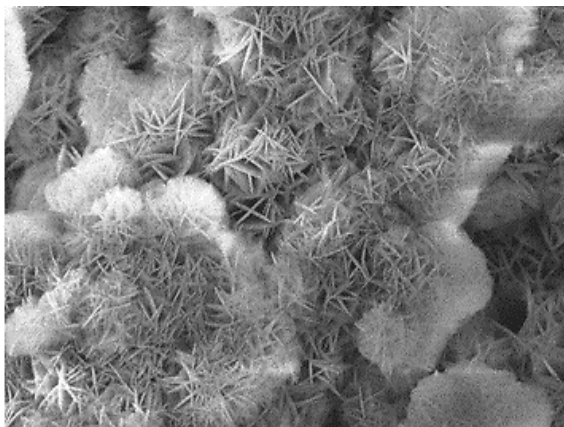
Figure 19 Precipitation of brucite on steel surface in natural seawater at 25°C, galvanostatic polarization at 200 mA/m² over a period of 168 hours [52].

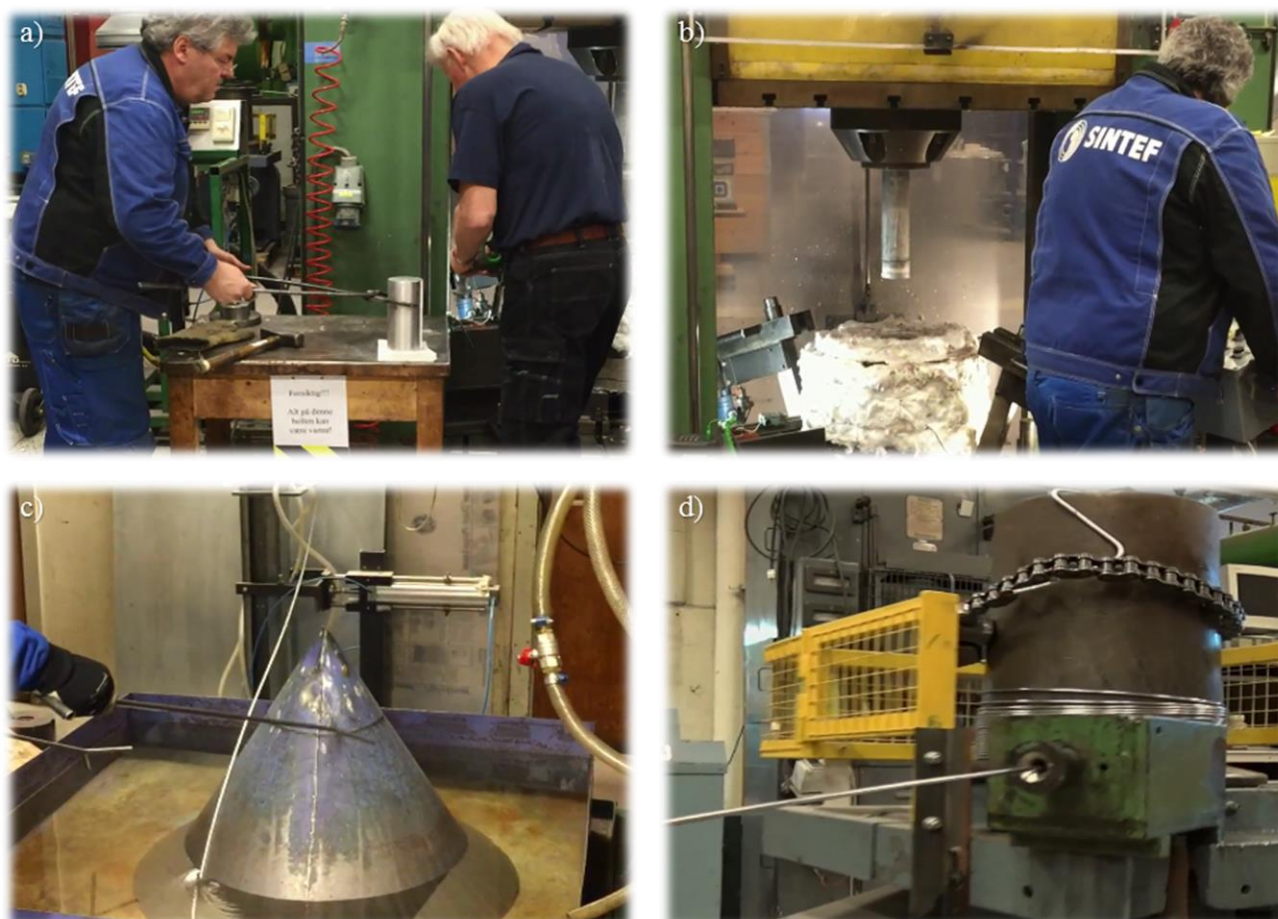
Figure 20 Illustration of the extrusion process: a) An ingot of re-melted traditional flush-mount anode with $\text{\O}100$ mm, b) The ingot is hot pressed through an orifice forming wire-die with $\text{\O}5$ mm. c) The hot pressed wire is produced and cooled and d) The wire is subsequently reduced to $\text{\O}2$ mm for thermal spraying.

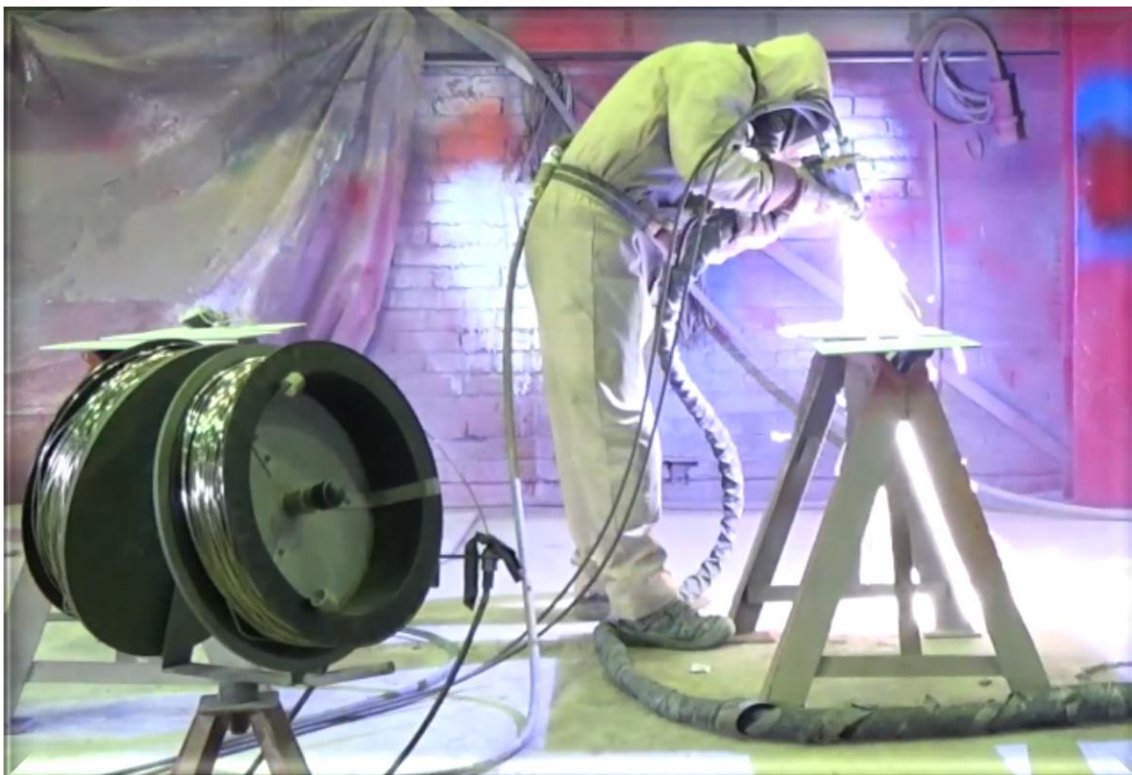
Figure 21 Coatings applied using electric arc spray.

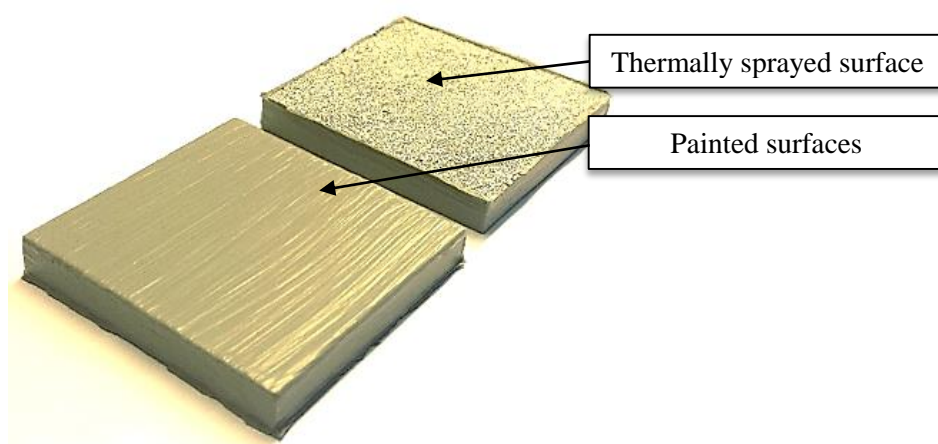
Figure 22 Thermally sprayed carbon steel specimen with area 50 × 50 mm, coated with Jotun Jostamastic 87 std 038 to ensure that only the DSA or TSA surface were exposed.

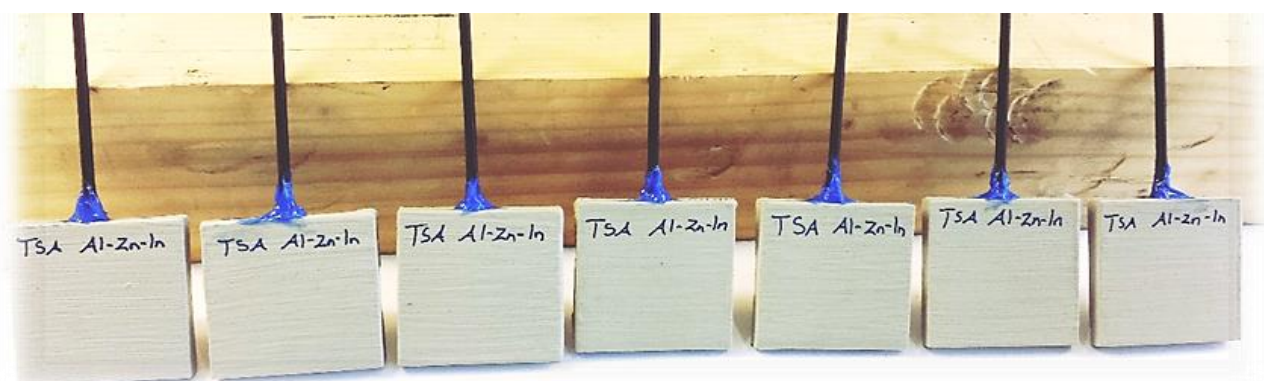
Figure 23 DSA specimens connected to a 3 mm insulated threaded rod, ready for exposure (the painted sides of the specimens are shown). Notice that the specimens are called TSA Al-Zn-In. This was before it was decided to name the new coating system for DSA.

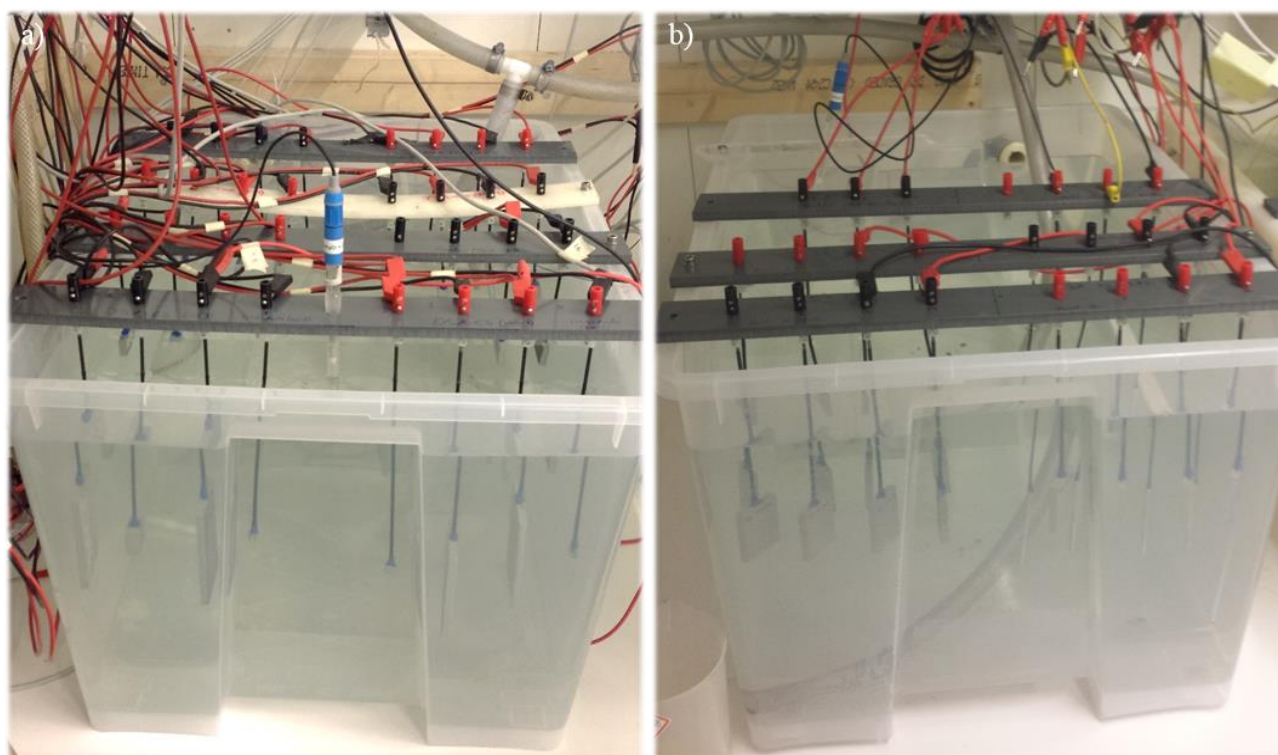
Figure 24 Experimental setup a) galvanic couplings and b) freely exposed specimens

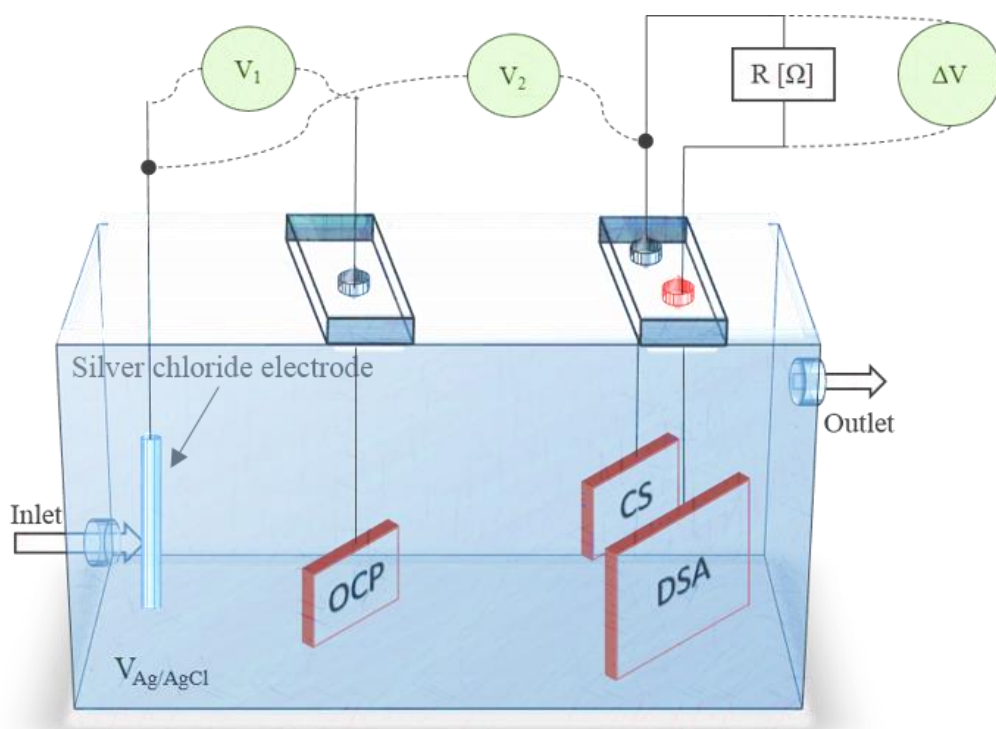
Figure 25 Simplified illustration of the setup showing the OCP - and coupling potential measurement (V_1 and V_2) with respect to an Ag/AgCl reference electrode. In addition, the potential drop over the couplings is measured to determine the current density.

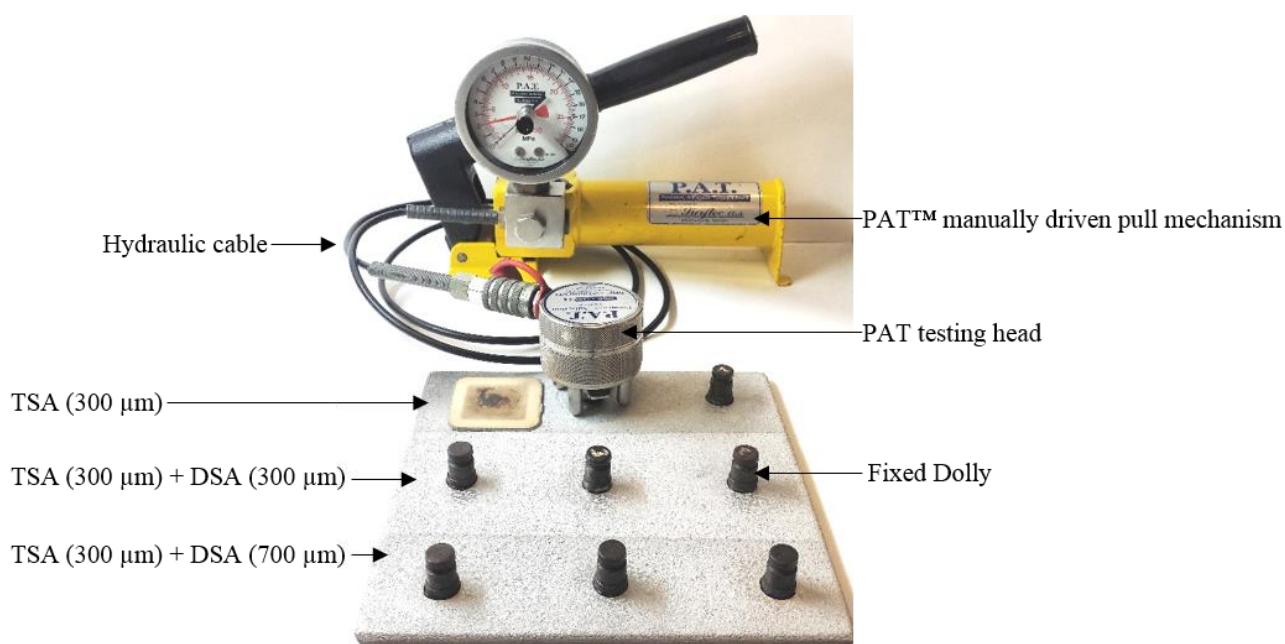
Figure 26 The adhesion pull-off setup used for this experiment.

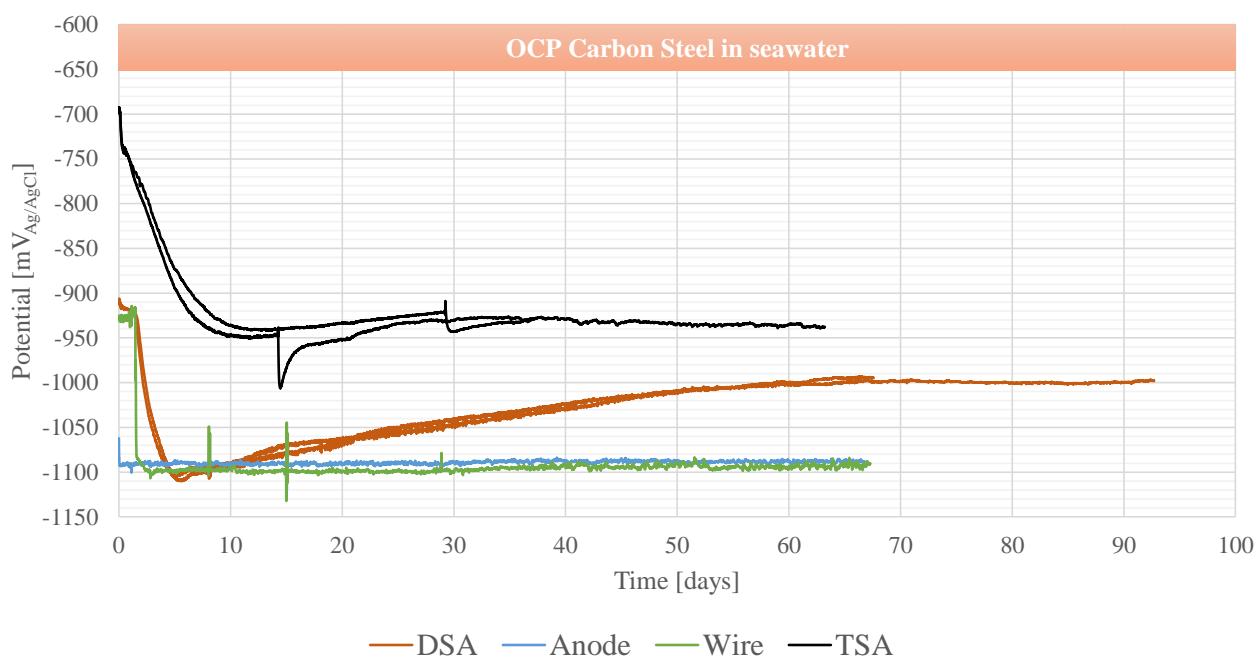
Figure 27 Open-Circuit potential development for DSA- and TSA coated steel specimens, and conventional Al-Zn-In anode alloy and a corresponding extruded wire specimen exposed to natural seawater at $10\pm 2^\circ\text{C}$. The OCP for carbon steel in seawater is also marked.

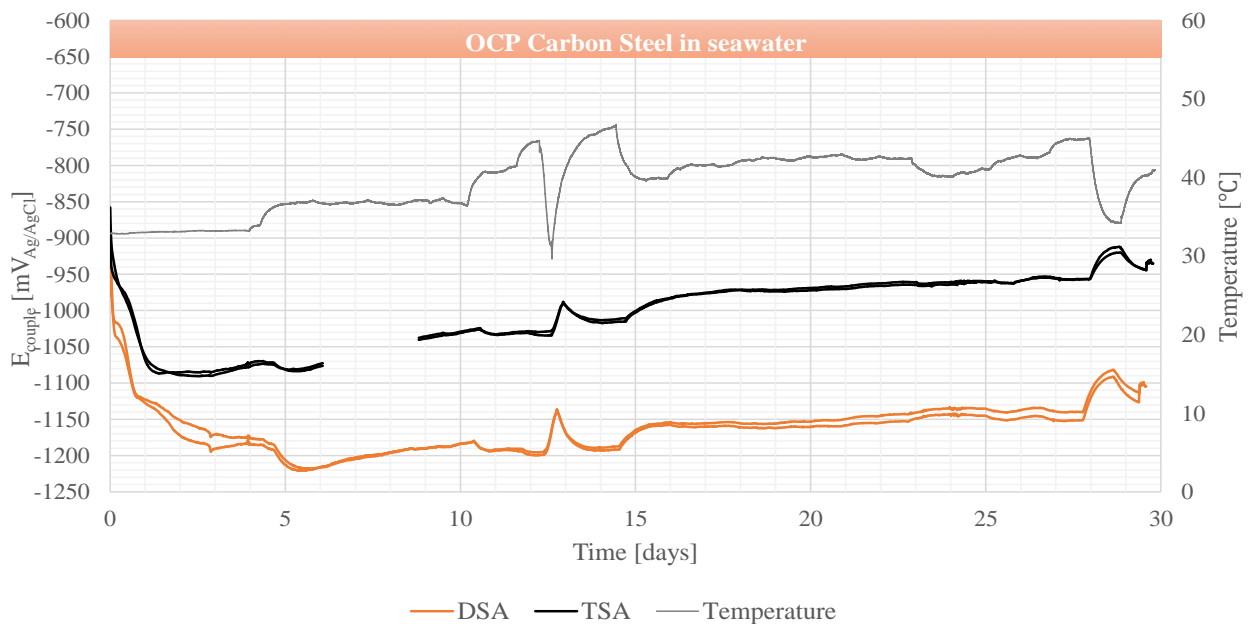
Figure 28 Open-Circuit potential development for DSA and TSA coated steel specimens exposed to natural seawater at $40 \pm 5^\circ\text{C}$. The OCP for carbon steel in seawater is also marked.

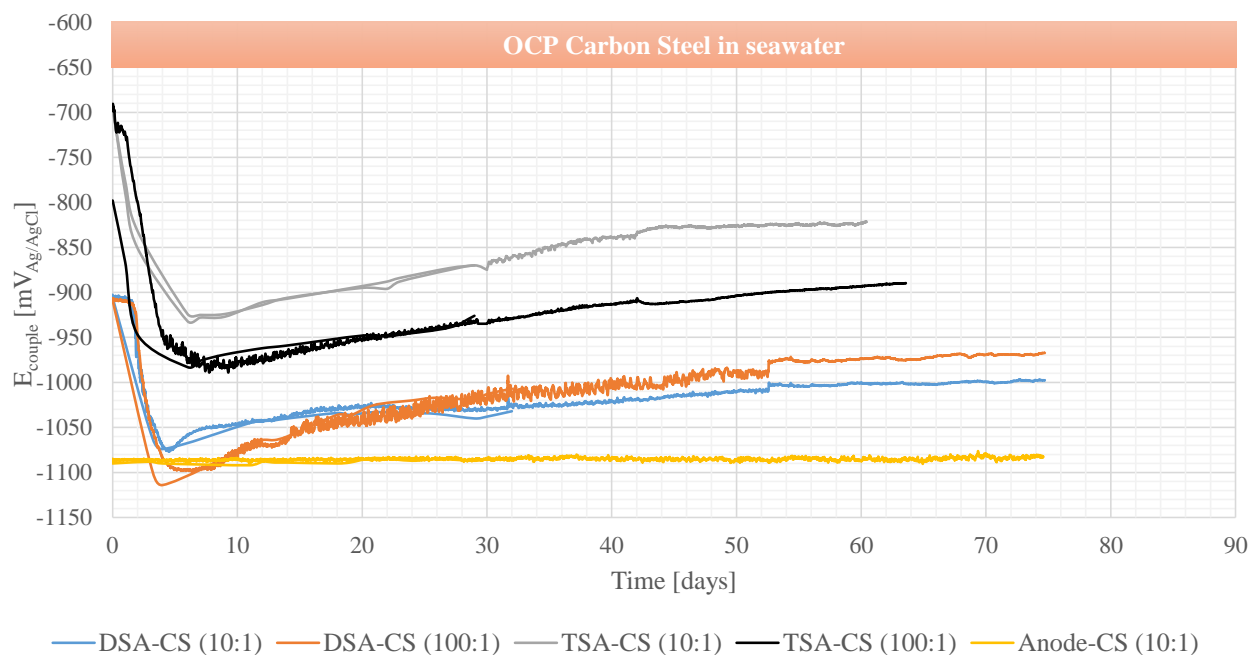
Figure 29 Couplings potential development for different couplings with area ratio 10:1 and 100:1, exposed to natural seawater at $10 \pm 2^\circ\text{C}$ under nearly stagnant conditions. The OCP for carbon steel in seawater is also marked.

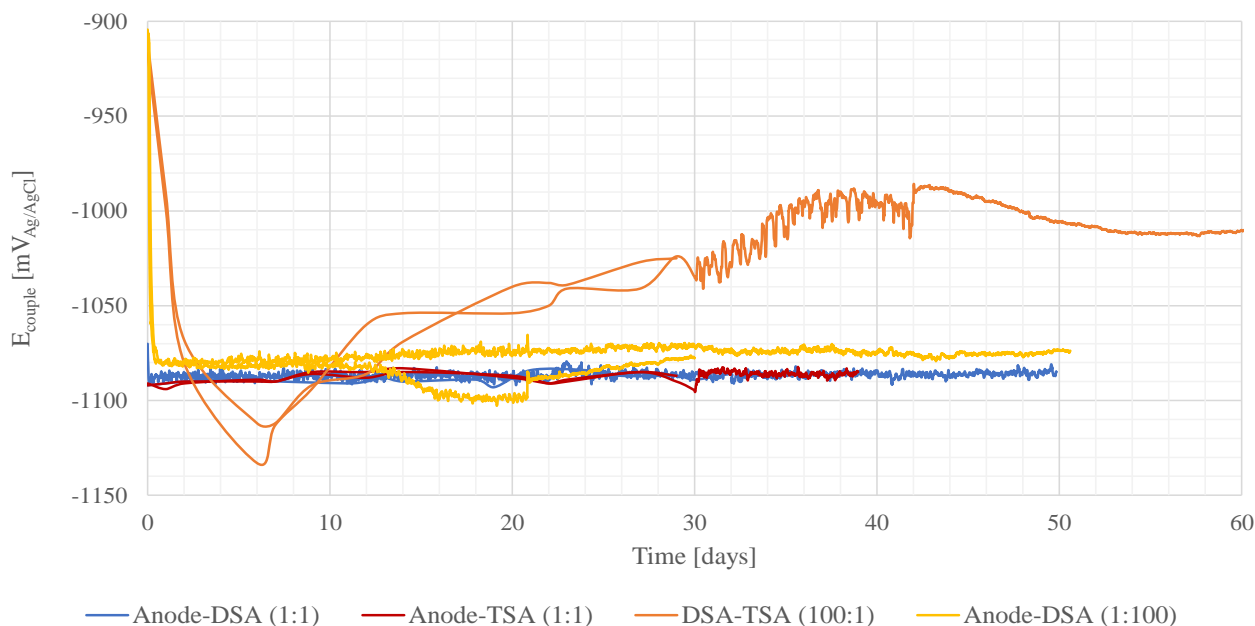
Figure 30 Couplings potential development for different couplings with area ratio 1:1 and 100:1, exposed to natural seawater at $10\pm 2^\circ\text{C}$ under nearly stagnant conditions.

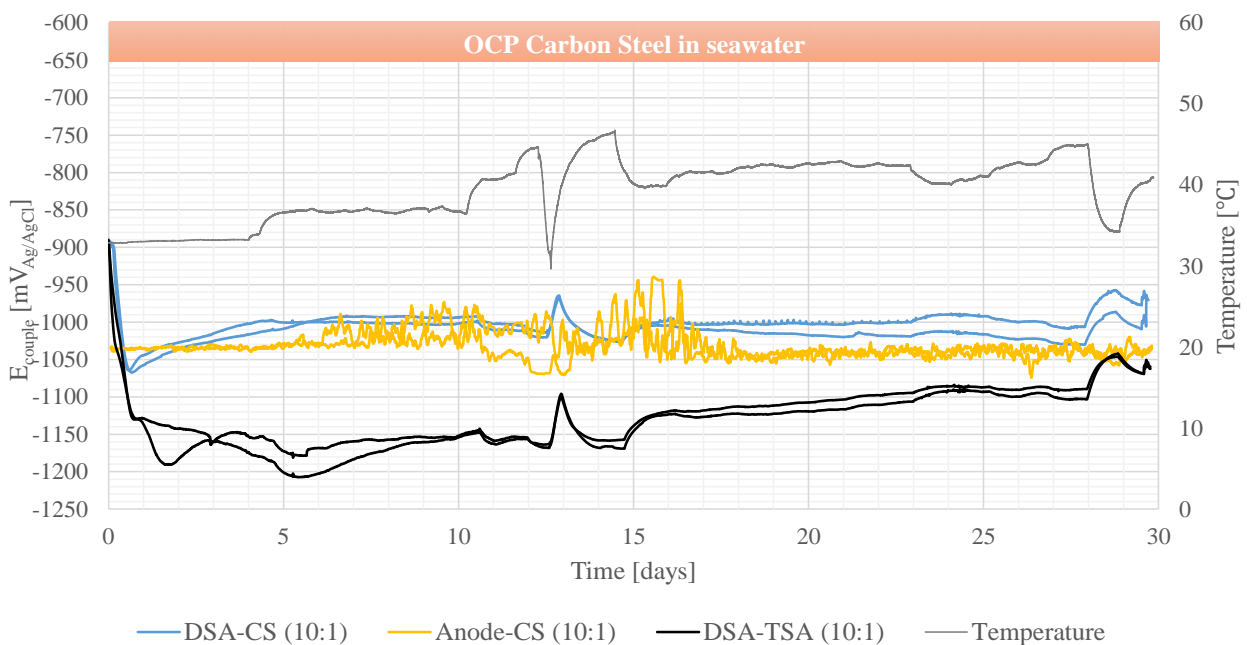
Figure 31 Couplings potential development for different couplings with area ratio 10:1, exposed to natural seawater at $40 \pm 5^\circ\text{C}$ under nearly stagnant conditions. The OCP for carbon steel in seawater is also marked.

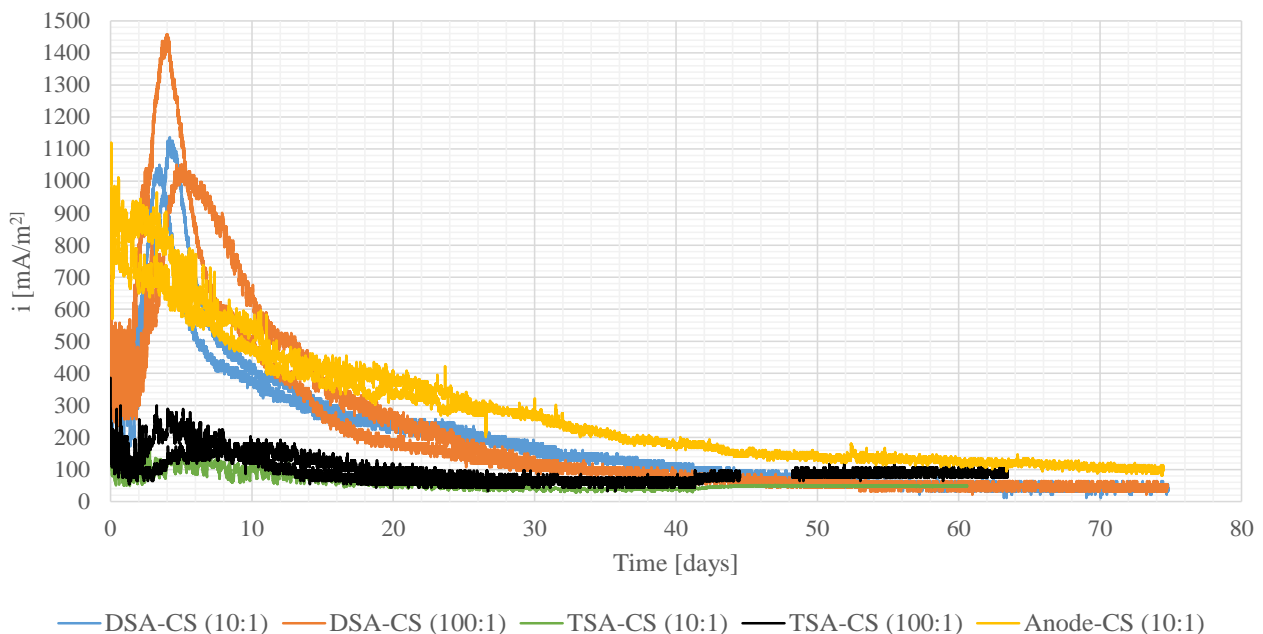
Figure 32 Current density development for CS in different couplings with area ratio 10:1 and 100:1, exposed to natural seawater at $10\pm 2^\circ\text{C}$ under nearly stagnant conditions.

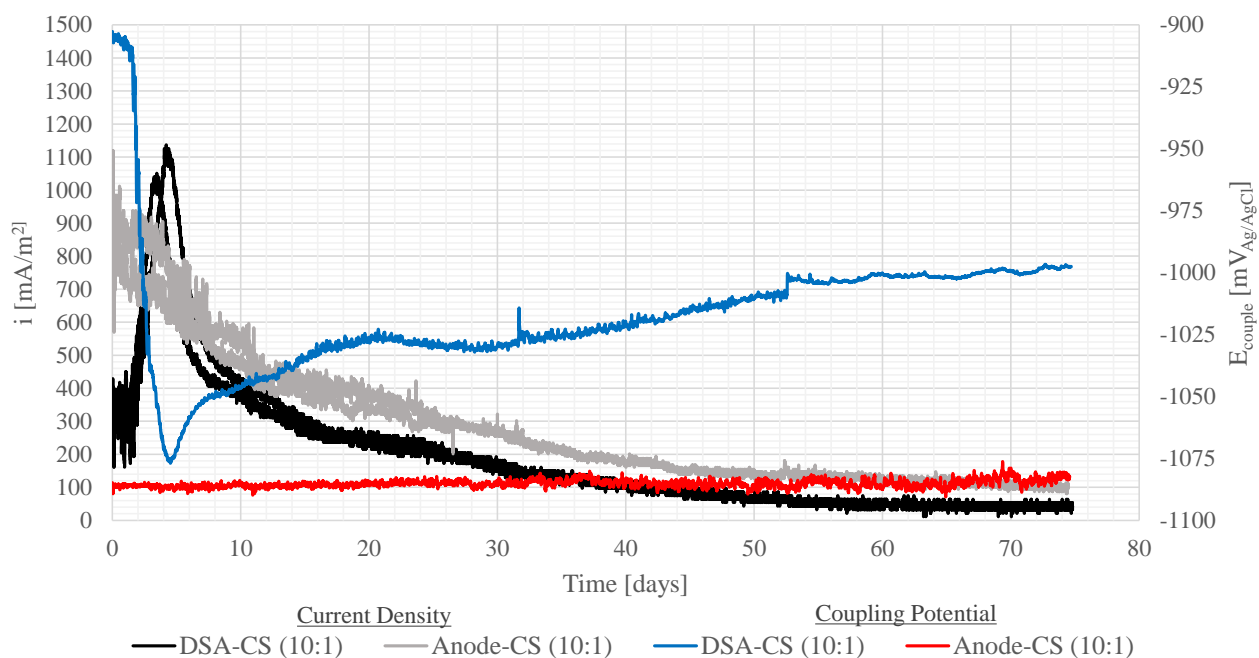
Figure 33 Coupling potential -and current density development on CS for DSA-CS (10:1) and Anode-CS (10:1), exposed to natural seawater at $10 \pm 2^\circ\text{C}$ under nearly stagnant conditions over a period 50 days.

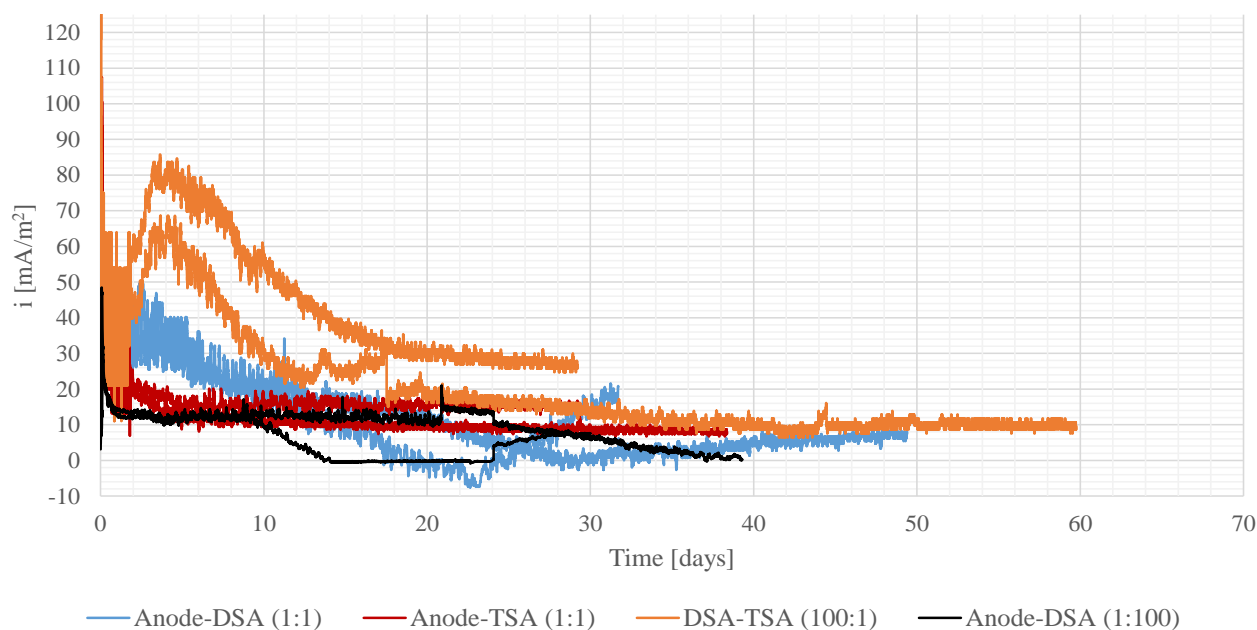
Figure 34 Current density development on DSA and TSA for different couplings with area ratio 1:1 and 100:1, exposed to natural seawater at $10\pm 2^\circ\text{C}$ under nearly stagnant conditions.
