Distributed Sacrificial Cathodic Protection

A New Cost Effective Solution to Prevent
Corrosion on Subsea Structures

Geir Quale

**MASTER THESIS SPRING 2016
FOR
STUD. TECHN. GEIR QUALE**

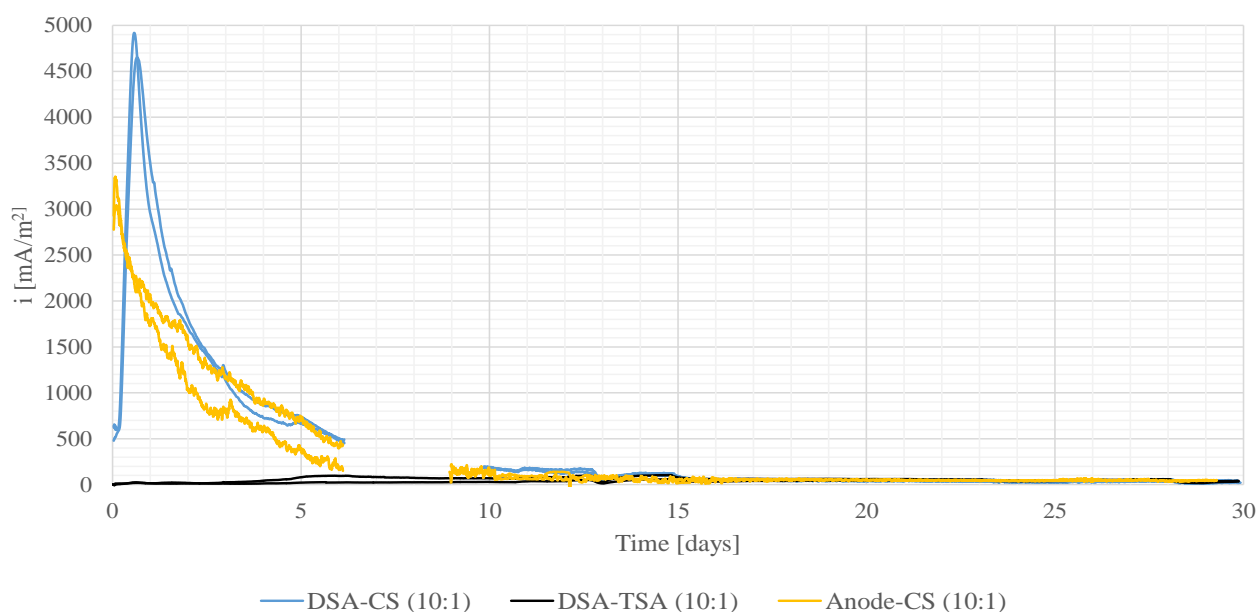
Figure 35 Current density development on CS and TSA for different couplings with area ratio 10:1, exposed to natural seawater at 40°C .

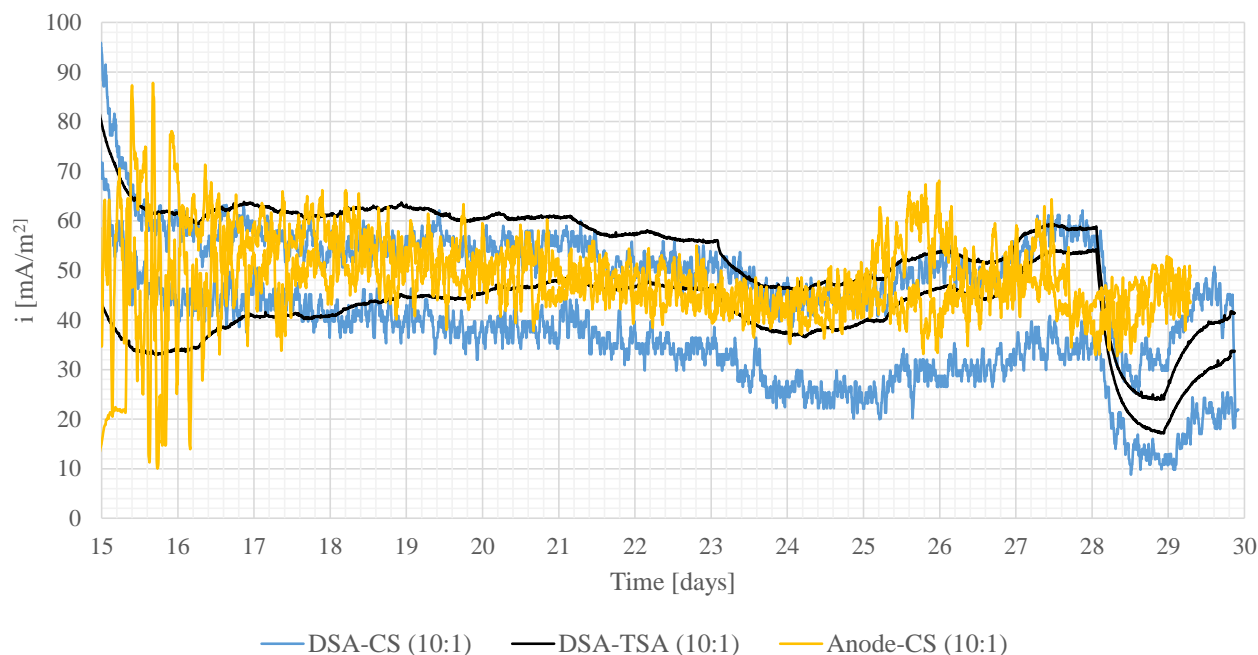
Figure 36 Current density development on CS and TSA for the last 15 days of exposure for couplings with area ratio 10:1 exposed to natural seawater at $40\pm 5^\circ\text{C}$.

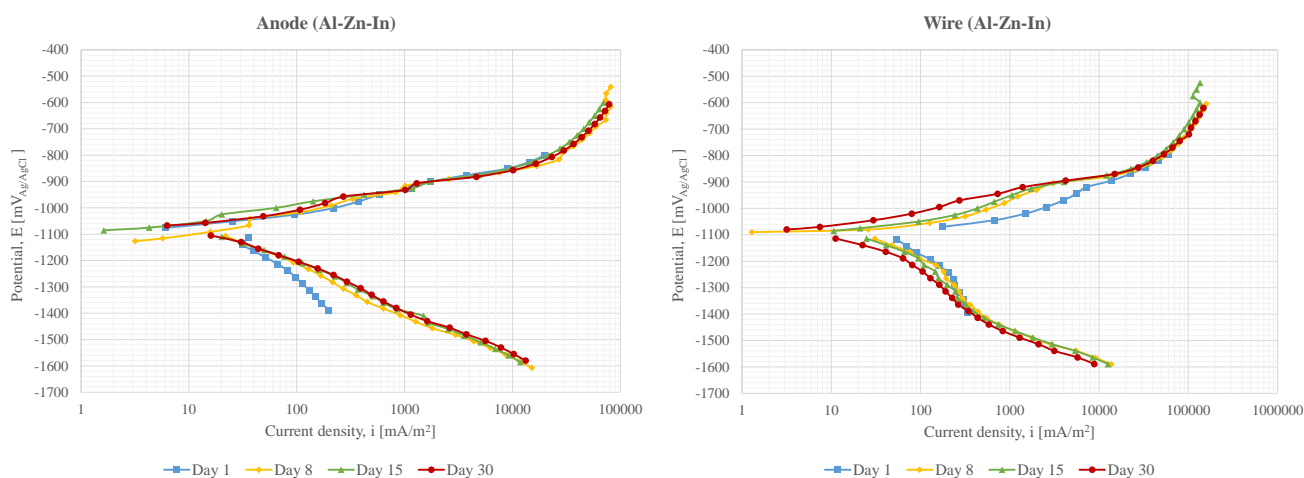
Figure 37 Polarization Curves for traditional sacrificial aluminum anode and the corresponding extruded wire, obtained after 1, 8, 15 and 30 days of exposure to natural seawater at $10 \pm 2^\circ\text{C}$ under nearly stagnant conditions.

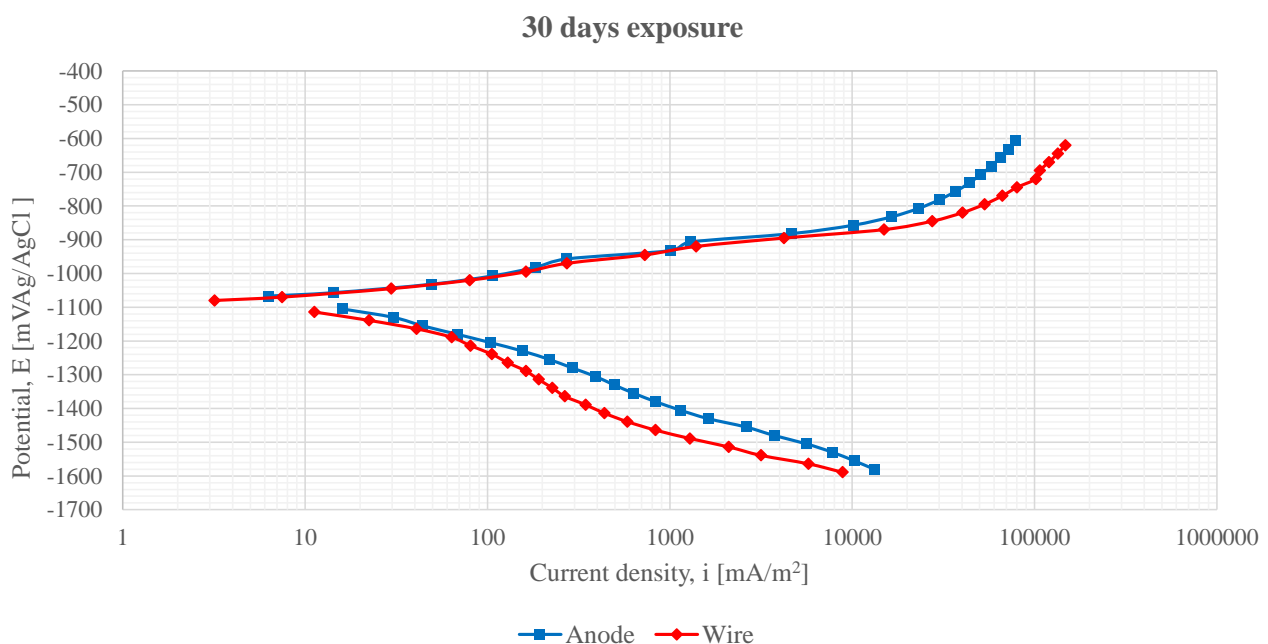
Figure 38 Polarization curves for conventional anode specimen and the corresponding extruded wire piece, obtained after 30 days exposure to natural seawater at $10 \pm 2^\circ\text{C}$ under nearly stagnant conditions.

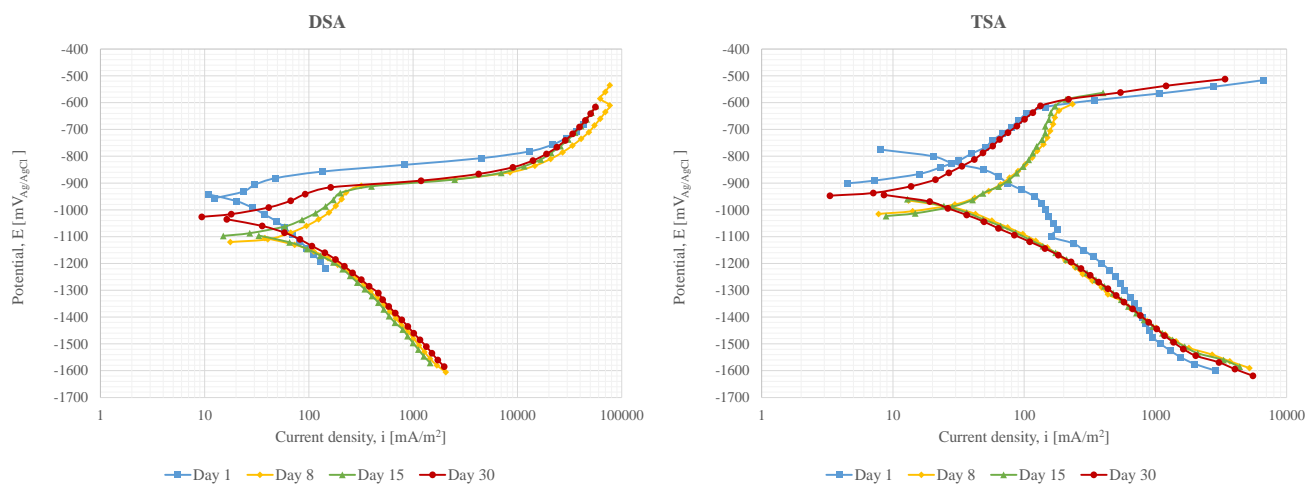
Figure 39 Polarization curves for DSA and TSA obtained after 1, 8, 15 and 30 days of exposure to natural seawater at $10 \pm 2^\circ\text{C}$ under nearly stagnant conditions.

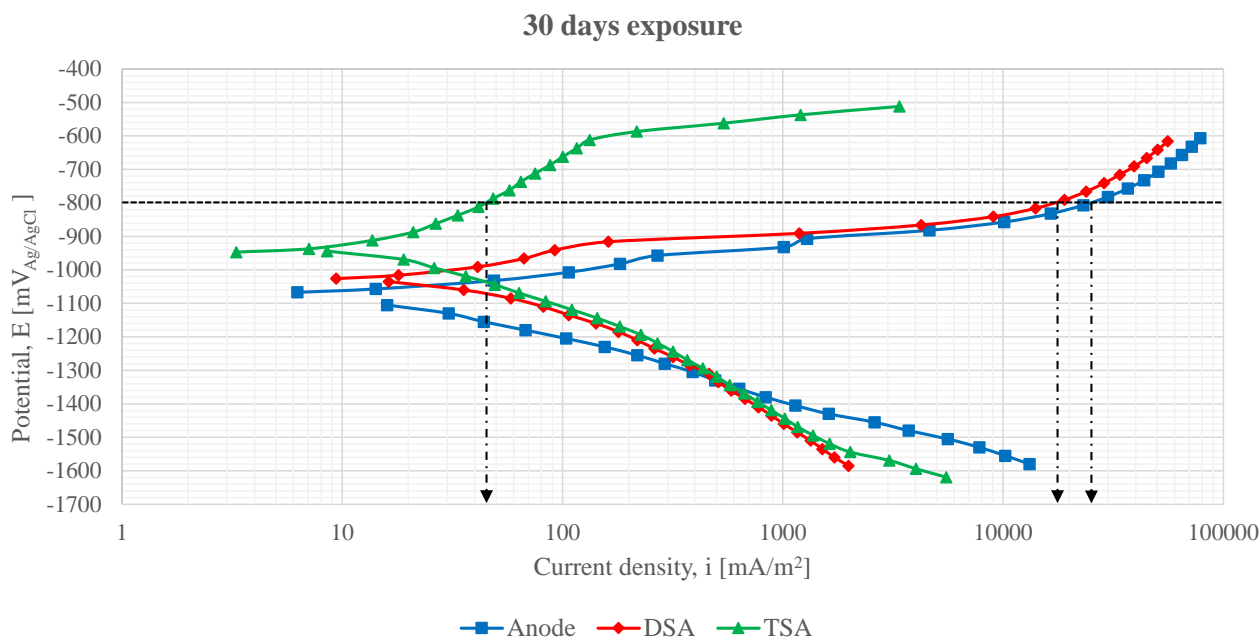
Figure 40 Polarization curves for Anode, DSA and TSA obtained after 30 days of exposure to natural seawater at $10 \pm 2^\circ\text{C}$ under nearly stagnant conditions.

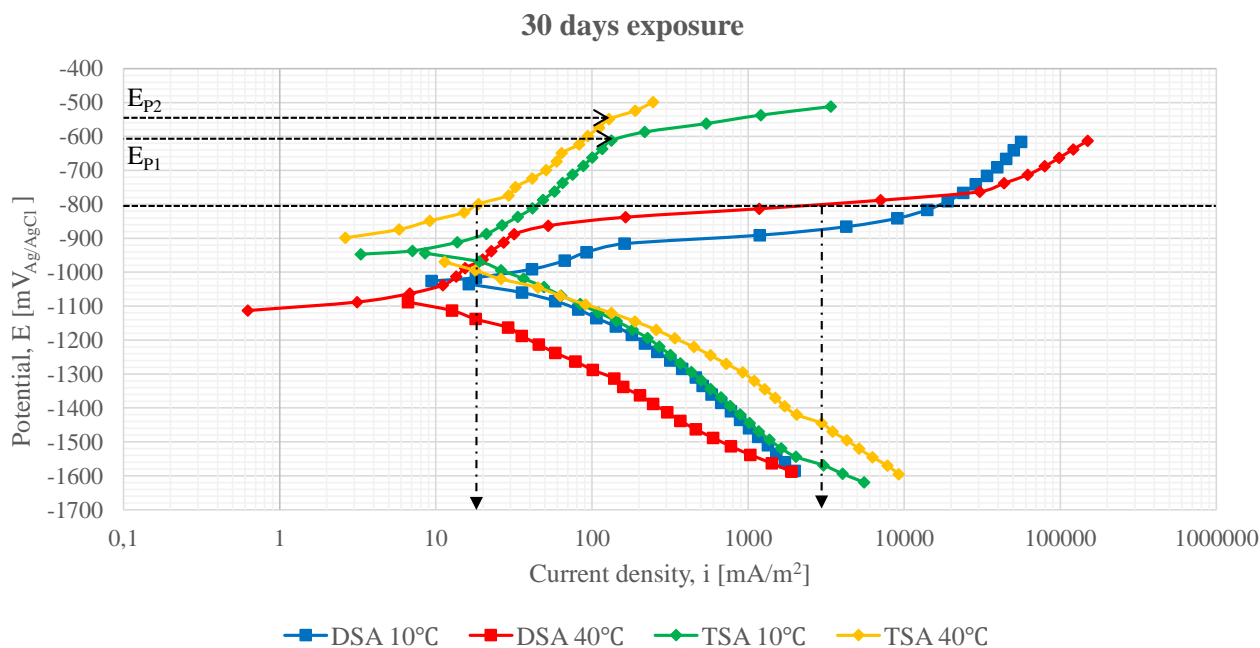
Figure 41 Polarization curves for DSA and TSA obtained after 30 days exposed to natural seawater at both 10 and 40°C, under nearly stagnate conditions.

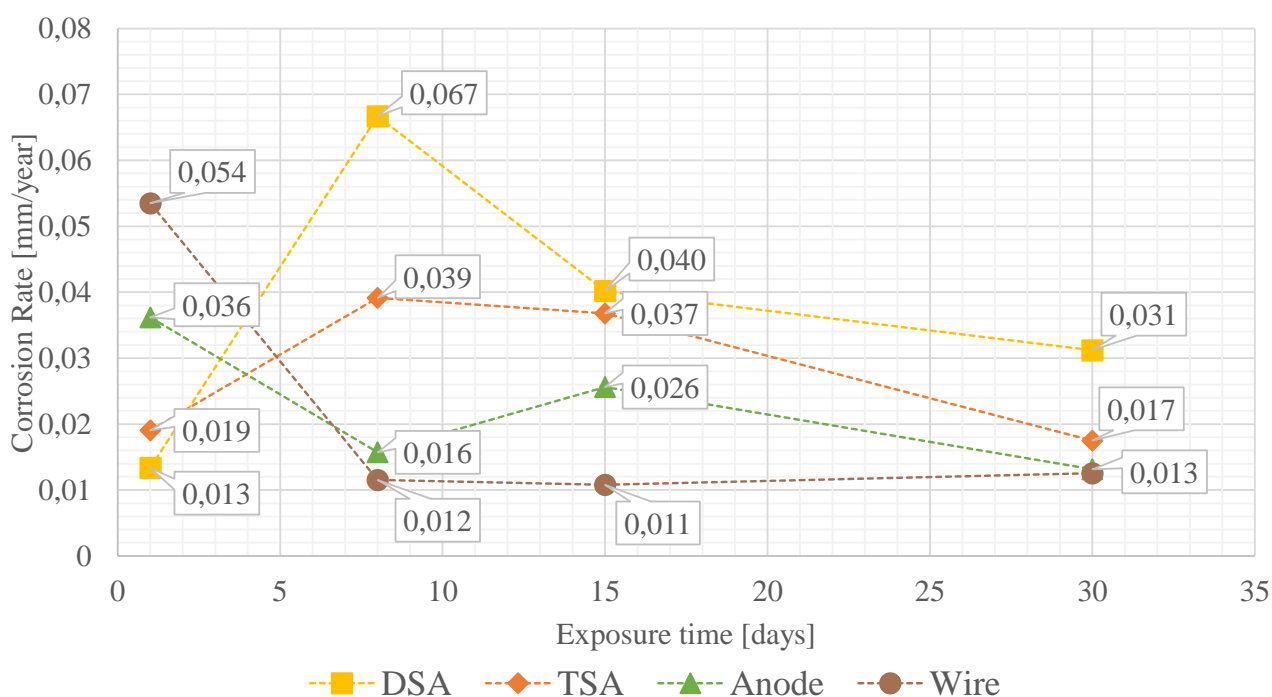
Figure 42 The corrosion rate development as a function of time, obtained from Tafel extrapolation of the polarization curves.

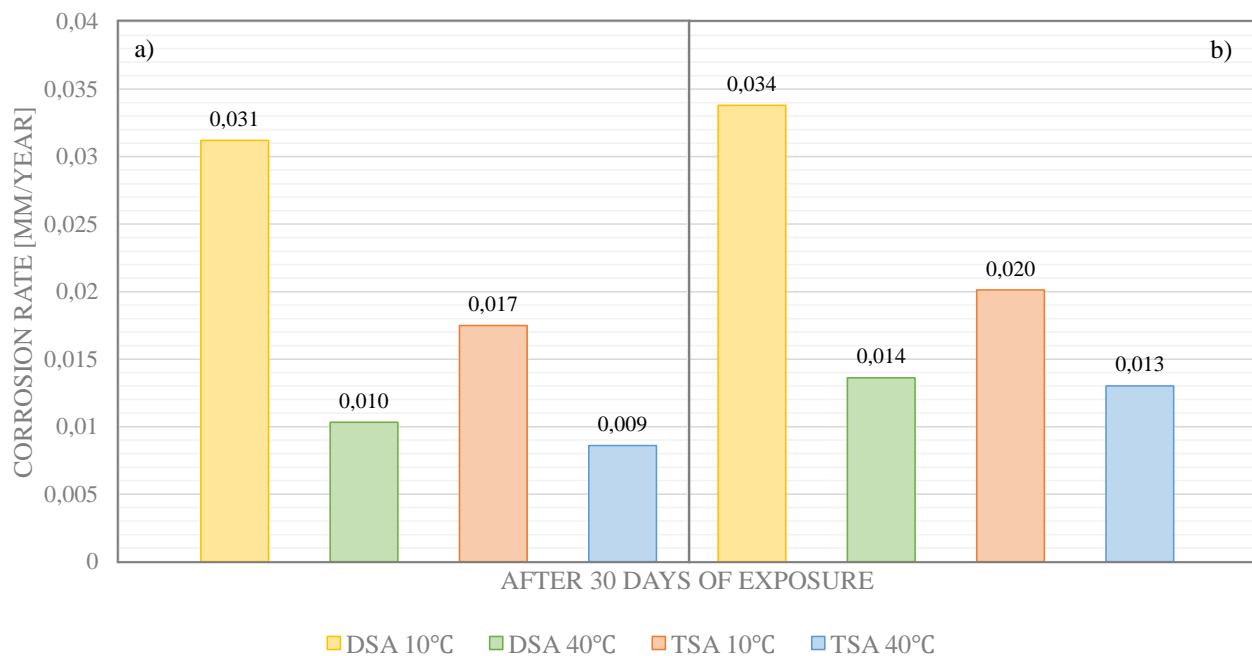
Figure 43 Corrosion rate of DSA and TSA after 30 days of exposure to natural seawater at both 10°C and 40°C, obtained from a) Tafel extrapolation and b) LRP measurements

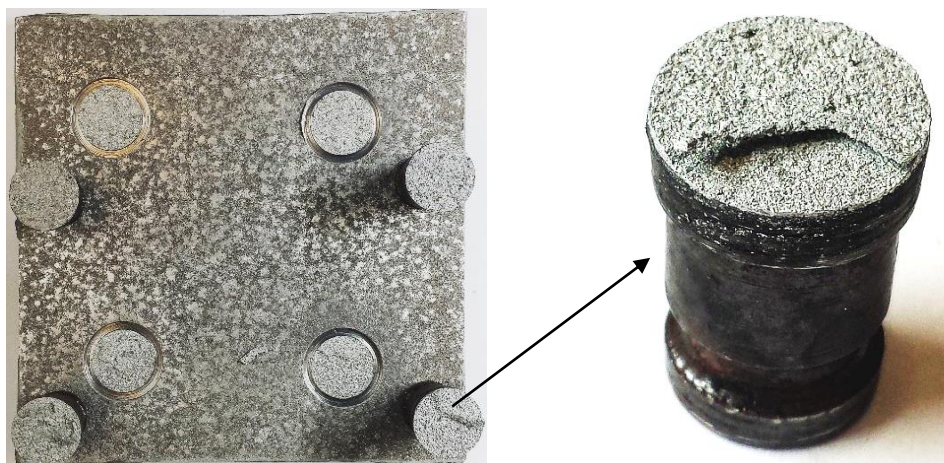
Figure 44 Pull-off test on DSA specimen with dimension 100 × 100 mm, Showing adhesive failure in the TSA-DSA interface, which have been coupled to CS for 30 days

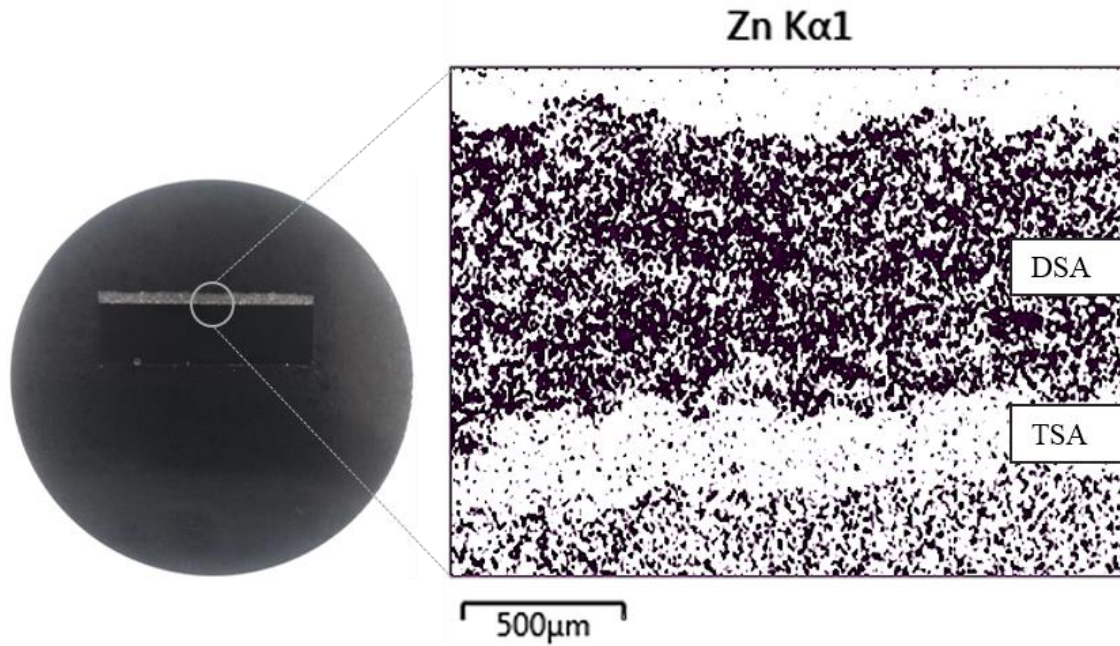
Figure 45 Embedded DSA piece polished to 1 μm with corresponding EDS (only Zn elements) showing the first and second thermally sprayed layer of TSA and DSA respectively.

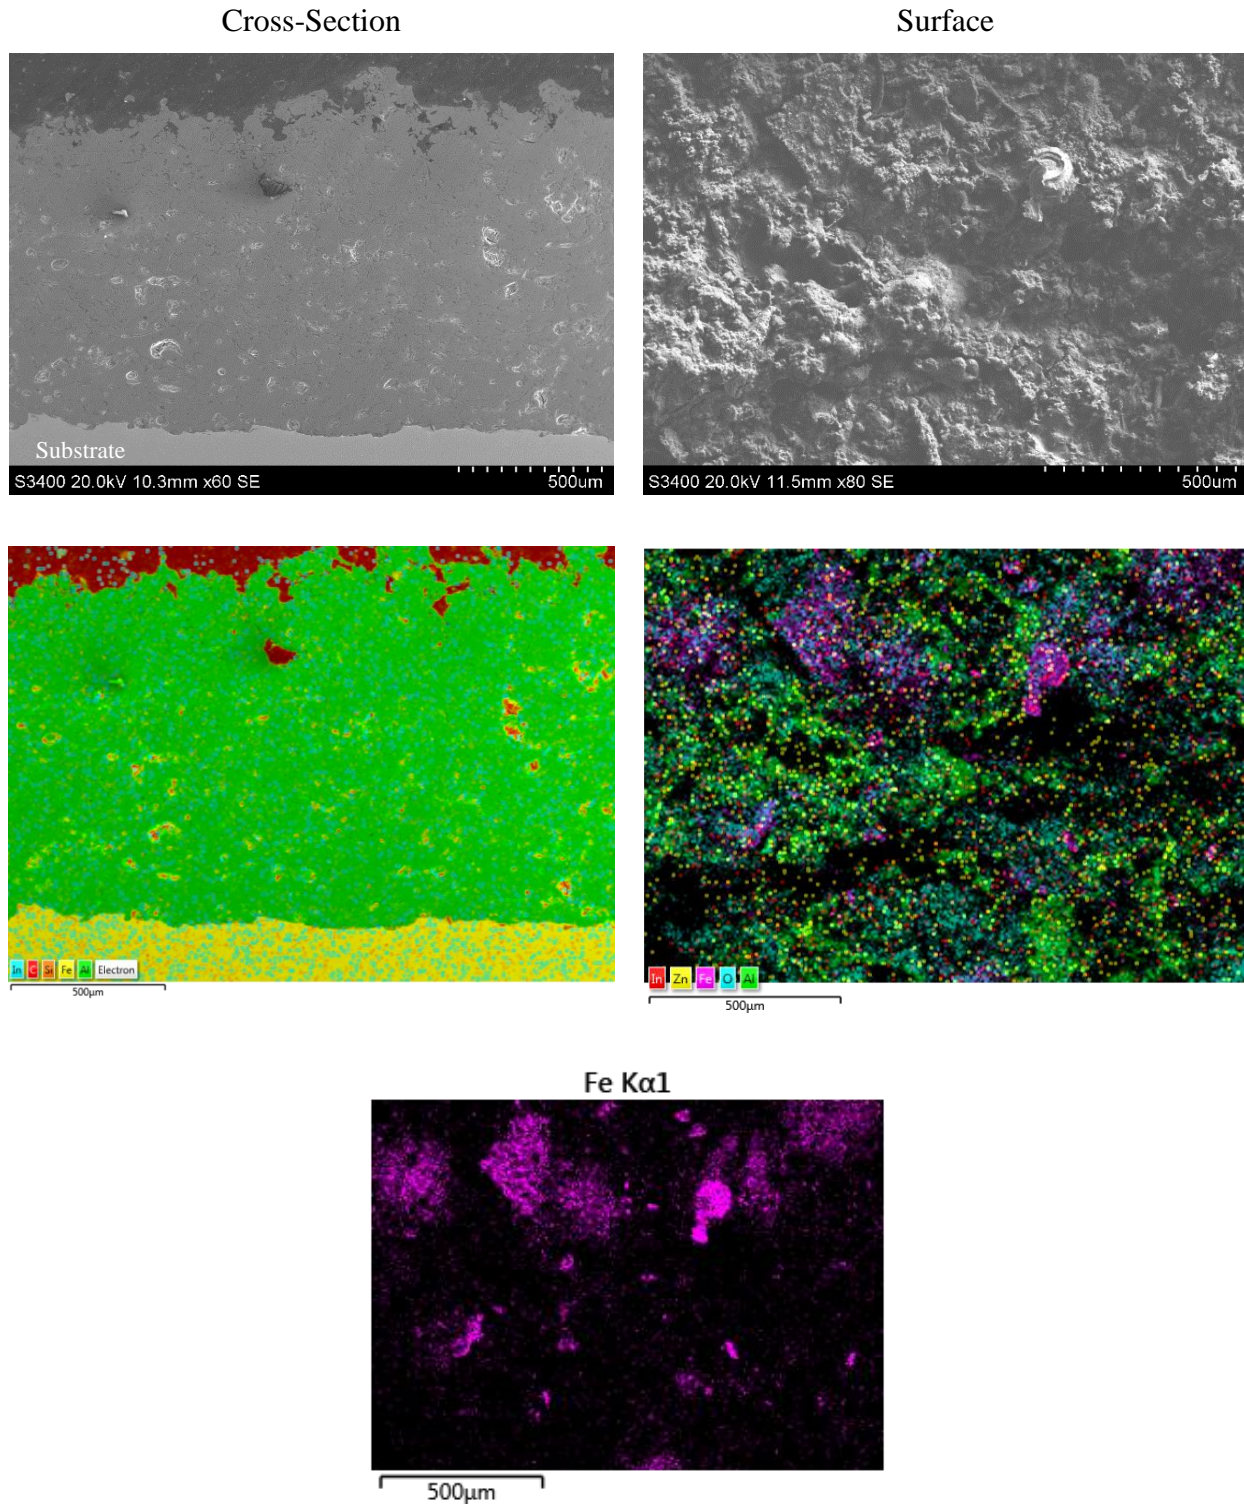
Figure 47 SEM and EDS mapping of DSA specimen exposed for 30 days, showing some iron rich areas. No degradation in coating thickness observed.

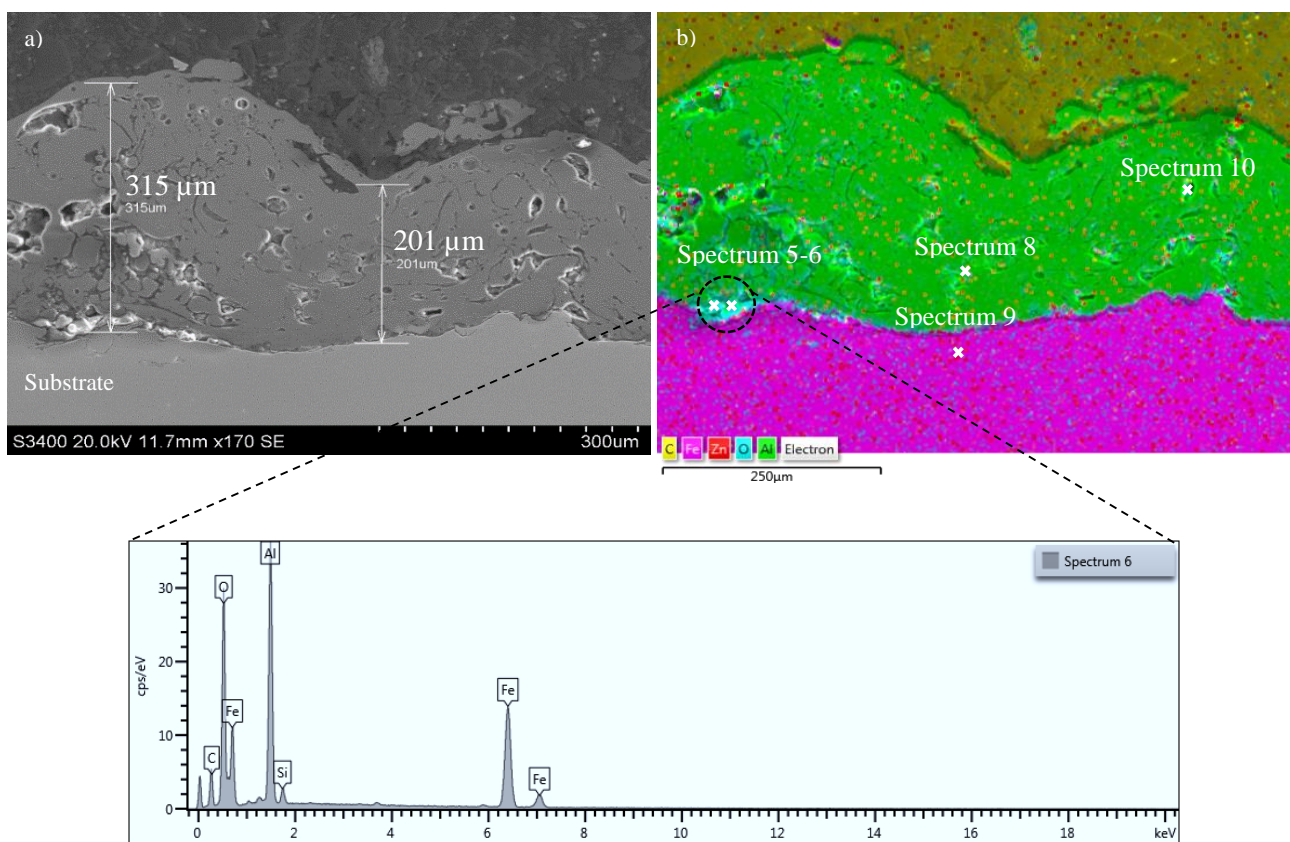
Figure 48 SEM and EDS photo of TSA (cross-section) after 30 days, freely exposed to natural seawater at $10\pm 2^\circ\text{C}$.

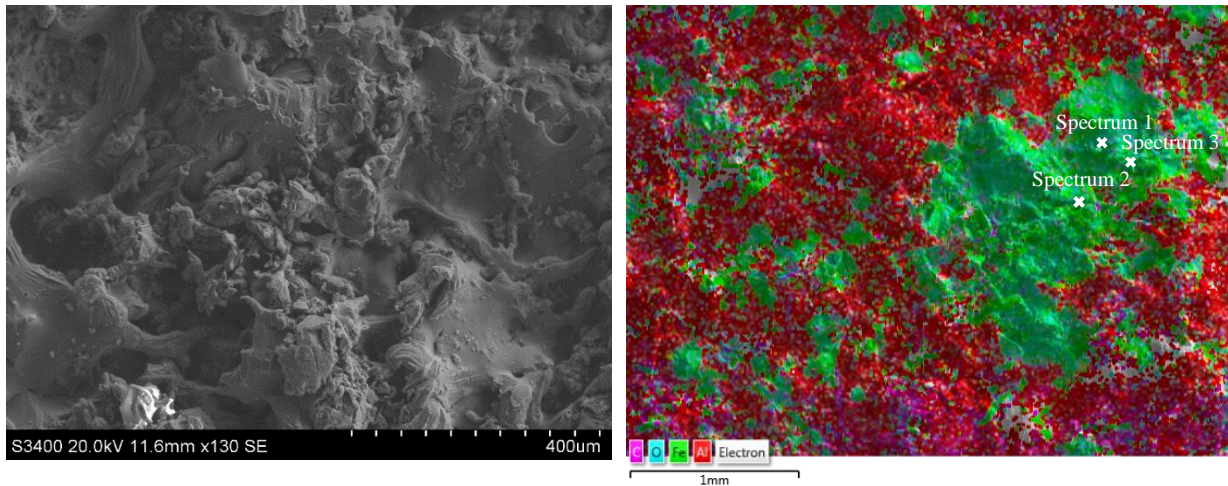
Figure 49 SEM and EDS photo of TSA (surface) after 30 days, freely exposed to natural seawater at $10\pm 2^{\circ}\text{C}$, showing major areas of iron rich contents.

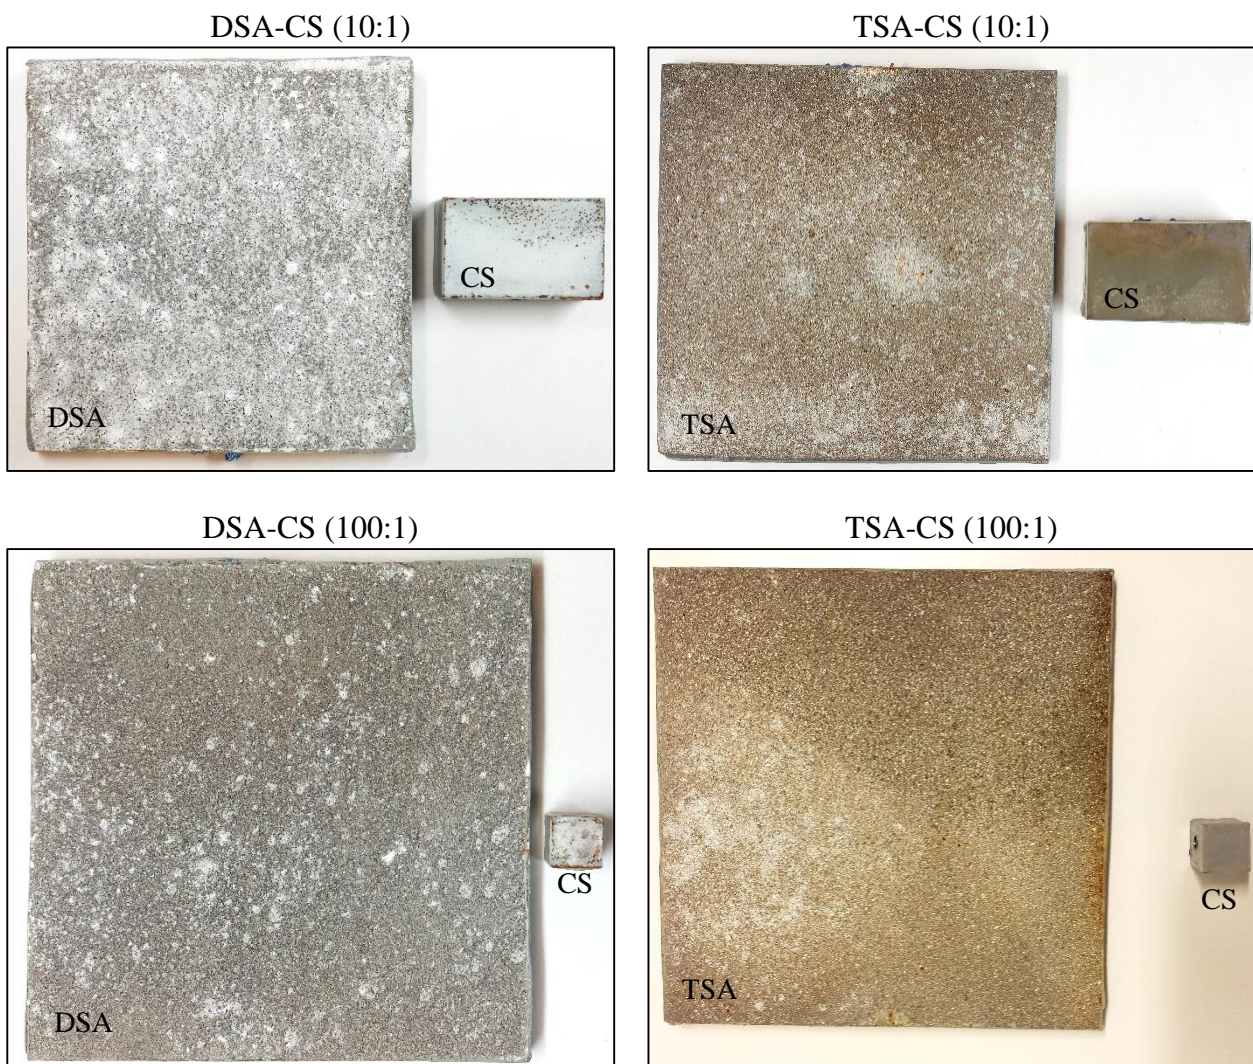
Figure 50 Pictures of galvanic couplings between thermally sprayed specimens (TSA and DSA) coupled to carbon steel with an area ratio of 10:1 and 100:1, exposed to natural seawater at 10±2°C for 30 days.

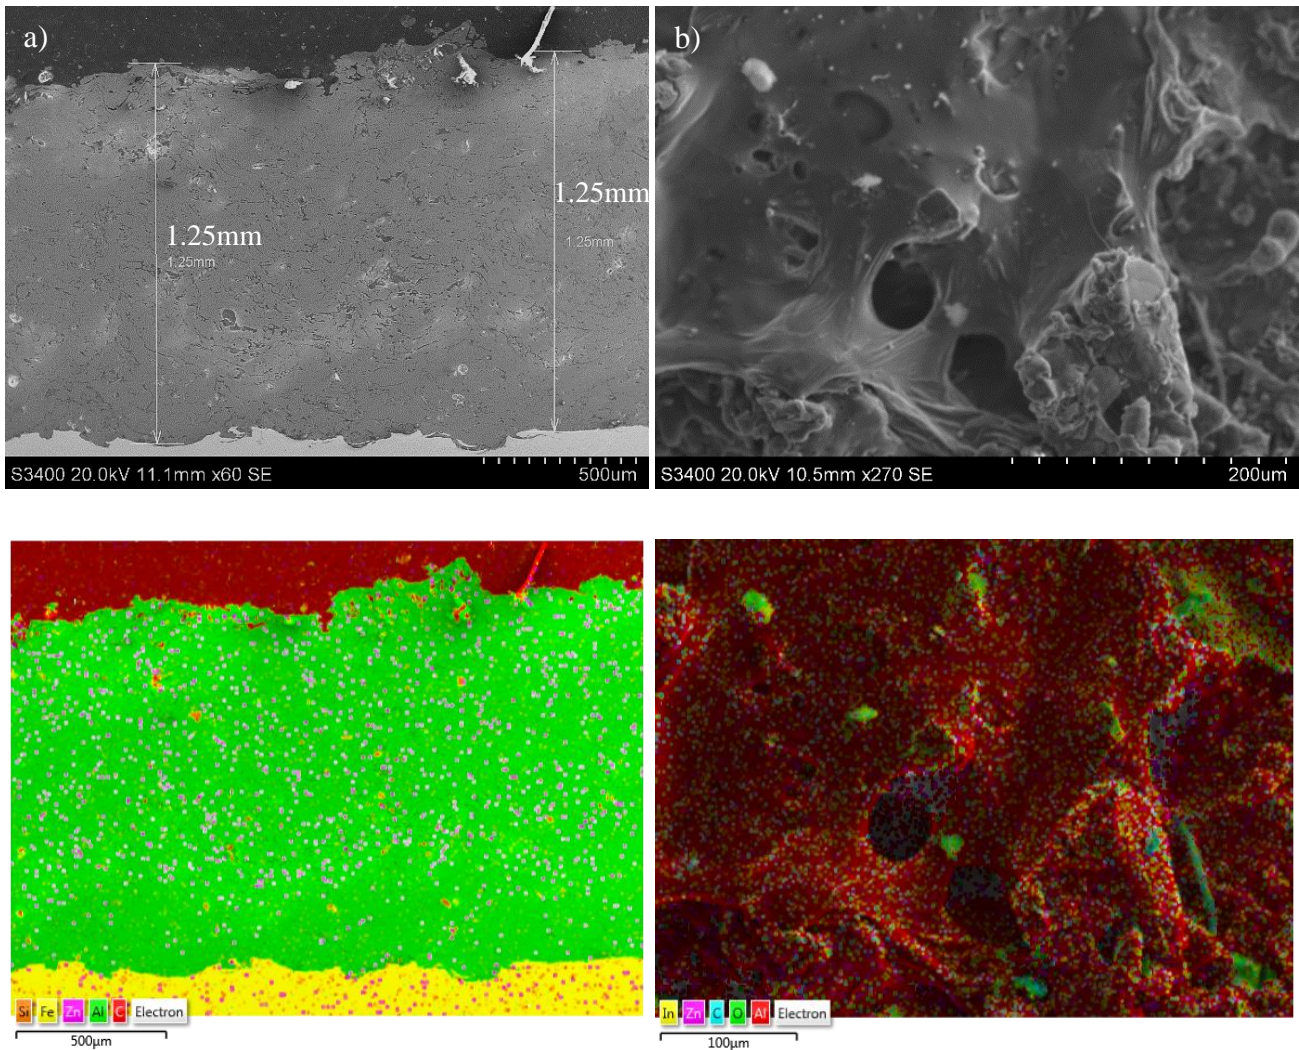
Figure 51 SEM and EDS image of DSA, a) cross-section and b) surface, coupled to CS with an area ratio of 10:1. No degradation in coating thickness can be observed after 30 days of exposure to natural seawater at $10\pm 2^\circ\text{C}$.

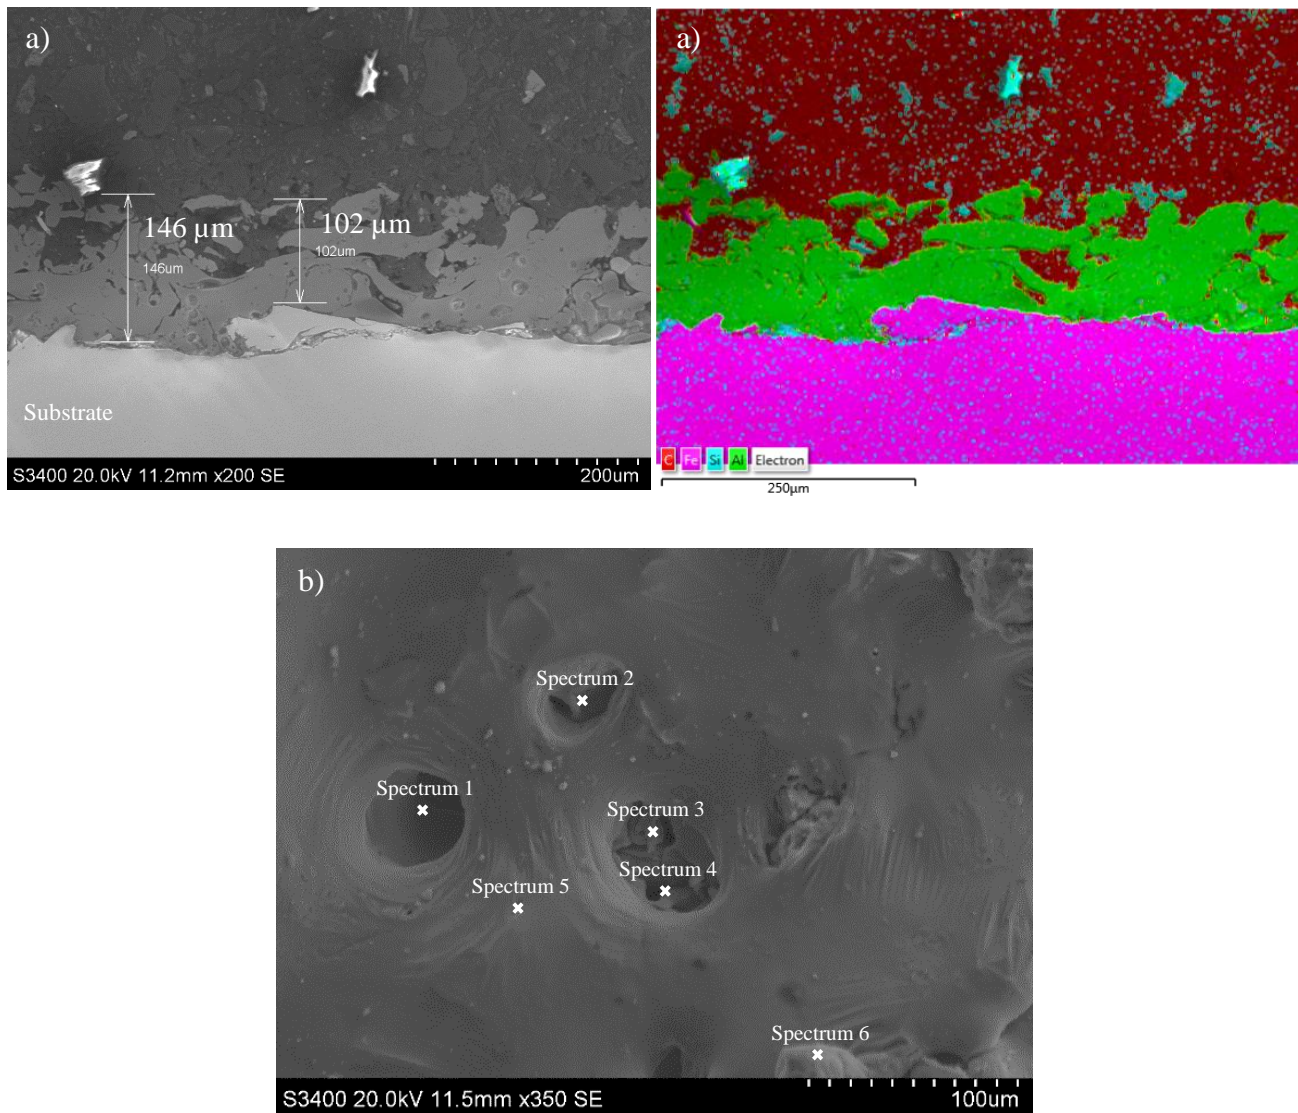
Figure 52 SEM and EDS image of TSA, a) cross-section and b) surface, coupled to CS with an area ratio of 10:1. Substantial coating degradation can be observed as well as small content of iron on some pits on the coating surface.

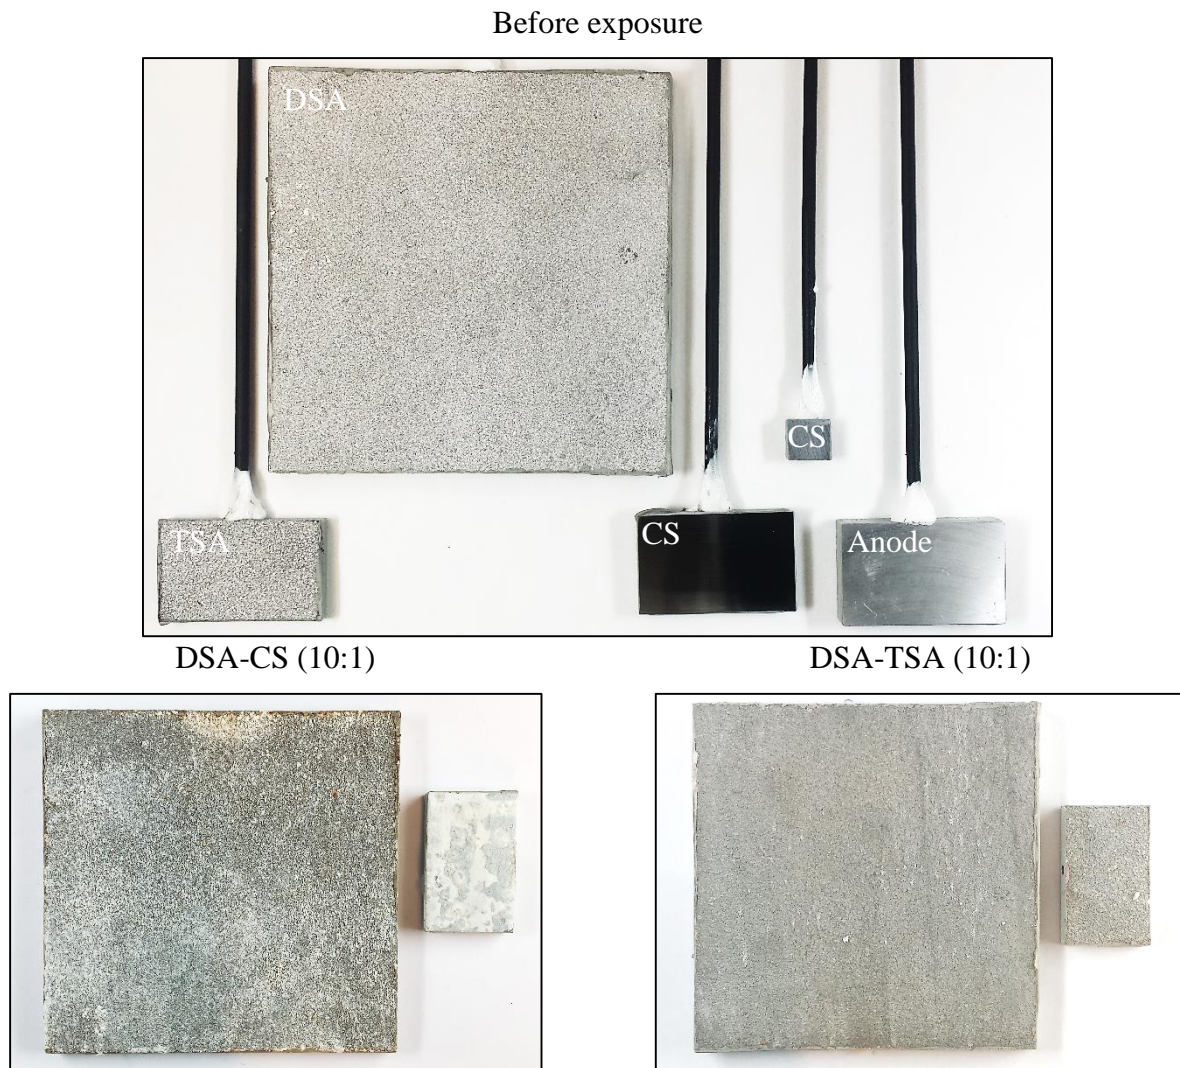
Figure 53 Images of galvanic couplings before and after exposure to natural seawater at 40°C.

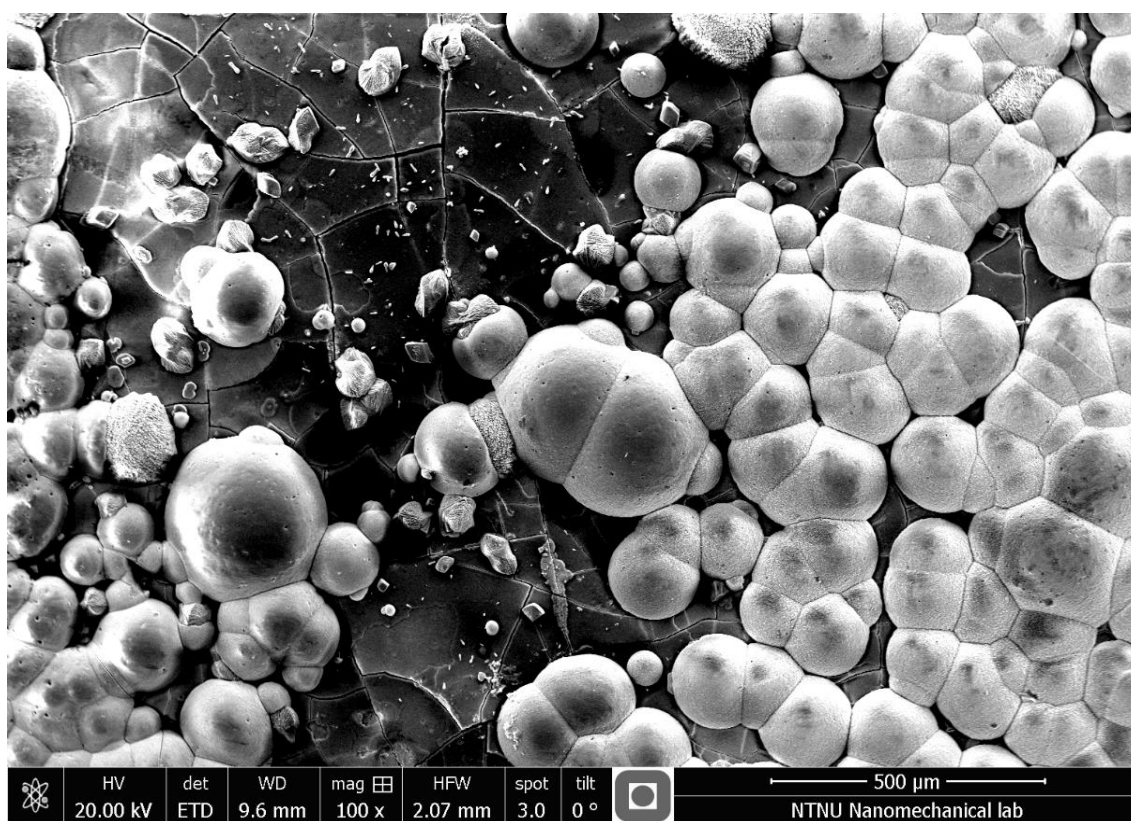
Figure 56 Calcareous deposition on carbon steel surface cathodic protected by DSA for 30 days in natural seawater at 10±°C.

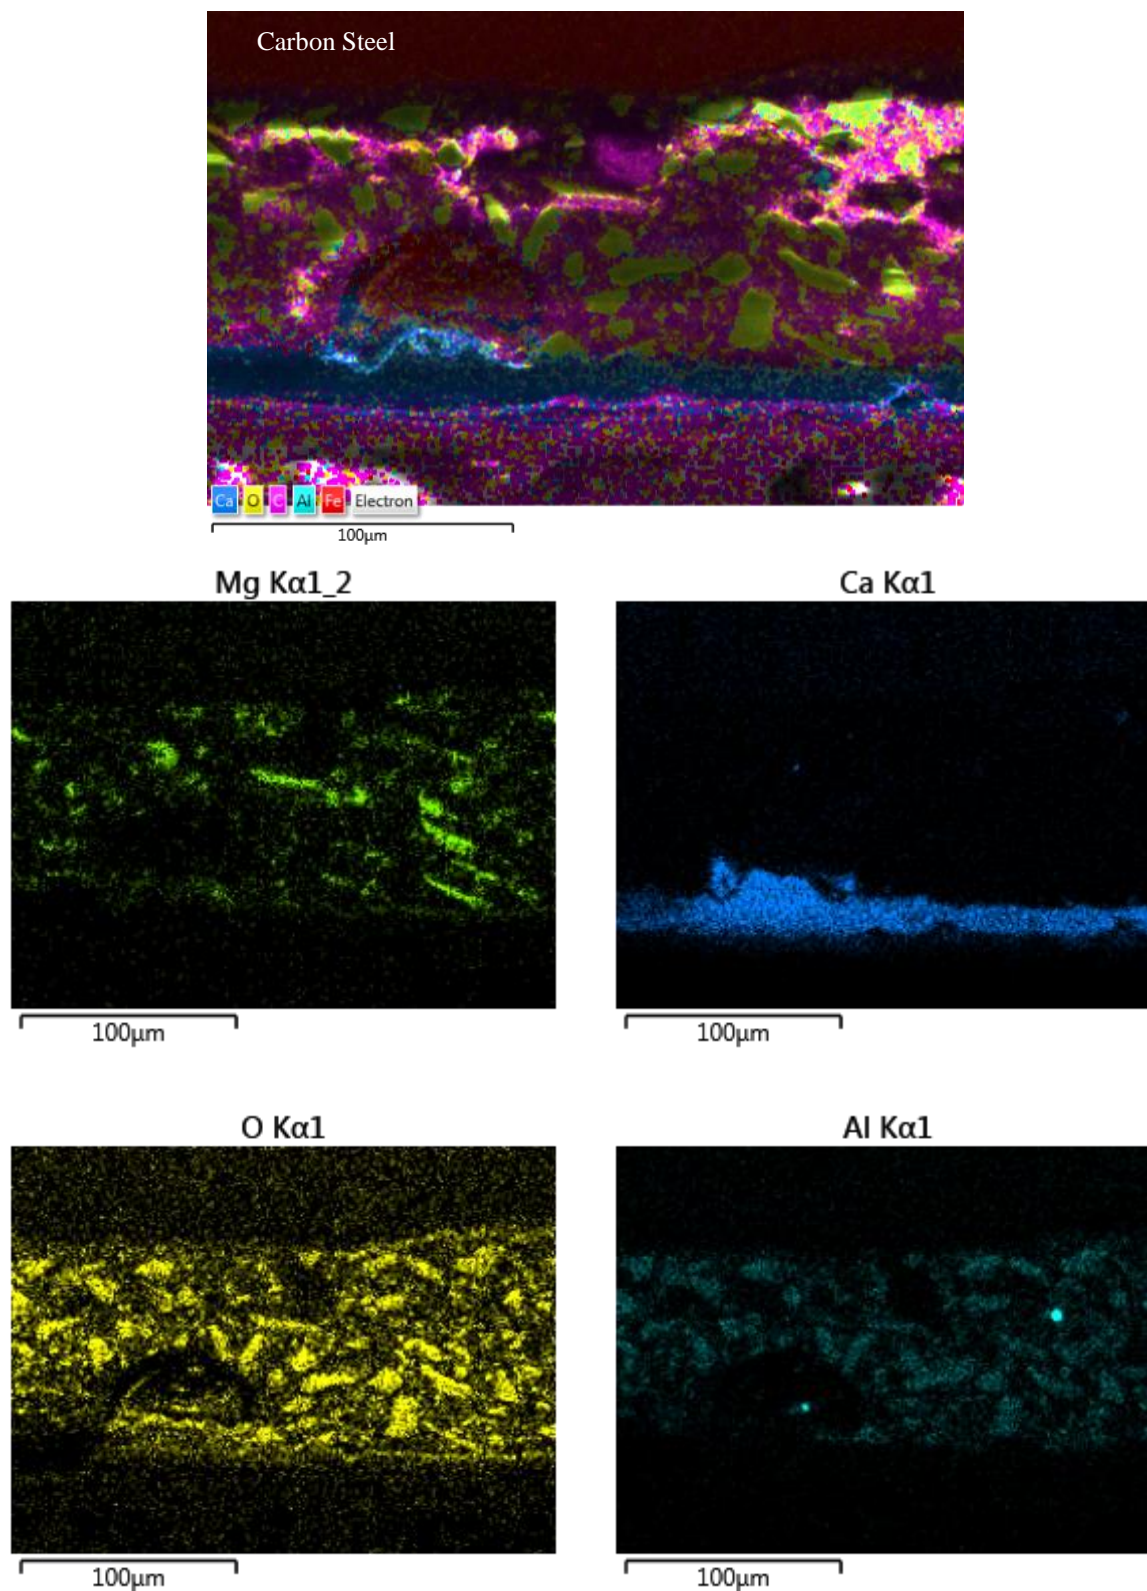
Figure 57 EDS cross-section images of calcareous deposition on carbon steel surface cathodic protected DSA for 30 days in natural seawater at $10\pm^{\circ}\text{C}$.

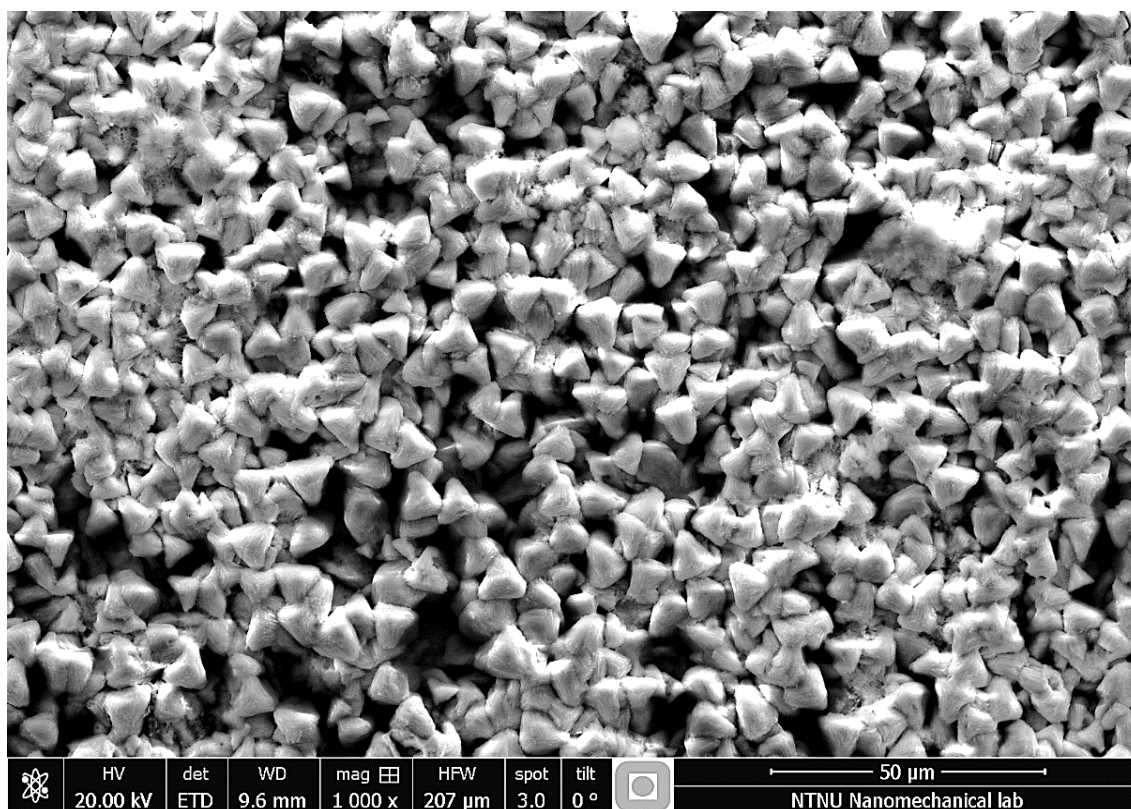
Figure 58 Calcareous deposition on carbon steel surface cathodic protected by TSA for 30 days in natural seawater at 10°C.

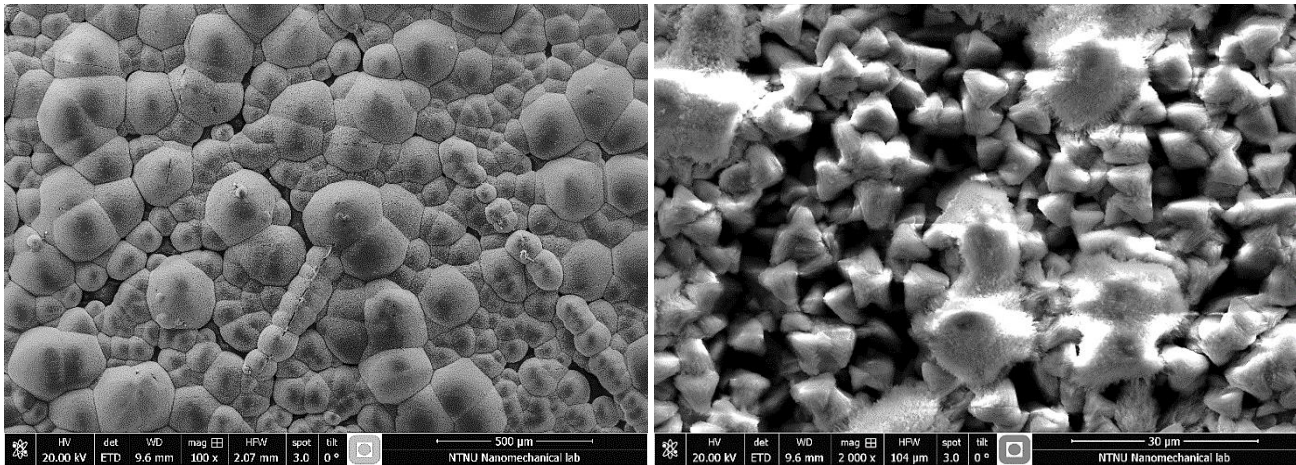
Figure 59 Calcareous deposit on CS surfaces coupled to respectively DSA and TSA for 30 days in natural seawater at 10°C.

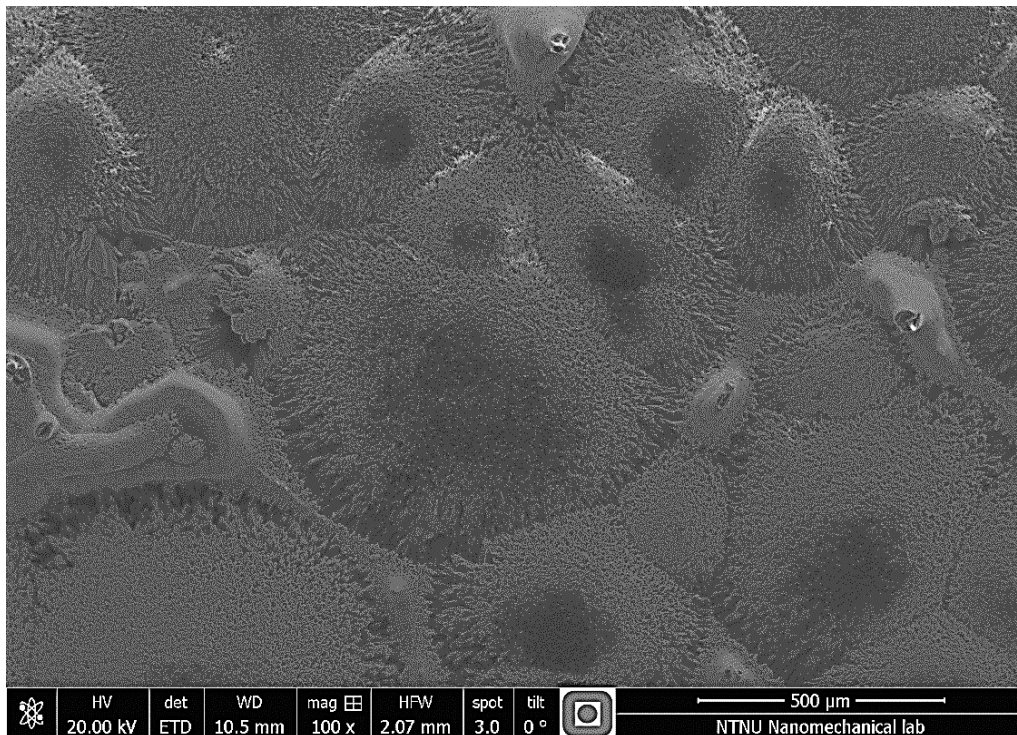
Figure 60 Calcareous deposition on carbon steel surface cathodic protected by DSA for 30 days in natural seawater at 40°C.
