Distributed Sacrificial Cathodic Protection

A New Cost Effective Solution to Prevent
Corrosion on Subsea Structures

Geir Quale

**MASTER THESIS SPRING 2016
FOR
STUD. TECHN. GEIR QUALE**

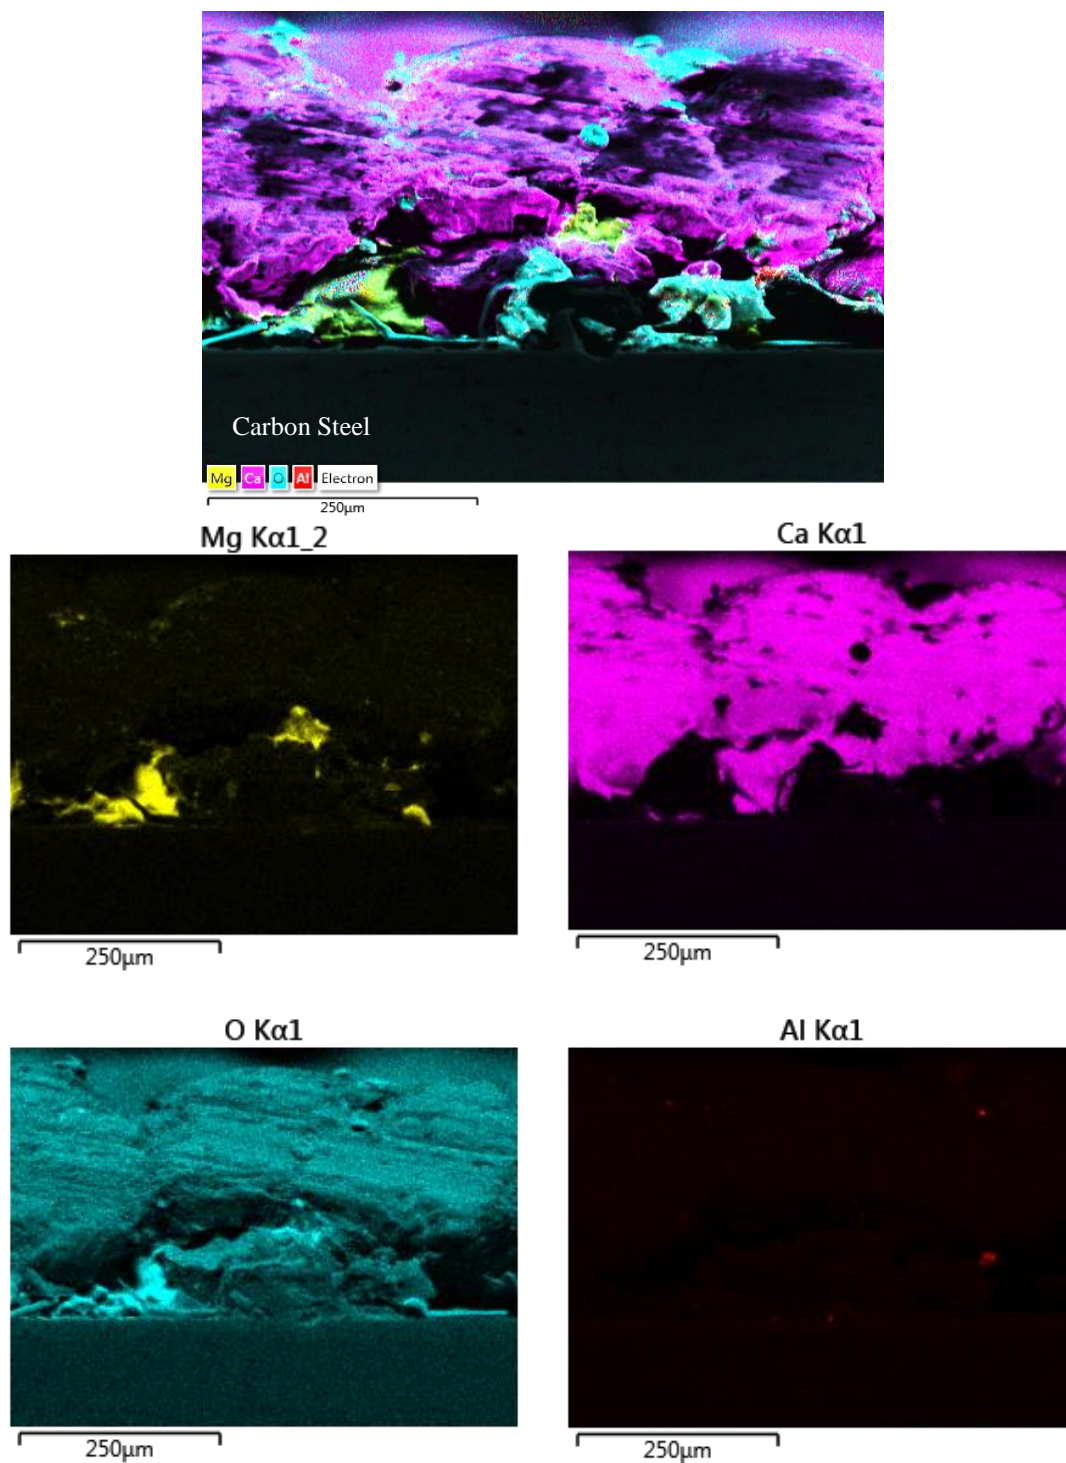
Figure 61 EDS cross-section images of calcareous deposition on carbon steel surface cathodic protected by DSA for 30 days in natural seawater at 40°C.

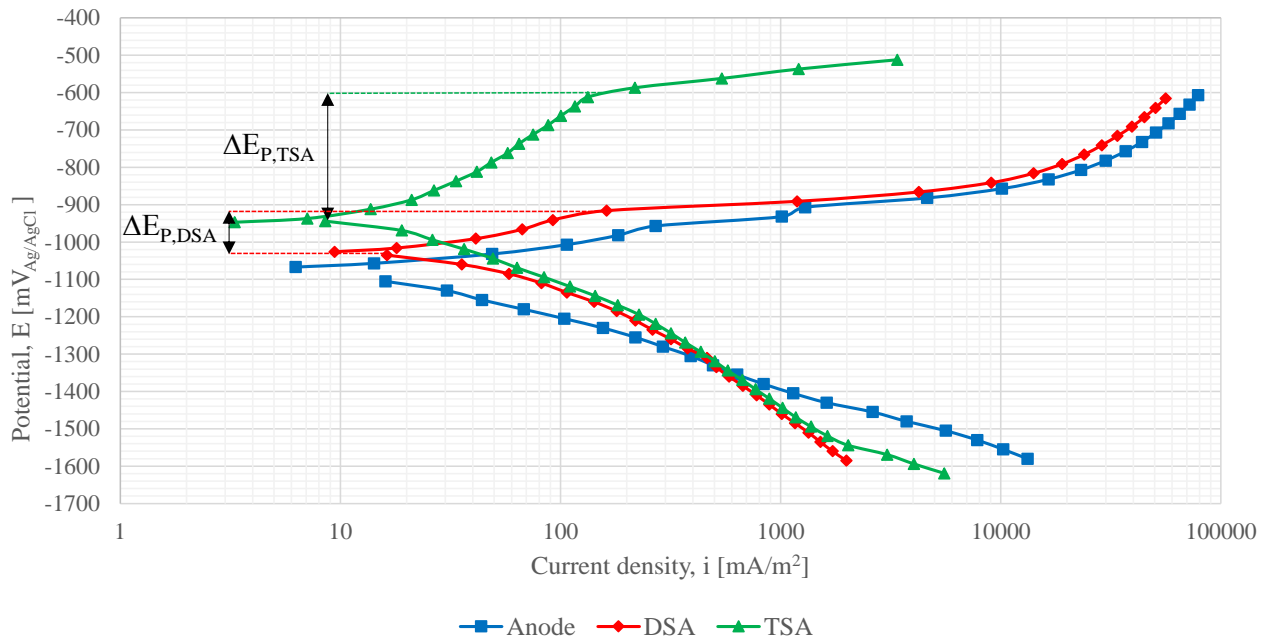
Figure 62 Polarization curves for Anode, DSA and TSA obtained after 30 days of exposure to natural seawater at $10 \pm 2^\circ\text{C}$ under nearly stagnate conditions. Increased passive region can be observed for TSA compared to DSA and Anode specimens.

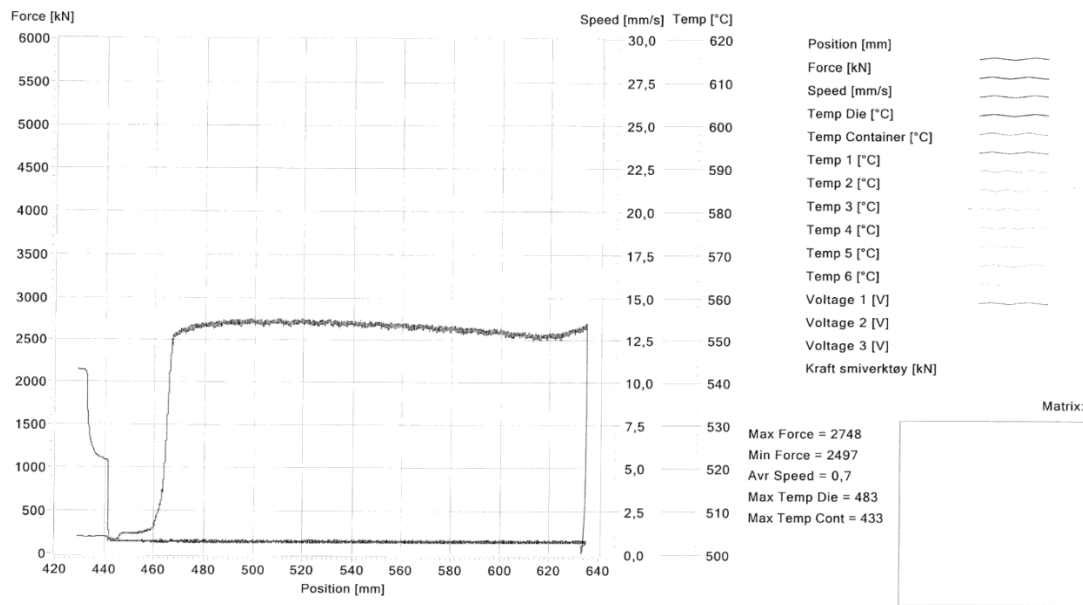
Figure B. 2 First stage of the wire extrusion process.

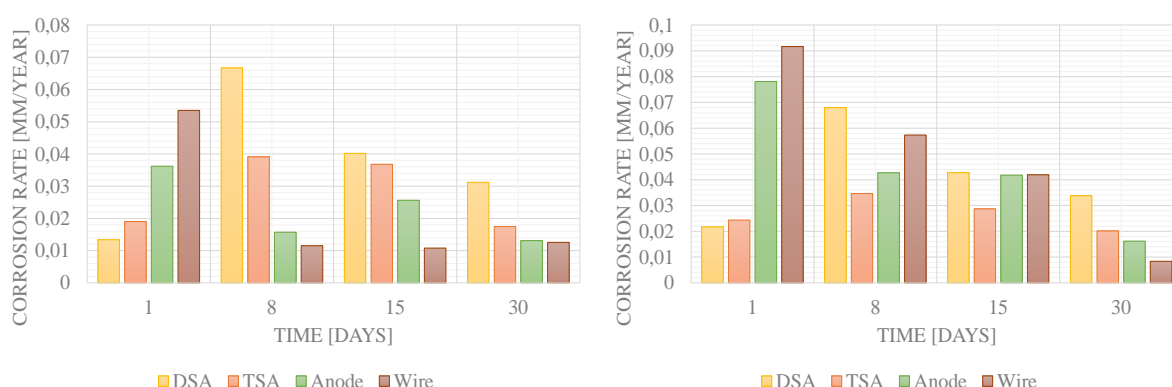
Figure C. 1 Corrosion rate calculation as a function of time, obtained by Tafel extrapolation and LPR measurement respectively.

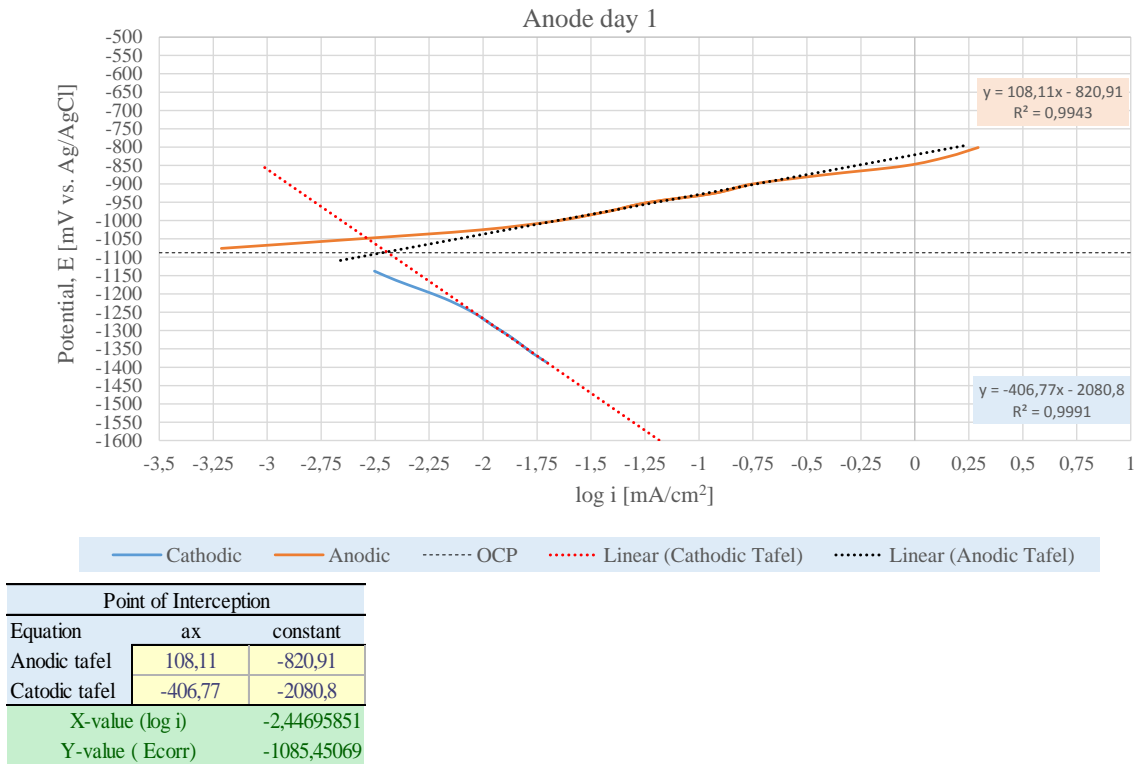
Figure C. 2 Polarization Curves of anode with calculated tafel constant, obtained day 1 in natural seawater at 10°C.

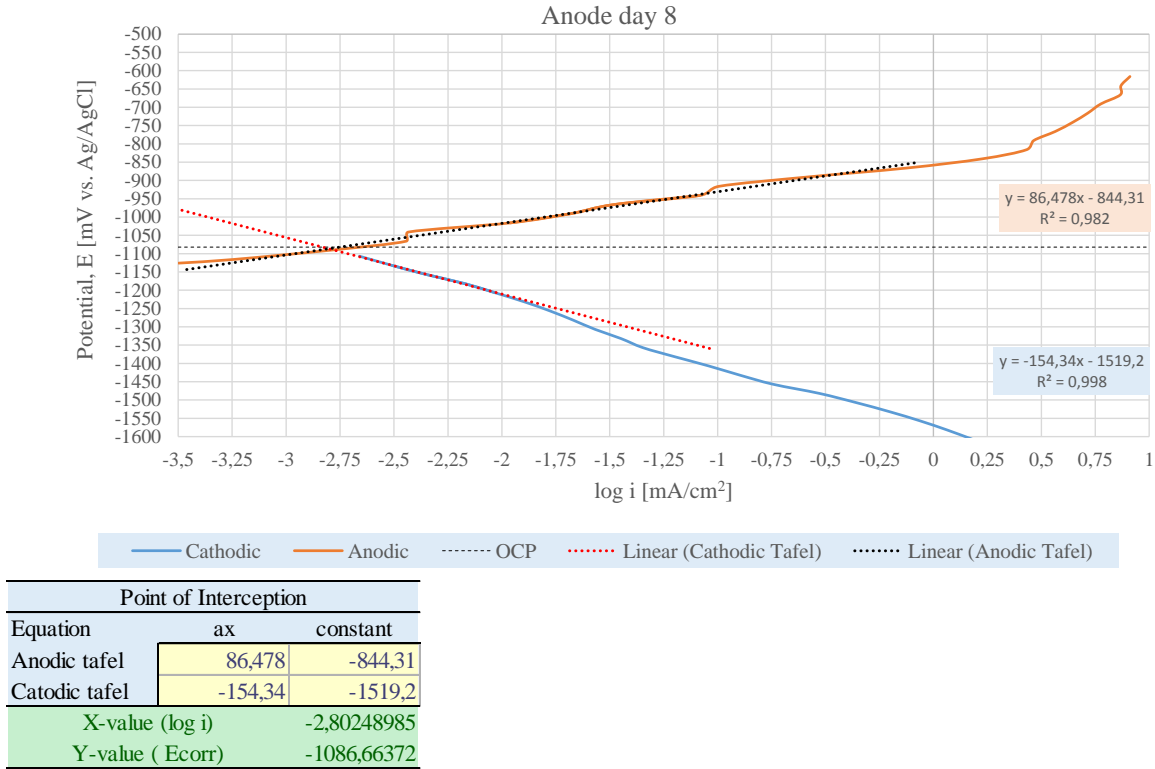
Figure C. 3 Polarization Curves of anode with calculated tafel constant, obtained day 8 in natural seawater at 10°C.

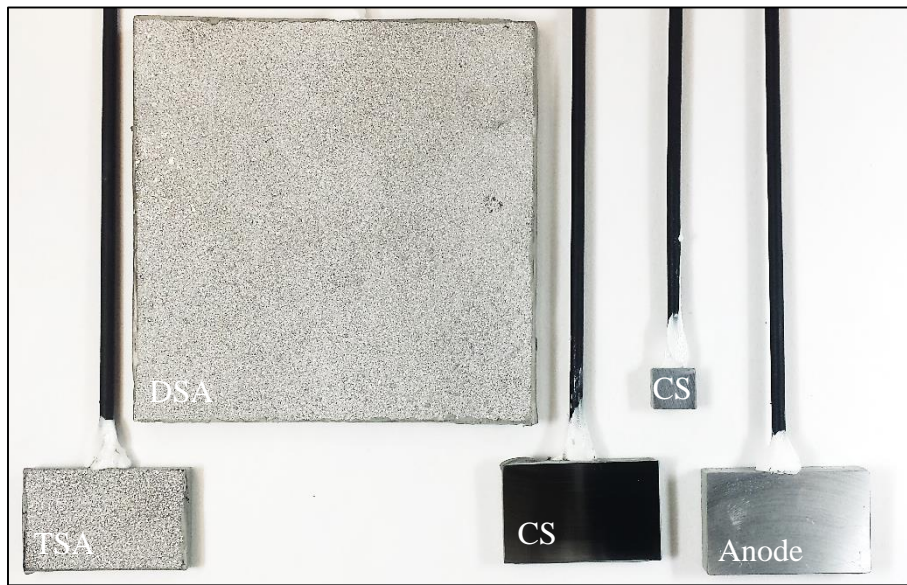
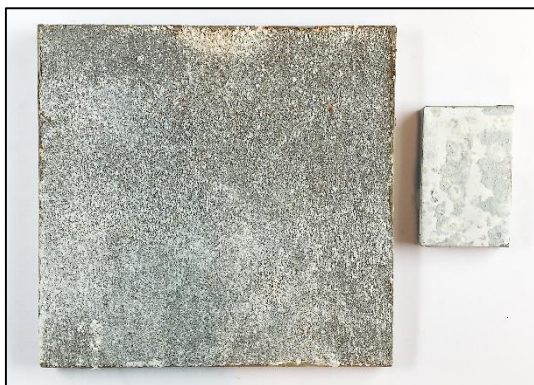
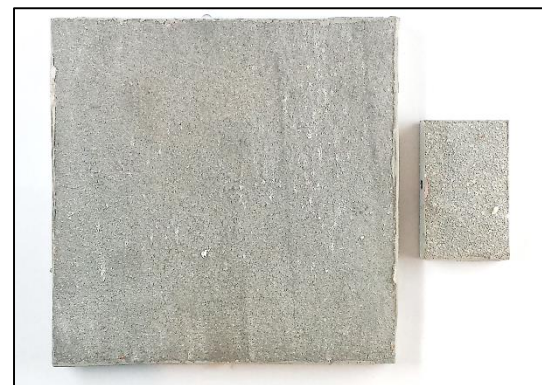
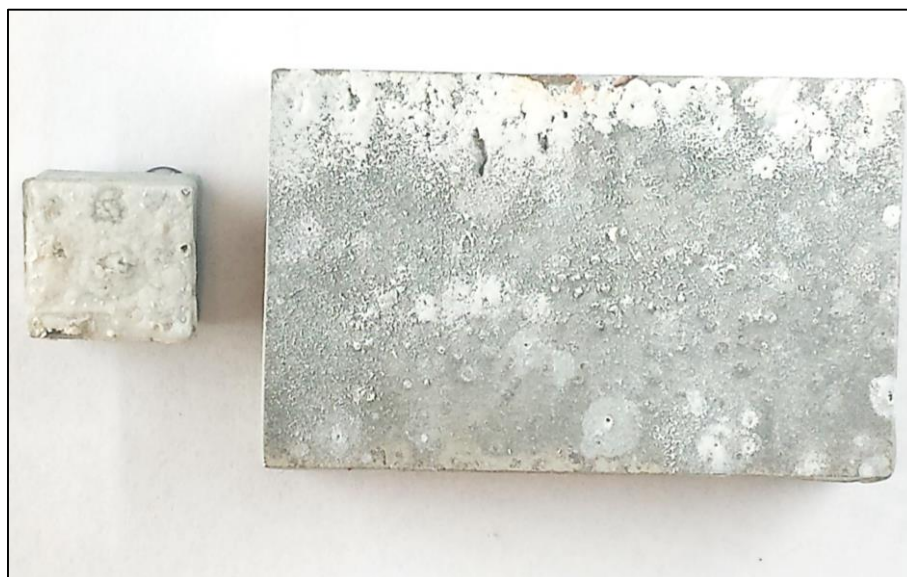
Figure D. 4 Galvanic Couplings before and after 30 days of exposure to natural seawater at $40 \pm 5^\circ\text{C}$

Photos of galvanic couplings after 30 days exposure at $40 \pm 10^\circ\text{C}$.
